**DISPUTE CONCERNING
CERTAIN ACTIVITIES CARRIED OUT BY NICARAGUA
IN THE BORDER AREA
(COSTA RICA V. NICARAGUA)**

**COUNTER - MEMORIAL
OF THE REPUBLIC OF NICARAGUA**

**VOLUME IV
(ANNEXES FROM 112 TO 142)**

Technical Report
Environmental Impact Assessment on “Construction of 120 km road on
the San Juan de Nicaragua River’s right bank”

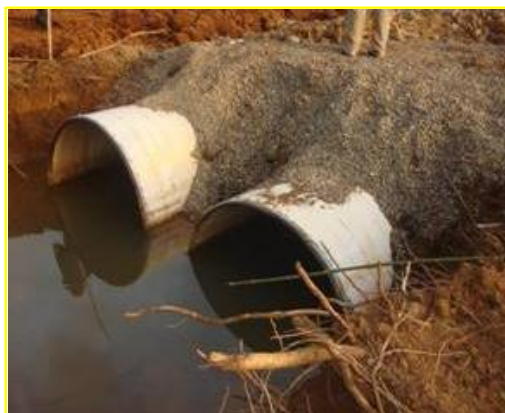
Figure 10: Culverts located on Nicaraguan territory

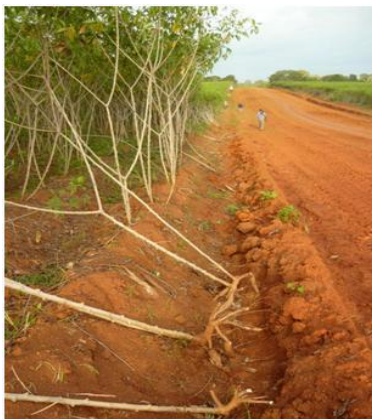
Figure 11: Crop damages

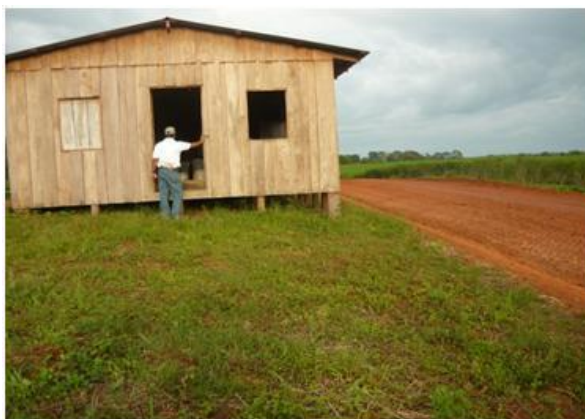
Figure 12: Dwelling at edge of road slope

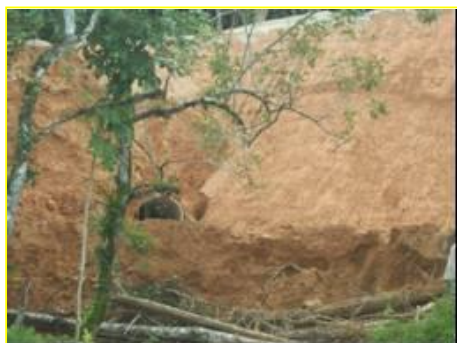
Figure 13: Culvert with a smaller diameter than recommended

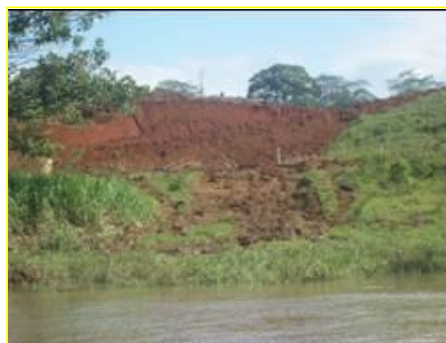
Figure 14: Cross-section of inadequately sloped embankment

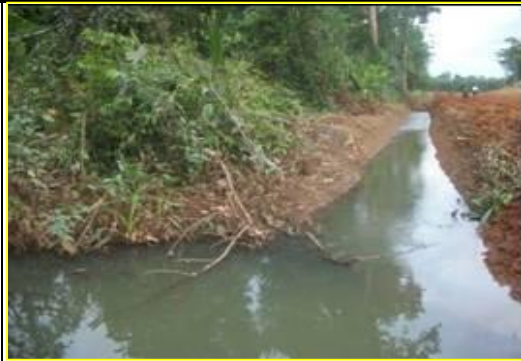
<p>Figure 15: Soil being washed off by surface runoff</p>	<p>Figure 16: Man-made drainage canal altering hydrological regime</p>

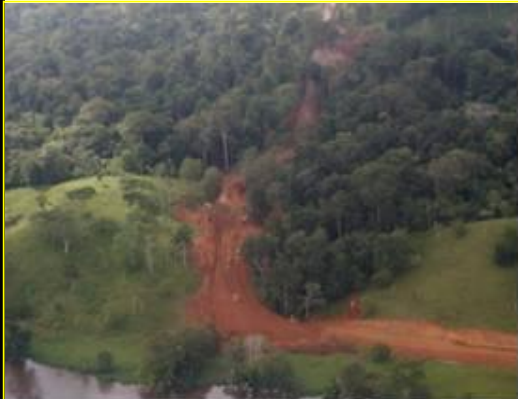
<p>Figure 31: Critical point owing to risk of substances spilling over the San Juan River</p>	<p>Figure 32: Critical point owing to risk of affecting San Juan River flow rate</p>

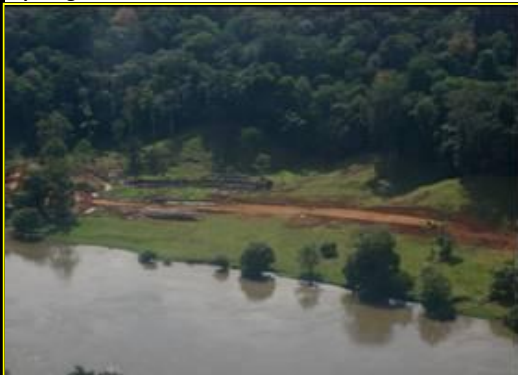
<p>Figure 33: Critical point owing to risk of road flooding along the San Juan River</p>	<p>Figure 34: Critical point due to severe geomorphological damage in a geologically unstable area</p>

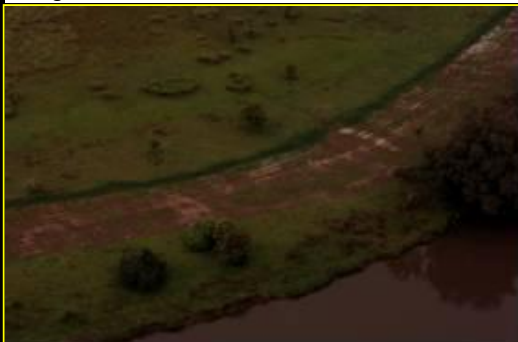
<p>Figure 35: Critical point due to potential road flooding along the San Juan River</p>	<p>Figure 36: Critical point due to geological instability</p>

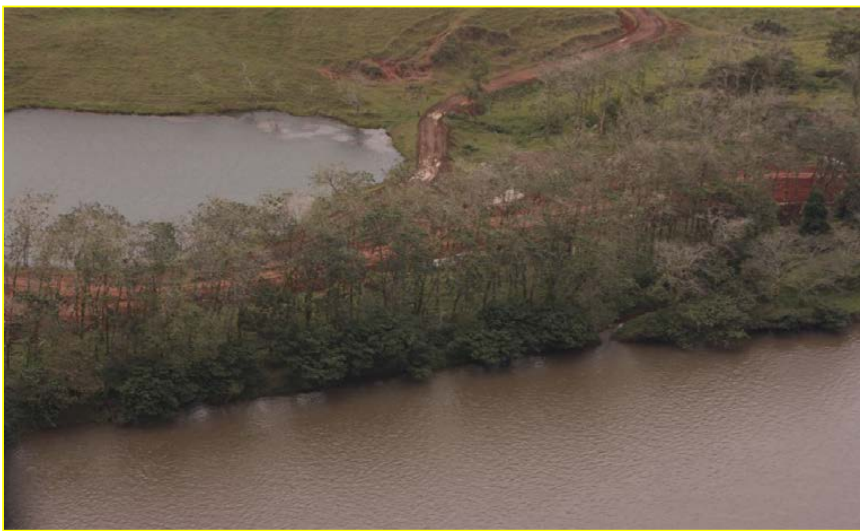
Figure 51: Barrier effect caused by road between wetlands and the San Juan River

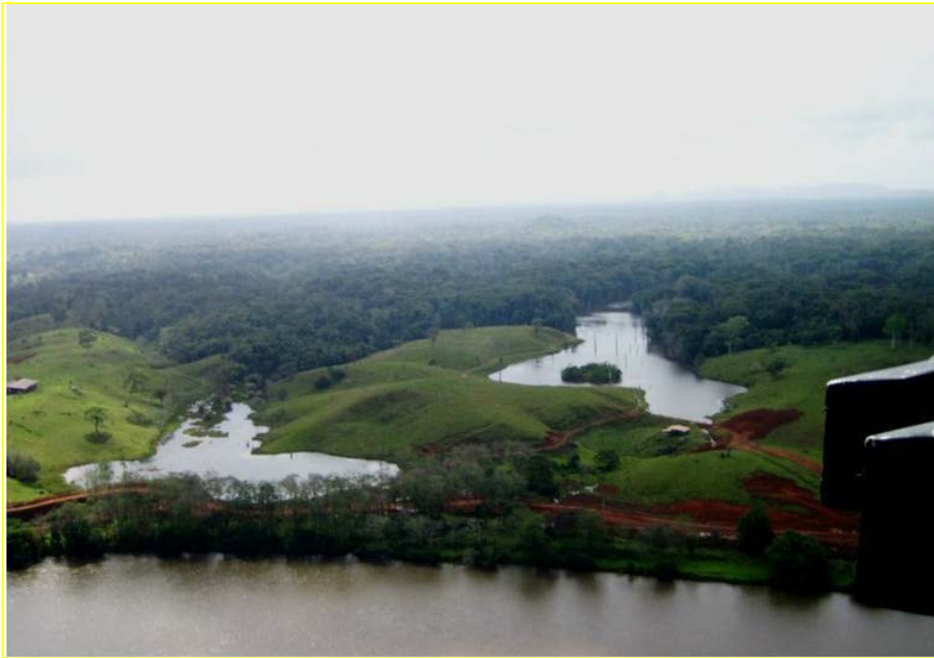
Figure 52: Wildlife species home range disturbances

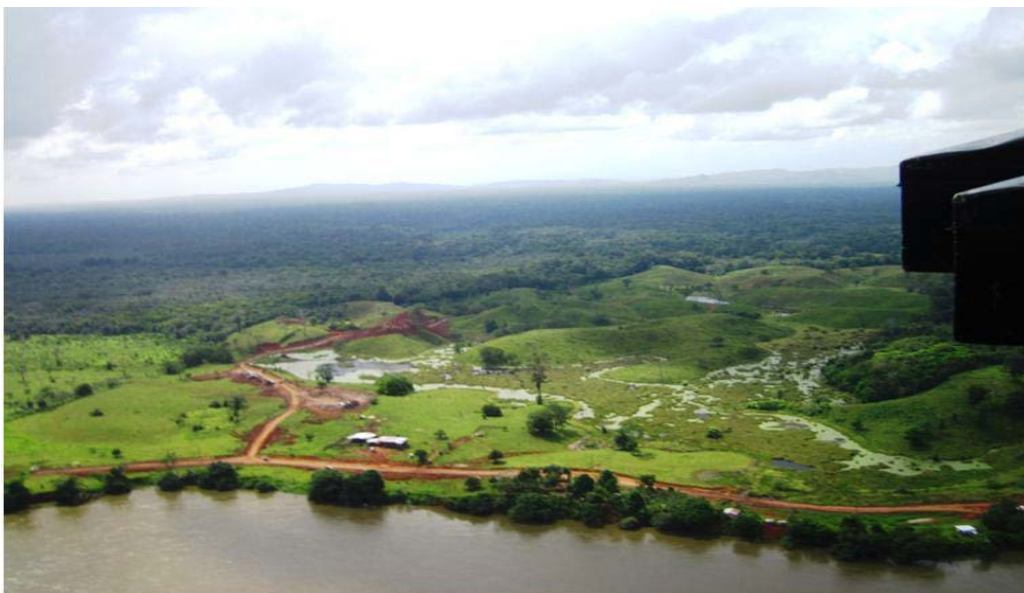
Figure 53: Plant and wildlife destruction caused by road construction

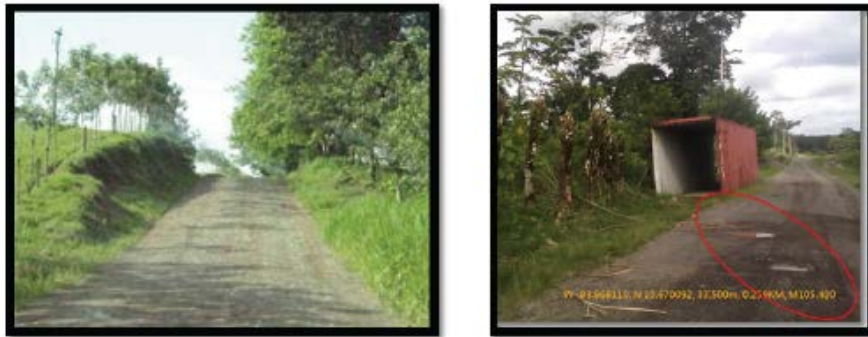
F1. The roads have no drainage ditches, cleared areas in this stretch have no bluff.

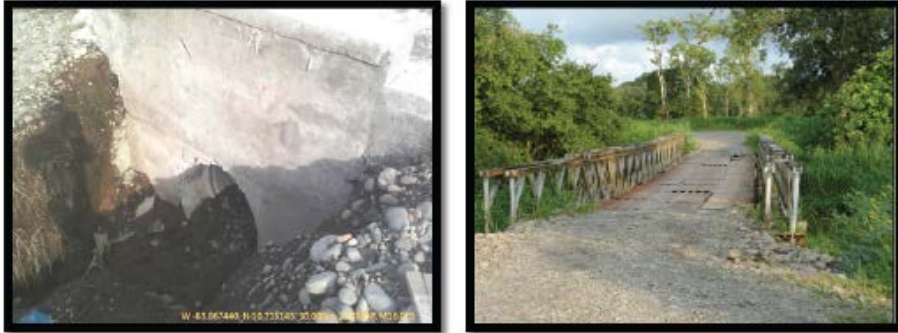
F3. A PVC drainage is obstructed by movement of *finos* of the base layer.

F4. The Bailey bridge is in a state of advanced deterioration, with loose planks.

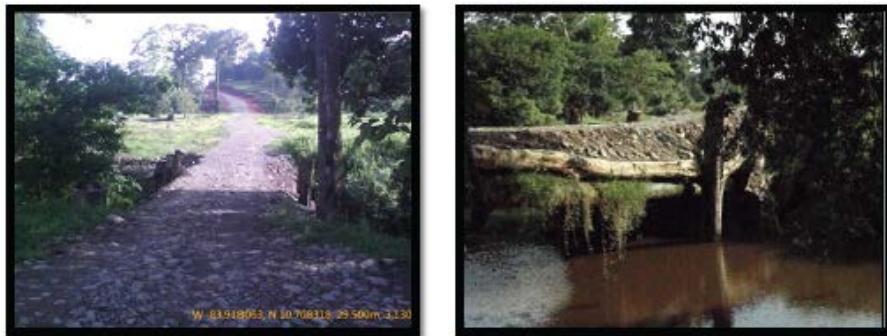
F5. Bridge with a base built from wooden logs.

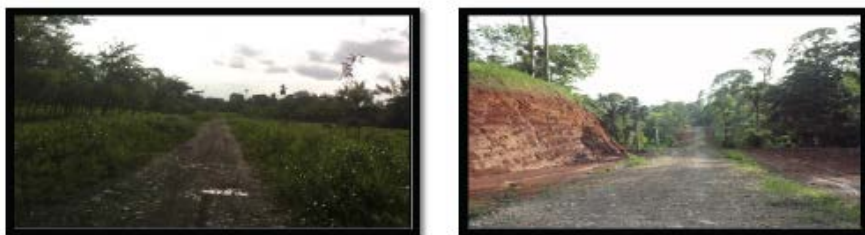
F6. The route has no drainage, there are cracks and holes, and areas where there are oversized boulders not apt for roads.

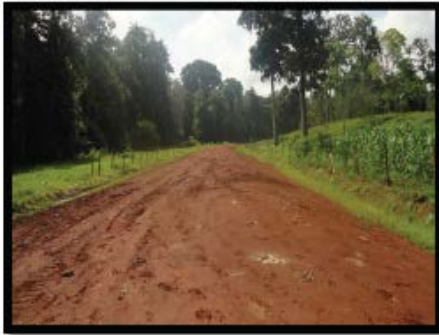
F11. Paths with compacted earth.

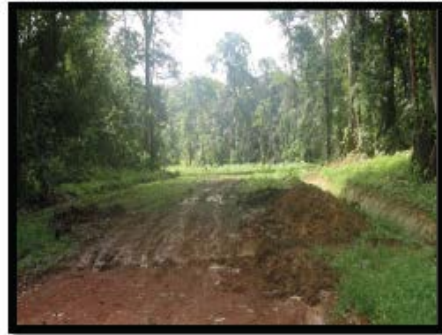
F12. Dirt roads where water has accumulated making transit impossible. Impact on the forest can be observed.

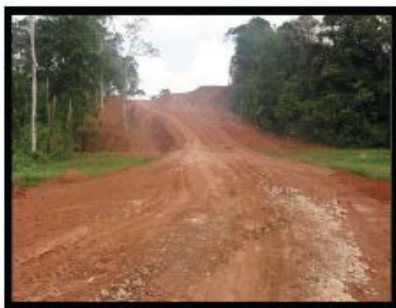
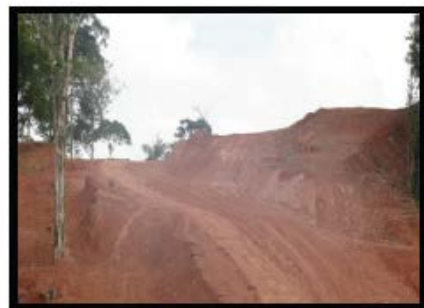
F14. A dirt road with no drainage; as it was not based on plans, disorganized cuts and fills were carried out.

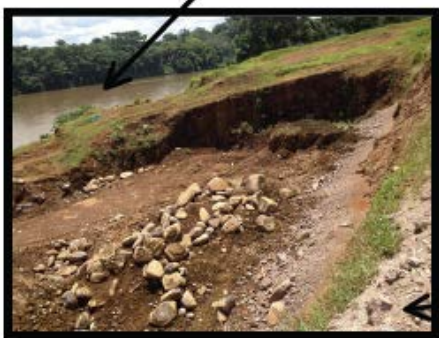
F19. Materials used are only meters away from the Río San Juan; very big boulders can be observed as well as piles of broken boulders. Here, what is apparently a trench is located between the Río San Juan and the road, several meters from the river. These situations should be evaluated.

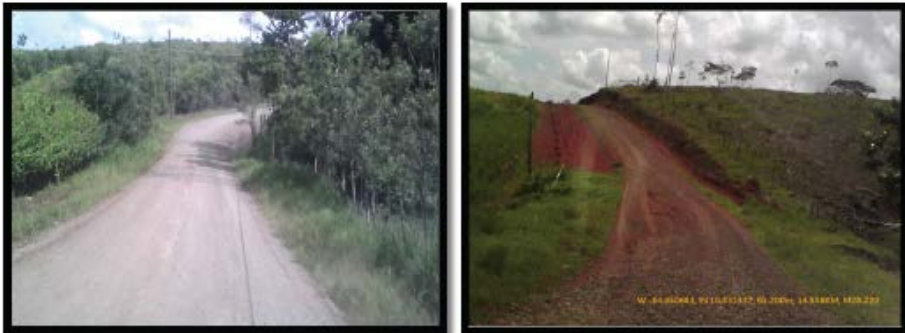
F20. Lack of maintenance to the drainage canals.

F21. One of the areas with cracks and holes, besides very elevated longitudinal slopes.

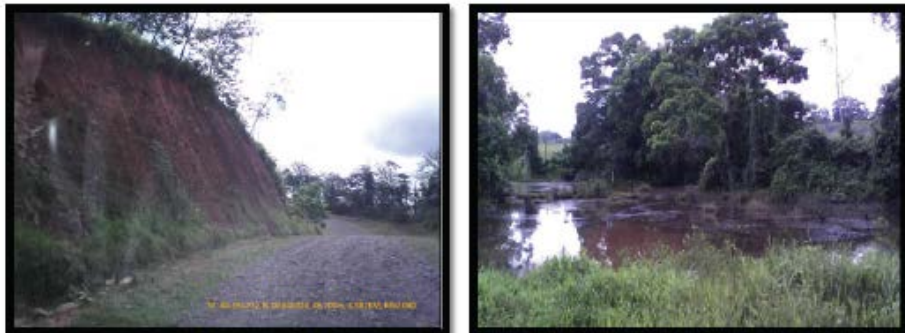
F22. Slope approximately six meters in height with an almost vertical slope.

F23. Possible impact to wetlands.

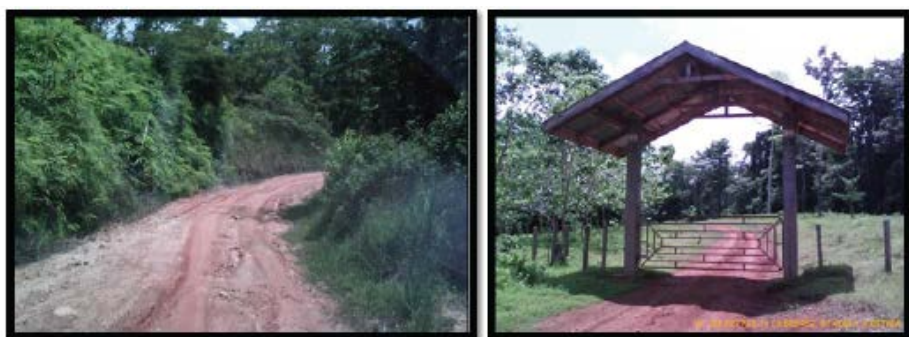
F24. Areas with cracks and holes and no drainage.

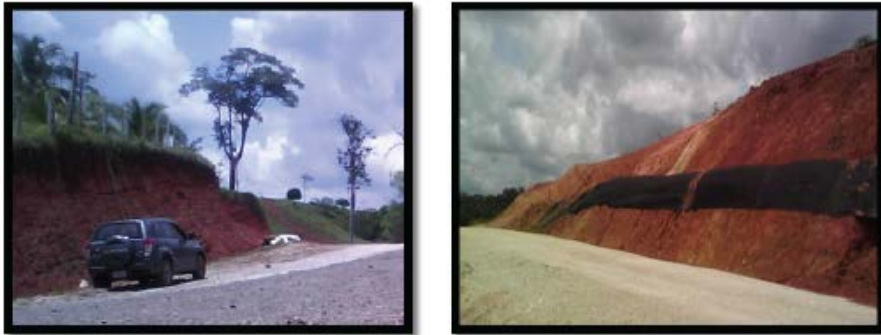
F27. There are huge slopes with high peaks in this area and no protection whatsoever.
