**DISPUTE CONCERNING THE CONSTRUCTION OF A ROAD IN
COSTA RICA ALONG THE SAN JUAN RIVER**

REJOINDER OF COSTA RICA

VOLUME III

ANNEXES 4 - 14

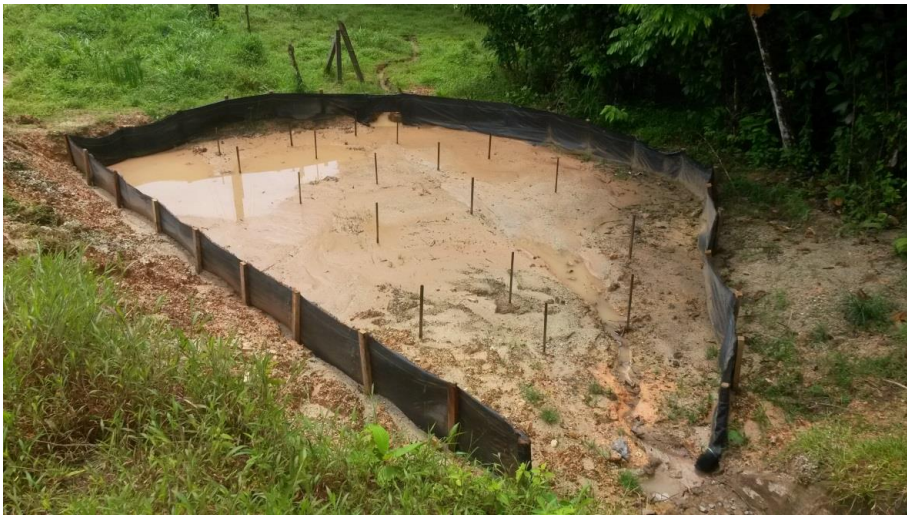
As mentioned in the 2013 report, during the final visit on September 21 Sediment trap #2, numbered as Site 5 in Figure 1, was observed to be full. This impeded continued measurements in the same sediment trap as the area the trap was too large to remove the sediment by hand. The opportunity of cleaning the trap with machinery presented itself when maintenance and mitigation works resumed in Route 1856.

Figure 10. Sediment trap #2 on October 1, 2014.

During August, 2014 a back-hoe excavator was used to remove the sediment accumulated in Sediment trap #2. This process required the replacement of the silt fence which formed the sides of the trap. Iron L-beam sections 1 m in length were also driven into the sediment trap and the length of each beam left unburied was recorded. Finally, the precise location of each boundary post and L-beam was recorded using a topographic total station. Figure 10 illustrates the sediment trap and the placement of L-beams within it.

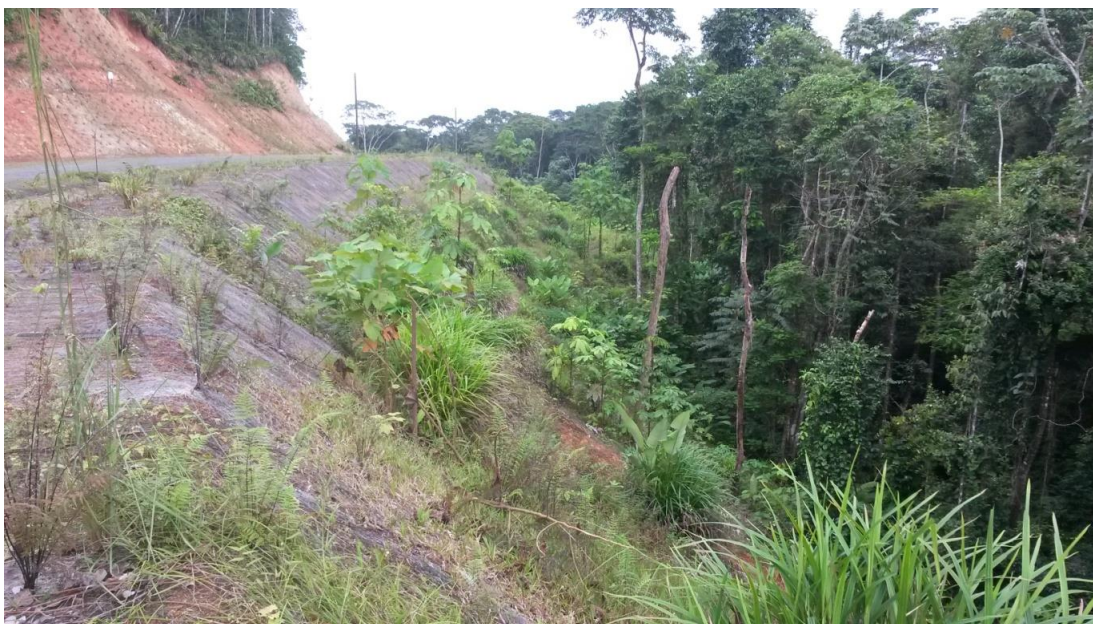
Again Kondolf refers to features observed in an October 2012 image of the site. Figure 13 shows the riverside edge of the road as observed in August 2014, it clearly shows mitigation efforts and re-vegetation of this slope. There is no evidence of landslide scarps of erosion into the road. This case shows how Dr. Kondolf has used outdated images of Route 1856 to comment on the state of the road, leading on occasion to demonstrably false statements such as the ones he has made in relation to Site 4 and the adjacent slopes.

Figure 13. Landside edge of Route 1856, August 19, 2014.
