**APPLICATION OF THE INTERNATIONAL CONVENTION FOR THE SUPPRESSION
OF THE FINANCING OF TERRORISM AND OF THE INTERNATIONAL
CONVENTION ON THE ELIMINATION OF ALL FORMS OF RACIAL
DISCRIMINATION**

REJOINDER

Report of JSC Air and Space Defense Corporation "Almaz-Antey" on the results of studies related to the technical investigation into the crash of the Malaysian airlines Boeing 777-200 9M-MRD (flight MH17), 2023

on the results of studies related to the technical investigation into the crash
of the Malaysian airlines Boeing 777-200 9M-MRD (flight MH17)

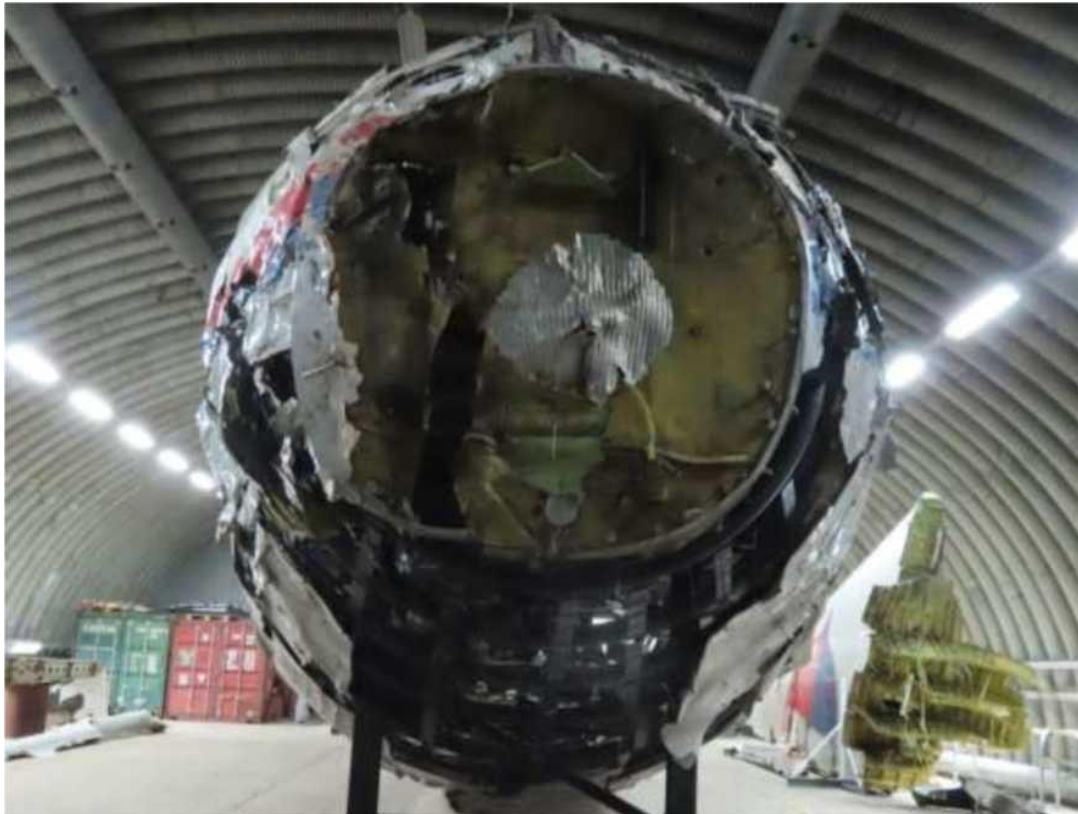
Among the damaged parts that are important for determining a possible missile launch area, the forward pressure bulkhead shown in Figure 5.1.6 is of particular importance.

No through-and-through holes were found on its surface that could be identified as being caused by projectiles.

According to DSB experts, the forward pressure bulkhead (STA 132.5) is the objective forward boundary of the damage area where damage is caused by high-

Figure 5.1.6 - Forward pressure bulkhead has no traces of fragmentation damage

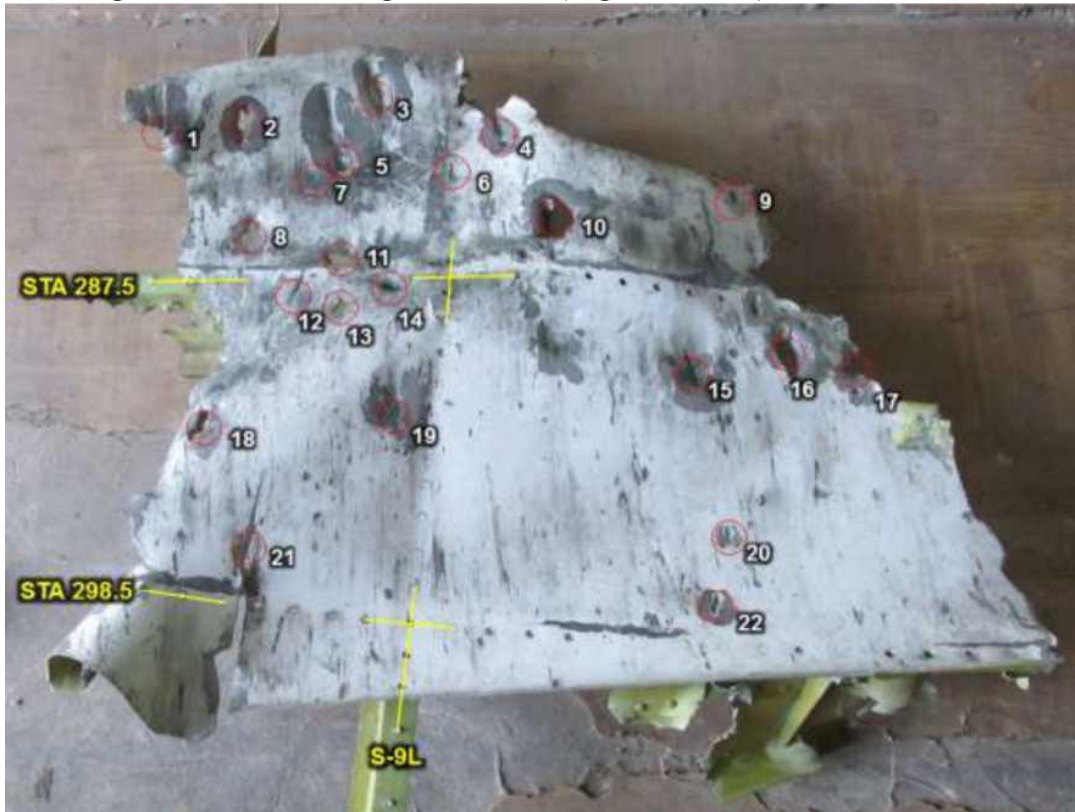
Figure 5.1.28 - Exterior view of the upper port hull fragment with numbered holes resulting from battle damage

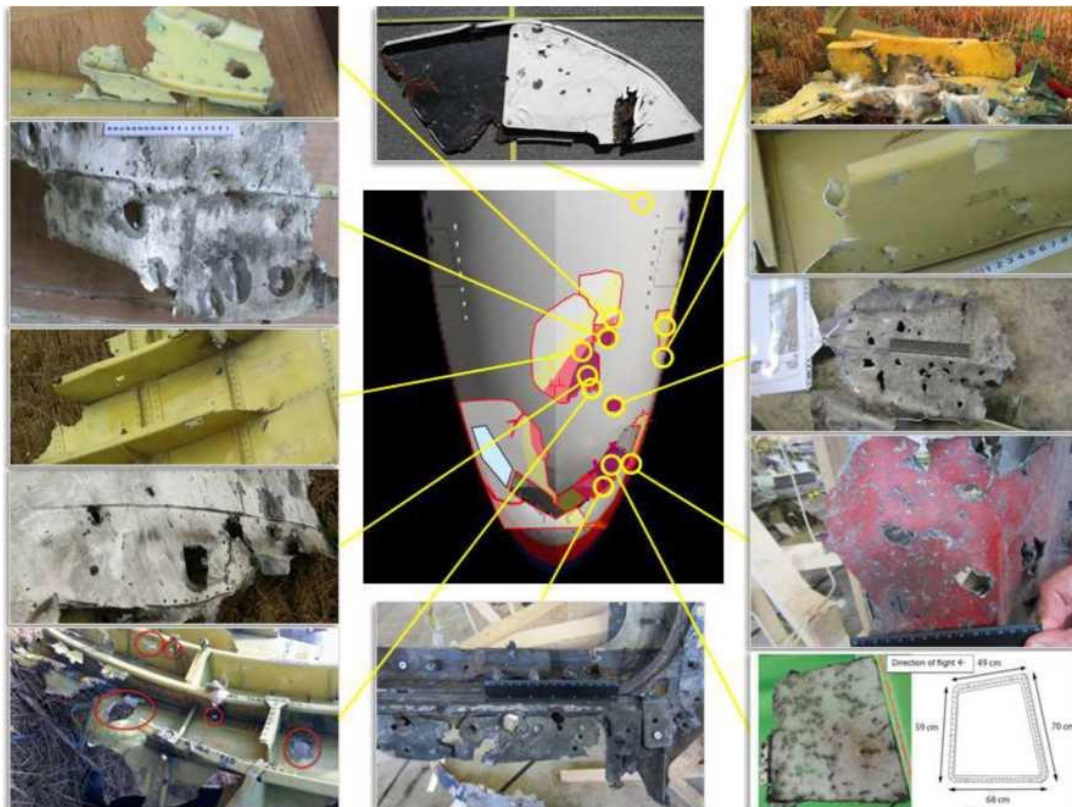
Figure 5.1.35 - Layout of the outer skin and airframe fragments with the highest density of damage and signs of close blast effects

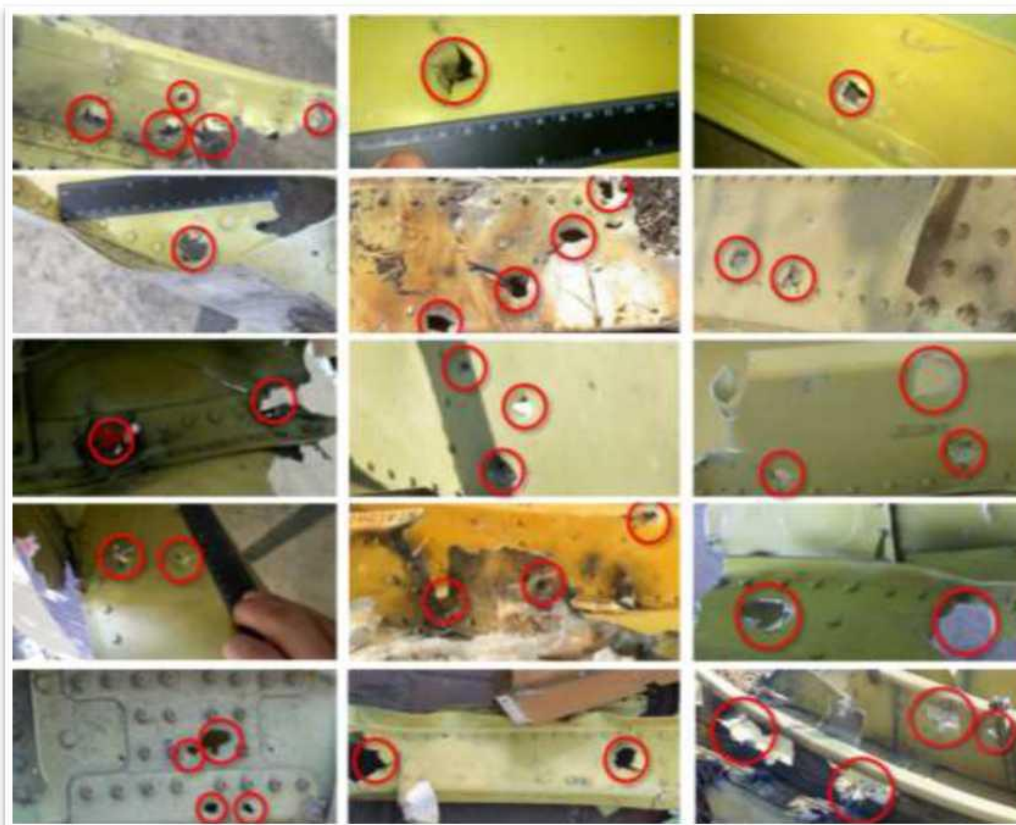
Figure 5.1.37 - Examples of damage to bulkheads

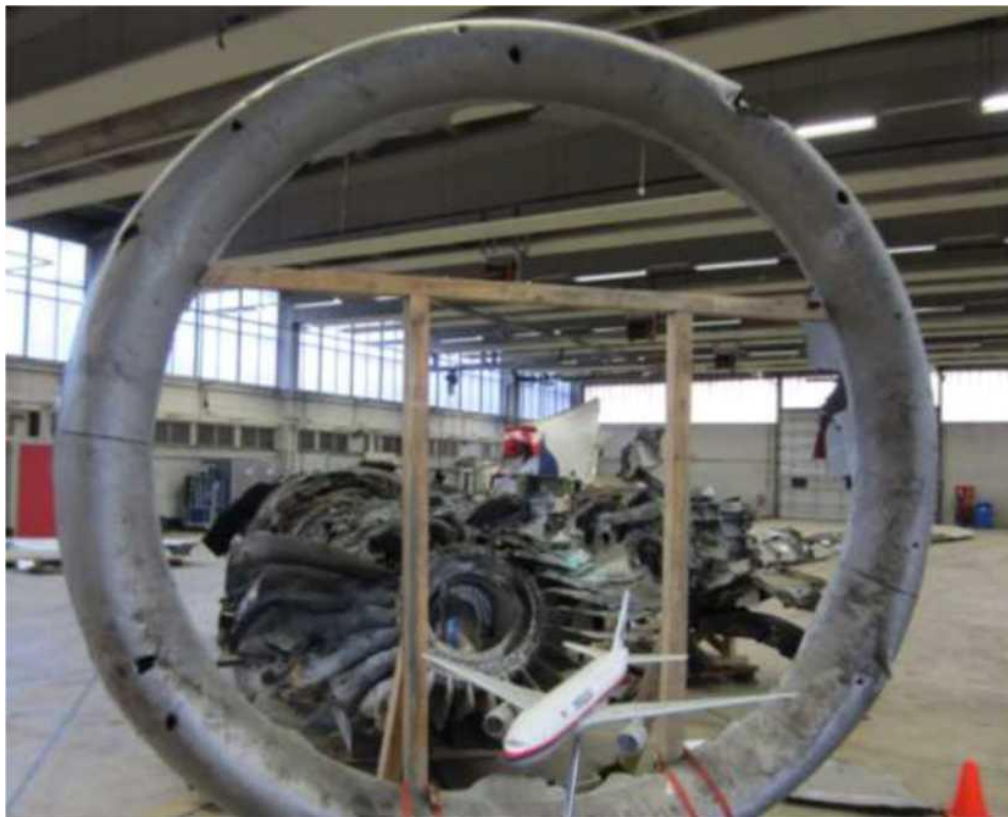
Approximately similar damage, but slightly larger and less densely located, is found in the left engine air intake edge (Figure 5.1.54).

Figure 5.1.54 - Left engine air intake edge

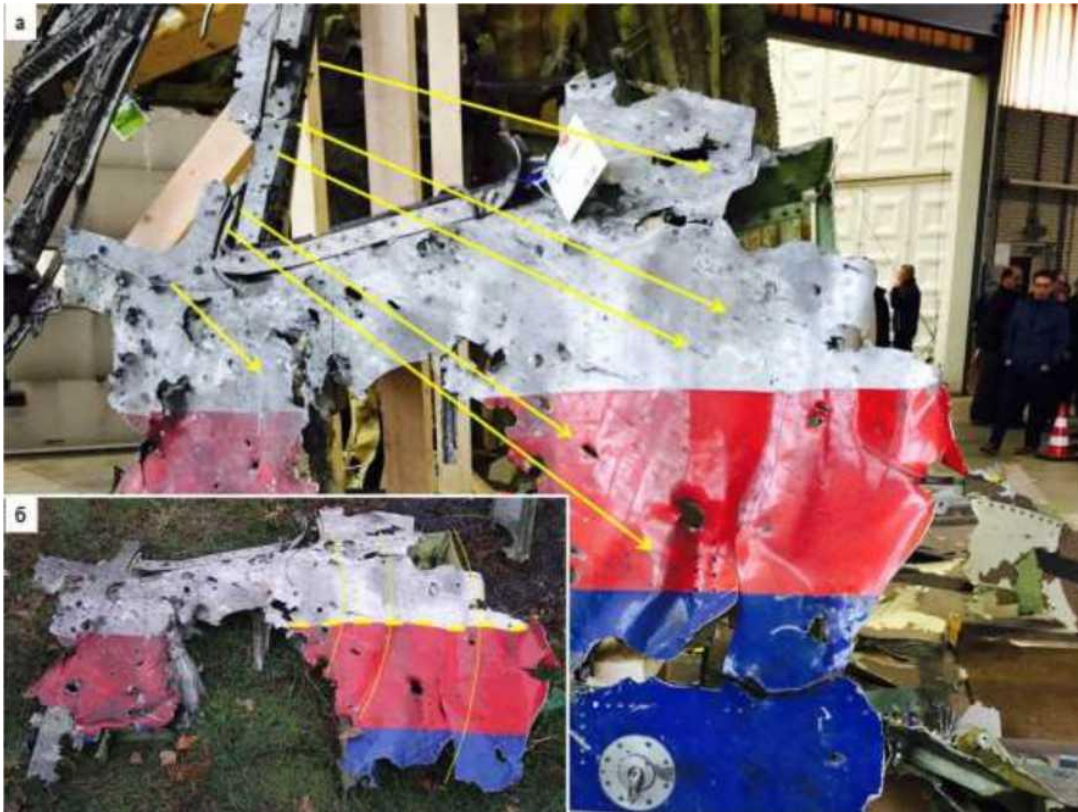
The features of the thermal impact and compression of the bulkheads observed in a fragment of the port side skin of the aircraft below the transparency bezel of the cockpit commander are shown in Figure 5.1.66.

Figure 5.1.66 - Thermal stress and compression marks on bulkheads

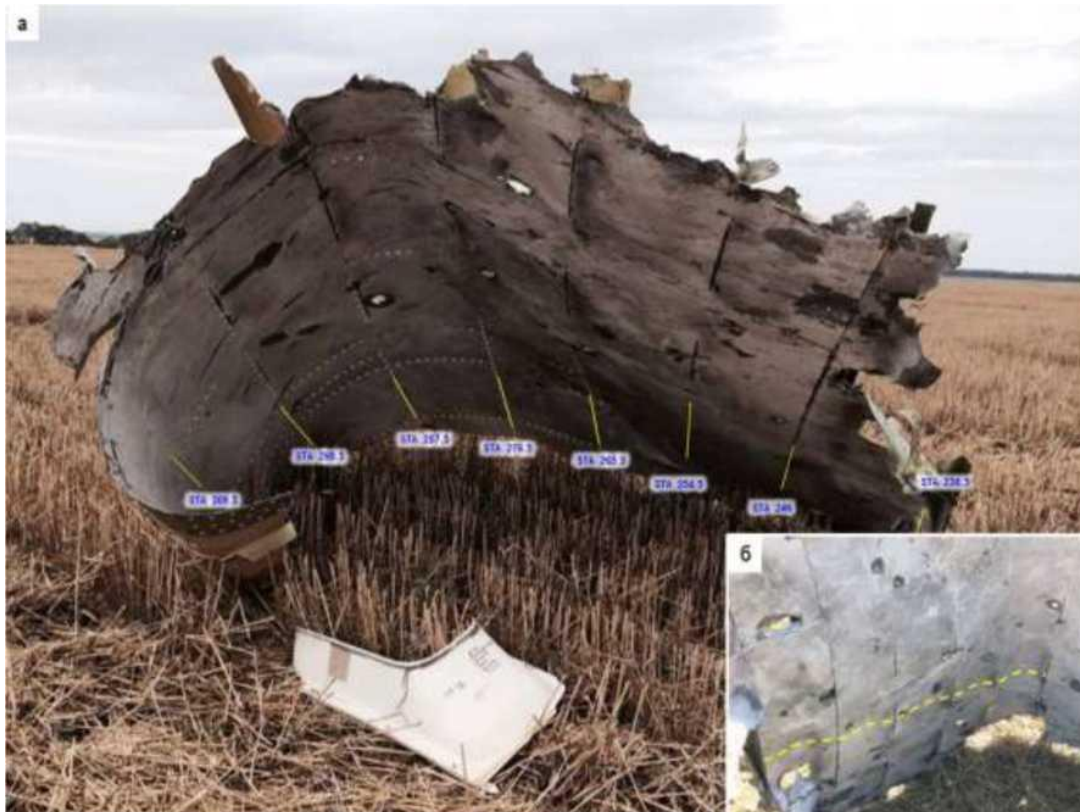
Another example of this damage to the aircraft structure is the part of the roof behind the cockpit shown in Figure 5.1.67.

Figure 5.1.67 - Impact of blast on roof fragment above cockpit

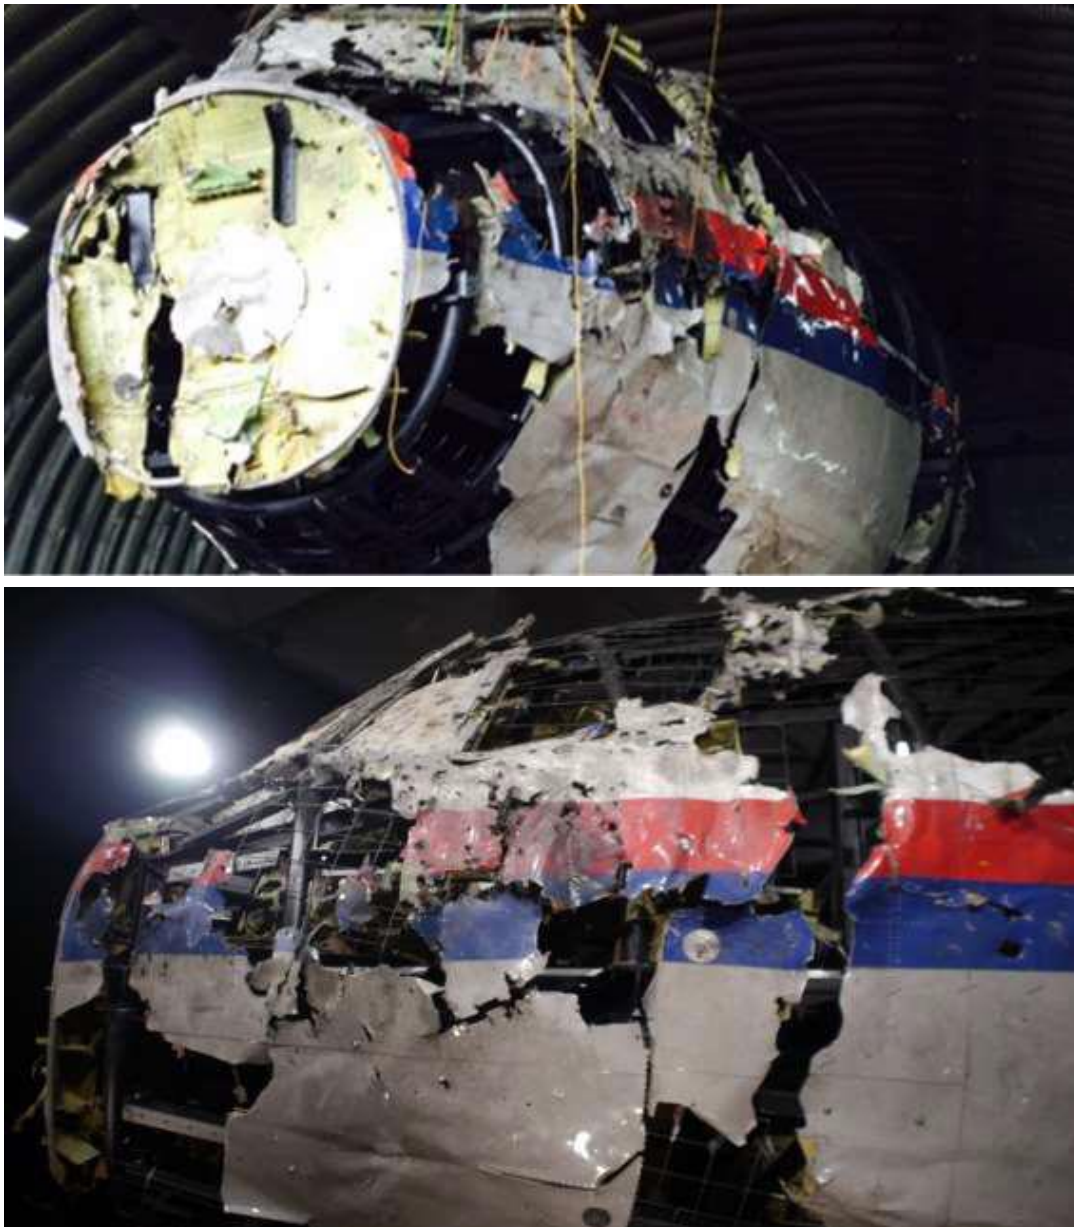
The main ones are: breaking and deformation of the outer skin sheets, tearing of the skin sheets from the load-bearing elements, destruction and deformation of the load-bearing elements of the airframe (Figure 5.1.68).

Figure 5.1.68 - Destruction and deformation of the aircraft nose structure

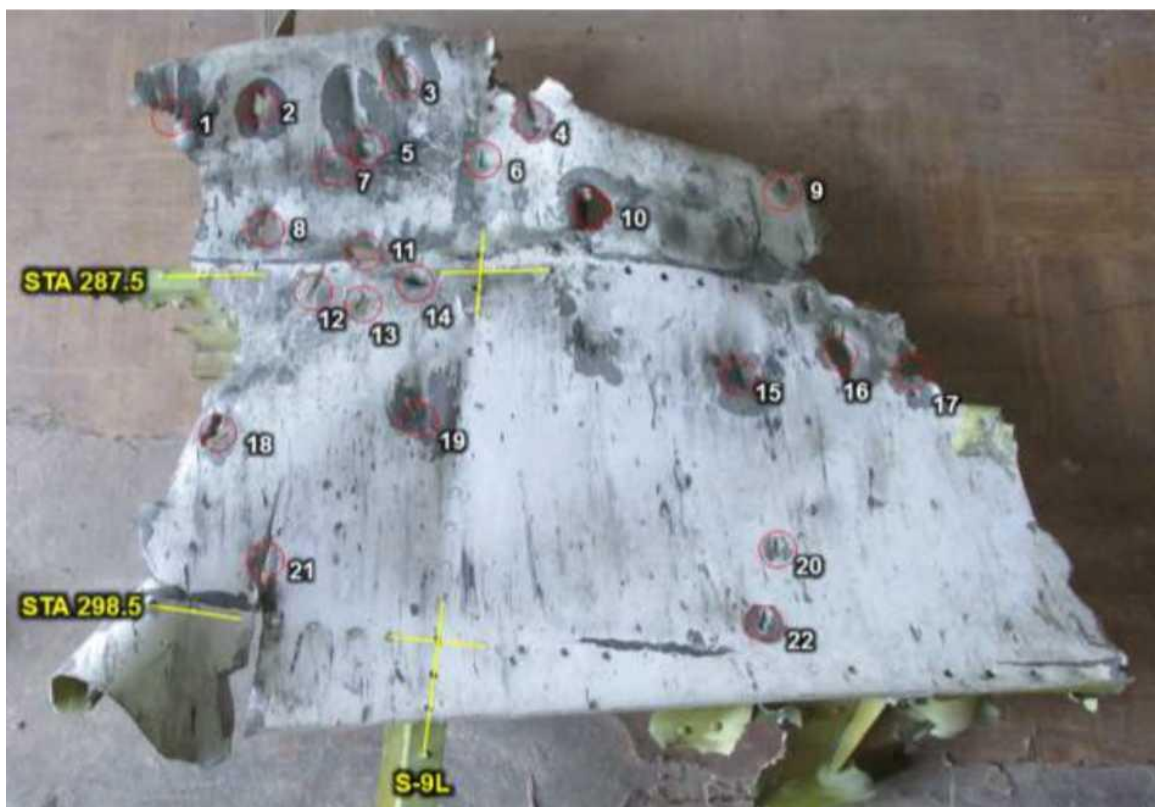
Figure 5.2.24 - Fragment with high density of fragmentation damage not included in final reconstruction and not included in NLR models

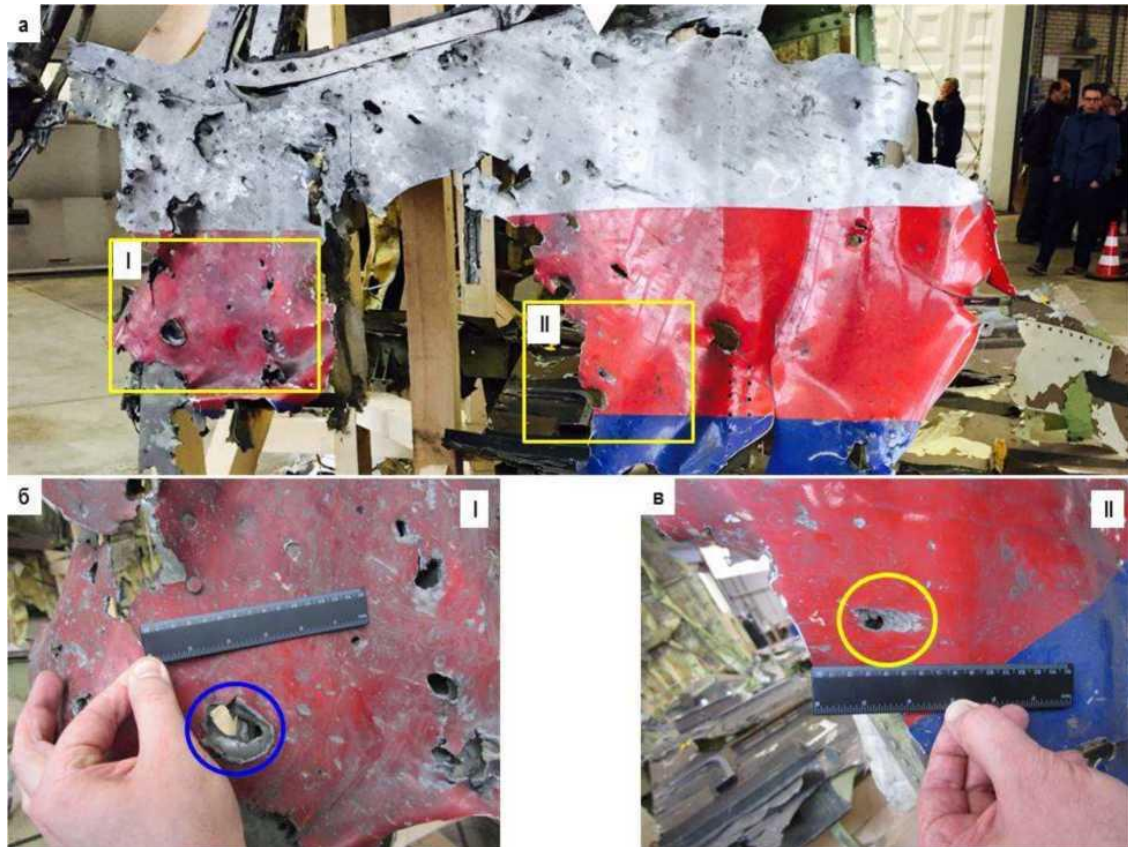
Figure A. 2.1 - Change of damage pattern on the outer skin of F.4

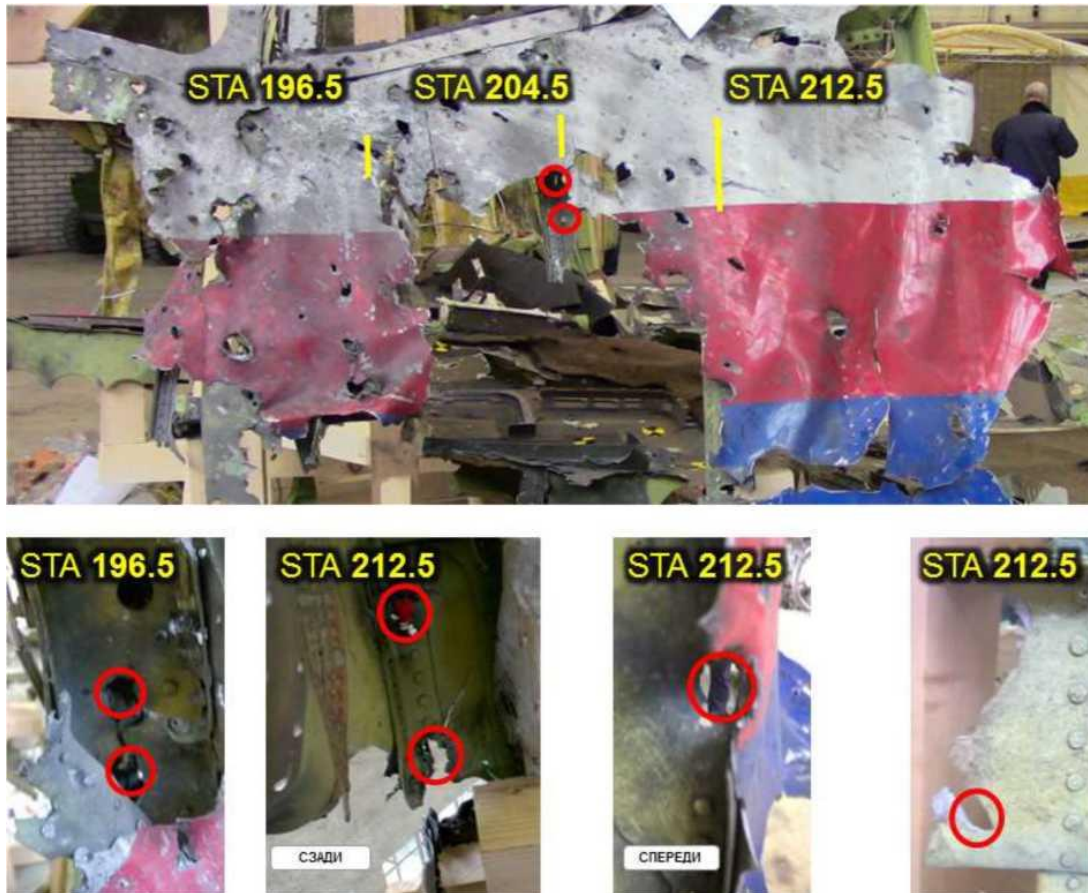
Figure A.3.2 - Punctures in bulkheads STA 196.5 - STA 212.5 under the glazing of the left side of the cockpit

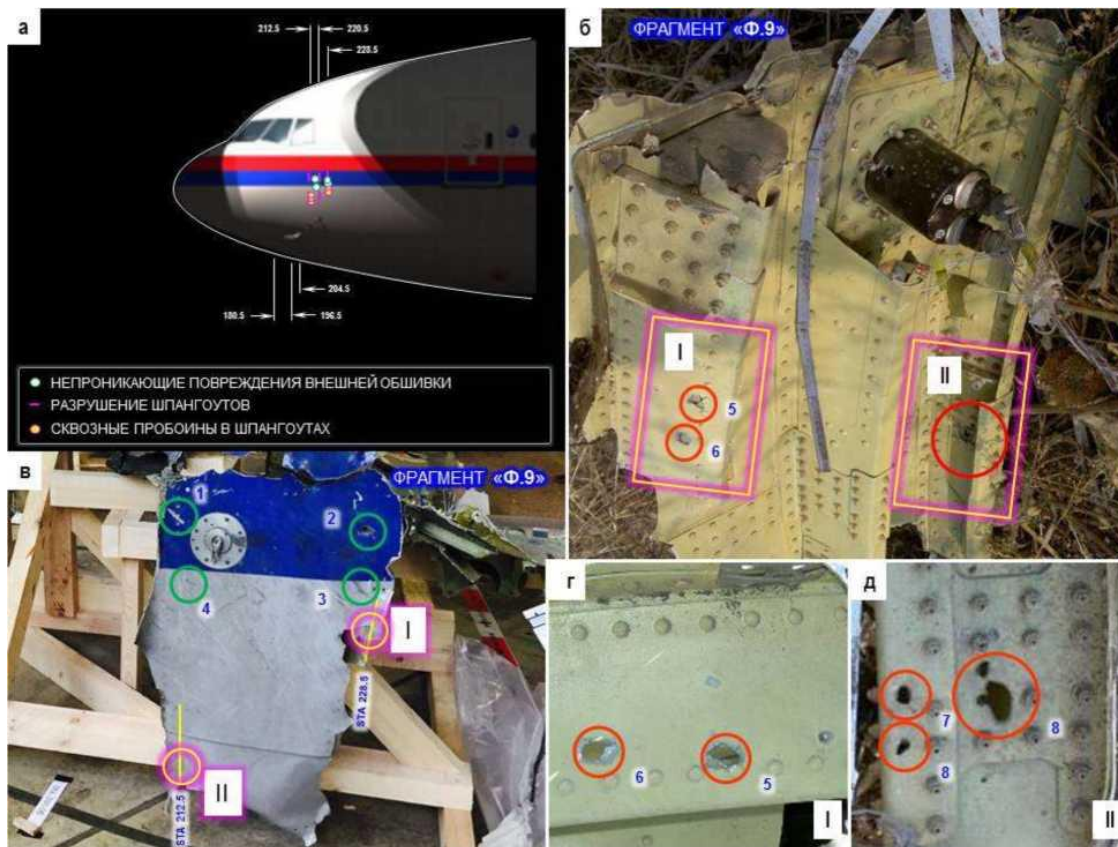
Figure A.3.8 - Damage diagram of the port side fragment with ROV (a), inside (b), outside (c) and through-holes in the bulkheads (d, e)

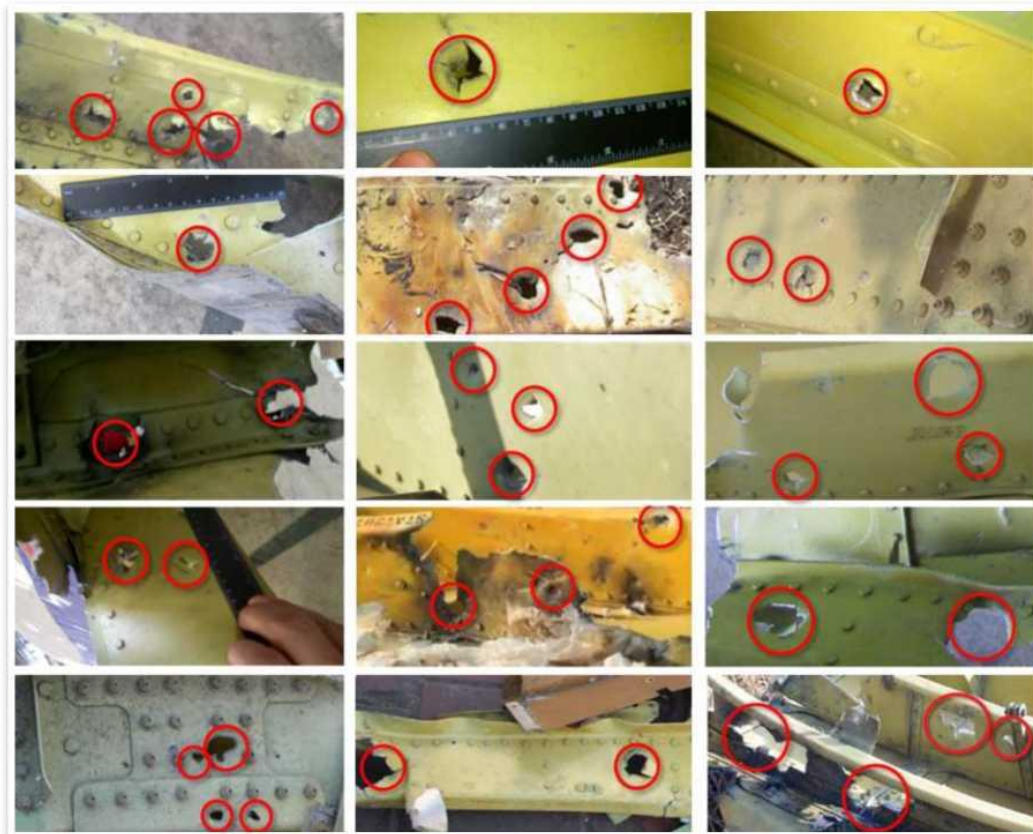
Figure A.3.11 - Examples of damage to bulkheads
