INTERNATIONAL COURT OF JUSTICE

**DISPUTE CONCERNING
CONSTRUCTION OF A ROAD IN COSTA RICA
ALONG THE SAN JUAN RIVER
(NICARAGUA V. COSTA RICA)**

MEMORIAL
OF THE REPUBLIC OF NICARAGUA

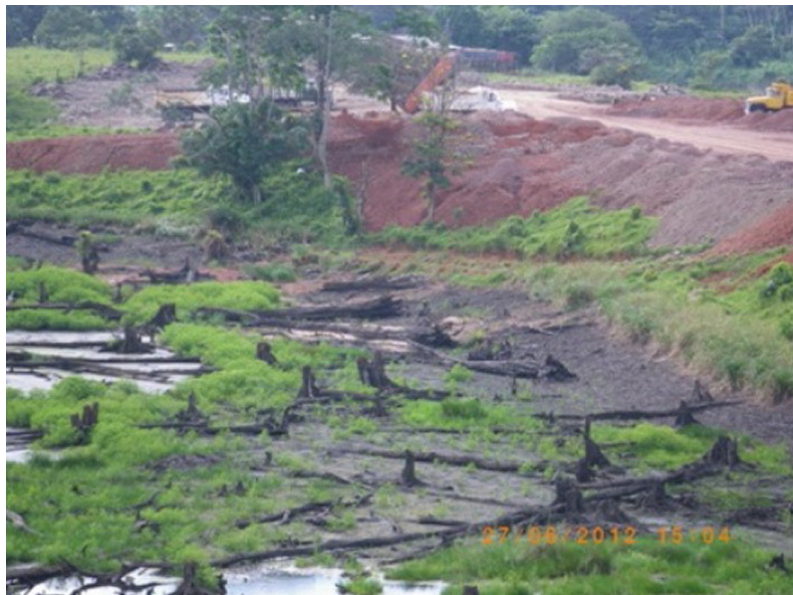
121

damage.”¹¹⁹ Likewise, Costa Rica’s Administrative Environmental Court found, in an inspection report released in July 2012, that the road construction involved “excessive and unjustified felling [of forests.]” Indeed, the Administrative Environmental Court observed that, in some places, Costa Rica clear-cut a swath of forest *eight times* larger than was appropriate.¹²⁰ In an article entitled “Environmental Court Confirmed Excessive Felling for Construction of 1856 Trail,” the Costa Rican newspaper *El País* illustrated the environmental damage in the following photograph:

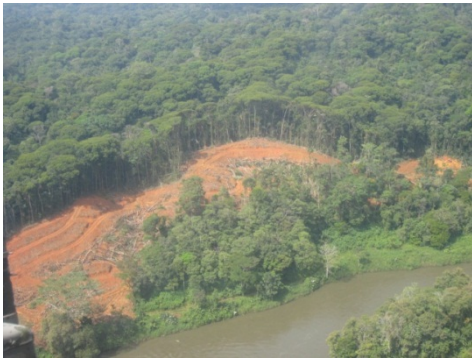
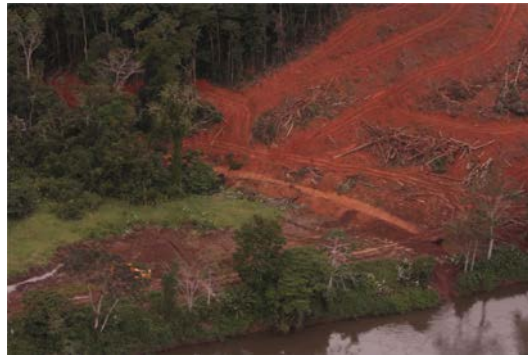
acronym) and the Nicaraguan Foundation for Sustainable Development (FUNDENIC), provide additional examples of the forest destruction caused by Costa Rica during its construction of the Road, and the proximity of such activities to the San Juan River, which is visible in the bottom portion of both images:

3.11 Images like these, as well a site visit to the project area, led the Central American Court of Justice to make the factual determination that “the felling of a large number of trees in Costa Rican territory” created “vast areas where only reddish and clayish soil remains.”¹²⁴

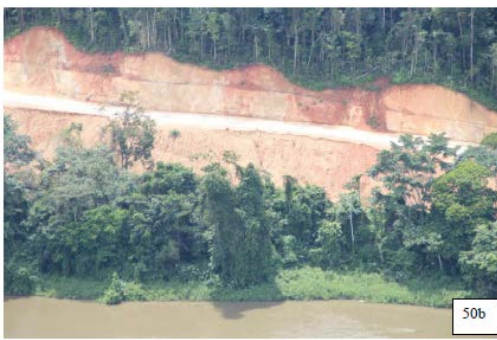
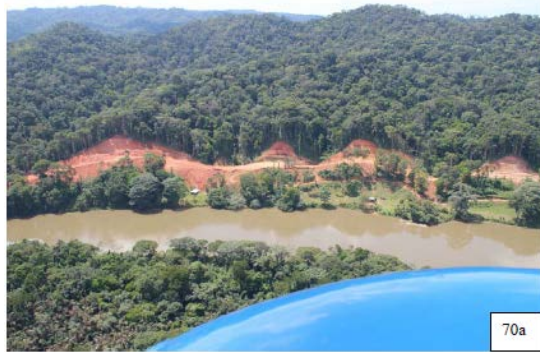
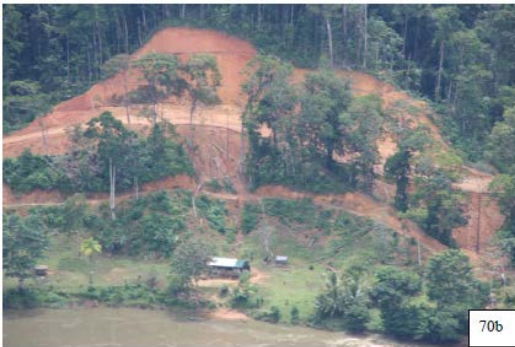
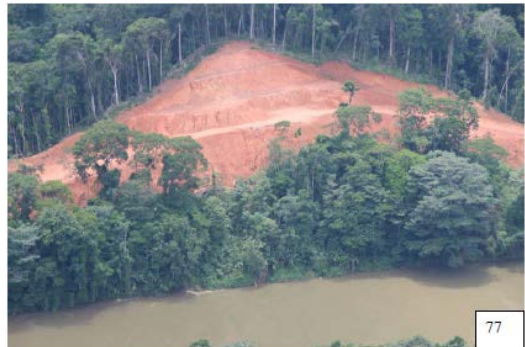
3.13 To Nicaragua’s knowledge, Costa Rica has not attempted to carry out the meager remedial measures that its own inadequate and after-the-fact plan concludes are necessary. When Dr. Kondolf and his team visited the San Juan River in October 2012, many deforested areas adjacent to the River were still readily visible, including those pictured in the following photographs from Dr. Kondolf’s report:

3.14 Dr. Kondolf’s review of “numerous ground photos” taken by LANAMME and CFIA, together with his own reconnaissance *in situ* in October 2012, “revealed a near complete lack of secondary, post-construction erosion control measures at the many areas of exposed, bare soil created by the road-related construction and quarrying. This serious omission has resulted in

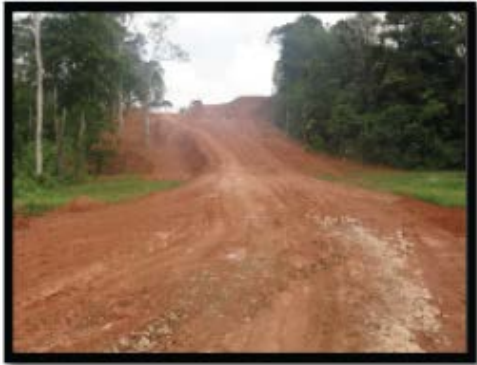
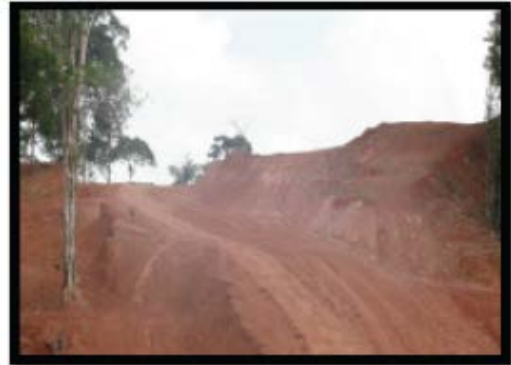
135

cuts and fills, including “very elevated longitudinal slopes” that make transit in certain sections of the Road “almost impossible”.¹³³ The CFIA report provides the following images of what it calls “[a] dirt road with no drainage: as it was not based on plans, disorganized cuts and fills were carried out.”¹³⁴

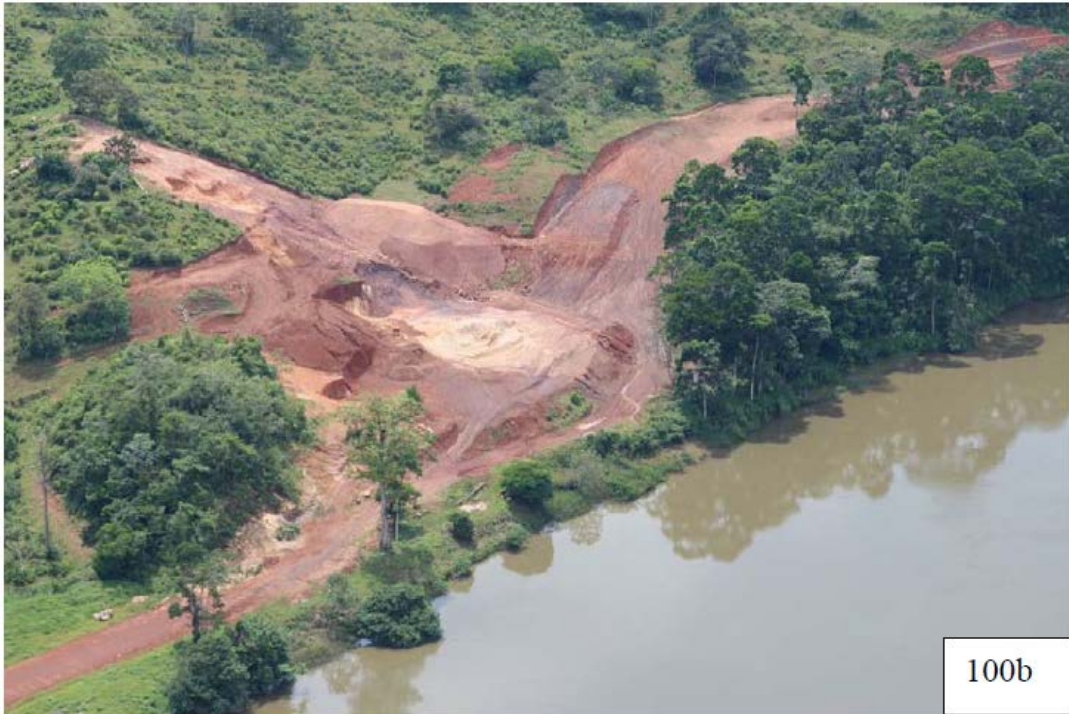
3.20 As is apparent, Costa Rica’s earthmoving works in very close proximity to the San Juan River created and exposed large areas of sediments to the elements, making erosion and the transfer of materials to the River via wind and water inevitable. The University of Costa Rica’s National Laboratory observed “surface run-off impact” in these areas, namely “the development of gullies” that erode the soil of the slopes, making them unstable¹⁴³ and prone to collapse, especially when it rains.¹⁴⁴ The National Laboratory therefore warned that Costa Rica’s excessive and disorganized earthmoving efforts would inevitably result in the transfer of sediments to nearby waterbodies – especially

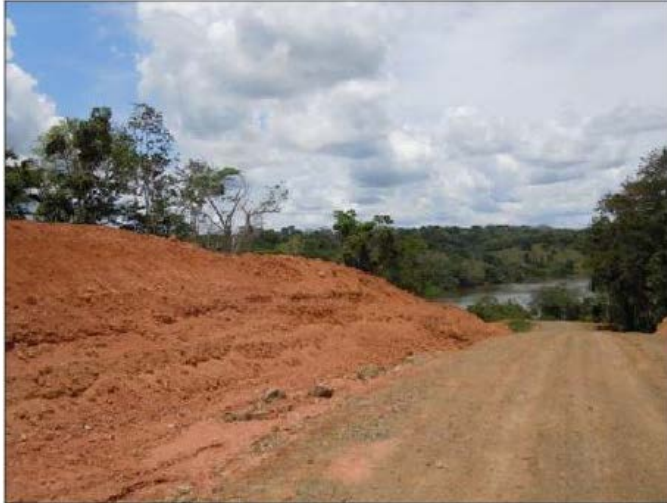
146

the San Juan River – during the rainy season; the following photograph was provided as an example.¹⁴⁵

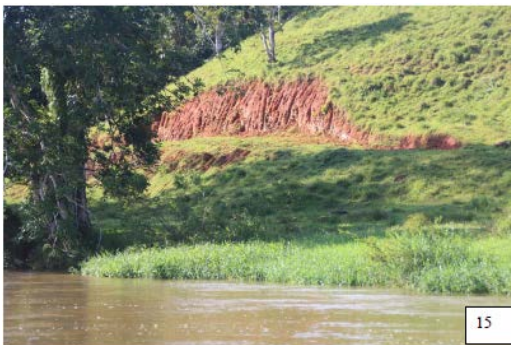
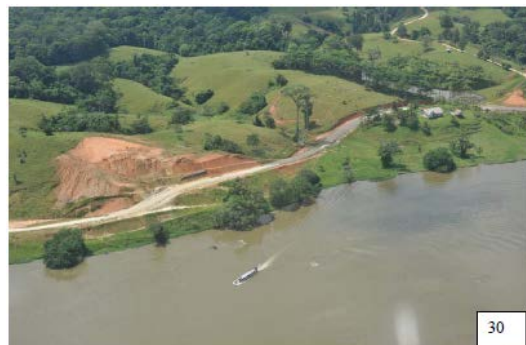
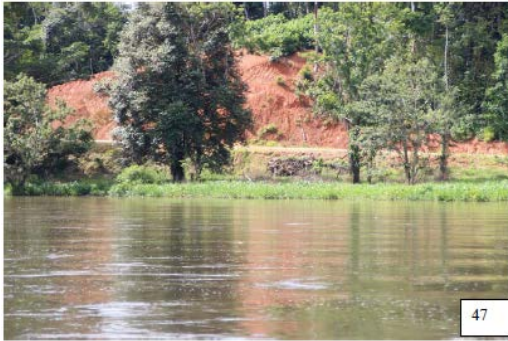
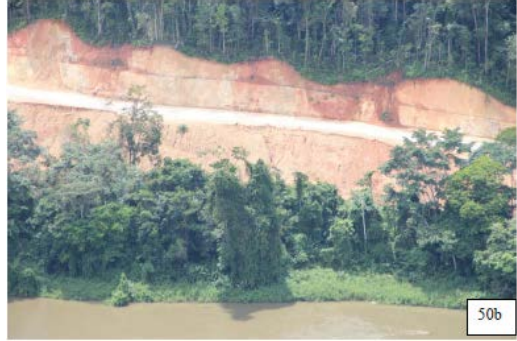
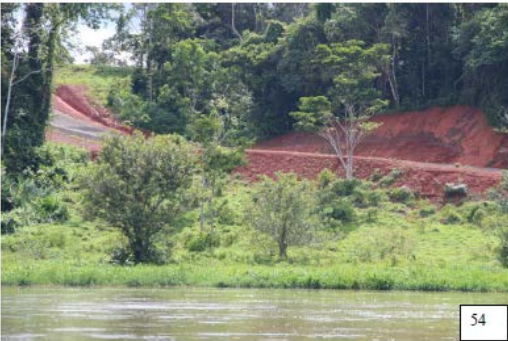
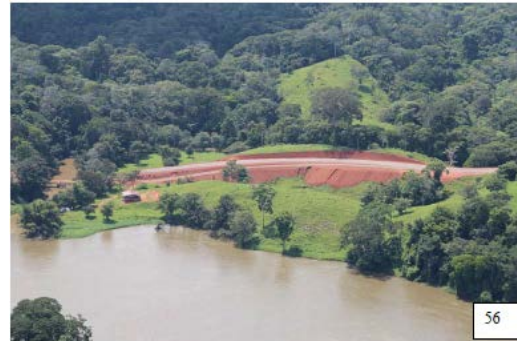
3.31 These are not isolated problems. There are numerous sites of concern, including those in the following images, which Dr. Kondolf and his team captured during their site visit. All of these images, which Dr. Kondolf’s report characterizes as “*just a few* of the observed incipient to active instabilities that are present along the road,”¹⁷⁸ illustrate different problem areas directly adjacent to the San Juan River:

3.32 According to Dr. Kondolf, “during the short time period since road construction activities began and as a result of generally average rainfall events,” these unstable, unprotected slopes have already caused problems.¹⁷⁹ In particular,

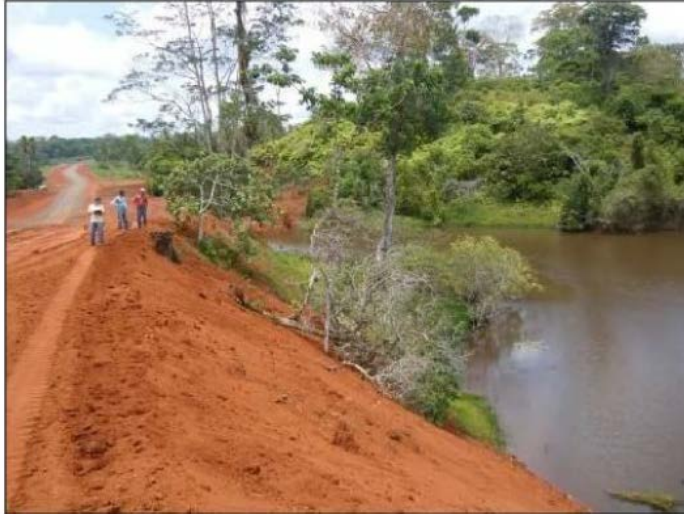
191

3.36 The National Laboratory characterized this as “a totally inadequate practice, from both the construction and engineering point of view, that damages not only [the] body of water but also [the Road itself], since there is no erosion control to prevent loss of material under rainy conditions”.¹⁹²

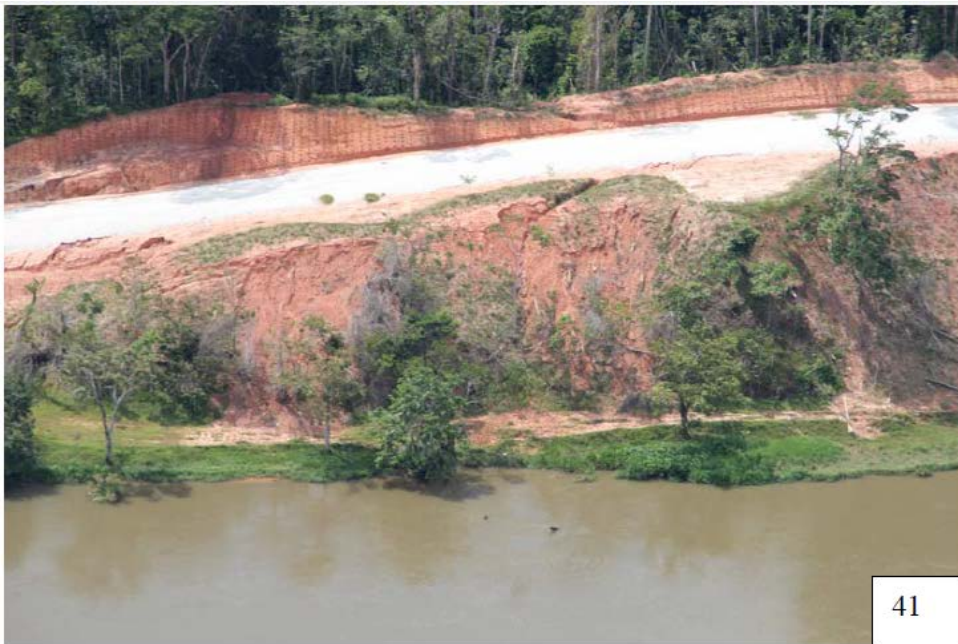
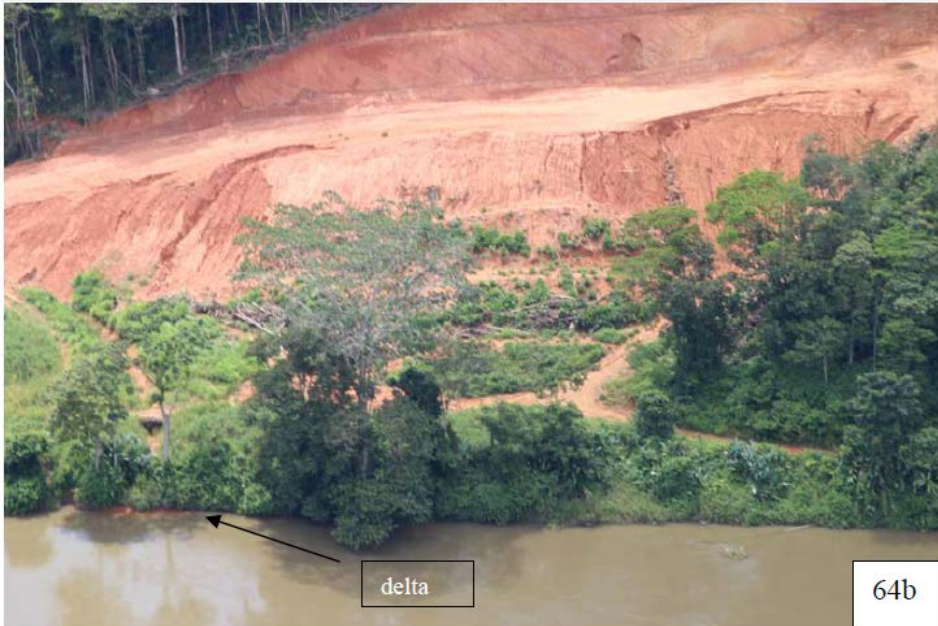
trees that were buried by sidecast fill.”¹⁹⁵ According to Dr. Kondolf, “[t]hese construction methods – sidecasting, lack of compaction and incorporation of woody debris in fill materials – are a recipe for continued slope failure and off-site sediment delivery,”¹⁹⁶ and have already “resulted in numerous, active fillslope and hillslope failures, ranging in size from shallow sidecast failures to large deep-seated landslides, with consequent downstream sediment delivery into the Río San Juan.”¹⁹⁷ The following photographs taken by Dr. Kondolf and his team illustrate the point:

3.38 According to Dr. Kondolf, urgent interventions are necessary to prevent further erosion and sediment transport in these and many similar locations: “Without immediate efforts to stabilize these failing fillslopes (i.e. utilizing excavators to retrieve all the failing fills and creating a ‘full bench’ road), ongoing erosion and sedimentation impacts will continue to occur at extreme rates,”¹⁹⁸ with dangerous consequences for the San Juan River.

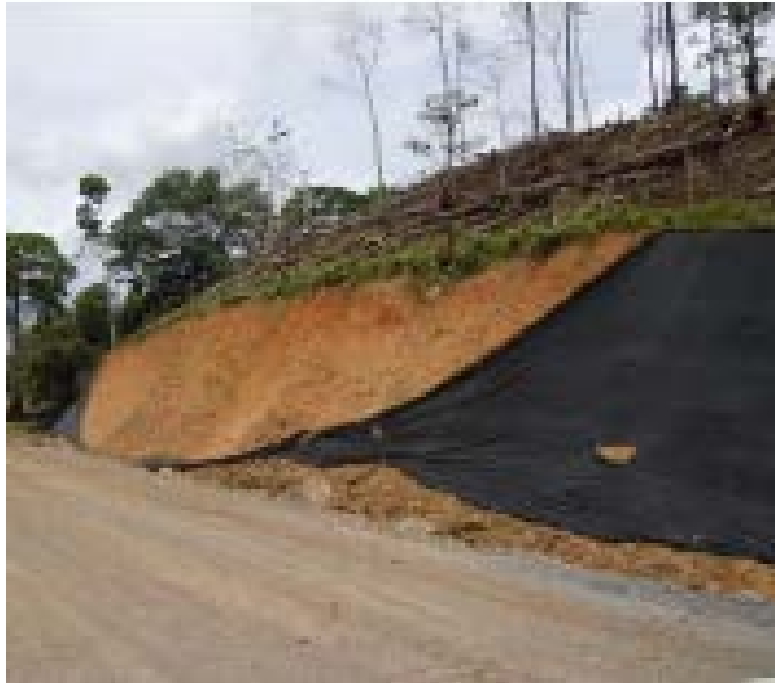
205

3.41 As late as October 2012, aerial and river-based inspection showed that Costa Rica’s “cuts” and “fills” of exposed earth in close proximity to the San Juan River remained uncovered or inadequately covered, just as its slopes remained precariously steep and its fills inadequately compacted. Dr. Kondolf and his team “observed unprotected, eroding bare soil areas to be ubiquitous throughout virtually all construction areas along the alignment.”²⁰⁶ There was an “evident lack of measures to prepare for the wet season and [a] lack of erosion control measures along the route,” which already resulted in “persistent and serious erosion of bare soils” all along the recently bulldozed Road, and the delivery of eroded sediment to the San Juan River.²⁰⁷

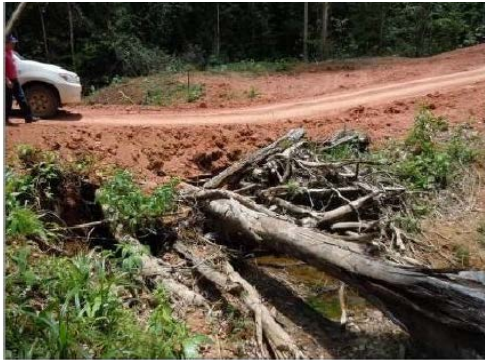
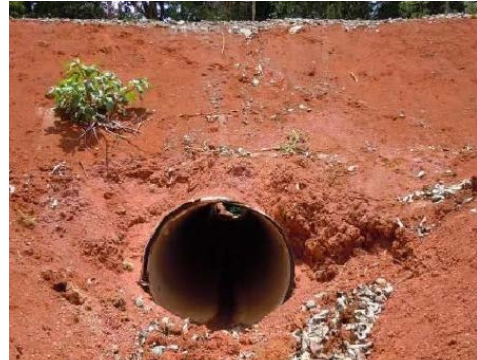
and in imminent danger of collapsing.”²⁵⁰ The reports provide the following images to illustrate these concerns:

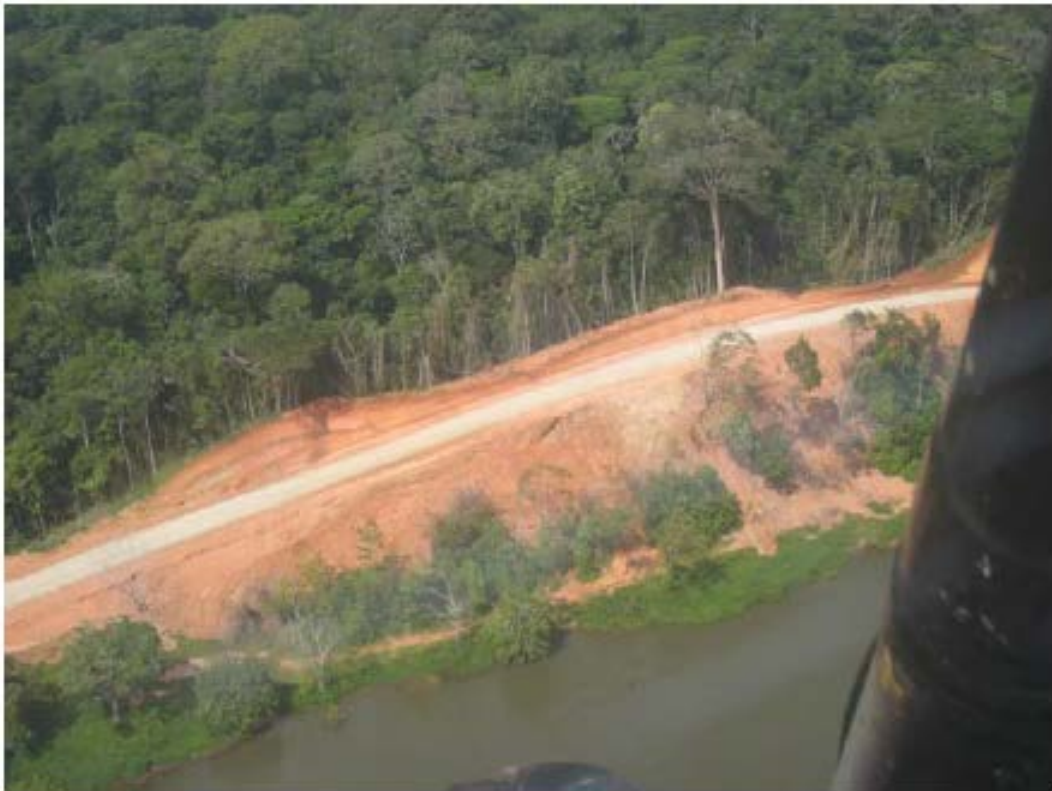
there is photographic evidence, including the example below, of “raw, eroding slopes,” some of them “clearly show[ing] tongues of coarse sediment, reflecting the transport of sediment by surface runoff from the disturbed area directly into the channel” of the San Juan²⁷¹:

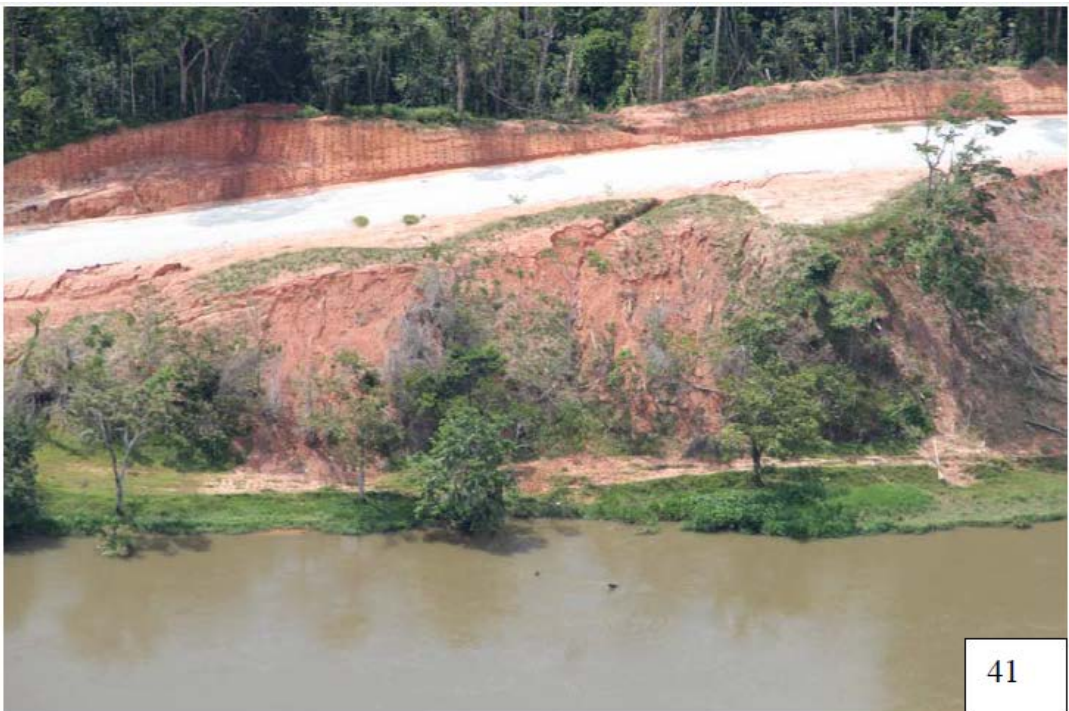
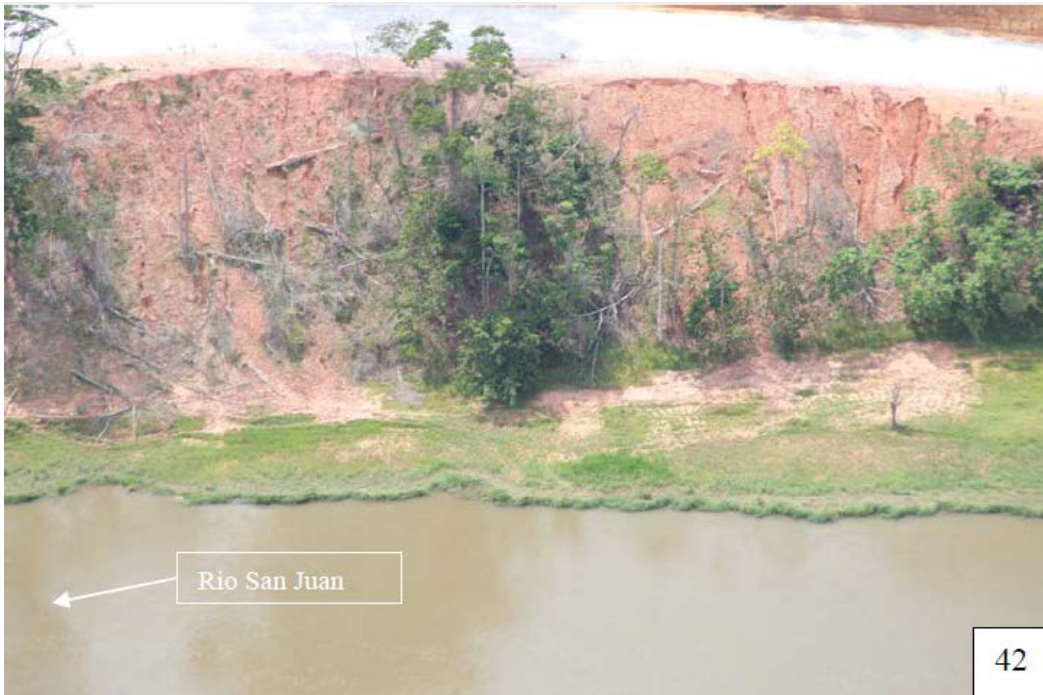
3.71 The most obvious sediment delivery points are those where slopes were found to be eroding and collapsing directly into the River. As Dr. Kondolf observed, “At many locations, fillslopes appear to be actively adjusting and virtually ‘melting’ downslope with little evidence of maintenance or corrective effort along the route. As a consequence, accelerated human-caused erosion processes remain unchecked, and sediment continues to be delivered directly to the Río San Juan.”²⁸⁹ He captured the following images to illustrate this problem, immediately adjacent to the San Juan River:

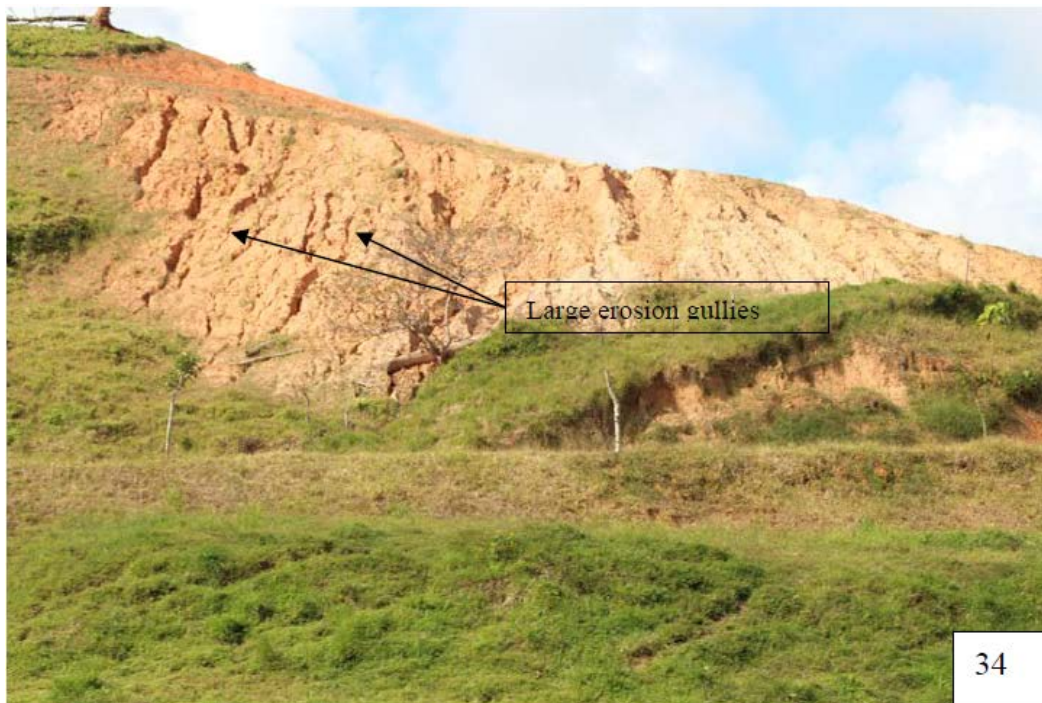
seasonable construction activities.”²⁹² The following image, taken from a boat just off the south bank of the River, provides an example:

3.73 As Dr. Kondolf explained, the “widespread and serious gully erosion” visible along much of the Road “delivers eroded sediment directly to the Río San Juan” when water flows through and continuously erodes the gullies, collecting sediment as it goes, and makes its way downhill the short distances to the River.²⁹³ Indeed, there is “direct evidence that sediment from gullies in

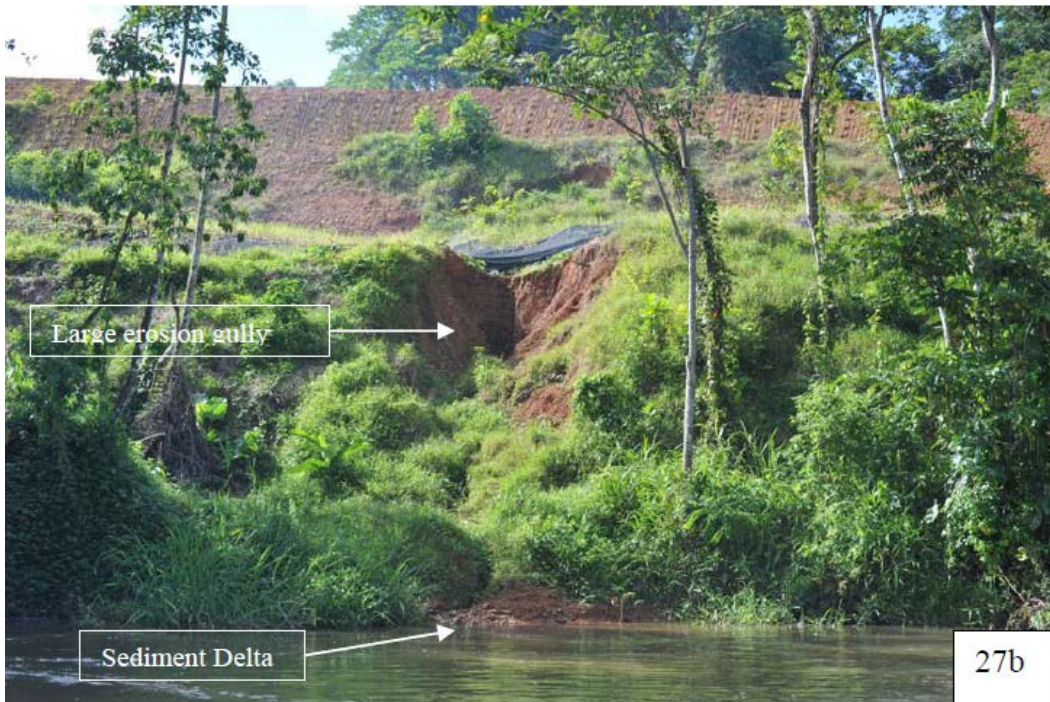
earthen road fill has been delivered to the Río San Juan.”²⁹⁴ In several locations, Dr. Kondolf and his team photographed the “sediment deltas” that have formed in the River as a result of this gully erosion and related sediment transport, as shown in the following example:

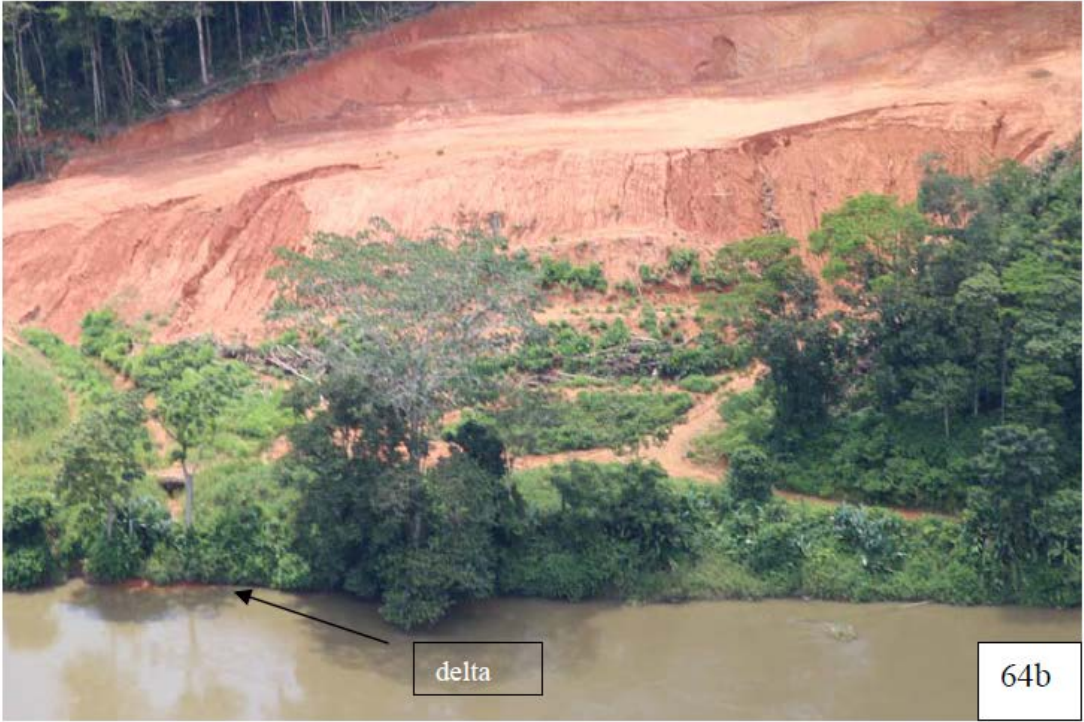
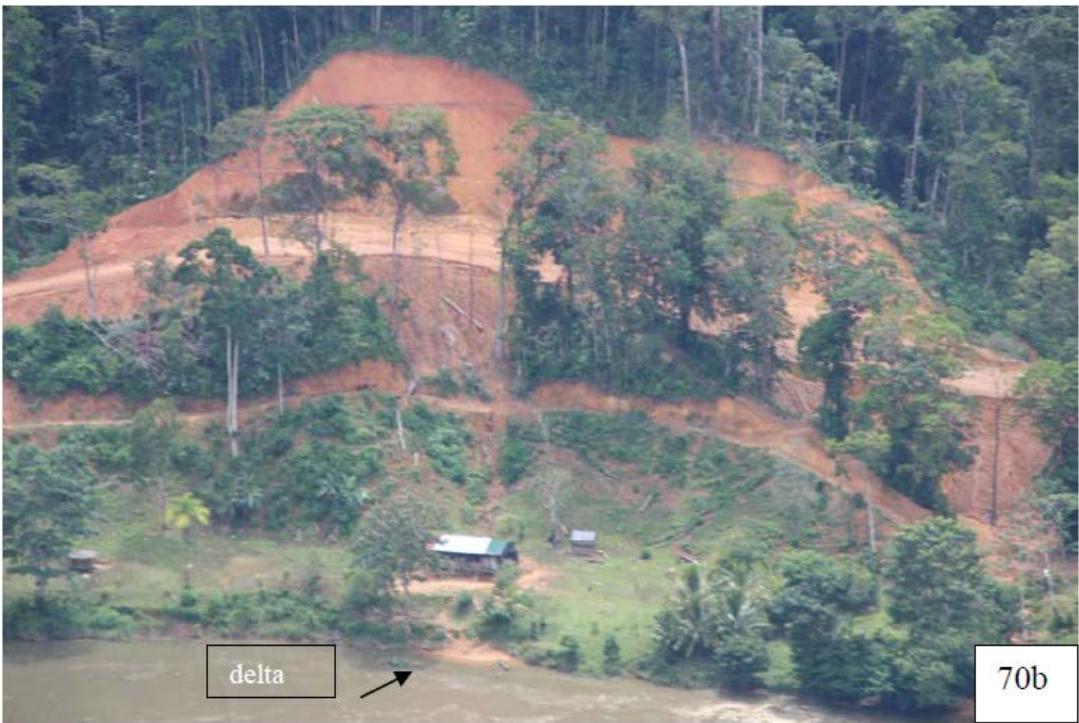
Some of the “sediment deltas” that have formed in the San Juan River as a result of the widespread gully erosion caused by Costa Rica’s improper road construction techniques are more visible from the air, exhibiting the same reddish hue that characterizes the disordered, unstable gashes Costa Rica has carved into the landscape. The following photographs were taken from a helicopter:

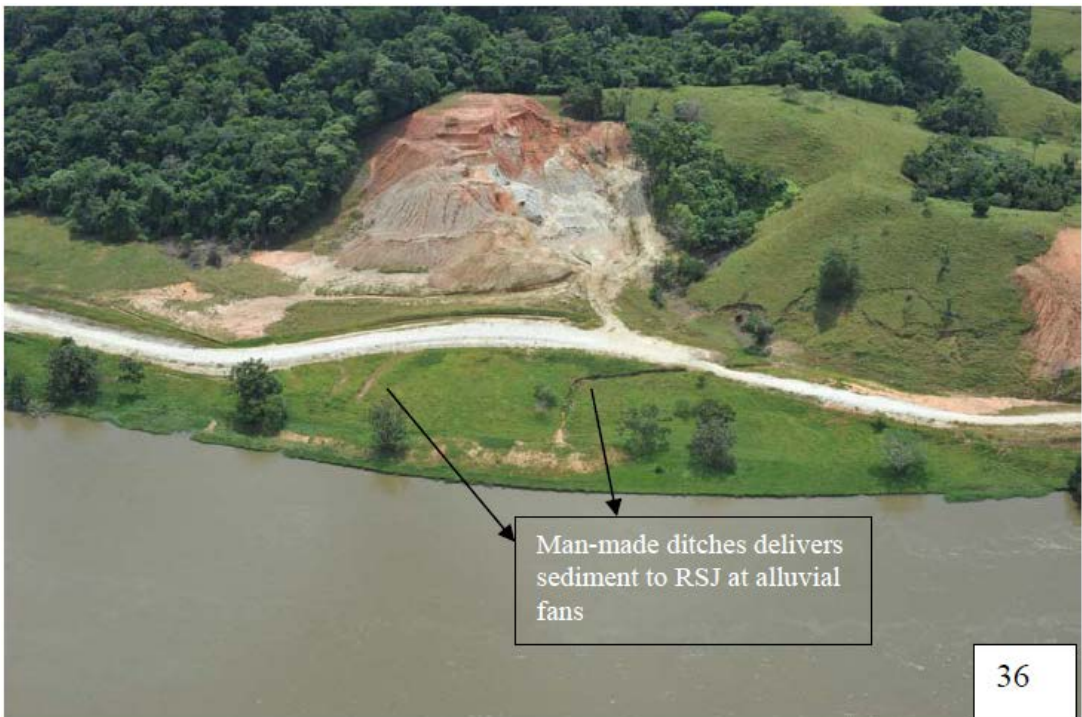
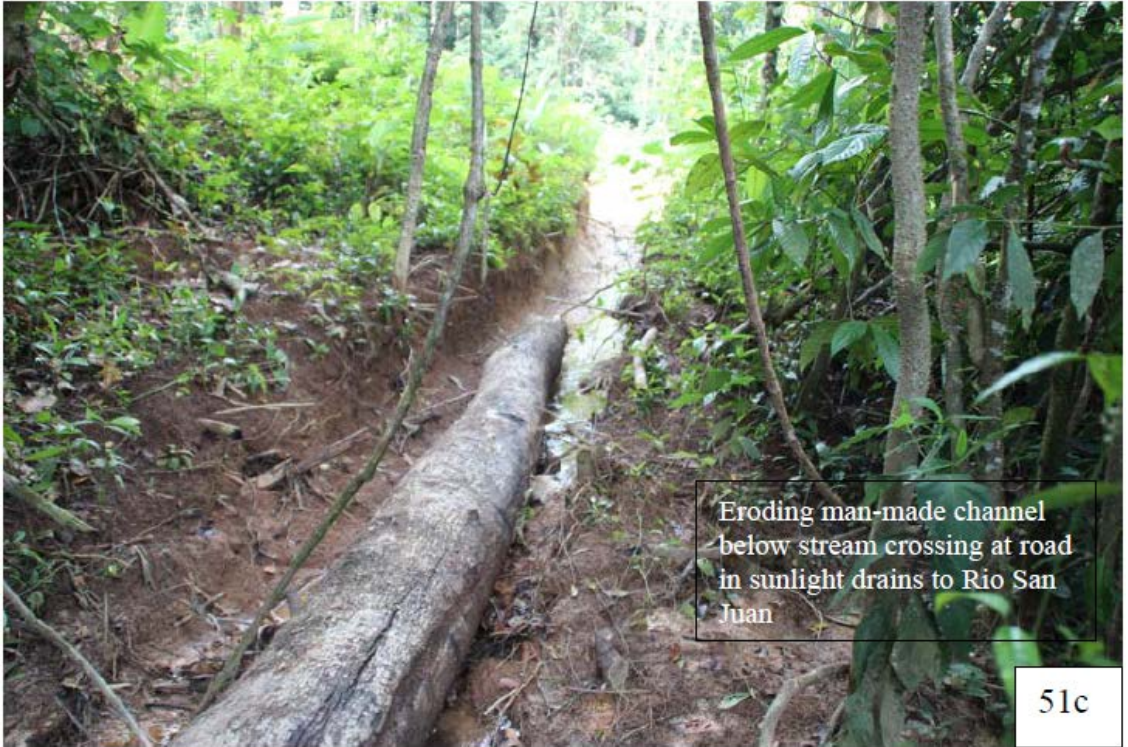
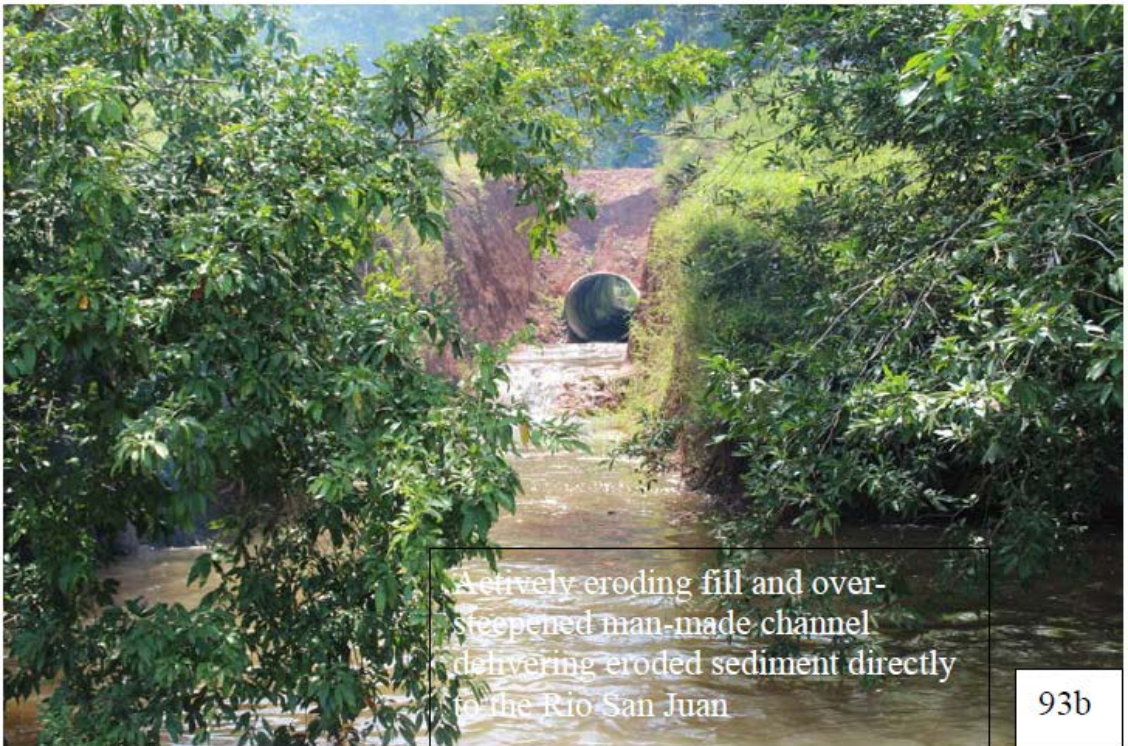
3.75 The fourth sediment delivery mechanism consists of the drainage channels that Costa Rica has dug, intentionally connecting its Road to the San Juan River and ensuring that water carrying sediment from the Road will be transferred to the River. As Dr. Kondolf found, Costa Rica’s construction of its Road involved the digging of man-made ditches, as well as the “intentional re-routing and diversion of natural stream channels,” which “focused concentrated flow to areas where erosion is accelerated and sediment delivery to the Río San Juan is virtually assured.”²⁹⁸ Some of these man-made channels connecting the Road to the River are visible in the following images:

3.76 The sediment fans, choked vegetation and other obvious signs of Road impacts on the River resulting from these four sediment delivery mechanisms which Dr. Kondolf and his team observed and documented reflect only a fraction of the much larger sediment transfers to the River that have taken place to date as a result of Costa Rica's construction of the Road:

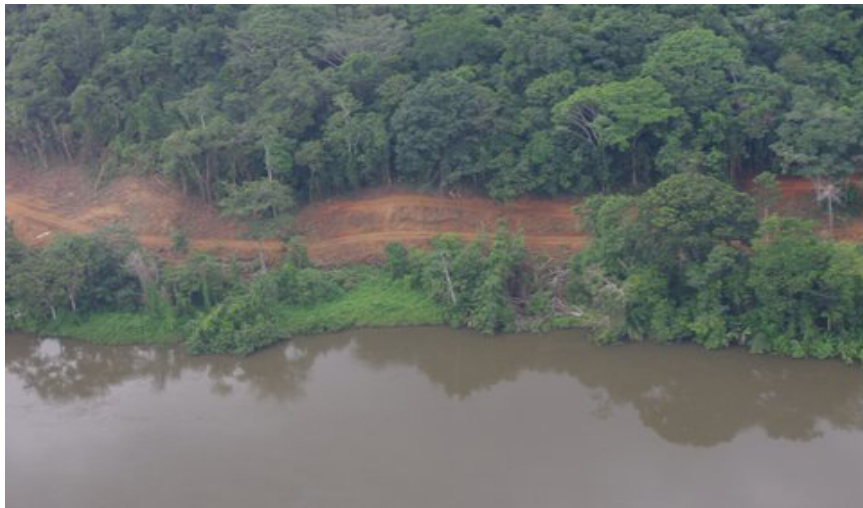
Figure 5.1⁴⁹⁶

⁴⁹⁶ Site Visit on the 1st of December, 2011. *Note: This photograph was taken from the San Juan de Nicaragua River. (Application Instituting Proceedings, 22 December 2011, Construction of a Road in Costa Rica along the San Juan River (Nicaragua vs. Costa Rica), Annex 1).*

Nicaragua’s] reasons” is “intended to require that the requesting State have more than a vague and unsubstantiated apprehension. A serious and substantiated belief is necessary”⁴⁹⁴ Nicaragua in fact had more than a “serious and substantiated belief” since, in addition to the Costa Rican press accounts, the Road project was visible from the San Juan River’s left (Nicaraguan) bank, as shown in the following photographs annexed to the Application.⁴⁹⁵

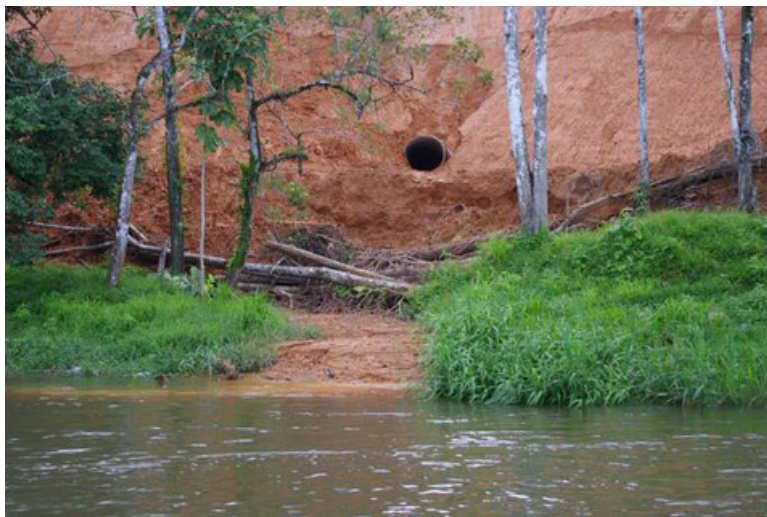
Figure 5.4⁴⁹⁹

⁴⁹⁹ Site Visit on the 1st of December, 2011. *Note: This photograph was taken from the San Juan de Nicaragua River (Application Instituting Proceedings, 22 December 2011, Construction of a Road in Costa Rica along the San Juan River (Nicaragua vs. Costa Rica), Annex 8).*
