INTERNATIONAL COURT OF JUSTICE

**DISPUTE CONCERNING THE CONSTRUCTION OF A ROAD IN
COSTA RICA ALONG THE SAN JUAN RIVER**

COUNTER-MEMORIAL OF COSTA RICA

Assessment of the Impact of the Construction of the Border Road in Costa Rica on the San Juan River

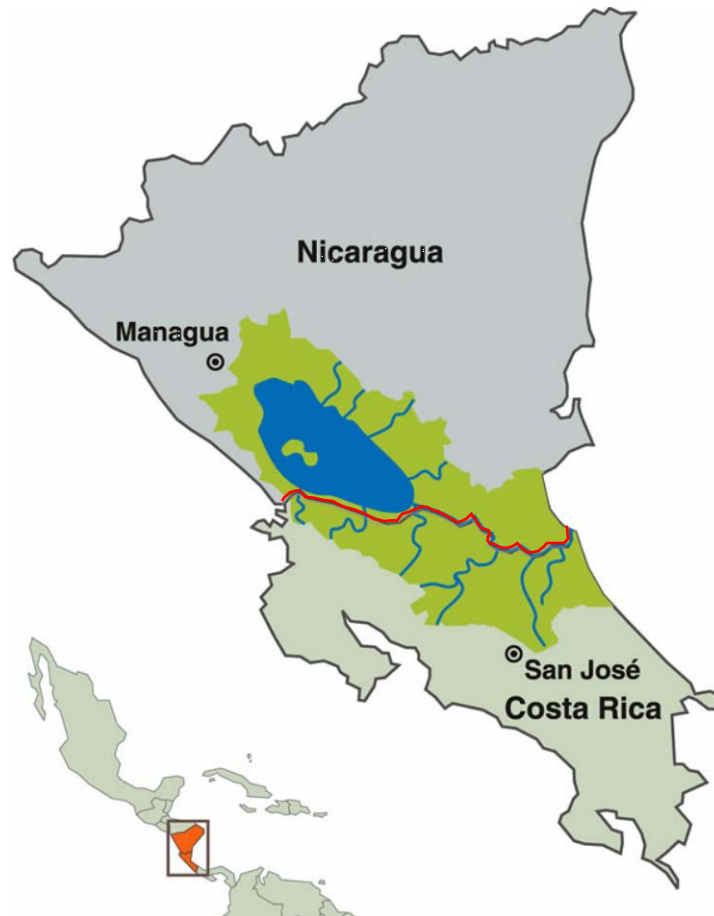
Figure 1. Bi-national basin of San Juan-Colorado rivers. Source: “PROCUENCA. Diálogo sobre agua y Clima. Enfrentando la variabilidad del clima en una cuenca transfronteriza de América Central: La cuenca del río San Juan (Costa Rica y Nicaragua)”. Available at: <http://www.oas.org/sanjuan/spanish/documentos/dialogo/dialogo/01-characterization/mapas/map1.html>

1.7 The San Juan-Colorado rivers basin is the largest in Central America. It drains a catchment of an area of some 40,000 km² in size from both Costa Rican and Nicaraguan basins.⁸ **Figure 1** shows the size of this bi-national basin. Lake Nicaragua (Cocibolca), where the San Juan River originates, discharges around 16% of the total water flow, while Costa Rican tributaries provide 70% and Nicaraguan tributaries 14%.⁹ If the discharge from Lake Nicaragua is excluded, Costa Rican tributaries alone account for 83% of the overall water flow of the San Juan-Colorado

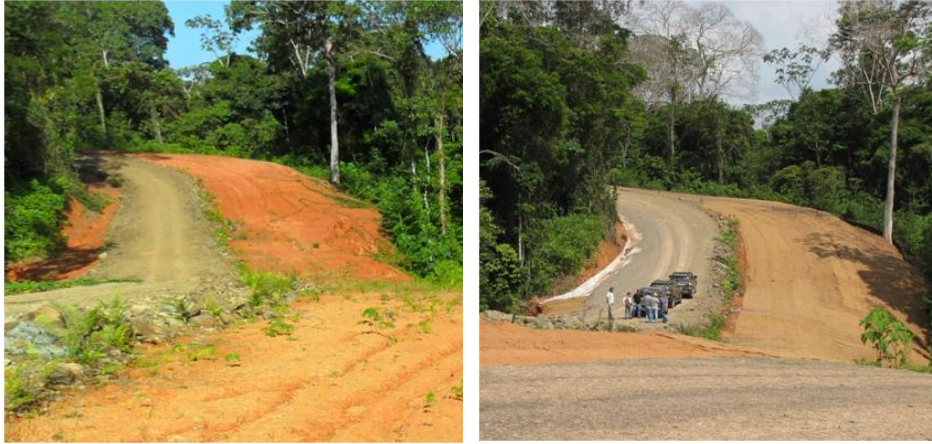
Figure 2.3 The Road near Marker II (a) prior to mitigation work on 15 February 2013 and (b) on 7 May 2013 with mitigation measures in place.¹¹⁹

2.39 The photographs below are illustrative of some of the remedial works that have already been carried out:

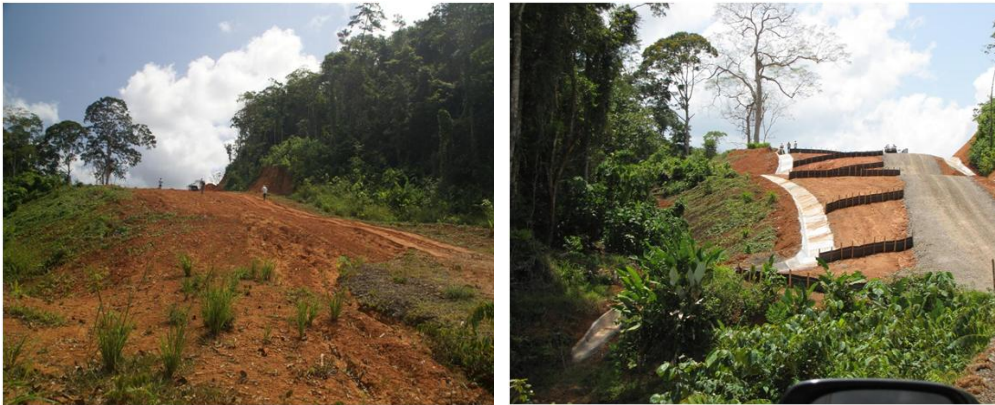
Figure 2.4 Road at East 502480, North 321561, close to the Río Infernito (a) on 15 February 2013, and (b) the same stretch of road on 7 May 2013.¹²⁰

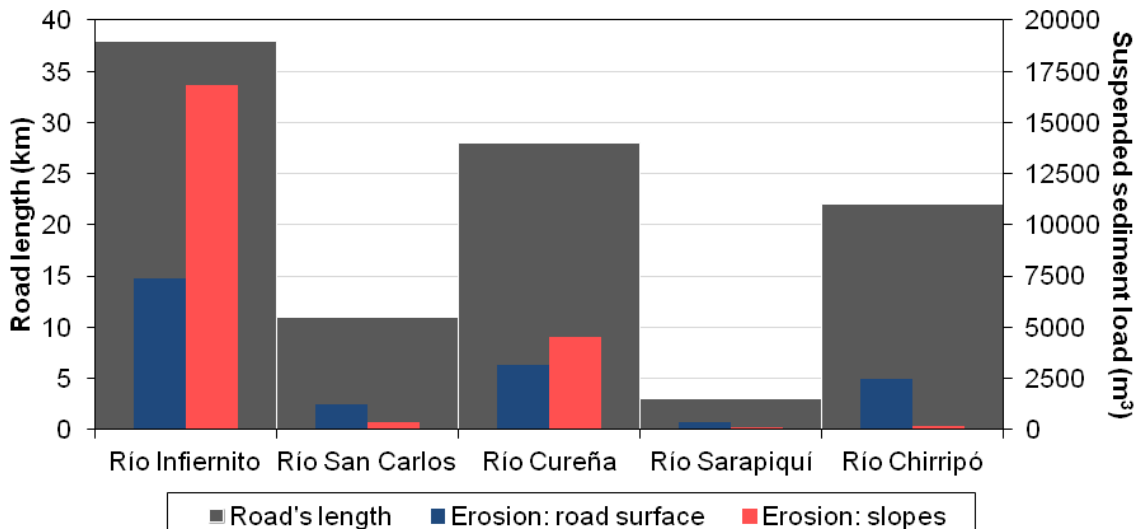
Figure 31 (a) Map showing the major tributary basins between Lake Nicaragua and Delta Costa Rica (b) Length of Road and estimated annual average inputs of sediment to the Rio San Juan from erosion of the road and cut/fill slopes in basins CR3 (Infiernito) to CR7 (Chirripó) between Marker II and the Delta (from 2013 ICE Report).

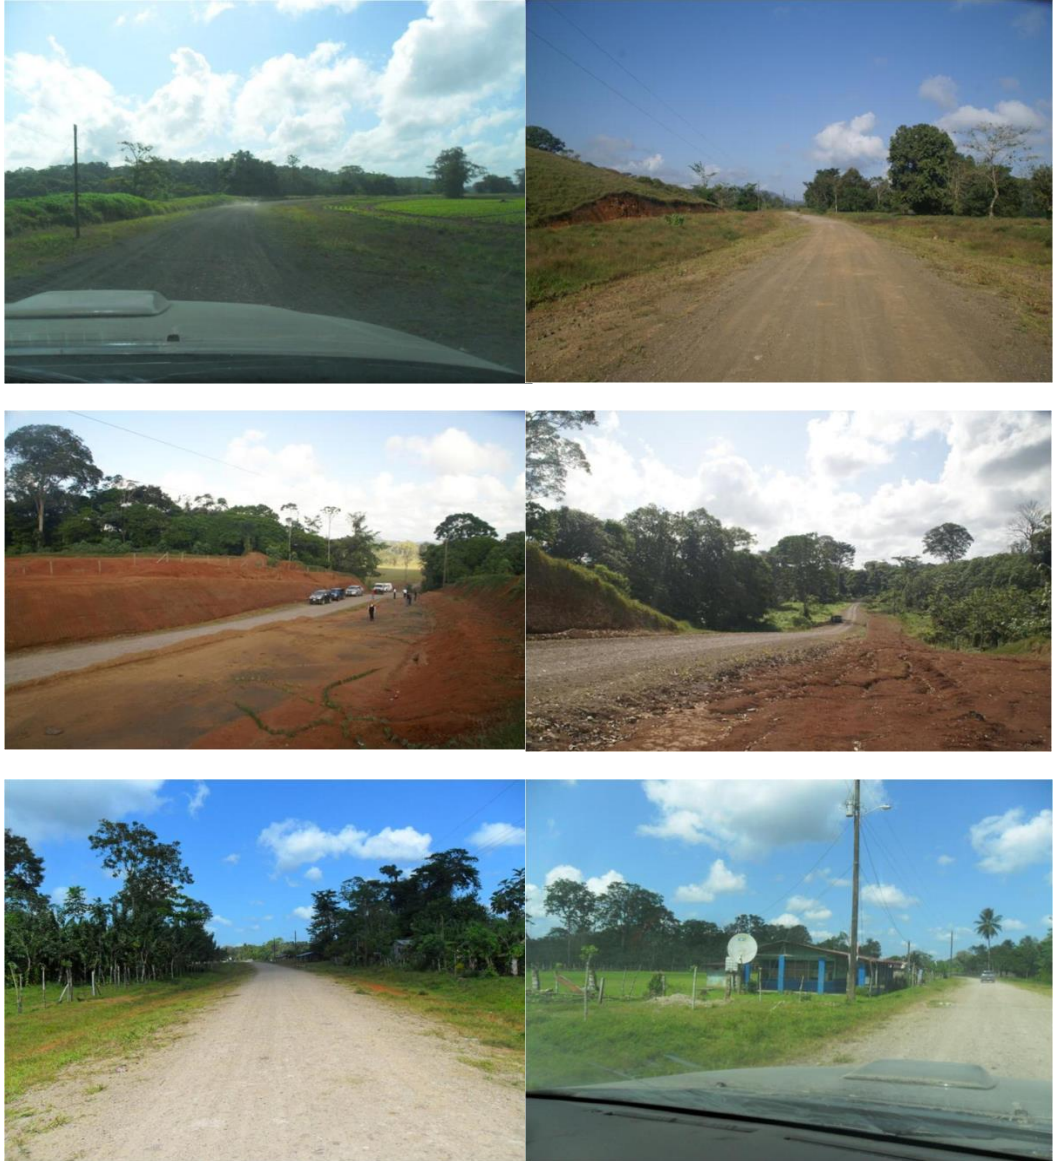
Figure 1. Photographs representative of conditions observed by the author along the Road between Boca San Carlos and Boca Sarapiquí on the ground on February 16, 2013.

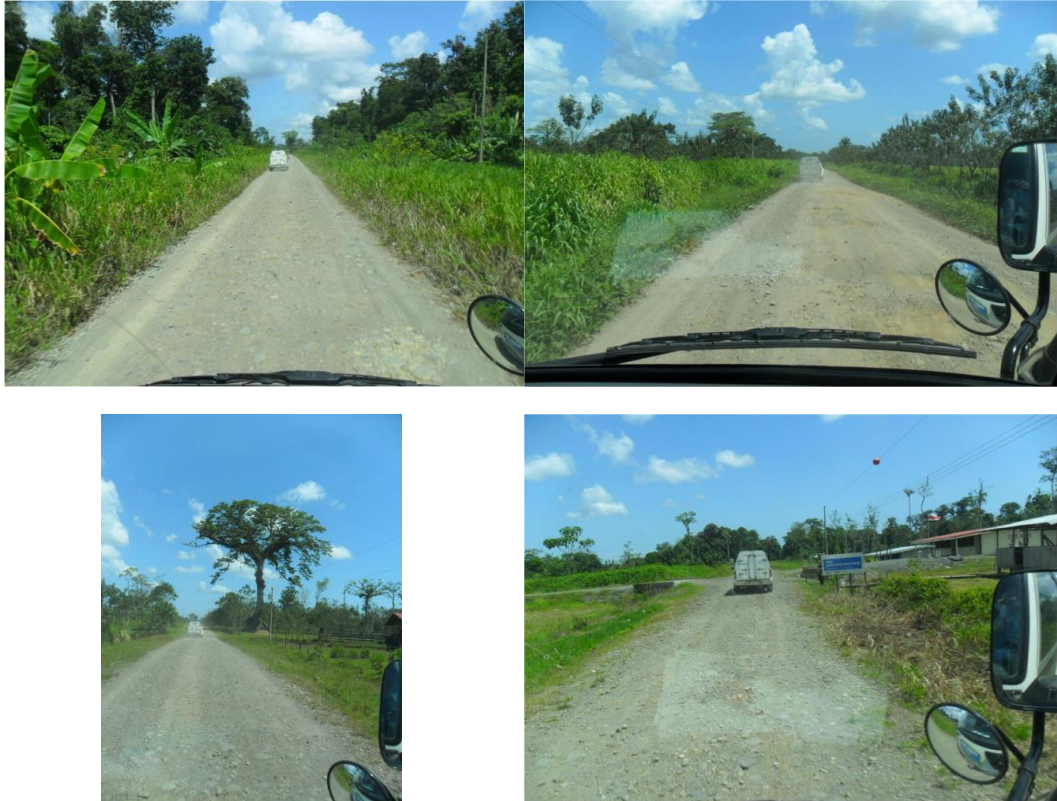
Figure 2. Photographs representative of conditions observed by the author along the Road between Boca Sarapiquí and the Delta on the ground on February 16, 2013.

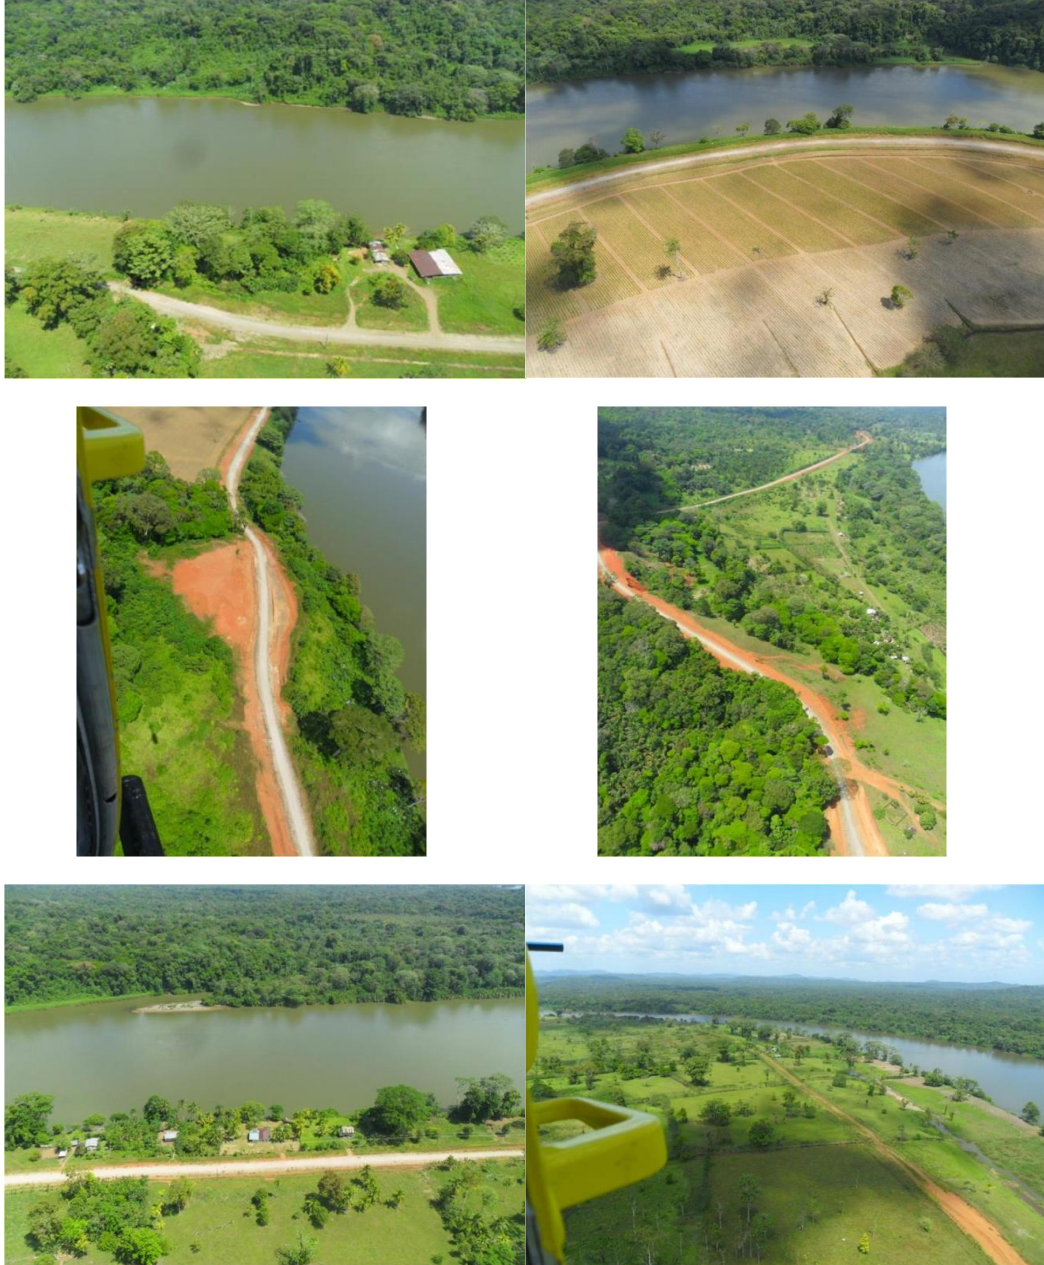
Figure 3. Photographs representative of conditions along the Road between Boca San Carlos and Boca Sarapiquí observed from the air by the author on February 16, 2013. The only slopes observed along the Road are in the catchment of the Río Cureña.

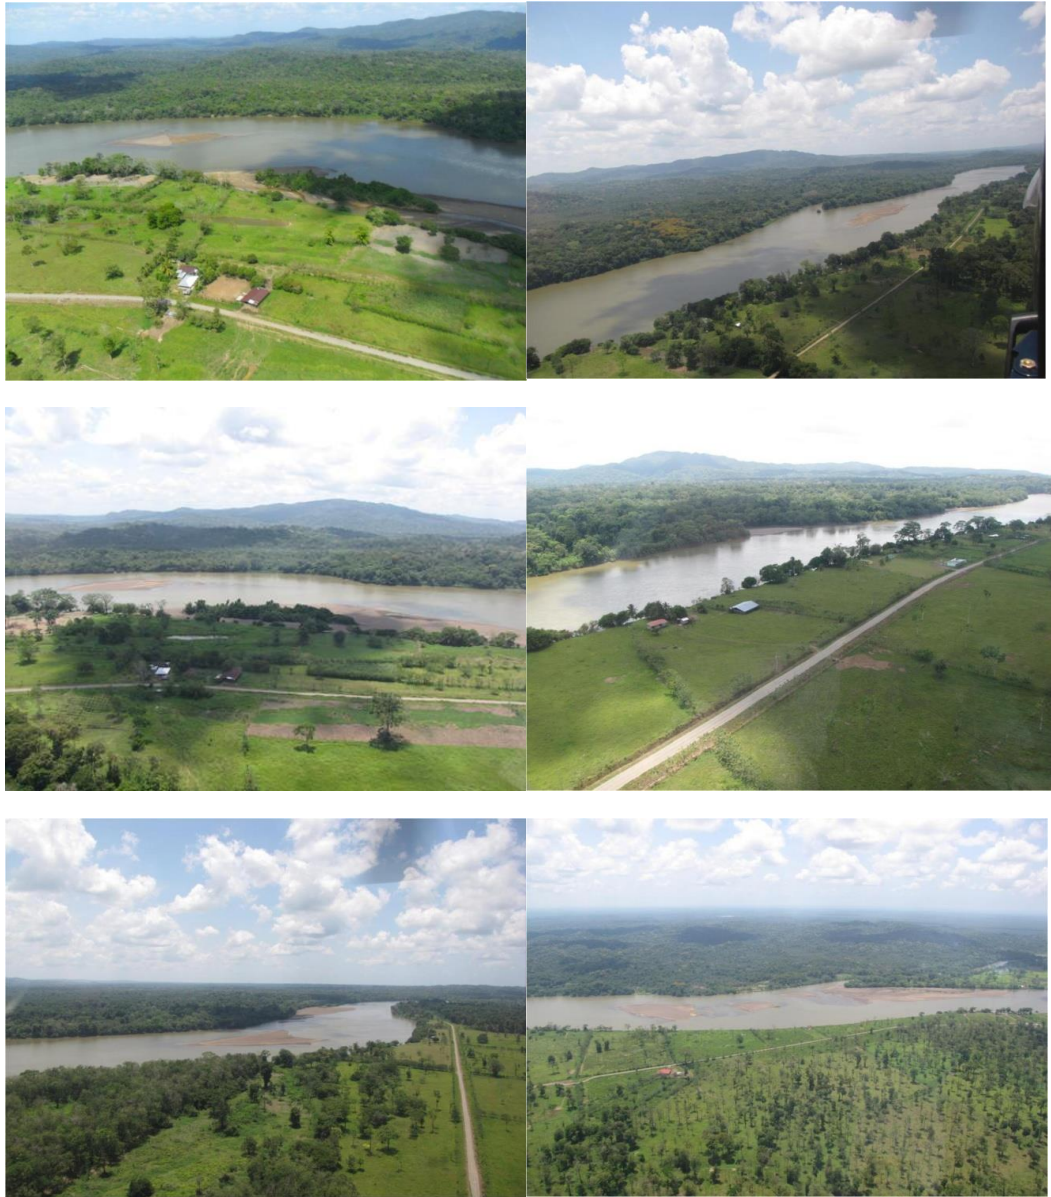
Figure 4. Photographs representative of conditions along the Road between Boca Sarapiquí and the Delta observed from the air by the author on February 16, 2013.

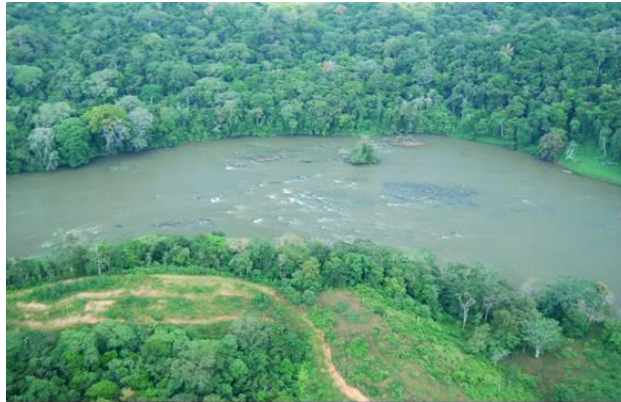
Figure 9. Example of rapids that control the bed elevation and long-stream slope of the Río San Juan between the confluence with the Río Pocosal and Boca San Carlos. These particular rapids are located just downstream of Río Infiernito tributary confluence.

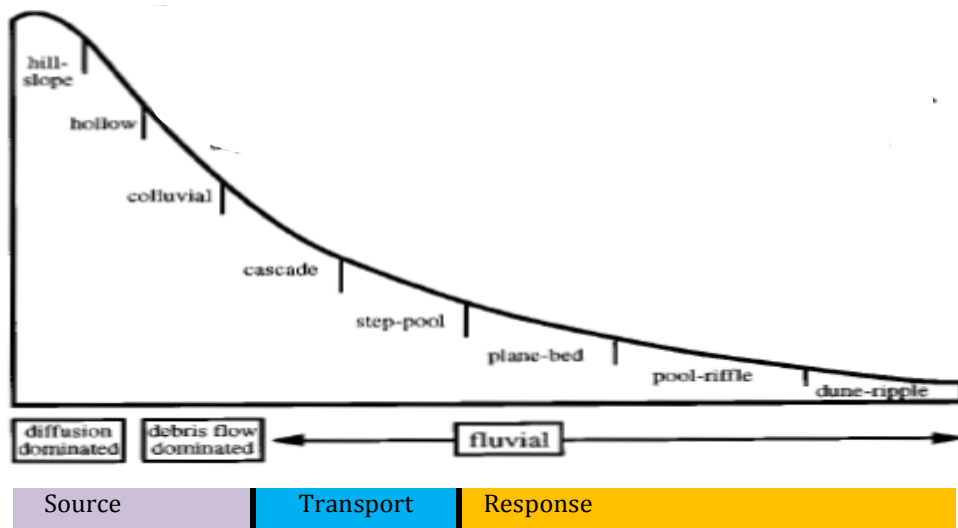
Figure 10. Typical river long profile from source to sea. Note the concave shape with a gradient that is steep in the upper course, gentle in the middle course and low in the lower course. Annotations represent the Montgomery-Buffington (1997) stream classes based on channel type and the ratio between sediment transport capacity and supply (see Figure 11). Modified from Montgomery and Buffington (1997).

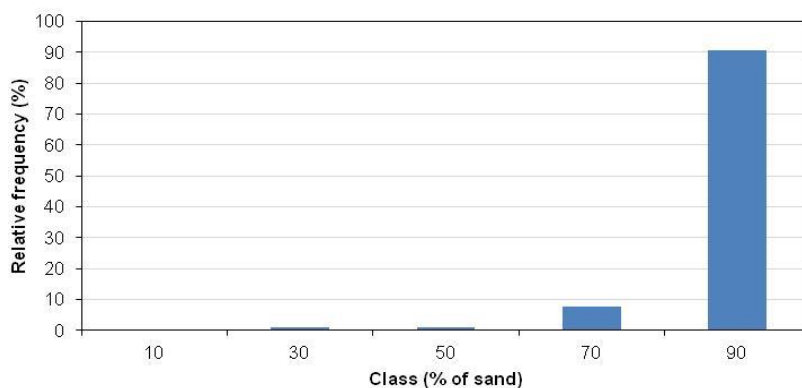
Figure 19. Frequency distribution of the sand percentages in all bed load samples, indicating that downstream of Boca San Carlos 90% of the bed of the Río San Juan is formed in mobile sand.

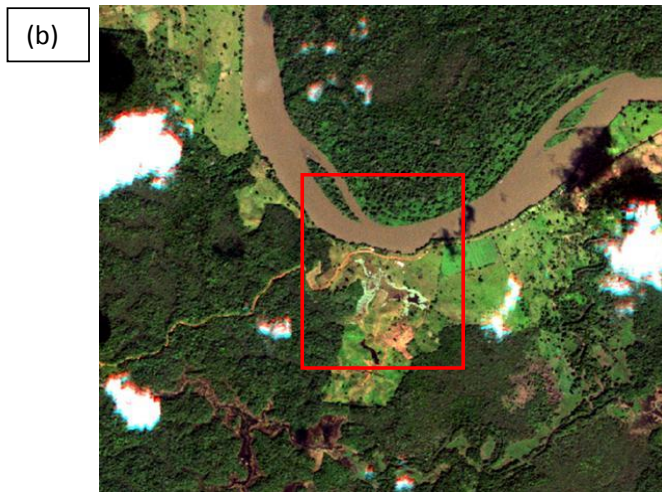
Figure 21. (a) Figure 4 from page 18 of the 2012 Kondolf Report. (b) Rapideye image of areas around Isla Relej – Palo Seco in 2009 supplied to Nicaragua by Spatial Solutions and in Figure 4 of the 2012 Kondolf Report. Red box indicates the area depicted in the left (2009) image in Figure 4 of the 2012 Kondolf Report. I obtained this image from Spatial Solutions in June 2013. Mr Jeff Campbell of Spatial Solutions supplied both images and he attested to me that the image in (b) is an exact duplicate, identical to the image he supplied to Nicaragua in 2012 - which was used to produce the left hand (2009, pre-Road) image in (a).

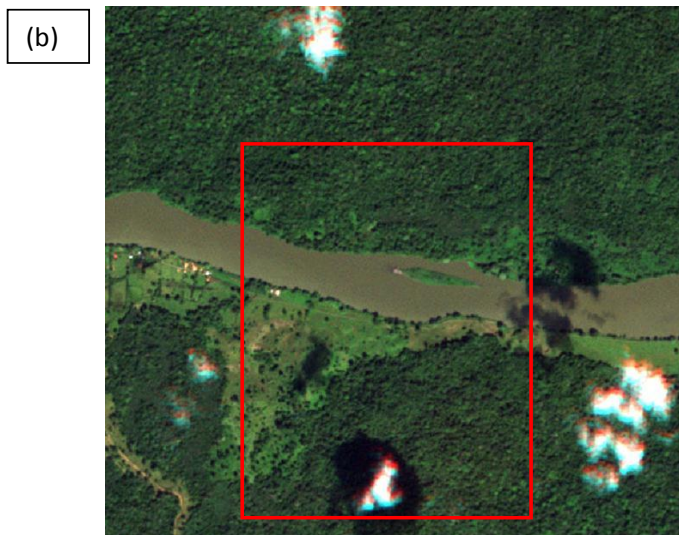
Figure 22. (a) Figure 5 from page 18 of the 2012 Kondolf Report. (b) Rapideye image of area around 2.3 km downstream from Boca San Carlos and across from the mouth of Quebrada Guapote in 2009, supplied to Nicaragua by Spatial Solutions and used in Figure 5 of the 2012 Kondolf Report. Red box indicates the area depicted in the left (2009) image in Figure 5 of the 2012 Kondolf Report. I obtained this image from Spatial Solutions in June 2013. Mr Jeff Campbell of Spatial Solutions supplied both images and he attested to me that the image in (b) is an exact duplicate, identical to the image he supplied to Nicaragua in 2012 - which was used to produce the left hand (2009, pre-Road) image in (a).

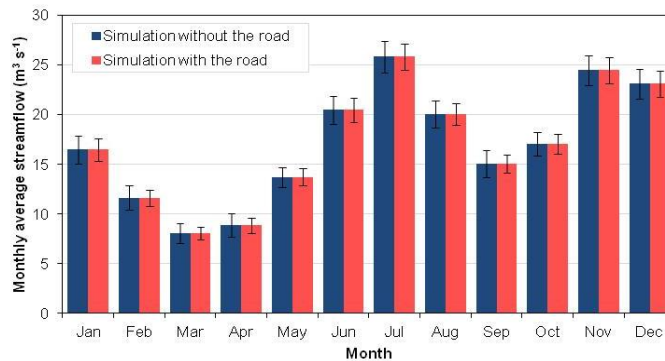
Figure 24. Mean monthly discharges from micro-basins draining to the Río San Juan with and without Route 1856. Bars indicate error margins (from 2013 ICE Report).

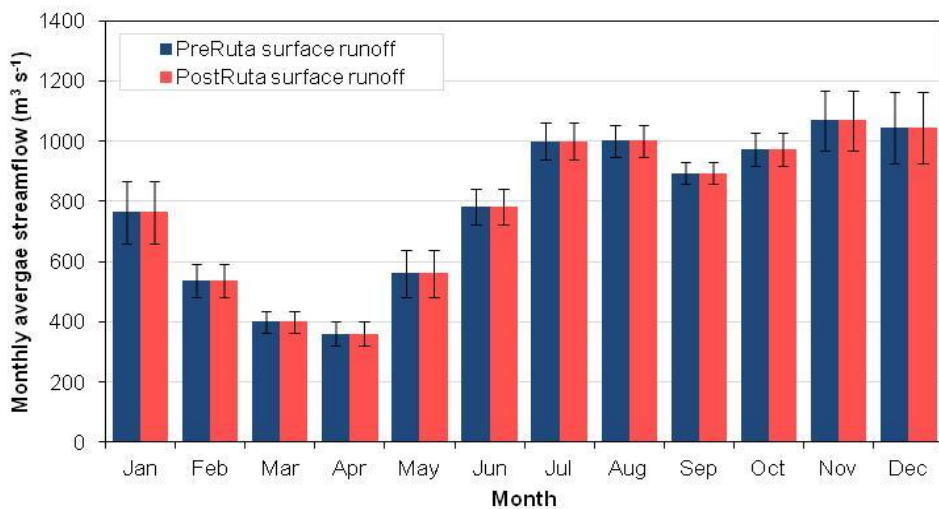
Figure 25. Monthly average stream flows for all Costa Rican tributary basins (micro and macro) draining to the Río San Juan under Pre- and Post-Route 1956 conditions. Times series generated from 1971 to 2006. Bars indicate error margins (from 2013 ICE Report).

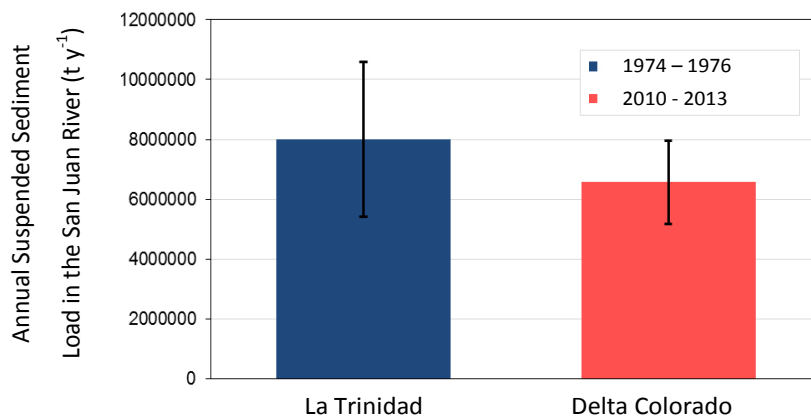
Figure 27. Mean annual suspended sediment loads in the Río San Juan based on measurements at La Trinidad (1974-1976) and Delta Colorado (2010-2013). Vertical bars indicate 95% confidence intervals. Note that the loads based on measurements at Delta Colorado station have been adjusted to represent the Río San Juan on the basis that at the Delta suspended load is divided in the same proportion as discharge (from the ICE Report).

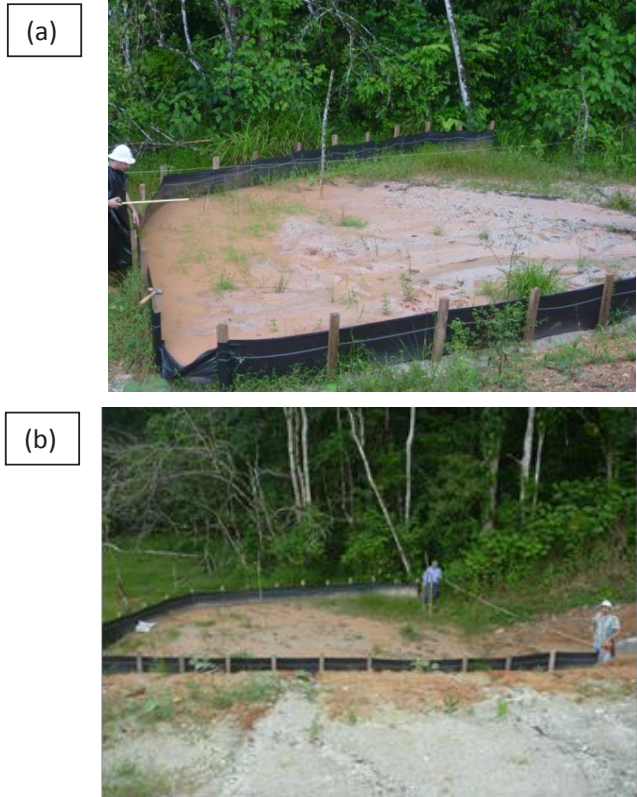
Figure 29. Sediment trap #2 on (a) 8 June and (b) 22 July 2013 (from the UCR Report).

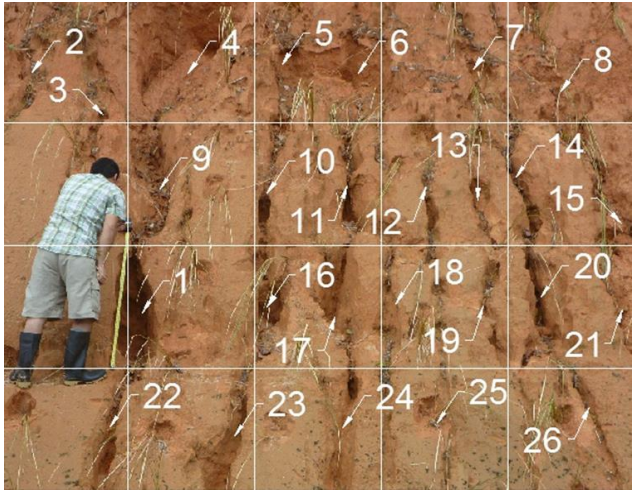
Figure 30. Rill erosion monitoring site on a cut slope, with rills numbered and 1 metre grid overlaid for scale (from the UCR Report).

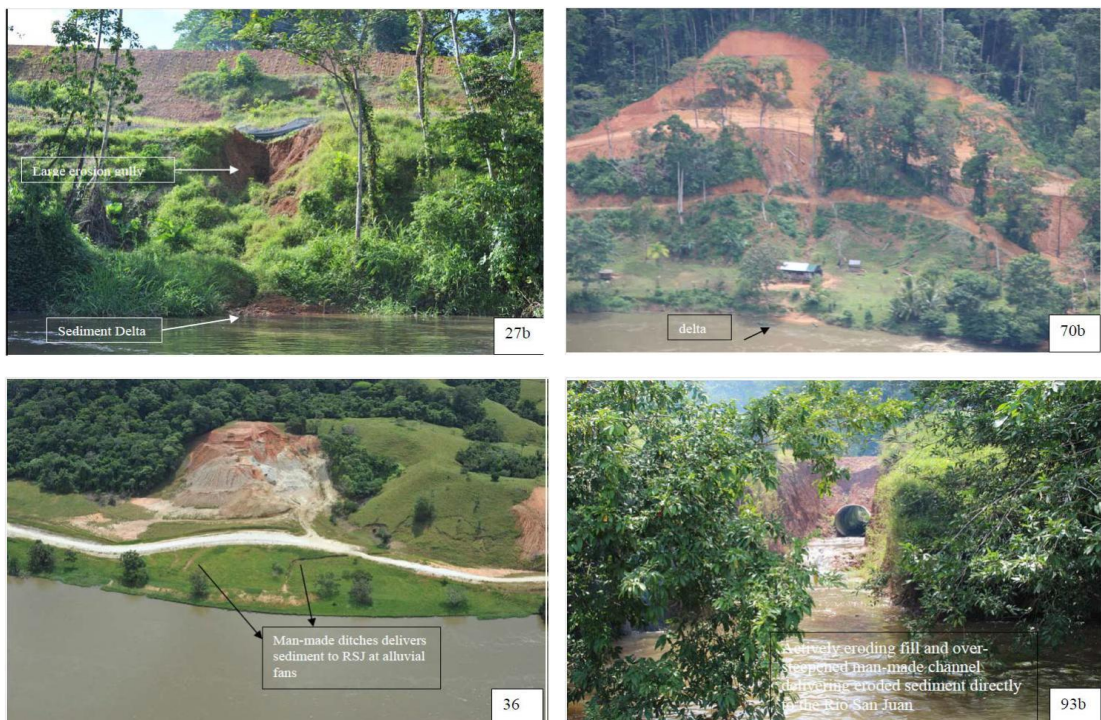
Figure 35. Photographs reproduced directly from Appendix B of the Kondolf Report. Dr Kondolf presumably selected them to be representative of the deltas of Road-derived he observed in October 2010. If so, the deltas he observed appear small and inconsequential in the context of this large River.

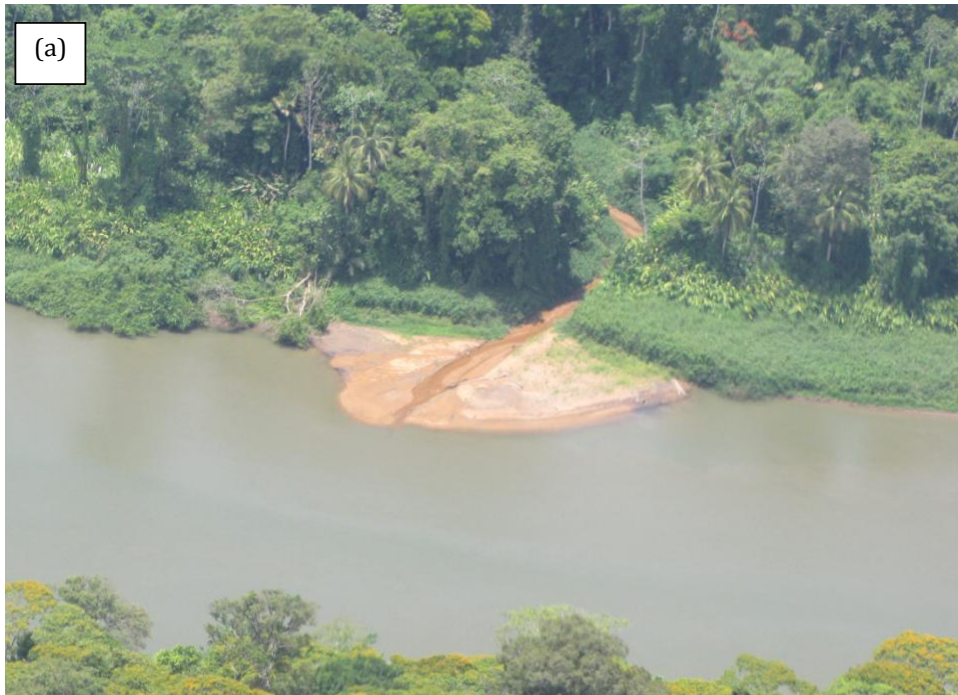
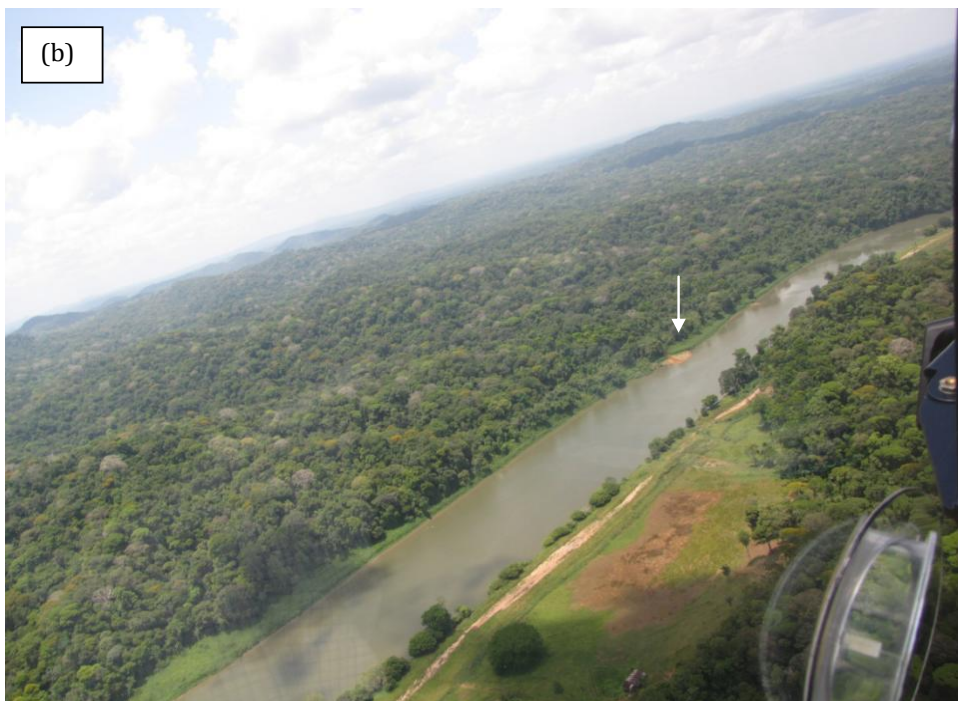
Figure 36. Prominent sediment delta observed in the Río San Juan from a helicopter in Costa Rican airspace on 7 May 2013 (a) close up and (b) wide angle view showing clearly that this delta is on the left (Nicaraguan) bank of the River. Route 1856 is clearly visible on the right (Costa Rican) side of the River (both photographs by author).

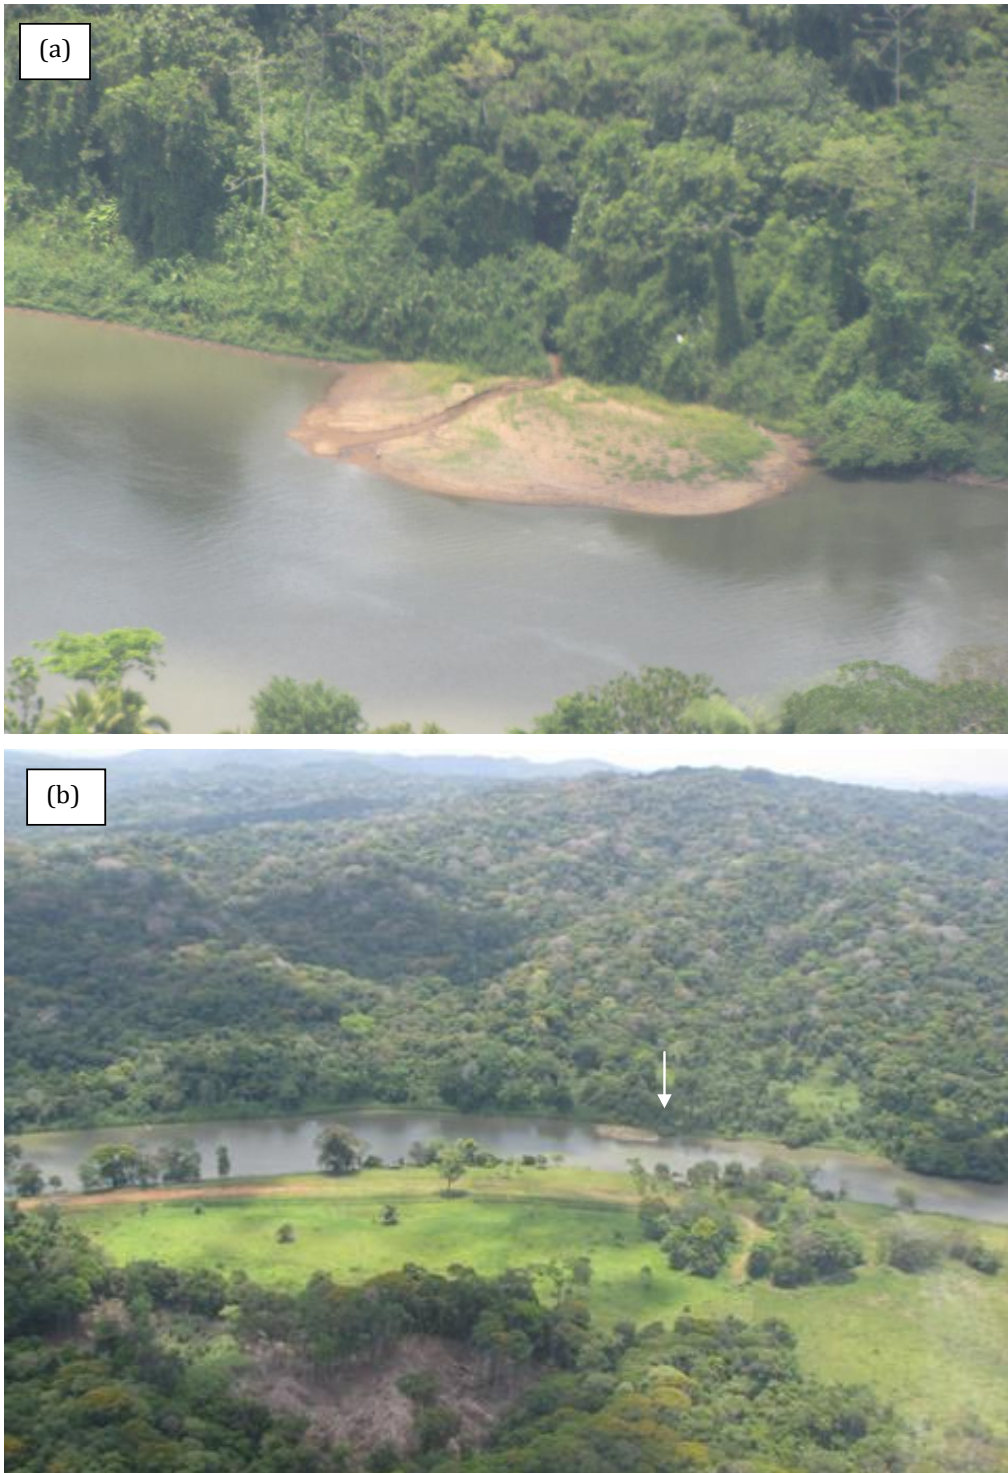
Figure 37. Sediment delta observed in the Río San Juan from a helicopter in Costa Rican airspace on 7 May 2013 (a) close up. (b) wide angle view showing clearly that this delta is also on the far (Nicaraguan) bank of the River. Route 1856 is clearly visible on the near (Costa Rican) side of the River (both photographs by author).

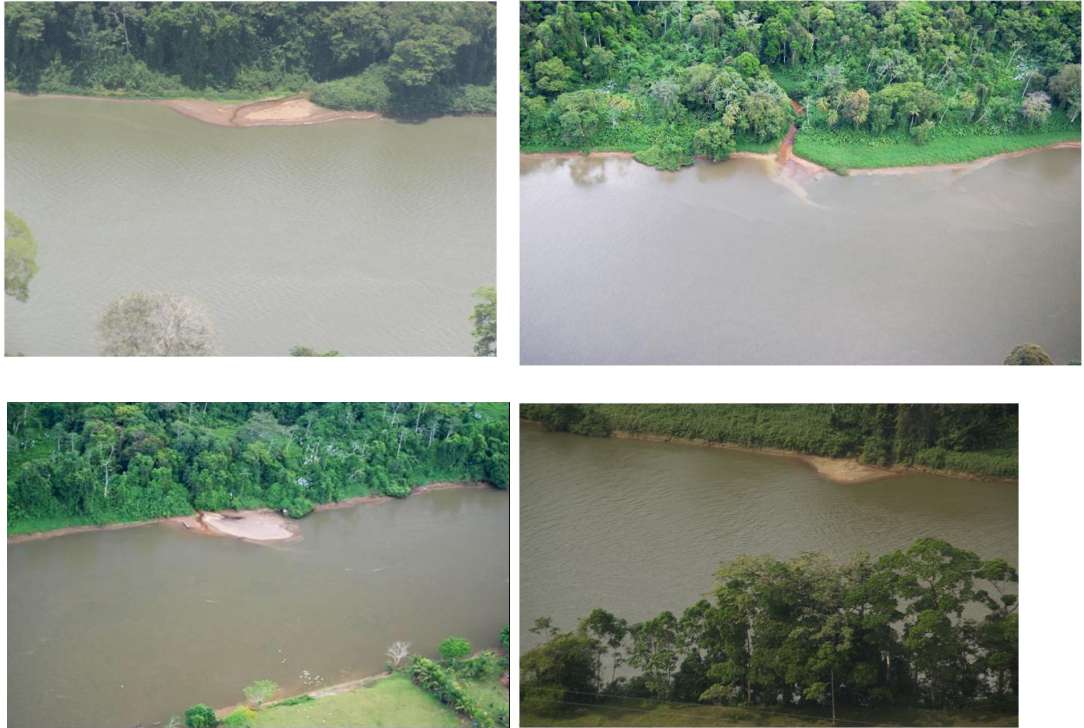
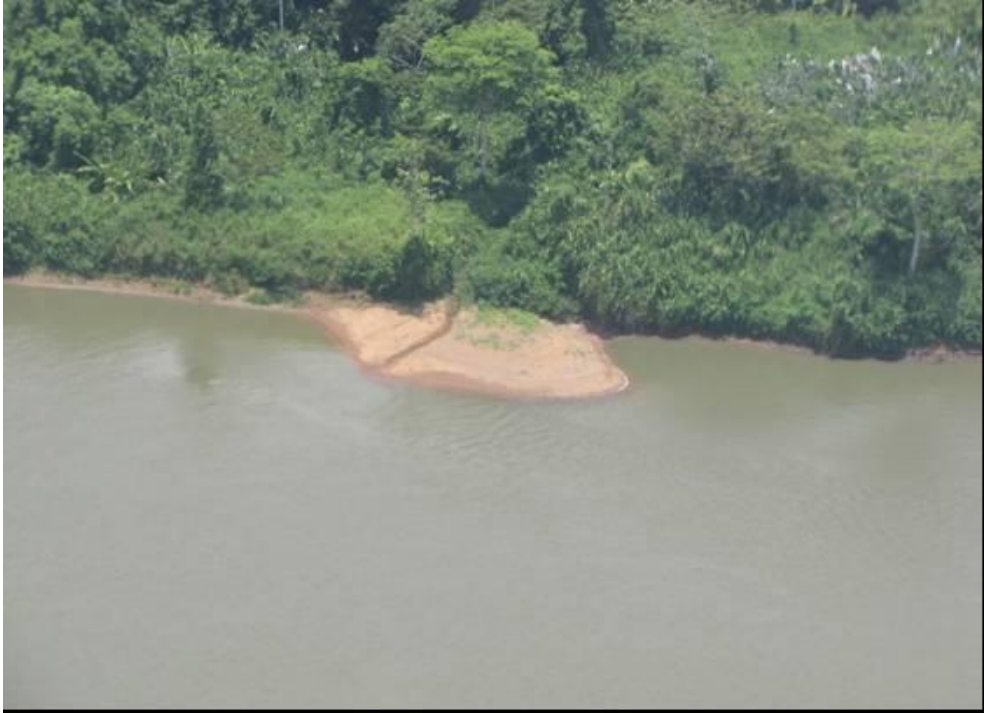
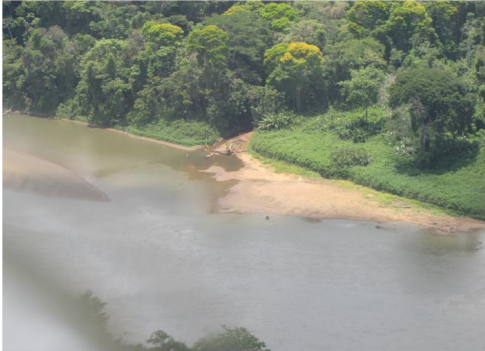
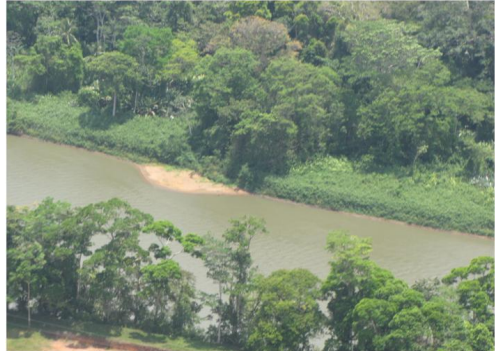
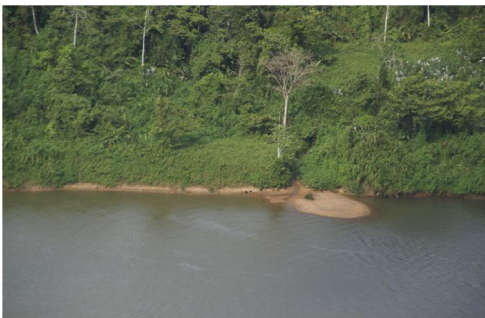
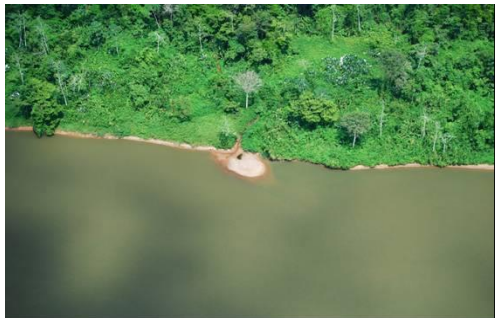
Figure 38. Photographs taken from Costa Rican air space on 7 May 2013. These show that deltas of sediment occur at most of the left bank tributaries of the Río San Juan between Marker II and Boca San Carlos. The deltas are unrelated to the Road and are formed by sediment delivered to the Río San Juan by streams draining catchments entirely within Nicaraguan territory.

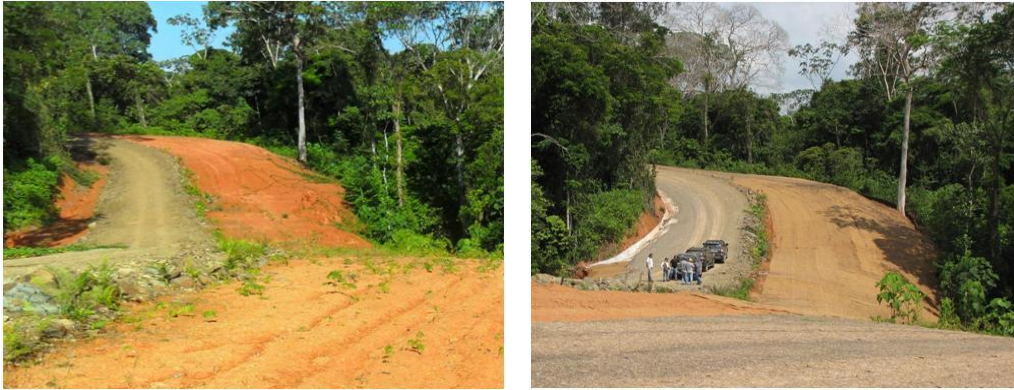
Figure 39. The Road near Marker II (a) prior to mitigation work on 15 February 2013 and (b) on 7 May 2013 with mitigation measures in place: note in-board drainage channel and extensive biodegradable, erosion control matting. Photographs by author.

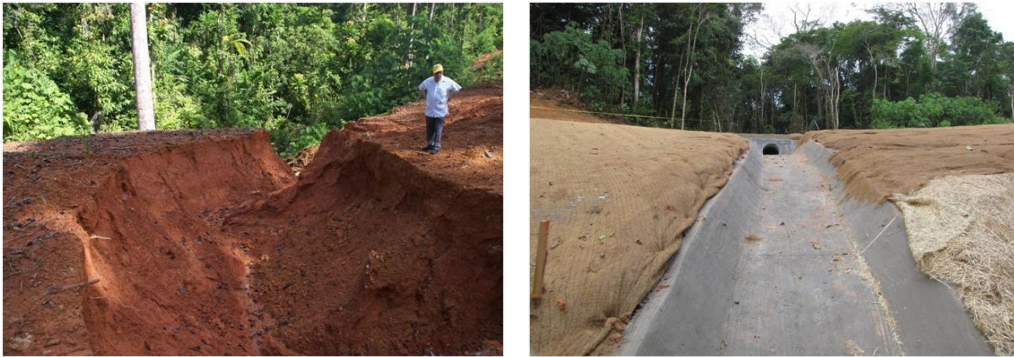
Figure 40. View down a large gully in a fill prism created by concentrated runoff from the Road draining to Costa Rican territory to the west of Marker II (a) in February when it was actively eroding and (b) in May when the gully had been back-filled and stabilized using a culverted cross-drain and concrete drainage channel, with coconut matting used to protect the surrounding fill slope from sheet and rill erosion. Photographs by the author.

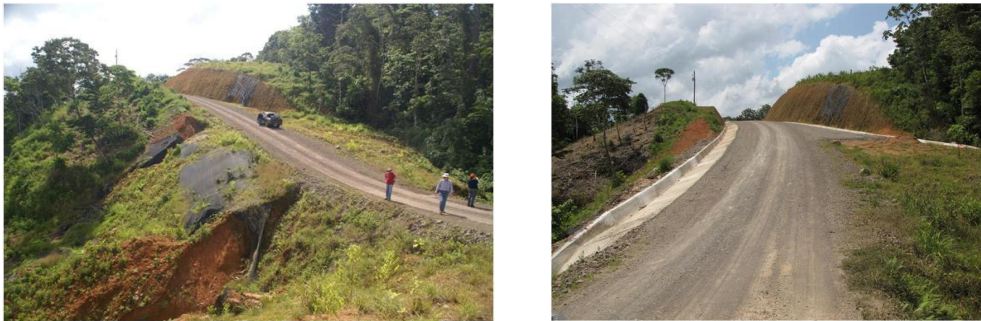
Figure 41. Road at East 497867, North 325463 about 6.4 km east of Marker II (a) on 15 February when failure of geotextile slope protection had allowed concentrated out-board runoff from the Road to create two gullies and in-board runoff was undercutting a cut slope (b) on 7 May 2013 after construction of concrete-lined out-board and in board ditches.

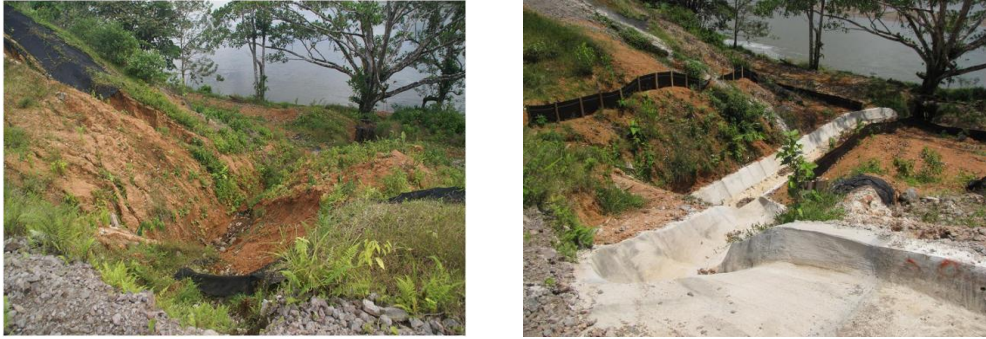
Figure 42. Road at East 498072, North 325345, about 6.6 km east of Marker II (a) on 15 February 2013 showing a network of gullies on an outboard slope and sediment accumulated as a run-out deposit on the flat terrace surface separating the foot of the slope from the bank of the Río San Juan (b) on 7 May 2013 showing mitigation works in the form of concrete channels and drop structures to convey runoff from the road bed, and silt fences to protect the slope from sheet and rill erosion, lined out-board and prevent road-derived sediment reaching the terrace. A sediment trap had also been constructed at the downstream termination of the gully system to prevent sediment reaching the River, though this cannot be easily identified in the photograph. Photographs by author.

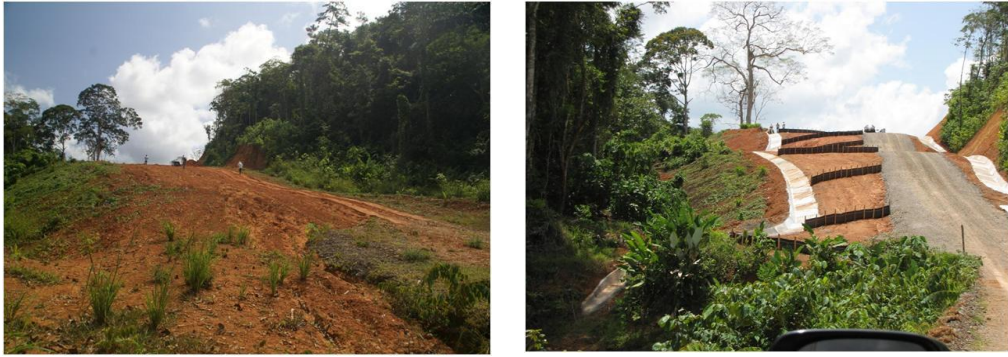
Figure 43. Road at East 502480, North 321561, close to the Río Infiernito (a) on 15 February when surface unmanaged runoff from the road bed and surrounding slopes disturbed during construction had caused sheet and rill erosion of bare soil surfaces. (b) The same stretch of road on 7 May 2013 after protection of the road surface using crushed rock, installation of silt fences to prevent sheet and rill erosion while directing down-slope surface runoff into concrete-lined outboard and inboard ditches. Photographs by author.

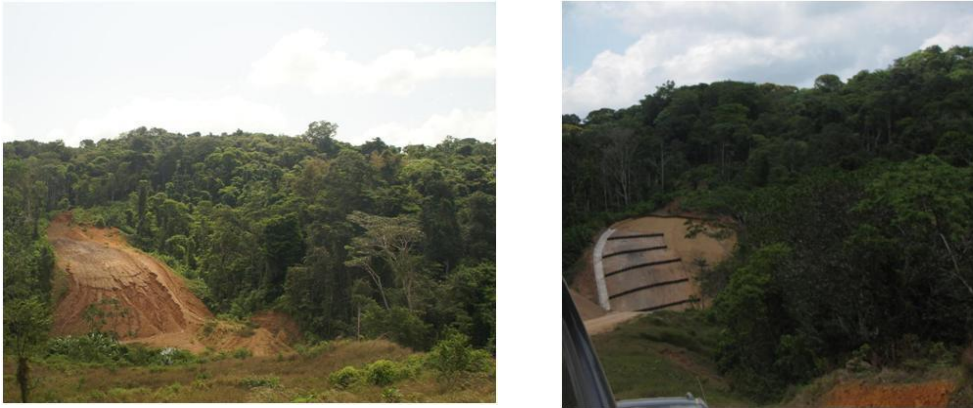
Figure 44. Path cleared for the Road near Crucitas, just east of the Rio Infiernito (a) on 15 February when unmanaged runoff from the path cleared in preparation for construction of the road bed had caused sheet and rill erosion. (b) The same area on 7 May 2013 after installation integrated measures to manage runoff involving regrading, silt fences, and concrete-lined outboard ditch. Photographs by author.
