INTERNATIONAL COURT OF JUSTICE

**DISPUTE CONCERNING
CONSTRUCTION OF A ROAD IN COSTA RICA ALONG THE SAN JUAN
RIVER
(NICARAGUA V. COSTA RICA)**

**REPLY
OF THE REPUBLIC OF NICARAGUA**

04 August 2014

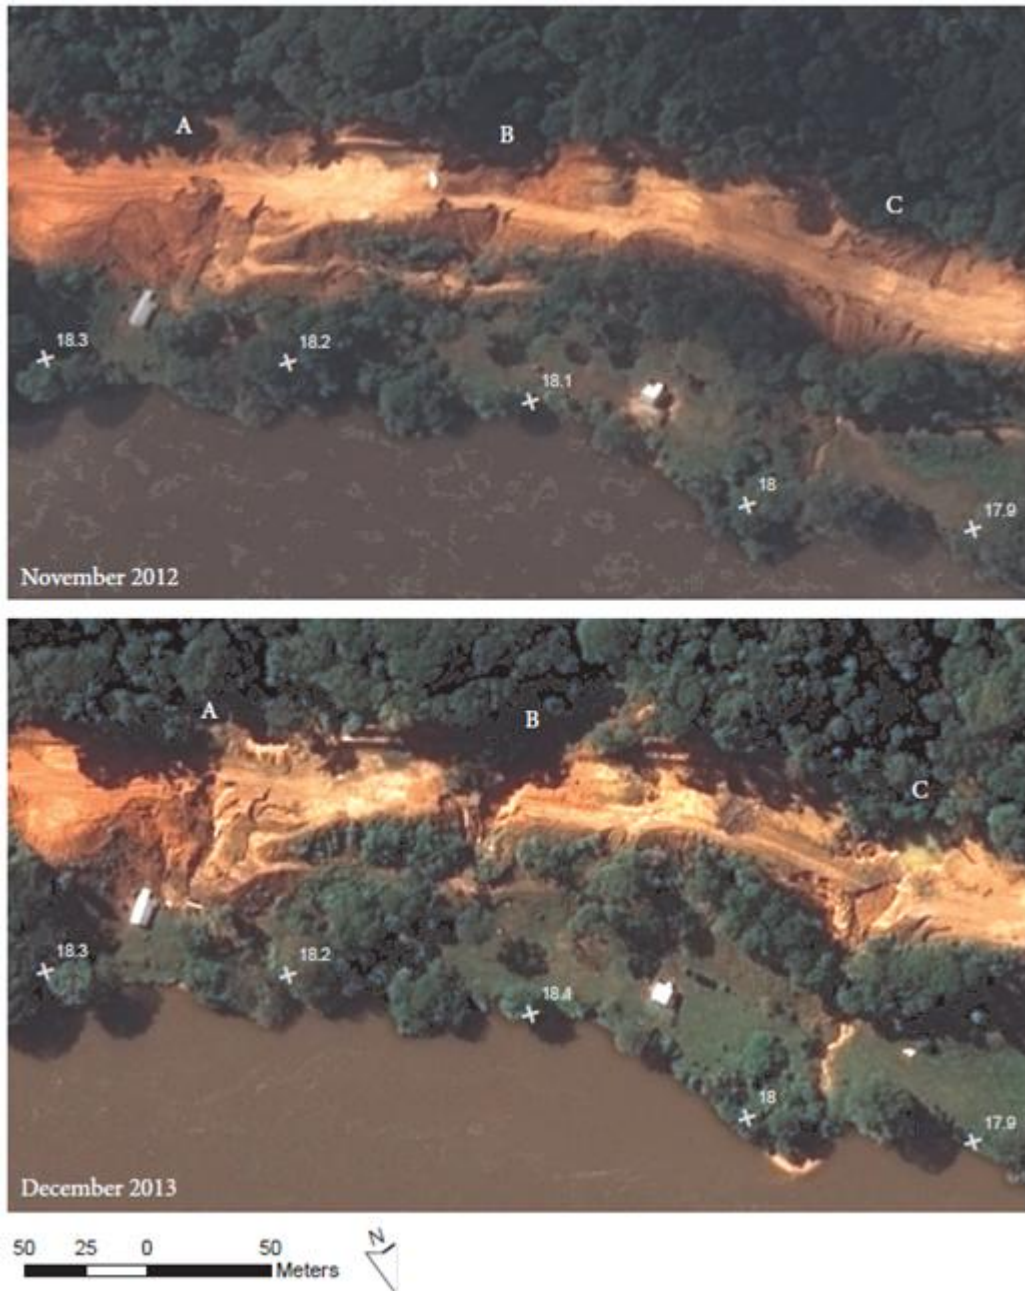
Figure 2.1. Comparison of satellite images from November 2012 and December 2013 at Las Crucitas fill crossings, 18.0-18.2 km downstream from Mojon II, demonstrating increased gullying and failure of the road surface and slopes.

2.14 Site “C” in the satellite images above corresponds to Site 9.4 in the Inventory of Severely Eroding Sites included as Appendix A to Dr. Kondolf’s 2014 Report.⁹⁰ The progressive worsening of the site’s erosion can be seen in the following three images: **Figure 2.2** from October 2012; **Figure 2.3** from December 2013; and **Figure 2.4** from May 2014.

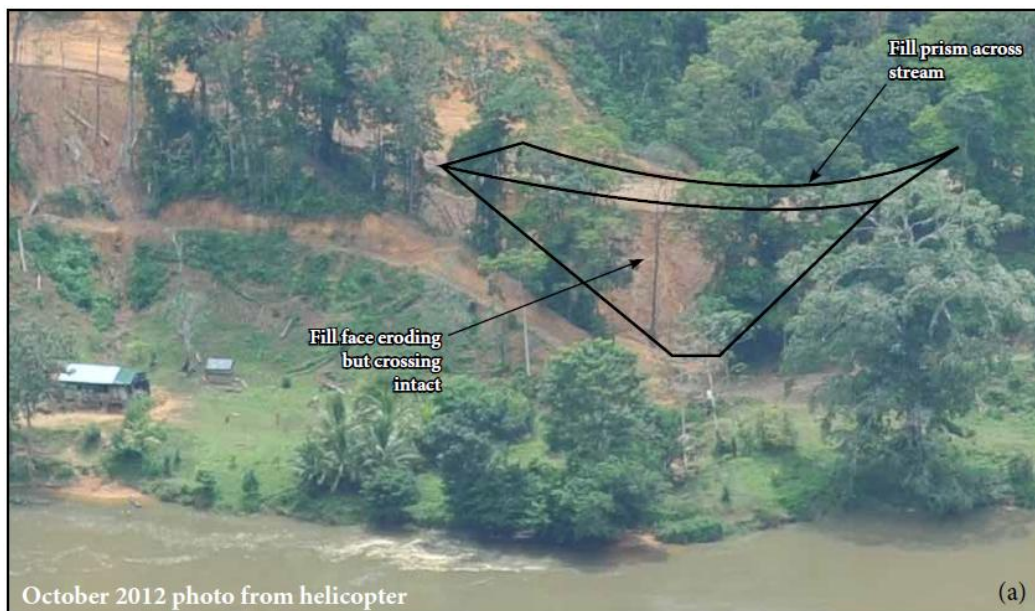
Figure 2.2. Severely Eroding Site 9.4, 18 km downstream of Mojon II. Oblique aerial view from October 2012.

2.15 When Dr. Kondolf inspected the site in October 2012, the fill prism blocking the stream that previously flowed into the River had a volume of approximately 21,900 m³.⁹¹ Although the fill prism was then still intact, the fill face was visibly eroded by rills, gullies and sheet erosion. Consistent with these findings, Mr. Hagans and Dr. Weaver describe the site as of 2012 as follows:

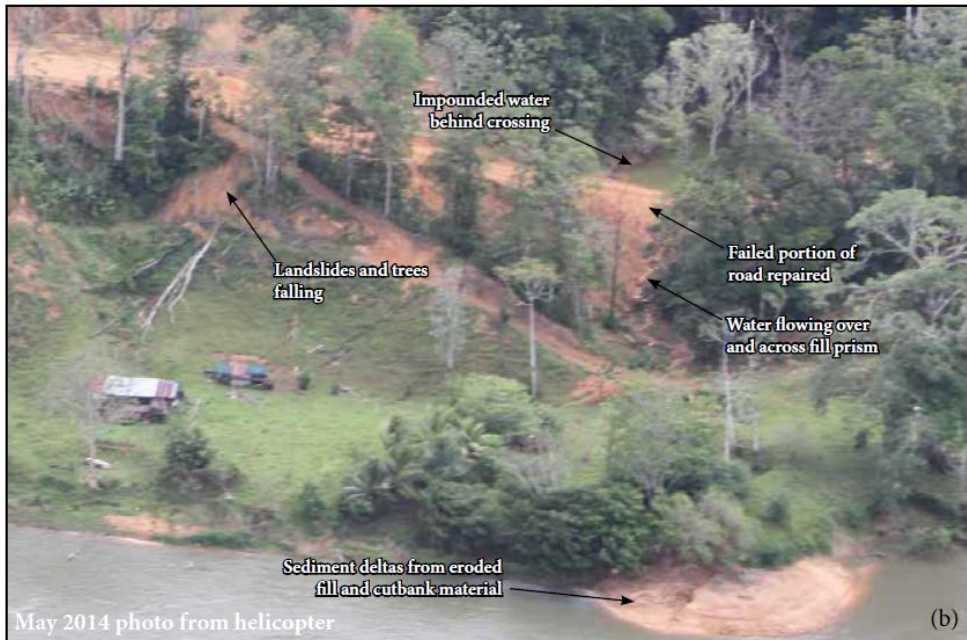
Figure 2.4. Severely Eroding Site 9.4, 18 km downstream of Mojon II.
Oblique aerial view from May 2013.

2.57 The delta caused by sediment eroding into the River from the site shown in **Figure 2.4** is also large. **Figures 2.22** and **2.23** provide closer views. Measurements taken on 30 March 2014 reveal that the delta extends 10 meters into the River, is 25 meters wide, and is 1.8 meters above the surface of the River.¹⁷⁰

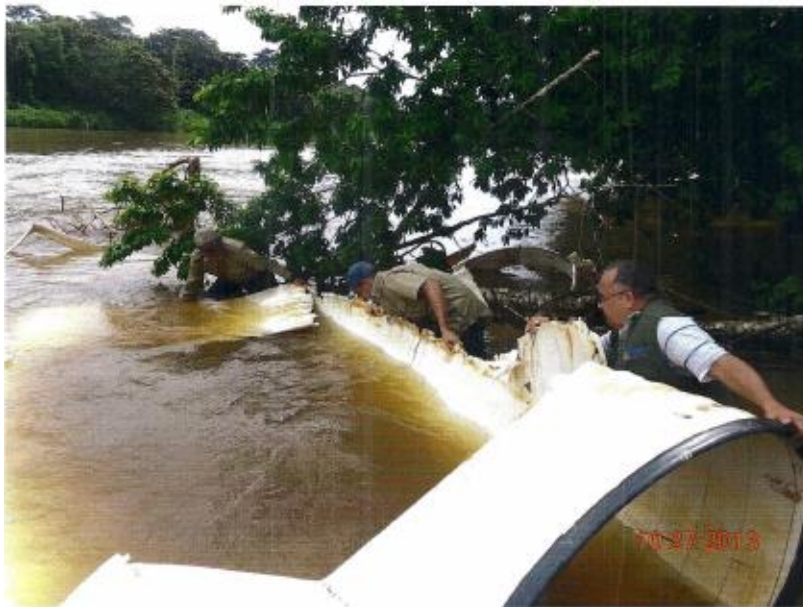
2.20 Portions of the initial inadequate culvert were transported to the River, and had to be removed by Nicaragua,¹⁰⁰ as shown in **Figure 2.5**.

Figure 2.5. Removal of culvert fragments from San Juan River adjacent to Severely Eroding Site 9.4, 18.0 km downstream of Mojon II. Photograph from October 27, 2013.

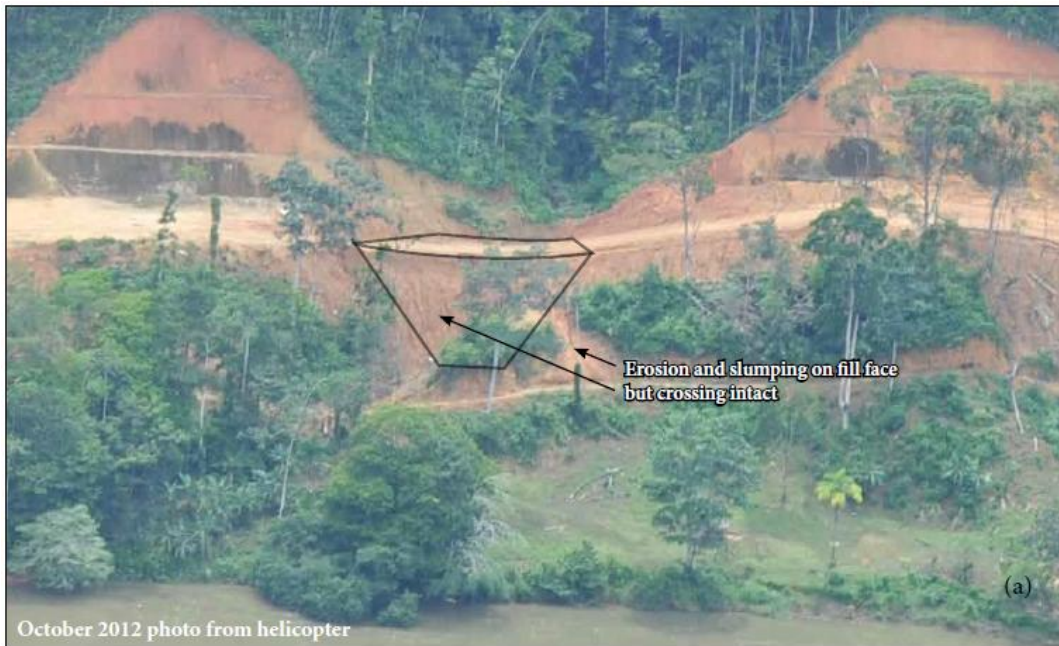
Figure 2.6. Severely Eroding Site 9.5, 18.1 km downstream of Mojon II. Oblique aerial view from October 2012.

2.26 This shows a substantially altered landscape. A large amount of excavated sediment -- approximately 12,000 m³ -- has been placed in the path of a stream that used to feed directly into the San Juan River.¹⁰⁹ Unfortunately, as Dr. Kondolf explains, this fill “appears to have been simply dumped and pushed in place by trucks and bulldozers, and not compacted or otherwise engineered and its

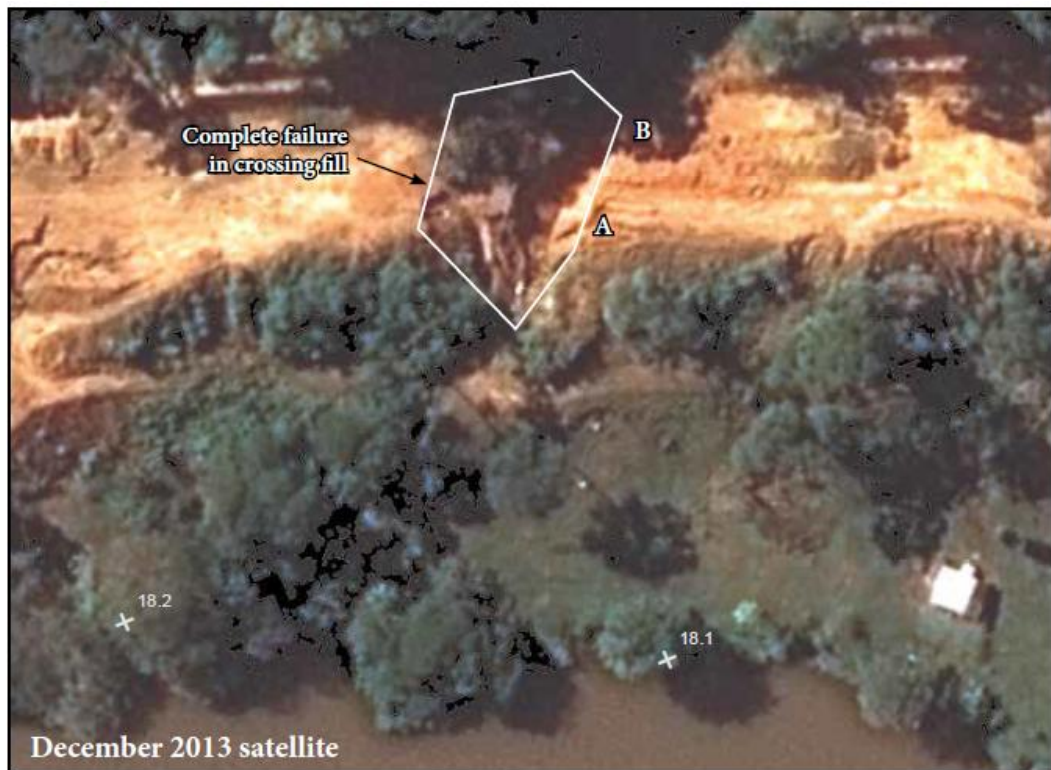
Figure 2.7. Severely Eroding Site 9.5, 18.1 km downstream of Mojon II.
High-resolution satellite image of December 2013.

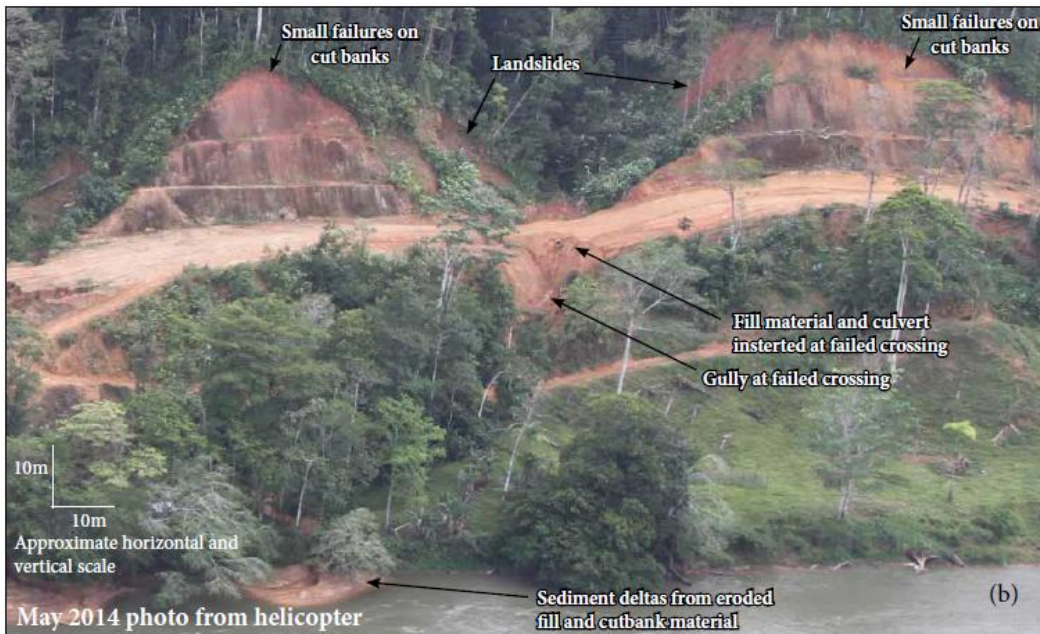
Figure 2.8. Severely Eroding Site 9.5, 18.1 km downstream of Mojon II.
Oblique aerial view from May 2014.

2.30 As can be seen in the May 2014 photograph reproduced at **Figure 2.8** above, the failed crossing had by that time been reconstructed, with new fill having been placed in the void left by the prior failure.¹¹⁸ However, this did not solve the problem. Erosion had begun anew and the stream crossing failed again.¹¹⁹

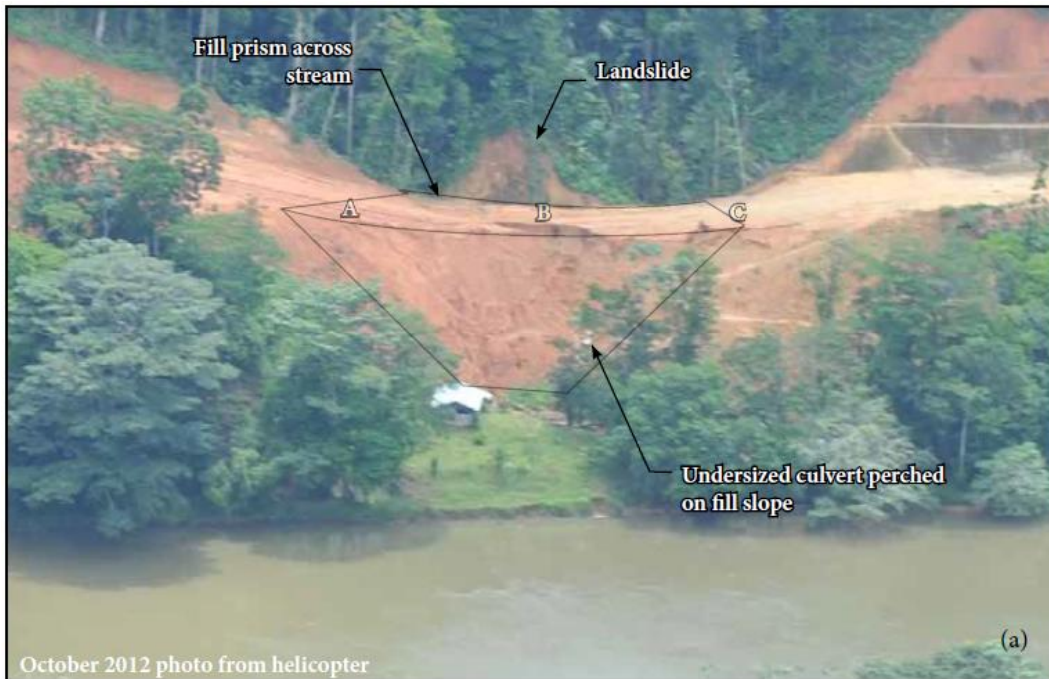
Figure 2.9. Severely Eroding Site 9.6, 18.2 km downstream of Mojon II.
Oblique aerial view from October 2012.

2.34 Once again, a stream crossing has been blocked with fill to allow the Road to cross over. Mr. Hagans and Dr. Weaver explain that this image shows that the site is already “undergoing serious deformation and erosion of the downstream fill slope very soon after construction.”¹²⁶ The amount of fill blocking the stream is much larger than in the preceding two examples, totaling approximately 44,000 m³ in volume.¹²⁷ In addition, the culvert, which is barely

visible in the lower right of the fill, is undersized and improperly placed.¹²⁸

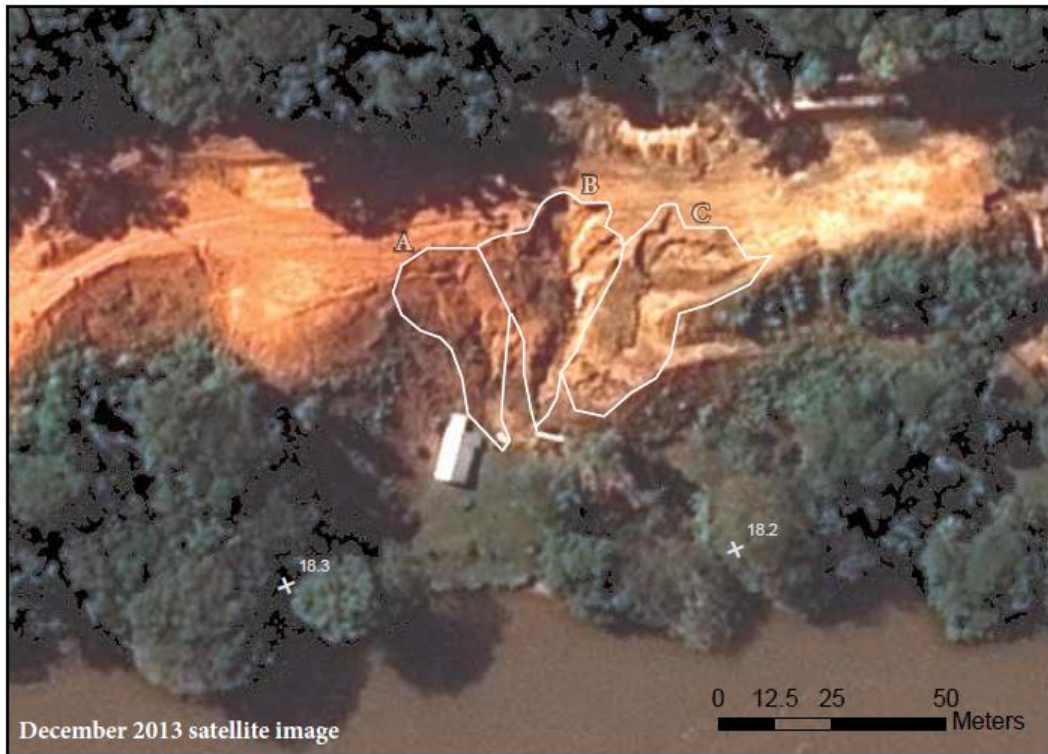
Figure 2.10. Severely Eroding Site 9.6, 18.2 km downstream of Mojon II.
High-resolution satellite image of December 2013.

2.37 Dr. Kondolf reports that “the[se] gullies measure 80 m across (in the direction parallel to the river bank), and 50 m horizontally from the headcuts down to the foot of the fill slope.”¹³³ He calculates that “the volume represented by these three gullies – the volume of sediment already eroded from the stream crossing fill prism – totals about 6,600 m³, or about 15% of the original total fill volume. This is a truly massive quantity of sediment, the equivalent of about 825

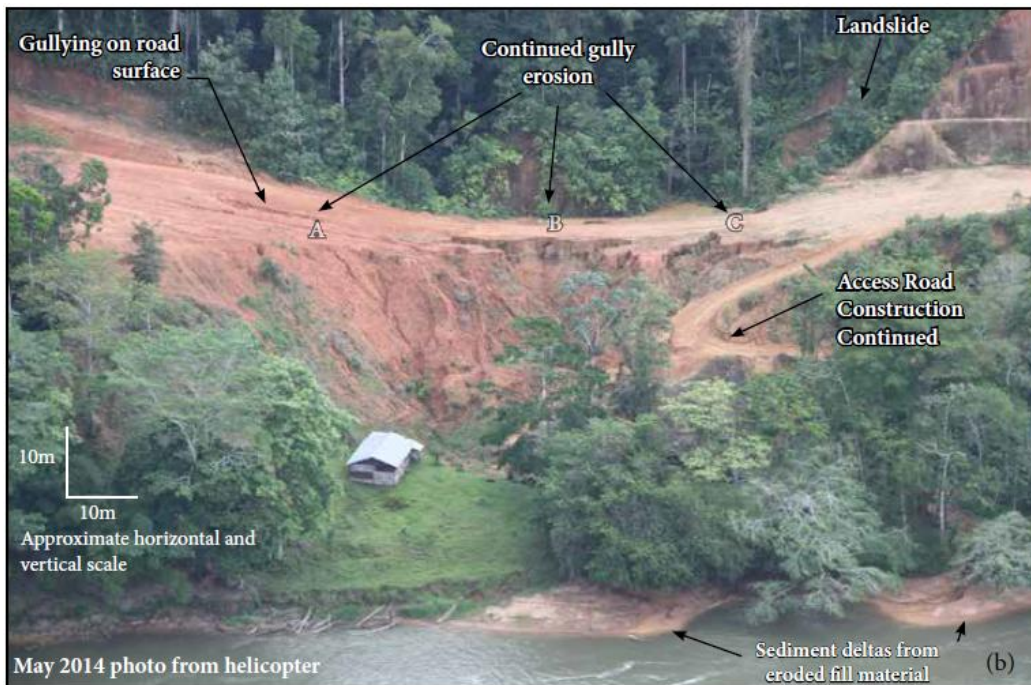
Figure 2.11. Severely Eroding Site 9.6, 18.2 km downstream of Mojon II. Oblique aerial view from May 2014.

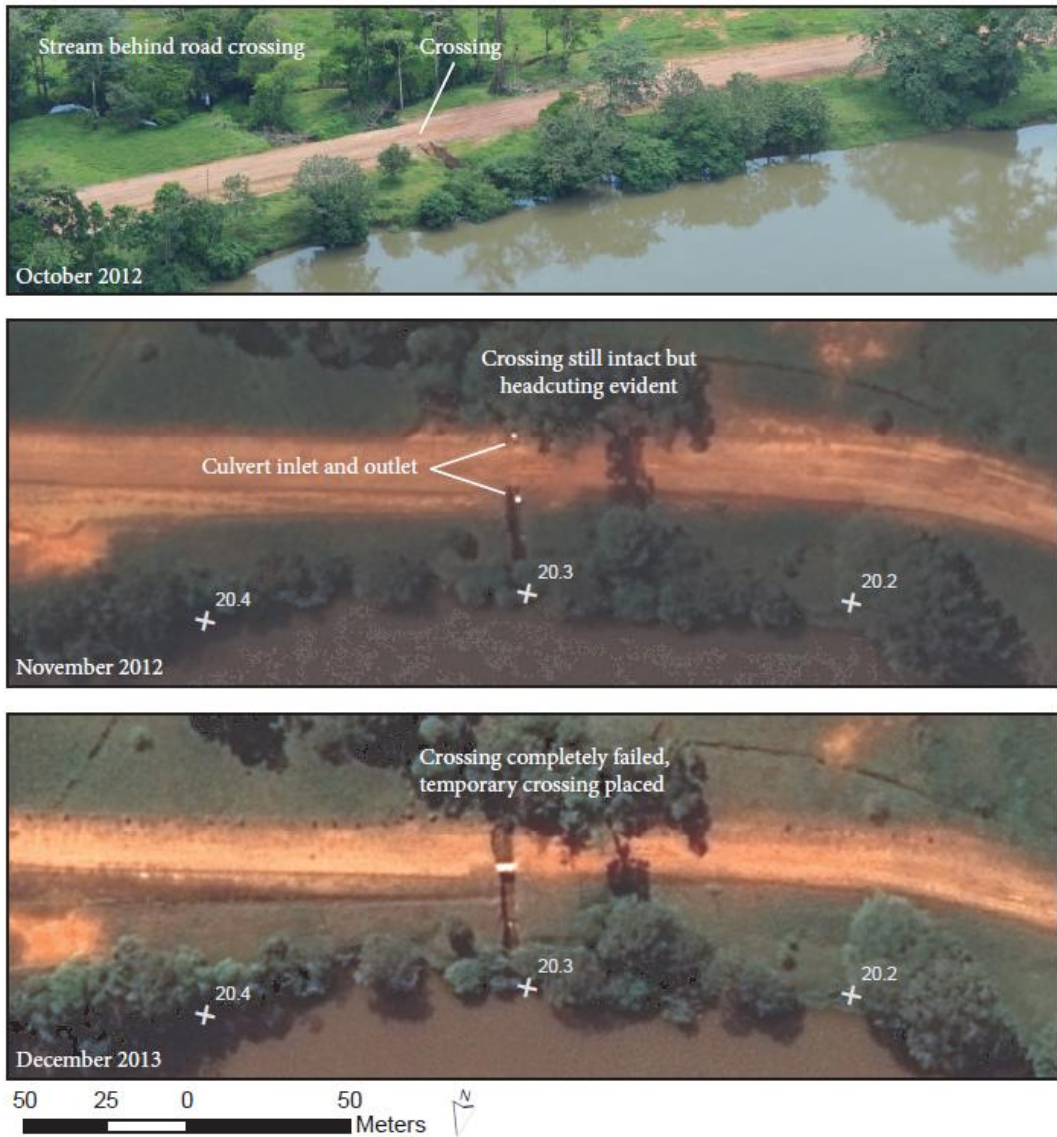
Figure 2.12. Helicopter and satellite imagery of failed fill crossing on flat land 20.3 km downstream of Mojon II.

2.40 When Dr. Kondolf first observed this site in October 2012, erosion was already evident at the edge of the stream crossing (top). By December 2013 (bottom), the crossing had failed completely, and both the fill and the culvert that

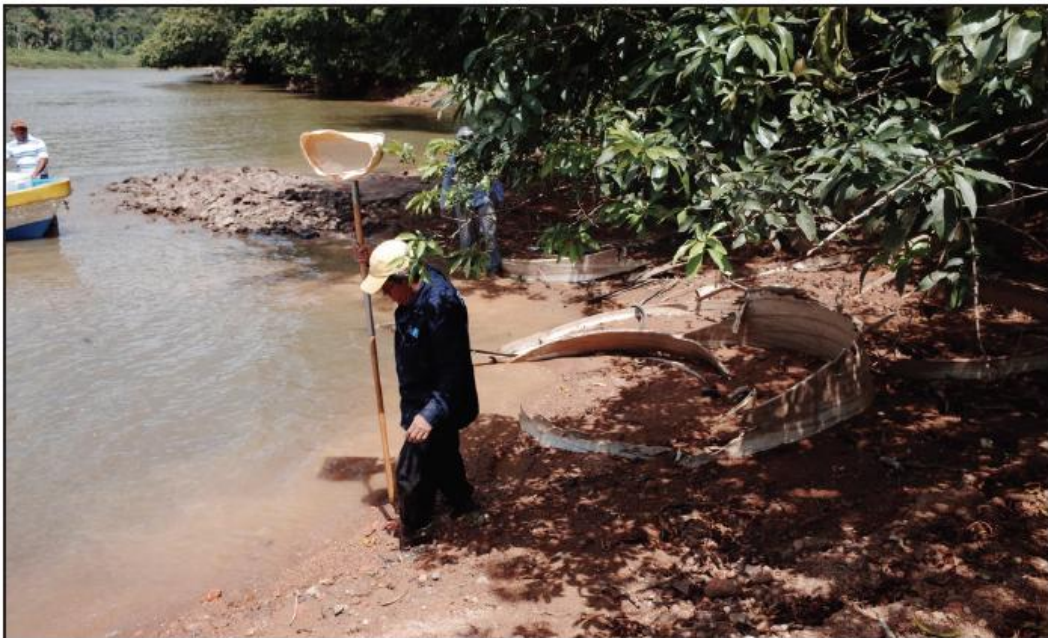
Figure 2.13. Broken culvert pipes and fill material extending into the San Juan River at location of stream crossing failure on flat land. Photograph from March 31, 2014.

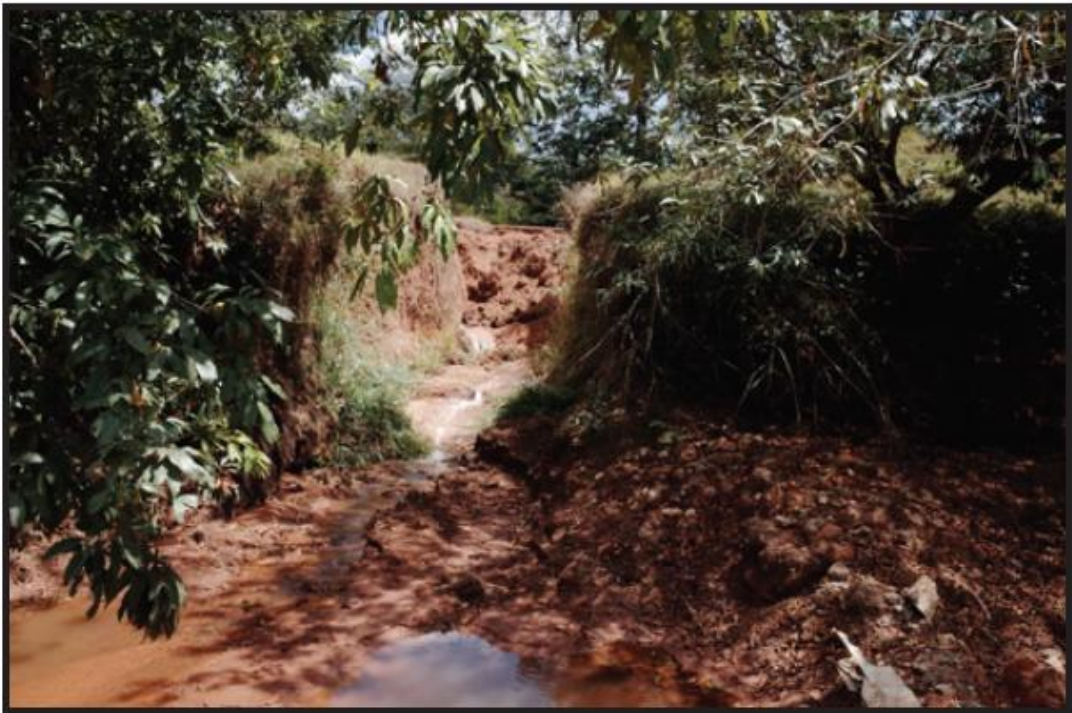
2.41 Since that failure, the crossing has been re-filled with fill material, only this time without the benefit any culvert at all, as can be seen in **Figure 2.14** below.¹⁴³ Consequently, water from the stream is flowing directly over the

Figure 2.14. Fill placed in channel with no culvert to provide temporary crossing, allowing water to flow over the fill. Photograph from March 31, 2014.

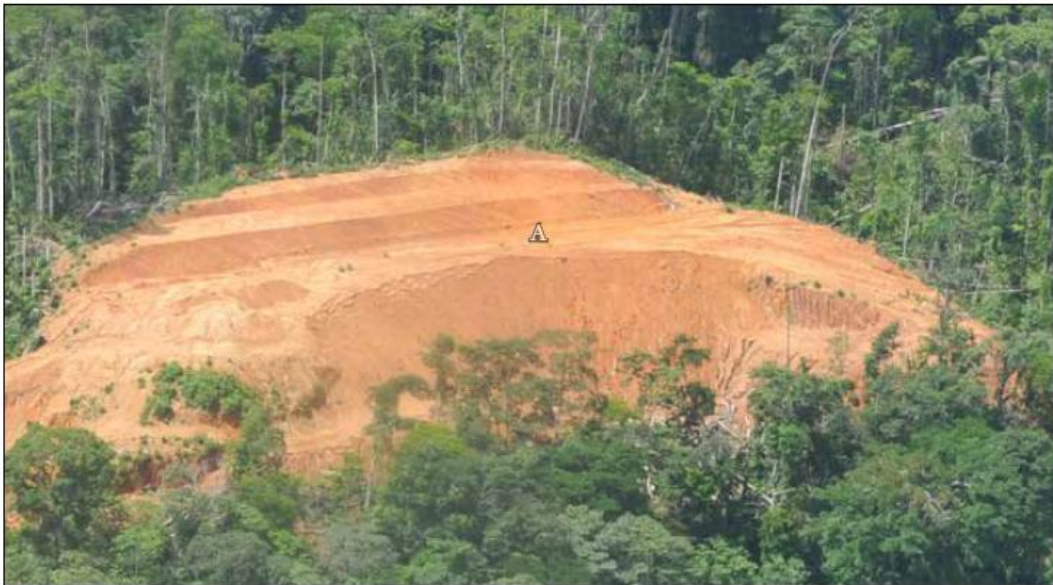
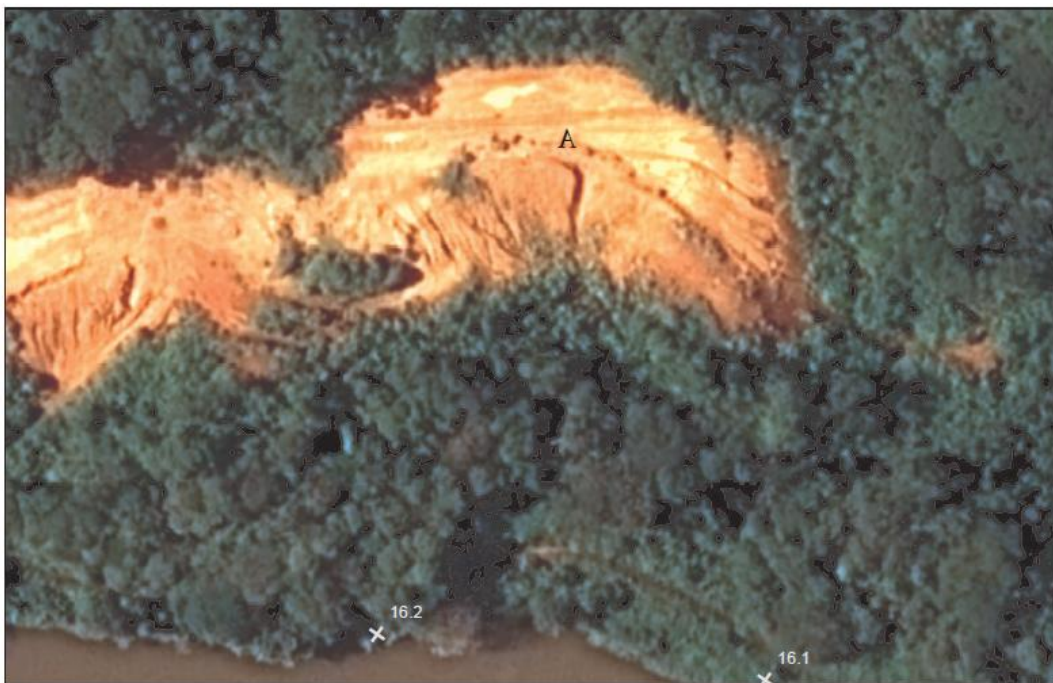
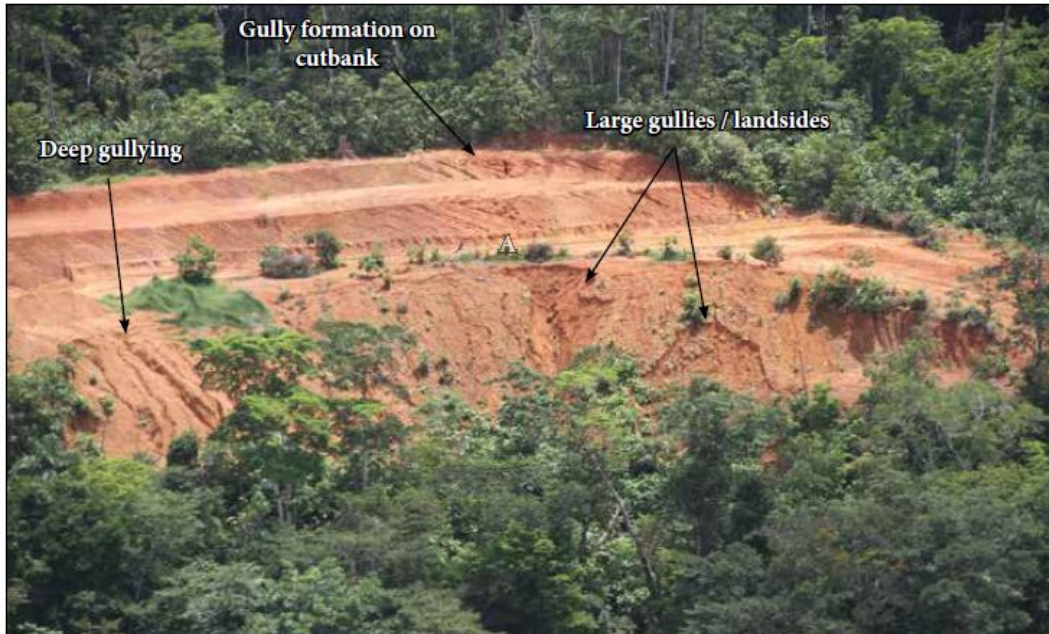
Figure 2.15. Severely Eroding Site 8.1, 16.1 km downstream of Mojon II.
Oblique aerial view from October 2012.

Figure 2.16. Severely Eroding Site 8.1, 16.1 km downstream of Mojon II.
High-resolution satellite image of December 2013.

Figure 2.17. Severely Eroding Site 8.1, 16.1 km downstream of Mojon II. Oblique aerial view from May 2014.

2.46 **Figure 2.15** is a photograph of the site taken from a helicopter in October 2012. **Figure 2.16** is a satellite image of the same site from December 2013. **Figure 2.17** is another helicopter-based photograph of the same site taken in May 2014. Comparison of the three images shows the effects of Costa Rica’s failure to take erosion-control measures, causing sediment to erode into the River. As Mr. Hagans and Dr. Weaver explain: “The sequence of three images captured in 2012, 2013 and 2014 indicate initial construction activities were completed along the road reach by October 2012, and no visible or substantive work on the failing road has been done since 2012.”¹⁵² In fact, “the only visible changes during the 20 month time period are actively developing, uncontrolled and

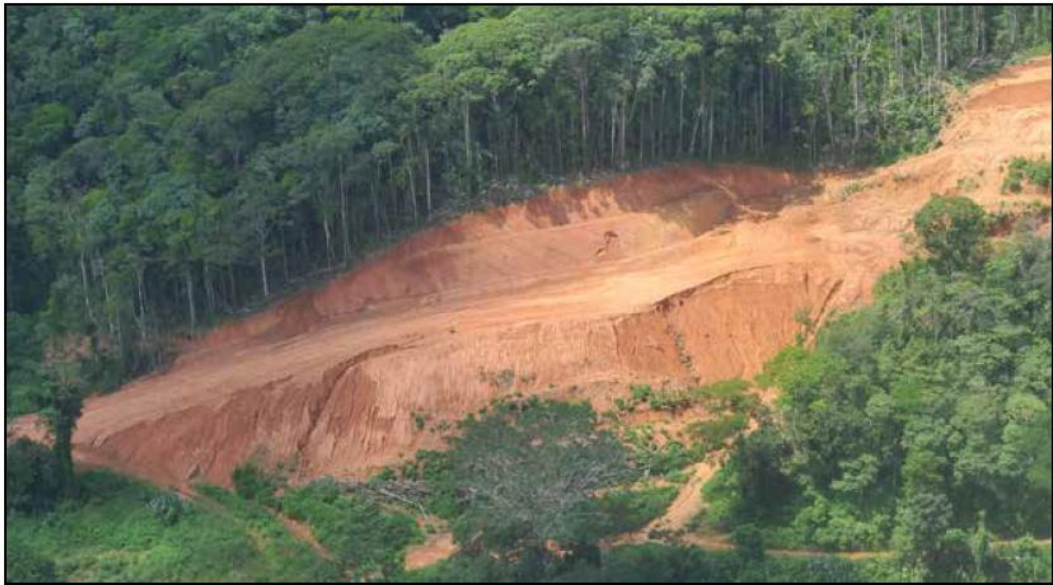
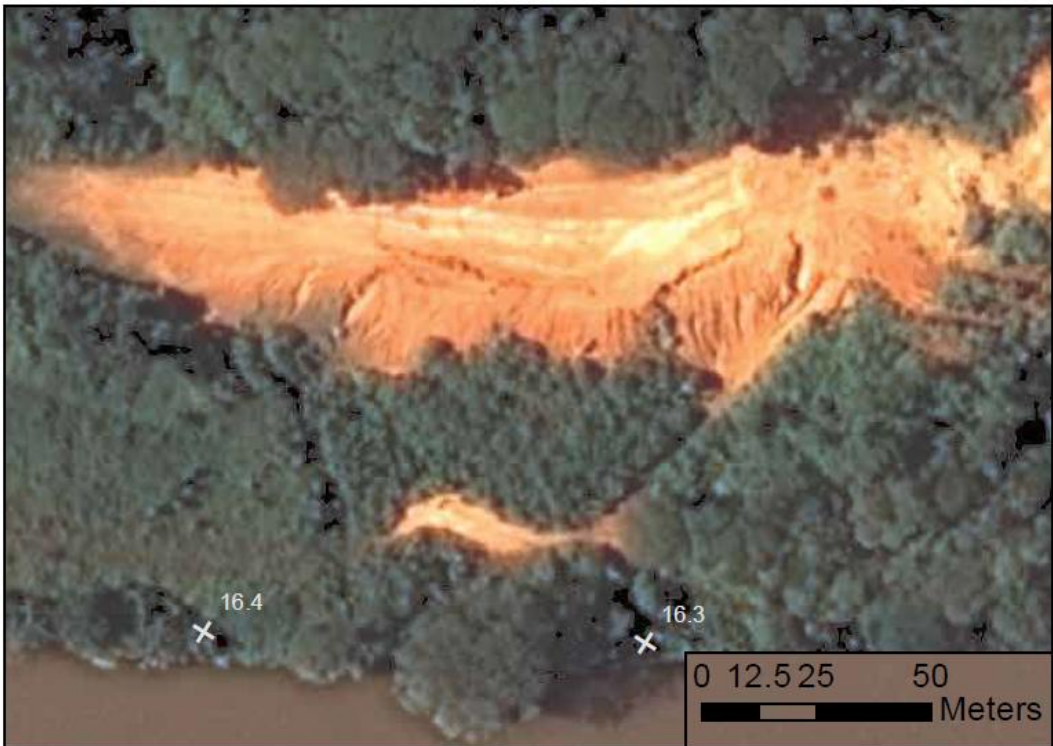
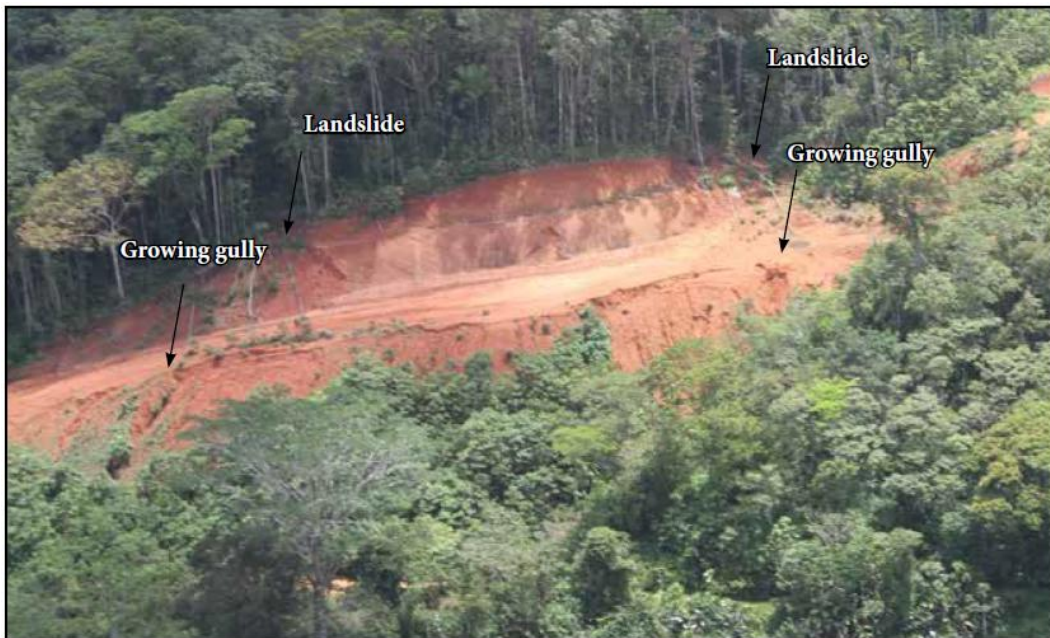
Figure 2.18. Severely Eroding Site 8.2, 16.2 km downstream of Mojon II.
Oblique aerial view from October 2012.

Figure 2.19. Severely Eroding Site 8.2, 16.2 km downstream of Mojon II.
High-resolution satellite image of December 2013.

Figure 2.20. Severely Eroding Site 8.2, 16.2 km downstream of Mojon II.
Oblique aerial view from May 2014.

2.50 In particular, Mr. Hagans and Dr. Weaver observe that in October 2012, there was already a “cut slope landslide” that may be seen “in the center of the photo.”¹⁶⁰ Also present in the photograph is a “developing arcuate crown scarp system along the outer edge of the road”; this indicates “pending fill slope failures within the un-compacted, loose sidecast fill materials that had been bulldozed onto the steep hill slope during road building.”¹⁶¹

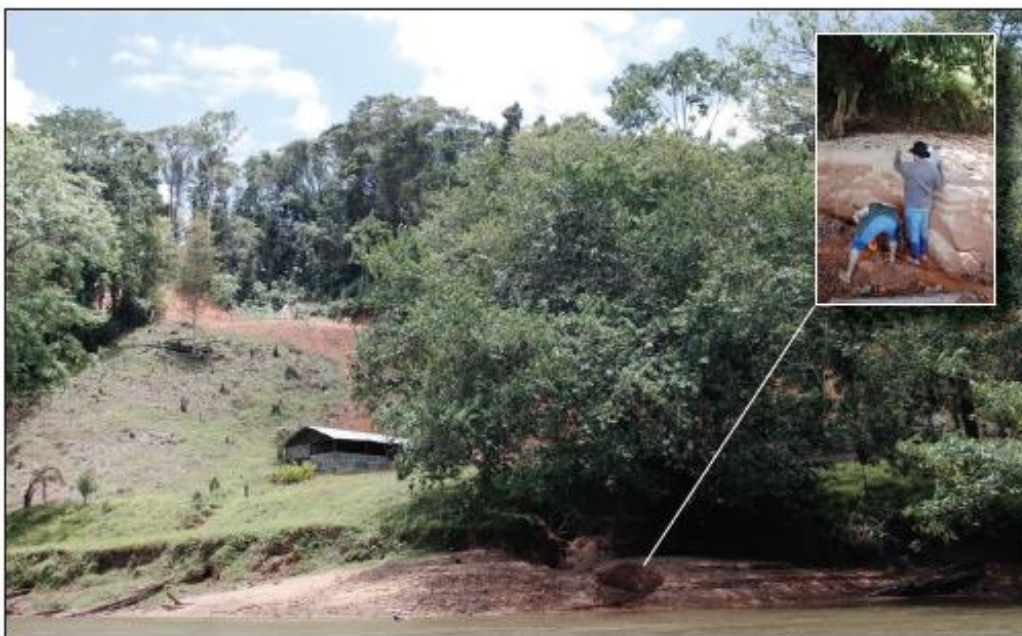
Figure 2.21. Delta deposit below Severely Eroding Site 9.6.
Photographs and measurements from March 30, 2014.

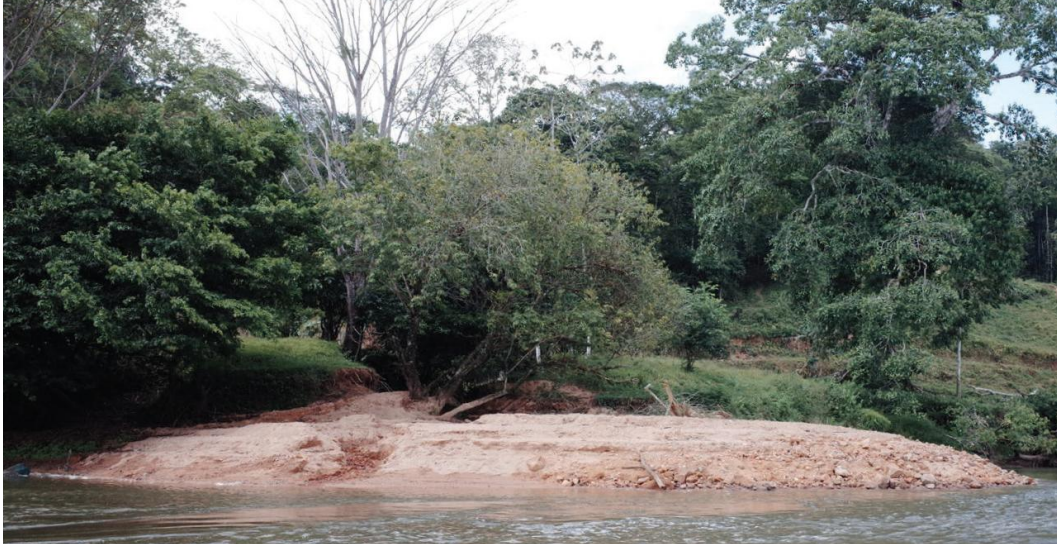
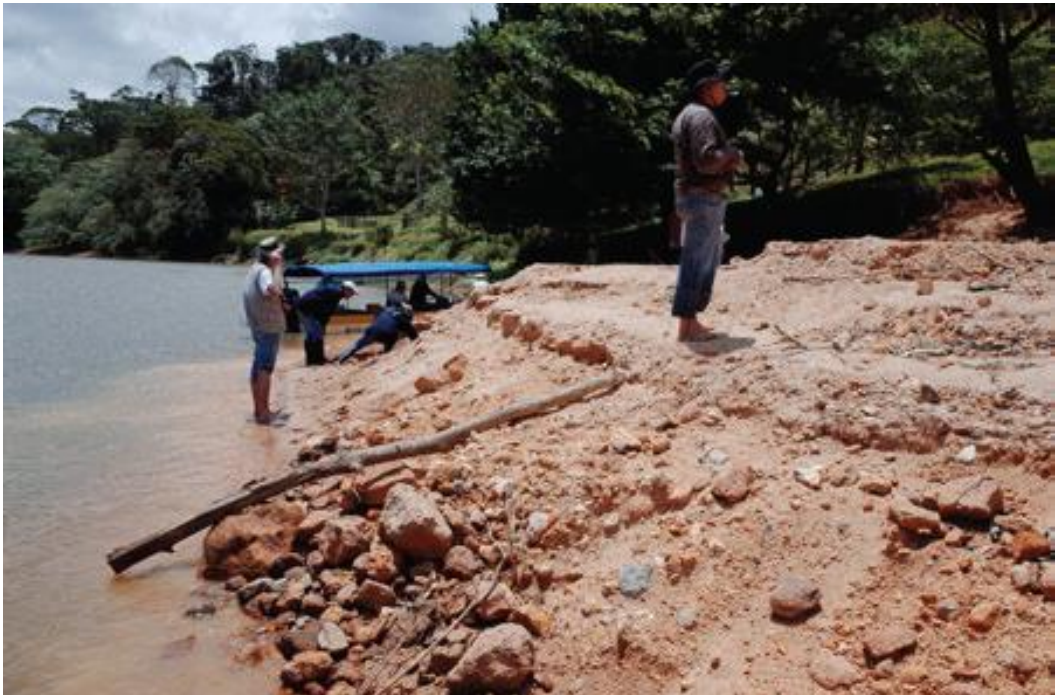
Figure 2.22. Delta deposit below Severely Eroding Site 9.4.
Photograph from March 30, 2014.

Figure 2.23. Delta deposit below Severely Eroding Site 9.4.
Photograph from March 30, 2014.

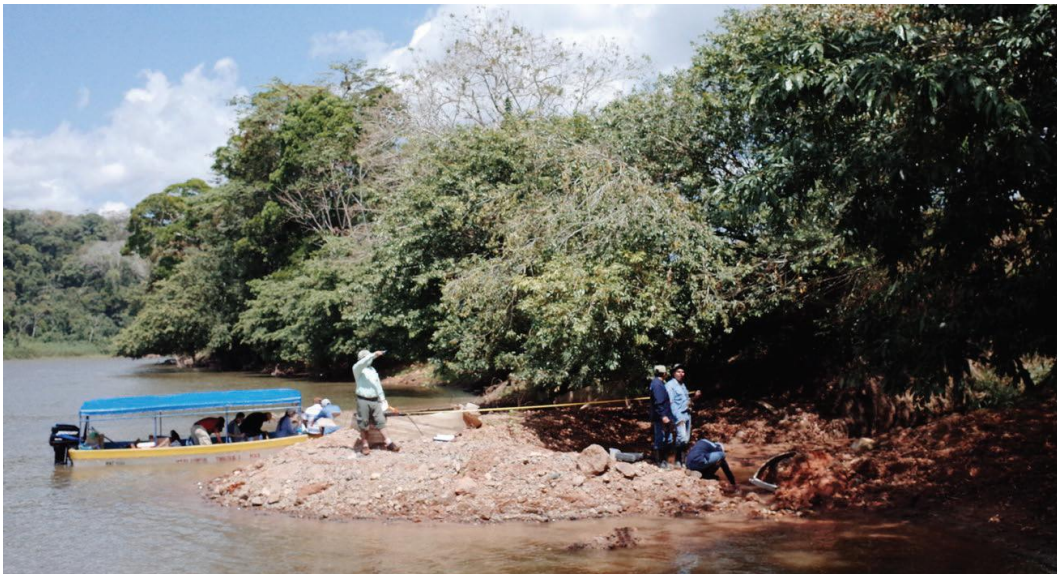
2.58 Similarly, as shown in **Figure 2.24**, a March 2014 inspection of the failed stream crossing on level terrain discussed at paragraphs 2.39-2.41 above, also reveals a large sediment delta reaching into the River that consists of approximately 40-80 tons of sediment (representing only a small percentage of what the full pulse had been), as well as fragments of the failed culvert.¹⁷¹

Figure 2.24. Delta deposit from fill material of failed crossing 20.3 km downstream of Mojon 2 extending into the San Juan River. Photograph from March 31, 2014.

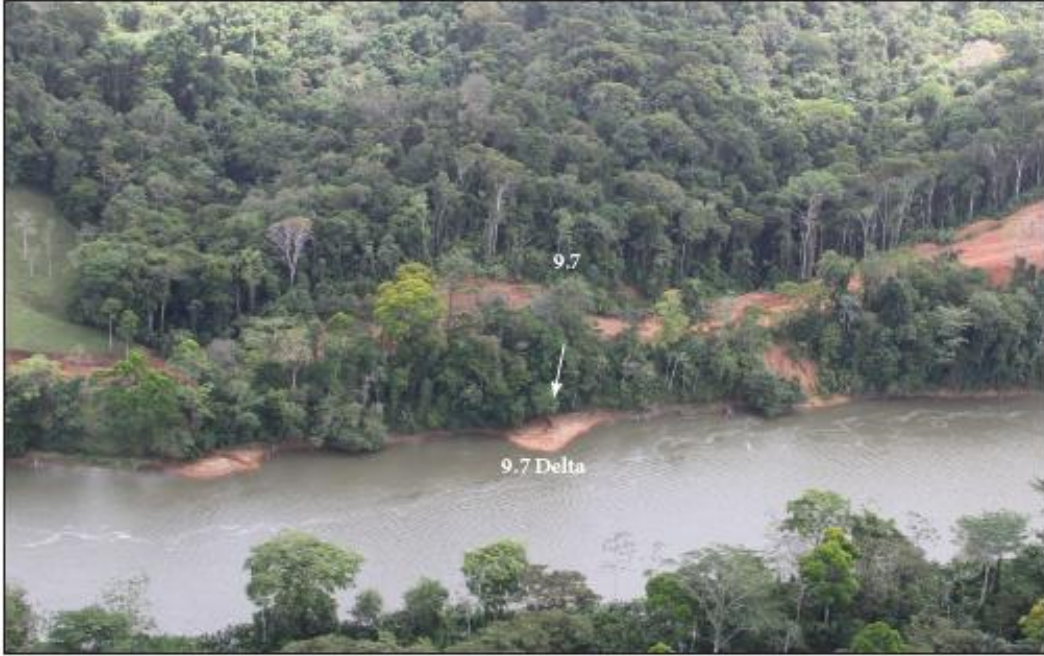
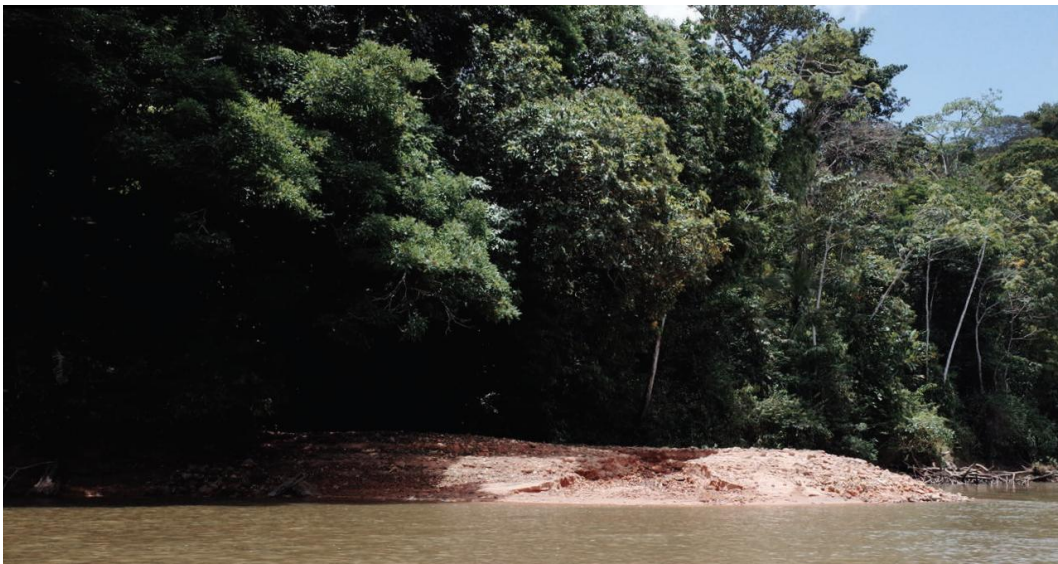
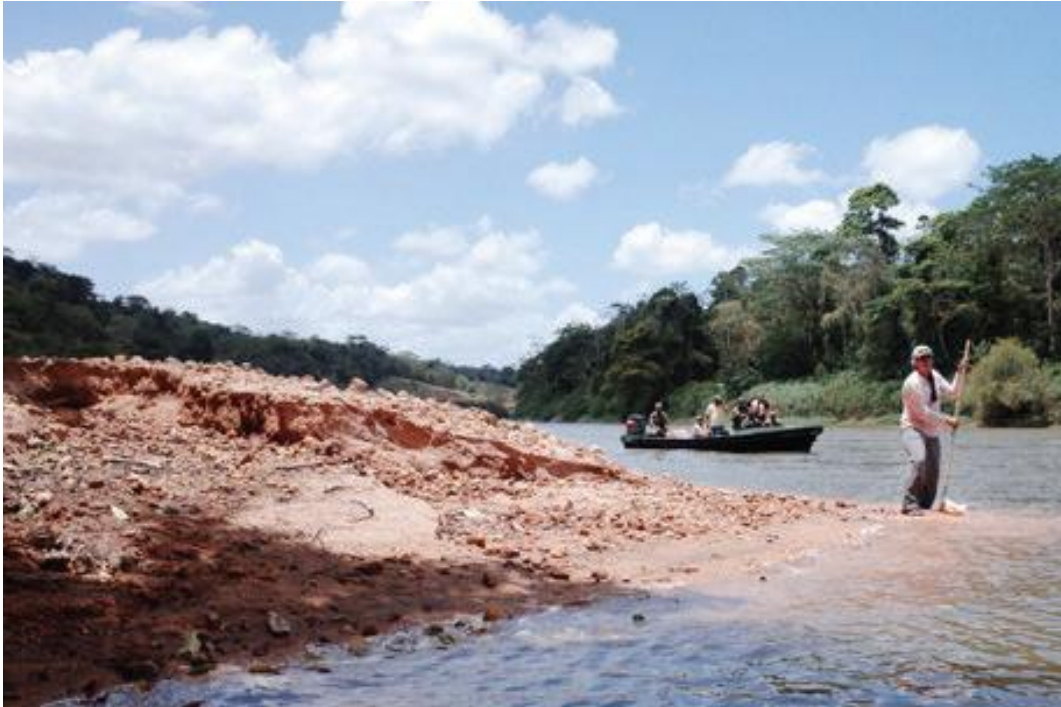
2.59 There are other examples as well, including the delta visible in **Figures 2.25-2.27**, below, which relates to Dr. Kondolf's Severely Eroding Site 9.7 (not one of the sites discussed in detail above).

Figure 2.25. Delta deposit from Severely Eroding Site 9.7.
Aerial photograph from May 2, 2014.

Figure 2.26. Delta deposit from Severely Eroding Site 9.7.
Photograph from March 30, 2014.

Figure 2.27. Delta deposit from Severely Eroding Site 9.7.
Photograph from March 30, 2014.

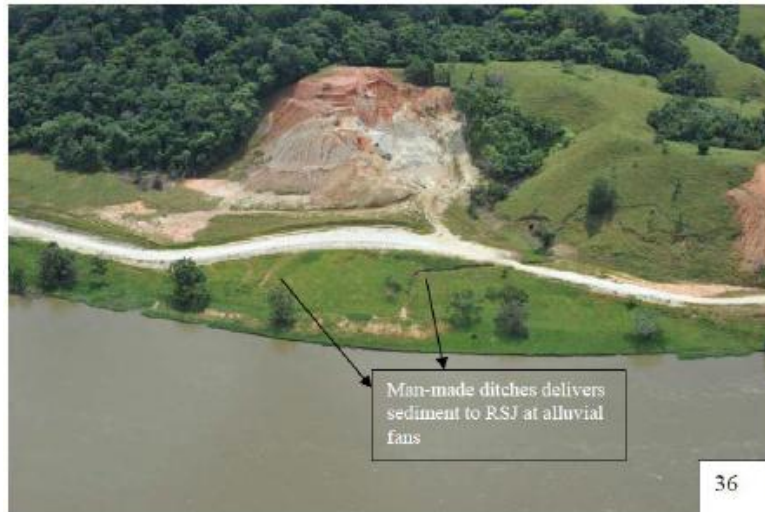
Figure 2.28. Quarry site approximately 7.7 km downstream from Mojon II, where man-made ditches deliver sediment to the River. Photograph from 2012 Kondolf Report, Appendix B (October 2012).

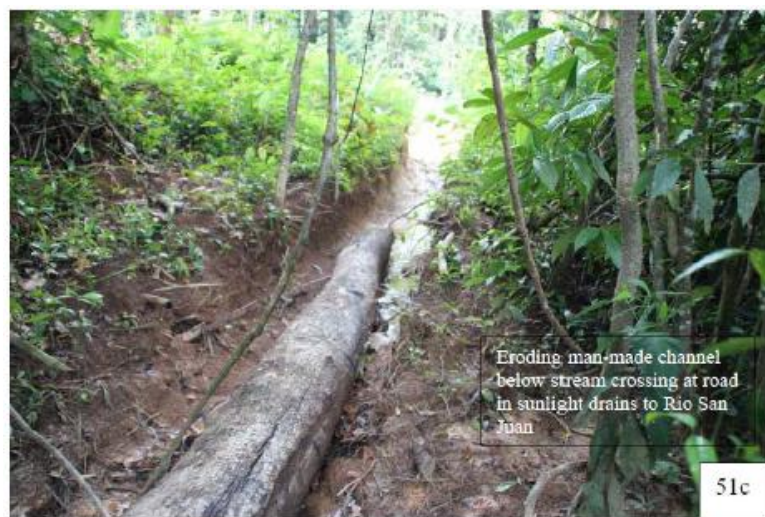
Figure 2.29. Eroding man-made channel connecting the Road to the River, located approximately 11.3 km downstream from Mojon II. Photograph from 2012 Kondolf Report, Appendix B (October 2012).

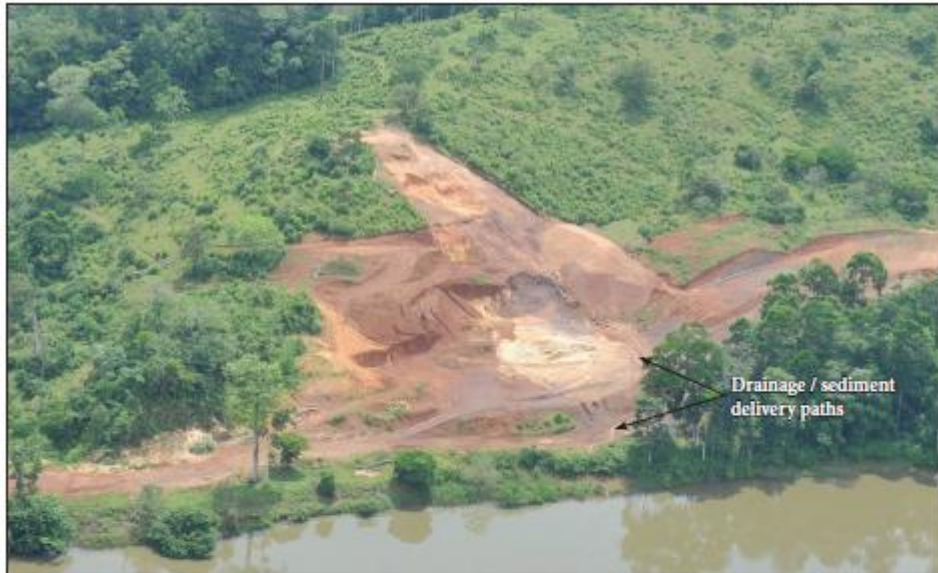
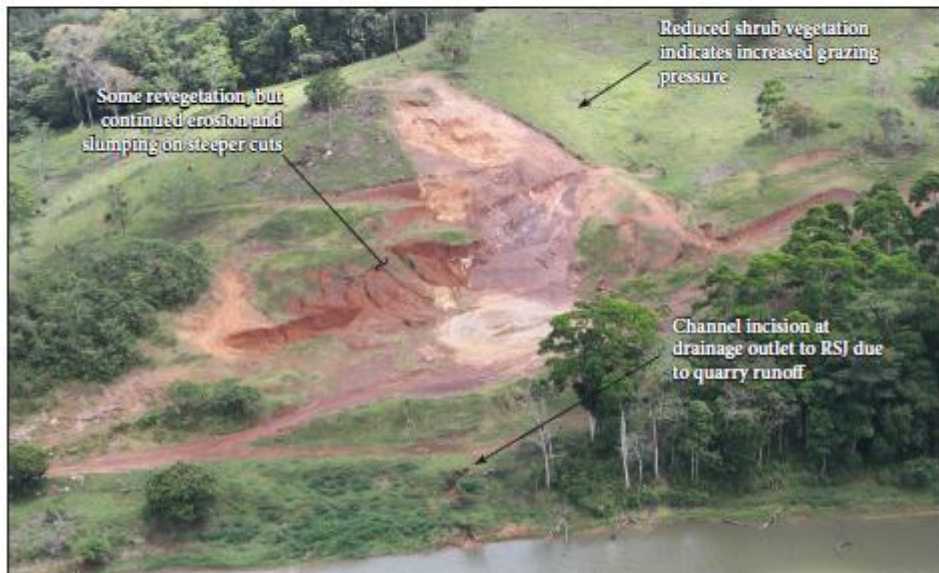
Figure 2.30. Comparison of October 2012 and May 2014 photographs taken by helicopter over Nicaraguan airspace. Site location: 25.3 km downstream from Mojon II.
