INTERNATIONAL COURT OF JUSTICE

**DISPUTE CONCERNING
CONSTRUCTION OF A ROAD IN COSTA RICA ALONG THE SAN JUAN
RIVER
(NICARAGUA V. COSTA RICA)**

**REPLY
OF THE REPUBLIC OF NICARAGUA**

04 August 2014

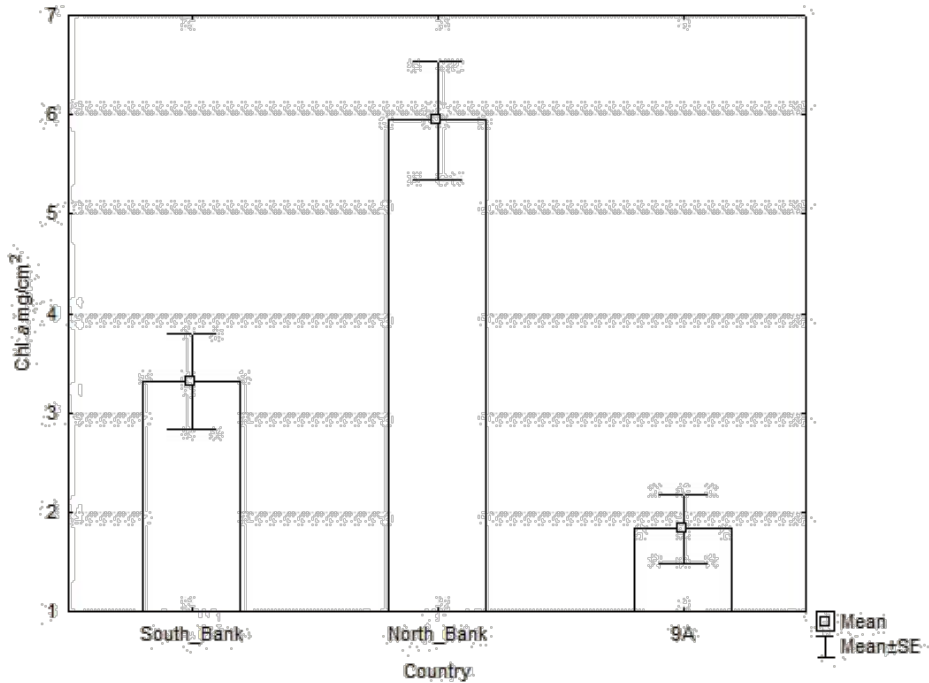
Figure 2.31. Periphyton biomass on benthic substrate (pebbles and cobbles) at deltas along the south bank of the Rio San Juan (receiving sediments eroded from Rte 1856), along the north bank (formed by streams draining forest), and at Point 9A (La Chorrera).

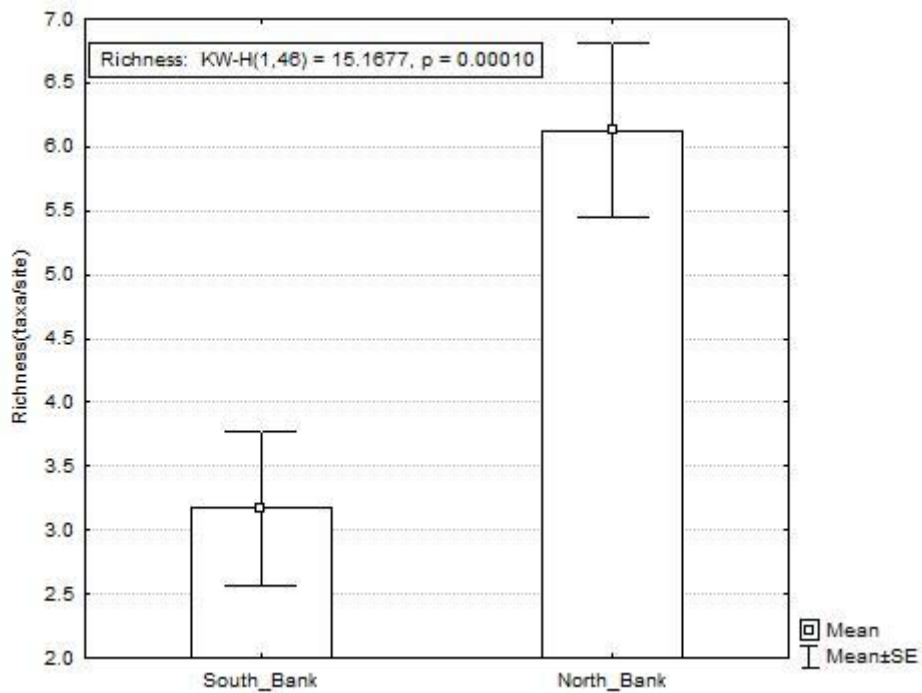
Figure 2.32. Differences in benthic macroinvertebrate richness at deltas on the north bank and the south bank of the San Juan River.

2.91 Dr. Rios concludes that these results demonstrate that “the aquatic communities of the streams draining the road are significantly degraded compared to those developed on the deltas of tributaries entering the north bank of the river, which are not affected by the road-derived sediment.”²³⁵ This “strongly suggest[s] that the sediments eroded from the road are having negative effects on the aquatic communities of the deltas affected by the sediments.”²³⁶

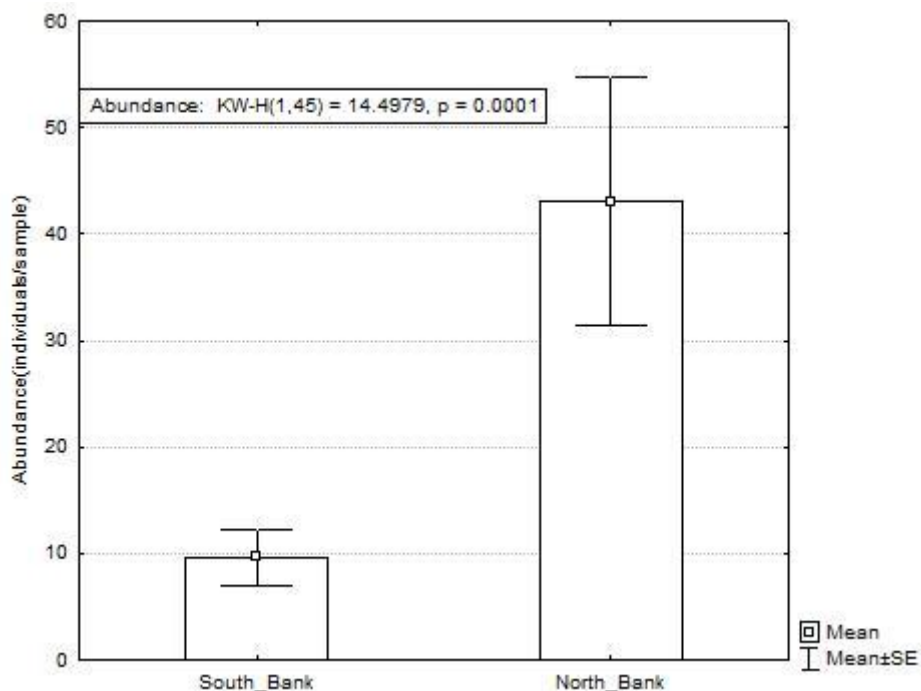
Figure 2.33. Differences in benthic macroinvertebrate abundance at deltas on the north bank and the south bank of the San Juan River.

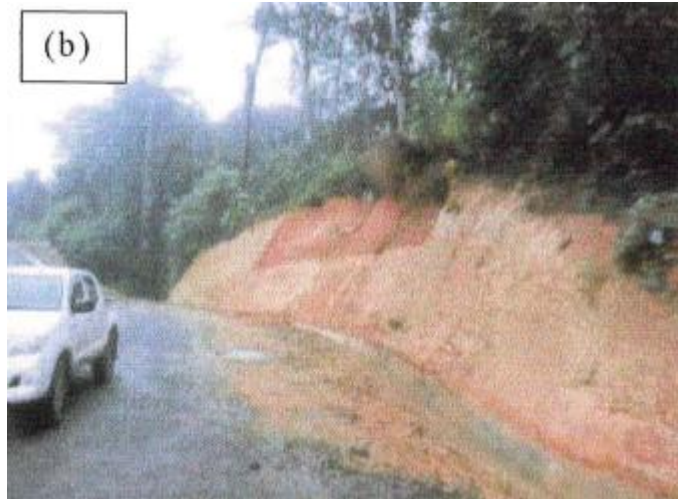
Figure 2.34. Photograph of UCR Site 1: Landslide on cut slope.

2.102 As these images make clear, although the erosion at these sites is significant, it is taking place on a much smaller scale than that occurring elsewhere, including at the sites described above in Section A of this Chapter, all of which were ignored by the authors of the UCR Report.

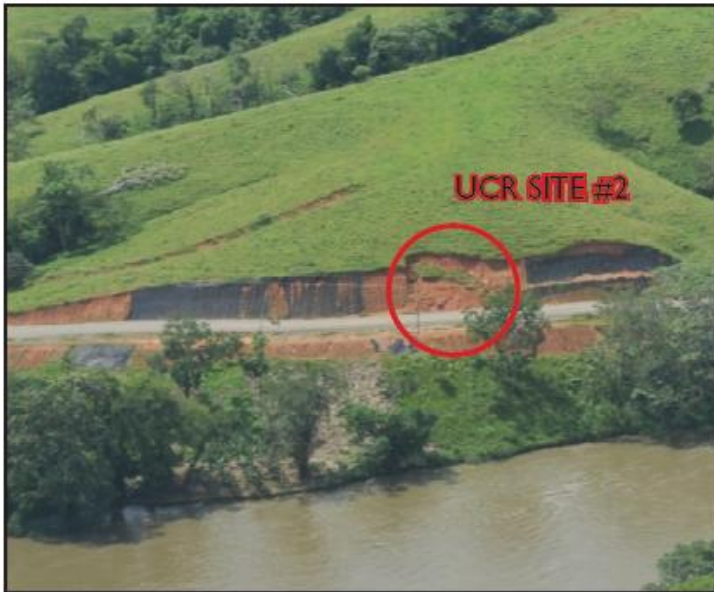
Figure 2.35. Aerial image of UCR Site 2: Landslide on cut slope.

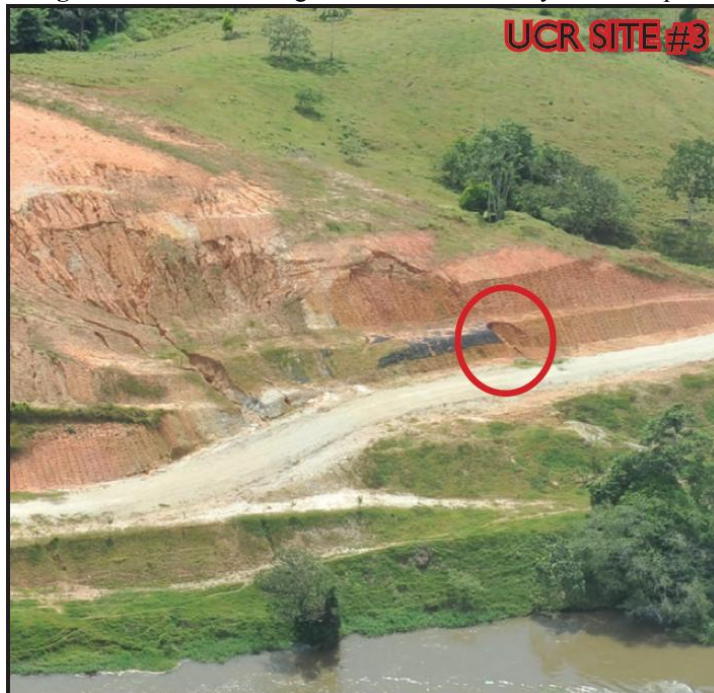
Figure 2.36. Aerial image of UCR Site 3: Gully on cut slope.

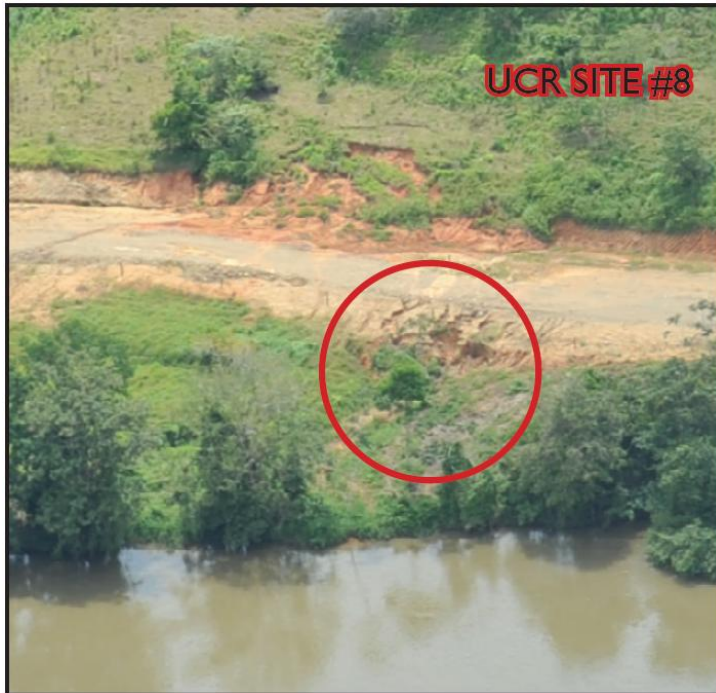
Figure 2.37. Aerial image of UCR Site 8: Gully on road fill.

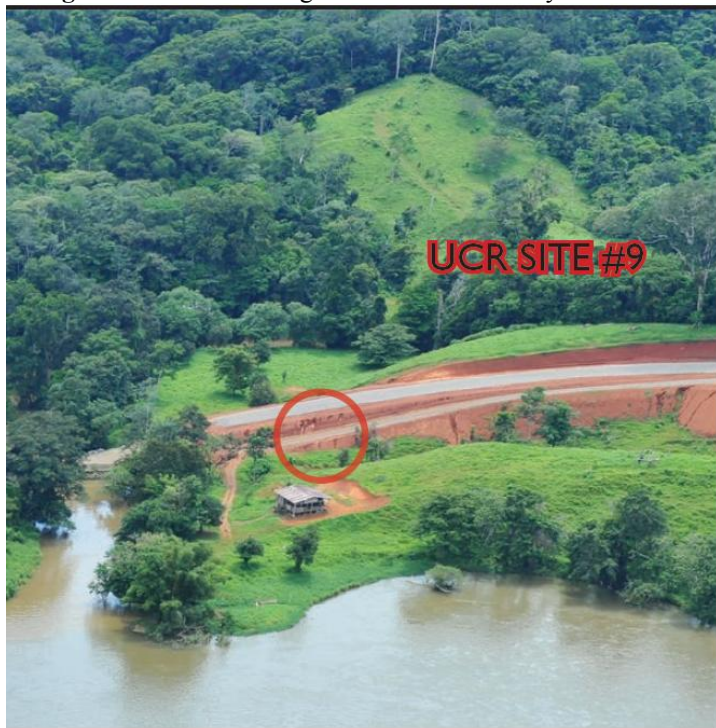
Figure 2.38. Aerial image of UCR Site 9: Gully on road fill.

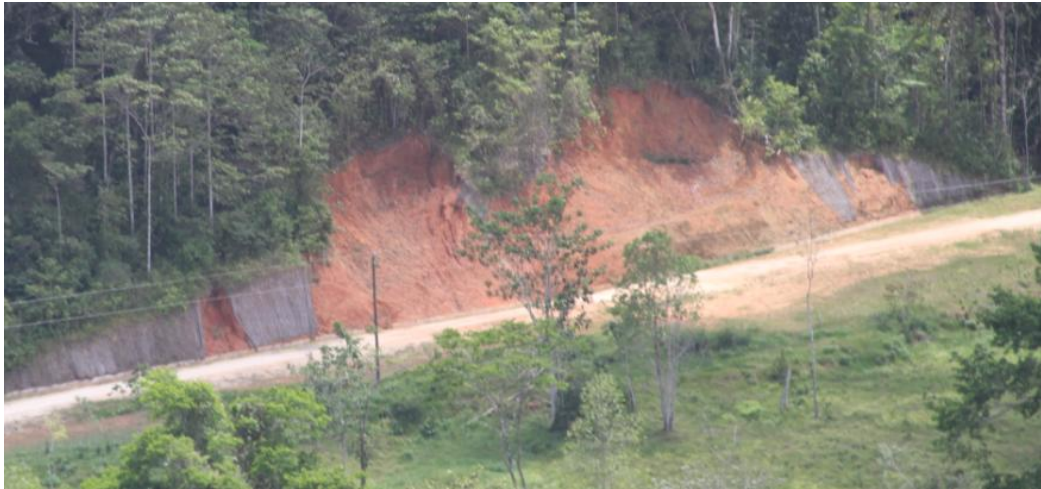
Figure 3.1. Failing geotextile approximately 10.0 km downstream from Mojon II.

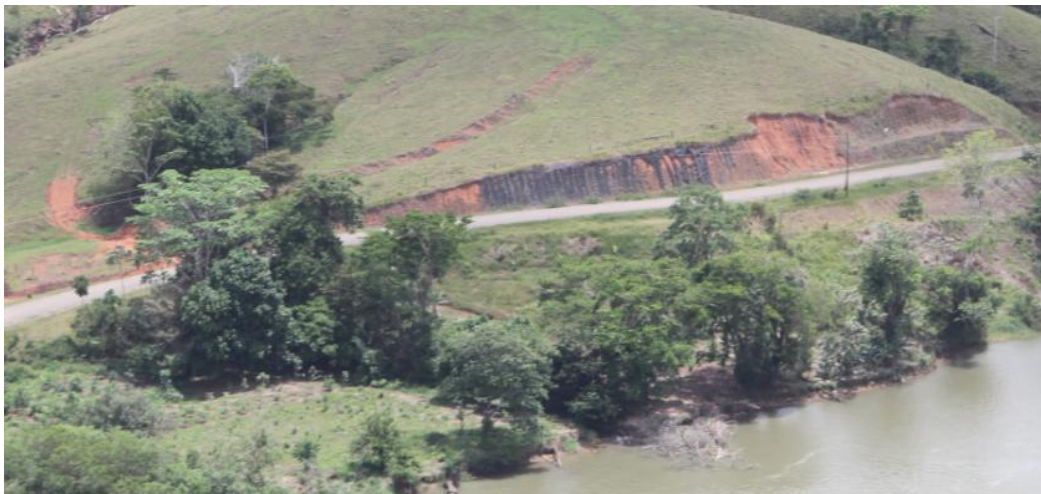
Figure 3.2. Failing geotextiles approximately 6.8 km downstream from Mojon II.

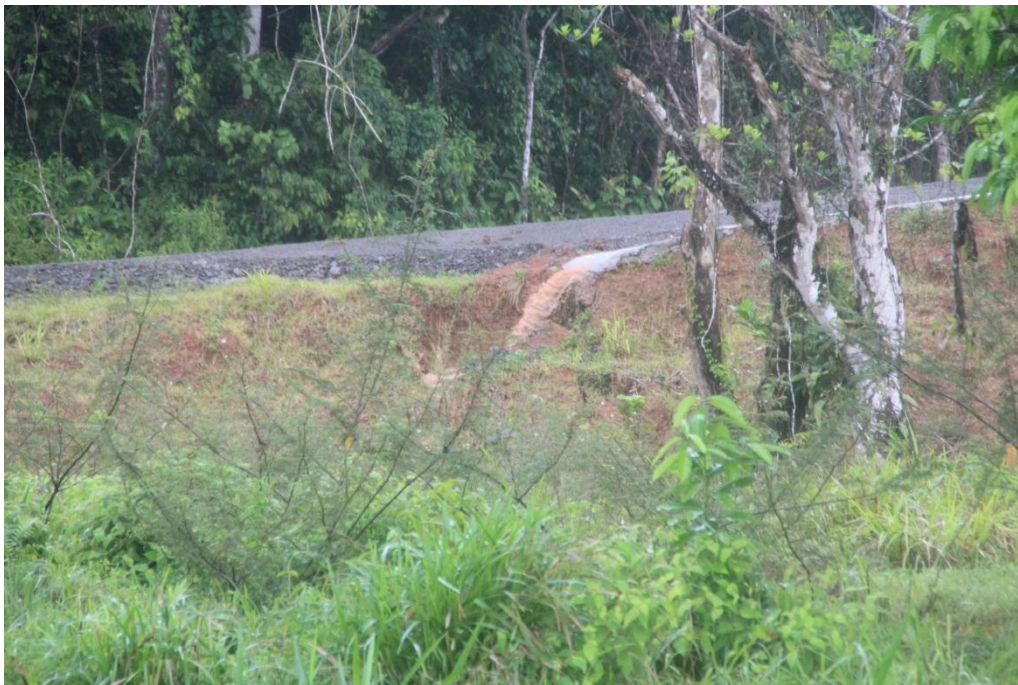
Figure 3.3. May 2013 photograph of road runoff directed from drainage structure into fill.

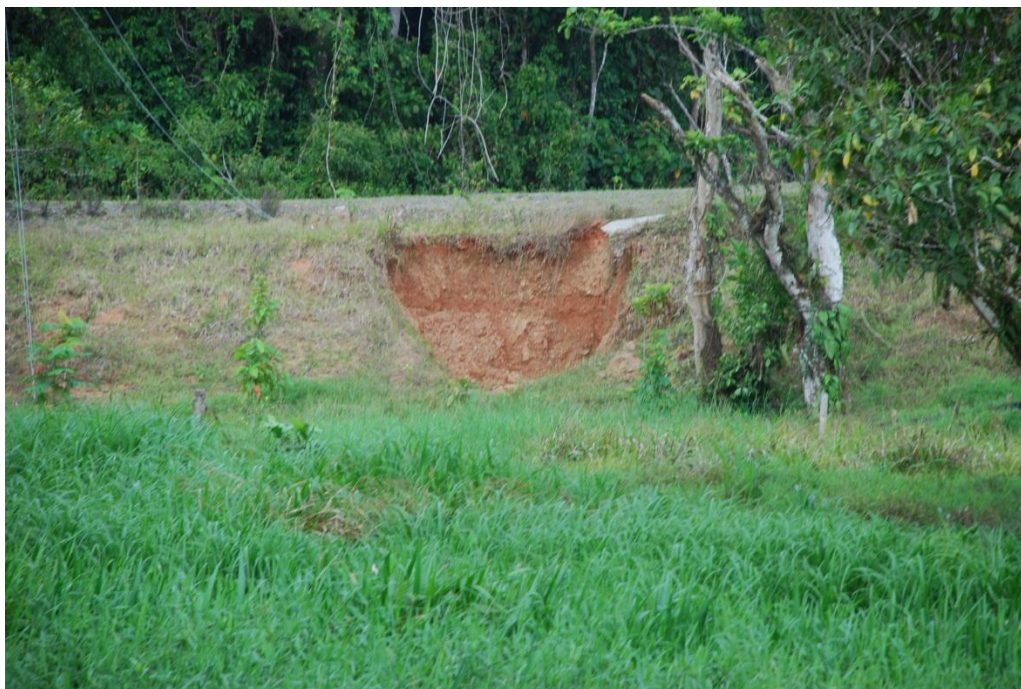
Figure 3.4. May 2014 photograph of erosion resulting from direct drainage from road onto fill.

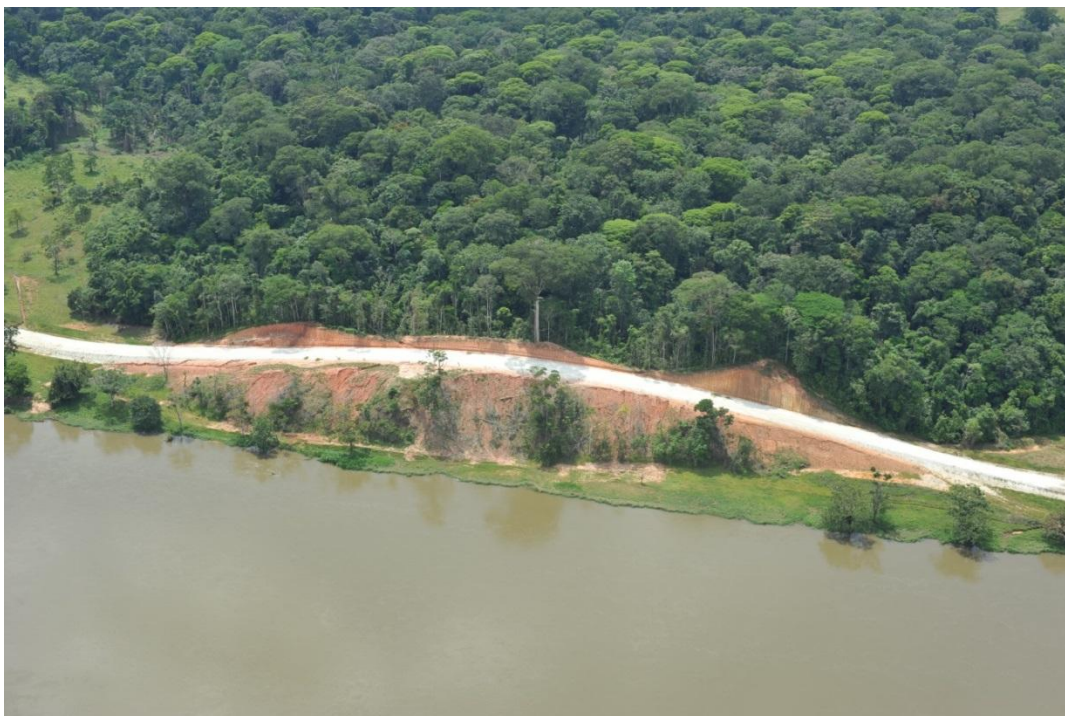
Figure 5.1. Severely Eroding Site 4.1, located 8.2-8.7 km downstream of Mojon II.

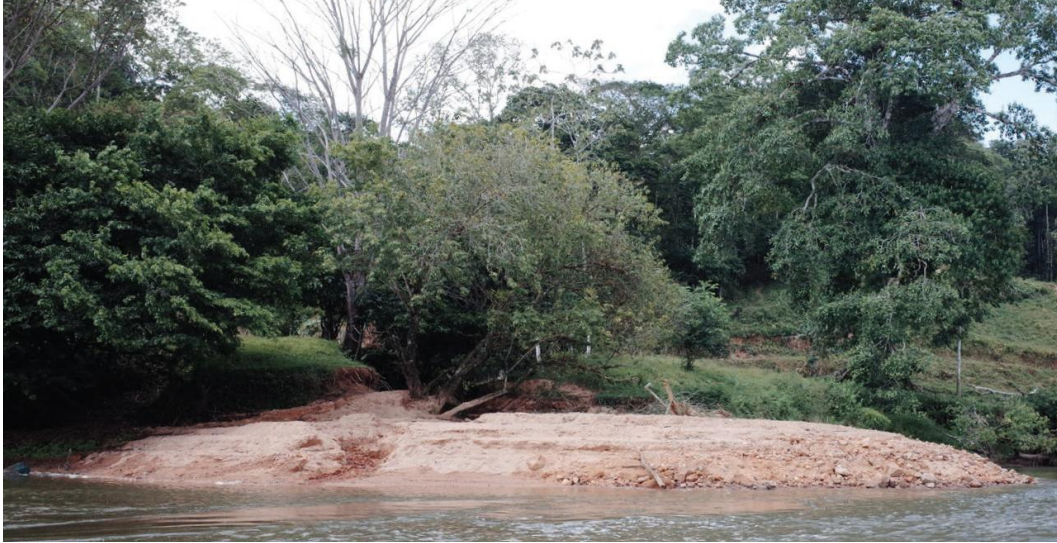
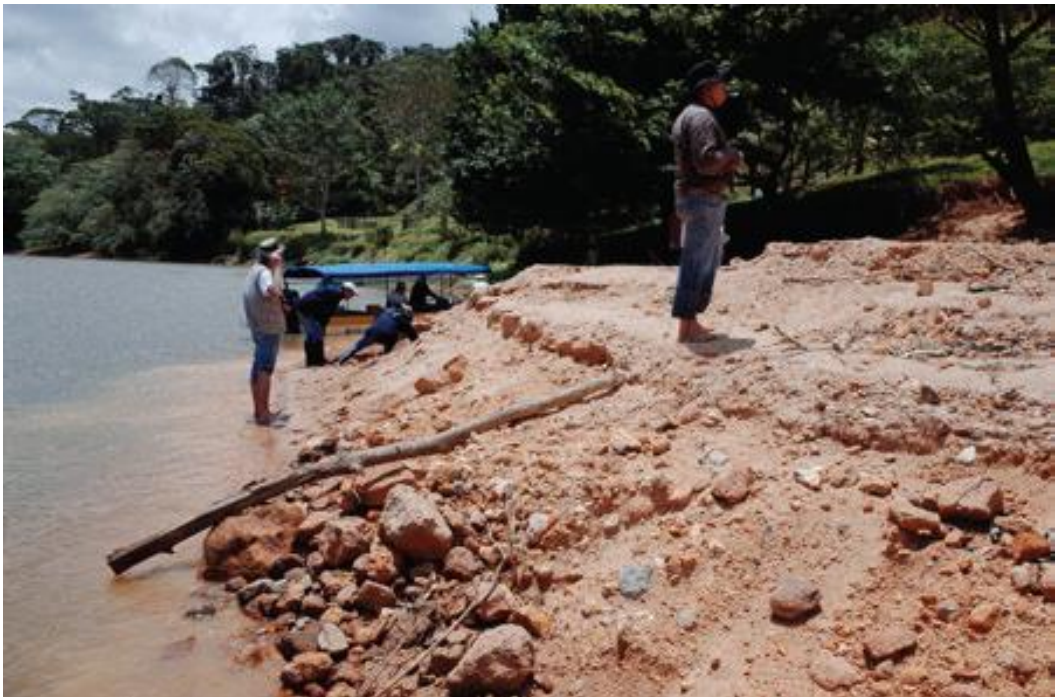
Figure 5.2. Delta deposit below Severely Eroding Site 9.4. Photograph from March 30, 2014.

Figure 5.3. Delta deposit below Severely Eroding Site 9.4. Photograph from March 30, 2014.

5.20 As Mr. Hagans & Dr. Weaver explain in their 2014 Report, these deltas will continue to enlarge in the absence of truly effective remediation measures.⁵⁰⁹

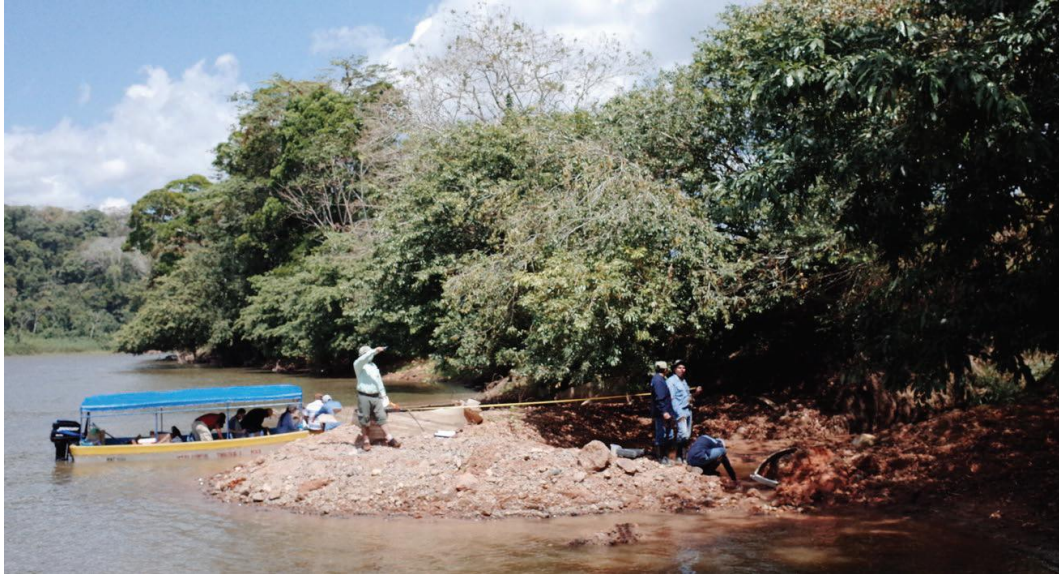
Figure 5.4. Delta deposit from fill material of failed crossing 20.3 km downstream of Mojon 2 extending into the San Juan River. Photograph from March 31, 2014.

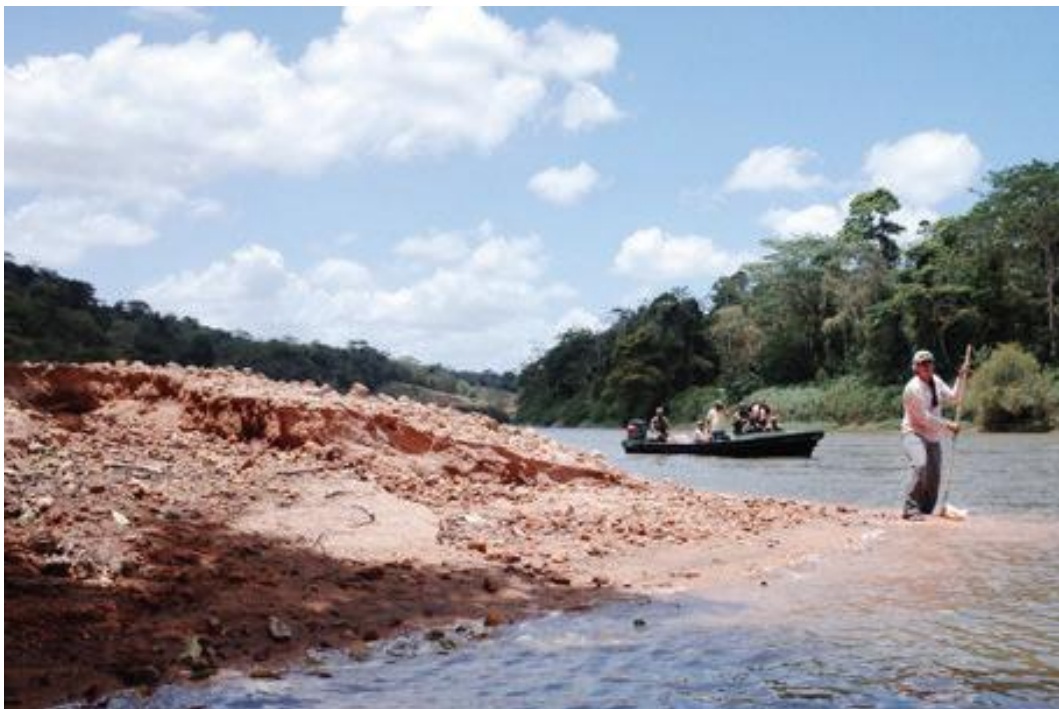
Figure 5.5. Delta deposit from Severely Eroding Site 9.7. Photograph from March 30, 2014.
