**DISPUTE CONCERNING THE CONSTRUCTION OF A ROAD IN
COSTA RICA ALONG THE SAN JUAN RIVER**

NICARAGUA v. COSTA RICA

REJOINDER OF COSTA RICA

2 FEBRUARY 2015

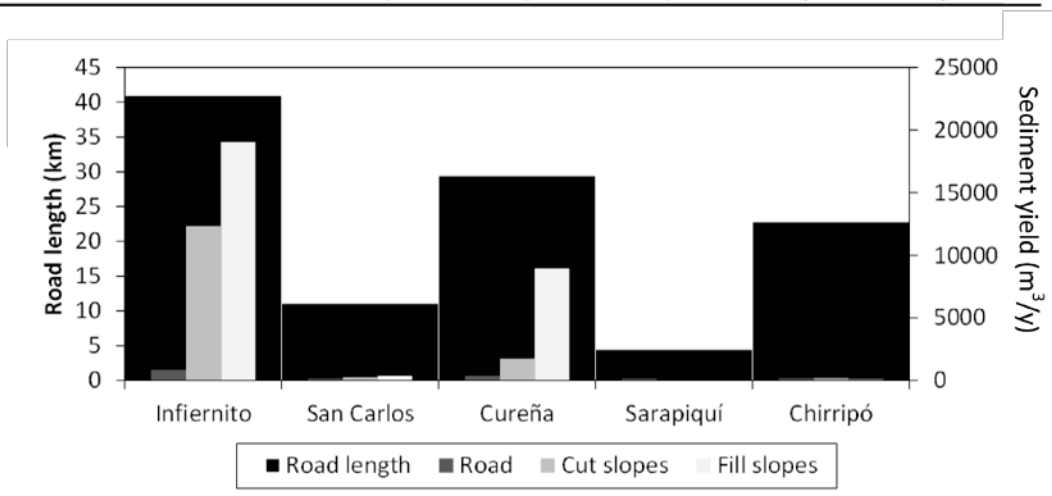
Figure 4.16 Annual yields of Road-derived sediment from the basins of major Costa Rican tributaries between Marker II and Delta Costa Rica under a ‘worst case’ rainfall scenario (from the 2014 ICE Report).

Tributary Basin	Road length (km)	‘Worst case’ sediment yields (m ³ yr ⁻¹)			Total	‘Worst case’ sediment yields (t yr ⁻¹)
		Road bed	Cut slopes	Fill slopes		
<i>Major Costa Rican tributary basins draining directly to the Río San Juan</i>						
Infiernito	41.0	855	12,348	19,051	32,253	53,863
San Carlos	11.1	173	253	399	825	1,378
Cureña	29.5	387	1,738	8,966	11,091	18,521
Sarapiquí	4.5	172	49	-----	221	369
Chirripó	22.8	192	190	107	489	817
<i>Costa Rican area draining directly to the Río San Juan</i>						
Total	108.8	1,778	14,578	28,523	44,880	74,949

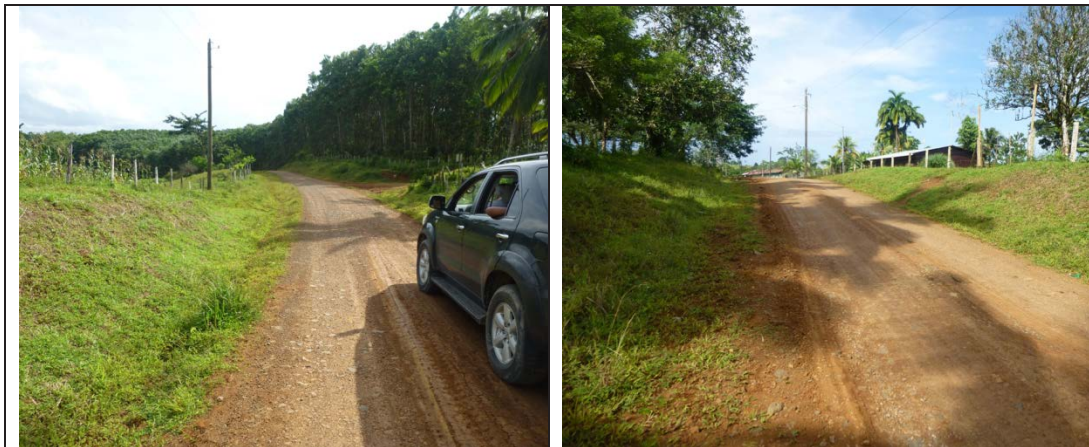
Figure 7.1 Typical views of access roads traversed during the field visit on 29 August 2014. Photographs by author [Professor Thorne].

“Bearing in mind the stable condition of the access roads, their remoteness from the River and the scarcity of streams linking them to the River, in my opinion it is highly unlikely that sediment from these access roads reaches the Río San Juan in any appreciable quantities.”¹¹³

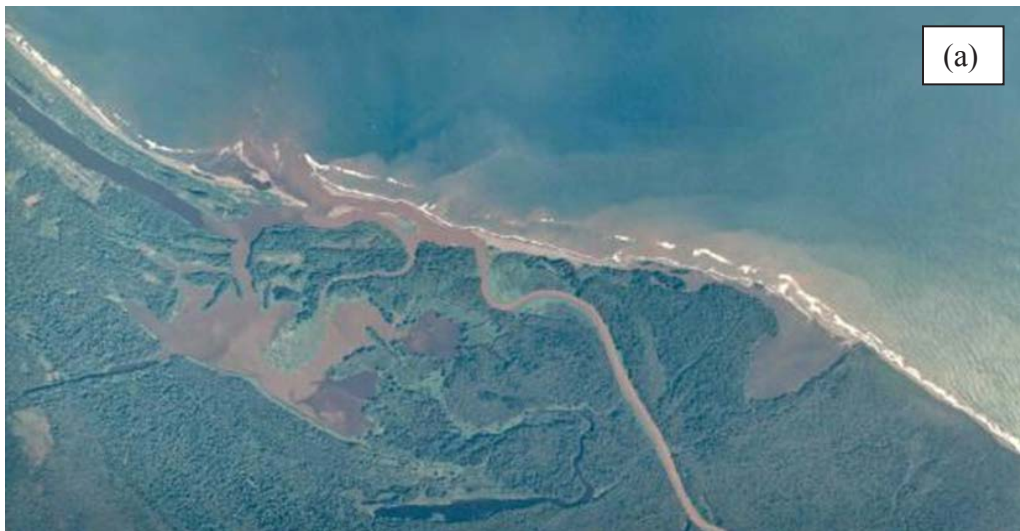
Figure 5.4 Satellite images showing that flow from the lower Rio San Juan carries turbid water with a high concentration of fine sediment into both the Bay of San Juan del Norte and the littoral sediment system of the Caribbean Sea. Image dates (a) 13 December 1997 (b) 26 November 2013.

“Dr Andrews’ opinion might be correct for a delta building into a marine water body that experiences frequent *‘tidal surges’*. But the Caribbean has a micro-tidal regime, with a diurnal tidal amplitude averaging only about 20 cm (Kjerfve, 1981). This explains why most of the fine sediment carried by the lower Río San Juan is not deposited within the delta but is carried into the Caribbean Sea, as I indicated in my 2013 Report and as illustrated in typical, rainy season satellite images (Figure 5.4), that show plumes of turbid river water extending into the Bay of San Juan del Norte and the littoral zone of the Caribbean Sea.”¹³¹

Indeed, this is demonstrated by the satellite images included in Figure 5.4 to Professor Thorne’s report, which show plumes of turbid river water extending into the Bay of San Juan del Norte and the littoral zone of the Caribbean Sea (reproduced below for convenience).

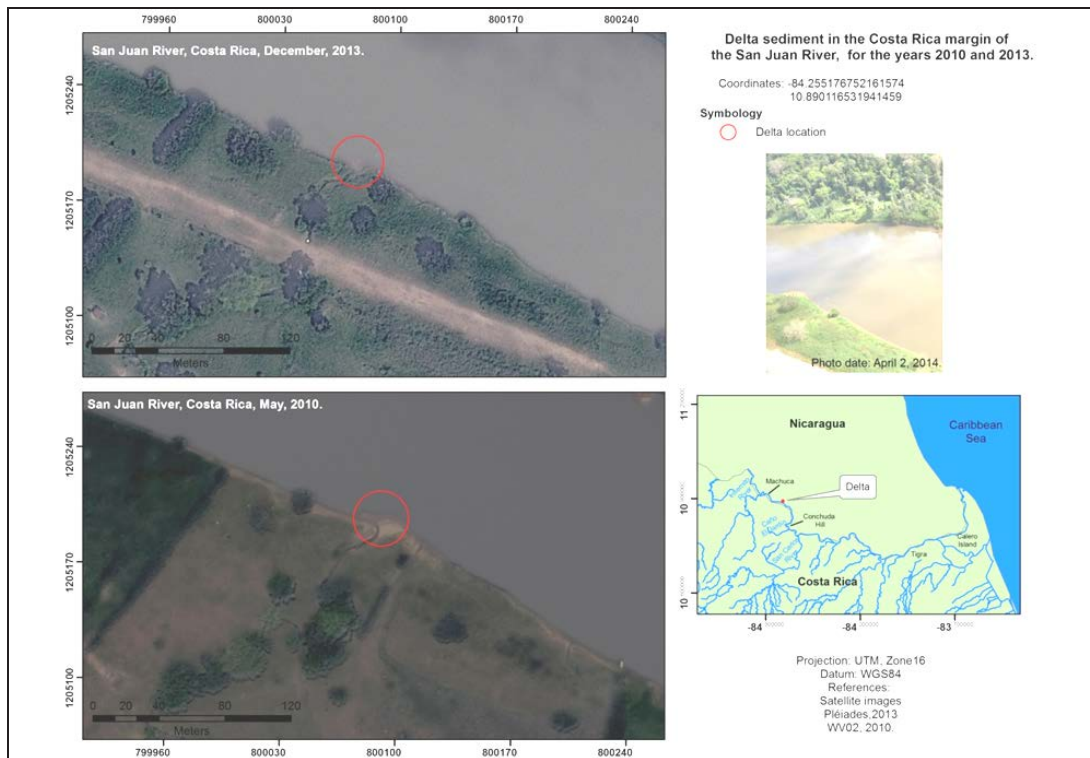
to heavy cloud cover in the region, cloud-free, high resolution satellite images are generally not available for the relevant period. However, cloud-free images are available for two of the locations identified by Dr Kondolf and those images demonstrate that the deltas pre-date the Road. They are included as Figure 5.3 to the 2015 Thorne Report and reproduced below for convenience. Professor Thorne concludes that he “cannot rule out the possibility that this is actually the case for most of [the deltas Dr Kondolf identifies as having been caused by the construction of the Road].”¹⁵⁶

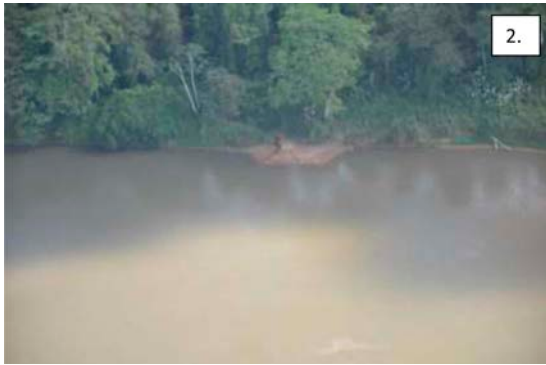
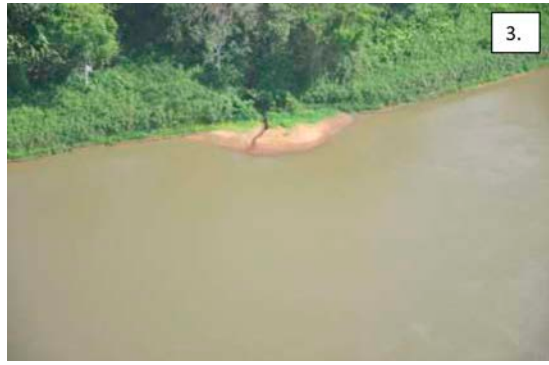
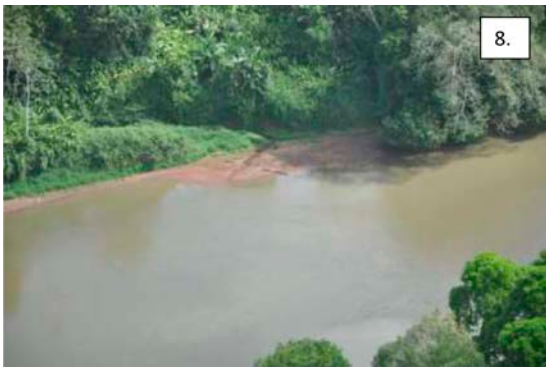
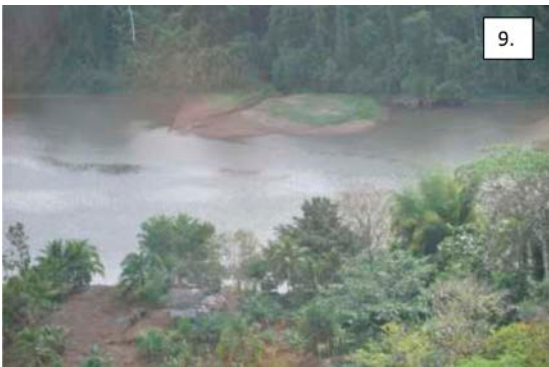
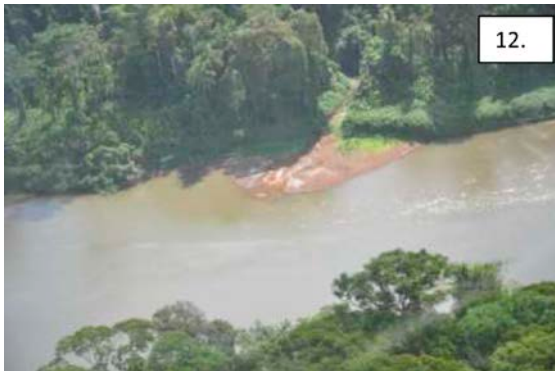
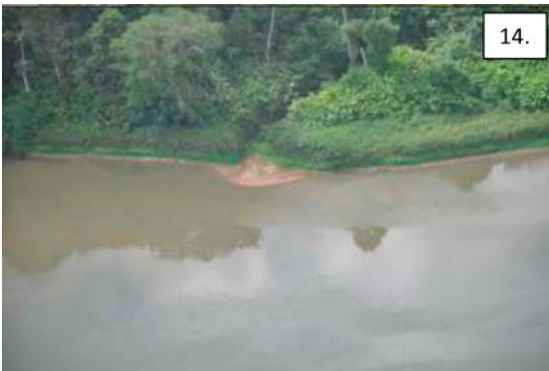
Extract of Figure 5.2 Fifteen north bank deltas photographed from Costa Rican airspace in April 2014. These deltas are formed in sediment eroded from Nicaragua and some are considerably larger than any of those photographed by Dr Kondolf along the south bank. The size and morphology of these deltas should be compared to those shown in Appendix F of the 2014 Kondolf Report, which were also taken at conditions of low flow in the Río San Juan. (Partial reproduction Appendix A, 2015 Thorne Report, pp. 92-95).

2.89. In any event, the eight deltas identified by Dr Kondolf on the southern bank are morphologically indistinguishable from those which exist on the northern bank (during an overflight in April 2014, 15 deltas were photographed in the Nicaraguan bank of the San Juan), and in fact it appears that deltas on the northern bank are larger than those on the southern bank (see Figure 5.2 to the 2015 Thorne Report, which is partially reproduced below).

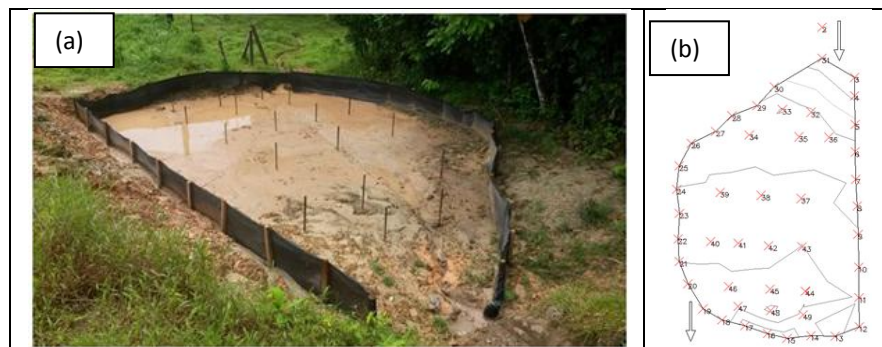
Figure 4.4 (a) Sediment trap at Site 5 on October 1, 2014. (b) Survey points and contour map of sediment surface elevations on October 22, 2014 (from the 2014 UCR Report).

4.10. The method used to estimate sheet erosion was refined from that used in 2013. The underlying principle remains using the sediment trap at site 5 to capture sediment eroded from a typical cut slope that was subject only to sheet erosion, but the method used to measure the depth of accumulated sediment was enhanced. In August 2014 an excavator was used to empty the sediment trap and a Total Station was used to establish its dimensions and topography. Stakes with which to record the depth of sediment throughout the trap and around its edges were installed and surveyed-in (Figure 4.4). Sediment surface elevations relative to the stakes were

measured on two subsequent dates in October 2014. Digital elevation models of the sediment surface were then differenced to calculate the volume of sediment that had accumulated in the trap between visits.

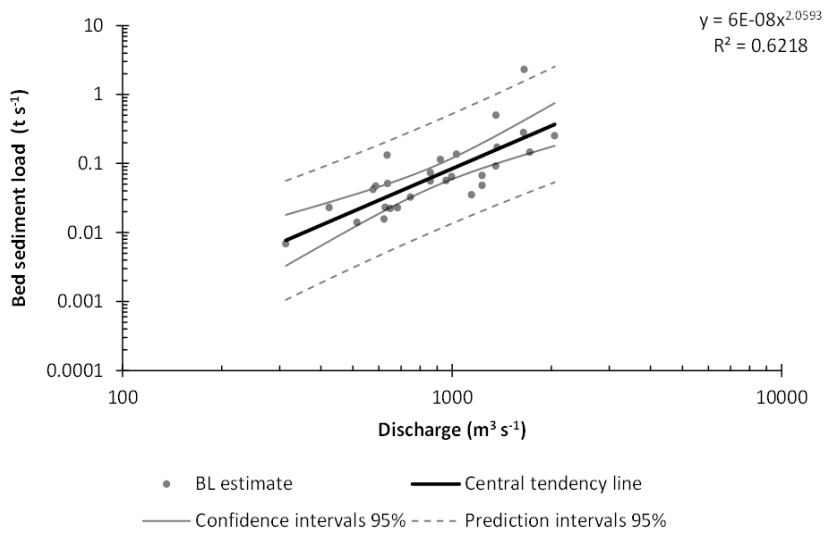
Figure 4.13 Bed load rating curve for the Delta Colorado (11-04) station (from the 2014 ICE Report).

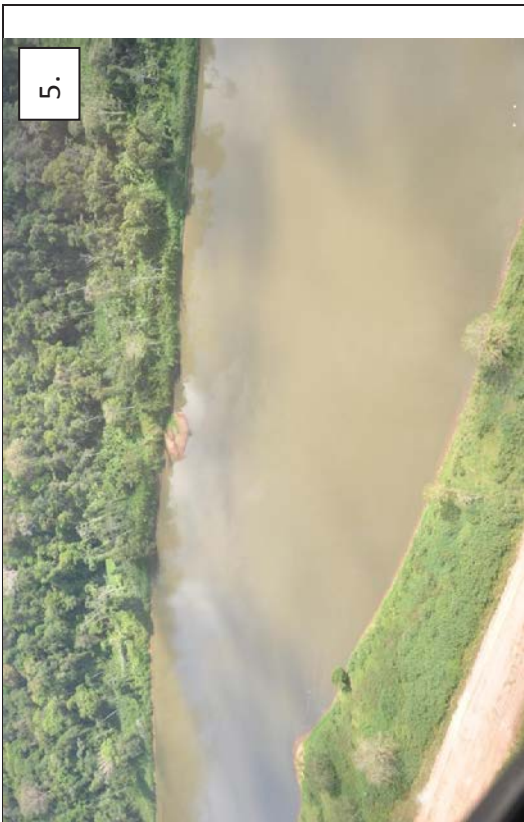
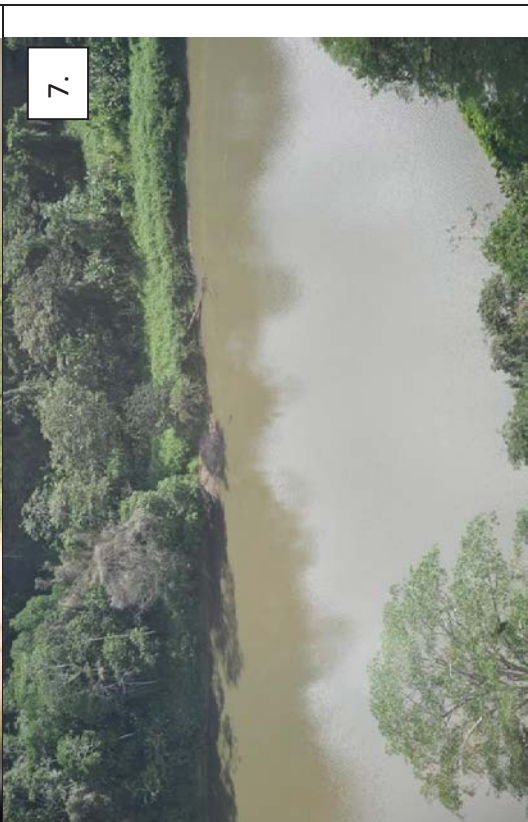
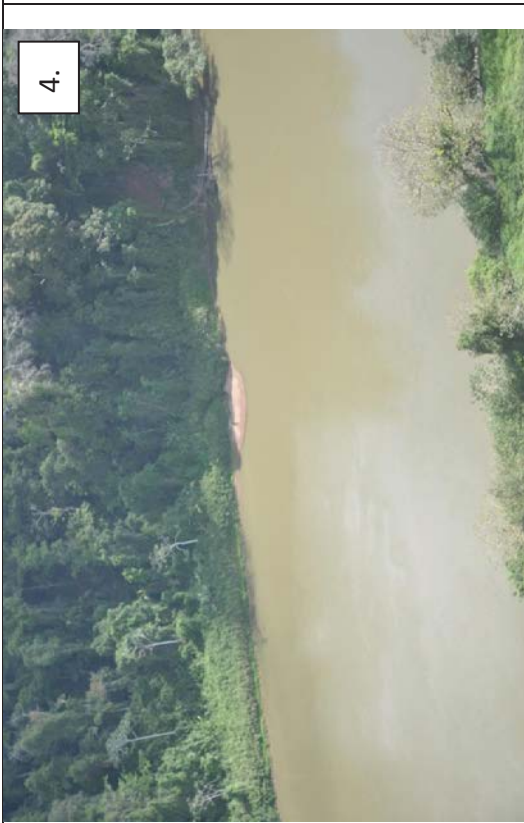
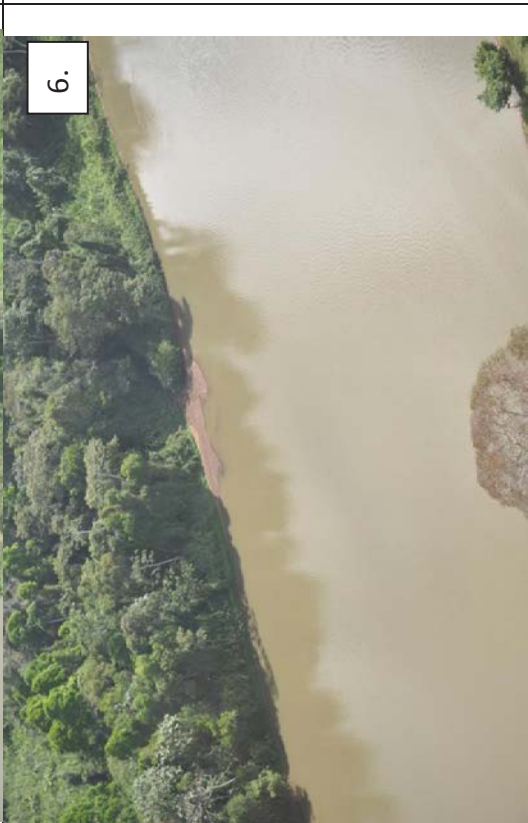
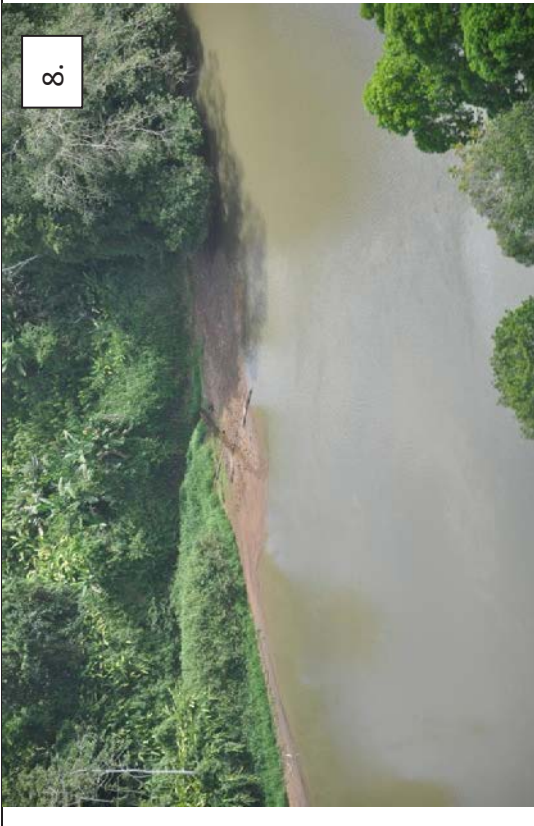
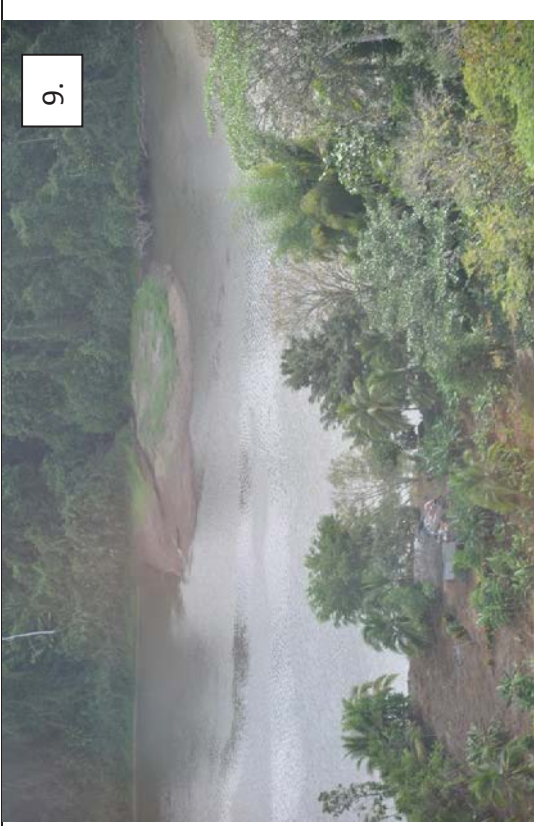
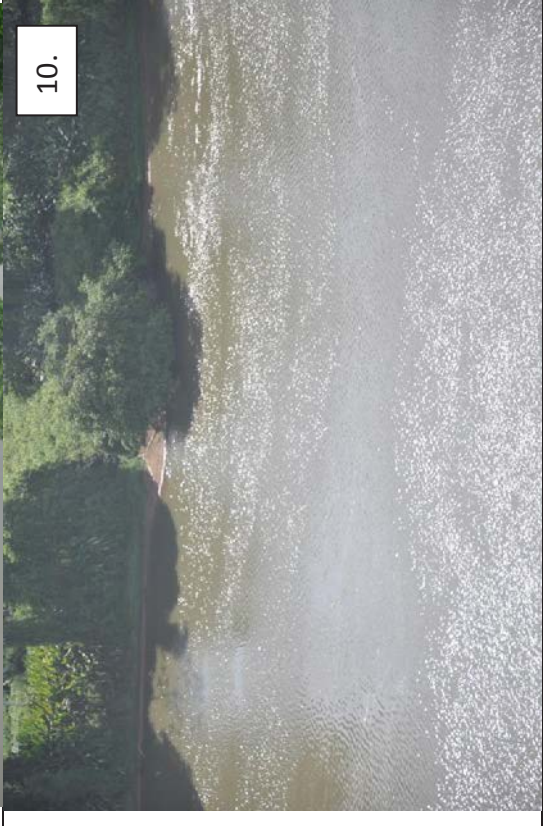
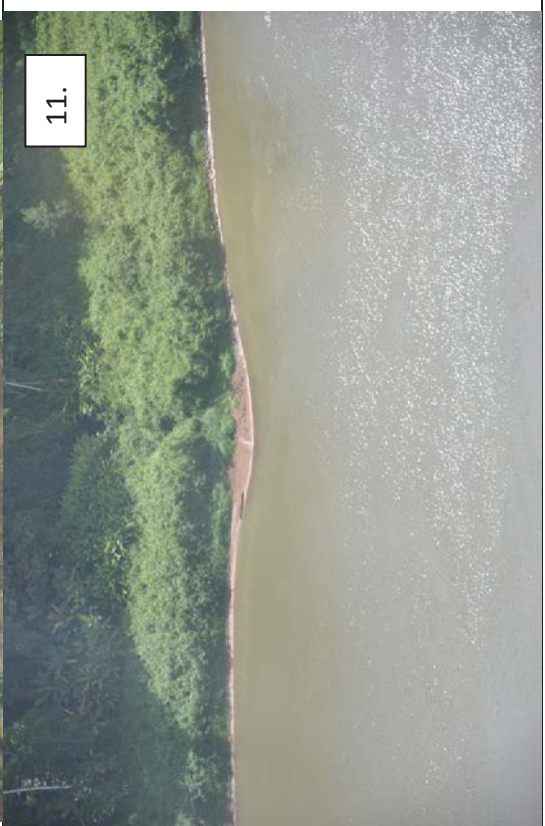
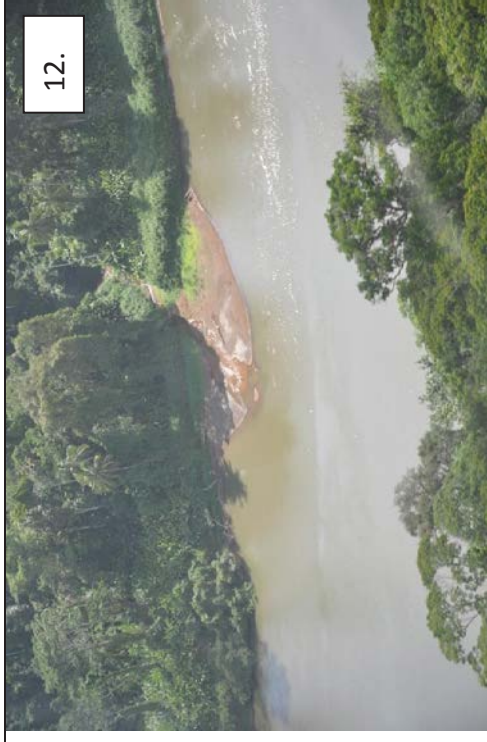
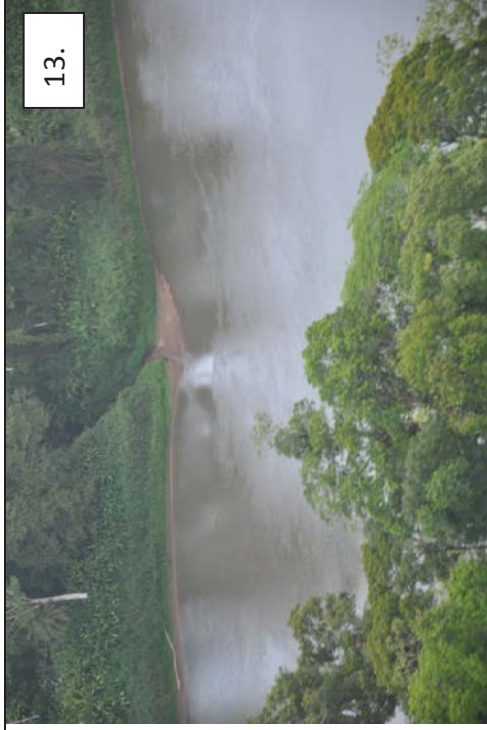
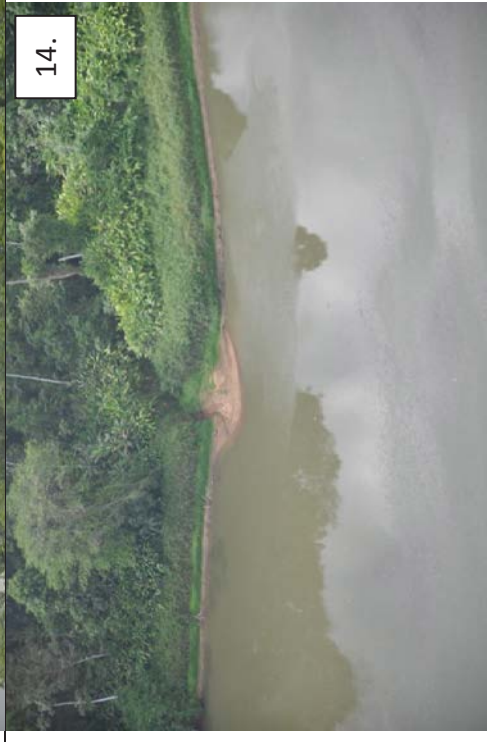
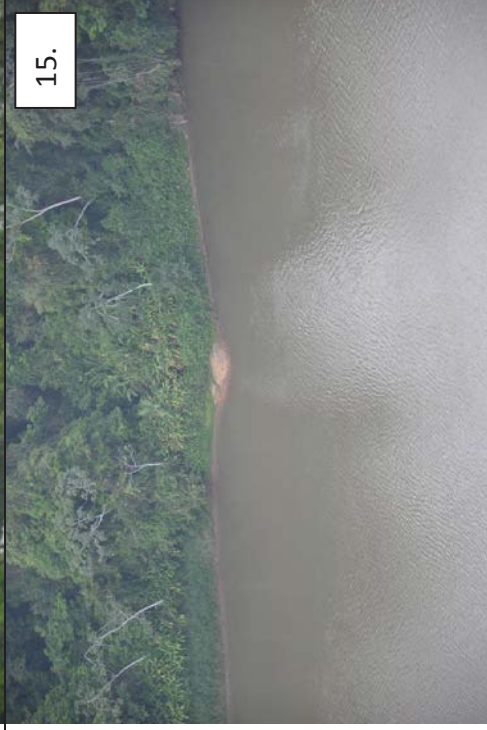
Figure 5.2 Fifteen north bank deltas photographed from Costa Rican airspace in April 2014. These deltas are formed in sediment eroded from Nicaragua and some are considerably larger than any of those photographed by Dr Kondolf along the south bank. The size and morphology of these deltas should be compared to those shown in Appendix F of the 2014 Kondolf Report, which were also taken at conditions of low flow in the Río San Juan.

- 5.9. In my 2013 Report, I pointed out that deltas similar to, but sometimes larger than, those along the south bank of the Río San Juan also exist on the Nicaraguan bank of the River. I substantiated this observation with photographs of thirteen north bank deltas. No GPS was available when those photographs were taken, and so I was unable to record coordinates for the deltas observed in May 2013. Hence, on receipt of a request from Nicaragua for the coordinates in 2014 (note of 25 March 2014, reference HOL-EMB-046) another flight, with GPS available, was arranged to meet that request and a new set of photographs was supplied to Nicaragua on 21 May 2014 (reference ECRPB-071-14). Despite these photographs having been supplied to Nicaragua, Dr Kondolf does not address them in his 2014 Report. On the second flight, two additional north bank deltas were observed and all 15 deltas are shown in Figure 5.2.

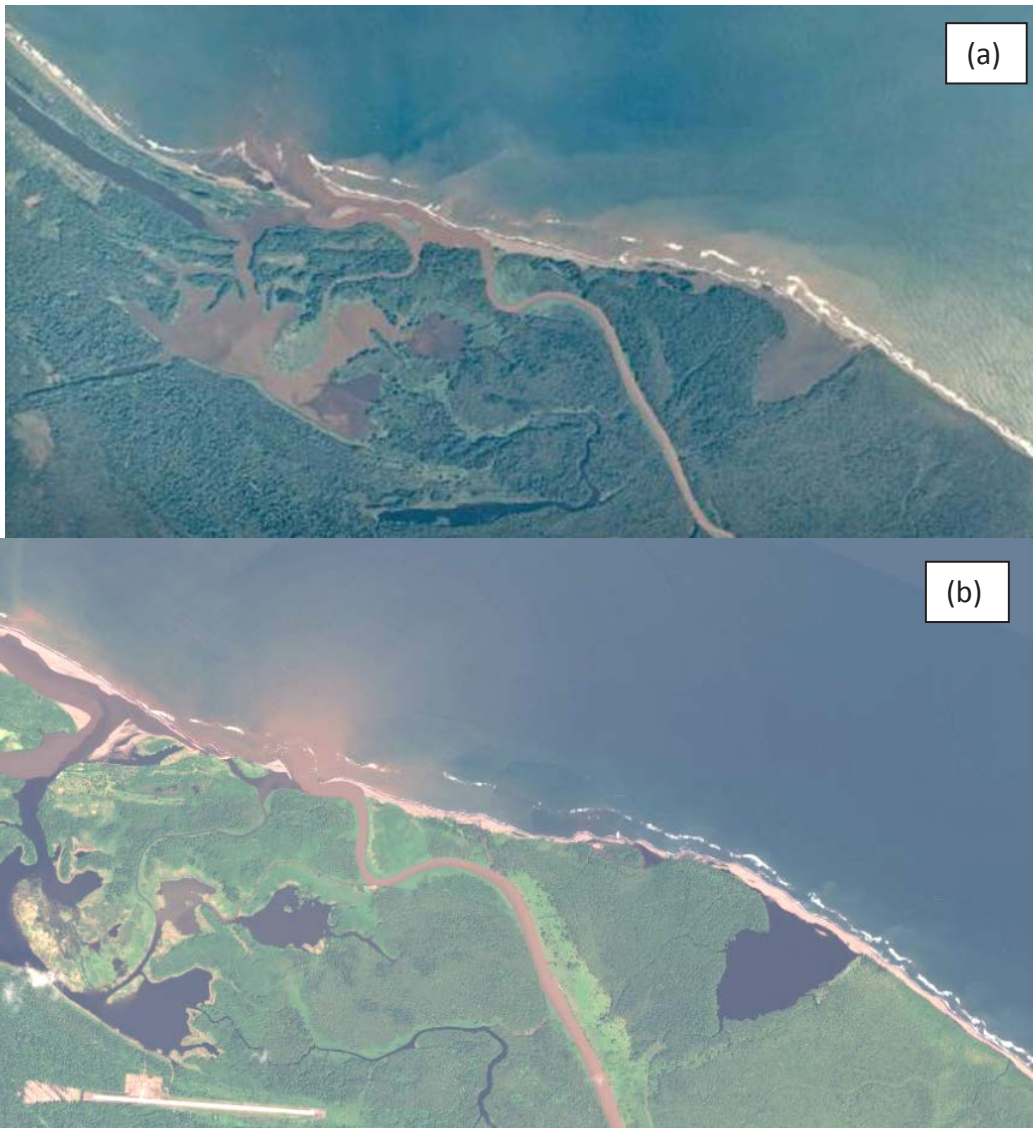
Figure 5.4 Satellite images showing that flow from the lower Río San Juan carries turbid water with a high concentration of fine sediment into both the Bay of San Juan del Norte and the littoral sediment system of the Caribbean Sea. Image dates (a) 13 December 1997 (b) 26 November 2013.

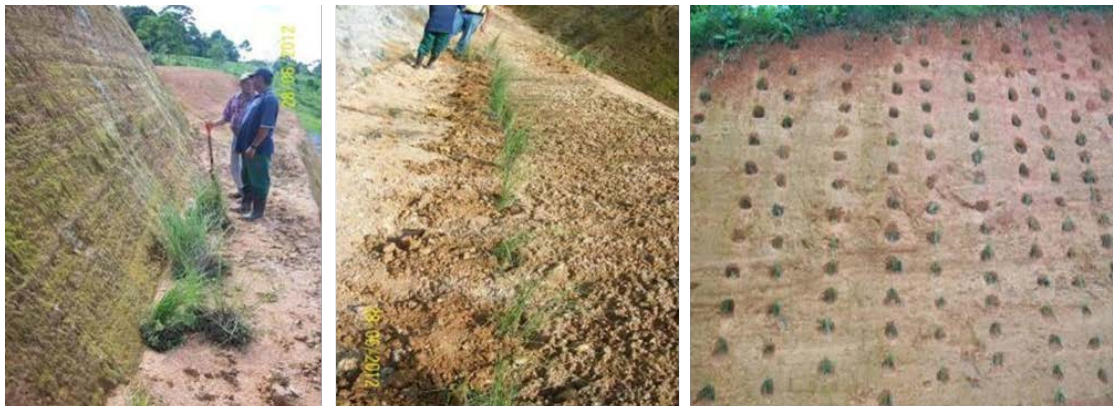
Figure 7.1 Examples of slope preparation and planting to provide surface protection by CODEFORSA along the Road between Marker II and Boca San Carlos

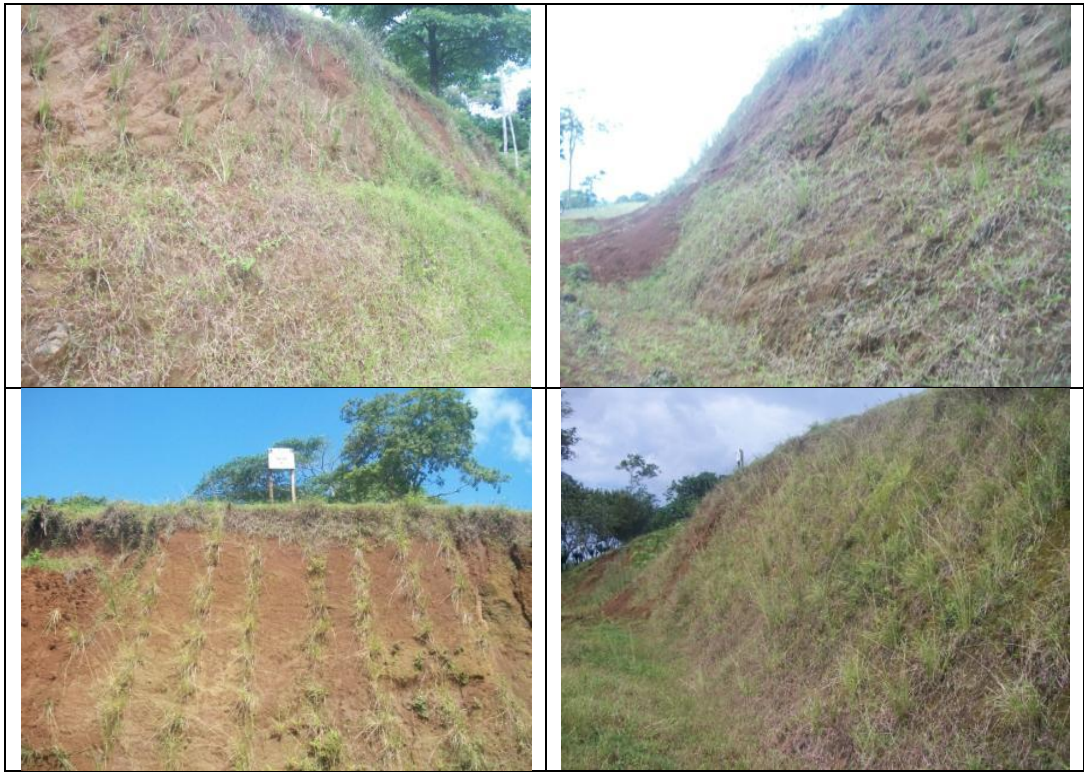
Figure 7.2 Slope 9 (near Tiricias) in February 2014, following treatment by CODEFORSA for surface protection (example taken from 2014 CODEFORSA Report)

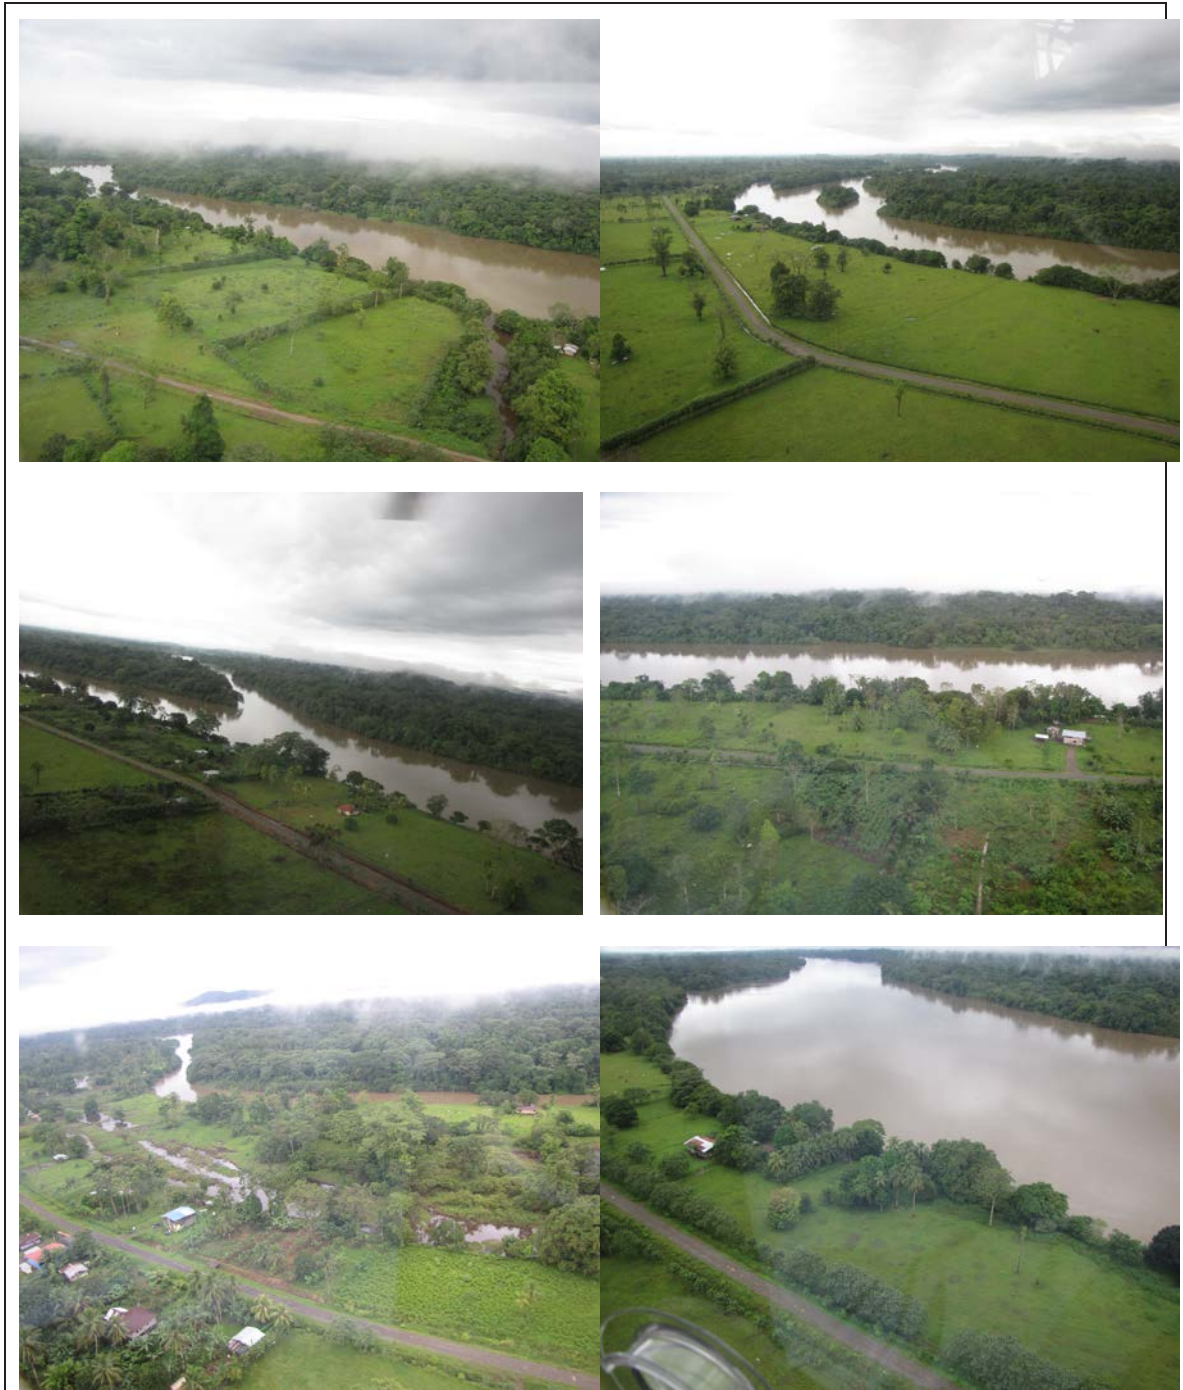
Figure 7.3 Photographs representative of conditions along the Road between Boca Sarapiquí and the Delta observed from the air by the author on 17 November, 2014.

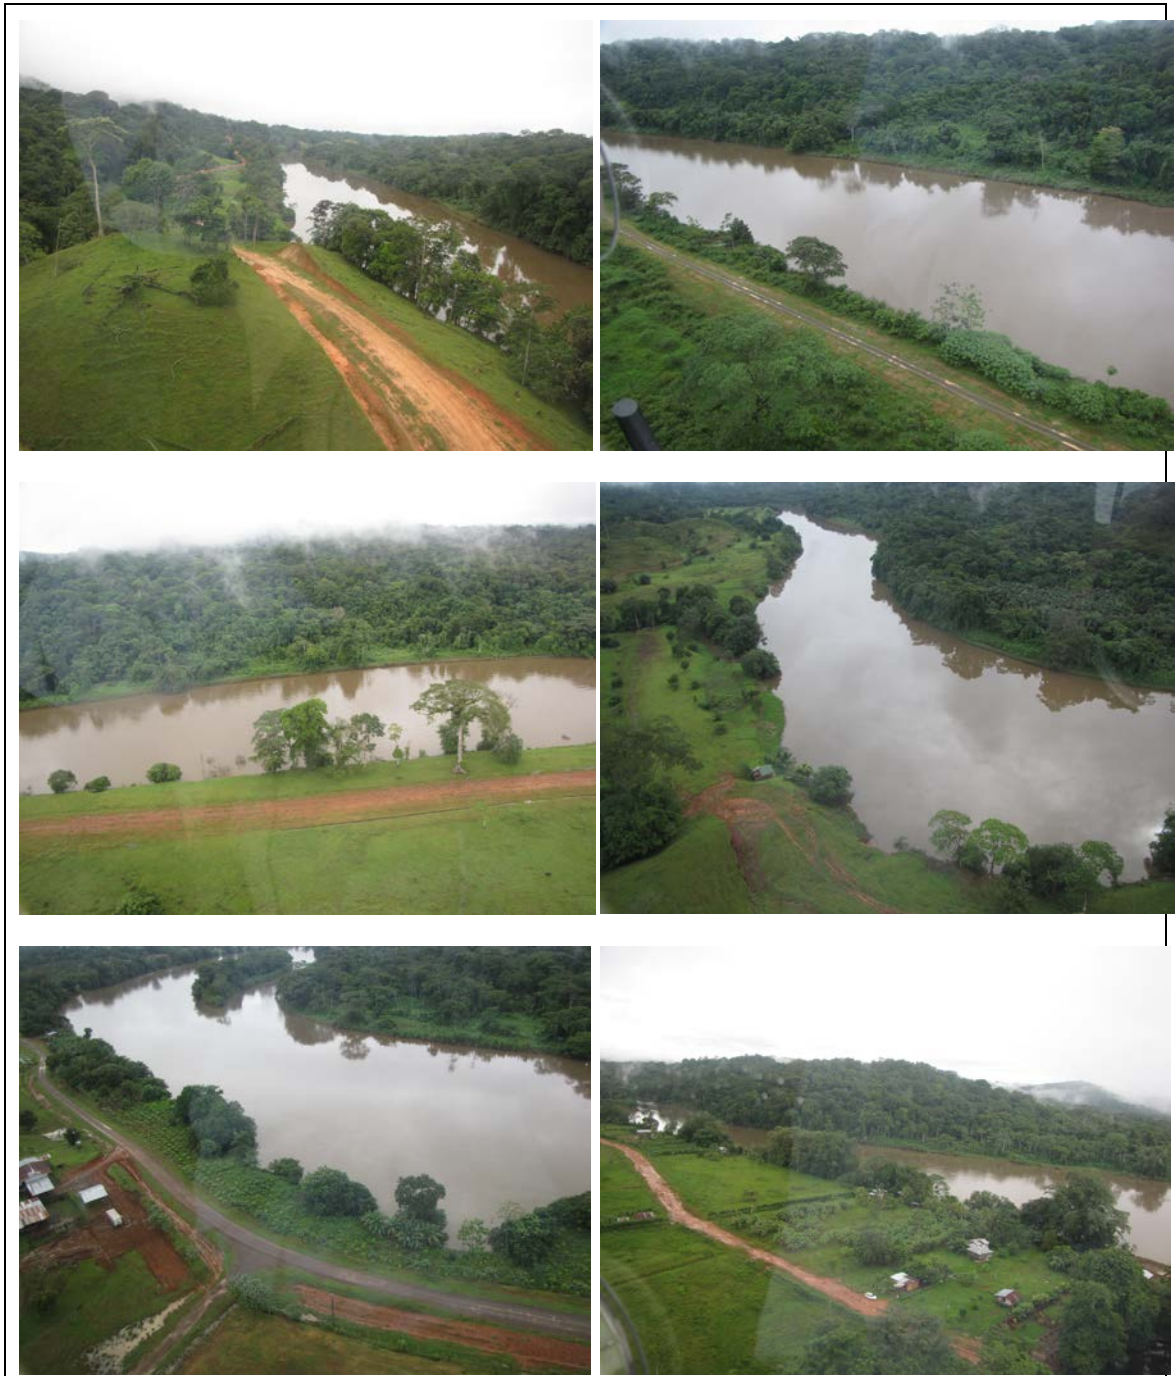
Figure 7.4 Photographs representative of conditions along the Road between Boca San Carlos and Boca Sarapiquí observed from the air by the author on 17 November 2014

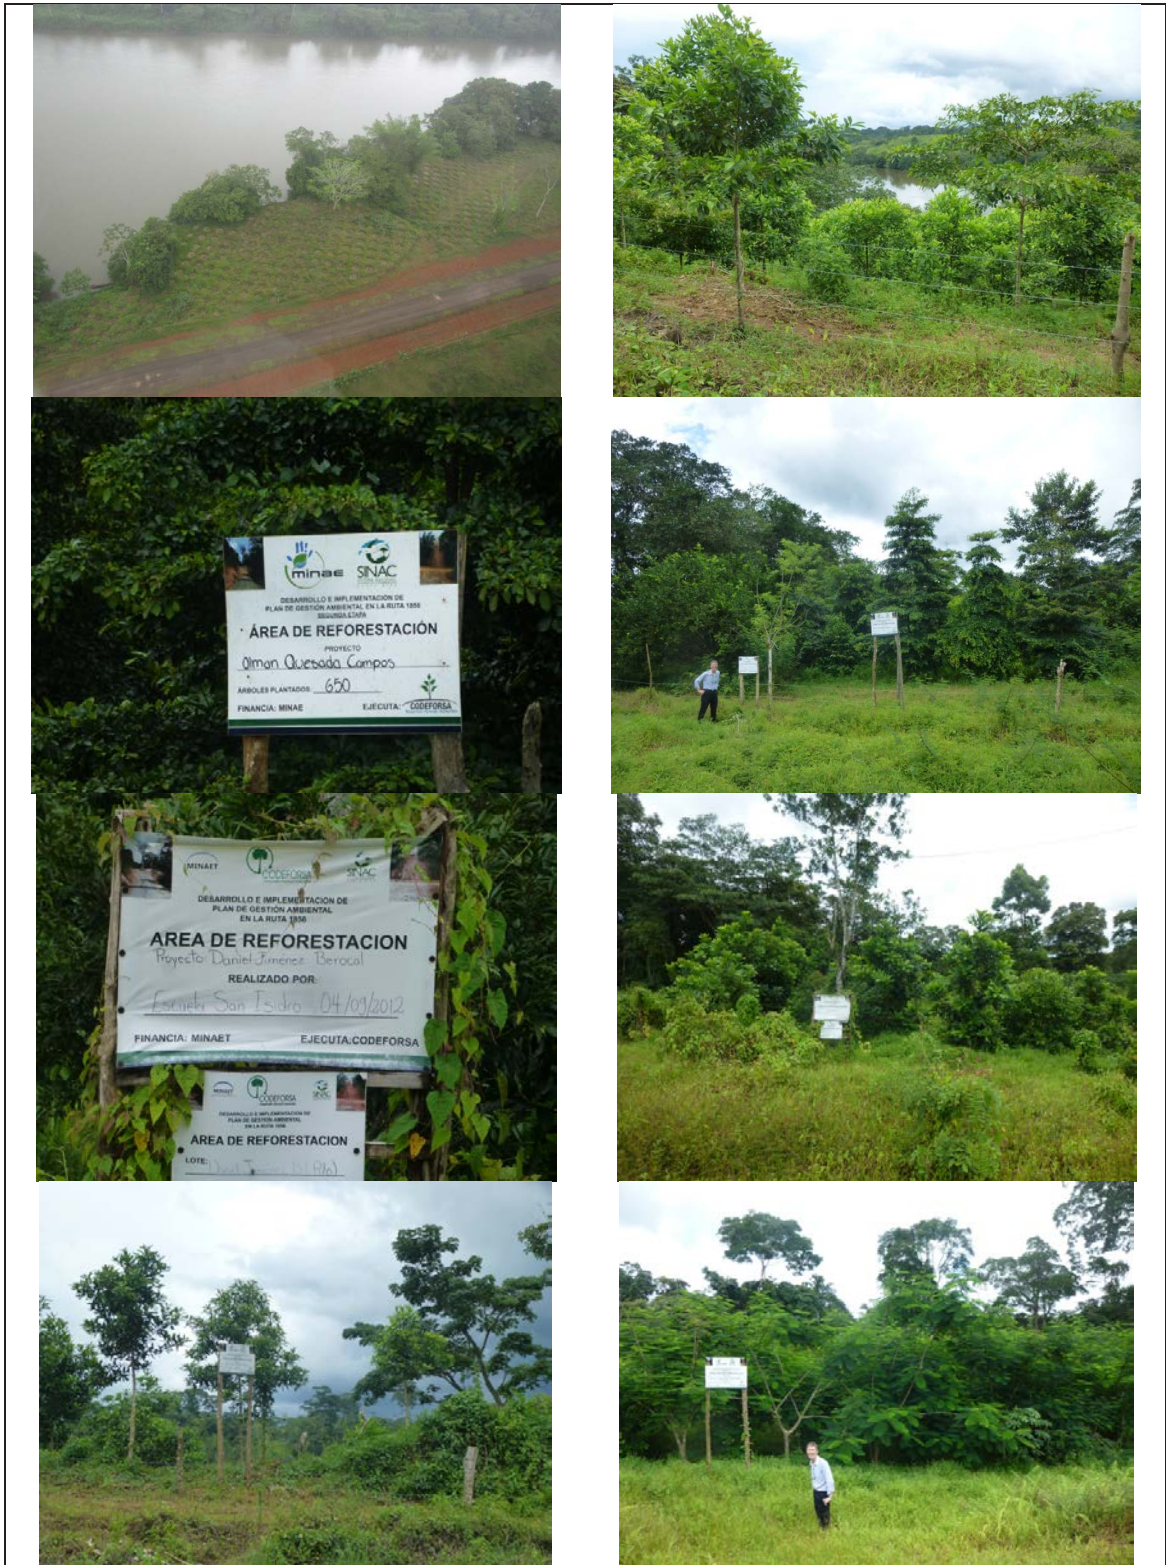
Figure 7.5 Condition of some of the CODEFORSA reforestation sites visited in 2014. Photographs by author.

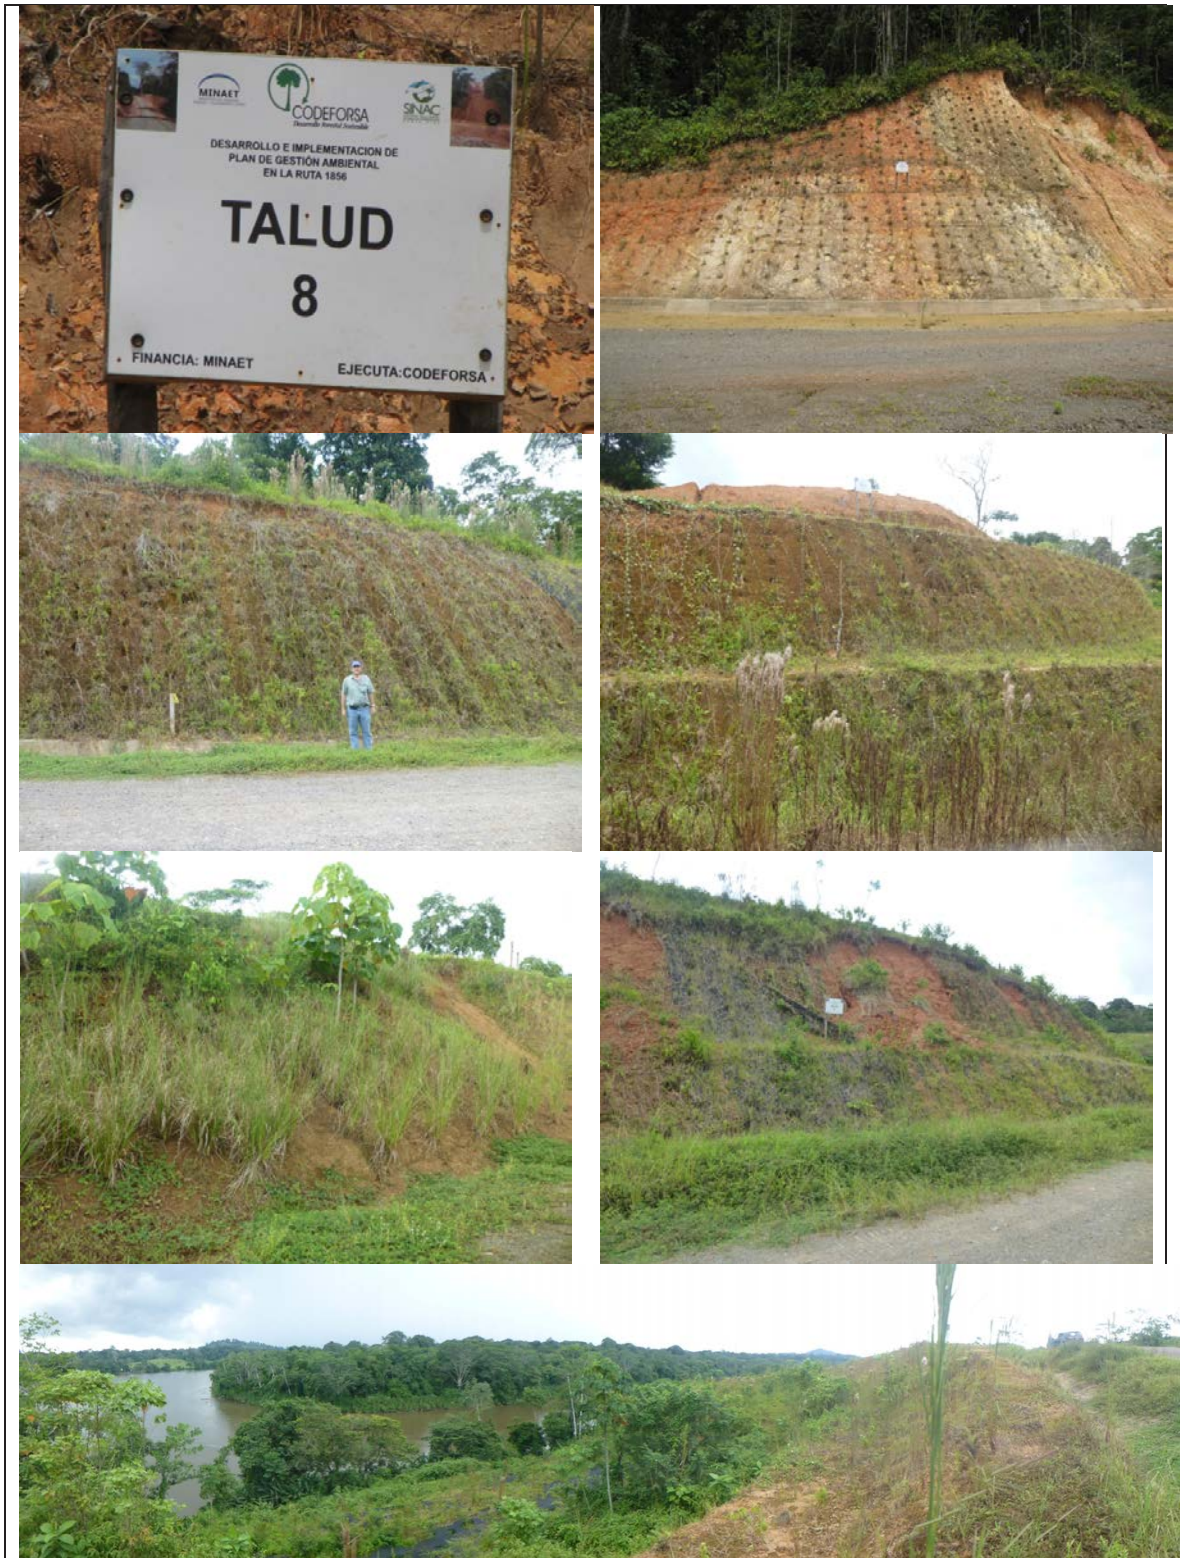
Figure 7.6 Condition of some of the slopes revegetated by CODEFORSA that were visited in 2014. Photographs by the author.

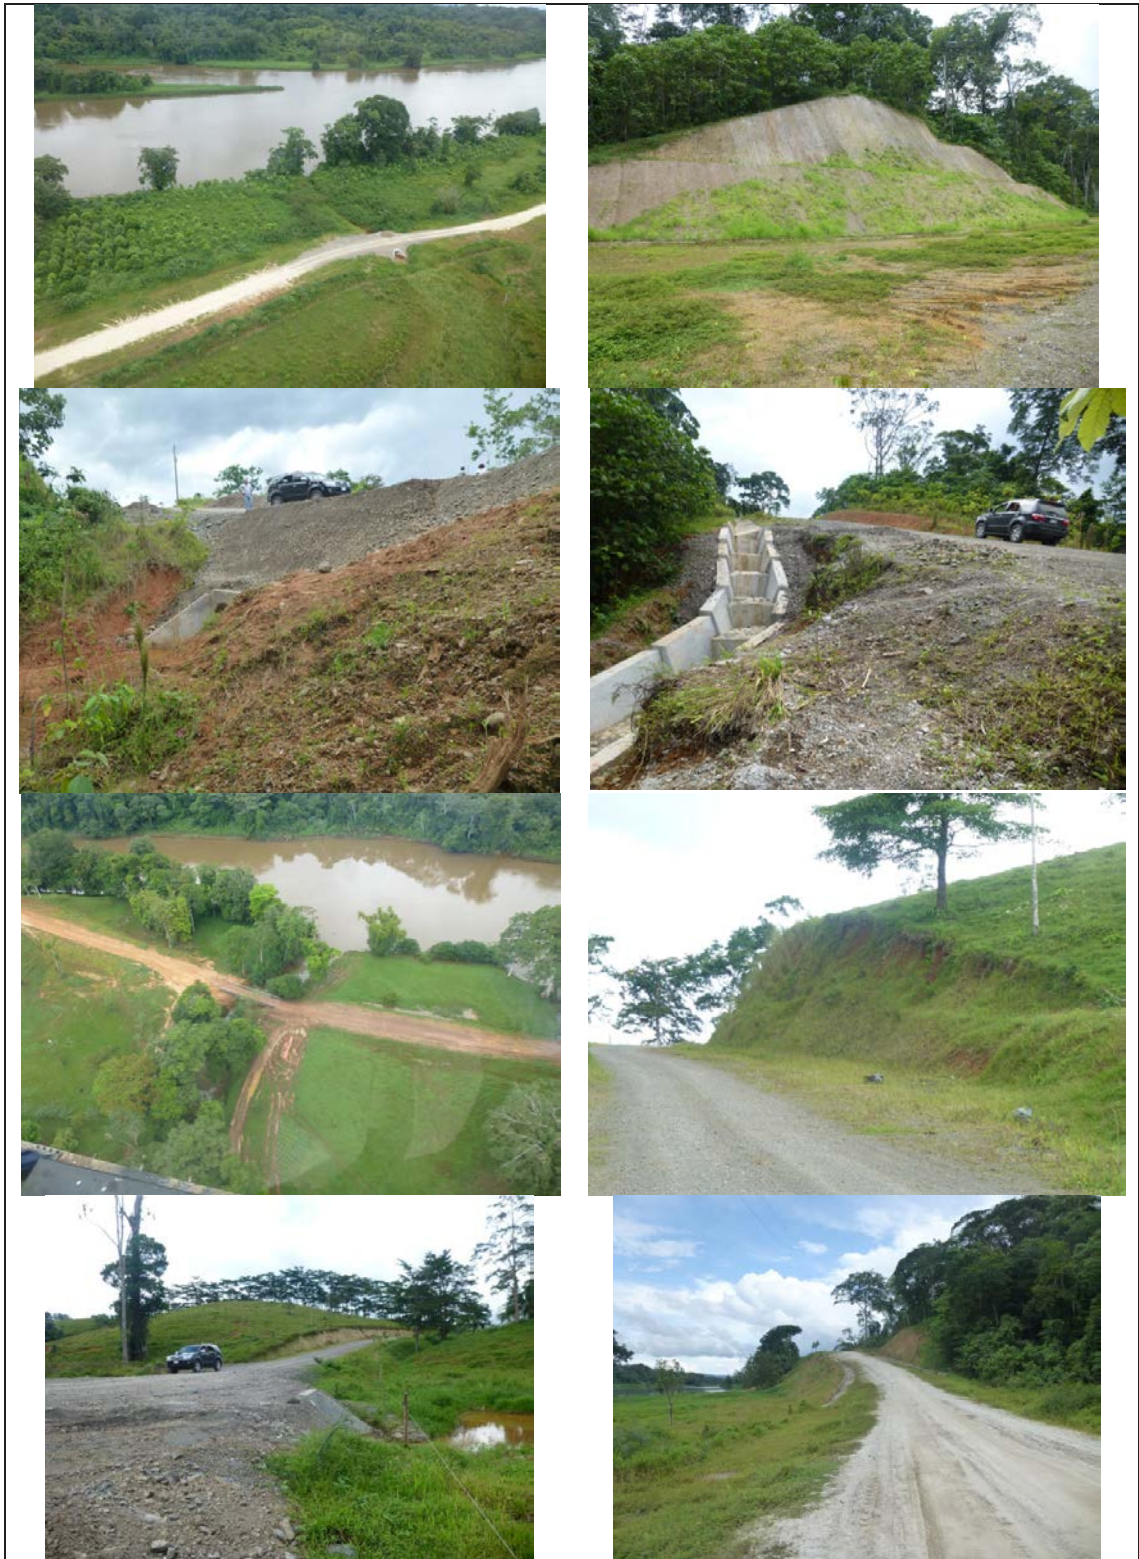
Figure 7.7 Condition of additional CONAVI erosion mitigation works inspected by the author in 2014: left watercourse crossings, and right slopes. Photographs by author.
