**DISPUTE CONCERNING THE CONSTRUCTION OF A ROAD IN
COSTA RICA ALONG THE SAN JUAN RIVER**

NICARAGUA v. COSTA RICA

REJOINDER OF COSTA RICA

2 FEBRUARY 2015

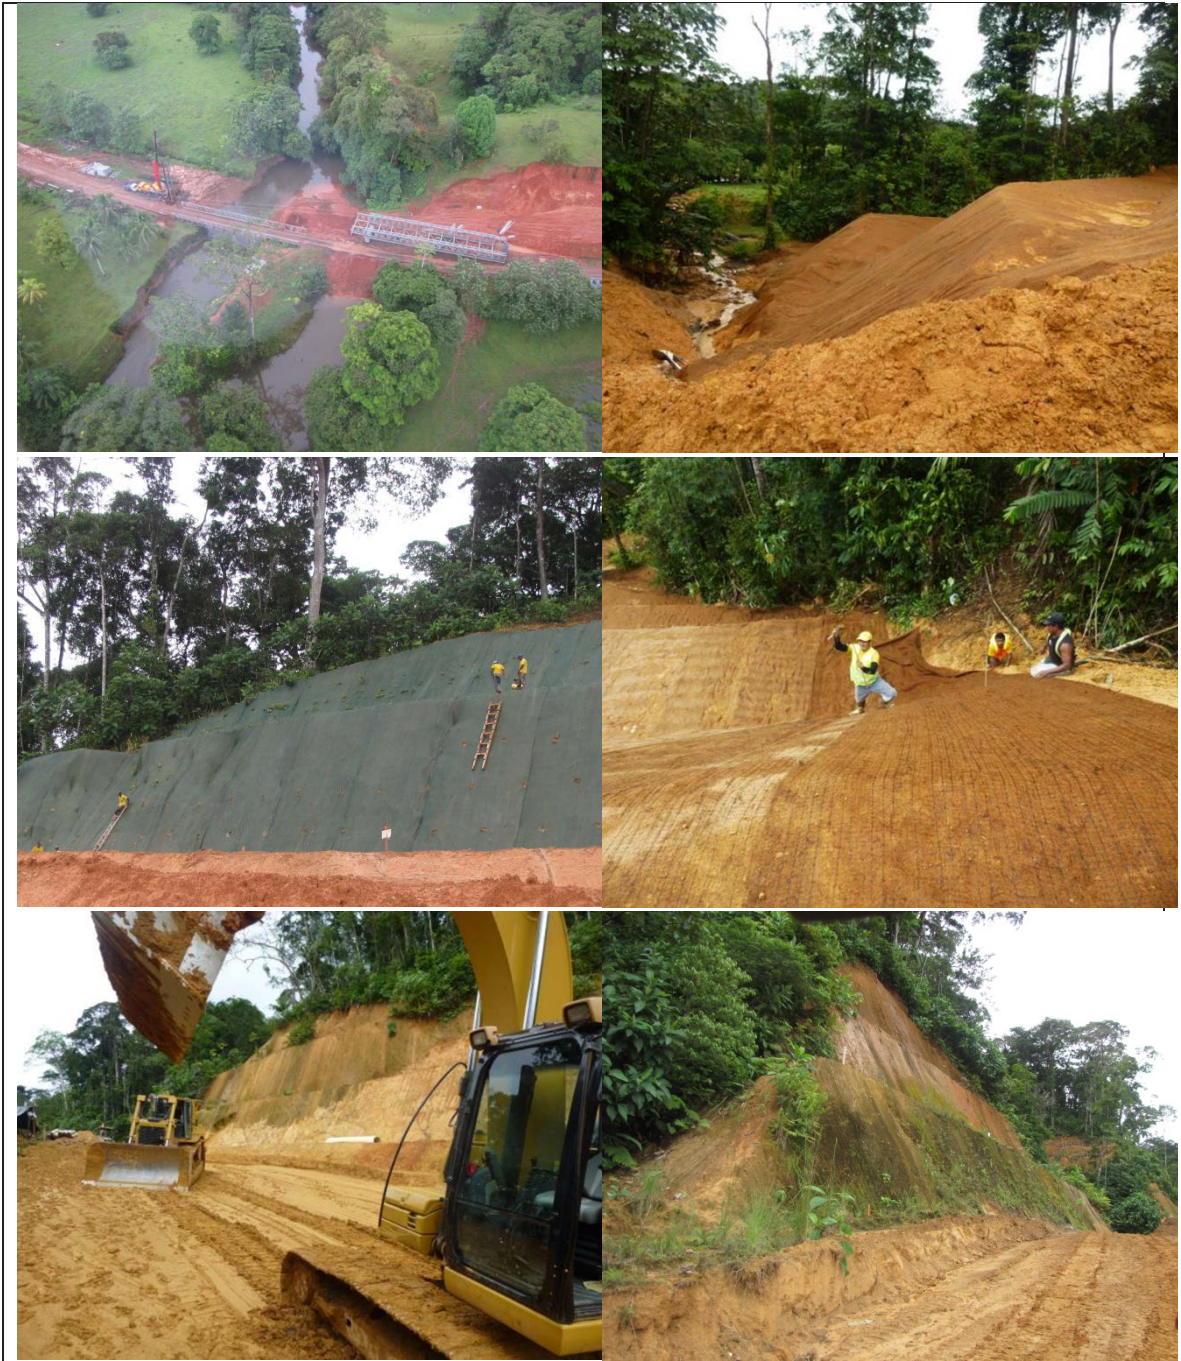
Figure 7.8 Large scale mitigation works by CONAVI on-going at sites around and Caño Cureña, inspected in November 2014. Photographs by author.

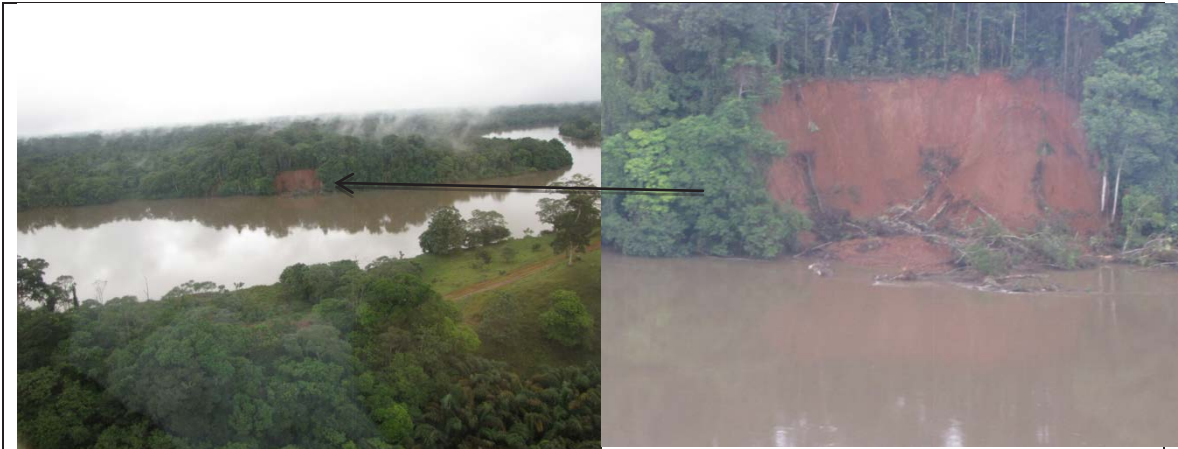
Figure 7.9 Natural landslide at the north (Nicaragua) bank of the Río San Juan observed from Costa Rican airspace at coordinates W 084o 03' 58.5" N 10o 45' 31.5" on 17 November, 2014. Note the temporary delta formed by sediment and fallen trees delivered directly to the river by the landslide. Sediment and trees enter the river due to natural processes to give Río San Juan naturally high sediment and debris loads and high turbidity, especially during the rainy season. Four other similar landslides were also observed during a single overflight that day. Photograph by author.

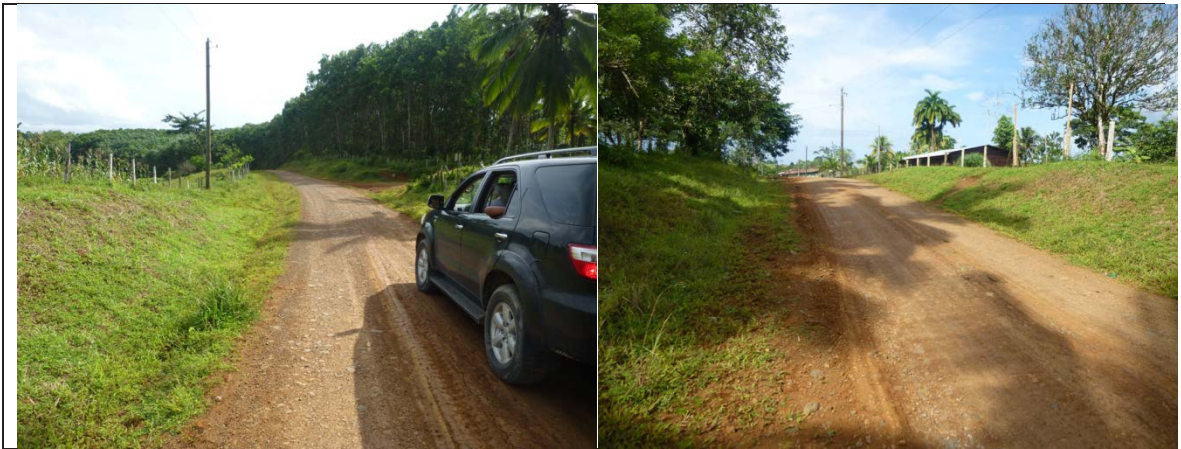
Figure 7.10 Typical views of access roads traversed during the field visit on 29 August 2014. Photographs by author.

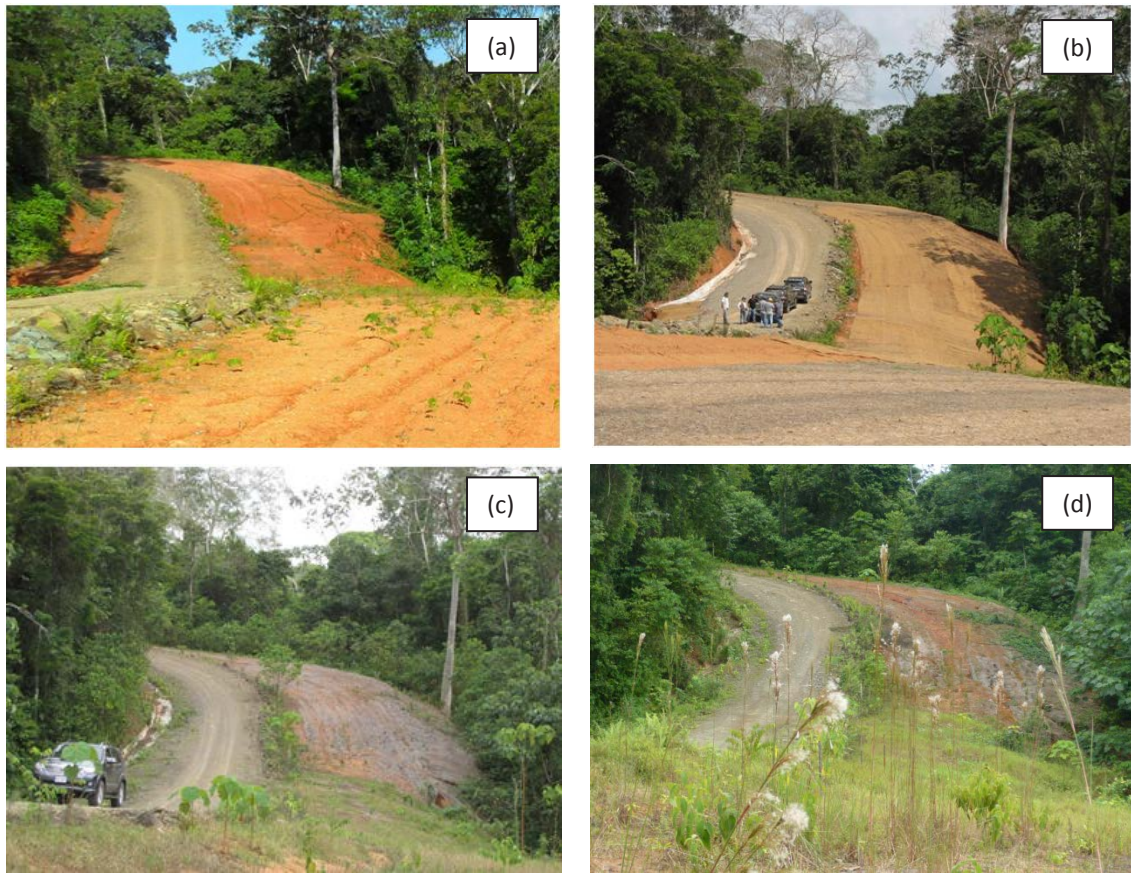
Figure 7.11 The Road near Marker II (a) prior to mitigation work on 15 February 2013 (b) on 7 May 2013 with mitigation measures in place: note in-board drainage channel and extensive biodegradable, erosion control matting (c) on 23 April showing that all mitigation measures survived the rainy season and (d) on 29 August showing that vegetation has stabilized both margins of the road bed and was spreading across the areas protected by coconut matting. Photographs by author.

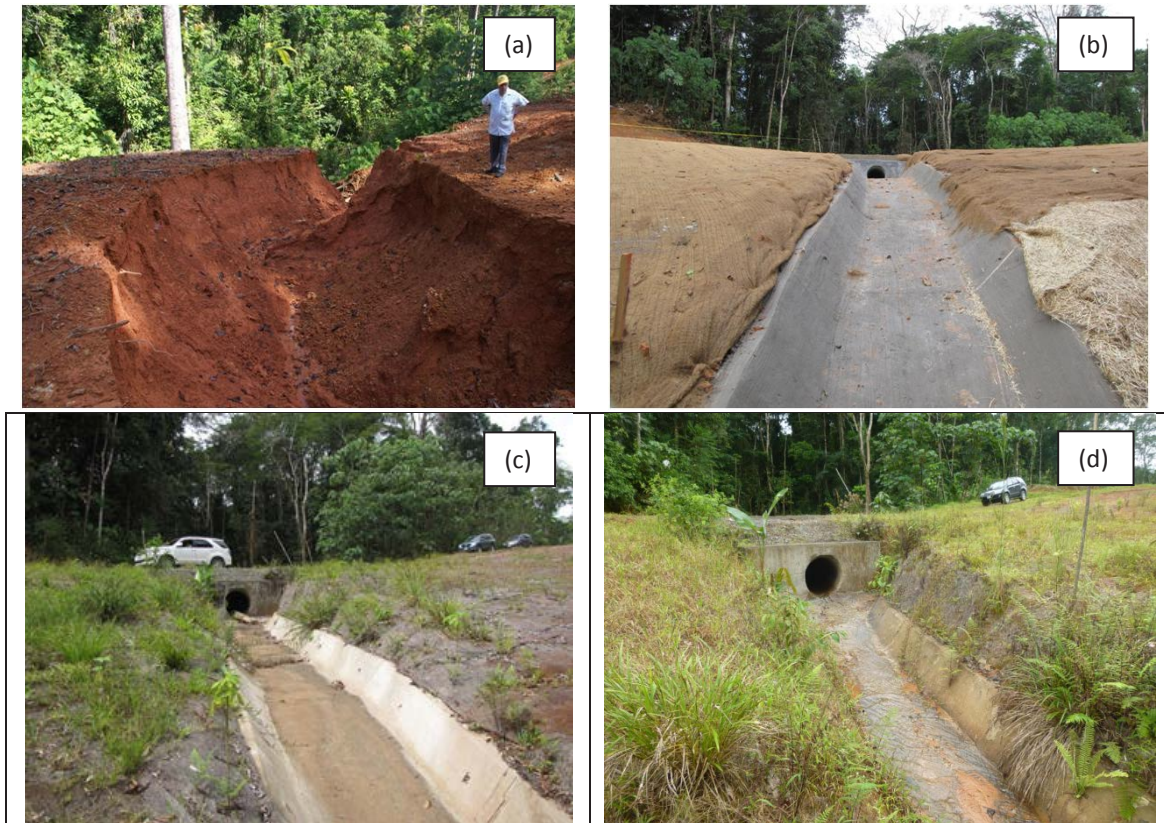
Figure 7.12 View down a large gully in a fill prism created by concentrated runoff from the Road draining to Costa Rican territory to the west of Marker II (a) in February when it was actively eroding and (b) in May when the gully had been back-filled and stabilized using a culvert and concrete drainage channel, with coconut matting used to protect the surrounding fill slope from sheet and rill erosion. Subsequent visits in (c) April and (d) August showed the culverted crossing to be intact after the rainy season and vegetation to be recolonizing the surrounding area. Photographs by the author.

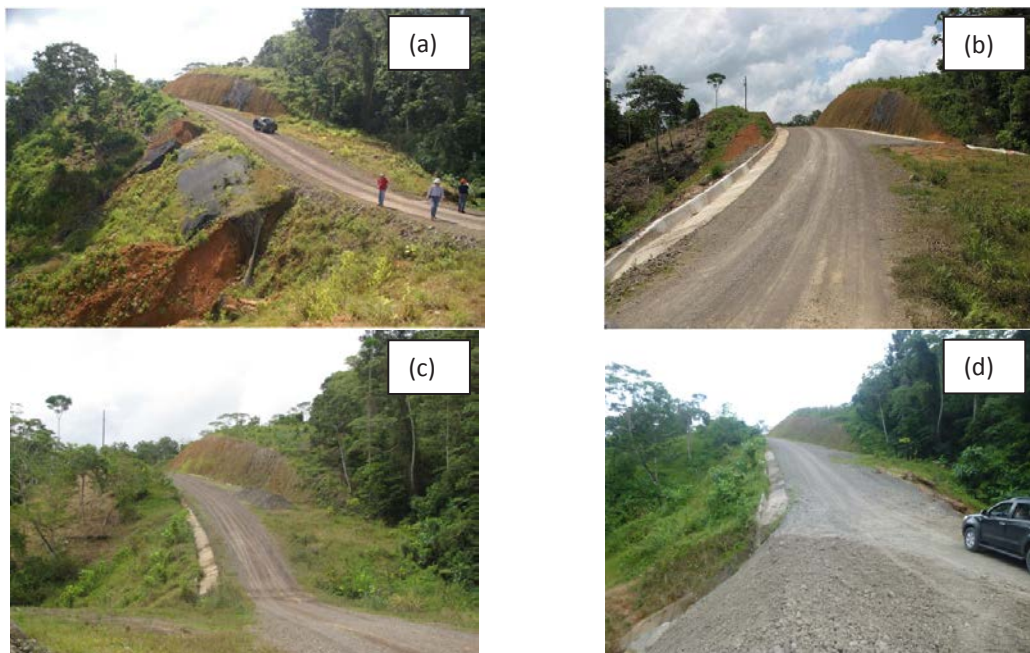
Figure 7.13 Road at East 497867, North 325463 about 6.4 km east of Marker II (a) on 15 February when failure of geotextile slope protection had allowed concentrated out-board runoff from the Road to create two gullies and in-board runoff was undercutting a cut slope (b) on 7 May 2013 after construction of concrete-lined out-board and in board ditches (c) and (d) in 2014 erosion has been effectively mitigated, the gullies have healed and both cut and fill slopes are revegetating. Photographs by author.

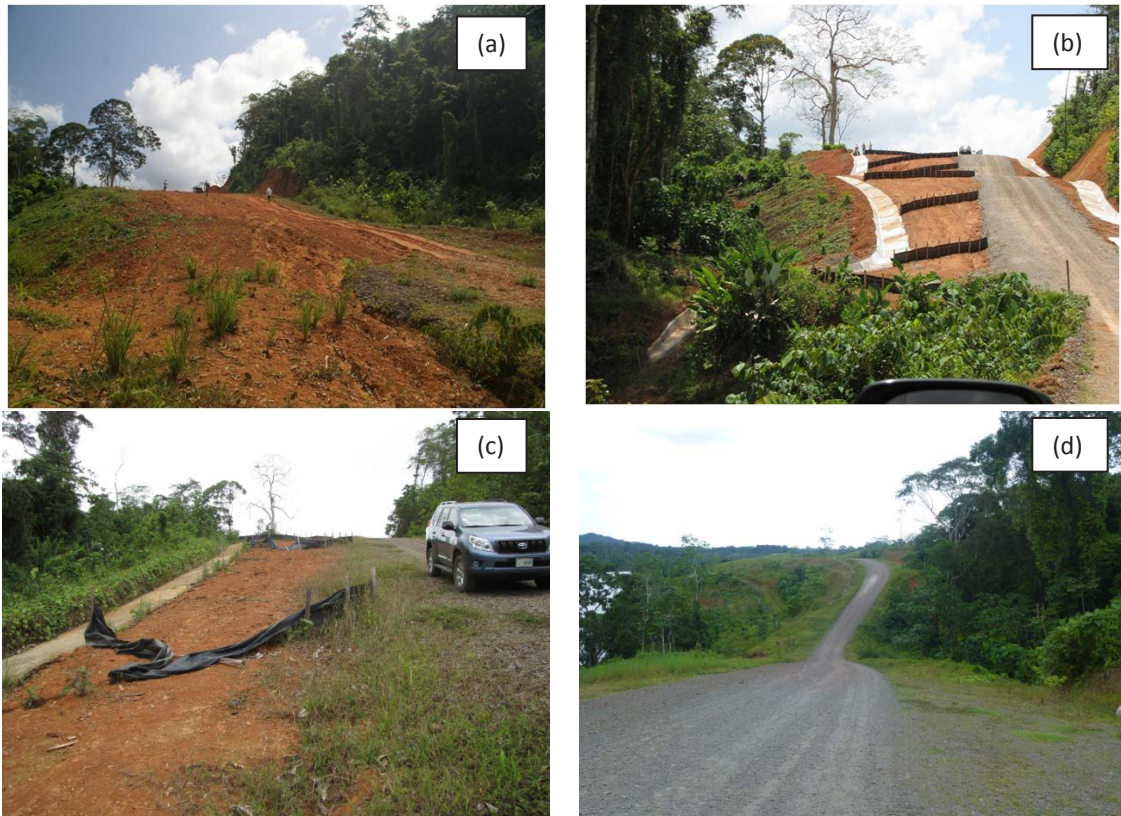
Figure 7.15 Road at East 502480, North 321561, close to the Río Infiernito (a) on 15 February when surface unmanaged runoff from the road bed and surrounding slopes disturbed during construction had caused sheet and rill erosion of bare soil surfaces. (b) The same stretch of road on 7 May 2013 after protection of the road surface using crushed rock, installation of silt fences to prevent sheet and rill erosion while directing down-slope surface runoff into concrete-lined outboard and inboard ditches (c) in April silt fences were showing wear and tear, but vegetation was spreading fast and by August (d) erosion mitigation had been successful at this site. Photographs by author.

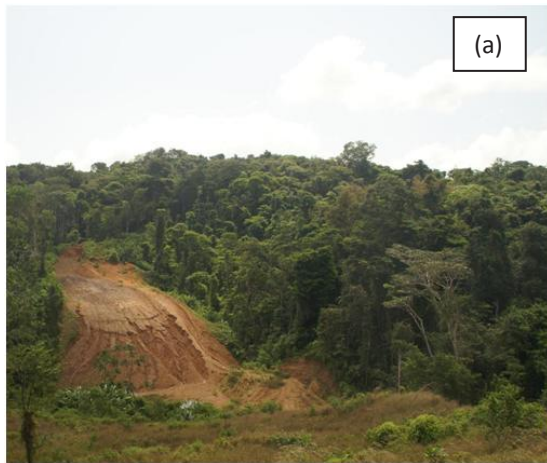
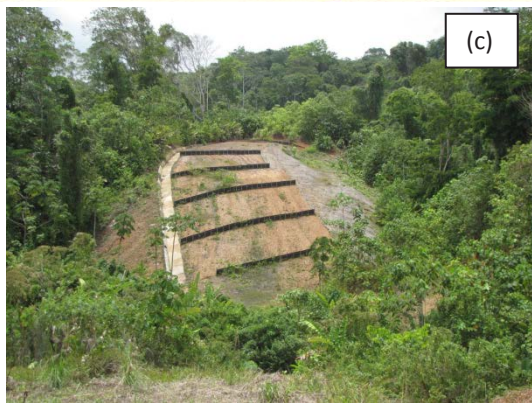
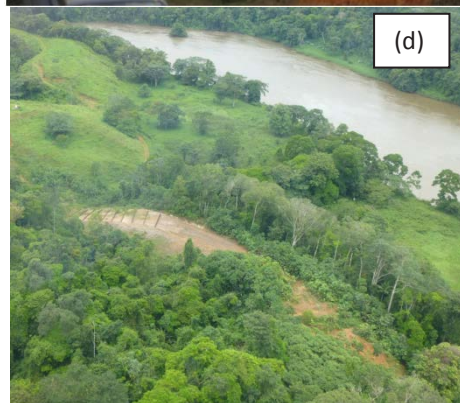
Figure 7.16 Path cleared for the Road near Crucitas, just east of the Río Infiernito (a) on 15 February when unmanaged runoff from the path cleared in preparation for construction of the road bed had caused sheet and rill erosion (b) The same area on 7 May 2013 after installation integrated measures to manage runoff involving regrading, silt fences, and concrete-lined outboard ditch (c) in April 2014, nothing had changed significantly and in August 2014 it was apparent that erosion mitigation continued to be successful and that no sediment from the site was reaching the Río San Juan. Photographs by author.
