**MARITIME DELIMITATION IN THE CARIBBEAN SEA AND THE PACIFIC OCEAN**

**(COSTA RICA V. NICARAGUA)**

**EXPERT OPINION**

**30 April 2017**

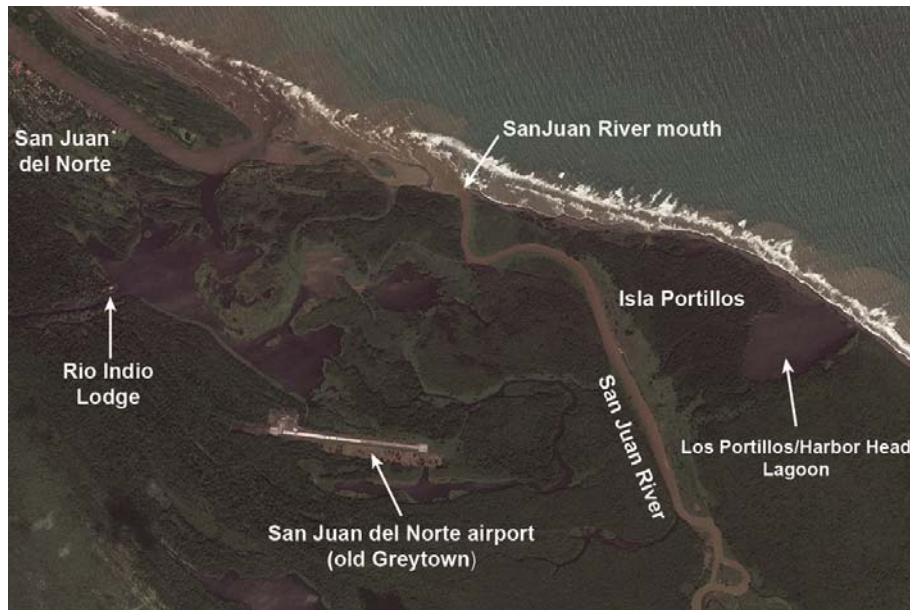
Figure 1. Annotated satellite image from December 2011 (U.S. Geological Survey) showing the location of San Juan del Norte village, Río Indio Lodge, the airport of San Juan del Norte built where Greytown used to be located, the San Juan River and its mouth (its position is highly variable), Isla Portillos, and the Los Portillos/Harbor Head Lagoon.

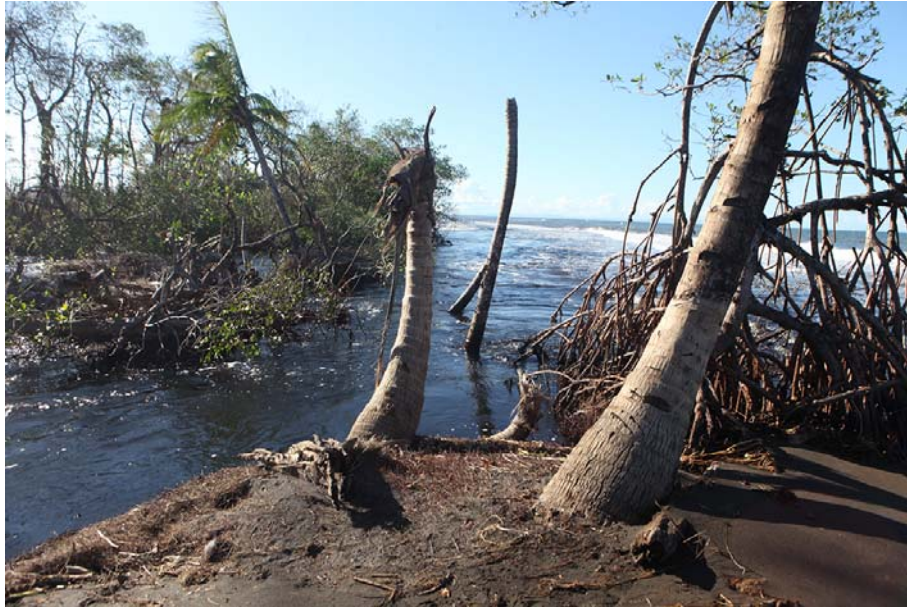
Figure 2. Drainage channel encountered during the first site visit, in which water was draining from the Los Portillos/Harbor Head Lagoon to the sea.

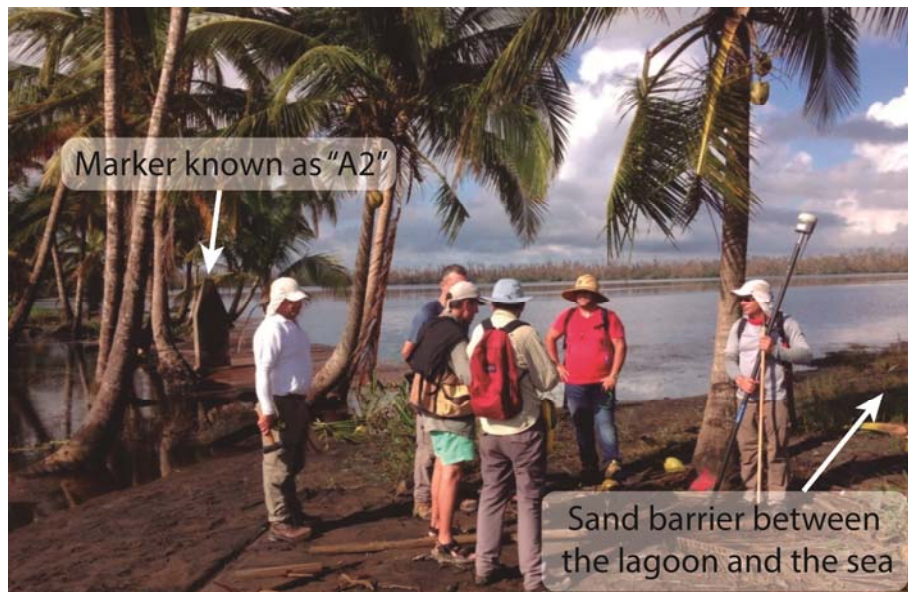
16. We then continued walking across the sand barrier between the lagoon and the Caribbean Sea. Arriving on the other (eastern) side of Los Portillos/Harbor Head Lagoon, we took note of the marker known as “A2” protruding from the water in the eastern corner of the lagoon (**Fig. 3**).

Figure 3. Image taken on the eastern corner of Los Portillos/Harbor Head Lagoon, showing the marker known as “A2”.

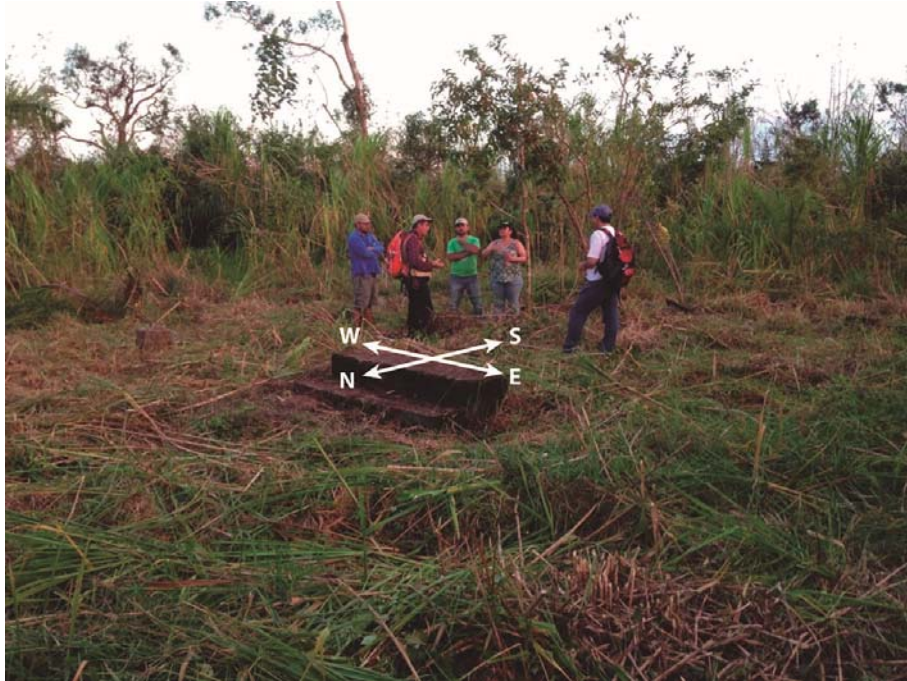
24. We continued in an easterly direction along a path parallel to the landing strip on its southern side. To the east of the cemeteries and south of the path, towards the eastern end of the landing strip, we reached a site where Nicaragua claimed it was possible to view the remains of steps which it considered were once part of the church overlooking Plaza Victoria. However, the steps in question ascended to the south, whereas the church in question would have faced south and its steps would have ascended to the north (**Fig. 4**). Moreover, according to old maps, as explained below, Plaza Victoria should be located north of the path.

Figure 4. Steps presented by Nicaragua as possibly being those of the church that would have been built on Plaza Victoria. Arrows indicate the orientation of the stairs, ascending to the south (co-ordinates measured with a hand-held GPS: 17P 0204495E, 1208408N).

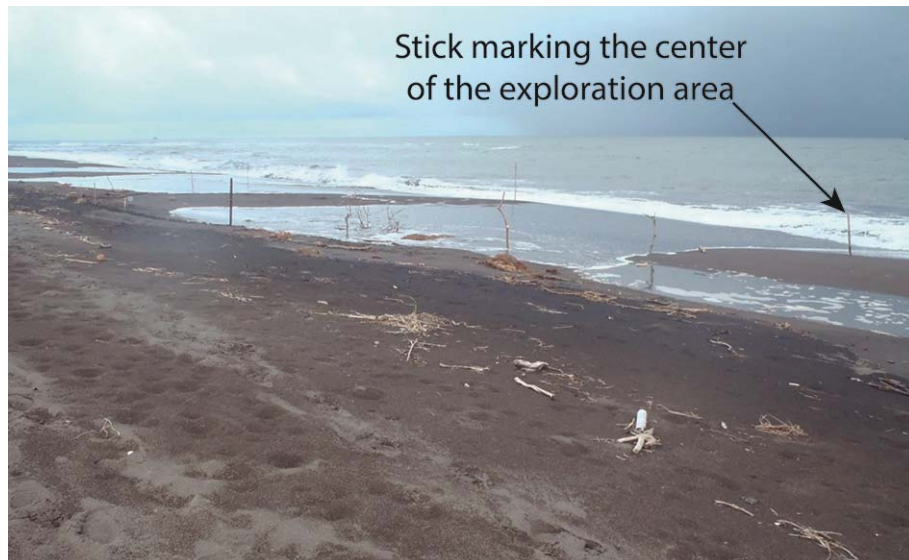
Figure 6. Exploration area around a point established assuming that the average of the co-ordinates measured on 25 November 2003 correspond to the location of auxiliary marker  $A_m$  and using the triangulation values indicated in the sketch-map included in *Proceedings XX of the Costa Rica-Nicaragua Demarcation Commissions (1897-1900)*.

28. Noting that the average of the co-ordinates taken in 2003 currently correspond to a point situated in the sea, we operated on the hypothesis that the marker previously found was  $A_m$  (if it were to be  $A_1$ , both points would be in the sea). We therefore used the triangulation values between markers  $A_m$  and  $A_1$  indicated in the sketch-map included in *Proceedings XX of the Costa Rica-Nicaragua Demarcation Commissions (1897-1900)* (**Fig. 5**) to find the approximate location where  $A_1$  could be buried on the beach. Then, we marked off a semi-circular research area of 15 m radius (estimated error margin of the hand-held GPS device) for potential exploration around this point on the beach side (**Fig. 6**). The remaining semi-circular area was located in the sea.

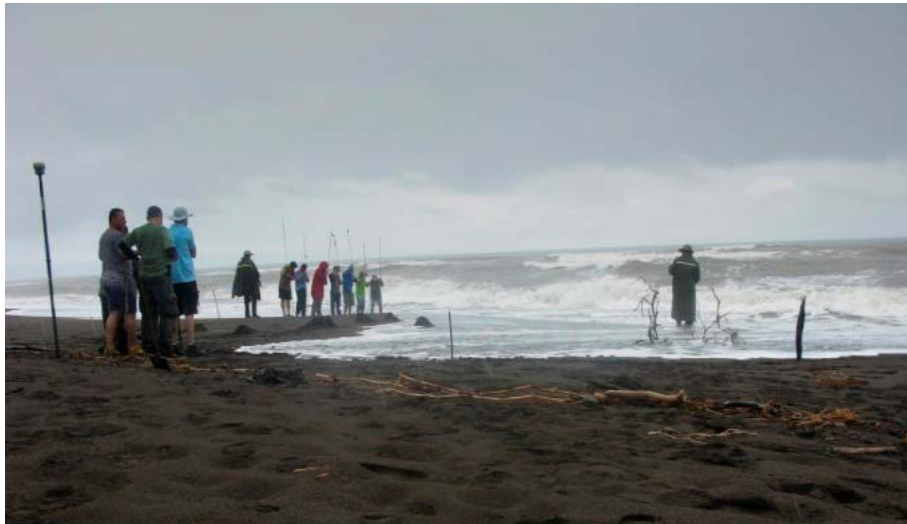
40. Together with members of each delegation, we formed a line and started probing the sand with iron rods (**Fig. 7**). Unfortunately, the equipment was rather inadequate. The corrugated rods not being easy to handle or sharp enough, they did not penetrate the ground more than 50 cm. Some workers helped the search with shovels.

Figure 7. Row of delegates probing the sand with iron rods.

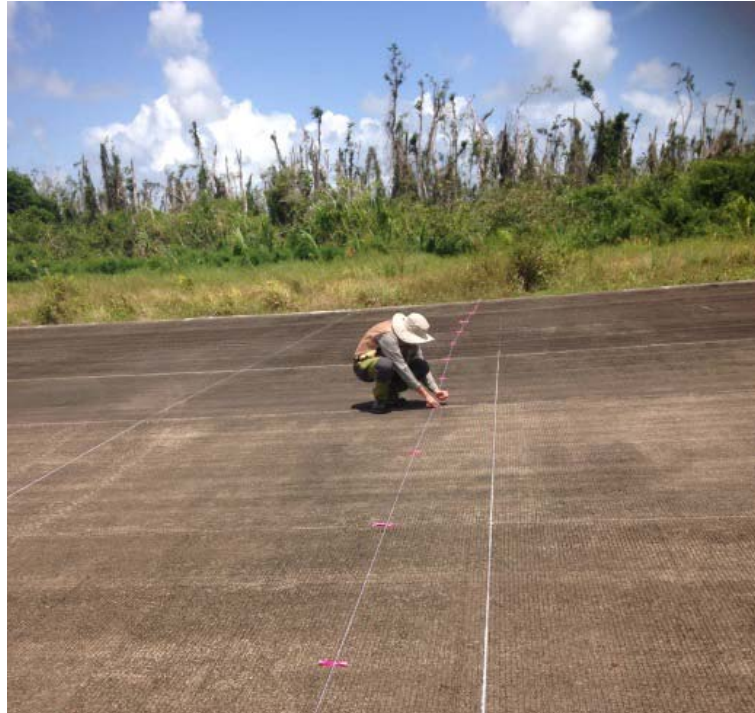
49. The landing strip itself measured 25 m wide. Two cords were placed across it, marking off the eastern and western extremities of the initial research area, and short colored (pink) ribbons were tied on these cords every 155 cm, these representing the extremities of the Ground Penetrating Radar (“GPR”) profiles (**Fig. 10**).

Figure 10. Placing of colored ribbons every 1.55 m on the cords marking off the eastern and western extremities of the initial research area, covering a 60 m long section of the landing strip.

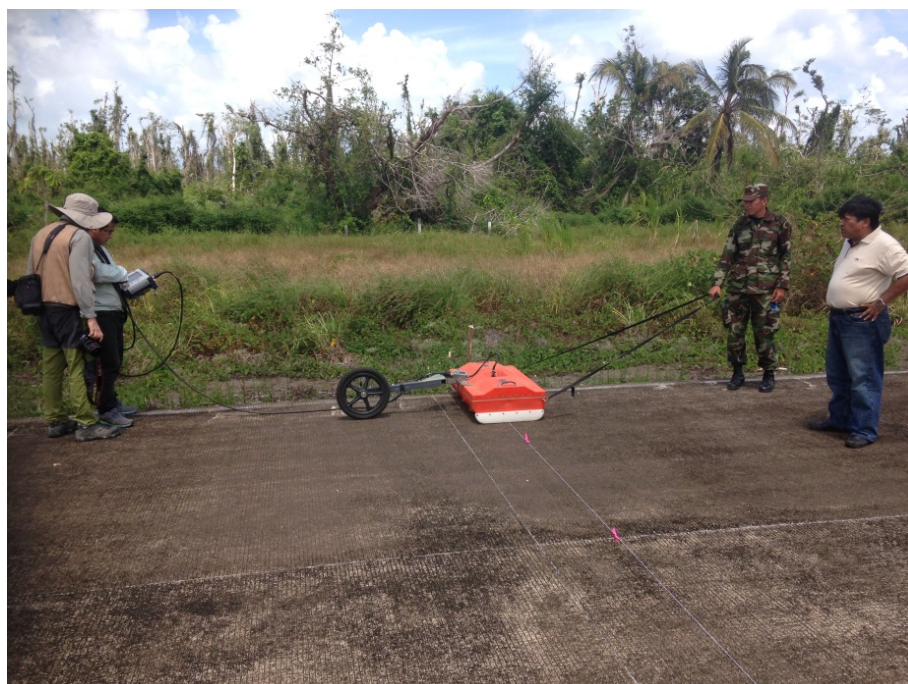
Figure 11. Acquisition by Nicaragua of GPR profiles using a GSSI system equipped with a 200 MHz shielded antenna.

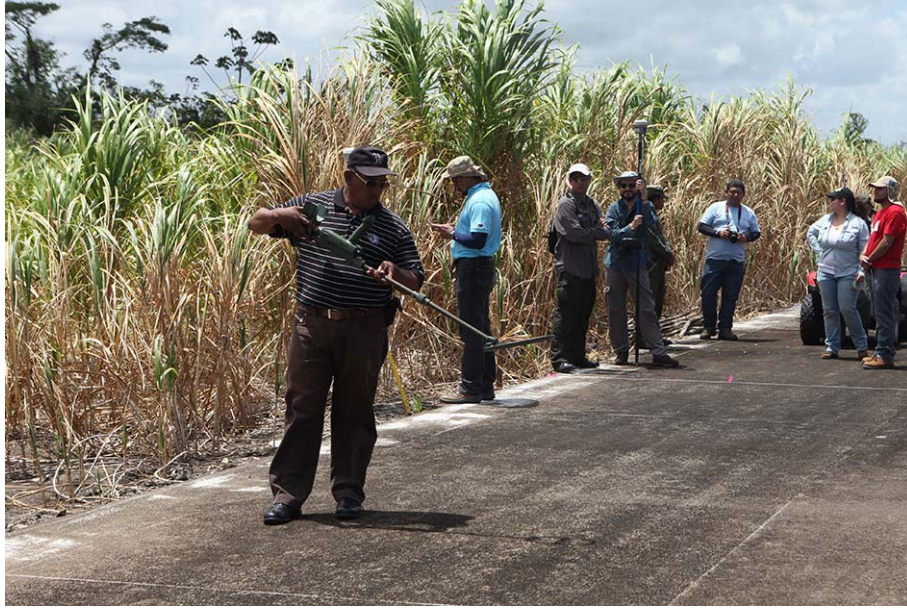
Figure 12. Surveying of the landing strip with the Nicaraguan metal detector (VALLON model VMH3CS).

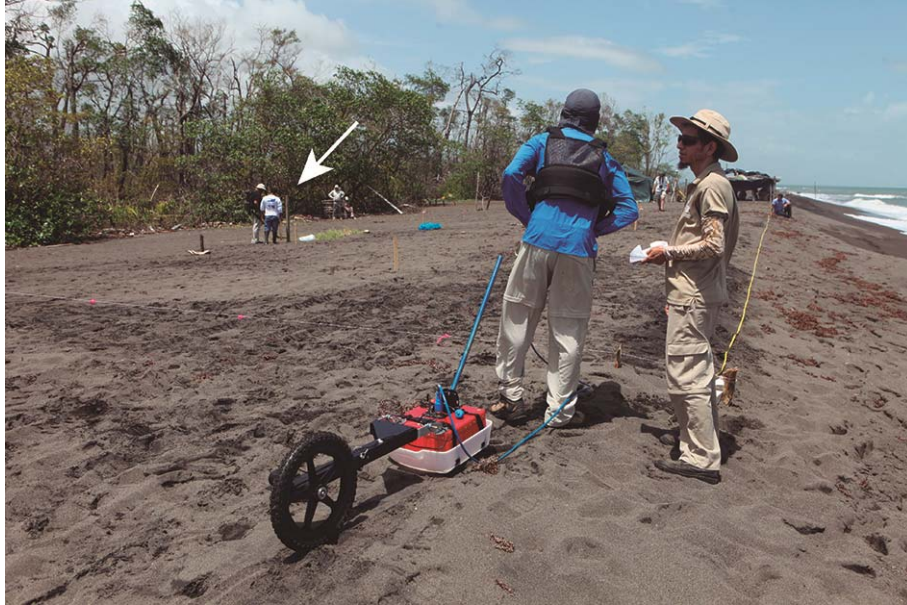
Figure 14. Initial research area established on the western side of Los Portillos/Harbor Head Lagoon using the co-ordinates given by Nicaragua for the marker found on 26 November 2003 ( $10^{\circ} 56' 2.3''\text{N}$ ,  $83^{\circ} 40' 24.4''\text{W}$ ). The location of that point was marked with a wooden stick (see arrow). The Nicaraguan operator of the metal detector is standing next to the stick. In the foreground, the GSSI GPR system of Costa Rica with a 400 MHz shielded antenna.

58. Based on co-ordinates provided by Nicaragua, we established a research area measuring 22 m by 27 m on the beach, near the northwestern corner of the lagoon, in order to look for the marker found on 26 November 2003, submerged in Los Portillos/Harbor Head Lagoon, and which Nicaragua said “in shallow water and not difficult to locate” (letter dated 21 December 2016 from the Agent of Nicaragua to the Registrar of the Court). Cords were stretched at each end and marked every 2 m with ribbon, after which the Costa Rican GPR team collected data of the entire area (a total of 12 profiles 27 m long) in the same manner as that carried out by the Nicaraguan GPR at the landing strip the previous day (**Fig. 14**).

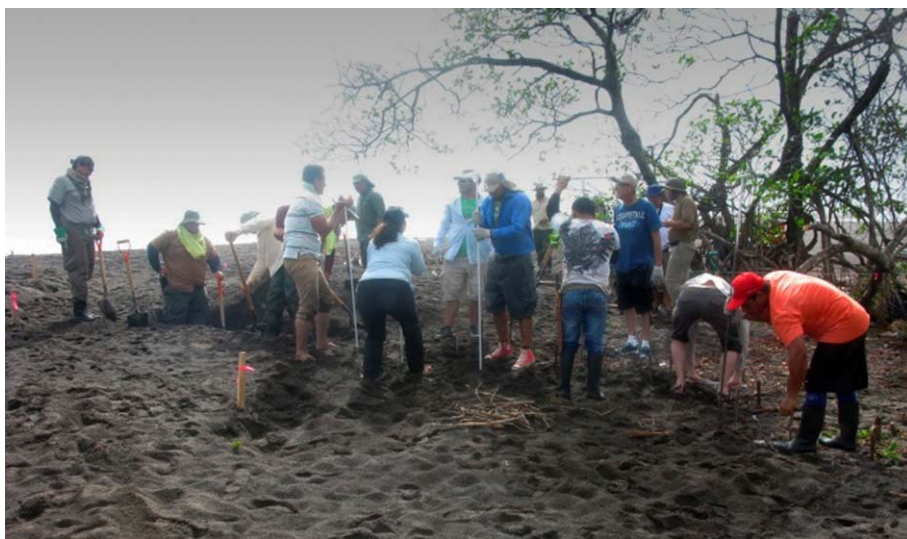
Figure 15. Piercing the sand with 2 m long iron rods.

60. It was also decided, following consultation with the Parties, to expand the research area towards the southwest, slightly into the vegetation and closer to the channel-shaped north-western edge of the lagoon. Piercing the sand with the 2 m rods proved effective albeit difficult, and it was decided to return to the same area the following day and repeat this procedure more systematically, piercing every corner of a large grid composed of 40 cm squares.

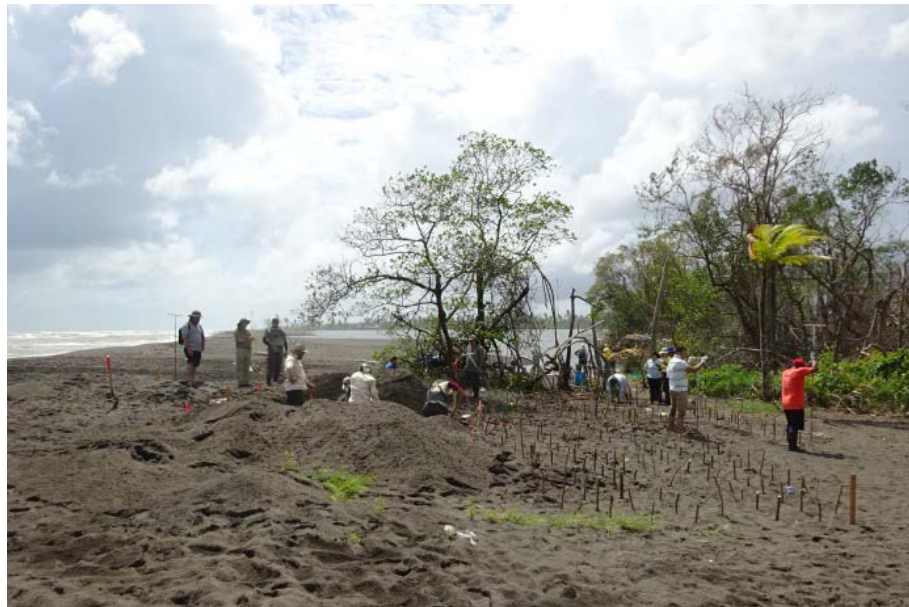
Figure 16. Lowering the higher portion of the beach with shovels and piercing systematically the sandy ground with 2 m long iron rods. The sticks mark the investigated points, forming a grid with a spacing of around 0.4 m.

64. On the way, we stopped near the western edge of the lagoon to define a research area to be examined systematically with iron rods. One section (defined the previous day in order to locate the marker that Nicaragua had found on 26 November 2003) of approximately 27 m by 15 m was marked off to be examined with the 2 m iron rods, piercing every 40 cm. Another area, closer to the sea, in which the ground surface was higher, of approximately 27 m by 7 m, was marked off to be first cleared of 1 m of sand with shovels and then examined in the same manner as the first one, with the iron rods. The teams began this process, with almost everyone taking part and working together. Sticks were placed in the holes after the rod had pierced 2 m without encountering an obstacle (**Fig. 16**).

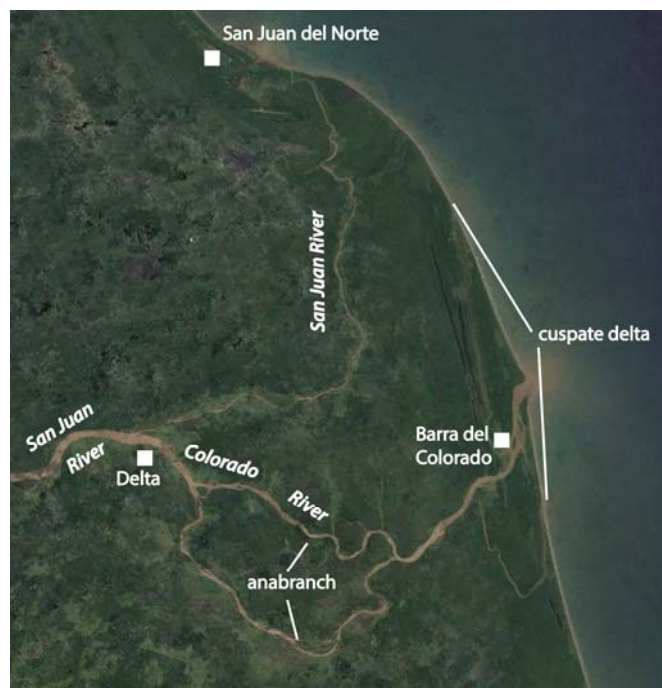
92. The starting-points of the maritime boundary between Nicaragua and Costa Rica in the Caribbean coast proposed by both Parties are located in a coastal stretch associated with Los Portillos/Harbor Head Lagoon and the mouth of the San Juan River. This river, around 200 km long and with a catchment area of approximately 38,500 km<sup>2</sup>, starts from Lake Nicaragua (or Cocibolca Lake) in Nicaragua. At around 19 km west of the Caribbean coast near Delta, the San Juan River splits into two main channels (**Fig. 19**). The southern one is called the Colorado River, which shows a major anabranch. Nowadays it carries most of the discharge of the fluvial system and has formed a wave-dominated cusped delta in the Barra del Colorado area. Deltas in coasts with strong wave action tend to have a cusped morphology, with a high width/length ratio, whereas deltas in which fluvial sediment supply overwhelms the erosional effect of waves tend to project into the sea showing a lower width/length ratio and a lobate or triangular geometry. The northern channel, despite its current lower flow, is designated as the San Juan River. This branch has an E-W orientation in its initial stretch and at around 9 km west of the coast turns into a general N-S direction.

Figure 19. Annotated satellite image (Landsat, December 2016) showing the main geographical-geomorphic features of the lower reaches of the San Juan fluvial system associated with the Caribbean coast.

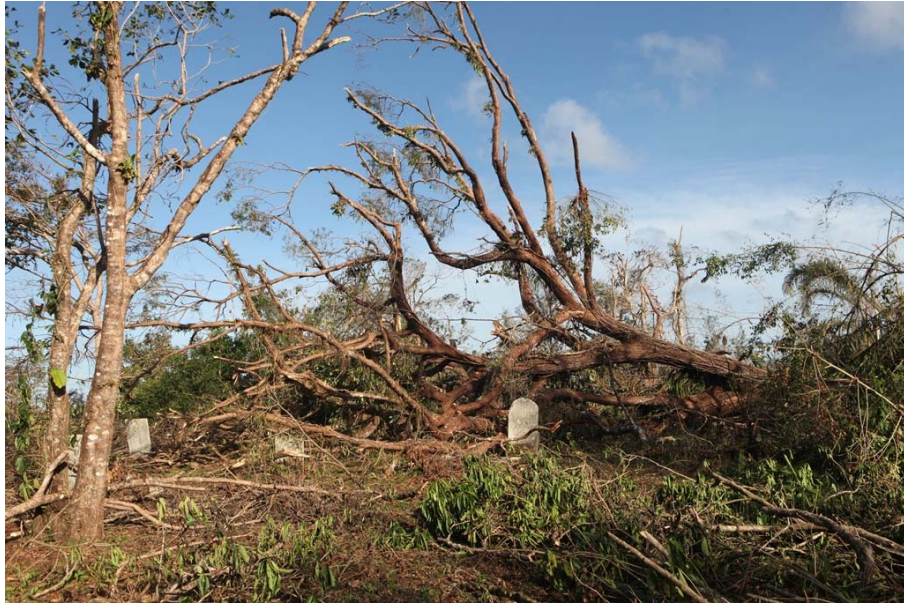
Figure 20. Effects of Hurricane Otto in the cemetery of Greytown. Image taken during the first site visit on 6 December 2016 (twelve days after Otto made landfall in the area).

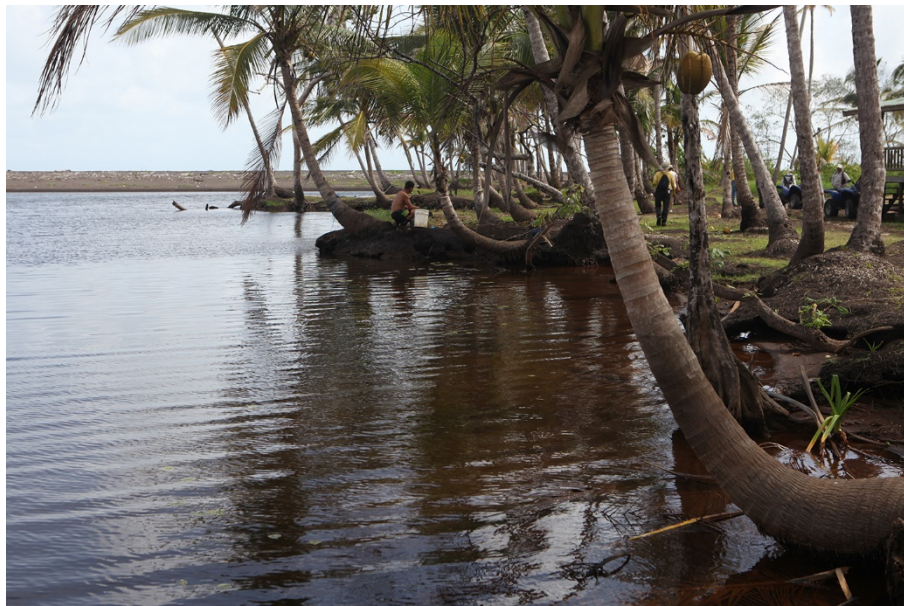
Figure 23. View of the relatively firm and stable land covered by coconut trees that forms the eastern edge of Los Portillos/Harbor Head Lagoon. In the background and to the left, the spit-barrier of Los Portillos/Harbor Head Lagoon is visible. Image taken during the second site visit on 15 March 2017.

mainly consists of loose sand and is attached to more solid land on the eastern corner of the lagoon (**Figs. 23, 24, 25**).

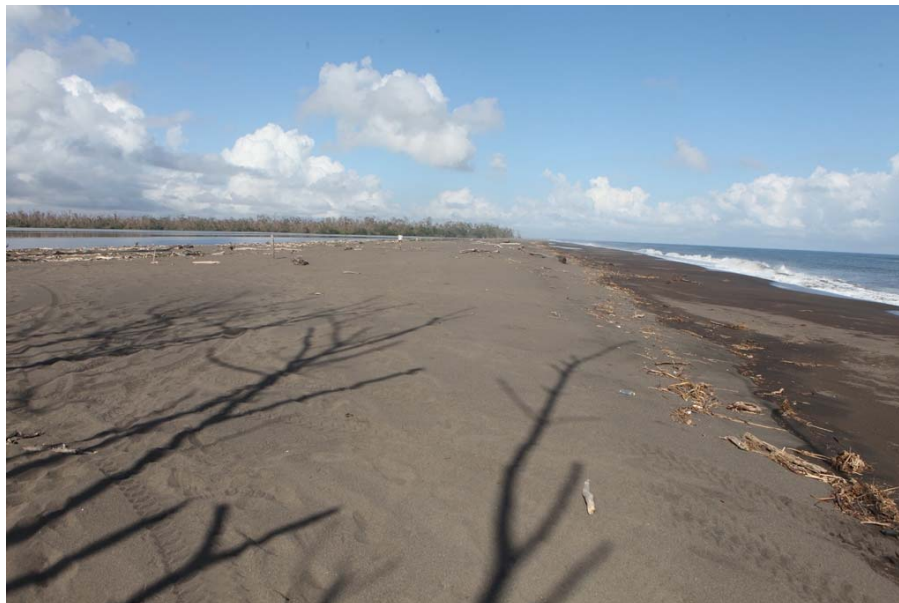
Figure 24. Sand spit-barrier between Los Portillos/Harbor Head Lagoon (left) and the Caribbean Sea (right). View looking to the west. Image taken during the first site visit on 6 December 2016.

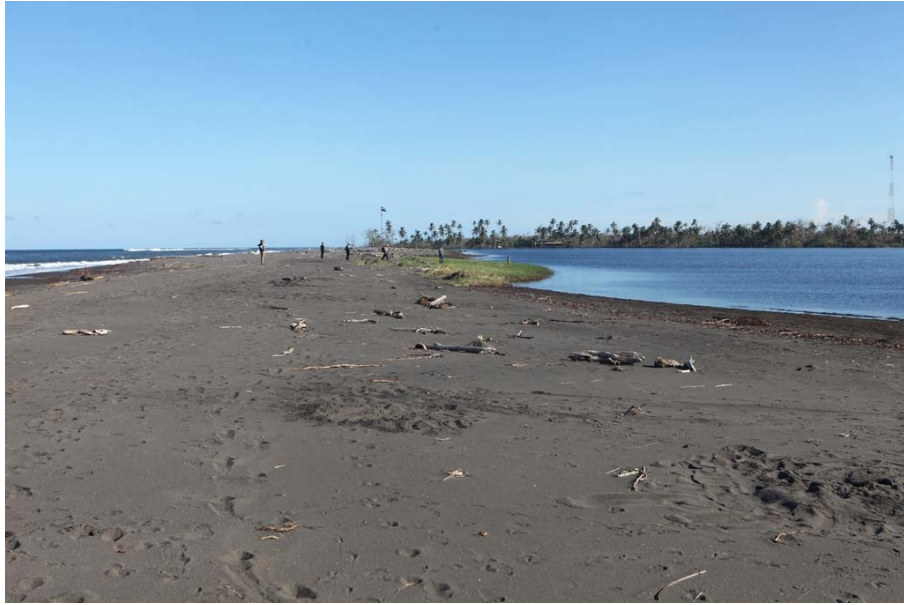
Figure 25. Sand spit-barrier between the Caribbean Sea (left) and Los Portillos/Harbor Head Lagoon (right). View looking to the east. Image taken during the first site visit on 5 December 2016.

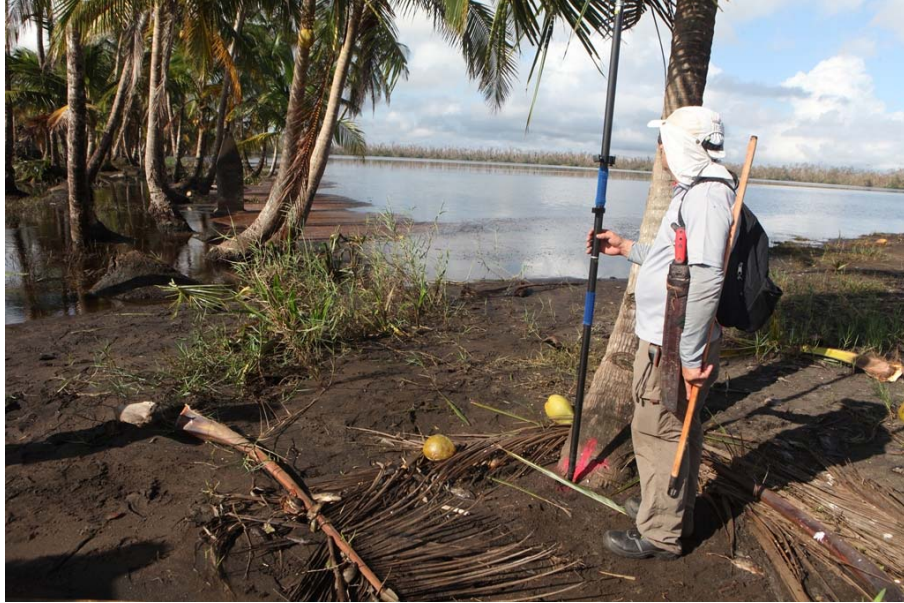
Figure 27. Point Ple located at the base of the sand spit-barrier of the Los Portillos/Harbor Head Lagoon. This point is located at the contact between the relatively stable surface covered by tree vegetation on the eastern margin of the lagoon, and the accumulation of loose sand that forms the spit-barrier. The GPS receiver of Costa Rica is located at the base of a coconut tree. The flooded coconut trees in the background reveal the high water level that reached the lagoon after Hurricane Otto. Image taken during the first site visit on 6 December 2016.

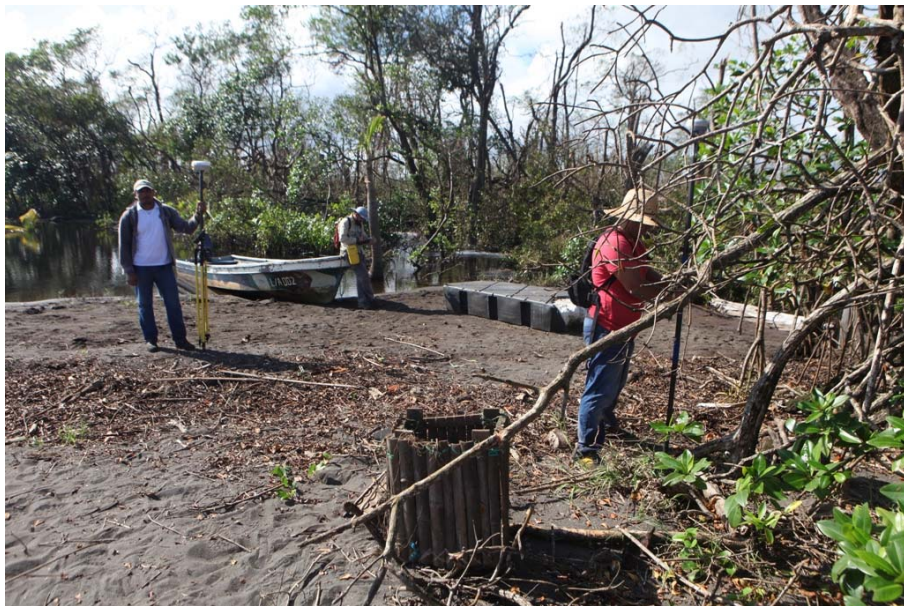
Figure 28. Point Plw measured during the first site visit at the western extremity of Los Portillos/Harbor Head lagoon. The point was located at a high-water mark defined by stranded vegetation indicating the maximum level reached by the water of the lagoon after Hurricane Otto. Image taken on 6 December 2016.

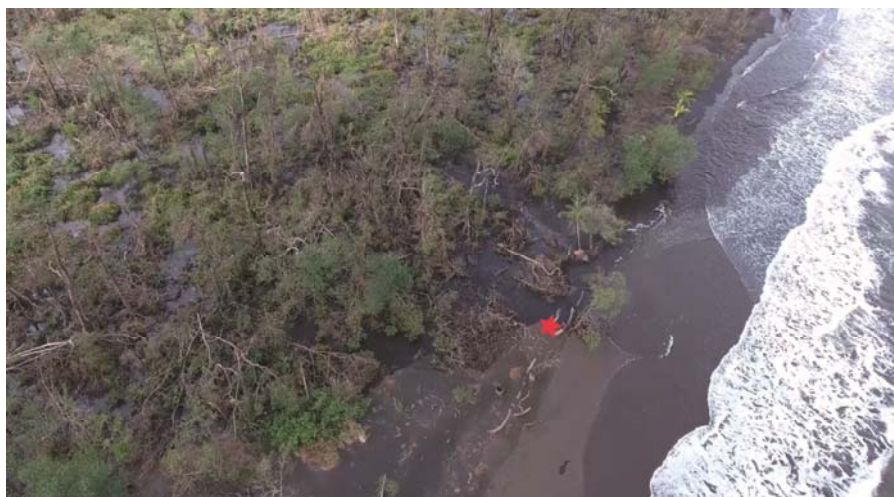
101. During this first visit the lagoon was draining towards the sea through a channel situated next to point Pch, around 200 m to the northwest of point Plw, most probably breached by Hurricane Otto (**Figs. 29, 30, 31**). In the second site visit, the eastern and western extremities of the water body of the lagoon were measured at points Ple2 (**Fig. 32**) and Plew2 (**Figs. 33, 34**), respectively. The intersection between the shoreline and the projection of the northeastern corner of the Los Portillos/Harbor Head Lagoon perpendicular to the coast was measured in the second visit at low tide (15 March 2017; 8:57 a.m.) at point Pleb (**Fig. 35**). In this second visit, the channel that was draining the lagoon during the first visit was closed by a sandy beach deposit (**Fig. 36**).

Figure 29. Channel breached in the beach of Isla Portillos, west of the spit-barrier of Los Portillos/Harbor Head Lagoon. The water of the lagoon was flowing towards the sea through this channel. The star indicates the location of point Pch. Image captured from a video recorded by the Nicaraguan delegation during the first site visit in December 2016.

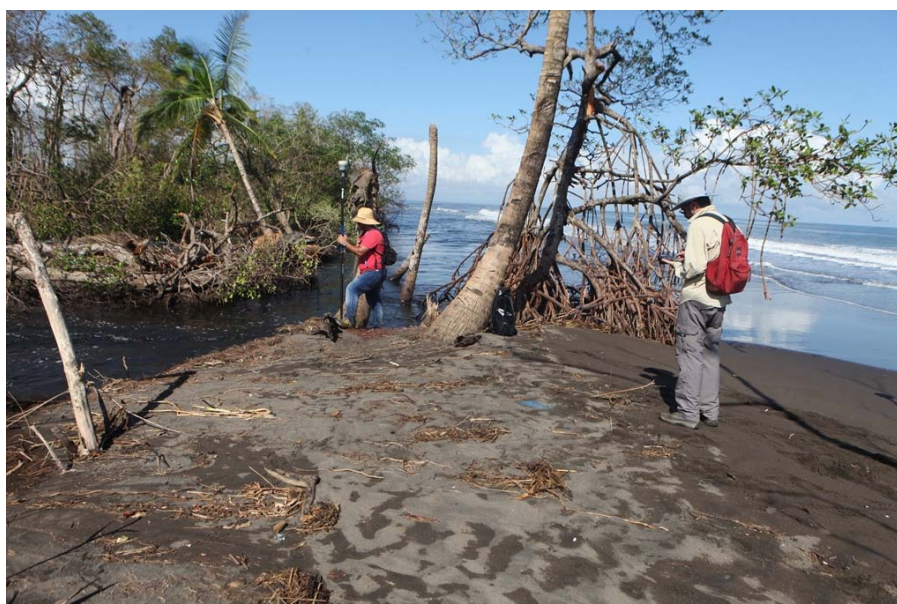
Figure 30. Topographer of the Costa Rican delegation measuring the eastern bank of the channel through which the lagoon was draining towards the sea (point Pch). On the other side of the channel the tree vegetation is in direct contact with the sea waves. Image taken during the first site visit on 6 December 2016.

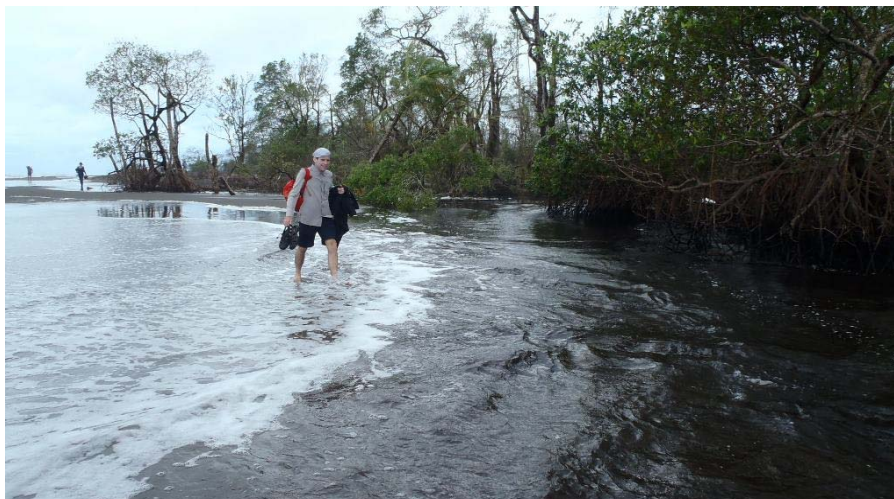
Figure 31. Channel opened in the beach of Isla Portillos, close to the western extremity of the Los Portillos/Harbor Head Lagoon. The water of the lagoon was flowing into the sea. Flow direction is towards the camera. Image taken during the first site visit on 8 December 2016.

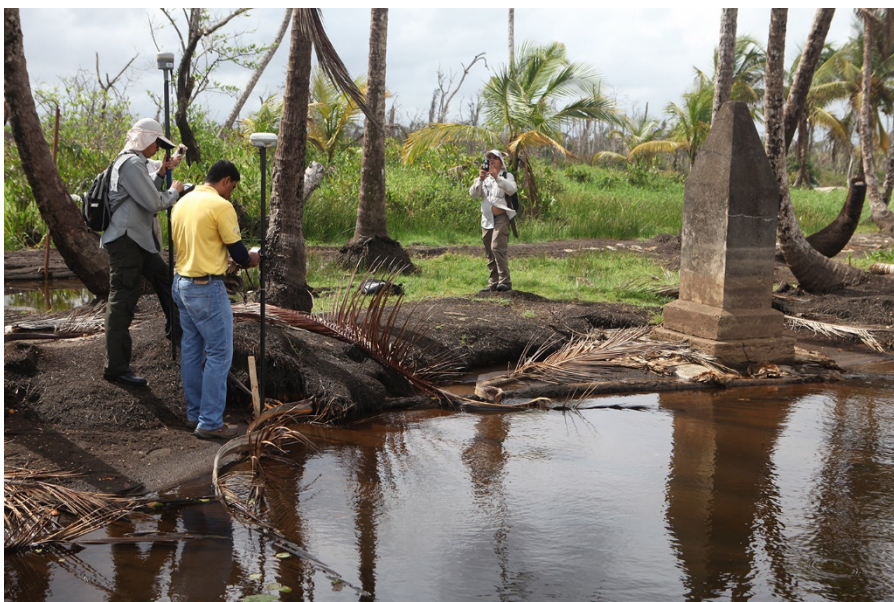
Figure 32. Image of Point Ple2, which represents the easternmost edge of the water body of Los Portillos/Harbor Head Lagoon on its northeast corner during the second site visit. The point was marked with a wooden stick, being measured by a topographer from Nicaragua (right). The monument to the right corresponds to a marker whose designation ( $\Delta$  and a reversed s as subscript, referred to by the Parties as the “A2” Marker) has not been identified in the Proceedings of the Costa Rica-Nicaragua Demarcation Commissions of the end of the 19<sup>th</sup> century. Image taken during the second site visit on 15 March 2017.

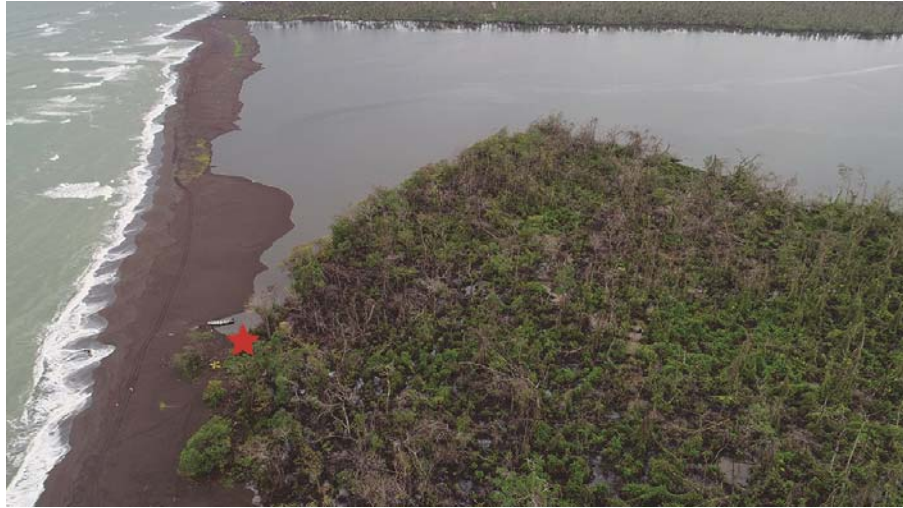
Figure 33. Point Plw2 (asterisk) measured during the second site visit at the western extremity of the water body of Los Portillos/Harbor Head Lagoon and general view of its sand barrier. Image captured by the drone of the Costa Rican delegation in March 2017.

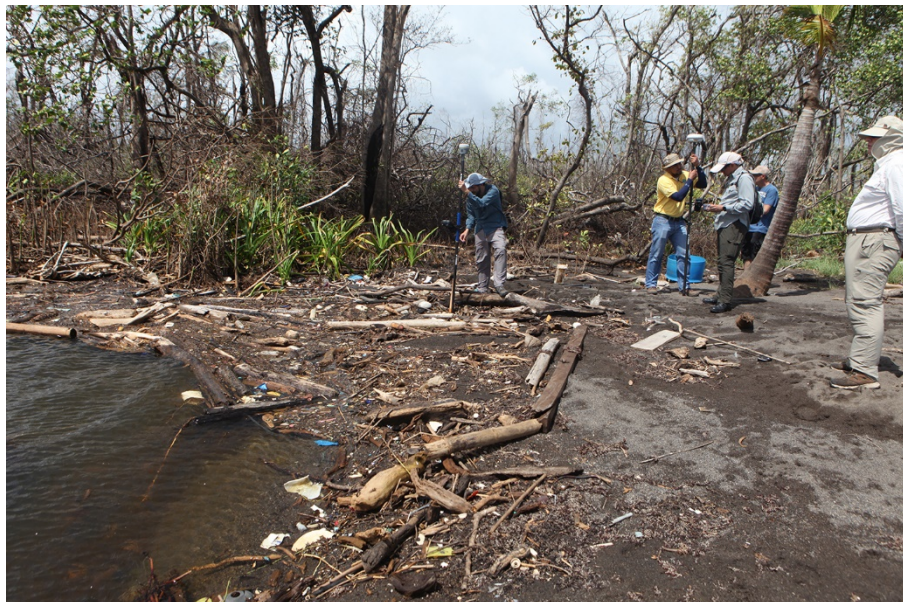
Figure 34. Topographer of Costa Rica (left) measuring the co-ordinates of the western extremity of the water body of Los Portillos/Harbor Head Lagoon (covered by floating debris) during the second site visit. Image taken on 15 March 2017.

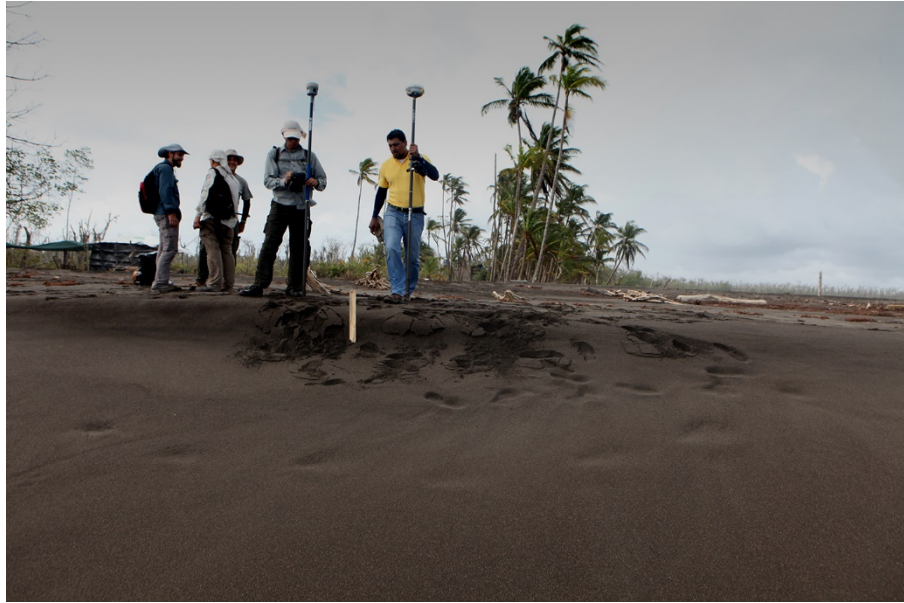
Figure 35. Point Pleb (wooden stick) measured during the second site visit at low tide (15 March 2017, at 8:57 a.m.). This point represents the intersection between the shoreline and the projection of the northeastern corner of the Los Portillos/Harbor Head Lagoon perpendicular to the coast.

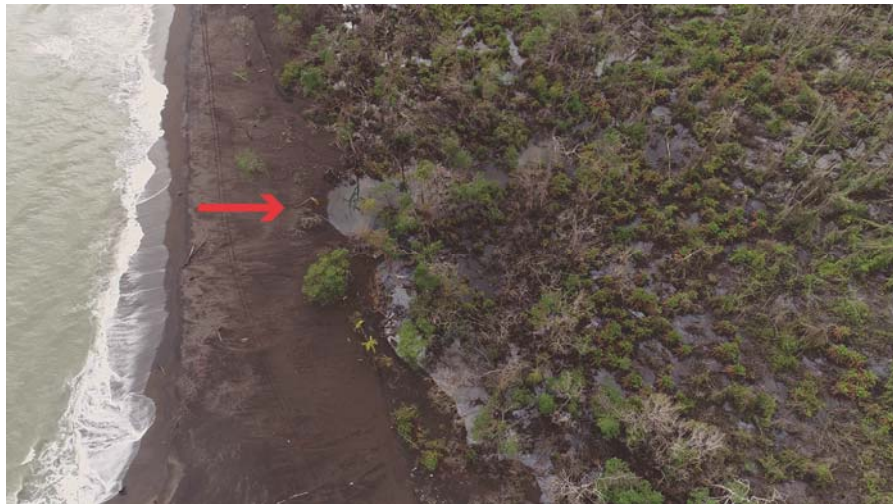
Figure 36. Position of the channel opened by Hurricane Otto (arrow). The channel was closed during the second site visit due to the recovery of the sandy beach. Image captured by the drone of the Costa Rican delegation during the second site visit in March 2017.

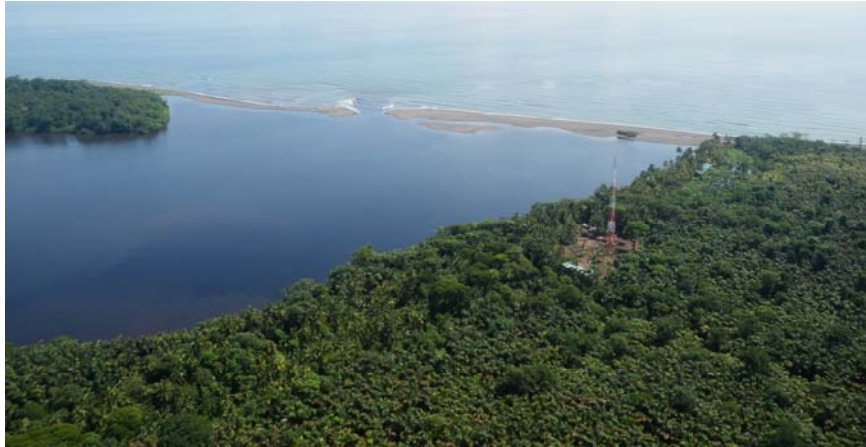
102. The spit-barrier of the lagoon is a labile feature highly susceptible to coastal erosion and the development of inlet channels. Photographs taken in June, July and August 2012 by Costa Rica show a breach in the central sector of the spit-barrier (**Fig. 37**, provided by Costa Rica on 20 October 2016).

Figure 37. Oblique aerial photograph of the spit-barrier of Los Portillos/Harbor Head Lagoon showing a temporary inlet channel. Image taken on 3 August 2012.

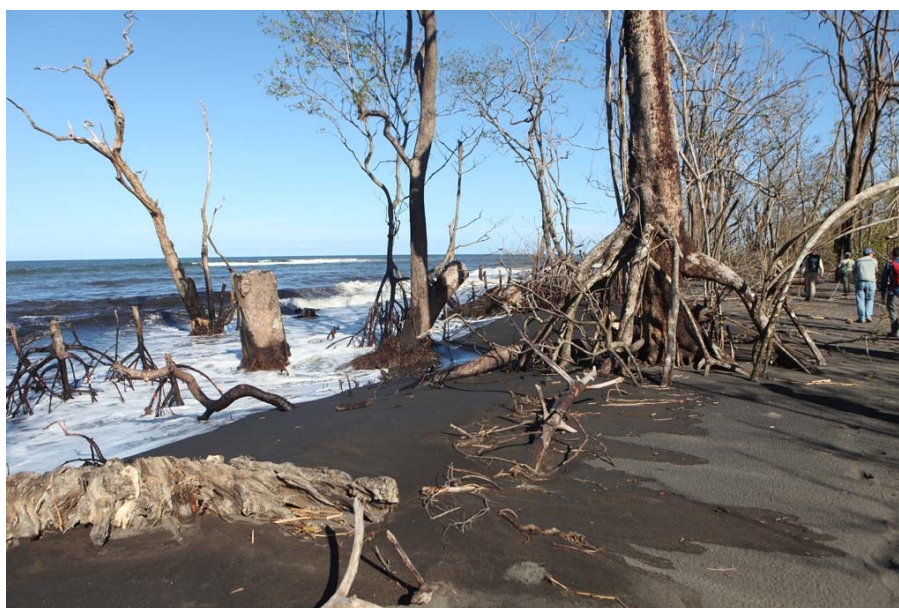
Figure 39. Image of the coastal stretch of Isla Portillos affected by severe erosional retreat. Here, the mangrove forest is in direct contact with the sea and affected by wave action. Image taken during the first site visit on 5 December 2016.

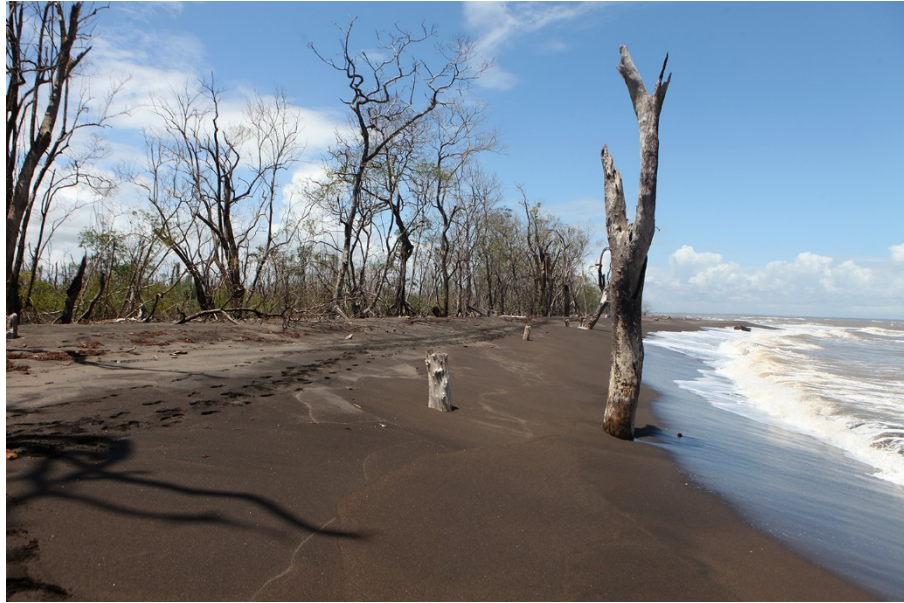
Figure 40. Coastal stretch of Isla Portillos, which was affected by severe erosional retreat during the first site visit. This image, taken during the second site visit, illustrates the considerable recovery of the beach by sand accumulation related to wave action under regular conditions.

106. In the second site visit, the sandy beach had largely recovered, reaching in most of this section a width of around 50 m (**Fig. 40**). Wave action during severe storms tends to erode beach deposits and transport them offshore. Beaches recover by progressive sediment accumulation under ordinary conditions. The remaining coastal sector of Isla Portillos showed a broad and continuous sandy beach during both visits. Between the beach and the area covered by tree vegetation there is a series of discontinuous coast-parallel lagoons (**Figs. 41, 42**). The elongated lagoons are essentially remnants of the channel-like water gap that used to exist in recent times between Isla Portillos and the spit of Los Portillos/Harbor Head Lagoon (**Fig. 26**). In the western sector of Isla Portillos, the forested area is in direct contact with the sand beach and there are no lagoons with free-standing water (**Fig. 43**).

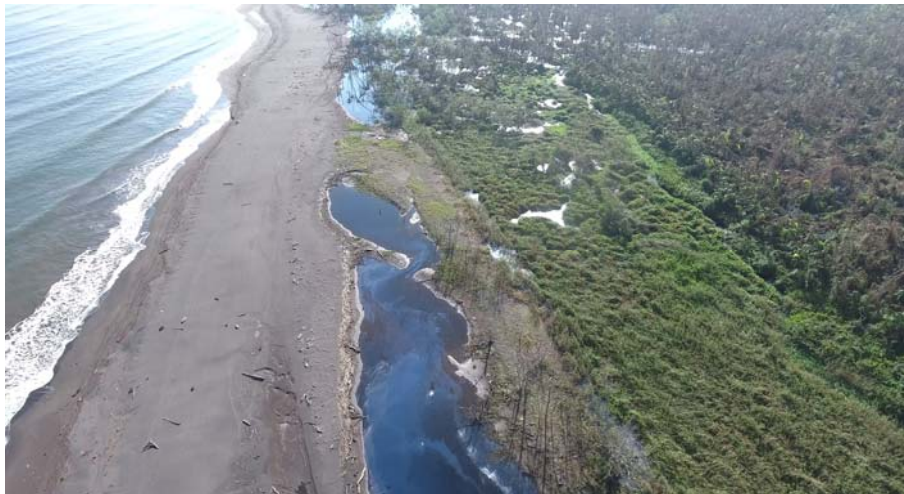
Figure 41. Discontinuous and elongated lagoons between the beach and the relatively stable area covered by dense vegetation of Isla Portillos. Image captured from a video recorded by Nicaragua with a drone during the first site visit in December 2016.

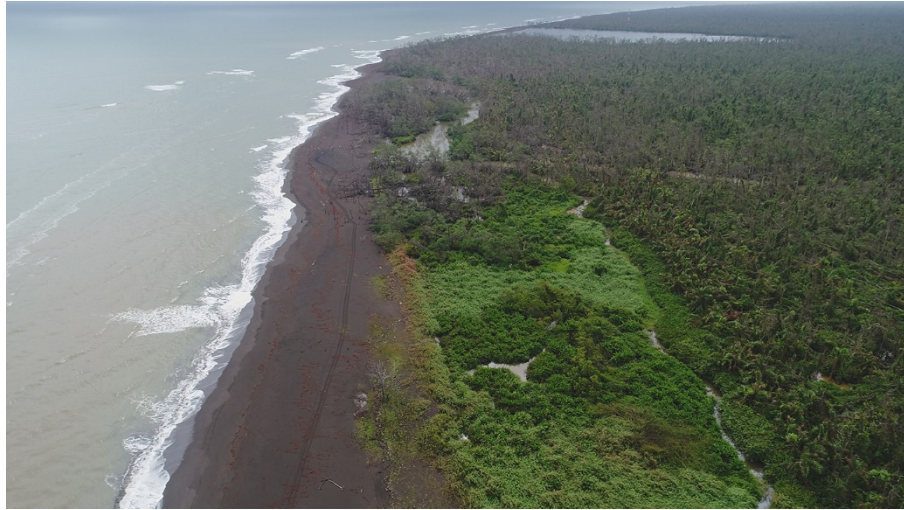
Figure 42. Oblique aerial view taken by the Costa Rican drone during the second site visit in March 2017, showing the discontinuous lagoons between the beach and the area covered by dense vegetation of Isla Portillos. Note that the lagoons were much less extensive than during the first site visit (see **figure 41** for comparison).

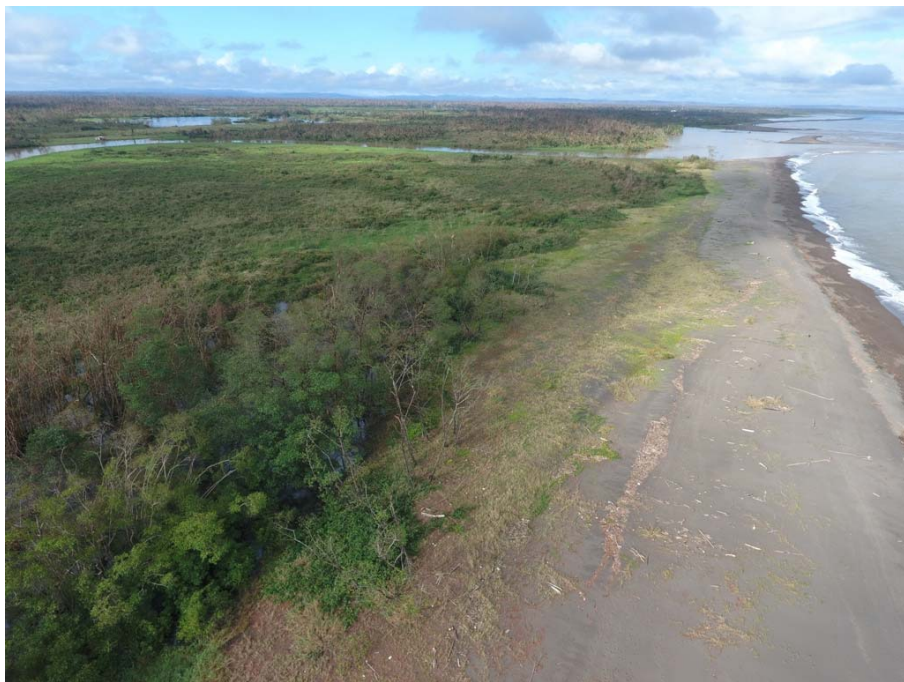
Figure 43. Western sector of the coast of Isla Portillos, close to the mouth of the San Juan River, where the lagoons or coastal lakes terminate before the mouth of the San Juan River. Image captured from a video recorded by Nicaragua with a drone during the first site visit in December 2016.

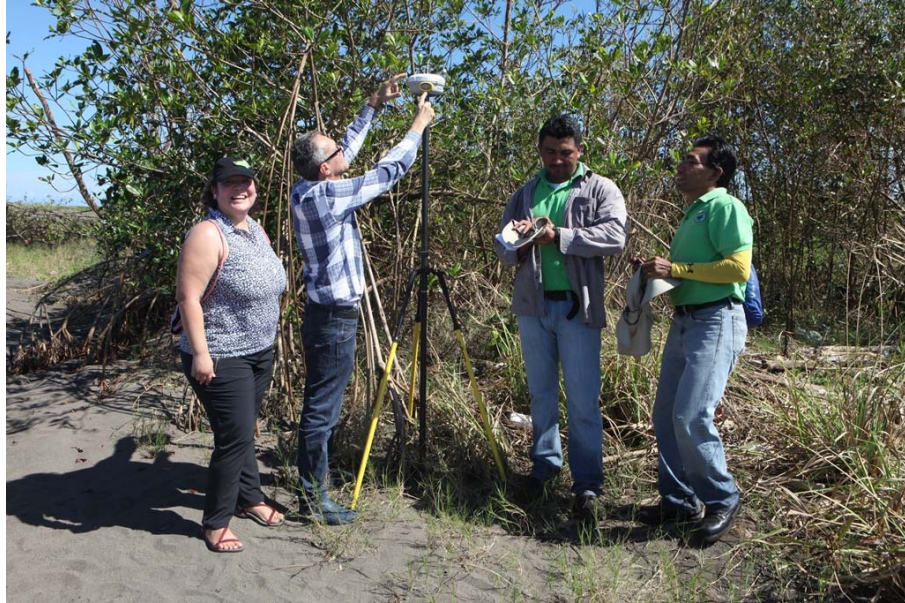
Figure 45. The Nicaraguan delegation measuring the geographical co-ordinates at the base of the sand spit of Isla Portillos (point Pv). Image taken during the first site visit on 5 December 2016.

109. In the first site visit the base of the spit was located at point Pv on the western edge of the tree vegetation growing on slightly higher ground, and where the loose sand deposit of the spit started (Figs. 45, 46). No changes were observed in the second site visit at this spot. During the first visit (December 2016) the spit was just around 210 m long at low tide, most probably due to significant erosion caused by the Hurricane Otto in the previous month (Fig. 46).
