**MARITIME DELIMITATION IN THE CARIBBEAN SEA AND THE PACIFIC OCEAN**

**(COSTA RICA V. NICARAGUA)**

**EXPERT OPINION**

**30 April 2017**

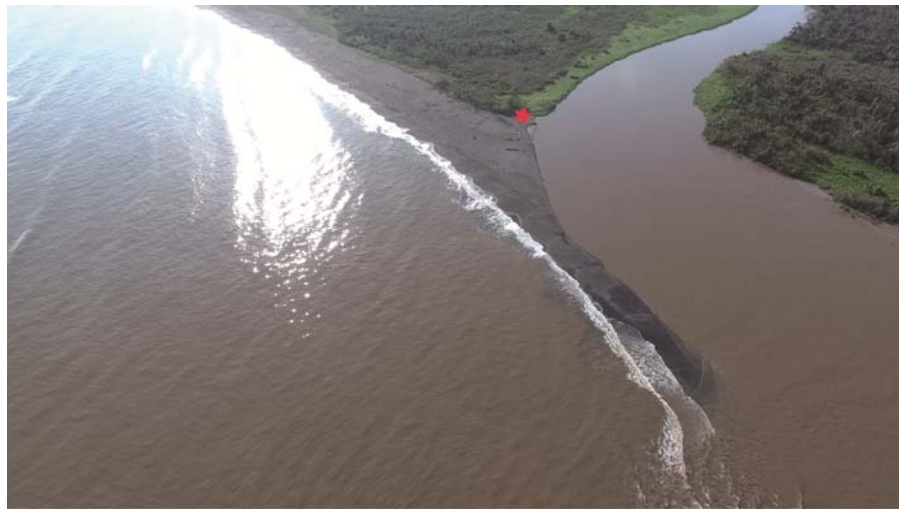
Figure 46. Image captured by the drone of the Nicaraguan delegation in December 2016, showing the spit of Isla Portillos and the mouth of the San Juan River on its eastern bank. The spit was most probably diminished by erosion associated with the Hurricane Otto (24 November 2016). The star indicates the location of point Pv.

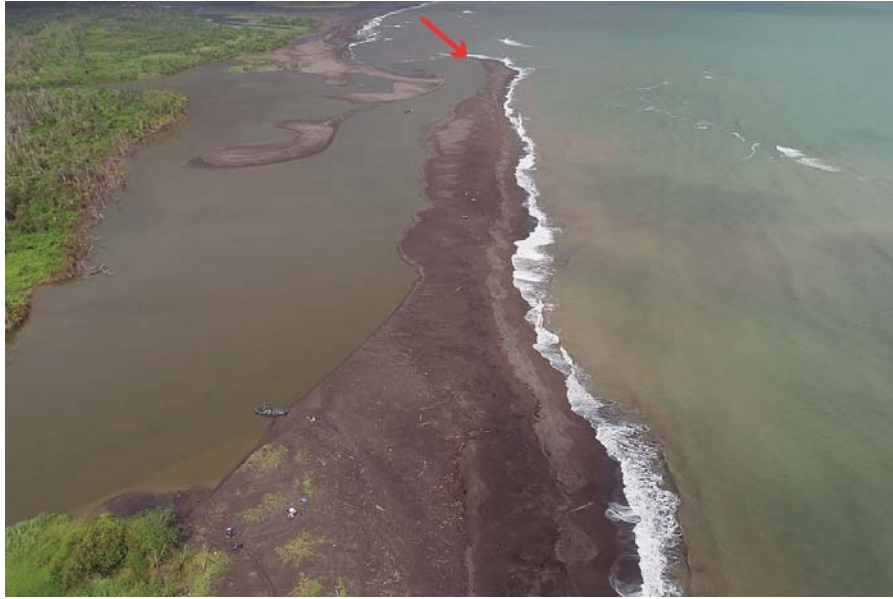
Figure 47. Spit of Isla Portillos and the mouth of the San Juan River on its eastern bank (arrow) during the second site visit. The spit experienced a significant westward growth by sand accretion between the first and the second visit (see Figure 46 for comparison). Image captured by the drone of the Costa Rican delegation in March 2017.

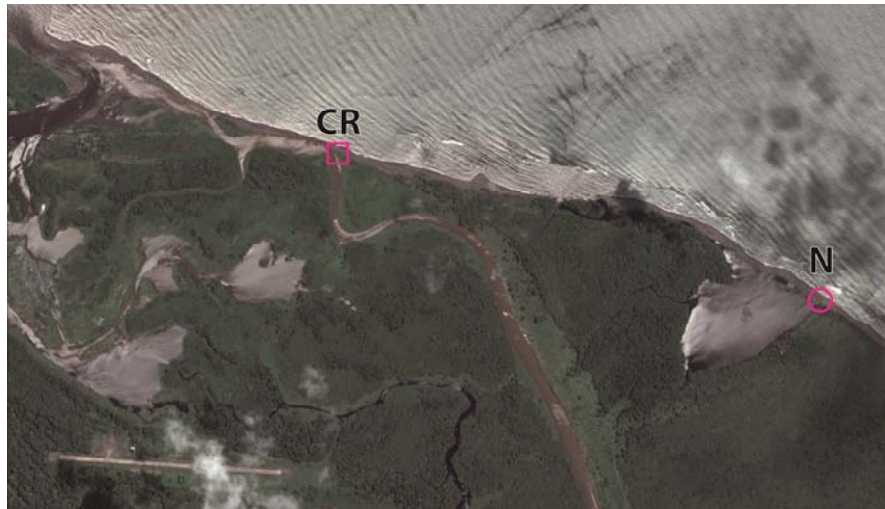
Figure 48. Annotated satellite image from June 2013 (Digital Globe; U.S. Geological Survey) indicating the approximate location of the starting-points of the maritime boundary proposed by Costa Rica (CR) and Nicaragua (N).

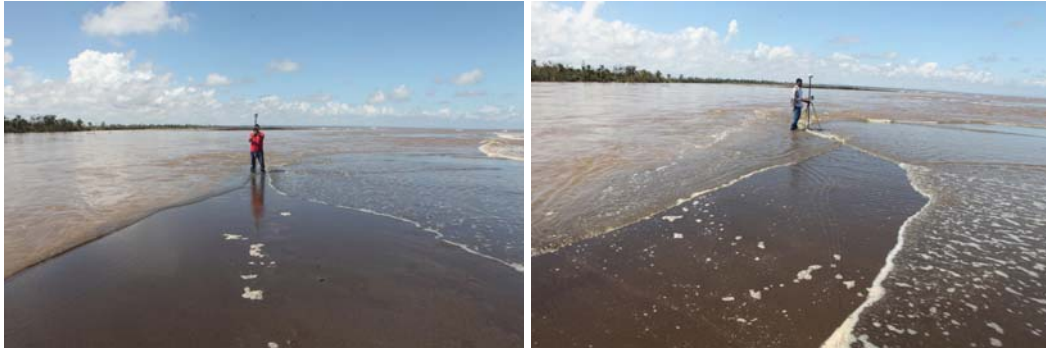
Figure 49. Measurement of co-ordinates by Costa Rica (left) and Nicaragua (right) of the point at which the right bank of the San Juan River (Prmb) meets the sea at low tide (6 December 2016, at 11:25-11:27 a.m.).

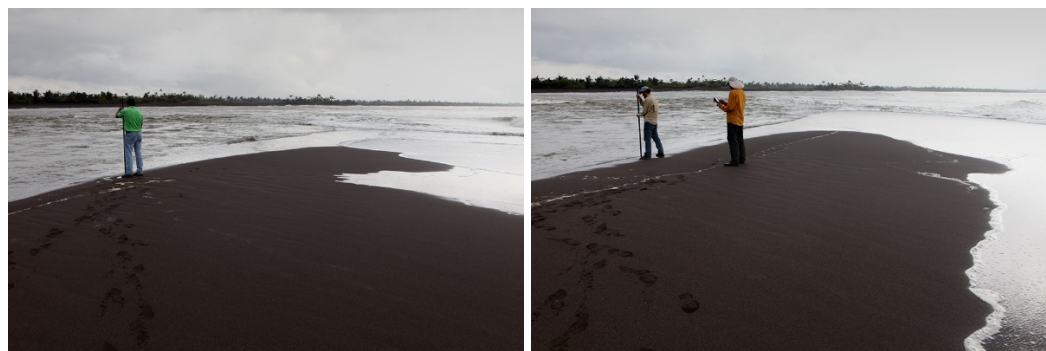
Figure 50. Measurement of co-ordinates by Nicaragua (left) and Costa Rica (right) of the point at which the right bank of the San Juan River (Prm2) meets the sea at low tide (14 March 2017, at 8:16-8:17 a.m.).

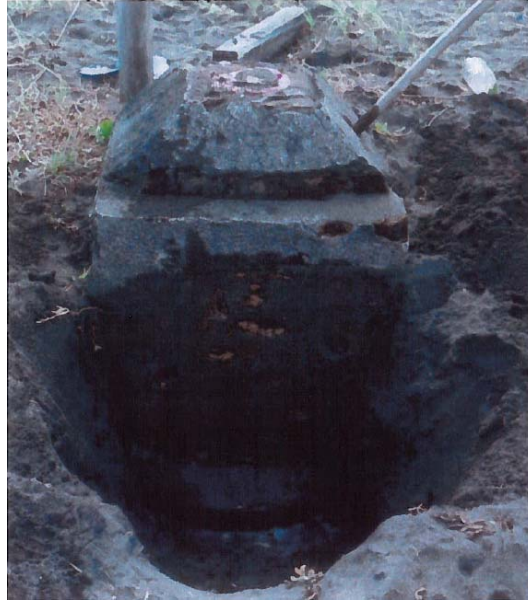
Figure 56. Marker found in the beach by the Sub-Commission on Limits and Cartography on 21 February 2003 and on 25 November 2003. The side exposed by the excavation was marked with a letter “A” accompanied by another illegible symbol. This marker was measured by both Parties for 2:50 hours with hand-held GPS devices.

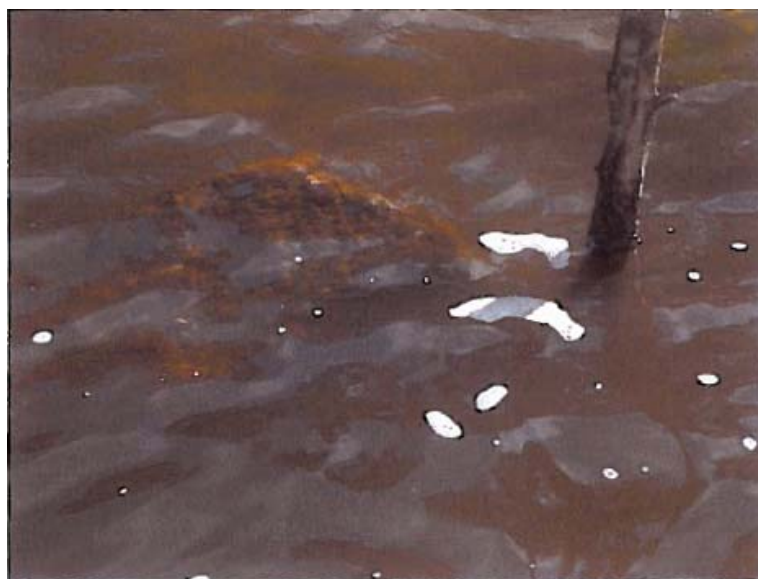
Figure 57. Submerged marker found on 26 November 2003 in Los Portillos/Harbor Head Lagoon. Co-ordinates were measured by Nicaragua with a hand-held GPS.

156. On 26 November 2003, a third marker was found, of “Model Type A... inclined and submerged in Los Portillos Lagoon by approximately 98 mt, to the south of the first Marker found on the coast on Tuesday, November 25” (*ibid.*) (Fig. 57). Nicaragua measured the co-ordinates of this marker with a hand-held GPS device (83° 40’ 24.4’’N, 10° 56’ 2.3’’W).

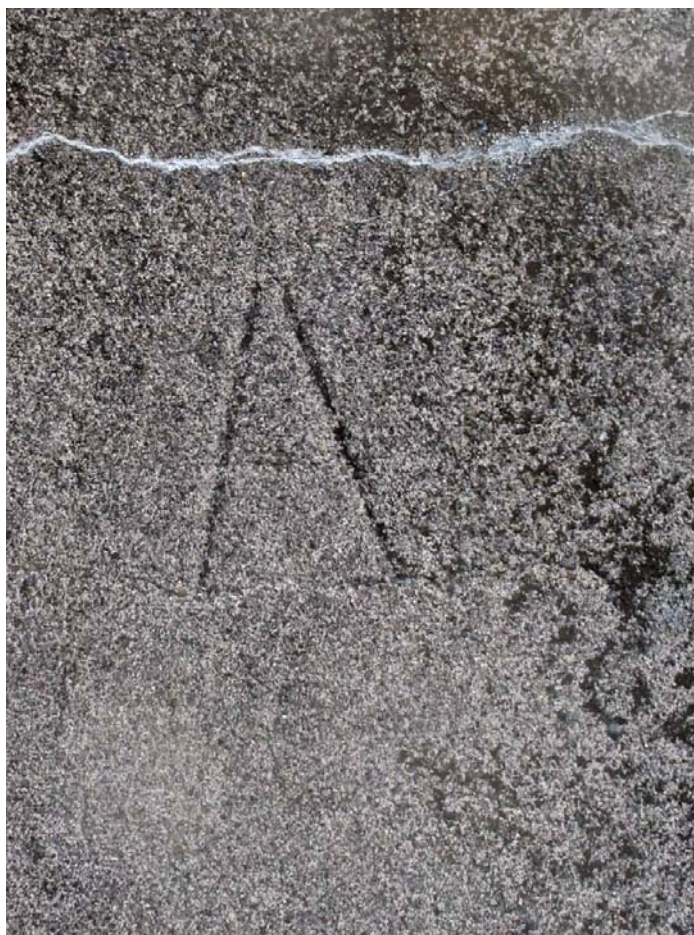
160. This conspicuous monument was examined during the first and second site visits. It is engraved with a “Δ” or an “A” and a symbol similar to a reversed “s” as subscript on its western side and cannot be ascribed to any of the markers recorded in the Proceedings of the Costa Rica-Nicaragua Demarcation Commissions (**Fig. 58**). It could be an unrecorded monument emplaced in more recent times.

Figure 58. Inscription on the western side of the monument located on the eastern side of Los Portillos/Harbor Head Lagoon. Image taken during the first site visit (7 December 2016).

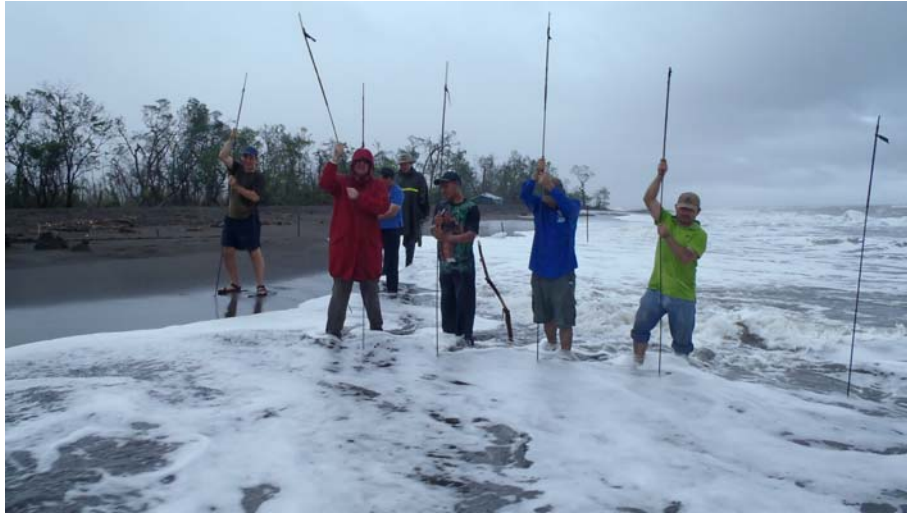
Figure 59. Investigation by probing in an area around the point estimated for the location of marker  $A_1$ , assuming that the marker found in the beach in 2003 was marker  $A_m$  and the average co-ordinates were the best approximation for its location. Image taken on 9 December 2016 during the first site visit.

162. During our first site visit we located the average geographical co-ordinates in the sea, at some distance from the shore. Assuming that the marker found could correspond to auxiliary marker  $A_m$ , and using the average co-ordinates as well as the distance and azimuth between auxiliary markers  $A_m$  and  $A_1$  (45 m,  $319^{\circ} 22'$ ) (Fig. 54), we located the probable position of marker  $A_1$  in a spot situated on the beach, close to the swash zone of the waves. The upper semicircular area of 15 m radius about this point was investigated by probing using iron rods with limited penetration (*ca.* 0.5 m), without obtaining a satisfactory result (Fig. 59).

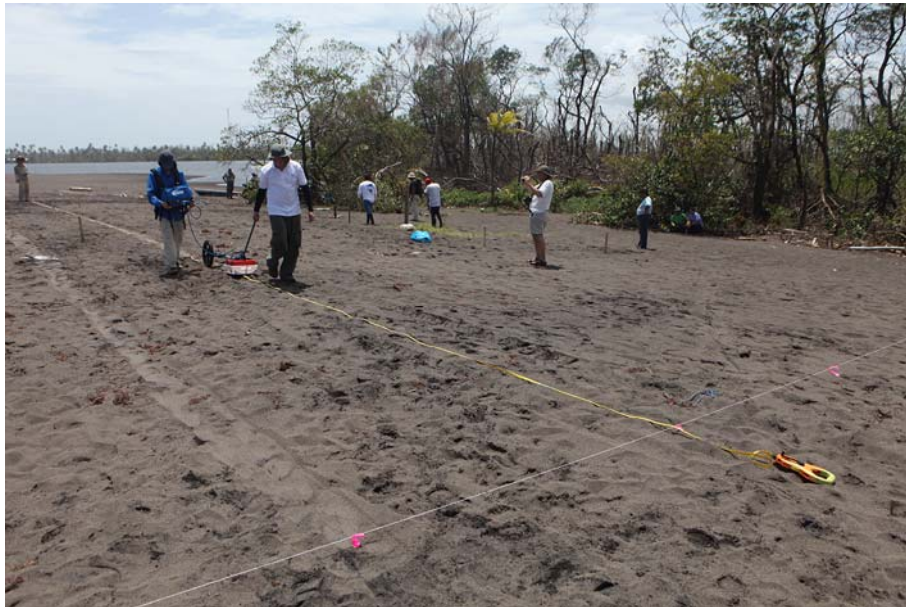
Figure 61. GPR survey carried out in an area enclosing the co-ordinates measured by Nicaragua for the marker found in 2003 submerged in Los Portillos/Harbor Head Lagoon. A total of 12 GPR profiles 27 m long were acquired with a spacing of 2 m. Pink flags indicate the starting and end points of the profiles.

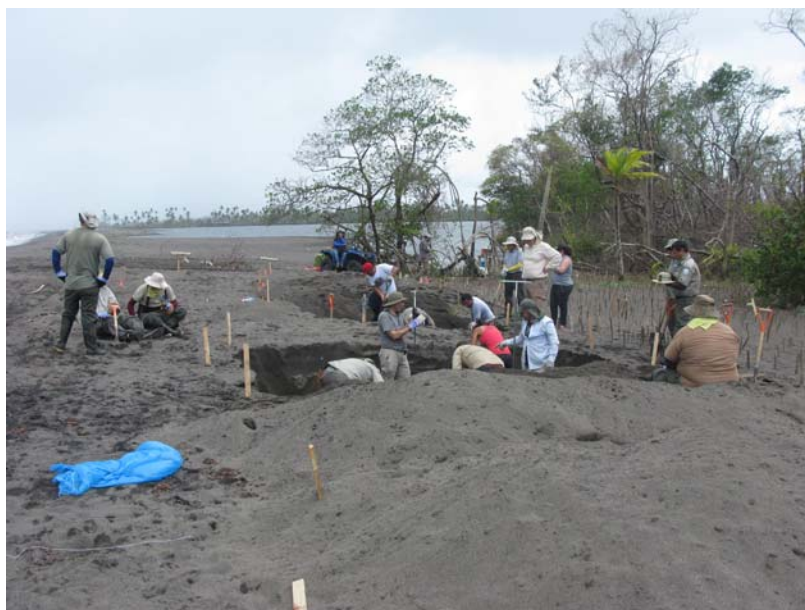
Figure 62. Partial view of the area investigated with GPR, metal detector and iron rods around a point established with the co-ordinates measured in 2003 by Nicaragua for the marker found submerged in the water. The sticks driven into the sand, with a spacing of around 0.4 m, mark the points investigated by probing with 2 m long iron rods. Excavations were carried out at the location of the GPR and metal-detector anomalies, as well as along the higher part of the beach, in order to introduce the probes at a lower elevation and increase the investigation depth.

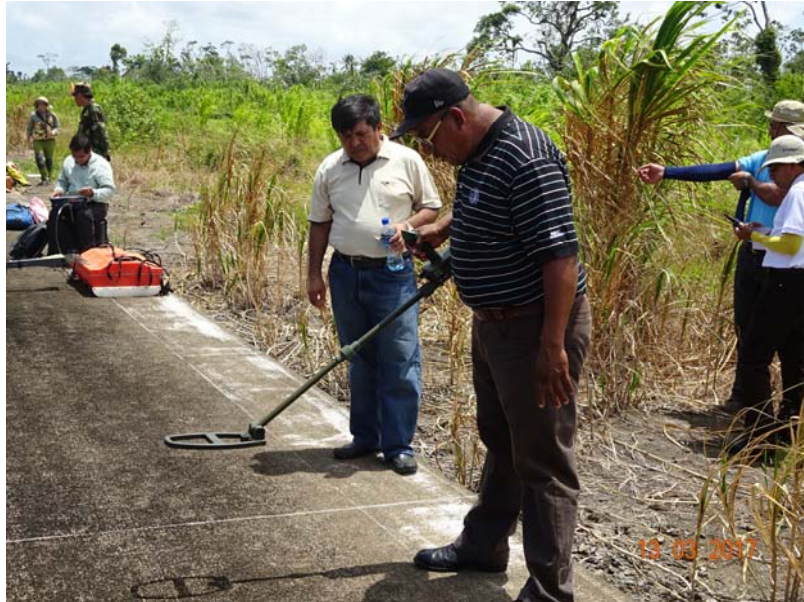
Figure 63. Survey with the metal detector of Nicaragua of the selected 180 m long portion of the airstrip at San Juan del Norte. Image taken during the second site visit on 13 March 2017.

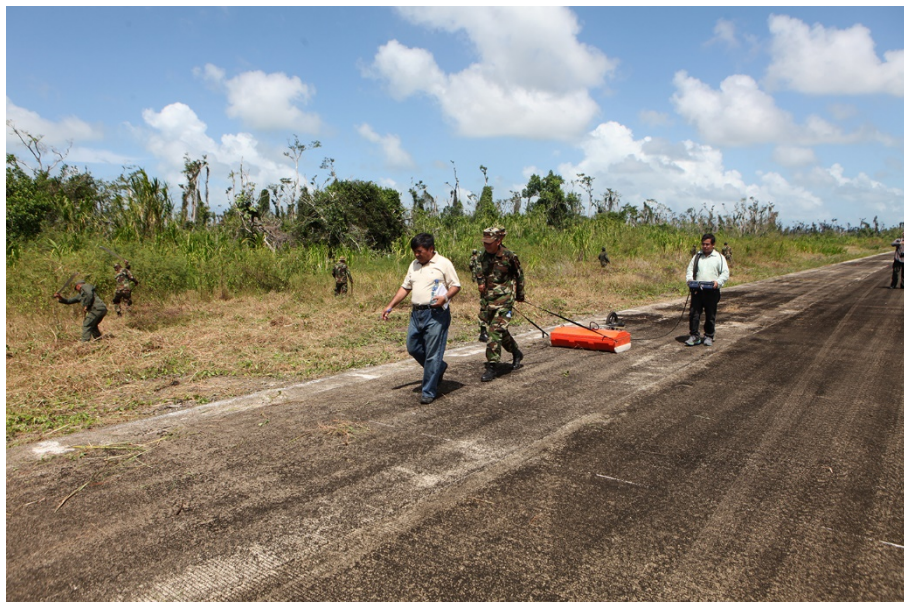
Figure 64. Prospecting for the marker of Plaza Victoria in the airstrip of the San Juan del Norte airport with a GPR (Ground Penetrating Radar) of the Nicaraguan delegation using a 200 MHz shielded antenna. The vegetation in the northern flank of the airstrip was being cleared for GPR and metal detector surveying. Image taken during the second site visit on 13 March 2017.

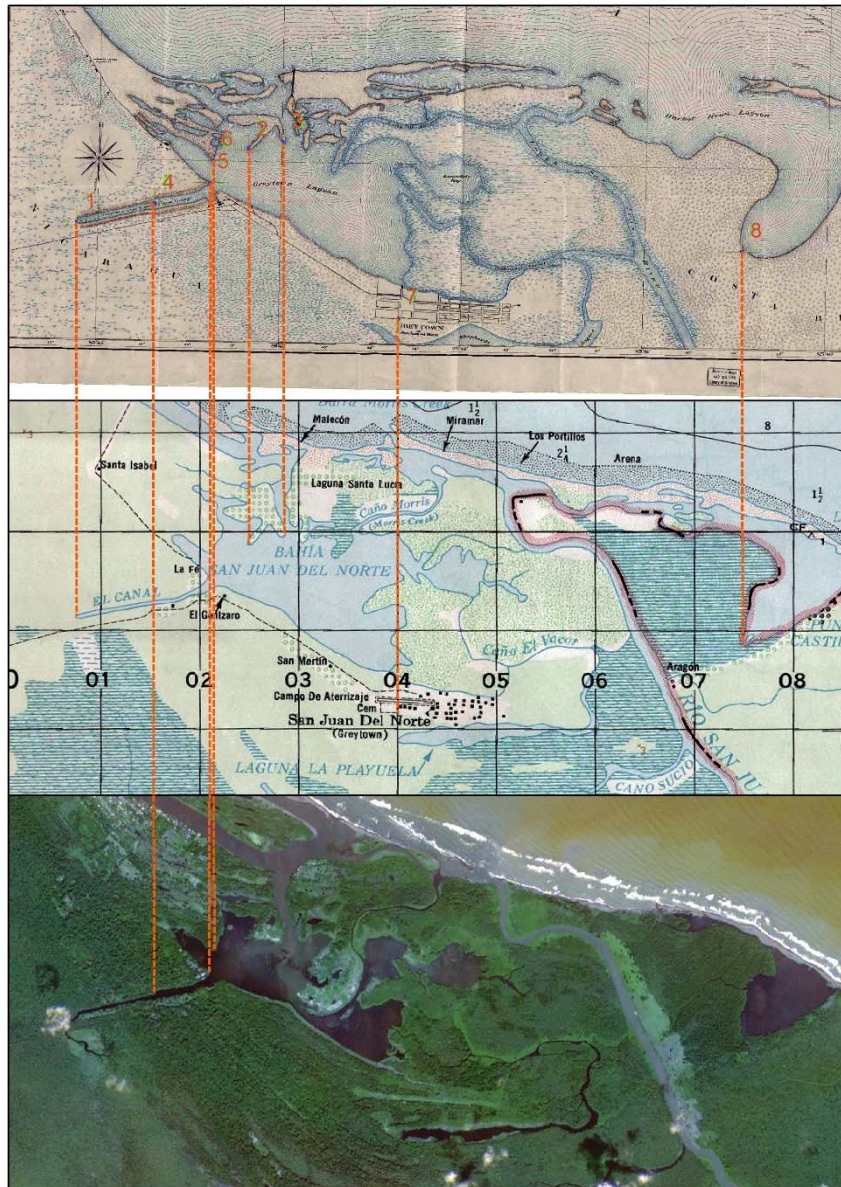
Figure 69. Ground Control Points used for georeferencing the Map of Greytown Harbor of 1899 (top) using as basemaps the Map of San Juan del Norte of 1966 (center) and a satellite image from 2009 (bottom).

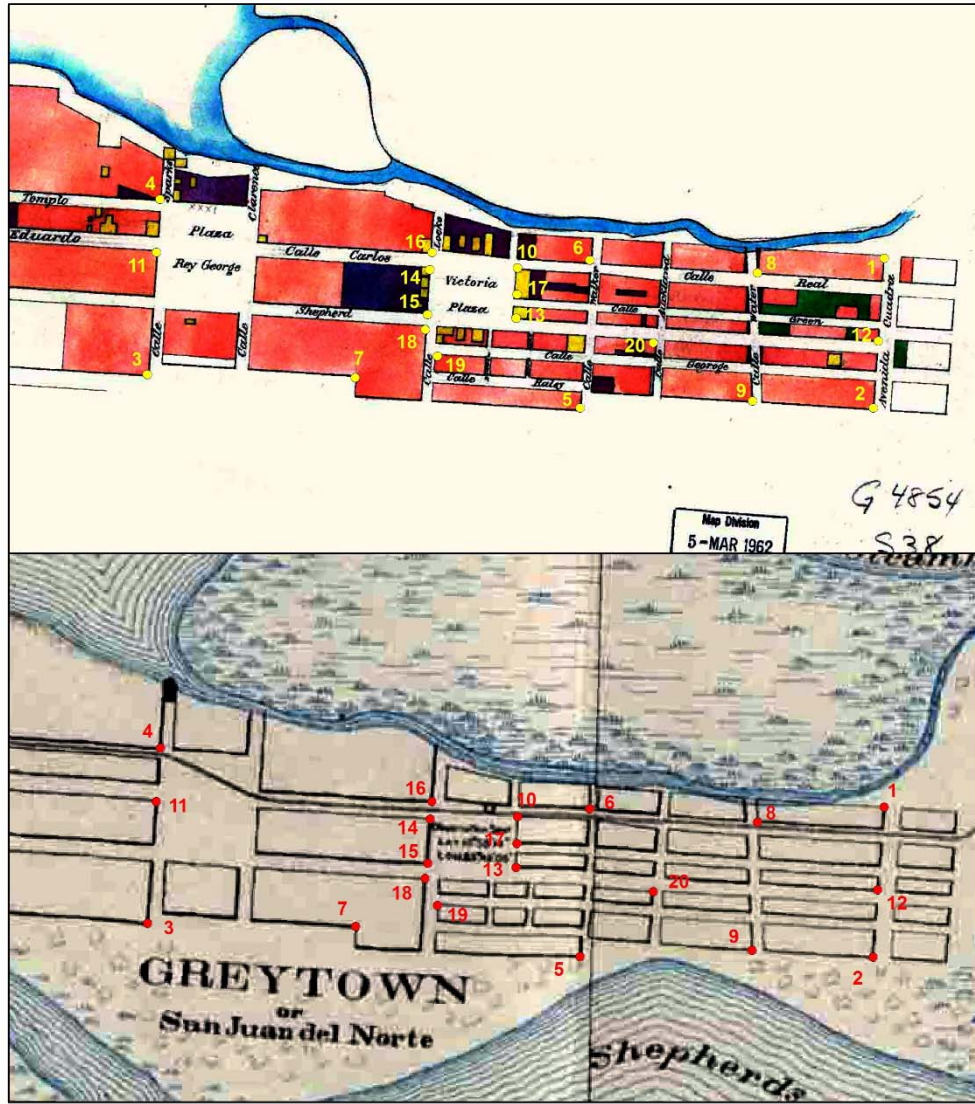
Figure 75. Map of Greytown of 1888 (top) and Map of Greytown Harbor of 1899 (bottom) indicating the 20 GCPs used for georeferencing the 1888 map and depicting the estimated location of the center of Plaza Victoria.

179. The precise position of the center of Plaza Victoria was estimated by georeferencing the Map of Greytown of 1888 (**Fig. 66**) using the previously georeferenced Map of Greytown Harbor of 1899 as a basemap. The configuration of the urban area is quite similar on both maps. The georeferencing was implemented using 20 evenly distributed GCPs in the urban area (**Fig. 75**) and applying a linear transformation, resulting in a total RMS error of 3.44 m.
