**DISPUTE CONCERNING
CERTAIN ACTIVITIES CARRIED OUT BY NICARAGUA
IN THE BORDER AREA
(COSTA RICA V. NICARAGUA)**

**COUNTER - MEMORIAL
OF THE REPUBLIC OF NICARAGUA**

**VOLUME IV
(ANNEXES FROM 112 TO 142)**

Technical Report
Environmental Impact Assessment on “Construction of 120 km road on
the San Juan de Nicaragua River’s right bank”

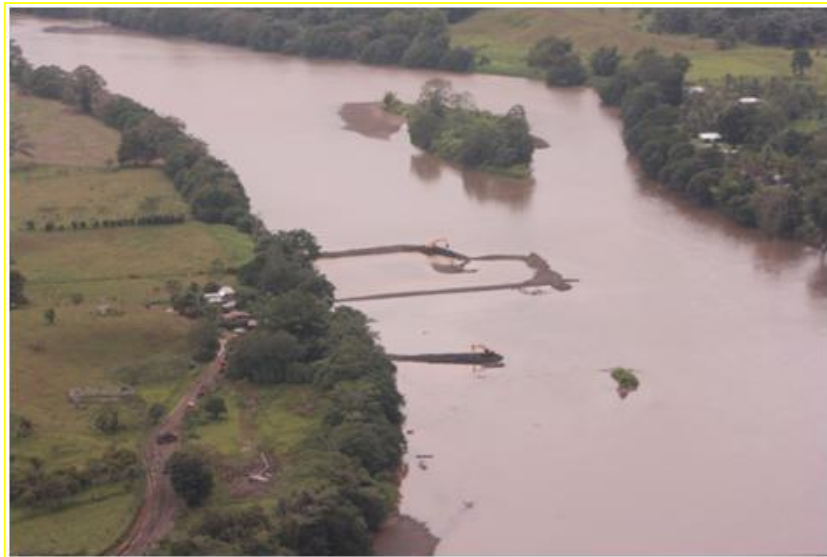
Figure 3 shows two photographs where concentration of sediments from Costa Rican rivers can be seen in water color difference. On the left, the mouth of the Sarapiquí River, and on the right the San Carlos River, coordinates UTM 794-57E/1207-986N. Figure 4 shows two Costa Rican backhoes extracting sediments from the San Carlos River to build the bridge over the river that will connect with the road under construction along the San Juan River.

Figure 4: Embankments to build a bridge over the San Carlos River
 Source: FUNDENIC, February 11, 2012.

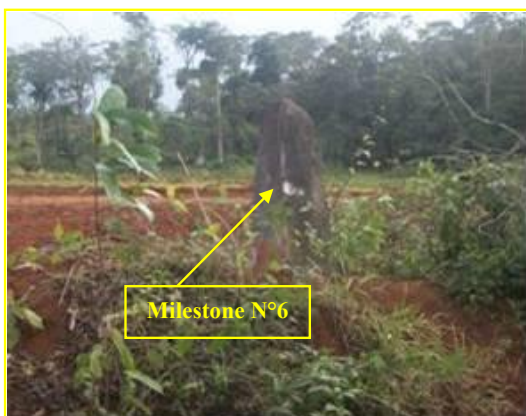
1. In line with the above section and based on visual evidence, it can be stated that **the road under construction invades Nicaraguan territory at some points** (See Figures 9 and 10).

Figure 9 shows a milestone lying within the road embankment slope. In Figure 10 the culvert appears without such protection works as headwalls, cutoff walls, and wing-walls at culvert outlets to retain slope fill materials. As a consequence, this is favoring sediment transport.

Figure 9: Milestone N° 6 within road embankment slope

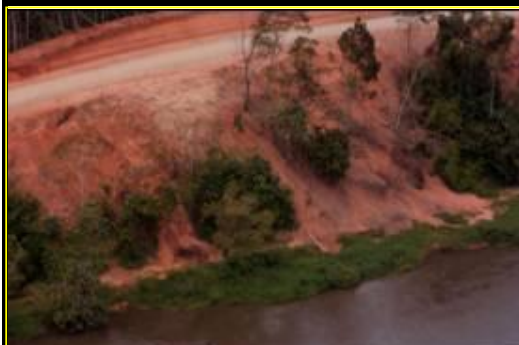
Figure 37: Critical point due to slope instability and ongoing erosion process

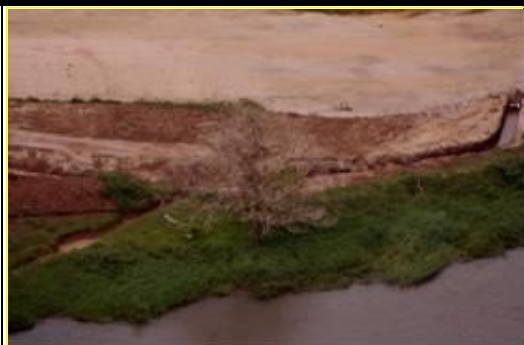
Figure 38: Critical point due to silting in the river channel

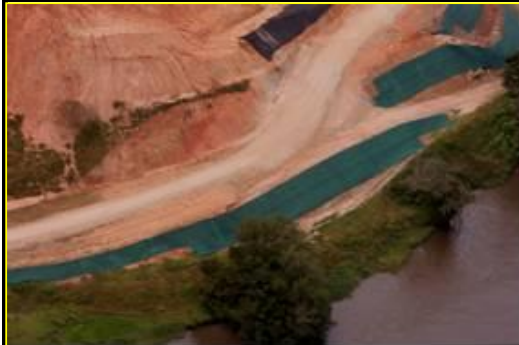
Figure 39: Critical point due to slope instability and ongoing erosion process

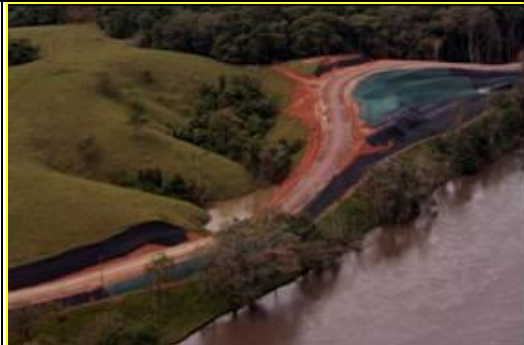
Figure 40: Critical point due to slope instability

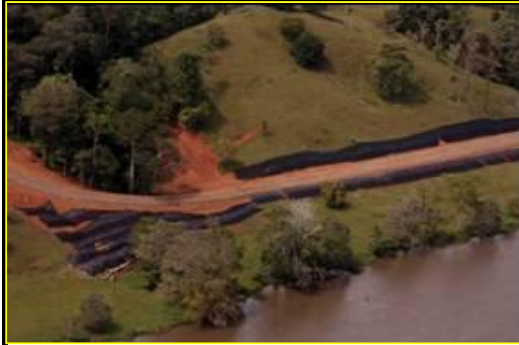
Figure 41: Critical point due to sediment runoff to river

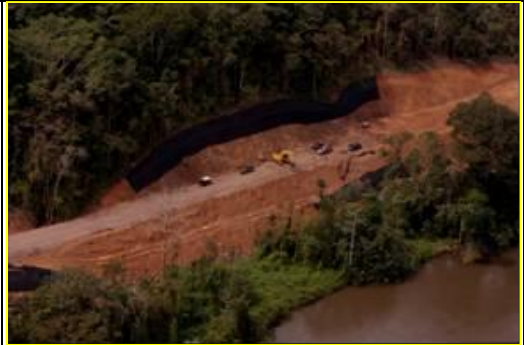
Figure 42: Critical point due to slope instability

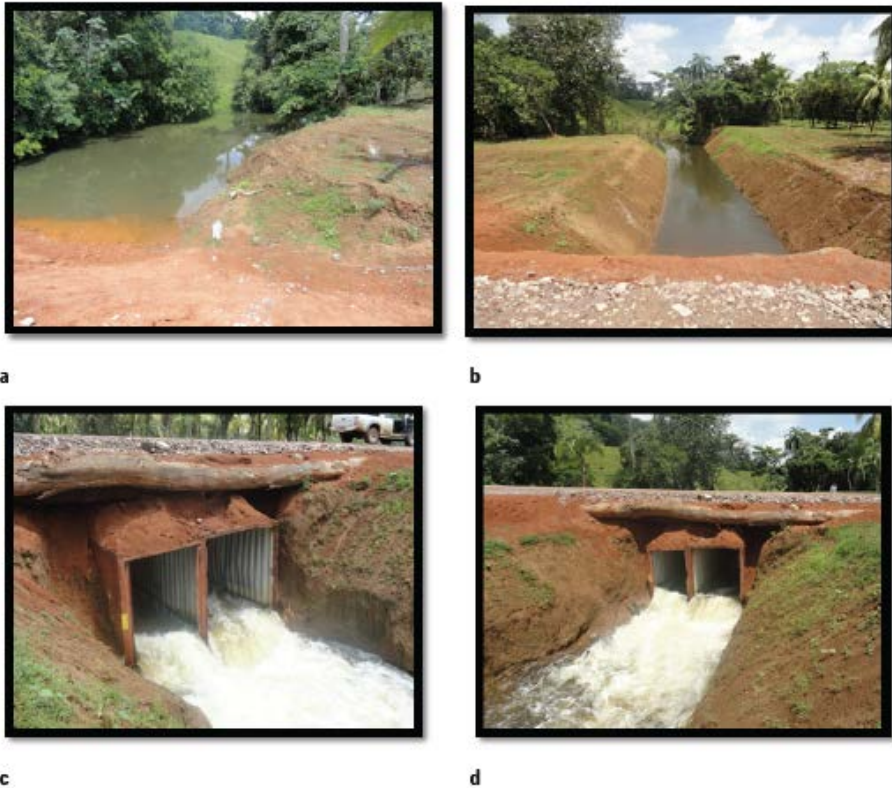
F17. Evident in the first photo (a) is the obstruction of the natural flow of the river; the second photo (b) shows the construction of a canal for re-routing the flow of the river; the last two photos (c and d) show the construction of a bridge where wooden logs and two container trailers used for drainage are part of the structure; bulging can be seen; bulging in the walls of the container trailers can also be seen.

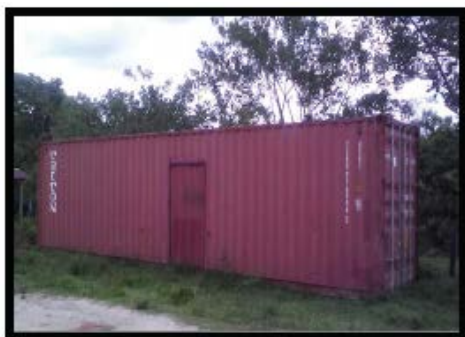
F26. There is a trailer container on the road approximately one kilometer before reaching Tiricias.

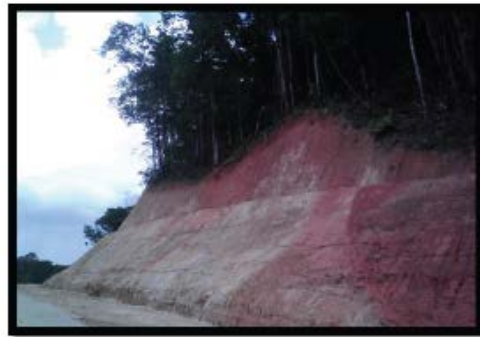
F.28. There are huge slopes with high peaks in this area and no protection whatsoever.

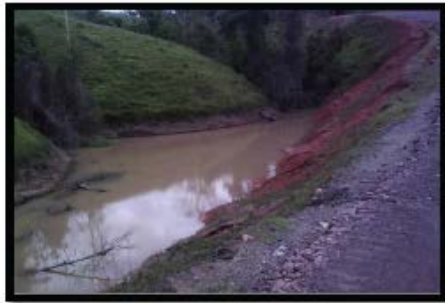
F34. Stagnant water with no drainage whatsoever.

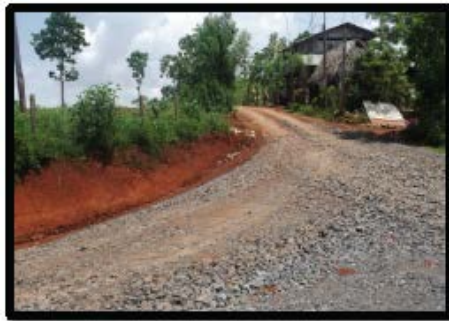
**F38.** Dirt road from Route 760 El Parque.

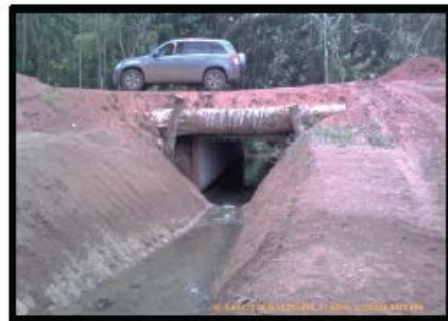
P42. A stretch of the road wide enough for only one vehicle.

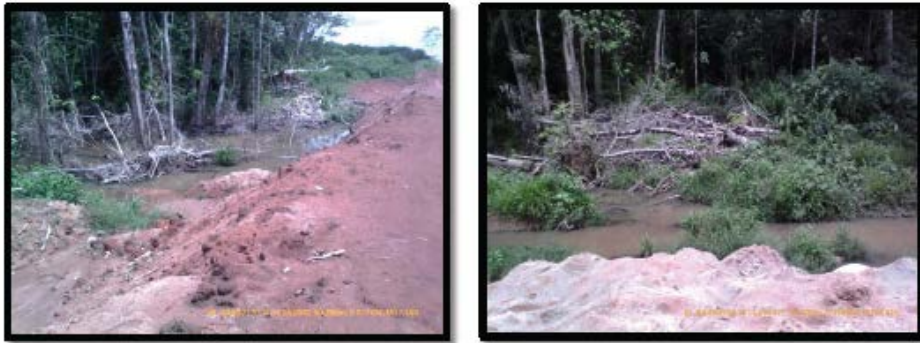
F43. Stagnant water and deforestation.
