**DISPUTE CONCERNING THE CONSTRUCTION OF A ROAD IN
COSTA RICA ALONG THE SAN JUAN RIVER**

REJOINDER OF COSTA RICA

VOLUME III

ANNEXES 4 - 14

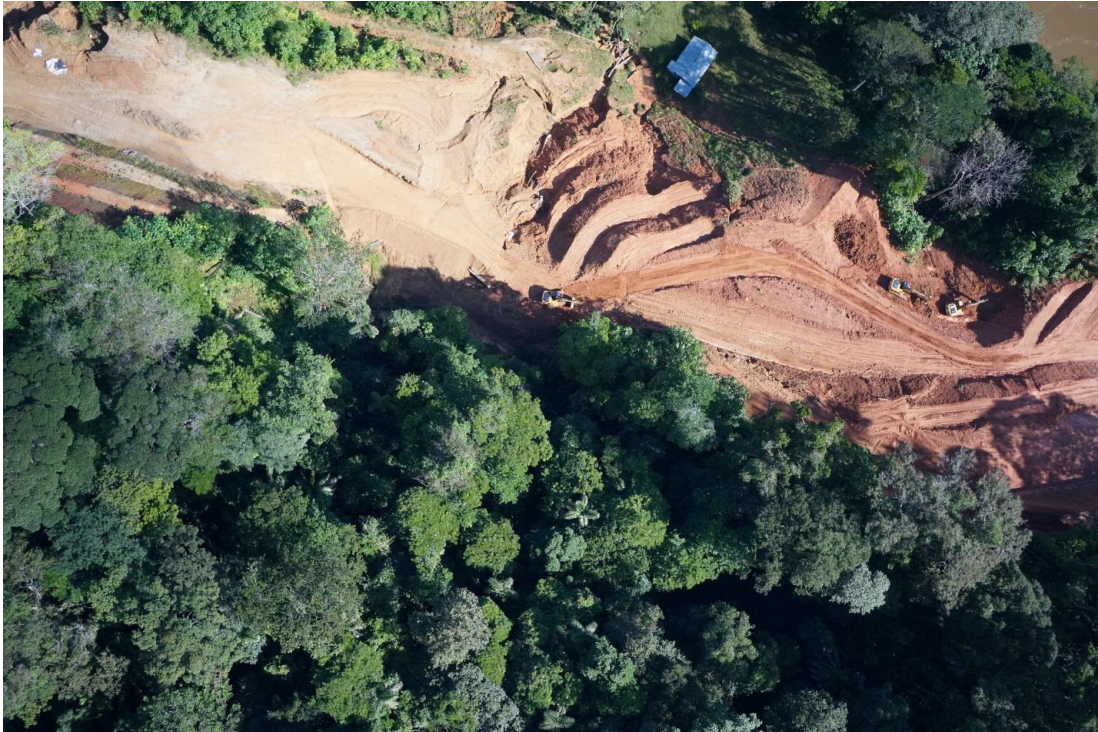
An example of an unprocessed photograph obtained using the UAV is shown in Figure 3. This photograph in particular shows recent and on-going mitigation efforts to stabilize slope T-72. The mitigation work on this site forced its exclusion from this report as it is being actively intervened.

Figure 3. Raw photograph of Route 1856 acquired using an UAV showing on-going mitigation work at slope T-72 (Eroding site 9.6), October 28, 2014.

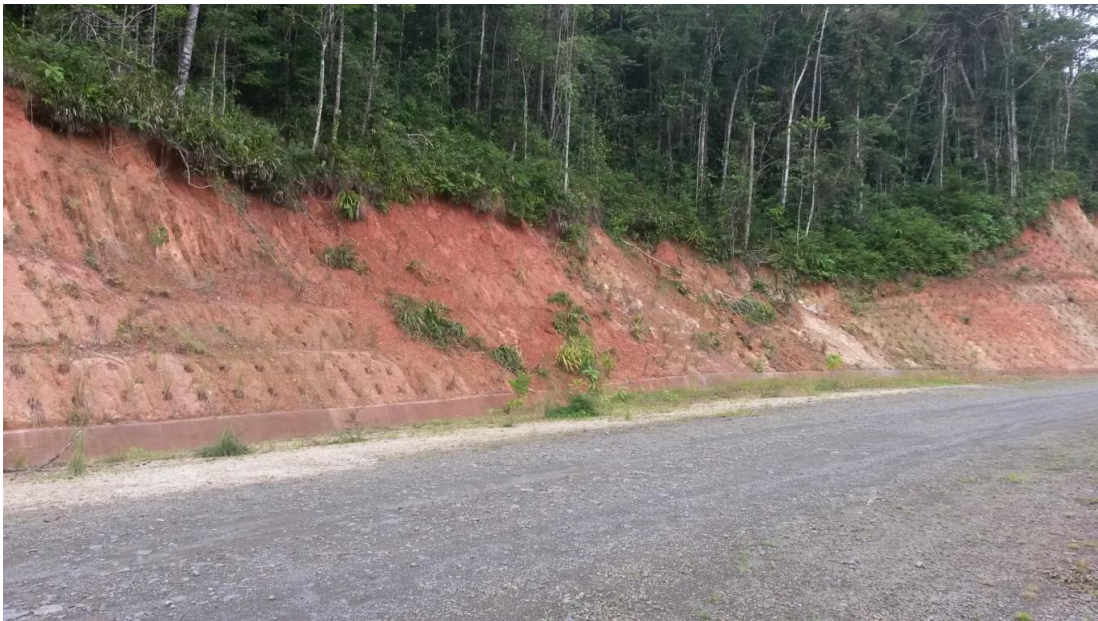
In page 46 of his July 2014 report, Dr. Kondolf states that landslides are present in the slope adjacent to Site 4. He has indicated shallow mass movements in the oblique aerial photographs acquired on October 2012. These mass movements mobilize small amounts of soil, most of which has remained on the cut slope as evidenced by Figure 12, which covers a similar area to Figure 28 b) of Dr. Kondolf's report.

Dr. Kondolf has also mentioned that large erosion features were omitted from study in Site 4, a simple comparison between the rills present in Figure 12 and those present in Site 4, visible in Figure 17, show that this statement is also false. The rills studied as part of Site 4 are the deepest and largest in the entire slope of which Site 4 is part.

Figure 12. Cut slope adjacent to Site 4 on August 19, 2014.

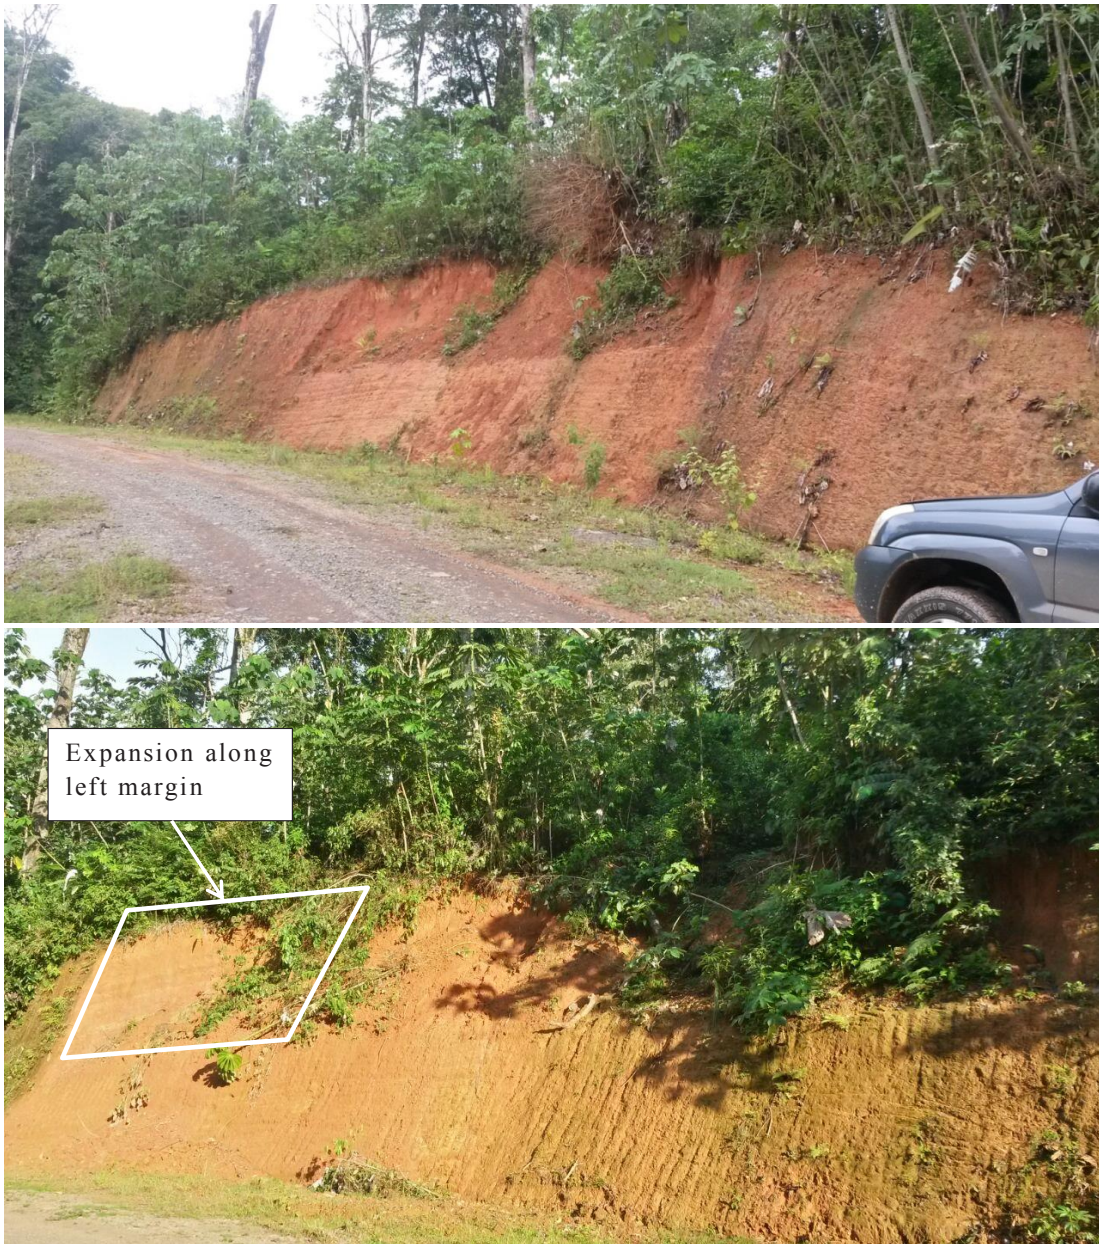
Site 1 has been subject to important changes over time. Figure 14 illustrates an increase in vegetation cover of the landslide and an increase in the landslide's area along its left margin. Vegetation prevents the direct impact of water on the slope and reduces erosion where it is found.

Overall an increase in the volume of eroded soil has been recorded for this site for the period between May and October, 2014. However when the addition in area is taken into account a net decrease in erosion depth occurs. 2013 estimates were found to be acceptable, when compared to the May 2014 volume calculation.

Figure 14. Photographs of Site 1 on May 27, 2014 (top) and October 22, 2014 (bottom).

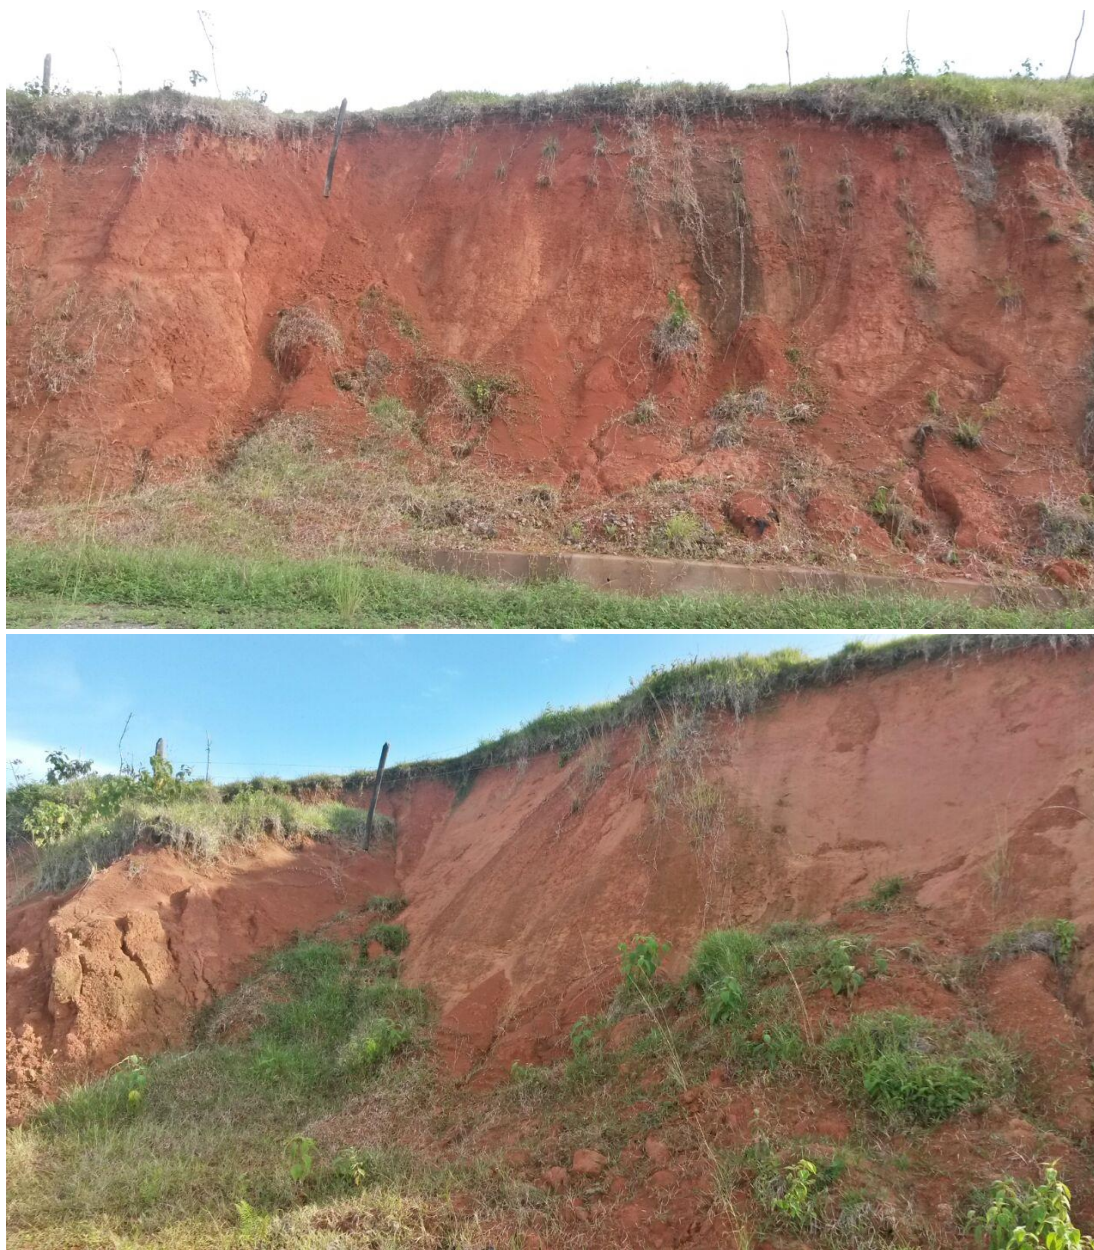
Figure 15 shows that the slope on the left margin of the landslide has failed along a deep slip surface. The failed material has suffered a vertical displacement into the old landslide area. This is registered in the volume calculations as a net decrease in the eroded volume as material from the left margin of the landslide has been deposited in the landslide's toe.

Figure 15. Photographs of Site 2 on May 27, 2014 (top) and October 22, 2014 (bottom).

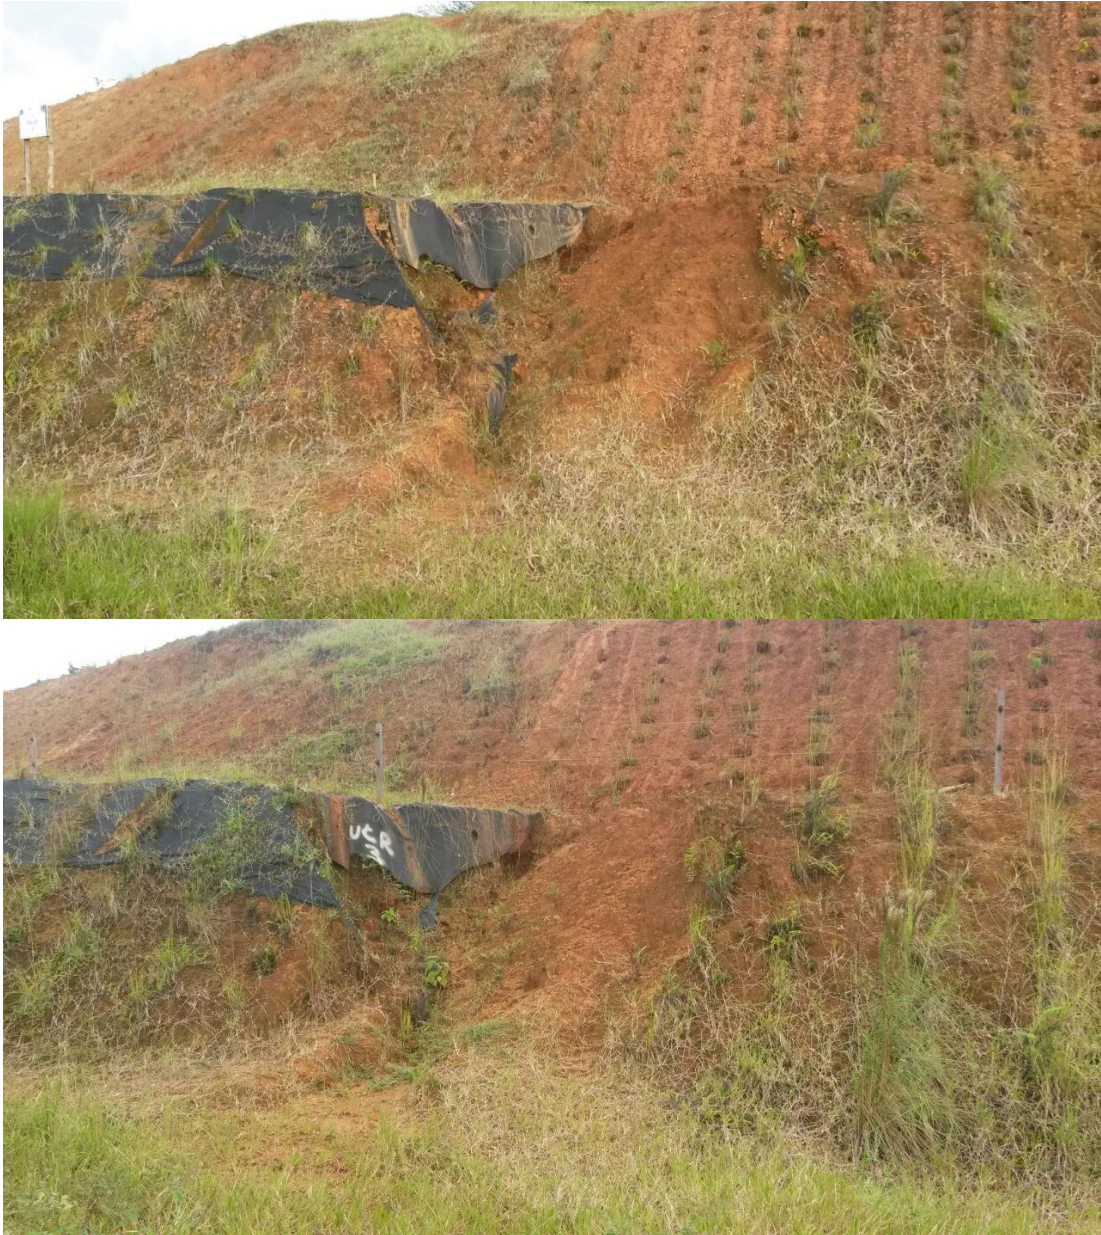
Site 3 is a large gully partially covered with a geotextile along its left margin. Unlike Sites 1 and 2 this site shows no drastic change over time. Most erosion takes place at the head of the gully and its upper edges where the steepest slopes are found. This site has shown a near constant erosion rate according to the laser topography measurements.

Figure 16. Photographs of Site 3 on May 27, 2014 (top) and October 22, 2014 (bottom).

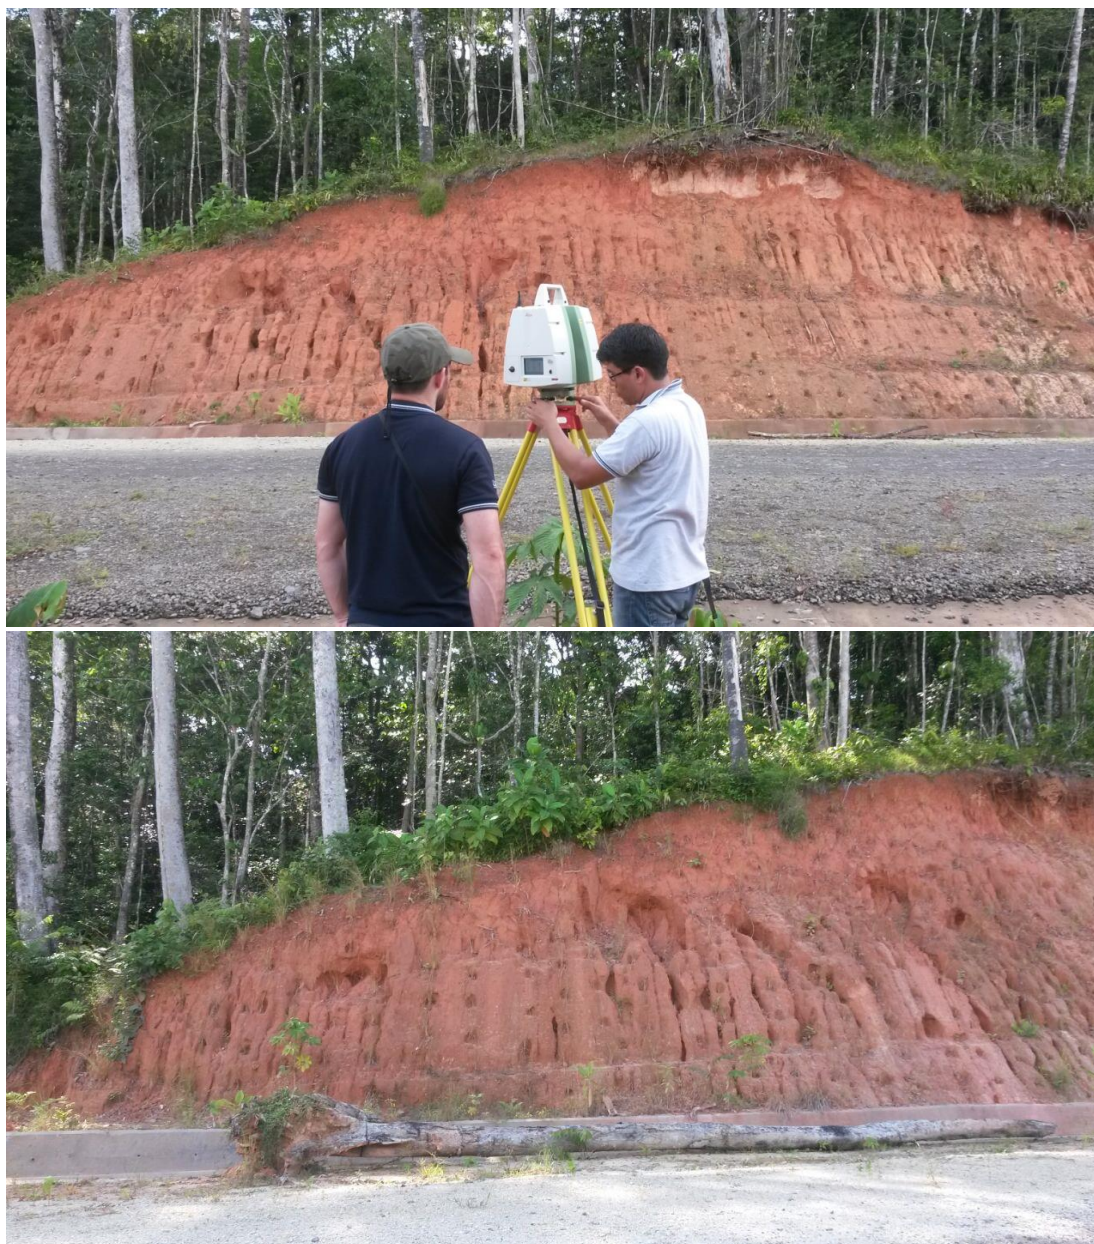
Figure 17. Photographs of Site 4 on May 27, 2014 (top) and October 22, 2014 (bottom).

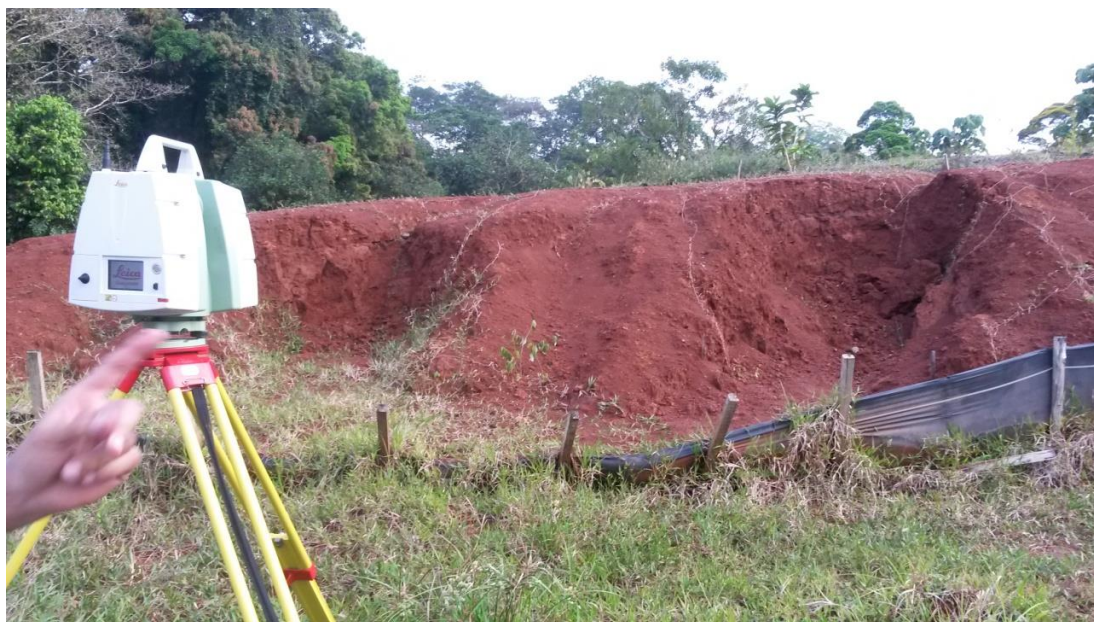
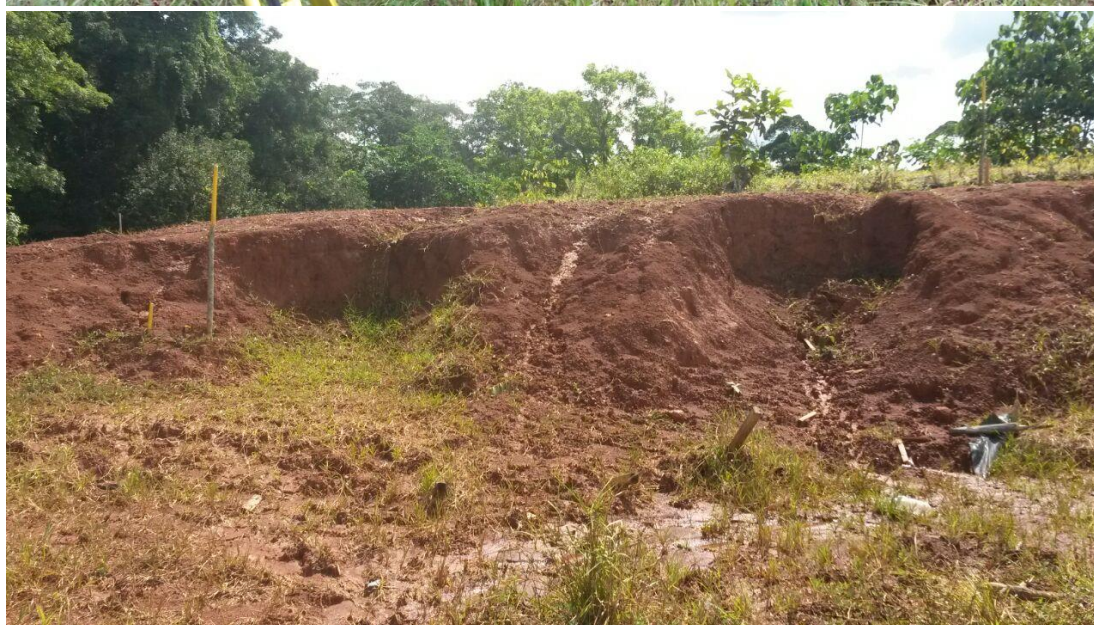
Site 9 corresponds to a pair of gullies which have developed at the end of a fill prism near Río Infiernito. Only one of these gullies was subject to erosion estimation during 2013 however the volume estimate was found to be much greater than the measurement using LiDAR. Like most sites there haven't been dramatic changes in shape or size of either gully at this site.

Figure 19. Photographs of Site 9 on May 27, 2014 (top) and October 22, 2014 (bottom).

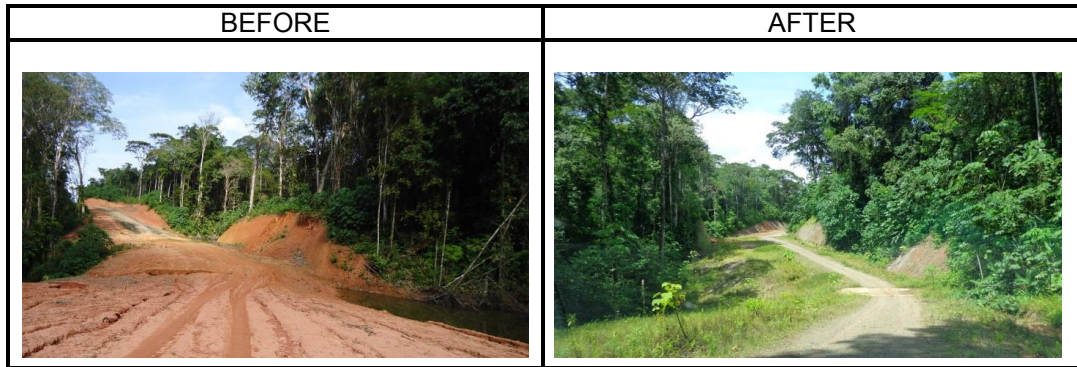
Point: Marker 2

- Name: View toward Marker 2
- Location: E496655 N329700
- Description: Placement of coconut fibre, construction of ford. Station 0+100.

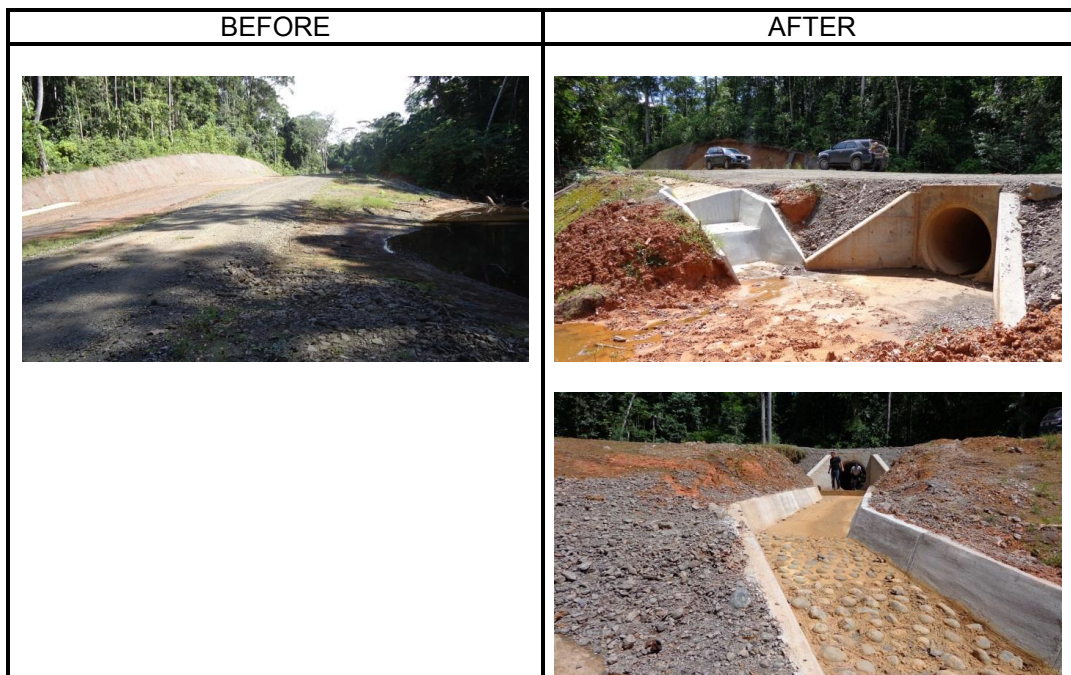
Point: Culvert

- Name: Culvert # 9
- Location: E496918, N 329956
- Description: Placement of a culvert to allow the passage of water which was stagnant. Station 0+213.

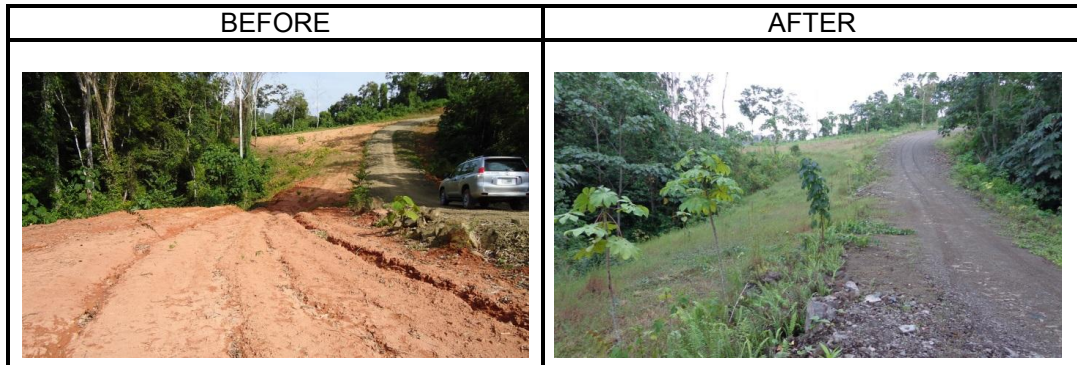
Point: Marker 2

- Name: Entrance to marker 2
- Location: E497210, N330195
- Description: Placement of coconut fibre near the water course has substantially promoted vegetation growth. Station 0+900

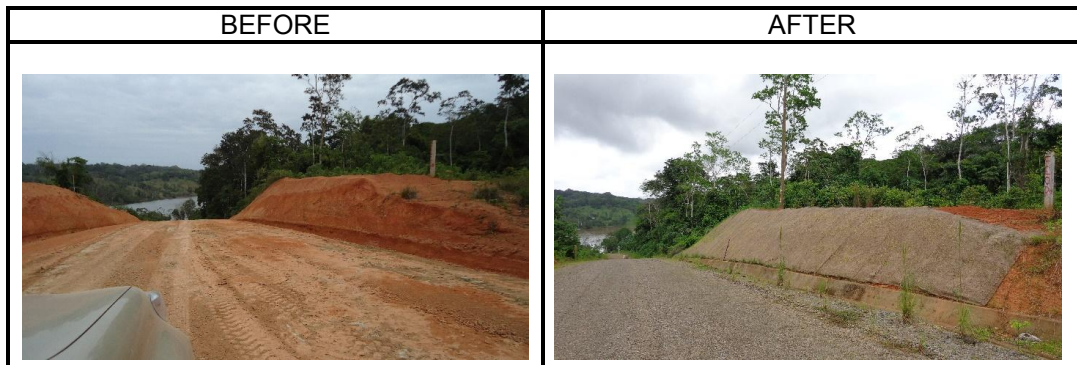
Point: T-6

- Name: Slope
- Location: E497318, N329883
- Description: Contouring of slopes, placement of coconut fibre and placement of lined ditch. Station 1+100, corresponding to slope T-6

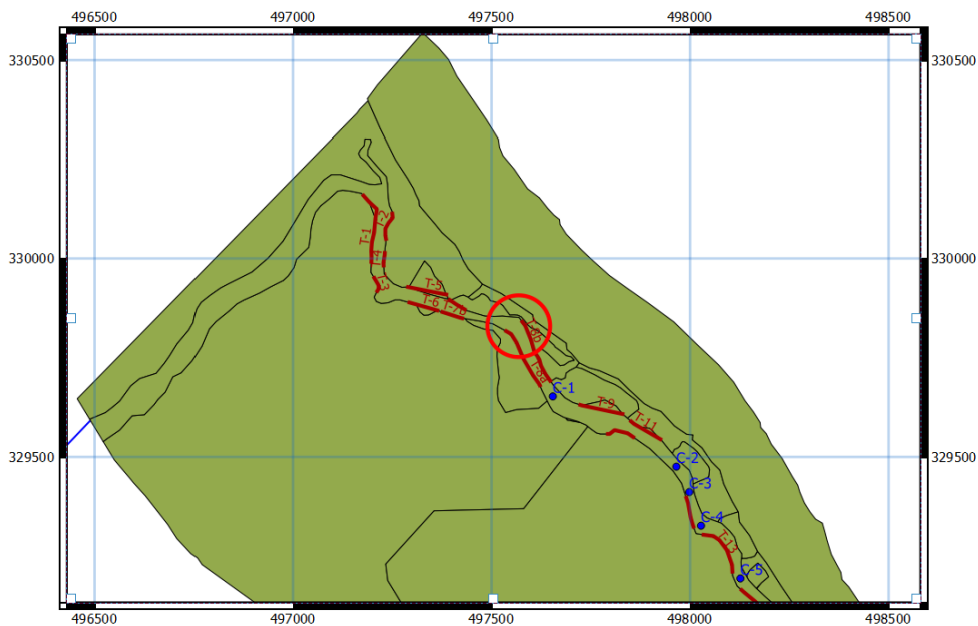
Point: T-8a

- Name: Landslide
- Location: E497578, N329755
- Description: Clearing away of landslide material, contouring of slopes, placement of lined ditch. Station 1+427, corresponding to slope T-8a

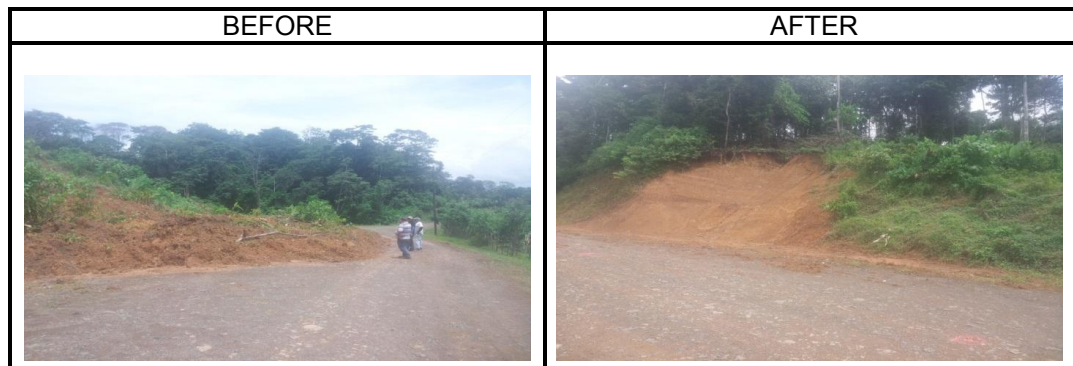
Point: T-10

- Name: Landslide
- Location: E 497850, N 329600
- Description: Clearing of landslide material off the road. Station 1+800, corresponding to slope T-10

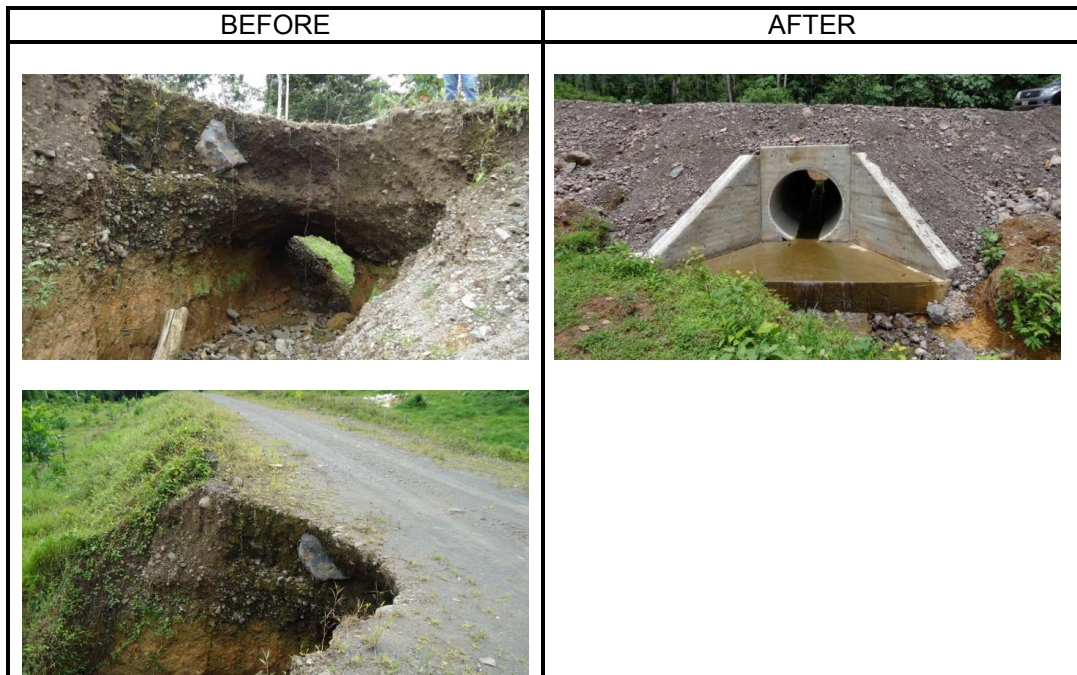
Point: C-8

- Name: Culvert # 1
- Location: E: 498517 N: 328350.
- Description: Placement of culvert at a pass where there was an imminent fault and removal of sediment at water course C-8. Station 2+764.

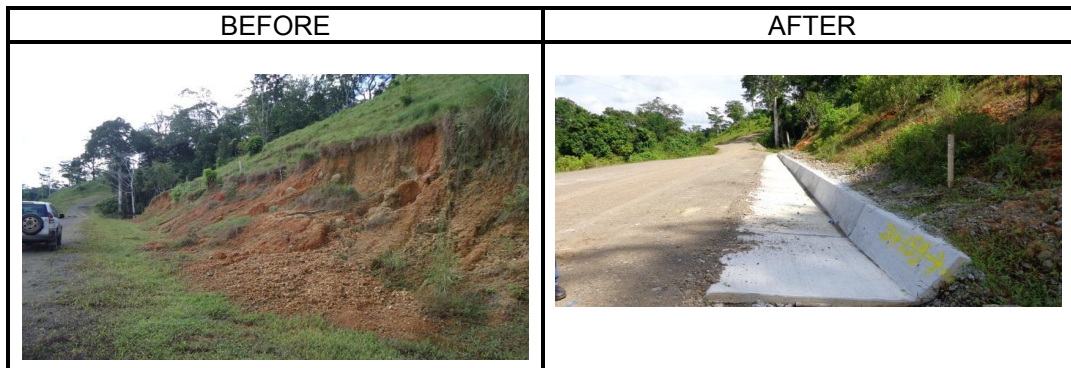
Point: T-17

- Name: Slope and lined ditch
- Location: E498634, N328436
- Description: Tidying of slope, placement of lined ditch.

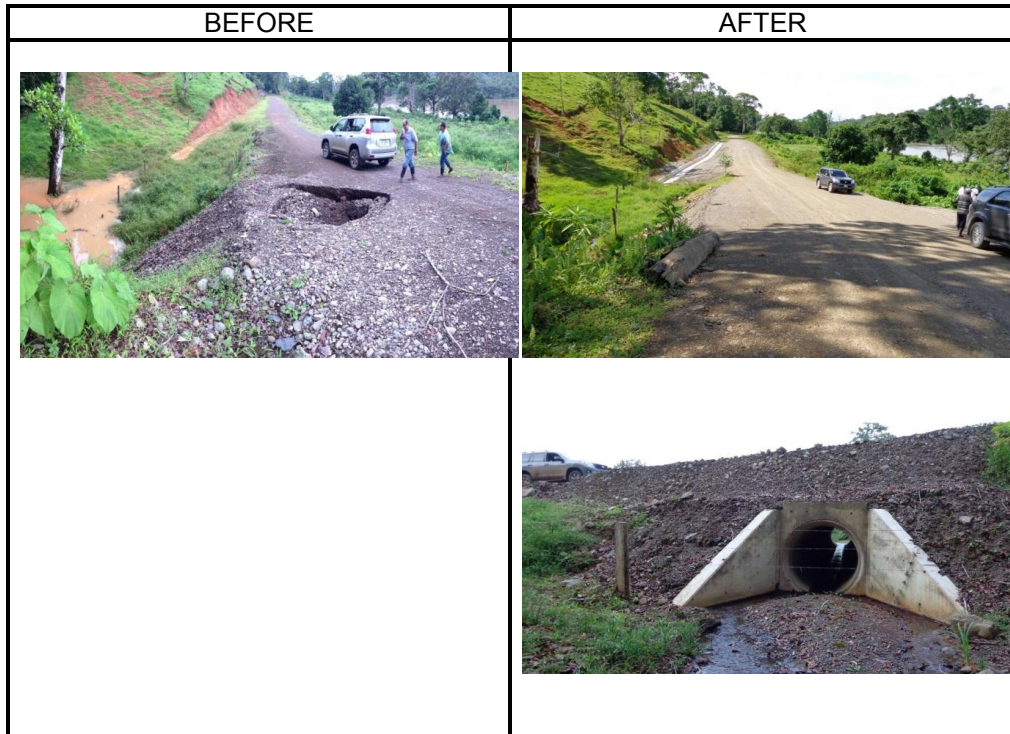
Point: C-9

- Name: Culvert # 2
- Location: E498700, N328350
- Description: Placement of culvert in a land pass undermined due to existing fence. Elimination of fence, placement and compacting of gravel. In addition, construction of a lined ditch at slope near water course C-9. Station 3+270.

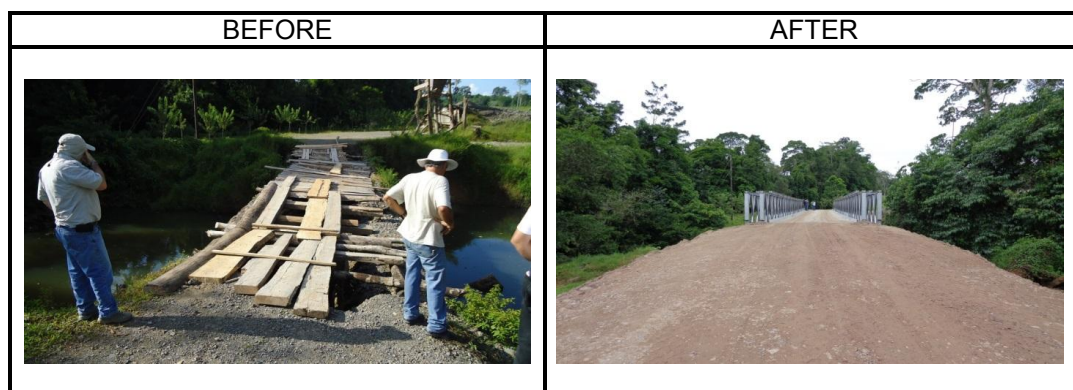
Point: C-12

- Name: Caño Trinidad
- Location: E497870, N325822
- Description: Removal of logs and placement of new panel-type modular bridge. Station 6+500

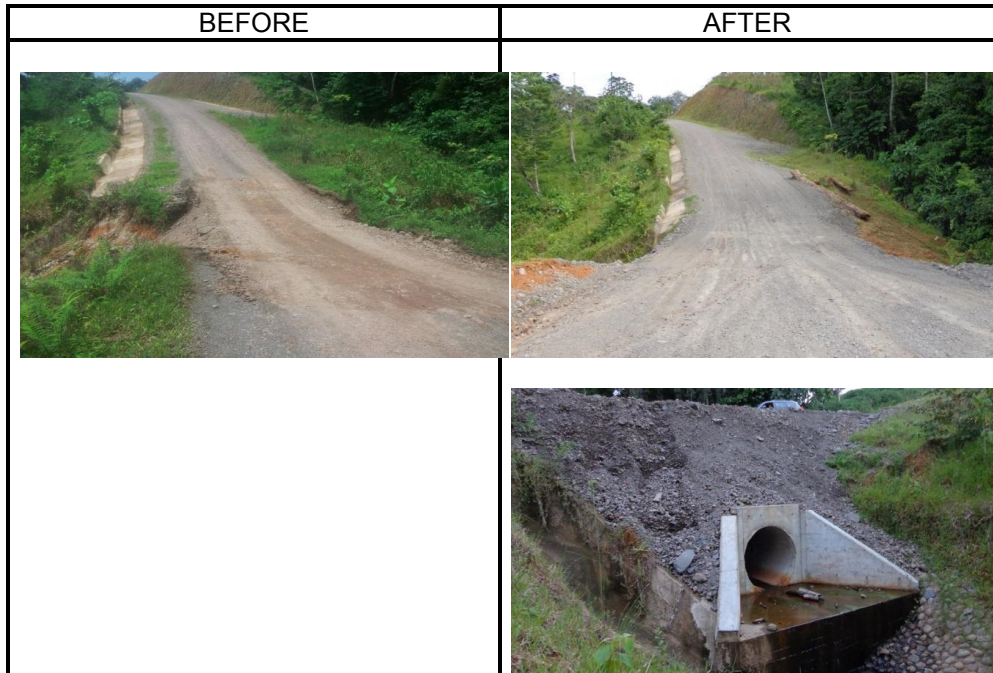
Point: C-13

- Name: Culvert # 8
- Location: E 498089, N 325299
- Description: Placement of culvert. Station 6+900, water course C-13

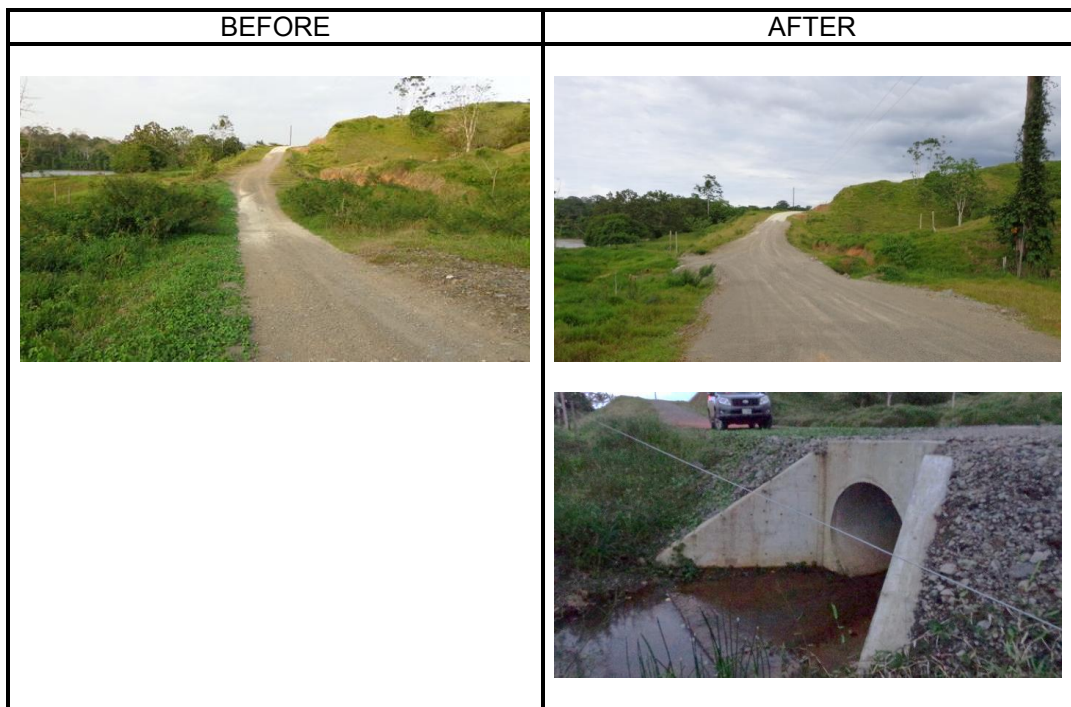
Point C-17

- Name: Culvert # 3
- Location: E499087, N324972
- Description: A concrete culvert is placed in water course C-17. Station 8+034.

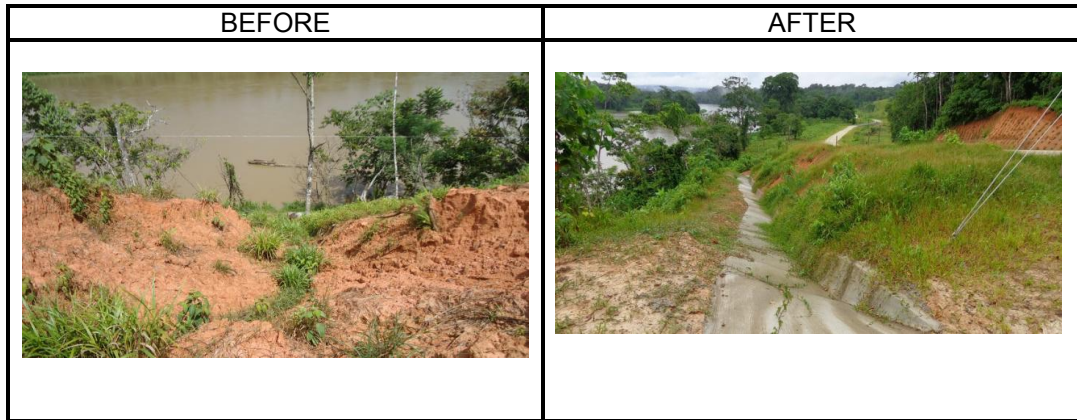
Point: T-38

- Name: Point 1, important slope.
- Location: E499520, N324600
- Description: Lined ditch, contouring of slope, construction of berm at slope T-38. Station 9+040

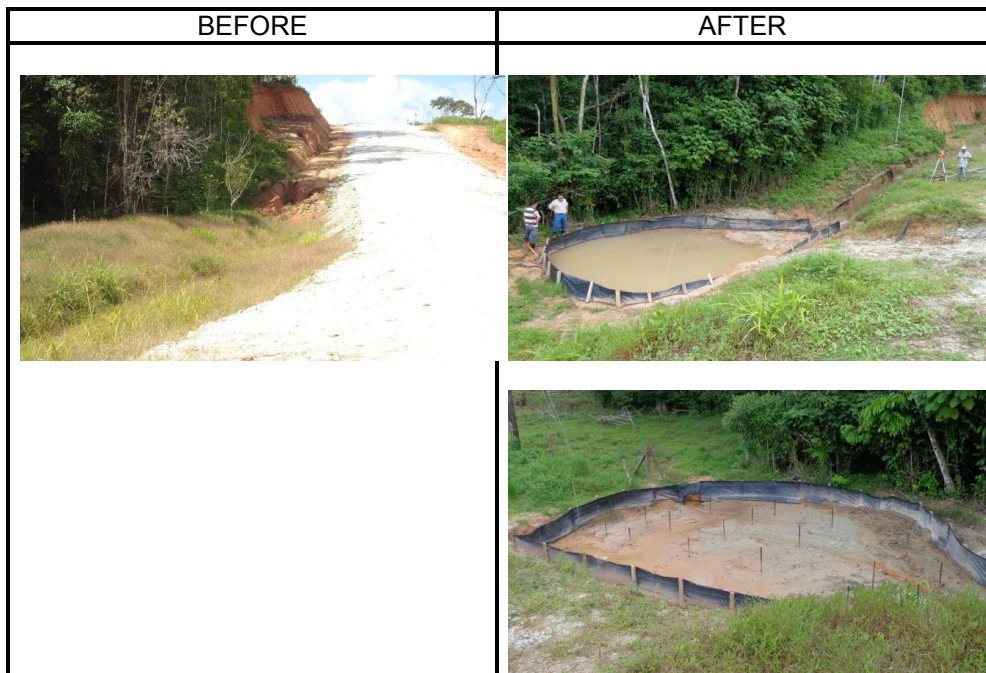
Point: T-39

- Name: Lined ditch and sediment trap
- Location: E499250, N324459
- Description: Sediment trap of the University of Costa Rica (UCR) to control and monitor sedimentation from slope T-39, construction of lined ditch at the slope. Station 9+040

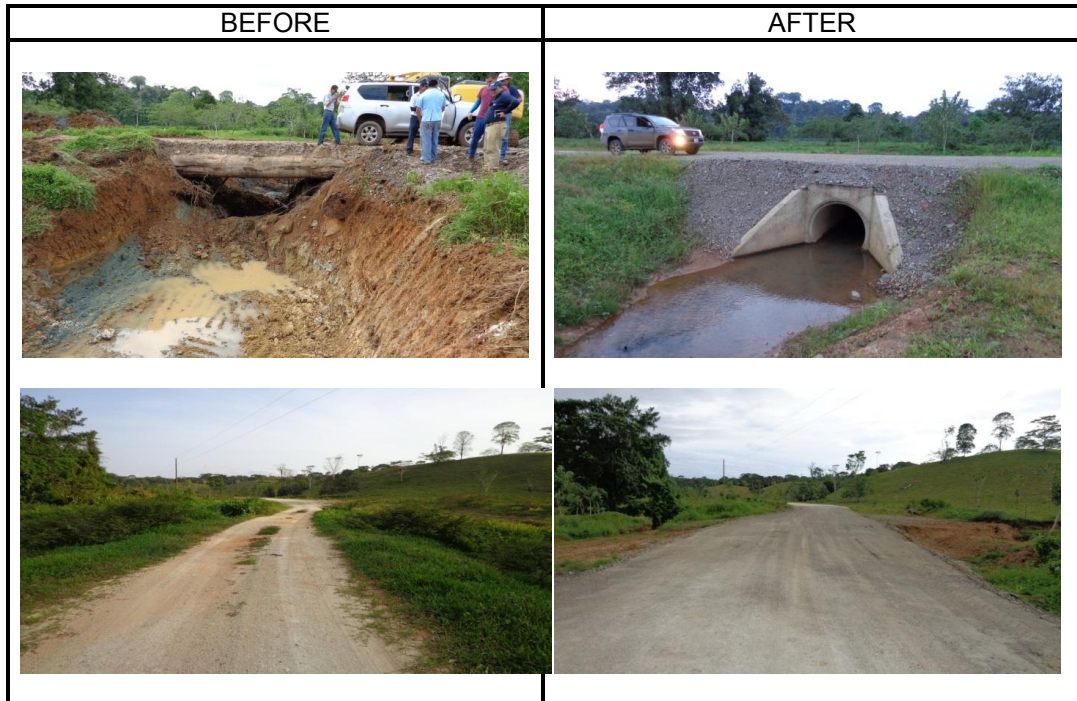
Point: C-19

- Name: Culvert # 4
- Location: E499753, N324049
- Description: Removal of logs and placement of new culvert in water course C-19. Station 9+040

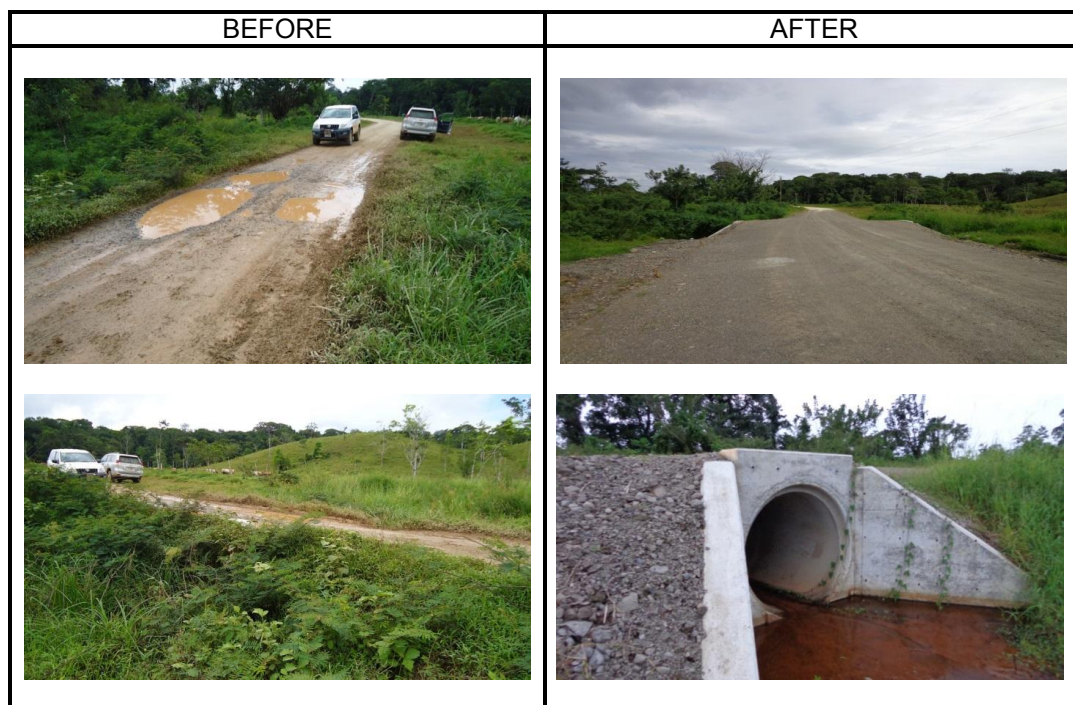
Point C-21

- Name: Culvert # 5
- Location: E499856, N323698
- Description: Removal of logs and placement of new culvert in water course C-21. Station 9+783

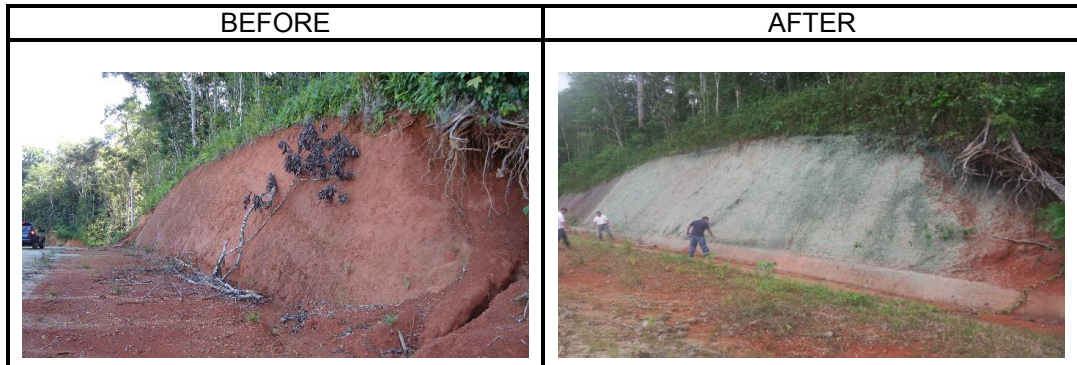
Point T-40

- Name: Lined ditch and hydroseeding
- Location: E 499982 N 323271
- Description: Planting on slope using hydroseeding on slope T-40. Station 10+350,

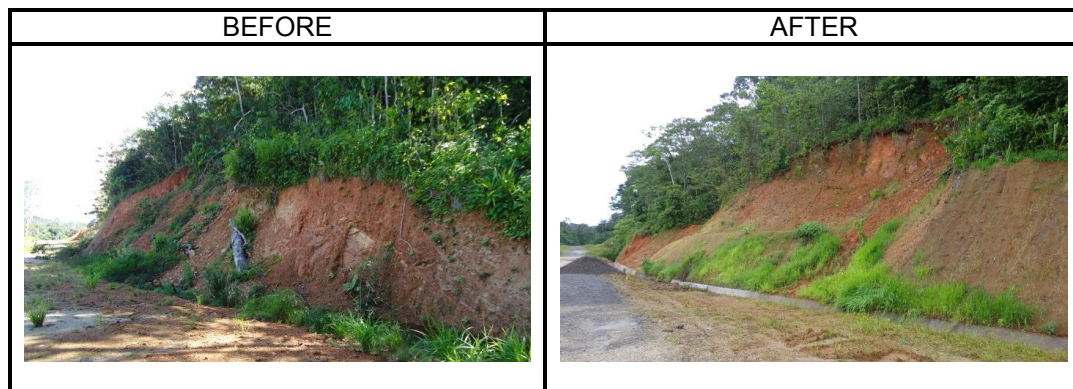
Point T-40

- Name: Lined ditch, hydroseeding and coconut fibre
- Location: E500088 N 323078
- Description: Contouring of slopes, construction of lined ditches, placement of coconut fibre, application of hydroseeding at station 10+428, on slope T-40

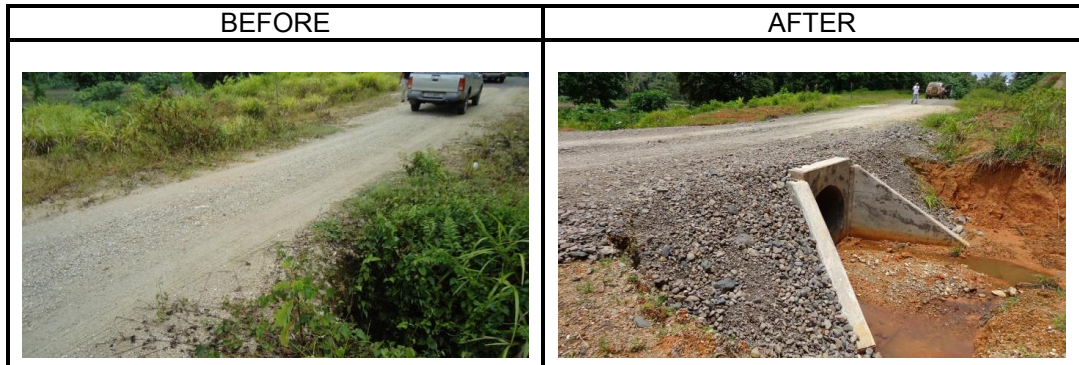
Point C-24

- Name: Culvert # 6
- Location: N:500187 E:323027
- Description: Placement of culvert at water course C-24. Station 10+585

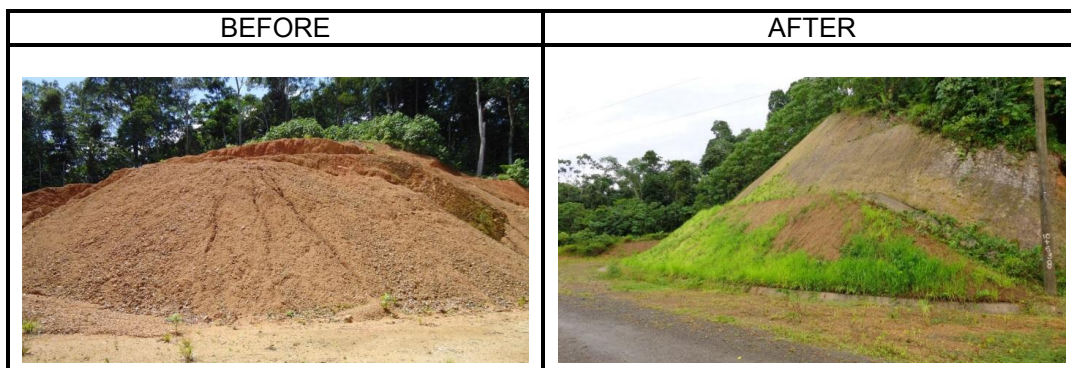
Punto T-41

- Name: Lined ditch, contouring of slope with fibre and planting.
- Location: E500075, N323103
- Description: Contouring of slopes, construction of lined ditch, placement of coconut fibre, application of hydroseeding at station 10+630, on slope T-41

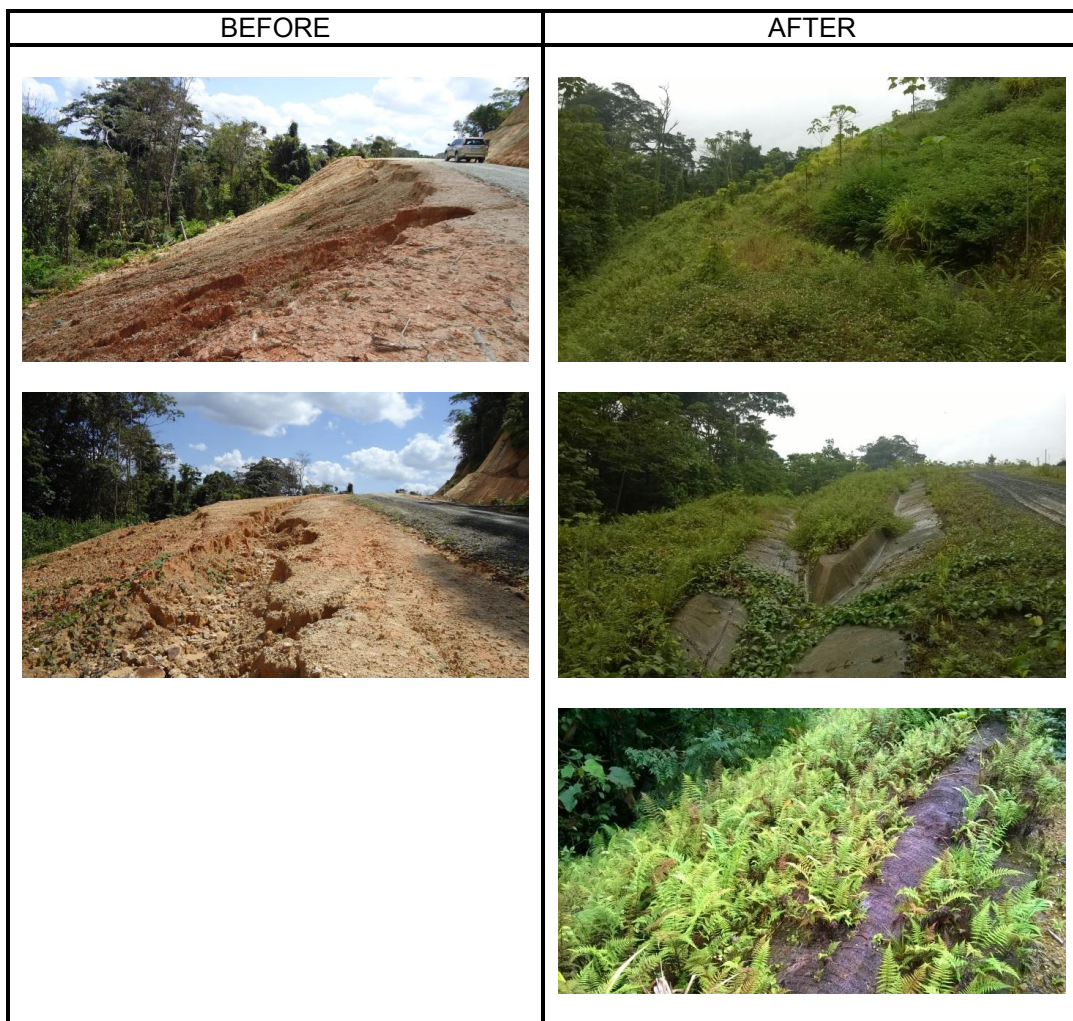
Point: T-43

- Name: Lined ditch, contouring of slope with fibre.
- Location: E500797, N322258
- Description: Contouring of slopes, construction of lined ditch, placement of coconut fibre, at station 11+825, on slope T-43. There has been a very significant growth of vegetation along all the slope.

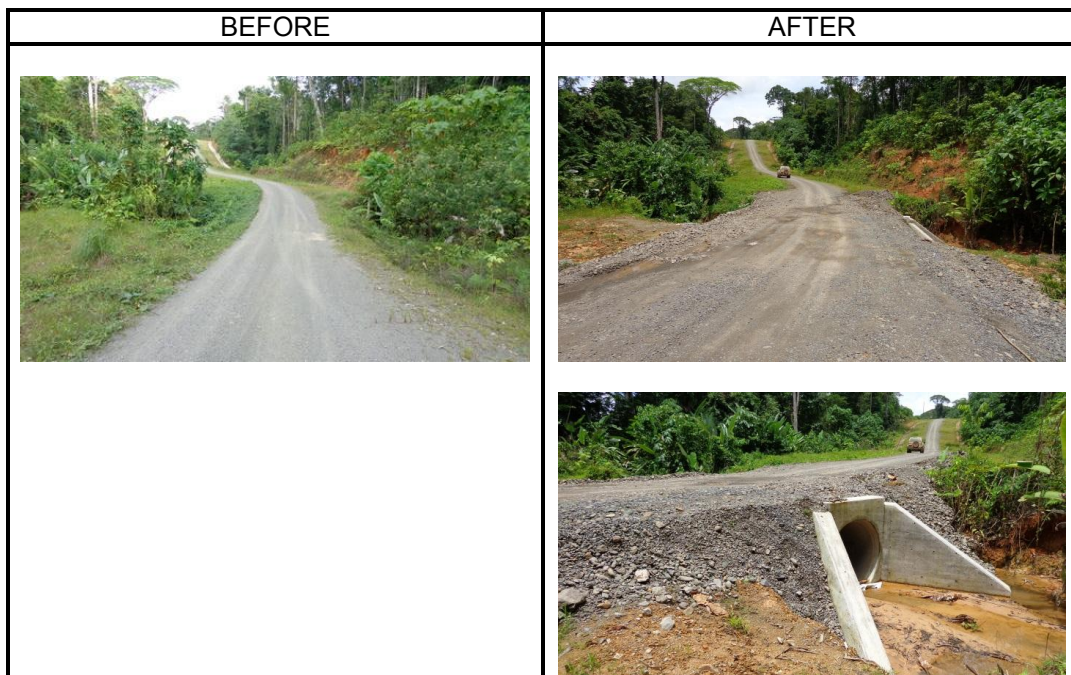
Point C-30

- Name: Culvert # 7
- Location: E 501099, N321688
- Description: Culvert placed on log pass over water course C-30. Station 12+200
