**DISPUTE CONCERNING THE CONSTRUCTION OF A ROAD IN
COSTA RICA ALONG THE SAN JUAN RIVER**

REJOINDER OF COSTA RICA

VOLUME III

ANNEXES 4 - 14

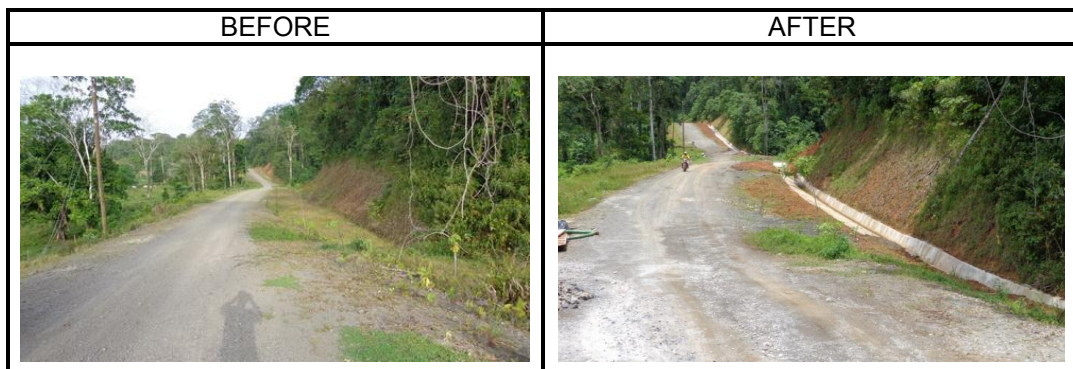
Point T-49

- Name: Lined ditches
- Location: E 501457 N 321529
- Description: Construction of lined ditches along slope T-49. Station 12+635

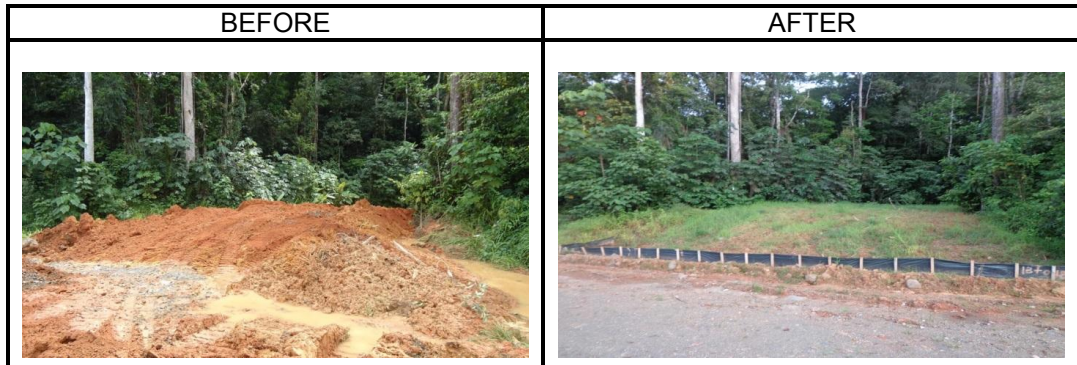
Point: T-50

- Name: Site for excess material
- Location: E 501855, N 321475
- Description: Site contemplated to deposit excess material from the digging performed at the end of slope T-50. Station 13+050

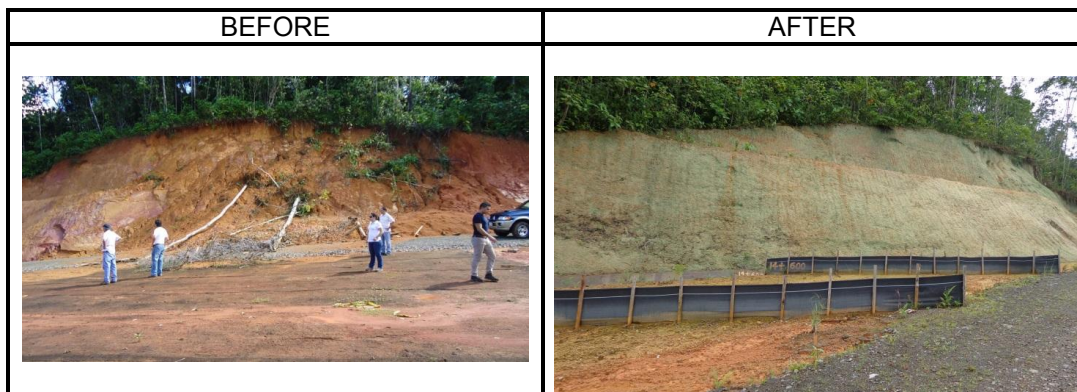
Point T-58b

- Name: Infiernito
- Location: E503111, N321375
- Description: Contouring of slopes, lined ditch, hydroseeding and placement of silt fence sediment traps along slope T-58b. Station 14+600.

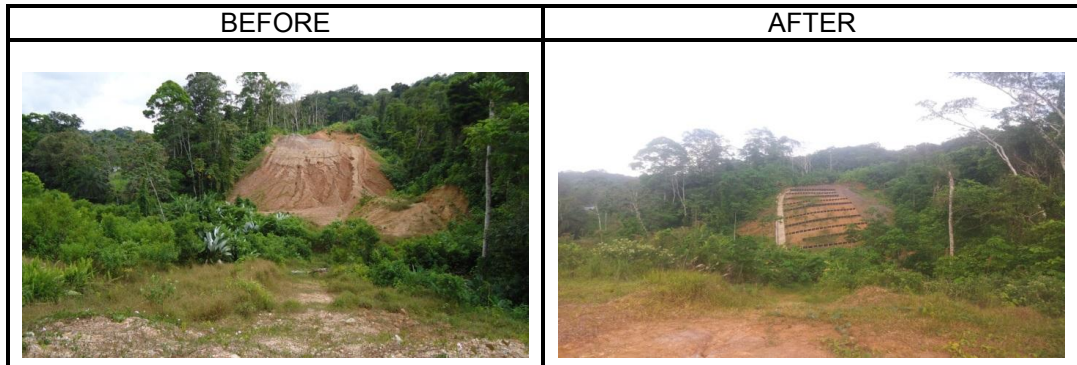
Point T-63

- Name: Infiernito Crucitas
- Location: E506807, N321188
- Description: Contouring of slope, lined ditch, and placement of silt fences.
Station 15+400

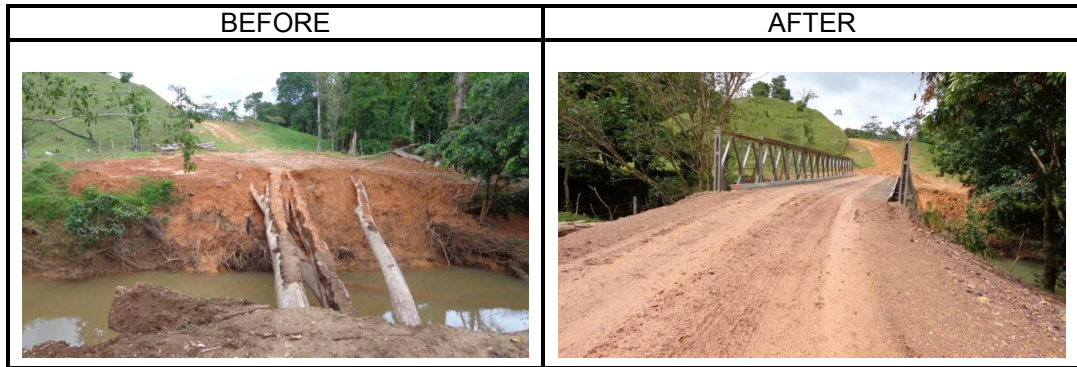
Point C-45

- Name: Caño Venada
- Location: E507041, N318778
- Description: Removal of logs and placement of new bridge over Caño Venada

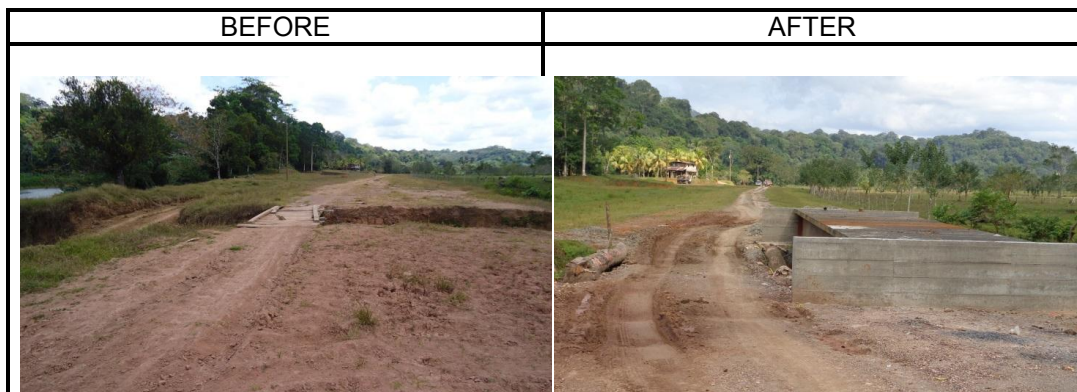
Point C-46

- Name: Caño Venada - Crucitas
- Location: E507408, N318879
- Description: Placement of bridge over creek C-46

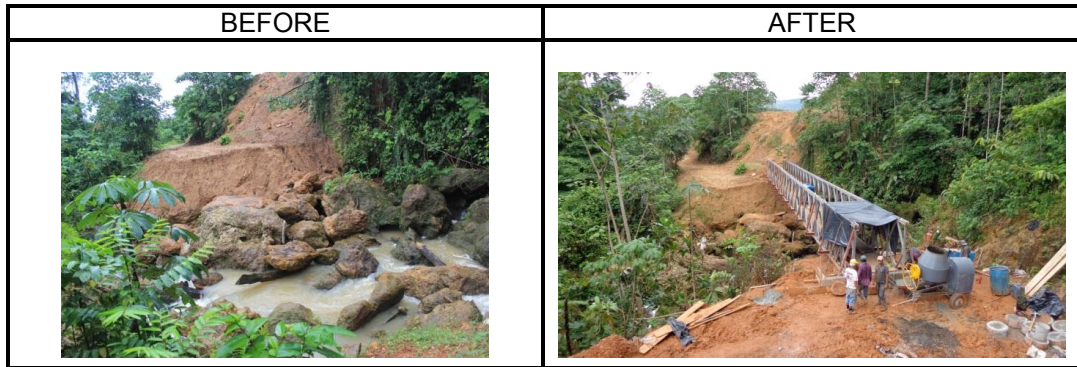
Point C-49

- Name: Caño La Chorrera
- Location: E510406, N317065
- Description: Placement of pedestrian bridge over La Chorrera creek (C-49)

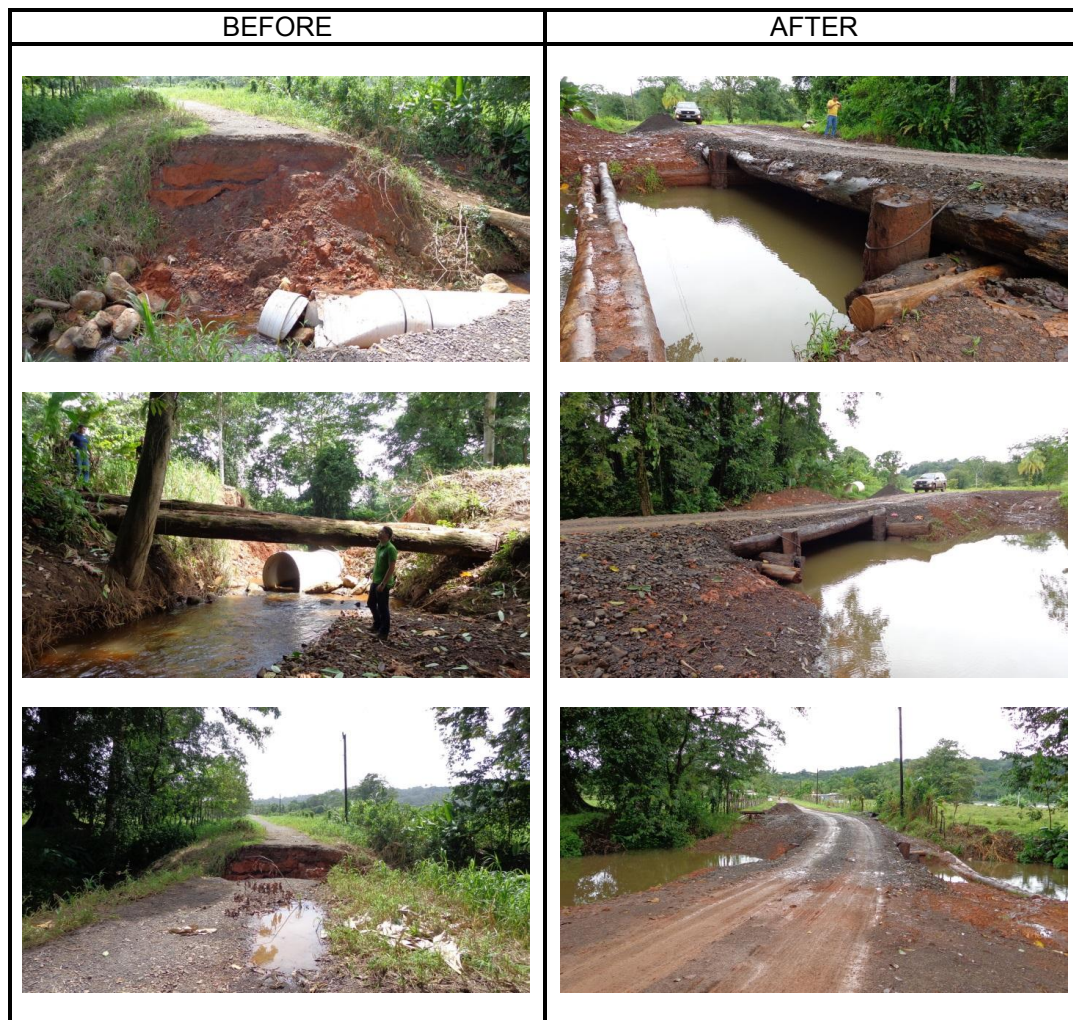
Point C-69

- Name: Quebrada
- Location: Boca San Carlos, E 516386 N307325
- Description: Removal of smooth pipe at collapsed pass and placement of log pass on water course C-69.

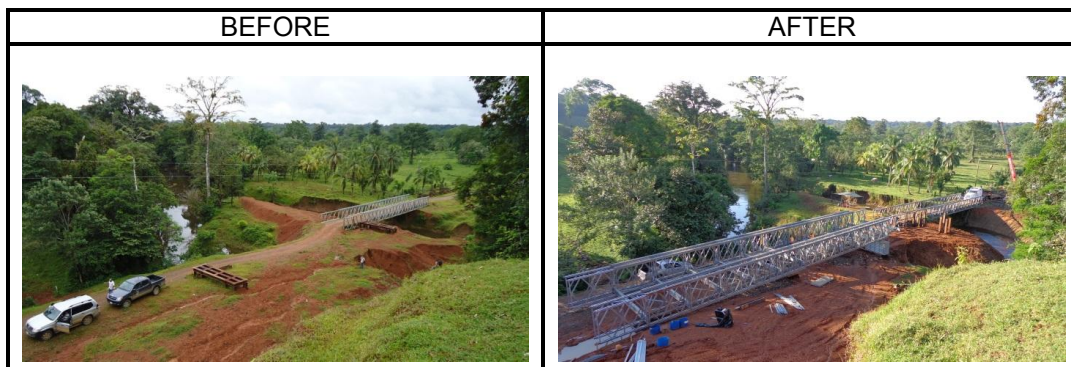
Point C-86

- Name: Caño Cureña
- Location: E 526425, N 304545
- Description: In the process of building two panel-type modular bridges.

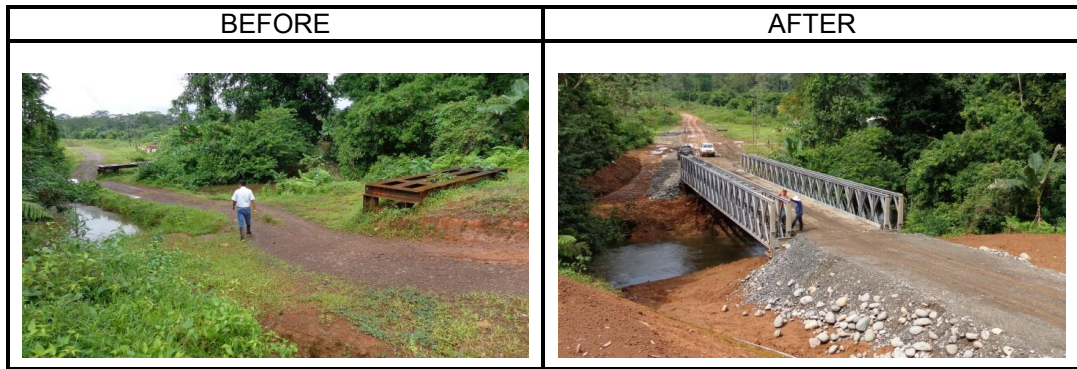
Point C-89

- Name: Caño Cureñita
- Location: E 528087, N 303657
- Description: Removal of logs and placement of new panel-type modular bridge over water course C-89.

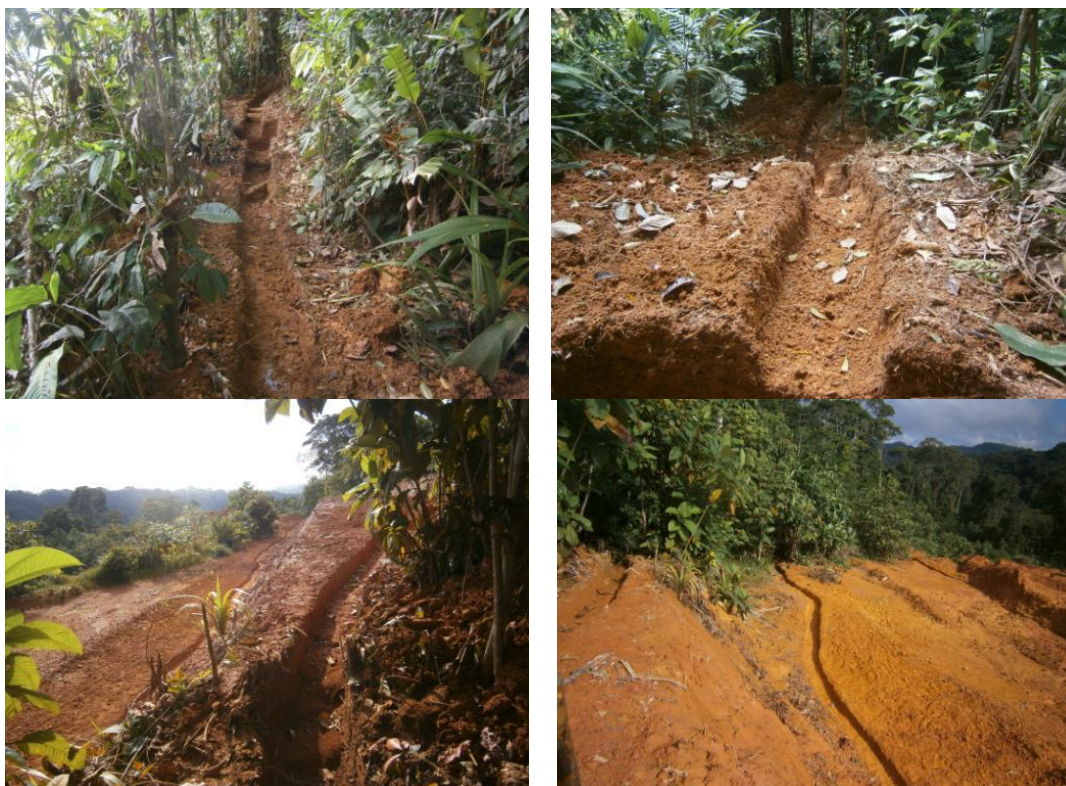
POINT 4.Construction of drain in the upper part of the cut slope.

Construction of drain in the terraces.

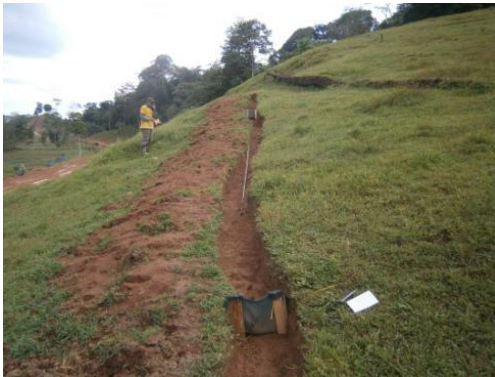
Upper drain, Slope T66a.

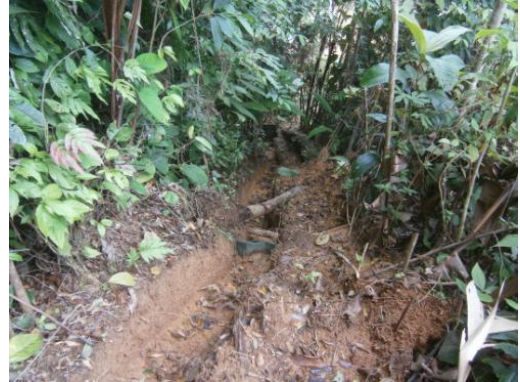
Upper drain, Slope T73a.

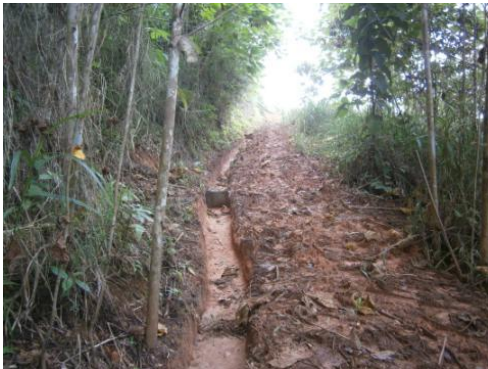
Drain on terrace, Slope T75

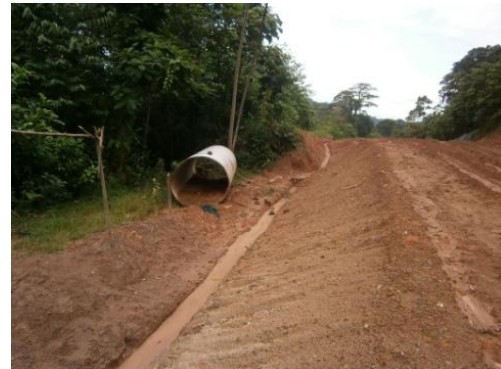
Drain on road, Slope T75.

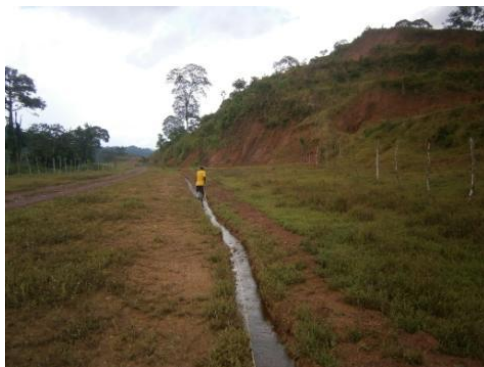
Drain at base of cut, Slope T81.

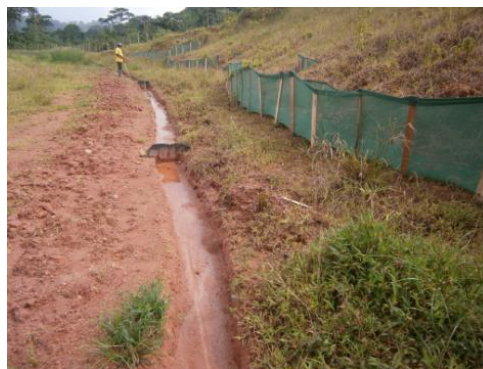
Drain at base of filling, Slope T82b.

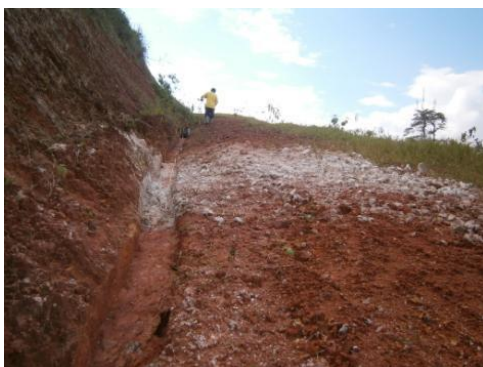
Drain on terrace, Slope T81

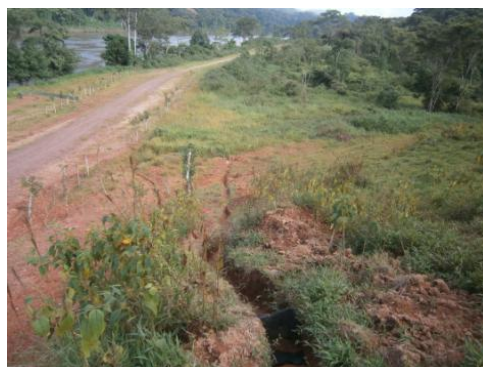
Drain on upper part of cut, Slope T82a.

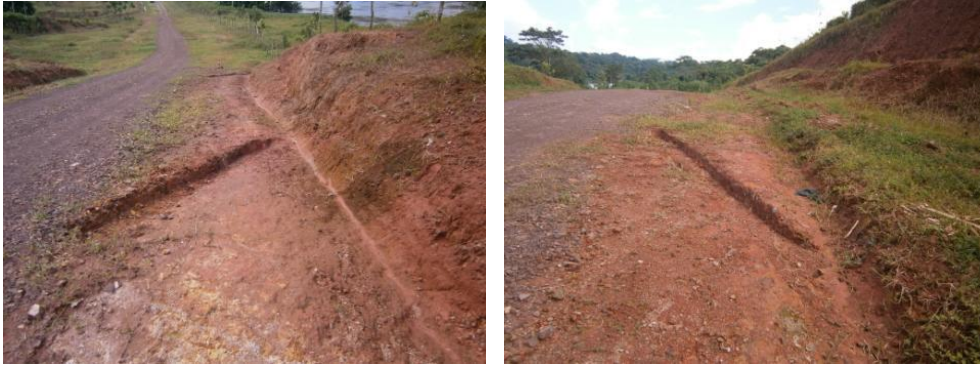
Cross drains built at Slope T82a on the edge of the road.

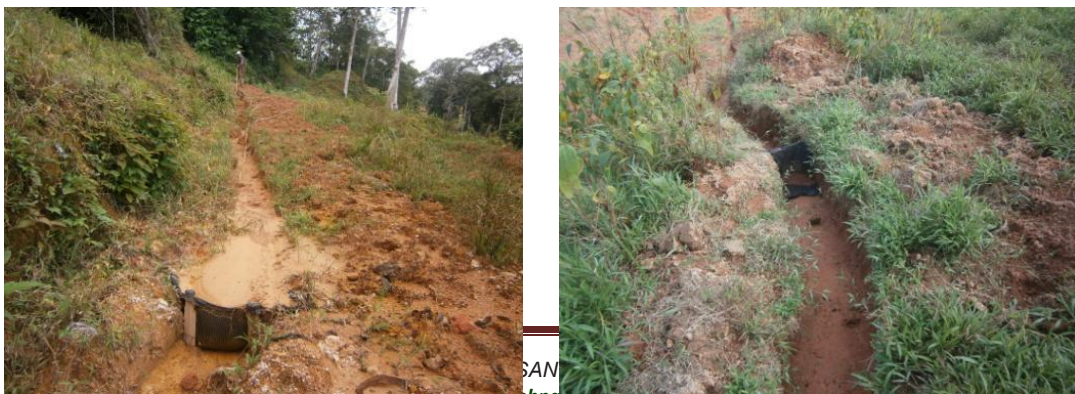
Fill Slope T69b.

Cut Slope T82a.

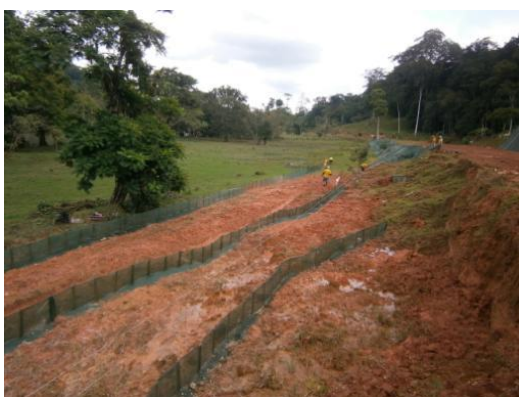
Large sediment trap, Slope T76b.

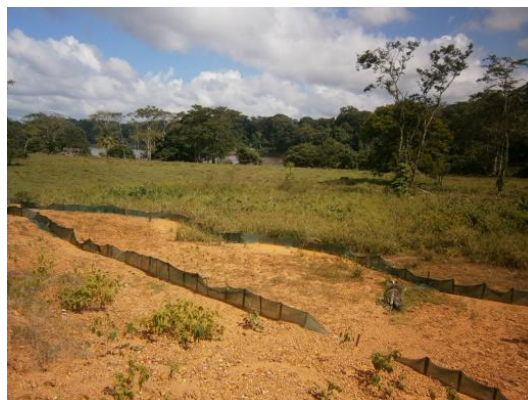
Large sediment trap, Slope T66b.

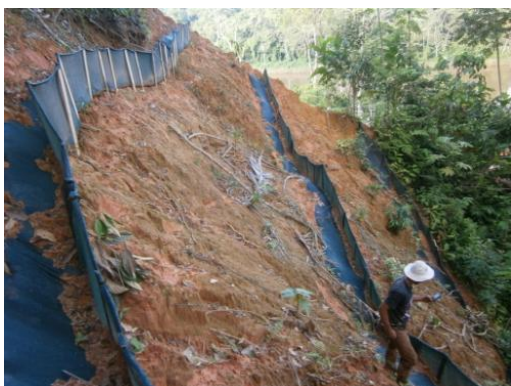
Large sediment trap, Slope T69a.

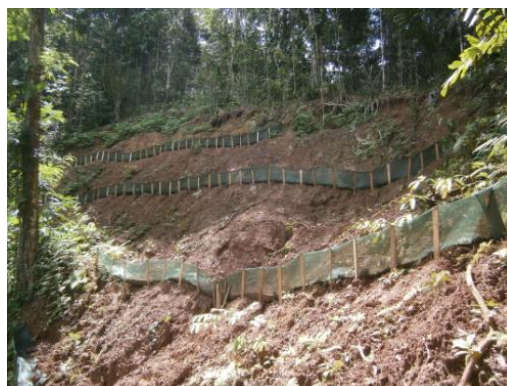
Large sediment trap, Slope T66a.

These sediment traps are placed in areas where landslides occur.

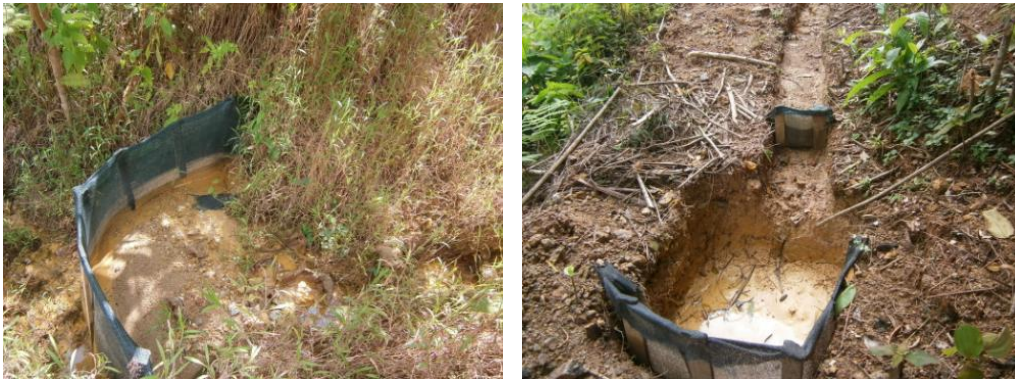
Box sediment traps in gullies and at the end of the drain

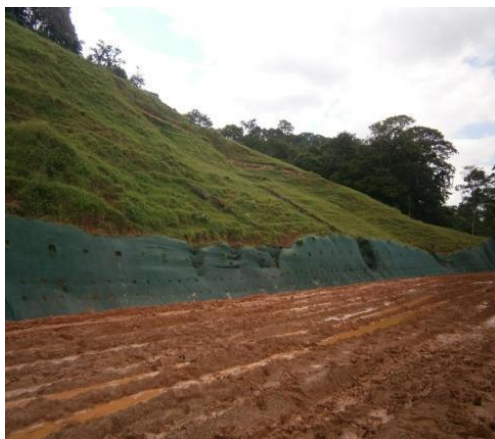
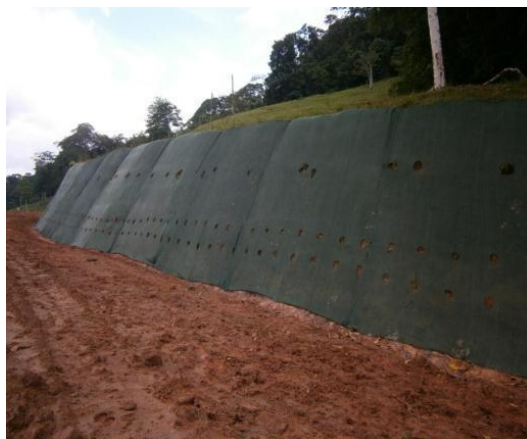
Placement of saran on Slope T76a.

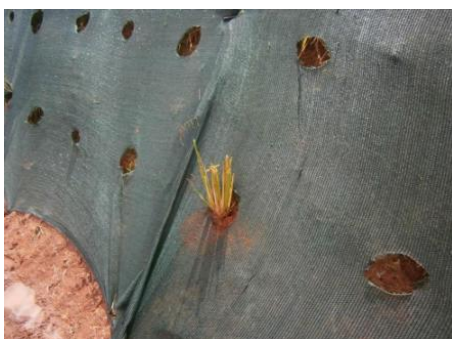
Planting of Vetiver

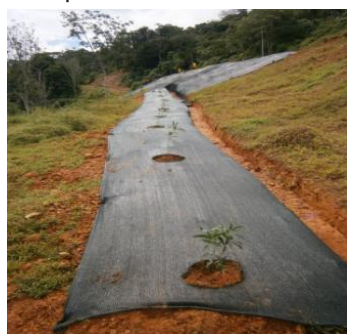
Planting of Sotacaballo trees

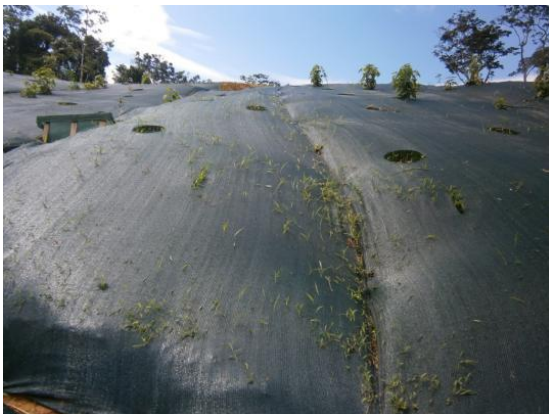
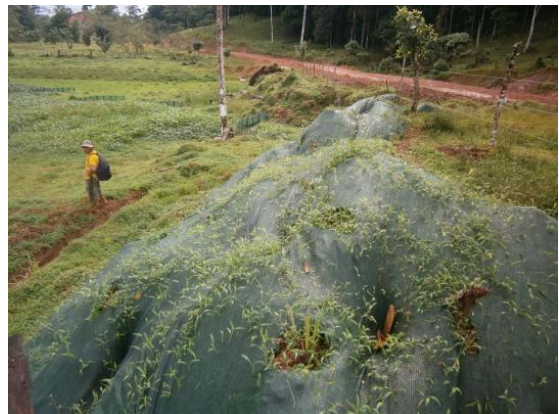
As can be seen in the picture, natural grass is already coming out of the saran, improving the coverage in the fill slope, in this case on Slope T66b. In the upper part of the picture you can see “Lengua de Vaca” plants that were already colonising the fill slope; a hole was made in the saran to let their development process continue in the fill area.

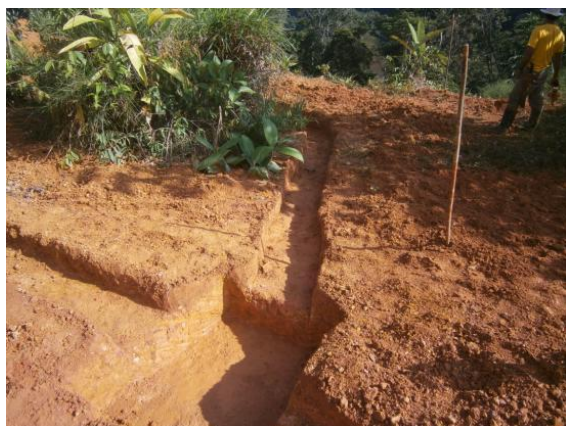
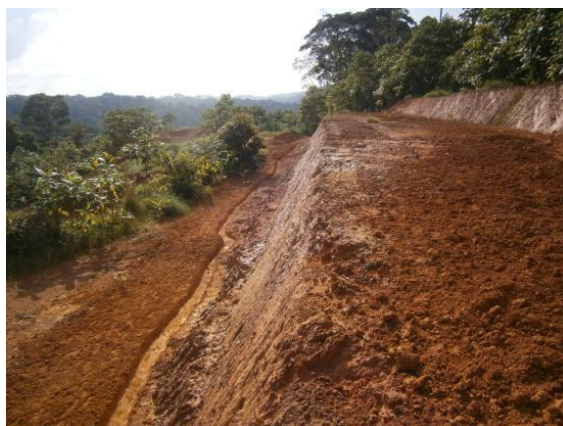
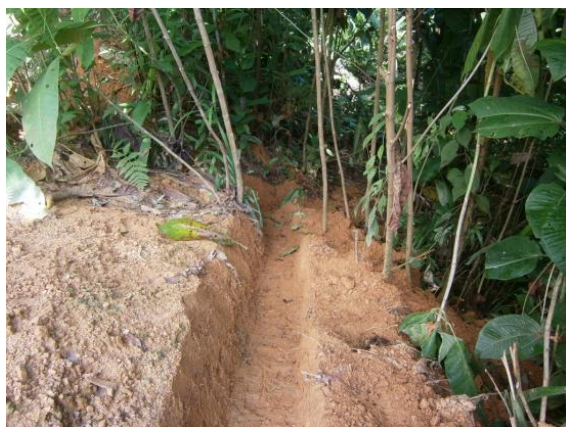
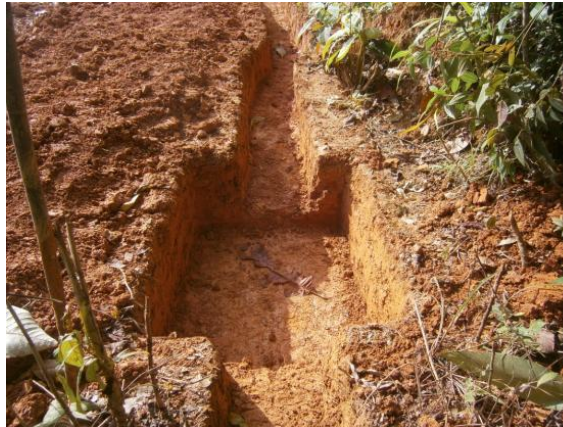
b) Slope T65 a & b:

Restoration measures to be implemented.		Number of units per activity.	Progress of activities	Percentage %
Cut slopes:	Drains at the base of the cut slope and on the terrace	300 metres	225	75,0%
	Drain in the upper part of the cut slope	150 metres	151,7	101,1%
	Small sediment traps for drains	14 units	0	0,0%
	Box sediment traps at the end of the drain	8 units	7	87,5%
	Coverage of areas without vegetation	3.233 m ²	0	0,0%
Road surface:	Cross drains to divert waters	120 metres	0	0,0%
Fill slopes:	Drains at the base of the fill slopes	150 metres	0	0,0%
	Box sediment traps for drains and gullies	38 units	0	0,0%
	Large sediment traps	24 units	0	0,0%
	Coverage of areas without vegetation	1.861 m ²	0	0,0%

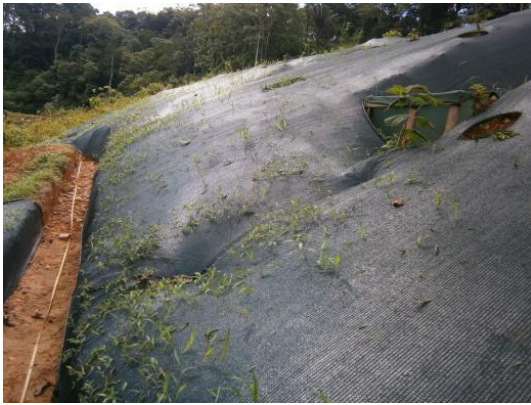
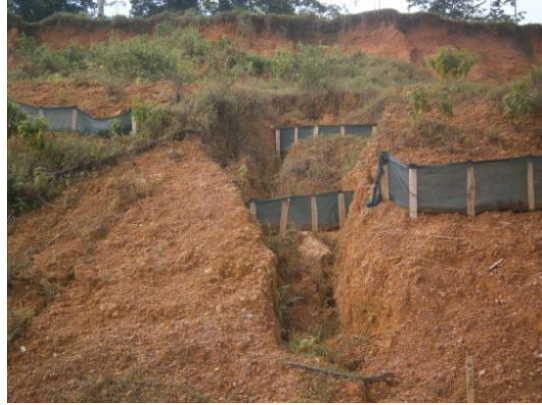
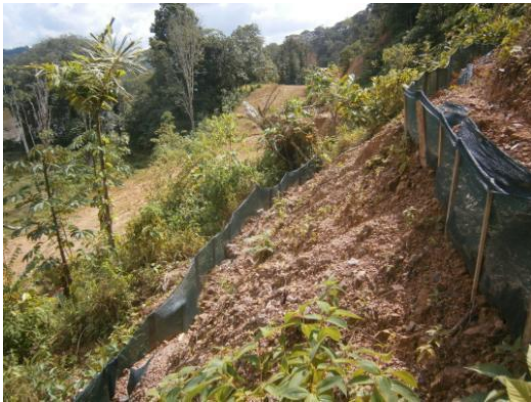
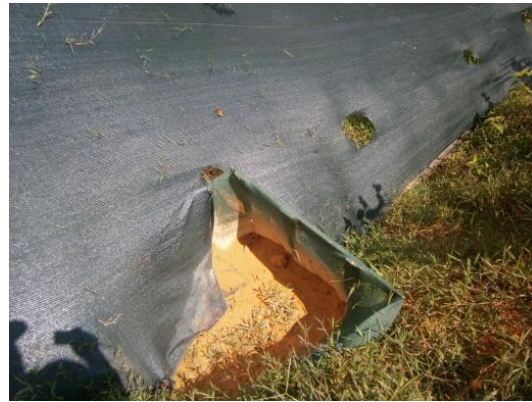
b) Slope T67

Restoration measures to be implemented		Number of units per activity	Progress of activities	Percentage %
Cut slopes:	Drains at the base of the cut slope and on the terrace	150 metres	60	40,0%
	Drain in the upper part of the cut slope	50 metres	75	150,0%
	Small sediment traps for drains	18 units	13	72,2%
	Box sediment traps at the end of the drain	8 units	2	25,0%
	Coverage of areas without vegetation	974 m ²	880	90,3%
Road surface:	Cross drains to divert waters	160 metres	0	0,0%
	Box sediment traps to intervene gullies	16 units	2	12,5%

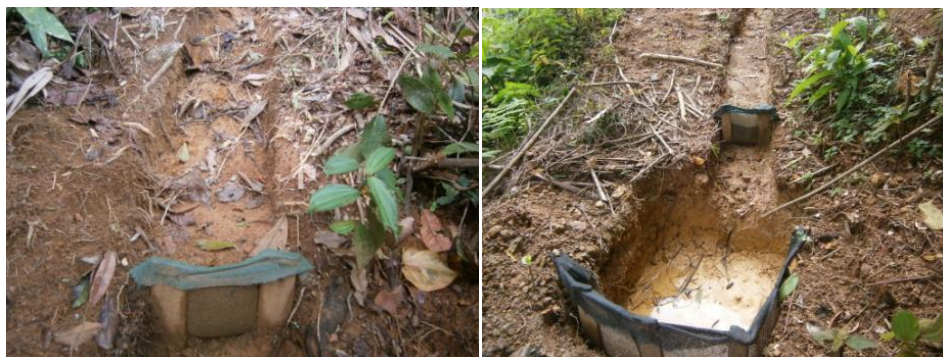
c) Slope T69 a & b:

Restoration measures to be implemented		Number of units per activity	Progress of activities	Percentage %
Cut slopes:	Drains at the base of the cut slope and on the terraces	600 metres	400	66,7%
	Drain in the upper part of the cut slope	250 metres	250	100,0%
	Small sediment traps for drains	25 units	28	112,0%
	Box sediment traps at the end of the drain	14 units	9	64,3%
	Large sediment traps (15 m) for landslide area	6 units	6	100,0%
	Coverage of areas without vegetation	2.450 m ²	1200	49,0%
Road surface:	Cross drains to divert waters	90 metres	0	0,0%
	Box sediment traps to intervene gullies	6 units	0	0,0%
	Small sediment traps.	12 units	0	0,0%

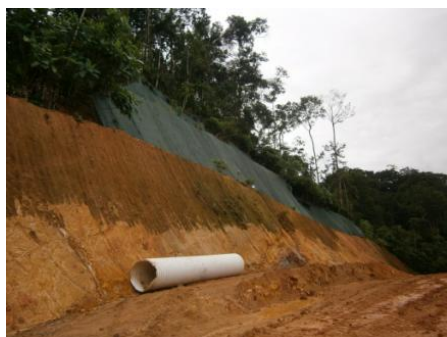
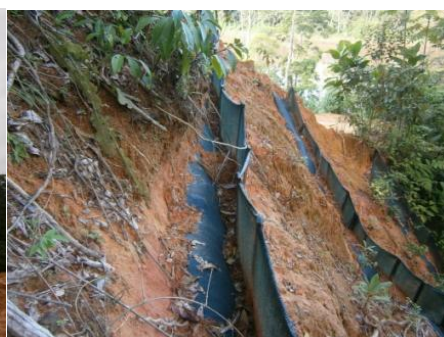
d) Slope T71

Restoration measures to be implemented		Number of units per activity	Progress of activities	Percentage %
Cut slopes:	Drains at the base of the cut slope and on the terraces	290 metres	200	69,0%
	Drain in the upper part of the cut slope	180 metres	180	100,0%
	Small sediment traps for drains	12 units	19	158,3%
	Box sediment traps at the end of the drain	8 units	7	87,5%
	Large sediment traps (15 m) for landslide area	2 units	0	0,0%
	Coverage of areas without vegetation	1.355 m ²	800	59,0%
Road surface:	Cross drains to divert waters	90 metres	0	0,0%
	Box sediment traps to intervene gullies	20 units	0	0,0%
	Small sediment traps.	10 units	0	0,0%

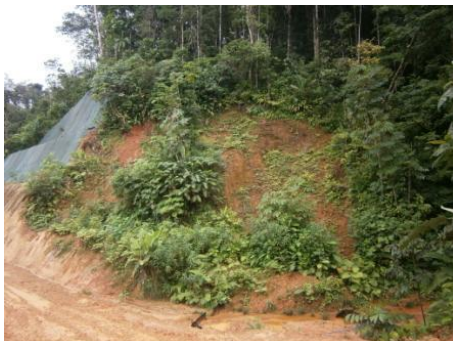
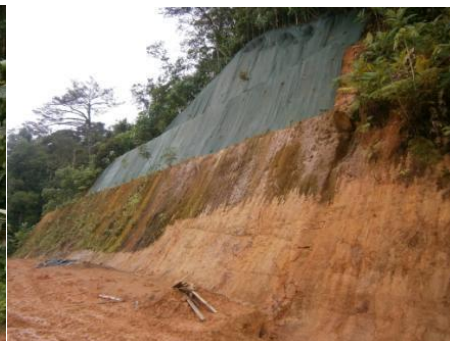
e) Slope T73 a & b:

Restoration measures to be implemented		Number of units per activity	Progress of activities	Percentage %
Cut slopes:	Drains at the base of the cut slope and on the terraces	400 metres	405	101,3%
	Drain in the upper part of the cut slope	200 metres	200	100,0%
	Small sediment traps for drains	25 units	18	72,0%
	Box sediment traps at the end of the drain	8 units	3	37,5%
	Large sediment traps (15 m) to surround mounds of soil.	4 units	0	0,0%
	Coverage of areas without vegetation	2.499 m ²	2300	92,0%
Road surface:	Cross drains to divert waters	90 metres	0	0,0%
	Box sediment traps to intervene gullies	36 units	13	36.1%

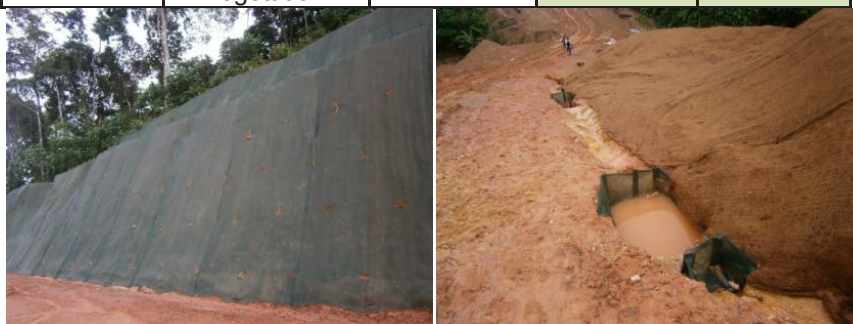
f) Slope T75

Restoration measures to be implemented		Number of units per activity	Progress of activities	Percentage %
Cut slopes:	Drains at the base of the cut slope and on the terraces	350 metres	348,5	99,6%
	Drain in the upper part of the cut slope	150 metres	150	100,0%
	Small sediment traps for drains	22 units	22	100,0%
	Box sediment traps at the end of the drain	6 units	5	83,3%
	Large sediment traps (15 m) to surround mounds of soil.	10 units	2	20,0%
	Coverage of areas without vegetation	745 m ²	1000	134,2%
Road surface:	Cross drains to divert waters	90 metres	0	0,0%

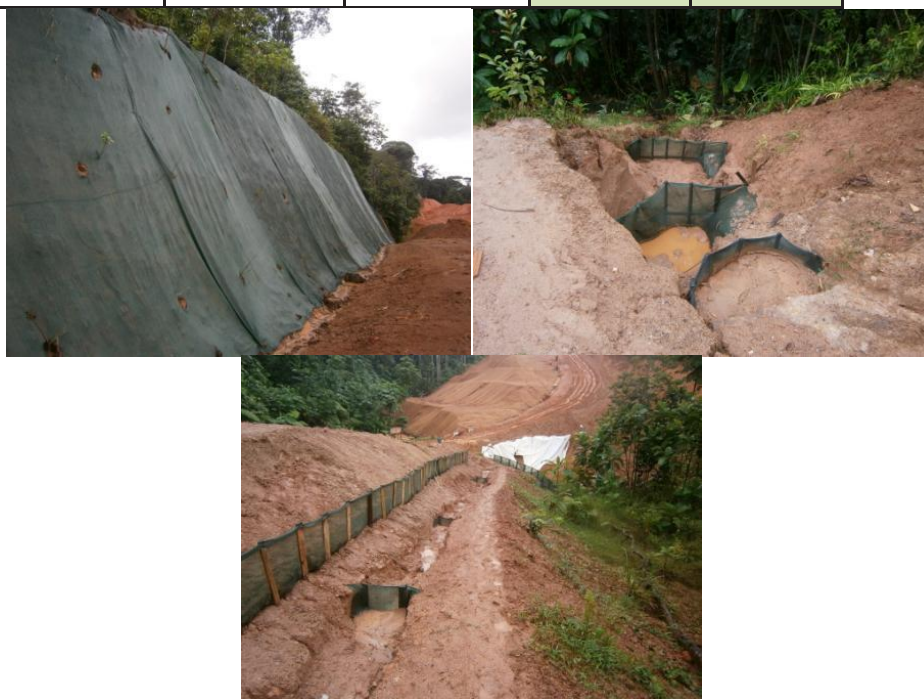
g) Slope T76 a & b:

Restoration measures to be implemented		Number of units per activity	Progress of activities	Percentage %
Cut slopes:	Drain at the base of the cut slope	400 metres	400	100,0%
	Drain in the upper part of the cut slope	400 metres	400	100,0%
	Small sediment traps for drains	34 units	34	100,0%
	Box sediment traps at the end of the drain	8 units	5	62,5%
	Large sediment traps (15 m) for landslides	6 units	6	100,0%
	Coverage of areas without vegetation	989 m ²	1100	111,2%
Road surface:	Cross drains to divert waters	90 metres	0	0,0%
	Small sediment traps.	10 units	0	0,0%
Fill slopes:	Drains at the base of the fill slopes	200 metres	200	100,0%

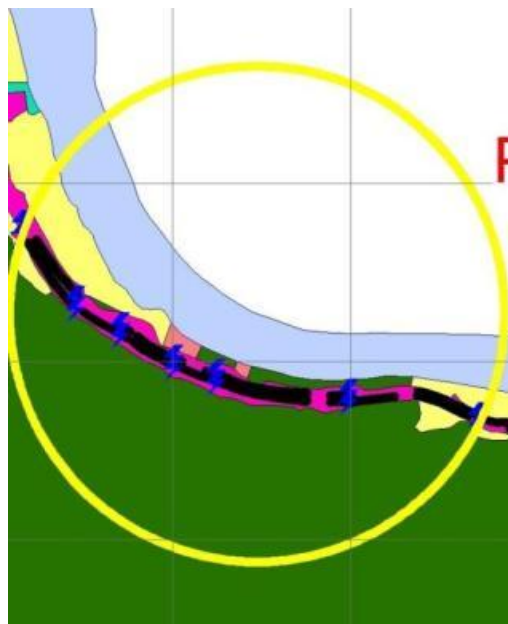
4. Water courses between slopes at Point 5.

Two waterfall-type sediment traps were built, of the necessary width in each case, and along the channel of the creeks both upstream from the road passage and along the trajectory between the road and San Juan River to reduce the water speed and also to filter sediments.

Five large sediment traps were built upstream from each of the seven water courses, and after the road passage sediment traps were built up to the mouth on the San Juan River; at least 10 sediment traps were placed in each creek.

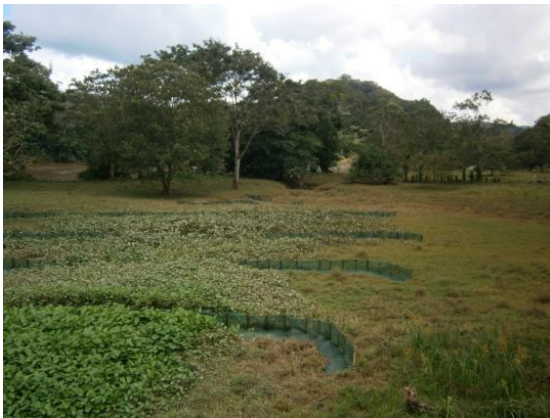
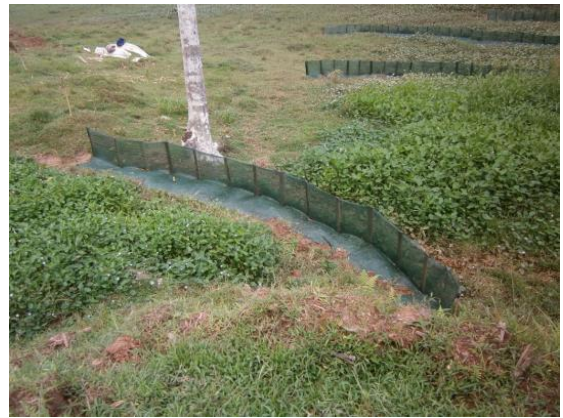
Construction of sediment traps downstream from the creek at the end of slope T76 b.

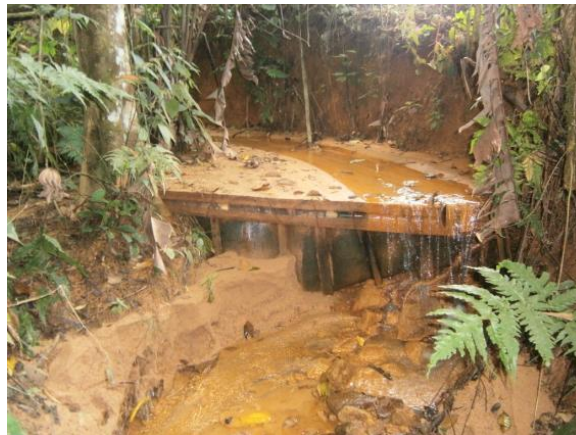
Sediment trap functioning, downstream between slopes T69 and T71.

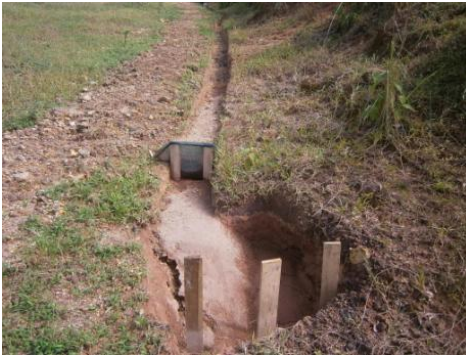
Sediment trap at creek, slope 66b.

The strength of the water current or sediment load can make the traps collapse; therefore the maintenance works contemplate the partial or full repair of the traps and drains in general, built according to the needs of the work.

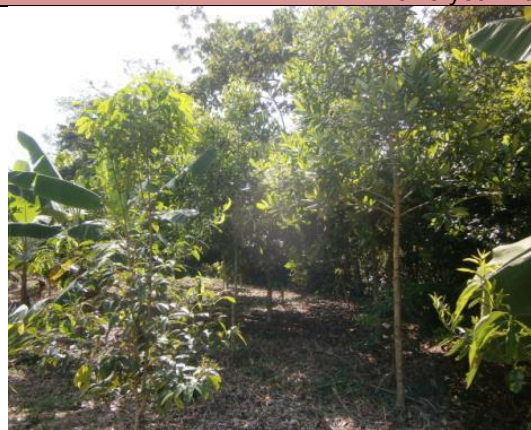
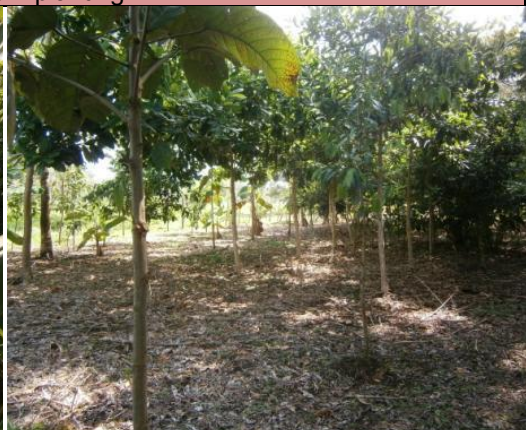
Current Condition (average height 3.2 m)

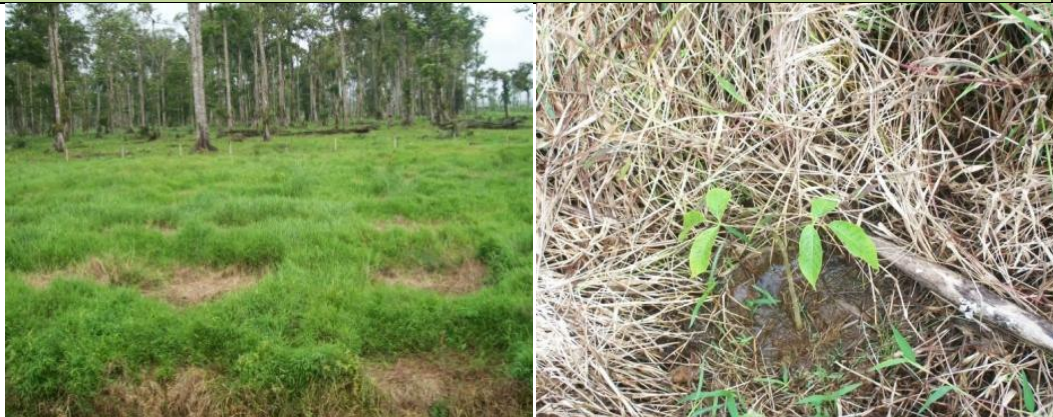
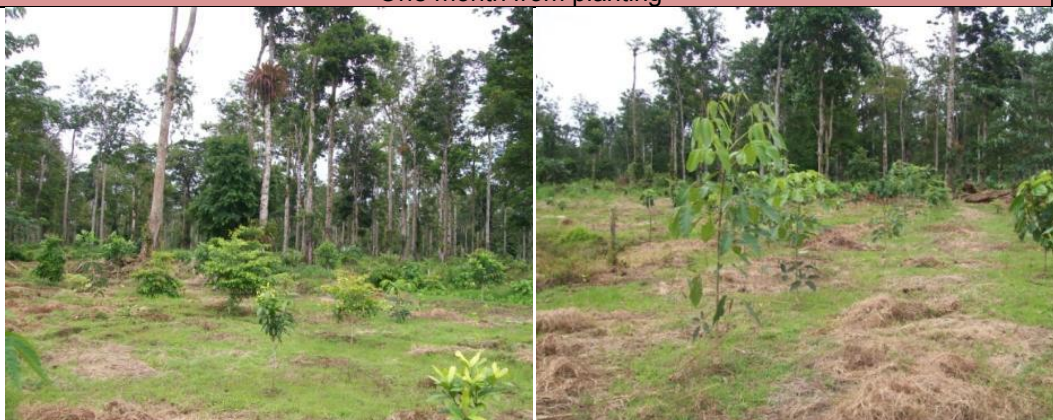
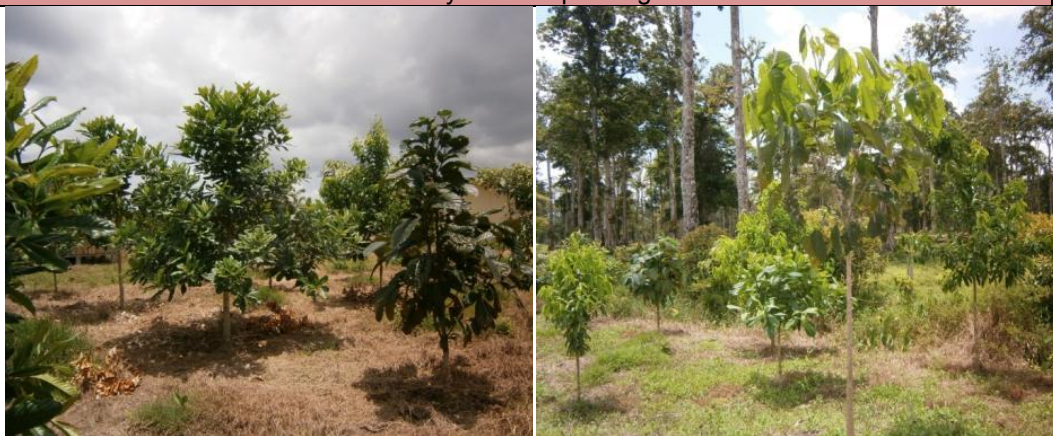
PLOT ESCUELA DELTA COSTA RICA

Current Condition (average height 2 m)

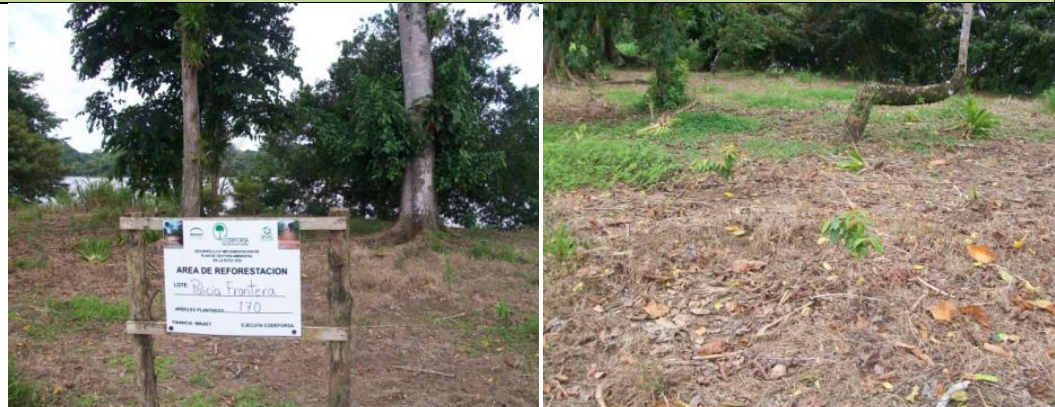
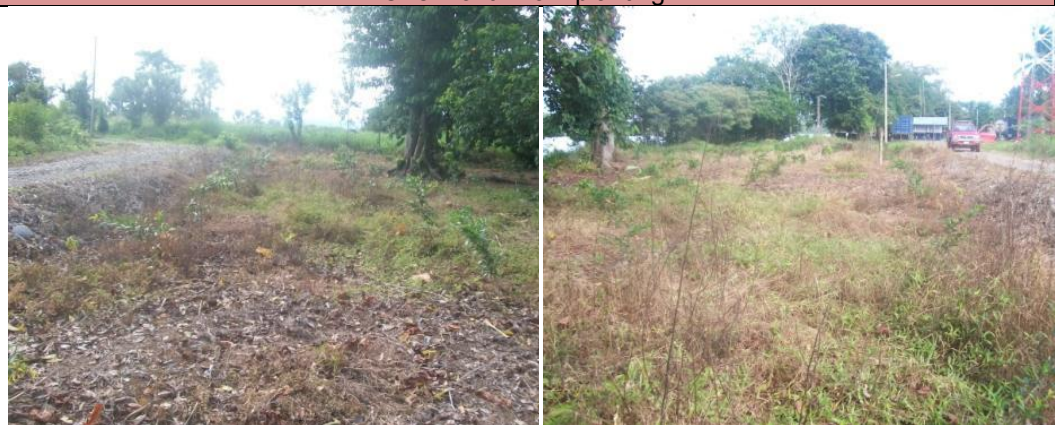
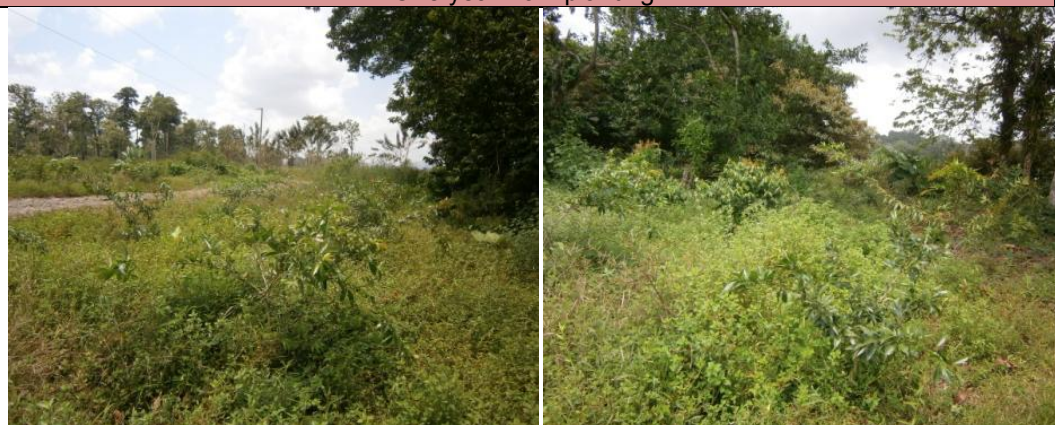
PLOT ESCUELA DELTA COSTA RICA- POLICIA FRONTERA

Current Condition (average height 1.8 m)

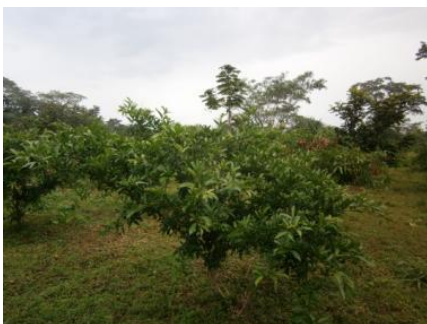
Below is a photo sequence of the development of the plantation from newly planted, to one year and the current state of the trees, which have an average height of 2 metres, with more development of the *cebo* and *pilón* trees. In addition, there was replanting of *genízaro* and *guaba* trees.

In this plot the average height decreases due to the effect of the *sotacaballo* trees, which represent approximately 50% of the total number of trees planted and have a lateral growth and fork in the shaft at a low height.

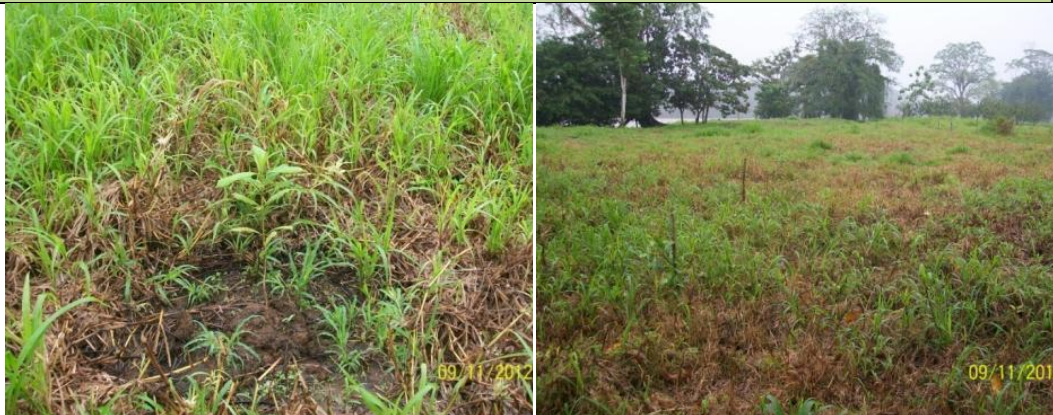
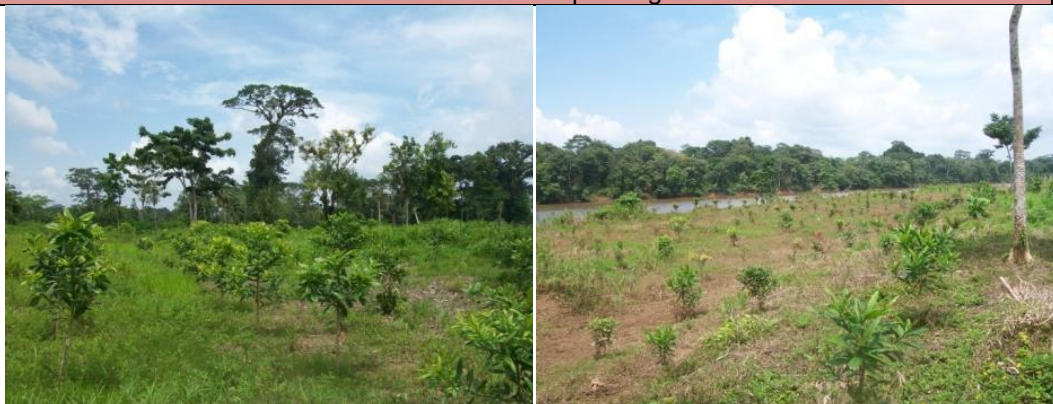
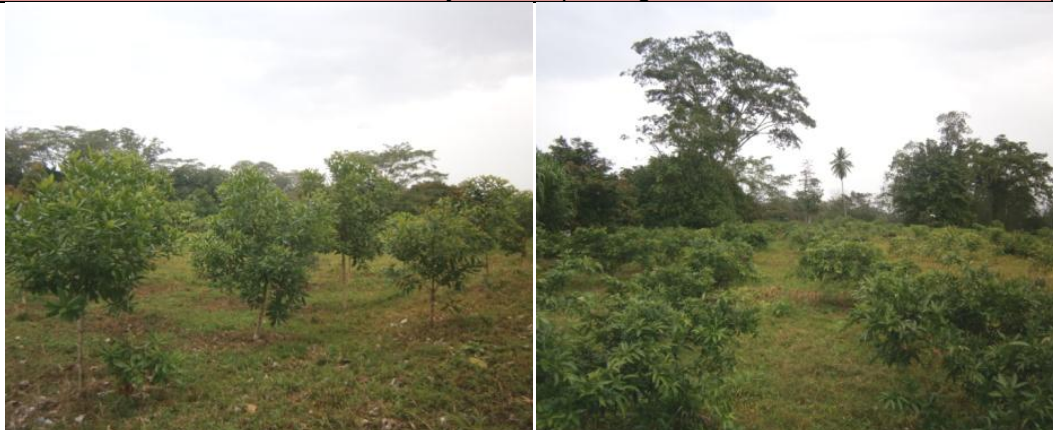
PLOT FREDDY ULATE CASTRO

Current Condition (average height 2 m)
