**DISPUTE CONCERNING THE CONSTRUCTION OF A ROAD IN
COSTA RICA ALONG THE SAN JUAN RIVER**

REJOINDER OF COSTA RICA

VOLUME III

ANNEXES 4 - 14

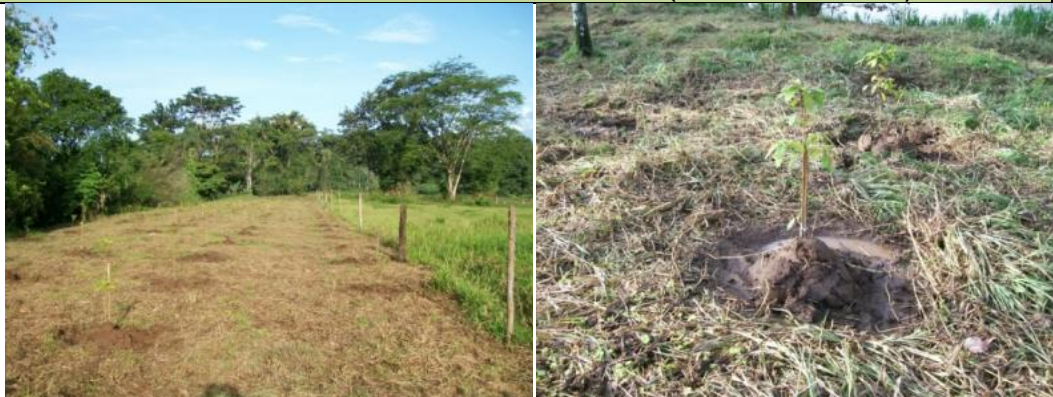
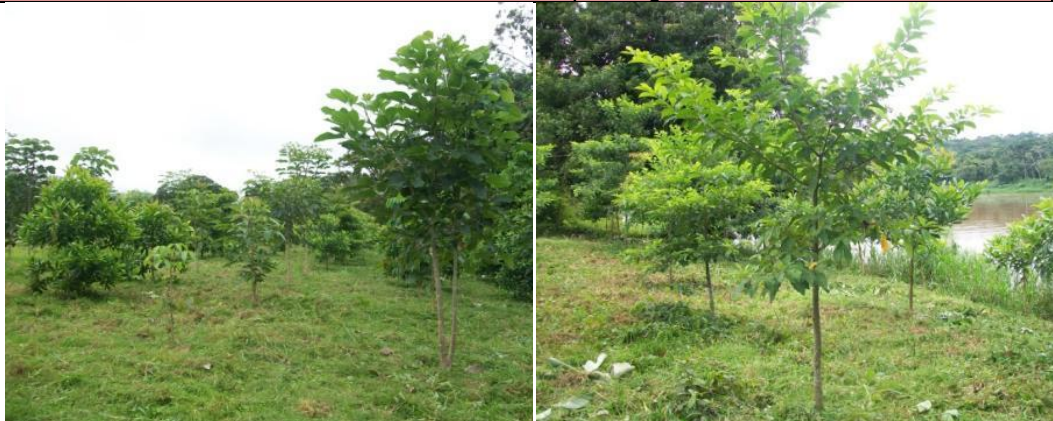
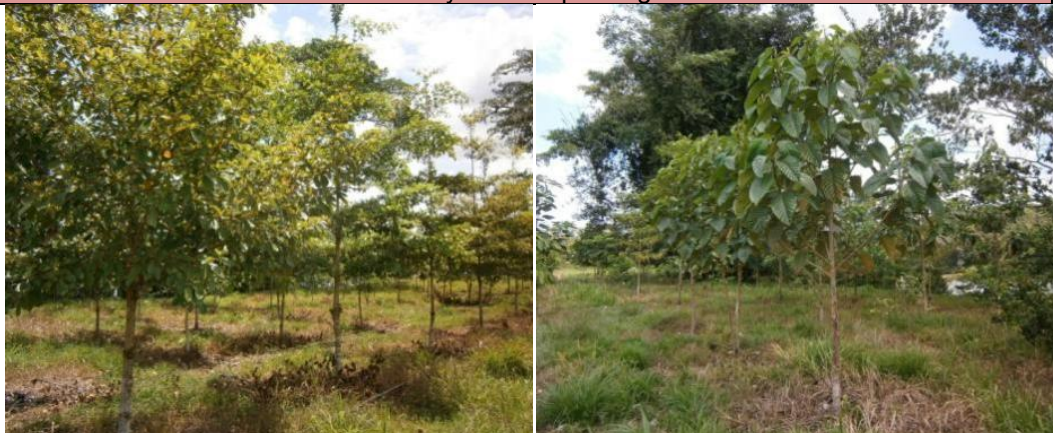
PLOT FABIO CEDEÑO GONZALEZ (SAN ANTONIO)

Current Condition (average height 3 m)

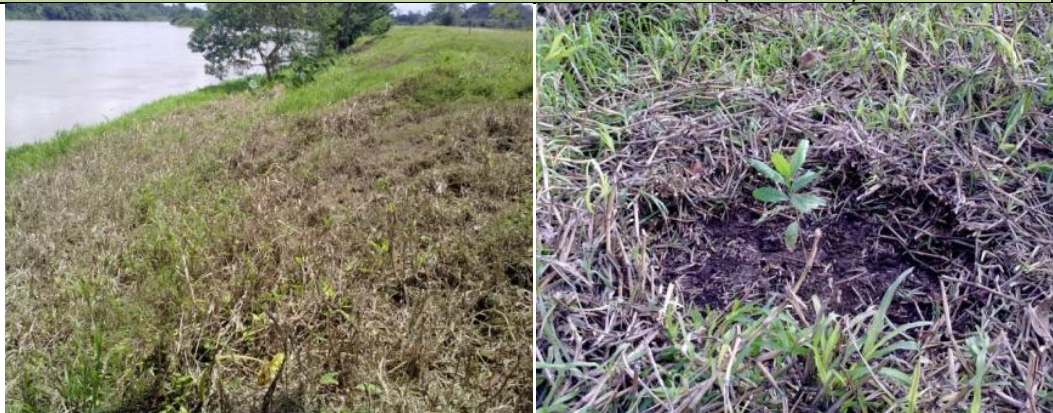
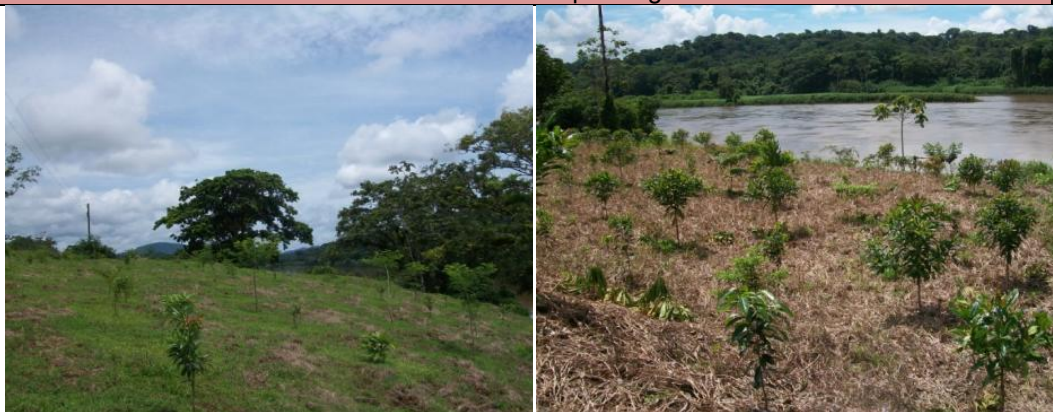
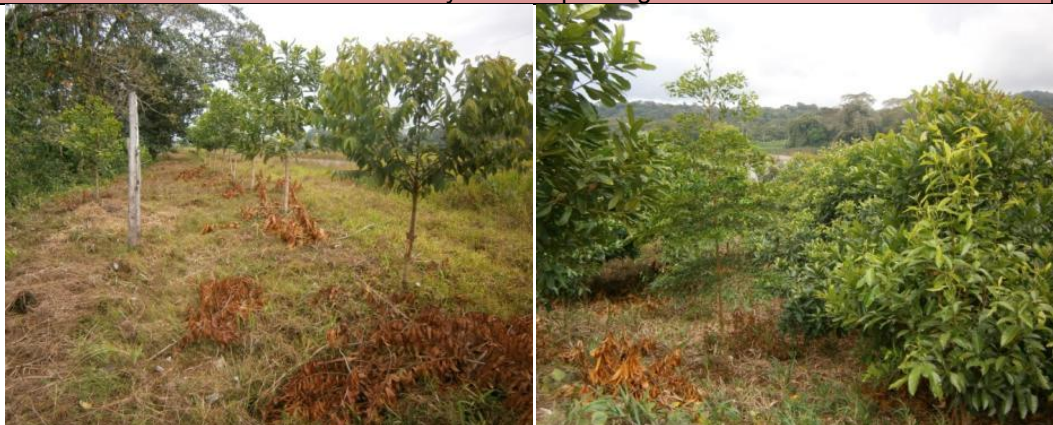
PLOT FABIO CEDEÑO GONZALEZ (OCHOA)

Current Condition (average height 2.2 m)

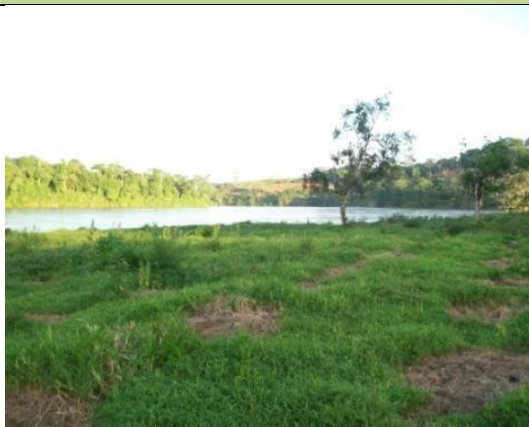
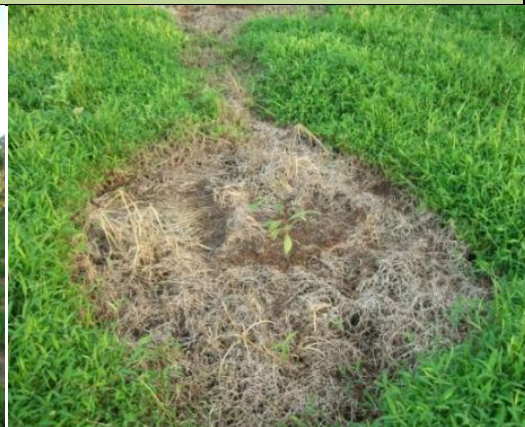
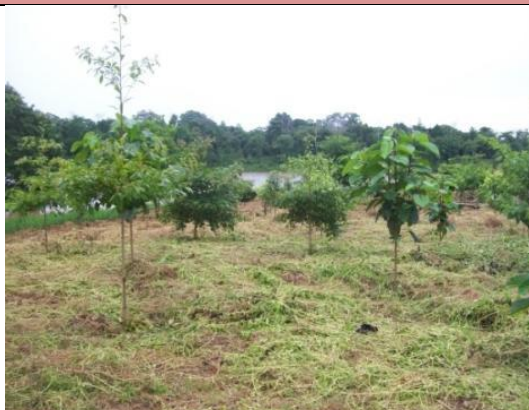
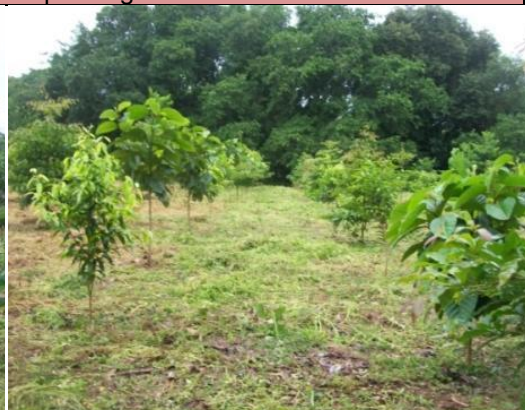
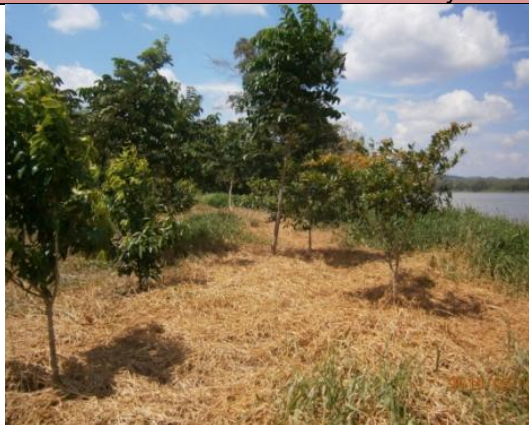
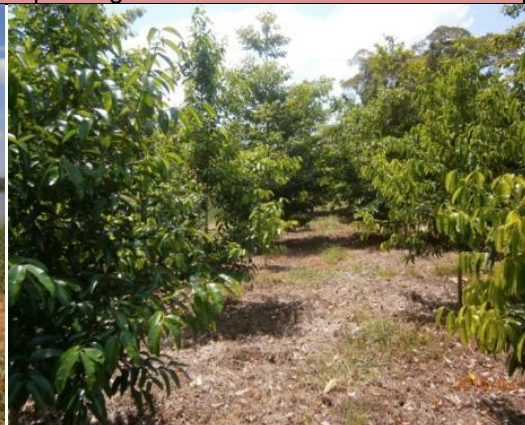
PLOT OLMAN QUESADA CAMPOS

Current Condition (average height 3.5 m)

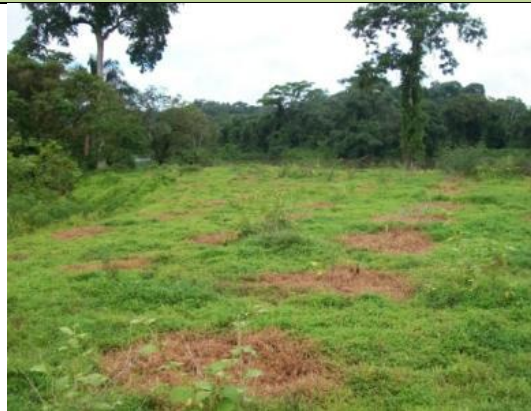
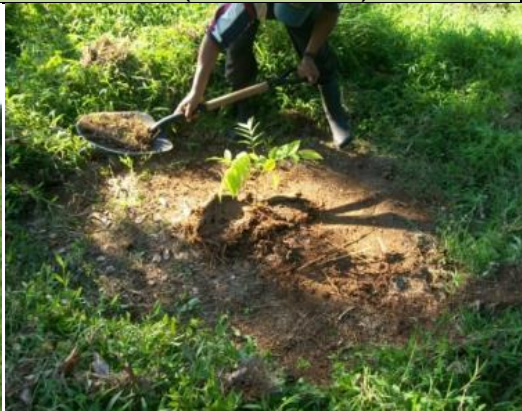
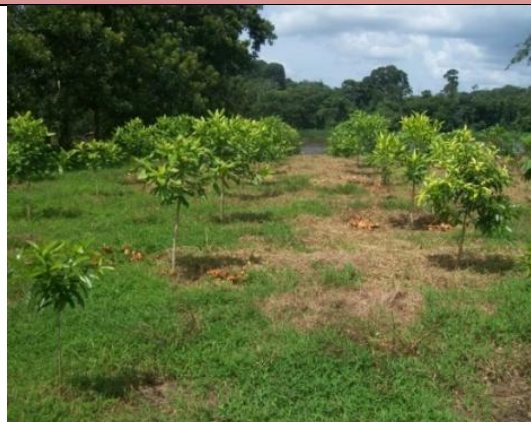
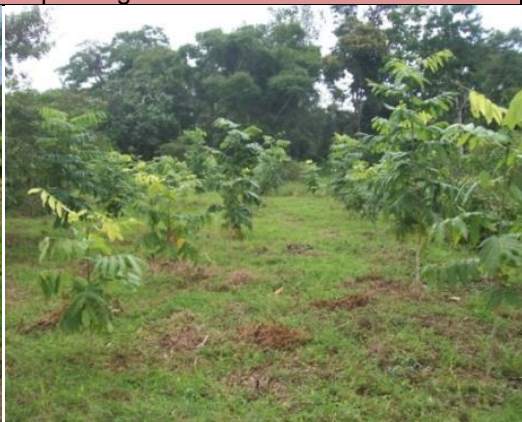
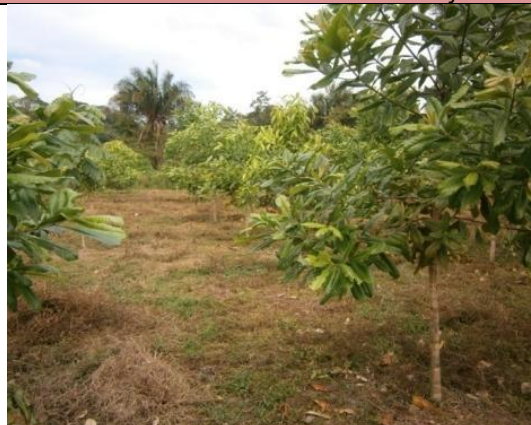
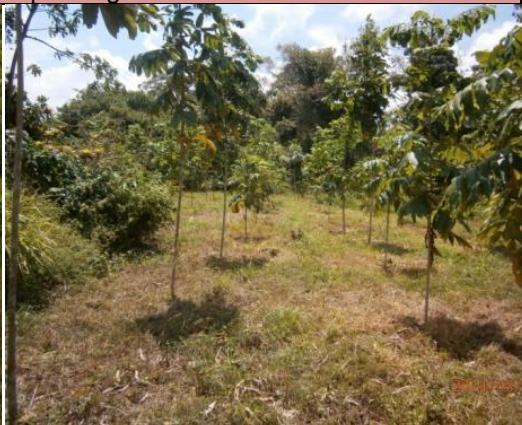
PLOT DANIEL JIMENEZ BERROCAL (EL GUABO)

Current Condition (average height 3 m)

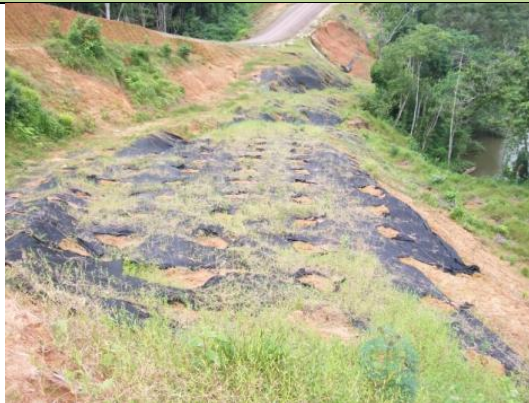
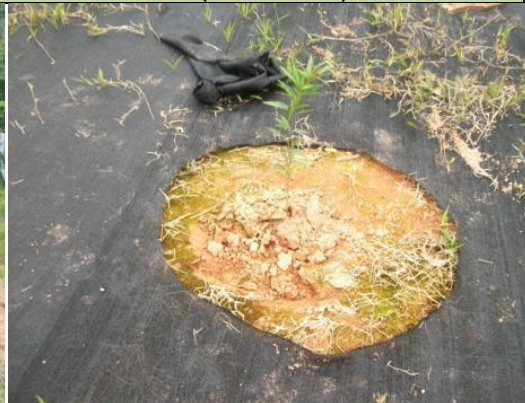
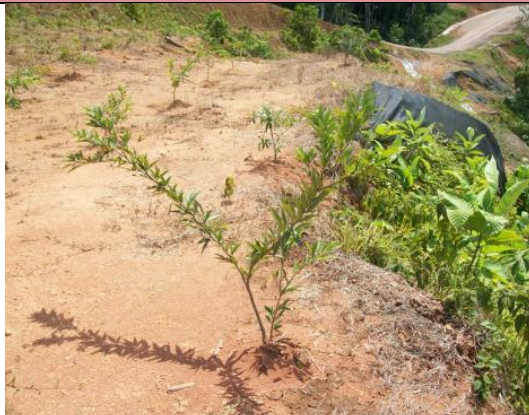
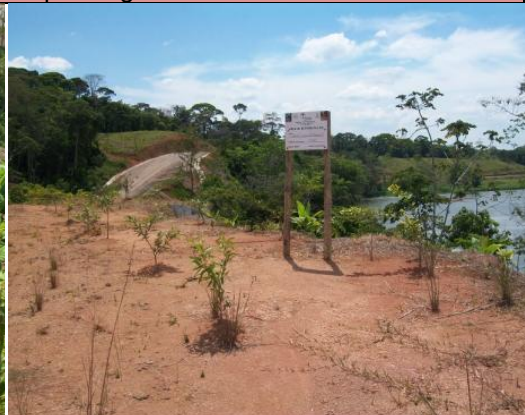
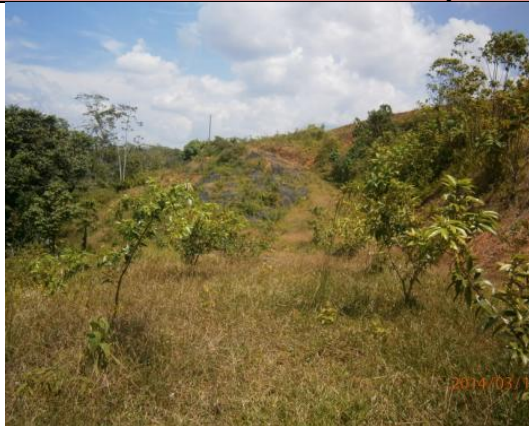
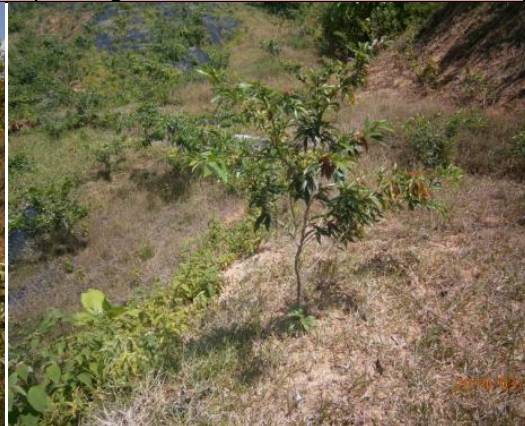
PLOT DANIEL JIMENEZ BERROCAL (SLOPES)

Current Condition (average height 1.8 m)

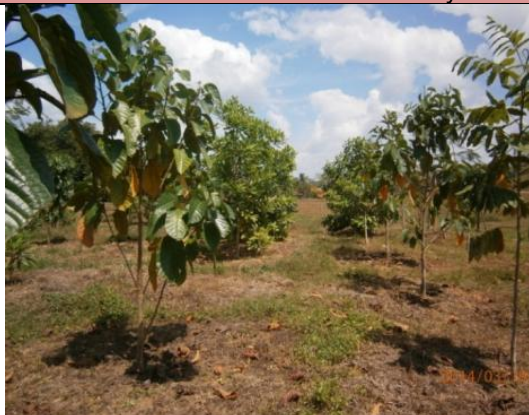
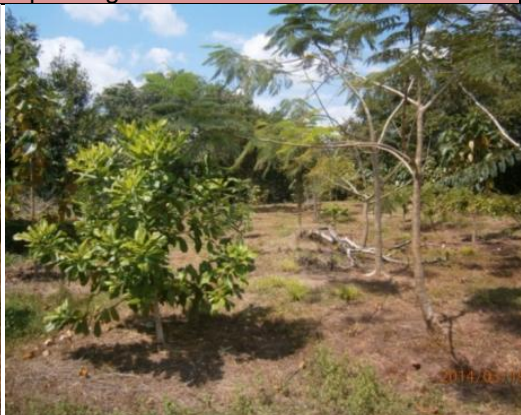
Current Condition (average height 2.3 m)

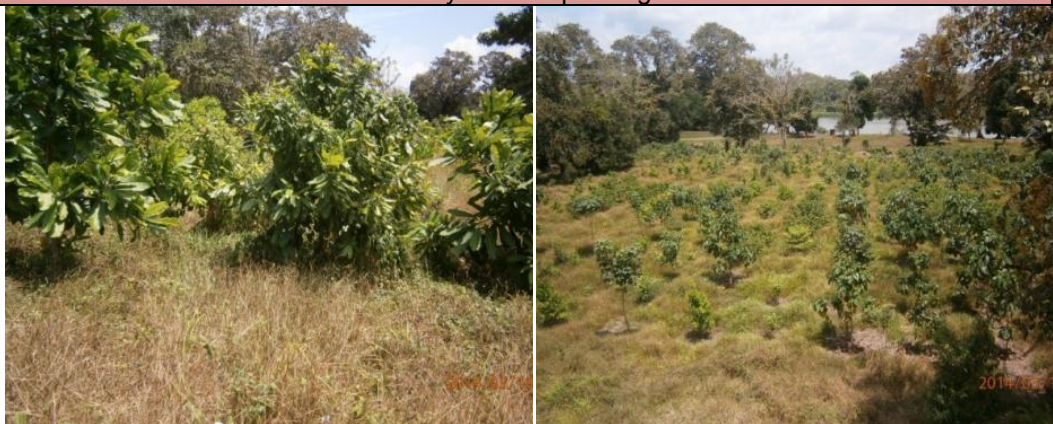
PLOT DANIEL JIMENEZ BERROCAL (PILO)

Current Condition (average height 2.8 m)

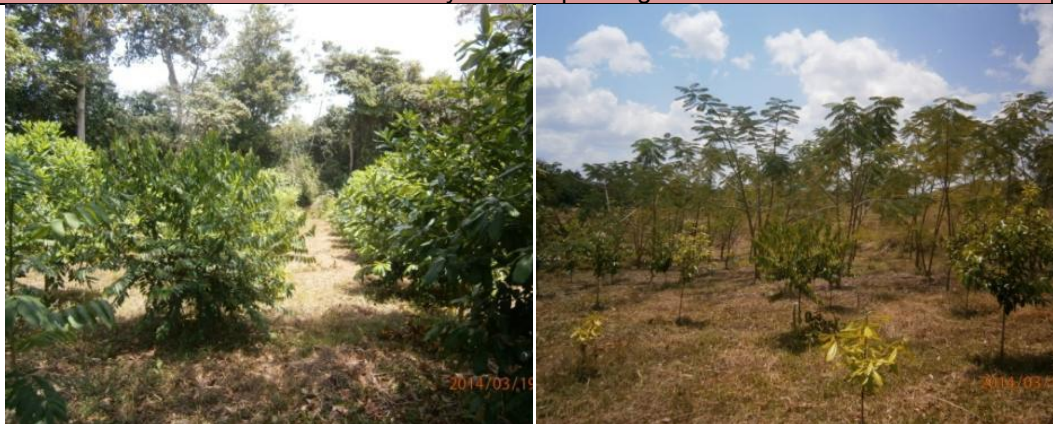
PLOT DANIEL JIMENEZ BERROCAL (BISMARK)

Current Condition (average height 2.1 m)

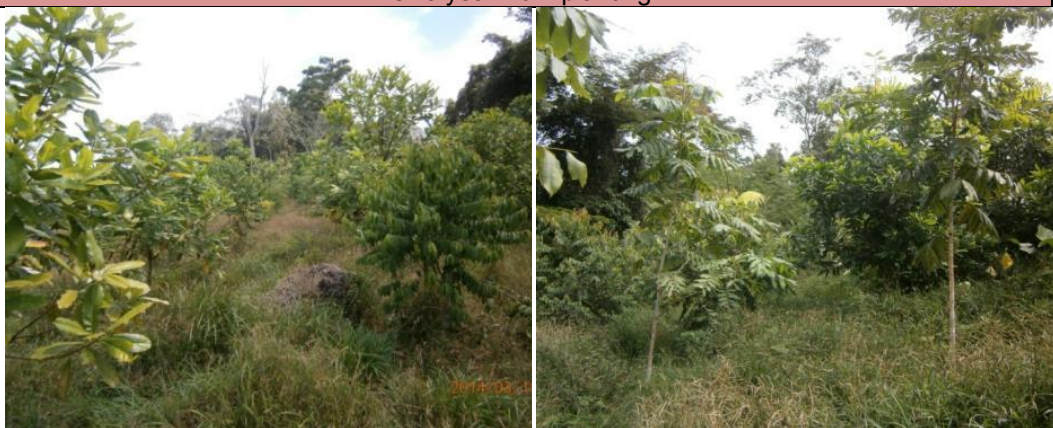
PLOT MARCELO MENDEZ MORALES

Current Condition (average height 2.4 m)

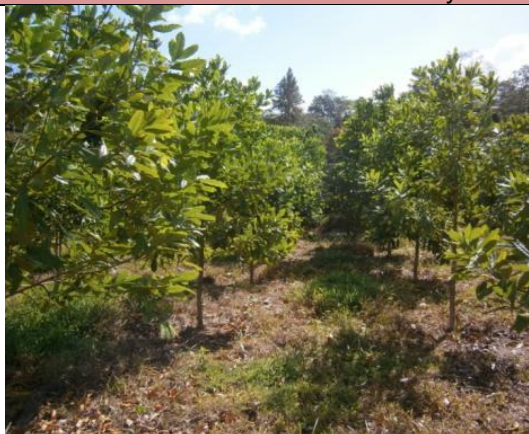
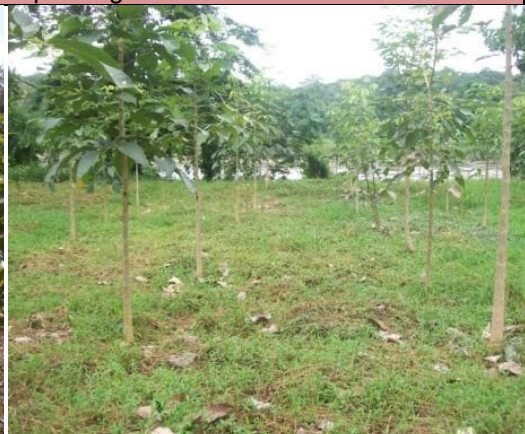
PLOT WILLIAM CORTEZ MADRIGAL

Current Condition (average height 2.1 m)

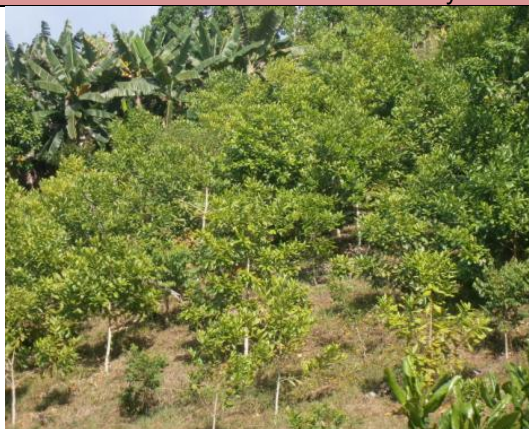
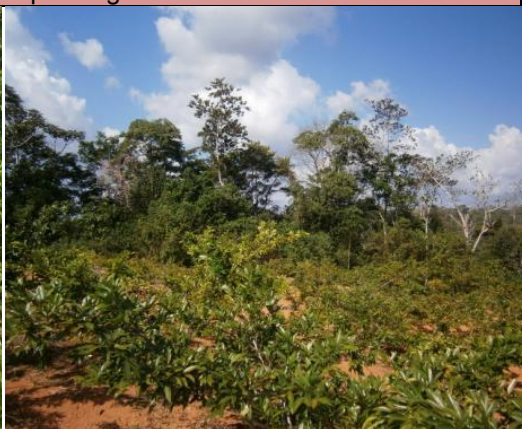
PLOT GERMAN DIAZ RUIZ

Current Condition (average height 2.1 m)

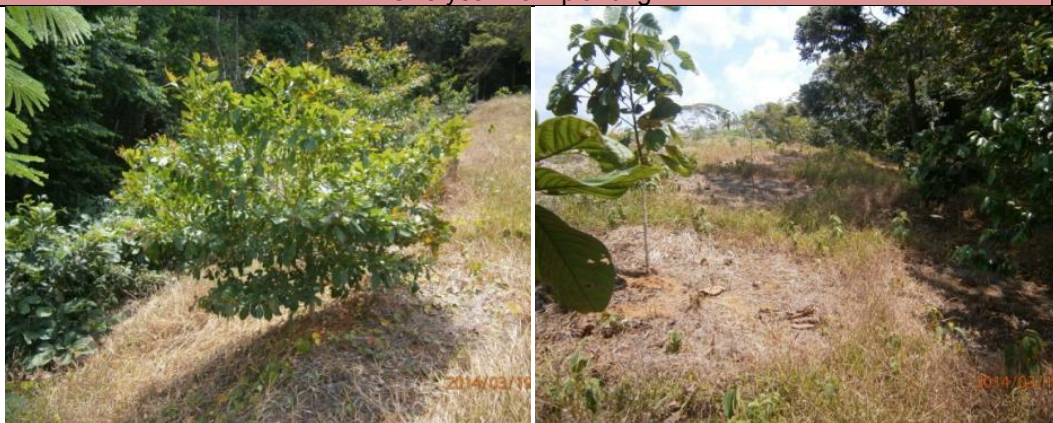
PLOT EDGAR SALAZAR RAMIREZ

Current Condition (average height 1.8 m)

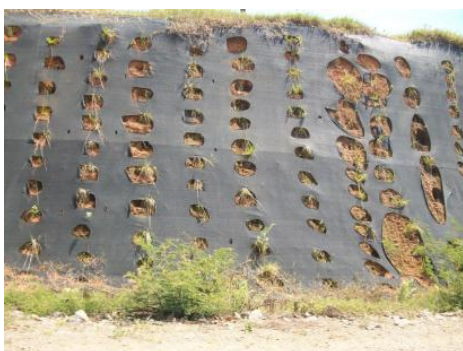
At some of the intervened slopes in the area of Tiricias, they were covered by saran, which had been placed during the process of construction of the border road. However, in many cases the saran was stolen from the site, so we decided to break it with the planting of the vegetation material to take advantage of its effect of reducing the impact of rain on the exposed soil of the slope and thus promote the decrease in sediment erosion and pollution of waters and finally so it would not be removed from the site.

View of planting of vegetation on Slope No 5

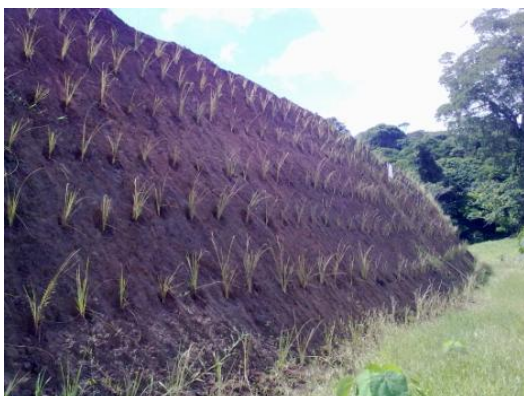
To complete the number of slopes to be intervened, work was performed on three slopes in the area of the mouth of San Carlos River, with the numbers 10, 11 and 12. In total there were nine slopes in the Tiricias area and three in the area of the mouth of San Carlos River.

View of Slope No. 10

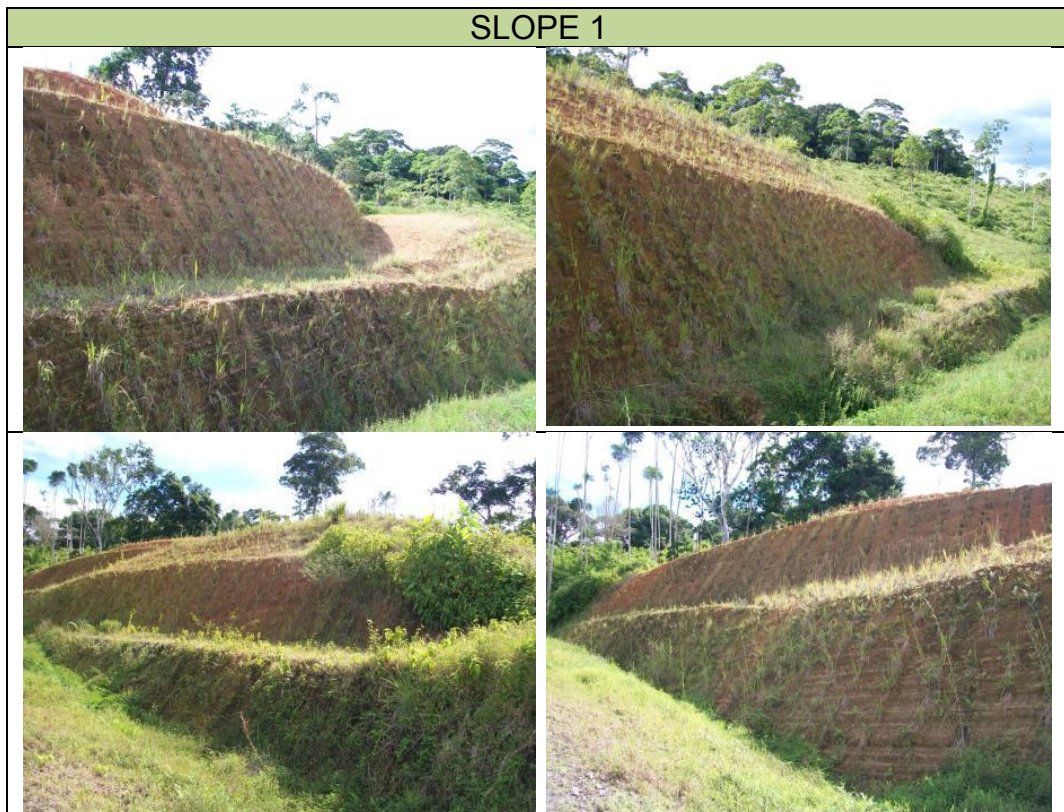
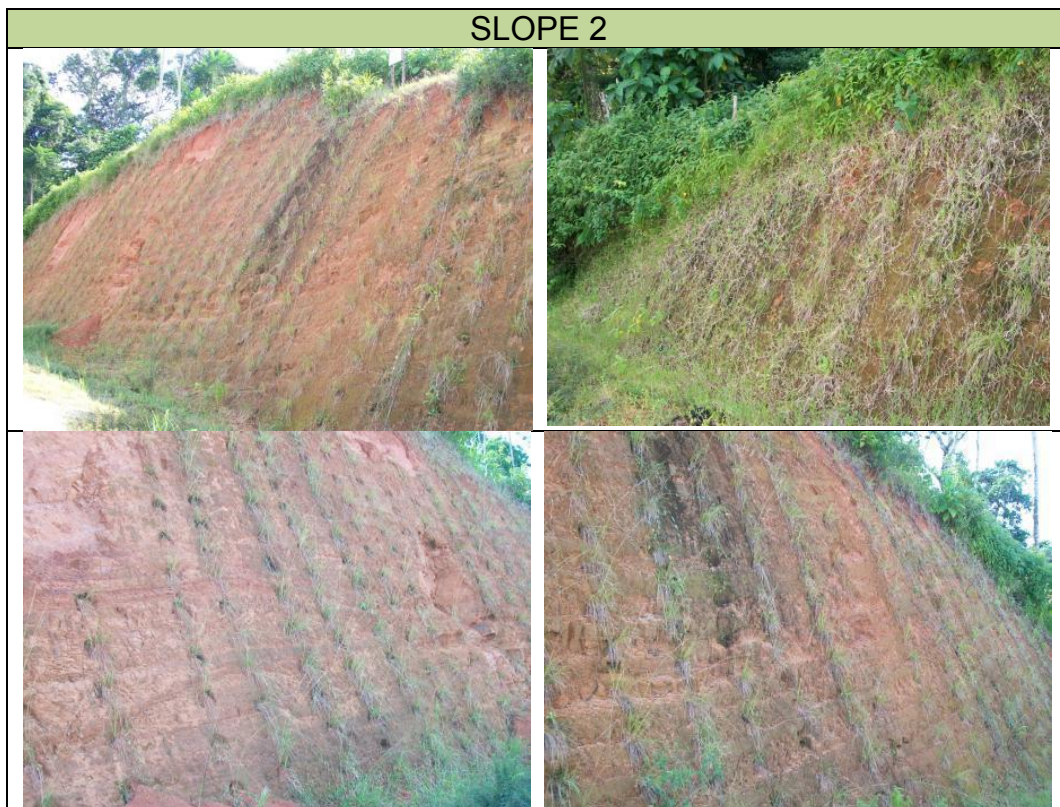
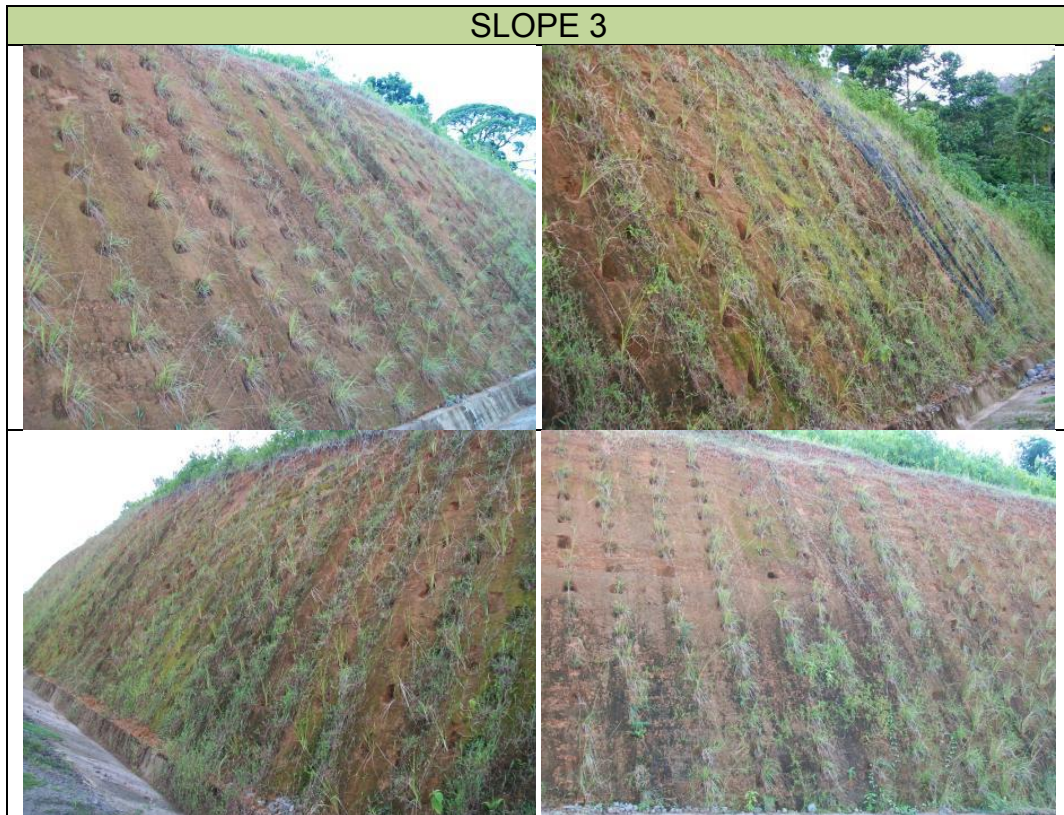
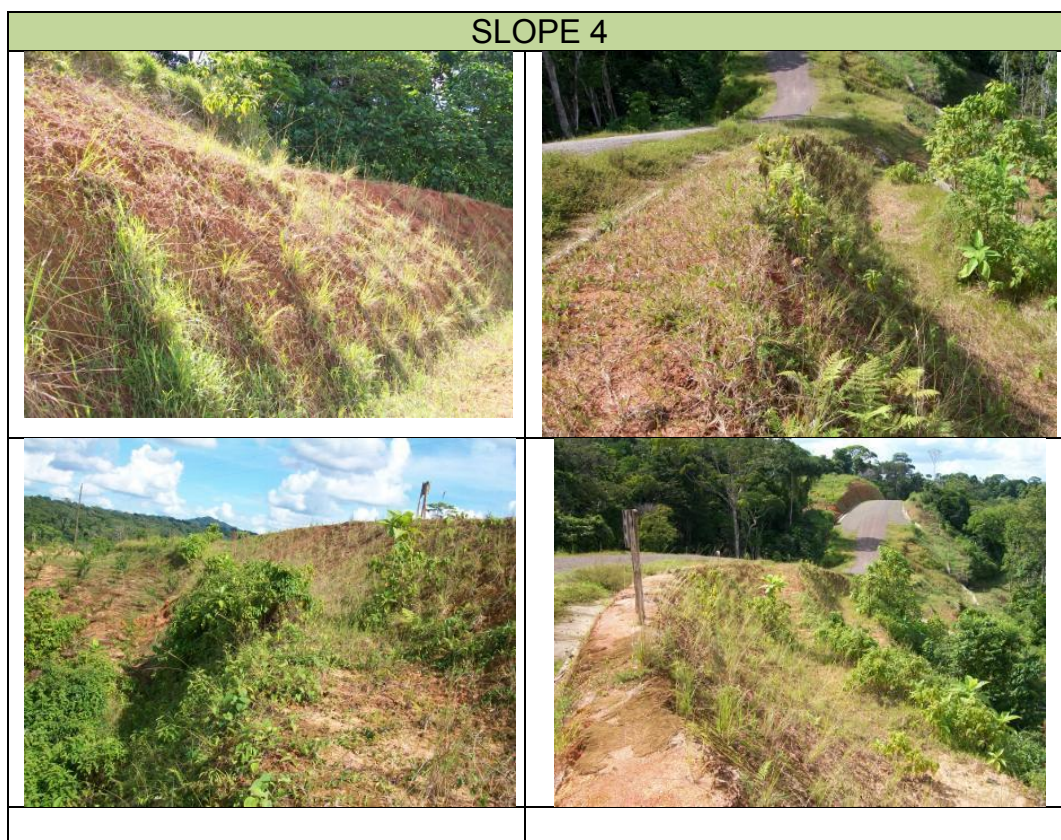
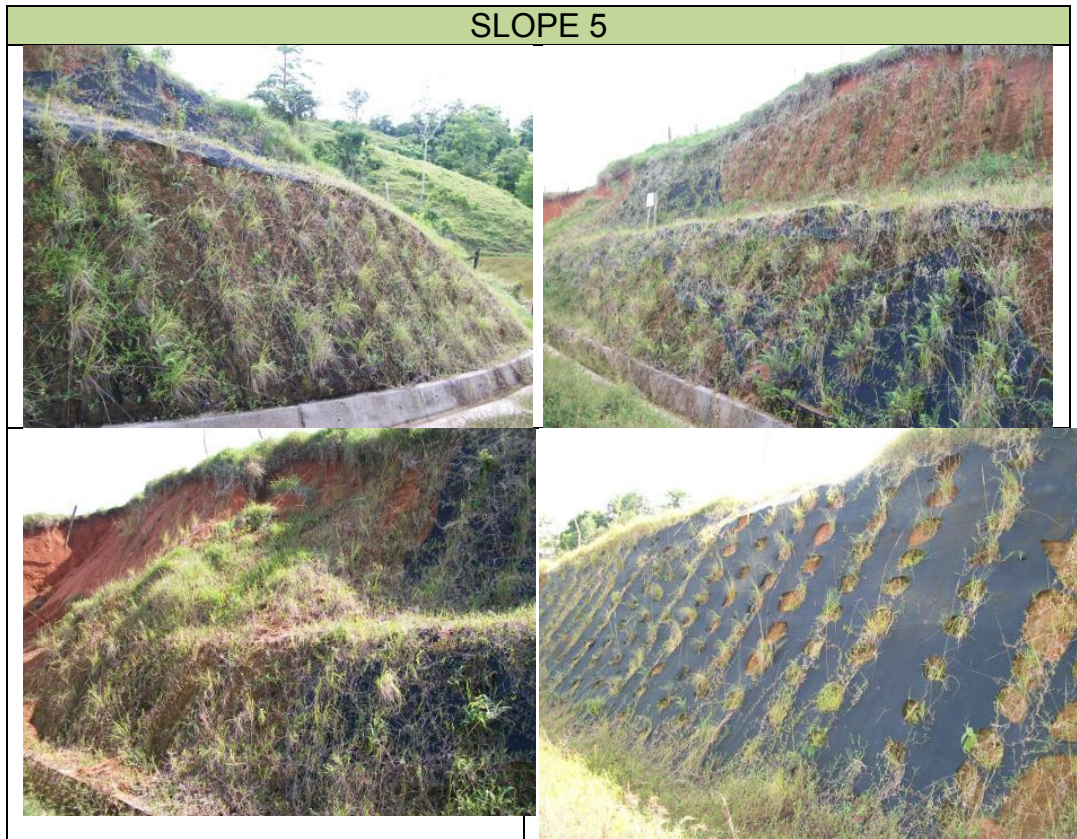
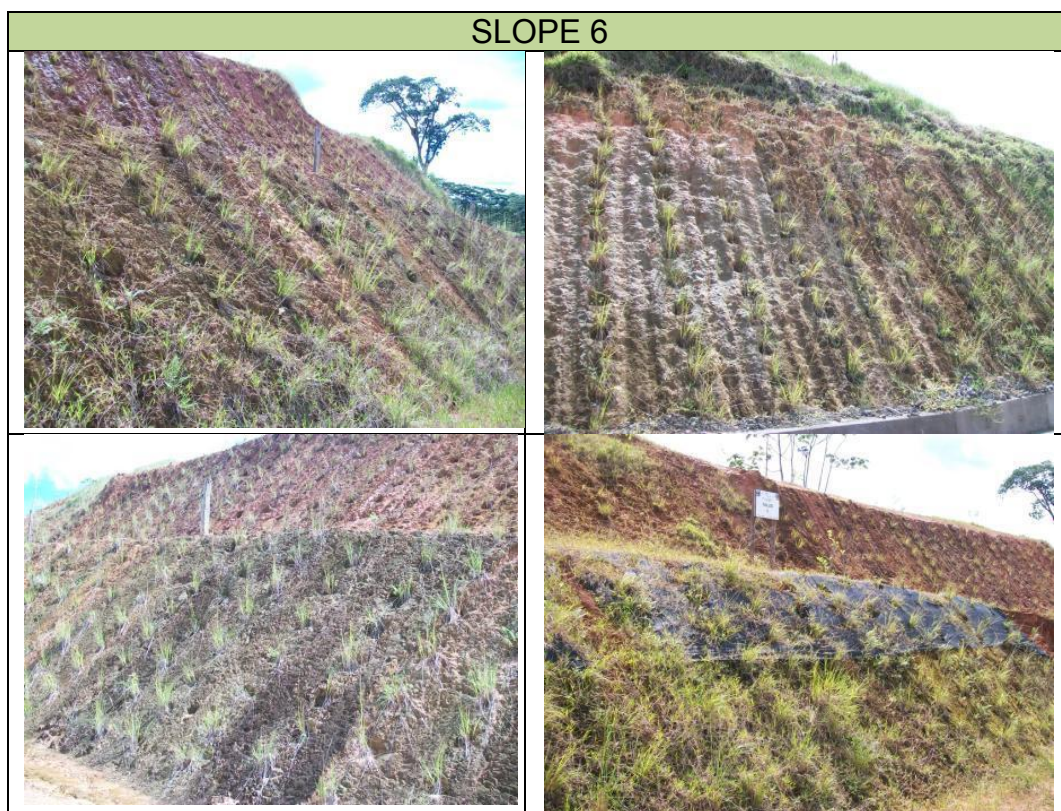
Below are photographs of the state of the slopes in February 2014. The photographs presented correspond to the visit made in February 2014.

The cover has suffered the impact of the dry season and shows a yellowing in the stumps; however, once the first rains fall this situation will normalize.

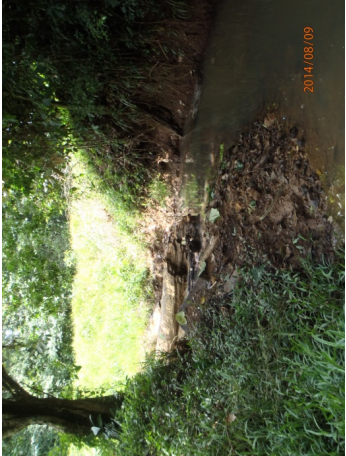
10.93294°N, -84.33327°O, 33 msnm	A: 3 m P: 0.5 m	Slow-stagnant	Rounded rocks, stones, clay, mud.	Shade windows	Presence of fish. Cloudy waters. Sediment on rocks. Secondary growth and pasture lands on both sides Sunny.

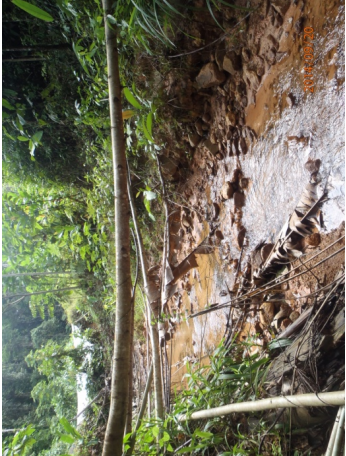
10.89238°N, -84.27883°O, 22 msnm	A: 1 m P: 0,15 m	Fast	Rounded rocks, stones and mud	Shade windows with	Presence of leaves and trunks, submerged branches. Sediment on rock surfaces. Transparent water. Secondary growth on both sides. Clouded.

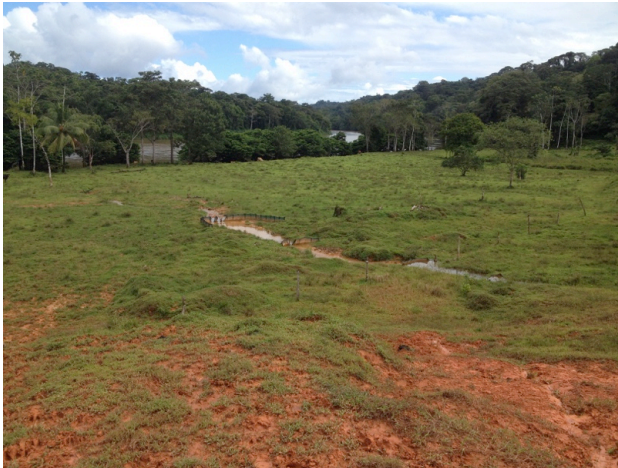
Photo 3: Sedimentation mitigation measures in section Infiernito river-Boca San Carlos.

In November 2014, CONAVI (together with CODEFORSA) made a significant intervention in this part of Infiernito-Boca San Carlos and Chorreras, developing a series of stabilisation activities on slopes as well as erosion control, thereby improving the environmental quality of the area (see Photo 4 to Photo 13). Specific activities undertaken in this section include the following:

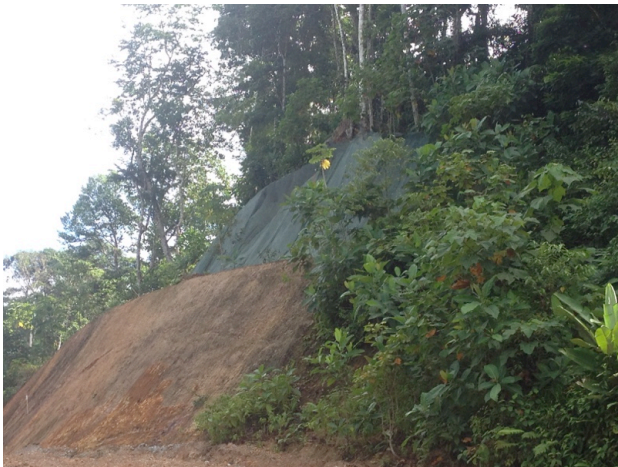
Photo 4: Sedimentation mitigation measures in section Infiernito river-Boca San Carlos.

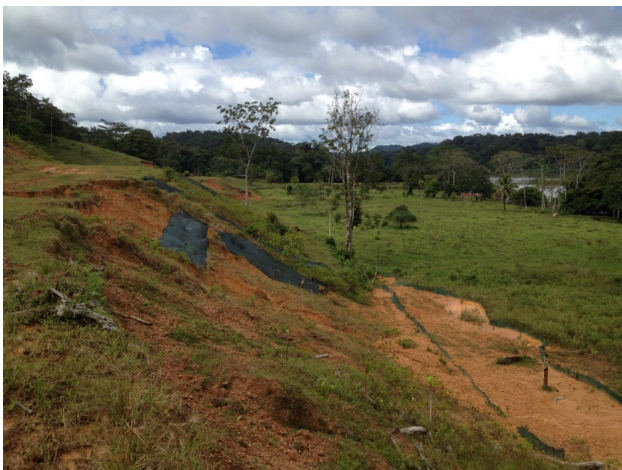
Photo 5: Sedimentation mitigation measures in section Infiernito river-Boca San Carlos.

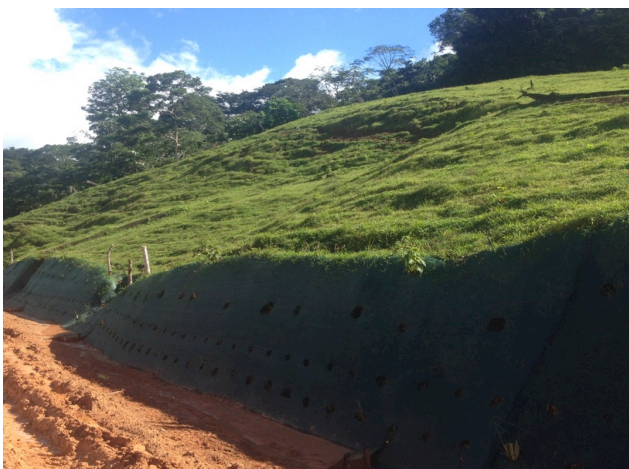
Photo 6: Slope contention in section Infiernito river-Boca San Carlos.

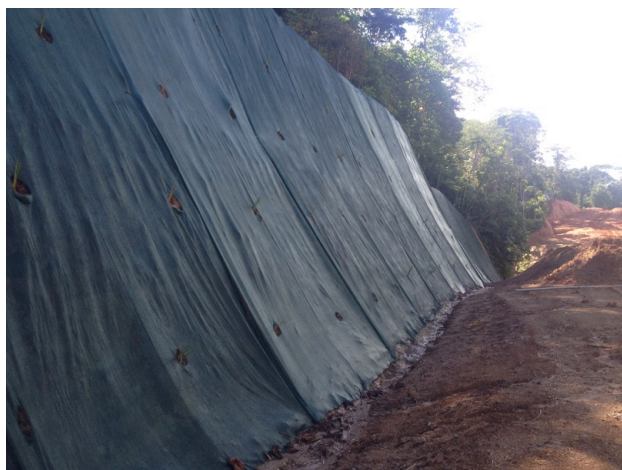
Photo 7: Slope contention in section Infiernito river-Boca San Carlos.

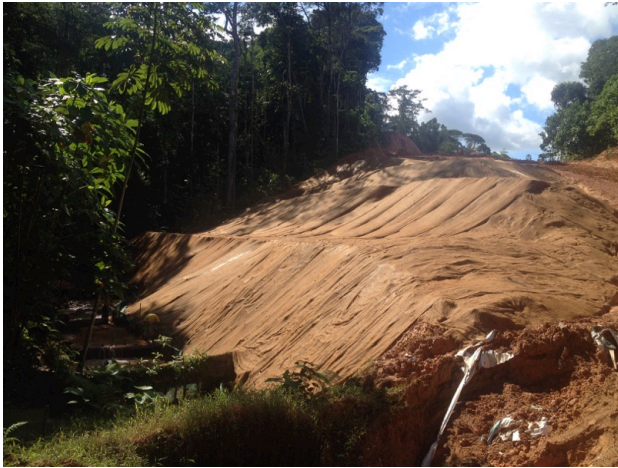
Photo 8: Slope contention in section Infiernito river-Boca San Carlos.

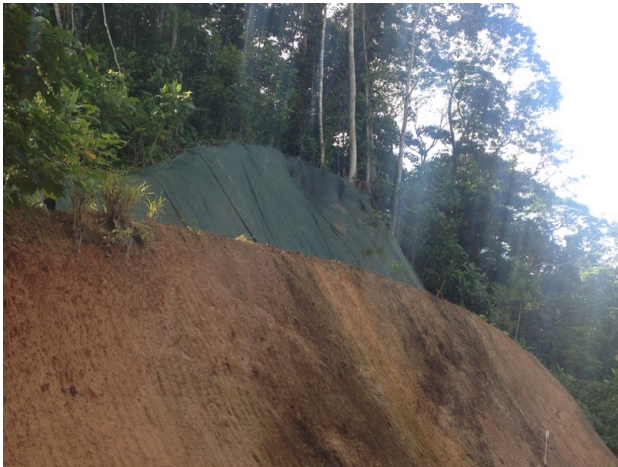
Photo 9: Slope contention in section Infiernito river-Boca San Carlos.

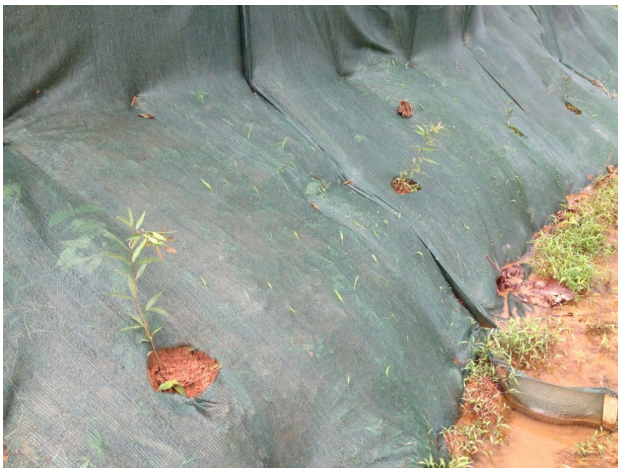
Photo 10: Sotacaballo trees planted on saran-covered slopes in Chorreras sector

Covering of areas without vegetation: In order to reduce and further avoid the loss of soil from laminar and pluvial run off, covering of all exposed soil areas has been carried out. To date, 4,140 m² of slopes have been covered with saran, 910 strains of vetiver grass and 783 sotacaballo trees have been planted.

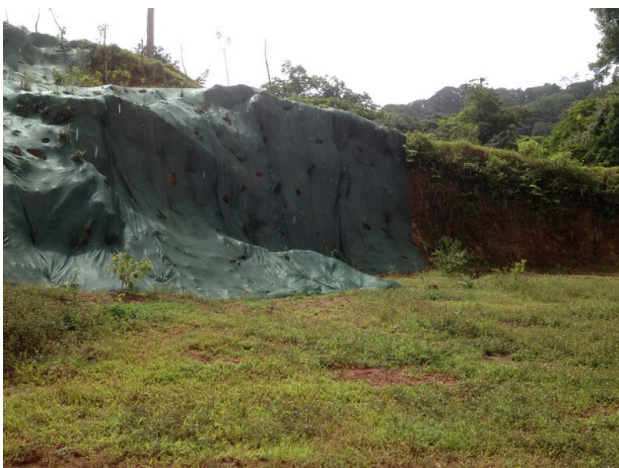
Photo 11: Sedimentation mitigation measures in the Chorreras sector.
