**APPLICATION OF THE INTERNATIONAL CONVENTION FOR THE SUPPRESSION
OF THE FINANCING OF TERRORISM AND OF THE INTERNATIONAL
CONVENTION ON THE ELIMINATION OF ALL FORMS OF RACIAL
DISCRIMINATION**

REJOINDER

Report of JSC Air and Space Defense Corporation "Almaz-Antey" on the results of studies related to the technical investigation into the crash of the Malaysian airlines Boeing 777-200 9M-MRD (flight MH17), 2023

on the results of studies related to the technical investigation into the crash
of the Malaysian airlines Boeing 777-200 9M-MRD (flight MH17)

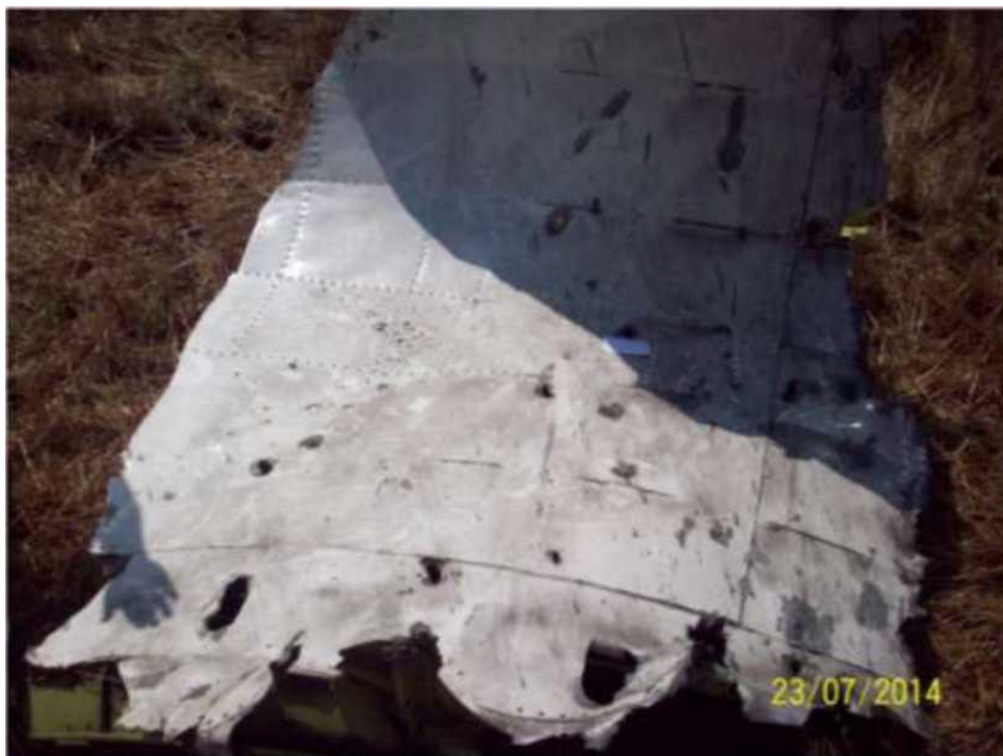
Figure 5.1.2 - Fragment of the cockpit roof.
In the Preliminary Report materials it was one of the main pieces of evidence for the impact of high-energy objects (DSB submissions)

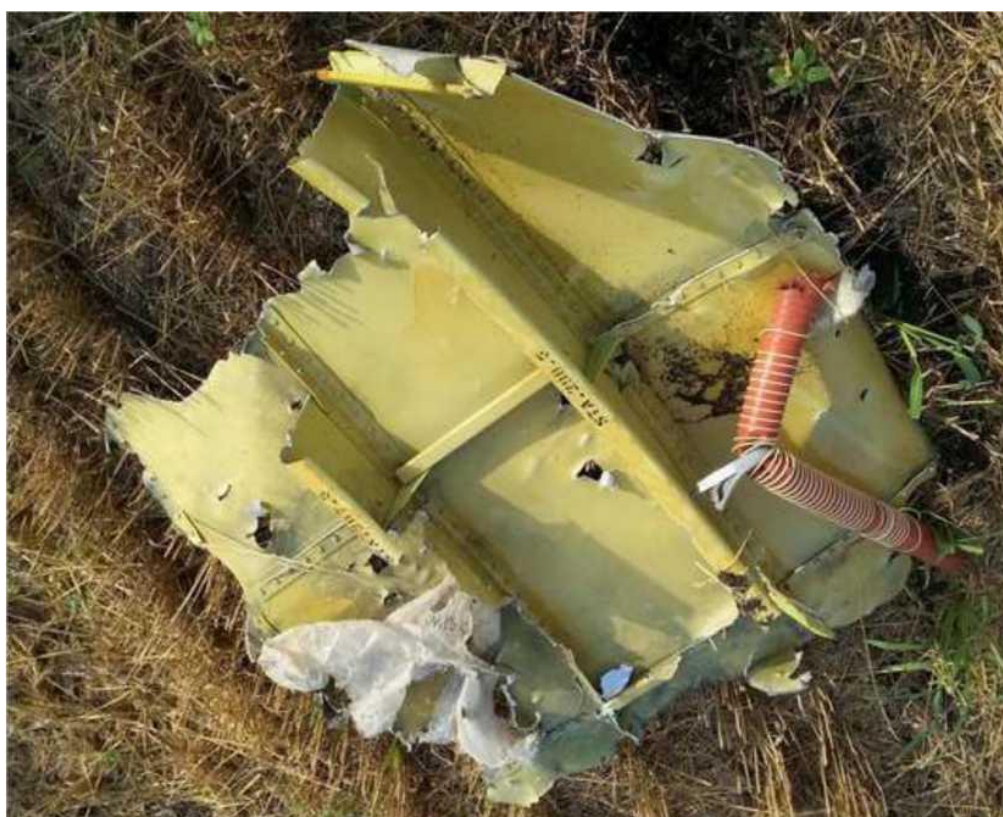
Figure 5.1.3 - Fragment of the middle port side (open-source photo)

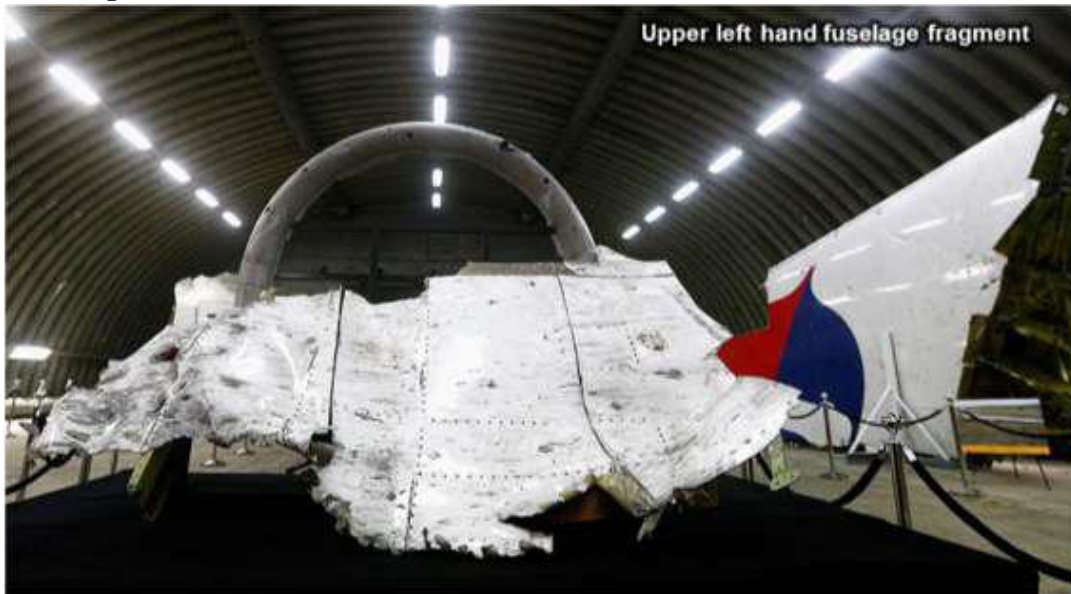
The third fragment, a fragment of the upper port side,¹⁴ was not included in the final 3D reconstruction and was located in another room during the presentation of the DSB report.

Figure 5.1.4 - Fragment of the top of the port side (front) and the nose of the left engine air intake (rear) were located elsewhere in the final reconstruction (open-source photo)

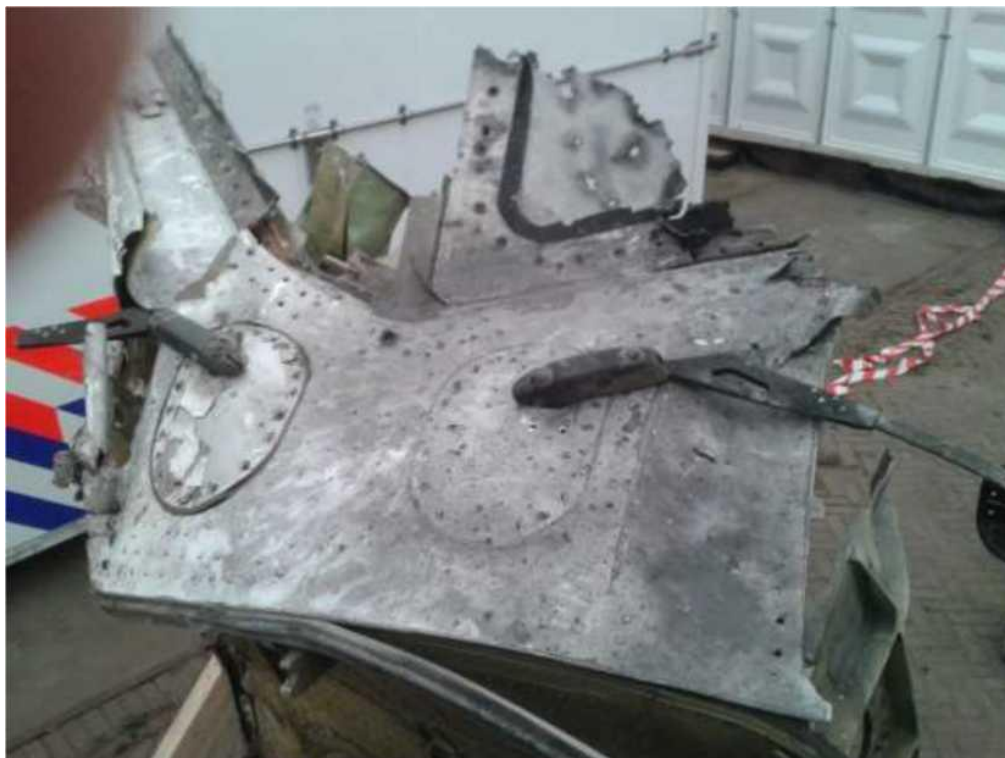
Figure 5.1.7 - Fragment of the nose of Boeing 777 adjacent to the forward pressure bulkhead, from above (photo of February, 2015)

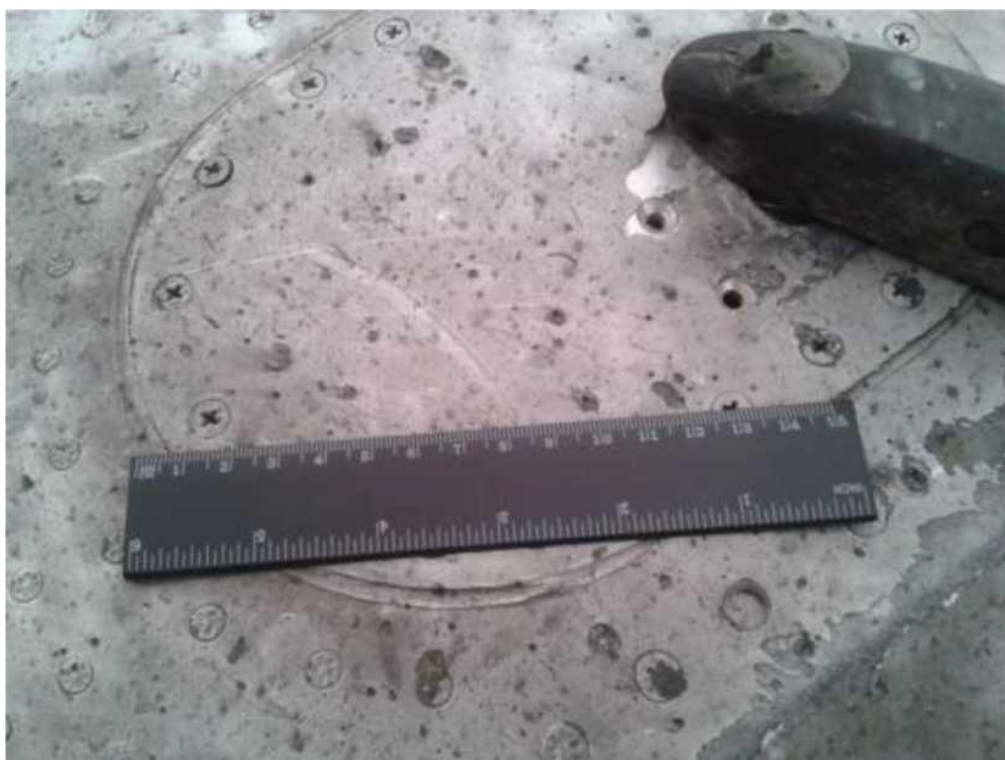
Figure 5.1.8 - Most of the fragment shows only clearly visible traces of close blast products: microcraters, thermal oxidation and soot (photo of February 2015)

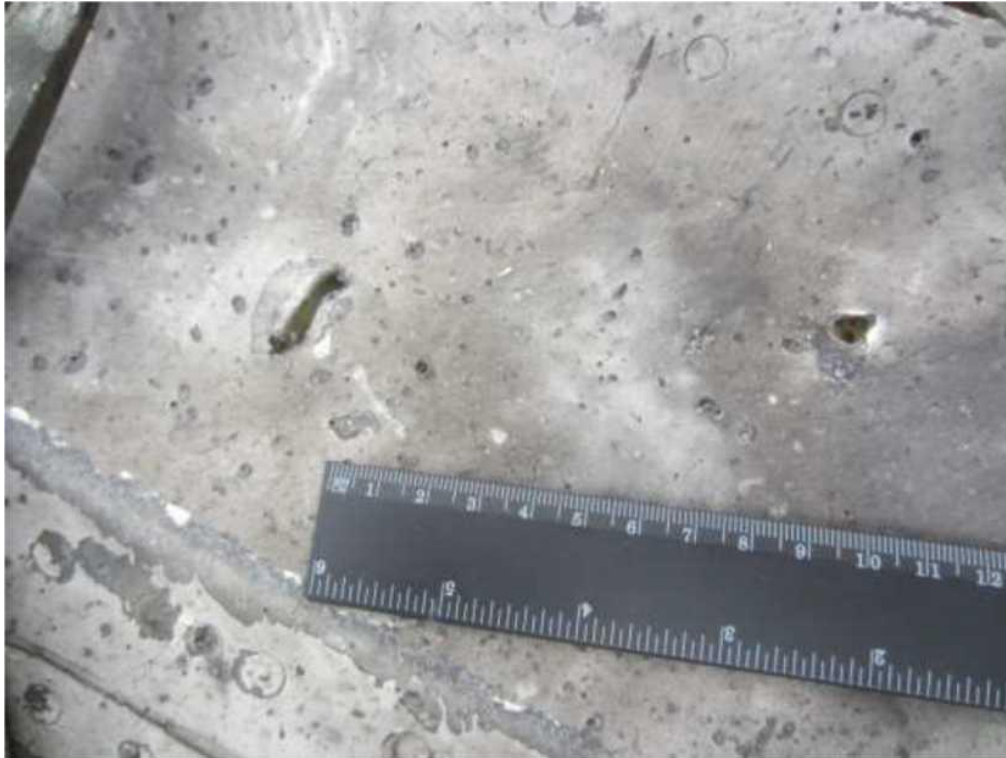
Figure 5.1.9 - There are four through-and-through holes in the fragment. It is most likely that these through-and-through holes are the result of impact of secondary fragments rather than prefabricated projectiles, as evidenced by the shape, appearance and linear dimensions of the holes (photo of May 2015)

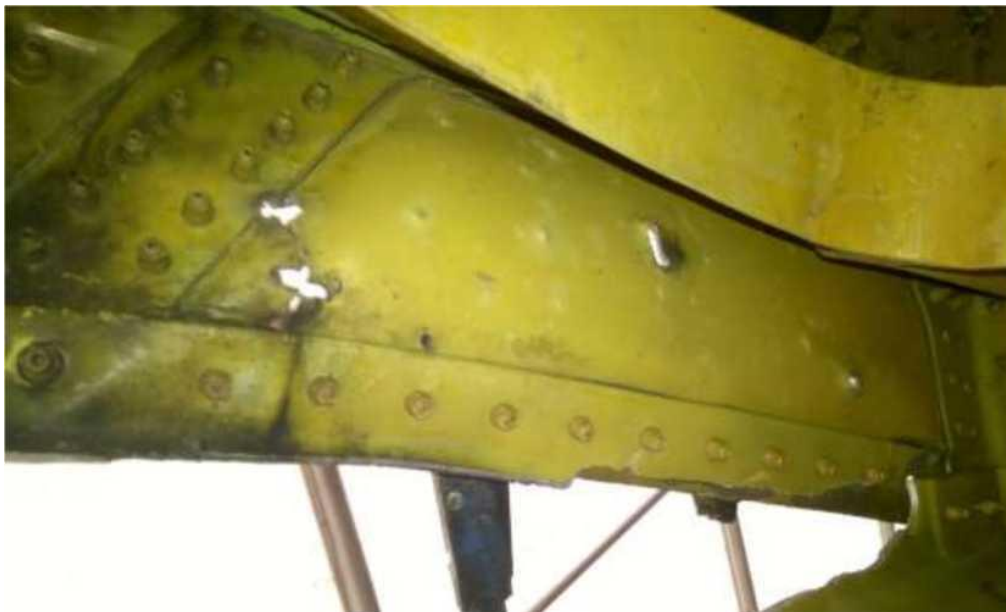
Figure 5.1.10 - Appearance of through-and-through holes. View from the inside of the fragment (photo of May 2015)

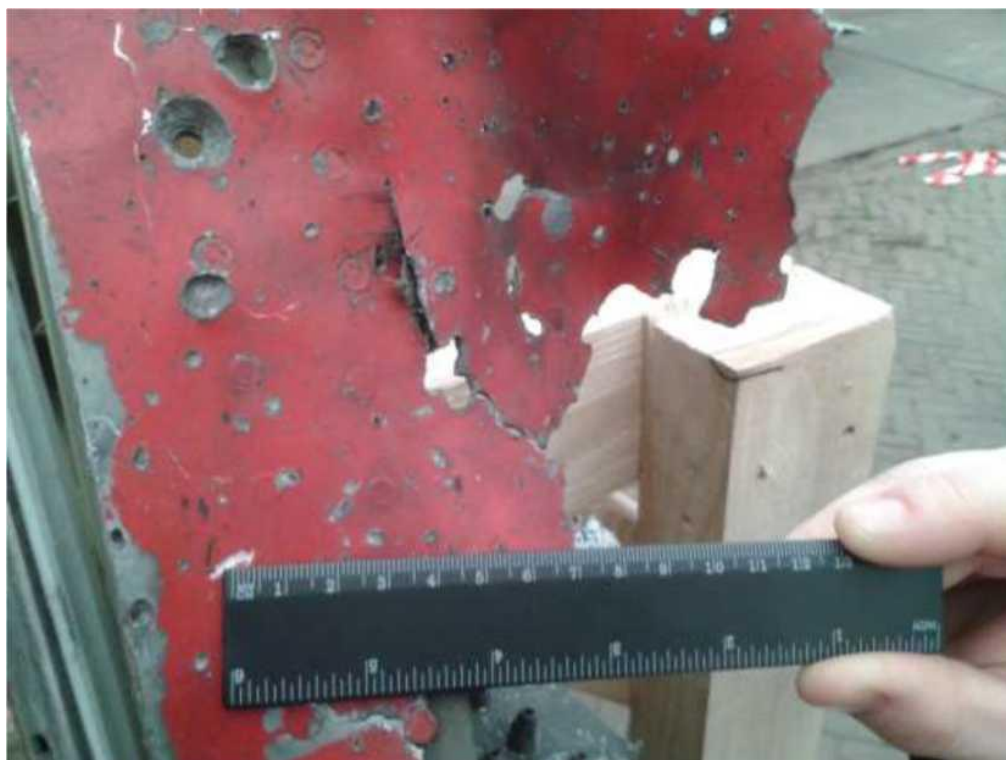
Figure 5.1.11 - Through-and-through holes identifiable as impact damage are located on the left side behind the bulkhead. Photo shows part of the port side adjacent to the bulkhead, with a clearly distinguishable forward boundary of the penetrating damage area.

These holes are the result of the impact of the rear front of the fragmentation field, which allows for their use as a marker for determining the orientation of the weapon in space (photo of February 2015)

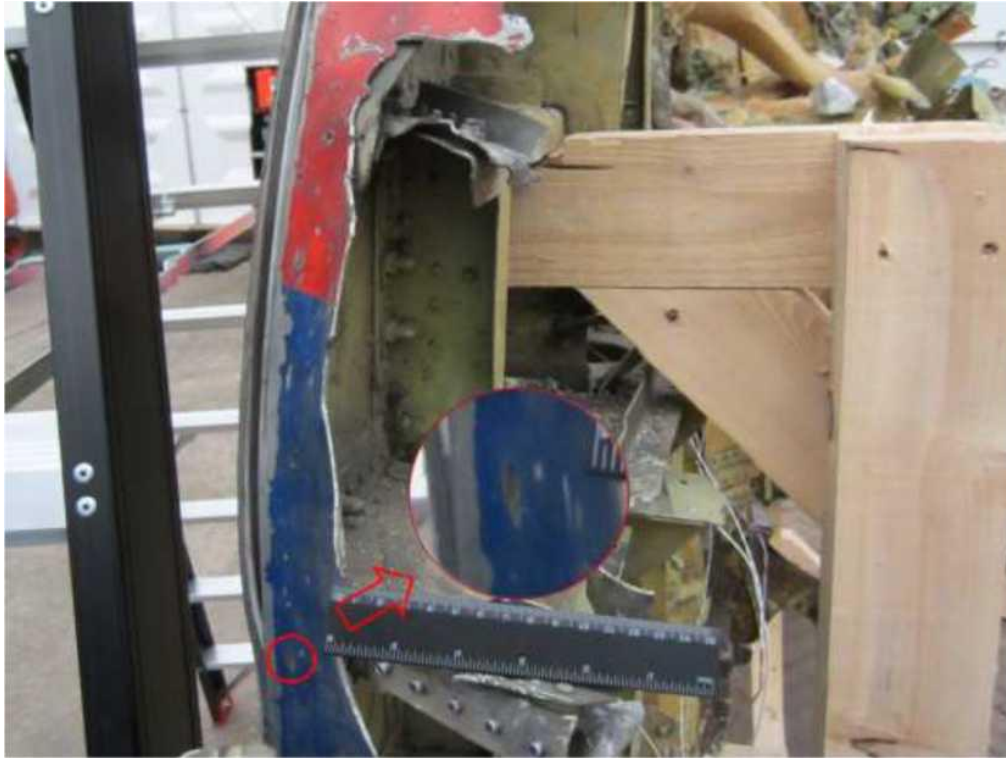
Figure 5.1.12 - Non-penetrating damage at the lower boundary of the coverage field in the area of the forward pressure bulkhead (STA 132.5). Approximate position of the coverage field boundary corresponds to the bottom cut of the measuring ruler

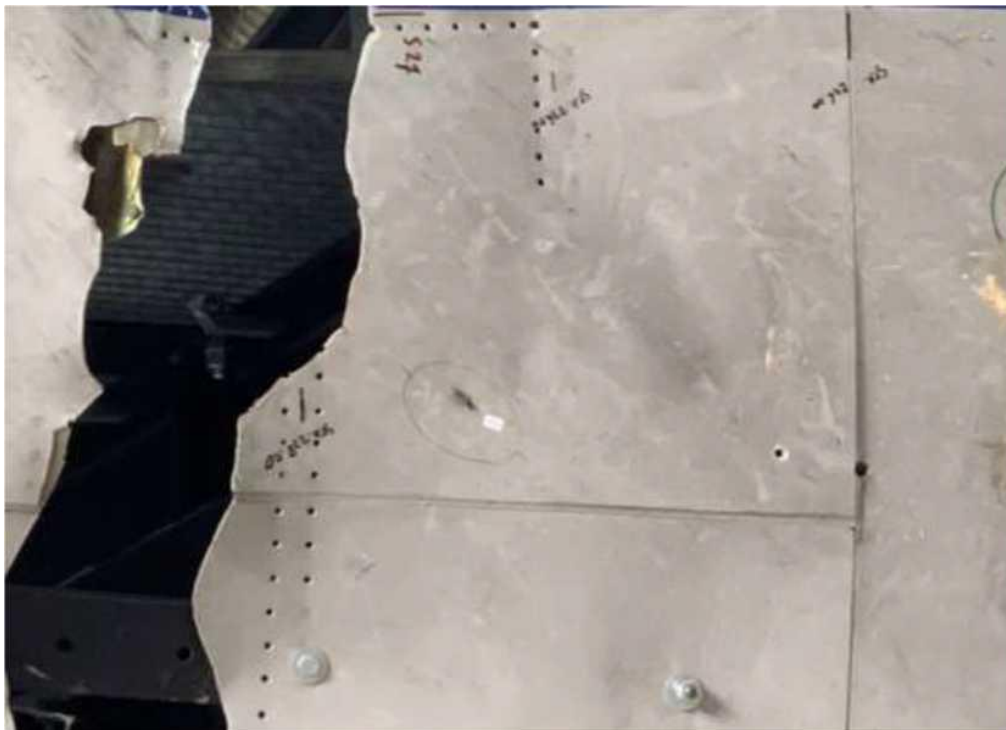
Figure 5.1.13 – Part-through non-penetrating damage at the lower boundary of the coverage field between bulkheads STA 228.5 and STA 236.5

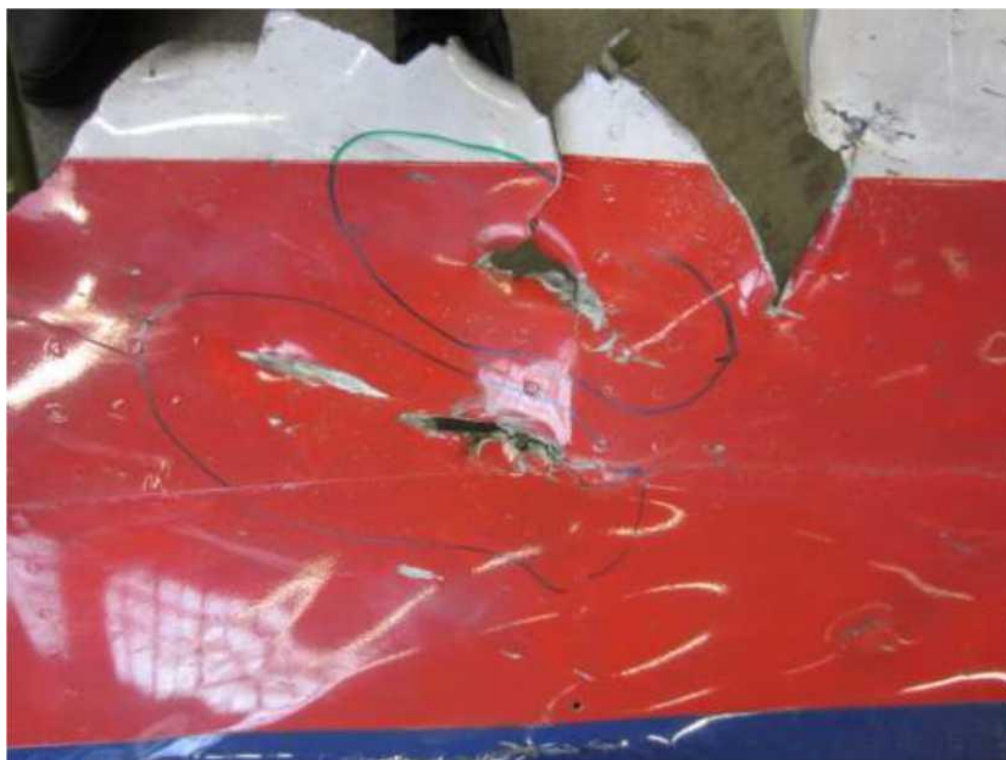
Figure 5.1.14 – Though-and-through and part-through non-penetrating damage at the lower boundary of the coverage field near bulkhead STA 265.5

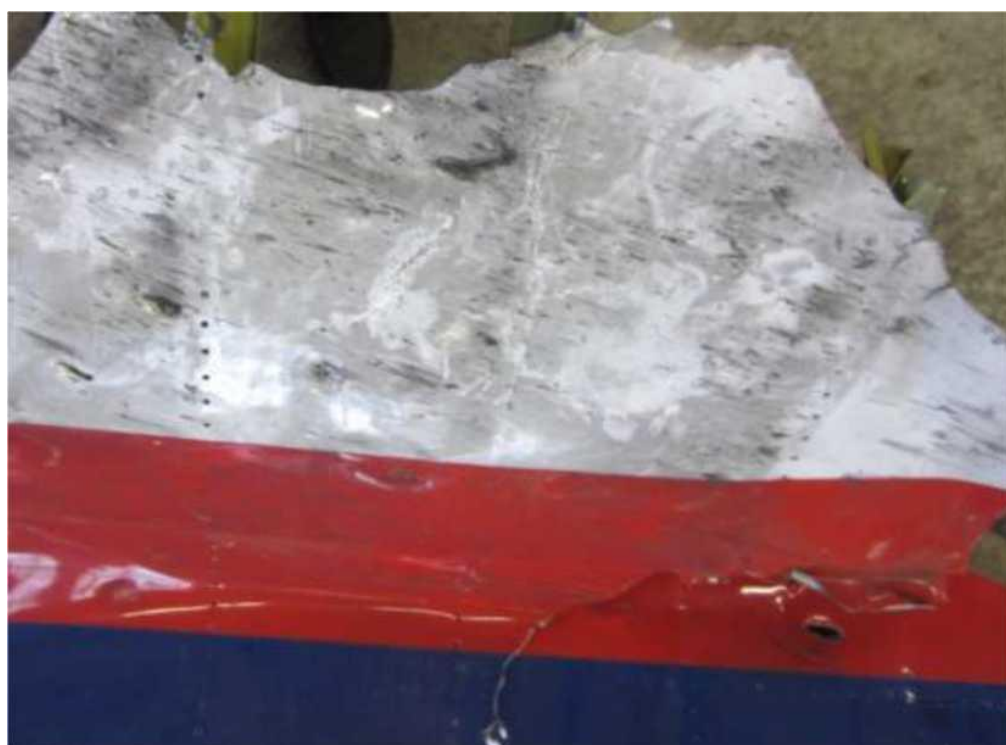
Figure 5.1.15 - Though-and-through and part-through non-penetrating damage at the lower boundary of the coverage field between bulkheads STA 276.5 (left), STA 287.5 (centre) and STA 298.5 (right)

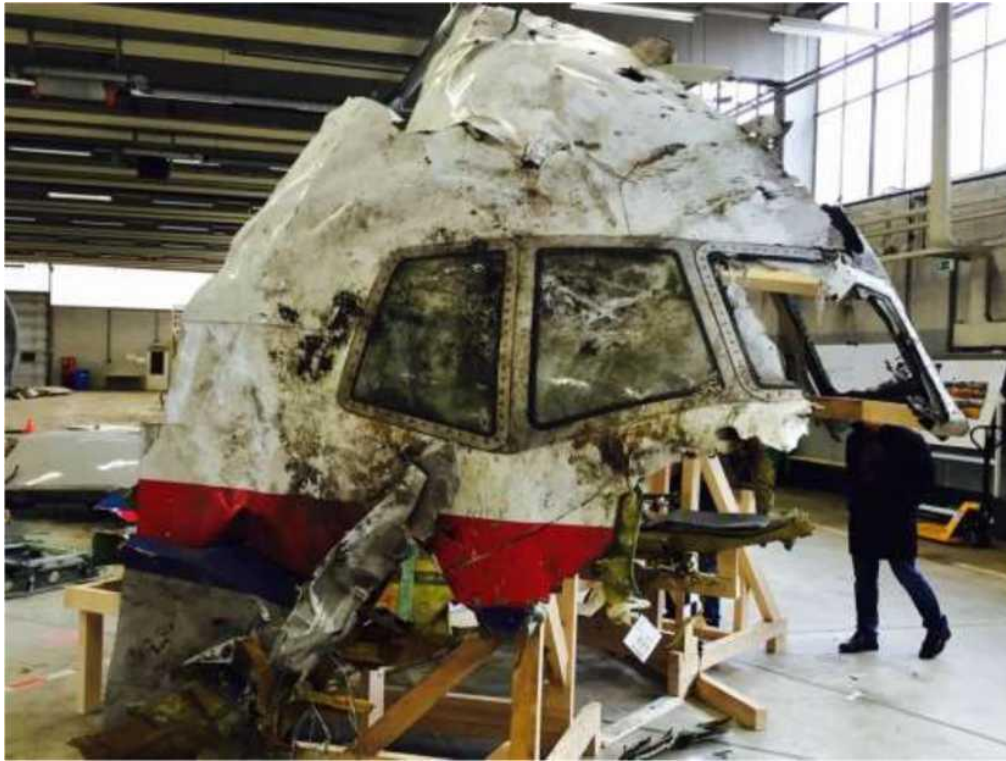
The right-hand boundary of the coverage field can be clearly seen on the fragment of the right-hand side of the cockpit with part of the roof and the preserved transparency on the right-hand side of the pilot (Figures 5.1.16-5.1.18).

Figure 5.1.16 - Fragment of the right-hand side of the cockpit with part of the roof and preserved transparency on the right-hand side

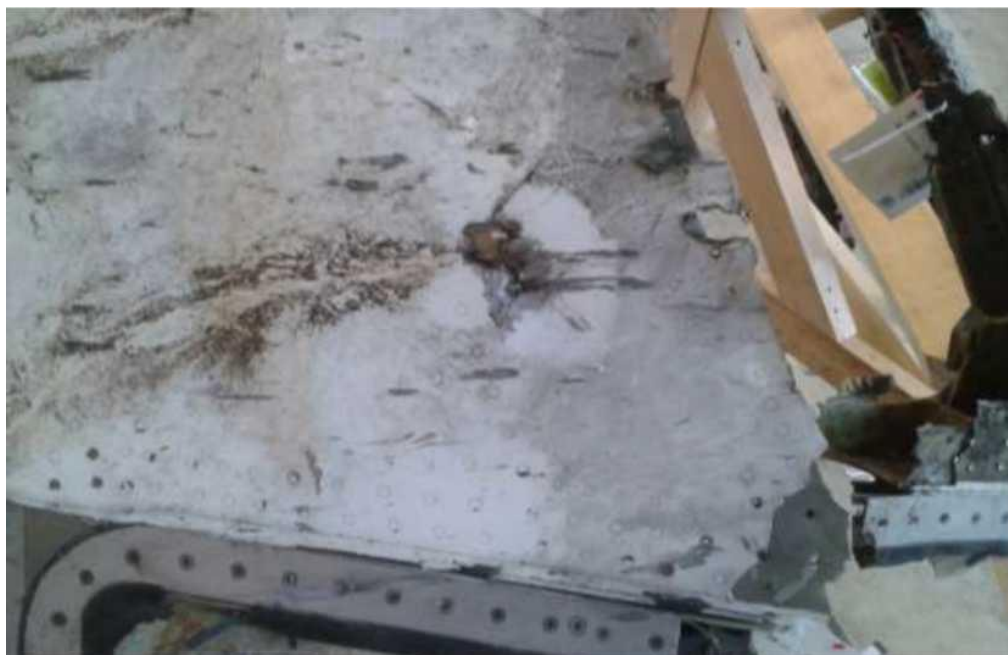
Figure 5.1.17 – Damage near the right boundary of the coverage field corresponds to the level of the upper right-hand corner of the right-hand pilot's front window

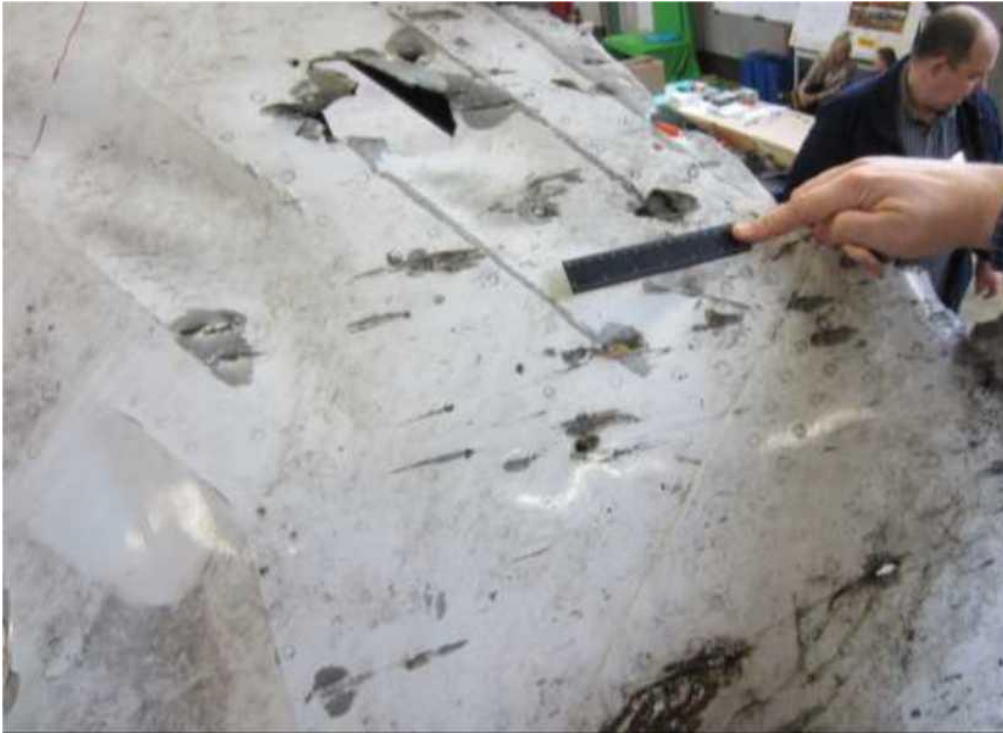
Figure 5.1.18 - Boundary damage to the right side of the cockpit

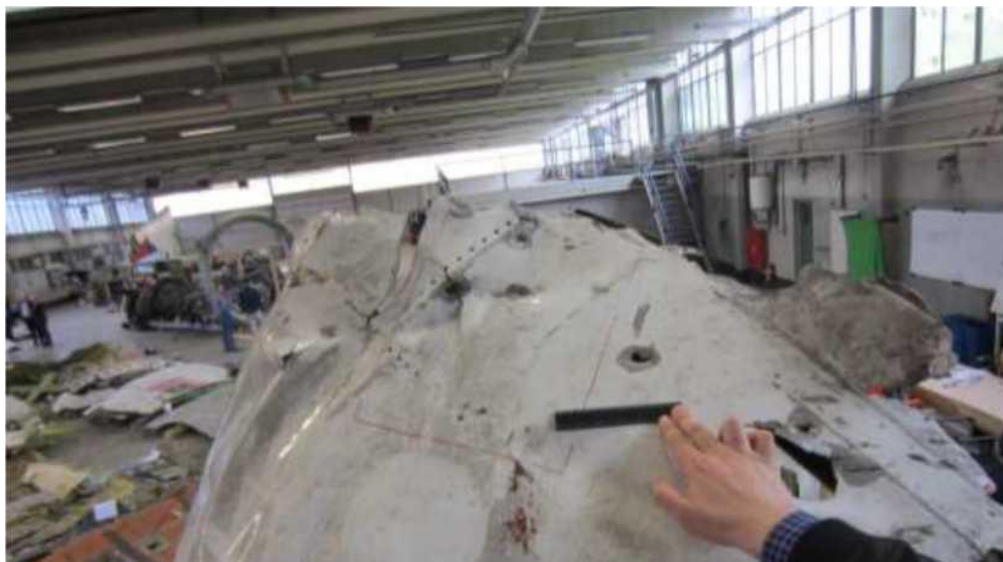
Figure 5.1.19 - Boundary damage in the upper part of the fragment of the right side of the cockpit

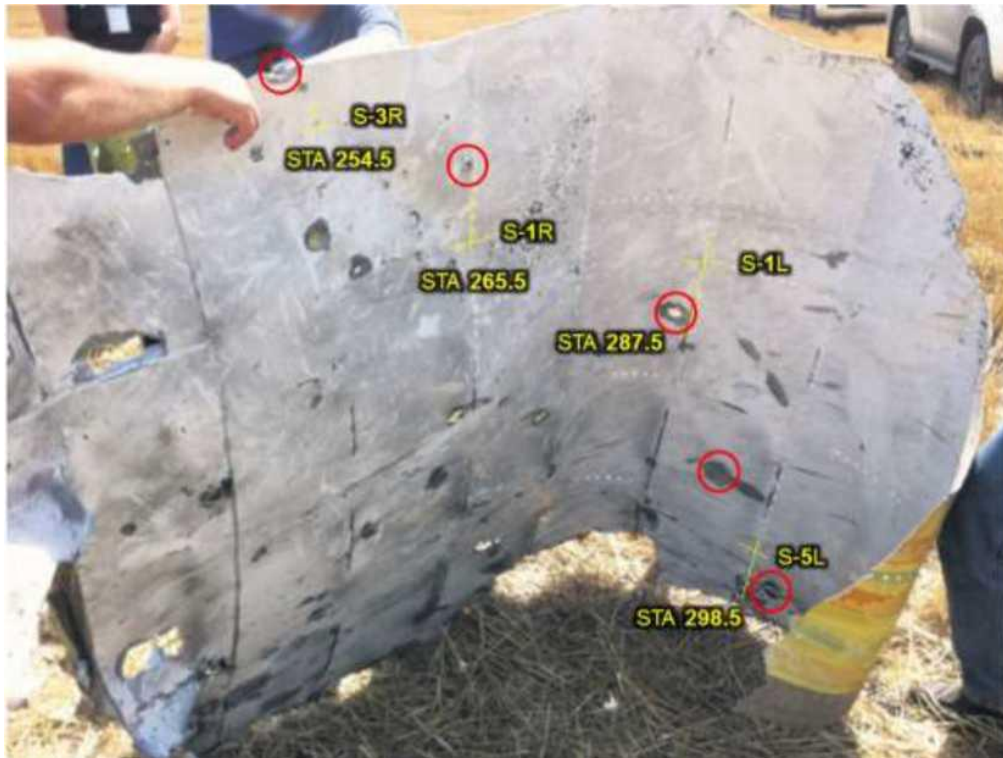
Figure 5.1.20 - A fragment of the cockpit roof objectively shows the boundary of the fragmentation field (photo - DSB resource)

The most important fragment that illustrates the location of the actual fragmentation damage area boundary is a fragment of the roof behind the cockpit. The furthest hole on the right-hand side is in the area of the STA 265.5 bulkhead.

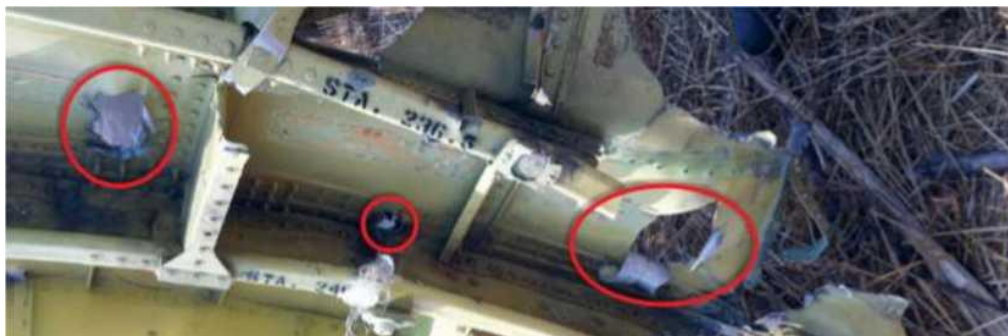
Figure 5.1.21 - Factory markings on the front bulkhead STA 236.5 and the bulkhead STA 246 which is behind it (rear cockpit wall) can be seen

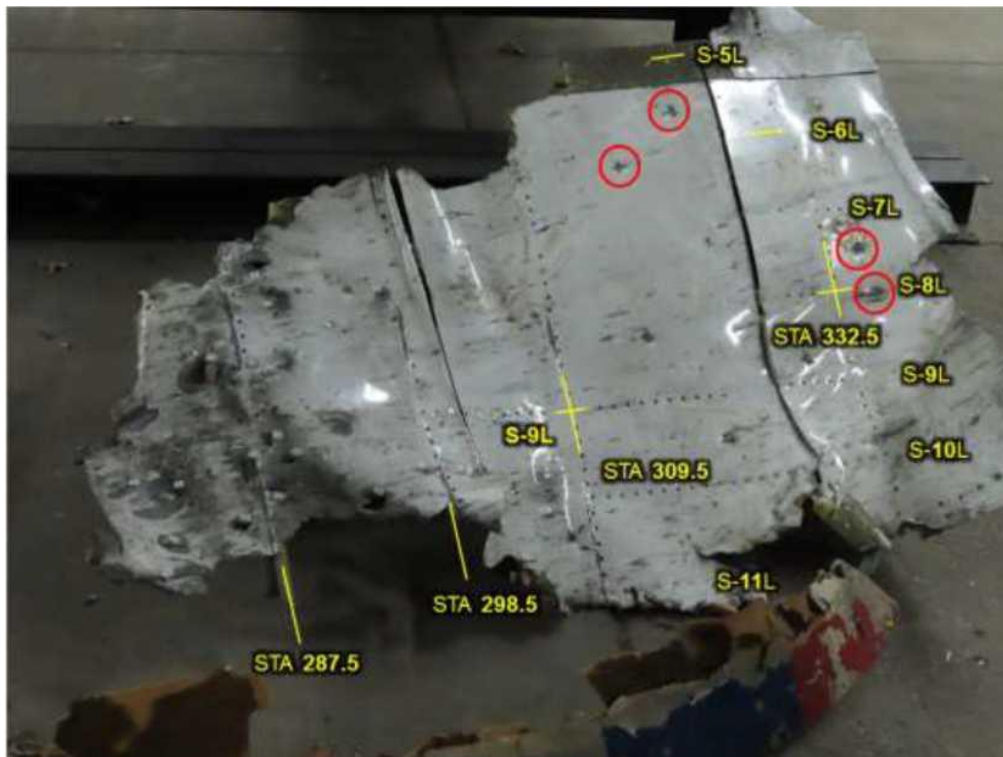
Figure 5.1.22 - Fragment of roof and top of port side behind cockpit. Through-and-through and part-through non-penetrating holes on the upper left side of the rear boundary of the coverage field are between the bulkheads STA 309.5 and STA 332.5

This fragment of the upper port side is closely adjacent to the roof fragment behind the cockpit (see Figure 5.1.20). The upper left part of the rear boundary of the coverage area in this fragment reliably matches the damage area boundary in the roof fragment behind the cockpit.

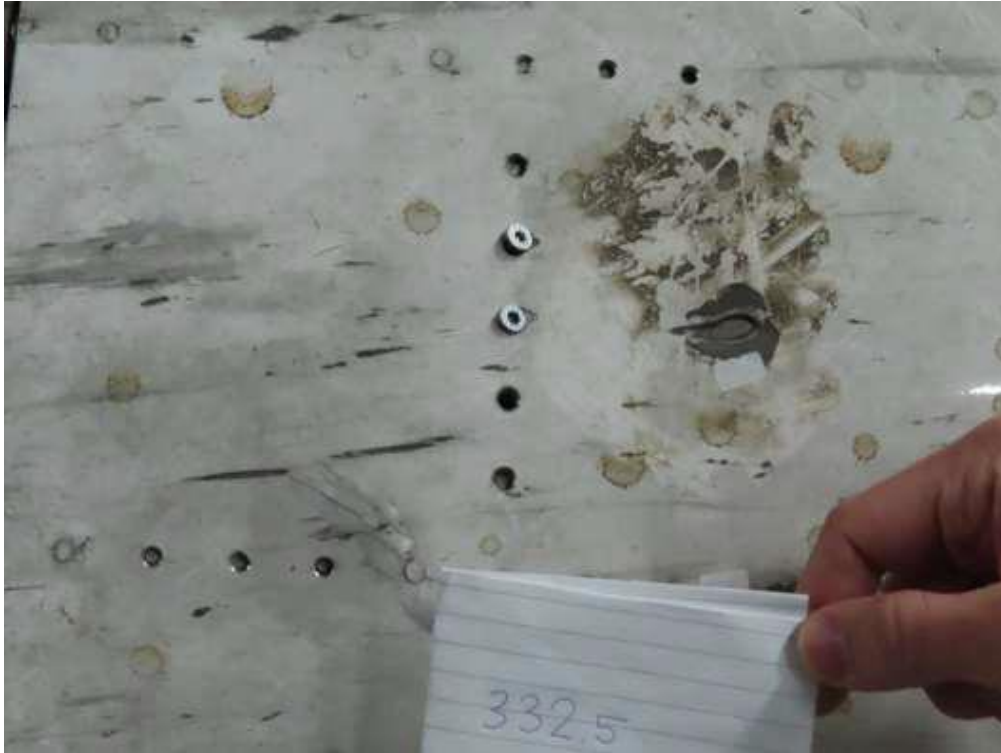
An important feature of the fragment is the presence of fragmentation damage beyond the STA 309.5 and STA 332.5 bulkheads (Figure 5.1.23).

Figure 5.1.23 - Example of damage to the outer skin at the boundary of the cover field beyond the level of the STA 332.5 bulkhead

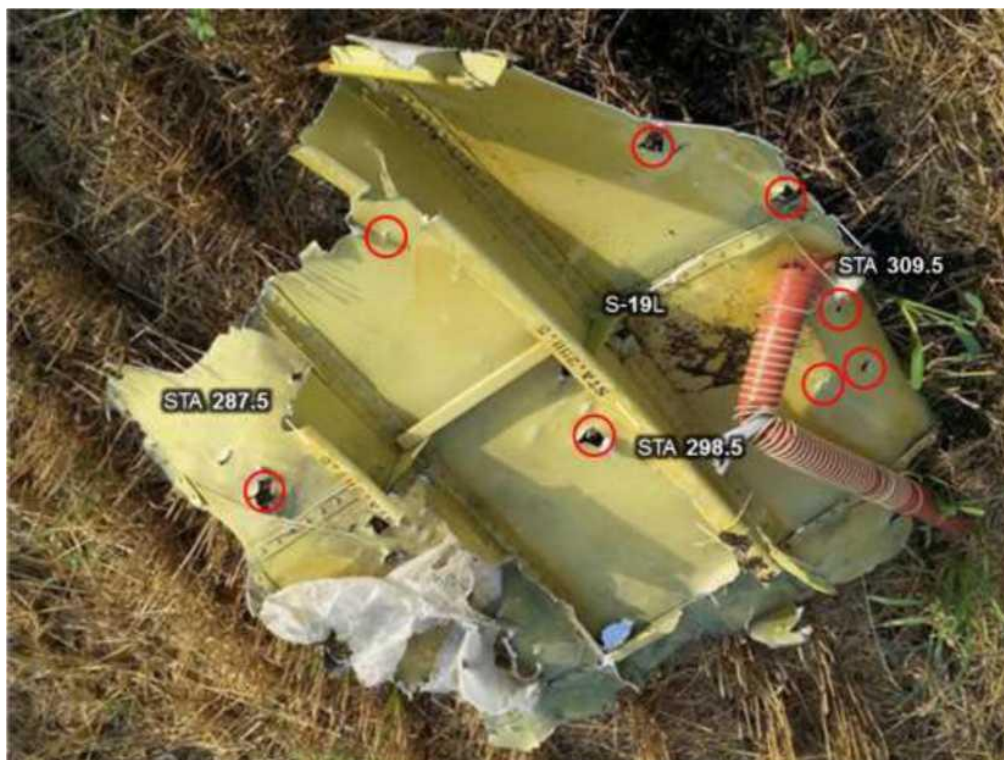
This fragment is located at S-19L level and is adjacent to the fragment of the lower port side behind the cockpit (see Figure 5.1.15). An important feature of this fragment is that it is part of the flight crew rest compartment wall behind the cockpit on the port side (Figure 5.1.24).

Figure 5.1.24 - Fragment of the central part of the port side behind the cockpit. Figure shows examples of through-and-through and part-through damage between the STA 287.5 and STA 309.5 bulkheads

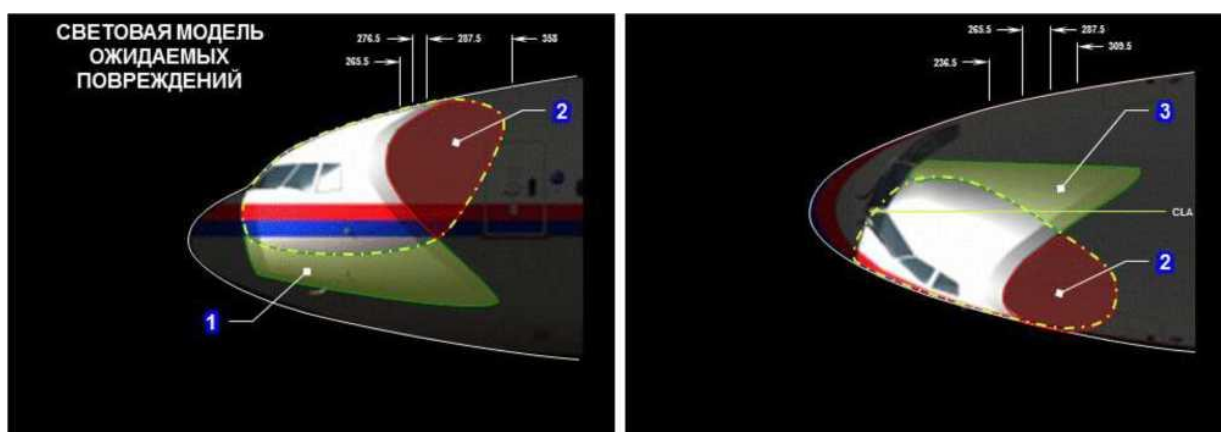
Figure 5.1.25 - Diagram of actual fragment coverage field boundaries as compared to DSB's "reference" model (light model of expected damage): left - left side view; right - top view

Comparison of the damage pattern (the fragmentation coverage boundary diagram) with the light model of expected damage ("reference model") shows that the actual fragmentation coverage area differs significantly from that which was modelled and accounted for by the DSB experts.²¹

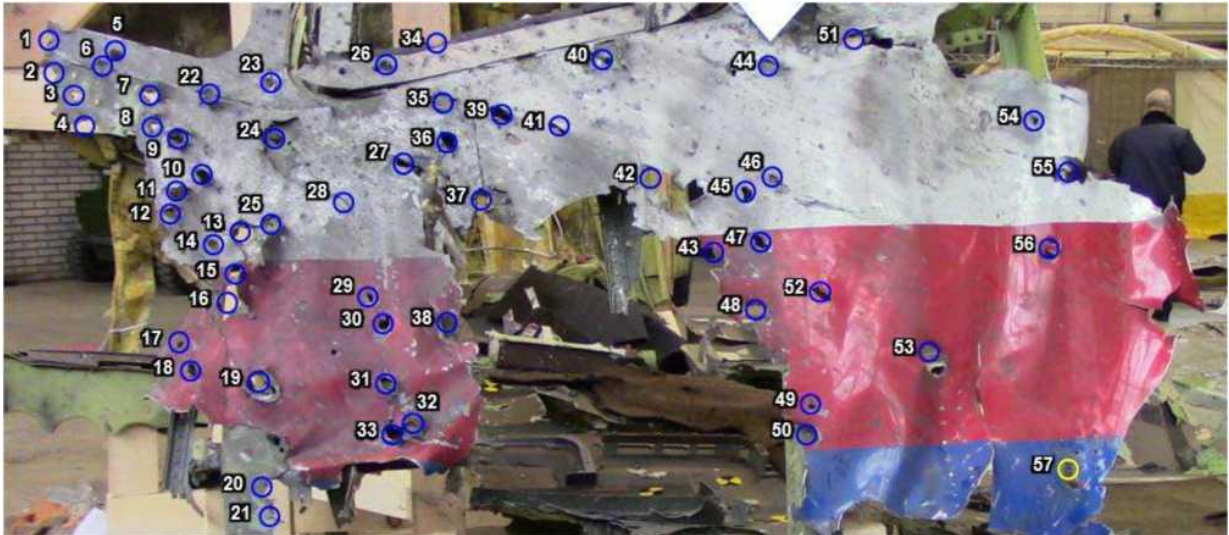
Figure 5.1.26 - Exterior view of a fragment of the aircraft's port side skin below the crew commander's transparency bezel with numbered holes resulting from battle damage

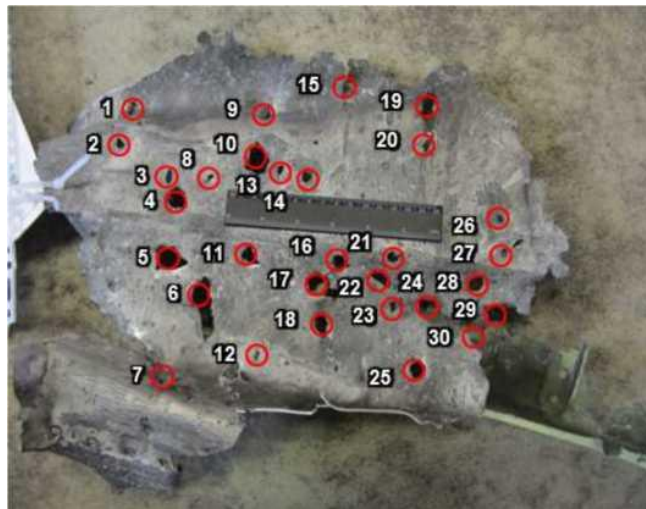
Figure 5.1.27 - Exterior view of the port side skin fragment from the top rear of the crew commander's vent with numbered holes resulting from battle damage

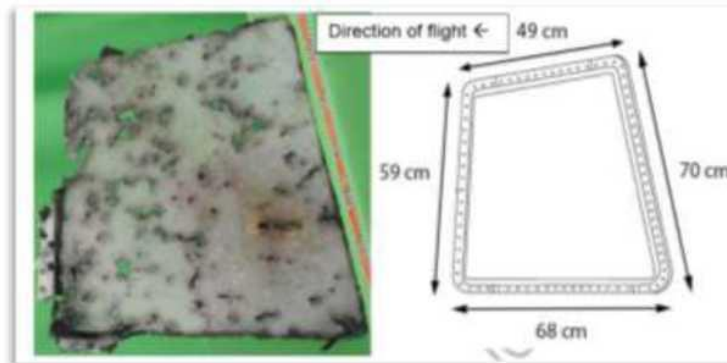
In the materials of the Dutch experts, the transparency area on the left side of the cockpit is taken as fragments with the highest density of fragmentation damage, in particular, the second window of the cockpit commander (Fig. 5.1.29), where 102 holes were identified.²⁵

Figure 5.1.29 - Second crew captain window (left side)

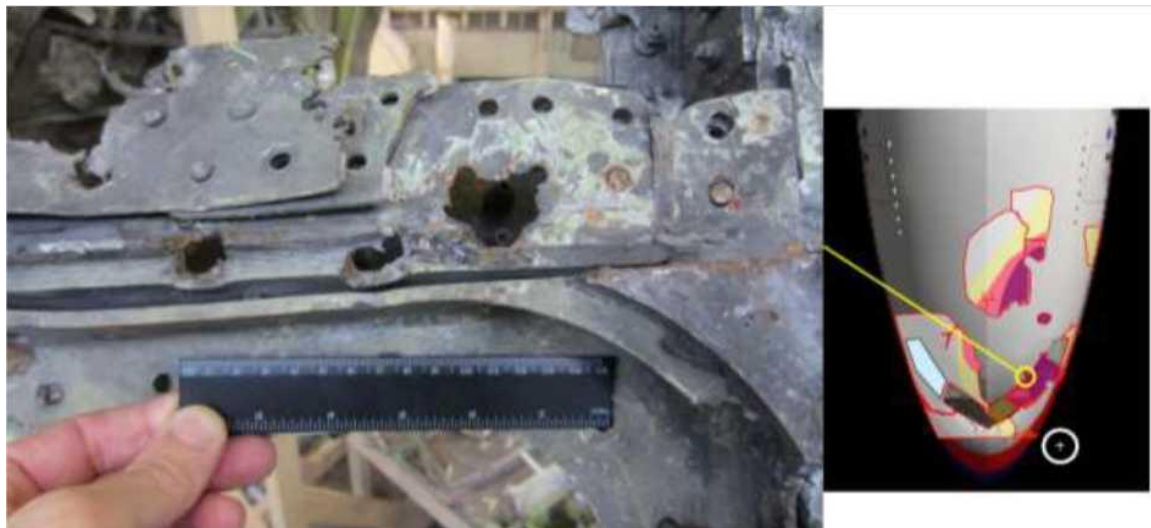
In the course of studies of combat damage to the Boeing 777, specialists of Almaz-Antey Corporation identified several more fragments of the forward part of the aircraft with a high density of damage. Figures 5.1.30 to 5.1.34 show images of some of these fragments.

Figure 5.1.30 - Upper part of the frame of the left-hand cockpit window

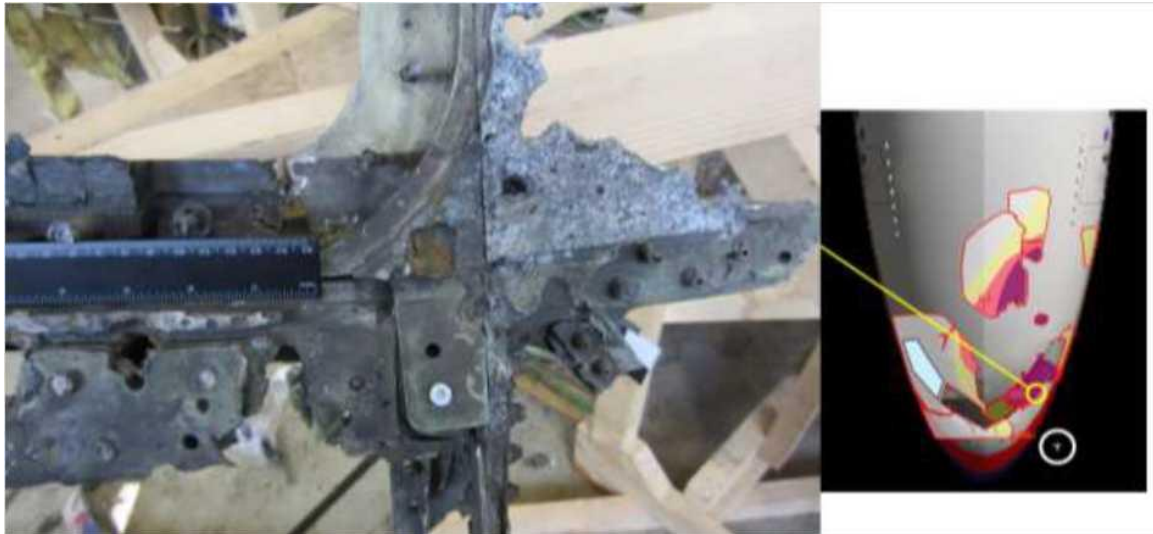
Figure 5.1.31 - Lower part of the frame of the left-hand cockpit window

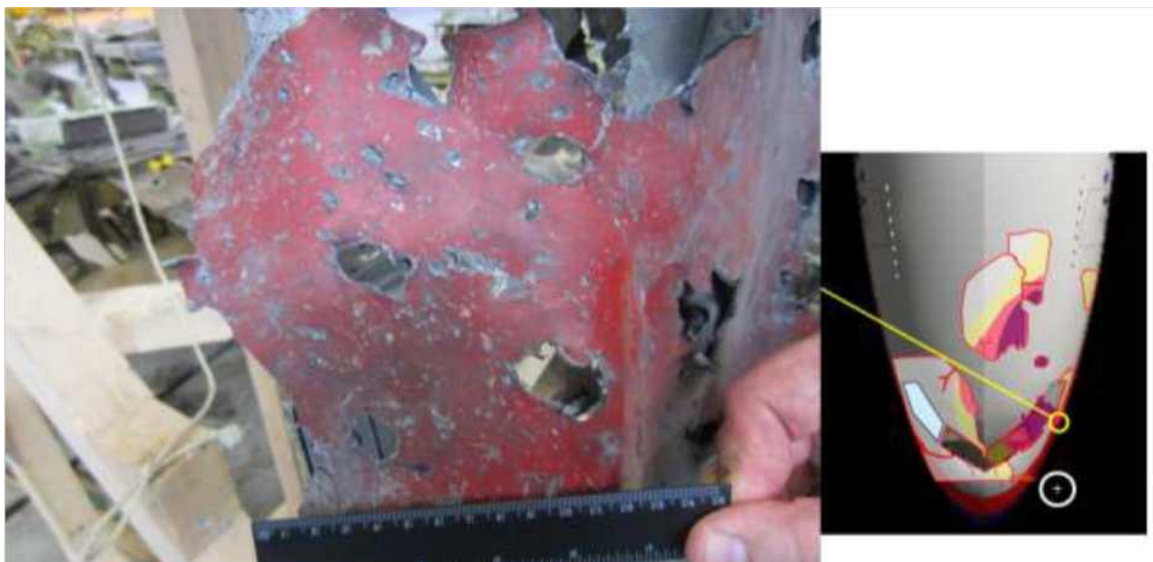
Figure 5.1.32 - Fragment of the port side below the cockpit window frame

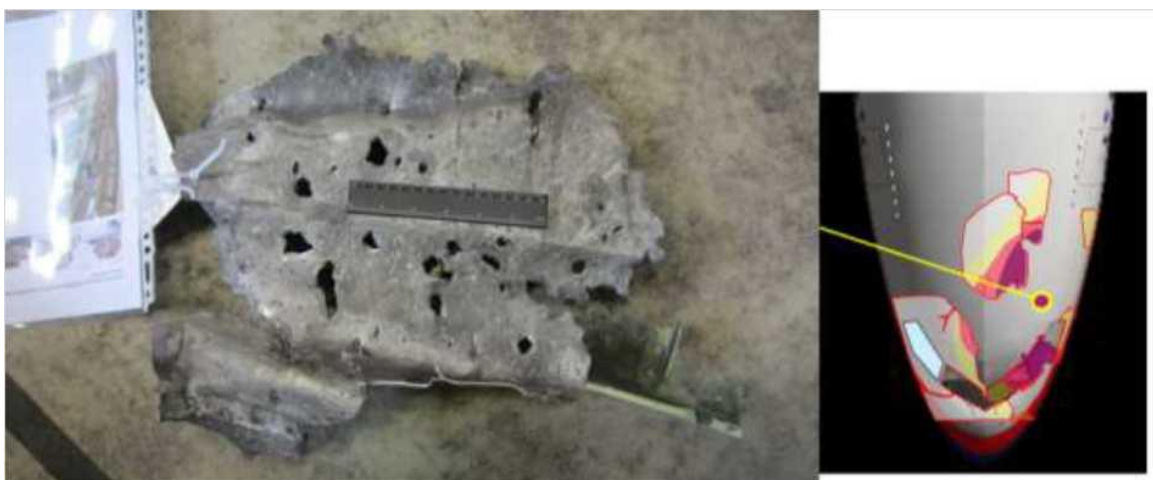
Figure 5.1.33 - Fragment of the port side behind the cockpit windows

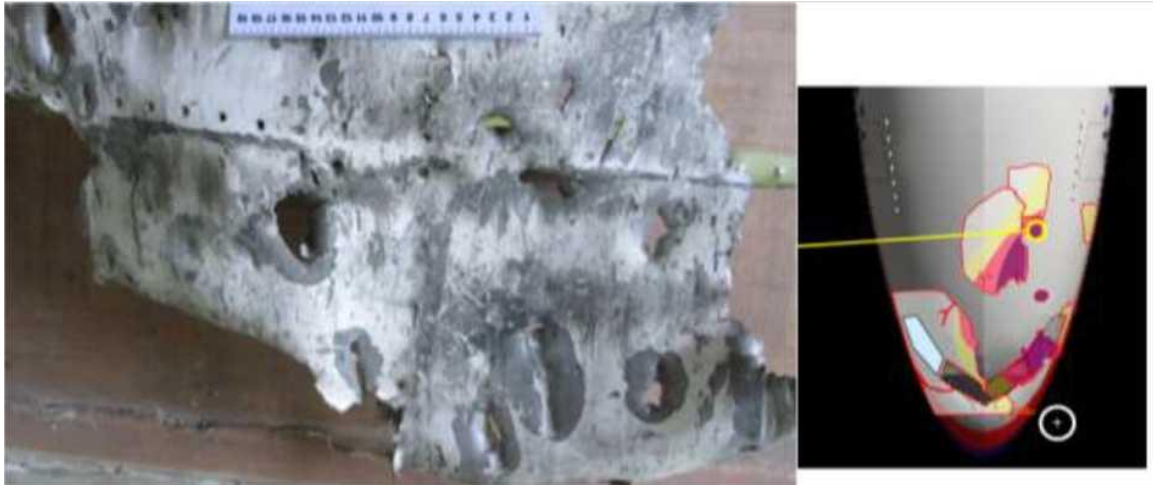
Figure 5.1.34 - Fragment of roof and upper port side (not included in final 3D reconstruction)

In addition to the fragments shown in Figures 5.1.30-5.1.34, the area of high fragmentation damage density includes fragments of the roof behind the cockpit (its left front part) and fragments of the port side, which are not shown in the final 3D reconstruction. Figure 5.1.35 shows the layout of the aircraft fragments with the highest density of damage.

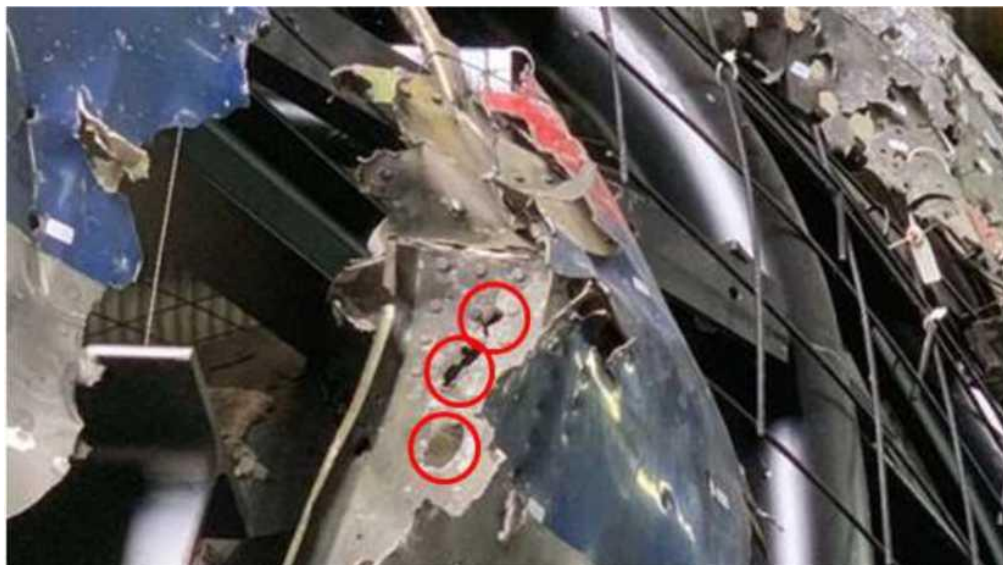
Such damage starts practically from the forward boundary of the fragmentation field (from STA 148 near the forward pressure bulkhead) and extends to the front passenger door L1, including the level below the cockpit floor.

Figure 5.1.36 - Through-and-through holes in the bulkheads start from the forward boundary of the fragmentation field
