**APPLICATION OF THE INTERNATIONAL CONVENTION FOR THE SUPPRESSION
OF THE FINANCING OF TERRORISM AND OF THE INTERNATIONAL
CONVENTION ON THE ELIMINATION OF ALL FORMS OF RACIAL
DISCRIMINATION**

REJOINDER

Report of JSC Air and Space Defense Corporation "Almaz-Antey" on the results of studies related to the technical investigation into the crash of the Malaysian airlines Boeing 777-200 9M-MRD (flight MH17), 2023

on the results of studies related to the technical investigation into the crash
of the Malaysian airlines Boeing 777-200 9M-MRD (flight MH17)

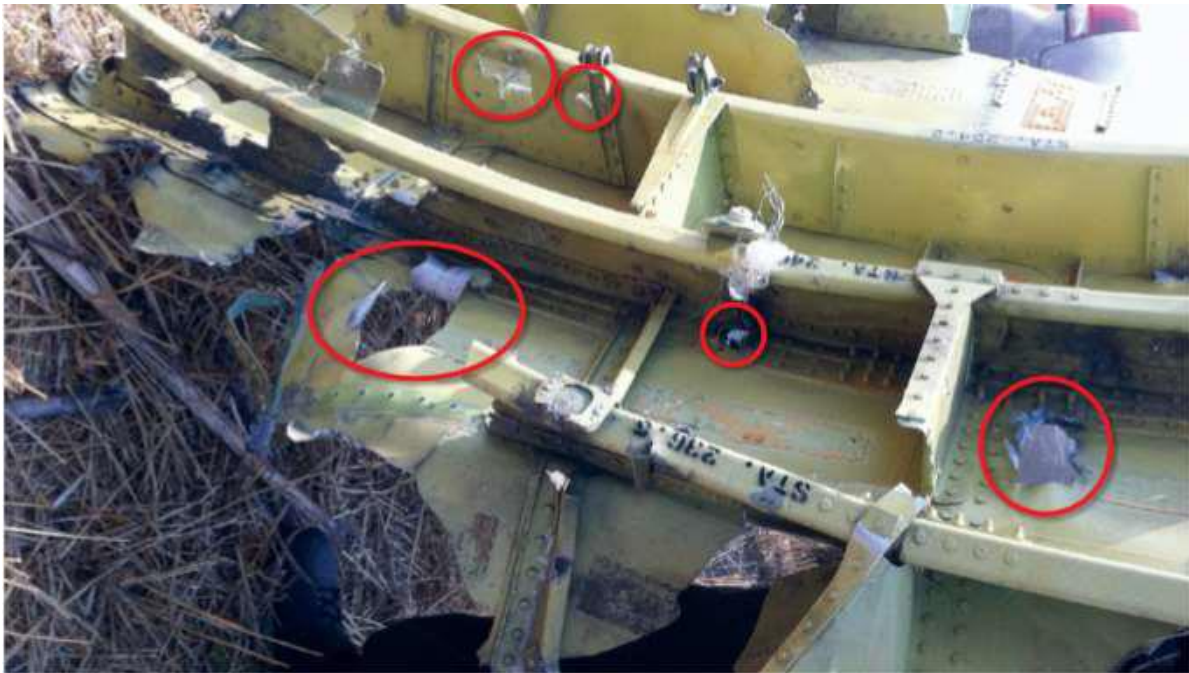
Figure 9: Part of the inside cockpit roof, indicating penetration with objects from outside. (Source: DCA)

Figure 5.1.38 - Left side of roof fragment behind cockpit (inside view). Multiple holes in STA 236.5, STA 246 and STA 254.5 led to deformation and failure of the structural elements
(Resource - Preliminary Report submissions)

³¹ A fragment of the roof behind the cockpit with multiple damage to the structure was the main evidence of the impact of high-energy objects on the aircraft (Preliminary Report, figure 9).

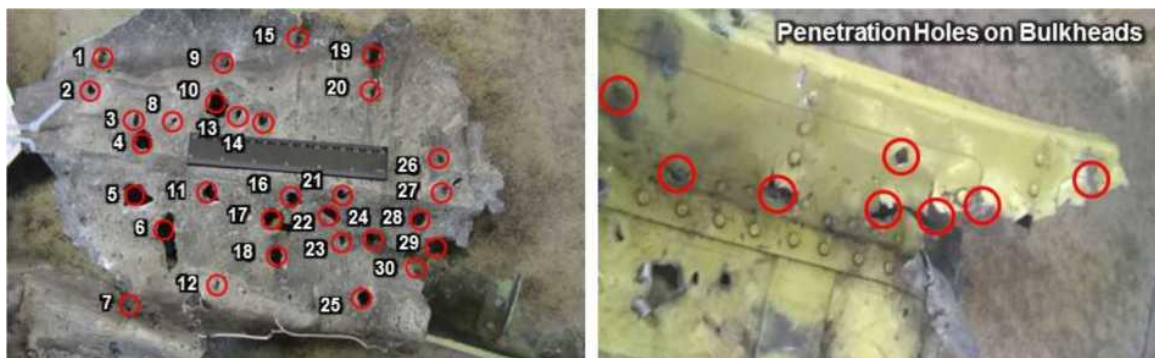
Figure 5.1.39 - Fragment of the port side skin from the top rear of the crew commander's window. Multiple holes in the bulkhead led to deformation and collapse of the structural element (photo on the right)

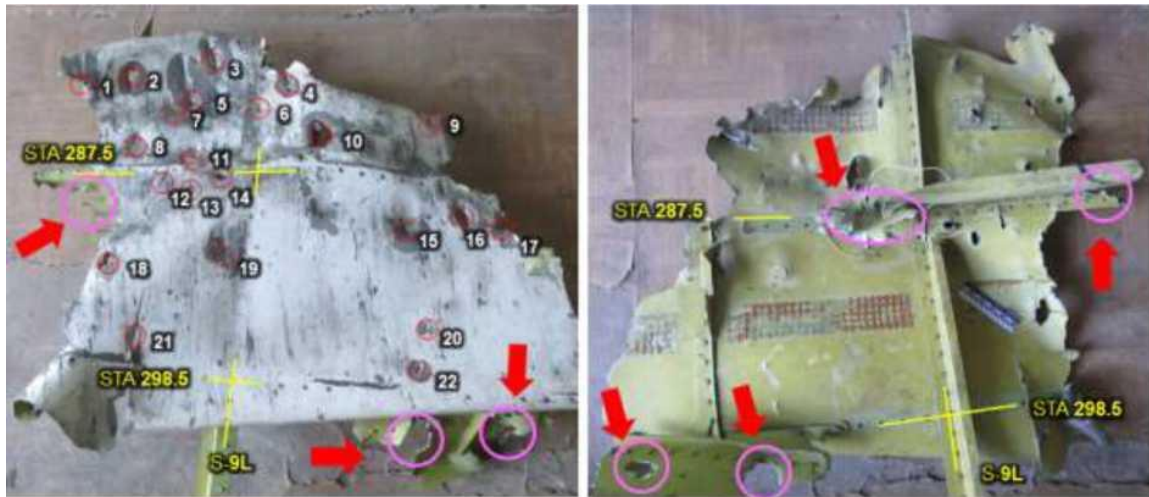
Figure 5.1.40 – Fragment of roof and upper part of the port side: external (left) and internal (right) views. Multiple holes in bulkheads STA 287.5 and STA 298.5 led to deformation and collapse of the structural elements (red arrows indicate characteristic damage)

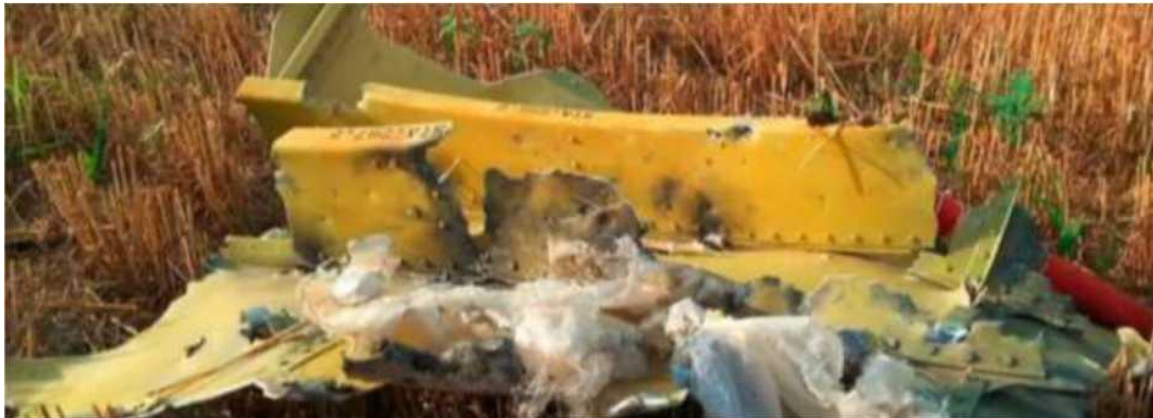
Figure 5.1.41 - Fragment of the centre port side behind the cockpit. Holes in the STA 287.5 and STA 298.5 bulkheads and traces of compression, deformation, tearing and breaking of structural elements are objectively observed

All of the examples of left side roof and port side fragments show penetrating and non-penetrating damage to the outer skin. Holes and traces of compression, deformation, tearing and destruction of the airframe elements are objectively observed in the airframe elements.

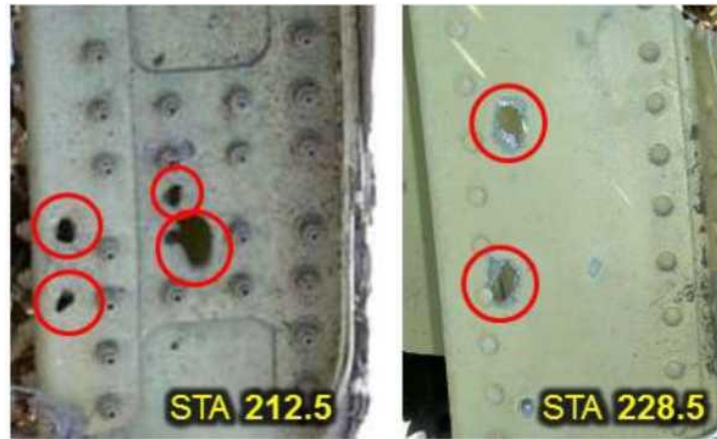
Damage to the transverse structural elements (bulkheads) along the port side extends beyond the boundary of the fragmentation coverage field on the outer skin. As an example, Figure 5.1.42 shows damage to the bulkheads STA 212.5 and STA 228.5 on the port side fragment with the angle of attack sensor. The damage is below the floor level and the lower boundary of the outer skin coverage field.

Figure 5.1.42 - Holes in bulkheads STA 212.5 and STA 228.5 are beyond the lower boundary of the fragmentation field on the outer skin

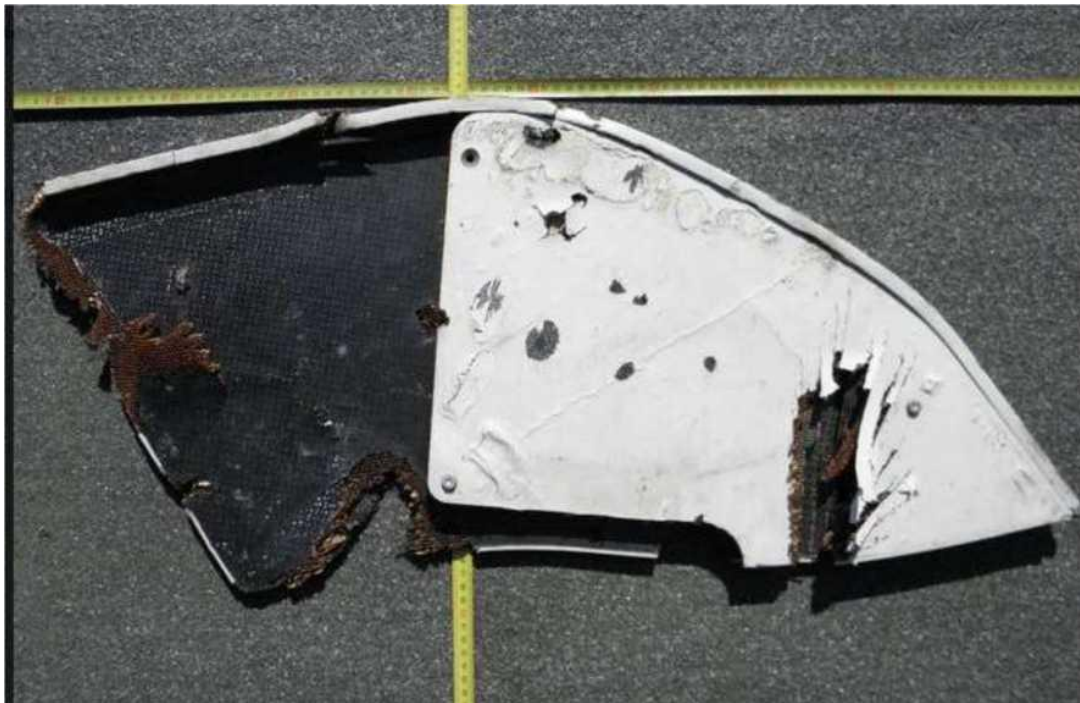
This is also true for the top side of the roof. Figure 5.1.43 shows a section of the passenger compartment luggage shelf that is positioned further away from the STA 382 level.

Figure 5.1.43 - Fragment of passenger compartment luggage rack with (presumably) fragmentation damage

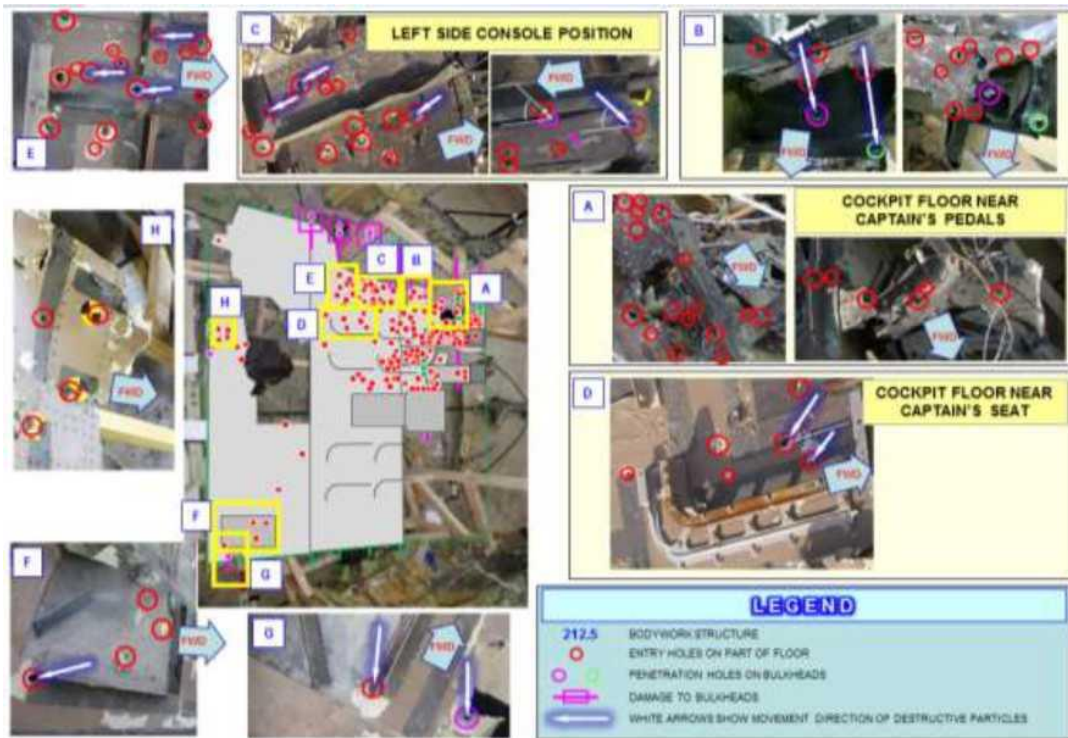
Figure 5.1.44 – Diagram showing distribution of cockpit floor and structure damage with examples of characteristic damage

In the cockpit of the Boeing 777, the main damage to the cockpit floor and interior is concentrated near the left-hand seat (commander's seat) with a gradual decrease in the density of through-and-through holes along the left-hand side. On the right side of the cockpit floor, only single through-and-through holes are noted and then only at the rear of the cockpit.

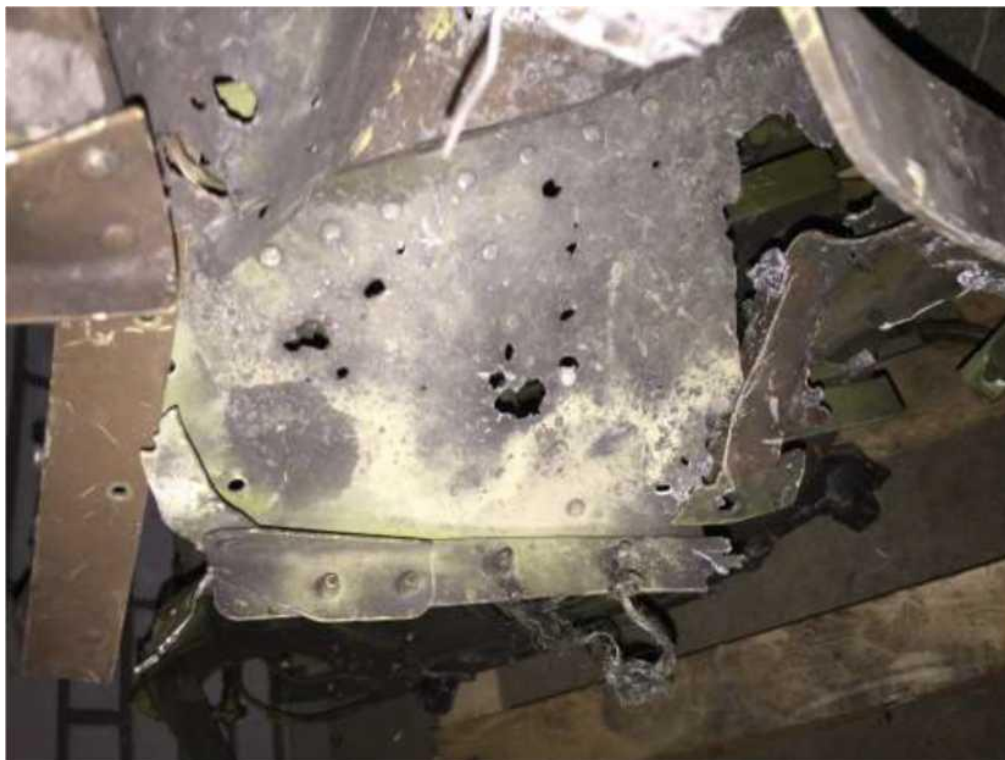
Figure 5.1.45 - Damage to cockpit floor and structural elements along the port side

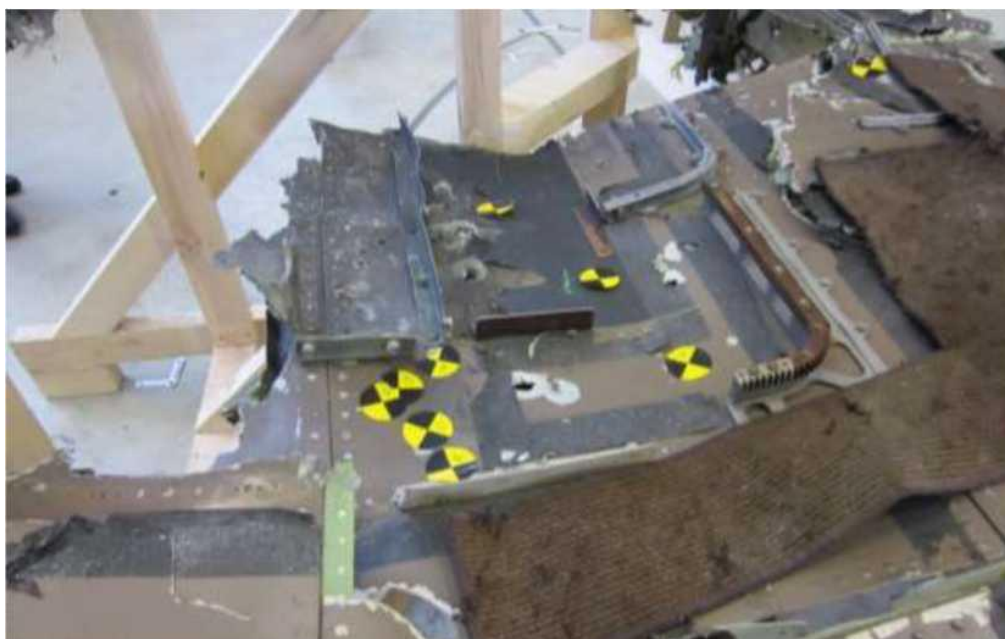
Figure 5.1.46 - Damage in the area of the commander's seat

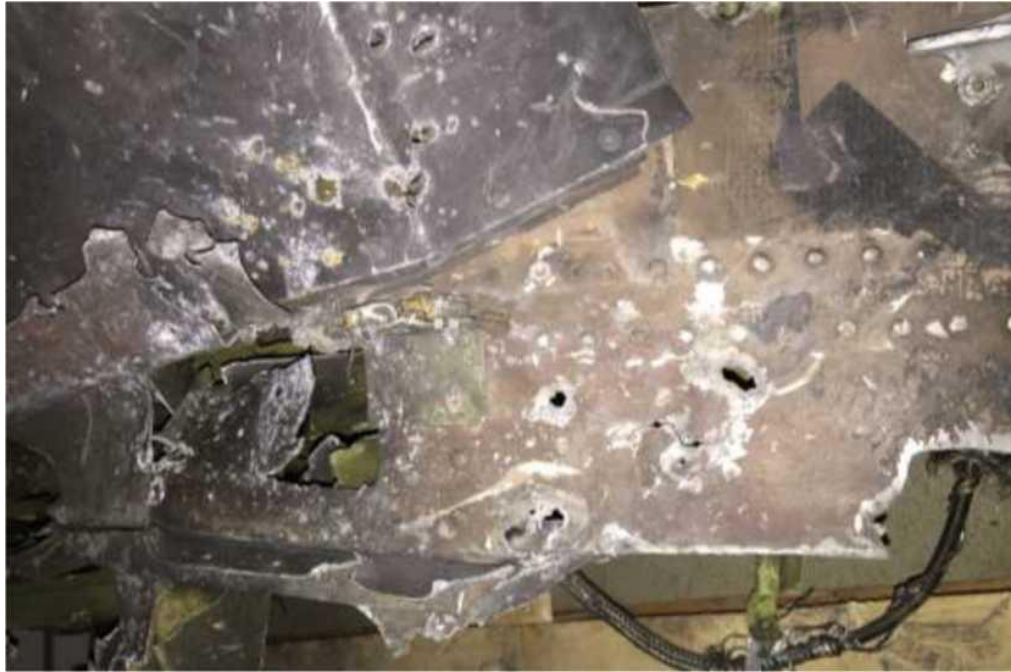
Part of the cockpit floor along the port side (Figure 5.1.47) is almost completely destroyed. In addition, there are multiple through-and-through holes in the transverse elements of the cockpit floor structure, which led to the destruction of these structural elements and the bulkheads along the left side of the aircraft.

Figure 5.1.47 - Damage density in cockpit floor to the left of the aircraft commander's seat (along the port side)

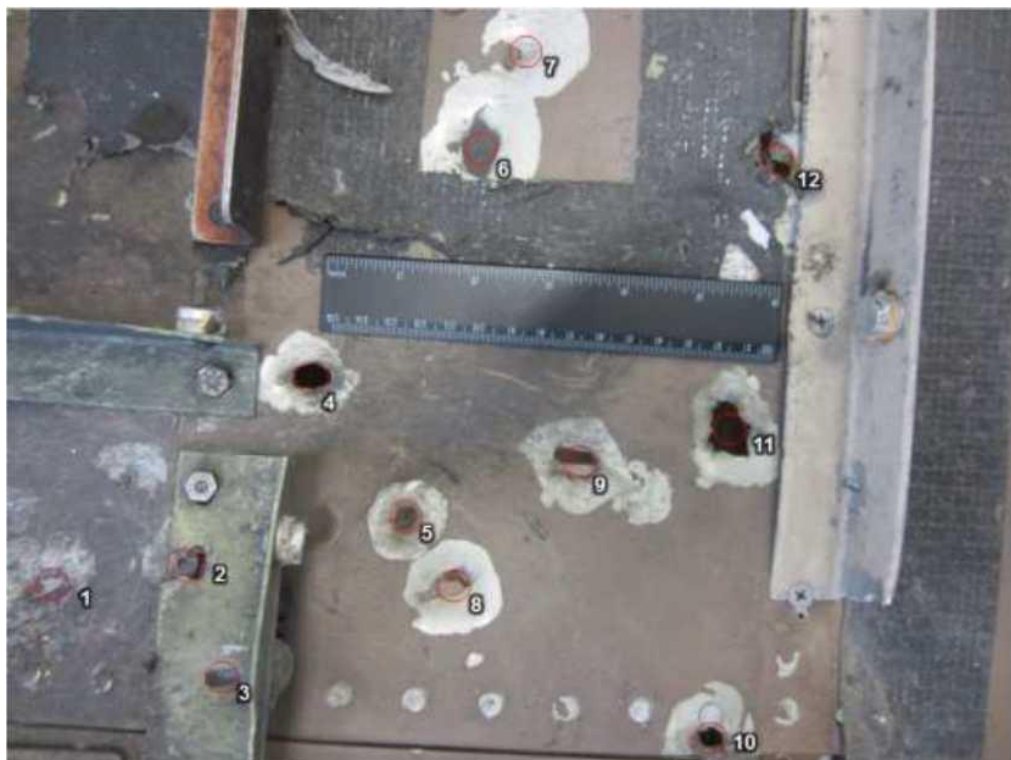
Figure 5.1.48 - Fragmentation damage to cockpit floor to the left of the aircraft commander's seat (along the port side)

The density of holes in some elements of the cockpit floor located along the port side exceeds the average density of damage to the outer skin (Figure 5.1.48).

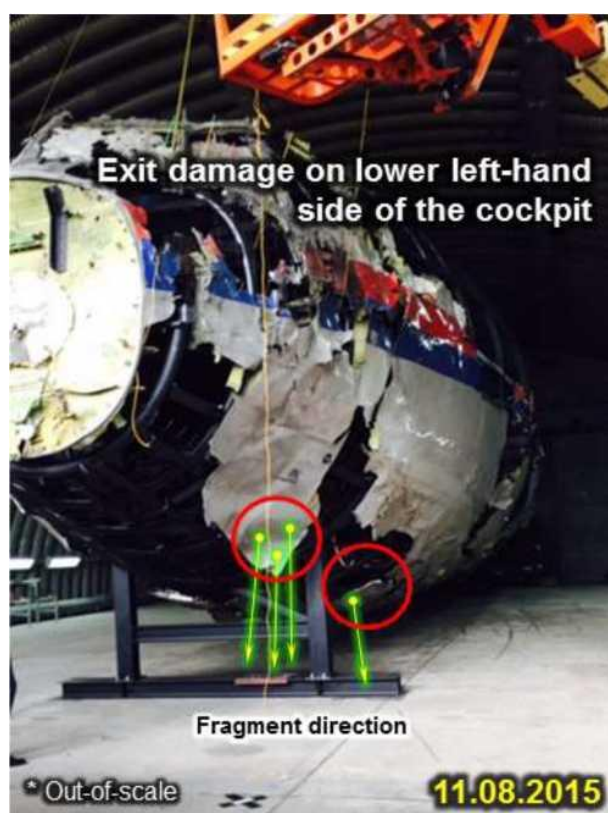
Figure 5.1.50 - Location of exit "inside-out" holes in the lower port side of the Boeing 777

At the same time, there is "inside-out" exit damage (holes and non-penetrating damage) in the cockpit fragments of the Boeing 777. It is, however, located not in the right, but in the left lower part of the fuselage. Figure 5.1.50 shows schematically the location of the main exit holes and the inside-out non-penetrating damage on the left side of the Boeing 777. The highest density exit damage is concentrated below the second left window and distributed further along the port side.

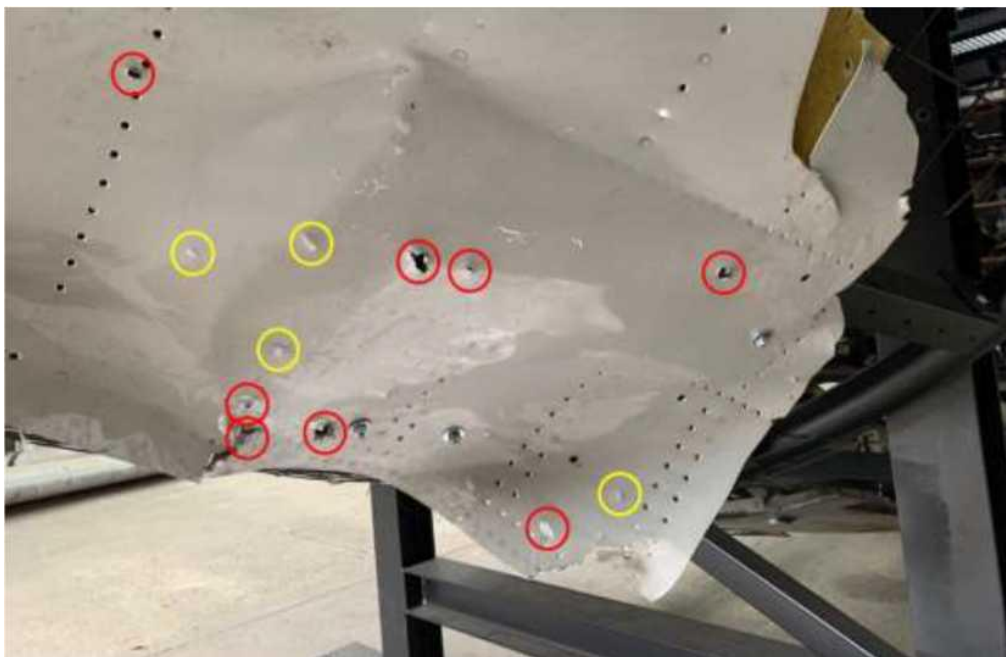
Figure 5.1.51 - "inside-out" exit damage in the lower port side of the Boeing 777 under the windows of the crew commander

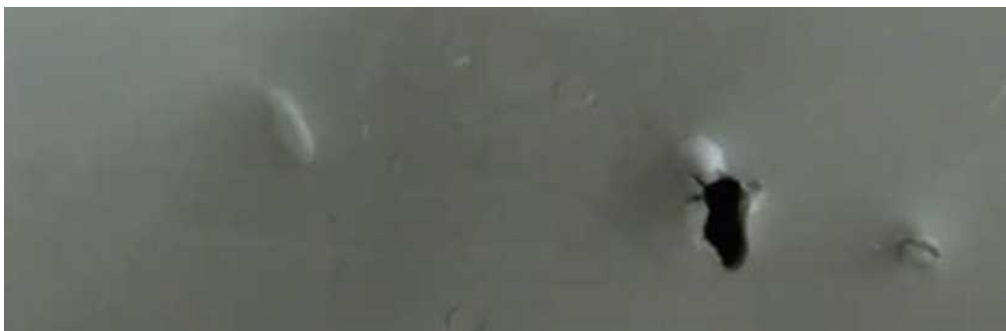
Figure 5.1.52 - Close-up of inside-out exit damage: non-penetrating damage (left) and through-and-through hole damage (right)

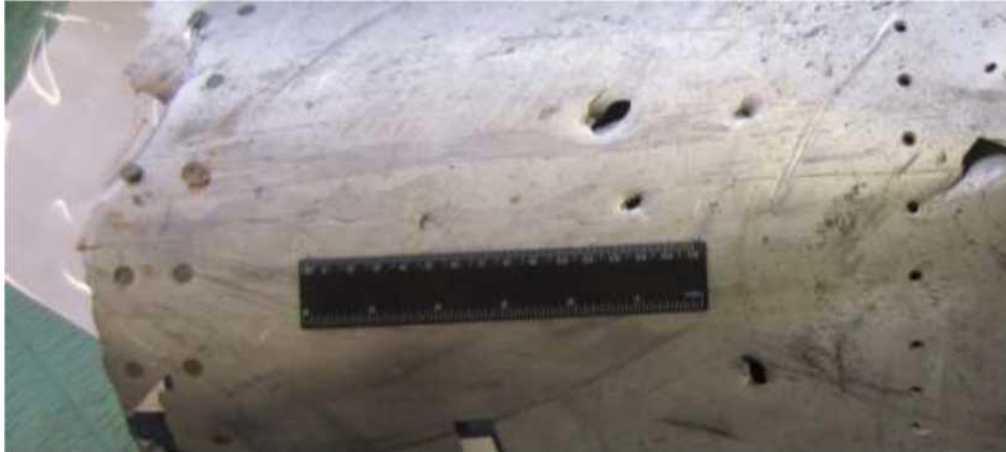
Preliminary layout inspections (February 2015 and May 2015) established that damage (mostly holes) that was identified as damage caused by "high-speed objects", was present in fragments of the left wing plane (Figure 5.1.53).

Figure 5.1.53 - Exterior view of fragment of Boeing 777 left wing tip with characteristic damage

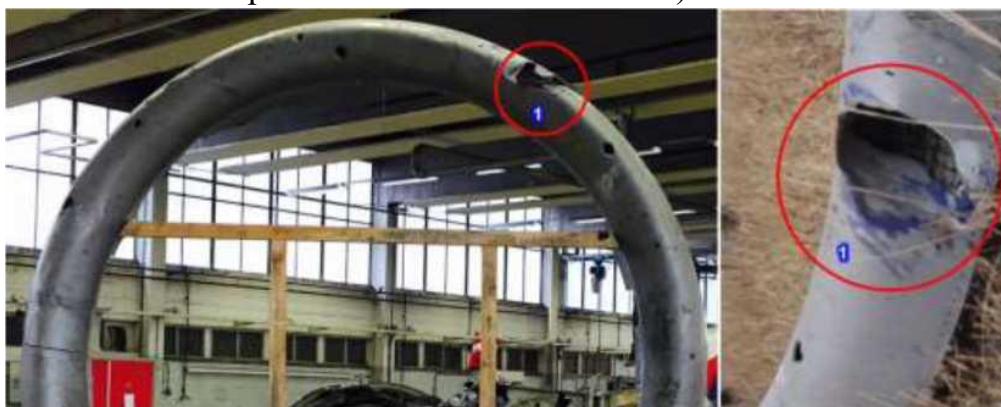
Some of the damage is large in size (significantly larger than the linear dimensions of preformed fragments) and was probably caused by the aircraft structural failure. An example is the damage to the air intake, around which blue paint smears were clearly observed in the crash area.

The presence of blue-coloured smears indicates that this damage was most likely the result of a collision with a fragment of a destroyed aircraft structure (e.g. the outer skin of the port side of the aircraft is blue).

Figure 5.1.55 - Example of secondary damage to the left engine air intake edge

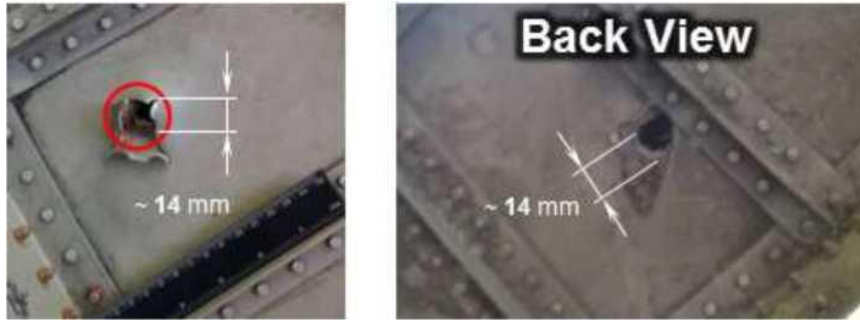
In this connection, the most important of the fragmentation damage to the left engine are the exit through-and-through holes with linear dimensions of about 14 mm located in the structural elements behind the edge of the left engine air intake (Figure 5.1.56).

Figure 5.1.56 - Exit through-and-through "inside-out" holes in the left engine air intake edge (rear view).

The linear size of the holes is about 14 mm

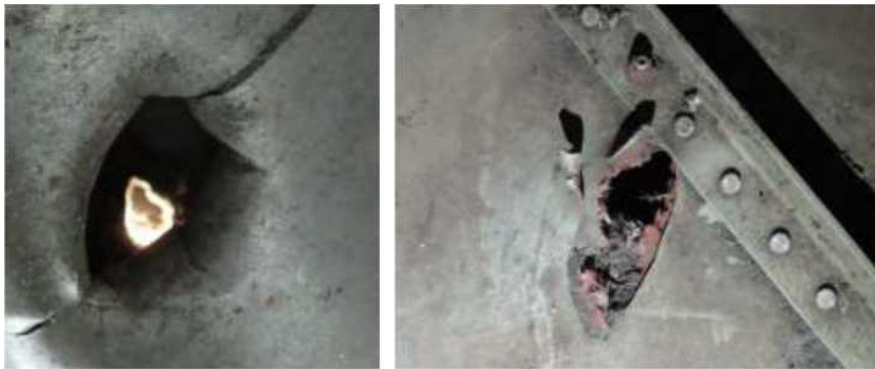
It is also important that these exit holes correlate with the corresponding entry holes in the outer skin of the air intake. Figure 5.1.57 shows: the entry hole in the air intake edge (left) and the 'inside-out' exit hole in the structural element behind the air intake edge. To demonstrate their mutual relationship, the hole is illuminated by a flashlight from behind.

Figure 5.1.57 - Exit "inside-out" through-and-through hole in the structural element of the left engine air intake edge (right). The linear size of the exit hole is about 14 mm

In such case, the entry hole shown in Figure 5.1.57 (left) is larger than the original dimensions of the preformed fragments. However, this is not a reason to attribute this damage to the impact of large missile body fragments, as was done in the DSB materials.

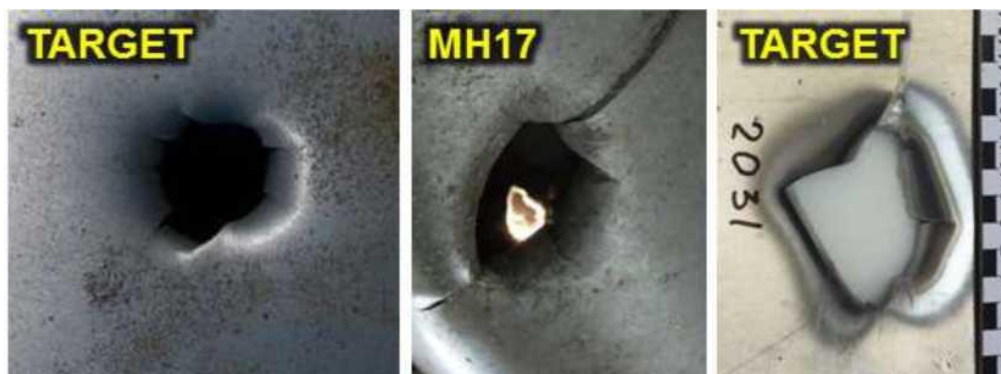
For example, similar results were obtained by Russian specialists. Figure 5.1.58 shows a comparison of the appearance of "large" holes on the edge of the left engine air intake (in the middle) and holes in targets resulting from tests and experiments carried out in 2015 and 2016.³⁵

Figure 5.1.58 - "Large" holes caused by preformed fragments: left - from tests involving a 9H314M warhead; middle - on a Boeing 777 air intake; right - from special experimental studies assessing the penetrating effect of preformed fragments

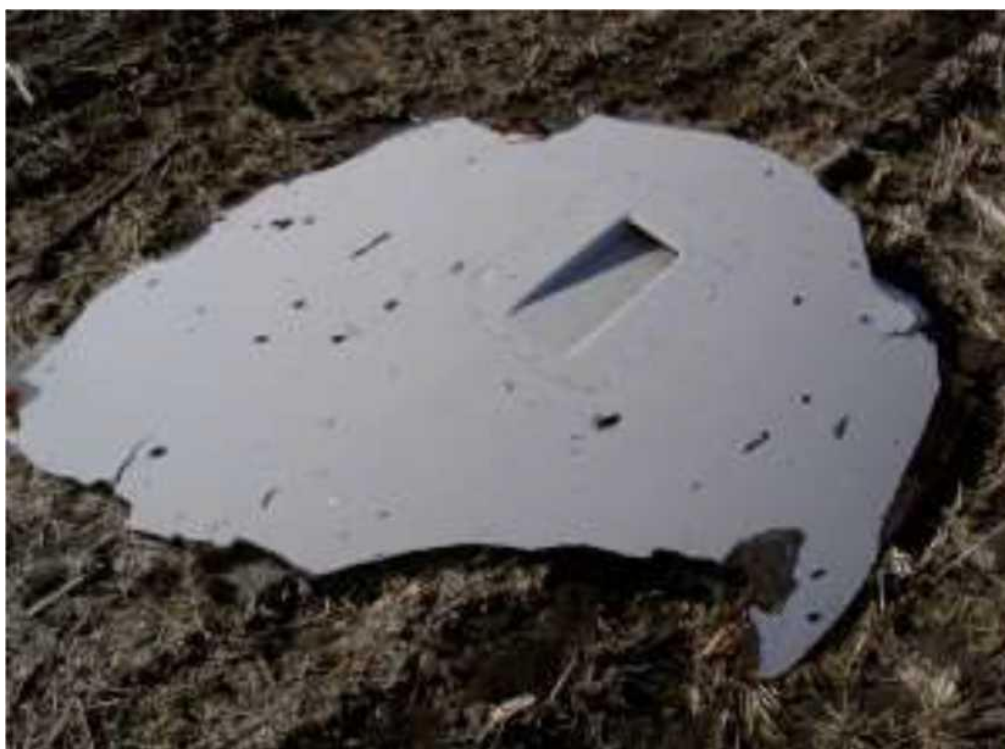
Figure 5.1.59 - Fragment of composite body of left engine nacelle (presumably) with traces of fragmentation damage

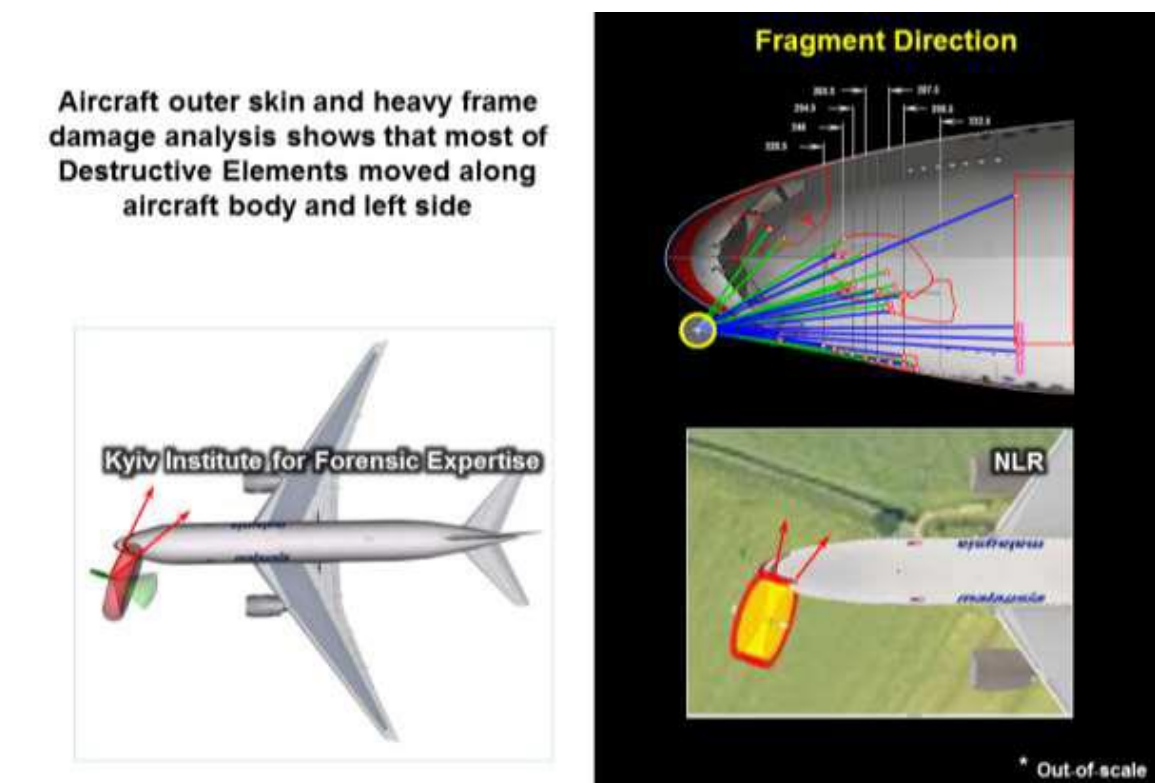
Figure 5.1.60 presents a generalised diagram showing the main directions of damage reconstructed using studies of the damage to the outer skin and the airframe of the Boeing 777 airliner.³⁷

Figure 5.1.60 - Direction of fragment movement along the aircraft structure: the direction of damage to the outer skin is shown by green lines and the direction of the aircraft structural frame damage (through-and-through holes in the bulkheads) is shown by blue lines

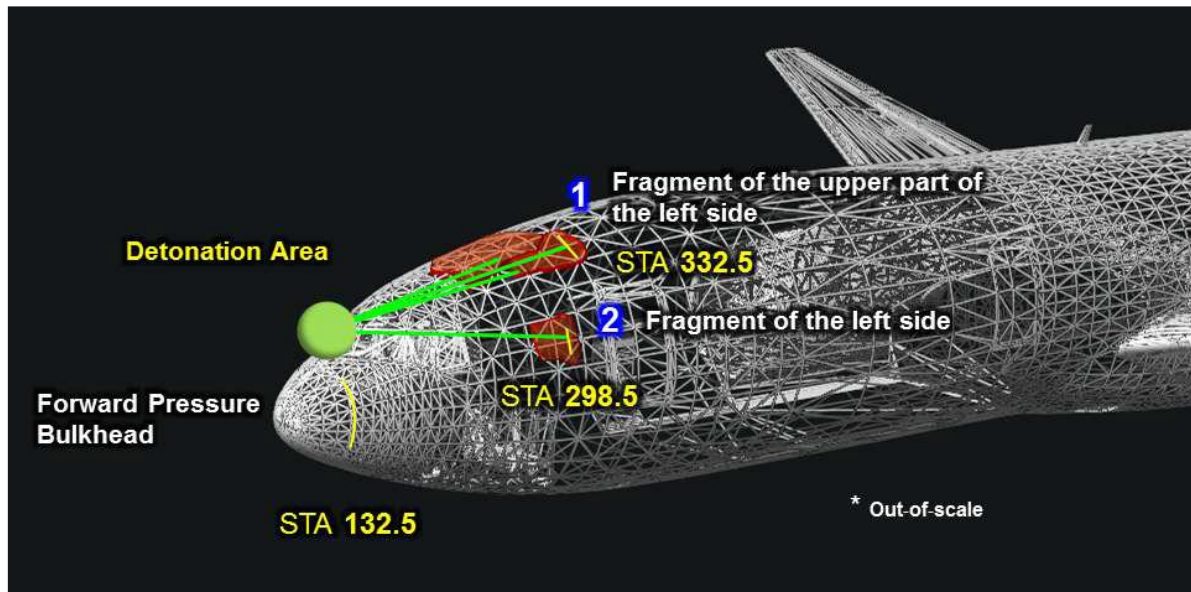
As an example, Figure 5.1.61 shows the possible reconstructed trajectories of part of the projectiles for important fragments with a high density of fragmentation damage, which, however, are not present in the final 3D reconstruction.

Figure 5.1.61 - Trajectories of projectiles along the aircraft structure as exemplified by two fragments at STA 298.5 and STA 332.5, where:
 1 is a fragment of upper port side (not included in 3D reconstruction);
 2 is a fragment of the port side (was not exported to the Netherlands)

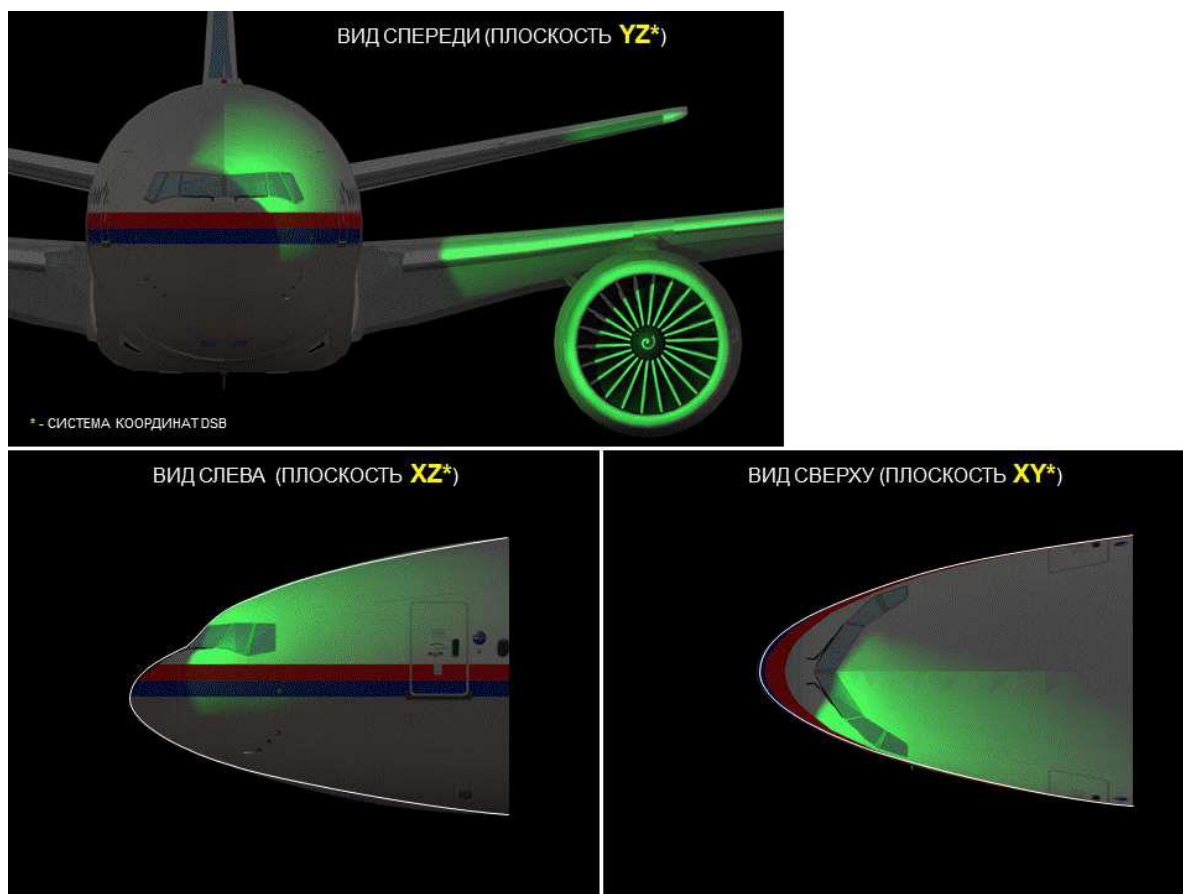
Taking into account the boundaries of the fragmentation field affecting the forward part of the aircraft which were determined from fragments of the cockpit, port and starboard side, cockpit roof and behind the cockpit, and elements of the left wing plane and left engine, a model of damage to the outer skin of the Boeing 777 (fragmentation field) was constructed and is shown in Figure 5.1.62.

Figure 5.1.62 Fragmentation field model for the forward part of the fuselage, left wing plane and left engine of a Boeing 777 aircraft

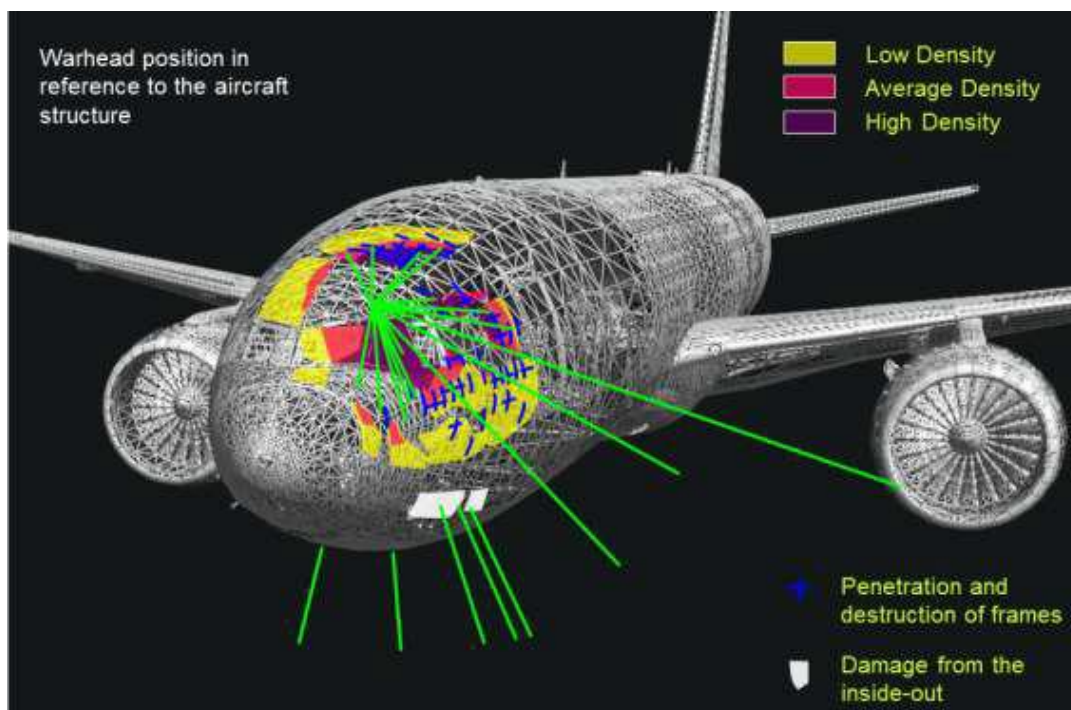
Figure 5.1.63 - Fragmentation damage density distribution coincides with the areas and directions of perforation and fracture of the Boeing 777 structural elements (along the port side and left side of the aircraft roof at a slight angle to the aircraft's structural axis)

Analysis of the location, distribution and direction of fragmentation damage shows that high density fragmentation impacted the front windows on the left side, along the top left side of the roof and further along the port side.

The main features of fragmentation damage (through-and-through holes and part-through holes) to the outer skin, airframe, floor and interior of the cockpit are:
 a clearly marked forward boundary of the coverage field - the damage starts from the forward pressure bulkhead STA 132.5;

on the starboard side of the pilot's roof the damage is recorded up to the level of bulkhead STA 265.5, while on the left side of the roof it is spread beyond the level of bulkhead STA 309.5, and in the upper part of the port side the damage to the outer skin is spread beyond the level of bulkhead STA 332.5;

damage to the airframe extends beyond visible damage to the outer skin;

the most damage is spread along the left side of the aircraft fuselage at a slight angle to the centreline (CLA).

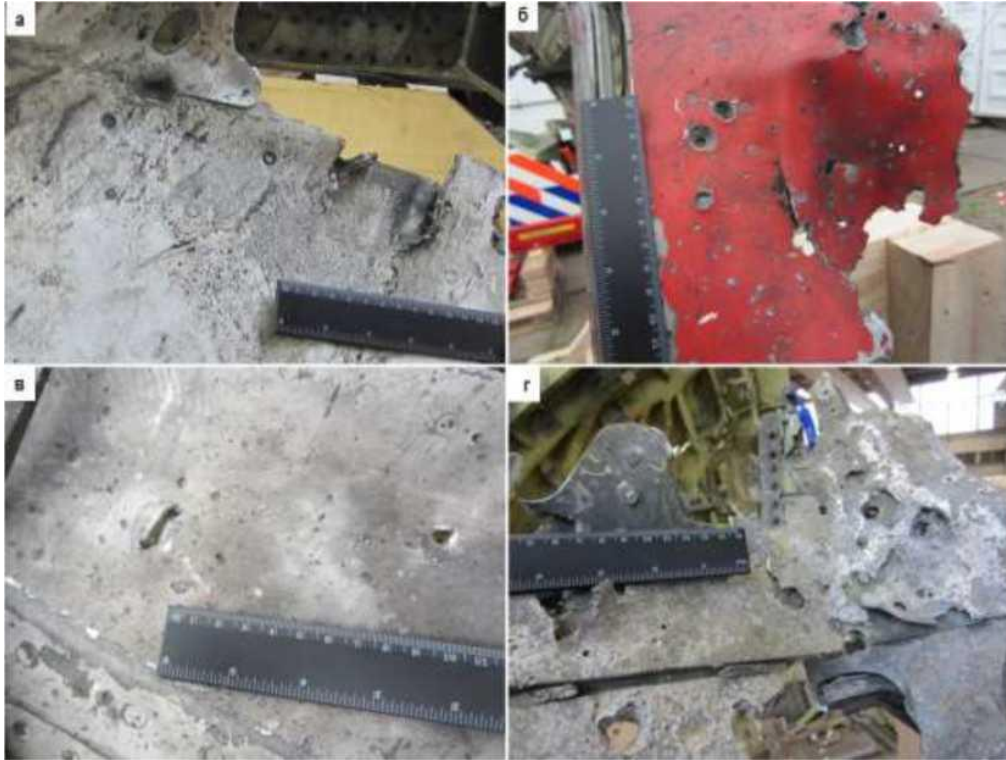
On the surface of the outer skin of the Boeing 777-200 (MH17), a cratering effect is observed in the area of some relatively large breaches. A rash of microcraters is damage caused by high velocity "dust" (particles of unburned explosive material, small particles of warhead structure and projectiles) accompanying the blast wave at a short distance from the blast site.

Figure 5.1.64 - Microcrater areas: right side of cockpit roof (a), forward part with pressure bulkhead (b, c), transparency frame (d)

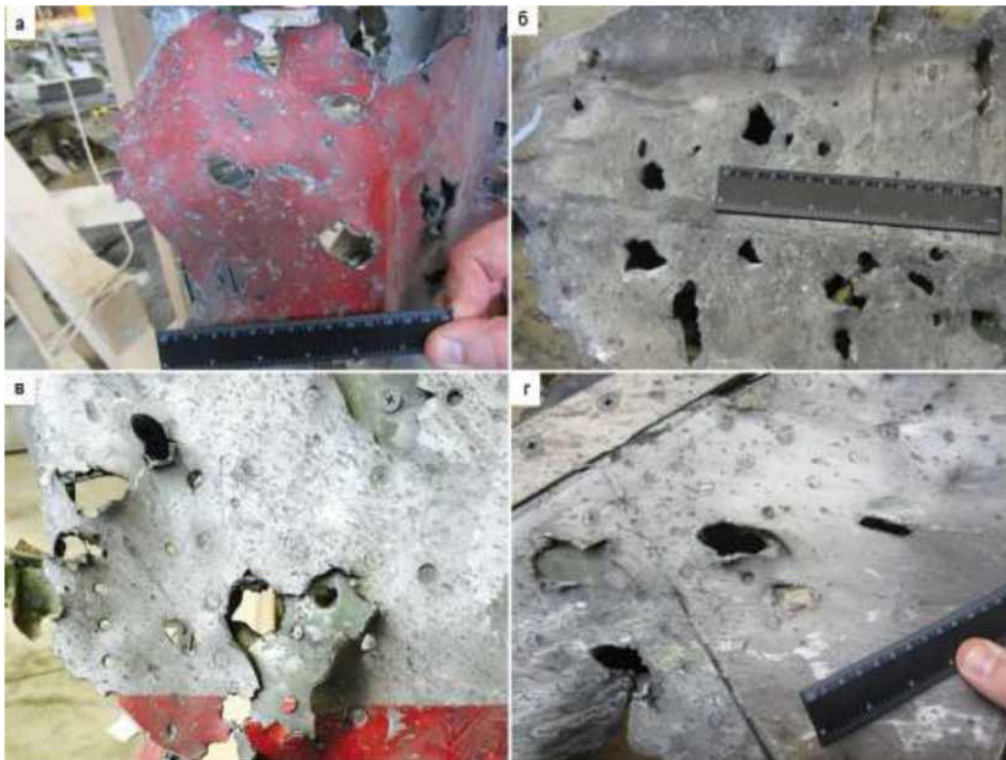
Figure 5.1.65 - Areas of microcrater formation on the port side

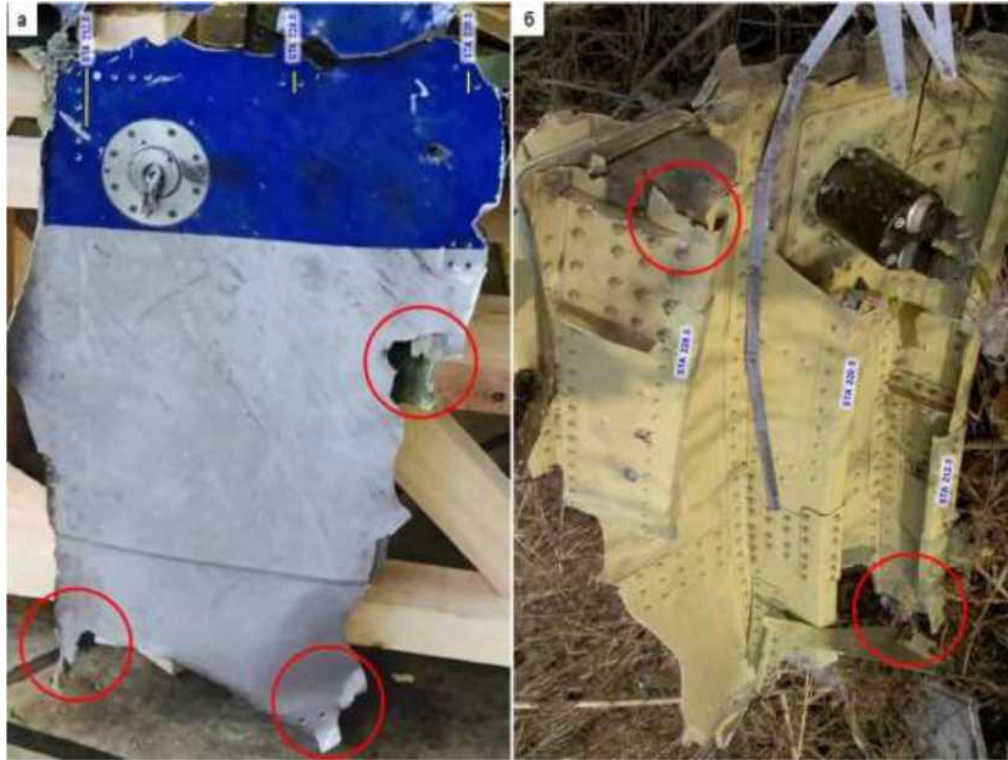
Thus, a fragment of the port sidewall skin with the angle-of-attack sensor, shown in Figure 5.1.69, shows all the main signs of damage typical of a close explosion (highlighted in red) - breaking and deformation of the skin sheets, destruction of the structural elements (bulkheads), and tearing of the skin sheets from the stringers and bulkheads.

Figure 5.1.69 - Blast damage on a fragment with an angle of attack sensor on the outer (a) and inner (b) sides

Figures 5.1.69 and 5.1.70 show in red the most typical damage, i.e. deformation of the load bearing elements and of the outer sheathing sheets. The airframe was destroyed by perforations (through-and-through holes from preformed fragments) in

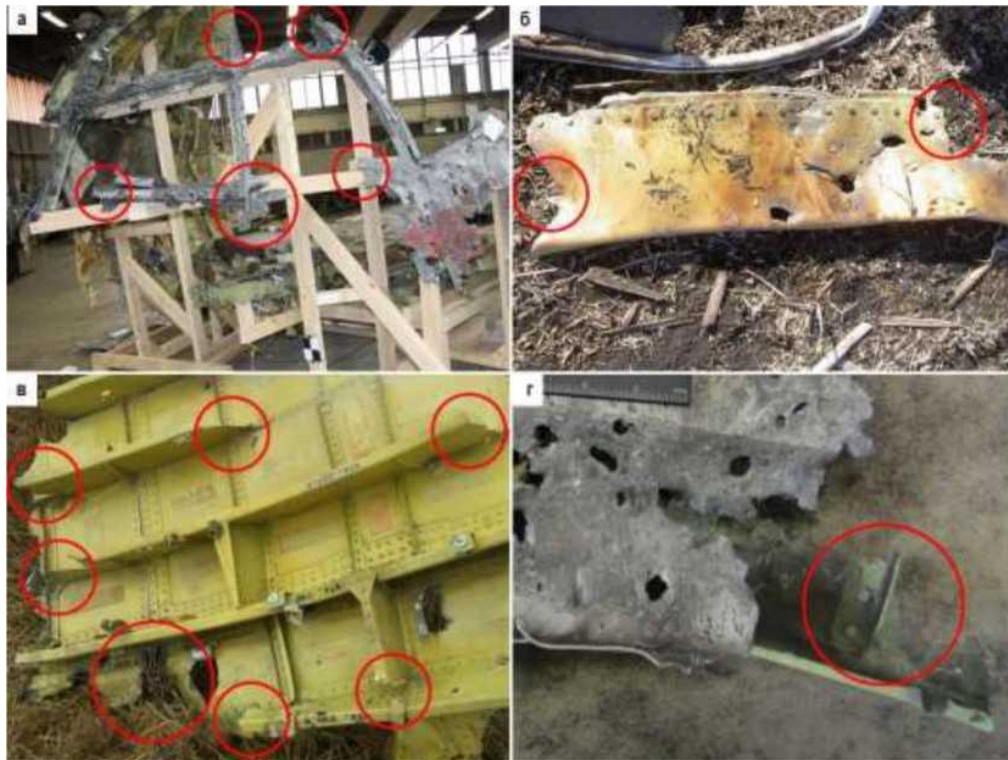
Figure 5.1.70 shows examples of blast damage to the transparency frame (a), roof fragments (b) and (c) and the port side behind the cockpit transparency (d).

Figure 5.1.70 - Deformation and destruction of structural elements

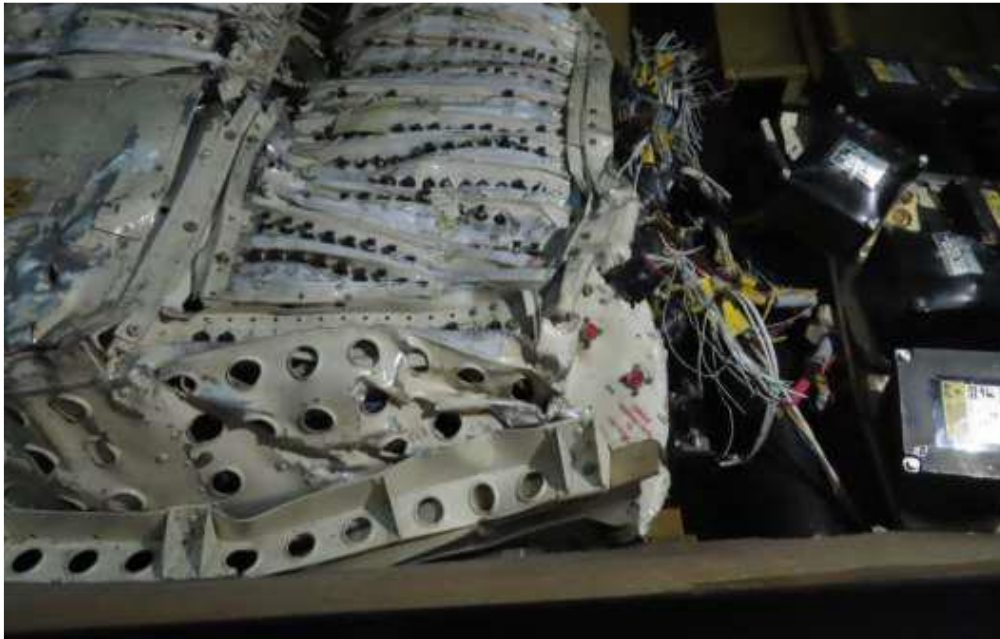
The internal equipment located in the Main Equipment Centre⁴⁴ shows signs of deformation on the port side up to the level of STA 409 (figure 5.1.71).

Figure 5.1.71 - Combined damage to avionics along the underside of the port side behind the cockpit (Main Equipment Centre)

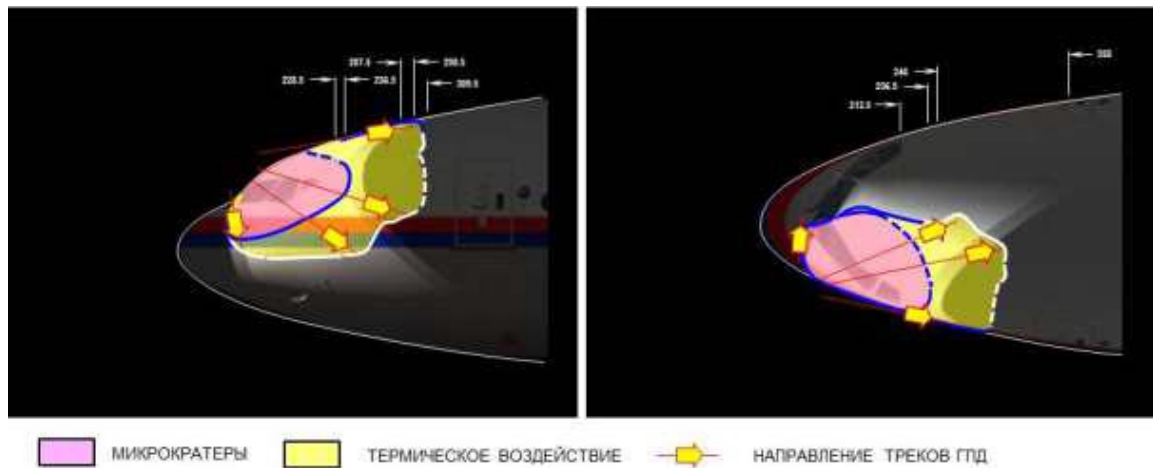
Figure 5.1.72 shows the area of damage caused by various blast factors: formation of microcraters, thermal effects and hot detonation product (HDP) tracks.

Figure 5.1.72 - Areas of the aircraft structure where traces of blast effects are observed

The amount, intensity and direction of spread of damage directly caused by blast factors suggest that the epicentre of the explosion was in the immediate vicinity of the transparency frames (between the windows of the crew commander) at a short distance (not more than 1.6-2.0 m) from the outer skin of the aircraft. A similar damage pattern in terms of intensity and location was obtained in the tests in the first experiment,⁴⁵ described in Exhibit A.4.3 of this report.⁴⁶

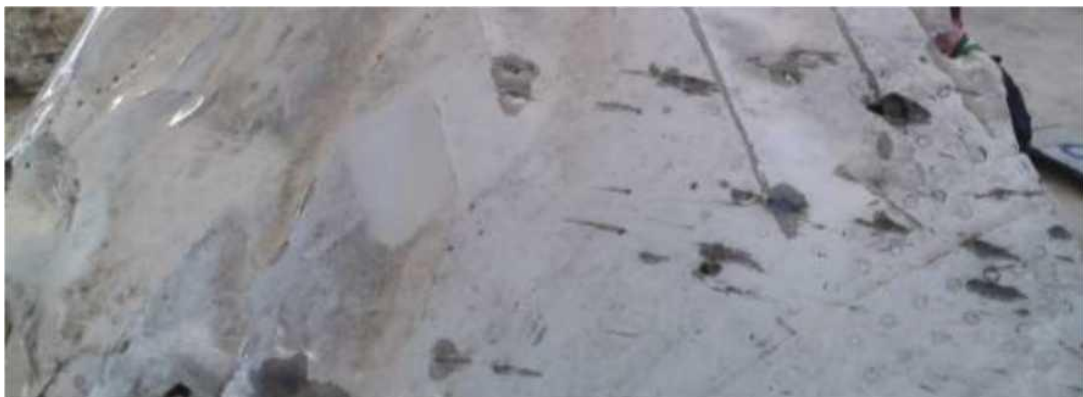
Battle damage near the boundary of the cover field is an elongated, clearly oriented rectilinear track, formed by the contact between the outer skin sheets and the projectiles, whose trajectories were oriented tangentially to the outer contour of the fuselage at this point (Figure 5.2.1).

Figure 5.2.1 - Example of characteristic damage near the boundary of the overlapping field on the right side of the cockpit roof
