**APPLICATION OF THE INTERNATIONAL CONVENTION FOR THE SUPPRESSION
OF THE FINANCING OF TERRORISM AND OF THE INTERNATIONAL
CONVENTION ON THE ELIMINATION OF ALL FORMS OF RACIAL
DISCRIMINATION**

REJOINDER

Report of JSC Air and Space Defense Corporation "Almaz-Antey" on the results of studies related to the technical investigation into the crash of the Malaysian airlines Boeing 777-200 9M-MRD (flight MH17), 2023

on the results of studies related to the technical investigation into the crash
of the Malaysian airlines Boeing 777-200 9M-MRD (flight MH17)

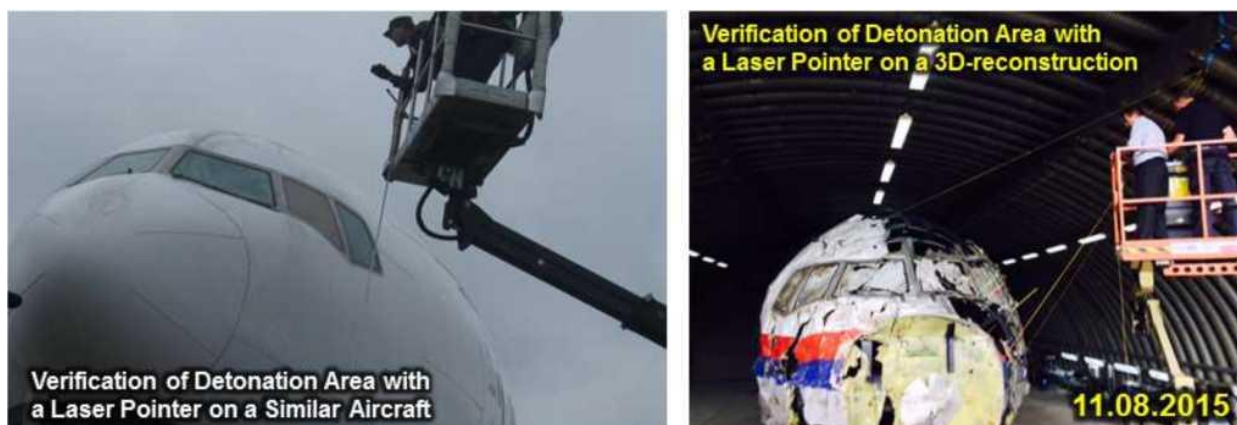
After calculations and modelling, the correspondence between the detonation point and the main marker points of the left side, the roof behind the cockpit and the right side of the cockpit roof were verified using a laser pointer on a Boeing 777 aircraft similar to MH17.

In addition, the validity of the resulting calculations was demonstrated directly at a 3D-reconstruction of the aircraft in August 2015 in a hangar at Gilze-Rijen Air Base.⁵¹

Figure 5.2.2 - Verification of the location of the detonation point area:
left - on the reference aircraft (Boeing 777-200);
right - on the 3D reconstruction in the hangar (Gilze-Rijen)

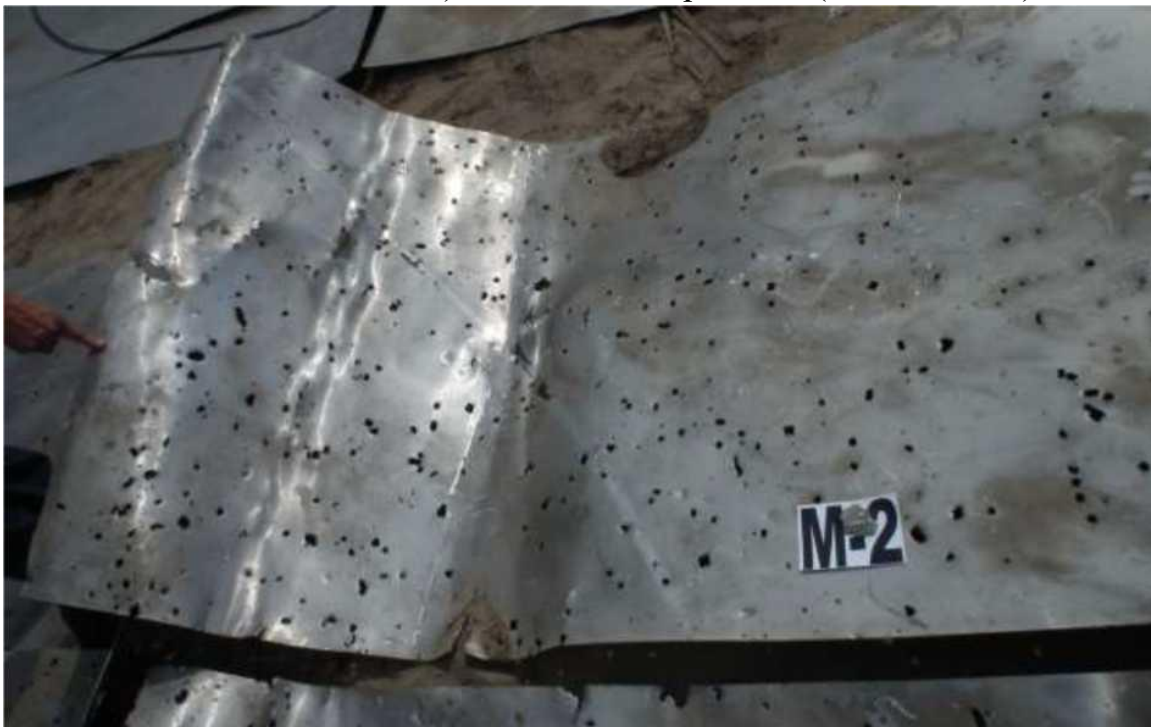
As an example (Figure 5.2.3), an exterior view of a fragment of a target layout (witness sheet) containing three types of penetrations: prefabricated projectiles (PEAs), hull projectiles (fragments of compartment bodies which may not have the same dimensions as the PEAs) and detonation products (1-3 mm holes) are shown.

Figure 5.2.3 - General view of fragment 2.1 of target No. 2

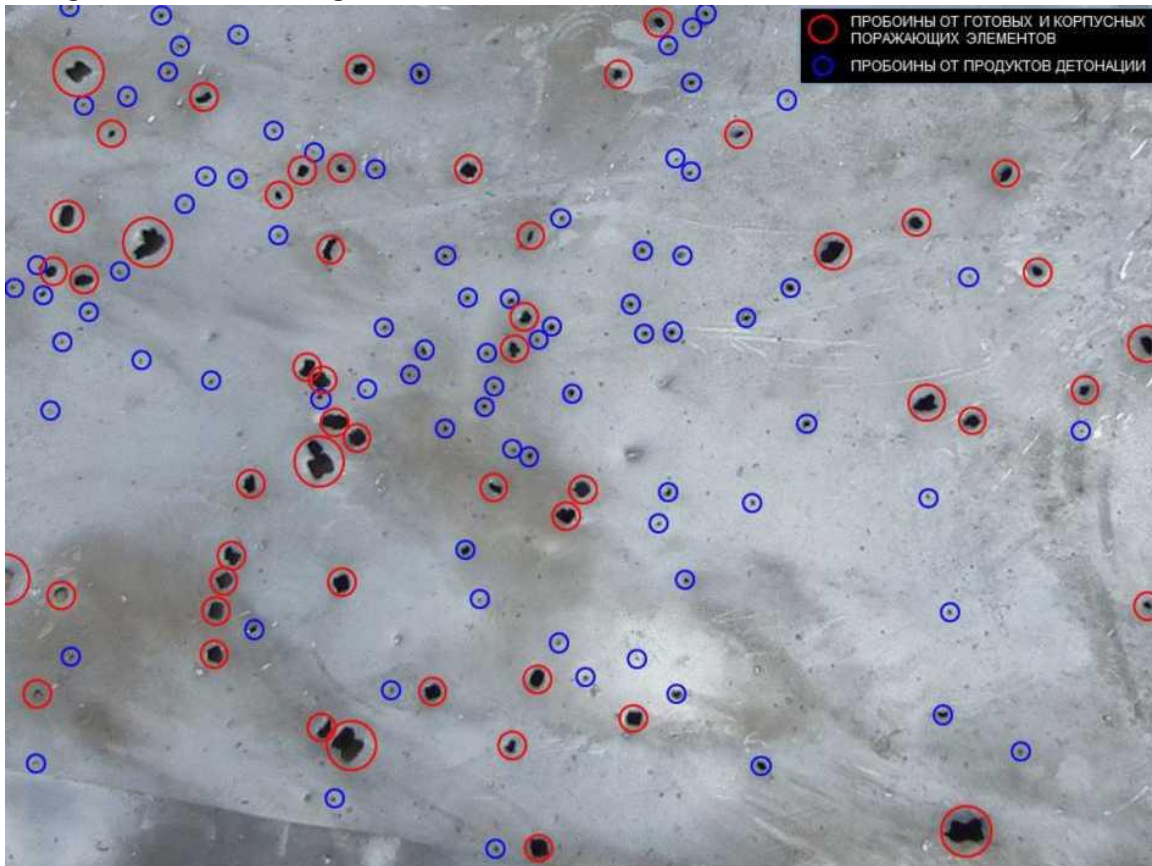
Figure 5.2.4 - Close-up of Fragment 2.1 of Target No. 2.

Entry holes vary in configuration from an elongated compact shape to a distinctive "butterfly" shaped hole for off-the-shelf projectiles and hull fragments, and small holes (1-3 mm) from detonation products

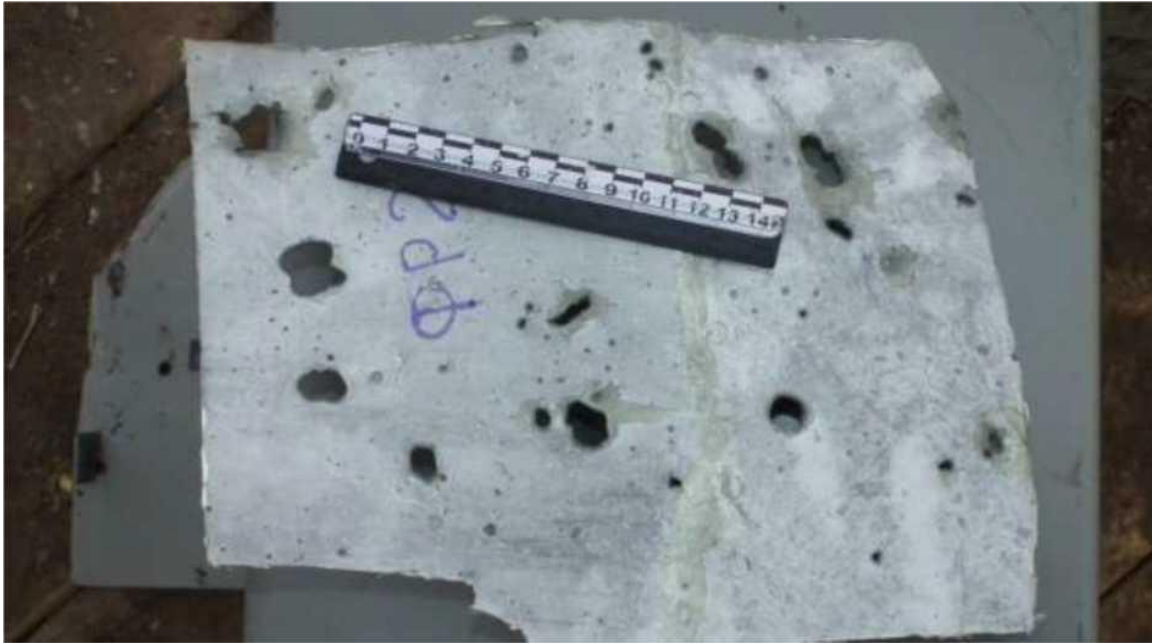
A similar pattern of damage was obtained in the second experiment with the IL-86 target aircraft, where a missile assembly was detonated. Figure 5.2.5 shows a photograph of a fragment of the target aircraft ("FR 2") with all three types of penetrations, including the distinctive butterfly-shaped penetration.

Figure 5.2.5 - Close-up of fragment "FR 2" of target GB-86

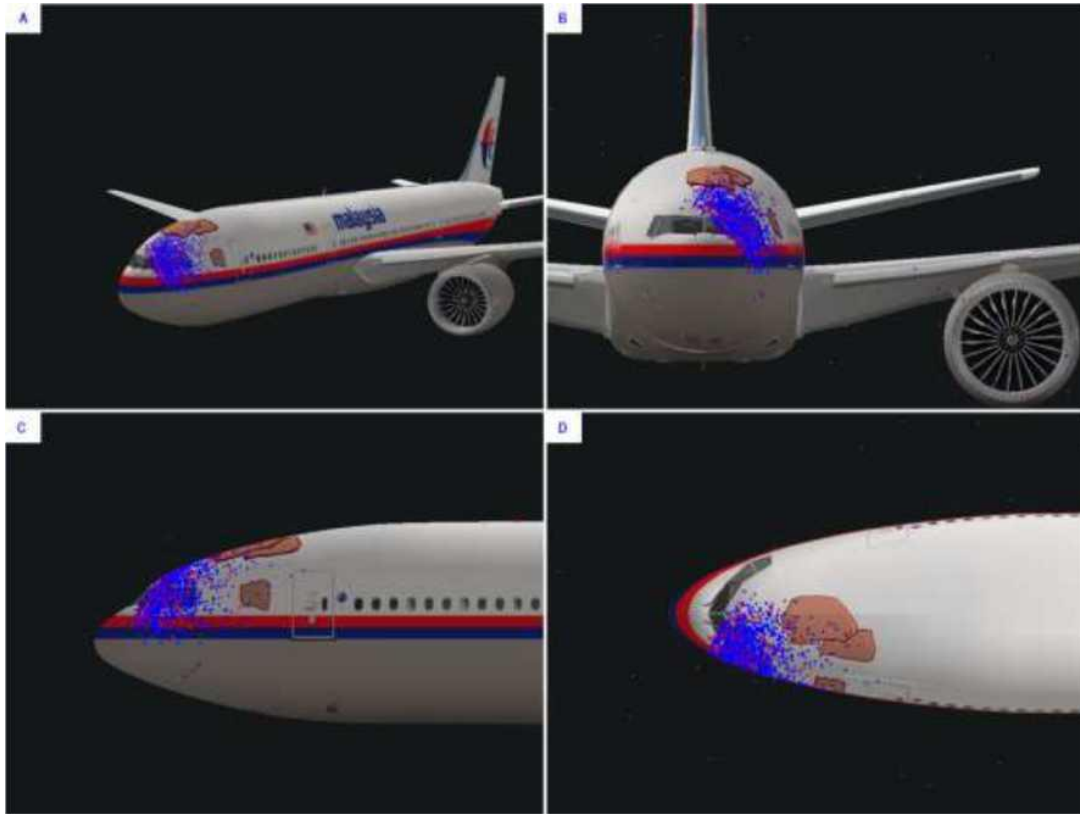
Figure 5.2.17 - Fragmentation cover field derived from modelling using a verified detonation area

The best results have been obtained for the horizontal angle of intersection of the missile with the aircraft's construction axis, ranging from -50° to -62° . The minimum missile velocity at impact (600 m/s) corresponds to the maximum intersection angle, while the velocity of 730 m/s corresponds to a minimum value of -50° .

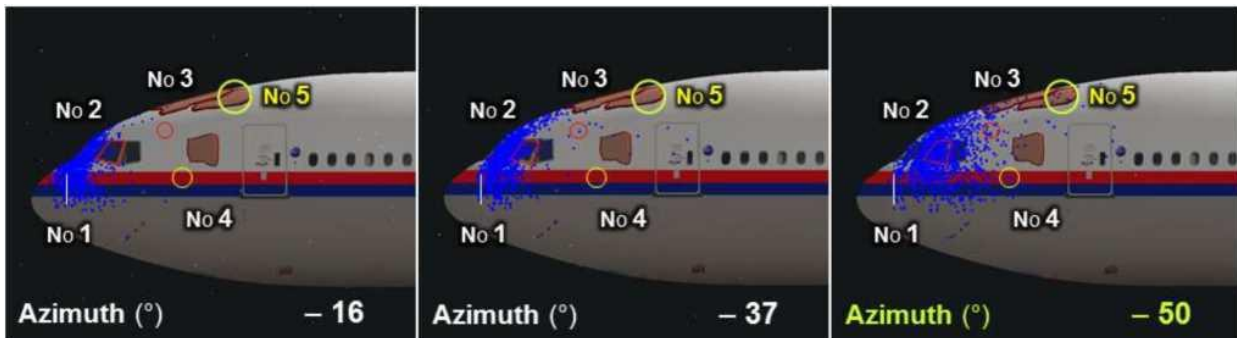
Figure 5.2.18 - Comparison of left side damage modelling results of Boeing 777 for three values of crossing angle

Among the variants considered, only for the "Azimuth -50° " variant do the boundaries of the fragmentation overlap between modelled and actual damage most closely coincide on reference fragments No 1-No 5 with characteristic damage.

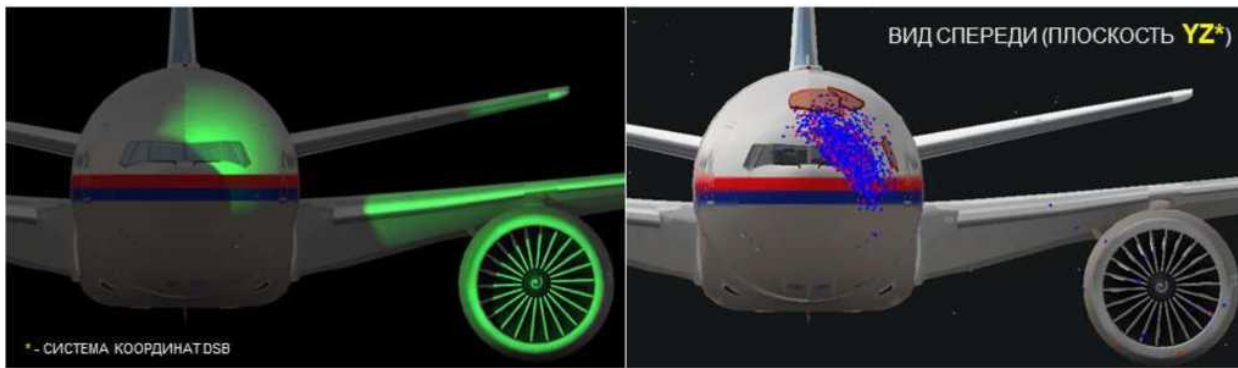
Figure 5.2.19 - Damage model visualisation for the "collision course" version, which explains all damage to the outer skin, airframe, left wing plane and left engine of the Boeing 777: left - damage boundary model; right - fragmentation coverage field

Figure 5.2.19 shows a visualisation of the fragmentation cover field for conditions ($AZ_{\text{Warhead}} = -55^\circ$; $EL_{\text{Warhead}} = 22^\circ$) showing the correspondence actual and modelled damage along the front fuselage overlap field boundaries, as well as including the left wing plane and left engine of the Boeing 777 aircraft.

It is at this orientation of the warhead (at least -50°) that comparison criteria No. 1 (conformity of cover field boundaries), No. 2 (no fragmentation damage to the forward gimbal), No. 4 (conformity of damage direction) and No. 8 (damage to the left wing plane and left engine preformed fragments), specified in paragraph 5.1.3, are met.

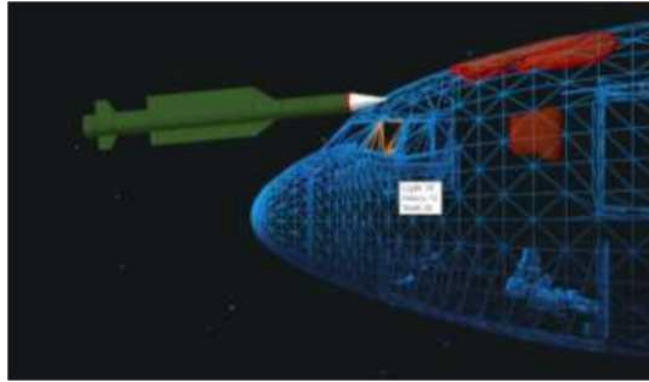
Figure 5.2.21 - Simulation of fragmentation damage to the nose of a Boeing 777 aircraft under Azimuth -16° conditions. The polygonal objects corresponding to the second left window are highlighted in orange on the interactive aircraft model

The simulation results in only 72 splinters in the second window:

The number of simulated damages (46 units) is 2.22 times less than the number actually recorded in the second window (102 units).

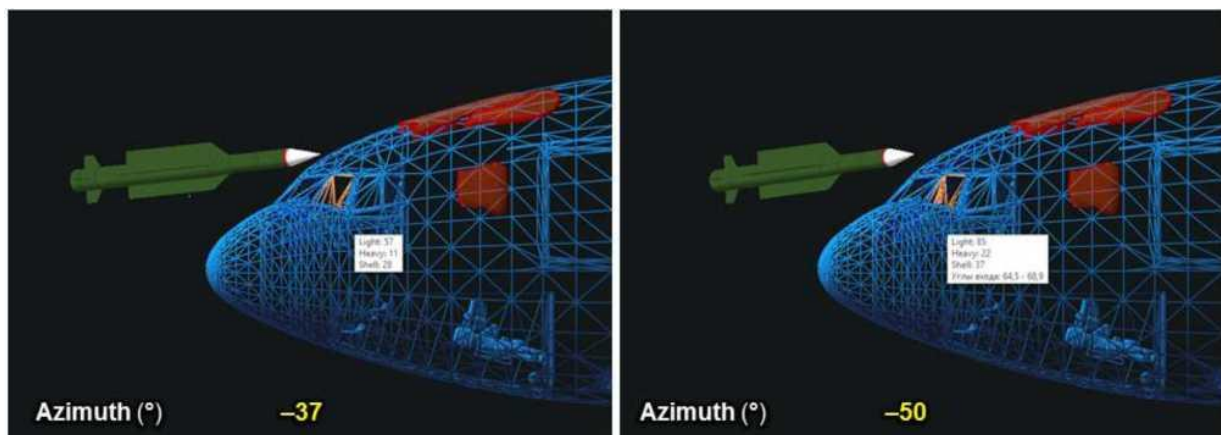
Figure 5.2.22 - Simulation of fragmentation damage to the nose of a Boeing 777 aircraft under Azimuth -37° (left) and Azimuth -50° (right) conditions

The number of modelled damage (107) is comparable to the number of actually recorded damage at the second window (102), and the modelled density is also comparable to the actual values recorded at the second window - about 250 punctures per square metre.

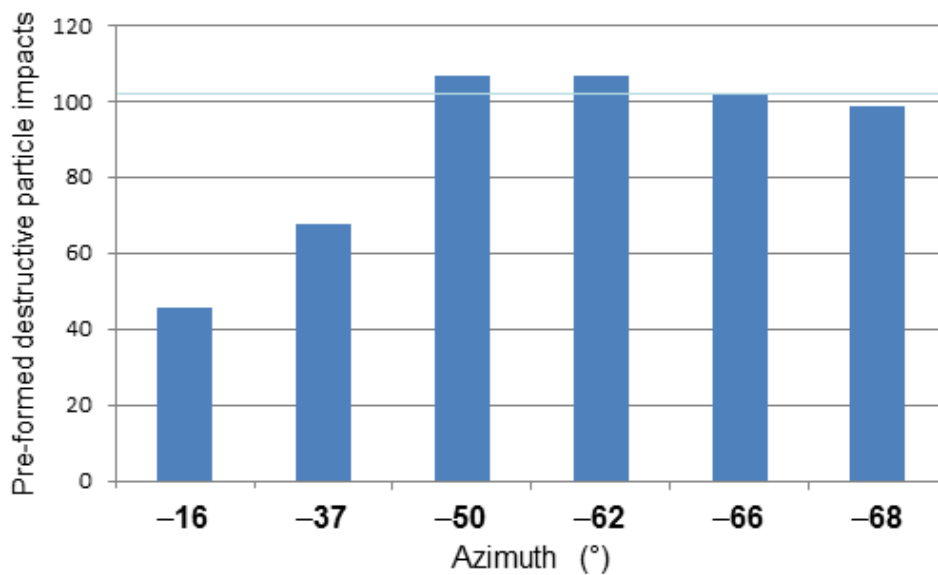
The modelling results for all variants are shown in Figure 5.2.23 as a histogram, from analysis of which the range of acceptable azimuth values is from -50° to -68° , with the best match for -66° .

Figure 5.2.23 - Fragmentation damage to the second left window when the missile's warhead is oriented at horizontal angles ranging from -16° to -68°

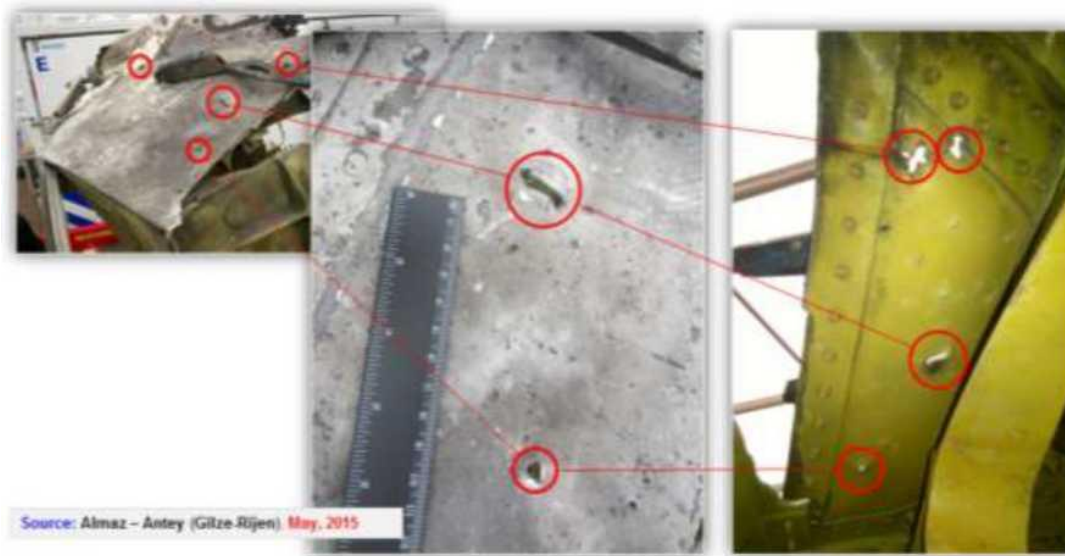
These photos were taken at Gilze-Rijen airbase in May 2015 and show examples of through-hull penetrations caused by hull-mounted projectiles.

That these injuries were not caused by prefabricated projectiles is confirmed by the shape, appearance and linear dimensions of the holes (Figure 5.2.28).

Figure 5.2.28 - Hull damage to the nose section of a Boeing 777 (external and internal view)

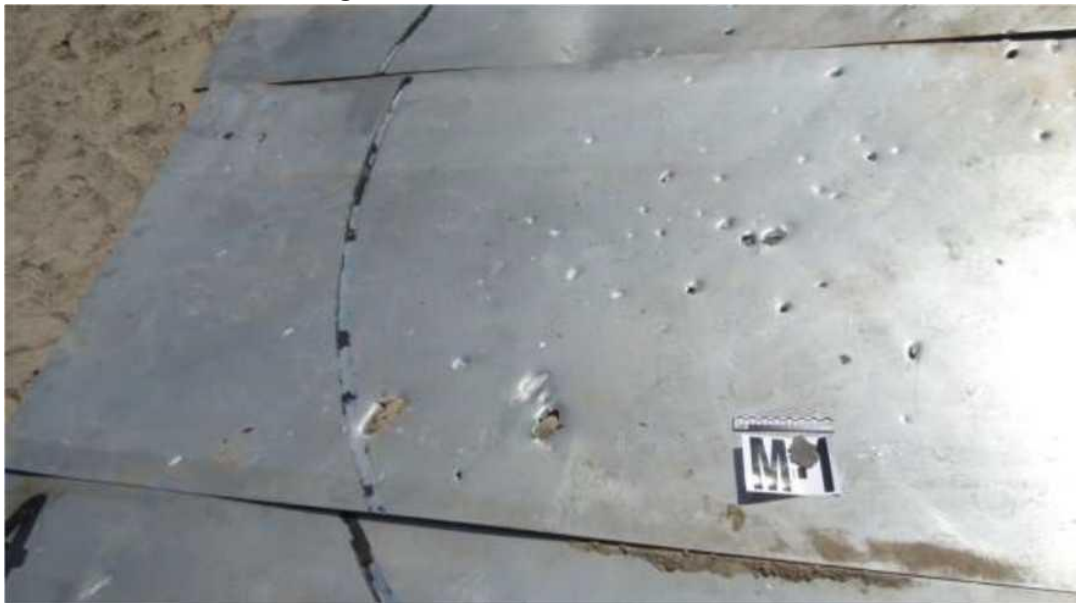
In this case, at small angles between the velocity vector and the plane of the obstacle, the housing fragments, unlike preformed fragments,⁹² do not preferentially penetrate beyond the obstacle and the element ricochets without penetrating the obstacle as shown in Figure 5.2.29.

Figure 5.2.29 - At small angles between the velocity vector and the plane of the obstacle, hull fragments do not penetrate beyond the obstacle and ricochet occurs

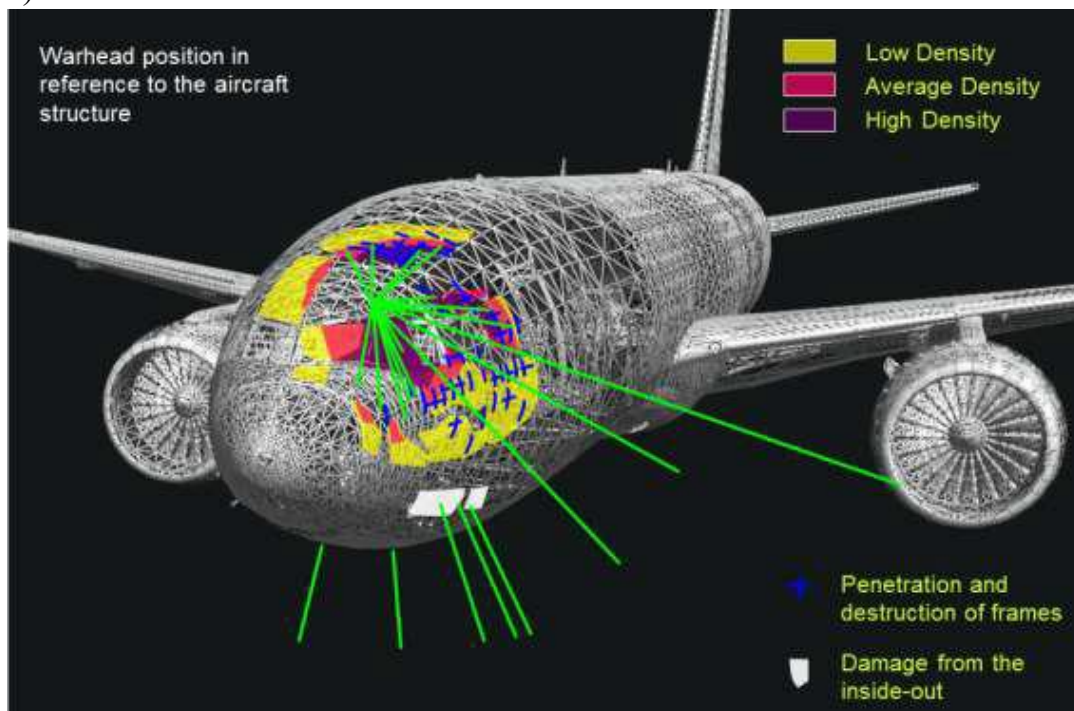
As noted in paragraph 5.1.2.9 of this report, the damage study of the Boeing 777 found that the distribution of fragmentation damage density coincides with the areas and directions of perforation and destruction of the Boeing 777 airframe, cockpit floor and the areas of "inside-out" exit fragmentation damage (Figure 5.2.31).

Figure 5.2.31 - Fragmentation damage density distribution coincides with the areas and directions of perforation and fracture of the Boeing 777 airframe elements

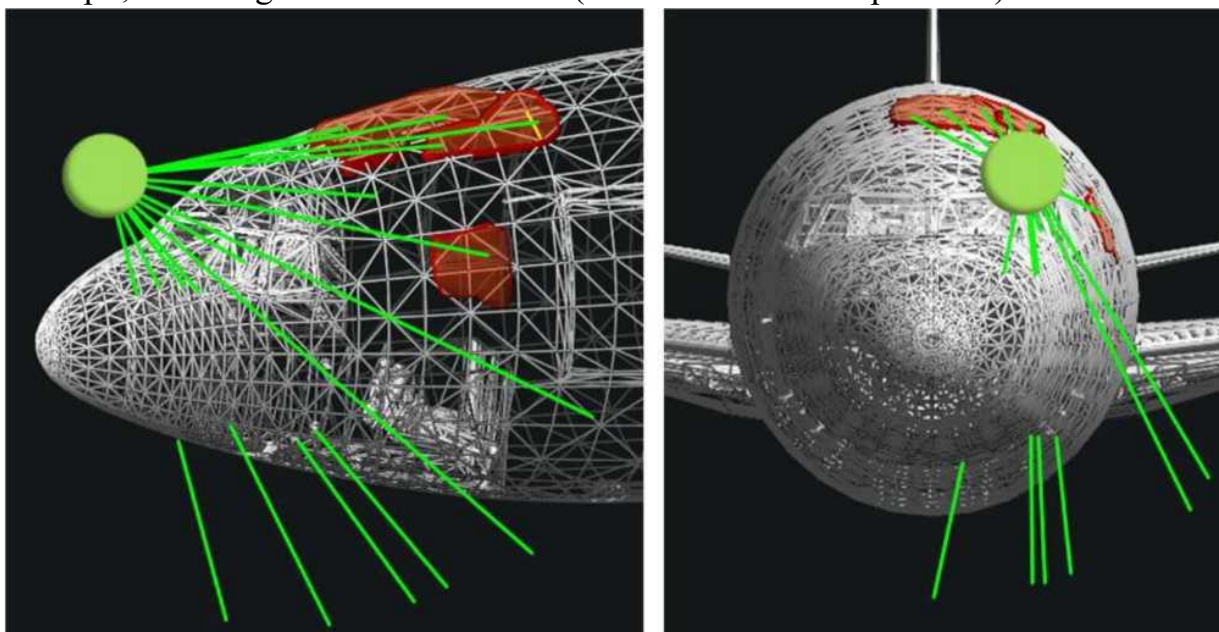
Figure 5.2.32. Visualization of approximate trajectories of ready-made projectiles in a dense fragmentation stream as it passes through or along the structure of the Boeing 777. The green ball indicates the verified detonation area, the green spokes show the directions of trajectories of preformed fragments in a dense fragmentation flow ("scalpel")

The best results for matching the spatial position of the dense fragmentation flux with the reference trajectories were obtained for values of the horizontal angle of intersection of the missile with the aircraft's construction axis ranging from -66° to -74° .

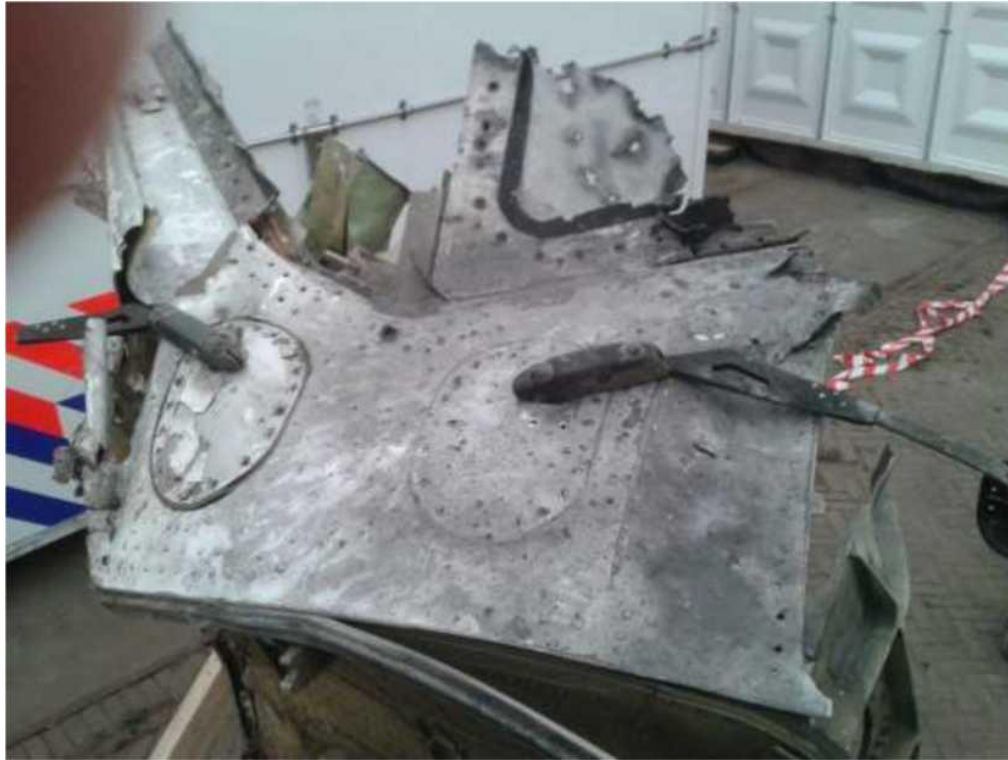
Such a fragment that satisfies these requirements is the nose section of the Boeing 777, adjacent to the front bulkhead at the top (Figure 5.2.34).

Figure 5.2.34 - Fragment of the nose of a Boeing 777, adjacent to the front bulkhead from above (photo February, 2015)

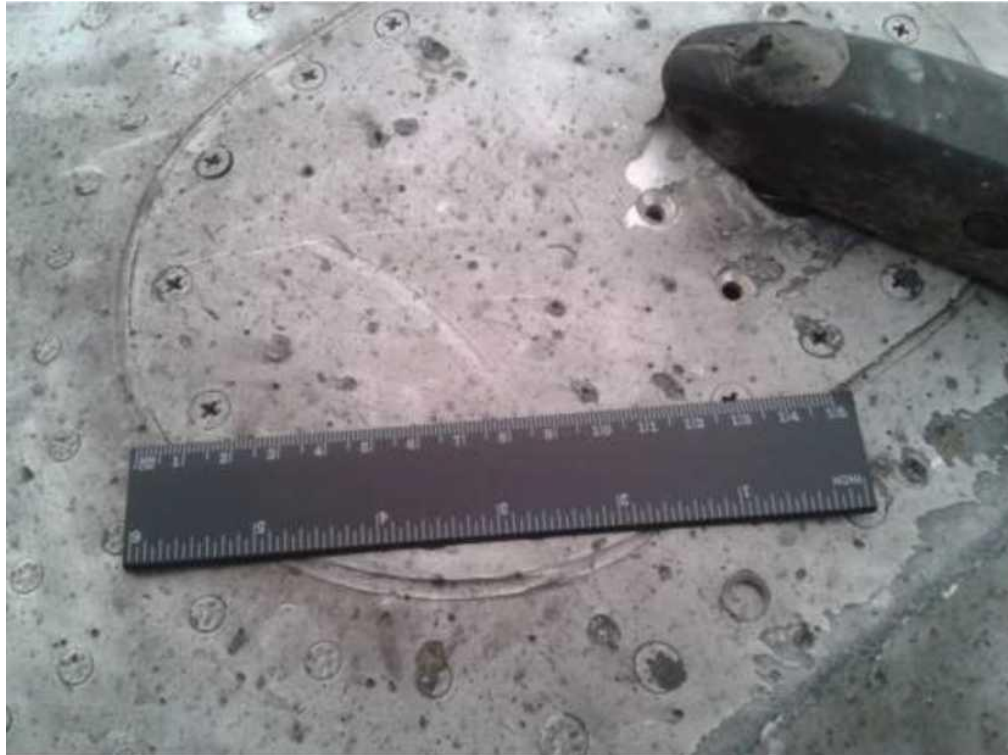
the remaining surface of the fragment before transparency shows only clearly distinguishable traces of close blast products: microcratering, thermal oxidation and soot (Figure 5.2.35).

Figure 5.2.35 - Most of the fragment shows only clearly visible traces of close blast products: microcratification, thermal oxidation and soot (photograph February 2015)

Thus, despite the close blast (not more than 2.0 m from the fragment), the high-explosive effect on this fragment was very low and did not exceed the critical (destructive) value with respect to the fuselage front structure in the cockpit area.

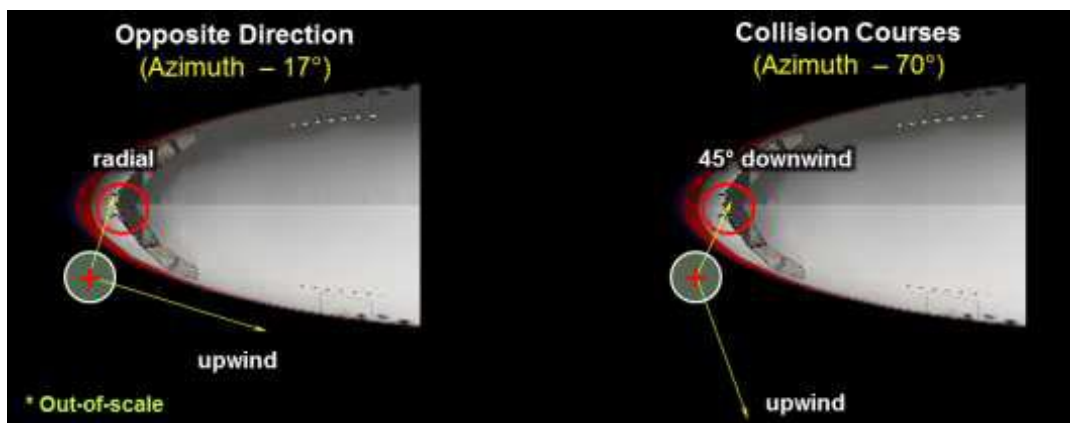
Figure 5.2.36 - Comparison of impact conditions on a fragment of Boeing 777 nose section adjacent to the front bulkhead from above: left - "on an oncoming course"; right - "on a collision course"

Figure 5.2.36 shows a diagram derived from the calculations, showing the blast wave impact directions from the verified detonation region for the two versions of the 9M38 missile impact considered.

Calculations have shown that if the explosion occurred within 1.6-2.0 m, the most likely conditions are that the missile crosses the course of the aircraft between -68° and -72° (Criterion #7).

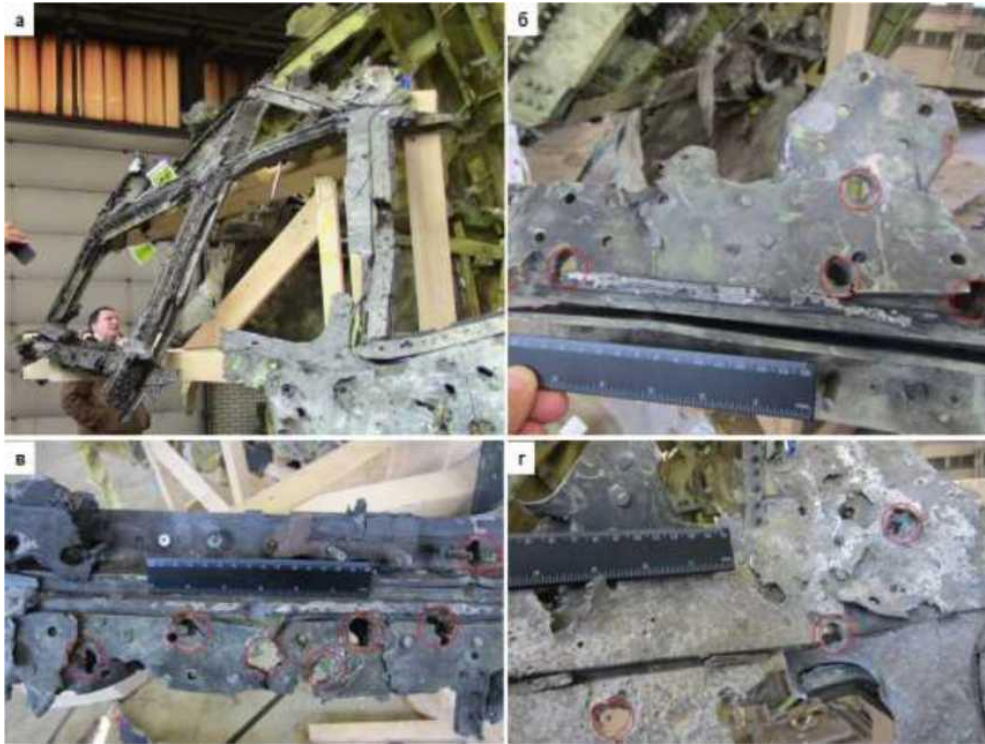
Figure A.1.2 - Exterior view of fragment "F.2" (a) and areas of the fragment with characteristic damage (b, c, d) highlighted in red

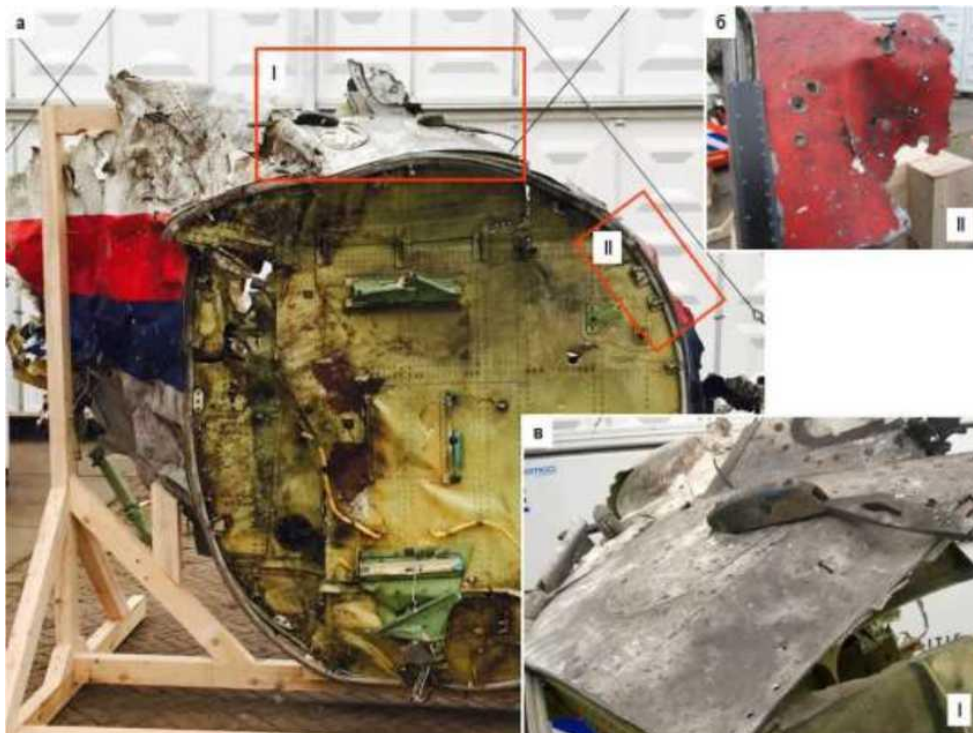
Figure A.1.3 - Exterior view of fragment "F.3" (a) and areas of the fragment with characteristic damage on the port side (b) and in front of the glazing (c)

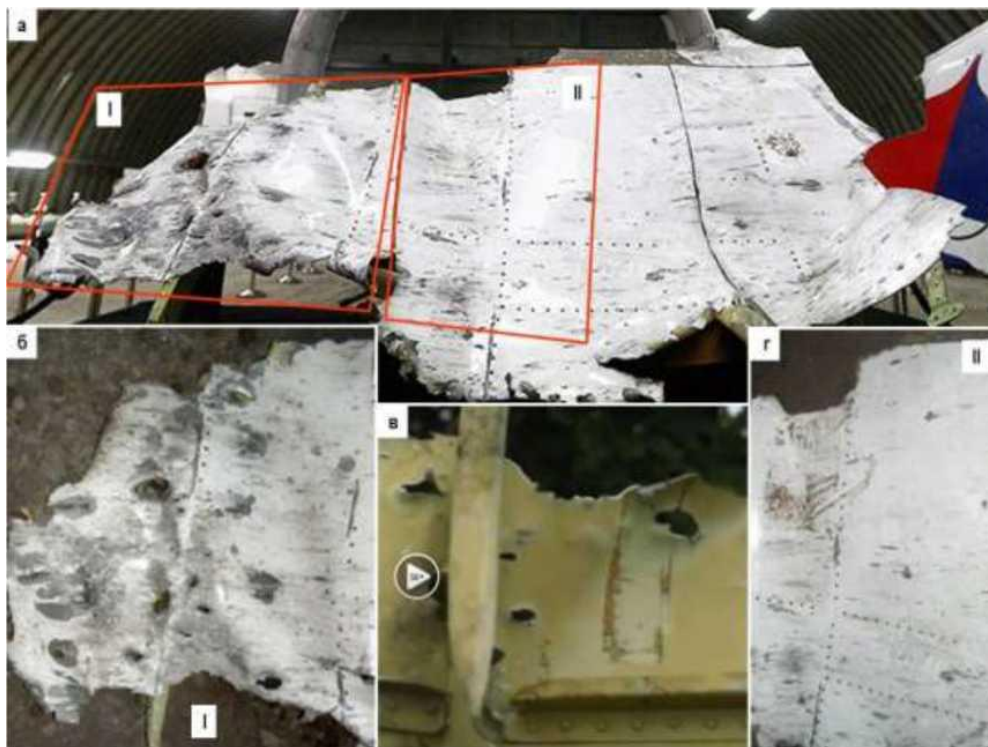
Figure A.1.7 - Exterior view of fragment "F.7" (a) and areas of fragment with characteristic damage from outside (b, d) and inside (c) the port side and roof behind the cockpit

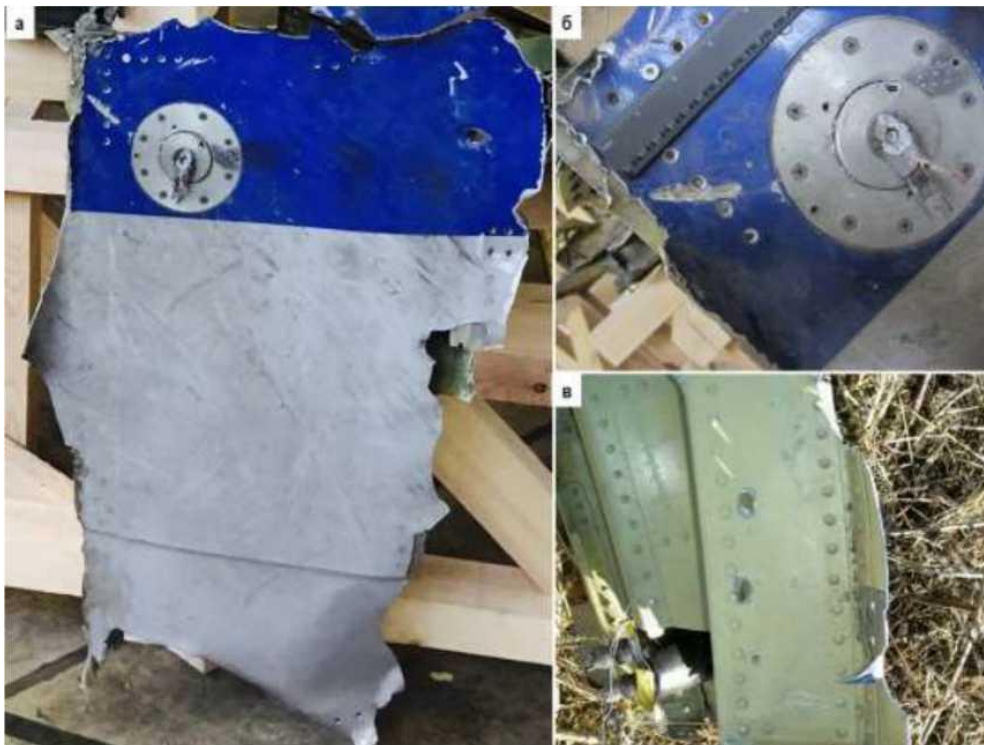
Figure A.1.9 - Exterior view of fragment "F.9" (a) and areas of the fragment with characteristic external (b) and lateral damage (c)

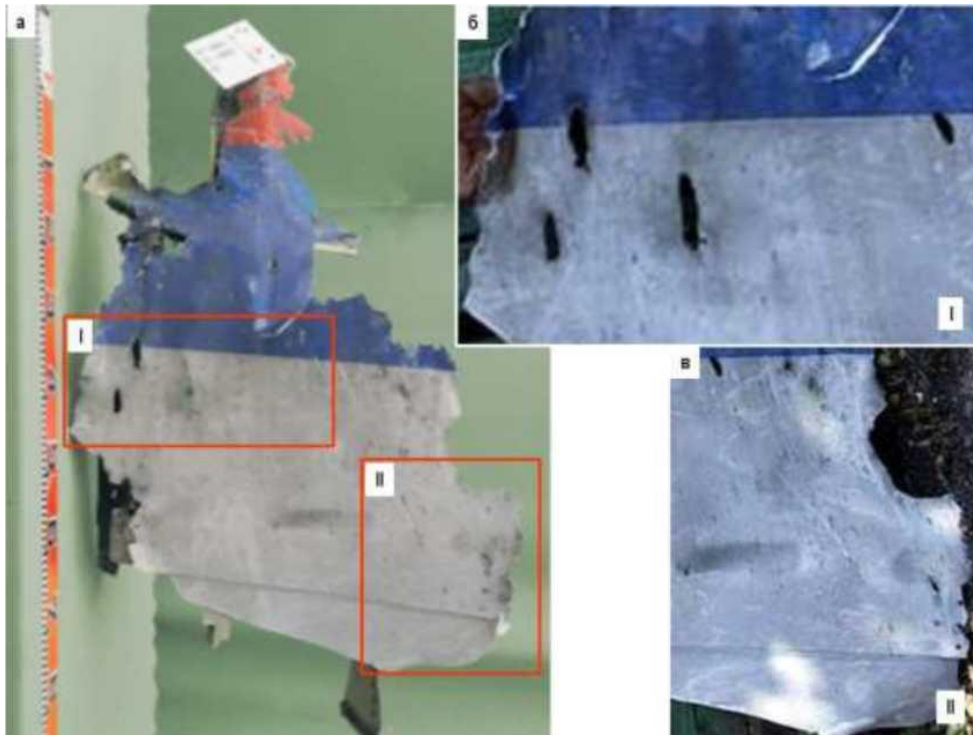
Figure A.1.10 - Exterior view of fragment "F.10" with characteristic damage (b, c)

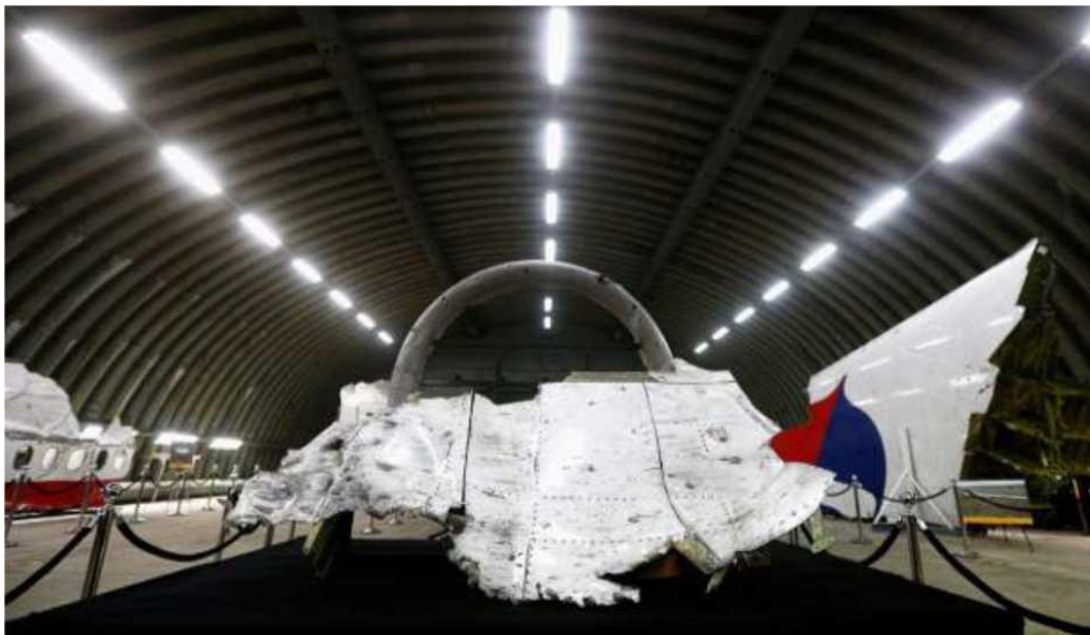
The fragment "F.7" (fragment of the upper part of the port side and the roof behind the cockpit) is also important for determining the nature and extent of the damage. Figure A.1.13 shows the exterior view of this fragment in one of the hangars at the layout site in the Netherlands. The fragment was handed over to the DSB specialists but was not included in the final 3D reconstruction of the fuselage, the analysis of its damage features was either not performed or not reflected in the Report.

Figure A.1.13 - Exterior view of upper port side and roof fragment behind the cockpit (fragment "F.7")

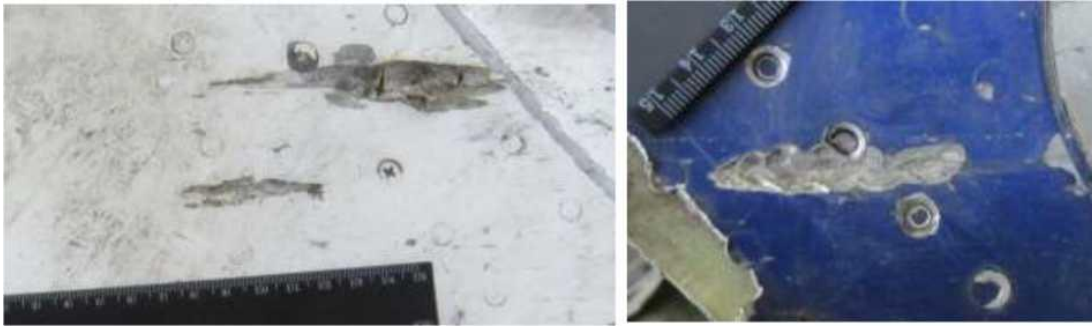
In fragments "F.1", "F.3"- "F.7" "F.9" and "F.10", the damage near the boundary of the fragment coverage area comprises elongated, well-aligned rectilinear sections ("tracks") caused by a contact with projectiles whose trajectories were tangential to the outer contour of the fuselage (Figure A.1.15).

Figure A.1.15 - Examples of boundary damage in fragment "F.1" (left) and fragment "F.9" (right)

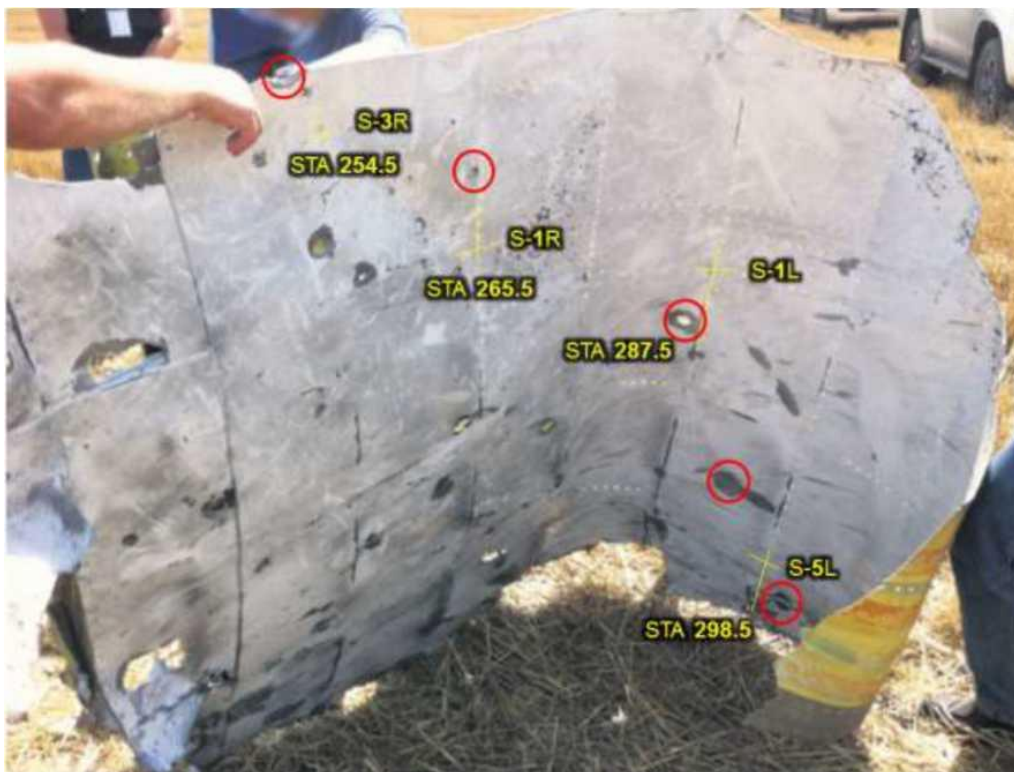
Figure A.1.16 – Fragment coverage area boundary on the fragment of roof behind the cockpit - fragment F.6 (photo by DSB)

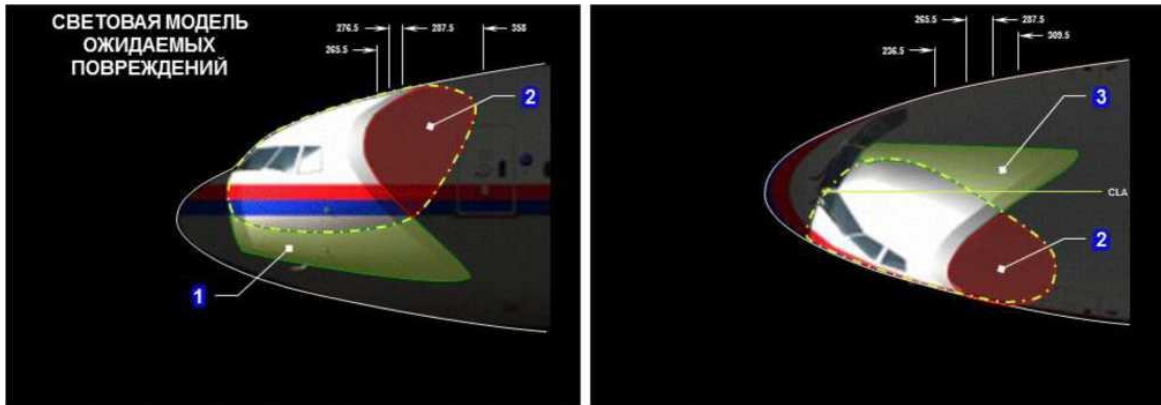
The schematics of through-and-through (penetrating and non-penetrating) damage as well as part-through damage (ricochets) for all fragments were used to build a general diagram of the boundaries of the fragment area covering the nose section of the Boeing 777 fuselage, which is shown in Figure A.1.17.

Figure A.1.17 - Schematic of actual fragment coverage area boundaries: left - port side view; right - top view

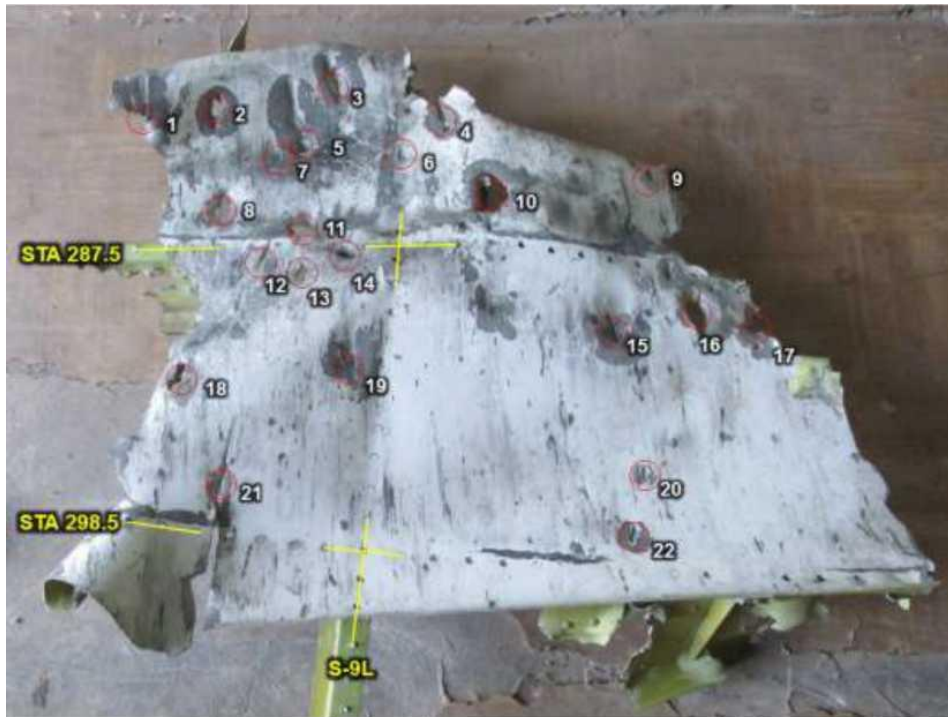
The F.7 fragment shows fragmentation damage near the bulkheads STA 287.5 and STA 298.5 (Figure A.1.18)⁵ and STA 309.5 and STA 332.5 (Figure A.1.19), which is almost 3 metres beyond the damage accounted for in the DSB model.

Figure A.1.18 - Forward part of fragment "F.7".
Fragmentation damage is located between bulkheads STA 287.5 and STA 298.5,
which is 2 metres further than the DSB 'reference'

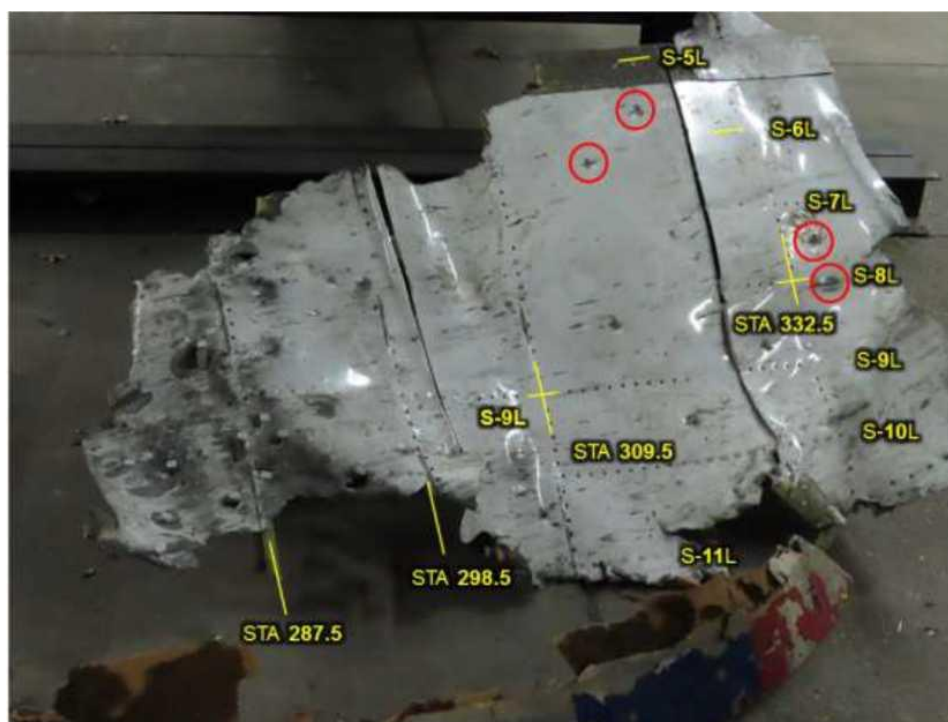
Figure A.1.19 - Fragment of the roof and top of the port side behind the cockpit. The
fragmentation damage is located between bulkheads STA 309.5 and STA 332.5,
which is almost 3 metres further than the DSB 'reference'

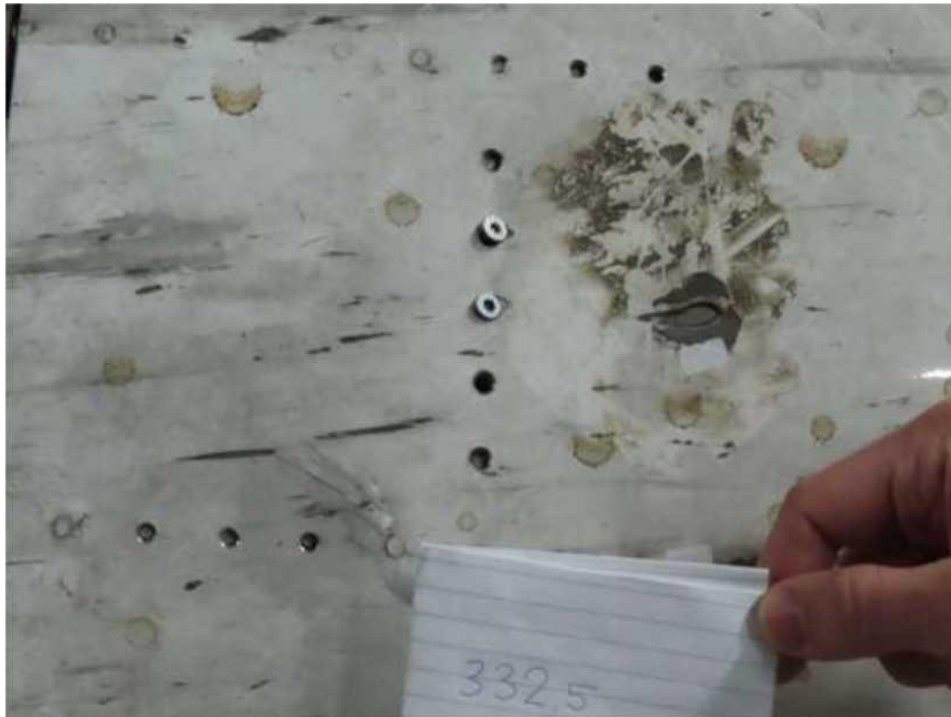
A narrow strip on the cockpit between bulkheads STA 132.5 to STA 220.5, i.e. only of about 2.24 m (220.5-132.5= 88 inches), was chosen as the damage "reference". Whereas the objectively observed damage in the upper part of the port side is spread considerably further, beyond the STA 332.5 bulkhead (Figure A.1.21), i.e. about 5.1 m (332.5-132.5= 200 inches) from the front bulkhead STA 132.5, taken as the front boundary of damage area.

Figure A.1.21 - Example of damage to the outer skin at the edge of the coverage area beyond the level of the STA 332.5 bulkhead

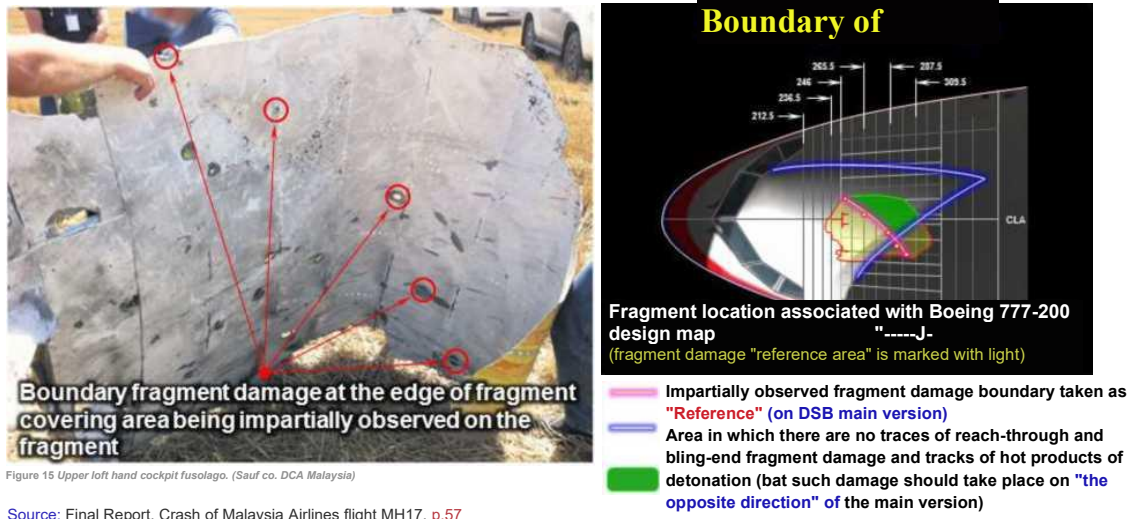
Zone "3" is on the roof behind the cockpit. In this zone, unlike the DSB light model, there is no fragmentation damage on the MH17 fuselage.

Figure A.1.22 - Objectively observed boundary of the fragmentation area on the roof section behind the cockpit as compared to the "reference" boundaries of the virtual model of NLR, which are shown by the illuminated area
