**APPLICATION OF THE INTERNATIONAL CONVENTION FOR THE SUPPRESSION
OF THE FINANCING OF TERRORISM AND OF THE INTERNATIONAL
CONVENTION ON THE ELIMINATION OF ALL FORMS OF RACIAL
DISCRIMINATION**

REJOINDER

Report of JSC Air and Space Defense Corporation "Almaz-Antey" on the results of studies related to the technical investigation into the crash of the Malaysian airlines Boeing 777-200 9M-MRD (flight MH17), 2023

on the results of studies related to the technical investigation into the crash
of the Malaysian airlines Boeing 777-200 9M-MRD (flight MH17)

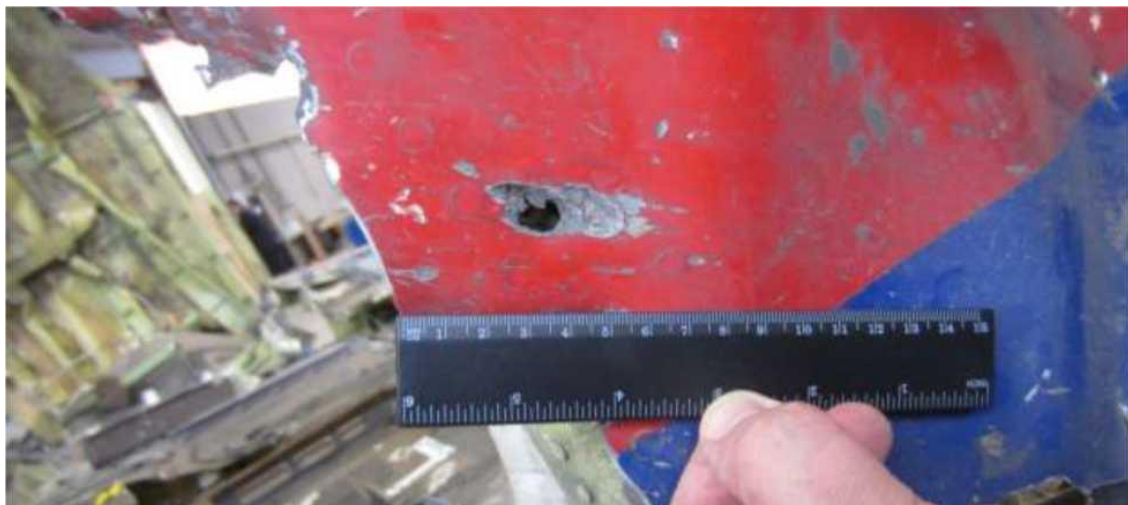
Figure A.2.2 - Exterior view of non-penetrating damage to the port side of the Voinp-777: the damage is under the cockpit glazing

This type of damage indicates that the projectiles did not travel across the board ("opposite direction"), but tangentially along the board, which is consistent with the "collision course" version.

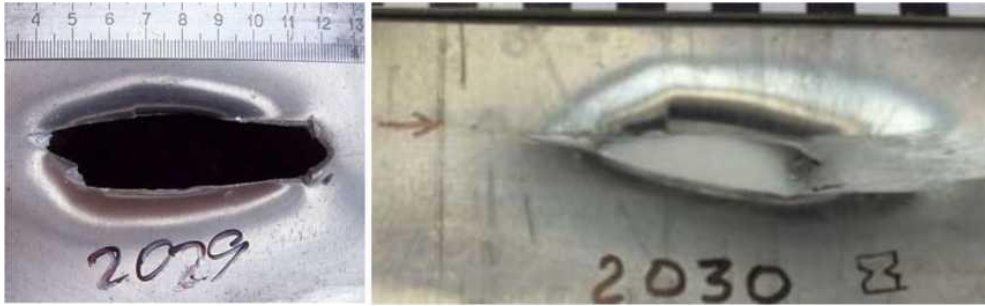
Similar damage was sustained under controlled conditions (on a special stand using a ballistic setup) only at low angles to the firing line (Figure A.2.3). The velocity range corresponded to the dynamic conditions under consideration.

Figure A.2.3 - Exterior view of damage at low angles to the firing line (tangential) under controlled conditions on the bench: left - angle 15°, speed 1683 m/s; right - angle 5°, speed 1640 m/s

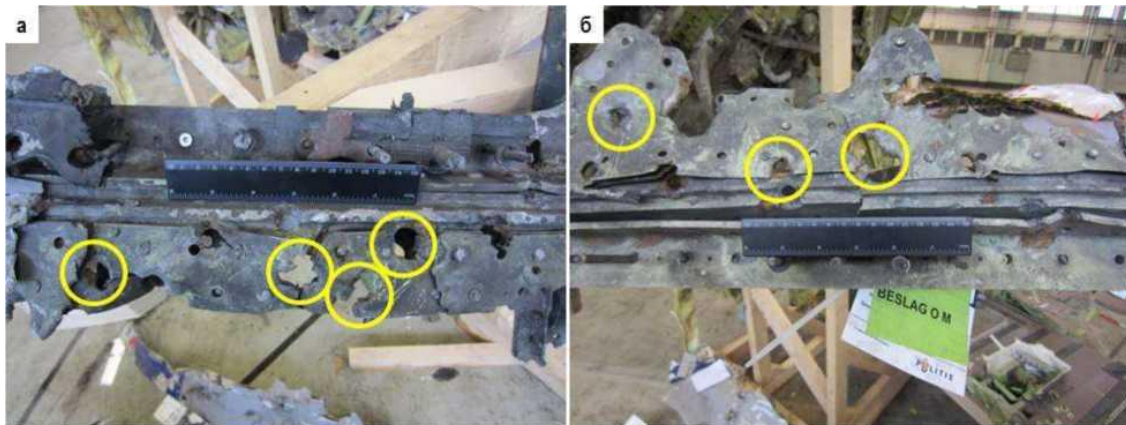
The glazing frame elements shown in Figure A.2.4 show multiple through holes from projectiles (highlighted in yellow) in a substantially more robust structure incorporating additional metal reinforcements and frame corners in addition to the outer sheathing sheets.

Figure A.2.4 - Penetrating damage to the cockpit glazing frame

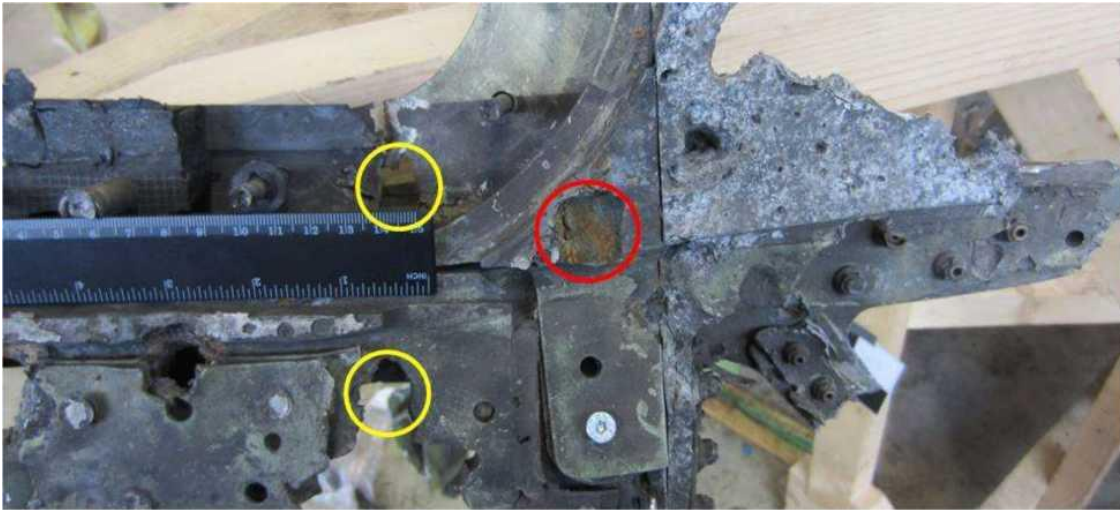
Figure A.2.5 - Example of non-penetrating damage to a glazing frame

Non-penetrating damage (highlighted in red) is an example of the erosive action of a warhead.¹⁰

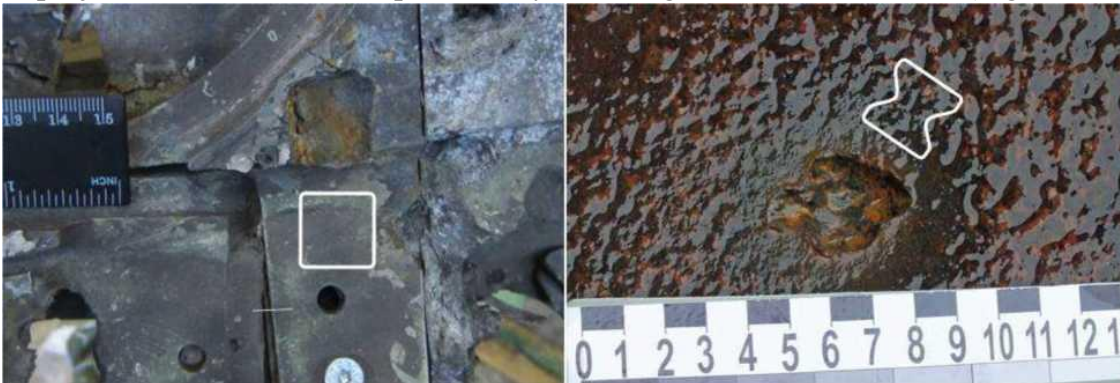
Similar damage was observed in the full-scale Almaz-Antey tests when the projectiles interacted with particularly hard target structure elements (Figure A.2.6).

Figure A. 2.6 - Characteristic non-penetrating damage: left - MH17; right - target acquisition (experiment)

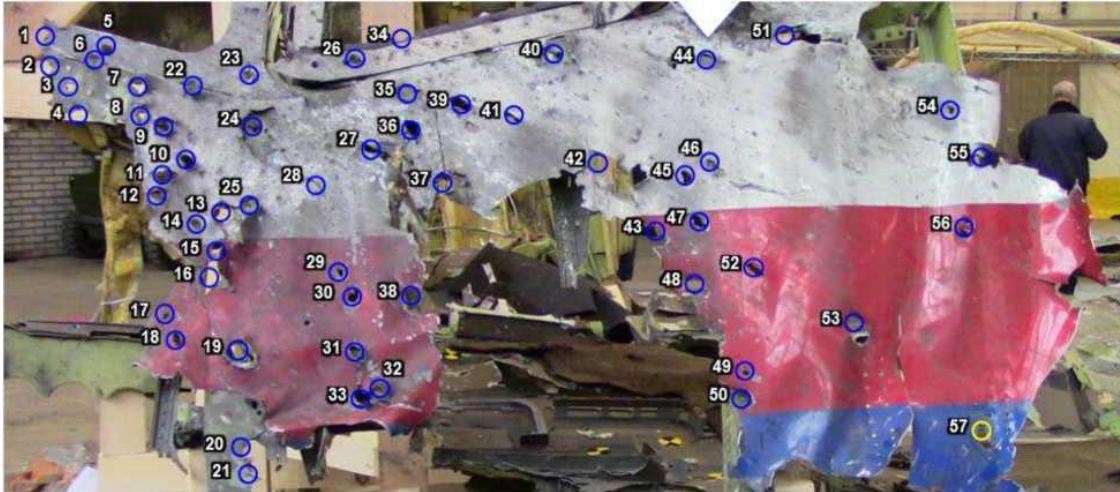
Another feature of cockpit fragmentation damage is the significant change in the density of fragmentation damage. Figure A.2.7 shows the distribution of combat damage density on fragment "F.4" (part of the port side below the windows of the cockpit commander).

Figure A.2.7 - Exterior view of fragment "F.4" with numbered battle damage

Combat damage from the projectiles in a relatively small area is extremely unevenly distributed. The density of damage decreases significantly from left to right (from the nose towards the tail section) and from top to bottom.¹¹

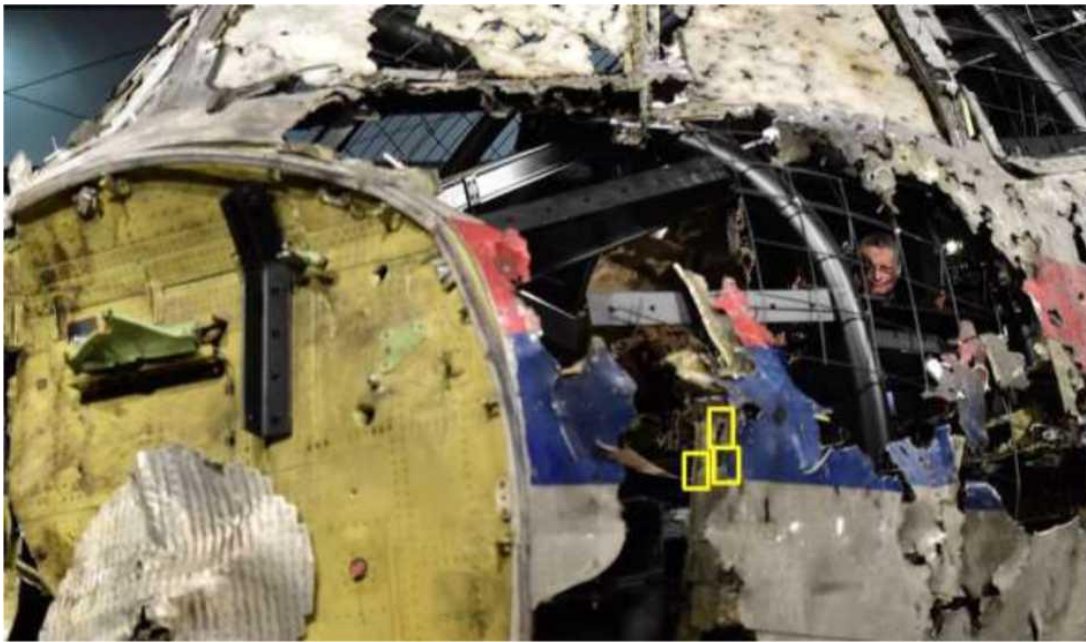
Figure A.3.1 - Through-and-through-and-through damage to the forward fuselage bulkheads

Figure A.3.1 shows through-holes in a bulkhead up to the cockpit glazing frame.

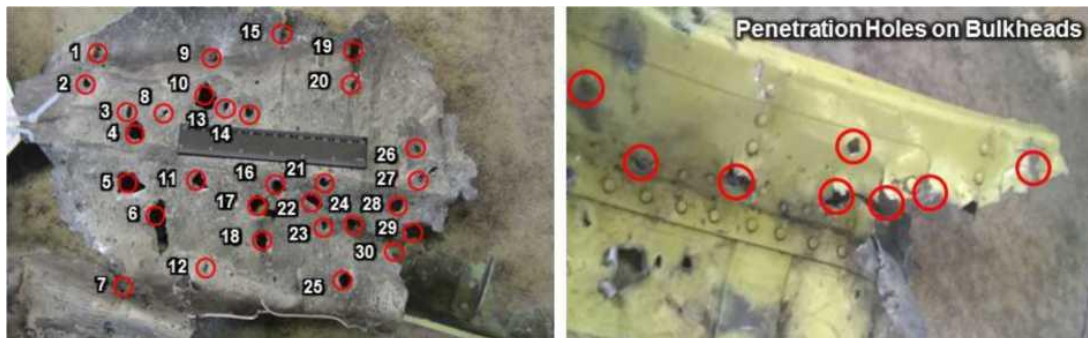
Figure A.3.3 - Fragment of the port side skin from the top behind the third window of the crew commander. Multiple holes in the bulkhead led to deformation and failure of the force element (photo right), indicating that this fragment was exposed to maximum density (mass and kinetic energy) of the projectiles and factors accompanying a close explosion

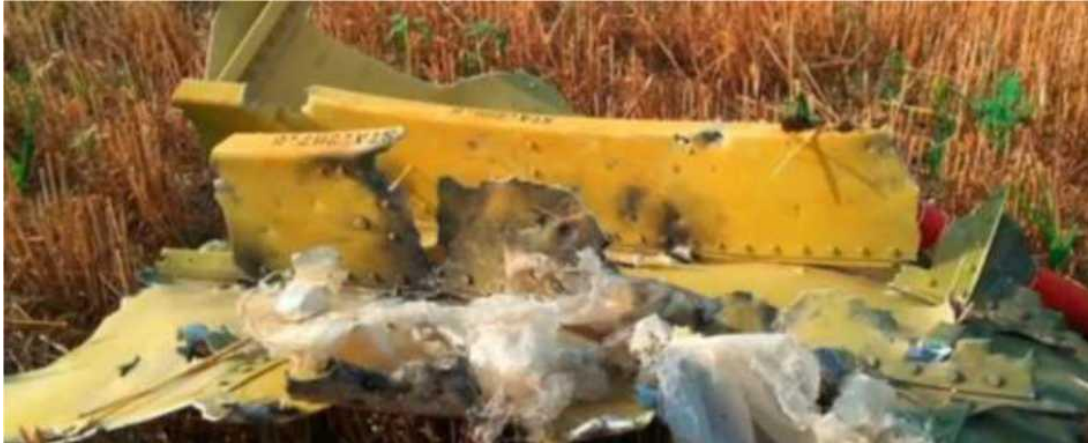
Figure A.3.4 - Fragment of the centre port side behind the cockpit. Objectively observed holes in the STA 287.5 and STA 298.5 bulkheads, traces of compression, deformation, rupture and destruction of structural members

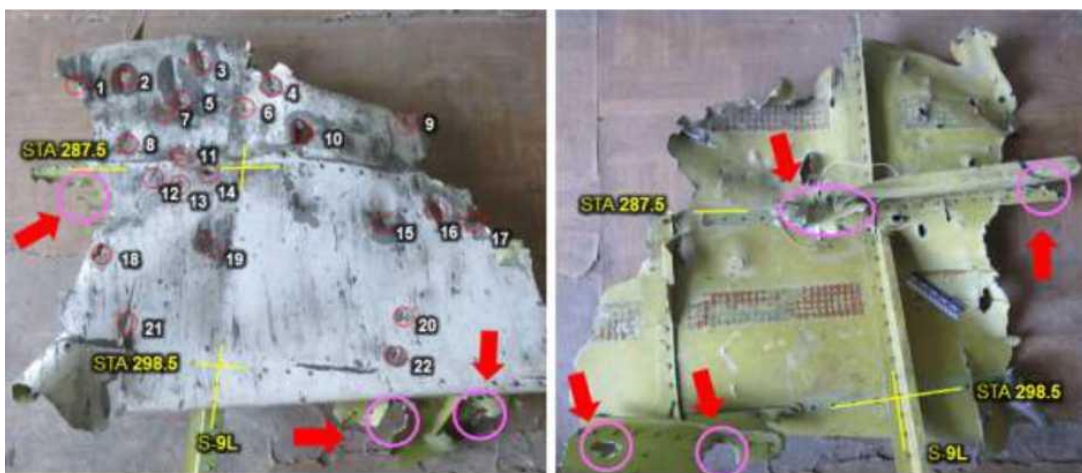
Figure A.3.5 shows the damage to the deck members located on the fragment of the top of the port side behind the cockpit.

Figure A.3.5 - Fragment of the upper port side behind the cockpit: external (left) and internal (right) views. Multiple holes in the STA 287.5 and STA 298.5 bulkheads resulted in deformation and failure of the structural elements (red arrows indicate characteristic damage)

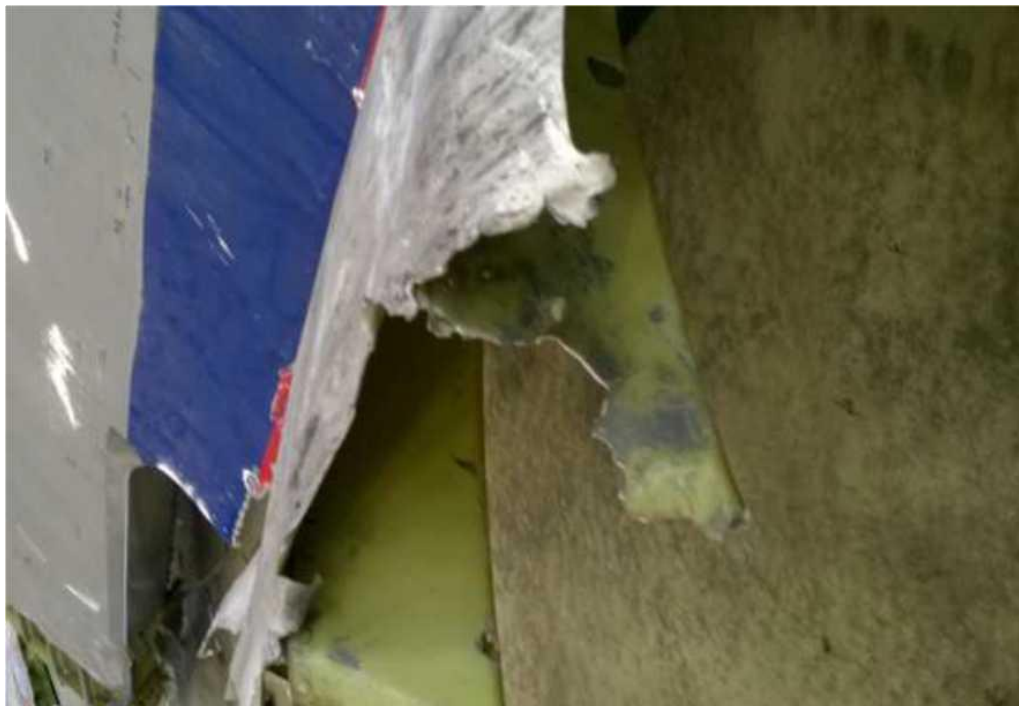
Figures A.3.6 and A.3.7 show the damage to the port side bulkheads which resulted in their rupture and subsequent structural failure of the mid and upper port side.

Figure A.3.6 - Destruction of port side bulkheads by perforation

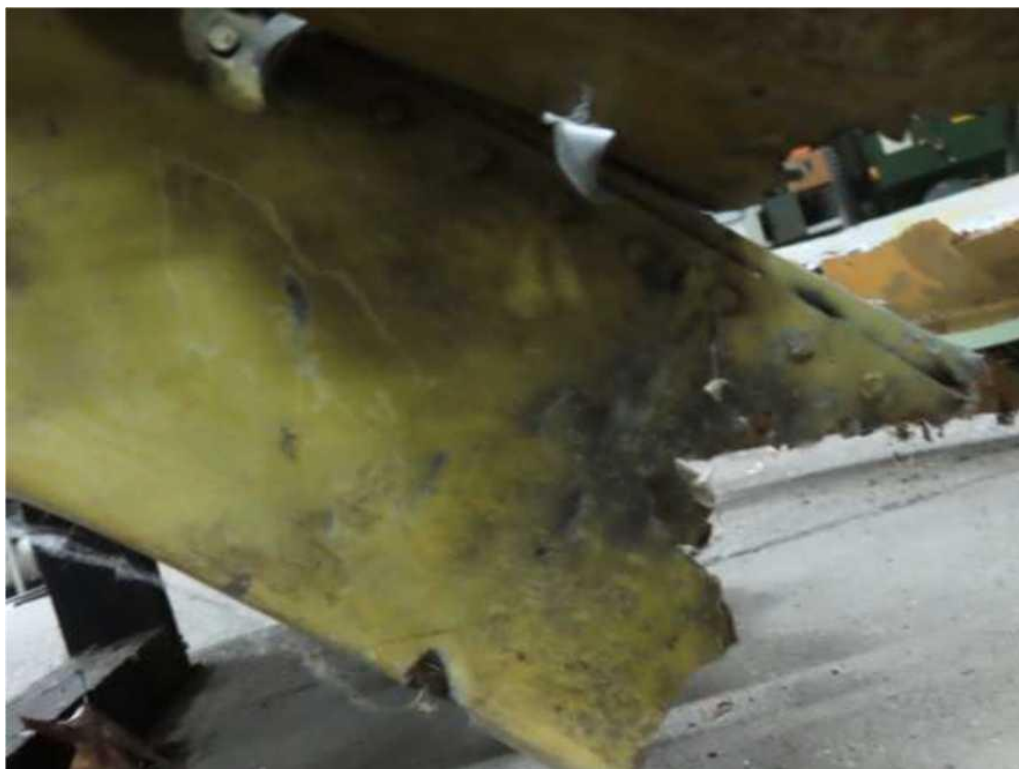
Figure A.3.7 - Perforation, thermal oxidation and deformation of the transverse strength members (bulkheads) resulted in their rupture and subsequent structural failure of the upper port side

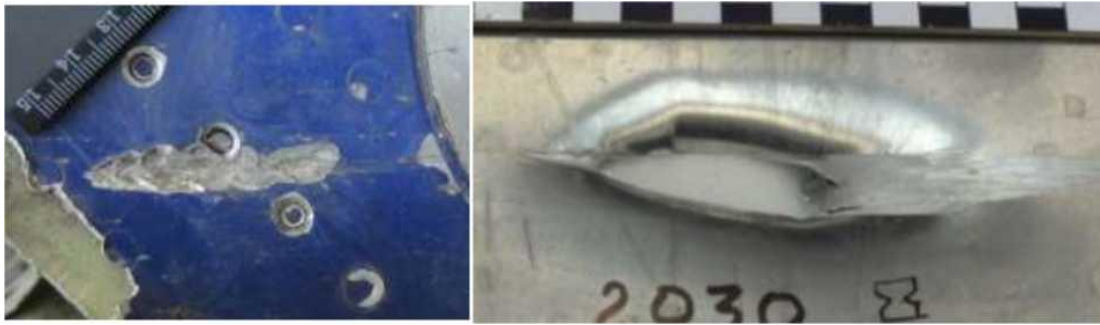
On the inside of this fragment there are five through-holes in the bulkheads marked with numbers from "5" to "9" (Figures A.3.8(b), A.3.8(d) and A.3.8(e)). A comparison of the exterior view of the damage located on the F.9 fragment with the results of special GSE penetration tests shows that the angle of attack of the projectiles when interacting with outer skin sheet was no more than 5 degrees, i.e. almost parallel to the aircraft structure (Figure A.3.9).

Figure A.3.9 - Exterior view of non-penetrating ricochet damage: on F.9 fragment of the left side of a Boeing 777 (left) and on the barrier after interaction with preformed fragments at an angle of 5° to the firing line (right)

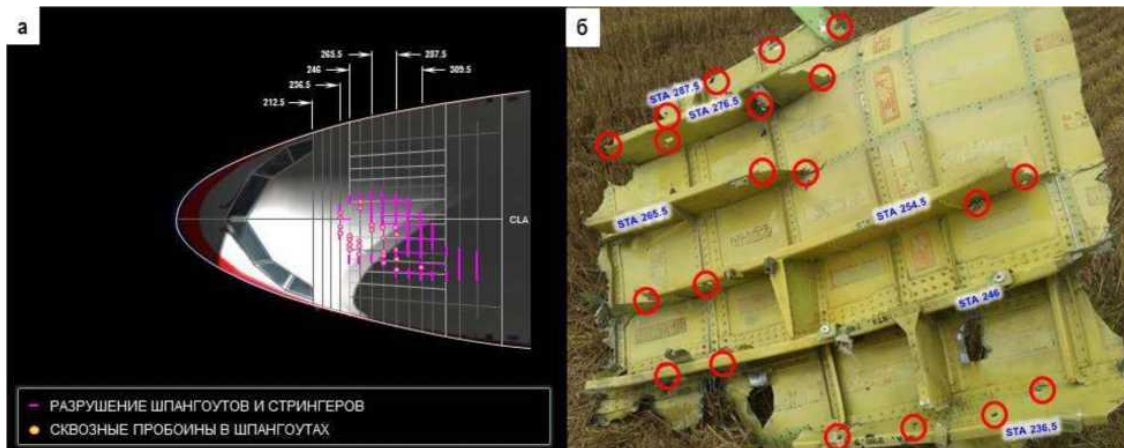
Figure A.3.10 - Schematic of damage to the roof structure behind the cockpit in the F.6 area (a) and through holes in the bulkheads (b)

Analysis of the force structure failure pattern (Figure A.3.10) shows that the area of through holes and destruction and deformation of the structural elements (bulkheads and stringers) exceeds the fragment coverage area. Through penetrations in the bulkheads are located well beyond the penetrating damage to the outer skin.

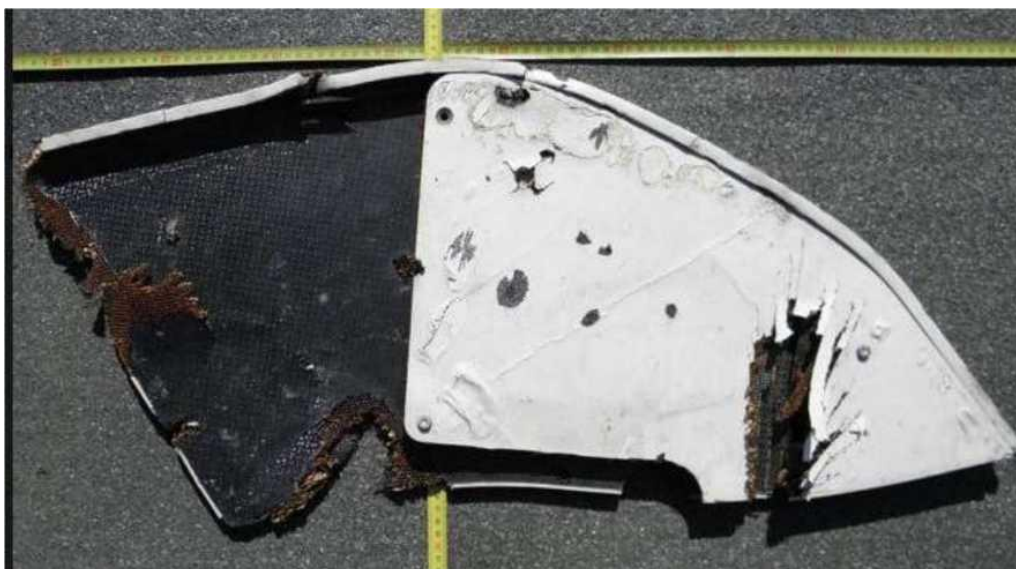
Figure A.3.12 shows a section of the passenger compartment luggage rack, which is located further away from the STA 382 level.

Figure A.3.12 - Fragment of passenger compartment luggage rack with (suspected) fragmentation damage

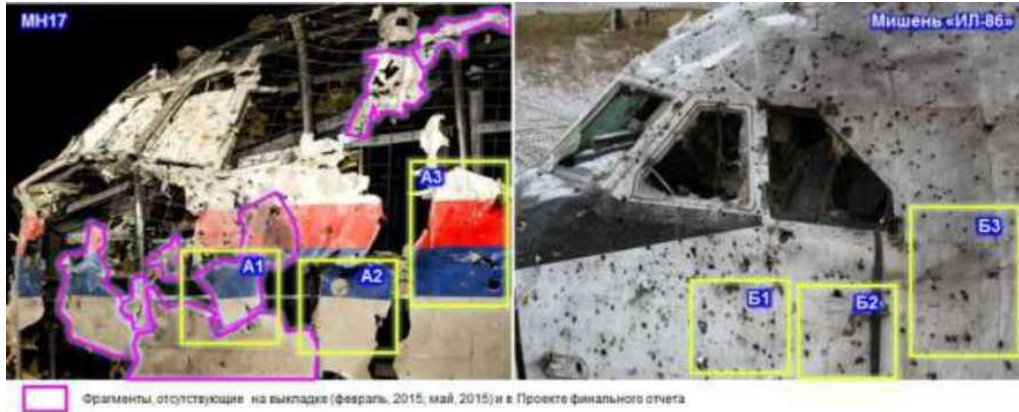
Figure A.4.1 shows fragments of the port side under the windows of the Boeing 777 crew commander (left) and the IL-86 target aircraft (right). Analysis of the photographs shown in the figure shows that on the port side fragments of Boeing 777 (left)¹³ many tangential non-penetrating holes (ricochets) from preformed fragments are observed, while on similar fragments of the left side of IL-86 target aircraft (right) there is no such damage.

Figure A.4.1 - Fragments of the left side of a Boeing 777 (left) and an IL-86 target aircraft (right)

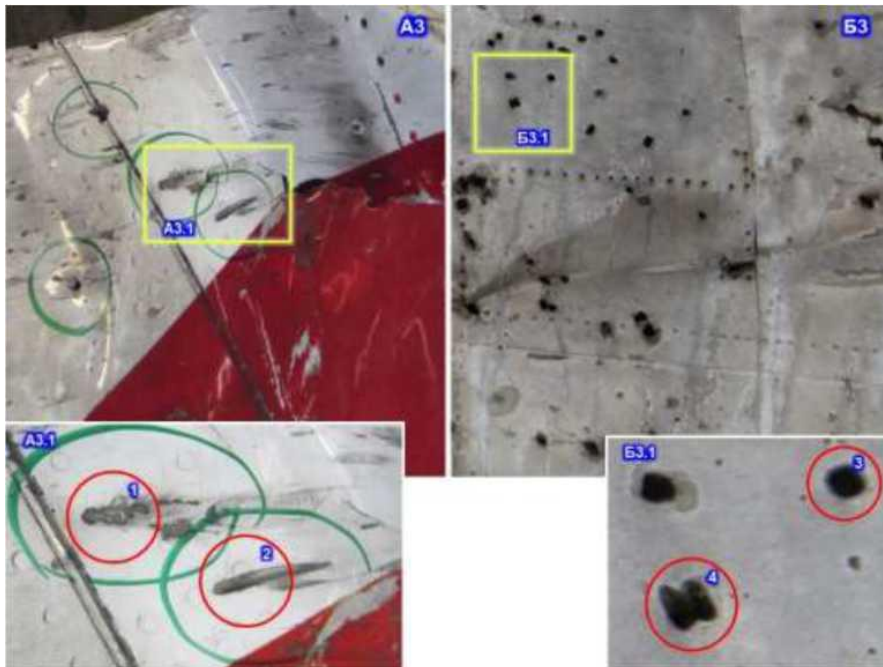
The main difference between the fragments of the port side of MH17 and the IL-86 target aircraft compared is the nature of the damage caused by preformed fragments. On the port side of MH17 there are many non-penetrating, non-piercing holes (both with partial metal damage, or only damage to the paint coating on the outer skin sheets). The IL-86 target aircraft shows clear penetrating penetrations, both from prefabricated projectiles and hull projectiles.

Figure A.4.2 - Fragment A3 of the port side of the Boeing 777 (left) and B3 of the port side of the IL-86 target aircraft (right)

Such a significant difference in the nature of damage to the port side skin can only be explained by different angles of approach of the projectiles to the obstacle (the surface of the outer skin of the aircraft's fuselage). Accordingly, different conditions of the aircraft's encounter with the missile (coordinates of the detonation point and angles between longitudinal axes).

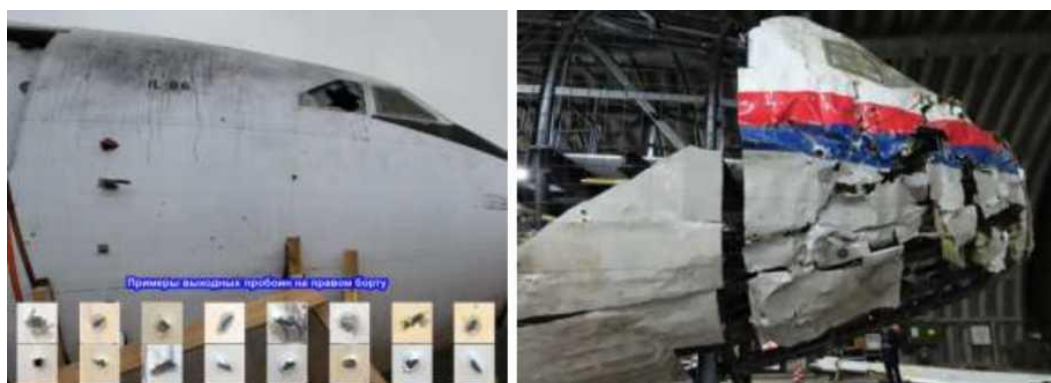
During the experiment, the structure of the target aircraft was holed, as evidenced by multiple through holes and non-skid exit damage "from the inside out" on the starboard side and the right lower part of the bottom of the IL-86 target aircraft (IL-86)¹⁴ (Figure A.4.3).

Figure A.4.3 - Examples of through-hole exit holes on the starboard side of the IL-86 target aircraft (left) and no exit holes on the starboard side of the Boeing 777 (right)

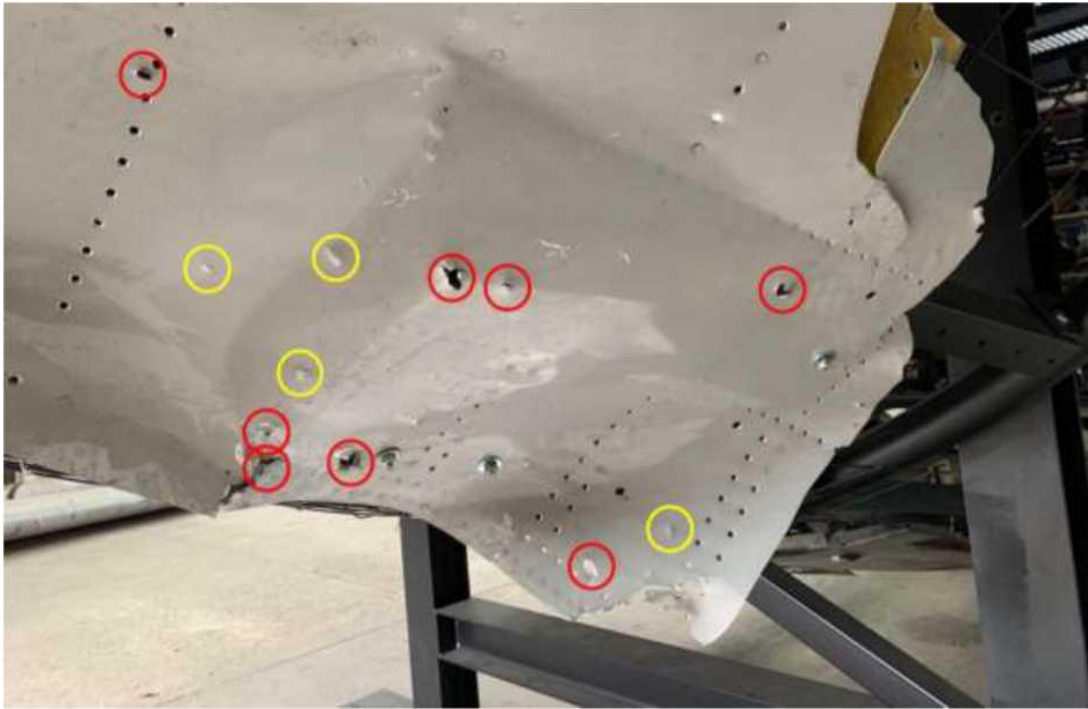
The highest density of exit damage is concentrated under the second left-hand window of the crew commander and spread further along the port side.

Figure A.4.4 - Exit damage "inside-out" on the lower port side of the Boeing 777 under the windows of the crew commander

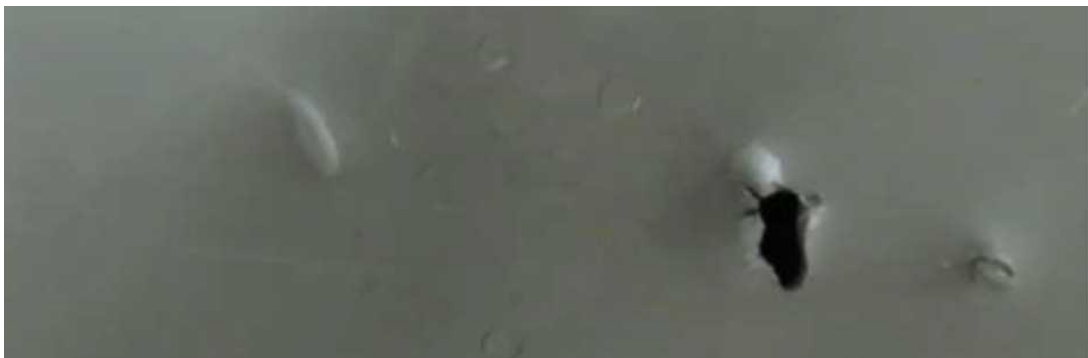
Figure A.4.5 - Close-up of inside-outside exit damage: non-clearance damage (left) and through-hole damage (right)

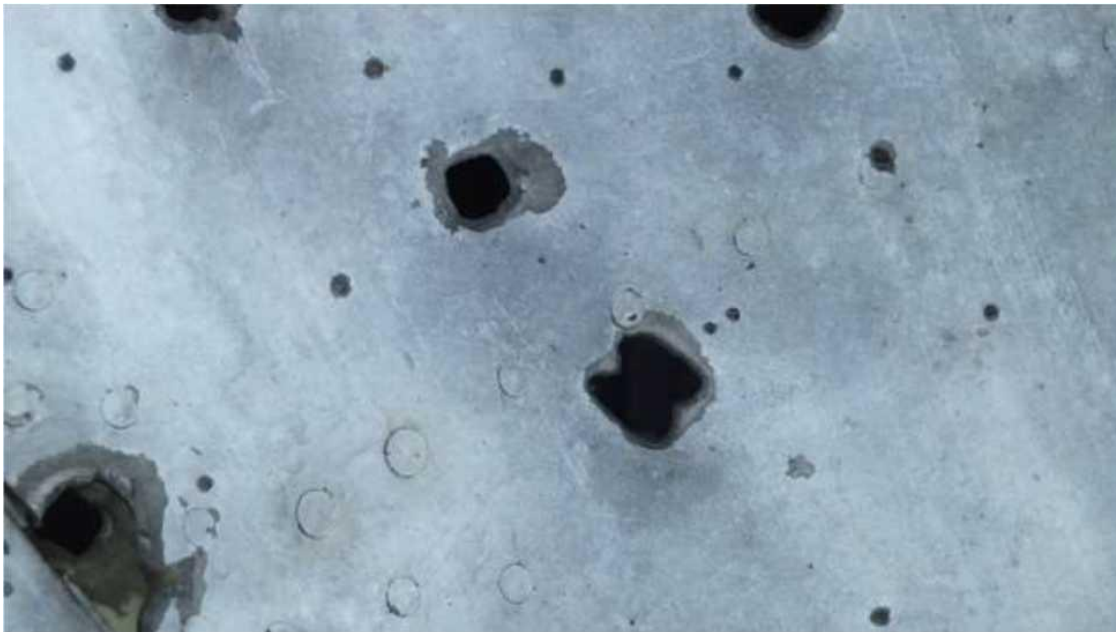
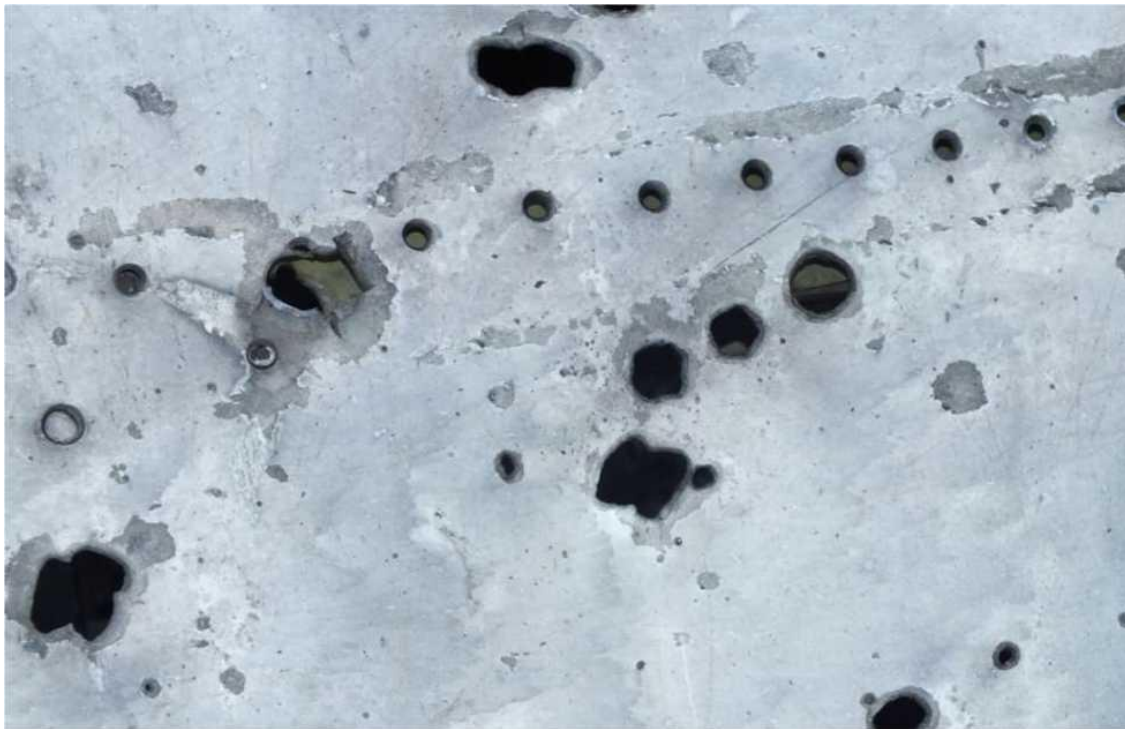
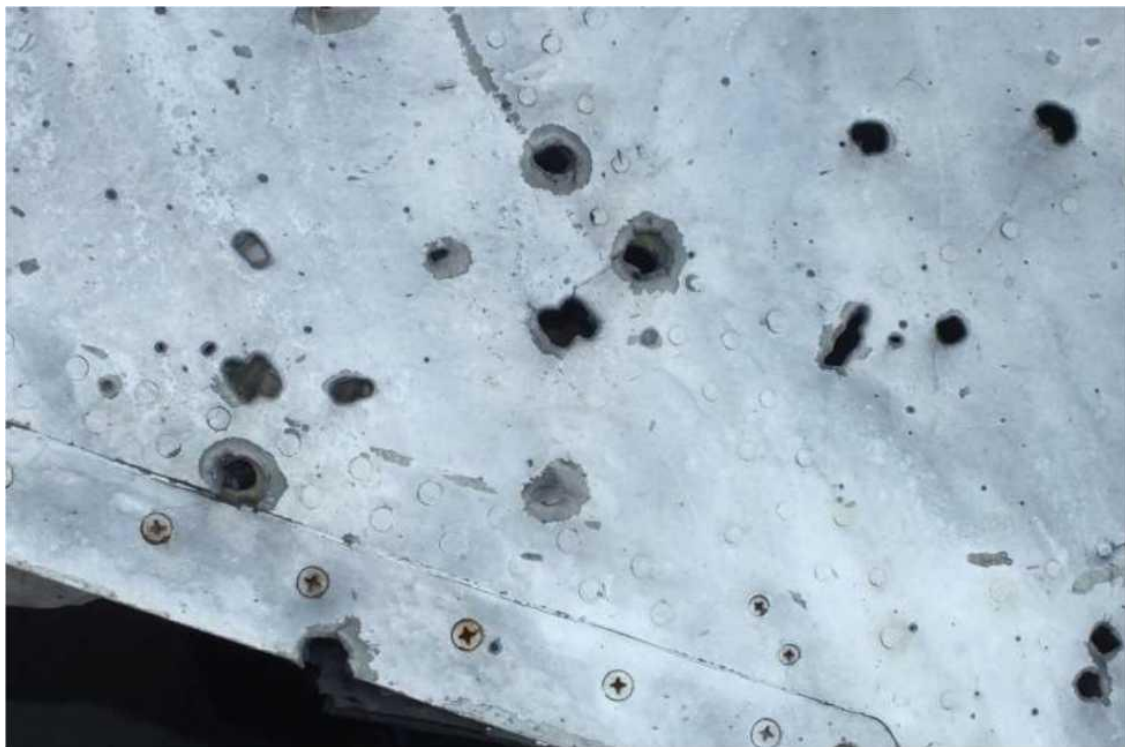
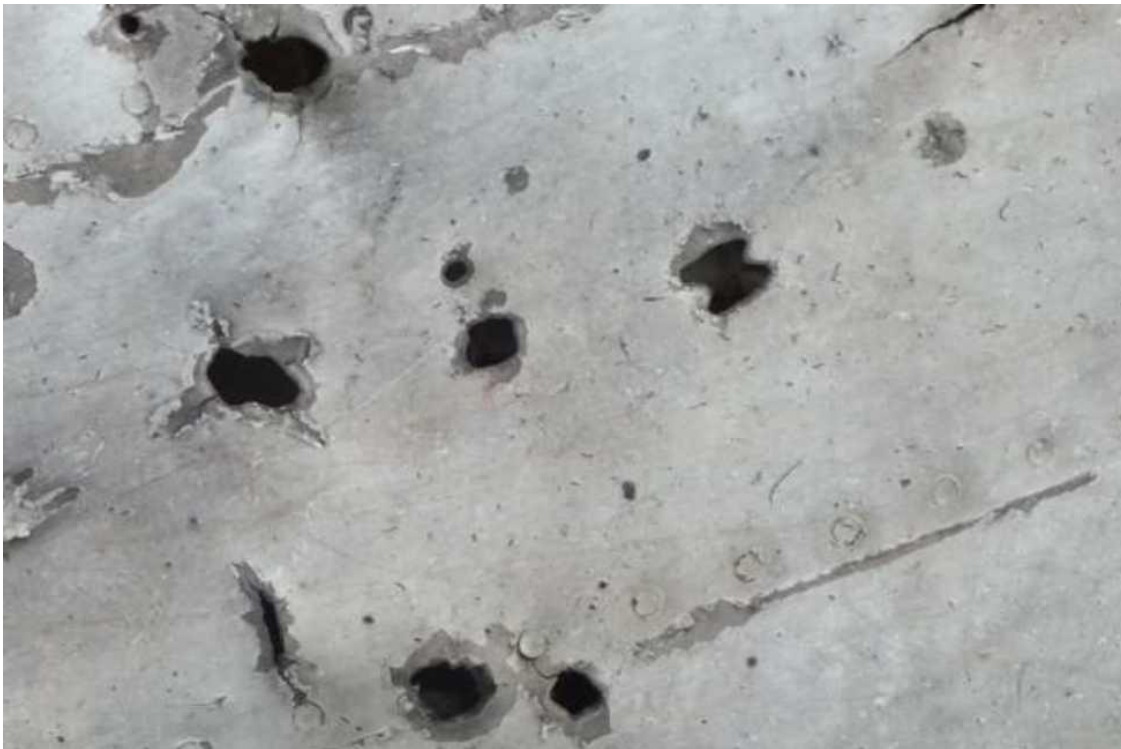
Dozens of such through-holes with a pronounced "butterfly" exterior view, left by the 9H314M 1-10 "bowtie" projectiles, have been observed on fragments of the outer hull of the IL-86 target aircraft (IL-86).

Figure A.4.6 - The skin of the port side of the IL-86 target aircraft (close-up)

Figure A.4.7 - The skin of the port side of the IL-86 target aircraft (close-up)

Figure A.4.8 - Fragment of the outer skin above the glazing of the aircraft commander (IL-86 target aircraft)

Figure A.4.9 - Cladding of the upper port side of the target aircraft "IL-86

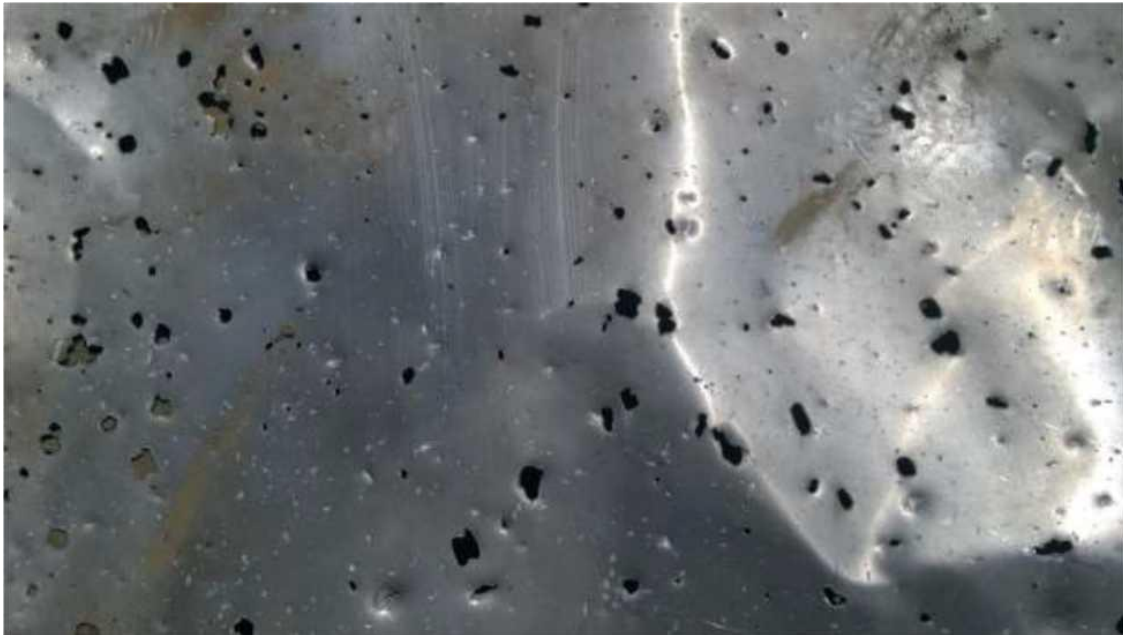
Examination of the damage (through-holes) to the fragments of the shielded targeting environment showed that all targets made of a duralumin alloy similar to the outer skin of the Boeing 777 aircraft had a large number of "butterfly" shaped holes, which leave the 9H314M 1-10 heavy fraction "hollowed-out" projectiles (Figure A.4.10).

Test results show that the finished 9H314M 1-10 warheads leave a distinctive "butterfly" punch not only on the first obstacle of a shielded target, but also on all subsequent obstacles.

Figure A.4.10 - Characteristic "butterfly" shaped holes in shielded target sheets

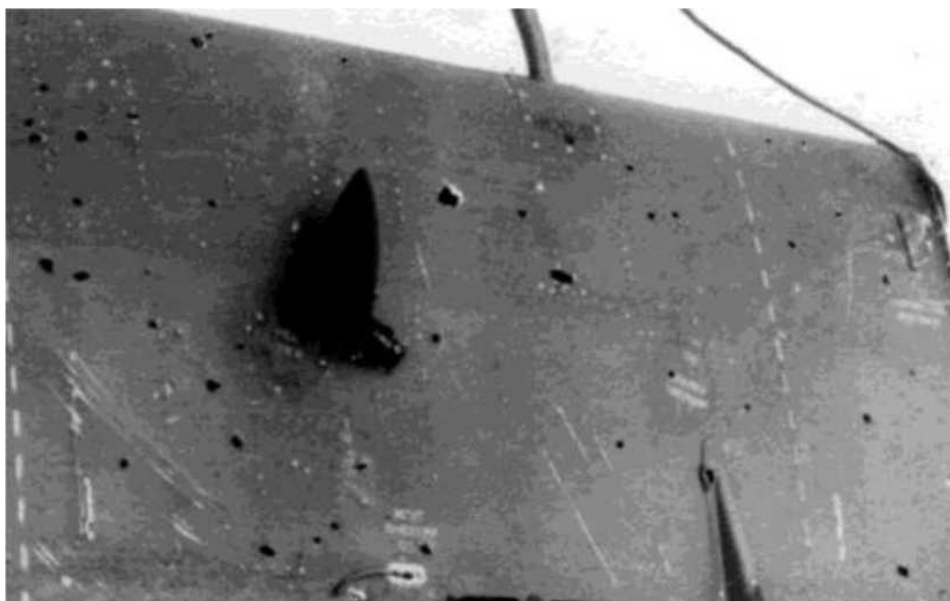
Figure A.4.11 - Exterior view of damage to an airborne target in a dynamic situation: "opposite direction"; mutual speed of target and missile is comparable to the conditions in question

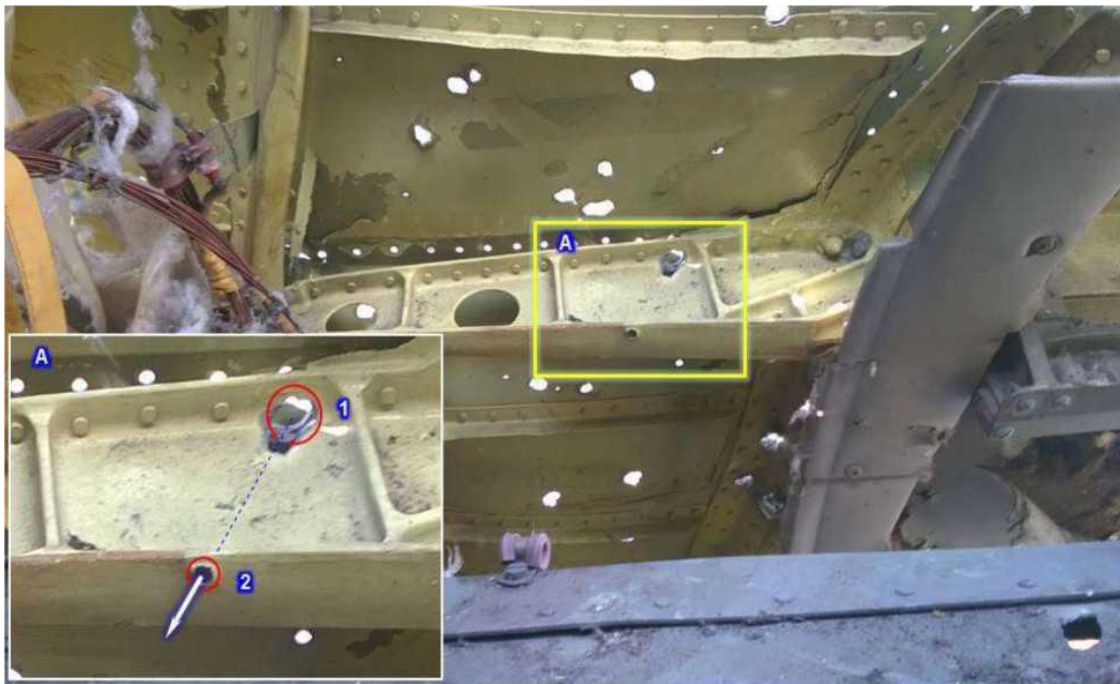
Figure A.4.12 - Through-holes in the outer skin of the port side (1) and in the reinforced stringer of the port side (2)

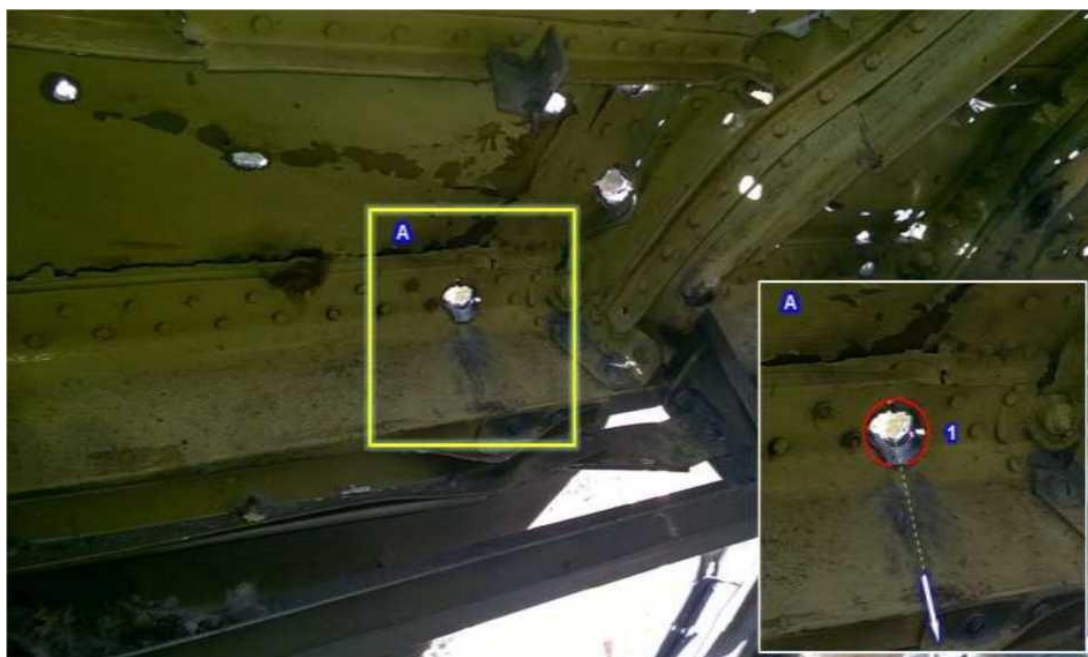
Figure A.4.13 - Direction of projectiles movement through the fragment of the upper port side (above the crew commander's window)

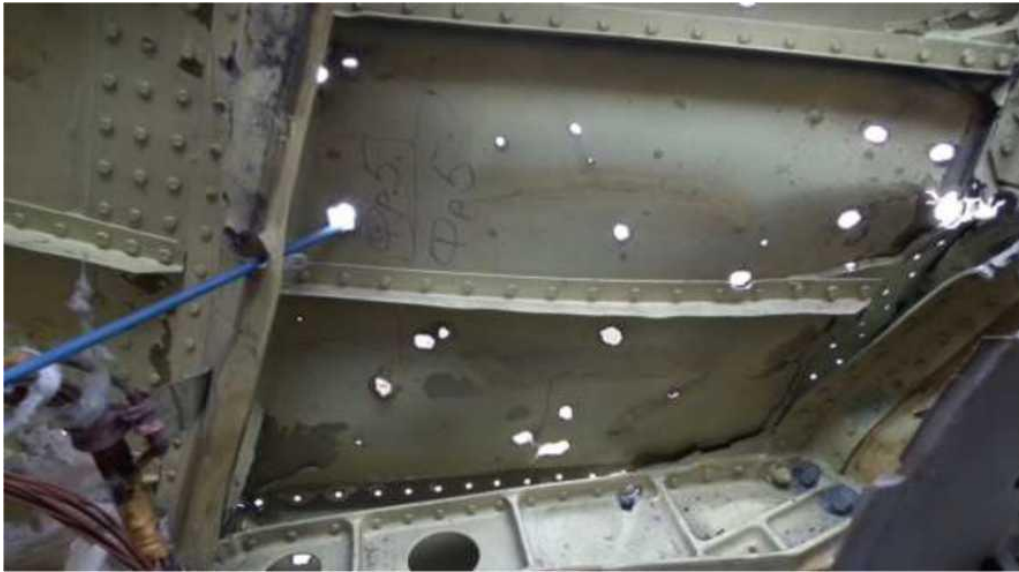
Another example showing the direction of the trajectory of the projectiles through an aircraft structure would be Fragment 5.¹⁸ Figure A.4.14 shows photographs of the fragment from different angles. View from inside the cockpit.

Figure A.4.14 - Direction of motion of the projectiles through the outer skin fragment and the port side bulkhead

The transverse structural elements (bulkheads) of the IL-86 target aircraft have damage of a nature that is radically different from the through holes in the bulkheads observed on the MH17.

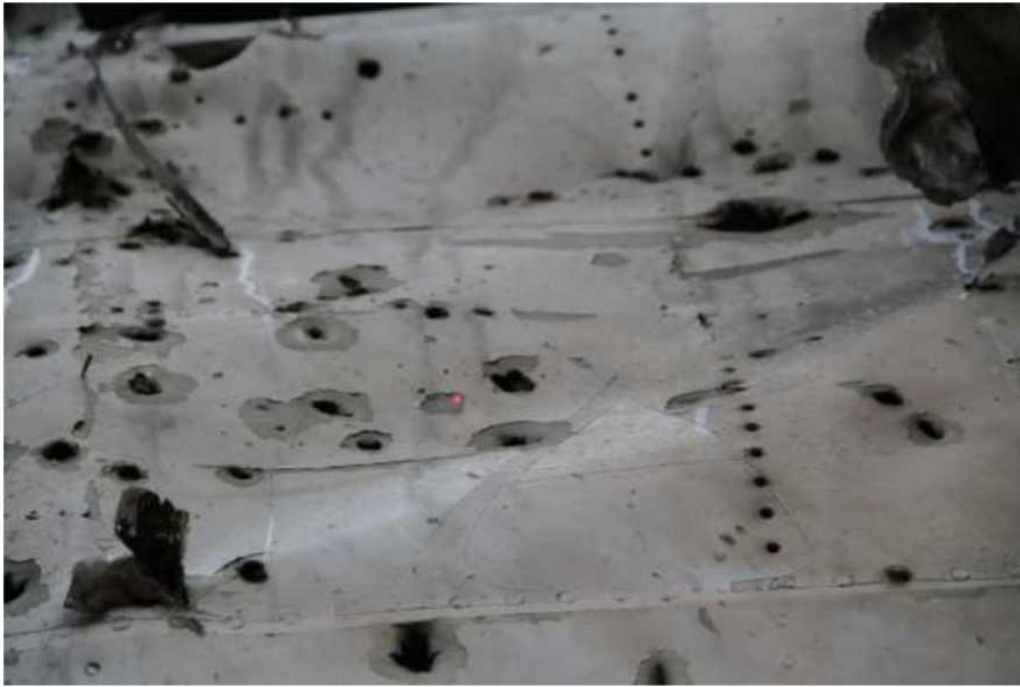
Unlike the MH17, in the IL-86 target aircraft, compression and deformation of the outer skin sheets occurred predominantly along stringers, the longitudinal load-bearing elements of the aircraft's structure.

Figure A.4.15 - Fragment of the left side of the IL-86 target aircraft below the windows of the aircraft commander

¹⁹ Figure A.4.15 shows the rows of multiple rivet holes which formed as a result of the outer skin being torn away from the primary structure. The main characteristic of this damage is that the tearing of the outer skin was predominantly along the bulkheads.

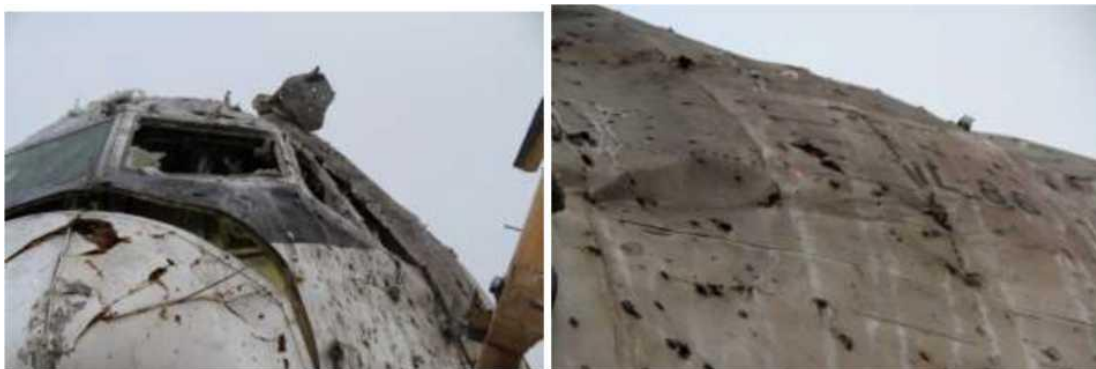
Figure A.4.16 - Deformation of the outer skin of the IL-86 target aircraft

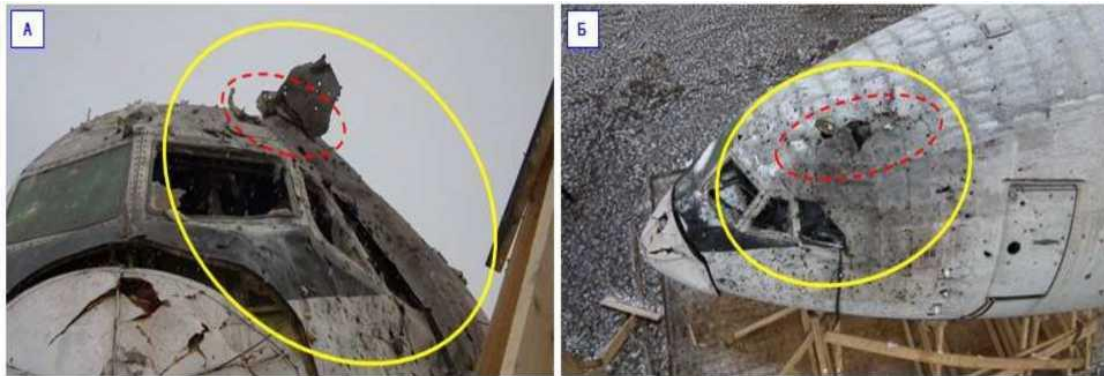
The impact of the explosion on the structure of the IL-86 target aircraft caused part of the left side of the roof and the left side to be pressed inwards into the aircraft structure (towards the right side). Figure A.4.17 shows traces of the impact on the cockpit of the IL-86 target aircraft obtained during the experiment.

Figure A.4.17 - Destruction of the target aircraft's load-bearing structure of the IL-86

The area of greatest damage is marked in yellow. In the centre there is an area of severe damage to the aircraft's primary structure (red dotted oval).

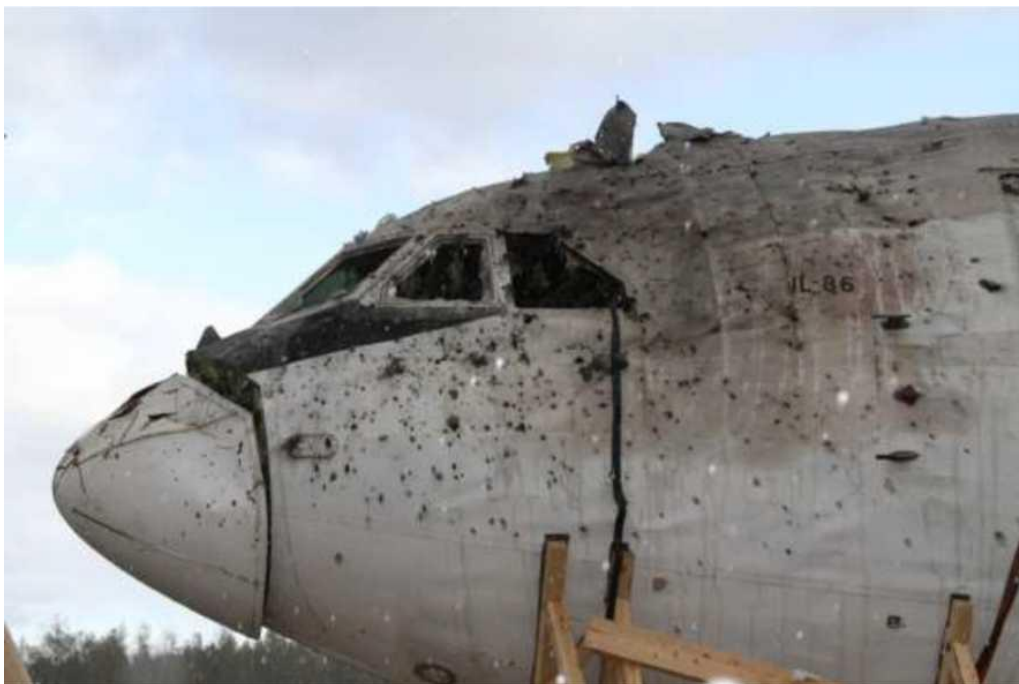
Figure A.4.18 - Thermal influence marks on the left side of the IL-86 target aircraft

From the analysis of the drawings, it appears that the greatest intensity of traces of Thermal influence is observed behind the third window of the crew commander. In contrast to MH17, there are virtually no thermal oxidation traces in the area of the windscreen and the left-hand side window.
