**APPLICATION OF THE INTERNATIONAL CONVENTION FOR THE SUPPRESSION
OF THE FINANCING OF TERRORISM AND OF THE INTERNATIONAL
CONVENTION ON THE ELIMINATION OF ALL FORMS OF RACIAL
DISCRIMINATION**

REJOINDER

Report of JSC Air and Space Defense Corporation "Almaz-Antey" on the results of studies related to the technical investigation into the crash of the Malaysian airlines Boeing 777-200 9M-MRD (flight MH17), 2023

on the results of studies related to the technical investigation into the crash
of the Malaysian airlines Boeing 777-200 9M-MRD (flight MH17)

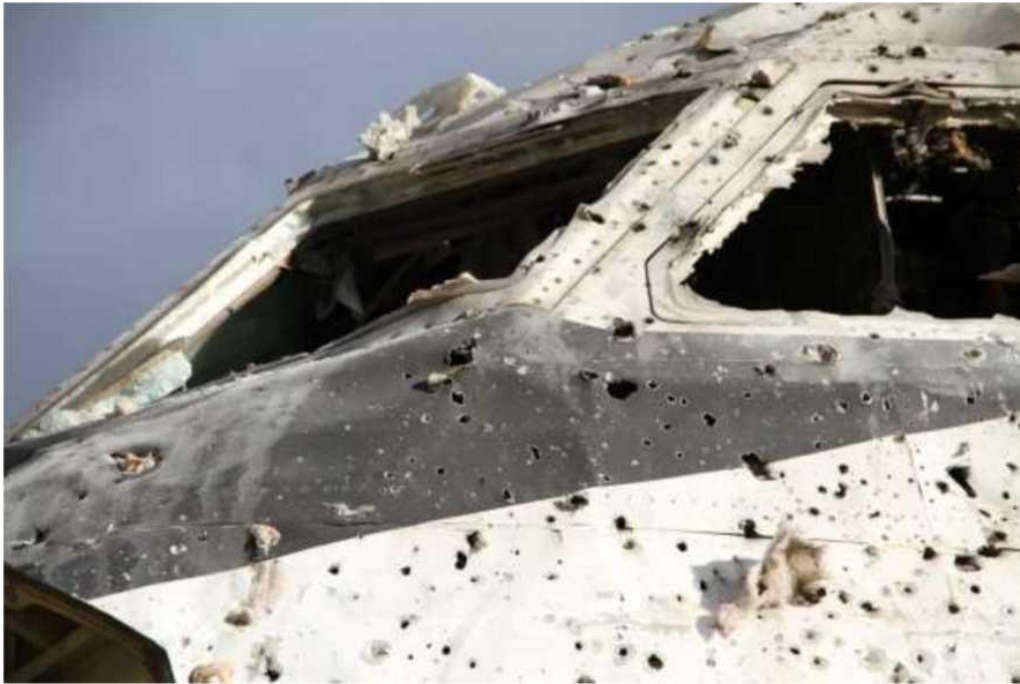
Figure A.4.19 - Aircraft commander's windscreen and small window

From the analysis of the drawings, it appears that the greatest intensity of traces of Thermal influence is observed behind the third window of the crew commander. In contrast to MH17, there are virtually no thermal oxidation traces in the area of the windscreen and the left-hand side window.

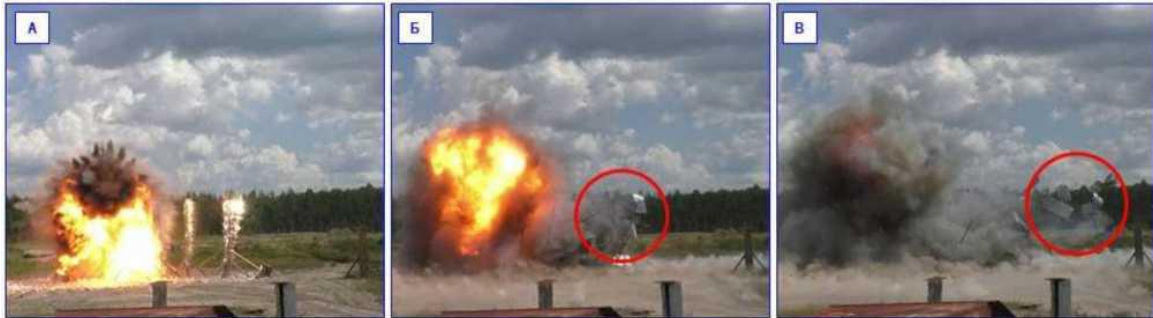
Figure A.4.20 - Destruction of the target environment (Stage 1 of the experiment)

The first phase of the experiment (31.07.2015) was conducted under missile-aircraft encounter conditions according to the Corporation's version. The first photo (left) shows how, before the shockwave impact started, all projectiles overcome five obstacles making part of the shield target layout (up to a total of 12-14 mm in dural equivalent). The other photographs (in the middle and on the right) show the impact of the shockwave.

This caused destruction of the shield target layout along the structure, predominantly on the left side. The impact of the explosive charge of the warhead caused significant deformation and fragmentation of the shield target.

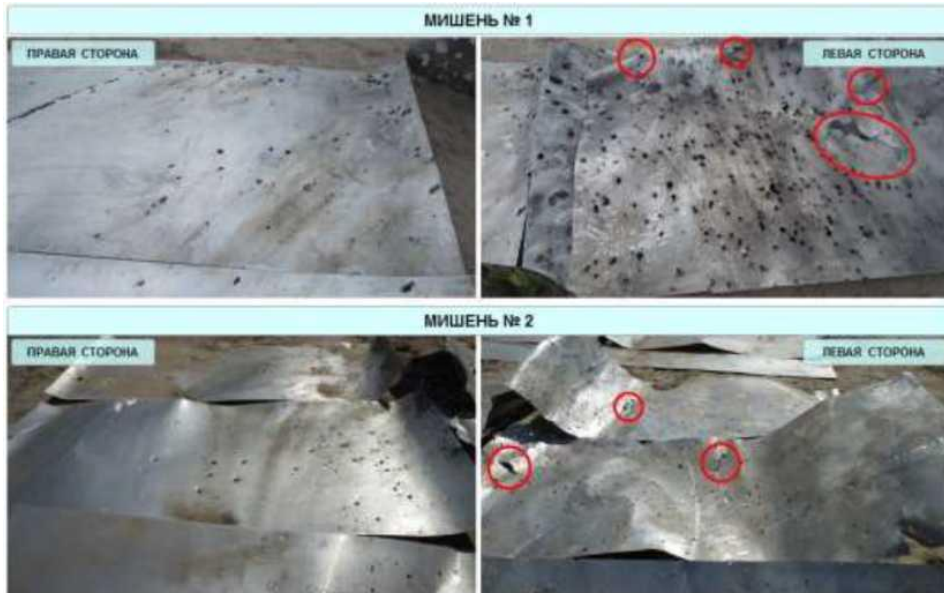
Figure A.4.21 - Fragments of targets No. 1 and No. 2 (Stage 1)

An analysis of fragments of targets No. 1 (top) and No. 2 (bottom) shows that it is when the missile warhead is oriented across the aircraft structure (according to the Corporation's version) that the main blast impact occurs along the left side of the structure. Photographs of the left side of the targets²² show evidence of much greater deformation and local ruptures and fractures (highlighted in red in Figure A.4.21).

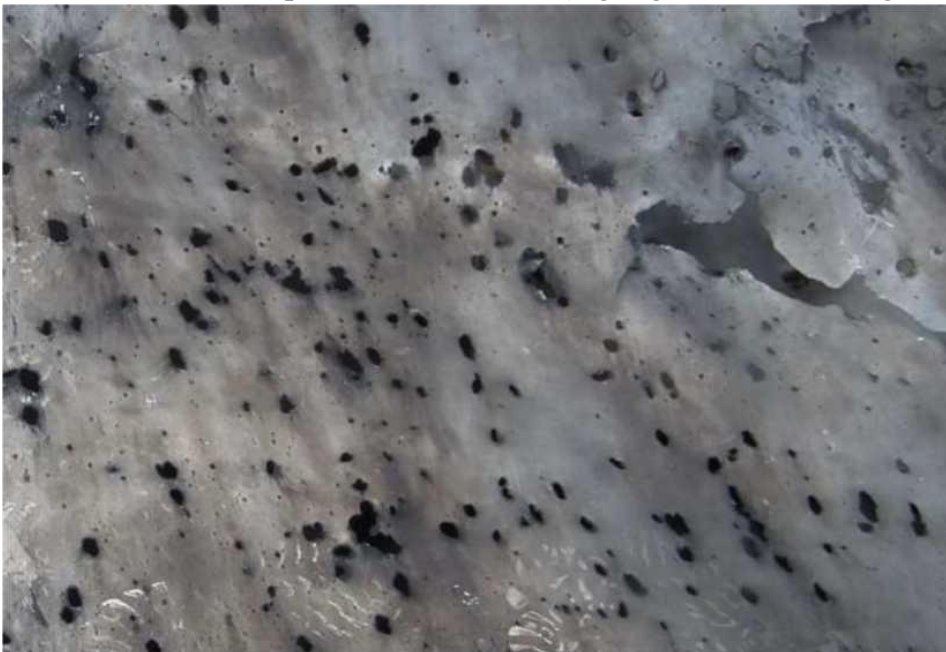
Figure A.4.22 - Fragment of target 1.1 (full-scale experiment in a shield target layout conducted on 31.07.2015)

It is important to point out that during the experiment in a shield target layout the fragment of target 1.1 was placed almost twice as far away from the detonation point as the actual one, which was due to adjustments for safety requirements.

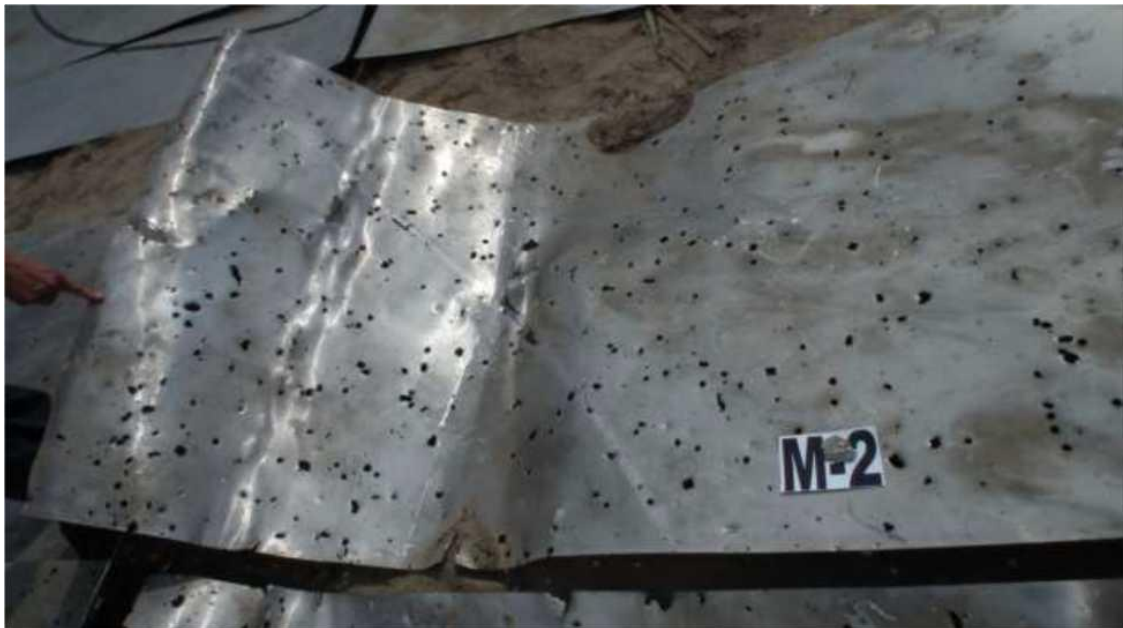
Figure B. 2.1 - General view of fragment 2.1 of target No. 2

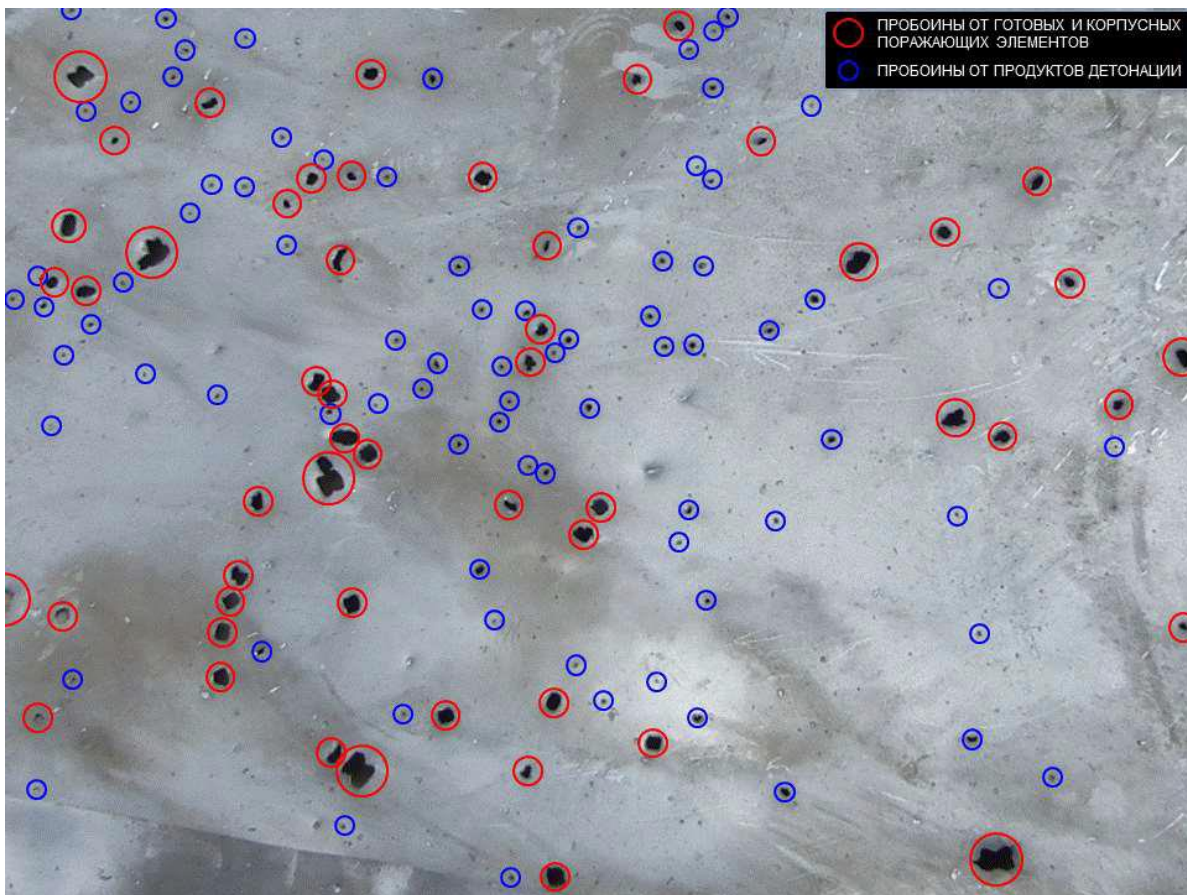
Figure B. 2.2 – Close-up of fragment 2.1 of target No. 2. Number of holes. During the tests, it was proven experimentally that the kill field of the 9H314M warhead when detonated as part of a missile compartment is up to three times larger than in virtual models that consider only preformed fragments.

The number of through-holes in 2 or 4 mm thick target shields is on average 2.4 to 2.6 times greater than when modelling prefabricated projectiles alone. When considering penetrations with linear dimensions corresponding to those of finished projectiles (6 to 13 mm), the number of penetrations is, on average, 1.8 to 2.0 times greater than when modelling finished projectiles only.

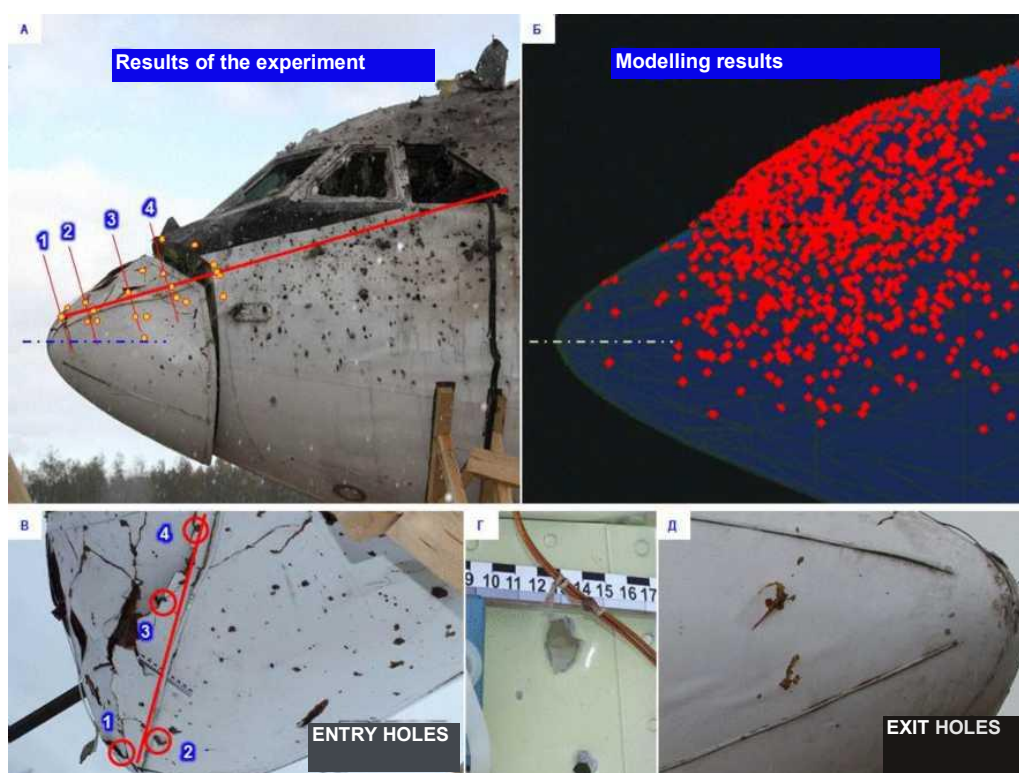
Figure B. 2.4 - Source data for estimating the rear edge of the 9H314M warhead's fragmentation field

The upper left corner (Figure B.2.4) shows the radio-transparent nose fairing of the IL-86 target aircraft. On it, numbers from "1" to "4" denote through-holes in the fairing, where "1" is the furthest single hole, and point "4" corresponds to the section where these hole marks are already present in high density.

On the top right (Fig. B.2.4) is the result of modelling the damage to the nose section of the IL-86 model under static experimental conditions. At the bottom of the figure are photographs illustrating entry and exit holes in the radio-transparent fairing, as well as damage to the weather radar equipment mounting bracket (corresponding to the section near point "3").

Calculations show that the through-holes located on the fairing and on the elements of the weather radar³⁷ correspond to a meridional angle of 120°-122°. The boundary of the furthest damage (cross-sections at points "2" and "1") corresponds to a value of over 124°-126°.

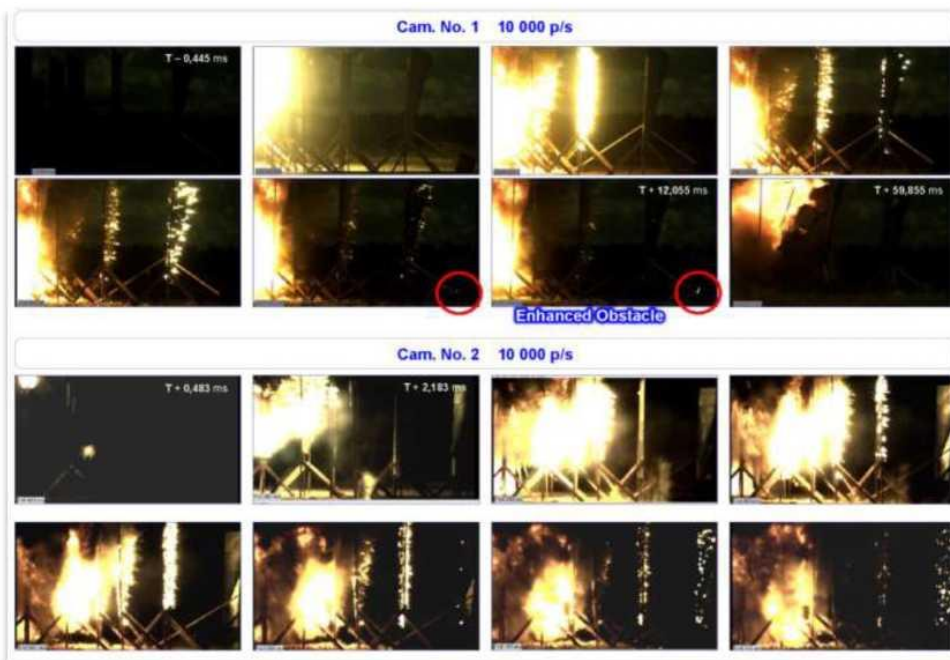
Figure B.3.1 - Demonstration of the mechanical (penetration) capability of the 9H314M projectile. The projectiles successively penetrate up to 5-6 combined obstacles

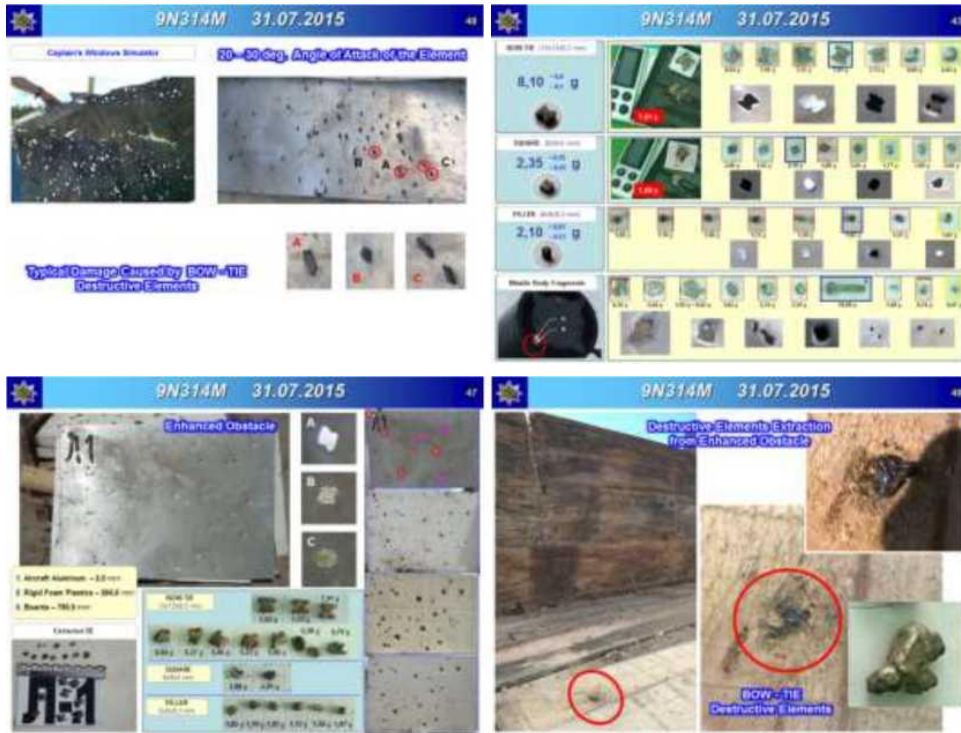
Figure B.3.2 - Fragments of material characterizing the mechanical (penetration) capacity of 9H314M warheads provided to DSB experts during the joint work phase in August 2015 (Gilze-Rijen, Netherlands)

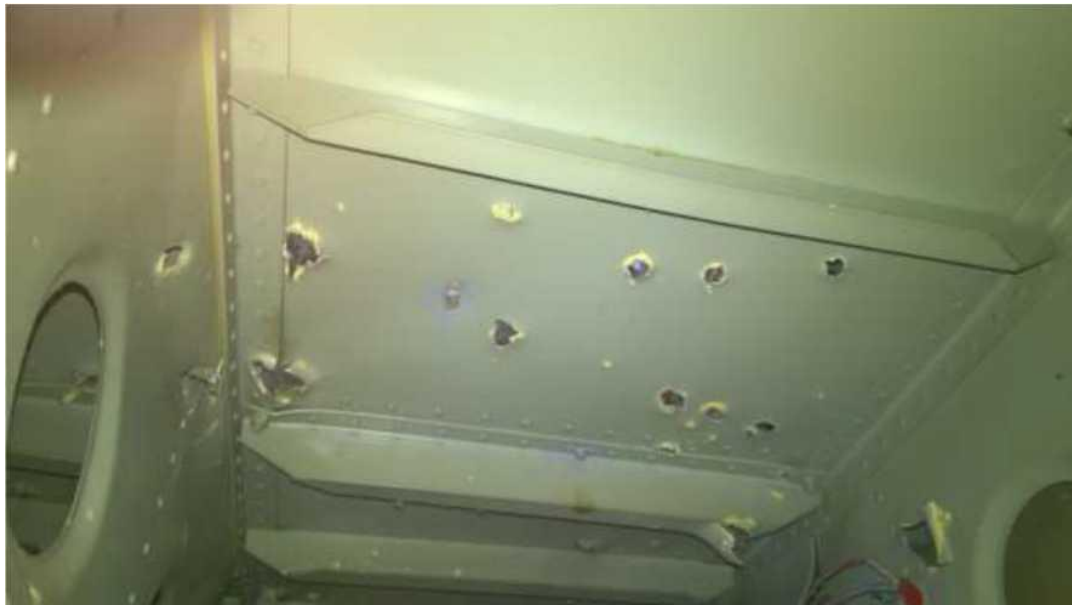
In the second experiment, the 9H314M warhead of the 9M38M1 missile was found to penetrate the cockpit structure when detonated according to the DSB report, as confirmed by the video and photographic evidence presented in the Corporation's report.⁴²

The projectiles that pierced the hull of the aircraft successively overcame at least three to five combined dispersed obstacles in varying combinations:

Figure B.3.17 - Example of through holes in the cockpit floor and framework of the B-86 target aircraft cockpit floor

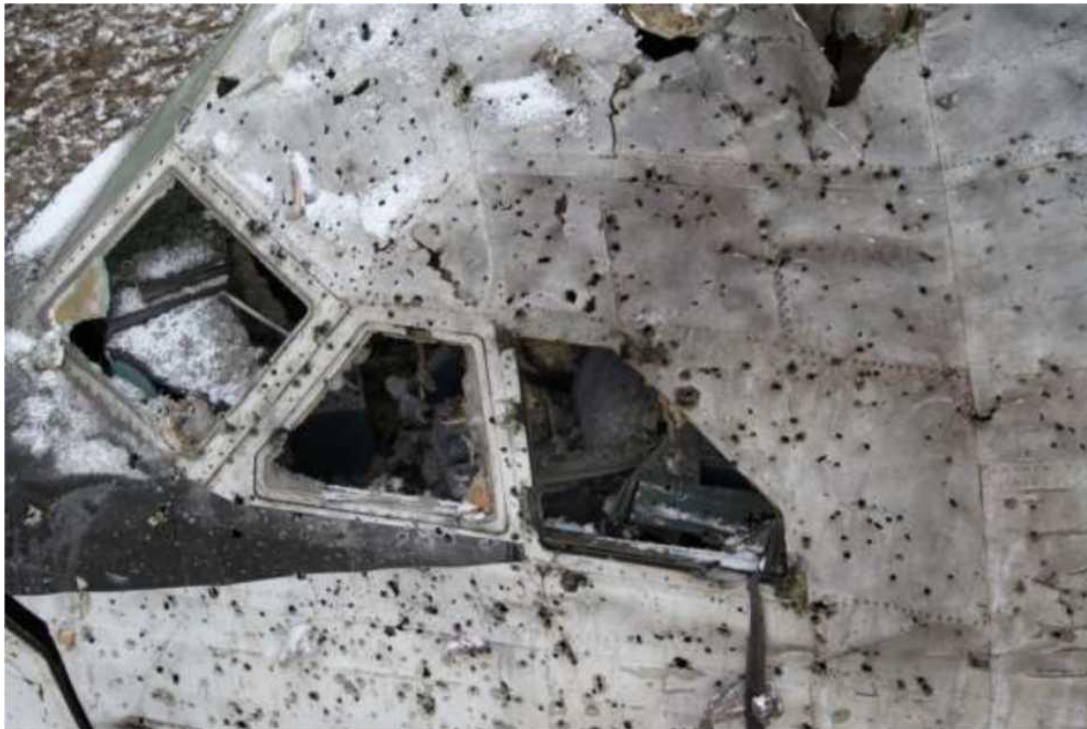
On the port side, penetrating fragmentation damage from preformed fragments was recorded from the nose fairing and weather radar to the front left passenger door L1 inclusive. Non-penetrating damage (ricochets) in the cockpit glazing area, unlike that of the Boeing 777, was not recorded (Figures B.3.18 and B.3.19).

Figure B.3.18 - No non-penetrating damage (ricochets) from preformed fragments on the port side of target aircraft b-86

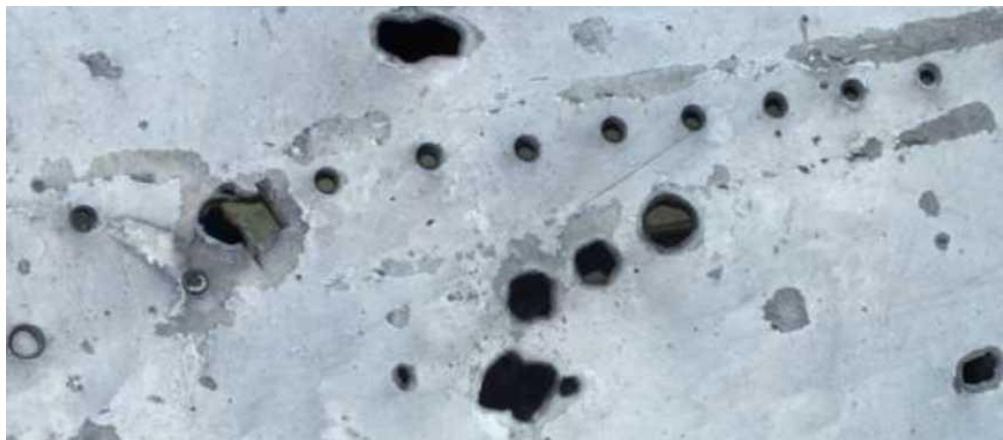
Figure B.3.19 - Fragment of the left side skin of the target behind the windows of the aircraft commander (close-up). No non-penetrating damage from any of the projectiles was observed. The fragment shows the characteristic "bowtie" holes from 9H314M 1-10 projectiles.

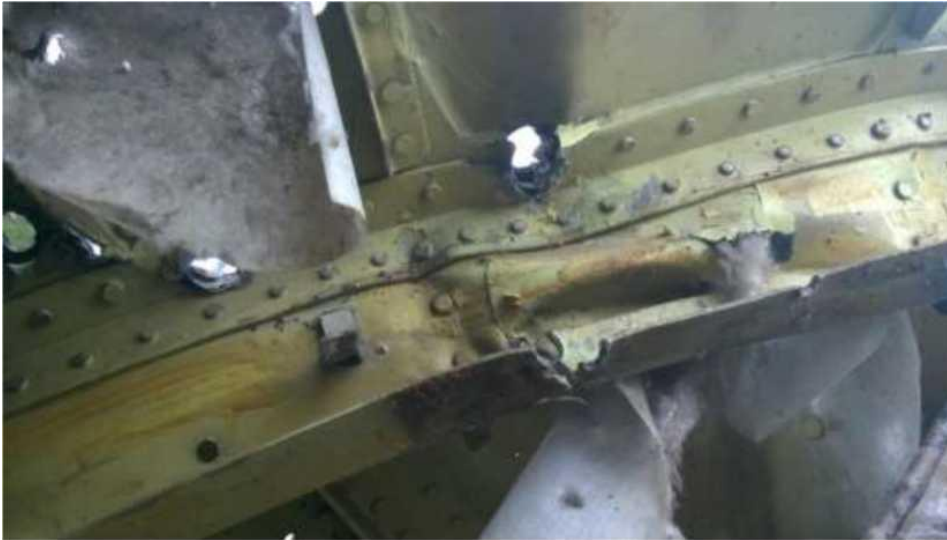
Figure B.3.20 - Characteristic view of the damage to the dovetails on the left side of the cockpit of the B-86 target aircraft (L-shaped reinforcements of the dovetails have been holed). The direction of motion of the projectiles is transverse to the structure of the aircraft. No piercing holes in the bulkheads

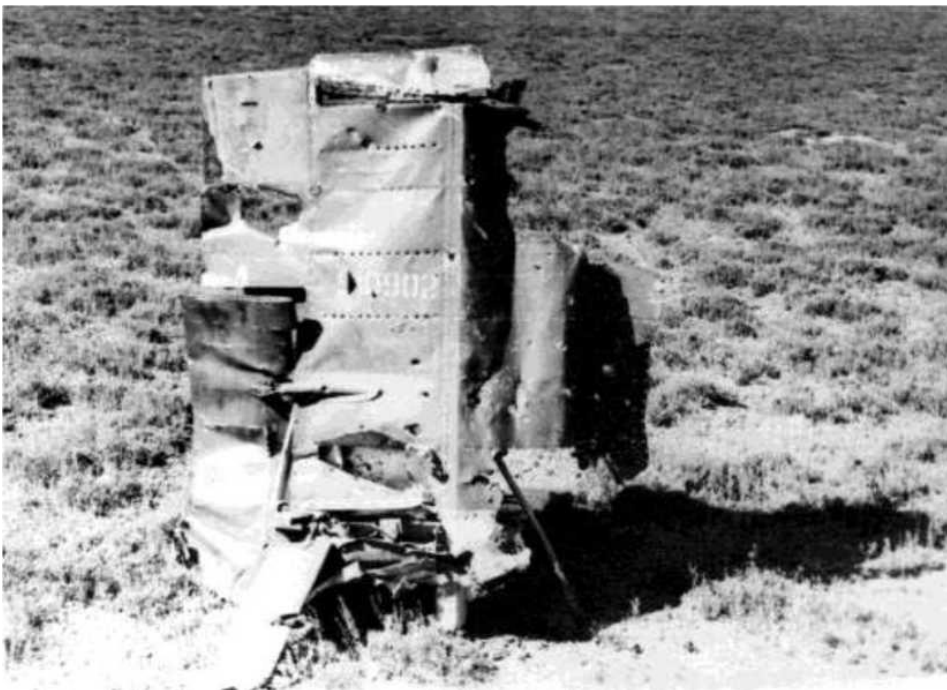
Figure B.3.21 - Target structure pierced through, outer skin and power frame perforated, deformed and destroyed (Resource: Almaz-Antey Archive)

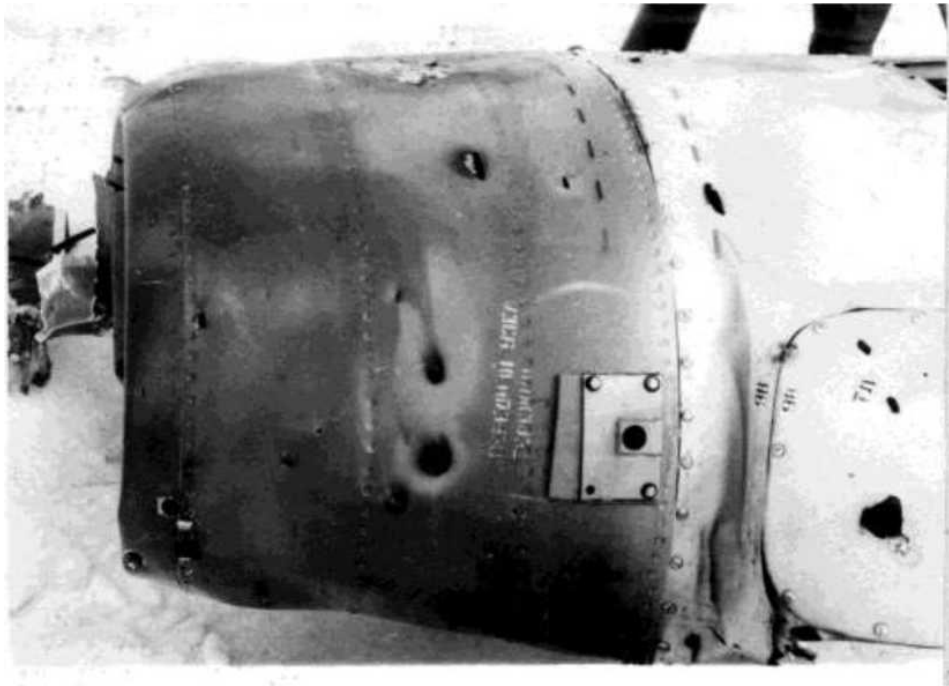
Figure B.3.22 - Target jet engine structure perforated, outer skin and power frame perforated and deformed (Resource: Almaz-Antey archive)

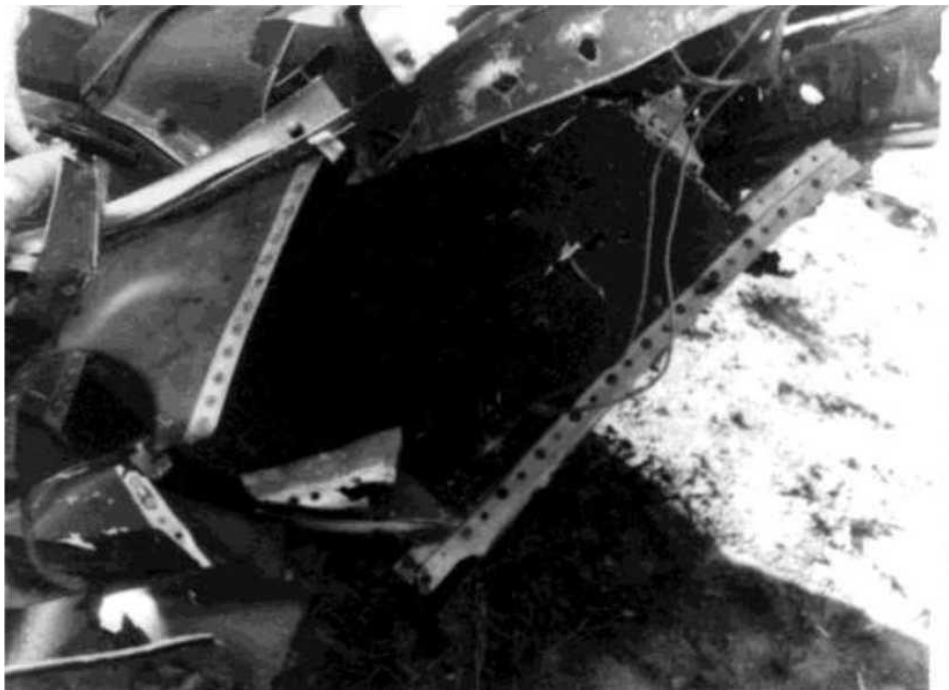
Figure B.3.23 - Target pierced through, outer skin and power frame perforated, deformed and destroyed (Resource: Almaz-Antey Archive)

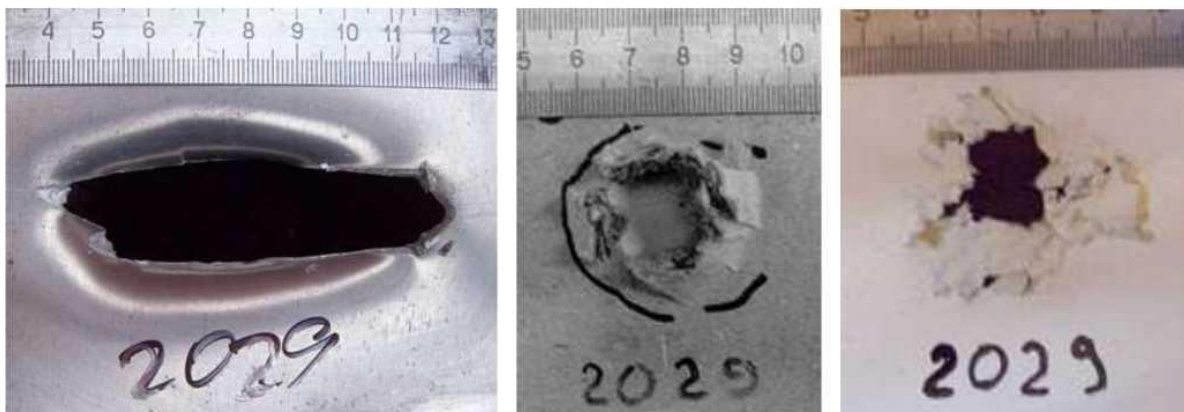
Figure B.4.10 - Experiment 2029. Exterior view of the barrier (left) and witnesses before (centre) and after the barrier (right) as a result of interaction with element no. 1 at an angle of 15° to the firing line at 1683 m/s

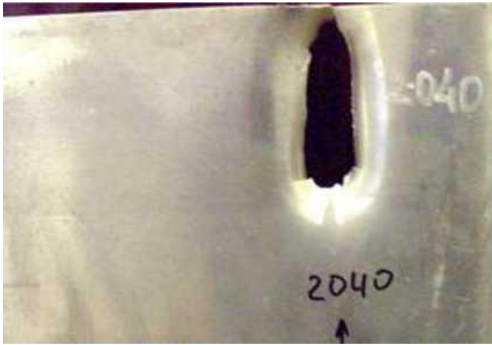
Figure B. 4.12 - Experiment 2040. Exterior view of obstacle after interaction with element no. 1 at an angle of 10° to the firing line at 1688 m/s

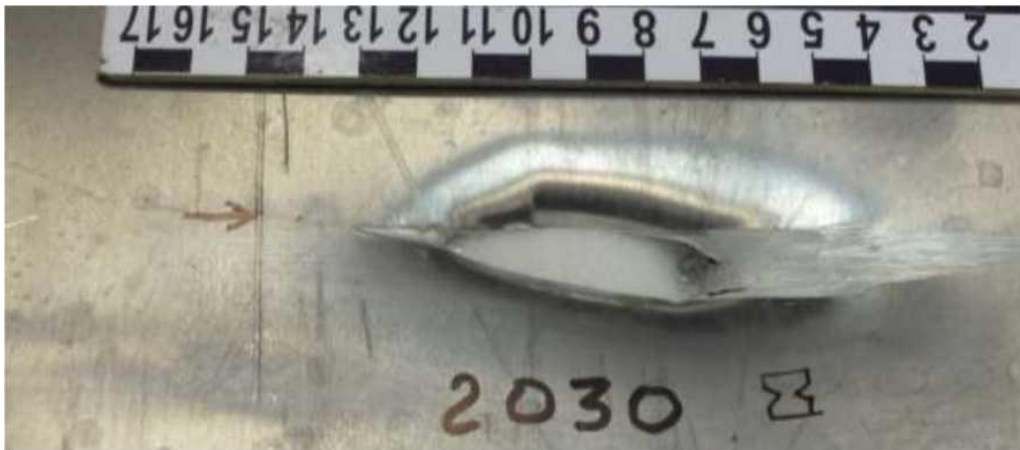
Figure B.4.13 - Experiment 2030. Exterior view of obstacle (Exterior view) after interaction with element no. 1 (9H314M 1-10) at an angle of 5° to the firing line at 1640 m/s

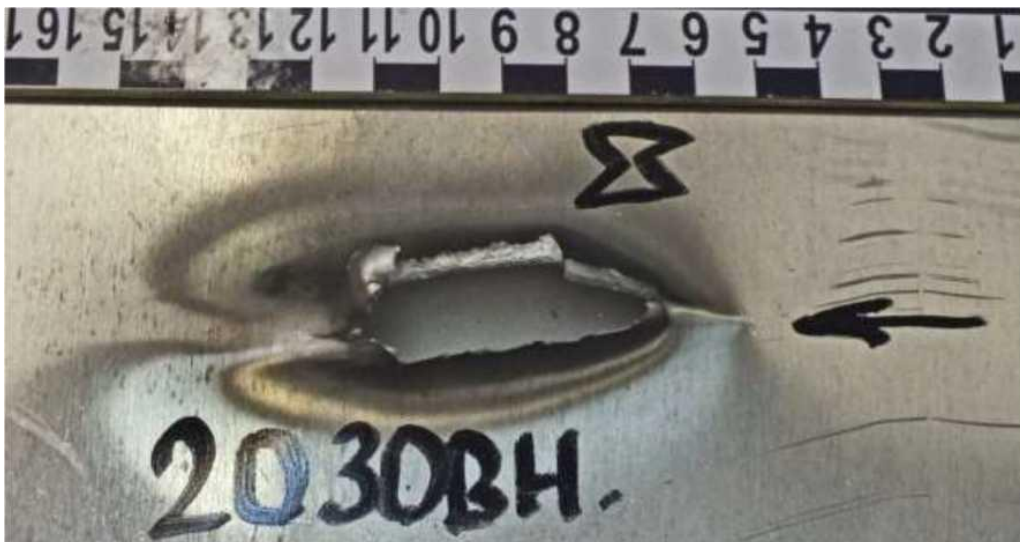
Figure B.4.14 - Experiment 2030. Exterior view of obstacle (inside view) after interaction with element No. 1 (9H314M 1-10) at an angle of 5° to the firing line at 1640 m/s

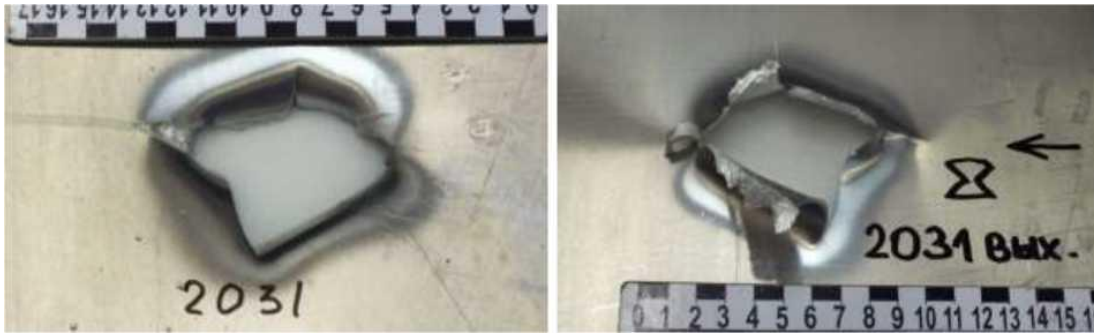
Figure B.4.15 - Experiment 2031. External (left) and internal (right) exterior view of the barrier after interaction with element no. 1 (9H314M 1-10) at an angle of 5° to the firing line at a velocity of 1770 m/s

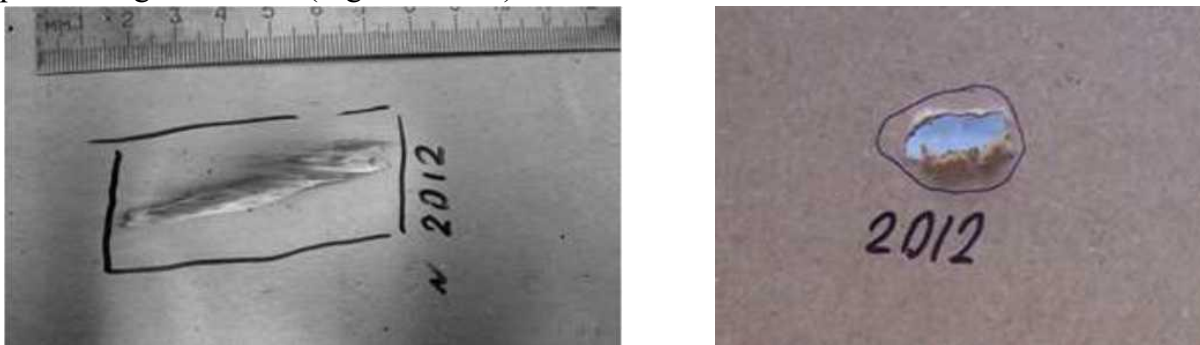
1. In all cases, a 15° angle barrier and a flush approach by the element to the barrier resulted in the element penetrating the barrier and penetrating behind the barrier.
2. In most cases of a 10° and 5° barrier, a penetration through the barrier with a ricochet of the element (without penetration beyond the barrier) occurred.
3. In a number of cases, a penetration of the barrier at angles of 10° and 5° resulted in a penetration of the barrier with the element penetrating behind the barrier.
4. In one case (experiment 2012) the element ricocheted into the barrier without penetrating the barrier (Figure B.4.16).

Figure B.4.16 - Experiment 2012. Exterior view of the barrier and witness after interaction with the element (no through penetration of the barrier)

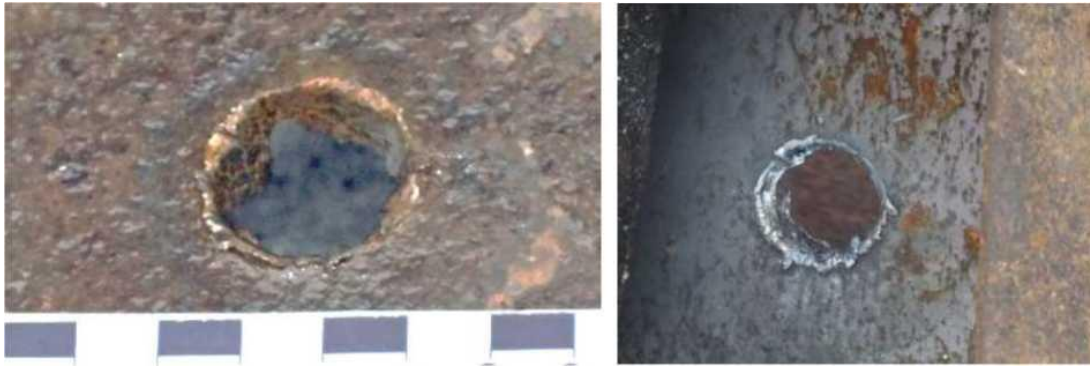
5. Projectiles penetrating behind the barrier and approaching the barrier flat maintained their orientation and ensured subsequent penetration of the 5.0 mm thick steel St3 shield (Figure B.4.17).

Figure B.4.17 - Exterior view of steel shield (St3 x 5.00 mm) after interaction with projectiles penetrating beyond the barrier (left side is a breach from element 9H314M 1-10 "bowtie")

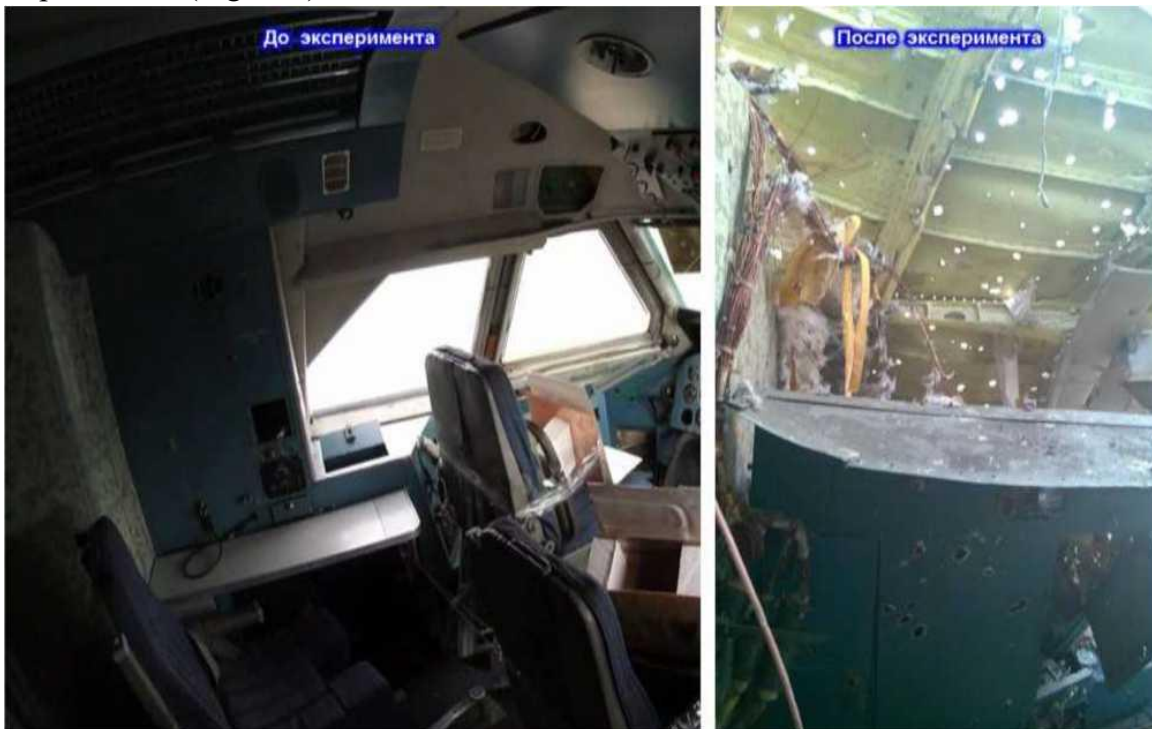
1. Additional metal cabinets with on-board electronic equipment and a steel safe on the port side⁴⁷ (Fig. C.4).

Figure C.4 - Metal cabinet and steel safe on the port side, located behind the crew commander's seat: left - before the experiment; right - after the experiment

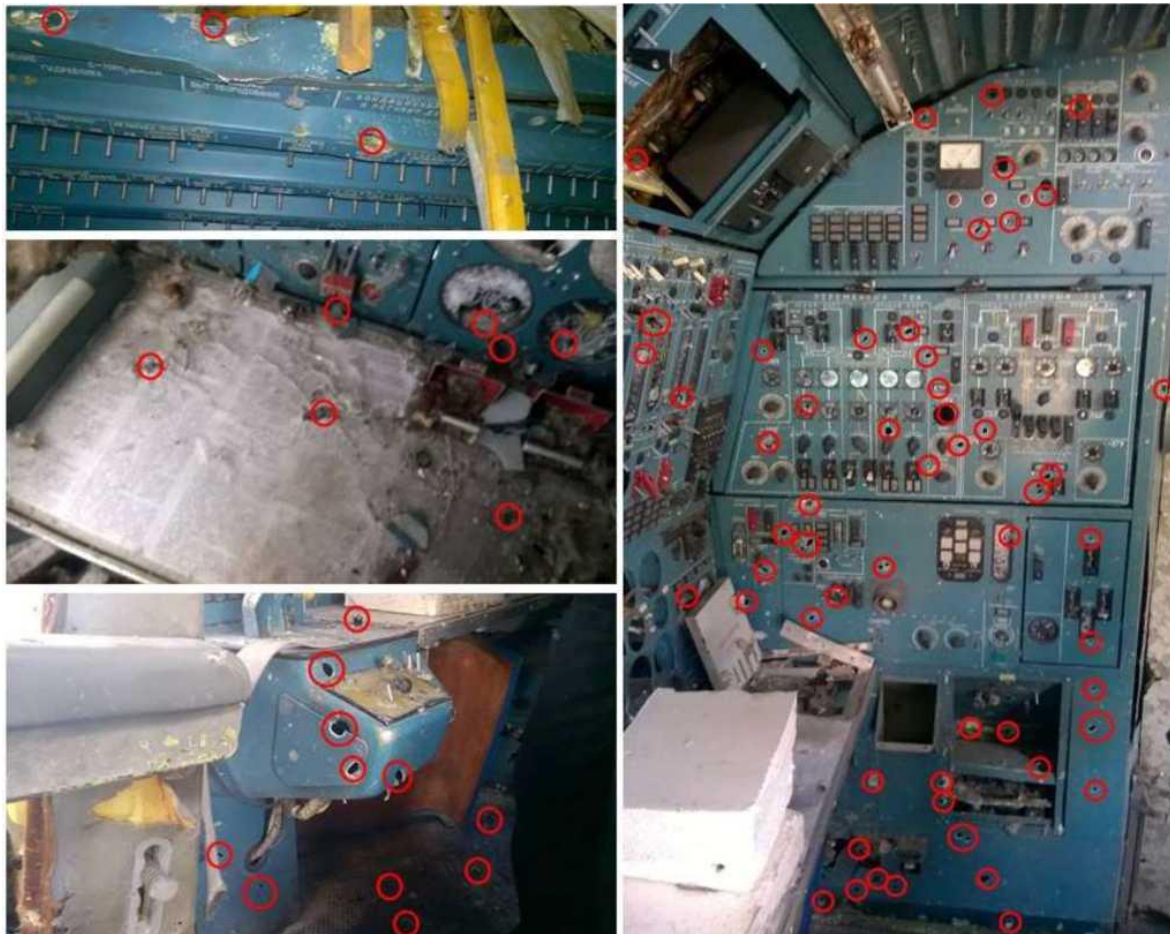
2. The presence of a flight engineer's workstation. This seat is located behind the starboard pilot and equipped with a metal cabinet with instrumentation and control panel located all along the starboard side and the right side of the cockpit roof (Figure C.5).⁴⁸

Figure B.5 - Control panel of the flight engineer of the IL-86 target aircraft (starboard, after the experiment)

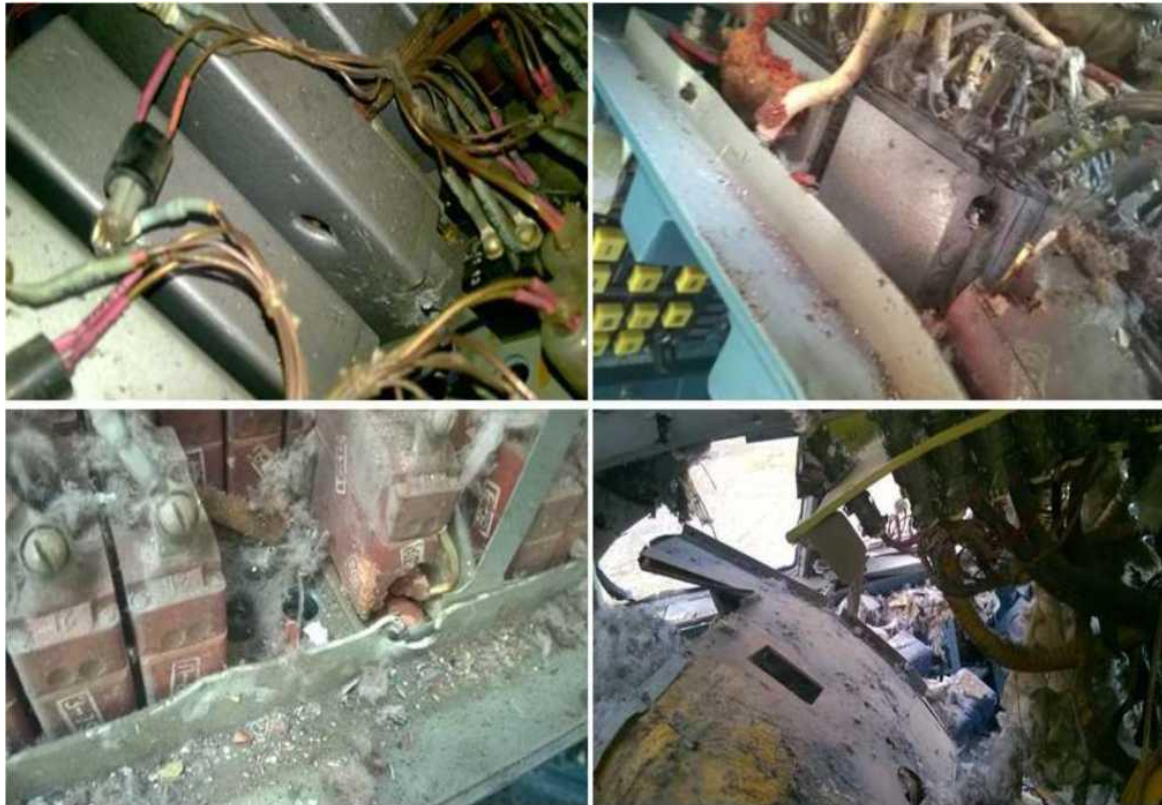
3. The analogue version of the GB-86 ("IL-86") aircraft's avionics with its many material-intensive electronic and electromechanical components from the 1970s-80s (Figure C.6).⁴⁹

Figure C.6 - Material-intensive components of on-board avionics equipment of the IL-86 target aircraft (starboard and starboard side of the roof)

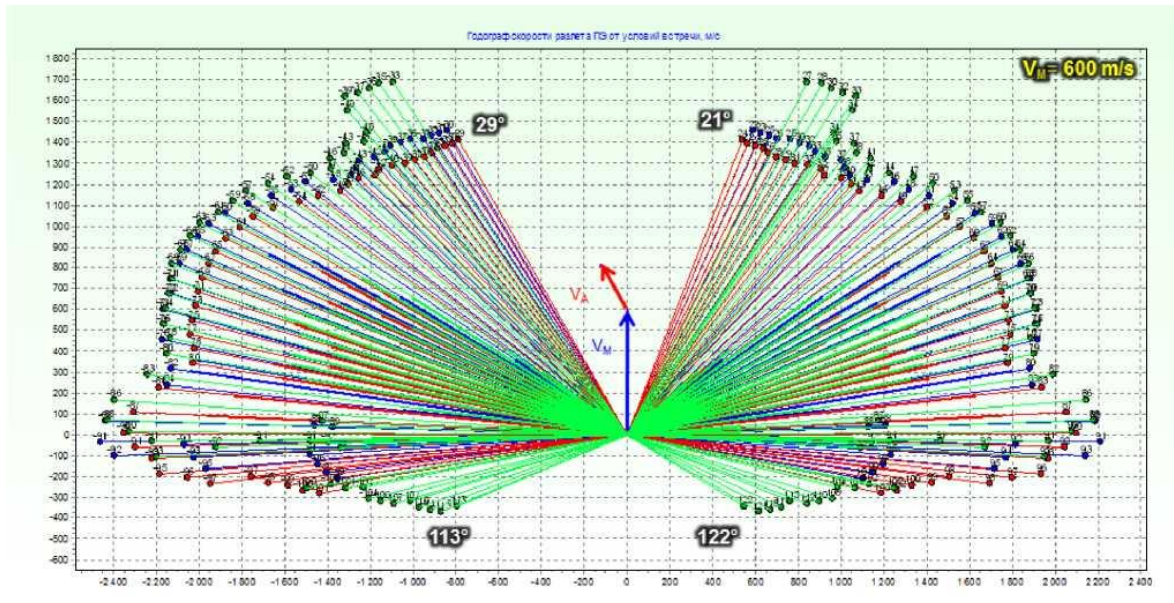
Figure D.5 - Unbalanced cross-section of the fragmentation field in the meridional plane

Analysis of Figure D.5 shows that the cross section of the fragmentation field in the meridional plane is asymmetrical. This is particularly evident in the value of the meridional angle of the trailing edge of the fragmentation field: towards the target (left) the trailing edge of the dynamic angle of departure is 113° and in the opposite direction (right) it is 122° .

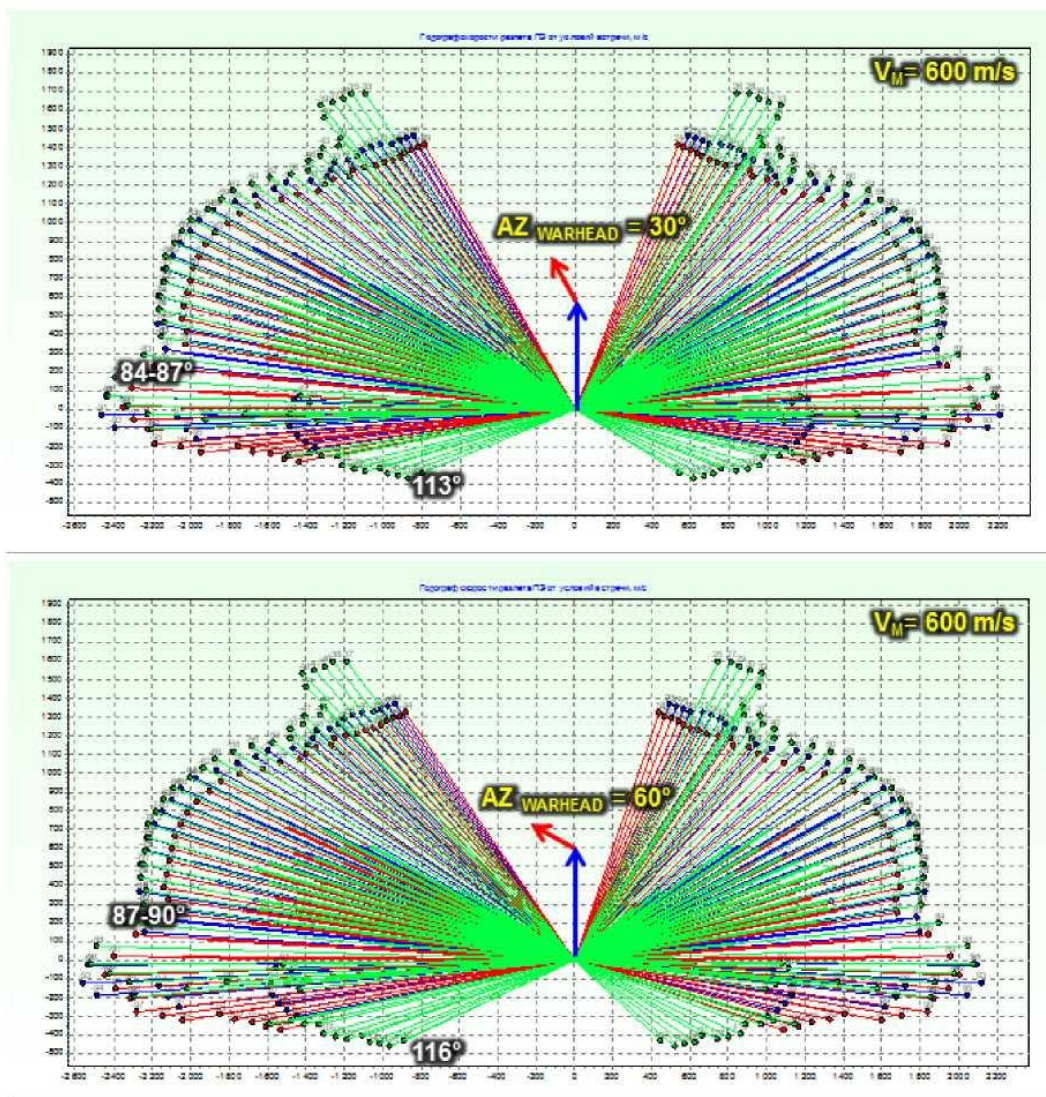
Figure D.6 - Effect of angle between aircraft and missile longitudinal axes $Az_{warhead}$ at the moment of detonation at the same rocket velocity $V_M = 600$ m/s: top - $Az_{warhead} = 30^\circ$; bottom - $Az_{warhead} = 60^\circ$

As the angle between the longitudinal axes of the aircraft and the missile increases ($Az_{warhead}$) at the moment of detonation, the value of the angle characterizing the posterior front of the fragmentation field increases.

In this case in the left hemisphere, towards the target from 113° to 116° .

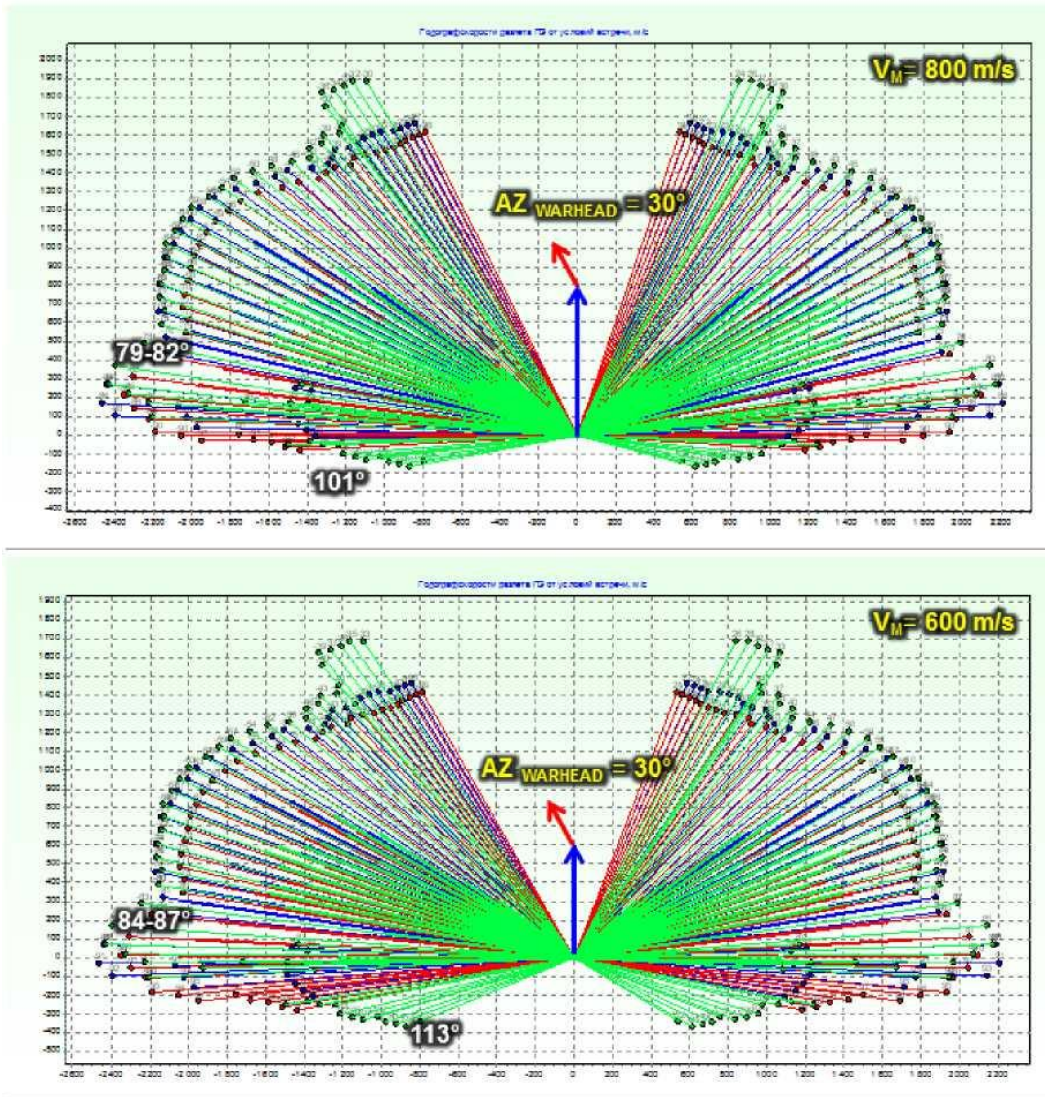
Figure D.7 - Effect of final missile velocity V_M at the moment of detonation at constant angle between the longitudinal axes of the aircraft and the $Az_{warhead}$ missile: top - $V_M = 800$ m/s; bottom - $V_M = 600$ m/s

As the final velocity of the missile increases, V_M at the moment of detonation, the value of the angle characterizing the trailing edge of the fragmentation field decreases. In this case, from 113° at 600 m/s to 101° at 800 m/s (in the left hemisphere).
