**APPLICATION OF THE INTERNATIONAL CONVENTION FOR THE SUPPRESSION
OF THE FINANCING OF TERRORISM AND OF THE INTERNATIONAL
CONVENTION ON THE ELIMINATION OF ALL FORMS OF RACIAL
DISCRIMINATION**

REJOINDER

Report of JSC Air and Space Defense Corporation "Almaz-Antey" on the results of studies related to the technical investigation into the crash of the Malaysian airlines Boeing 777-200 9M-MRD (flight MH17), 2023

on the results of studies related to the technical investigation into the crash
of the Malaysian airlines Boeing 777-200 9M-MRD (flight MH17)

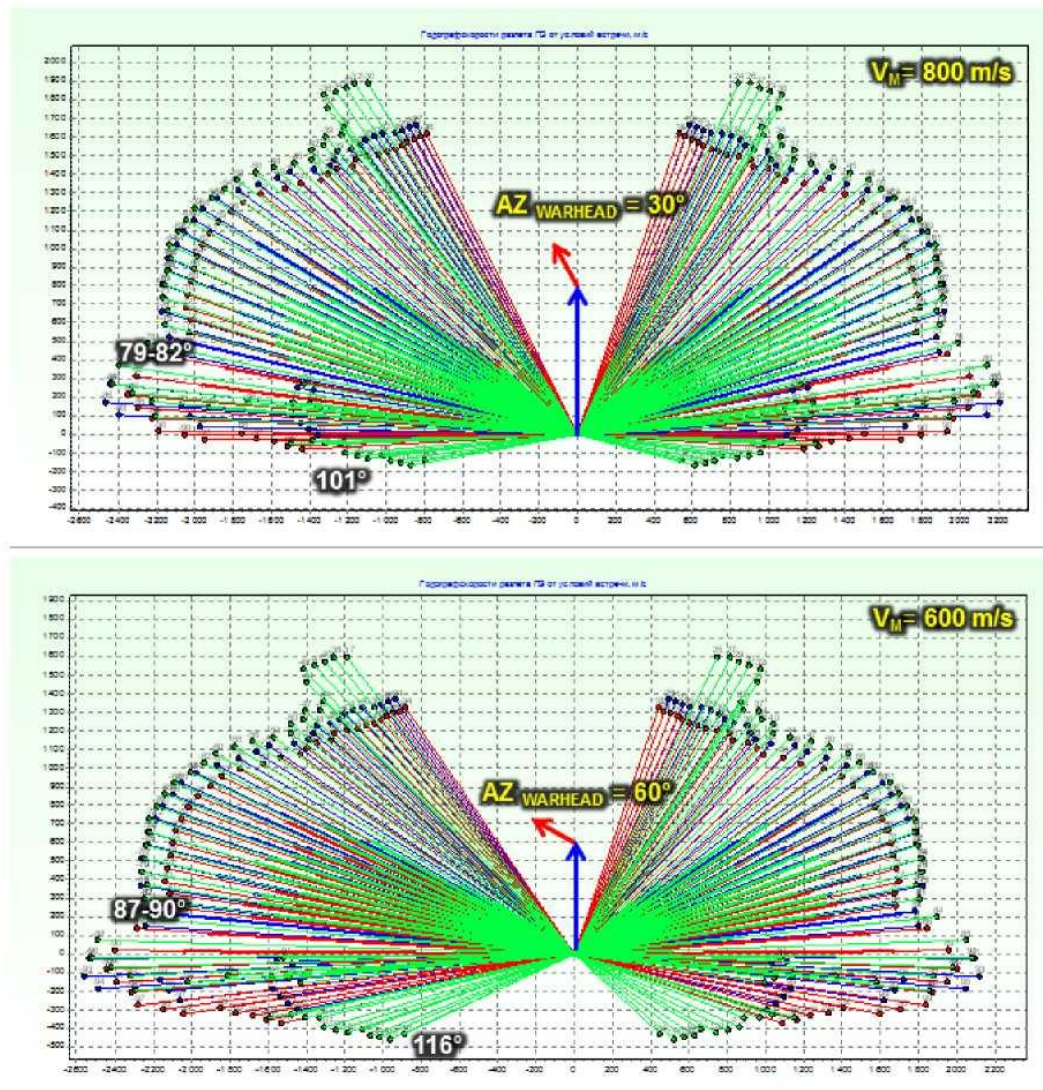
The maximum difference appears when the angle $Az_{warhead}$ between the longitudinal axes of the missile and aircraft changes simultaneously with the missile's terminal velocity V_M . In this case, errors in favour of the "opposite direction" version could be as much as 15° deg or more (see Figure D.8), where: for a trailing edge of fragmentation $116^\circ-101^\circ=15^\circ$.

Figure D.8 - Effect of simultaneous variations in final missile speed V_M and the angle $Az_{warhead}$ between the longitudinal axes of the aircraft and the missile.
top - $V_M = 800 \text{ m/s}$, $Az_{warhead} = 30^\circ$; bottom - $V_M = 600 \text{ m/s}$, $Az_{warhead} = 60^\circ$

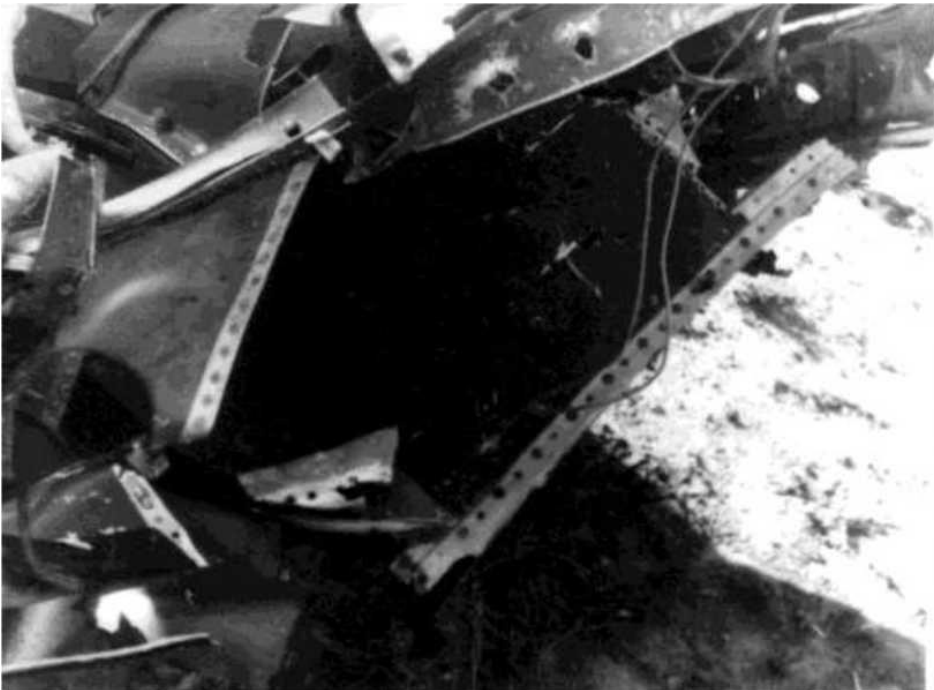
Figure D.14 - Fragment of an air target destroyed in an airborne dynamic test. Target perforated, outer skin and primary structure perforated, deformed and collapsed

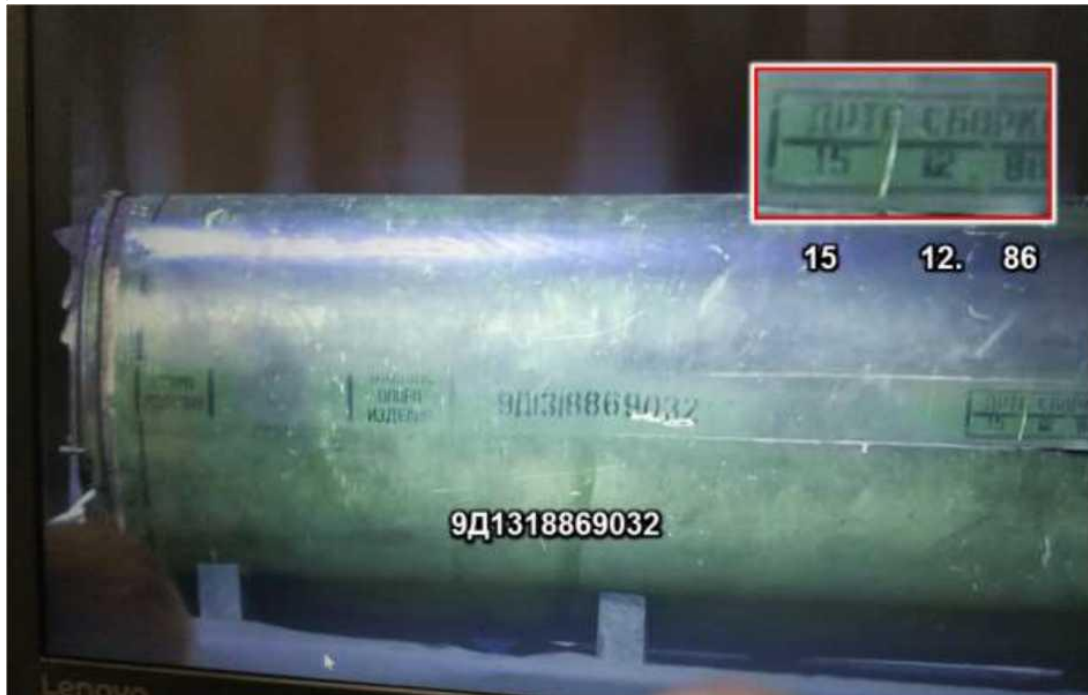
Figure E.1 - Missile fragment: rear of the 9D131 engine of the 9M38 missile (resource - JIT press conference)

This piece is stamped with serial number 9D1318869032, where:

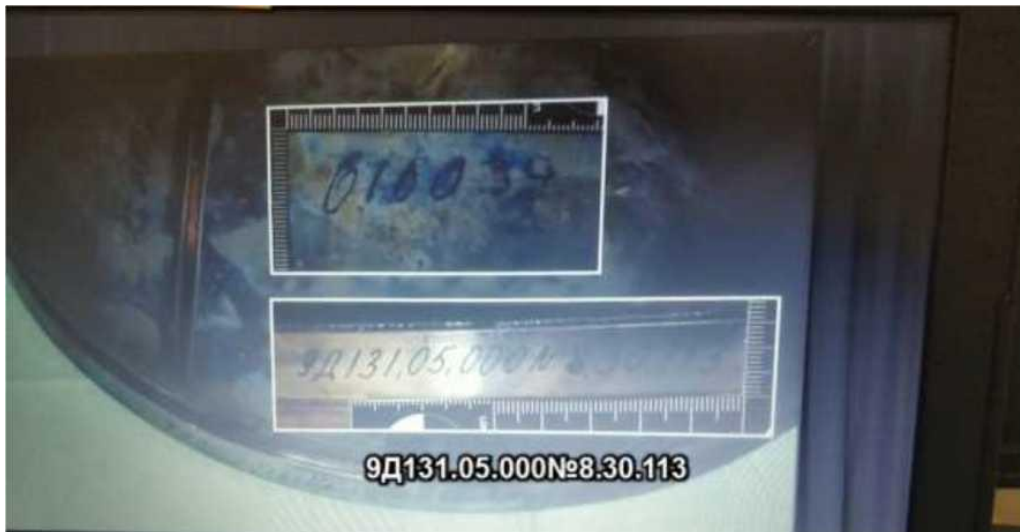
Figure E.2 - Rocket fragment: part of the nozzle, block "C" (resource - JIT press conference)

This fragment has serial number 9D131.05.000 No. 8.30.113.

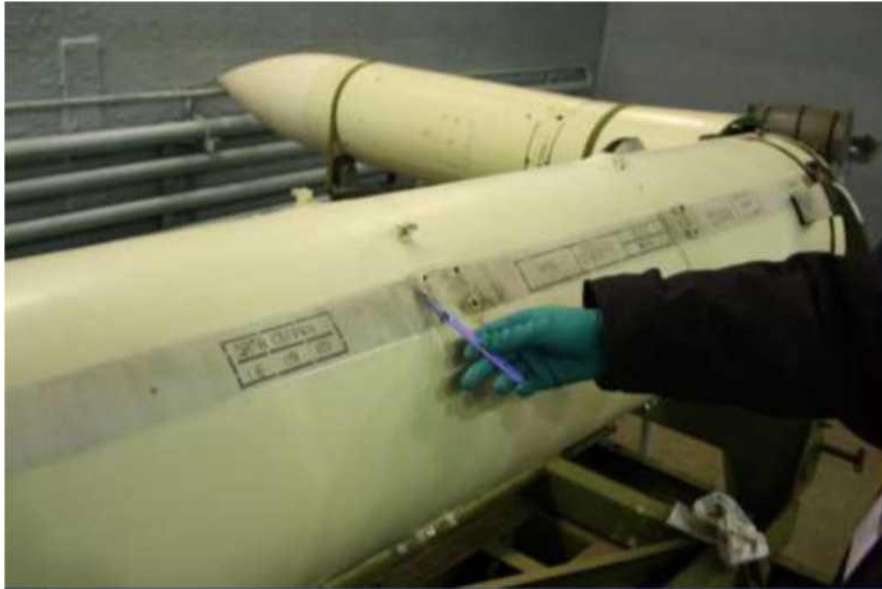
Thus, in Figure E.3 below, the 9M38 missile (white in colour) given by Ukraine to the investigation clearly shows the stamp "DATE OF CONVENTION" and "06.09.85". In addition, the photograph shows that the paint in the area of the stamp differs from the rest of the engine paint.

Figure E.3 - Stamp "ASSEMBLY DATE" on the 9M38 missile delivered by Ukraine to the investigation. The expert shows with his hand the attachment point of the wing on the shell of the third compartment. In order to see the stamp "Assembly date", the wing must be dismantled (resource - materials of KNIISE)

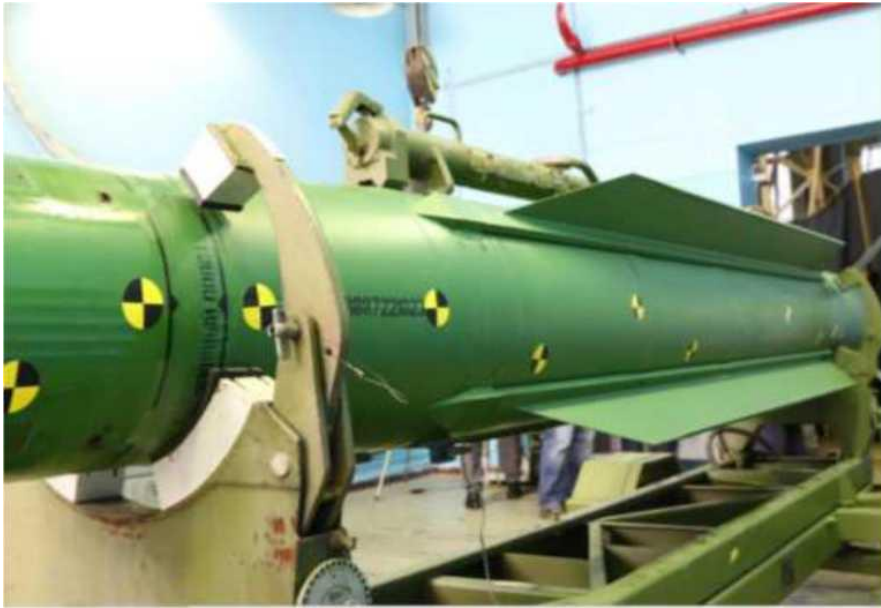
Figure E.4 - 9M38M1 missile delivered by Ukraine to the investigation (SBN materials). After installation of the wings, the process stamp "Assembling Date" is not visible - it is covered by the relevant wing

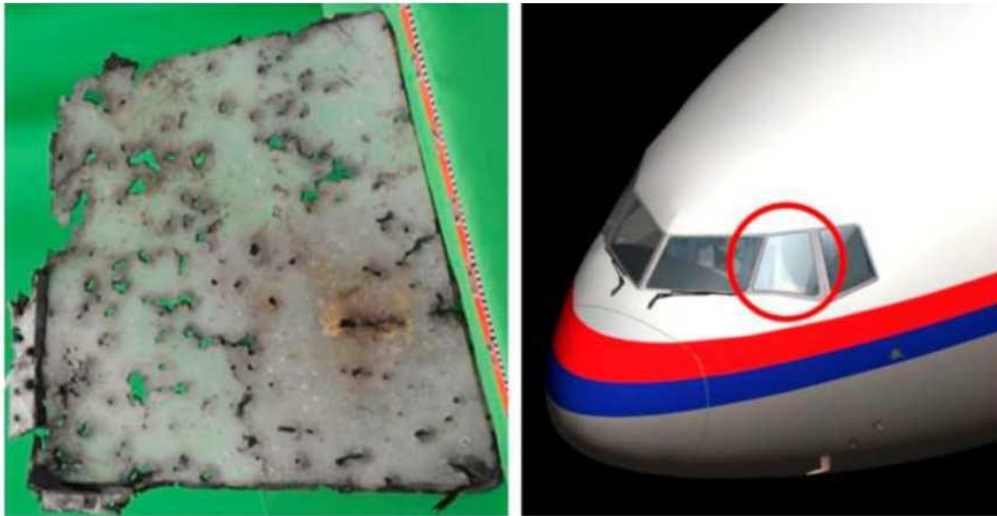
No 2 - the second window (window No 2) of the crew commander, on which DSB experts recorded 102 fragmentation holes and this window was in the area with the highest density of fragmentation damage – about 250 fragmentation holes per square metre.⁶⁰

Figure F.1 - According to the NLR report (Annex X of the DSB report), the second window on the left side of the cockpit has a maximum impact density of approximately 250 damage per square metre (Resource - NLR)

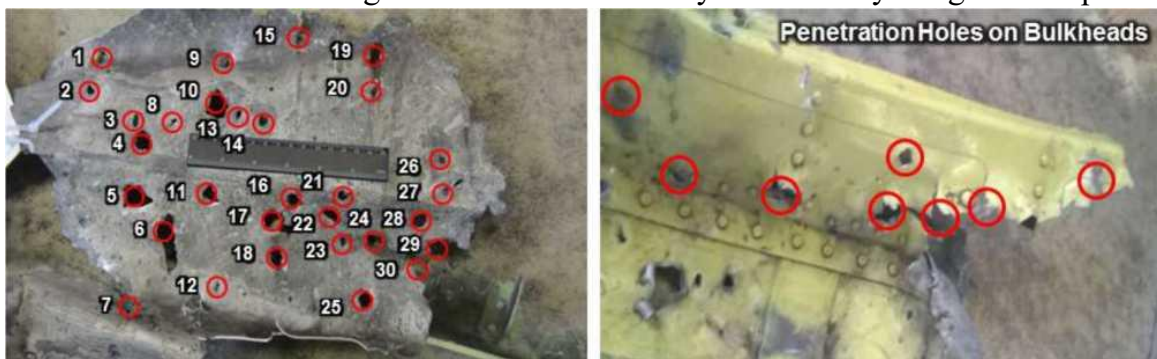
No. 3 - fragment of the upper port side (behind the crew commander's windows), which was in the area of maximum density (mass and kinetic energy) of projectiles and factors accompanying a close explosion.

Figure F.2 - Fragment of the port side planking from the top at the rear of the third window of the Crew Commander with evidence of multiple holes in the outer planking (left) and in the bulkhead (right)

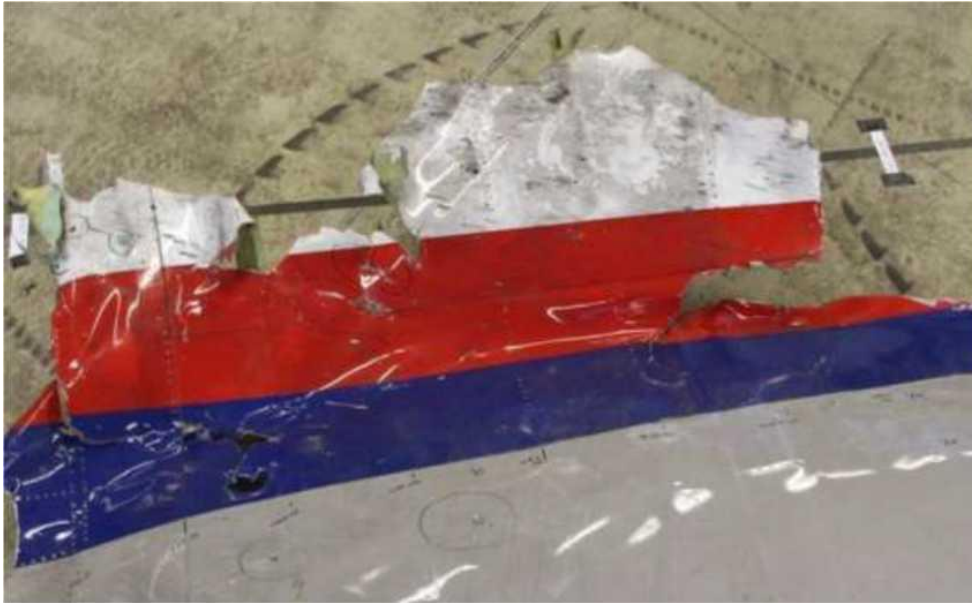
No 4 - fragment of lower port side from frame STA 228.5 to passenger door L1 with pronounced non-penetrating damage (ricochets) to the port side skin at the edge of the covering field.

Figure F.3 - Fragment of the underside of the port side with fragmentation damage at the edge of the covering field

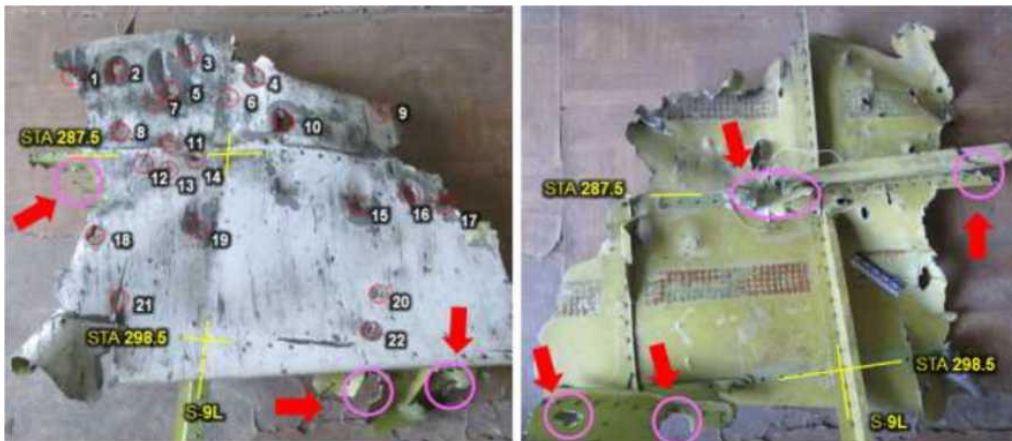
its forward section shows a high density of fragmentation damage, as well as multiple holes in the STA 287.5 and STA 298.5 bulkheads, which led to deformation and structural failure of the Boeing 777 (Figure F.4);

Figure F.4 - Fragment of upper port side: external (left) and internal (right) views. Multiple penetrations in bulkheads STA 287.5 and STA 298.5 caused deformation and failure of the structural members (red arrows indicate characteristic damage)

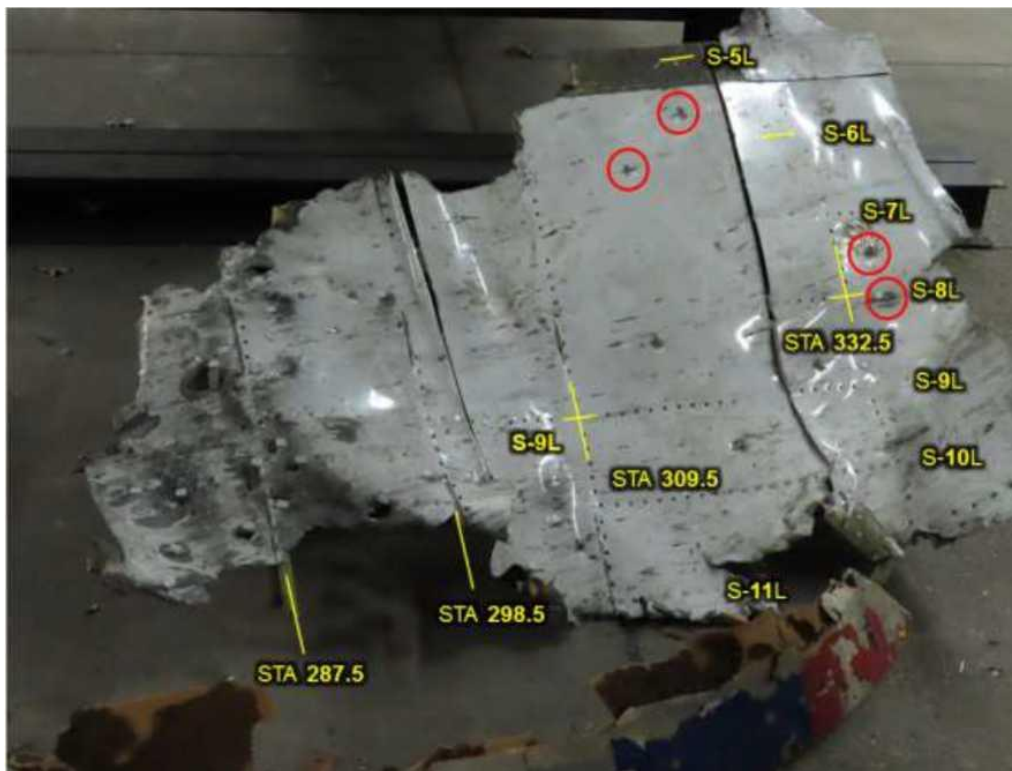
the rear part of the fragment has damage located between bulkheads STA 309.5 and STA 332.5 (figure F.5).

Figure F.5 - At the rear of the fragment, fragmentation damage is located between bulkheads STA 309.5 and STA 332.5, which is almost 3 metres beyond the accepted "reference" damage

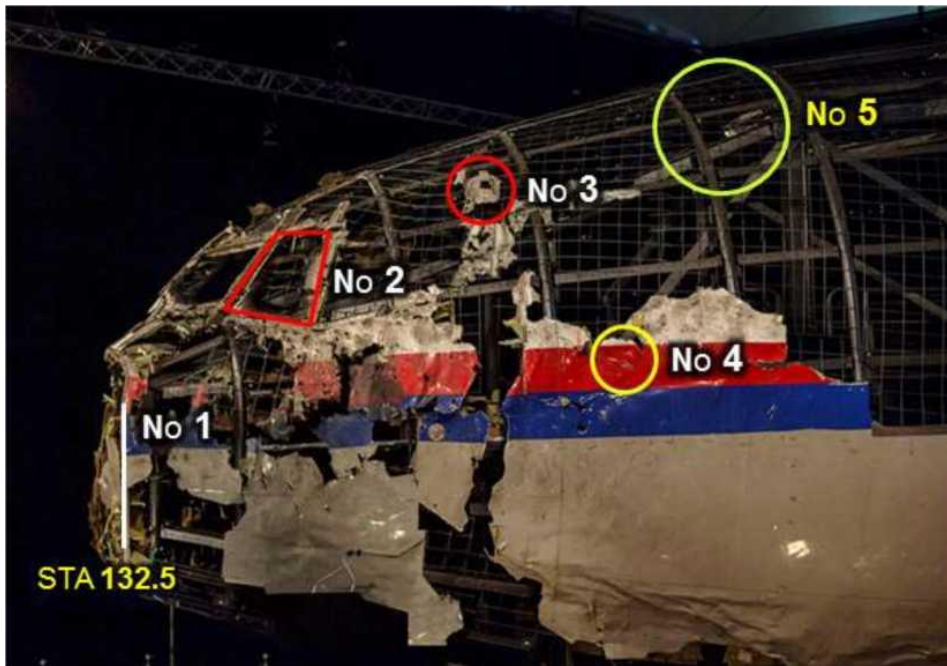
Figure F.6 - Fragments No 1, No 2, No 3 and No 4 are included in the final 3E reconstruction, while fragment No 5 is missing

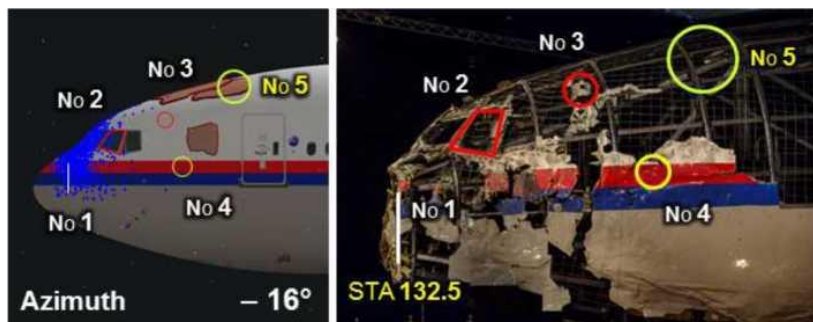
Figure F.7 - Simulation of Boeing 777 nose section damage under Azimuth -16° conditions

1. The anterior boundary of the fragmentation cover from prefabricated projectiles is much closer to the nose than the real one, starting behind the level of the forward pressure bulkhead (Fragment No 1). In reality this would have resulted in multiple through-holes in the forward pressure bulkhead and weather radar of the Boeing 777. For example, as happened during the second

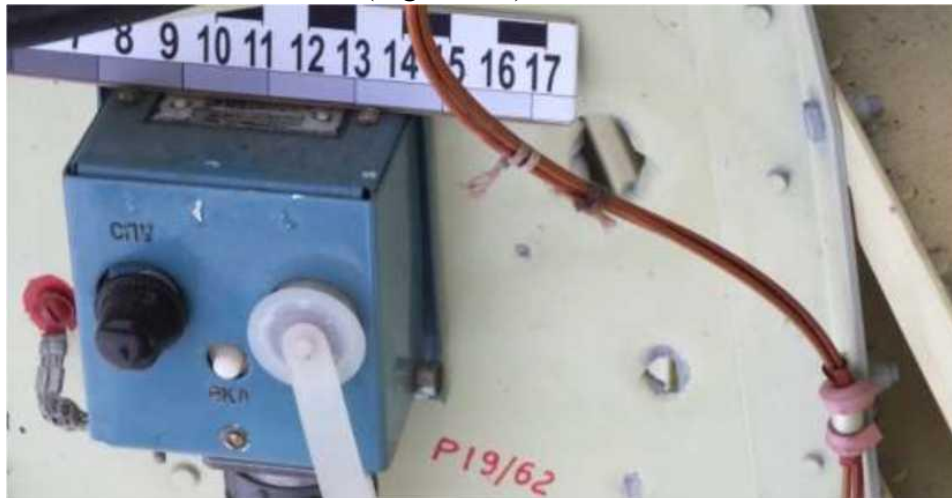
Figure F.8 - Example of through-holes in the weather radar equipment of target aircraft IL-86 (Proceedings of the Experimental Report)

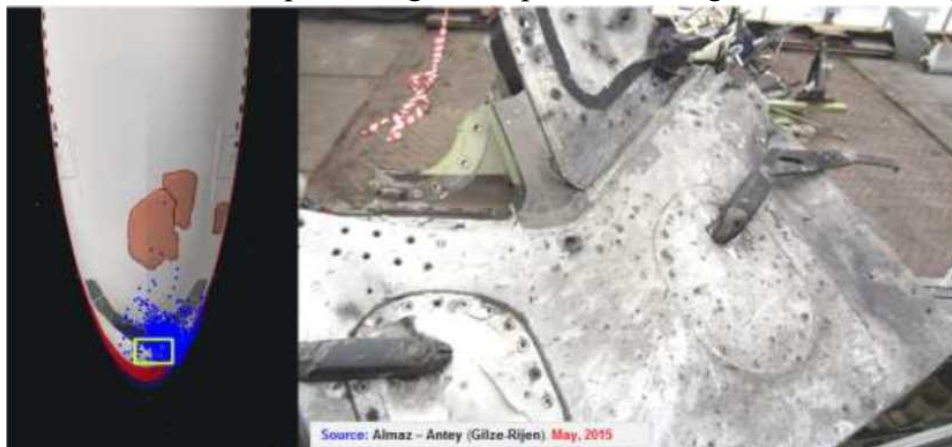
In addition, the fragment in front of the cockpit windshields should show multiple GVE damage from modelling and in-situ testing (Figure F.9).

In fact, there is no multiple damage from preformed fragments on this fragment.⁶⁵

Figure F.9 - Inconsistency of damage in front of cockpit windshields: according to modelling results, the fragment should show multiple GPE damage (left); the fragment in front of windshields does not have a high density of damage (right)

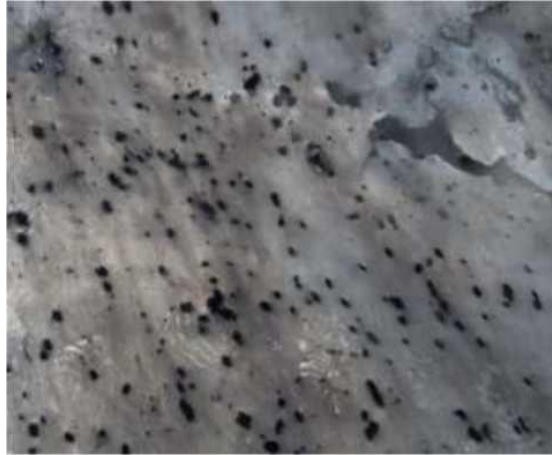
Figure F.10 - Fragment of Witness Sheet 1.1 of Target M. 1 (field experiment in a shield target layout conducted on 31.07.2015)

In reality, if the 9H341M detonated near target No. 1 (M.1) at a distance corresponding to the distance of the detonation point from the nose of the Boeing 777 (not more than 1.6-2.0 m), the number of fragmentation holes on Witness 1.1 would be three to four times greater than in the photograph (figure F.10).⁶⁶

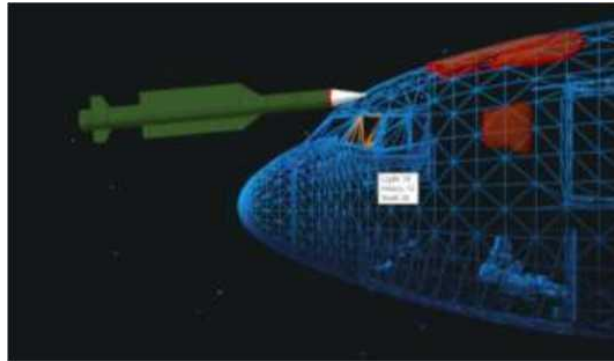
Figure F.11 - Simulation of fragmentation damage to the nose of a Boeing 777 aircraft under Azimuth -16° conditions. The polygonal objects corresponding to the second left window are highlighted in orange on the interactive aircraft model

The number of simulated damages (46 units) is 2.22 times less than the number actually recorded in the second window (102 units).

The nature of modelled damage to the second left window, recognized by the DSB experts as the area of maximum density, is fundamentally different from the actual damage to the Boeing 777: the number of damage (46 units) is 2.22 times less than the actual damage to the second window (102 units), while the density of damage is less than the actual damage and is about 110 holes per square meter.

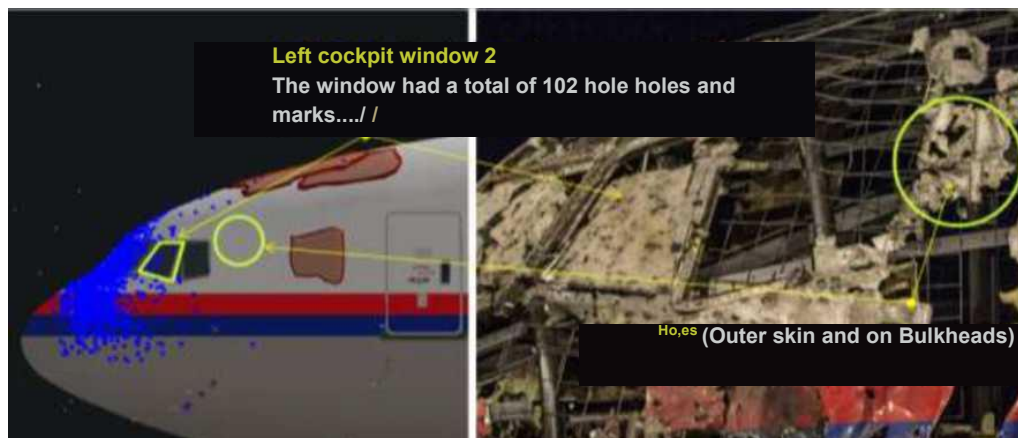
3. The area of the outer skin behind the second and third windows is not included in the tight fragment cloud at all, according to the modelling results (Figure F.12).

Figure F.12 - Inconsistency of damage in the area of the second and third windows on the left side of the cockpit

In fact, in the area behind the third window, there is multiple damage to both the outer skin and the load-bearing structure (the bulkheads).

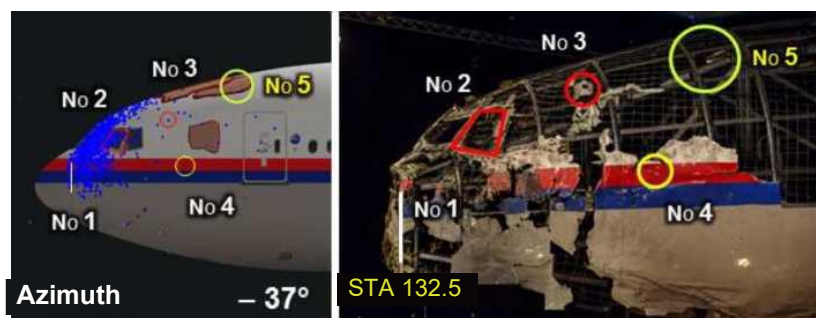
Figure F.13 - Simulation of Boeing 777 nose section damage under Azimuth -37° conditions

1. The forward boundary of the fragment cloud formed by prefabricated projectiles is closer (to STA 132.5 level) than the real one, starting behind the level of the forward pressure bulkhead (Fragment No. 1).

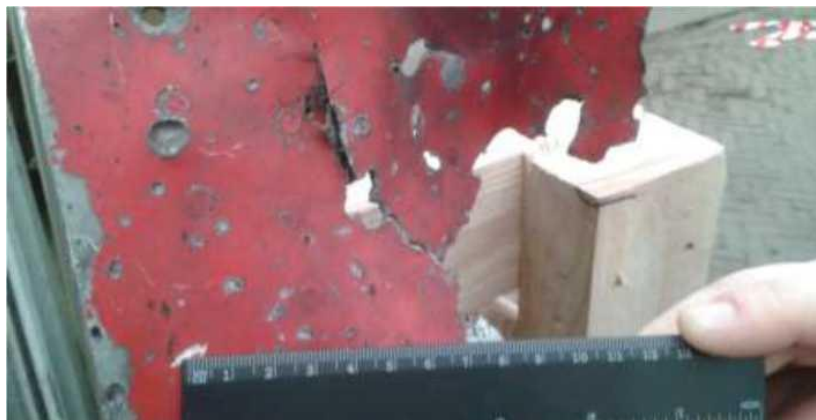
Figure F.14 - Actual through holes, identified as impact damage, located to the right of the bulkhead no closer than 5-10 cm from the level of STA 132.5

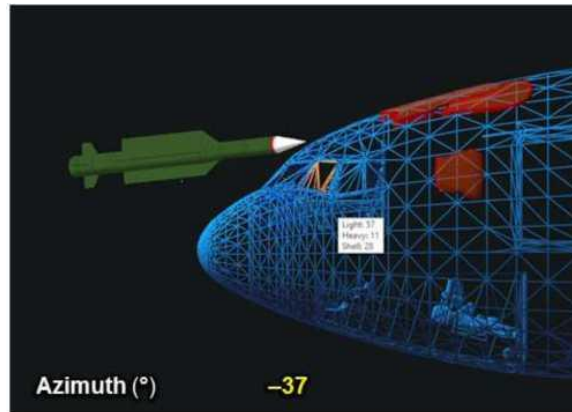
Figure F.15 - Simulation of fragmentation damage to the nose of a Boeing 777 under Azimuth -37° conditions

The number of simulated damages (68 units) is 1.5 times less than the number actually recorded in the second window (102 units);

The modelled damage density for Azimuth -37° conditions is 1.5 times lower than the actual damage density and is about 167 holes per square metre.

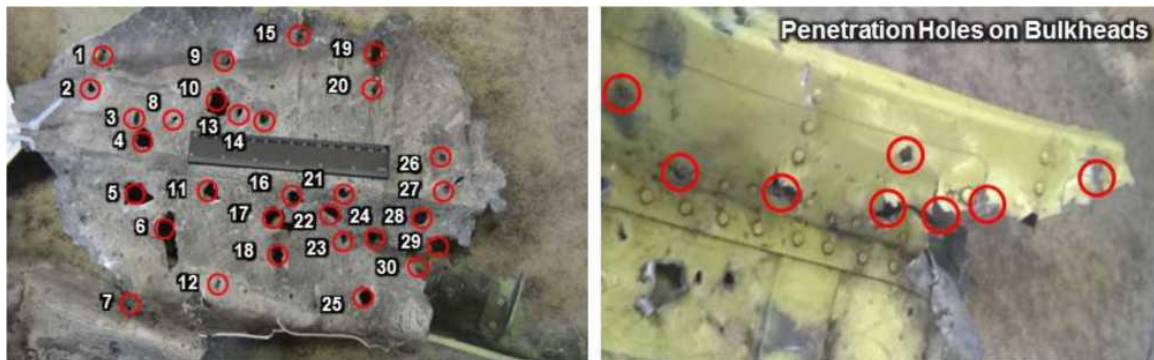
Figure F.16 - Fragment of port side no 3 actually has multiple damage to the outer skin and force element, indicating that the fragment was in a dense fragmentation stream

On the fragment the following was objectively fixed: high density of damages (30 holes of various sizes in area about 0,1 sq. m); strongly expressed traces of microcraterization, thermal oxidation, compression and rupture of sheets of outer hull; multiple through-holes in a bulkhead, accompanied by deformation and destruction of a force element on perforation.

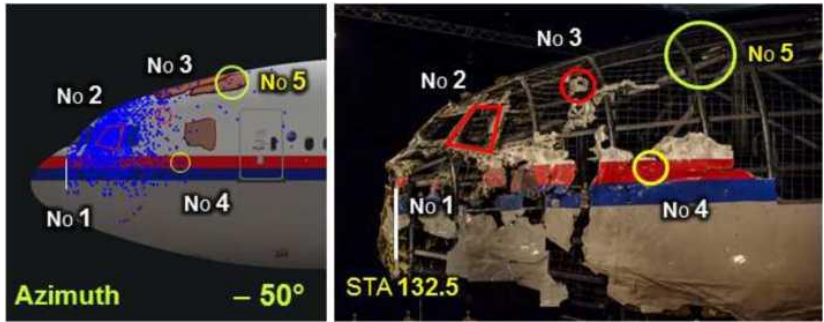
Figure F.17 - Simulation of Boeing 777 nose section damage under Azimuth -50° conditions

1. The front boundary of the fragmentation area from prefabricated projectiles is at the level of STA 132.5, which generally coincides with the actual front boundary of the fragmentation field.

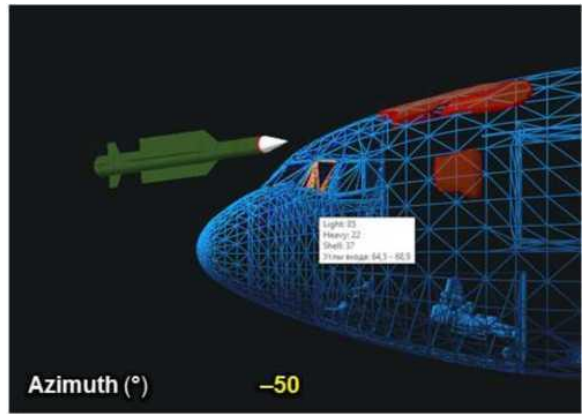
Figure F.18 - Simulation of fragmentation damage to the nose of a Boeing 777 under Azimuth -50° conditions

The number of modelled damage (107) is comparable to the number of actually recorded damage at the second window (102), and the modelled density is also comparable to the actual values recorded at the second window - about 250 holes per square metre.

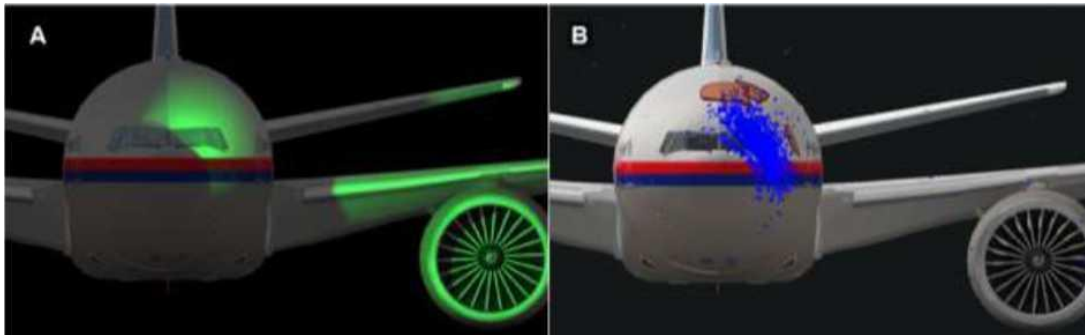
4. The Azimuth -50° option is the minimum value pertaining to "missile end state" in the horizontal plane which provides a logical explanation to the actual boundary of the fragment coverage area taking into account the characteristics of a BUK missile (Figure F.19).

Figure Frfr .19 - Boundaries of the fragment coverage area for a "collision course", which explains all damage to the outer skin, power structure, left wing plane and left engine of the Boeing 777: left - area of expected damage; right - results of the simulated fragment coverage area for the "Azimuth -50°" option

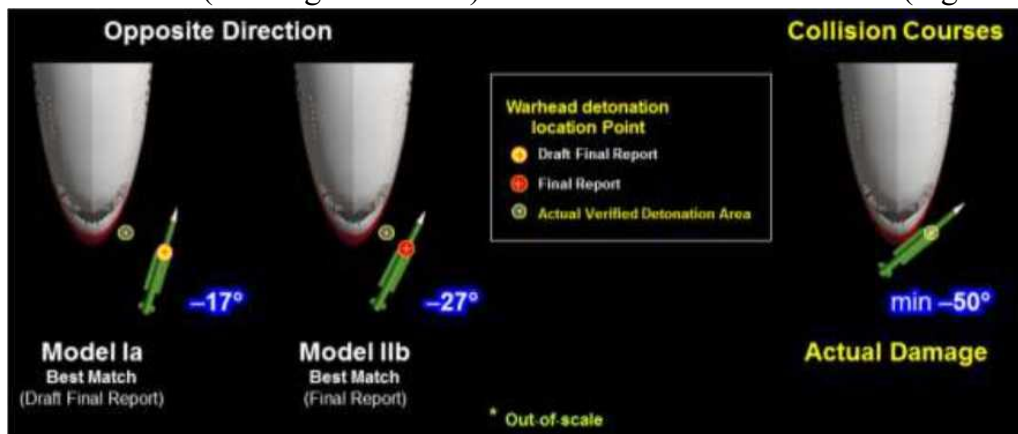
Figure G.1 - Missile encounter conditions: left - "opposite direction" DSB version; right - "collision course"

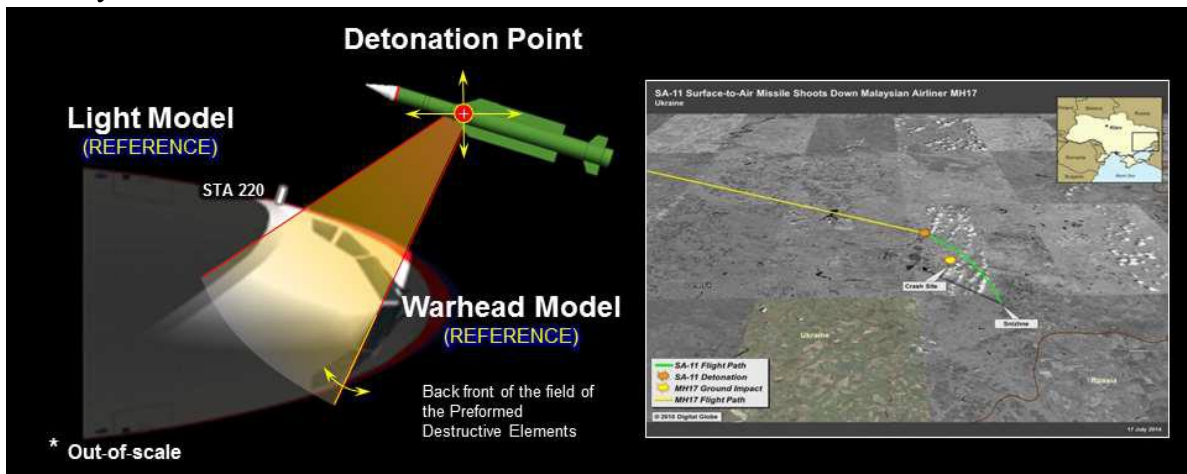
Figure G.1.2 - Model Ia - First "Best Match" option (NLR, February 2015)

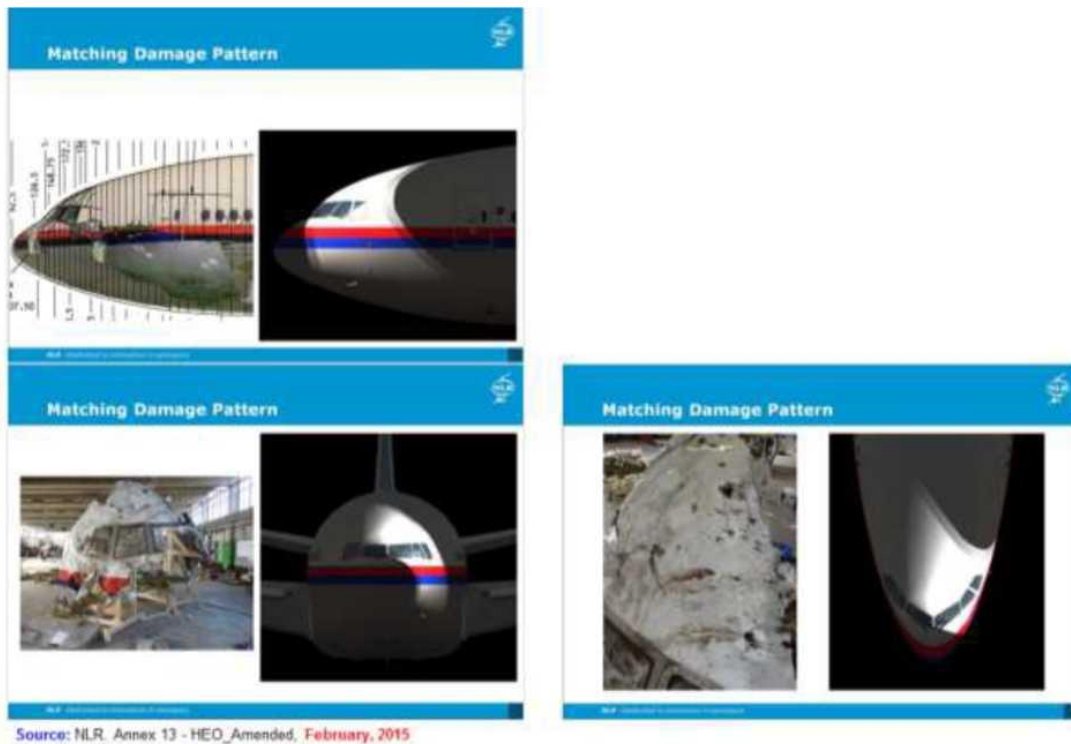
In order to justify the main DSB's version that the "aircraft was hit by a 9M38-series BUK missile travelling in an "opposite direction", the Dutch experts used only selected fragments of the aircraft that could fit the pre-determined version (Figure G.1.3).

Figure G.1.3 - Replacing the damage survey with a computer model

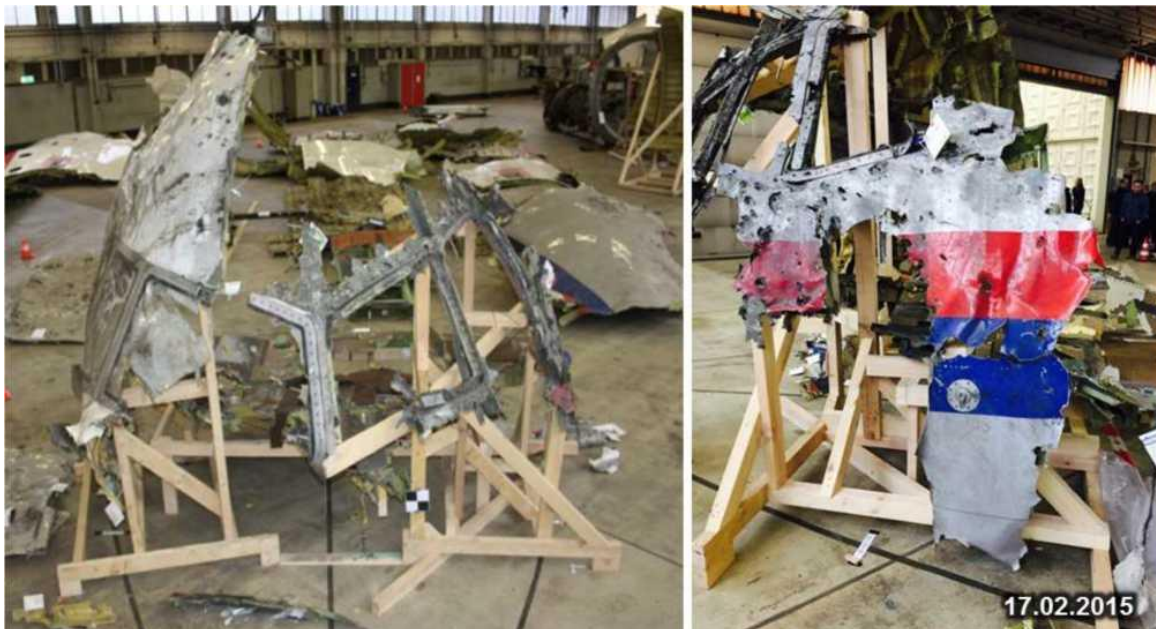
In this case, the front pressure bulkhead with fragments adjacent to it was located in another room. The other fragments were either ignored or not displayed at all in the public areas of the hangar.

Figure G.1.4 - The "reference" damage model is based on only a few sample fragments: left - front view; right - port side view

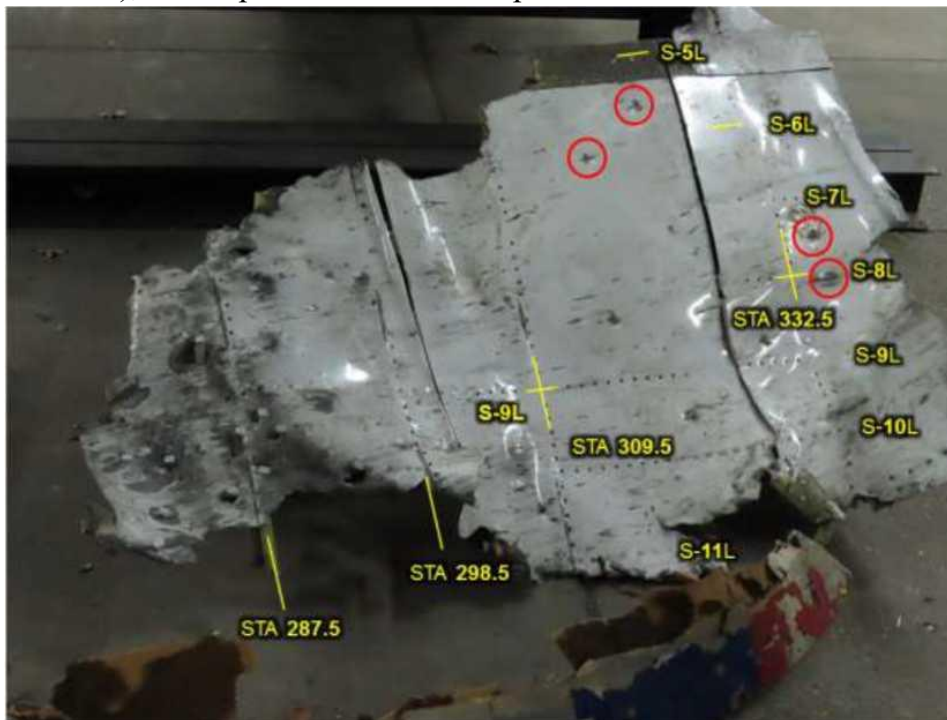
Figure G.1.6 - Fragment of roof and upper part of the port side behind the cockpit. The fragmentation damage is located between bulkheads STA 309.5 and STA 332.5, which is almost 3 metres further than the DSB 'reference'

Objectively observable damage in the upper port side spread considerably beyond STA 332.5, i.e. about 5.1 metres ($332.5-132.5=200$ inches) from the forward STA 132.5 bulkhead, taken as the leading edge of the damage.⁸⁷

Accordingly, the "reference" accounts for less than 1/2 of the actual damage to the top of the port side. Figure G.1.6 shows a fragment of the roof and top of the port side behind the cockpit which was not accounted for in the final reconstruction.

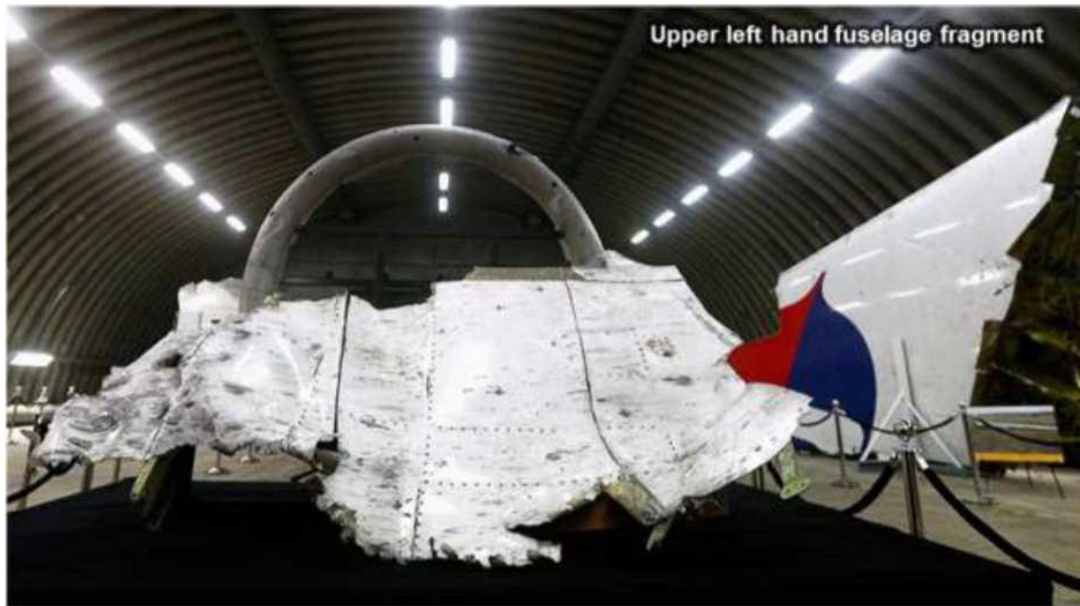
Also shown separately from the main display were a fragment of the roof and top of the port side behind the cockpit and the nose of the left engine air intake, shown in figure G.1.8.

Figure G.1.8 - Fragment of the roof and top of the port side (front) and toe of the left engine air intake (rear) were located elsewhere in the final reconstruction

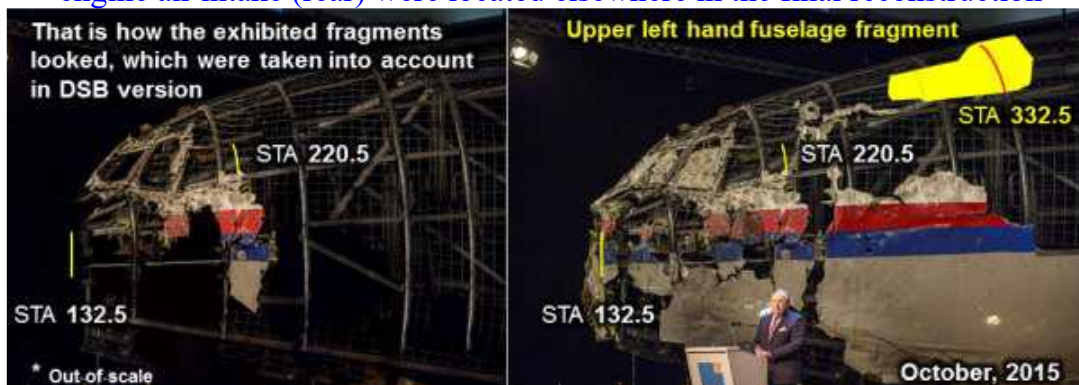
Figure G.1.9 - Source data for the model that has become the "reference": on the left are the fragments included the "reference"; on the right, the final layout

Figure G.1.9 compares the condition of the aircraft fragments layout at the time when the actual damage study was replaced with computer modelling.

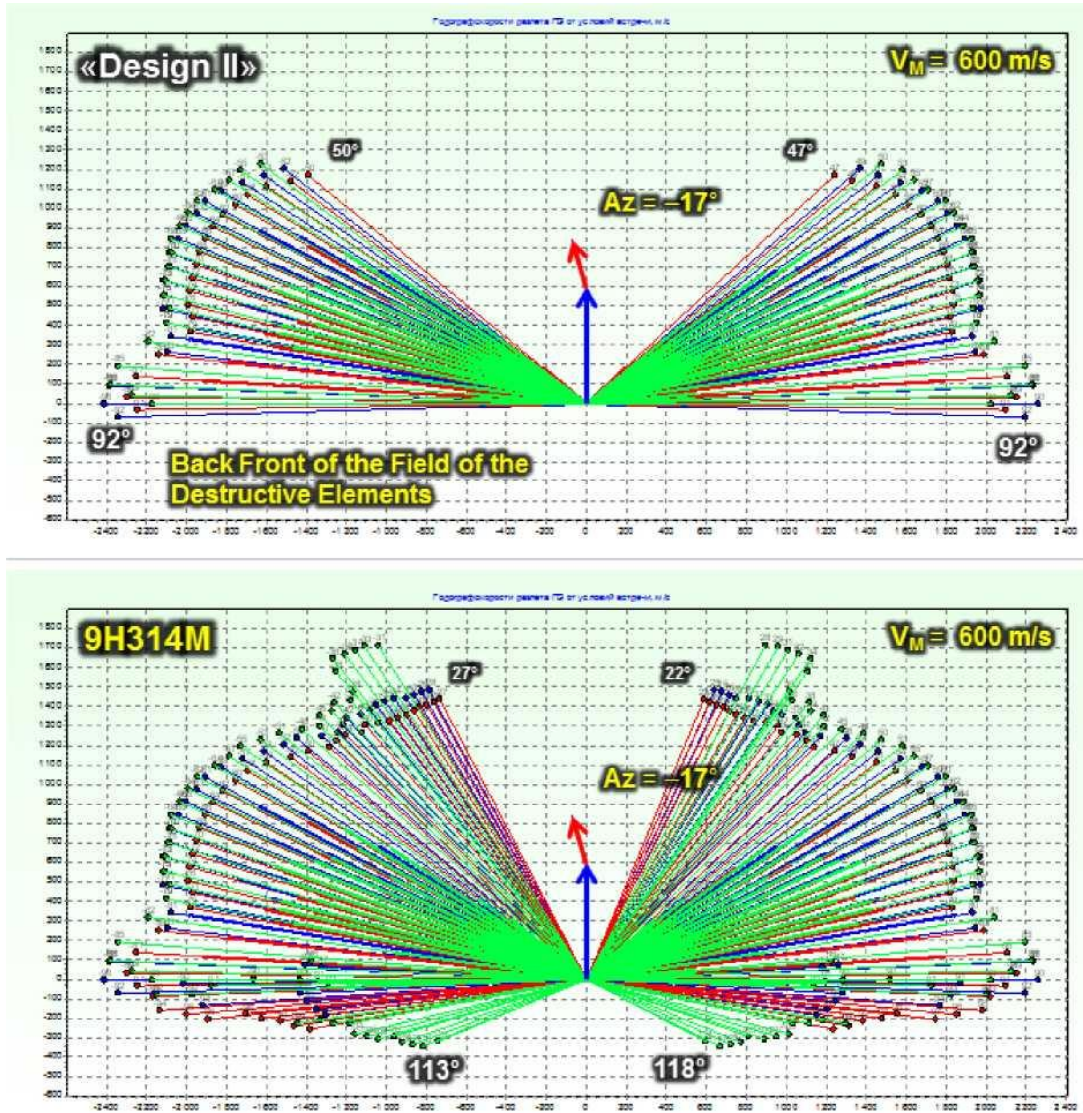
Figure G.1.21 - Comparison of the Design II 'reference' model (top) with the verified performance of the 9H314M (bottom)

Figure G.1.21 shows the results of a comparative dynamic fragmentation field simulation for "Best Match" DSB conditions corresponding to the basic version at most: missile velocity $v_M = 600$ m/s;

For the conditions considered, the error in determining the missile encounter conditions reaches -21° , where: for the trailing edge of the fragmentation field the difference is $113^\circ - 92^\circ = 21^\circ$.

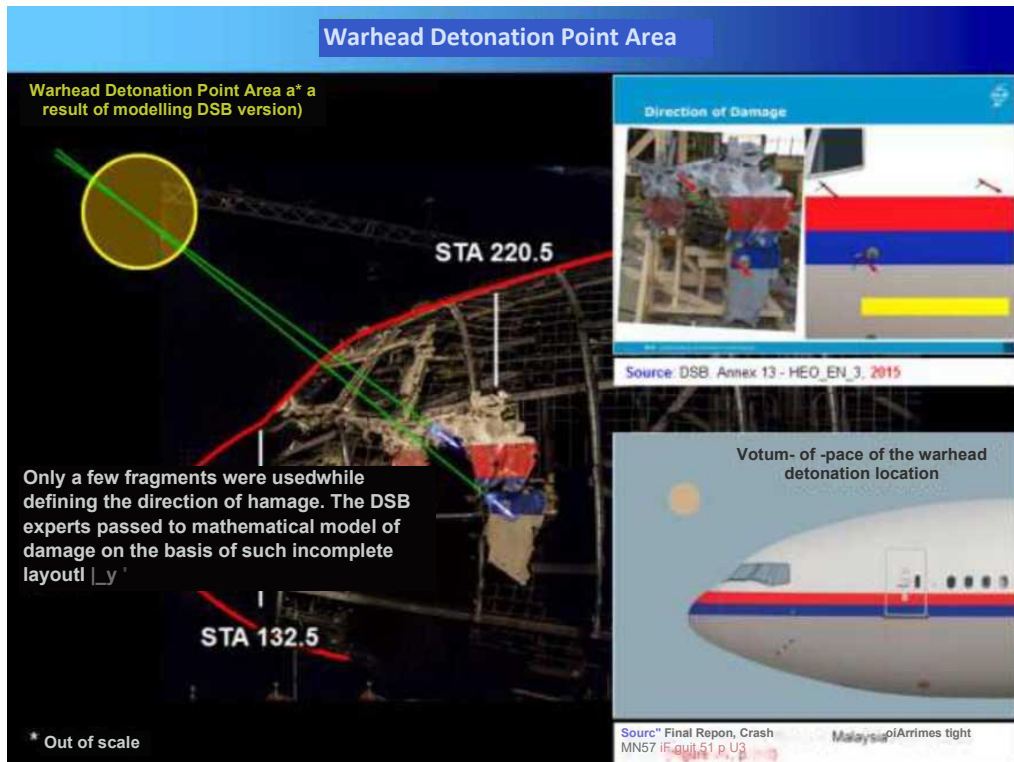
The NLR experts used only two fragments, the same fragments used to determine the port-side rear damage boundary and to create a damage "reference" (Light Model), as shown in Figure G.1.22.

Figure G.1.22 - Determining the detonation point location by coincidence of damage directions on the two port-side fragments

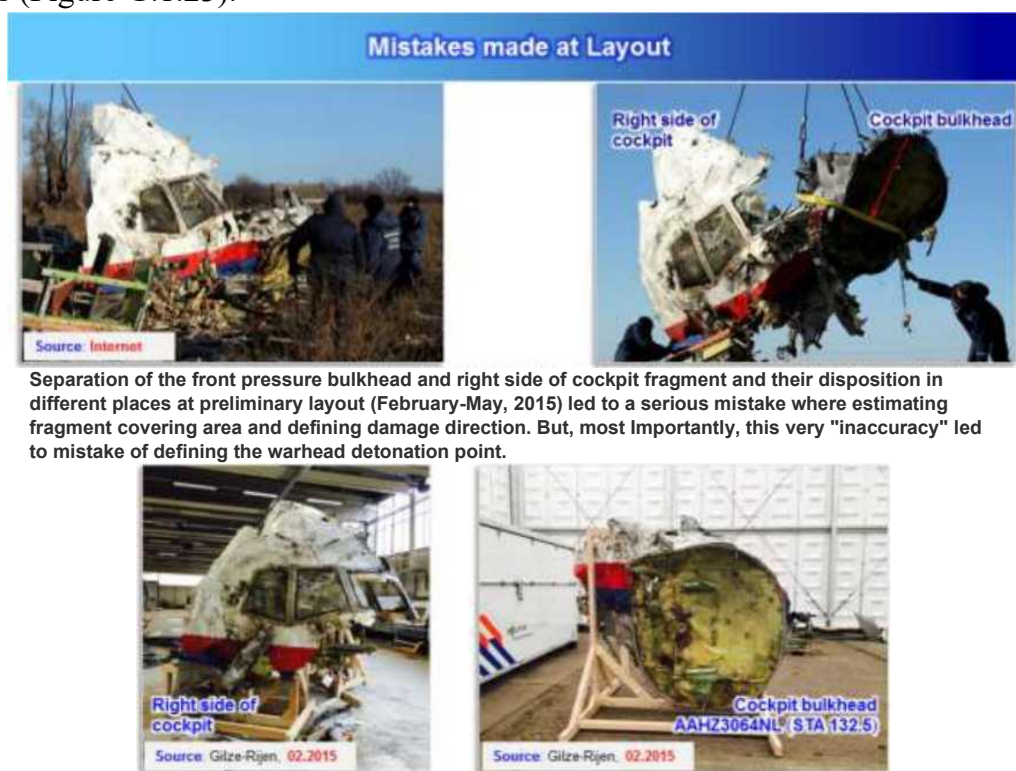
For example, the forward pressure bulkhead in the crash area was a single piece with the right side of the cockpit. Subsequently, without apparent necessity, this single piece was not only separated, but its component parts - the front pressure bulkhead itself and the right side of the cockpit at Gilze-Rijen airbase were placed in different hangar rooms (Figure G.1.23).

Figure G.1.23 - Separation of the forward pressure bulkhead with a fragment of the starboard cockpit and their subsequent location in different rooms led to a serious error in determining the detonation area
