**APPLICATION OF THE INTERNATIONAL CONVENTION FOR THE SUPPRESSION
OF THE FINANCING OF TERRORISM AND OF THE INTERNATIONAL
CONVENTION ON THE ELIMINATION OF ALL FORMS OF RACIAL
DISCRIMINATION**

REJOINDER

Report of JSC Air and Space Defense Corporation "Almaz-Antey" on the results of studies related to the technical investigation into the crash of the Malaysian airlines Boeing 777-200 9M-MRD (flight MH17), 2023

on the results of studies related to the technical investigation into the crash
of the Malaysian airlines Boeing 777-200 9M-MRD (flight MH17)

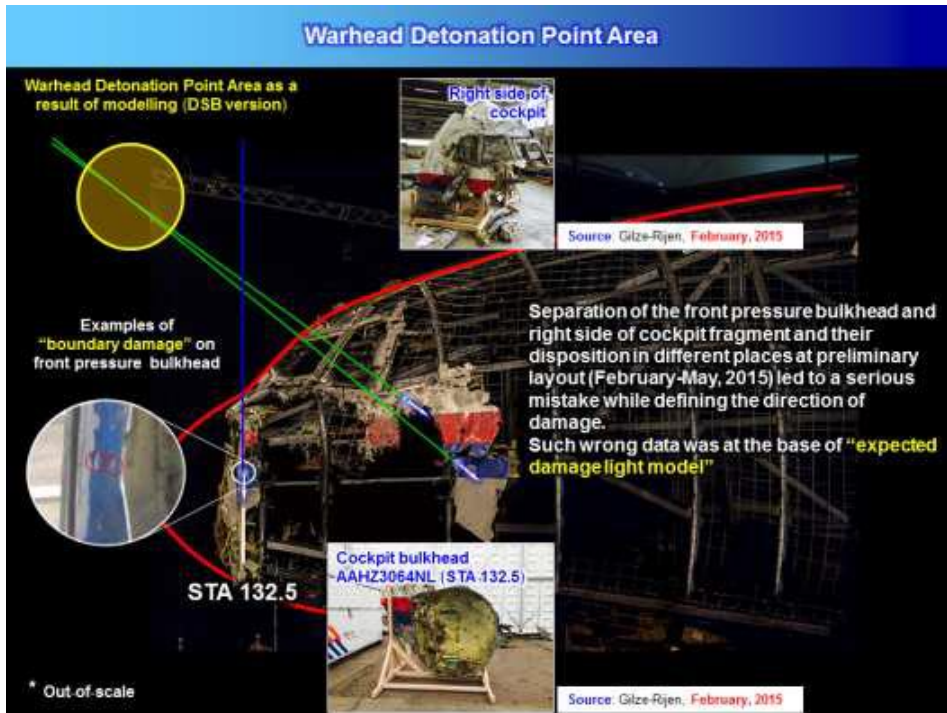
As can be seen from Figure G.1.24, it was the absence of a germoprop in the reconstruction during the damage direction survey that led to the serious error of fitting the location of the warhead detonation point to a predetermined version.

An example projection of the trajectory of an impactor that has left a track on the boundary of the debris field on the forward containment shell, contrary to the NLR version, is shown in Figure G.1.24 as shown by the blue line.

Figure G.1.24 - Damage to the forward furling bulkhead contradicts the detonation point area assigned by the fitting method

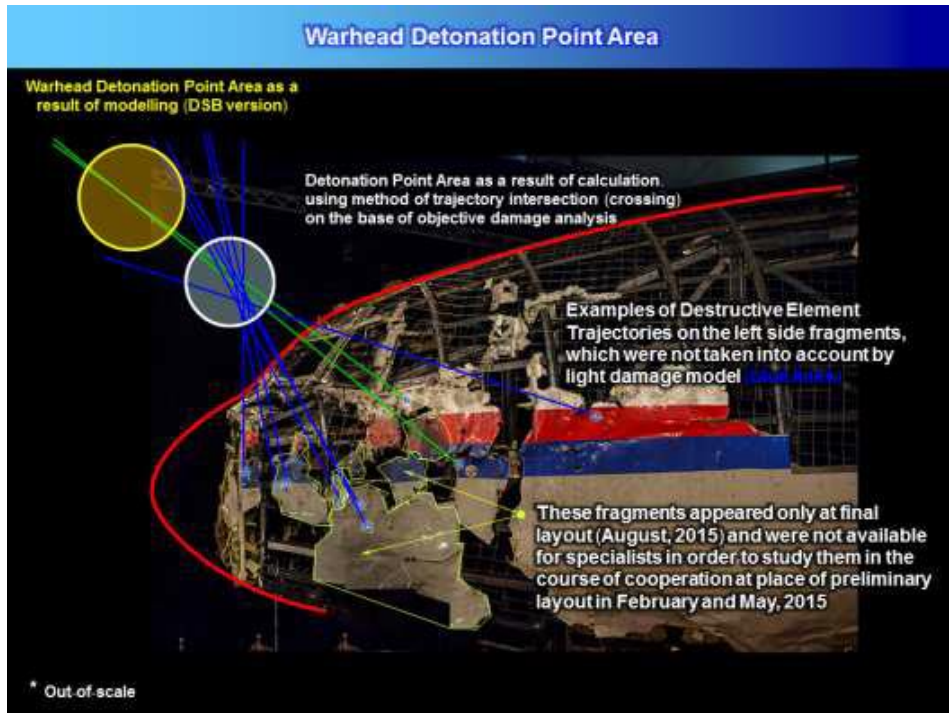
The blue lines in the diagram (Figure G.1.25) show the projections of the trajectories of the projectiles that left rectilinear tangential traces on the boundaries of the debris field on the port side fragments, which only appeared in the final plotted after comments to the draft DSB report were discussed in August 2015.

Figure G.1.25 - Damage on fragments unavailable for examination in February and May 2015 contradicts the detonation point area determined by the fitting method for a given result

All damage directions (tracks) converge to approximately one limited area of space. But this area, determined by crossing the tangents to the actual boundary damage, is quite different from the detonation area that the NLR specialists determined by the fitting method specifically for the first version of the "opposite direction".

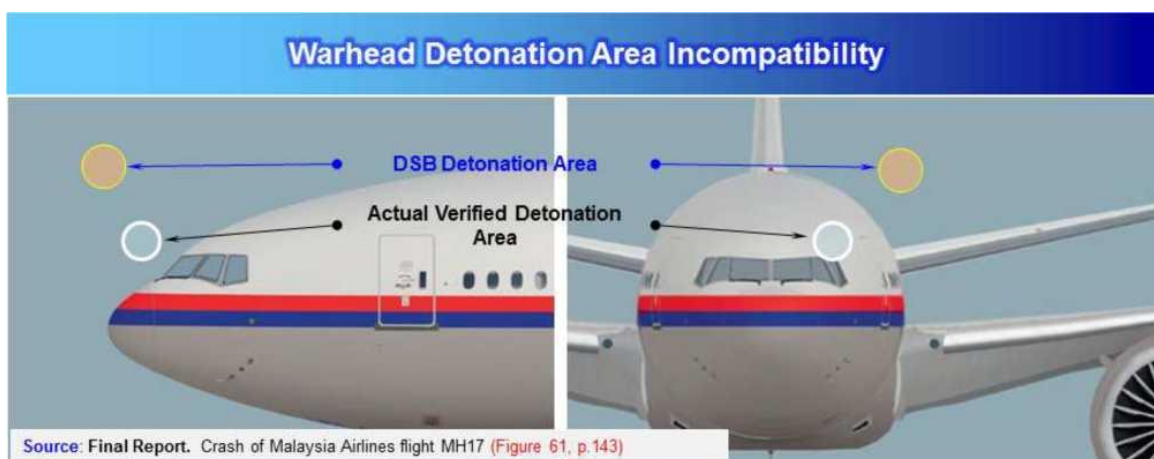
The difference between the location of the detonation point area obtained and verified by the actual damage study and the detonation point area obtained by the fitting method is shown in Figure G.1.26.

Figure G.1.26 - Detonation point areas

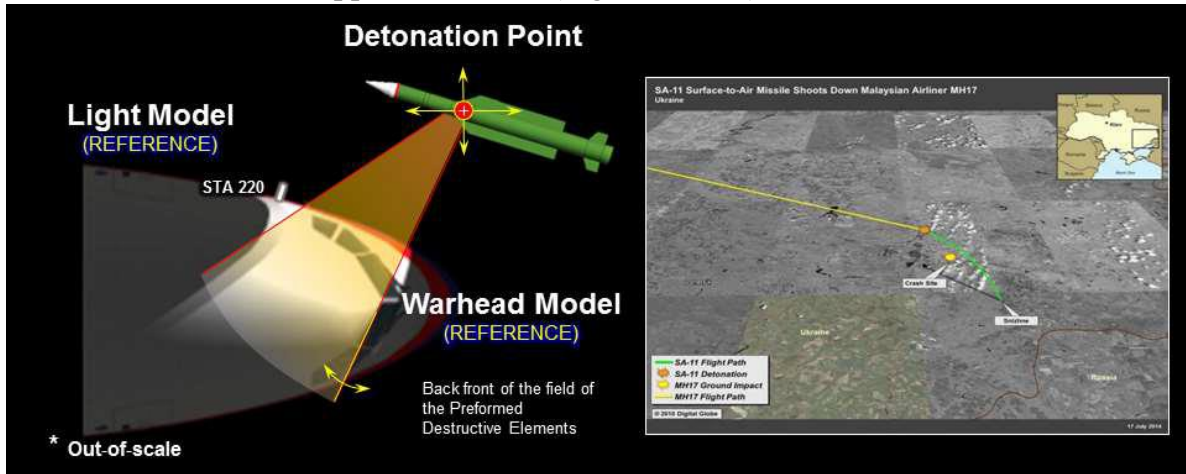
Figure G.1.27 - Combining the combination of the "reference" warhead model with the detonation point damage "reference" obtained by the fitting method resulted in an encounter condition value ("Best Match") ostensibly fully consistent with the "opposite direction" version

The figure shows how by fitting the rear edge of the fragmentation field in the "reference" warhead model (Model I) and selecting the detonation point coordinates to match the assigned light boundaries of the damage "reference" (Light Model) a "Best Match" (Model Ia) was obtained. This combination formed the basis of the Draft Final Report and was ideally suited to justify the "main version", providing the "Best Match" image shown in Figure G.1.27 at right.

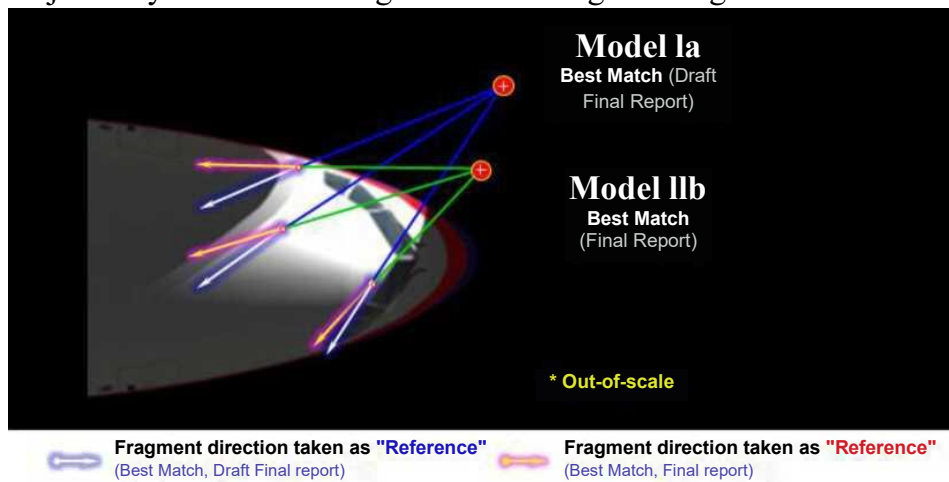
As an example to illustrate the contradictions of the "Best Match" search method of parameter matching, the diagram (Figure G.1.29) shows an example of "matching" damage directions on three aircraft nose section fragments for the two Model Ia and Model IIb variants which are the basis of the "Best Match" findings in Draft Final Report and Final Report.

The diagram in Figure J.1.29 shows that the damage directions from different areas of the detonation point differ significantly (**up to tens of degrees**) from each other and from the objectively observed damage on the Boeing 777 fragments.

Figure G.1.29 - Non-matching of damage directions in two "reference best match" variants

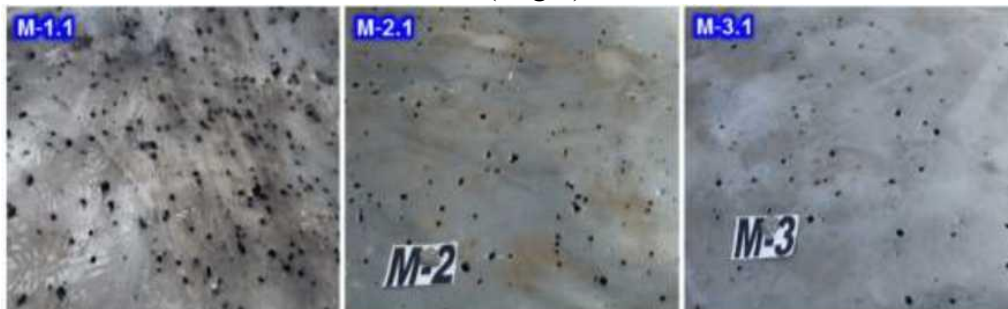
Figure G.1.31 shows photographs of three elements of targets No. M-1.1, No. M-2.1 and No. M-3.1 arranged in sequence at increasing distances from the detonation point of the warhead.^{124, 125}

Figure G.1.31. Variation of the fragmentation field density as a function of the distance of the target elements from the detonation point. In the shield target layout created for the full-scale experiment, target No. M-3.1 (right) was placed approximately twice as far from the detonation point as target No. M-1.1 (left)

As can be seen from the images in the photographs, the density of damage on target No. M-1.1 and No. M-3.1 at different detonation point distances, which differ by a factor of two, **is not the same**.

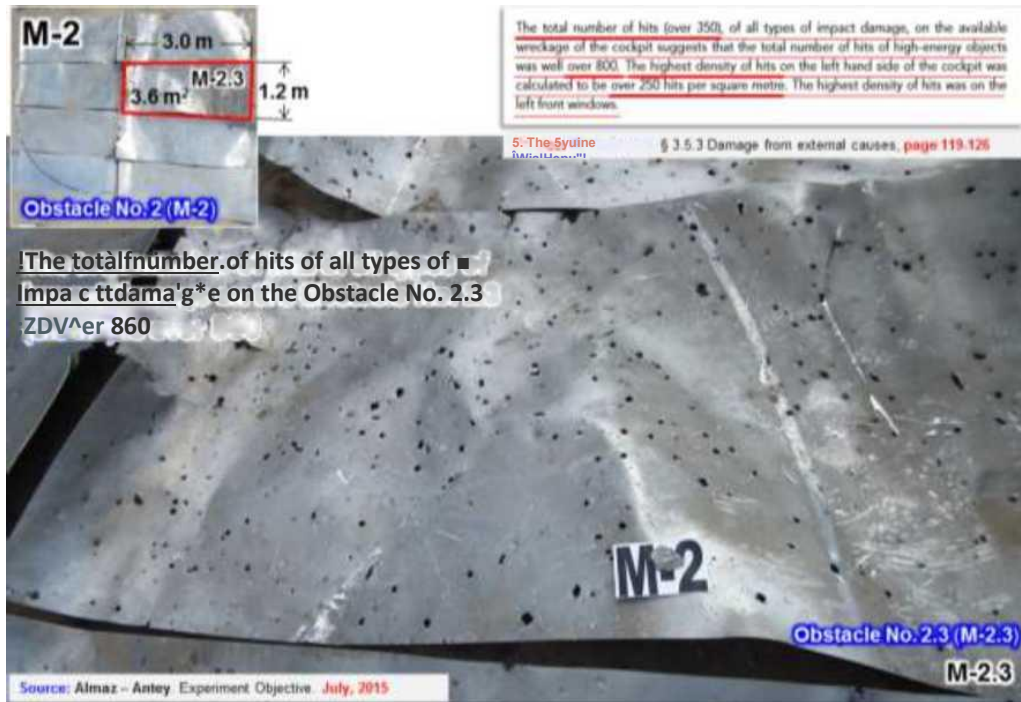
Figure G.2.4 - Over 860 through-holes of all types were recorded on Feature No. 2.3 of 3.6 m of Target No. M-2

When the 9H314M warhead was detonated at a distance corresponding to the distance of the detonation point according to the NLR, only one element of the 3.6 square metre shielded targeting area had more holes of all types (865) than were objectively recorded on all fragments of the Boeing 777 nose section.¹³⁶

A total of 3,620 holes of all types were recorded on the target and more than 2,200 within the circumference (cross section) (Figures G.2.4 and G.2.5).

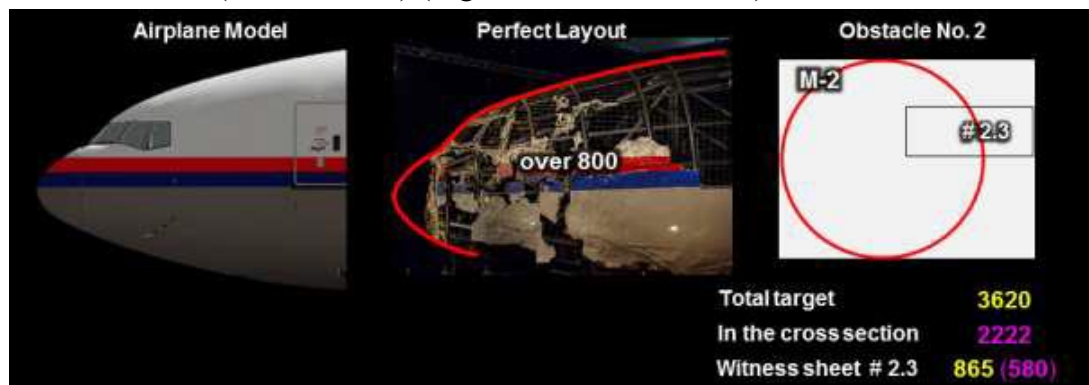
Figure G.2.5 - Comparison of target area No. 2 and its element No. 2.3 with the Boeing 777 aircraft model and final lay-out (scale observed)

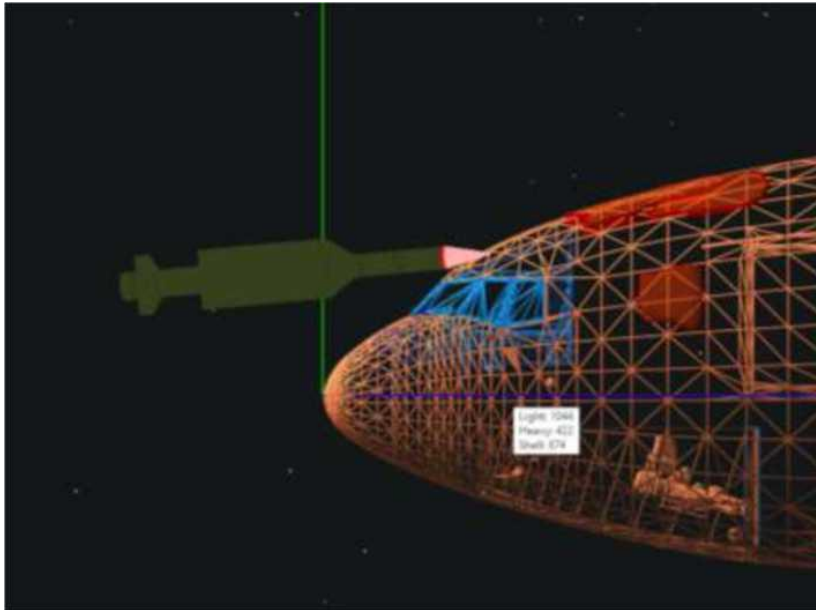
Figure G.2.6 - Simulation of fragmentation damage to the nose of a Boeing 777 aircraft. The nose section, excluding cockpit glazing, is selected (highlighted in orange) for evaluation: total of 2,340 fragments (Light - 1,044; Heavy - 422; Shell - 874)

The value of 2,800 fragmentation damage resulting from the modelling is more than **3.5** times higher than the number of penetrations on the entire aircraft hull indicated by the DSB experts (800 penetrations). If only prefabricated projectiles are taken into account, the excess is **2.28** times (1,822:800 2,277).

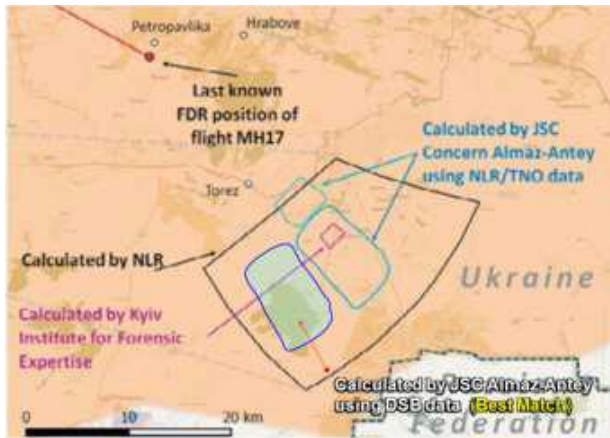
Figure G.3.2 - Launch area calculated for "Best Match" DSB Report taking into account actual aircraft longitudinal axis orientation

When using the DSB Final Report source data for the launch area calculation with encounter conditions recognized as "Best Match" ($Az = -27^\circ$) and considering the real position of the aircraft longitudinal axis in space "firing position at coordinates 47.974605, 38.760549" is not included in the calculation results (Figure G.3.2).

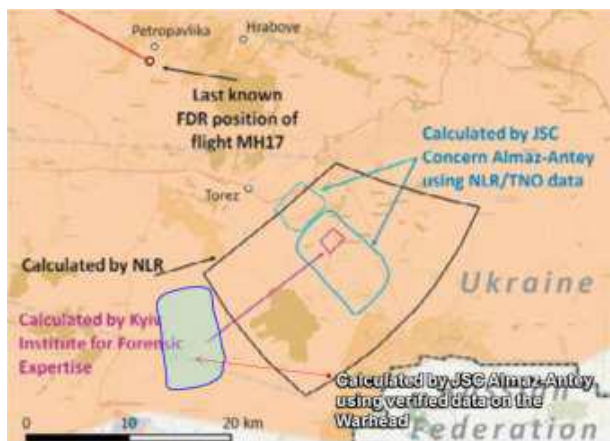
Figure G.3.3 - Launch area calculated using missile-aircraft encounter methodology, taking into account actual aircraft longitudinal axis orientation and verified warhead data

Using the NLR's methodology for determining the missile encounter conditions used in the DSB technical investigation, with these errors compensated for, the "Best Match" value (aircraft encounter conditions in the *Azwarhead* horizontal plane) would have been at least -48° , not -27° .

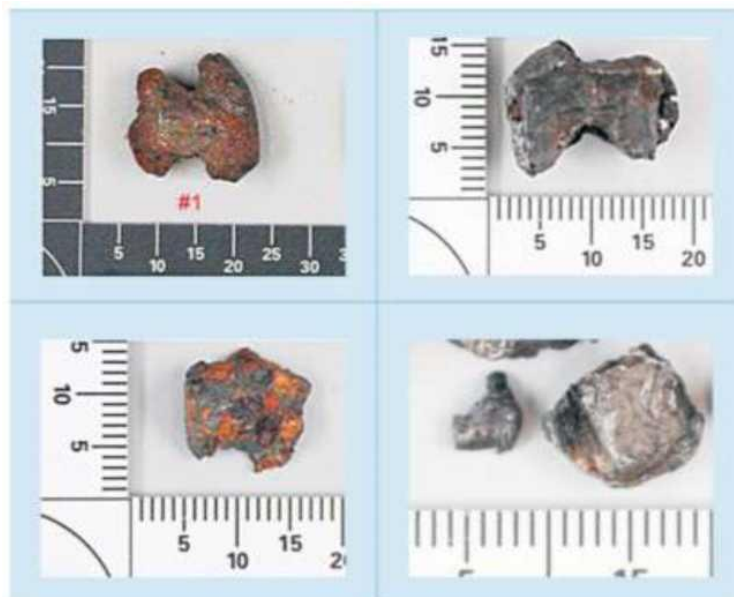
A total of four "distinctly shaped" fragments are mentioned and photographed in the technical investigation, among which the Final Report identifies two "bowties" and two "cubes"¹⁶¹.

Figure 37: Four distinctly shaped fragments. Top left: cockpit. Top right: Captain's body. Bottom left: Purser's body. Bottom right: First Officer's body. (Source: NFI). Scale is in millimetres.

Figure G.4.1 - Four distinctly shaped fragments (Final Report)

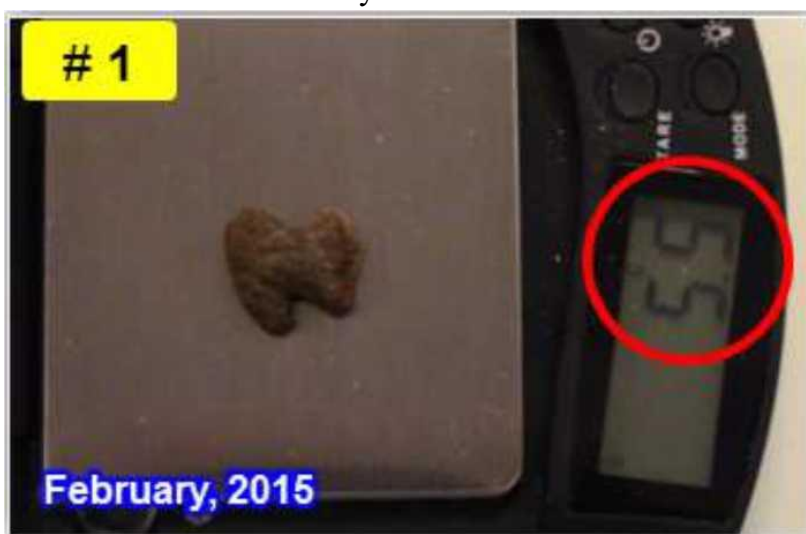
The location of the first "bowtie-like" impactor (Figure G.4.2) is not known with certainty. Unlike the other light fragments, no form (passport) was provided for this fragment during the NFI briefing (May, 2015), and during the Commission's work, fragments of starboard noise insulation, technical documentation and other locations were also cited as locations for discovery and retrieval.

Figure G.4.2 - Fragment similar to an "bowtie" with variable mass:
5.5 g (February, 2015); 6.1 g (October, 2015)

As a result, in the Final Report, the residual mass for this fragment was increased from 5.5 grams to 6.1 grams, and its original location statements were replaced by the streamlined wording "in the cockpit".¹⁶²

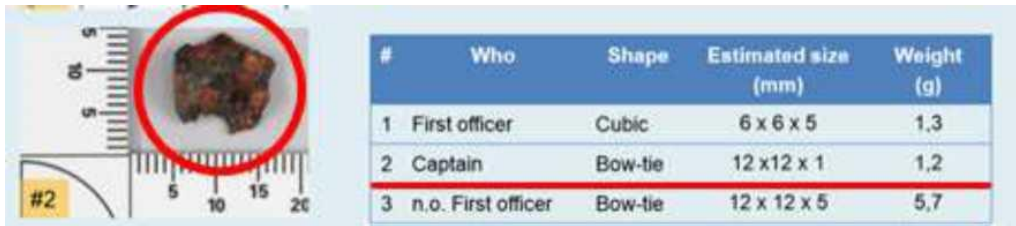
Figure G.4.3 - Variable shape fragment: "Bow-tie" (August, 2015); "Cubic" (October, 2015)

In the Final Report this fragment has not only changed shape from a "Bow-tie" to a "Cubic" (without specifying "Square" or "Filler"), but it has also changed "location of discovery". According to the caption under "Figure 37" in the Final DSB Report, this fragment was found in the Purser's body.¹⁶⁴

Fragment # 2 (shape change from "Bow-tie" to "Cubic") - was found in the body of the Captain, who was in the cockpit on the left pilot seat (August, 2015) or the Purser, whose exact location at the time of the crash is unknown, but is stated to have been in the cockpit (October, 2015);

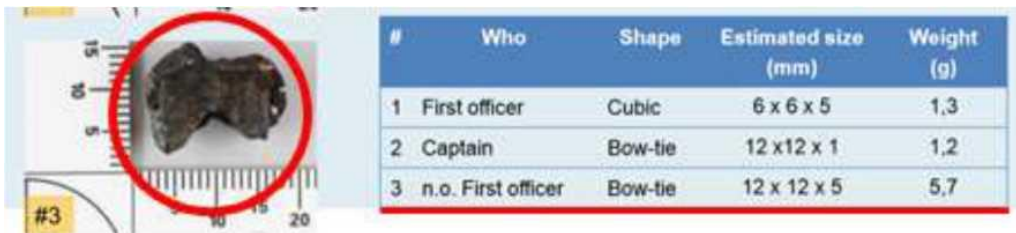
The fragment shown in Figure G.4.4 first appeared in the Draft Final Report. With reference to the NFI resource, this fragment, which resembles a 'bowtie', was positioned as having been found in the body of a flight crew member, without specifying which one in particular.¹⁶⁵

Figure G.4.4 - Fragment similar to a "bowtie"

In the presentation of the DSB (11.08.2015) on the study of high-energy objects, this fragment was positioned as a "Bow-tie" weighing 5.7 g and measuring 12 by 12 by 5 mm. The place of extraction indicated the body of the co-pilot of "Team B" (n.o.First officer), who was not controlling the aircraft at the time of the crash (was not in the right cockpit seat).¹⁶⁶ According to paragraph 2.5.1 of the Final Report, it is common practice for the Team B co-pilot to rest on bunks located behind the cockpit, on business class seats or on observer seats in the cockpit.

fragment #3 (similar to "Bow-tie") - was found in the body of the Team B co-pilot (n.o. First officer), who was not flying the aircraft at the time of the crash, or in the body of the Team A captain, who was in the left-hand pilot's seat. At the same time, the bodies

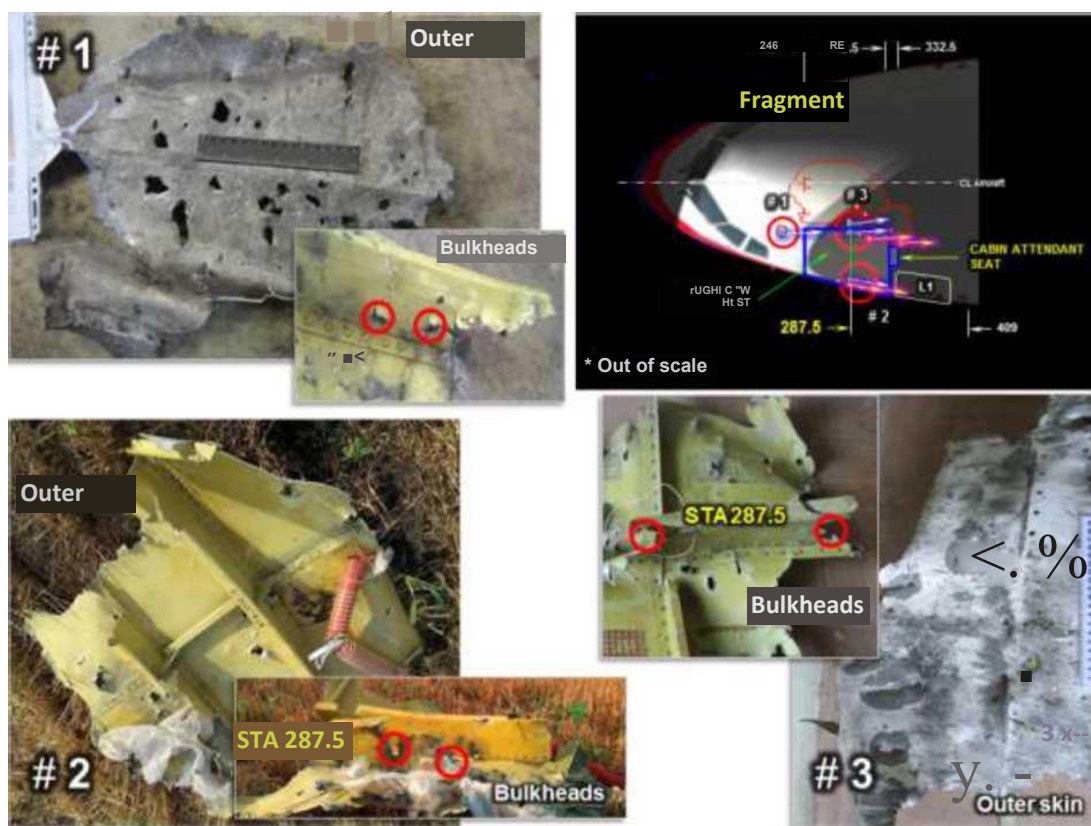
Figure G.4.5 - Possible locations of flight and cabin crew in the diagram are highlighted in blue: rest area behind the cockpit (Flight Crew Rest and Cabin Attendant Seat)

2. The possible locations of the "Team B" and cabin crew (from which "distinctly shaped" fragments were recovered) **are outside** the fragmentation cover of the "reference" used by the NLR specialists (the "expected" damage zone is shown by the light) for the "**opposite direction**" version.

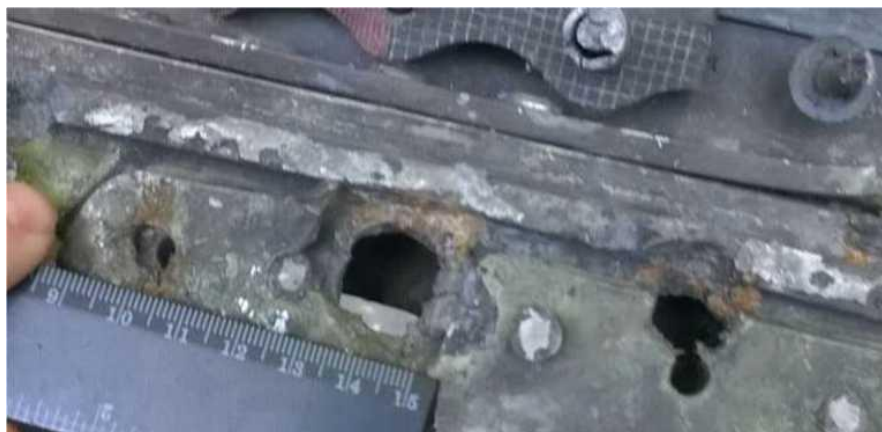
In this case, through holes are observed from 13-14 mm large projectiles, which may belong to the "heavy fraction".

Figure G.4.6 shows an image of one of the inlet openings in the power section of the Boeing 777 cockpit glazing frame in comparison with a ruler to estimate the actual dimensions of the inlet opening.

Figure G.4.6 - Entry hole in the structural member has a linear dimension of about 14 mm

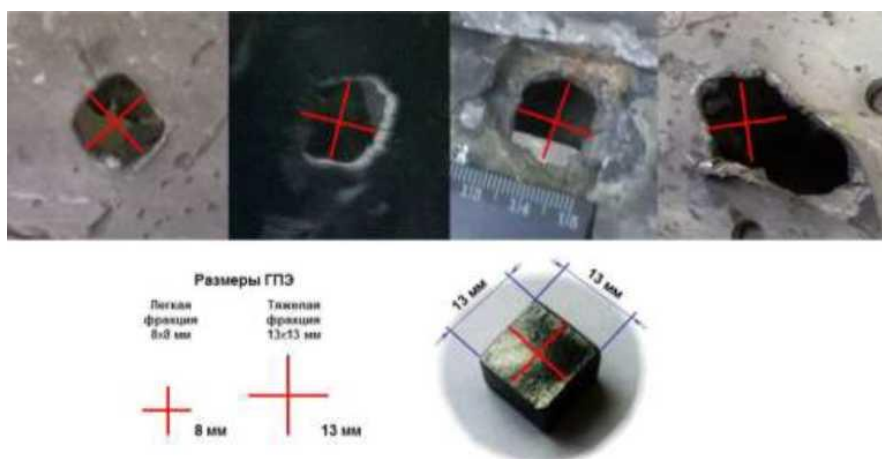
All of the 8-11 mm and 13-14 mm holes (presumably from light and heavy projectiles) observed on Boeing 777 structure elements have a characteristic rectangular shape. The red crosses in Figure G.4.7 show the likely orientation of the impactor (PI) when penetrating the barrier.

Figure G.4.7 - Characteristic through-holes on Boeing 777

If one considers the hypothesis of a BUK missile being used, such a shape could be left by the lightweight 8x8x6mm and the heavyweight 13x13x8mm fractions that have the "parallelepipedic" shape of the 9H314 warhead (without the bowties), which the obsolete 9M38 missile models were equipped with.

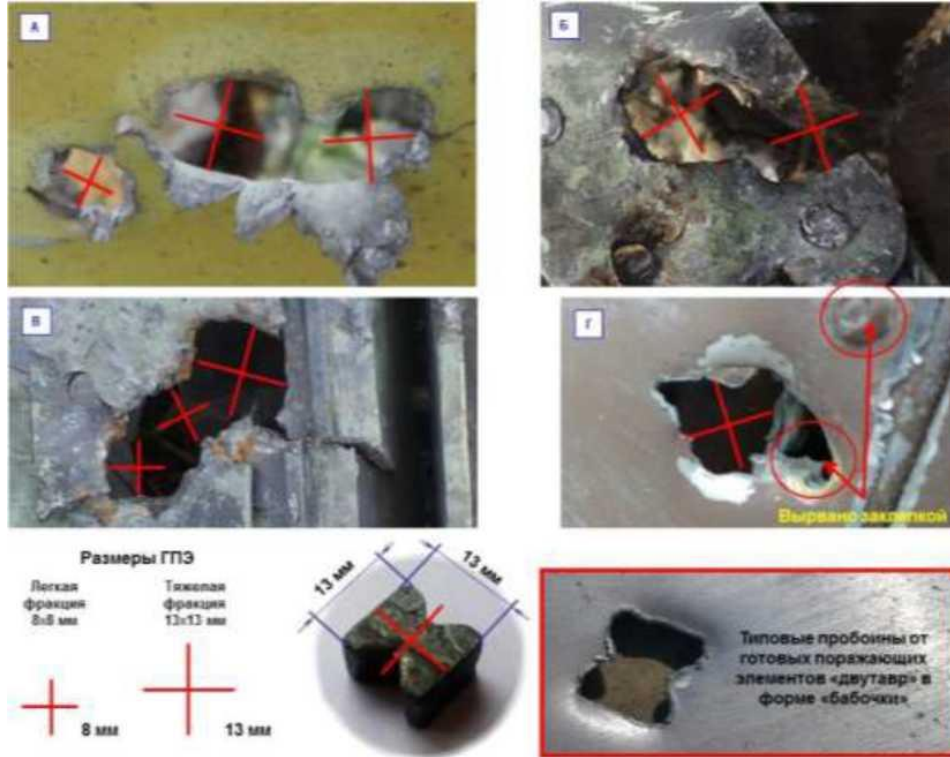
Figure G.4.8 - Through-holes on Boeing 777 (MH17) misrepresented as "butterflies"

Figure G.4.8 shows the orientation of the PE when penetrating the barrier with red crosses. An analysis of the dimensions of the penetrations which try to pass off as bowtie "butterfly" marks shows that the aspect ratio (height - width) is significantly greater than 1:2 - 1:3.

This can only be explained by the impact of two or three projectiles. Figure G.4.8 (d) shows a hole that resulted from the penetration of a structural element and the failure of a riveted joint of two elements (ripped out by a rivet).

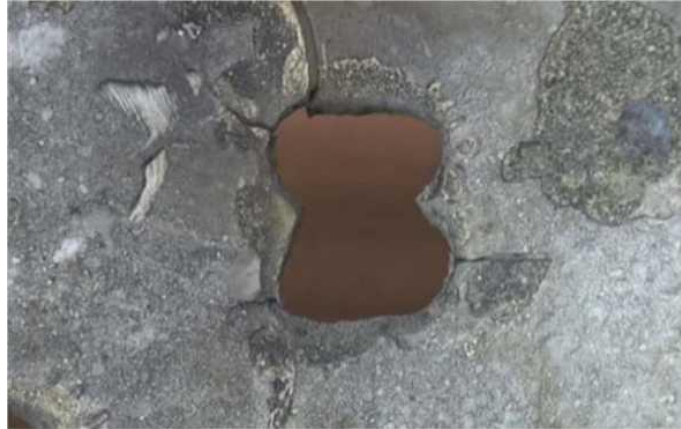
The results of both the first and second phases of the experiment clearly showed that the characteristic bowtie holes, which have a clear "butterfly" shape, on the

of the outer skin are not isolated or random.¹⁷⁷ An example of such an opening is shown in figure G.4.9.

Figure G.4.9 - Characteristic hole in the outer skin of the IL-86 target aircraft (experiment 07.10.2015)

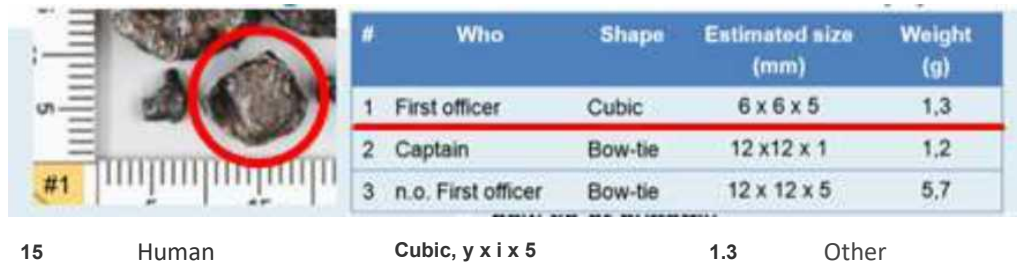
Figure G.4.12 - Fragment # 15 with a mass of 1.3 g is in the "Cubic" shape and does not belong to the two impurity groups "correlated with the warhead" (Table 11 from the DSB Report)

The fragment therefore does not clearly belong to a single warhead.

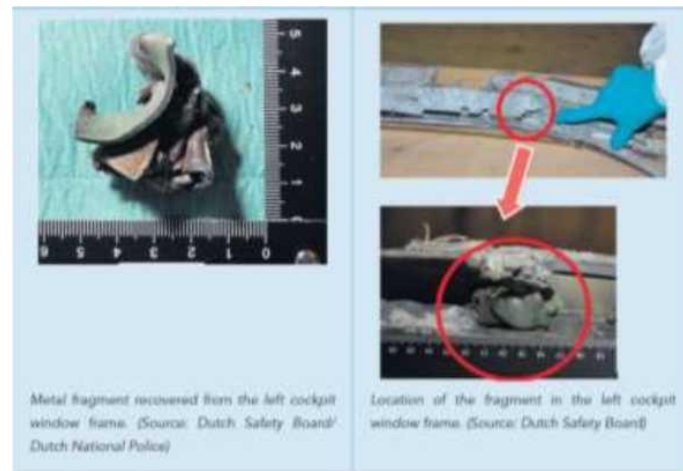
According to the Final Report (p. 93) one of the missile fragments ("metal fragment") was found stuck in the left window frame. Figure G.5.1 shows both the fragment and where it was found.

Figure G.5.1 – Place of discovery of a "metal fragment" (DSB contribution)

What makes this fragment particularly important is that it is the only one of all the fragments, including prefabricated warheads, presented by Dutch experts trapped in a part of the aircraft's structure and photographed at the discovery site to document the missile strike of the aircraft.

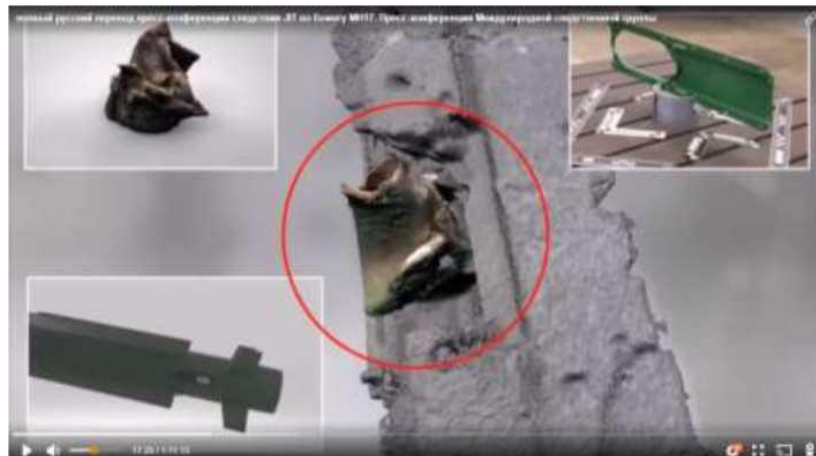
The following picture is a still image from a JIT press conference held in 2016, showing a completely different location for this 'metal fragment' discovery.

Figure G.5.2 - The new location of the "metal fragment" and its presumed location in the missile airframe (JIT materials)

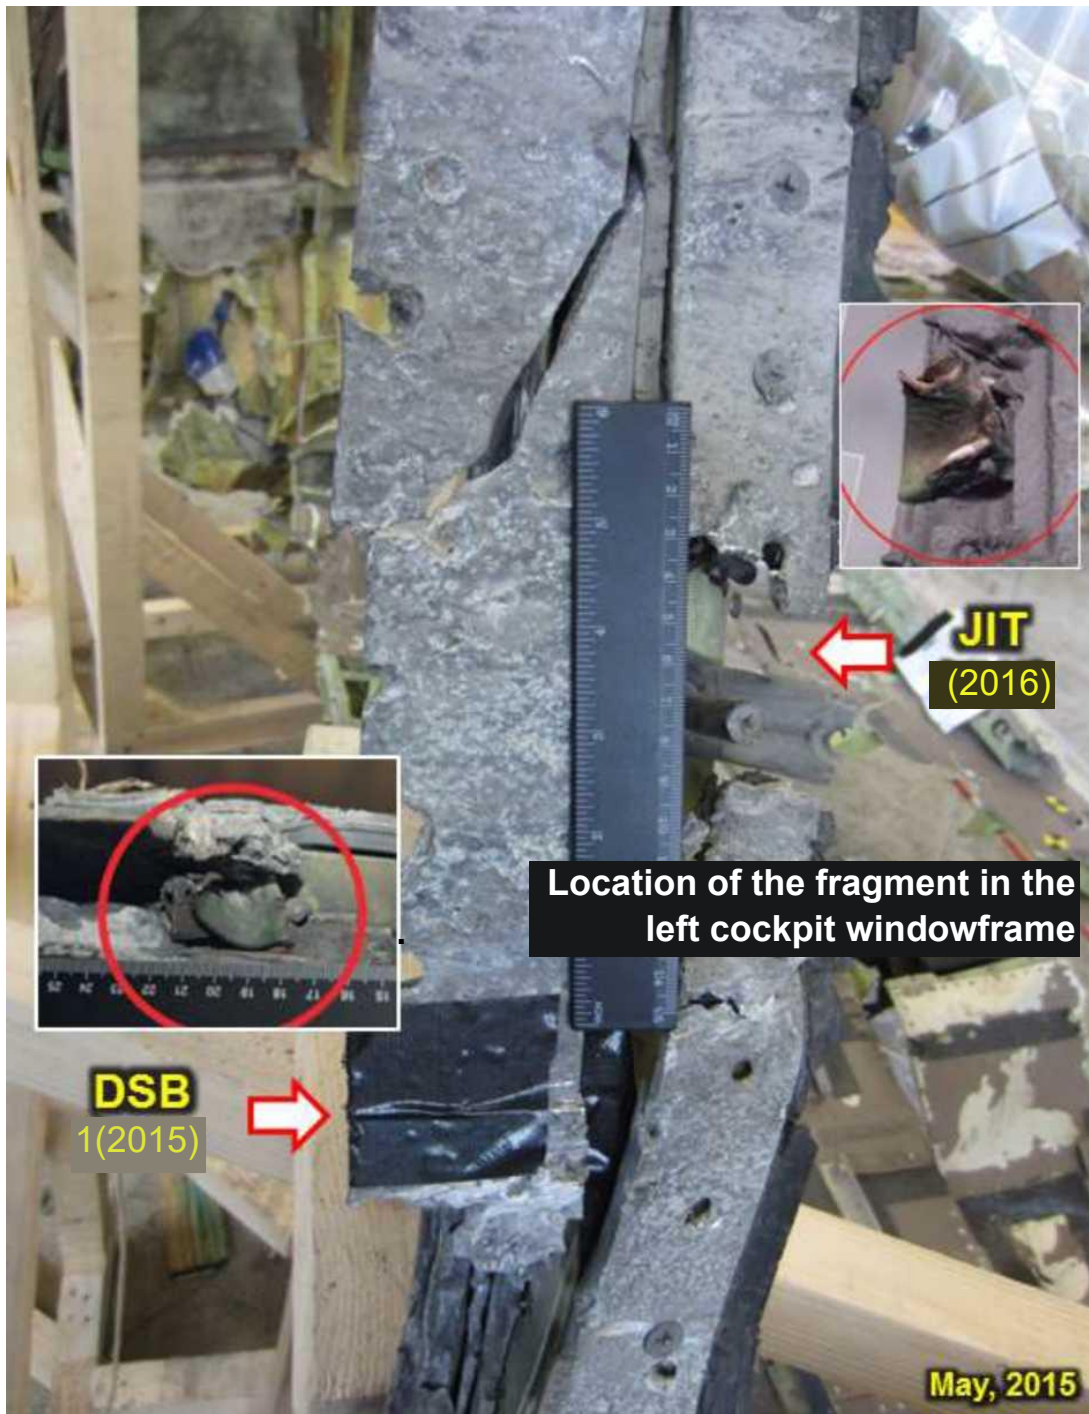
Figure G.5.3 - Two different 'metal fragment' detection locations under the hold-down bar of the second window of the aircraft commander (DSB, 2015); in the third windowframe break (JIT, 2016)

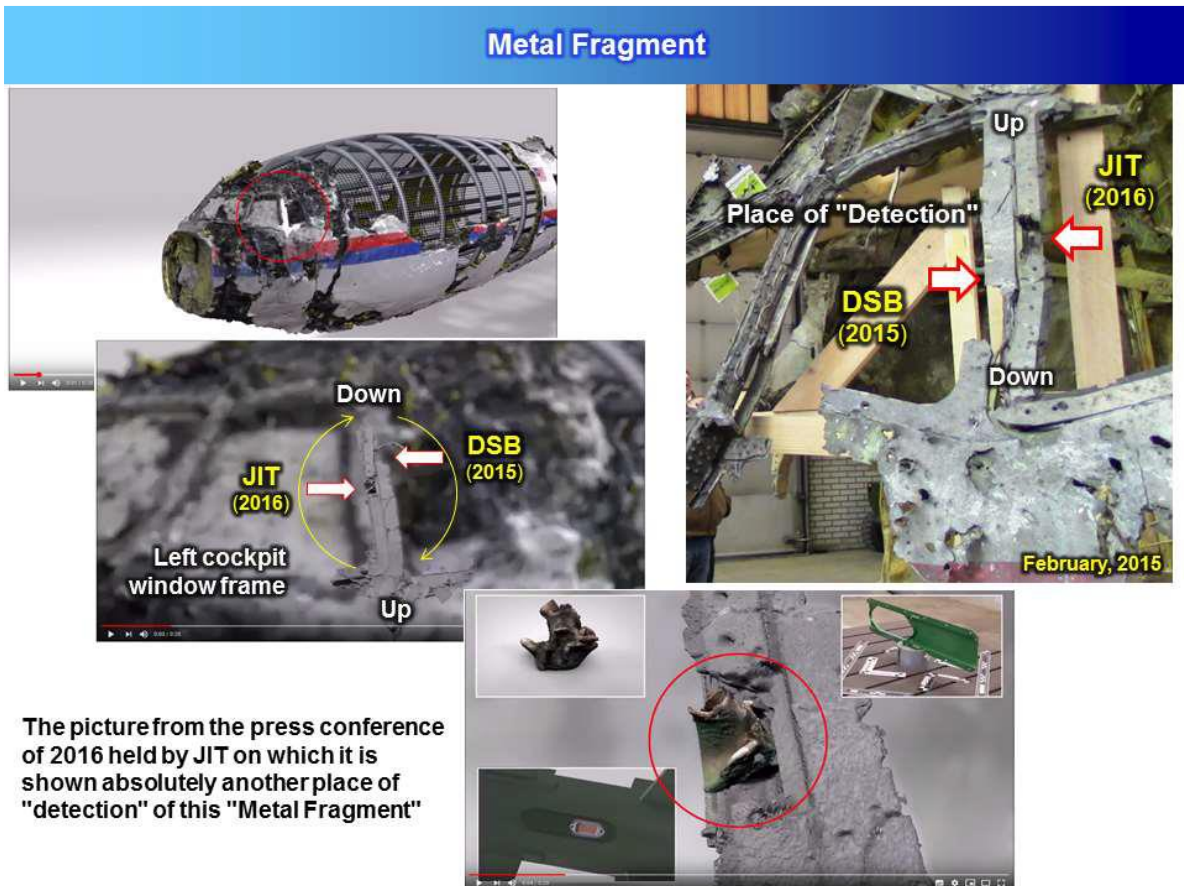
Figure G.5.4 - To show the new location of the 'metal fragment' detection, the JIT experts changed the real location of the frame fragment in the virtual 3D reconstruction

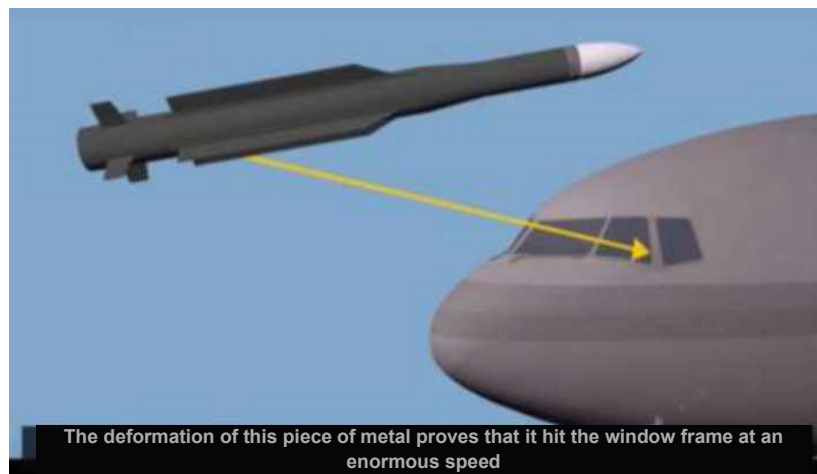
At the JIT press conference, this fragment is presented as important evidence of the detonation of a BUK-type SAM near the cockpit of a Boeing 777 (Figure G.5.5).

Figure G.5.5 - Representation of possible fragment trajectory (JIT materials)

First, - the position of this fragment in the rocket airframe in flight shown in the footage (Fig. G.5.5) contradicts the design features of BUK missiles. The 9M38 missiles are stabilized on roll. Therefore, the breakaway connector is at the bottom of the hull all the time in flight and cannot "turn" 90 degrees towards the right side of the missile.

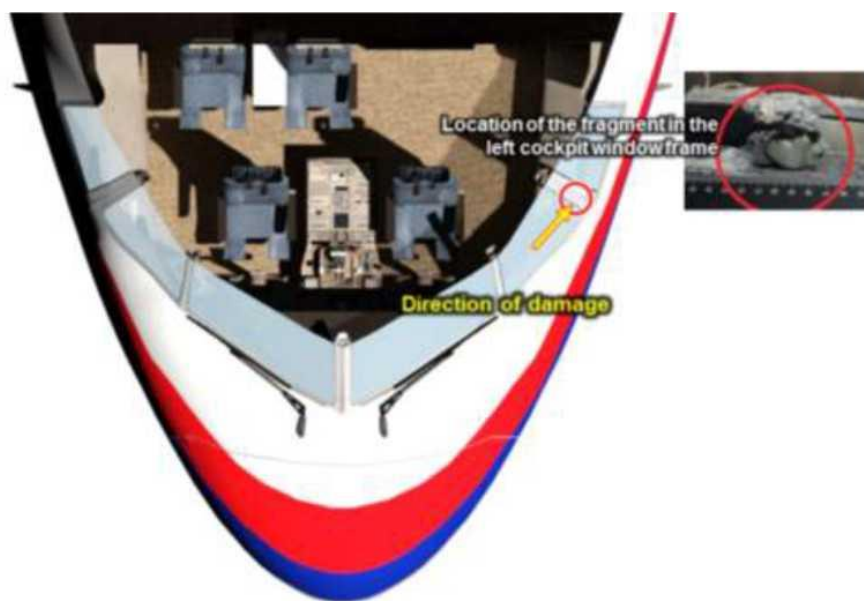
Secondly - the diagram in the JIT shot (yellow arrow in Fig. G.5.5), not only does not answer the question of how in the main version this "metal fragment" could get under the hold-down bar of the window frame, but also calls into question the "opposite direction" version itself (Fig. G.5.6).

Figure G.5.6 - Possible trajectory of the "metal fragment" detected under the window frame clamping strip - along the glass consistent with Corporation's "collision course" version

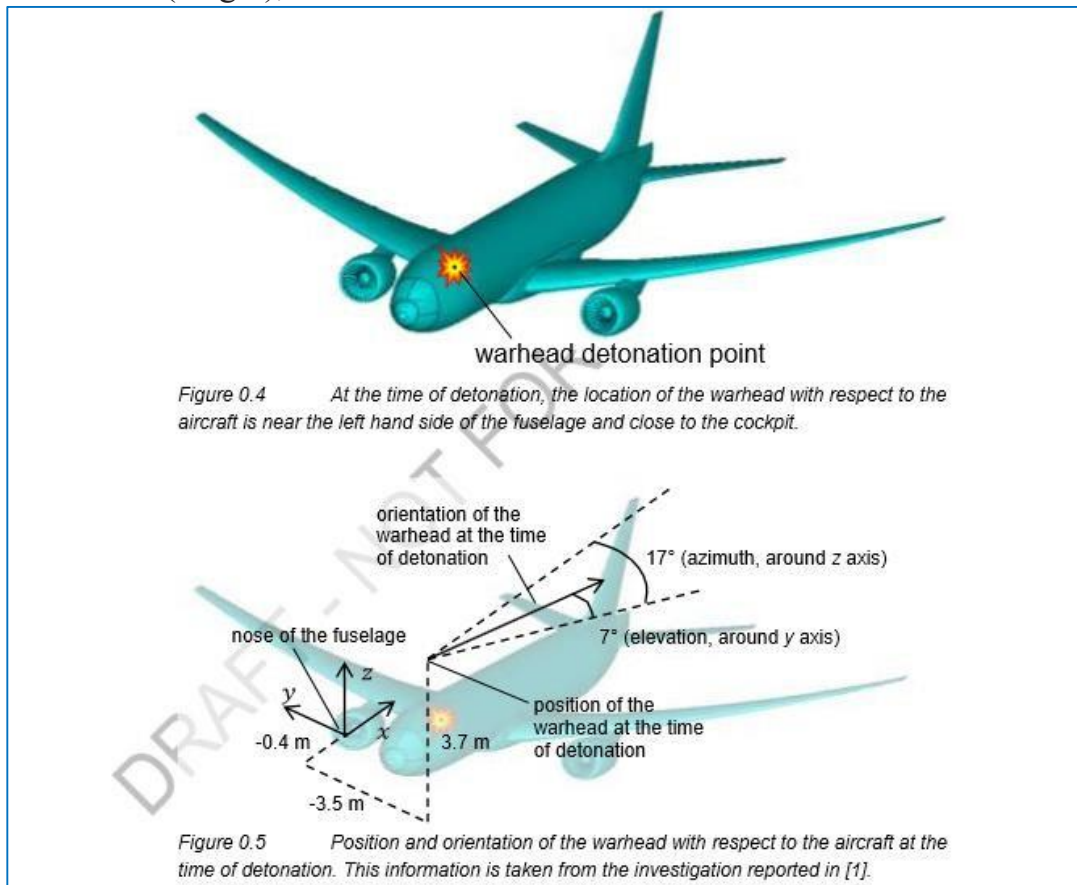
These conditions are illustrated in figure 3.1, which is a photograph of p. 363 of the Draft Final Report of the Dutch Safety Board (DSB).

X_{DSB} (range), m - 0.4 ... 0.0
 Y_{DSB} (parameter), m - 3.5 ... - 3.0
 Z_{DSB} (height), m 3.7 ... 4.0

Figure 3.1 - Source data (missile-aircraft encounter conditions) according to DSB experts

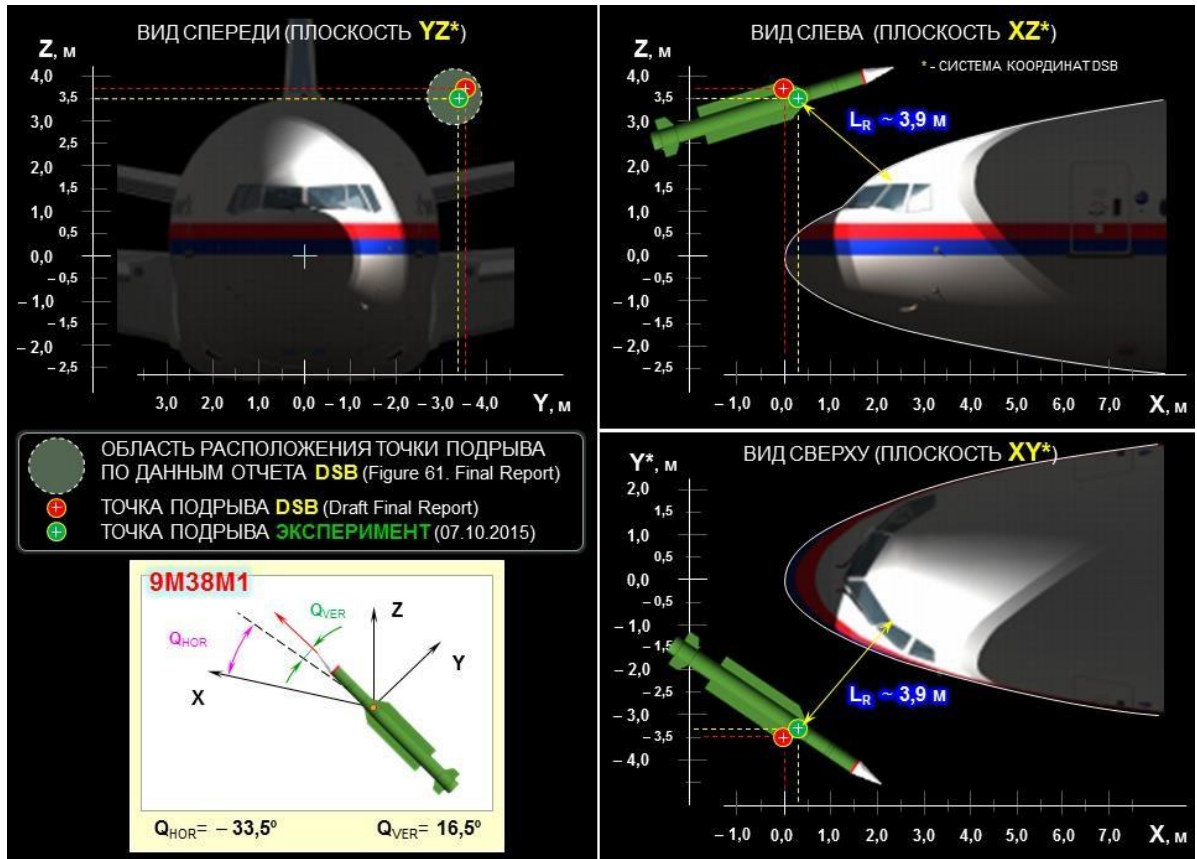
$$\Delta X, \text{ (range) m} \dots\dots\dots + 0.25 \Delta Y, \text{ (parameter) m} \dots\dots\dots + 0.15 \Delta Z, \text{ (height) m} \dots\dots\dots - 0,20$$

These corrections were used to create the target layout. The target layout is shown schematically in figure 3.2.

Figure 3.2 - Schematic target layout. The missile's orientation angles correspond to the data in the DSB Report taking into account the compensatory corrections.

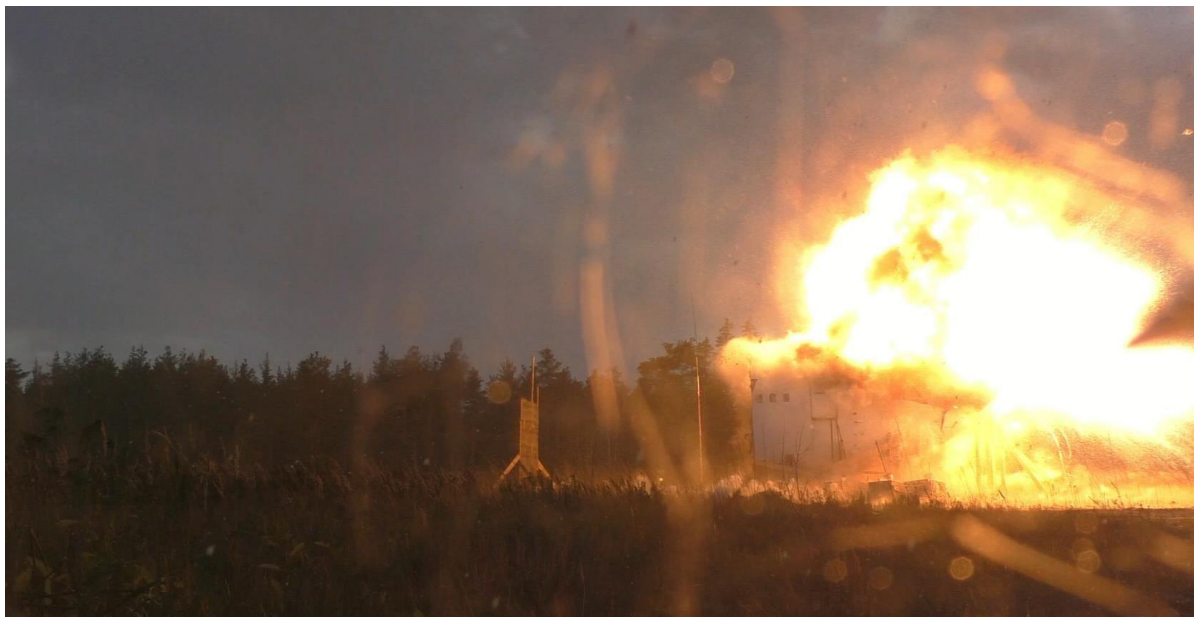
High detonation of the warhead occurred.

Figure 4.1 shows a still image from panoramic video camera 4P showing the moment the 9M38M1 missile is detonated.

Figure 4.1 - Camera No. 4P. Detonation of the 9H314M warhead as part of the item 9M38M1

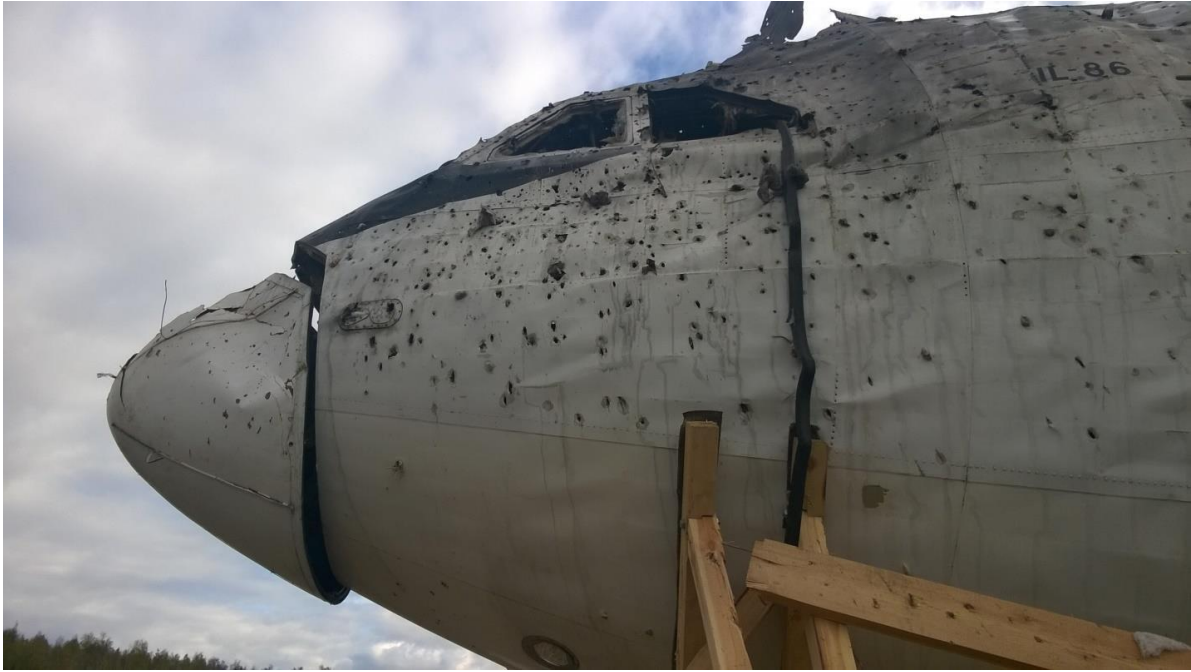
Figure 5.1 - Left side of the cockpit

An analysis of the exterior of the cockpit showed destruction of the entire left side of the cockpit glazing (windscreen of the aircraft commander, left direct-vision window and left rear window). There is significant deformation of the structural frame of the glazing, especially the rear left window. There is a significant density of fragmentation holes. At the same time, the shape of the entry holes varies from elongated compact shape to a distinctive butterfly-shaped hole. The entry holes in the area of the glazing have clear outlines, no traces of non-penetrating damage (ricochets) caused by preformed fragments have been recorded under the glazing.

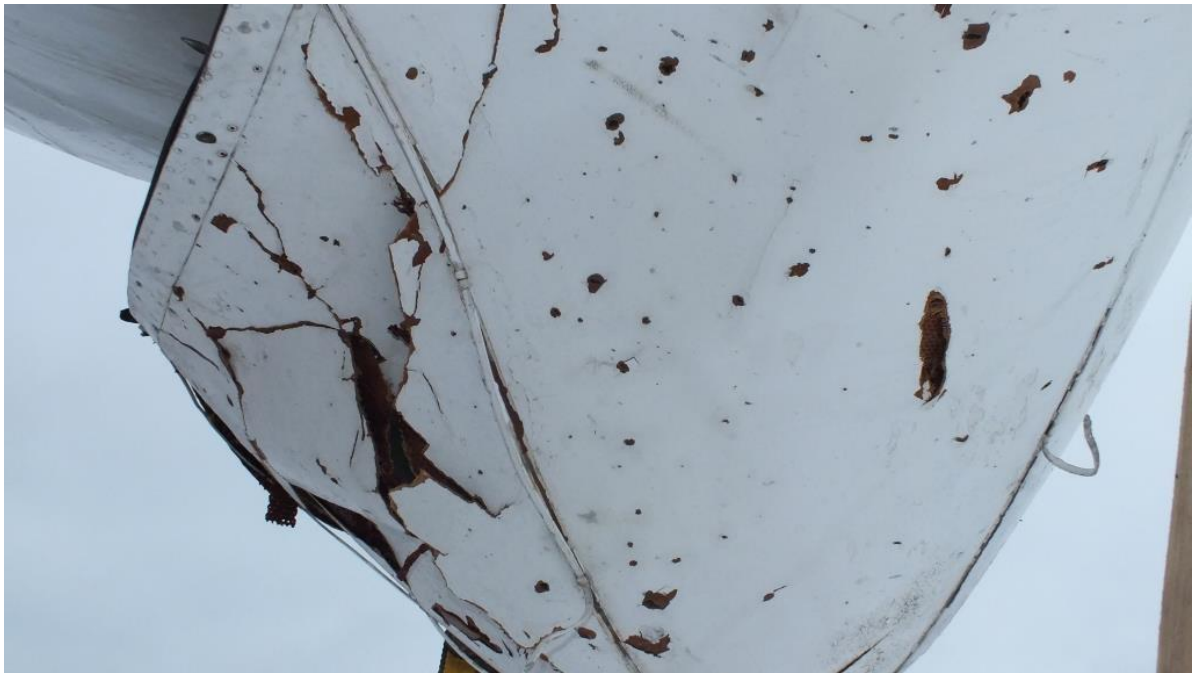
Figure 5.11 - Entry holes in the radiotransparent radome
