**APPLICATION OF THE INTERNATIONAL CONVENTION FOR THE SUPPRESSION
OF THE FINANCING OF TERRORISM AND OF THE INTERNATIONAL
CONVENTION ON THE ELIMINATION OF ALL FORMS OF RACIAL
DISCRIMINATION**

REJOINDER

Report of JSC Air and Space Defense Corporation "Almaz-Antey" on the results of studies related to the technical investigation into the crash of the Malaysian airlines Boeing 777-200 9M-MRD (flight MH17), 2023

on the results of studies related to the technical investigation into the crash
of the Malaysian airlines Boeing 777-200 9M-MRD (flight MH17)

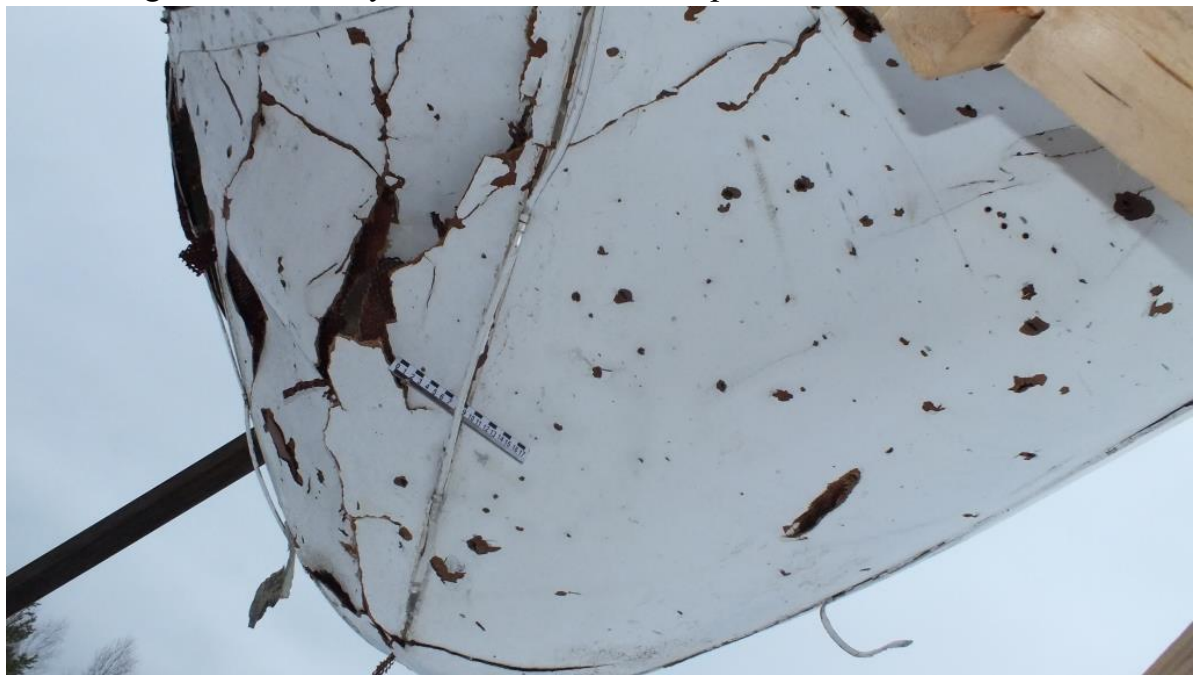
Figure 5.12 - Entry holes in the radiotransparent radome

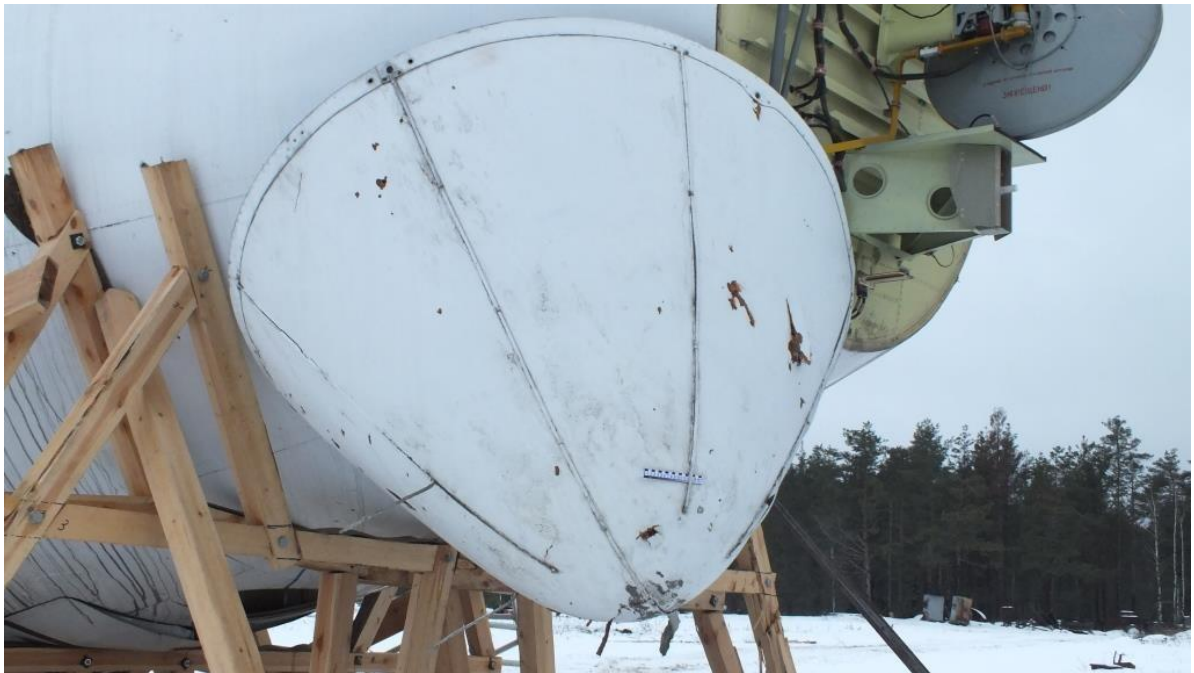
Figure 5.13 - Output holes in the radiotransparent radome

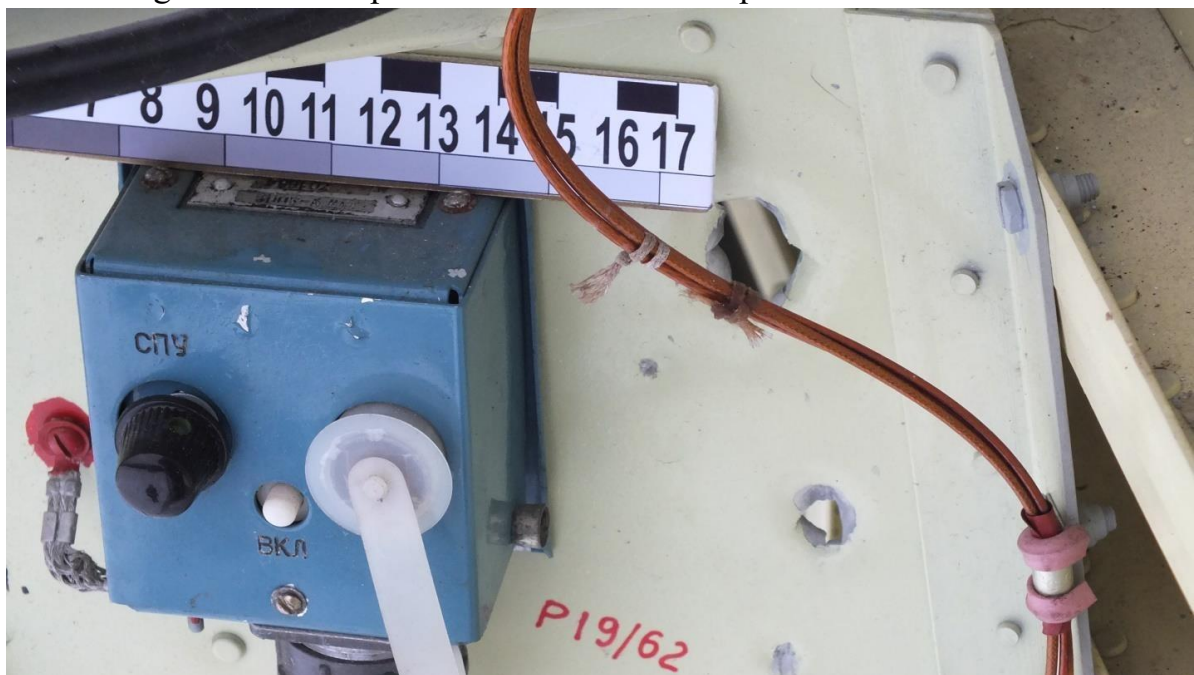
Figure 5.14 - Through-and-through holes in weather radar equipment

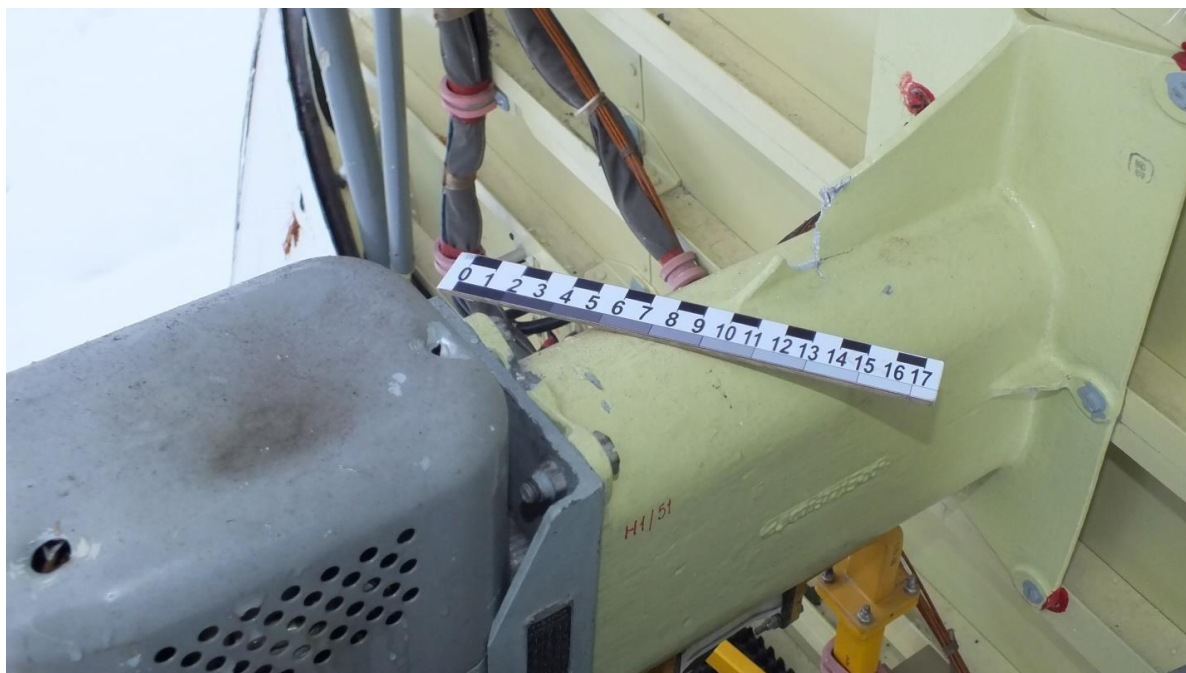
Figure 5.15 - Through-and-through holes in weather radar equipment

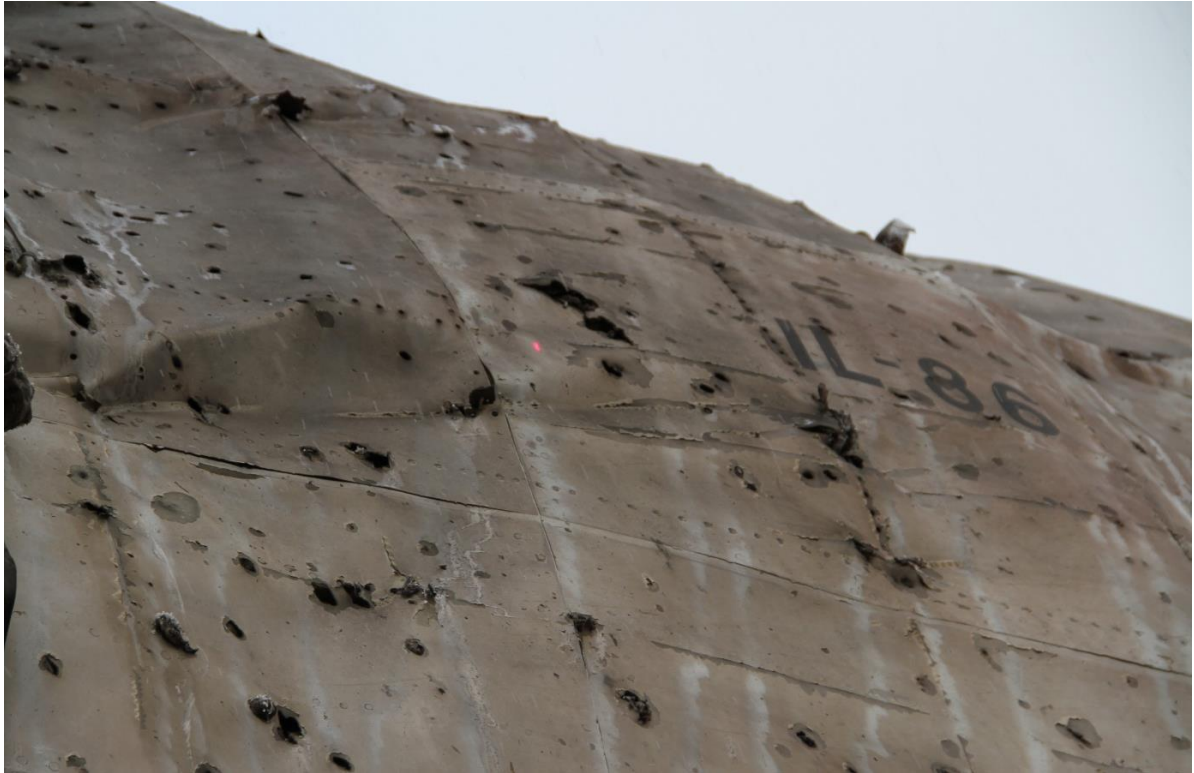
Figure 5.29 - Port outside the windows of the aircraft commander with signs of deformation of the outer skin, elements of the framework and thermal burn

There is significant deformation of the outer skin of the port in the direction from outside to inside, exposing the contours of the framework. Also, there are ruptures in the outer skin and its detachment from the framework as a result of the rivet heads detachment.

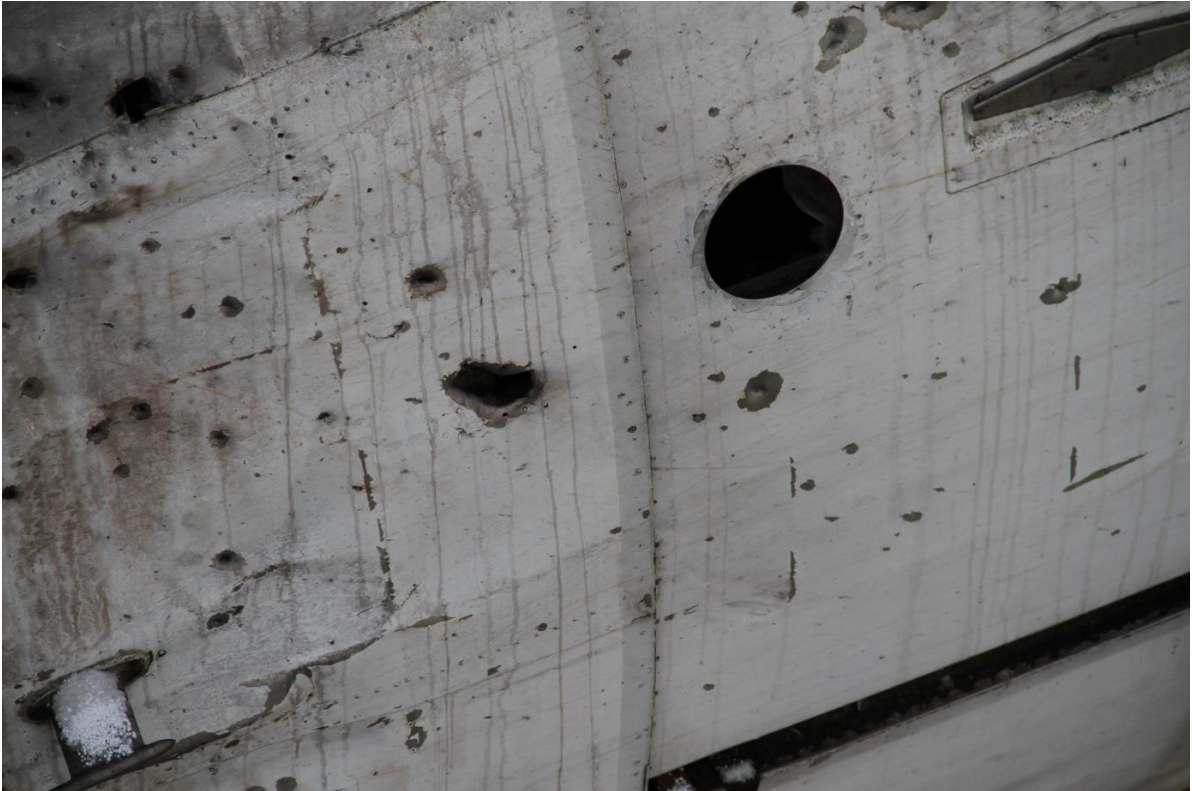
Figure 5.31 - Port side in L1 door area. Characteristic holes caused by hull fragments are seen the dimensions of which are significantly greater than those of holes caused by ready-made projectiles

The shape of the entry holes varies from an elongated compact shape to distinctive butterfly-shaped holes caused by ready-made projectiles and large (30 to 250 mm) shapeless holes caused by the second compartment (warhead compartment) fragments and small (1-3 mm) holes caused by detonation products.

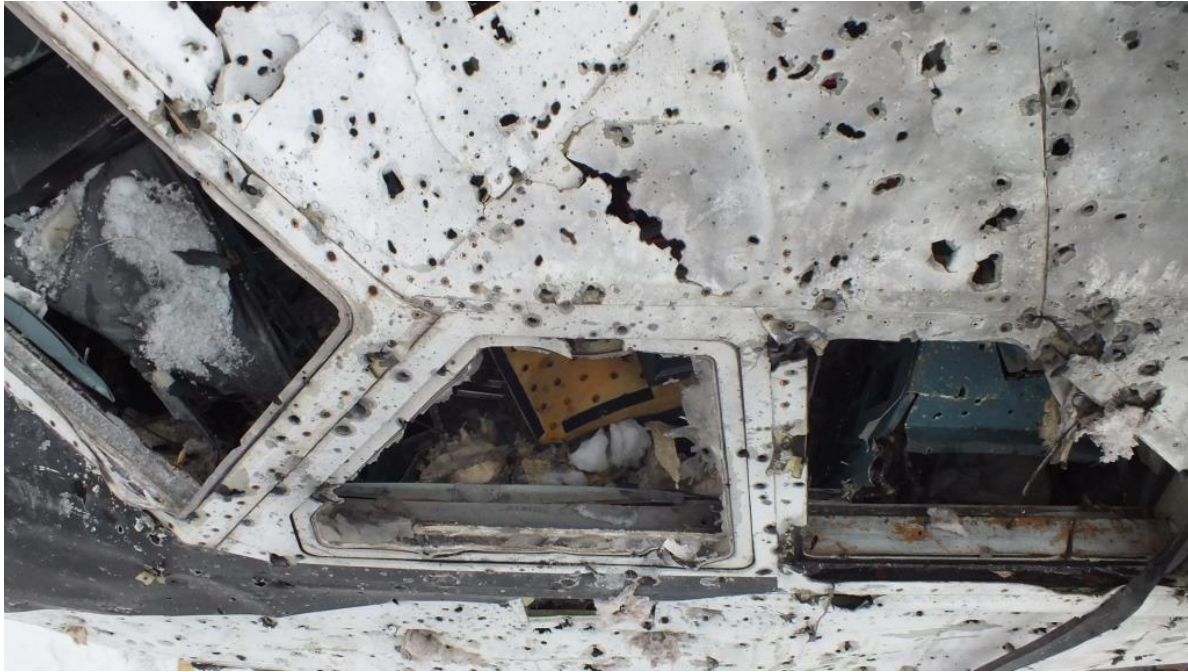
Figure 5.35 - Top of port side (overall view above the aircraft commander's windows). The fragment shows deformation and tearing of the outer skin

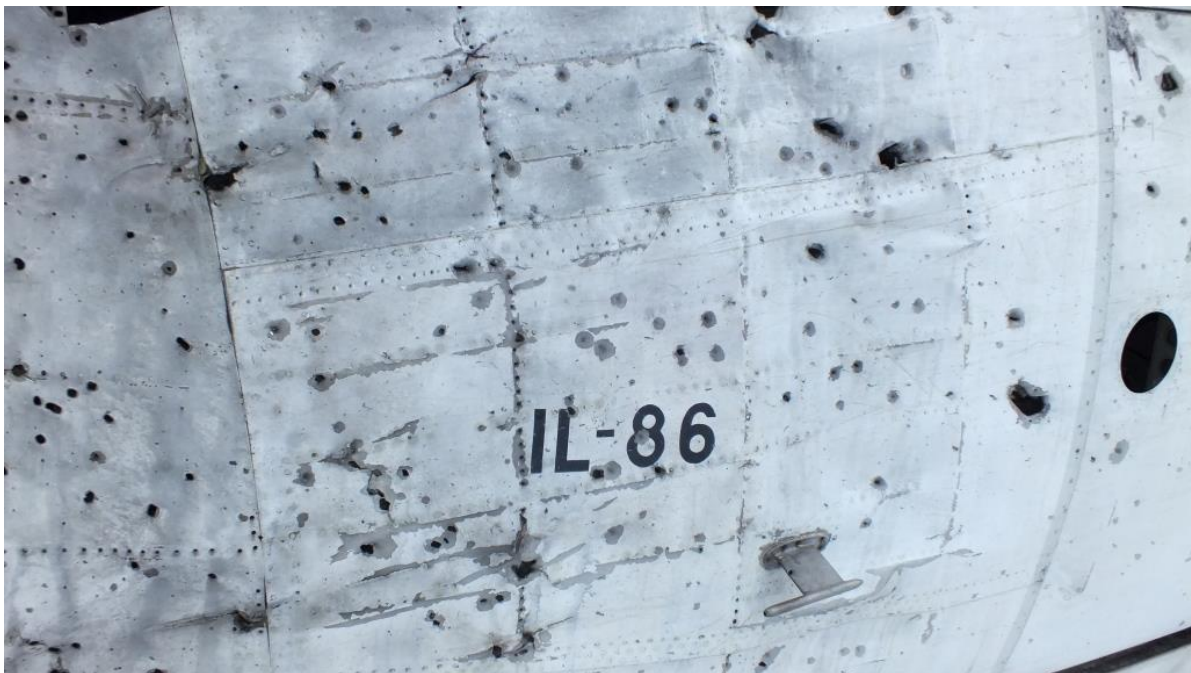
Figure 5.36 - Port side skin (overall view). The fragment shows detachment of the outer skin from the framework resulting from the detachment of rivet heads

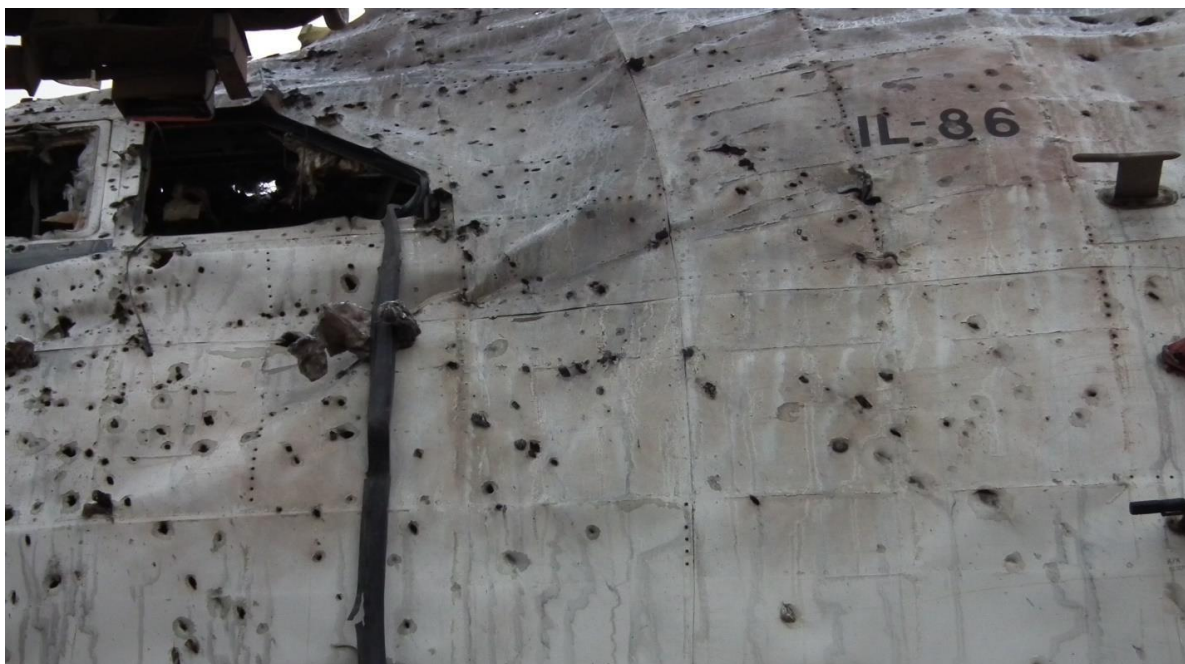
Figure 5.37 - Fragment of the outer skin of the port side (overall view). The fragment shows deformation of the outer skin in the direction from outside to inside, exposing the contours of the framework and detachment of outer skin elements

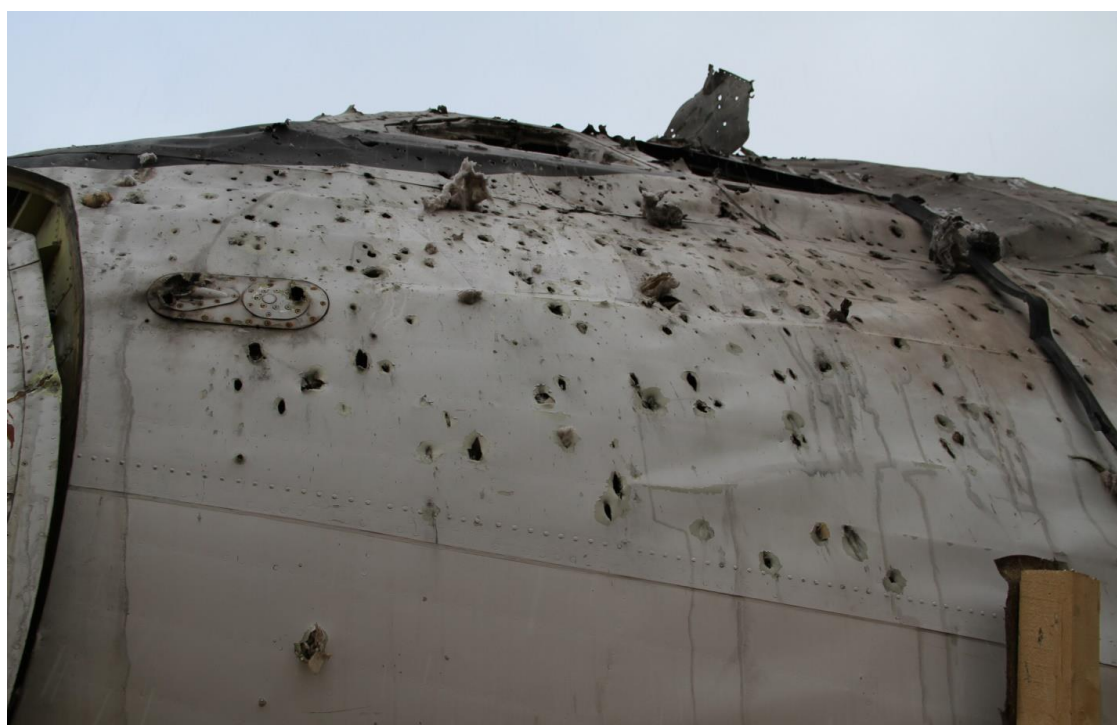
Figure 5.38 - Port side skin (overall view, bottom view)

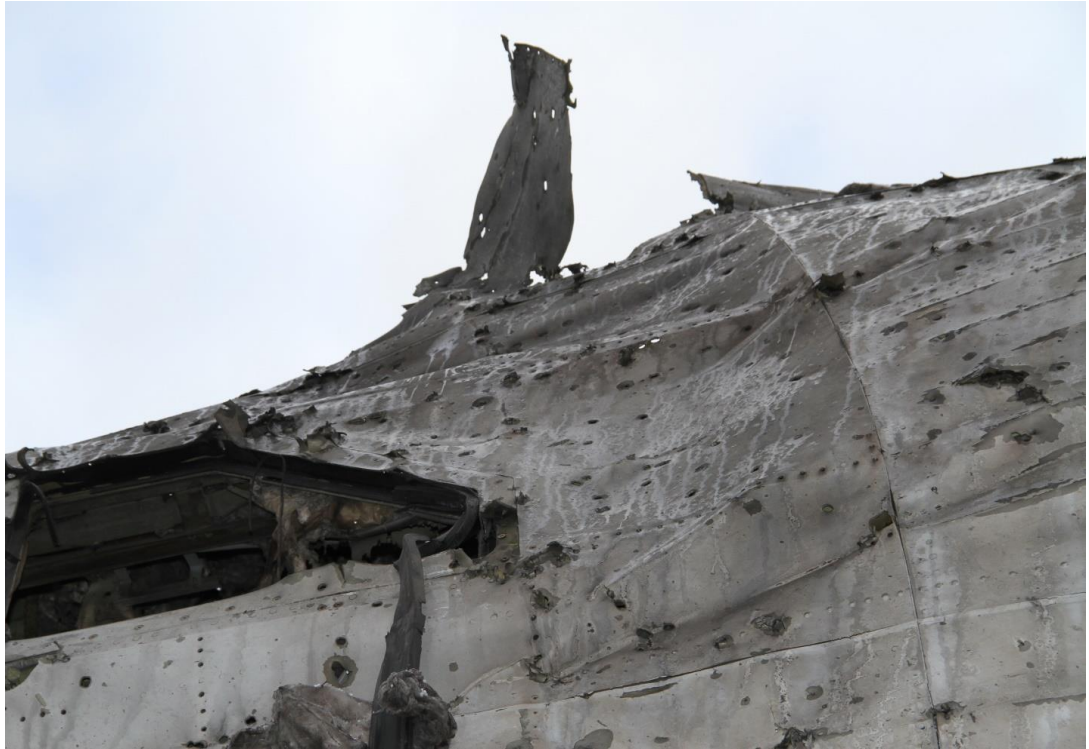
Figure 5.39 - Port side skin showing signs of significant deformation of outer skin in the direction from outside to inside

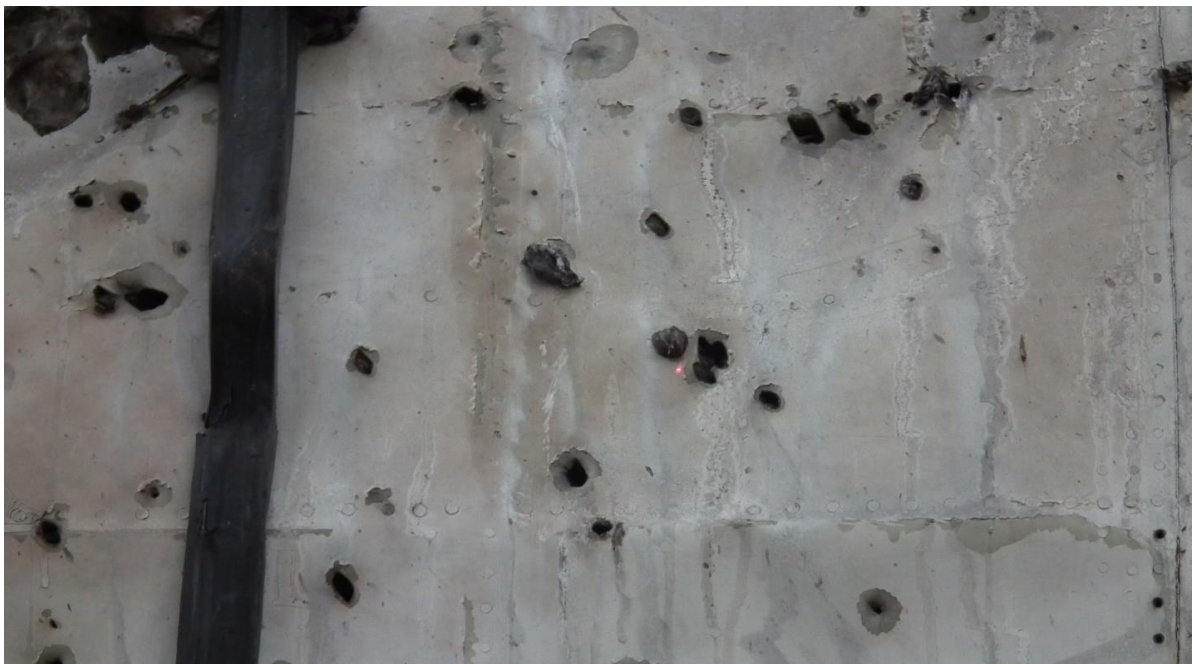
Figure 5.40 - Port side skin (close-up). No traces of non-penetrating damage (ricochets) caused by preformed fragments on the port side of the target aircraft

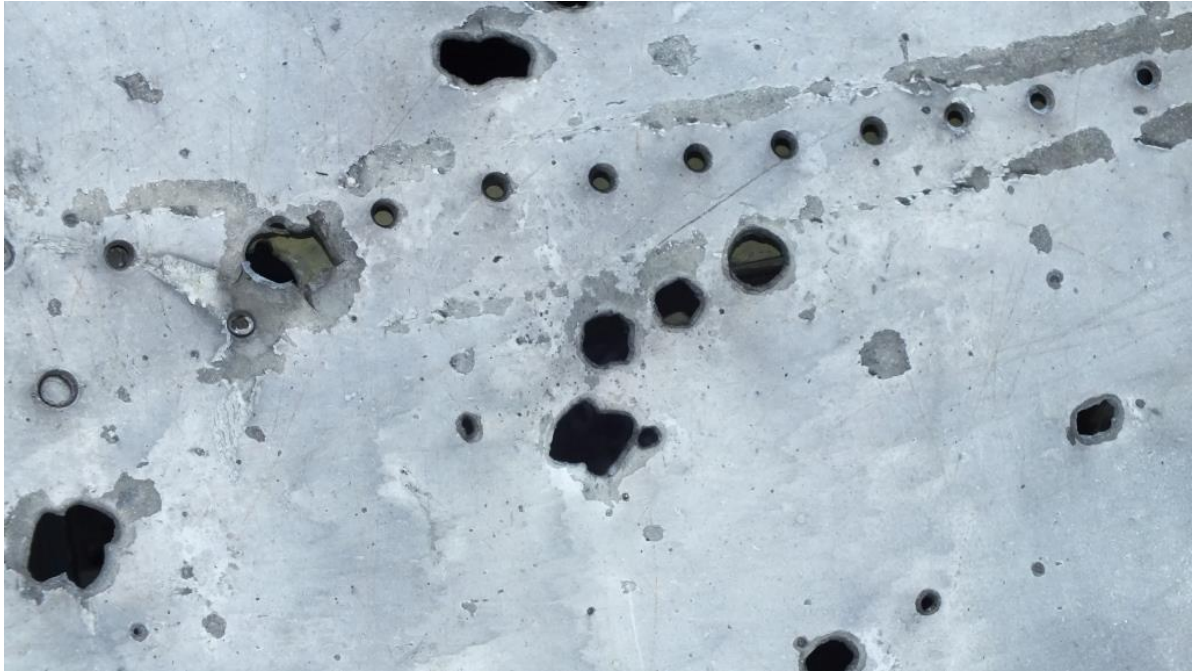
Figure 5.41 - Fragment of the port side skin (close-up).
The fragment shows the characteristic butterfly-shaped holes from the 9H314M 1-10
projectiles

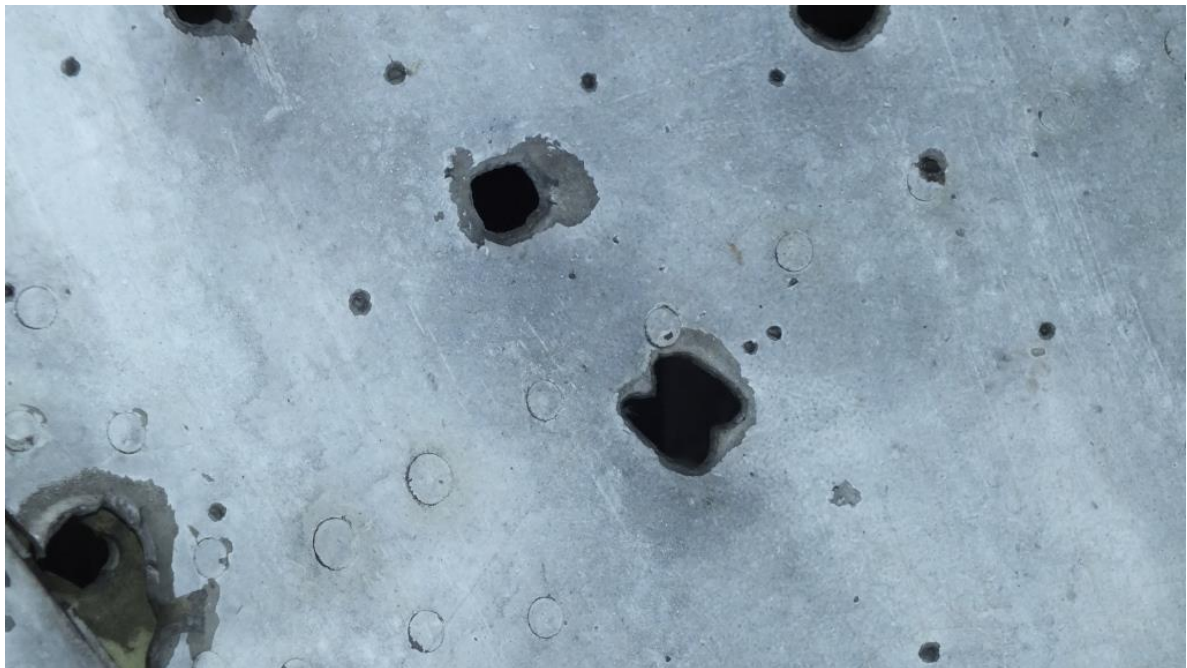
Figure 5.42 - Port side skin with a characteristic butterfly-shaped hole caused by a
projectile of 9H314M 1-10 (close-up)

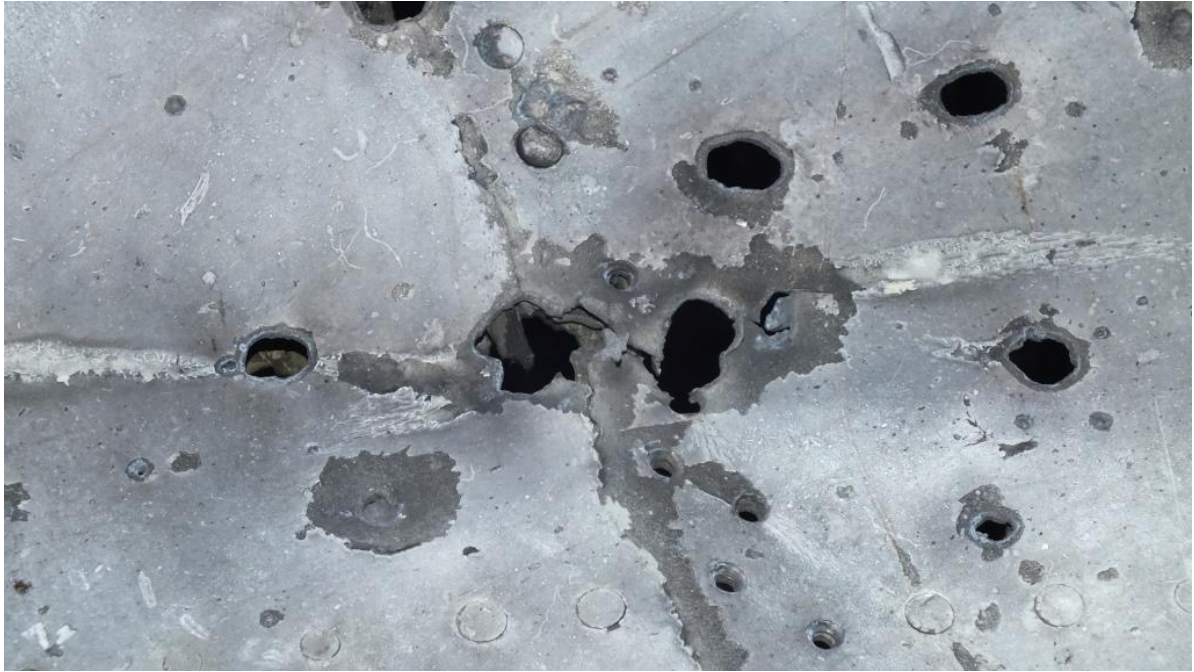
Figure 5.43 - Fragment of the port side skin with holes caused by all types of preformed fragments of 9H314M warhead (close-up)

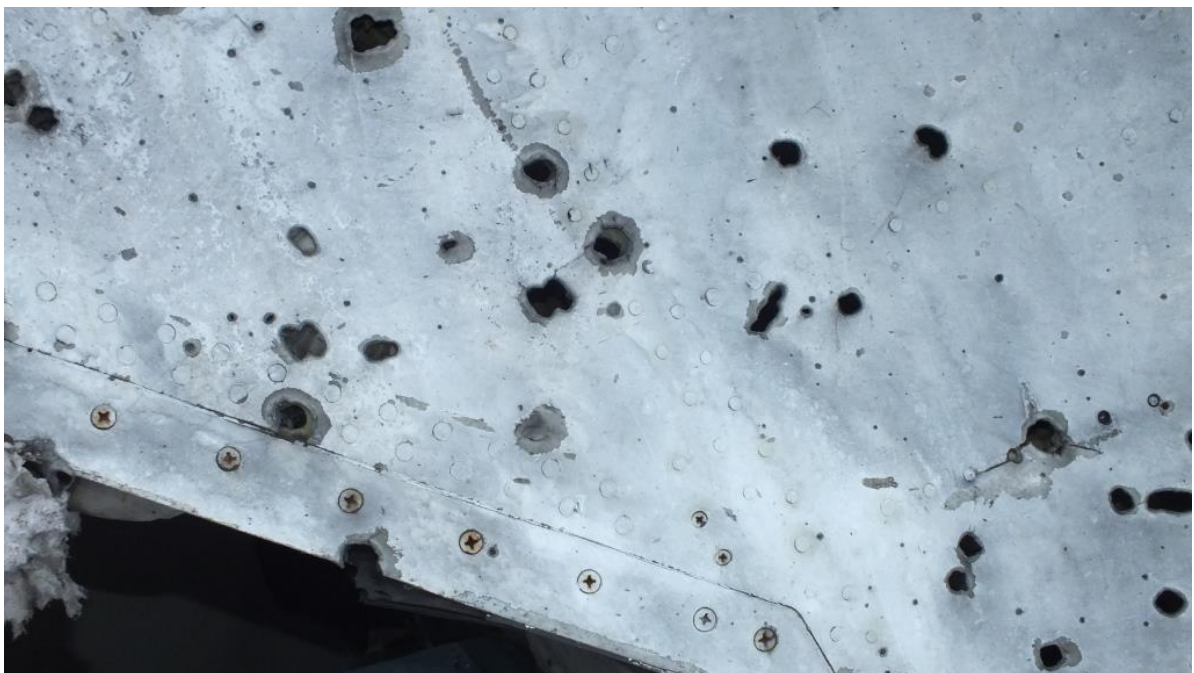
Figure 5.44 - Port side skin with micro-crater marks and characteristic butterfly-shaped holes caused by 9H314M 1-10 projectiles (close-up)

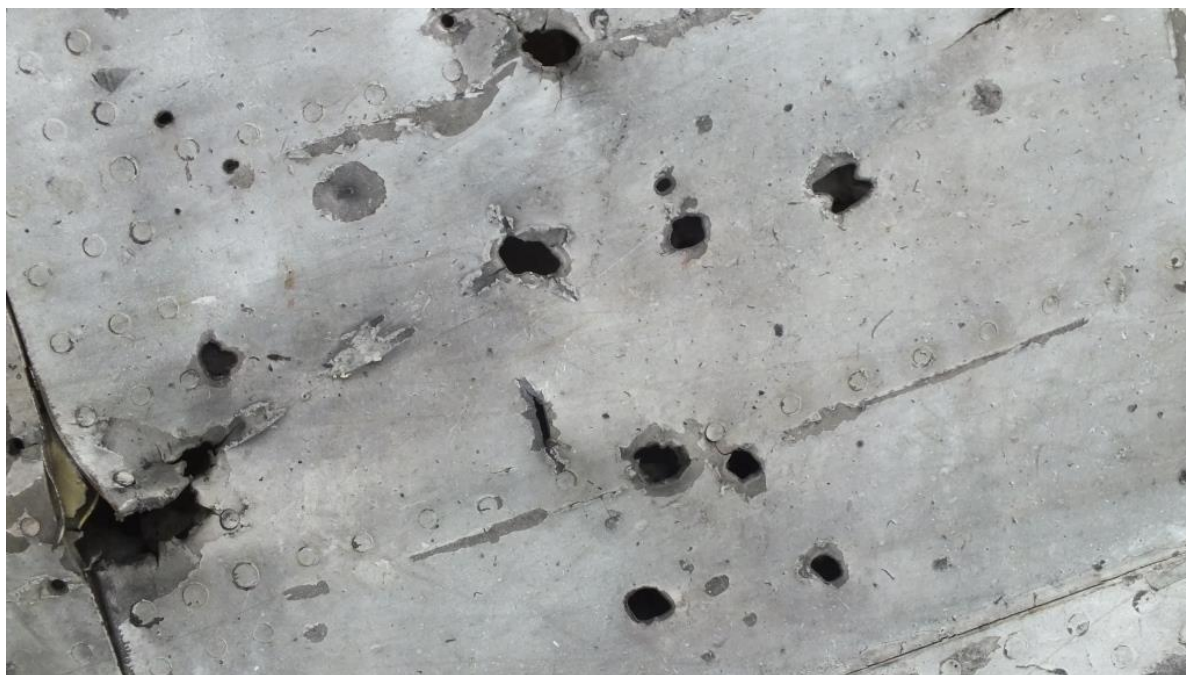
Figure 5.45 - Port side skin with characteristic butterfly-shaped holes caused by 9H314M 1-10 projectiles (close-up)

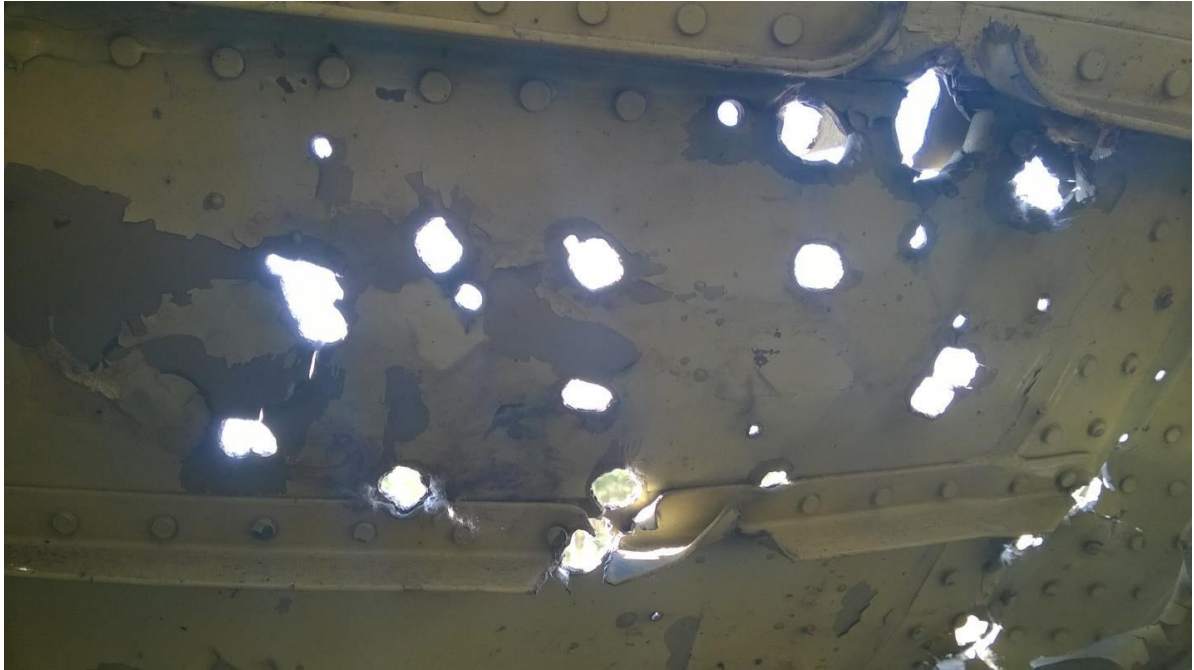
Figure 5.47 - Fragment of the upper part of the port with through-and-through holes caused by ready-made projectiles and missile hull fragments (inside view)

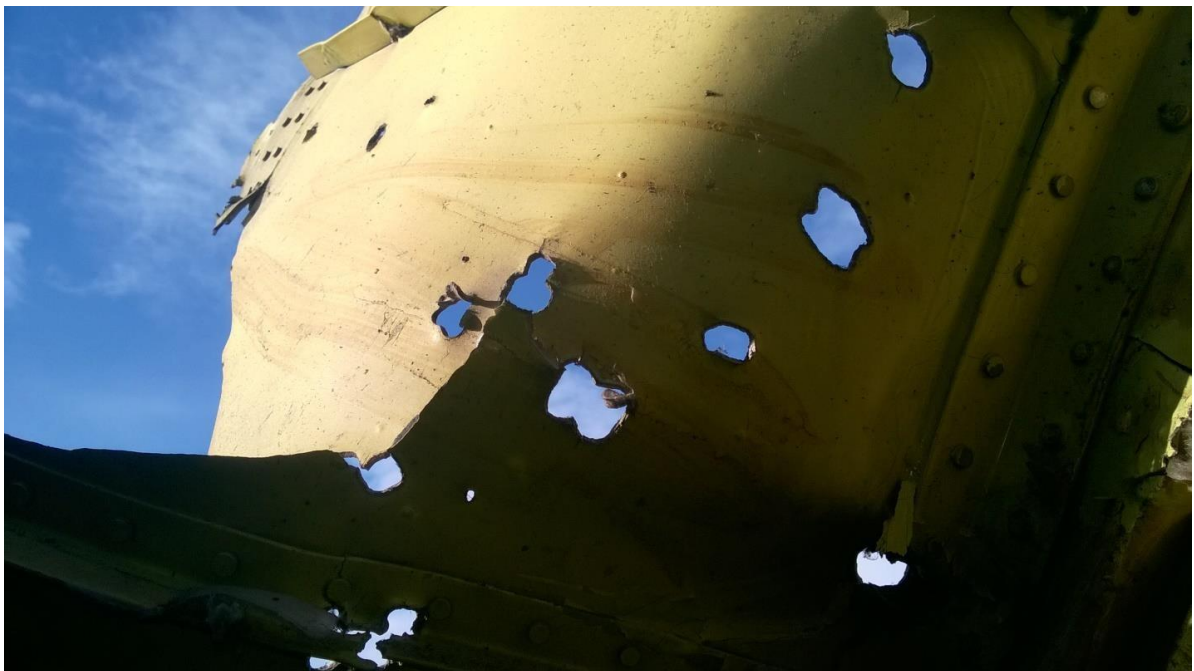
Figure 5.48 - Fragment of upper part of the port with characteristic butterfly-shaped holes caused by 9H314M 1-10 ready-made projectiles (inside view)

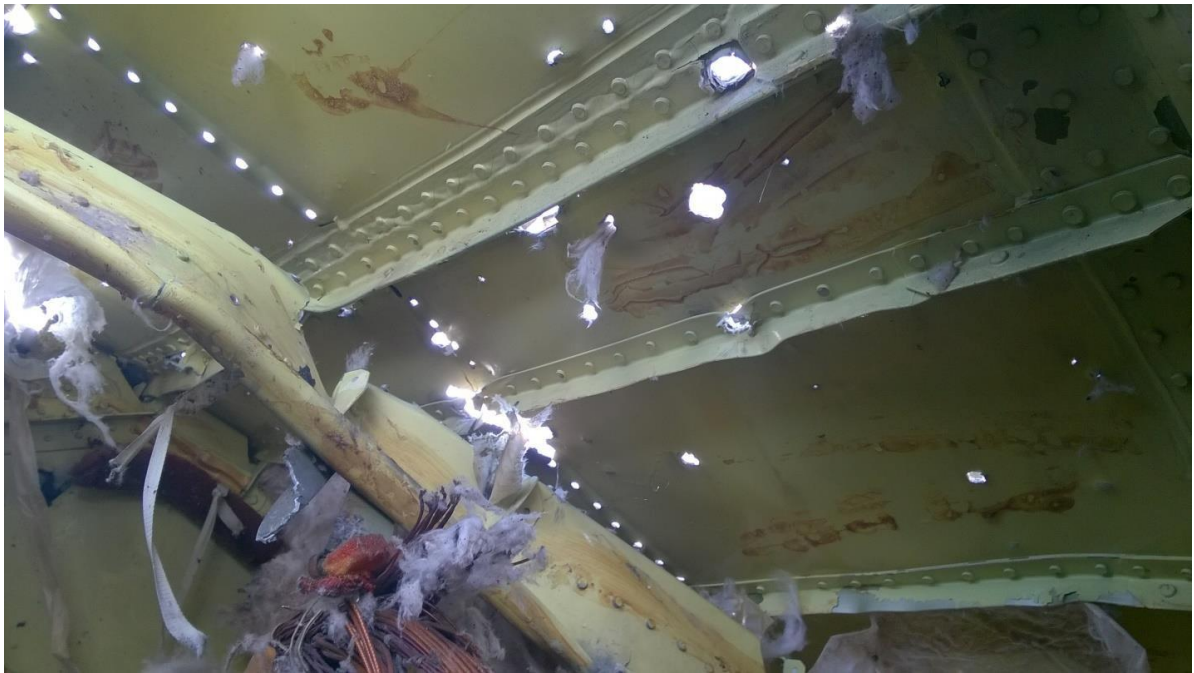
Figure 5.49 - Fragment of upper part of the port (inside view). The fragment shows deformation of the framework elements and detachment of the outer skin from the framework resulting from the detachment of rivet heads

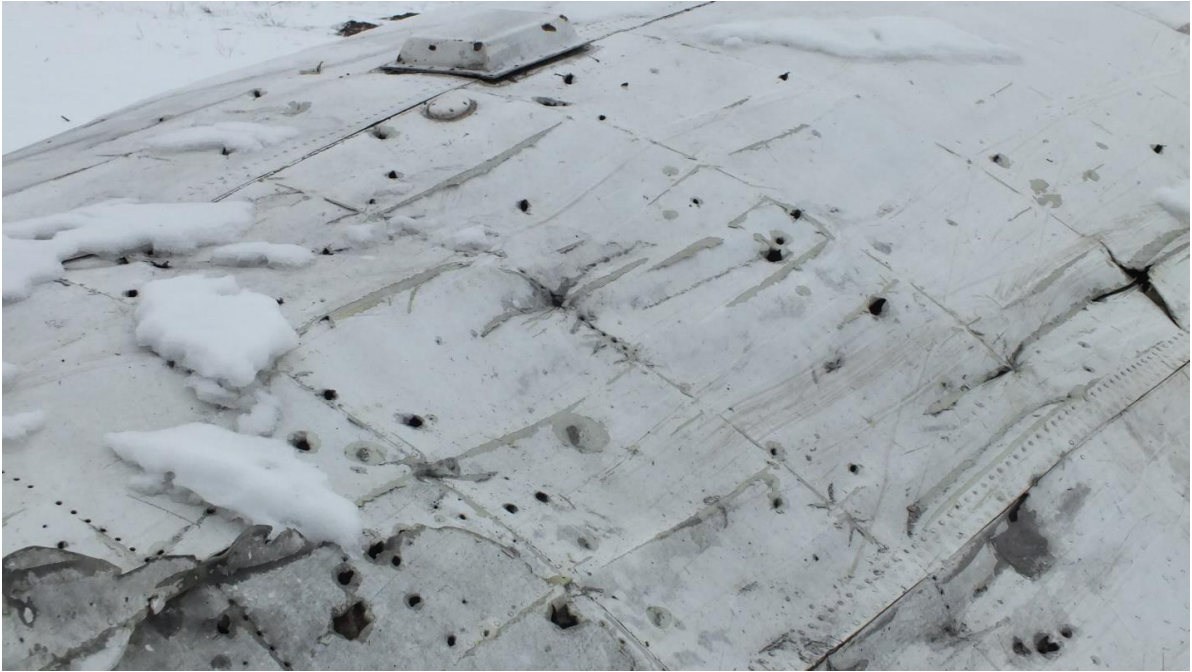
Figure 5.59 - Cockpit roof at the level of the front left passenger door L1 (top view). The roof fragment shows that through-and-through holes caused by ready-made projectiles are present on both left and right side on the roof

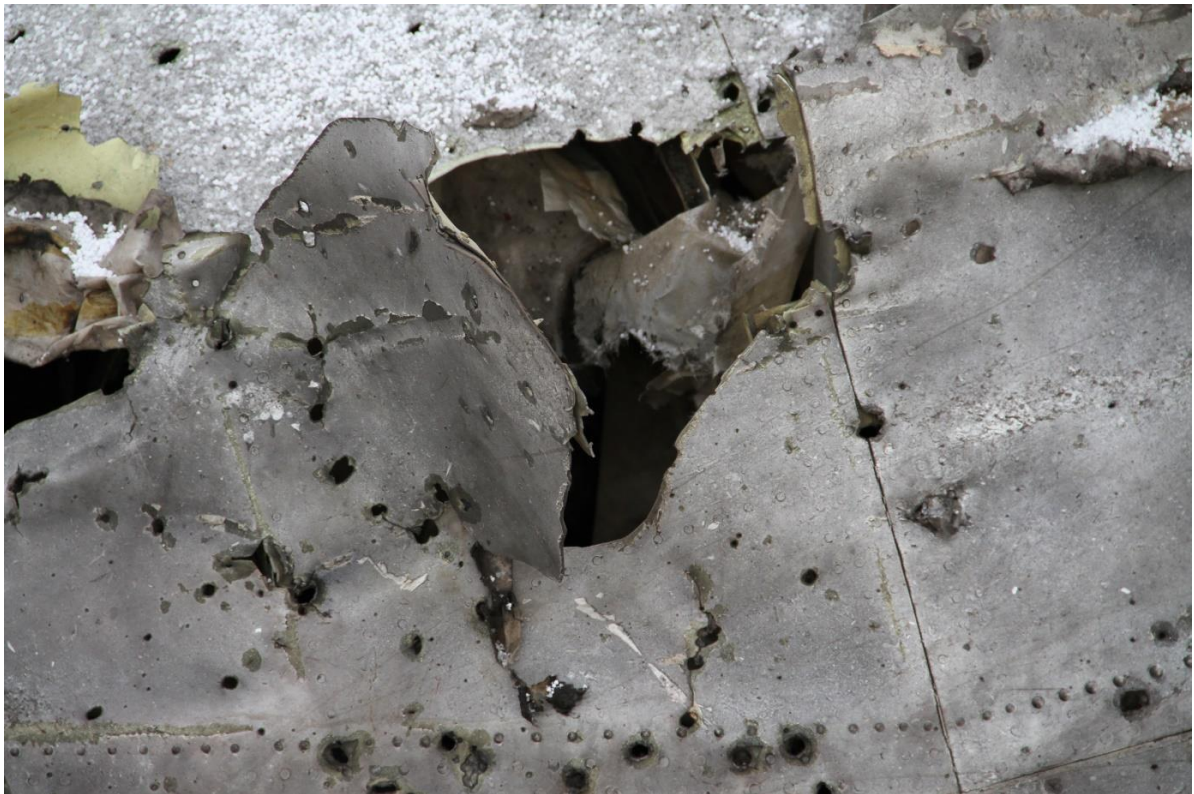
Figure 5.63 - Fragment of cockpit roof (close-up).

The direction of deformation of the roof structure elements from inside to outside indicates that an aero-strike resulted from the impact of 9H314M warhead explosion factors

In the left section of the cockpit roof, there is destruction of the structure and the outer skin. The direction of deformation of the aircraft's structural elements from inside to outside indicates that an aero-strike resulted from the impact of the explosion (figures 5.63, 5.64). Fragments of Boeing 777 show no traces of aero-impact.

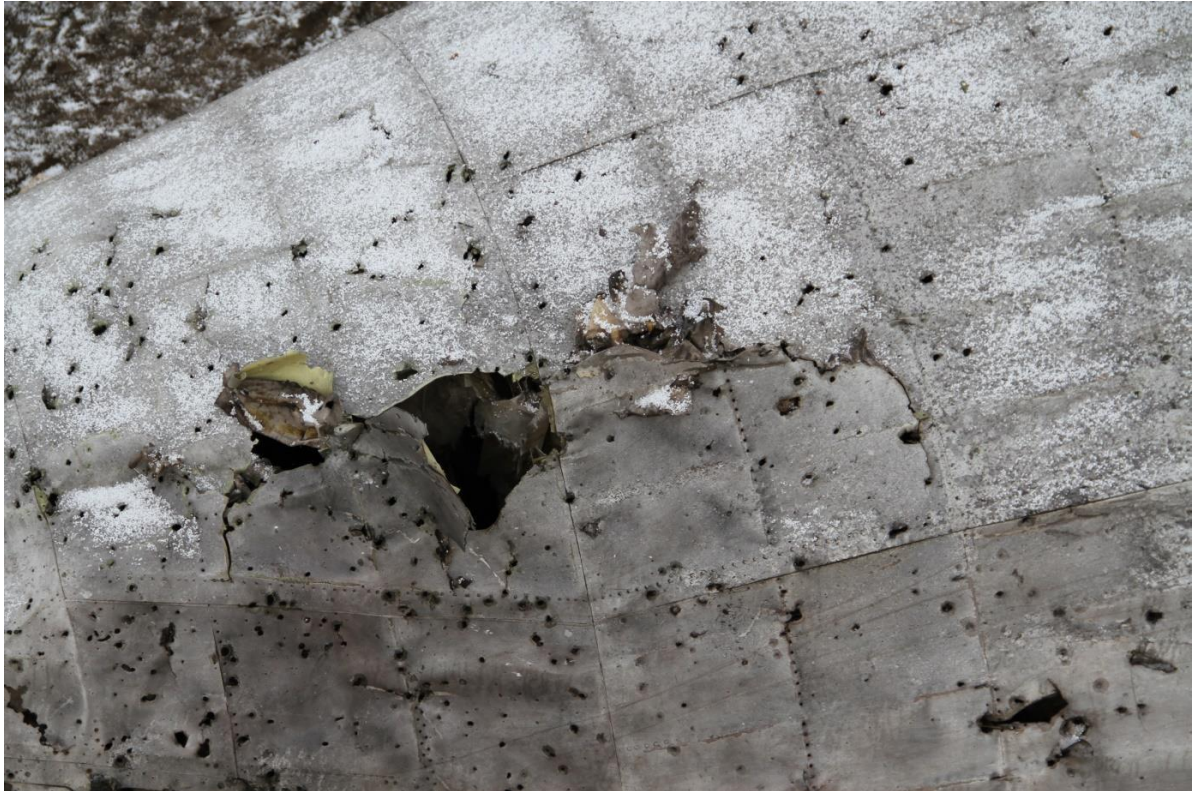
Figure 5.64 - Cockpit roof with aero-strike marks (overall view)

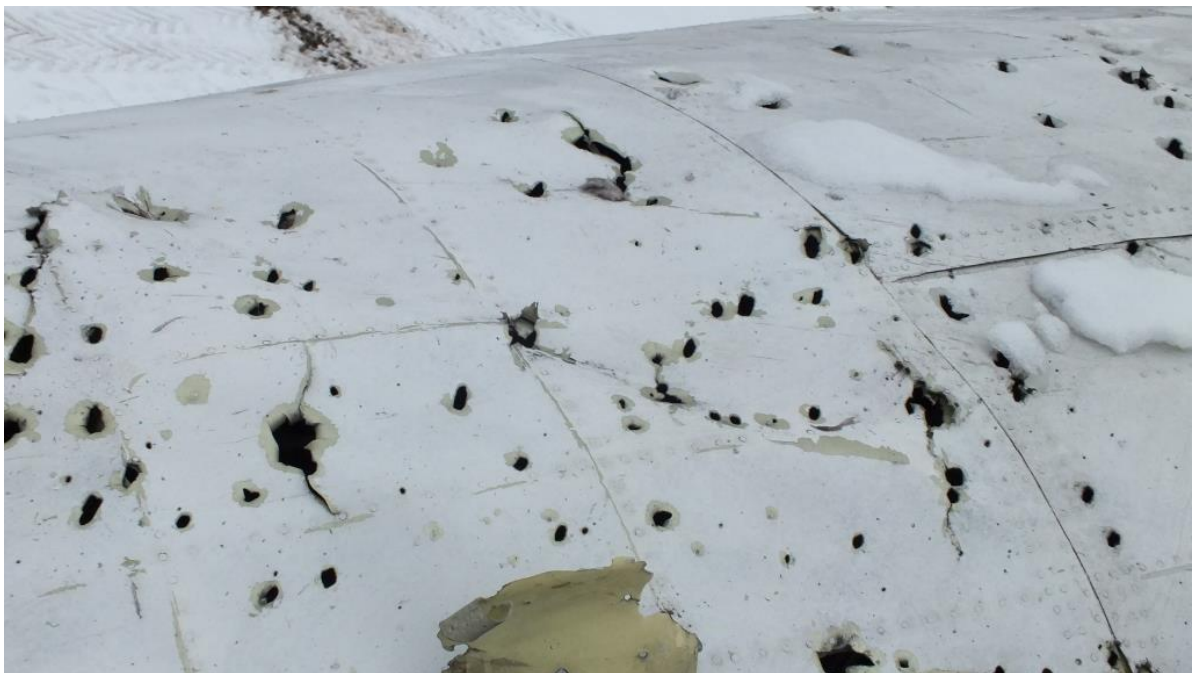
Figure 5.65 - Cockpit roof near the centre (axial) line of the aircraft. The fragment shows traces of damage caused by ready-made projectiles to both the left and right sides of the roof

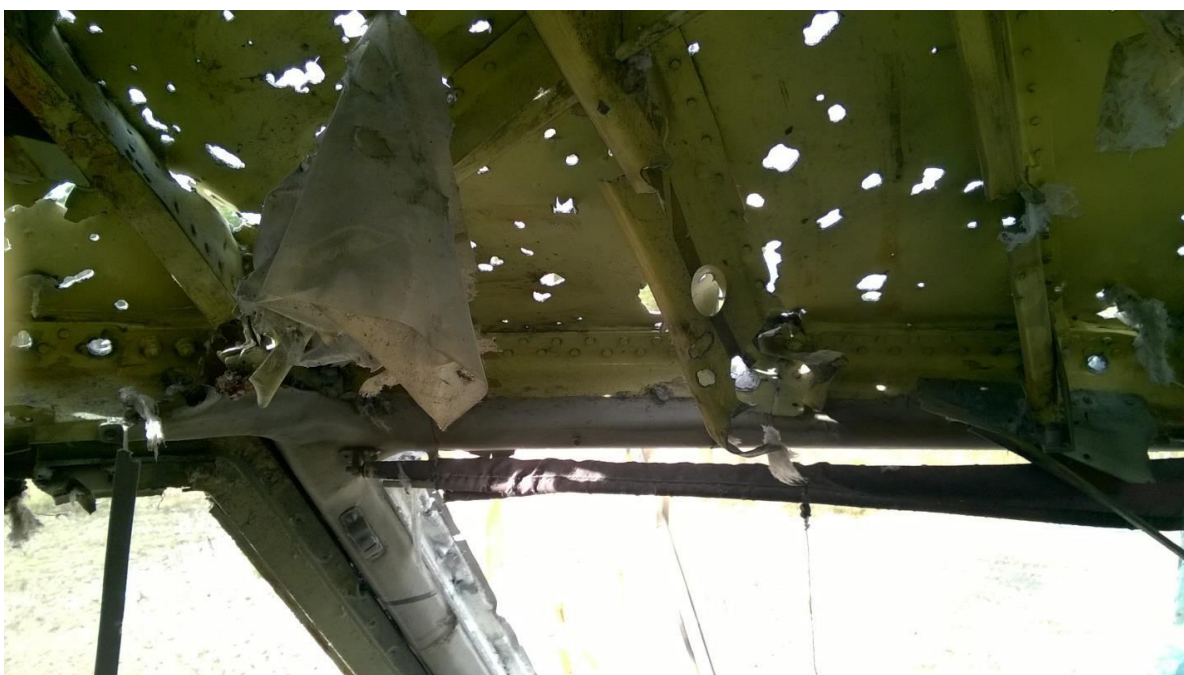
Figure 5.67 - Cockpit roof above the aircraft commander's seat with signs of destruction of transverse structural elements (stringers)

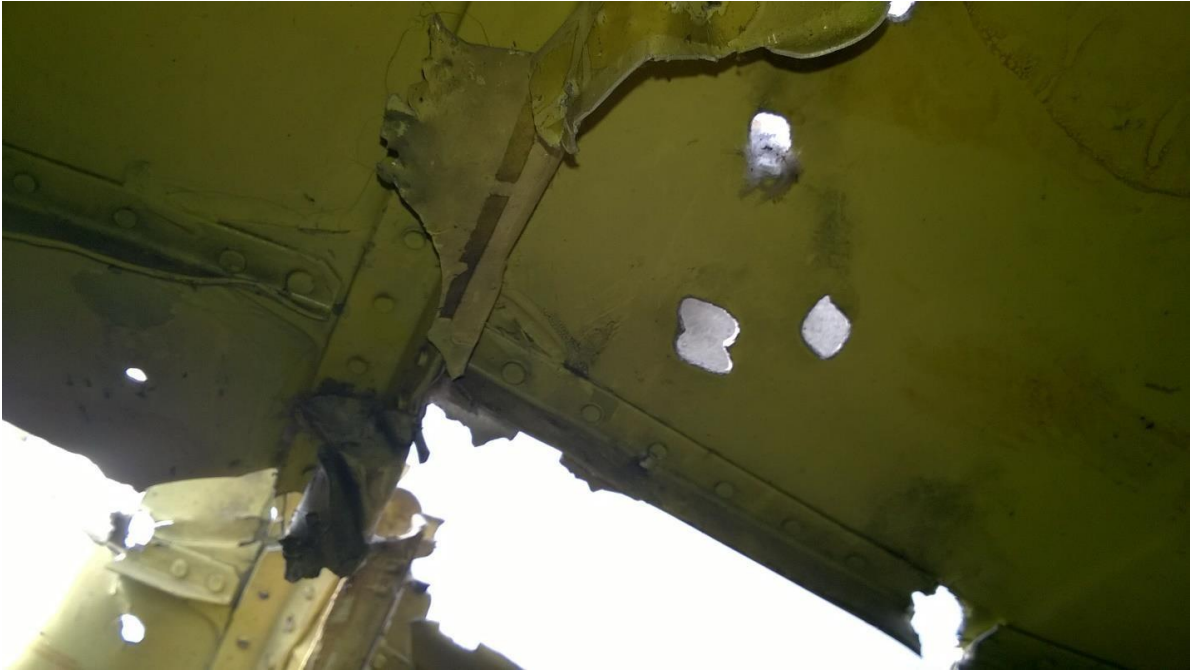
Figure 5.68 - Characteristic butterfly-shaped through-and-through holes in a fragment of the cockpit roof
