**APPLICATION OF THE INTERNATIONAL CONVENTION FOR THE SUPPRESSION
OF THE FINANCING OF TERRORISM AND OF THE INTERNATIONAL
CONVENTION ON THE ELIMINATION OF ALL FORMS OF RACIAL
DISCRIMINATION**

REJOINDER

Report of JSC Air and Space Defense Corporation "Almaz-Antey" on the results of studies related to the technical investigation into the crash of the Malaysian airlines Boeing 777-200 9M-MRD (flight MH17), 2023

on the results of studies related to the technical investigation into the crash
of the Malaysian airlines Boeing 777-200 9M-MRD (flight MH17)

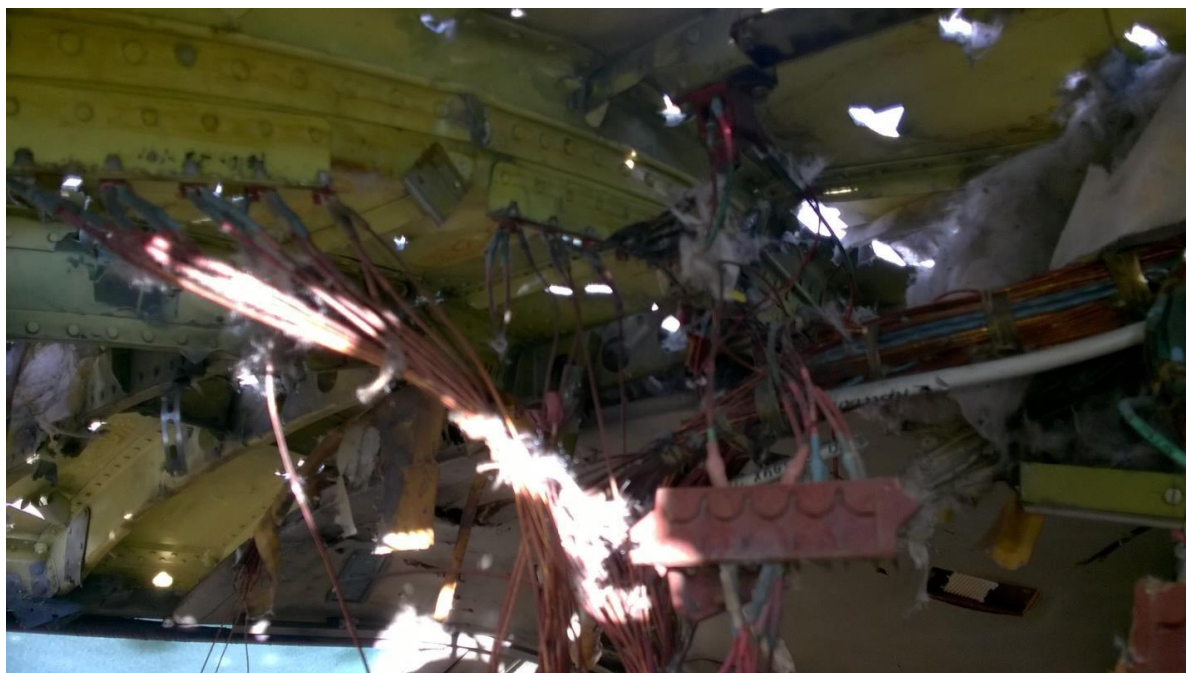
Figure 5.70 - Through-and-through holes on the right side of the cockpit roof (inside view)

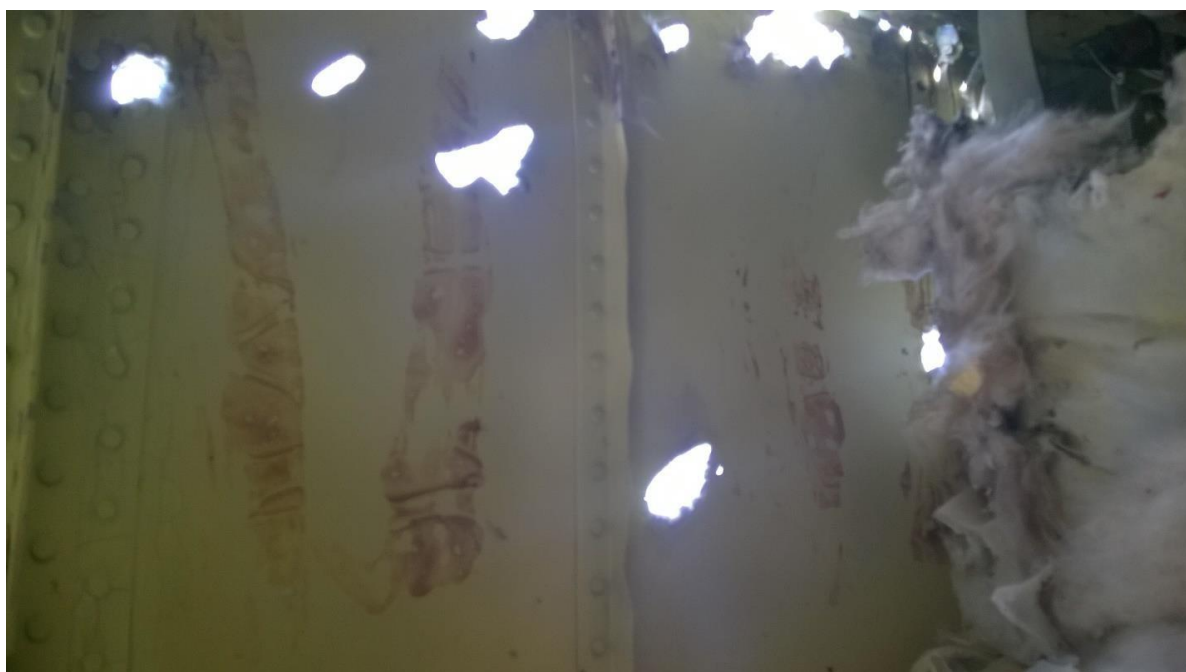
Figure 5.71 - Through-and-through holes in the cockpit roof (inside view)

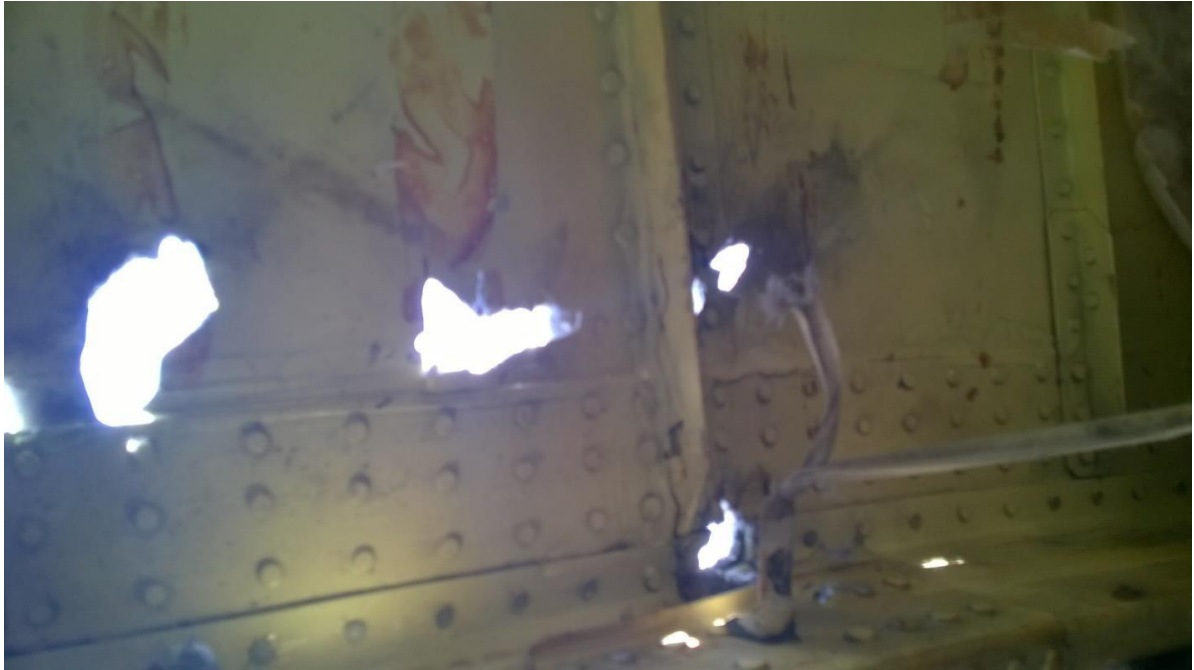
Figure 5.73 - Through-and-through holes in the cockpit roof (inside view)

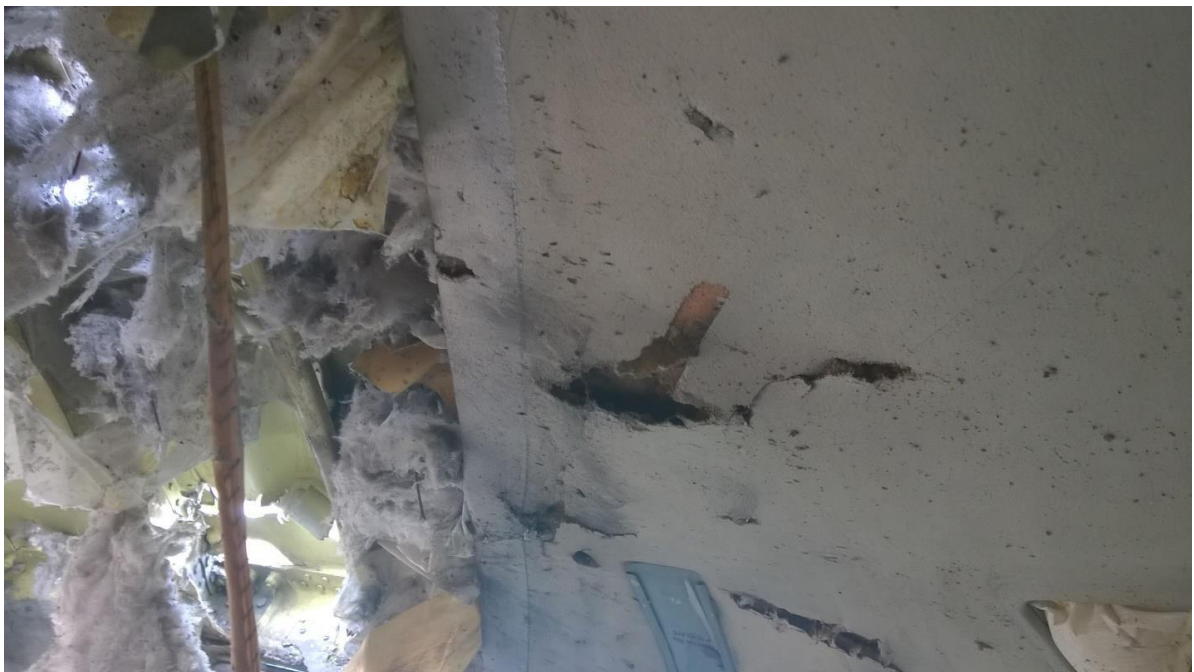
Figure 5.74 - Through-and-through holes in the outer skin and thermal and noise insulation panels on the right side of the cockpit roof (inside view)

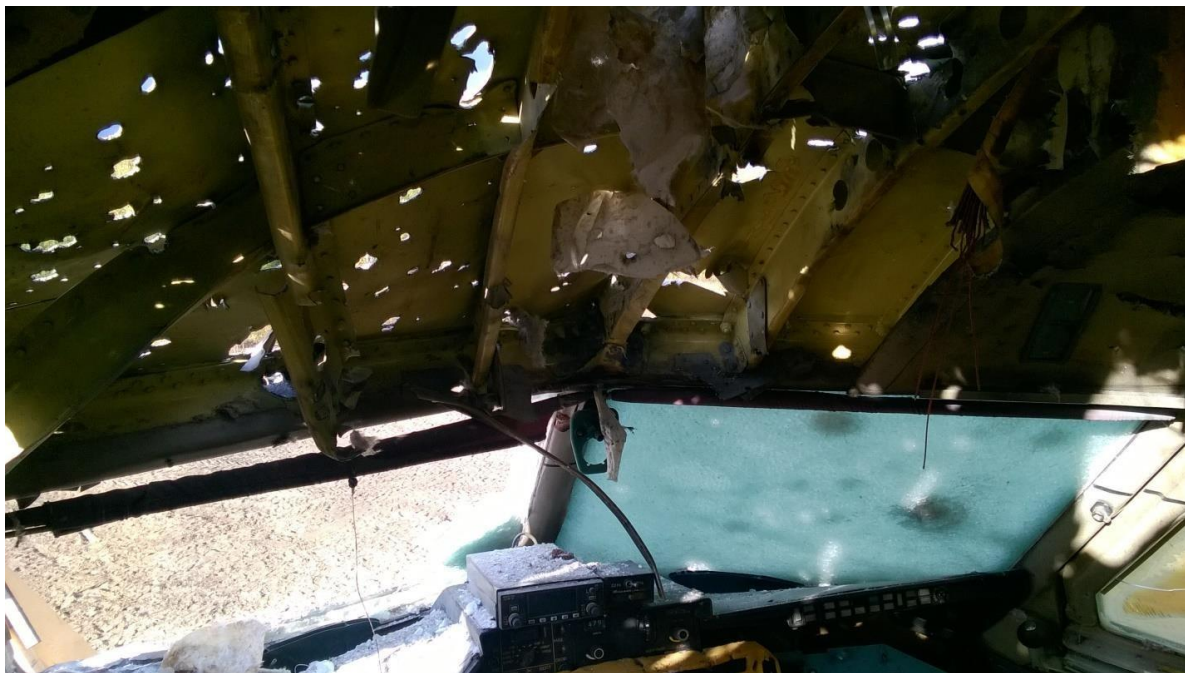
Figure 5.75 - Through-and-through holes in the central and right sections of the cockpit roof (inside view)

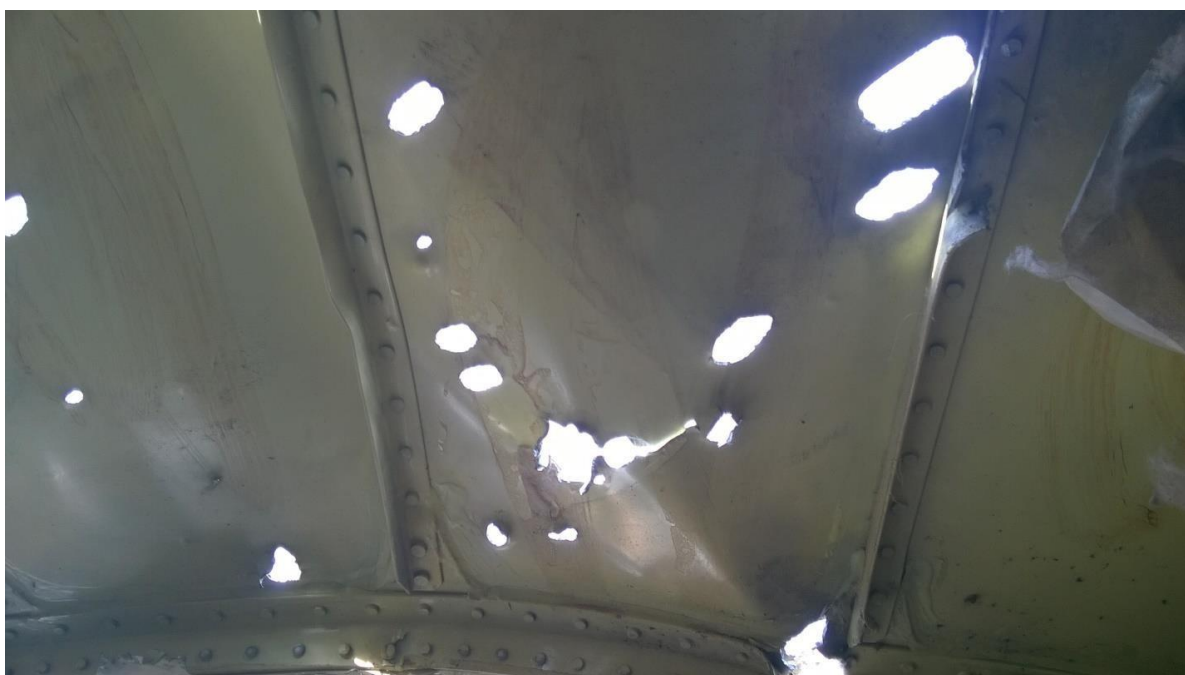
Figure 5.76 - Through-and-through holes in the central and right sections of the cockpit roof (inside view)

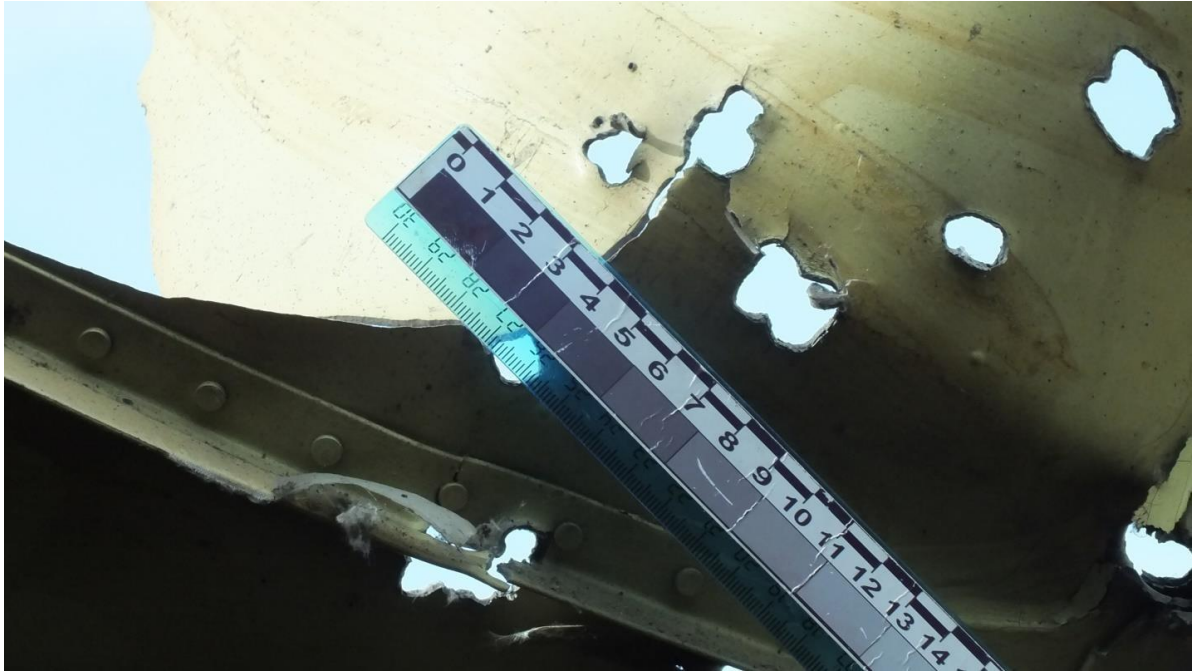
Figure 5-77 - Characteristic butterfly-shaped holes (inside view)

An analysis of the damage to the target roof showed that the number of entry holes and the total size of the fragmentation field on the target's roof¹³ are significantly greater than those on the Boeing 777 fragments.

The shape of the entry holes varies from an elongated compact shape to distinctive butterfly-shaped holes caused by ready-made projectiles and large (30 to 150 mm) shapeless holes caused by the second compartment (warhead compartment) fragments.

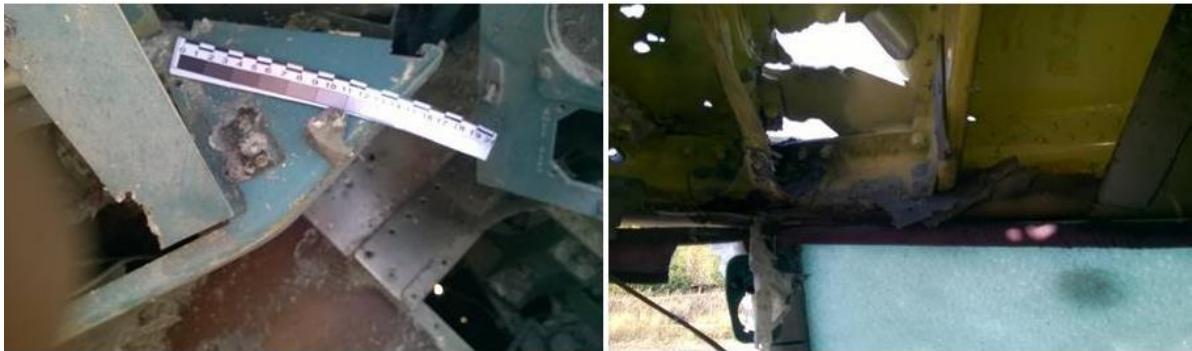
Figure 5.78 - Missile compartment hull fragments (left) and holes caused by them (right)

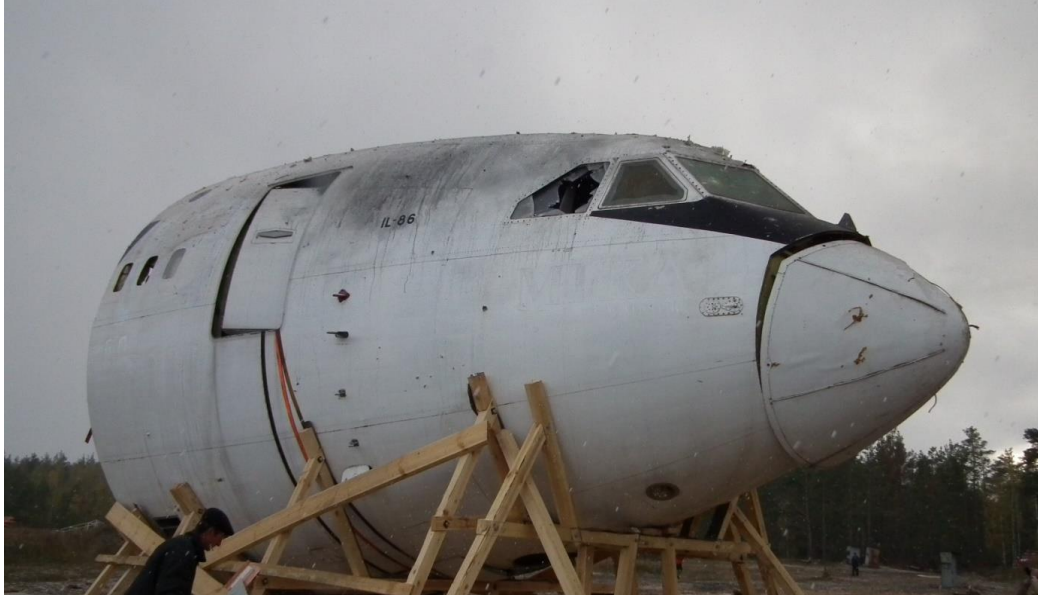
Figure 5.79 - Cockpit starboard side

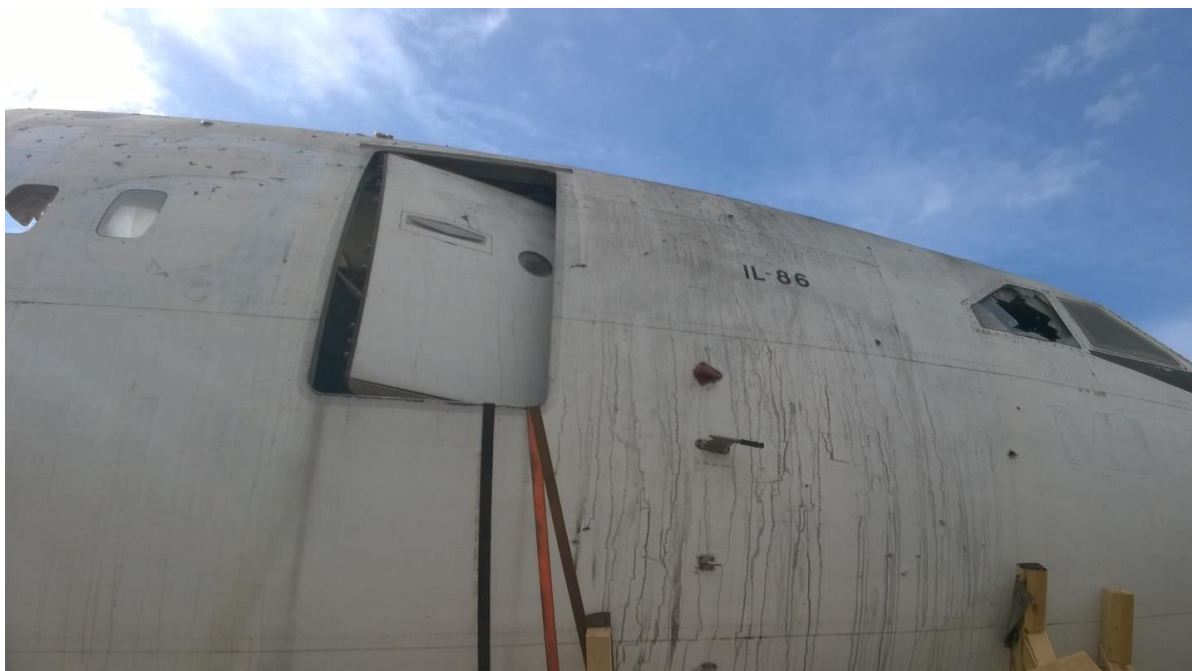
Figure 5.80 - Cockpit starboard side near door R1 (bottom view)

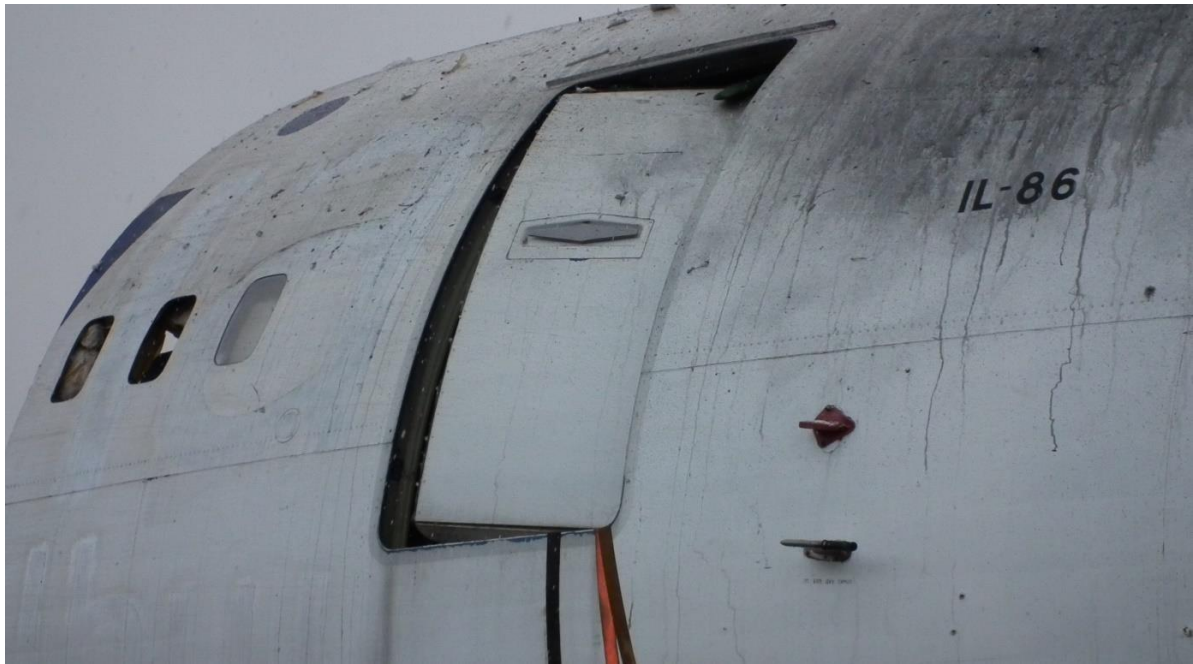
Figure 5.81 - Cockpit starboard side near door R1. Thermal burn marks can be seen in the upper right corner of the photograph

Part of the external surface of the starboard (near the roof) shows signs of exposure to explosion products in the form of thermal oxidation (burns), which differs significantly from the condition of the fragments of Boeing 777's starboard side.

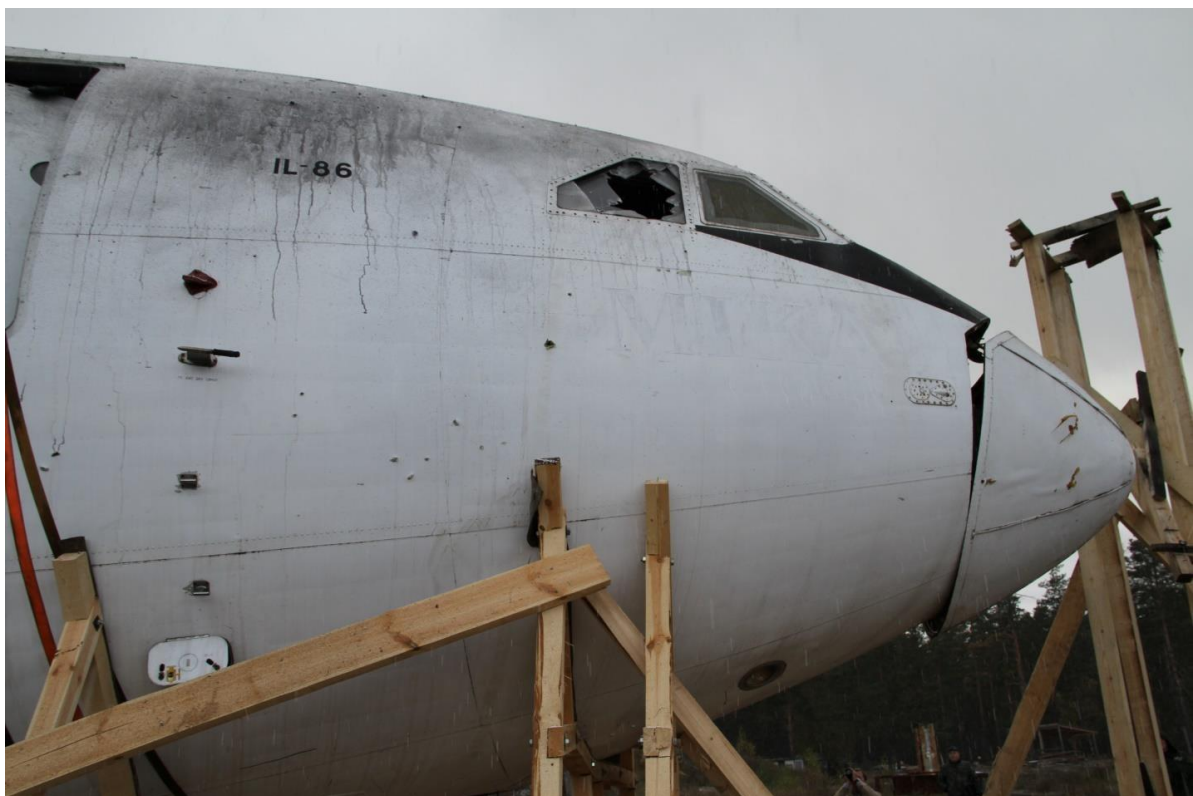
Figure 5.82 - Cockpit starboard side

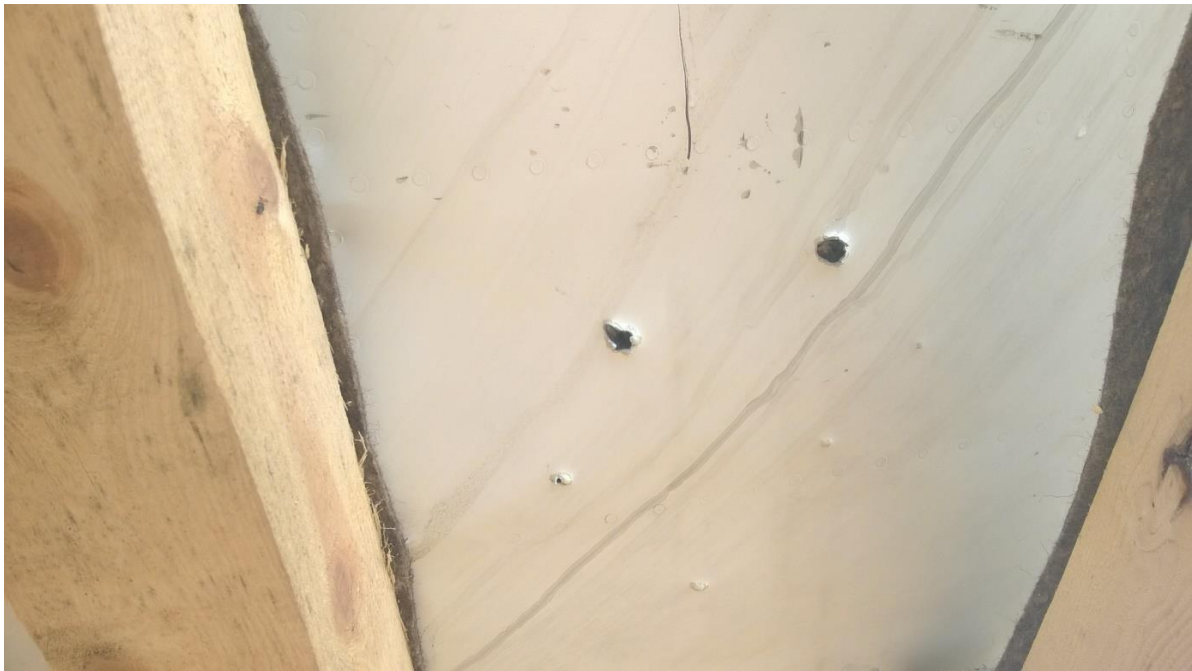
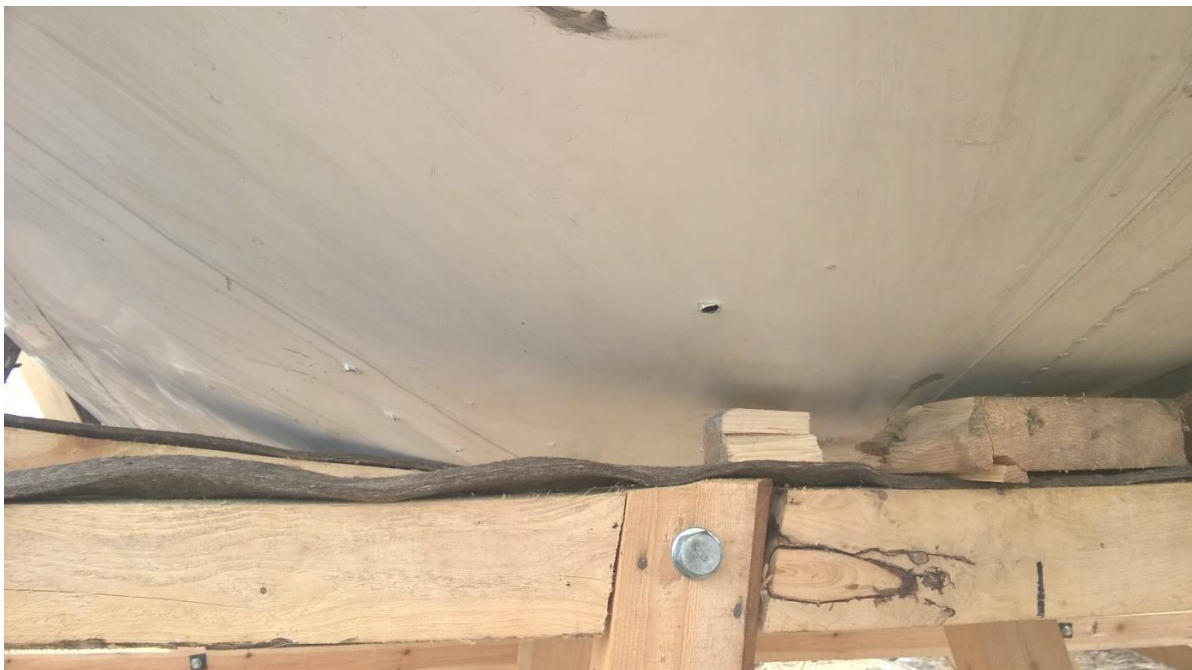
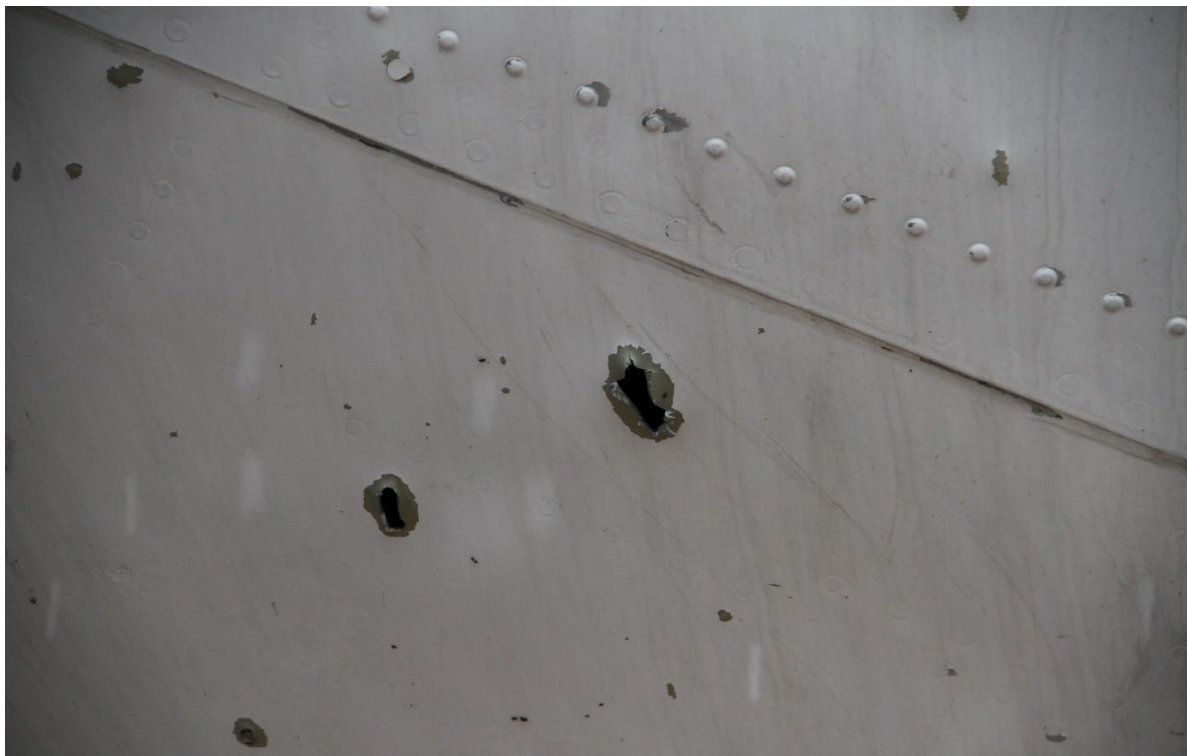
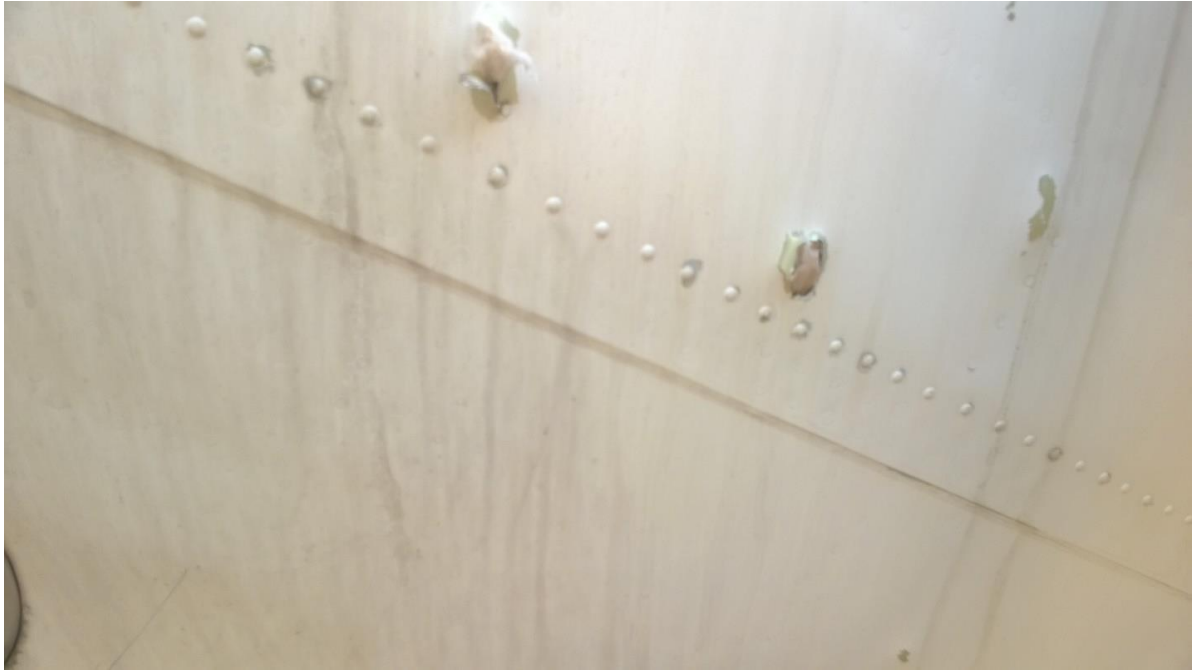
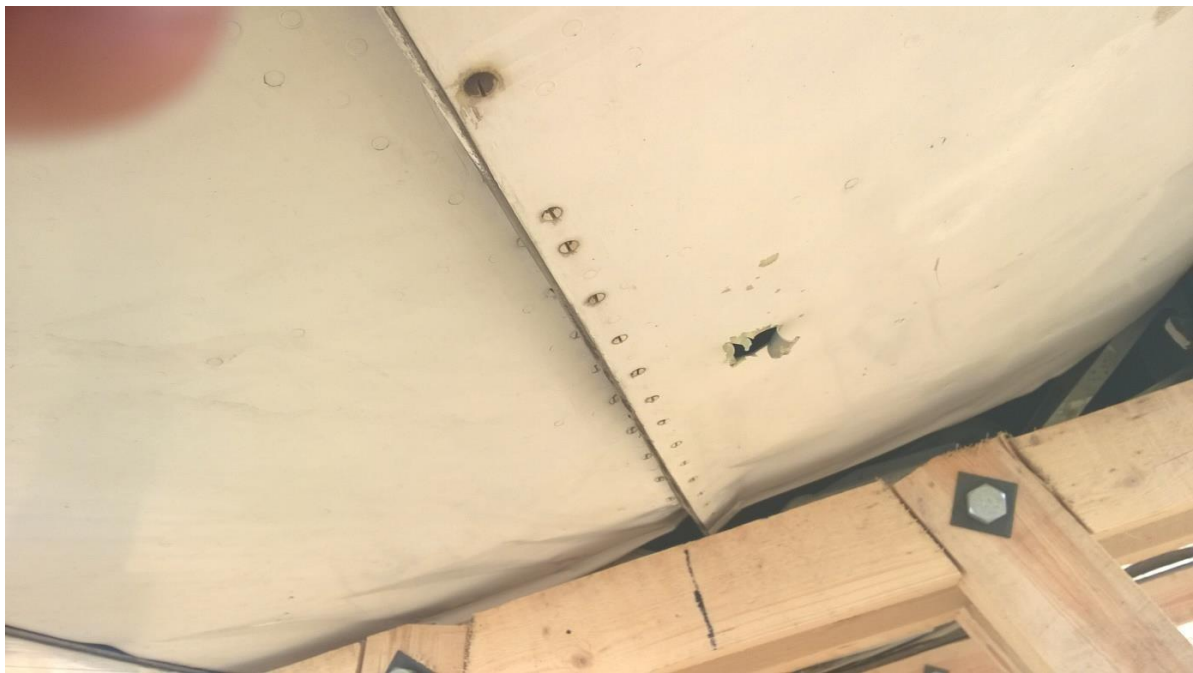
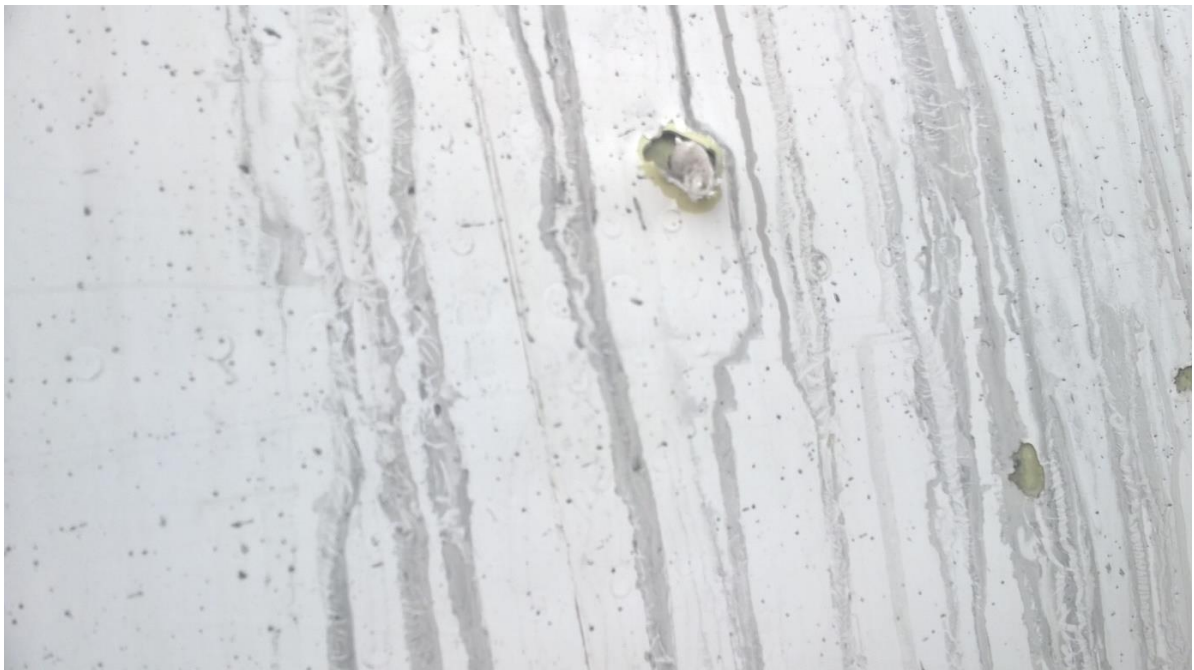
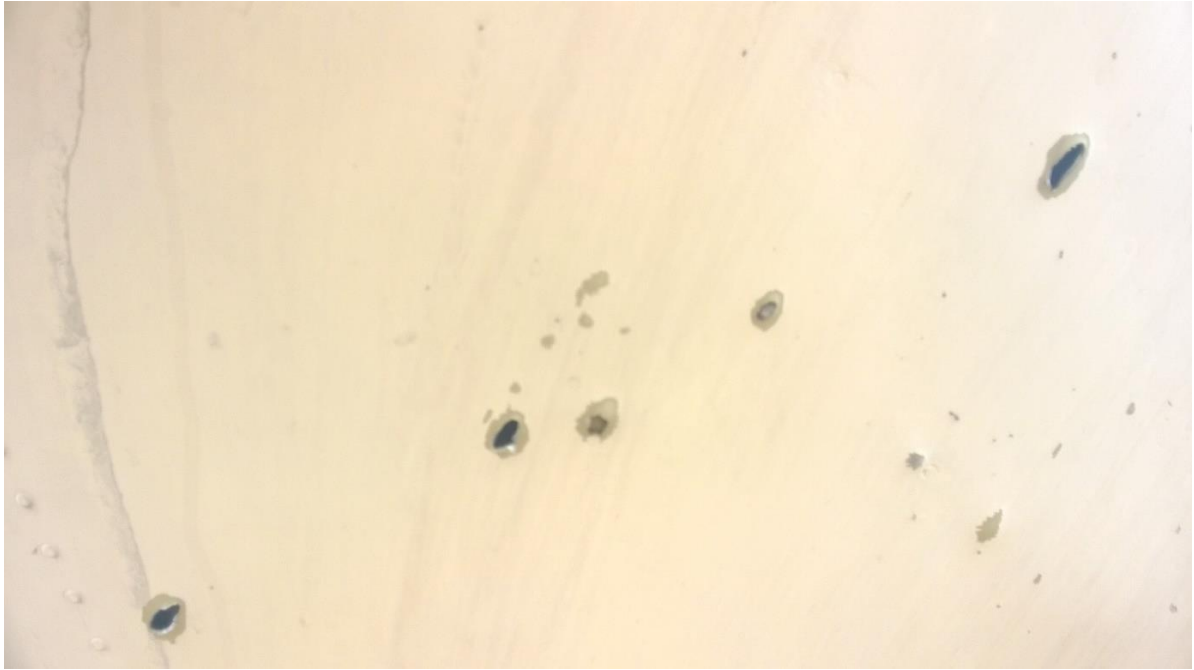
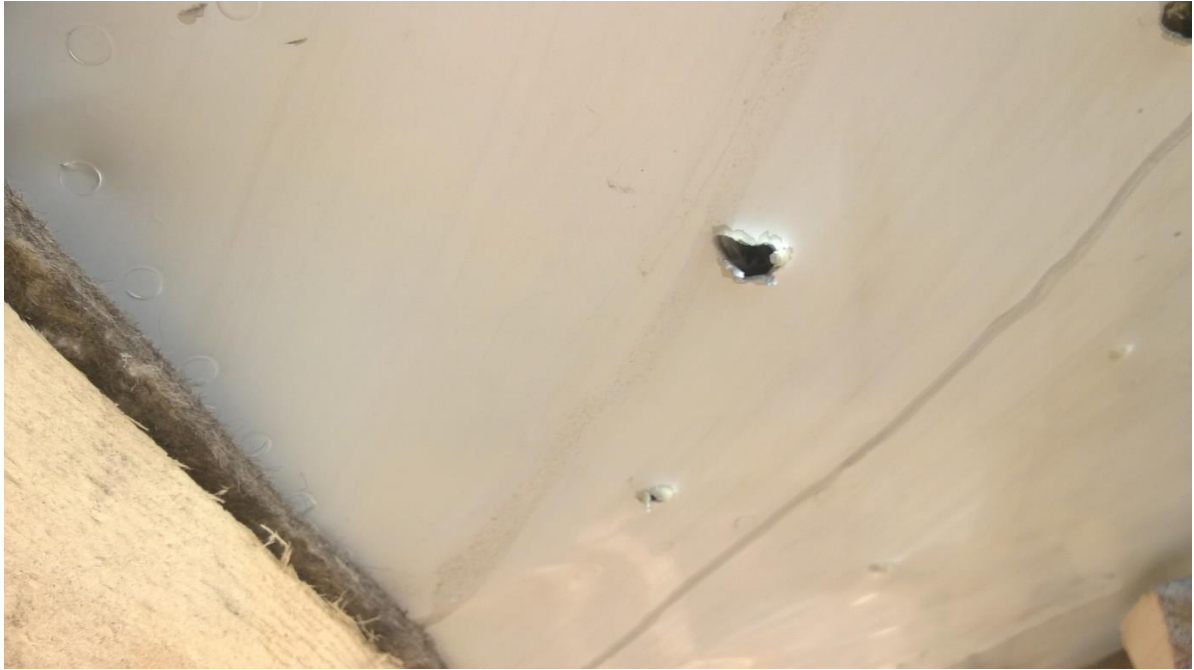
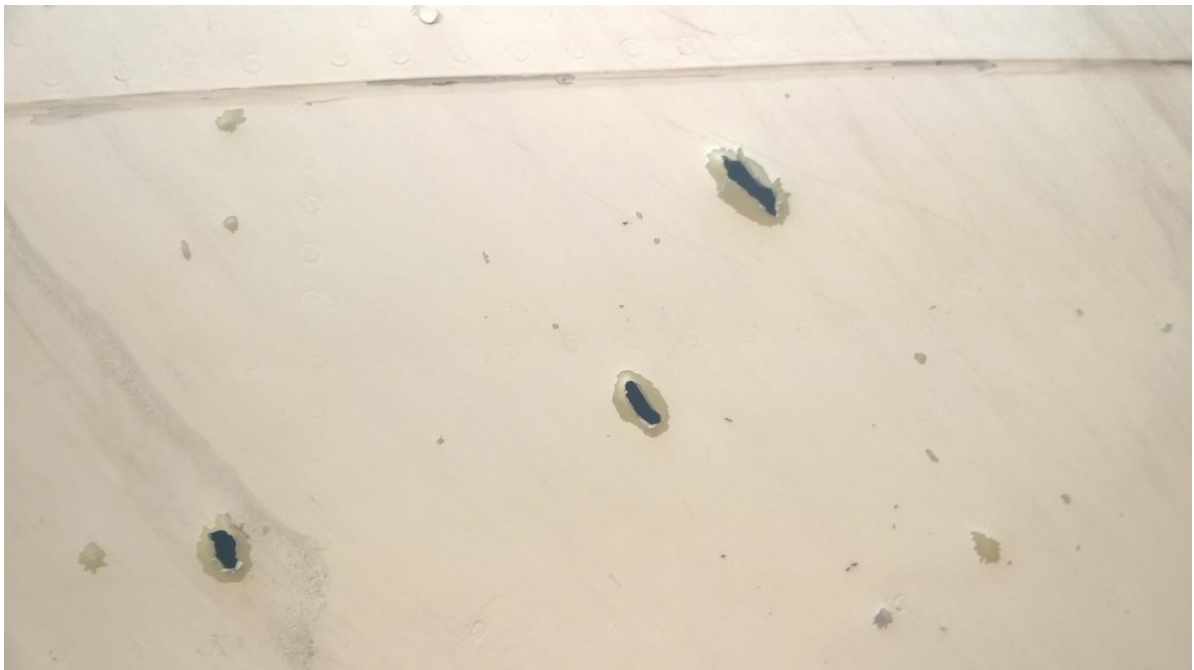
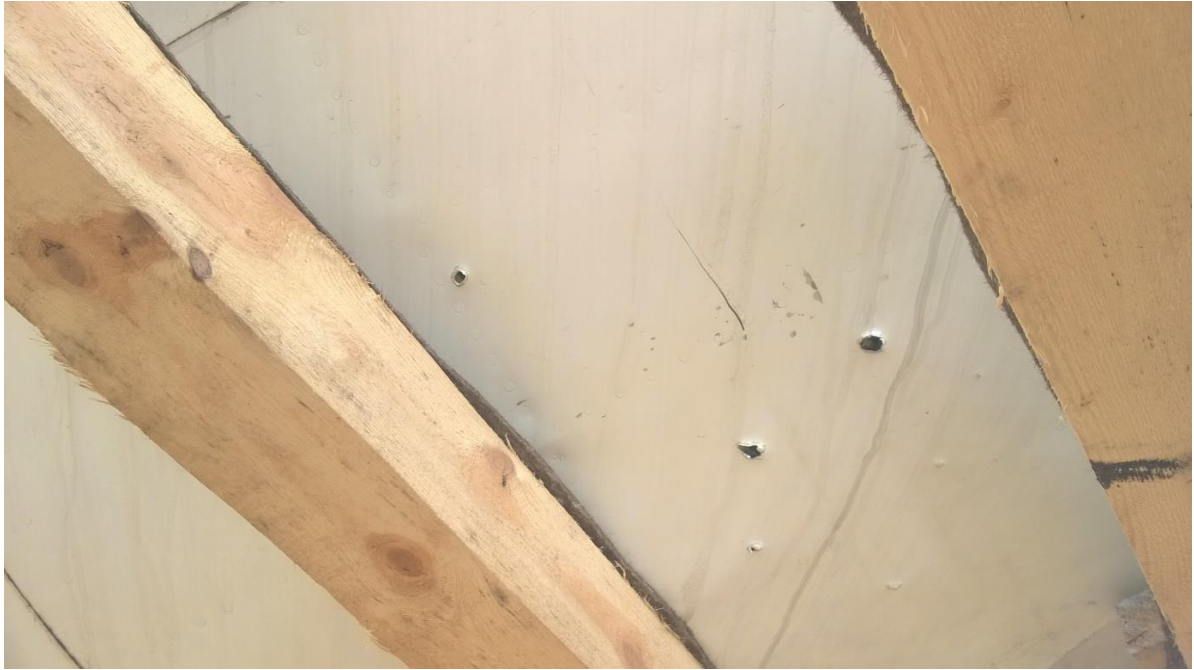
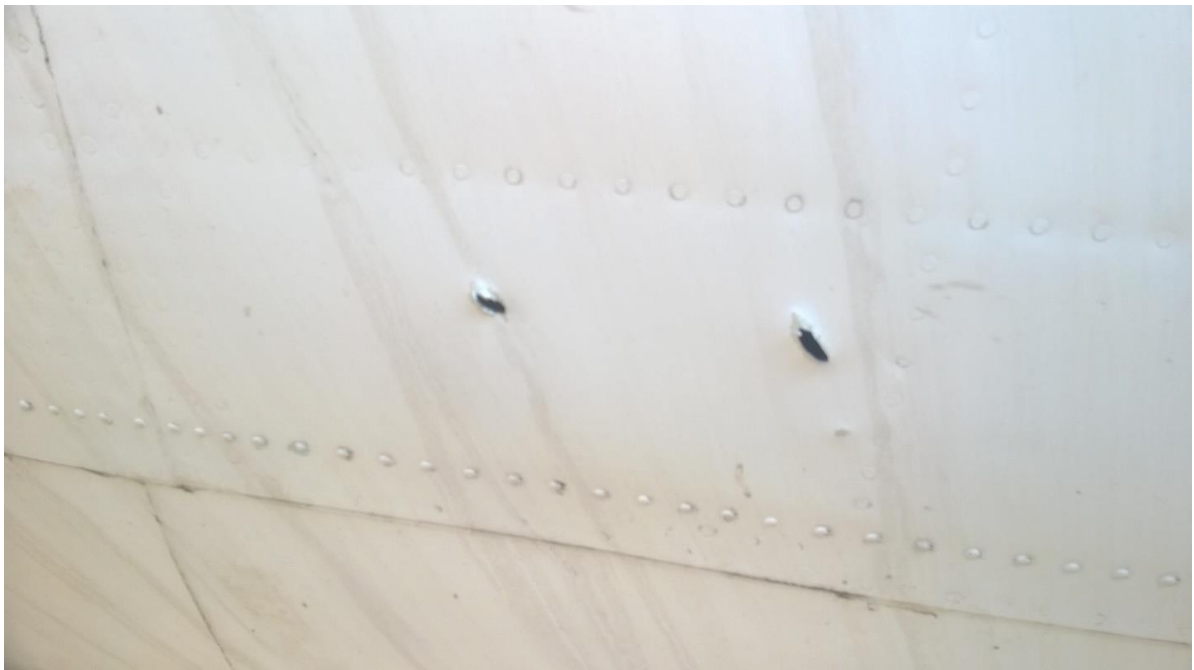
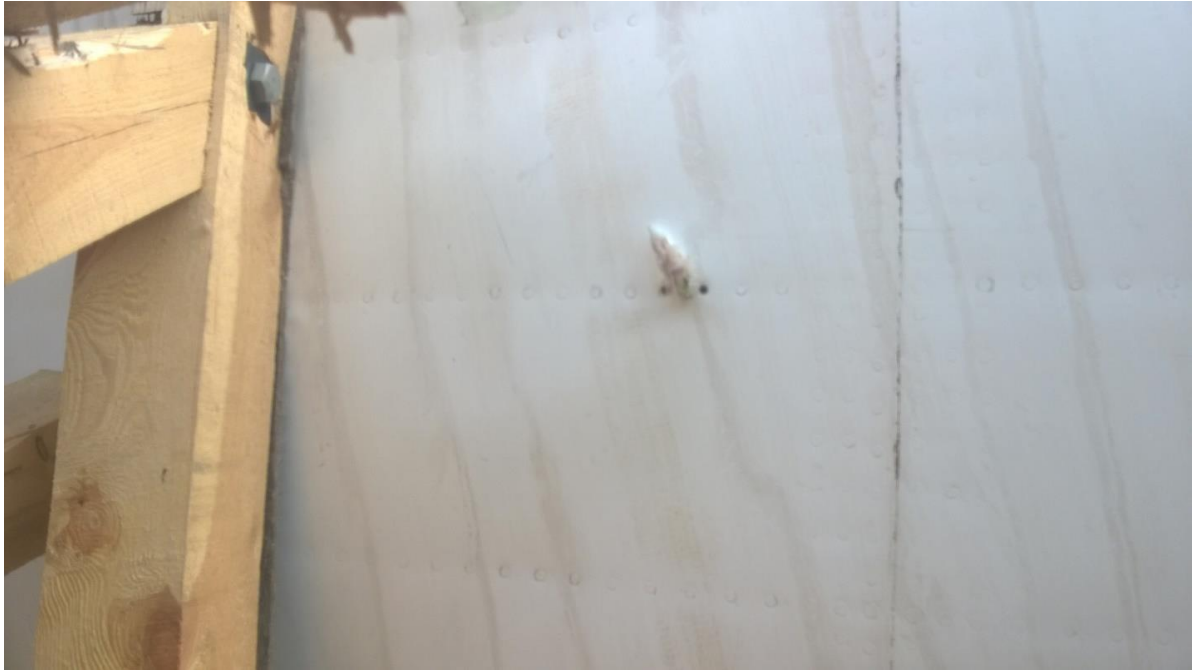
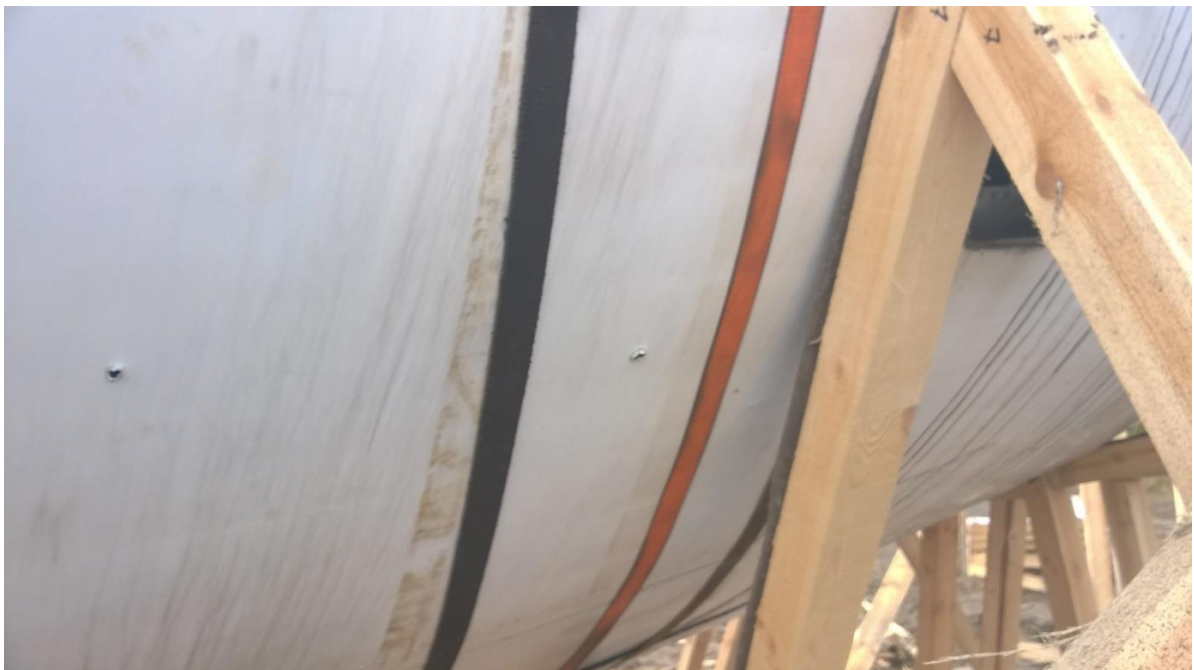
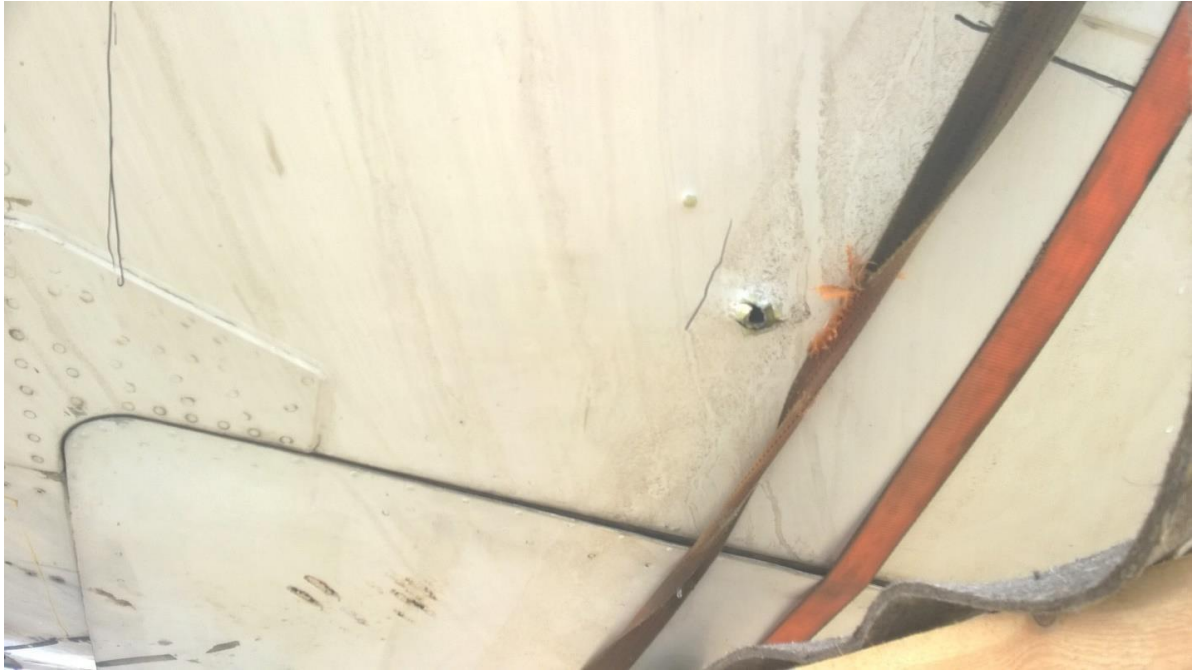
Figure 5.83 - Exit holes and non-penetrating damage

more than 30 exit holes caused by preformed fragments of 9H314M warhead are observed on the starboard surface, the lower part of the roof and the bottom in the cockpit area (including the front right passenger door R1).

Thus, the presence of fragmentation damage (exit holes) and marks of explosion products on the starboard side of the target creates a significant difference from the characteristics of damage to Boeing 777 fragments.
