**APPLICATION OF THE INTERNATIONAL CONVENTION FOR THE SUPPRESSION
OF THE FINANCING OF TERRORISM AND OF THE INTERNATIONAL
CONVENTION ON THE ELIMINATION OF ALL FORMS OF RACIAL
DISCRIMINATION**

REJOINDER

Report of JSC Air and Space Defense Corporation "Almaz-Antey" on the results of studies related to the technical investigation into the crash of the Malaysian airlines Boeing 777-200 9M-MRD (flight MH17), 2023

on the results of studies related to the technical investigation into the crash
of the Malaysian airlines Boeing 777-200 9M-MRD (flight MH17)

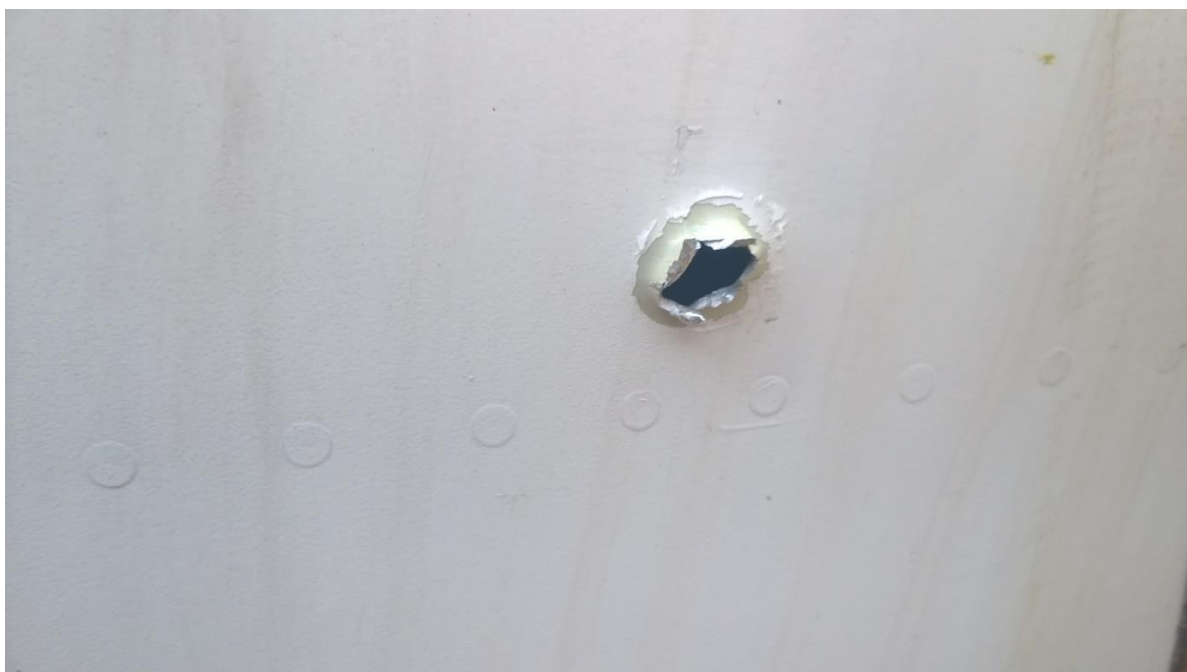
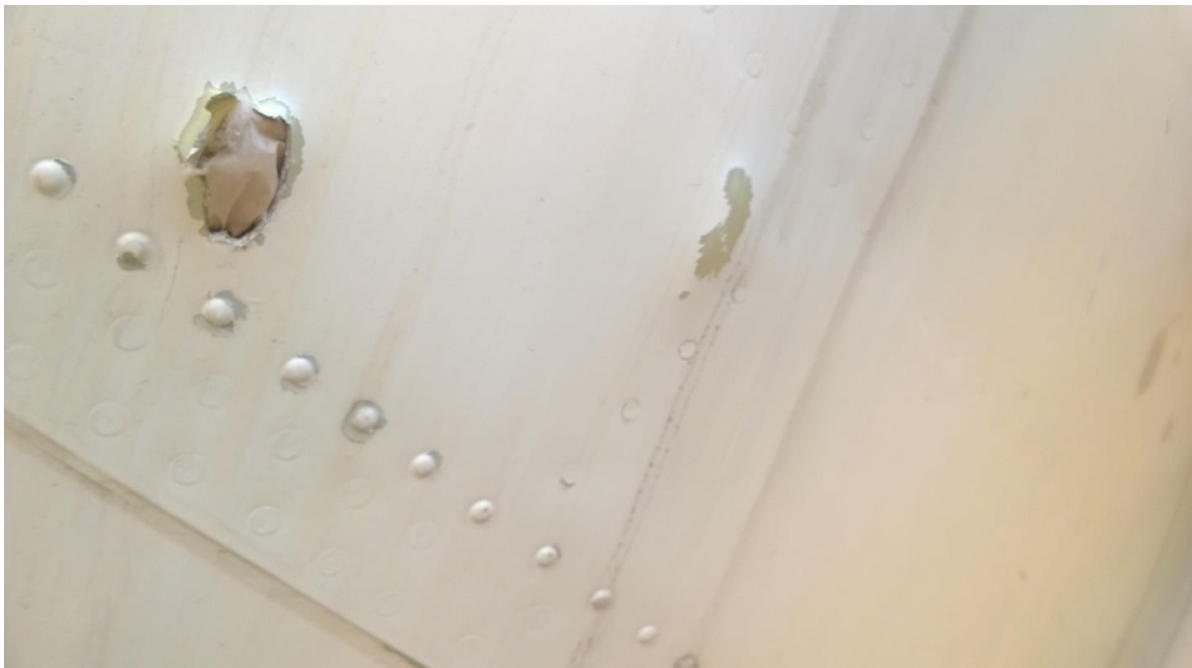
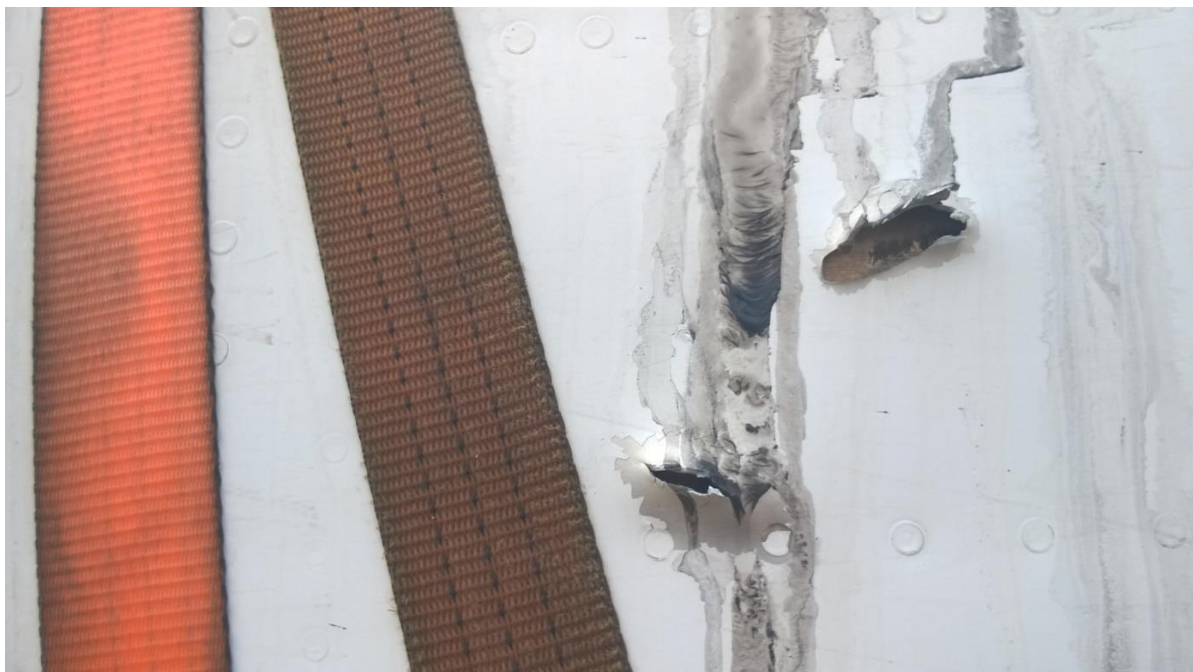
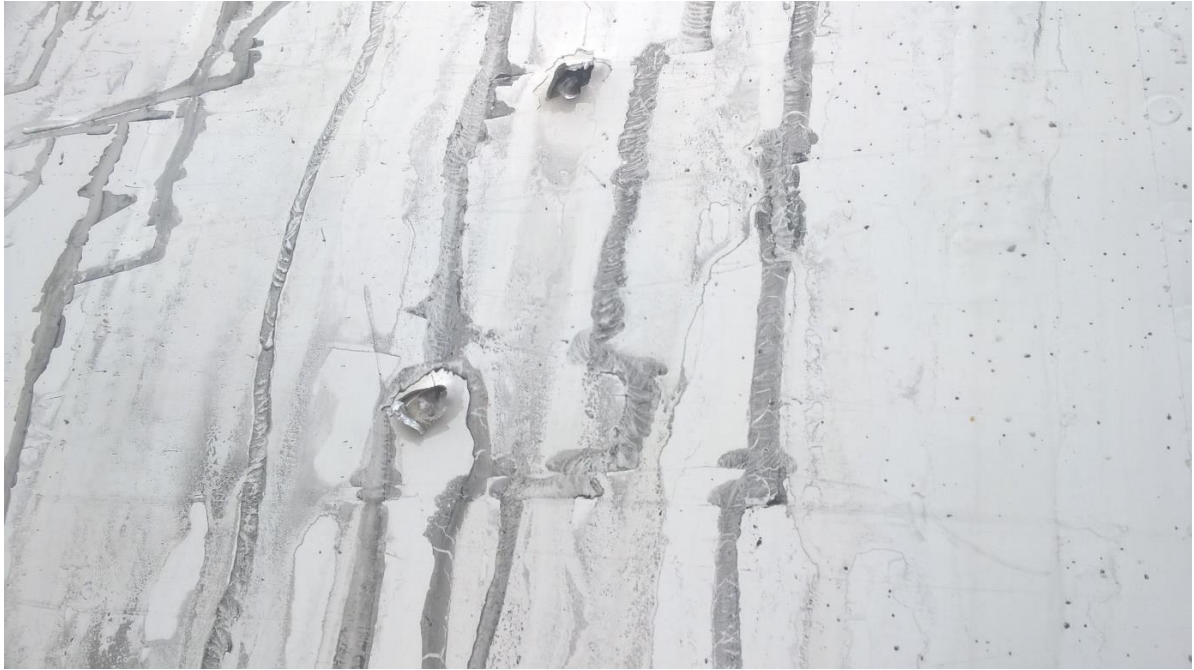
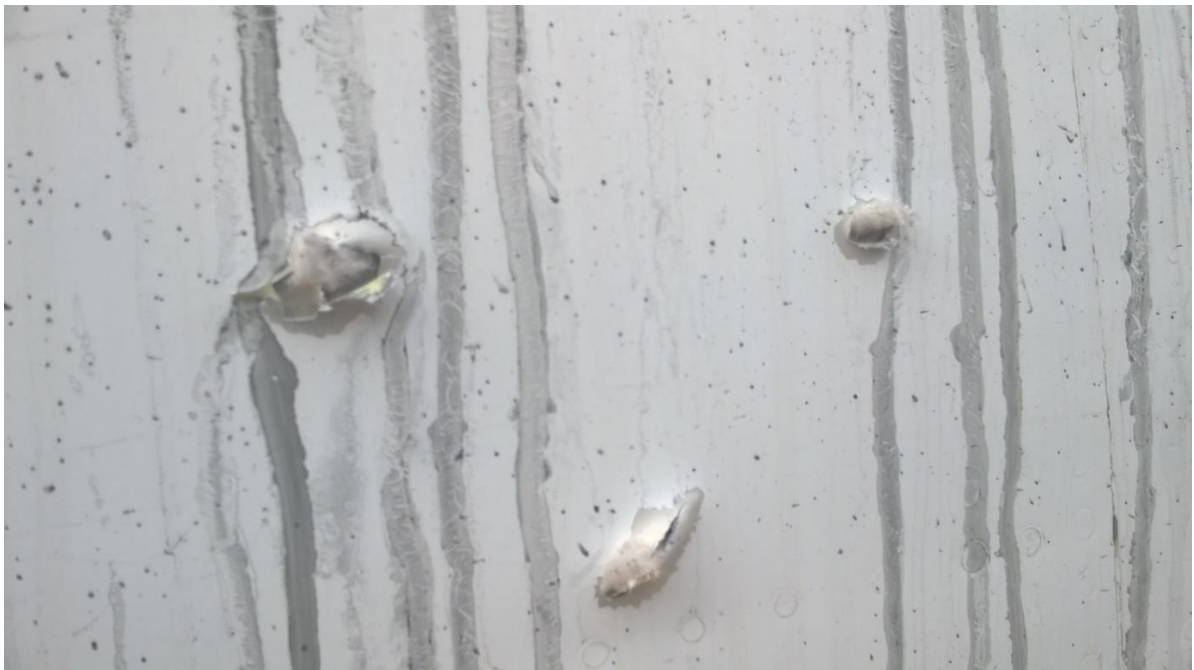
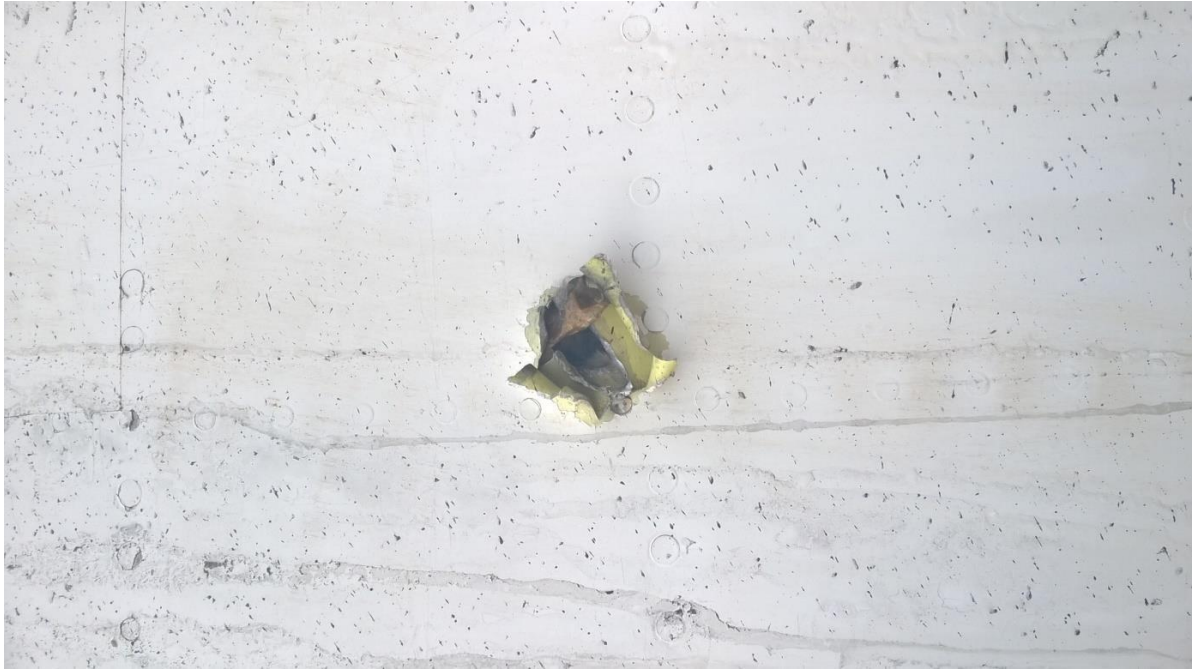
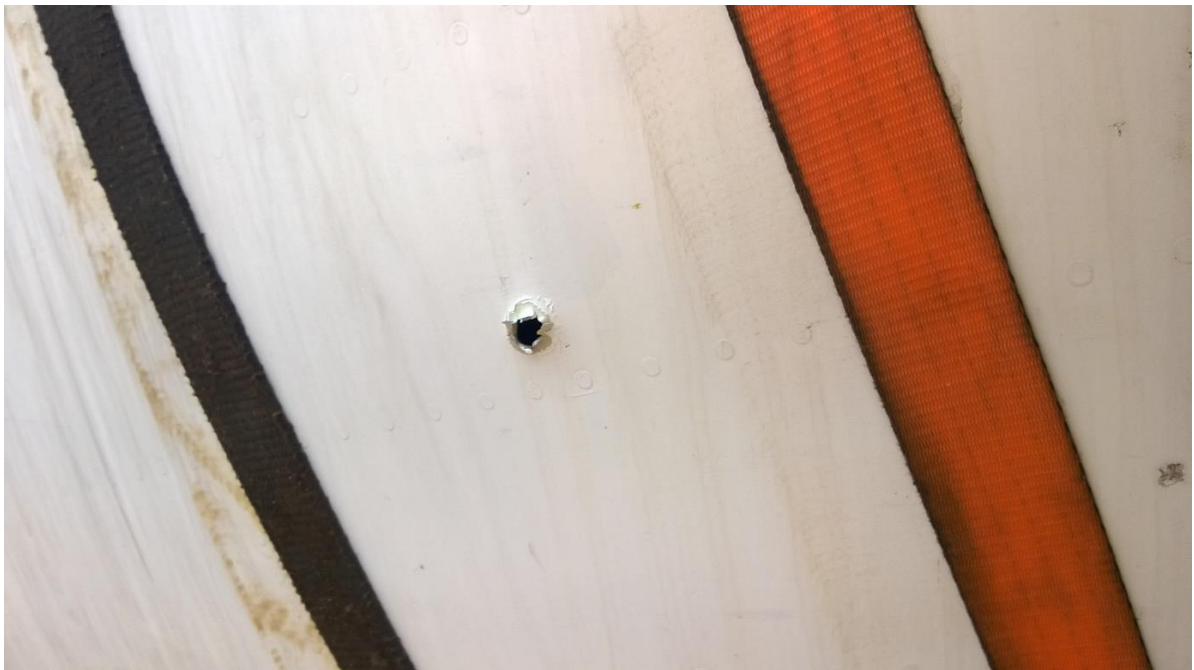
Figure 5.86 - Exit hole

Figure 5.88 - Exit hole (left) and non-penetrating damage (right) close-up

Figure 5.90 - Exit holes

more than 30 exit holes caused by preformed fragments of 9H314M warhead are observed on the starboard surface, the lower part of the roof and the bottom in the cockpit area (including the front right passenger door R1).

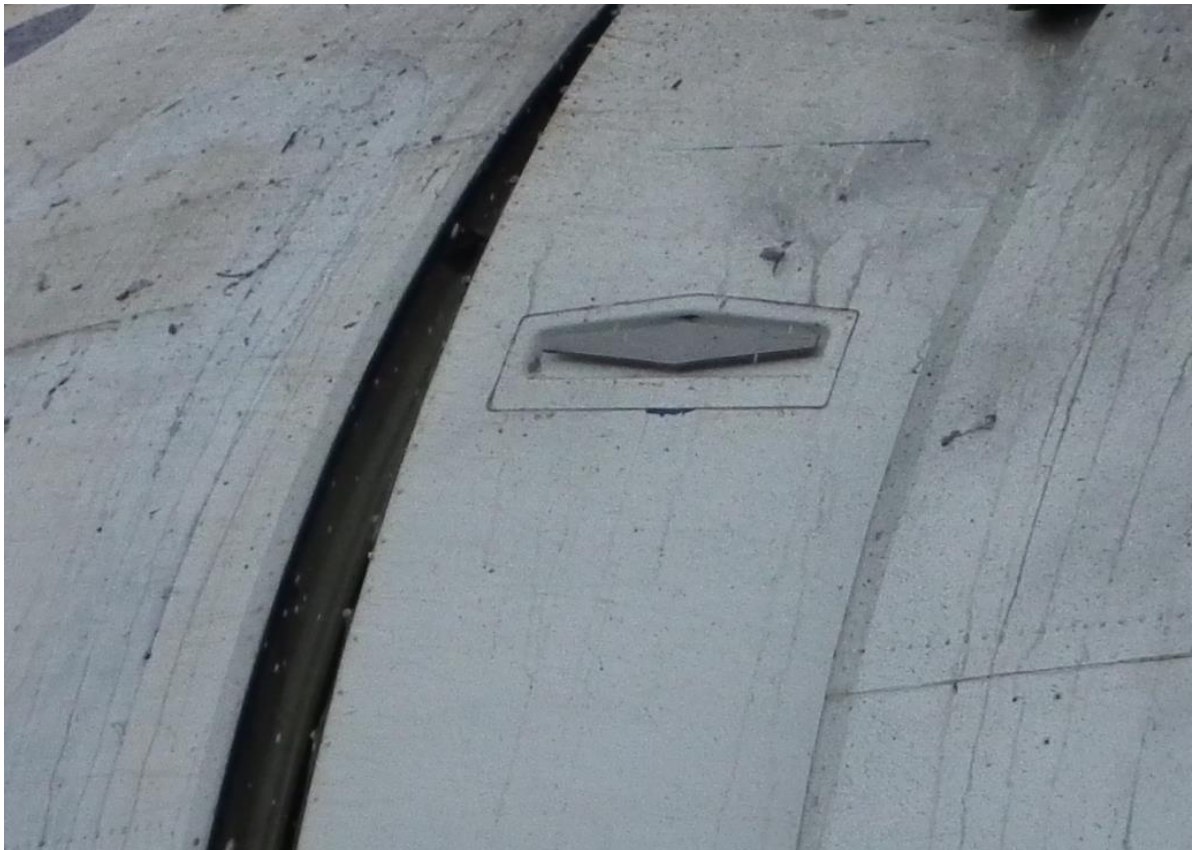
Figure 5.104 - Exit holes in R1 door area

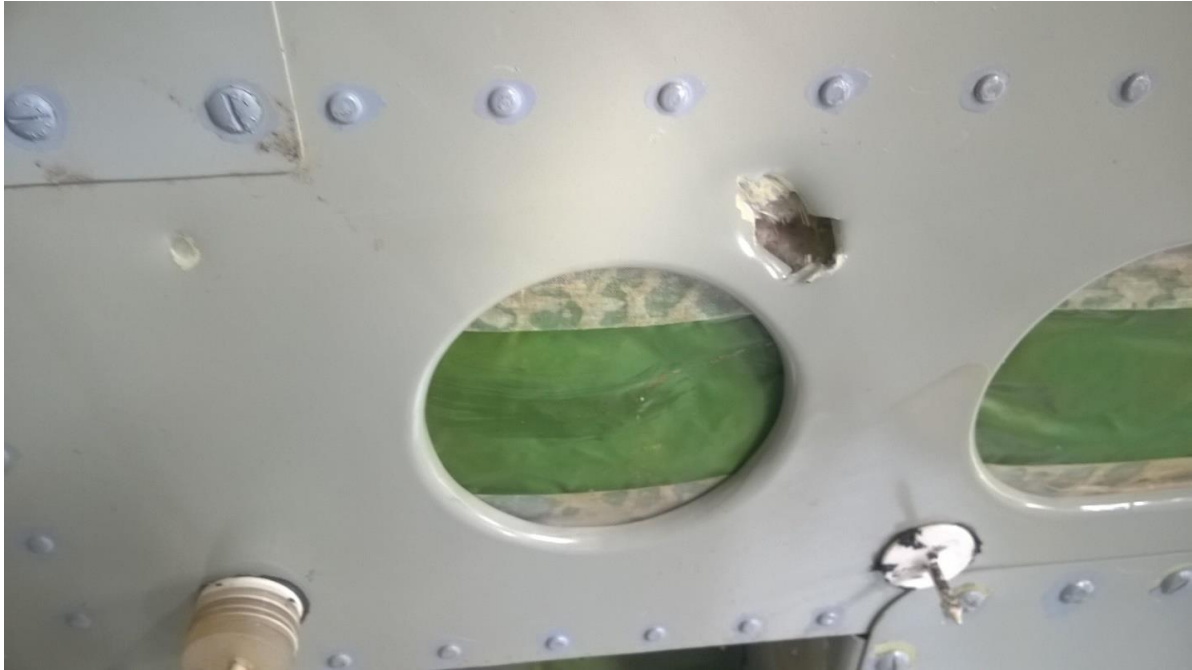
Figure 5.105 - Through-and-through hole in door R1 (inside view)

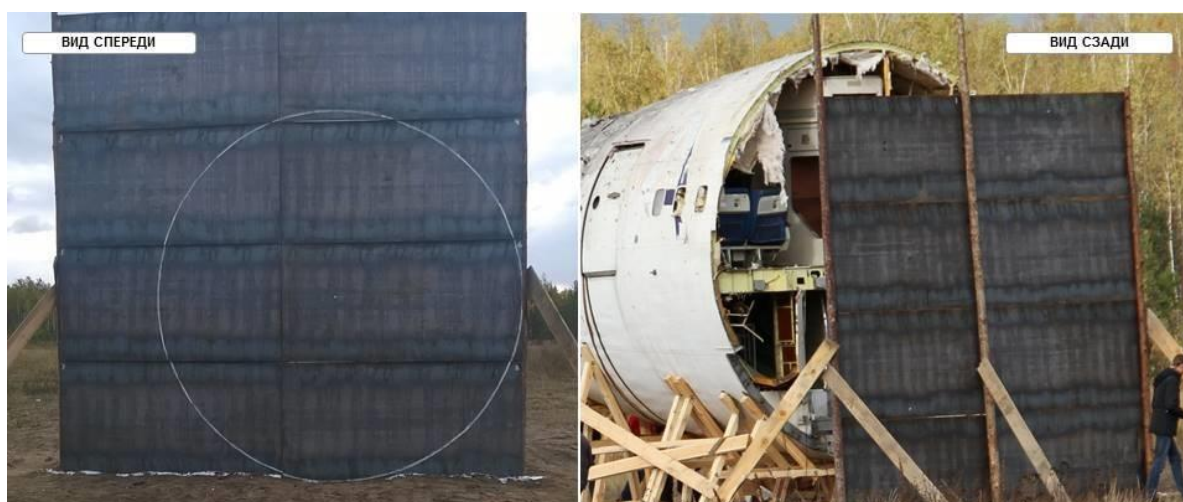
Figure 5.106 - Target No. 2 (left engine) after testing

The left engine simulator suffered no damage by preformed fragments.

Thus, when 9H314M warhead, which has been oriented under the conditions specified in the DSB Report materials, is detonated no damage is done to the left engine by preformed fragments.

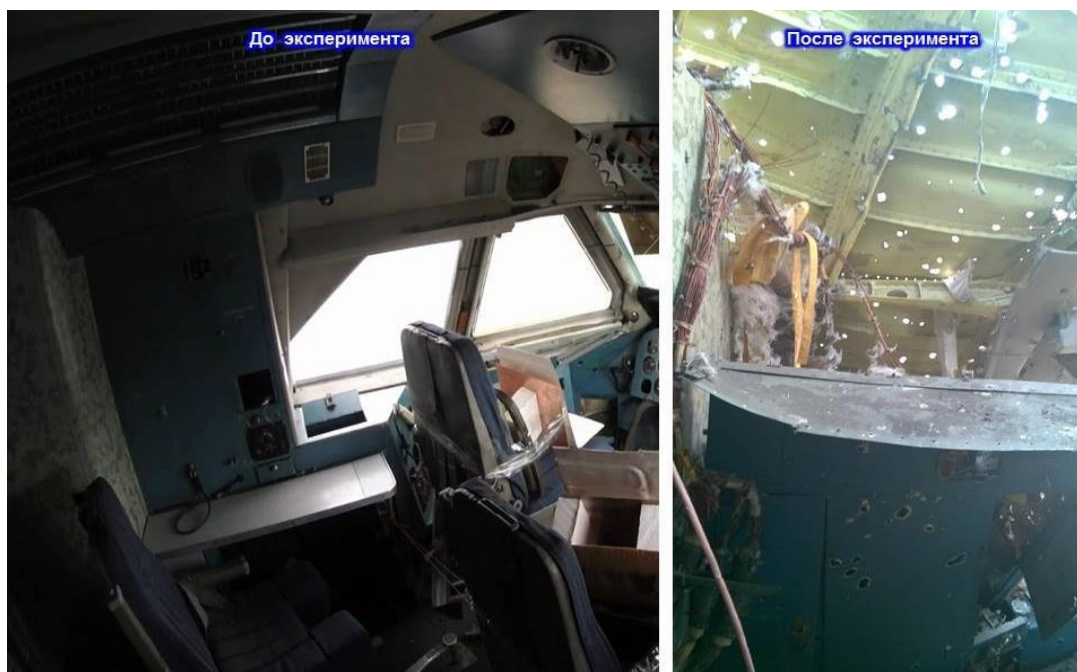
Figure 5.107 - Appearance of the cockpit's interior on the port side of the target aircraft: before the tests (left) and after detonation of the 9H314M warhead (right)

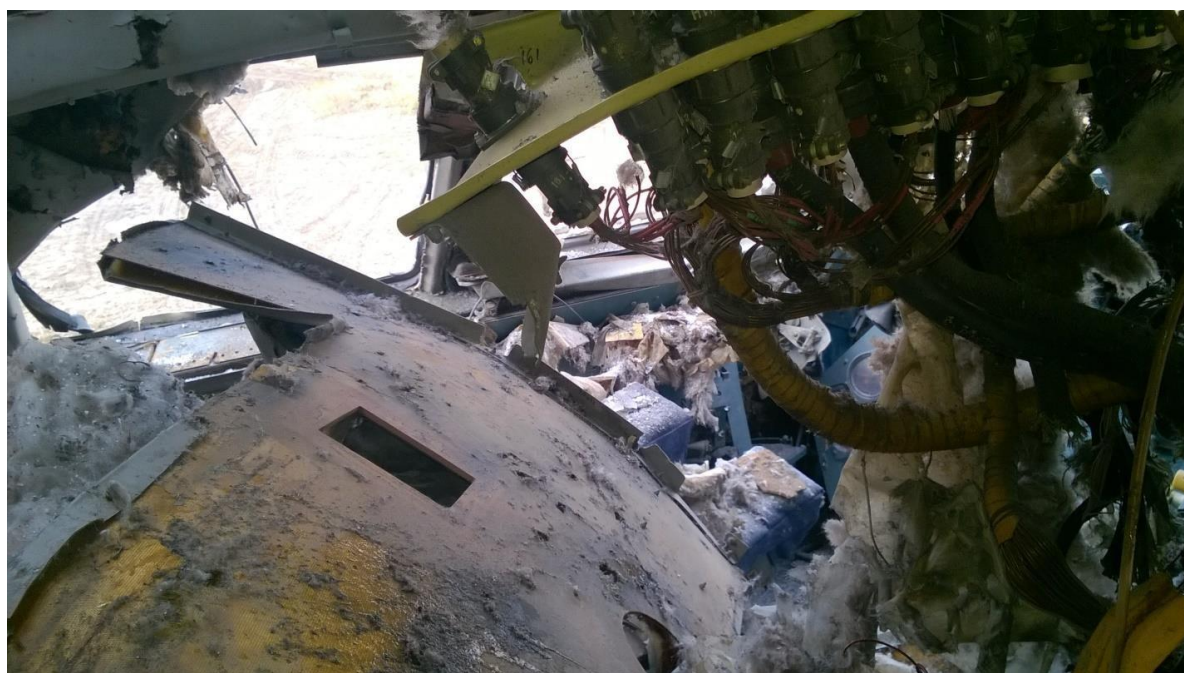
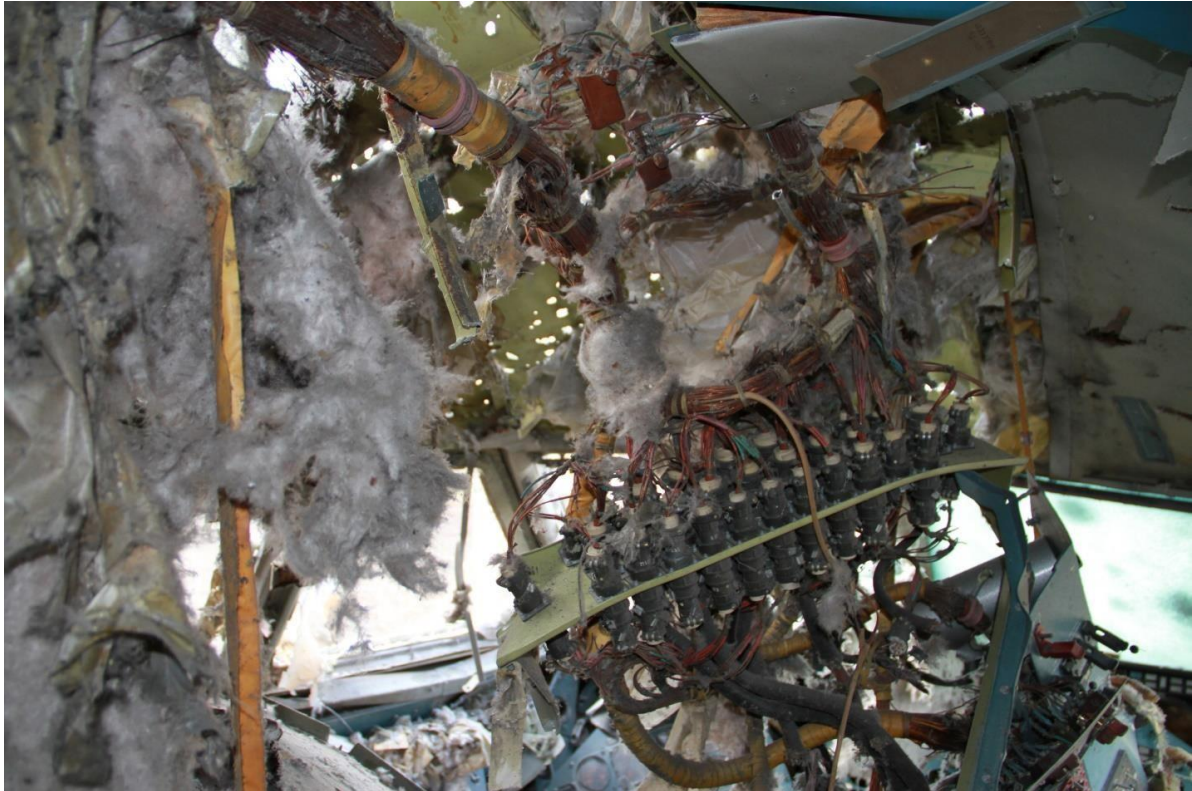
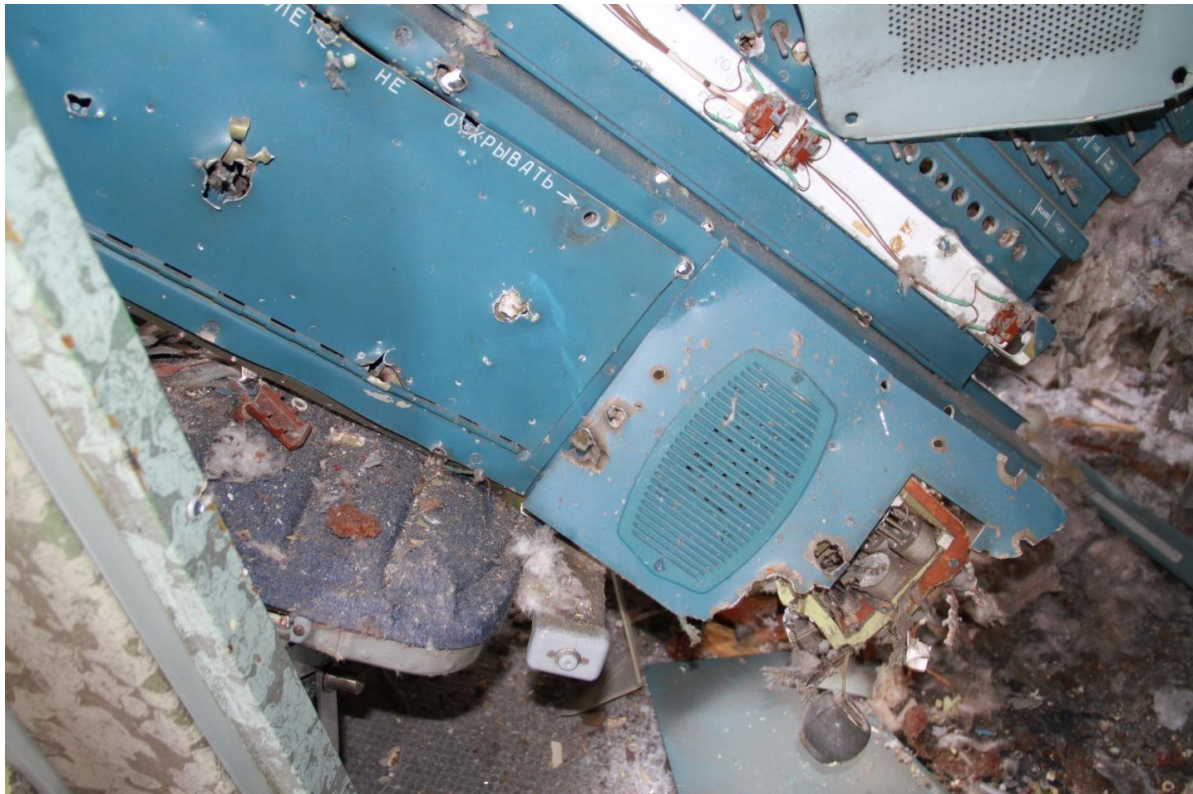
Figure 5.108 - Cockpit after the tests (inside view)

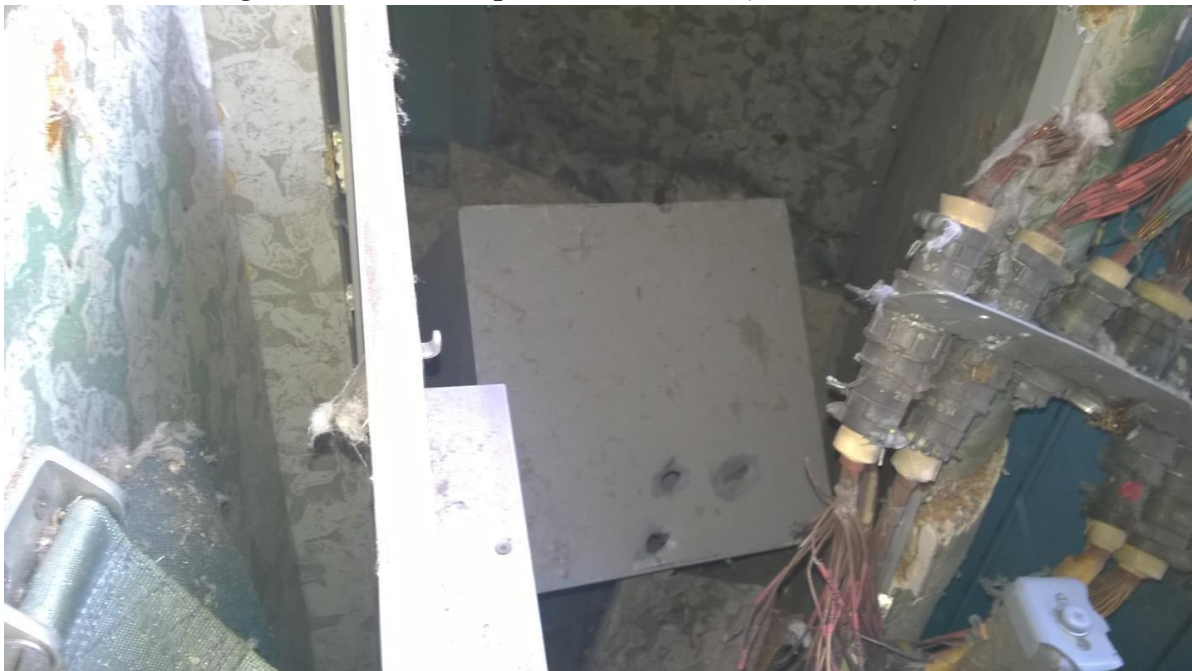
Figure 5.110 - Through-and-through holes in the aircraft commander's safe
(on the port side of the cockpit)

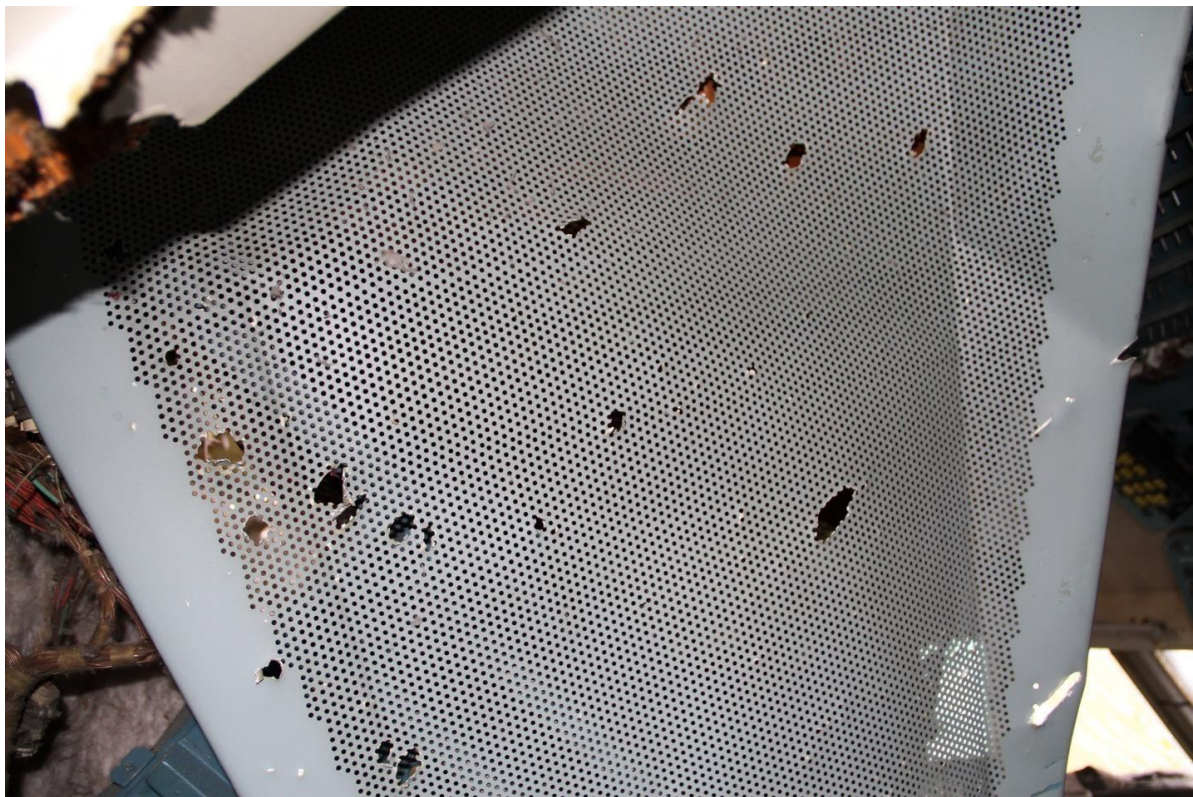
Figure 5.112 - Decorative panel of the cockpit roof

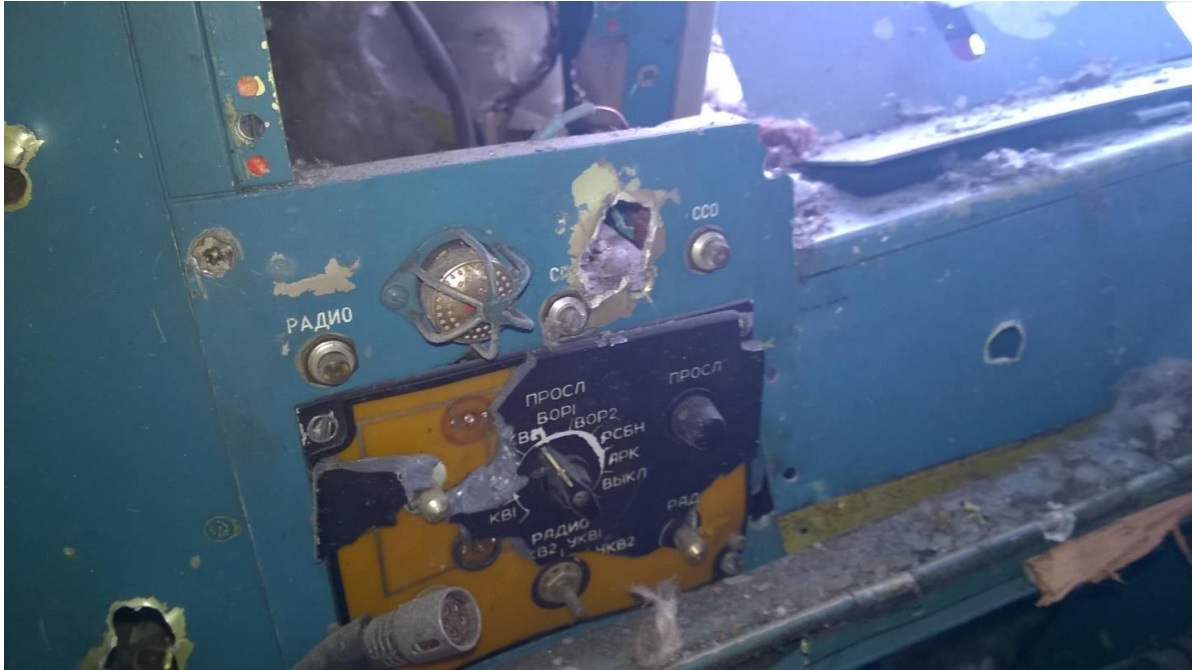
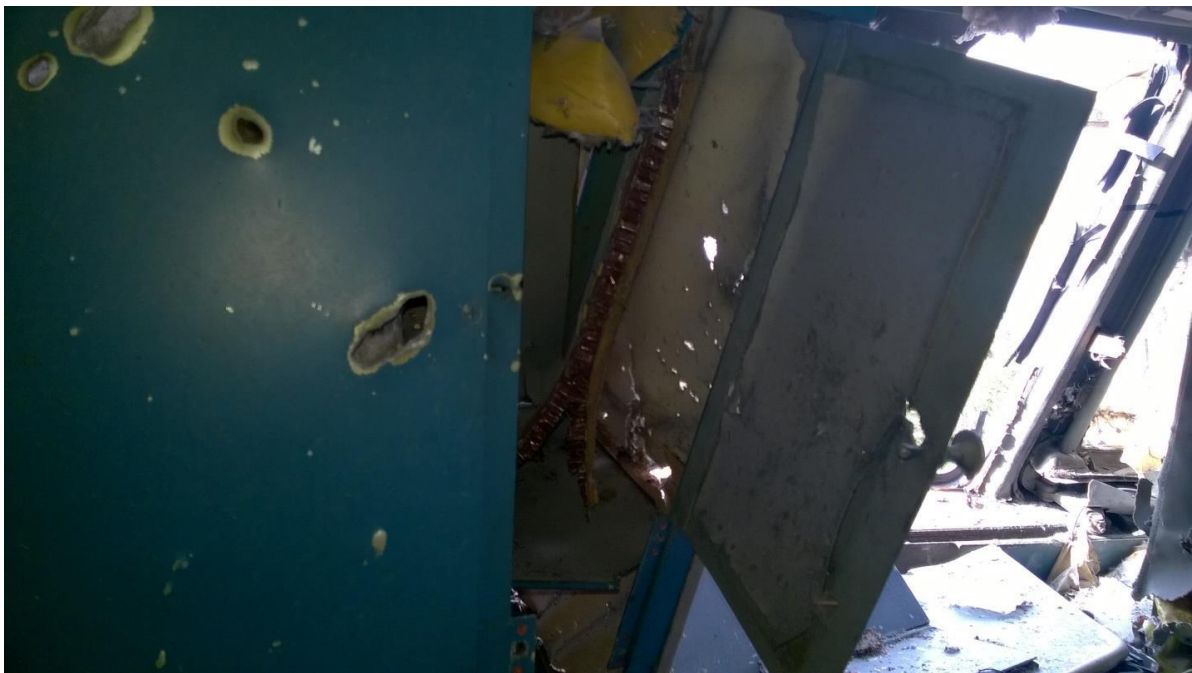
Figure 5.113 – Exit holes in the instrumentation cabinet on the port side (view from inside the cockpit)

Figure 5.114 - Exit holes in the instrumentation cabinet on the port side (view from the cockpit)

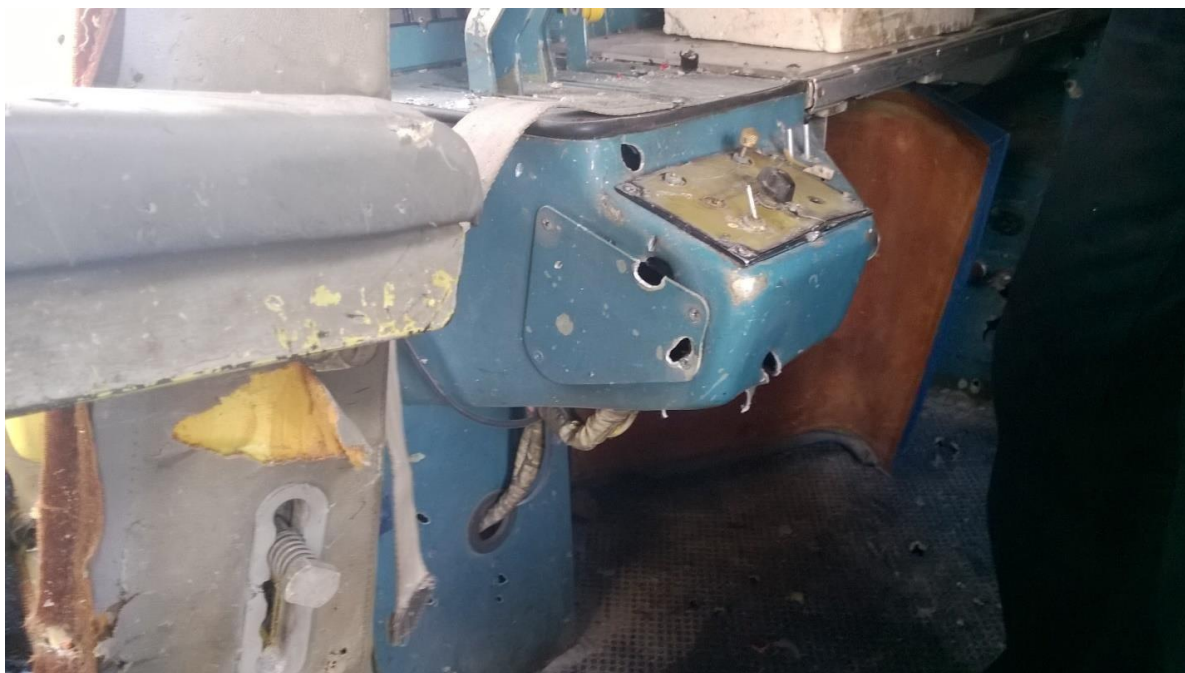
Figure 5.115 - Damage to the flight engineer's control panel (starboard side of the cockpit)

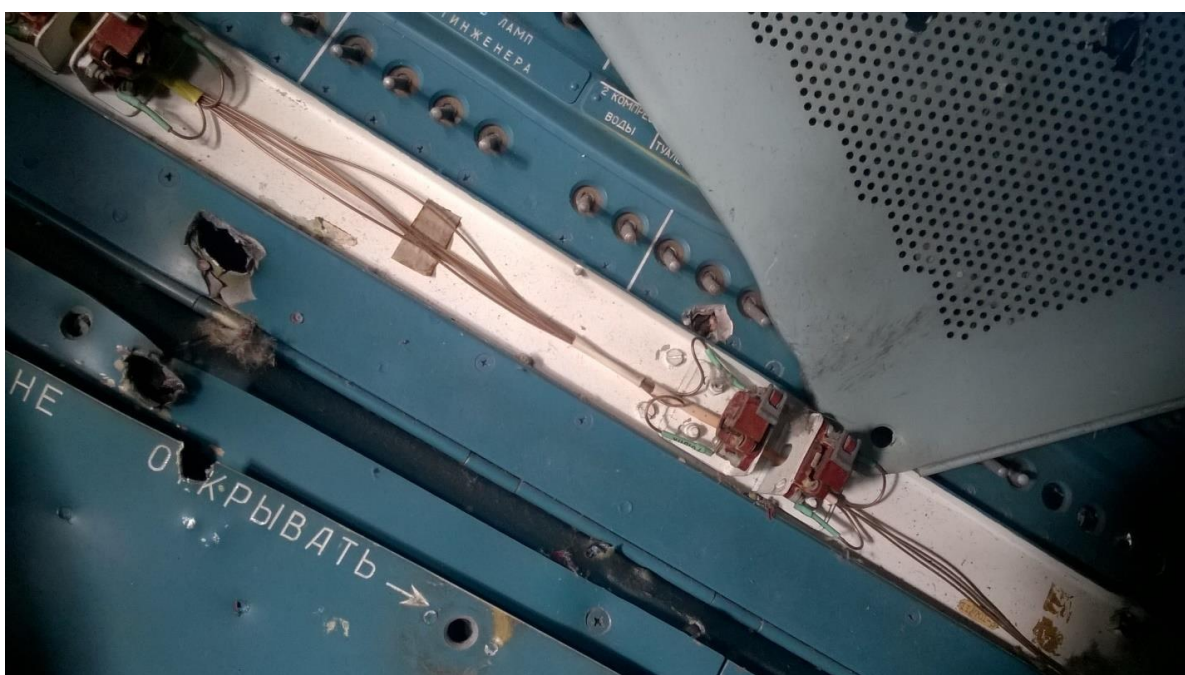
Figure 5.116 - Through-and-through holes in the control panel (cockpit roof)

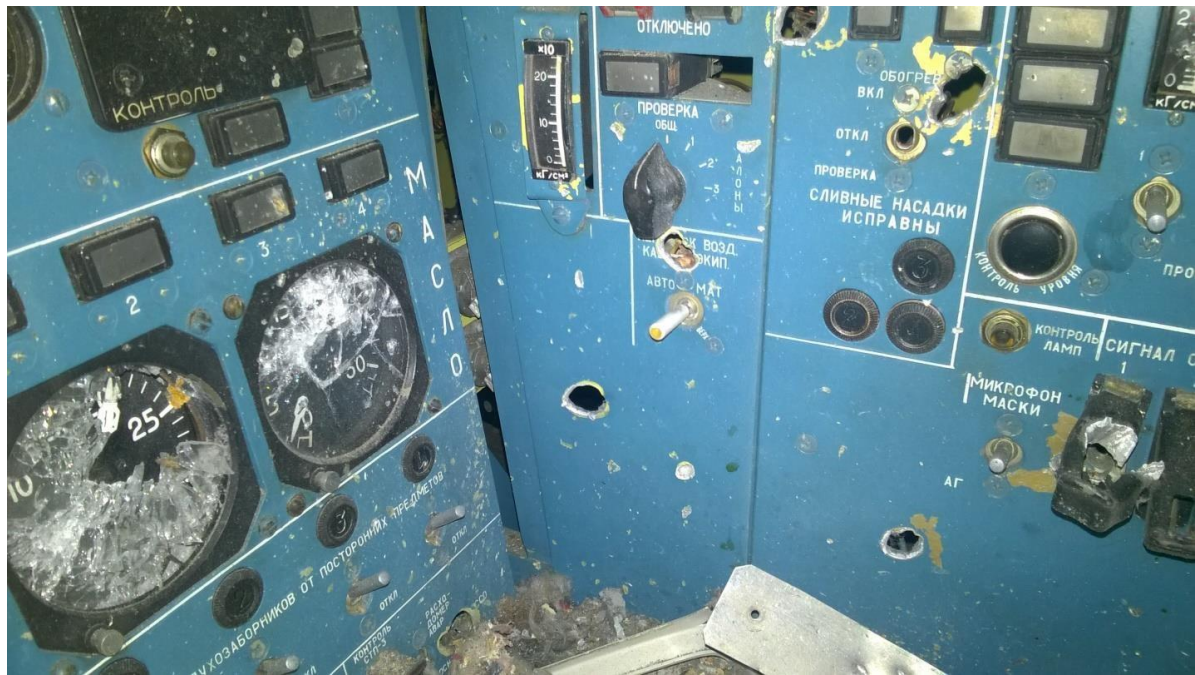
Figure 5.117 – Flight engineer's control panel
(ride side of the cockpit)

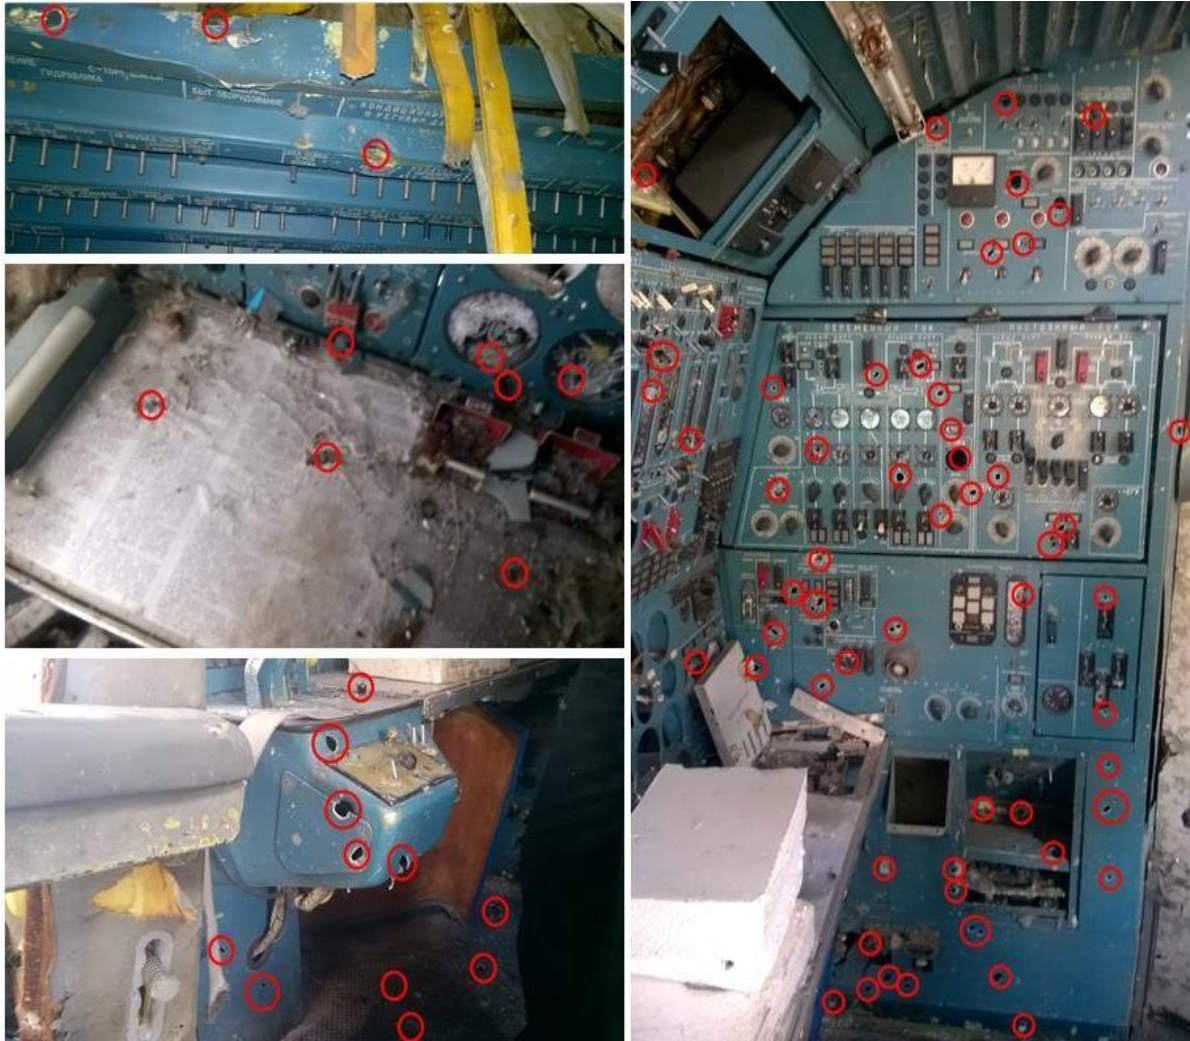
Figure 5.118 - Flight engineer's control panel (starboard)

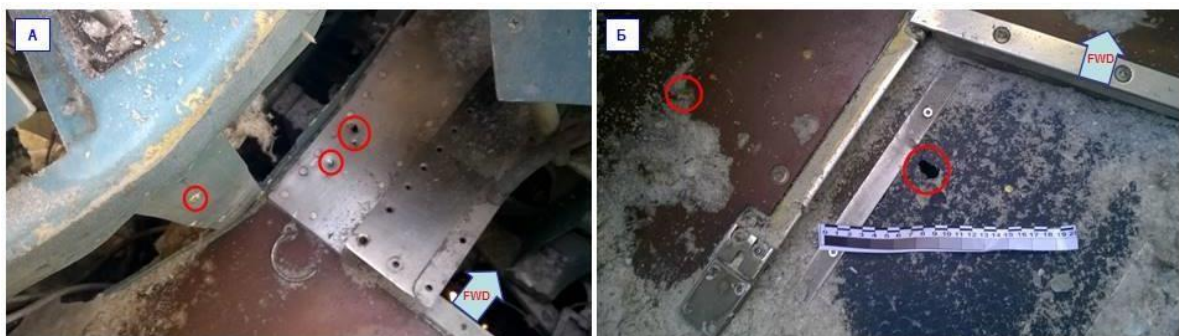
Figure 5.119 - Cockpit floor, port side(near the aircraft commander's seat)

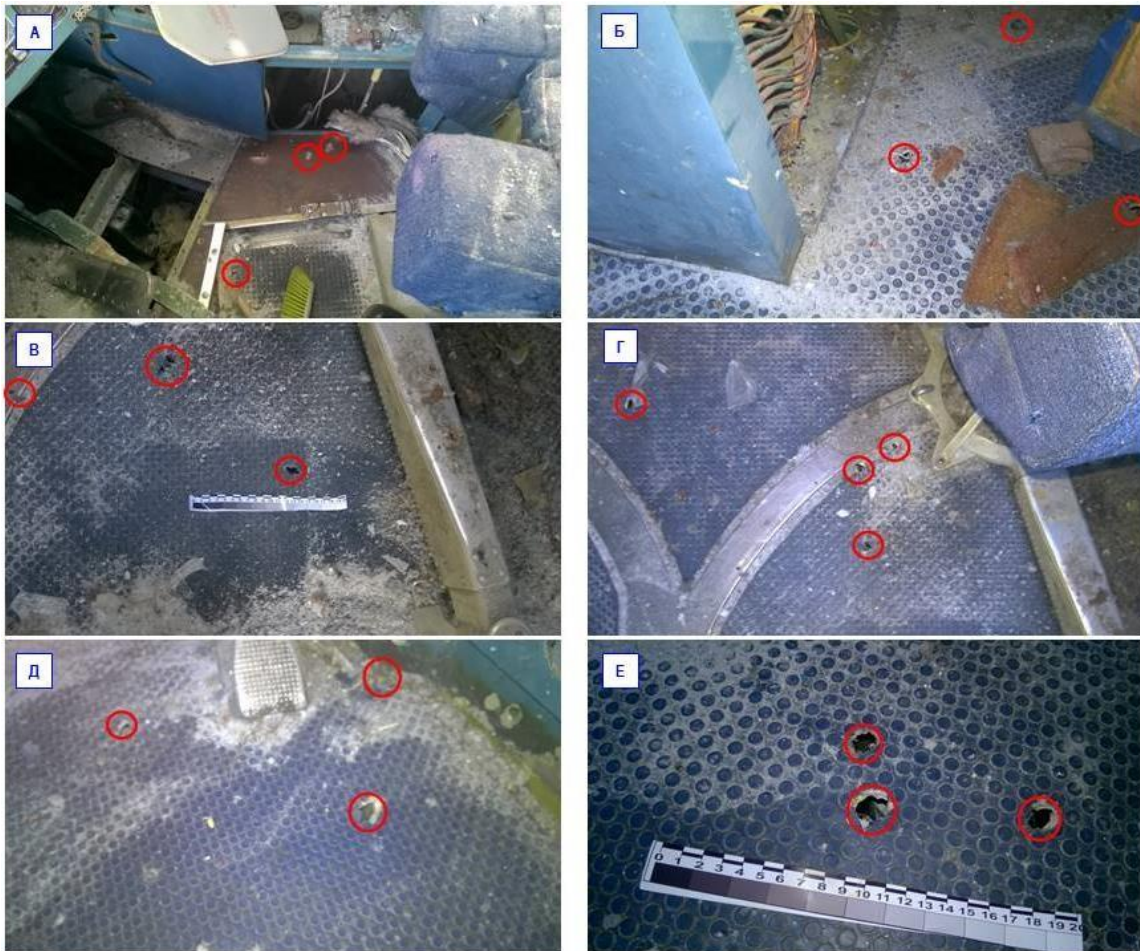
Figure 5.120 - Cockpit floor (central and right sections)

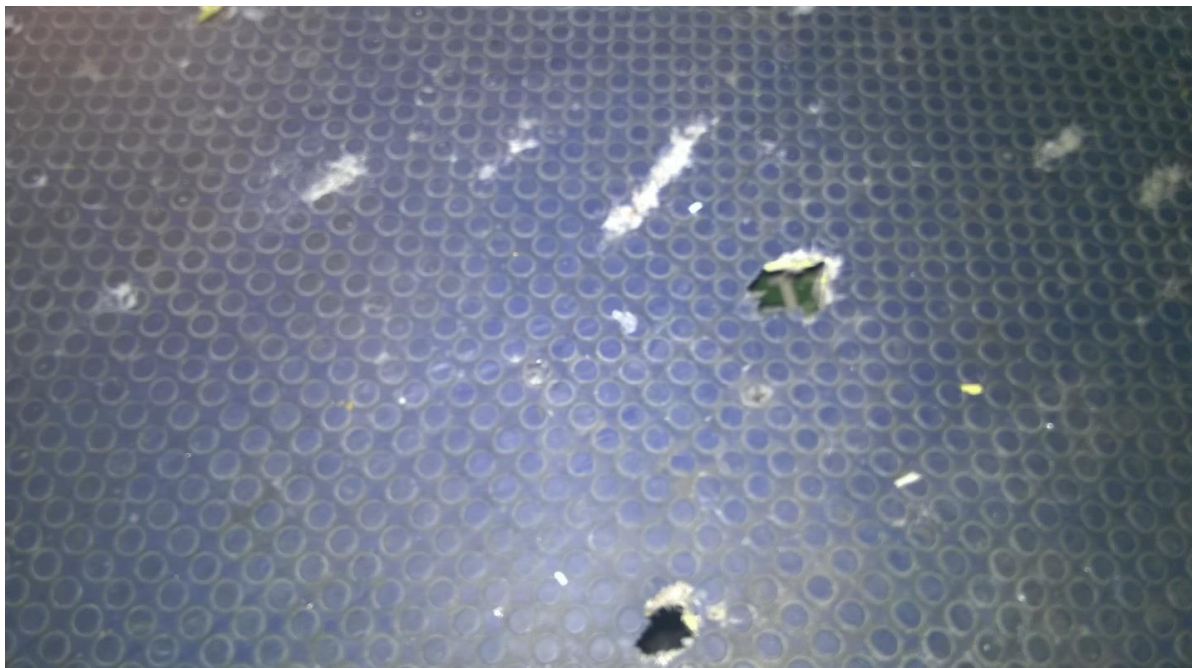
Figure 5.121 - Through-and-through holes in the cockpit floor

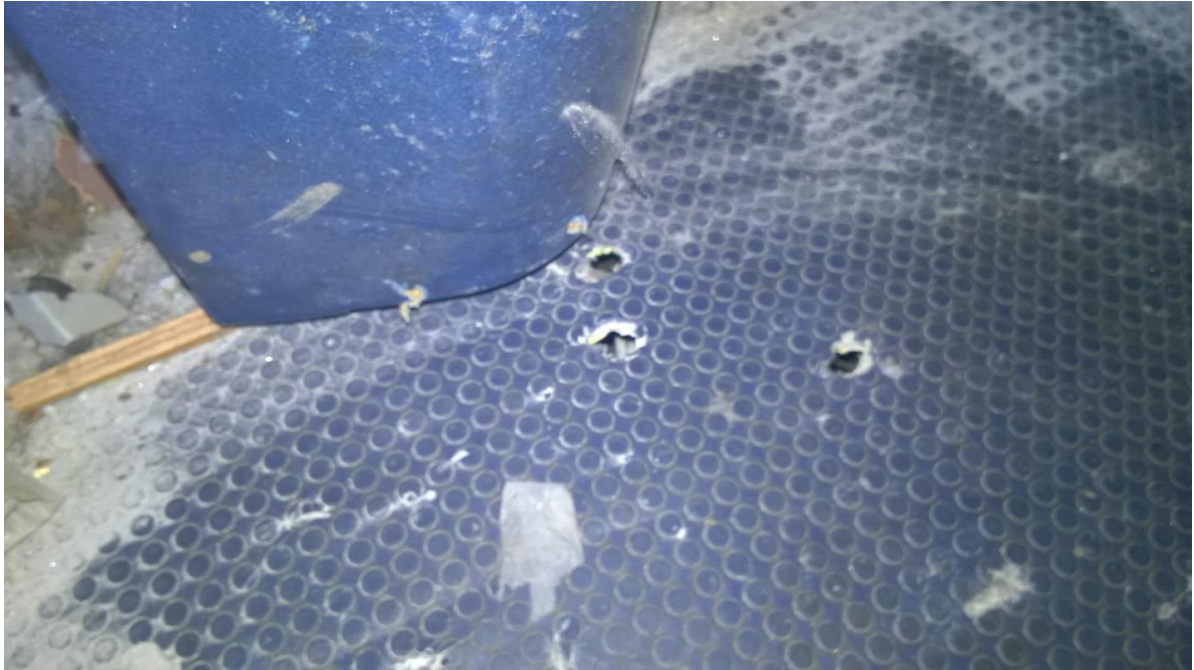
Figure 5.122 - Through-and-through holes in the cockpit floor (starboard)

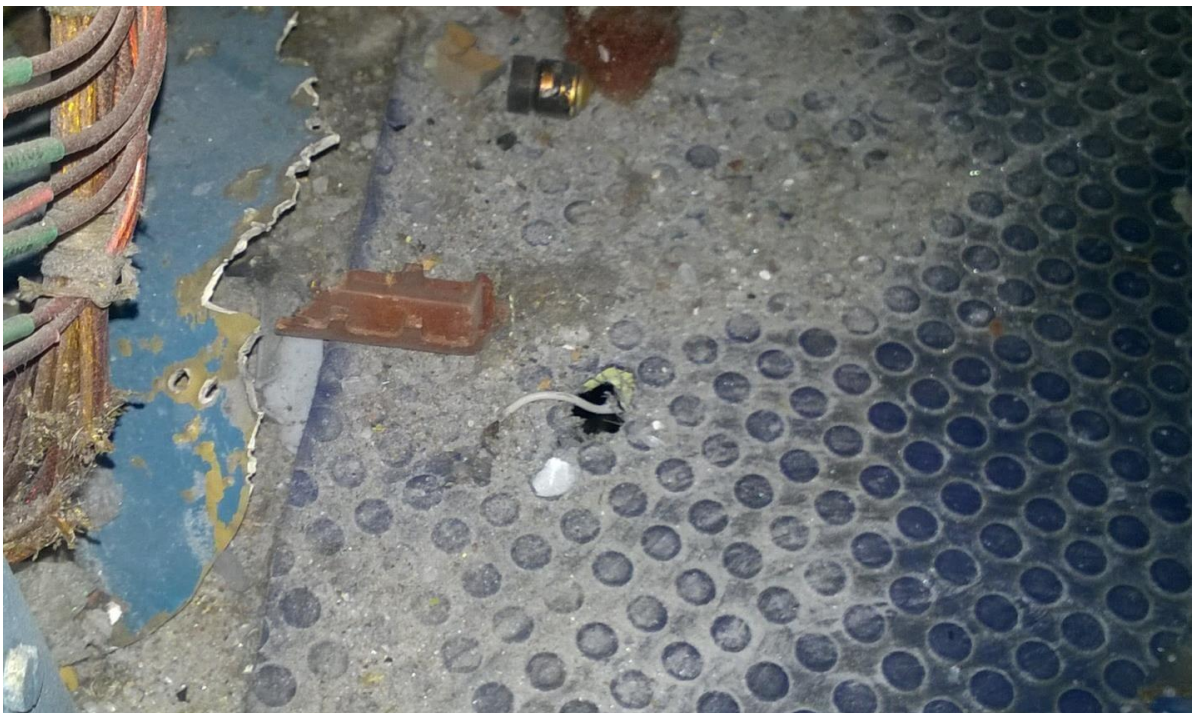
Figure 5.123 - Through-and-through holes in the cockpit floor (starboard)
