**APPLICATION OF THE INTERNATIONAL CONVENTION FOR THE SUPPRESSION
OF THE FINANCING OF TERRORISM AND OF THE INTERNATIONAL
CONVENTION ON THE ELIMINATION OF ALL FORMS OF RACIAL
DISCRIMINATION**

REJOINDER

Report of JSC Air and Space Defense Corporation "Almaz-Antey" on the results of studies related to the technical investigation into the crash of the Malaysian airlines Boeing 777-200 9M-MRD (flight MH17), 2023

on the results of studies related to the technical investigation into the crash
of the Malaysian airlines Boeing 777-200 9M-MRD (flight MH17)

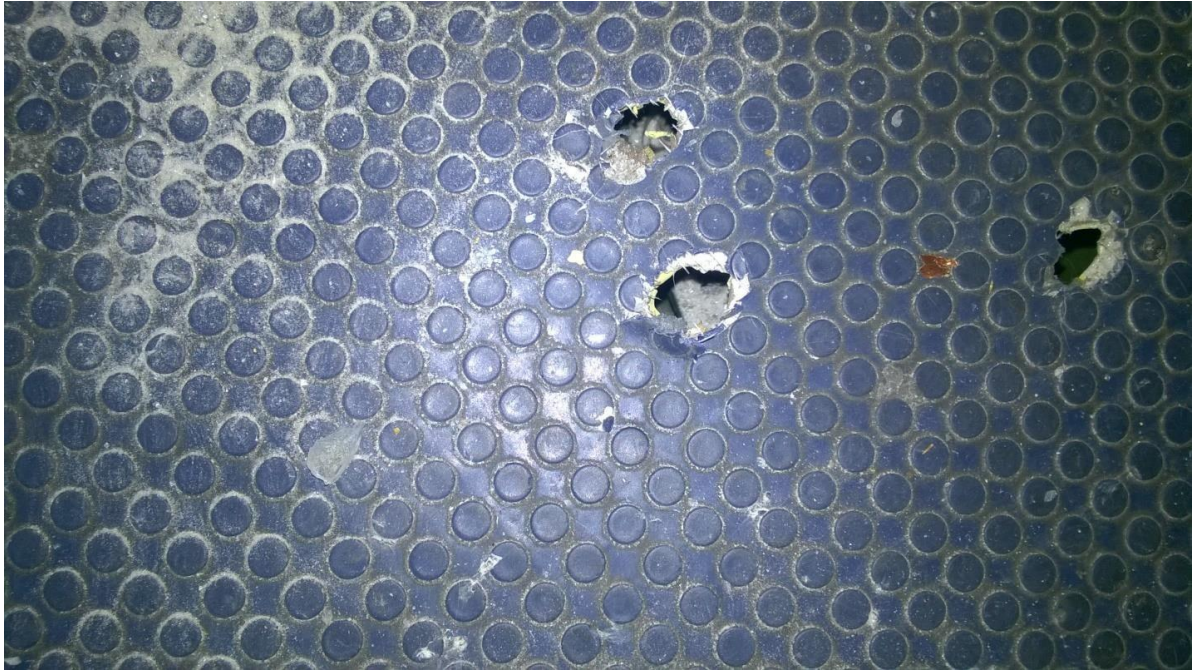
Figure 5.124 - Through-and-through holes in the cockpit floor (starboard)

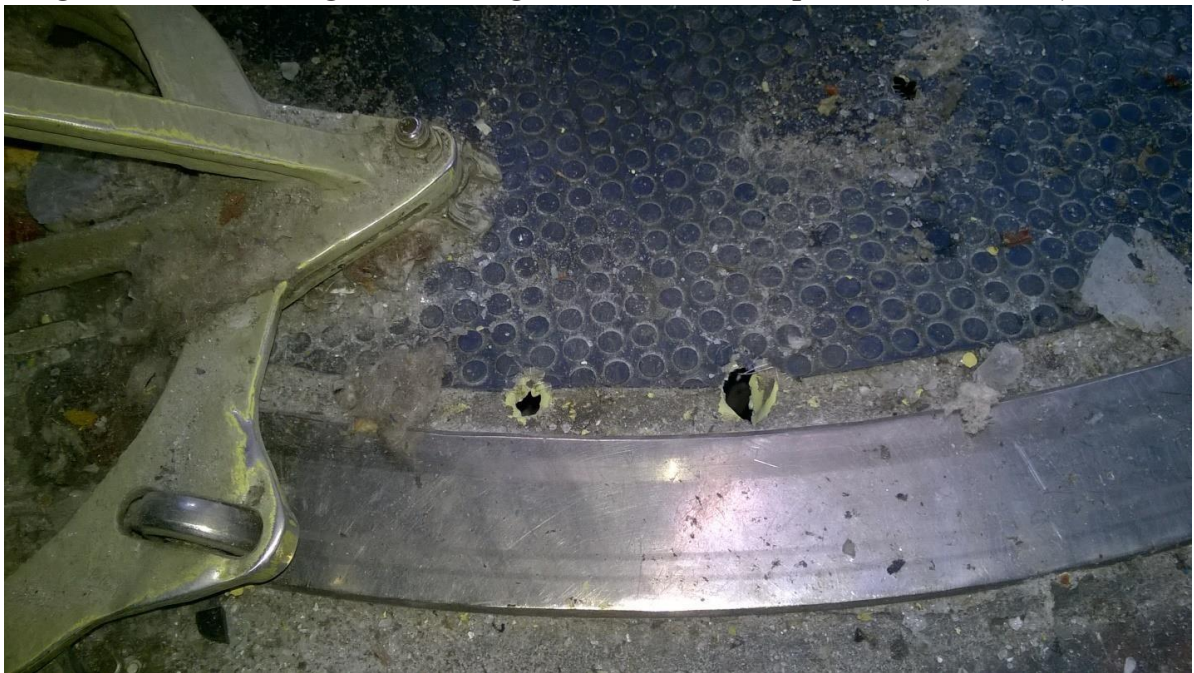
Figure 5.125 - Through-and-through holes in the cockpit floor (central part of the cockpit)

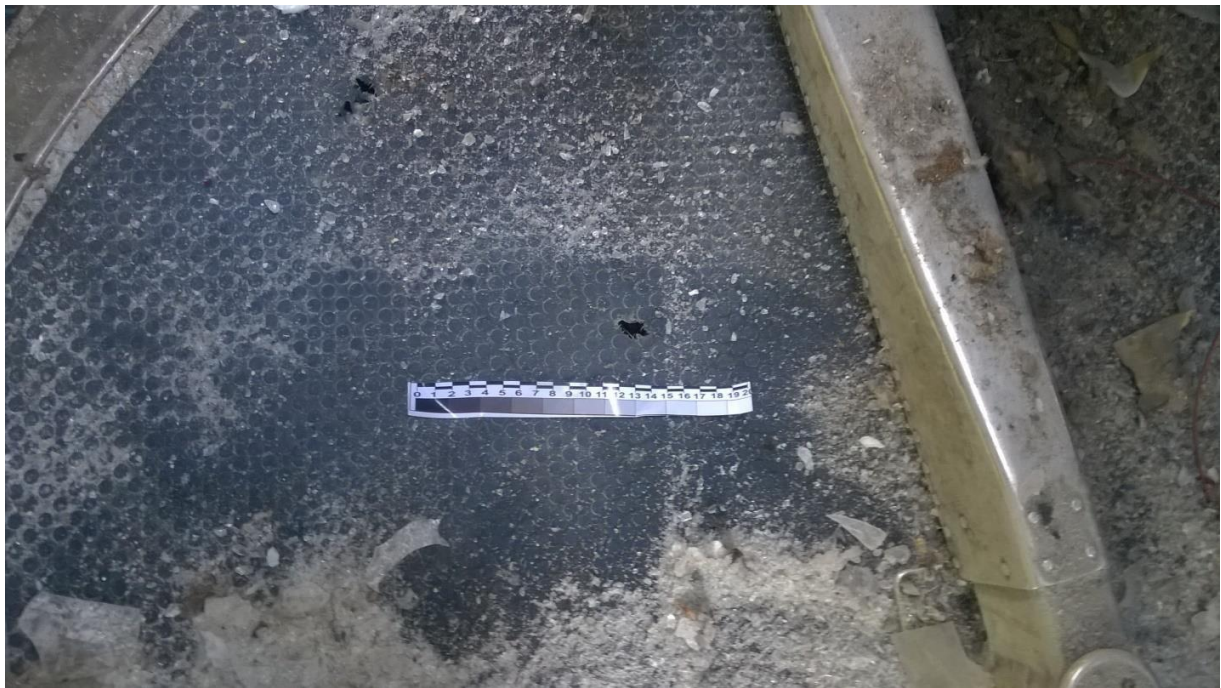
Figure 5.126 - Through-and-through holes in the cockpit floor

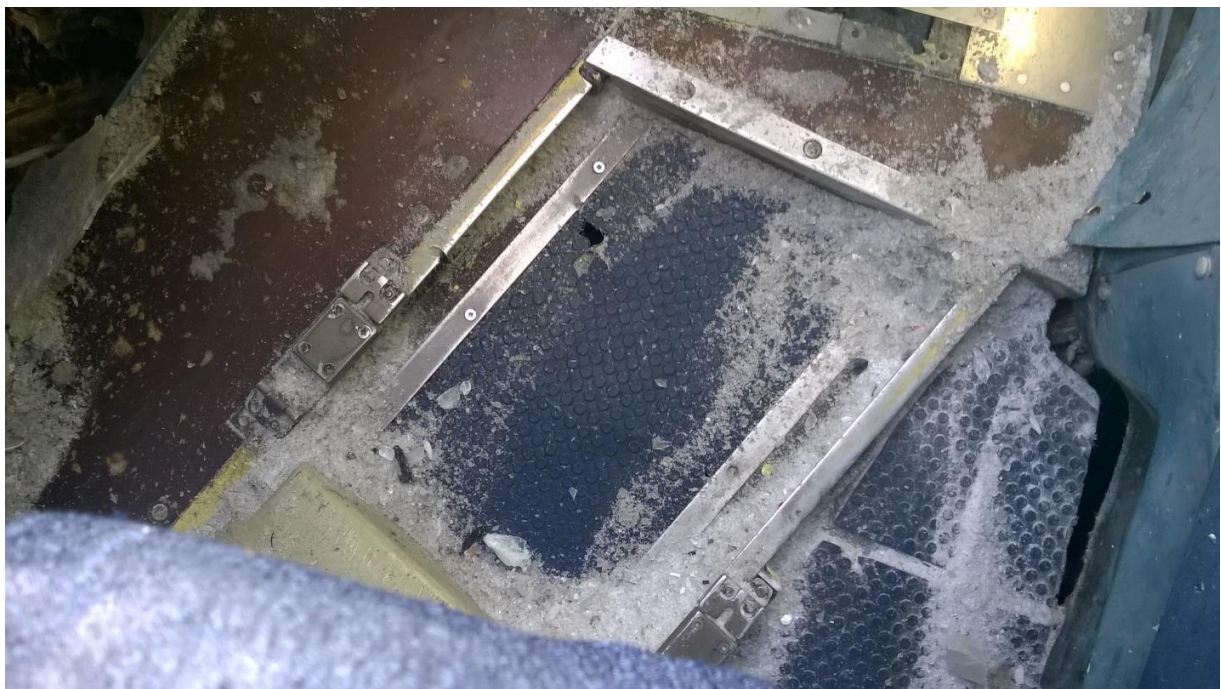
Figure 5.127 - Cockpit floor in the aircraft commander's seat area

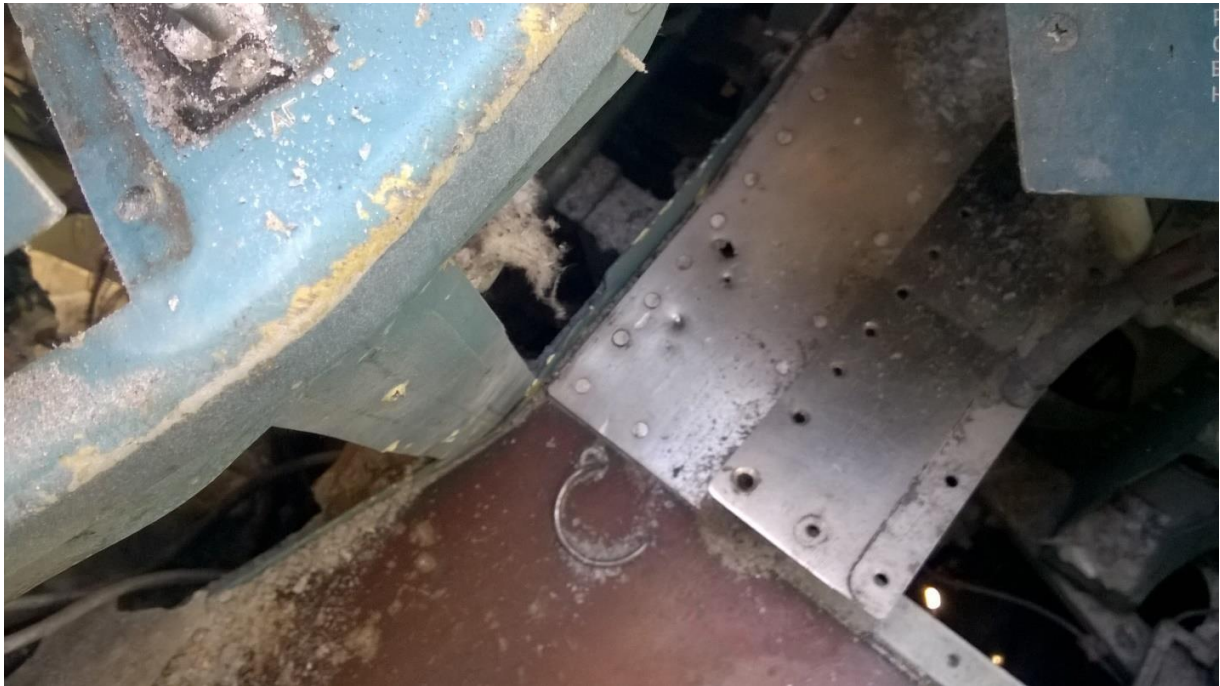
Figure 5.128 - Cockpit floor in the aircraft commander 's seat area

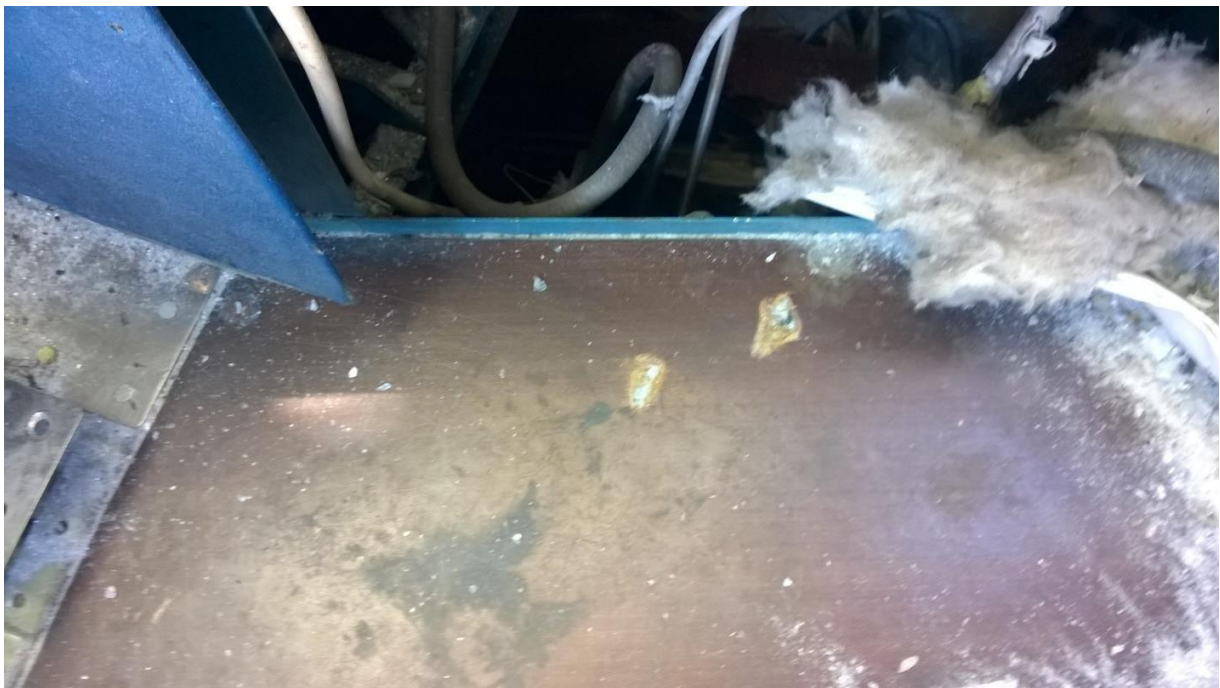
Figure 5.129 - Through-and-through holes in the cockpit floor in the aircraft commander 's seat area

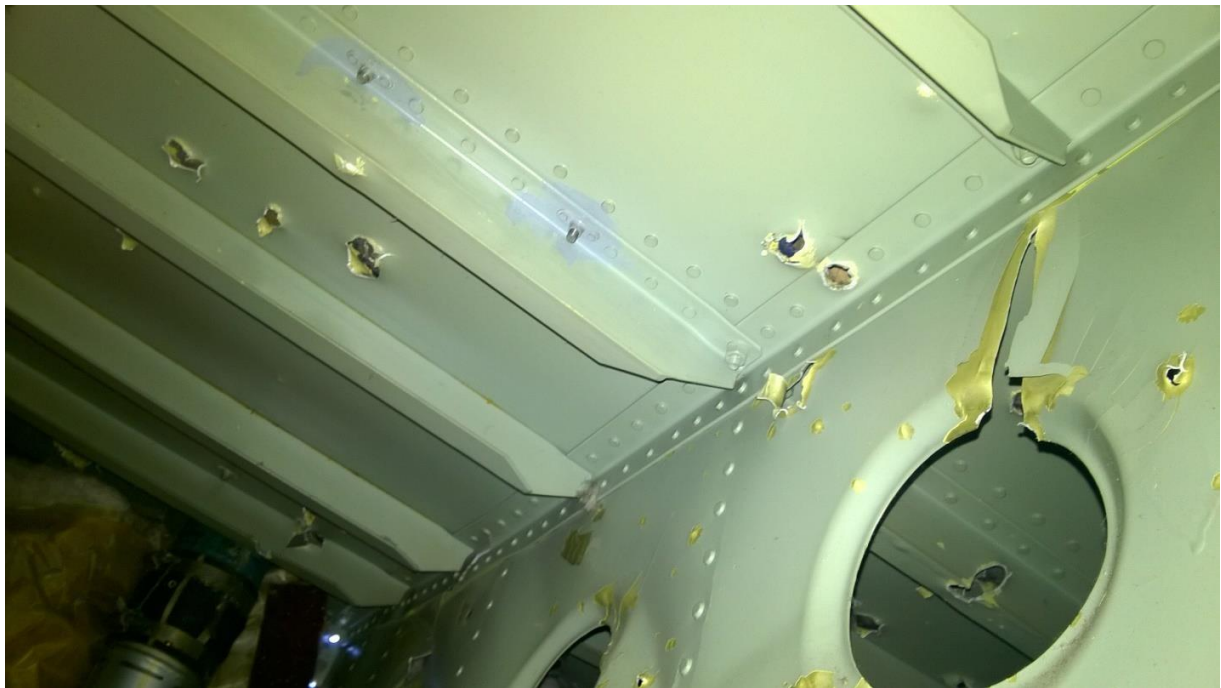
Figure 5.130 - Through-and-through holes in the cockpit floor (bottom view)

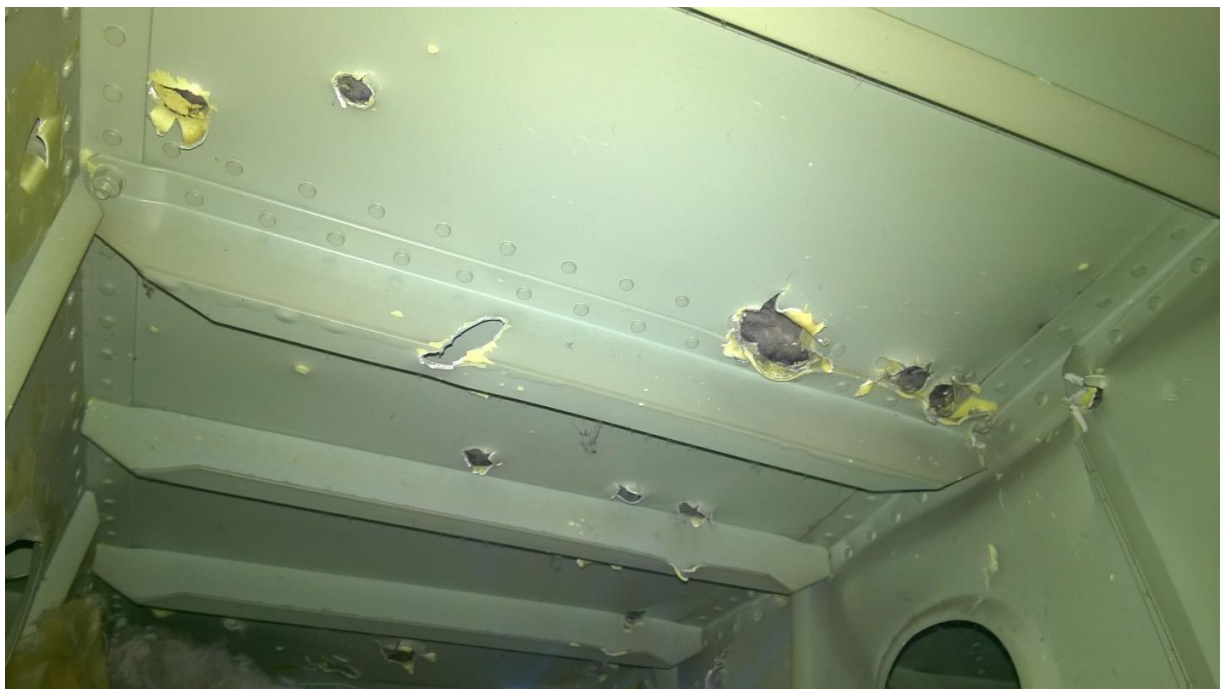
Figure 5.131 - Through-and-through holes in the cockpit floor (bottom view)

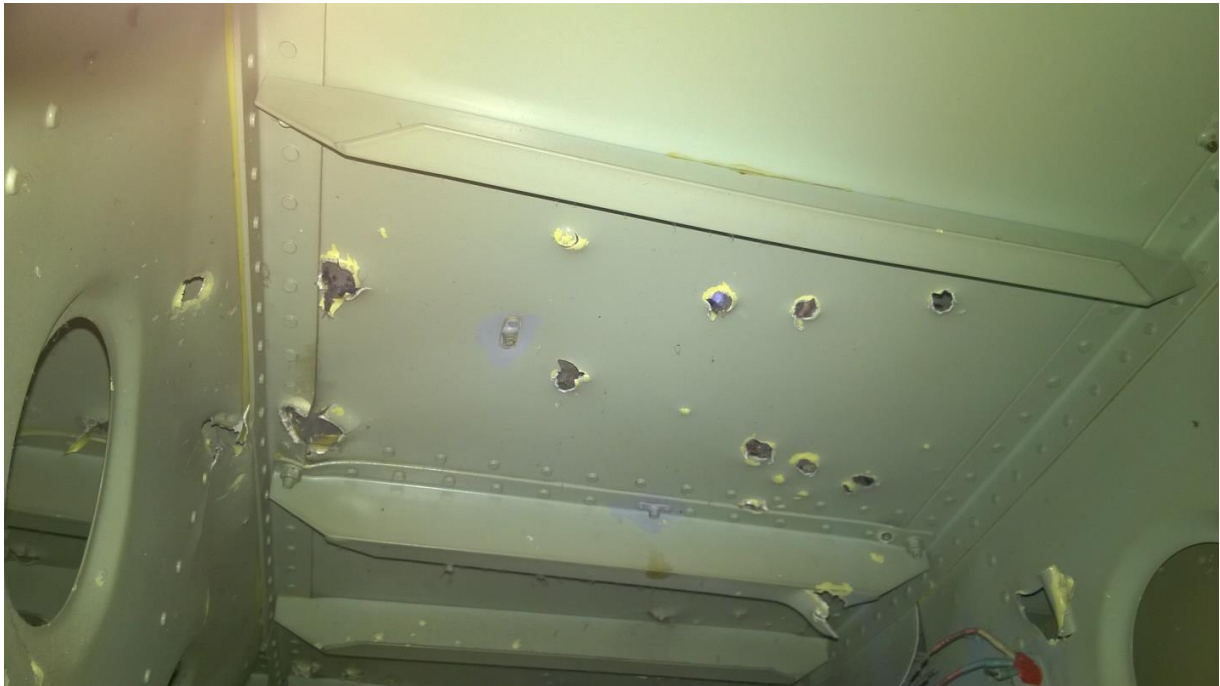
Figure 5.132 - Through-and-through holes in the cockpit floor (bottom view)

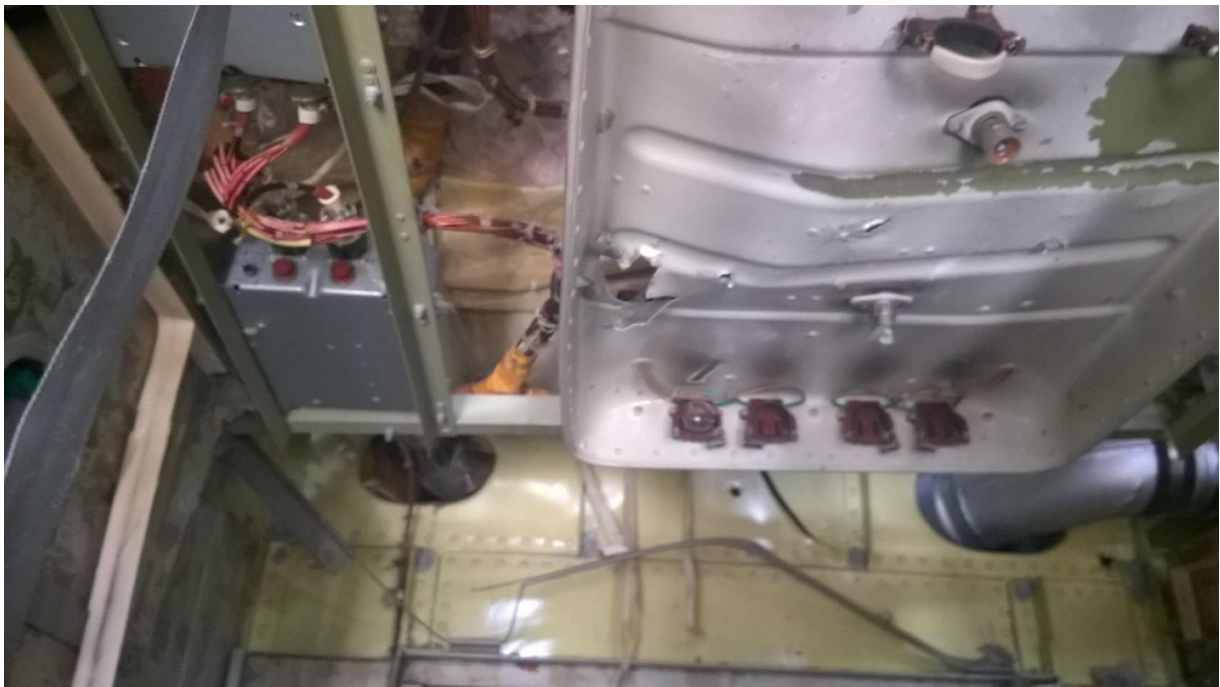
Figure 5.133 - Through-and-through holes in the floodlamp lighting (corridor behind the cockpit)

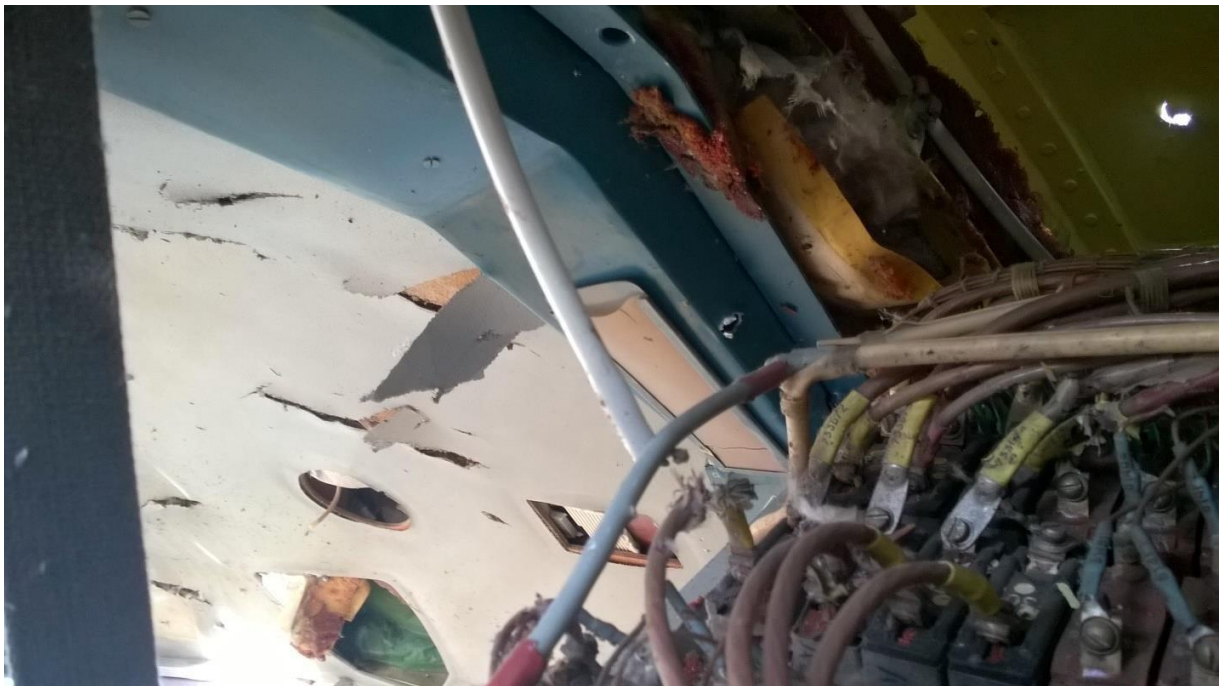
Figure 5.137 - Material-intensive components of the avionics equipment. Instrumentation panel in the top section of the starboard (in the top right corner, there is an exit hole in the right section of the cockpit roof)

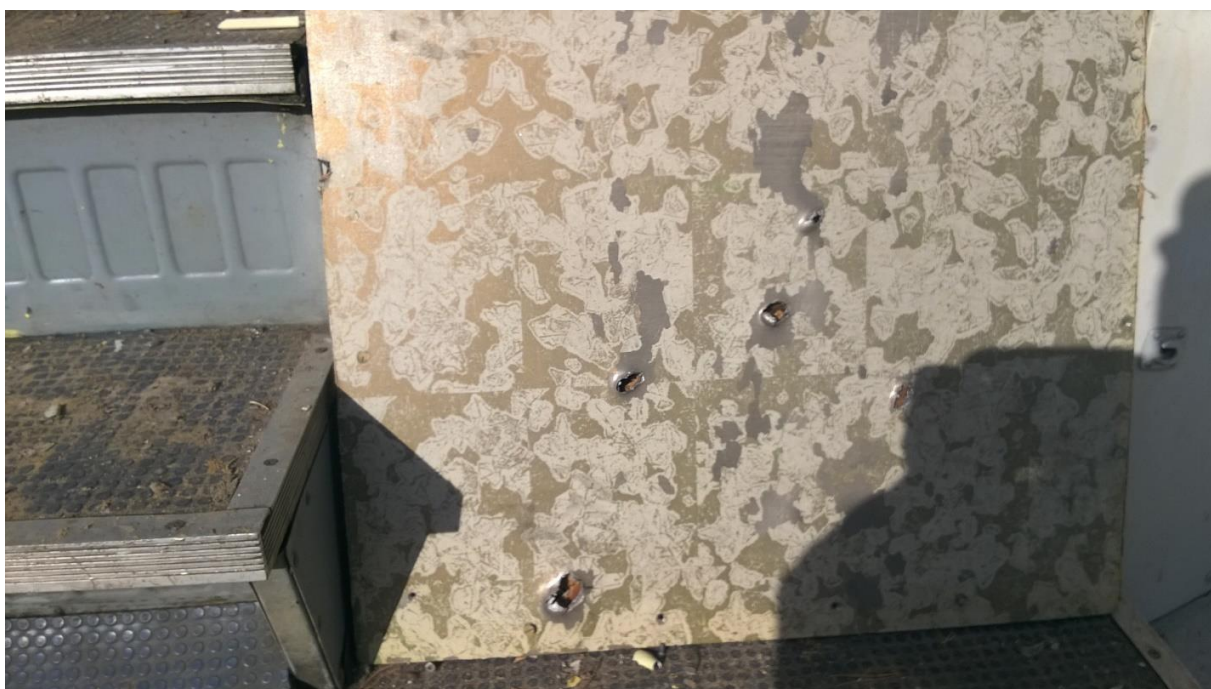
Figure 5.138 – Exit holes in the lower right section of the first passenger compartment (rear view)

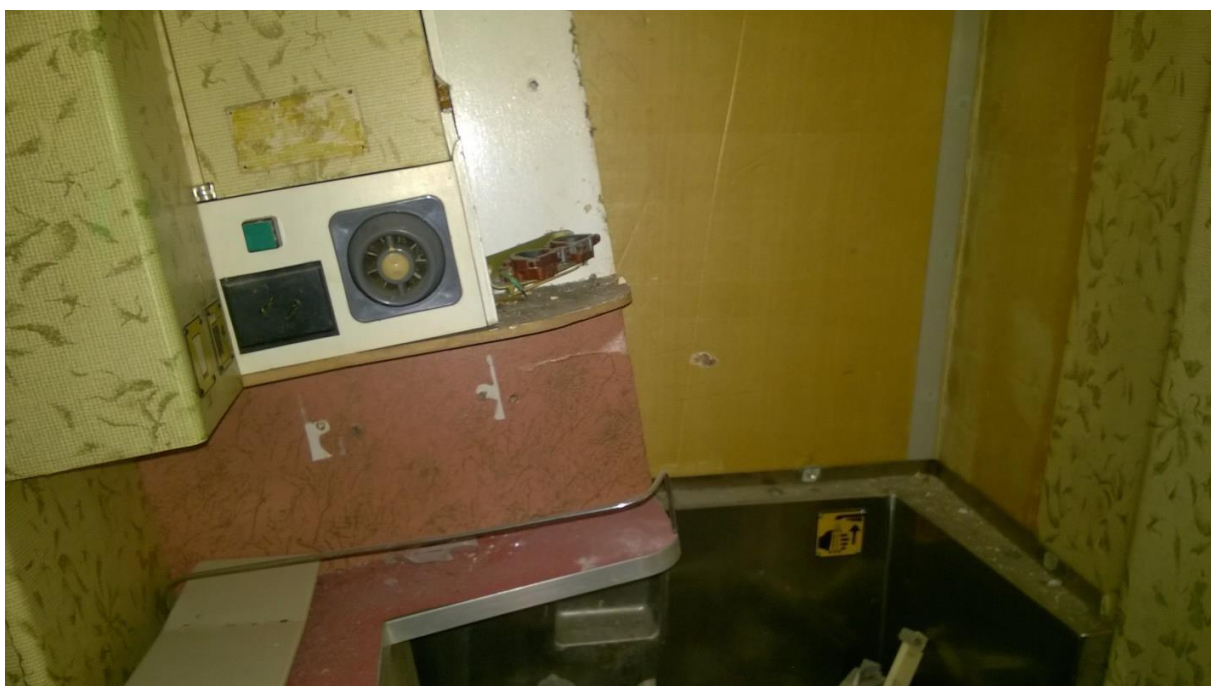
Figure 5.139 - Through-and-through holes in toilet cladding panels (starboard)

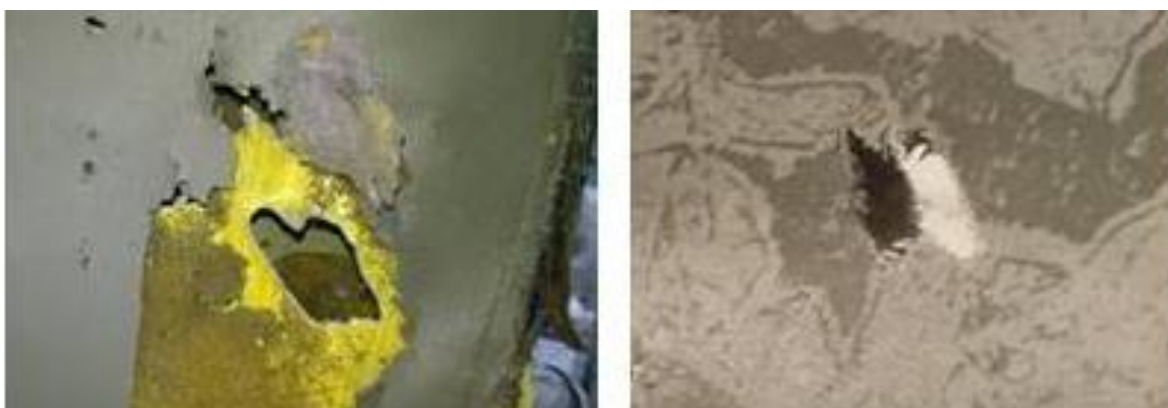
Figure 5.140 - Characteristic butterfly-shaped holes in the fragments of the cockpit's interior

An analysis of damage to the interior and structural elements showed that elements of the interior of the cockpit, kitchen, lavatory and forward part of the first passenger cabin had multiple fragmentation damage, including characteristic "butterfly"-shaped holes.

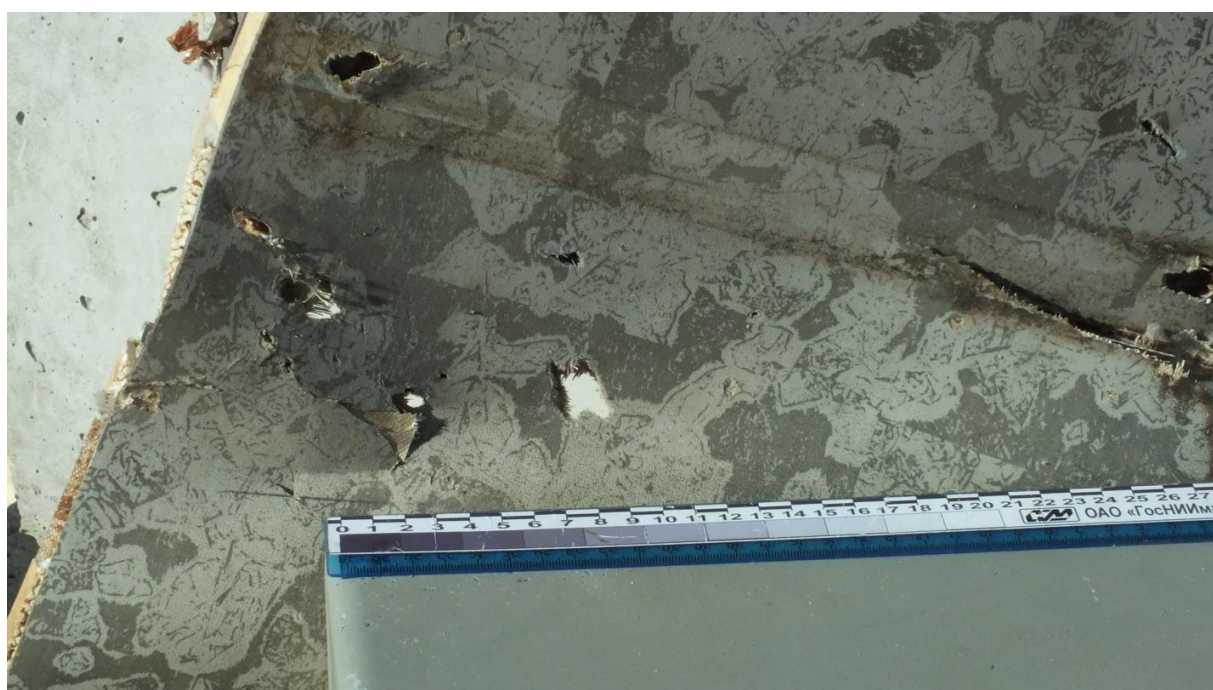
Figure 5.141 - Through-and-through holes in the galley wall

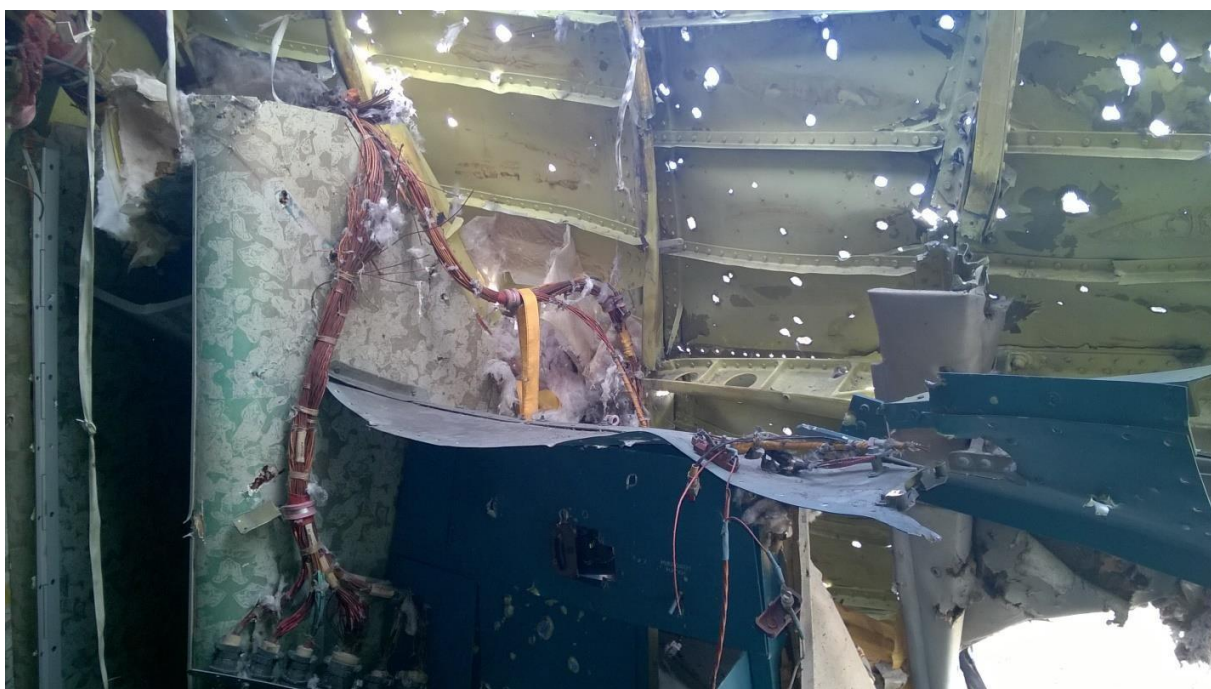
Figure 5.142 - Fragment of the port side with a broken frame

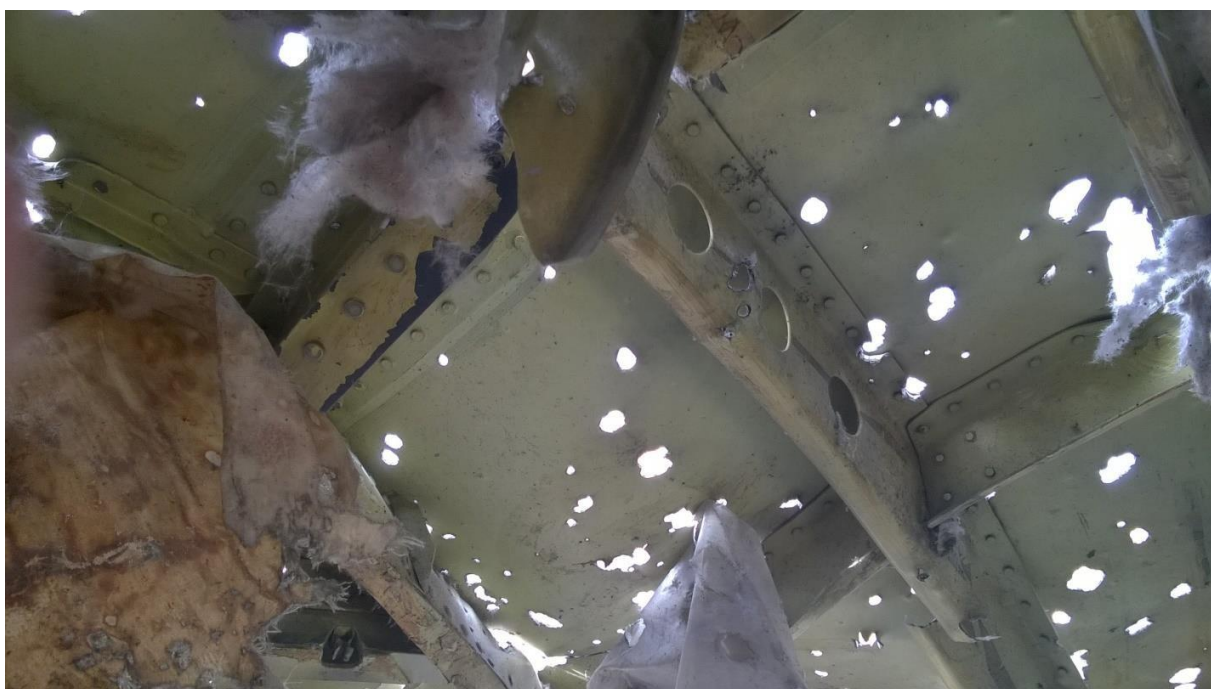
Figure 5.143 - Cockpit roof with through-and-through holes in stringers and signs of damage

The fragmentation damage to the structural elements is mainly concentrated in the longitudinal elements, the stringers. With regard to the frames, the holes are mostly found only on the L-shaped reinforcements of the frames.

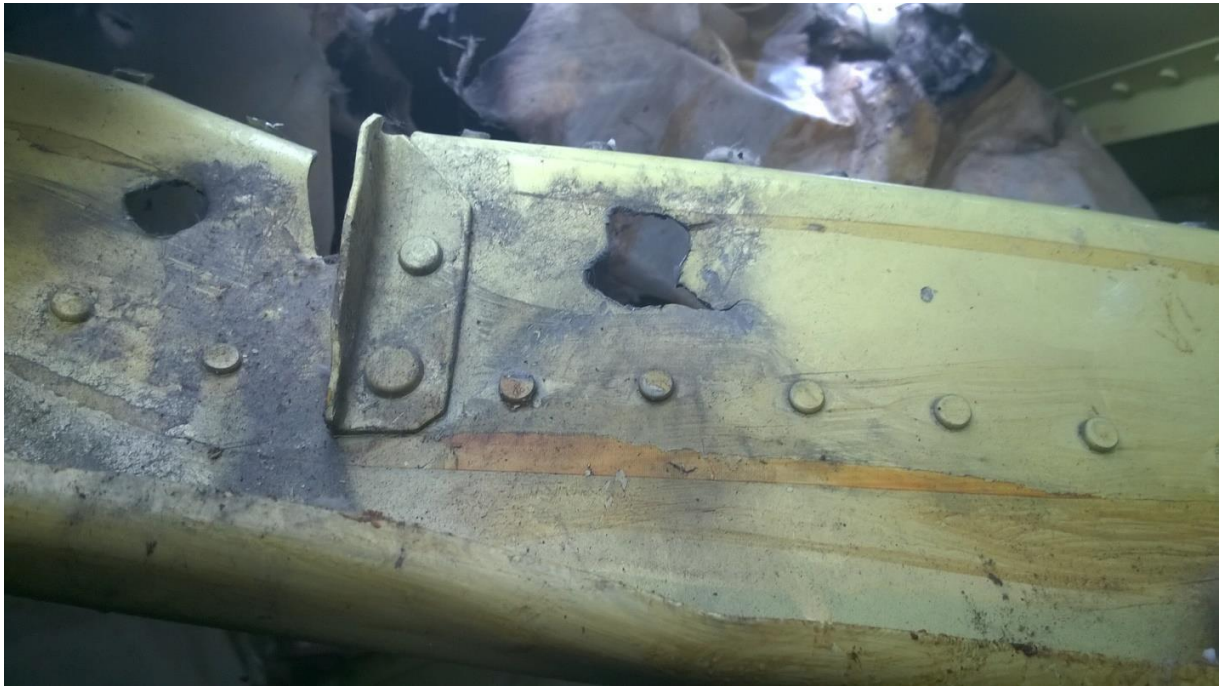
Figure 5.144 - Through-and-through holes in a power kit element

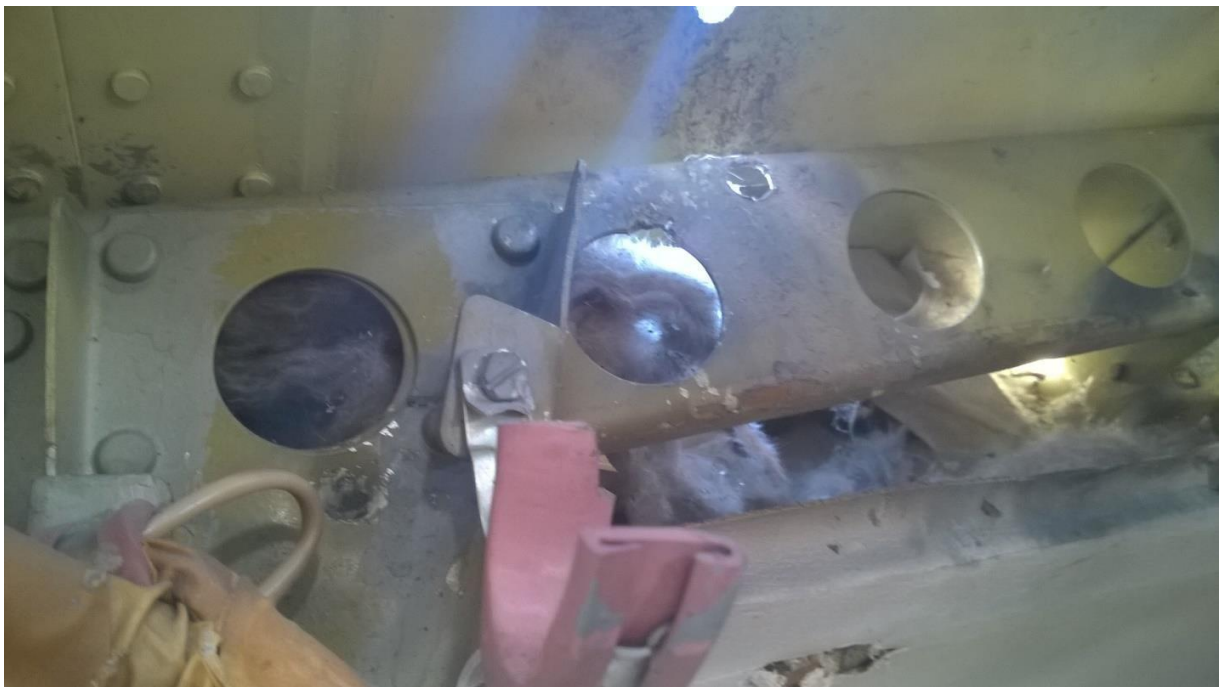
Figure 5.145 - Through-and-through holes in a structural element of the airframe (stringer)

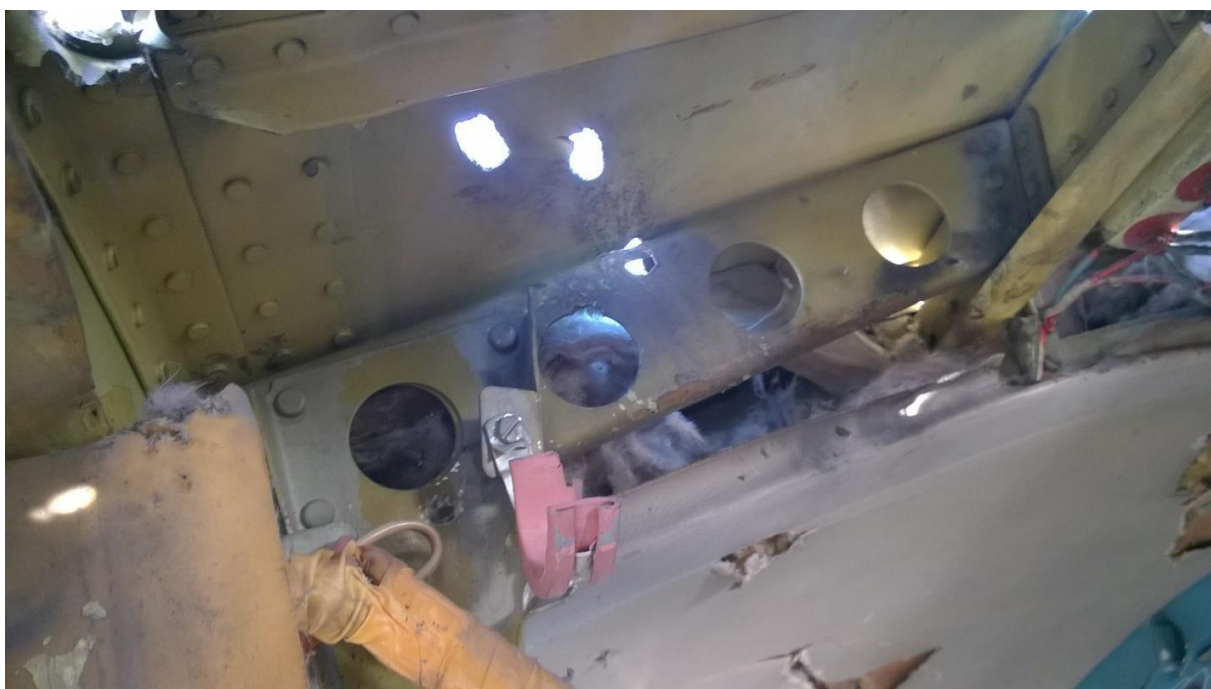
Figure 5.146 - Through-and-through holes in the roof and cockpit stringer (right side)

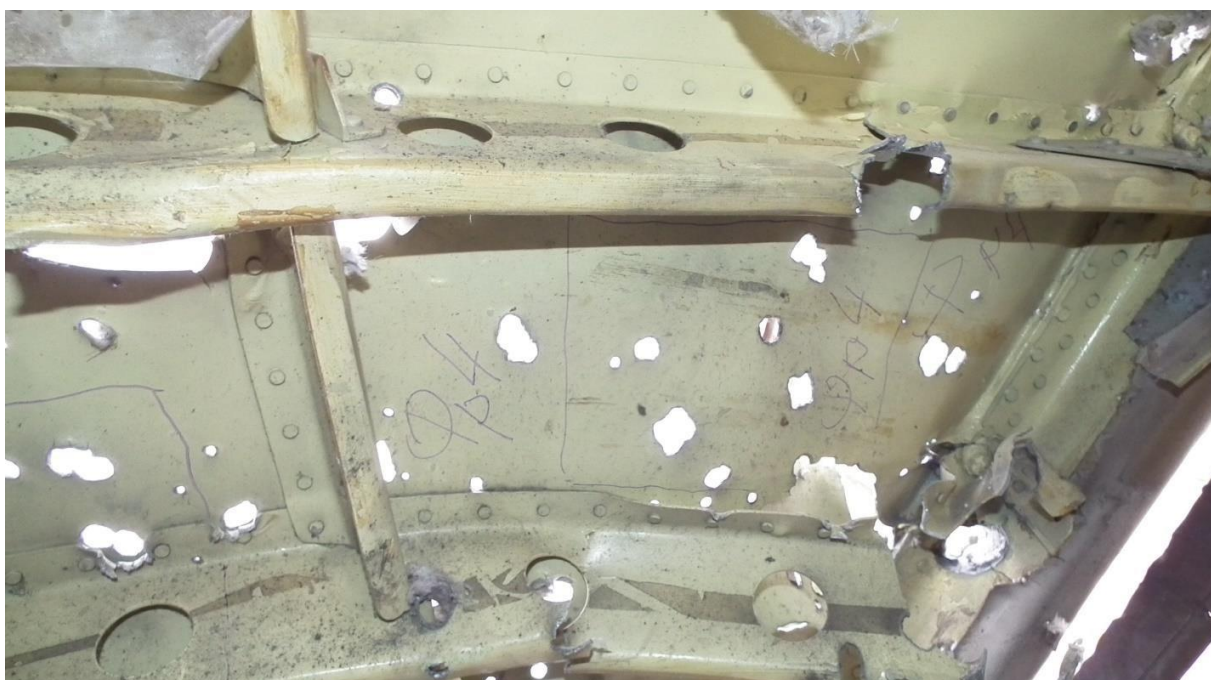
Figure 5.147 - Damage to stringers in the structure of the target aircraft's cockpit roof

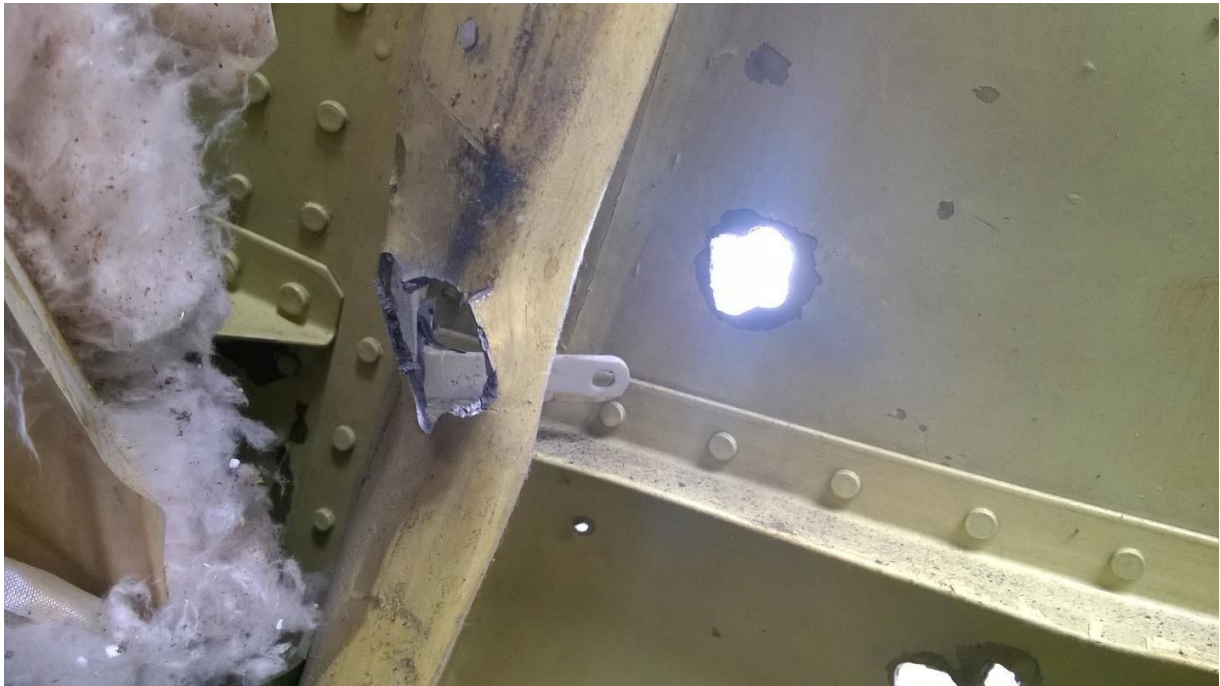
Figure 5.148 - Through-and-through hole in L-shaped frame reinforcement on the left side of the cockpit

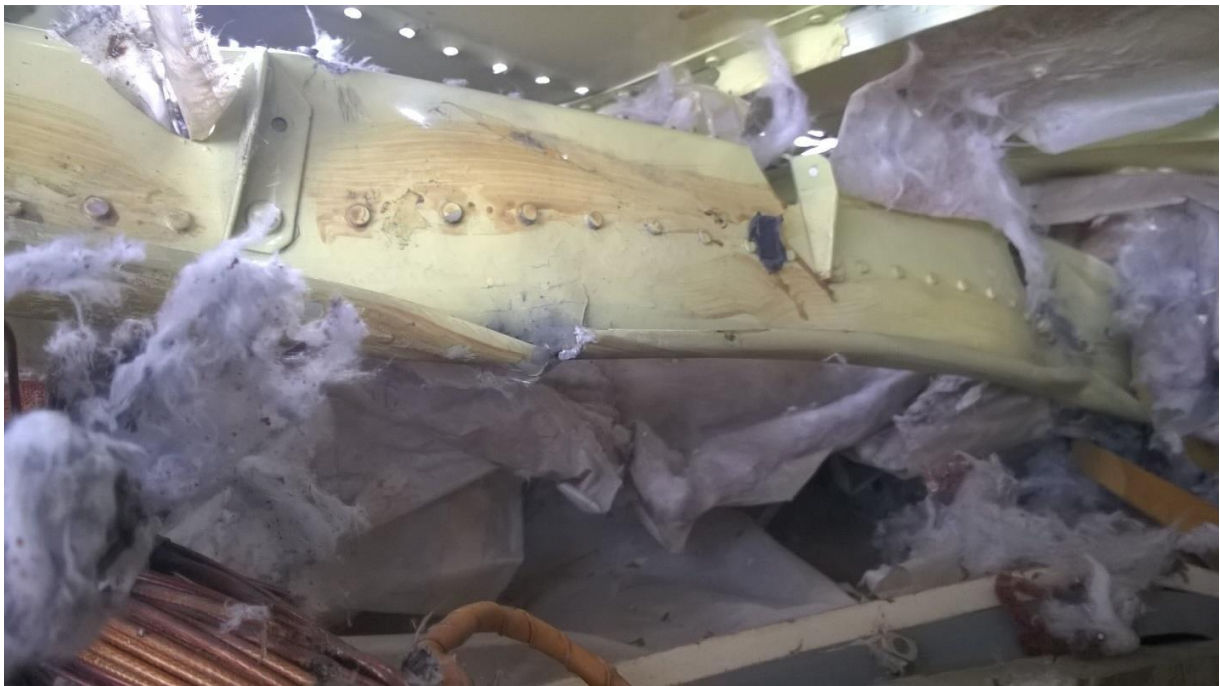
Figure 5.149 - Through-and-through hole in L-shaped frame reinforcement (port side of the cockpit)

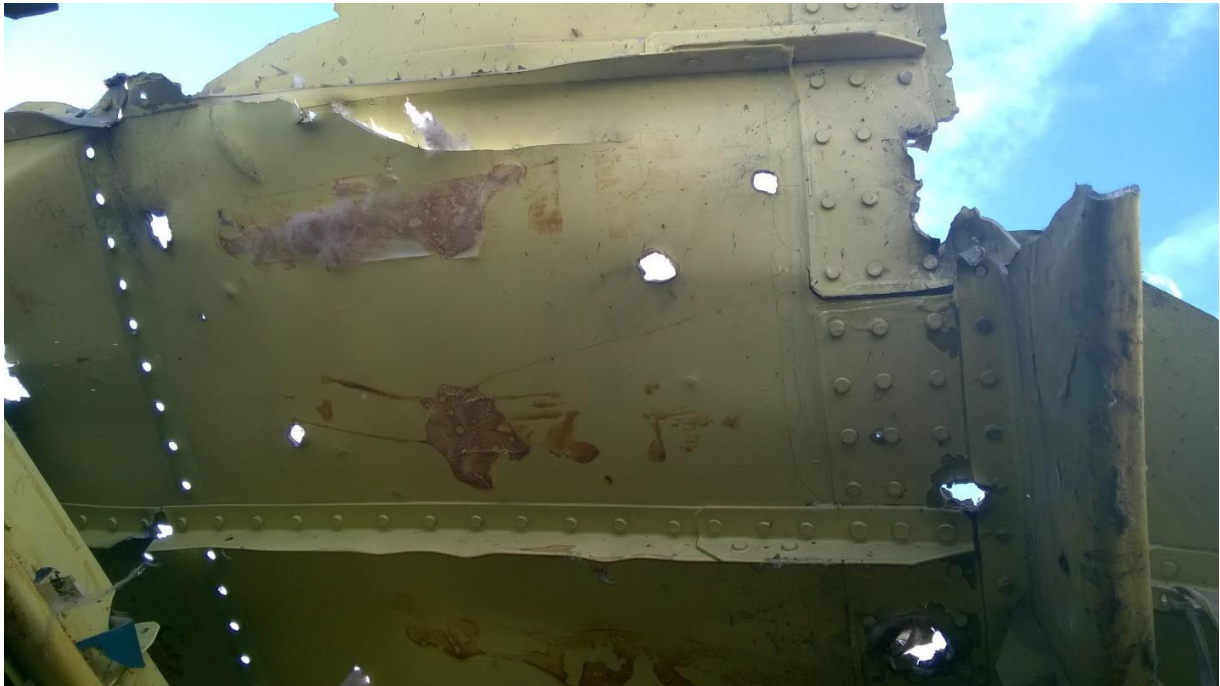
Figure 5.150 – Destruction of a frame (top of the port side)

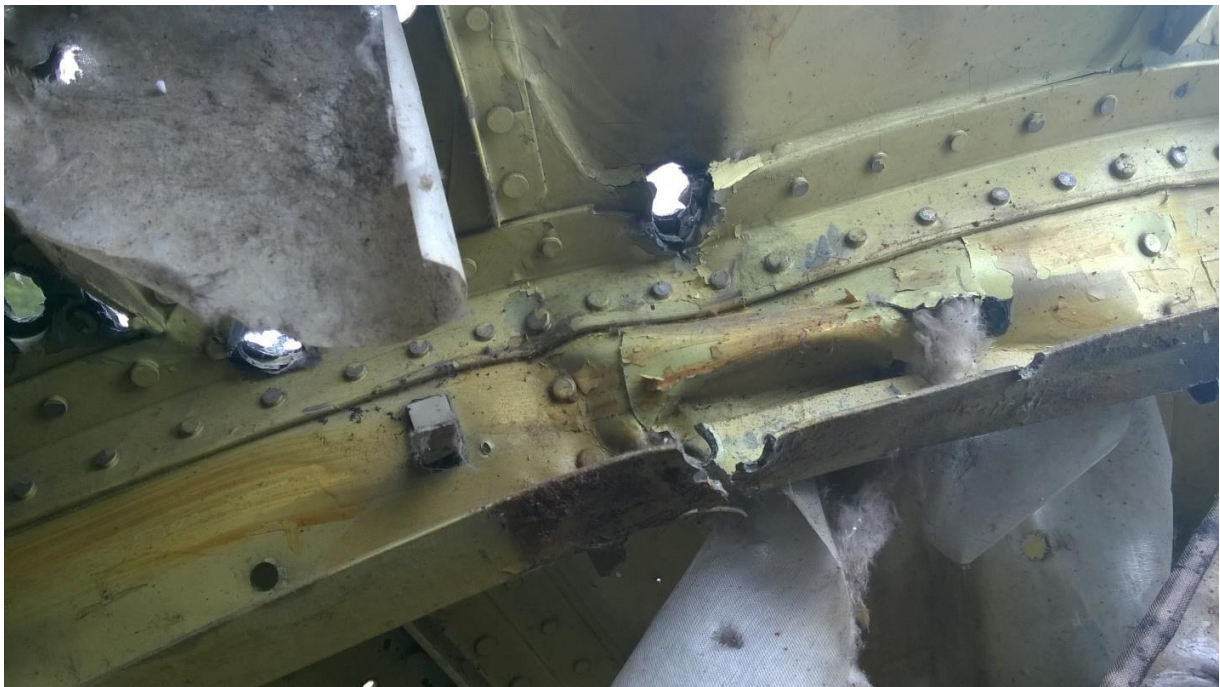
Figure 5.151 - Characteristic view of damage to frames on the left side of the cockpit (punctured L-shaped frame reinforcements). The direction of the motion of the projectiles is transverse to the aircraft structure. There are no through-and-through holes in the frames.

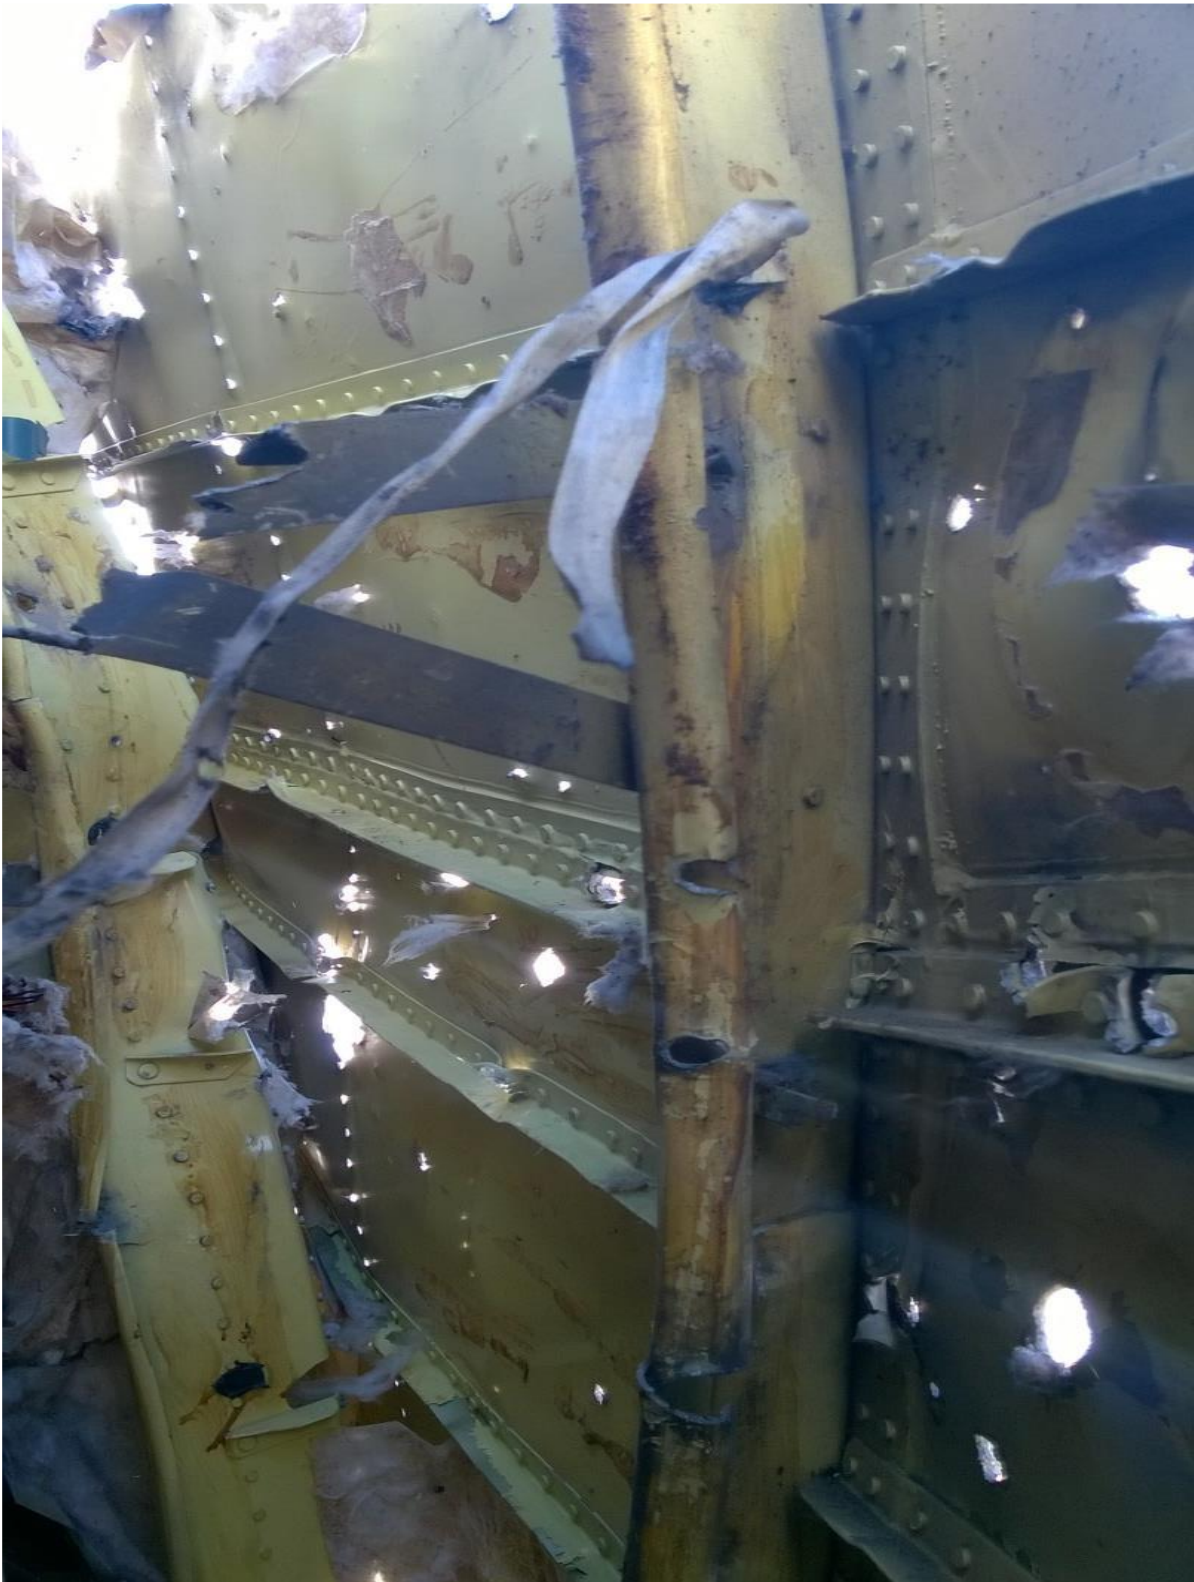
Figure 5.152 - Appearance of the port side frames
