**APPLICATION OF THE INTERNATIONAL CONVENTION FOR THE SUPPRESSION
OF THE FINANCING OF TERRORISM AND OF THE INTERNATIONAL
CONVENTION ON THE ELIMINATION OF ALL FORMS OF RACIAL
DISCRIMINATION**

REJOINDER

Report of JSC Air and Space Defense Corporation "Almaz-Antey" on the results of studies related to the technical investigation into the crash of the Malaysian airlines Boeing 777-200 9M-MRD (flight MH17), 2023

on the results of studies related to the technical investigation into the crash
of the Malaysian airlines Boeing 777-200 9M-MRD (flight MH17)

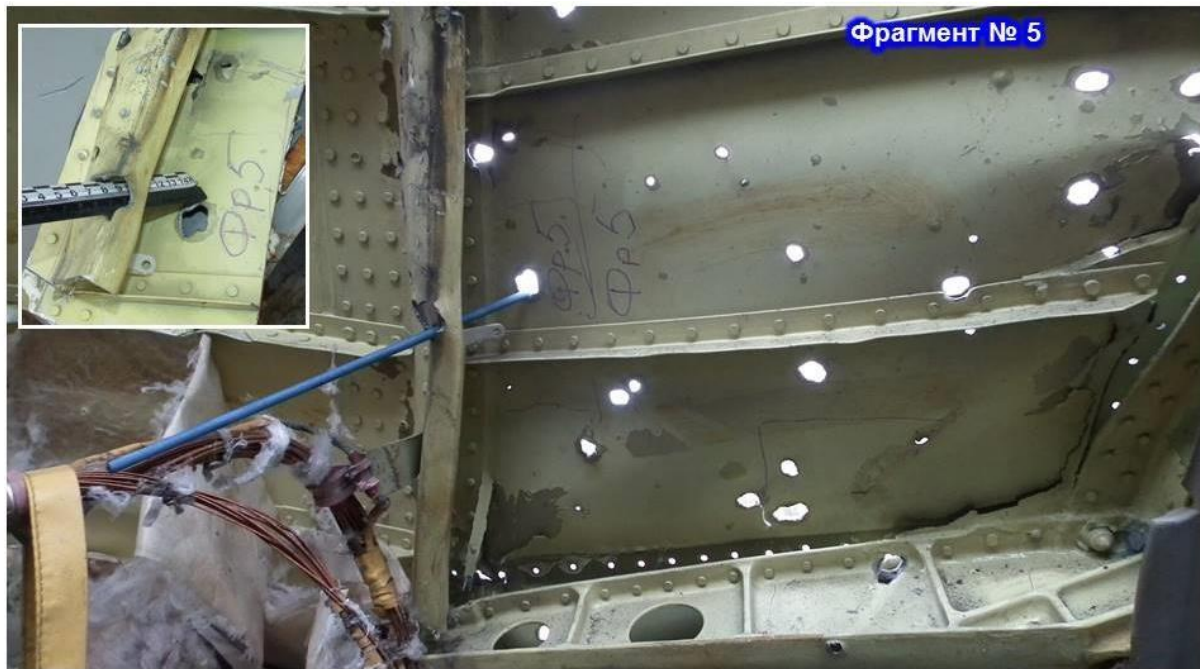
Figure 5.154 - Fragment No. 5

Fragment No. 5, a port side element behind the commander's seat, was also recovered. The fragment includes part of the port side skin panel and part of a transverse structural element (frame). A photograph of the fragment recovery location and its appearance are shown in figure 5.154.

In fragments No.1, No. 2, No. 4 and No. 5, characteristic butterfly-shaped through-and-through holes are clearly seen. They are left on the outer skin of the aircraft by bowtie-shaped ready-made projectiles of 9H314M 1-10.

Fragments No. 1 and No. 5 show the peculiarities of the damage to the transverse structural elements of the airframe, the frames. Fragment No. 2 demonstrates the peculiarities of the damage to longitudinal structural elements of the airframe (stringers). Fragments No. 3 and No. 4 show the peculiarities of the damage to the outer skin of the aircraft in the area of the glazing of the left side of the cockpit – there are no ricochets caused by ready-made projectiles.

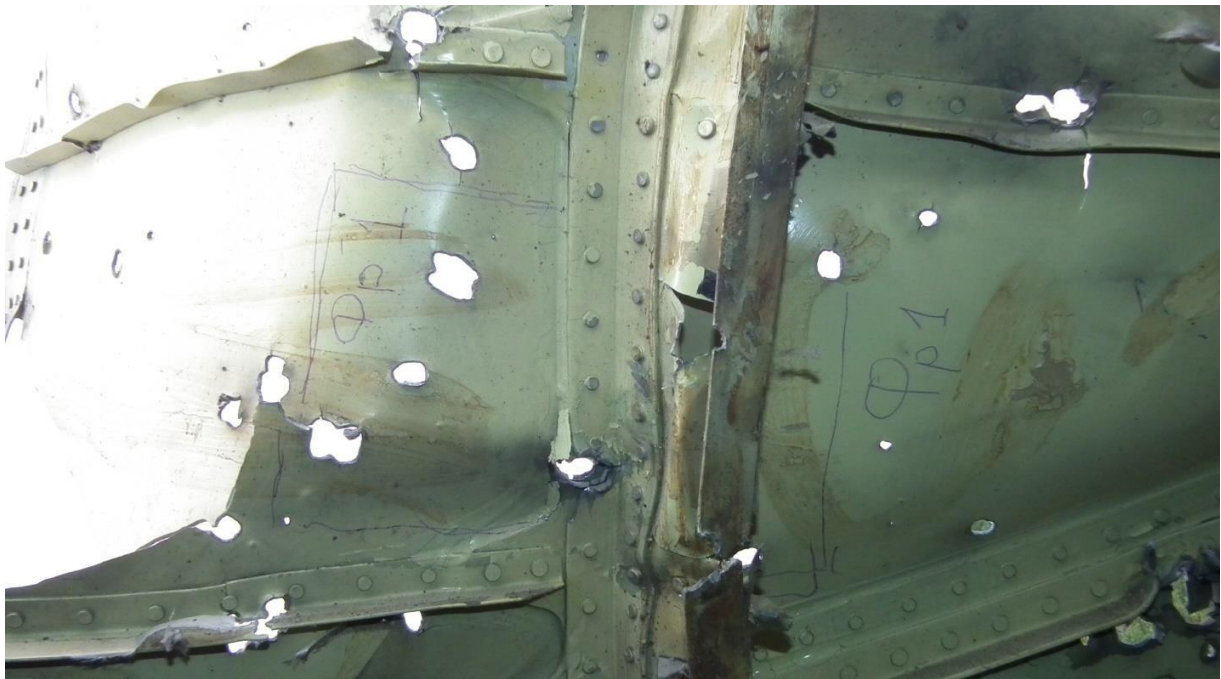
Figure 5.155 - Fragment No. 1 before extraction (inside view)

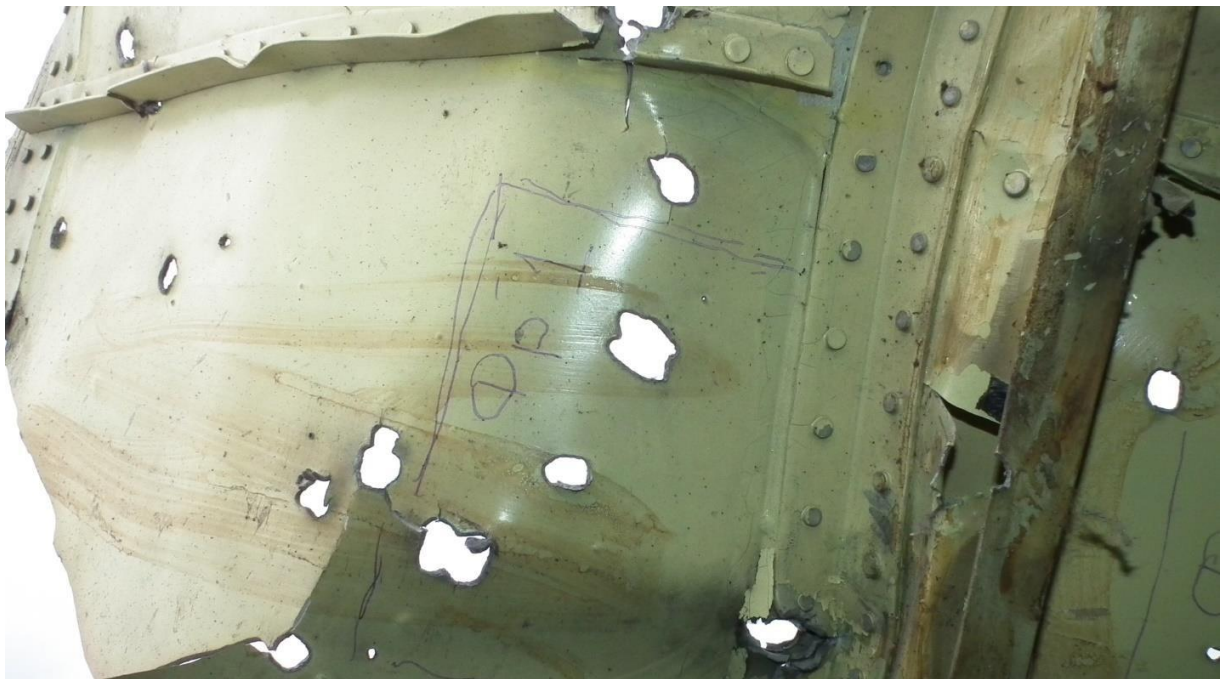
Figure 5.156 - Fragment No. 1 (close-up, inside view). Characteristic holes caused by preformed fragments of 9H314M 1-10 are seen on the inner surface of the skin.

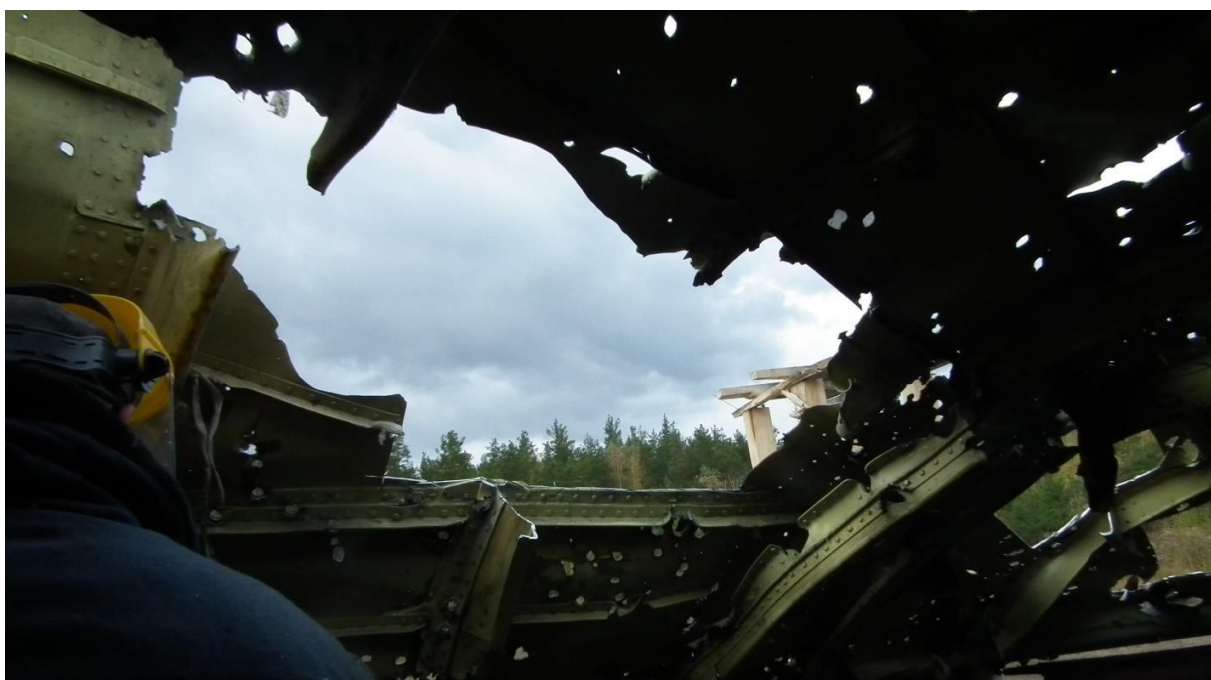
Figure 5.157 - Fragment No. 1 extraction place (internal view)

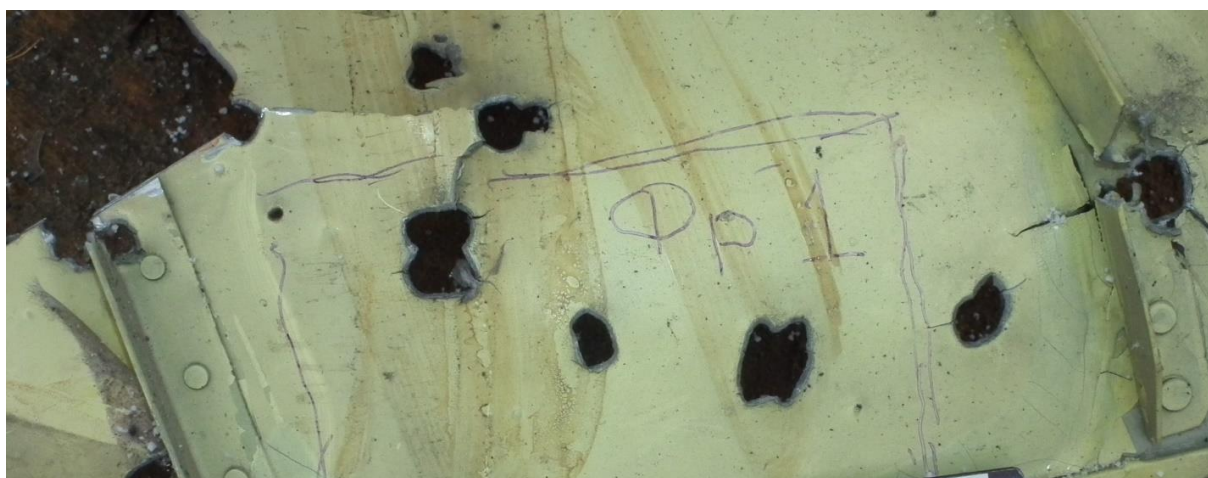
Figure 5.158 - Fragment No. 1 after extraction
(close-up, inside view)

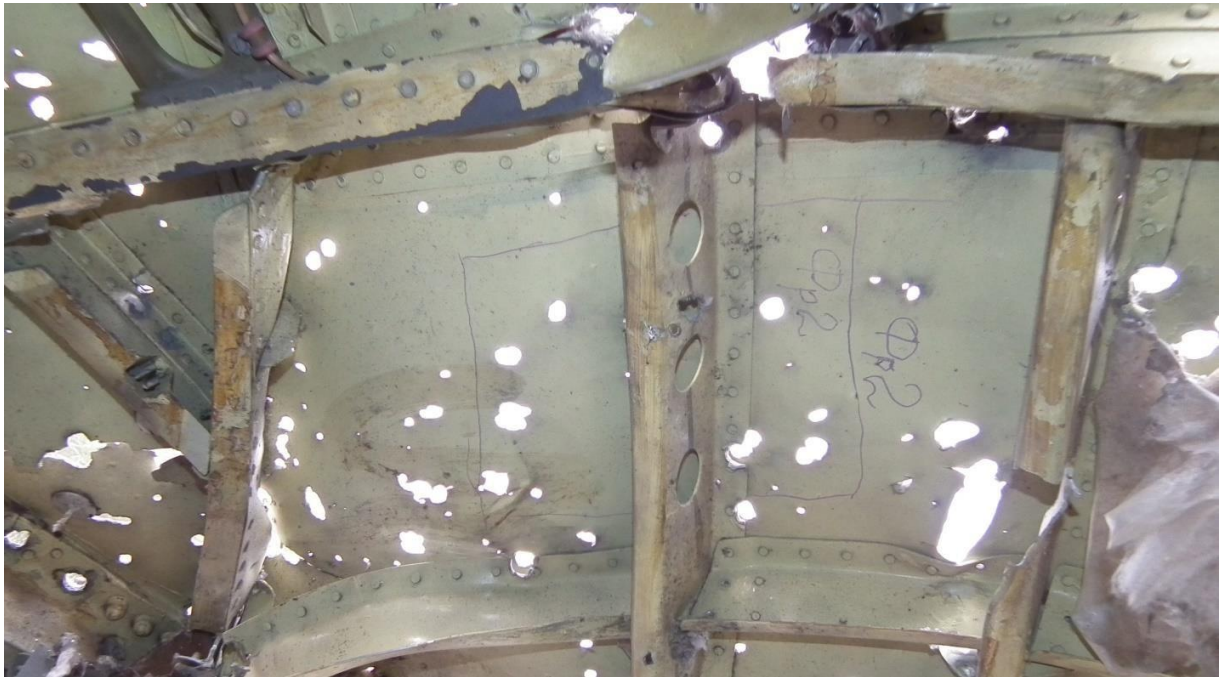
Figures 5.159 and 5.160 contain photographs of a detail of the outer skin of the cockpit with a stringer (Fragment No. 2).

Figure 5.159 - Fragment No. 2 before extraction (inside view)

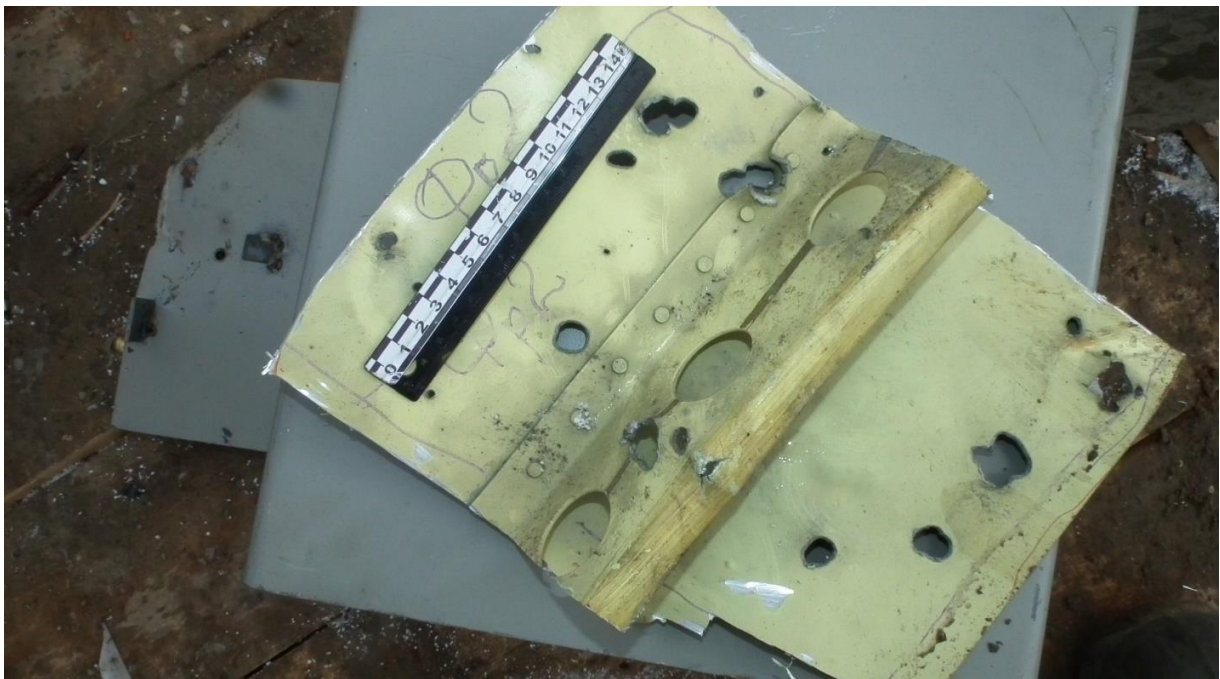
Figure 5.160 - Fragment No. 2 after extraction (inside view)

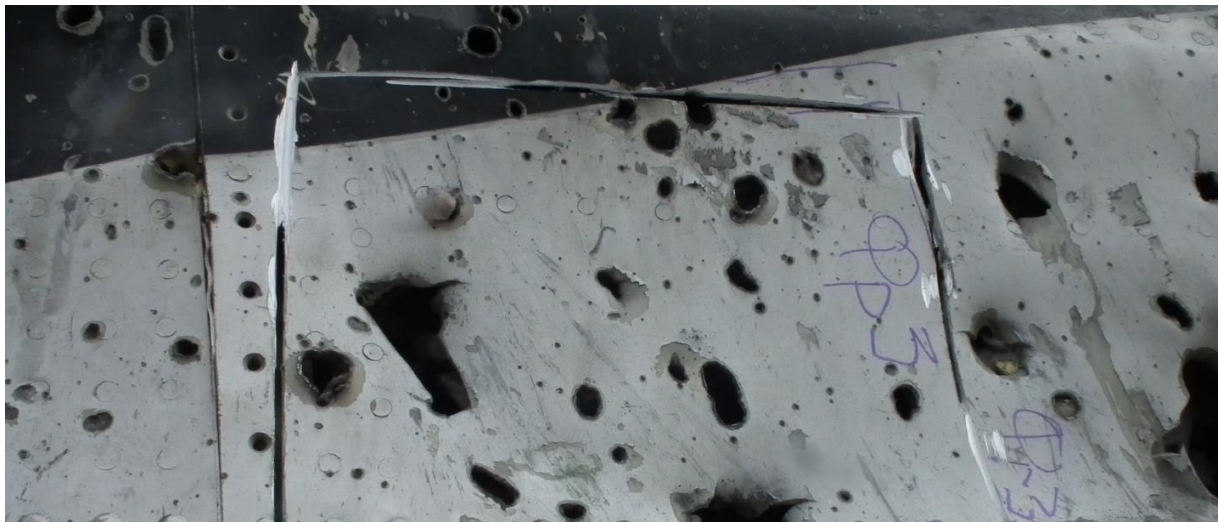
Figures 5.161 through 5.165 contain photos of a fragment of the outer skin of the left side of the cockpit (Fragment No. 3).

Figure 5.161 - Fragment No. 3 before extraction (external view)

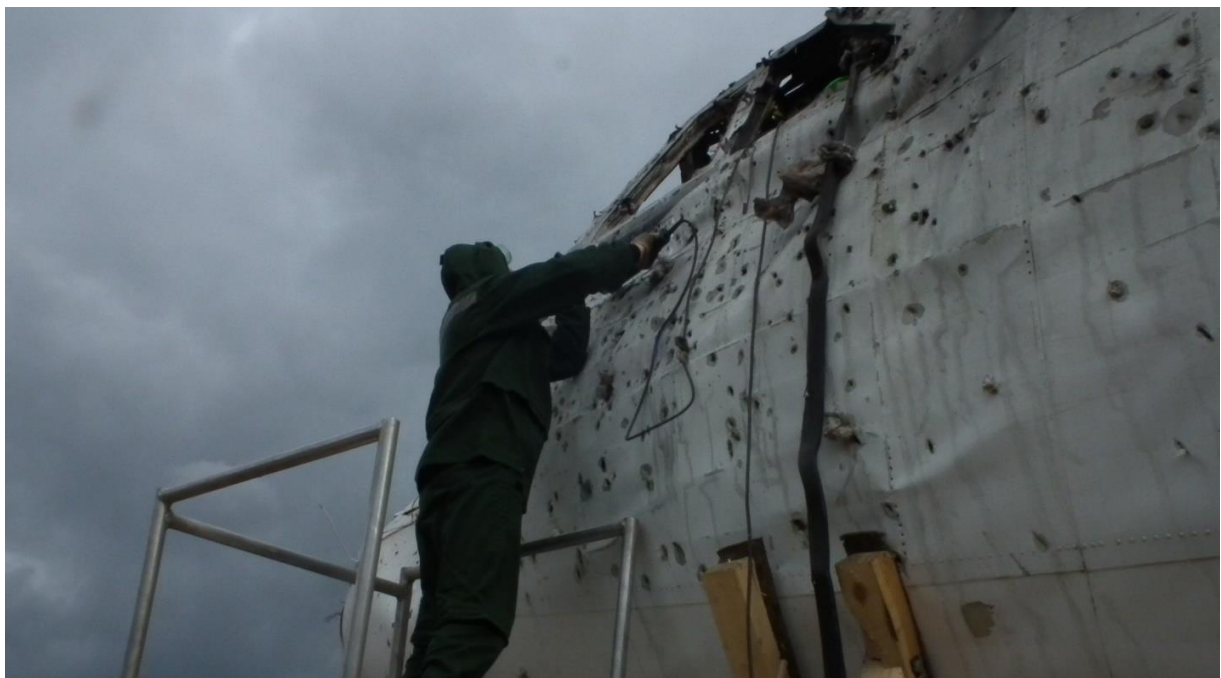
Figure 5.162 - Extracting fragment No. 3

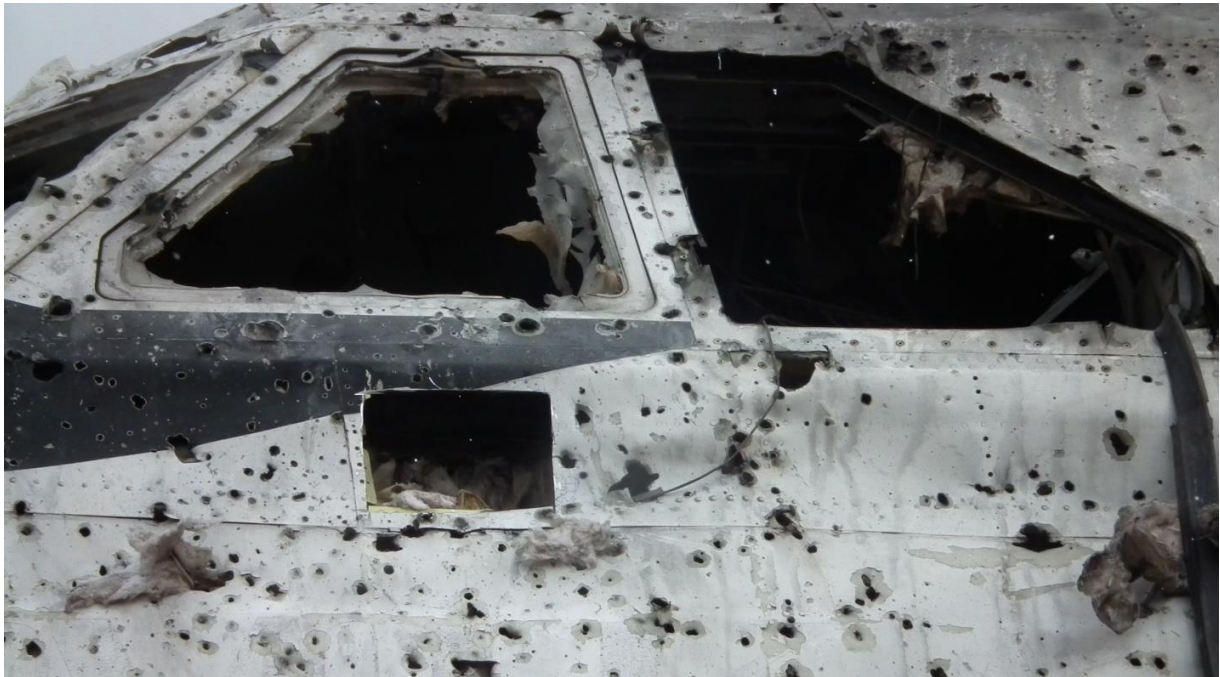
Figure 5.163 - Fragment No. 3 extraction place (external view)

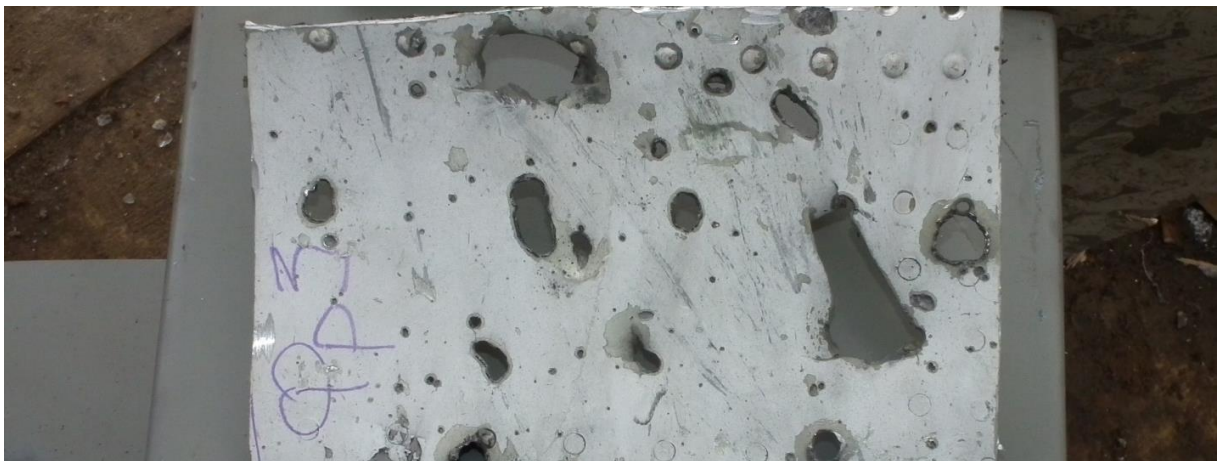
Figure 5.164 - Fragment No. 3 after extraction (external view)

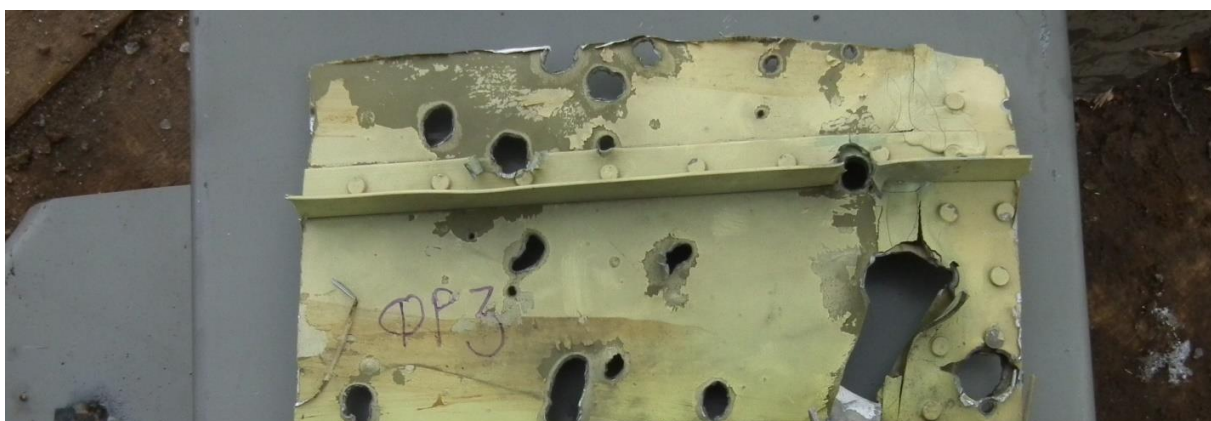
Figure 5.165 - Fragment No. 3 after extraction (internal view)

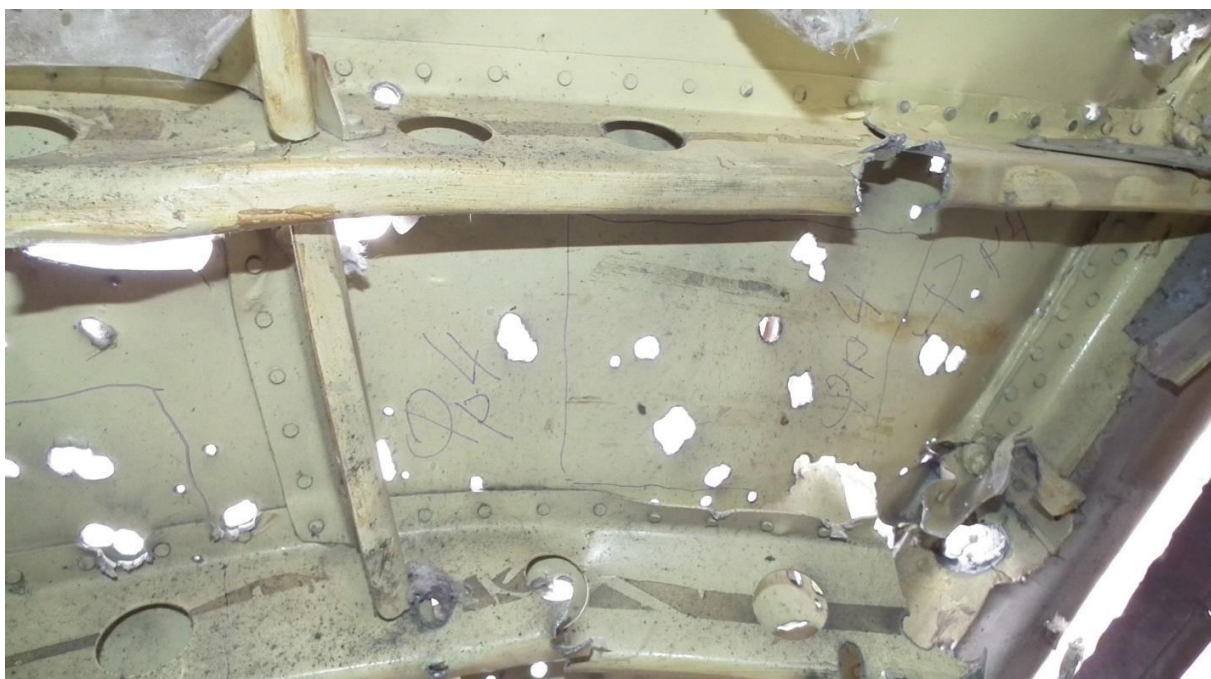
Figure 5.166 contains a photograph of a fragment of the outer skin of the cockpit roof (fragment No. 4) before extraction.

Figure 5.166 - Fragment No. 4 before extraction (internal view)

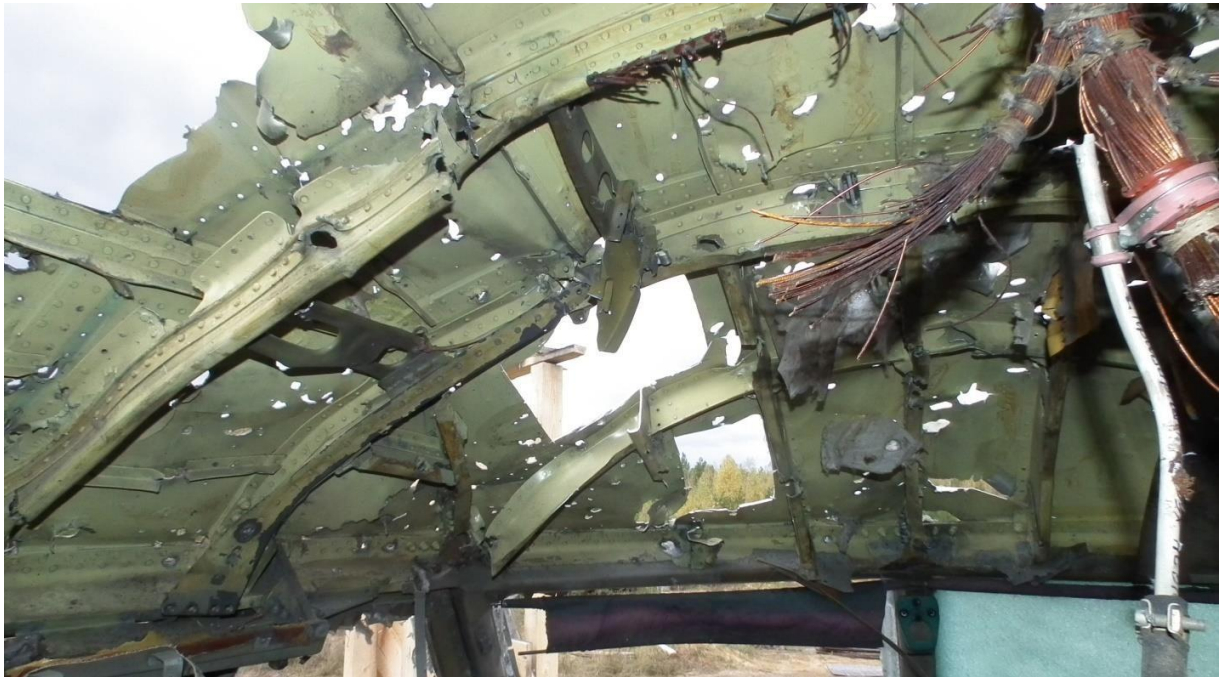
Figure 5.167 - Place of extraction of fragments No. 2 and No. 4 (internal view)

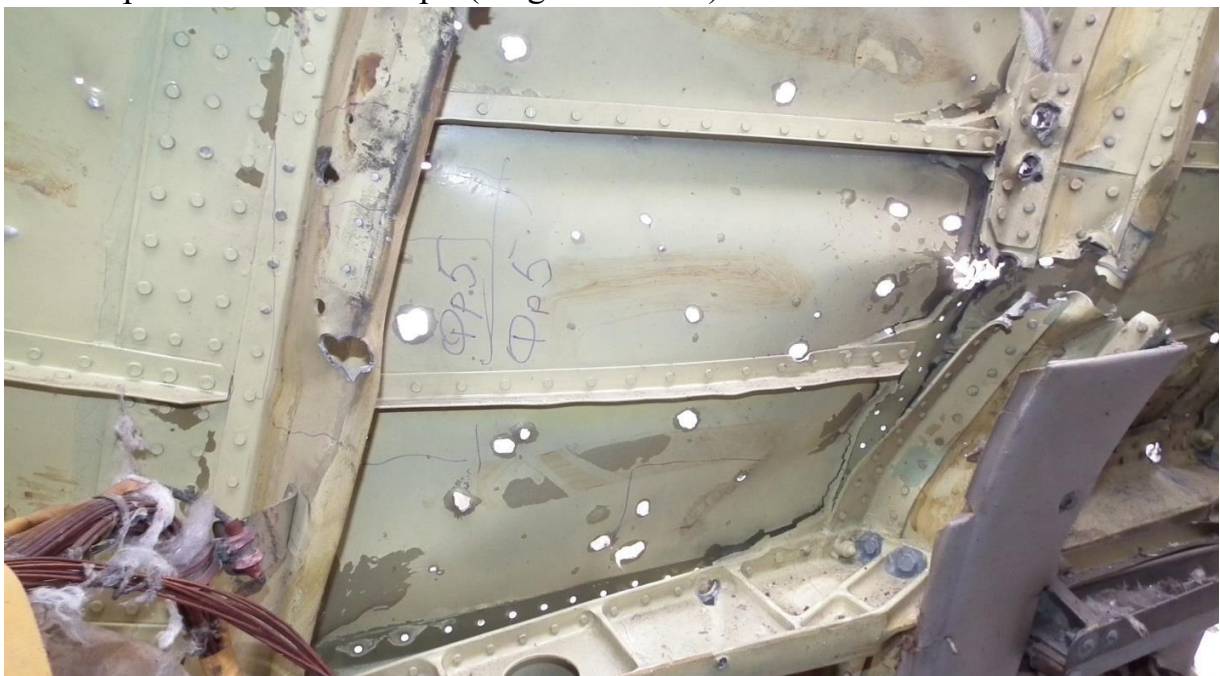
Figure 5.168 - Fragment No. 5 before extraction (internal view)

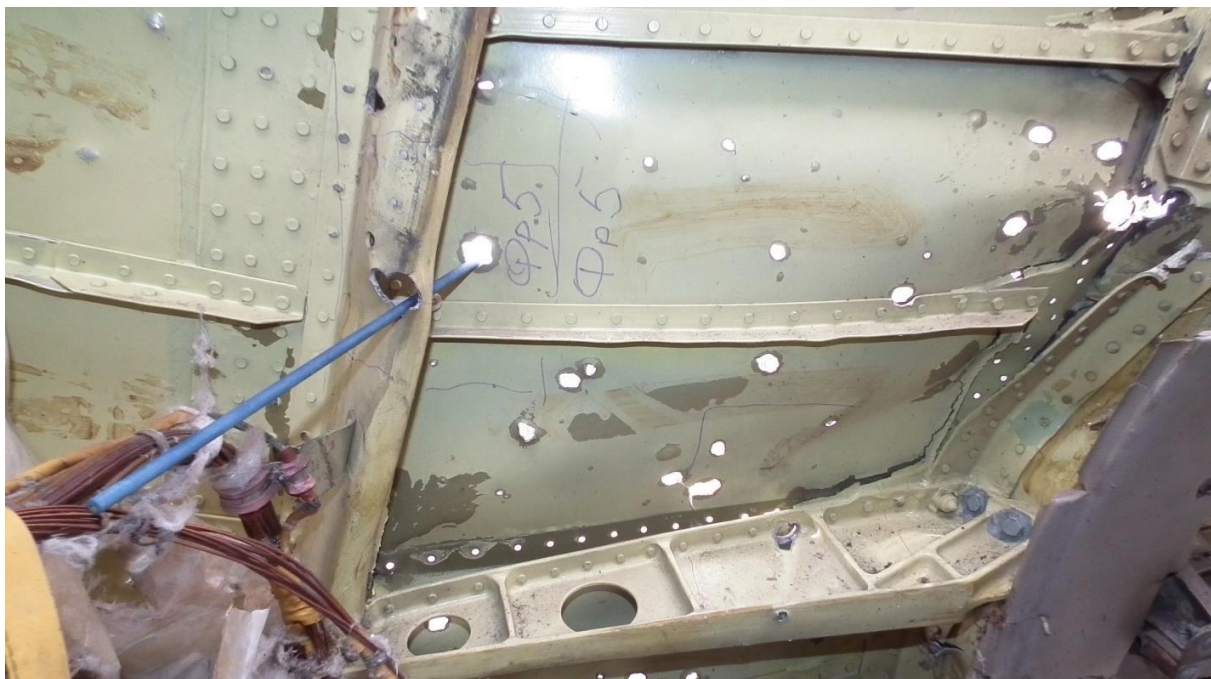
Figure 5.169 - Fragment No. 5 before extraction (internal view). The blue bar shows the trajectory of entry of a projectile of 9H413M 1-10, which, after piercing the outer skin, penetrated the L-shaped reinforcement of a frame

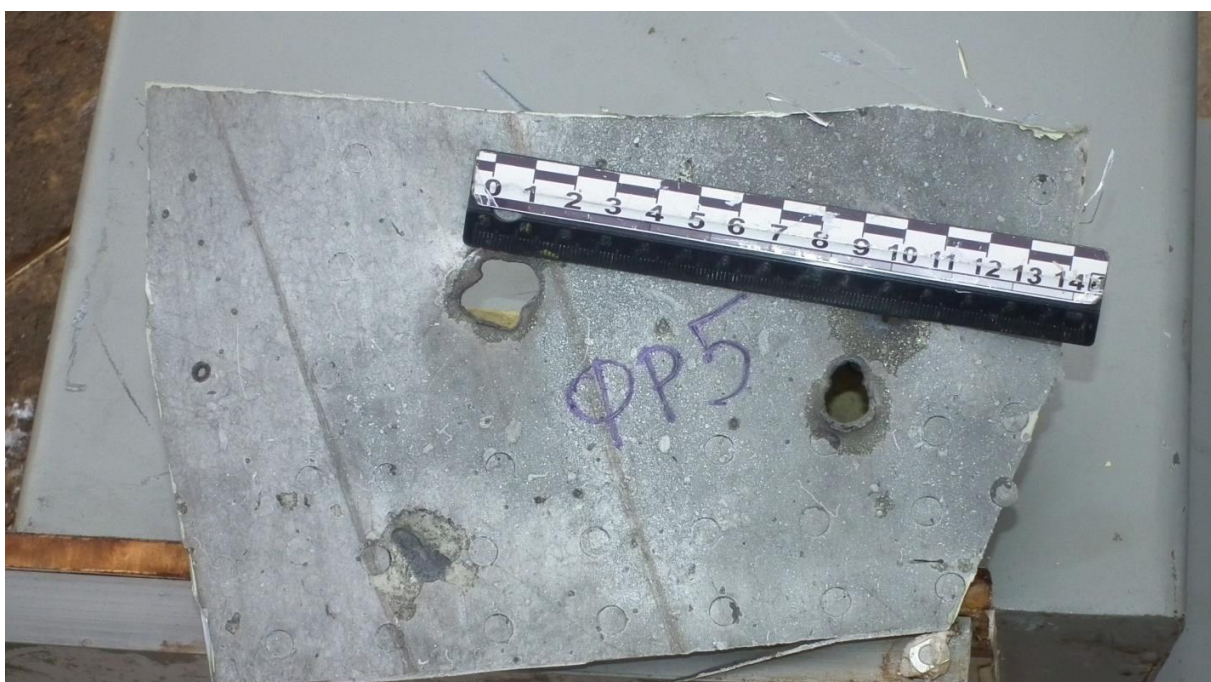
Figure 5.170 - Fragment No. 5 after extraction (external view)

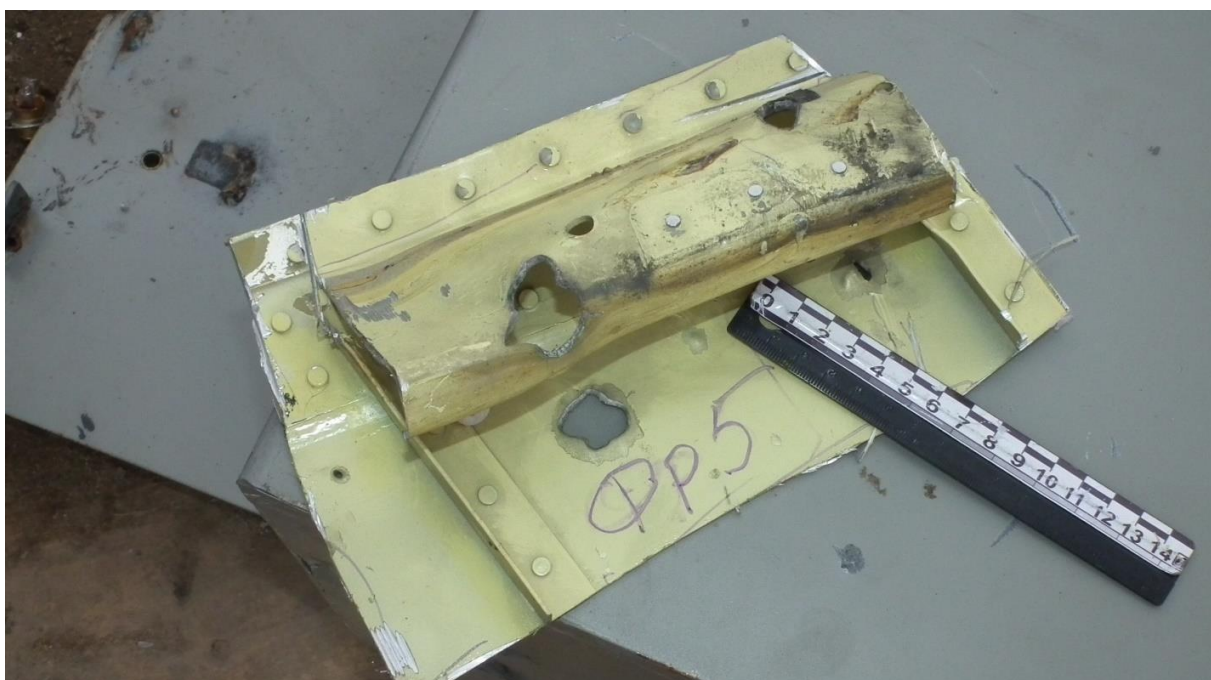
Figure 5.171 - Fragment No. 5 after extraction (internal view)

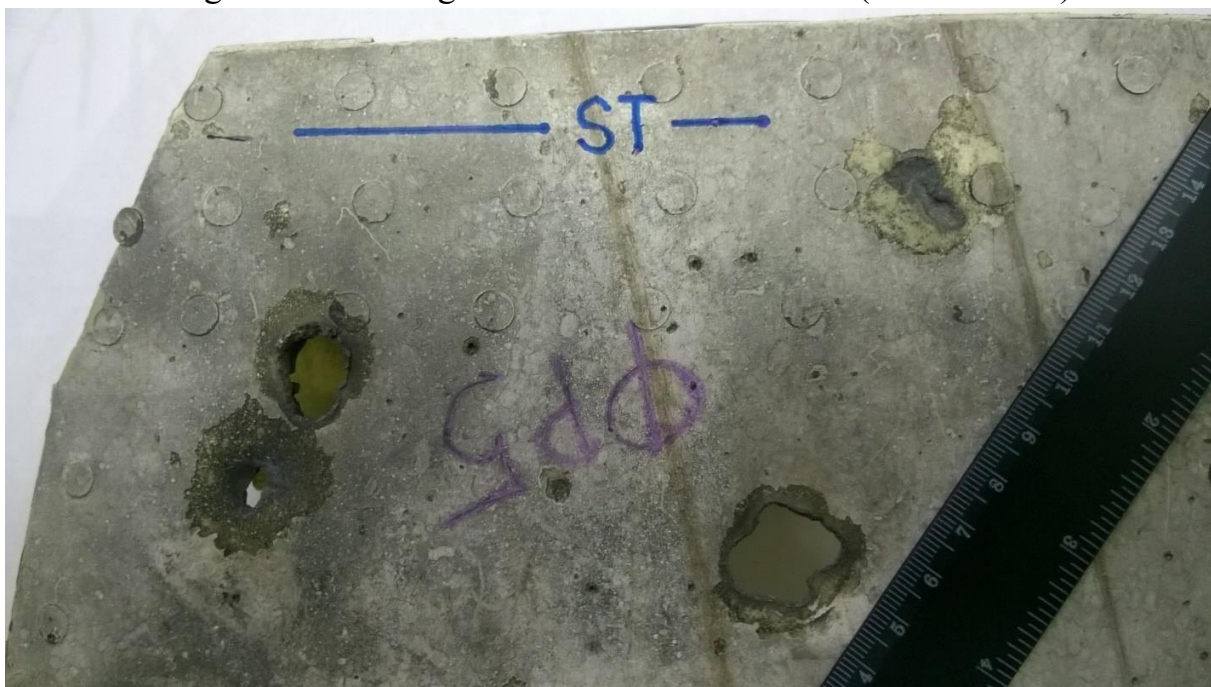
Figure 5.172 - Condition of the outer skin of the port with traces of blast effects (micro-craters, thermal influence) and penetrating and non-penetrating damage caused by ready-made projectiles and missile hull fragments

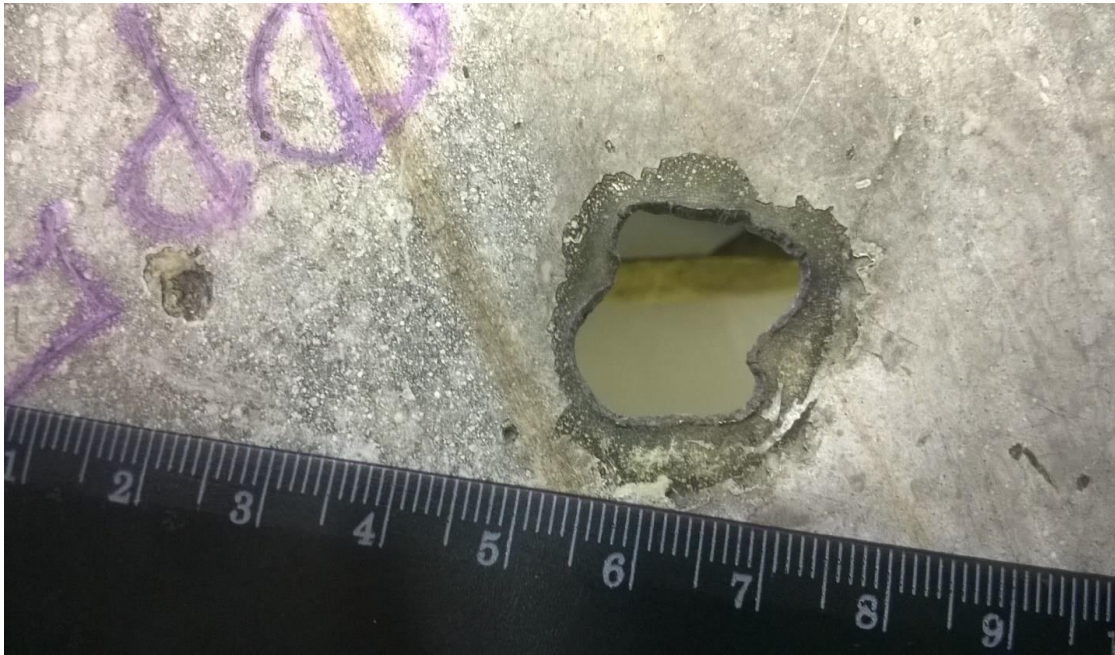
Figure 5.173 - Characteristic butterfly-shaped hole in the outer skin of the port caused by a bowtie shaped preformed fragment of 9H314M 1-10 (Fragment No. 5, outside view)

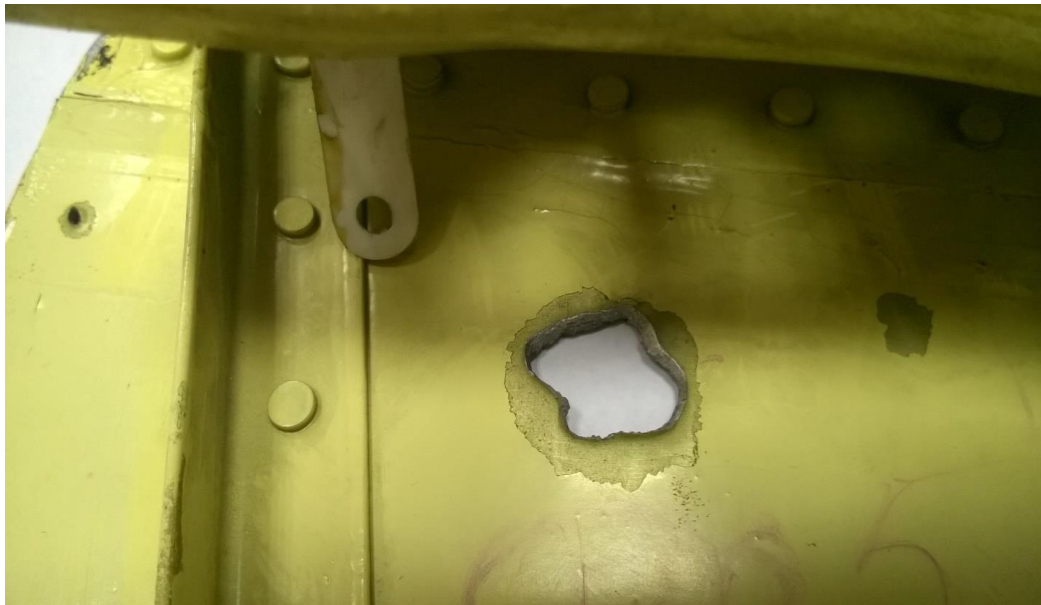
Figure 5.174 - Characteristic butterfly-shaped hole in the outer skin of the port caused by a bowtie shaped preformed fragment of 9H314M 1-10 (inside view)

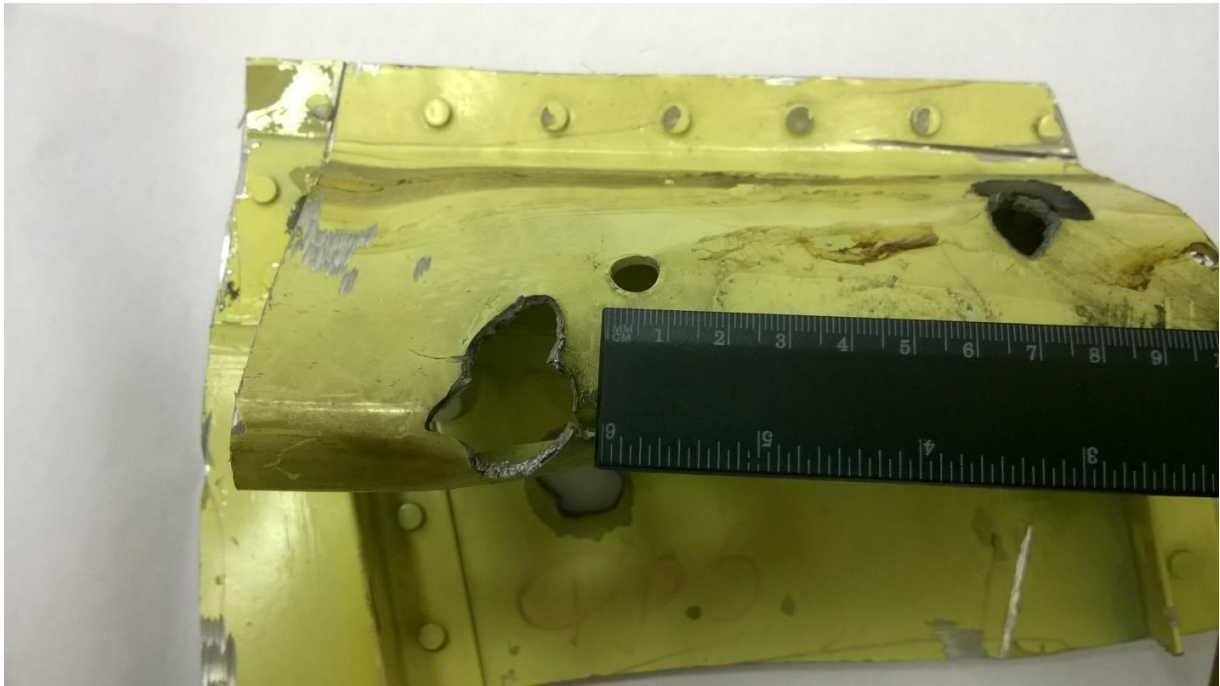
Figure 5.175 - Through-and-through holes in the frame in fragment No. 5

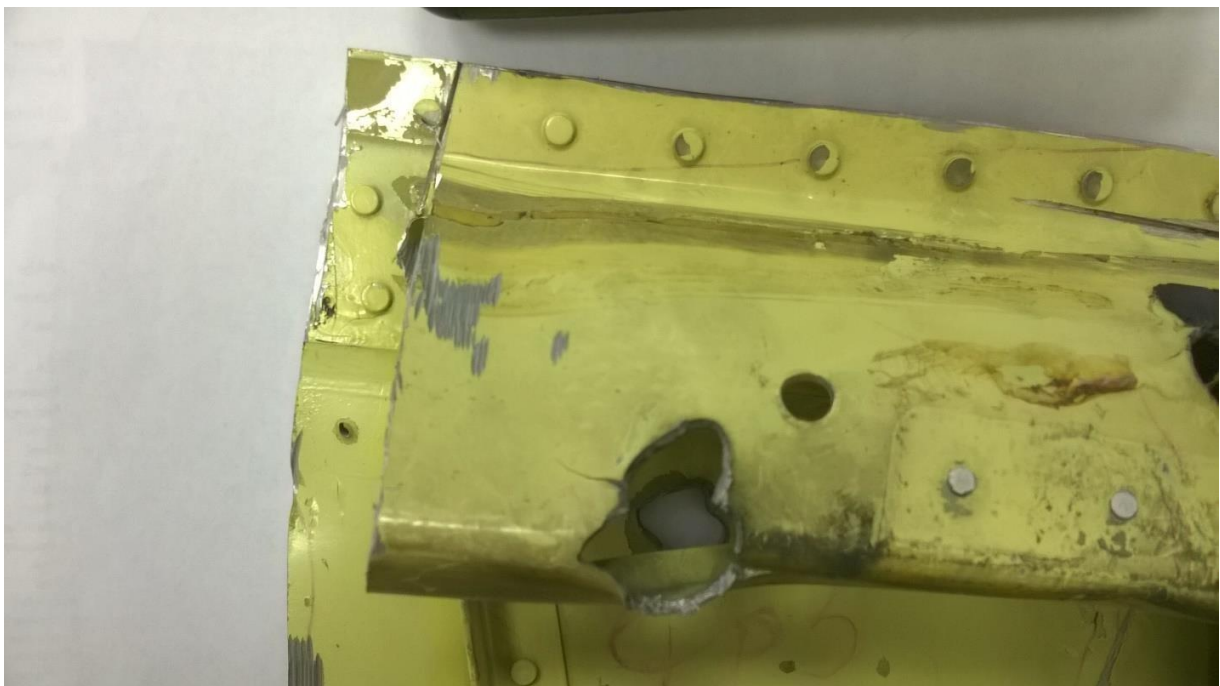
Figure 5.176 - Alignment of through-and-through holes in the frame and outer skin of fragment No. 5

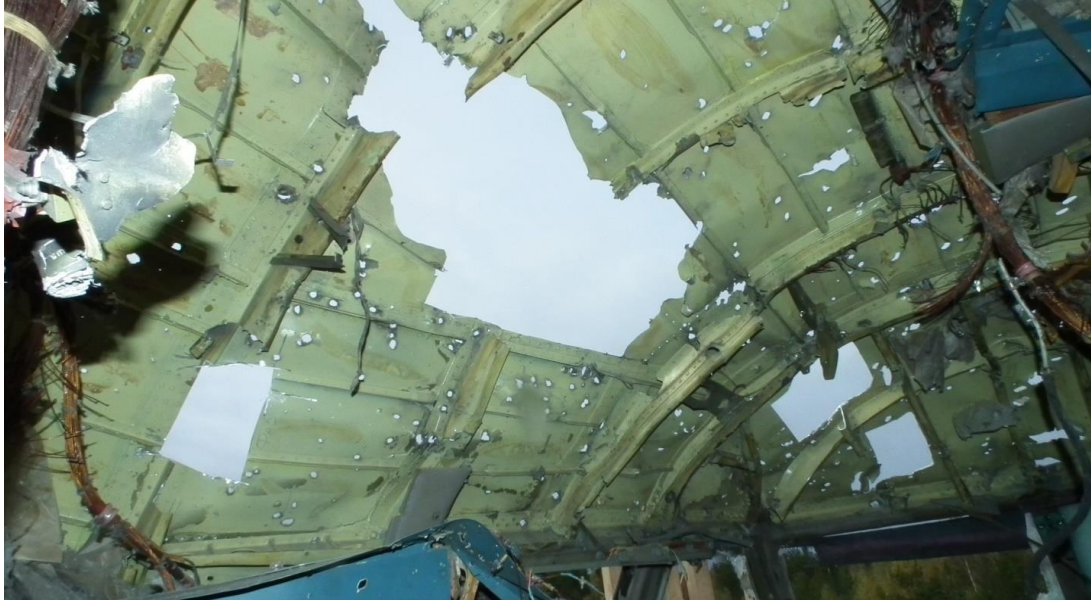
Figure 5.177 - Locations of extracted fragments No. 1, No. 2, No. 4 and No. 5 (inside view)

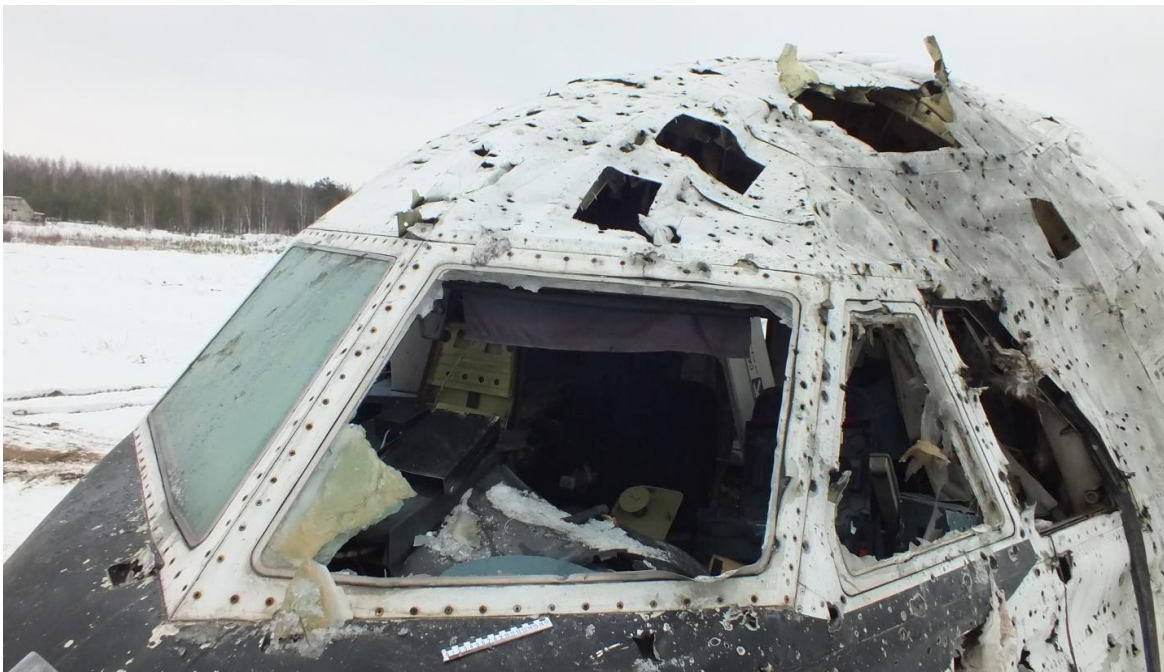
Figure 5.178 - Locations of extracted fragments (external view)

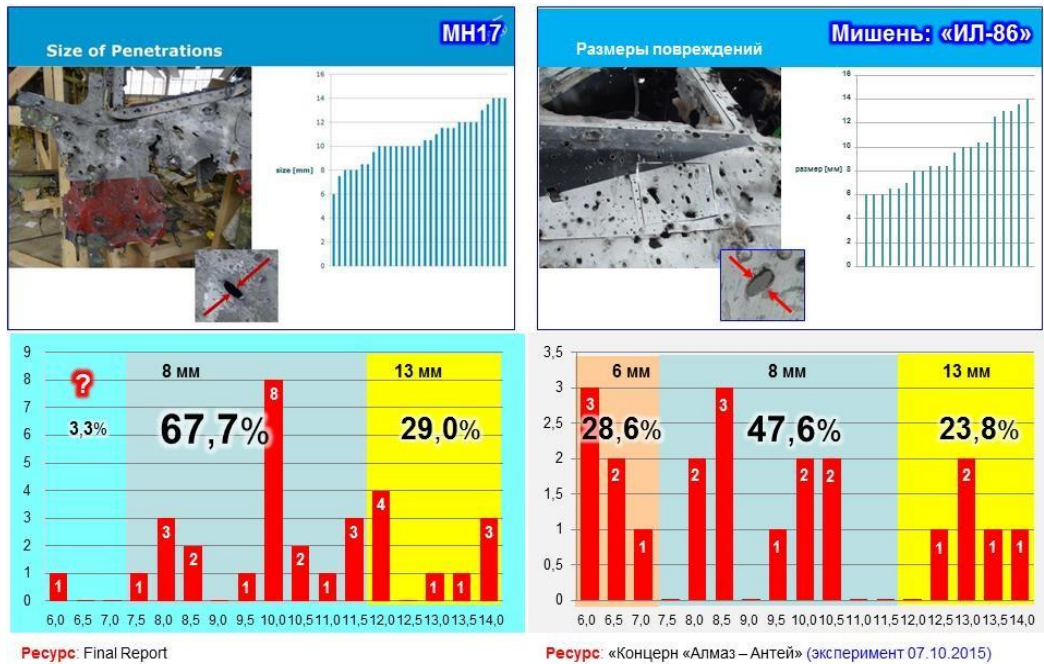
The Dutch experts performed measurements in relation to one of the port side fragments and measured 31 holes. Similar measurements were carried out on a fragment of the outer skin of the target aircraft (in the area of fragment No. 3), which has similar distribution in the aircraft structure. The cross-sectional dimensions of the entry holes and the results of their analysis are shown in figure 5.179.

Thus, a comparative analysis of the cross-sectional dimensions of the holes caused by preformed fragments indicates that the fragmentation damage to the Boeing 777 structure could not have been caused by preformed fragments of the 9H314M warhead.

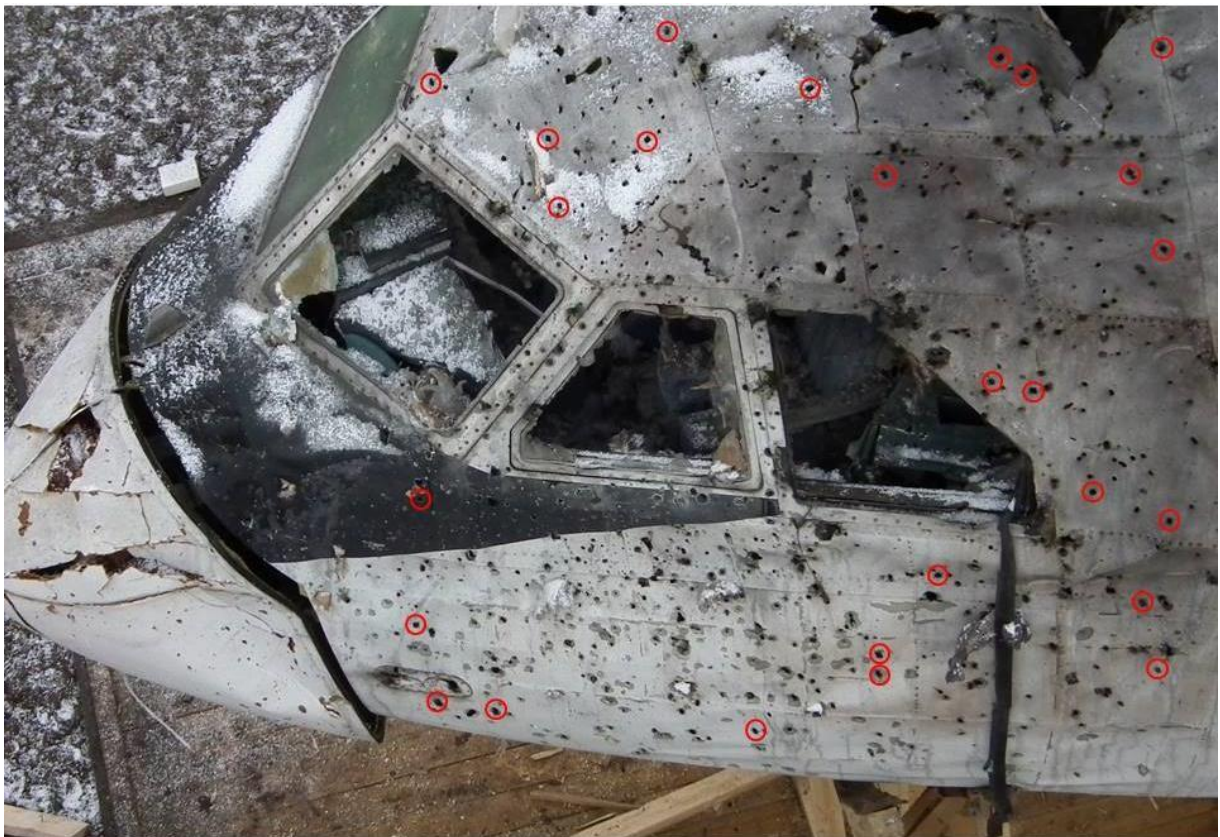
One of the main peculiarities of the damage to the outer skin of the target aircraft distinguishing it from damage to the Boeing 777 is the presence of multiple through-and-through holes on the port side and the cockpit roof, which have a characteristic butterfly-shape.

Figure 6.1 - Port side and left side of the cockpit roof of IL-86 target aircraft

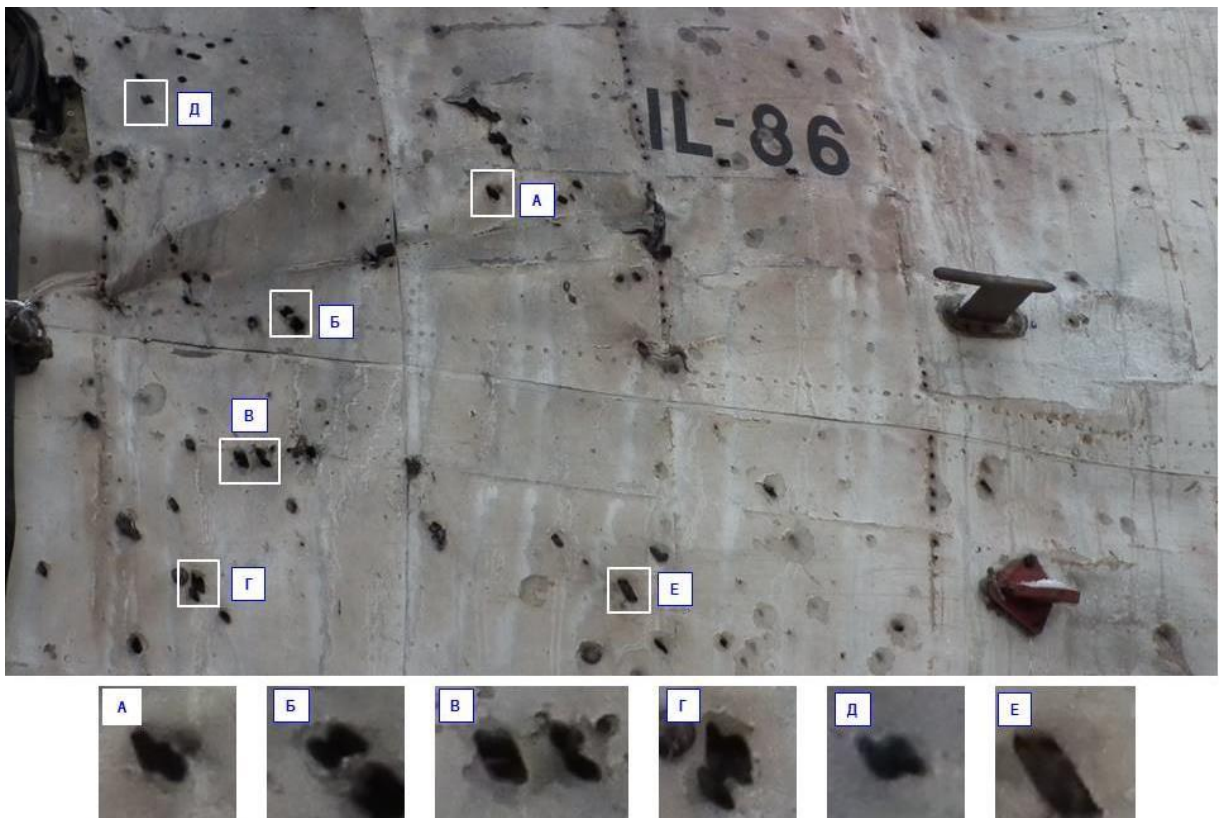
Figure 6.2 - Port side of the cockpit
