**APPLICATION OF THE INTERNATIONAL CONVENTION FOR THE SUPPRESSION
OF THE FINANCING OF TERRORISM AND OF THE INTERNATIONAL
CONVENTION ON THE ELIMINATION OF ALL FORMS OF RACIAL
DISCRIMINATION**

REJOINDER

Report of JSC Air and Space Defense Corporation "Almaz-Antey" on the results of studies related to the technical investigation into the crash of the Malaysian airlines Boeing 777-200 9M-MRD (flight MH17), 2023

on the results of studies related to the technical investigation into the crash
of the Malaysian airlines Boeing 777-200 9M-MRD (flight MH17)

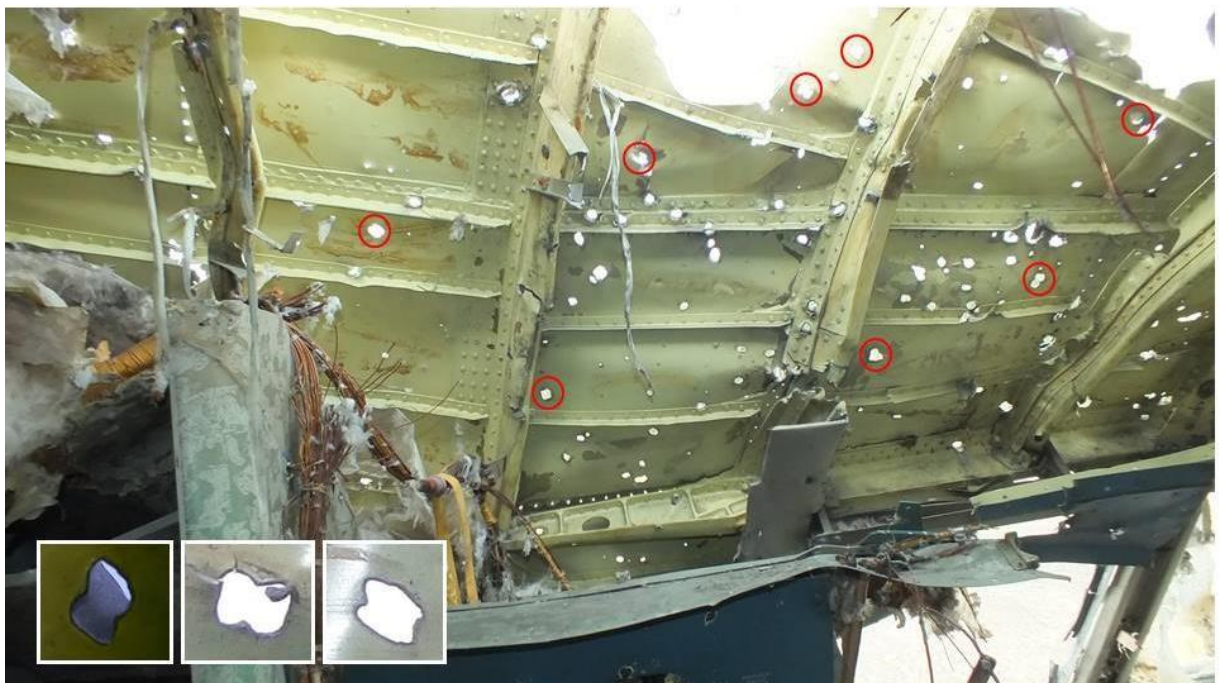
Figure 6.3 - Port side of the cockpit (inside view)

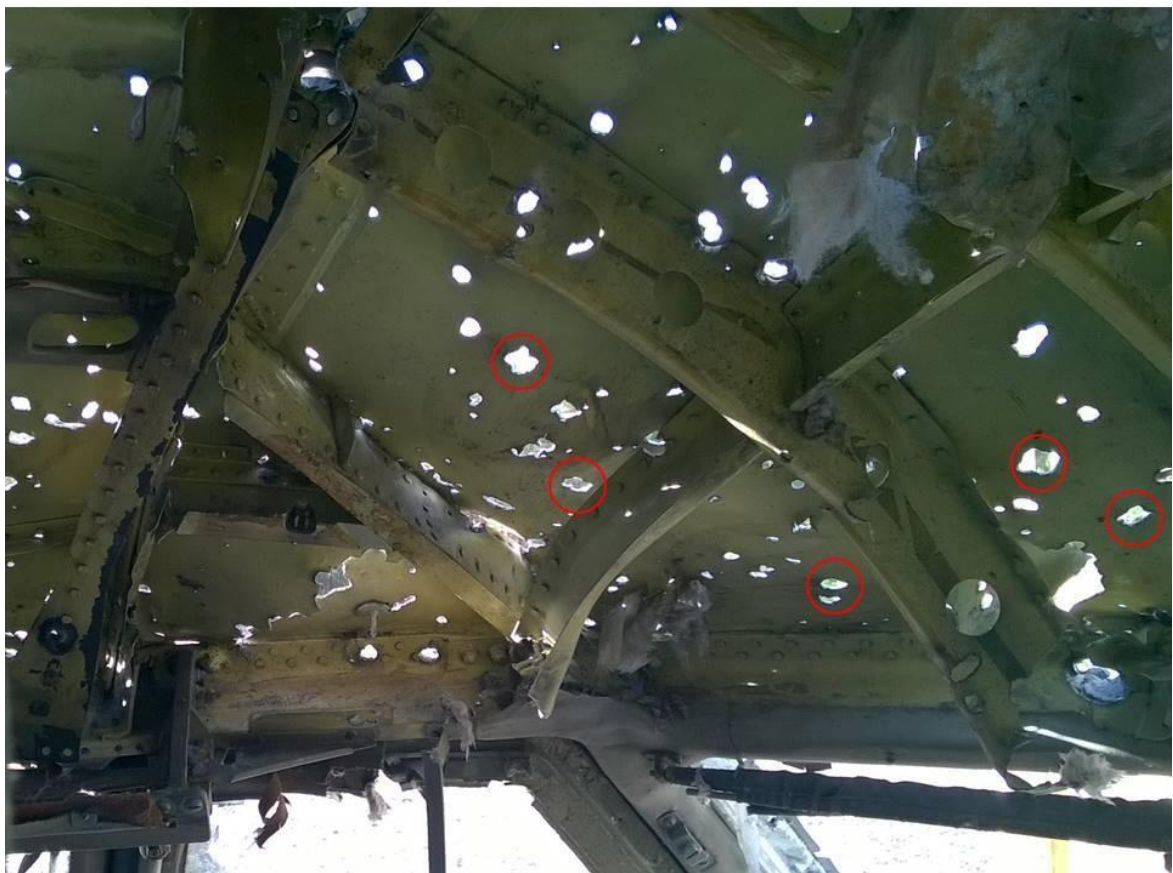
Figure 6.4 - Left-hand side of cockpit roof

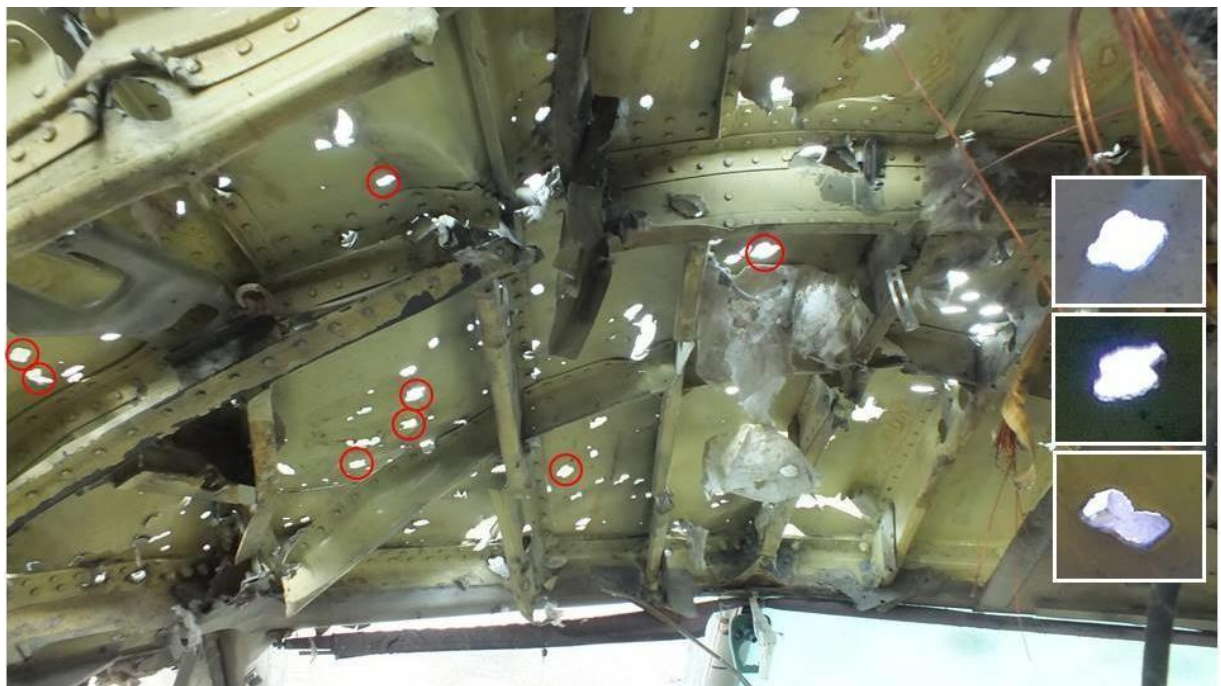
Figure 6.5 - Cockpit roof

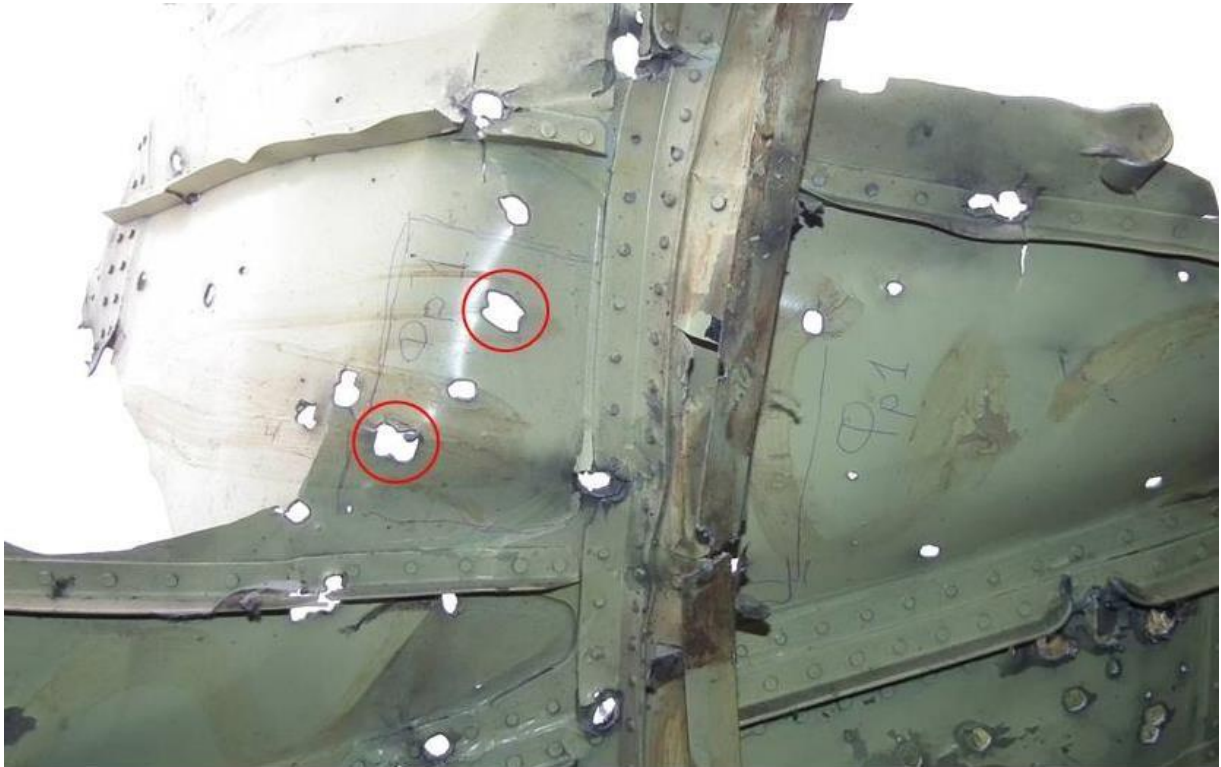
Figure 6.6 - Fragment of the upper section of the port behind the aircraft commander's seat

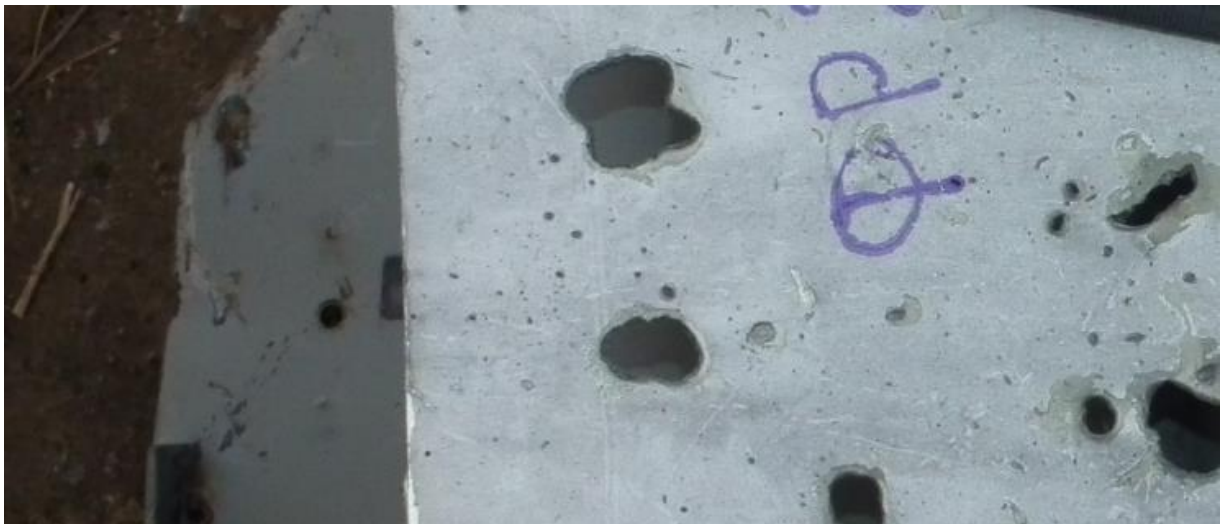
Figure 6.7 - Appearance of a characteristic butterfly-shaped hole in a fragment of the cockpit roof (external view)

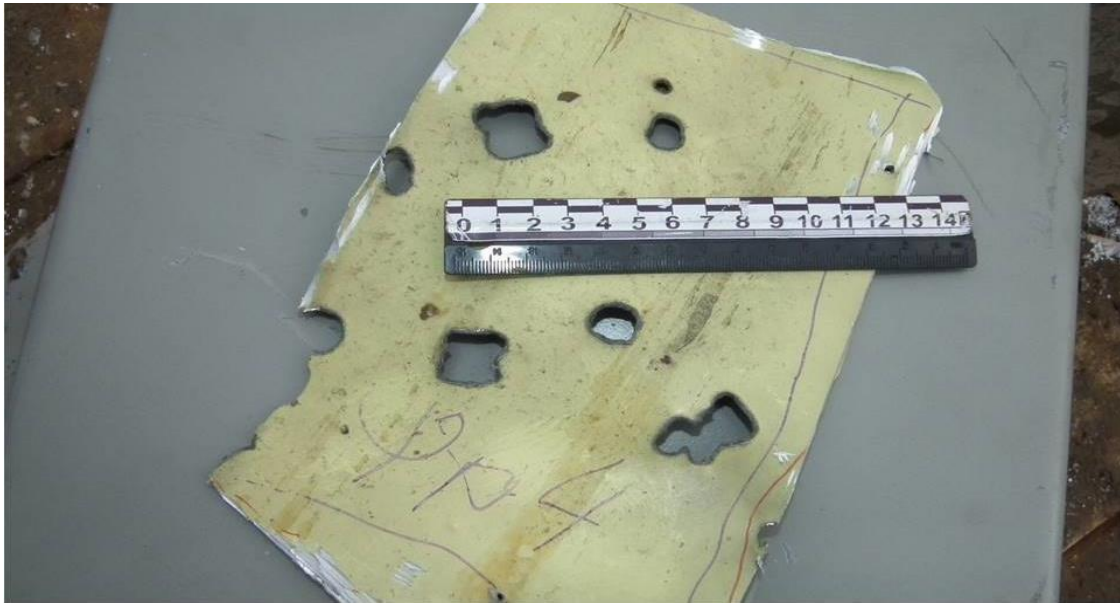
Figure 6.8 - Fragment of the left-hand side of the cockpit roof (inside view)

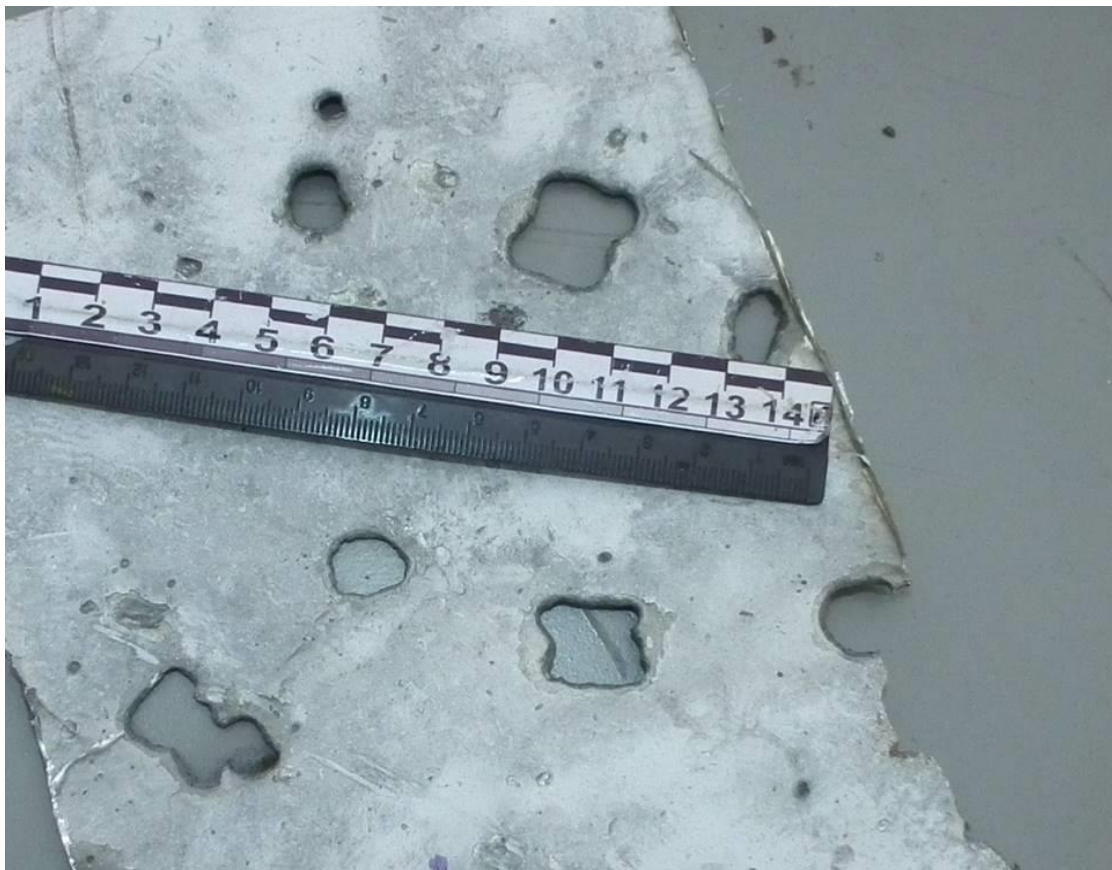
Figure 6.9 - Appearance of characteristic butterfly-shaped holes in a fragment of the cockpit roof (external view)

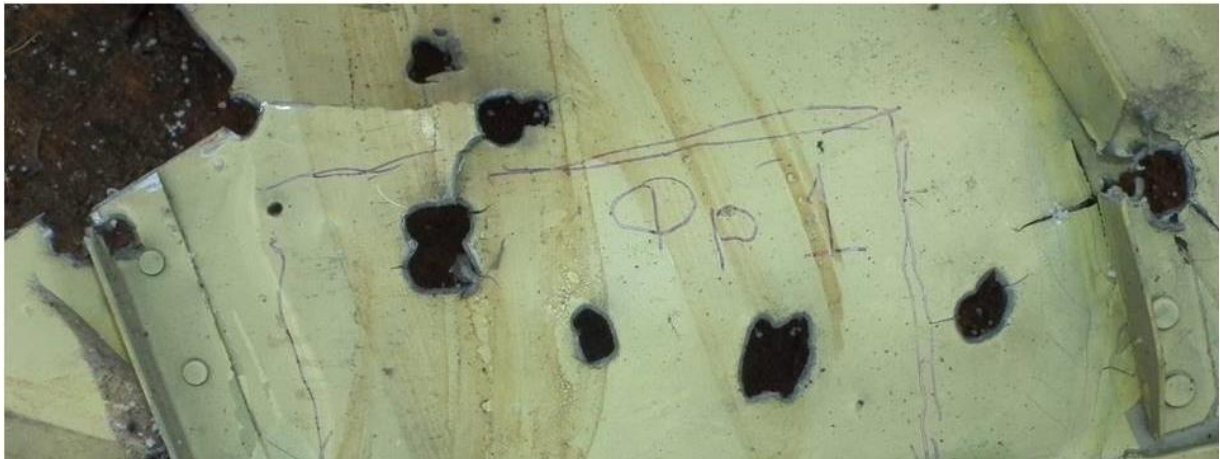
Figure 6.10 - Fragment of the port side

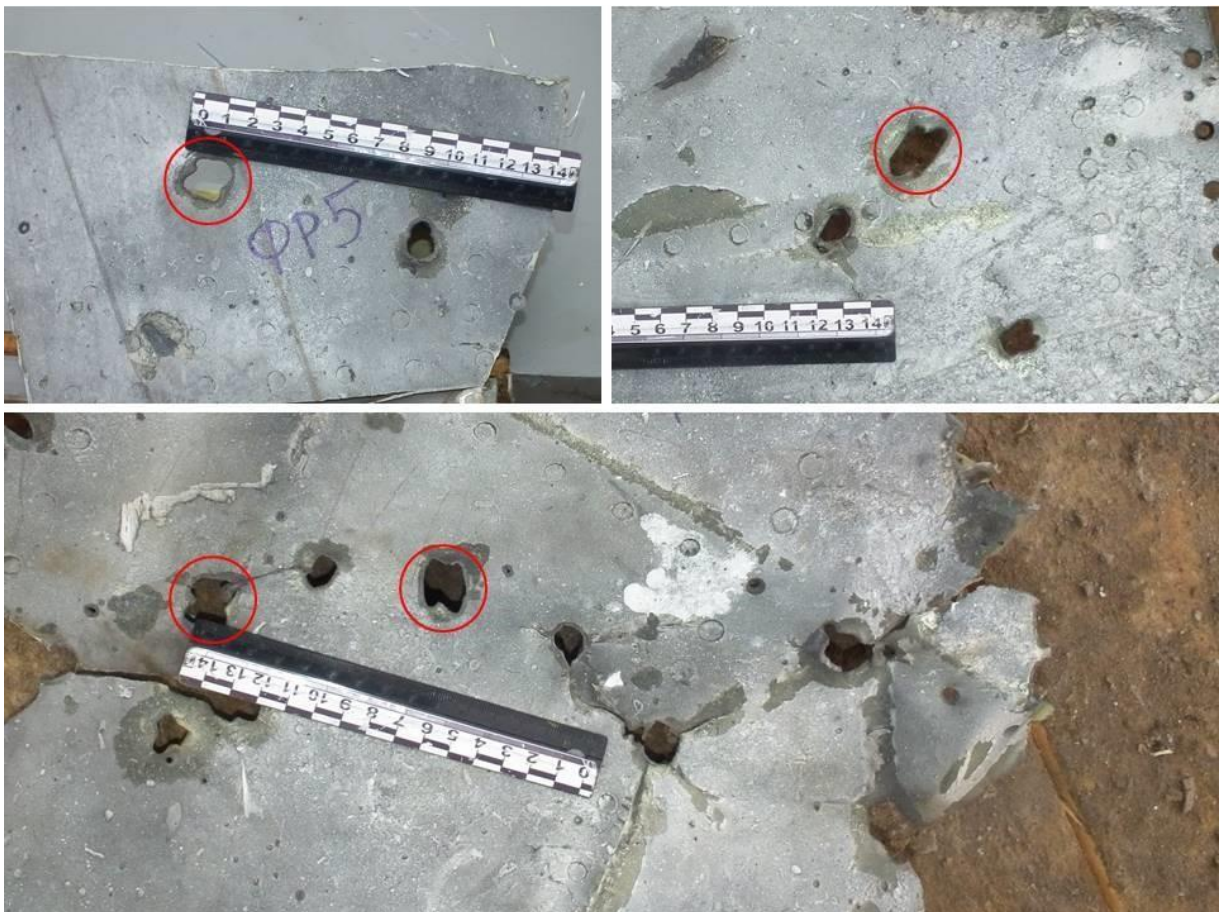
Figure 6.11 - Fragments of the port side and the cockpit roof

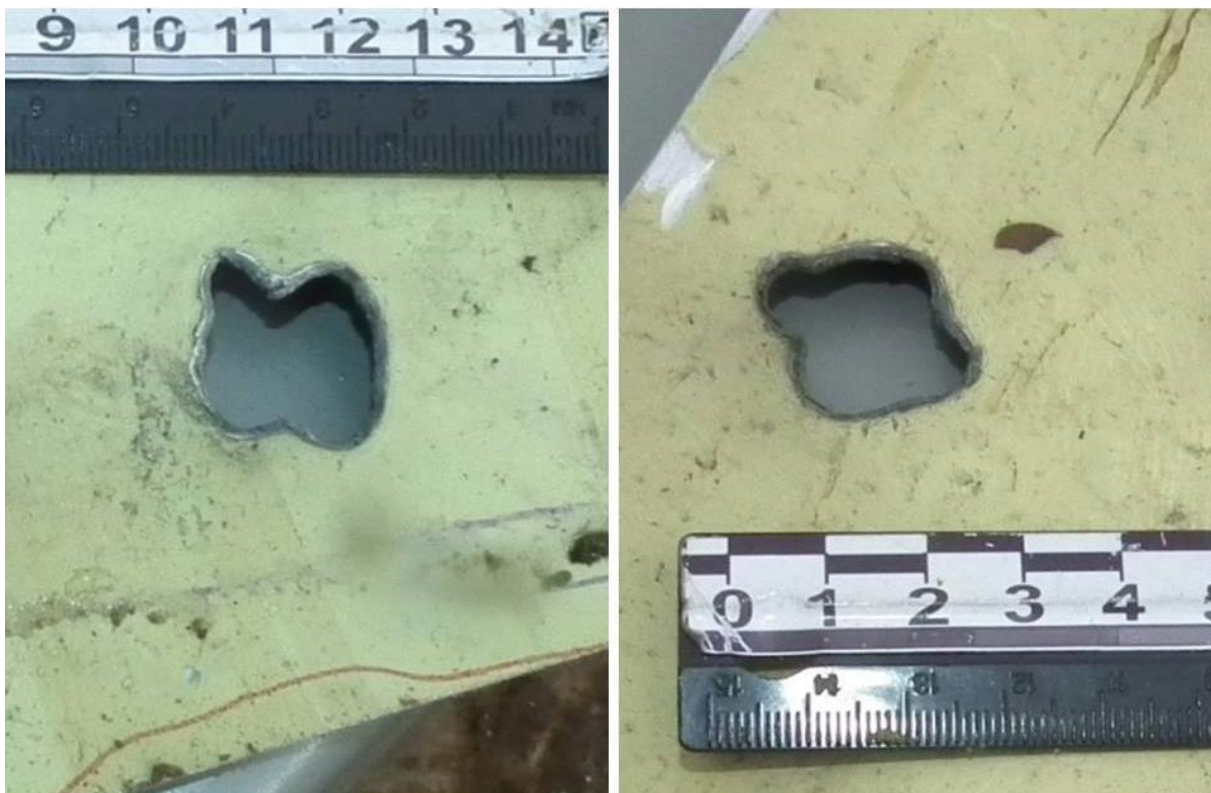
Figure 6.12 - Appearance of characteristic butterfly-shaped holes in the outer skin of the target aircraft (inside view)

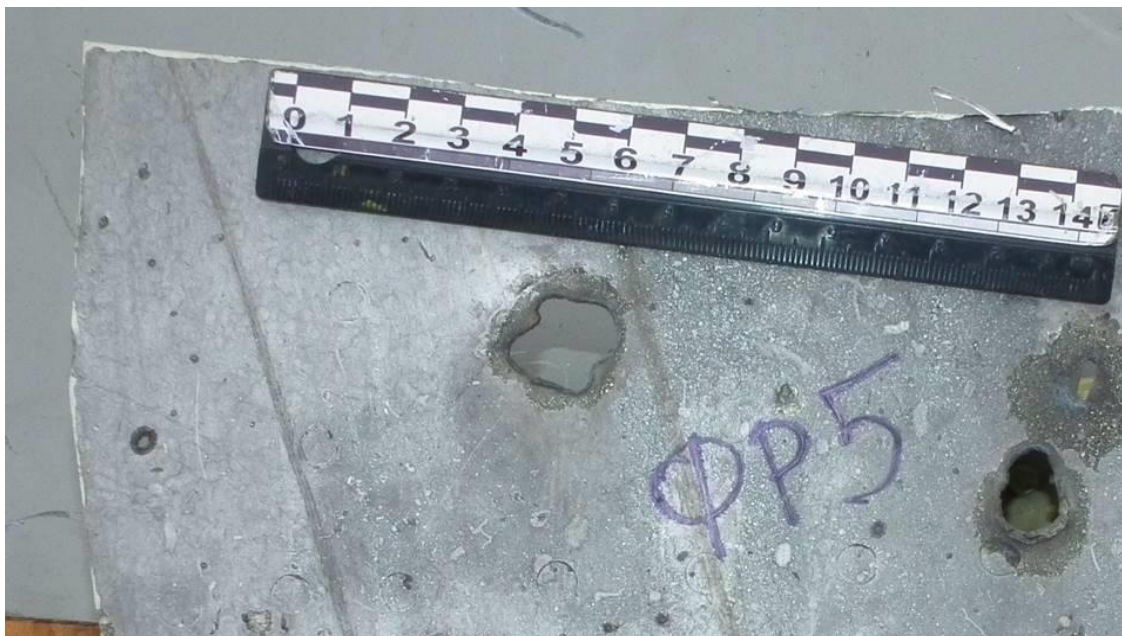
Figure 6.13 - Appearance of a characteristic butterfly-shaped hole in the outer skin of the target aircraft (external view)

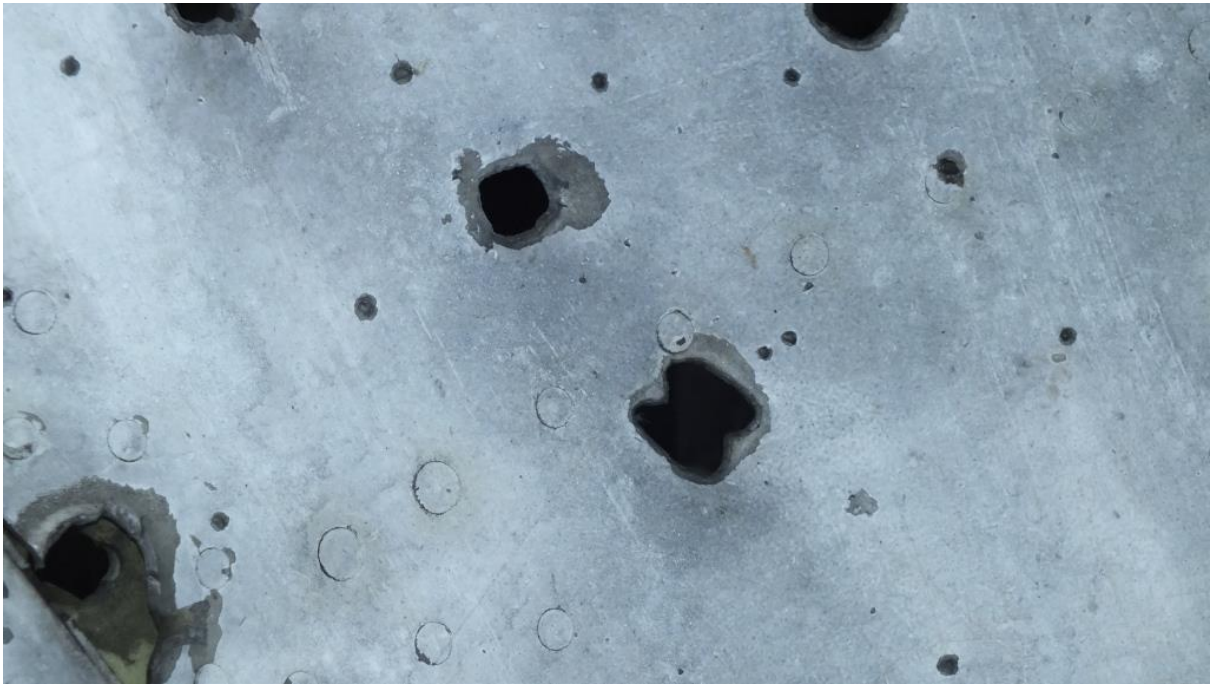
Figure 6.14 - Skin of the port side (close-up)

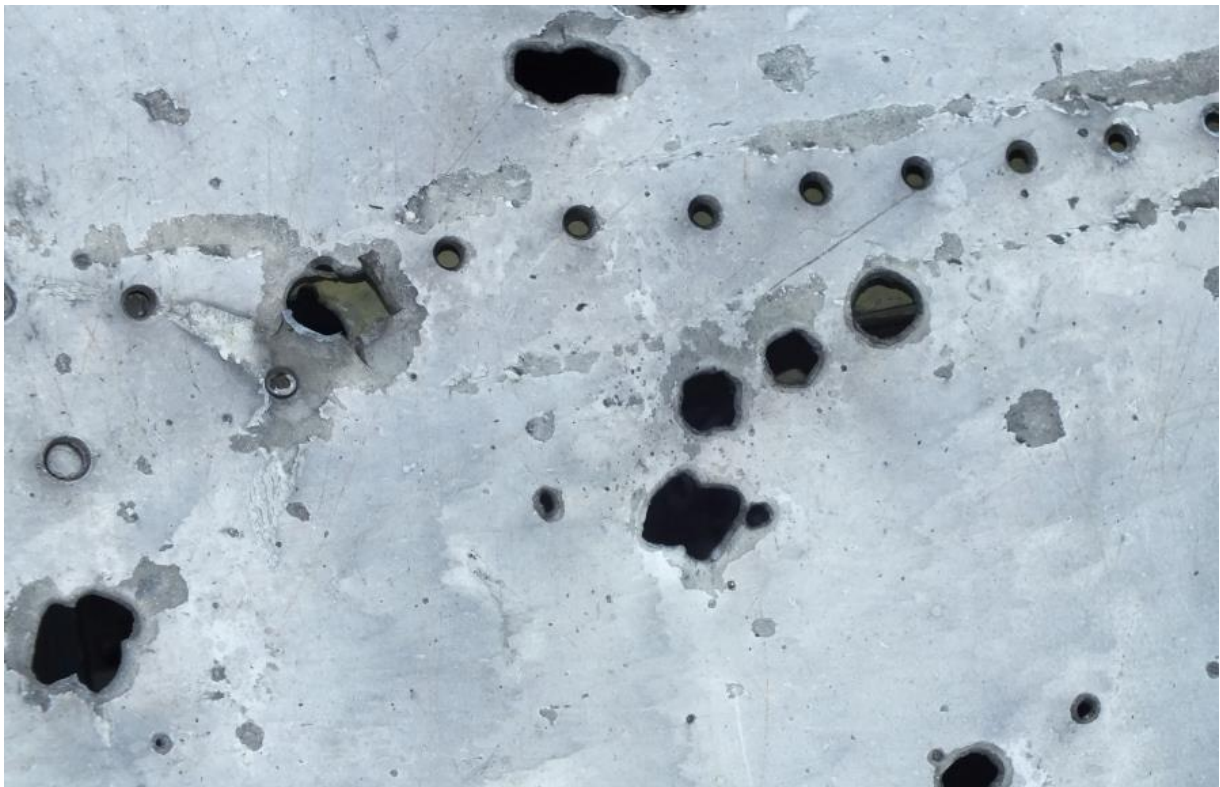
Figure 6.15 - Skin of the port side (close-up)

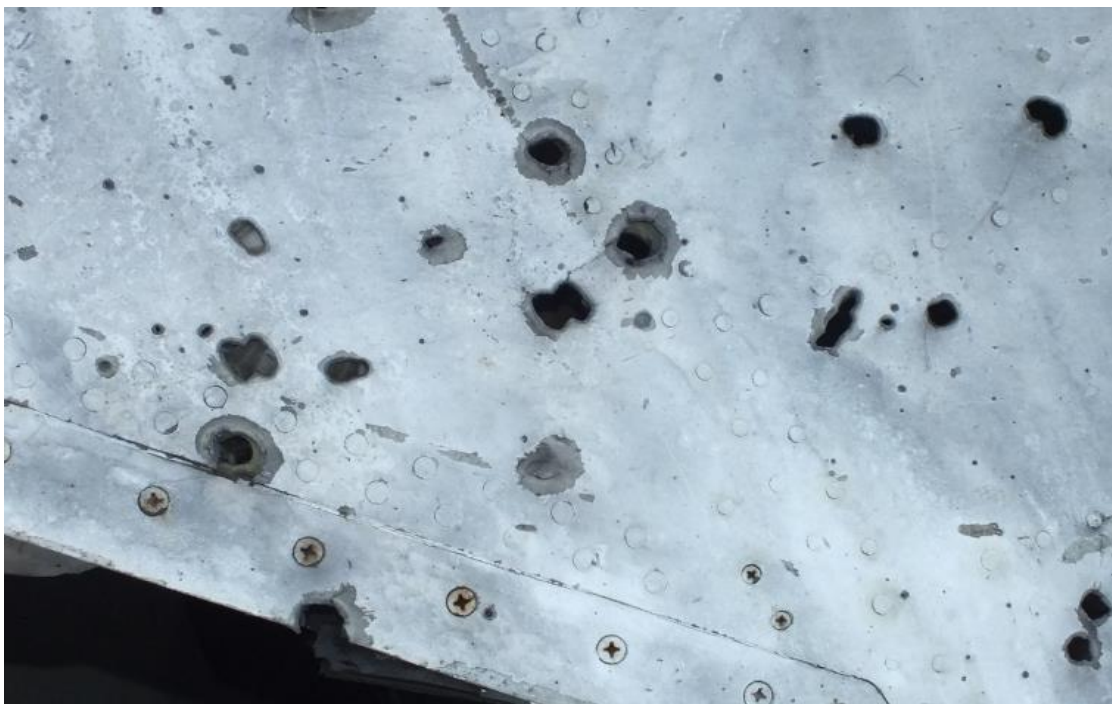
Figure 6.16 - Fragment of the outer skin above the aircraft commander's window

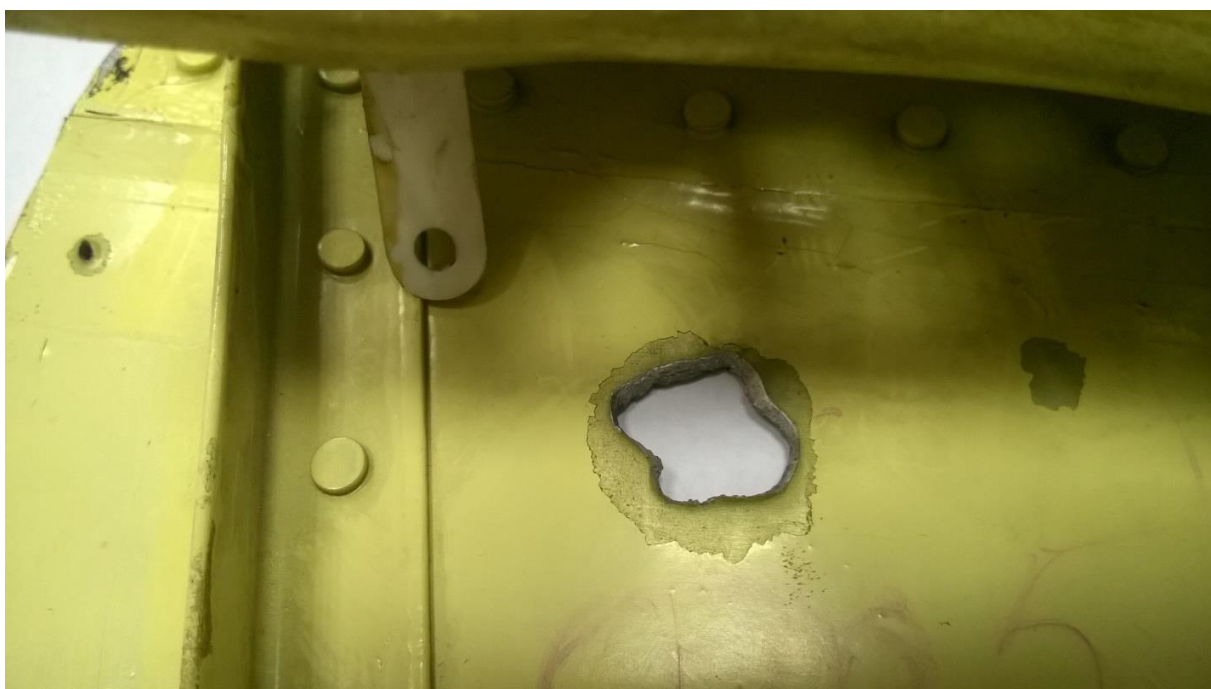
Figure 6.17 - Characteristic butterfly-shaped hole in the outer skin of the port hull caused by a preformed fragment 9H314M 1-10 (inside view)

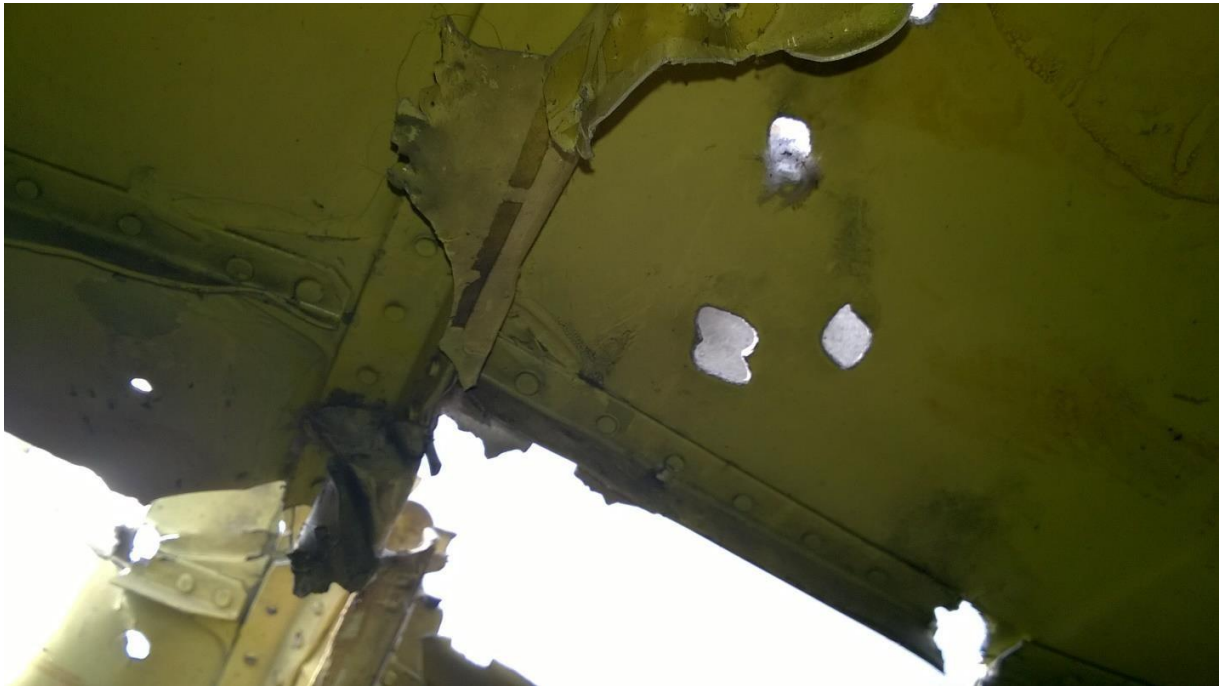
Figure 6.18 - Fragment of the left-hand side of the cockpit roof

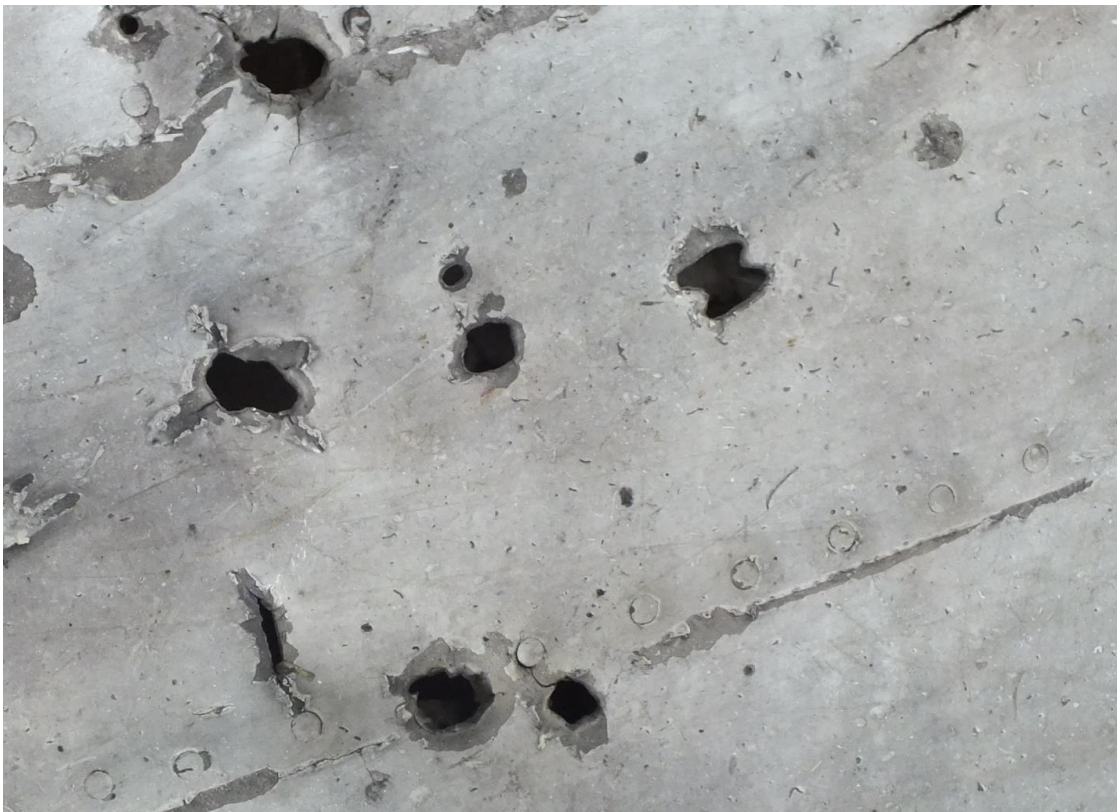
Figure 6.19 - Skin of the upper section of the port side (close-up)

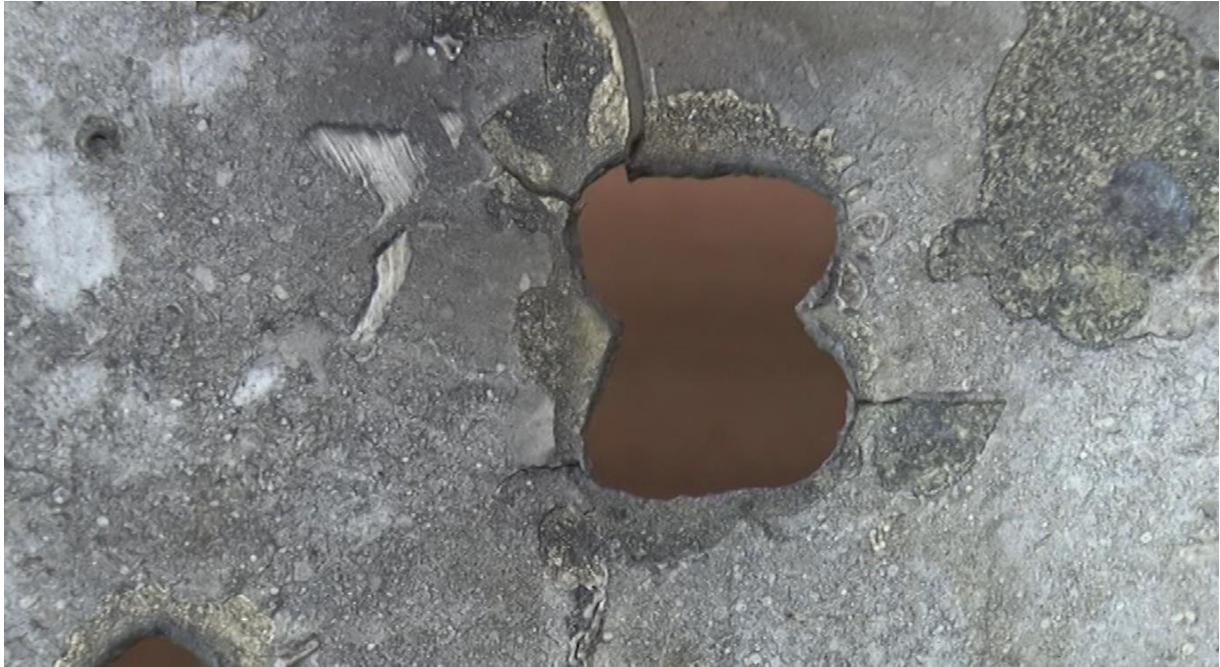
Figure 6.20 - Characteristic butterfly-shaped penetration

The through-and-through holes which have a characteristic "butterfly" appearance were created by projectiles of 9H314M 1-10 fractions which initially had "bowtie" shape.

There are dozens of such through-and-through holes with a distinct 'butterfly' appearance on fragments of the outer skin of the IL-86 target aircraft. No characteristic butterfly-shaped penetrations were found on the fragments of the structure of the Boeing 777 examined by the Almaz-Antey's specialists at the deposition site or in photographs from open sources.

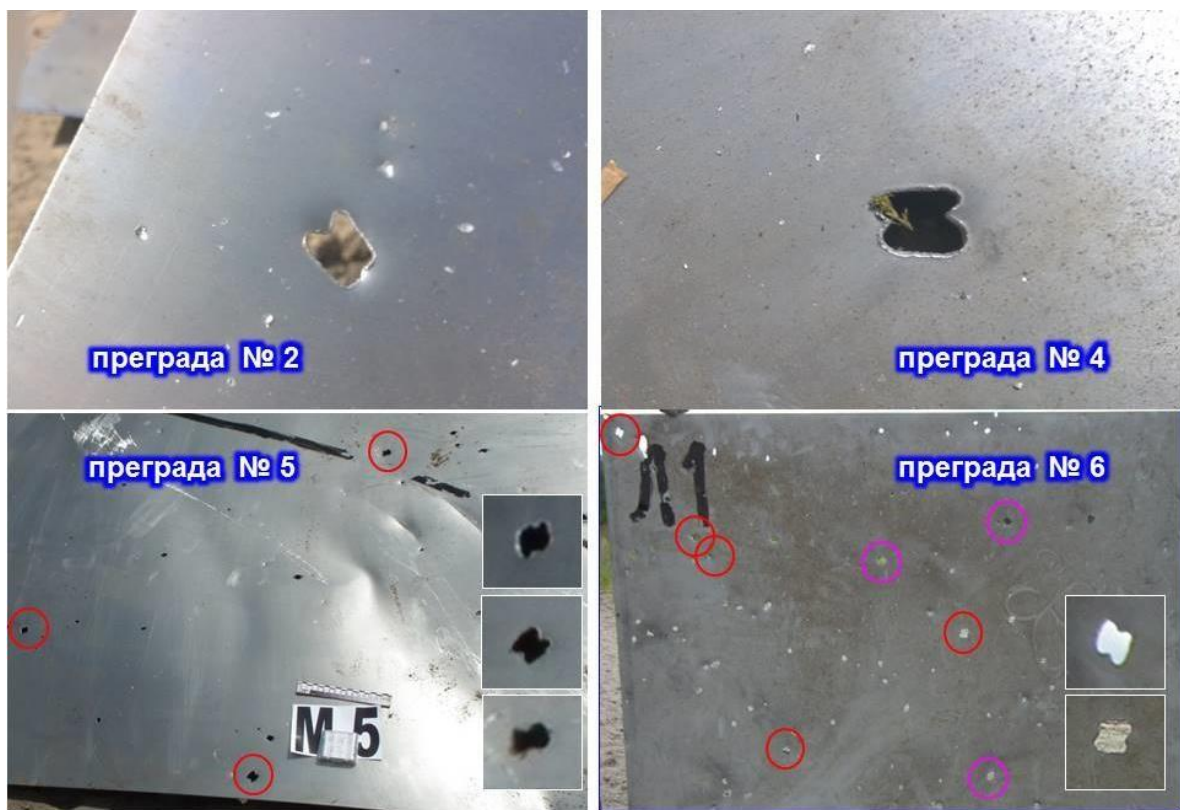
The test results show that the preformed fragments of 9H314M 1-10 warhead leave distinctive butterfly-shaped holes not only on the first obstacle in the shield target layout, but also on all subsequent obstacles. Figure 6.24 shows examples of butterfly-shaped holes left on mutually spaced obstacles in the shield target layout: obstacles Nos. 2, 4 and 5 (shields simulating the contour of the aircraft) and obstacle No. 6 - the outer layer of trap No. 1.

Figure 6.24 - Characteristic butterfly-shaped penetrations on different mutually spaced obstacles in the shield target layout

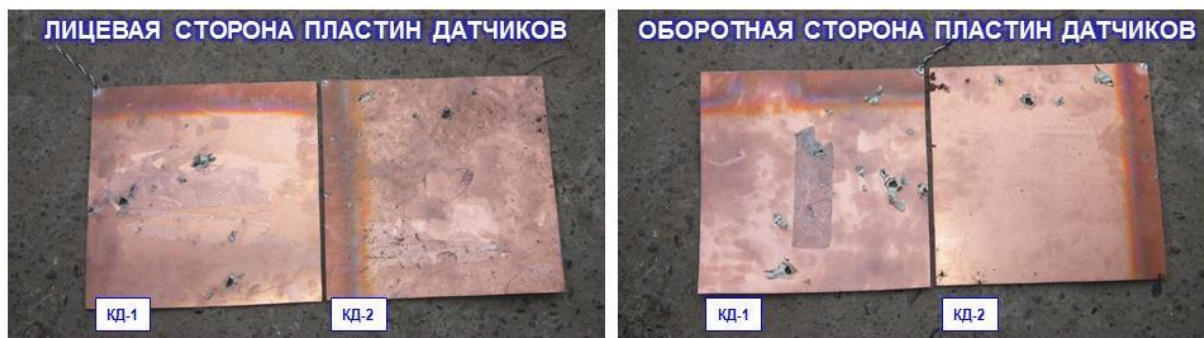
The sensor plate from the windscreen did not survive the experiment (was completely destroyed), while the appearance of the sensor plates of MVS-1 and MVS-2 from the aircraft commander's seat is shown in figure 7.2.

Figure 7.2 - Appearance of velocity sensor plates
(after the experiment)

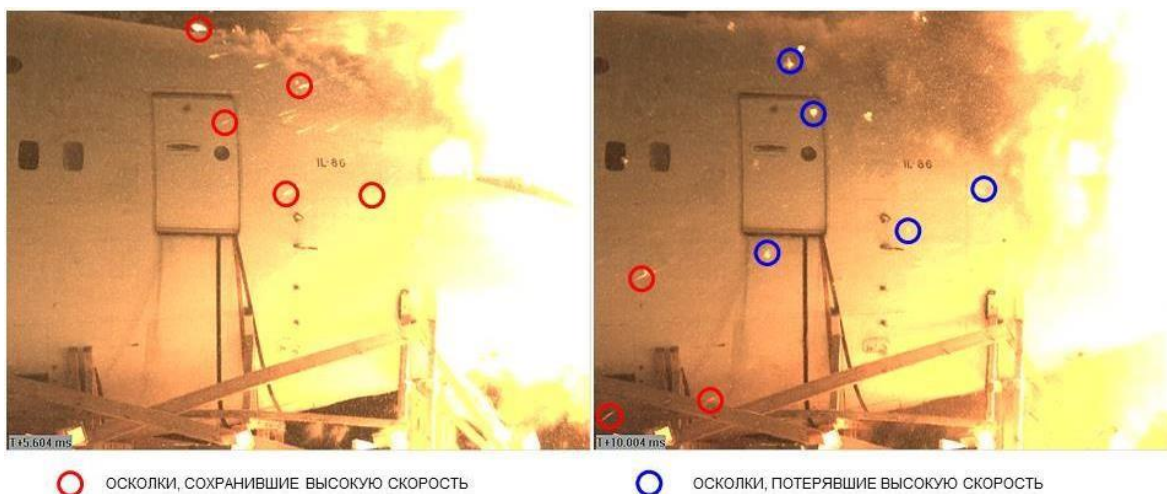
Figure 7.3 – Penetration by high-velocity fragments of the right side of IL-86
target aircraft's fuselage

In fig. 7.3, examples of paths of high-velocity fragment (white glowing dashes), which, after passing through the fuselage, retained high velocity and could have caused damage to the right wing or the right engine of the Boeing 777, are highlighted in red.

The examples of fragments (flares) that have lost high velocity and, therefore, kinetic energy after passing through the fuselage are highlighted in blue.

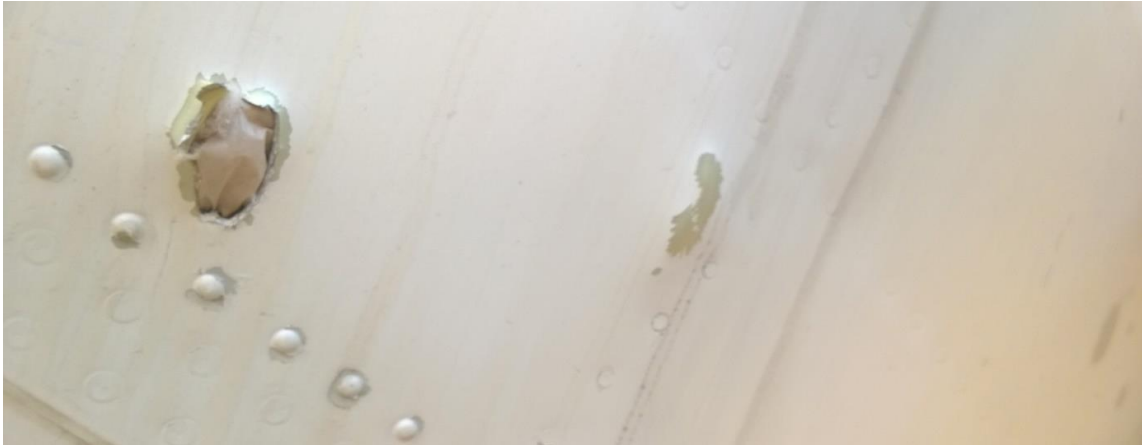
Figure 7.4 - Exit hole (left) and non-penetrating damage (right)

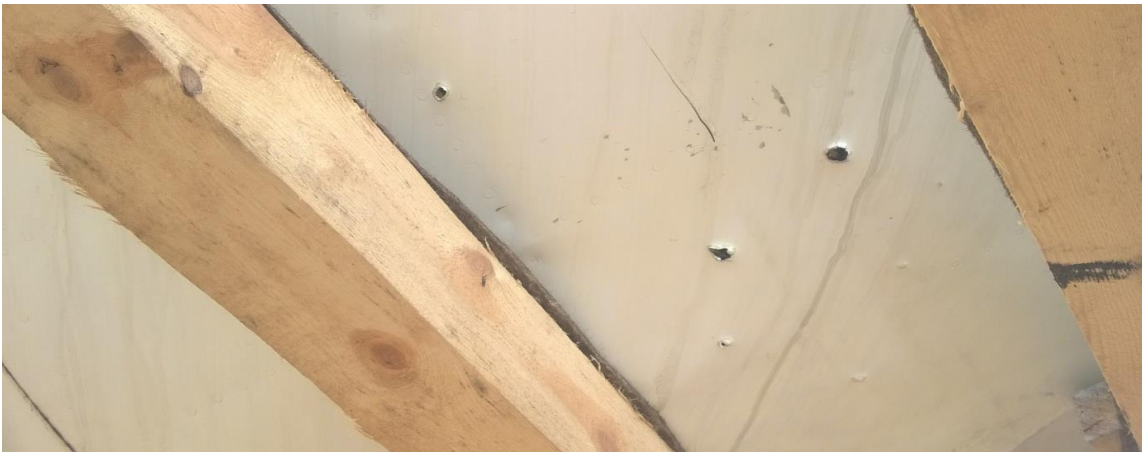
Figure 7.5 - Exit holes and non-penetrating damage to the starboard

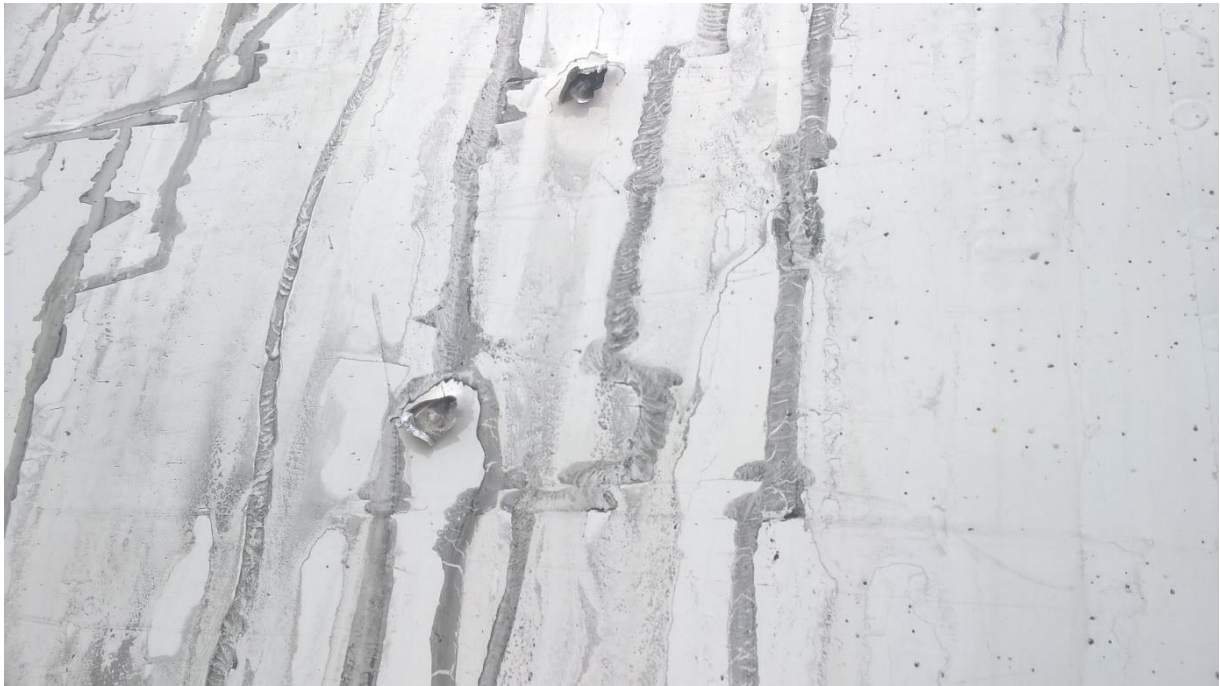
Figure 7.6 - Exit holes on the starboard side

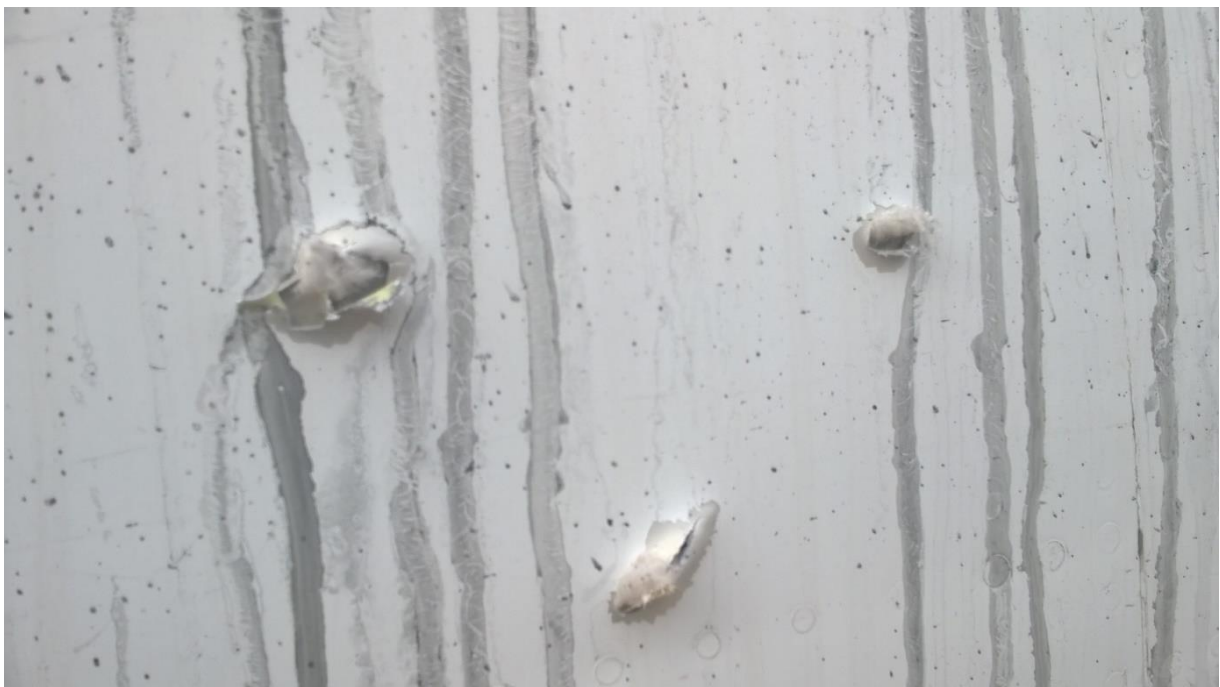
Figure 7.7 - Exit holes on the starboard side

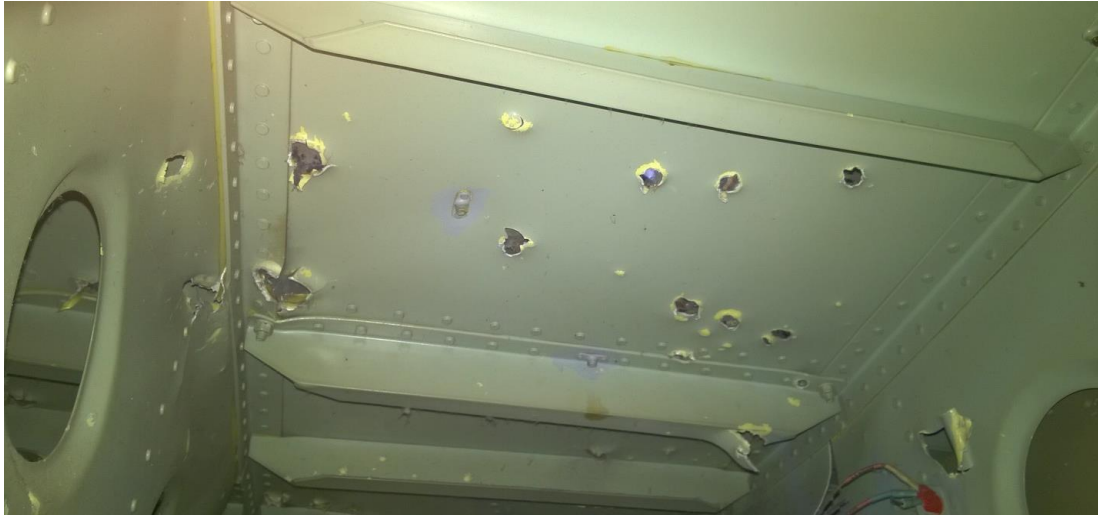
Figure 7.8 - Through-and-through holes in the cockpit floor (bottom view)

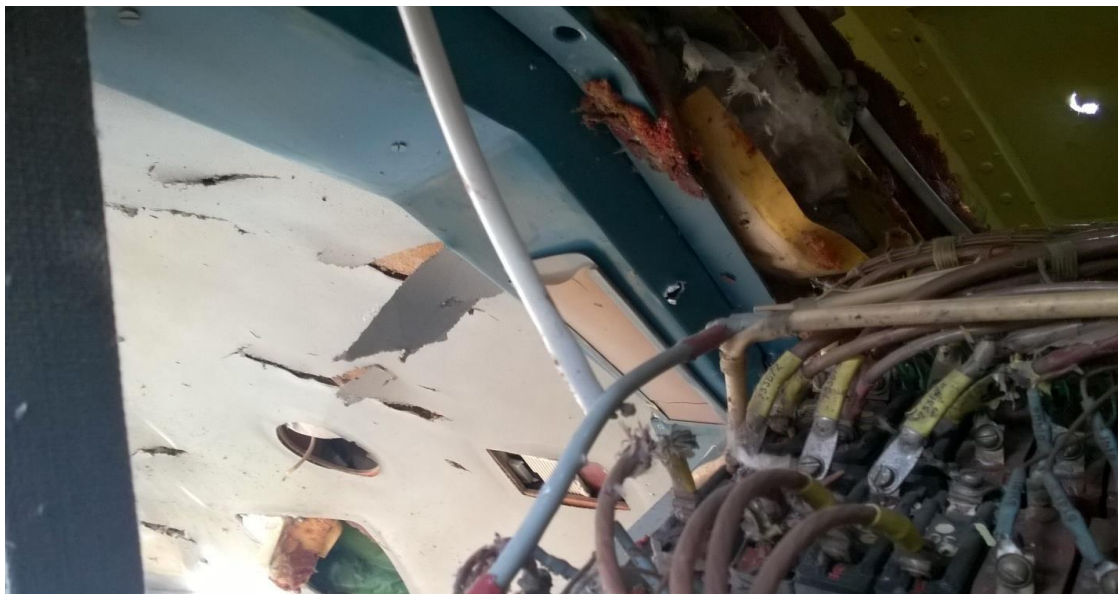
Figure 7.9 - Instrumentation cabinet panel at the top of the starboard side behind the co-pilot's seat. In the upper right-hand corner is an exit hole in the right section of the cockpit roof

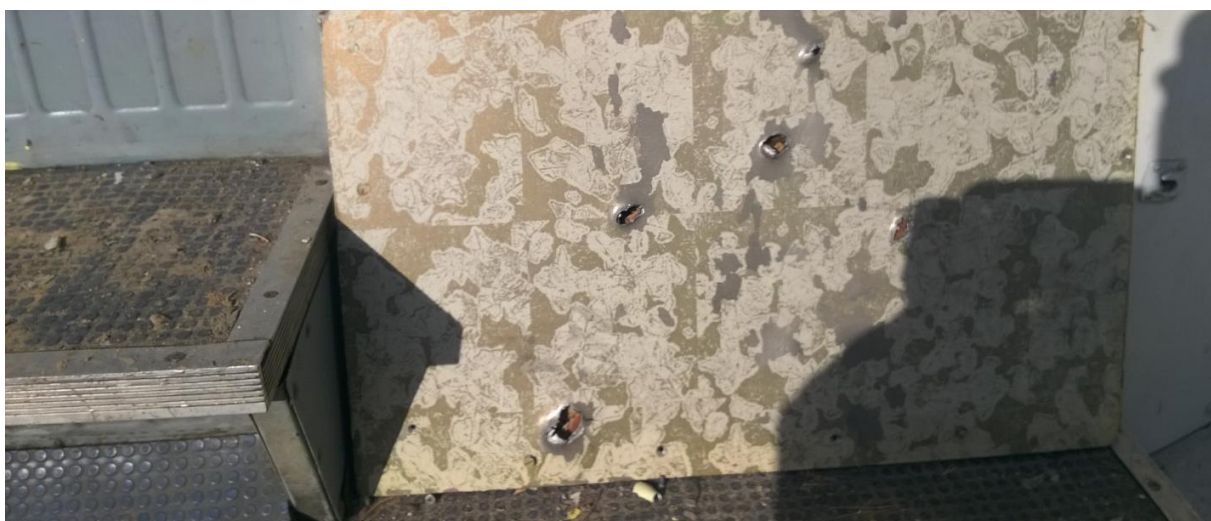
Figure 7.10 - Exit holes in the lower right-hand side of the first passenger compartment (rear view)
