**APPLICATION OF THE INTERNATIONAL CONVENTION FOR THE SUPPRESSION
OF THE FINANCING OF TERRORISM AND OF THE INTERNATIONAL
CONVENTION ON THE ELIMINATION OF ALL FORMS OF RACIAL
DISCRIMINATION**

REJOINDER

Report of JSC Air and Space Defense Corporation "Almaz-Antey" on the results of studies related to the technical investigation into the crash of the Malaysian airlines Boeing 777-200 9M-MRD (flight MH17), 2023

on the results of studies related to the technical investigation into the crash
of the Malaysian airlines Boeing 777-200 9M-MRD (flight MH17)

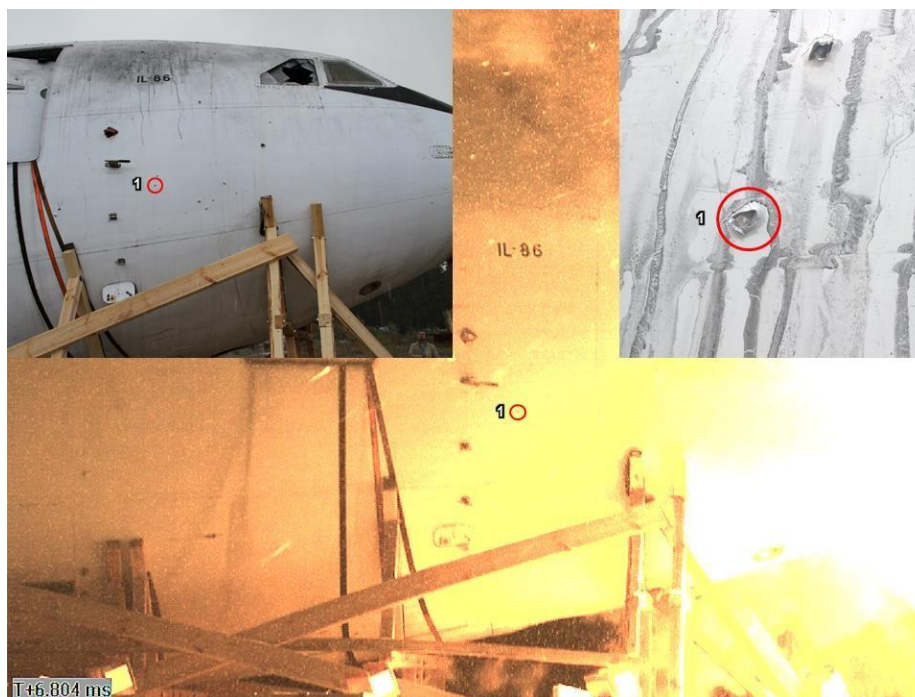
Figure 7.11 - Through-and-through hole in the starboard side made by a projectile

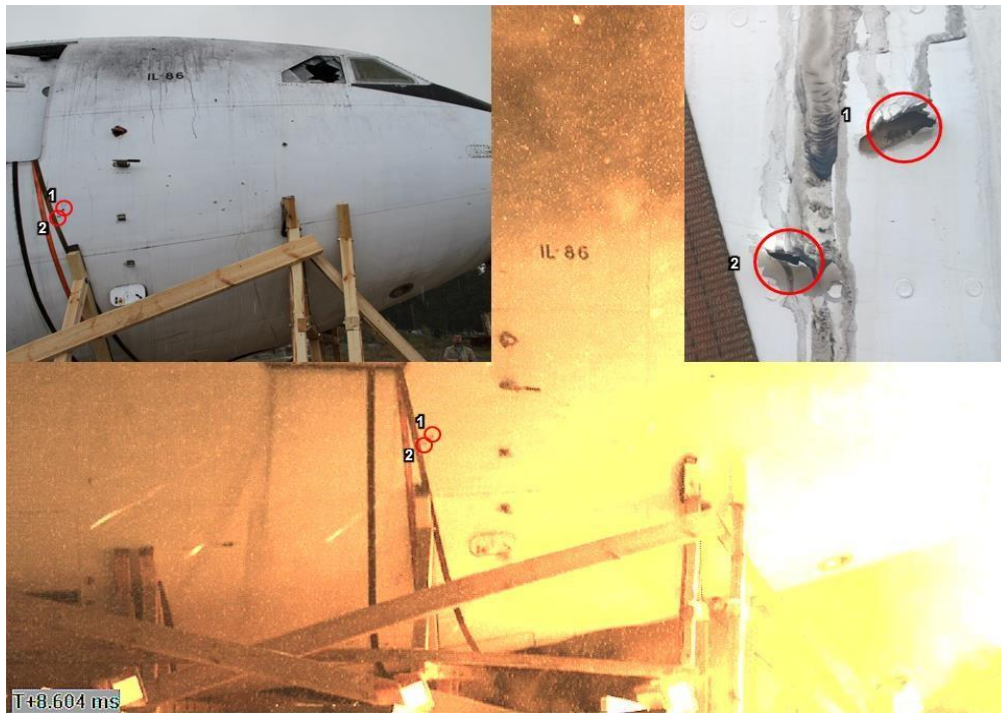
Figure 7.12 - Through-and-through hole in the starboard side made by projectiles

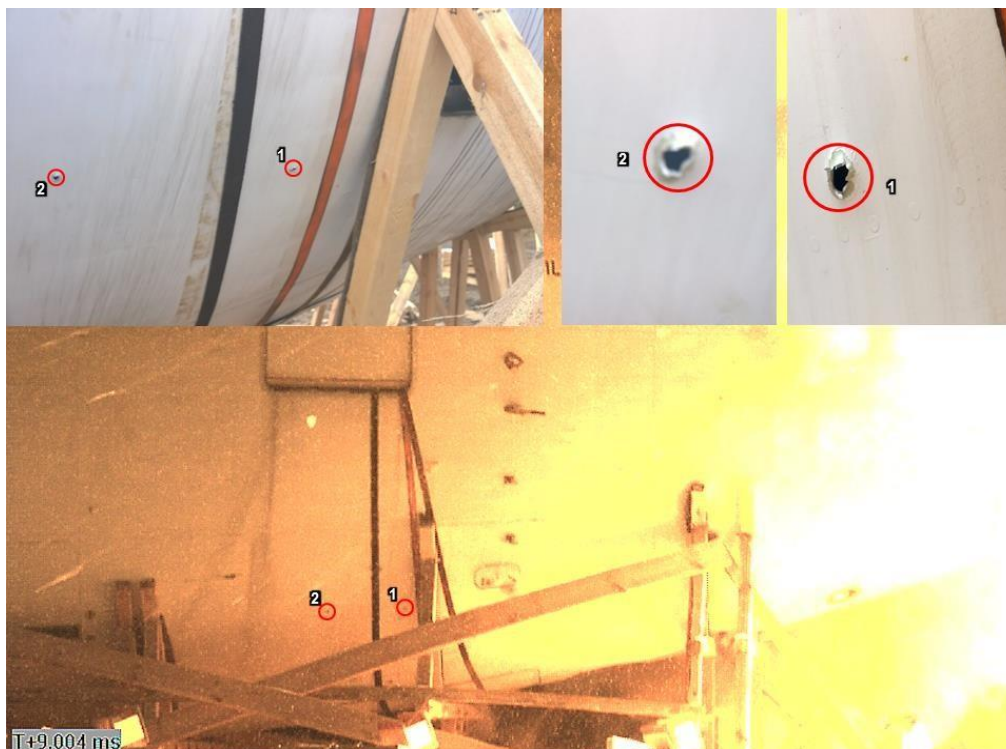
Figure 7.13 - Through-and-through hole in the starboard side made by projectiles

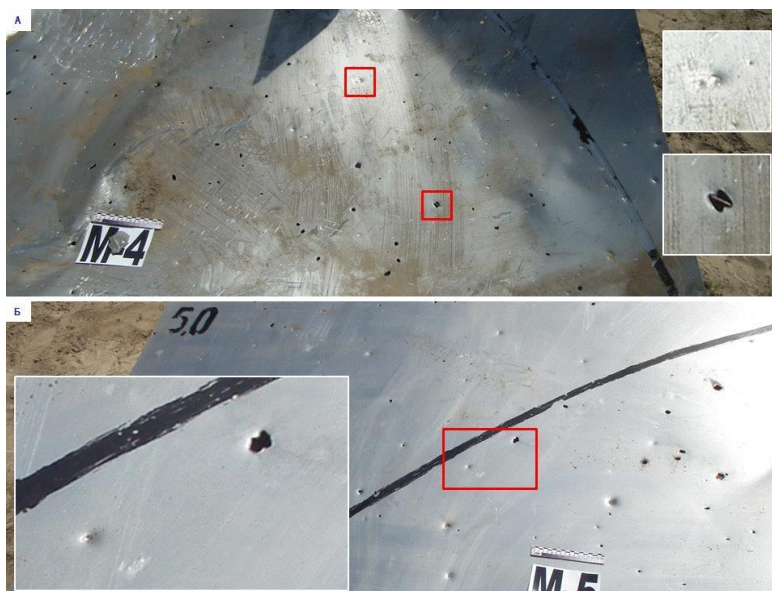
Figure 7.18 - Piercing and non-penetrating damage to obstacle No. 4 (A) and barrier No. 5 (B)

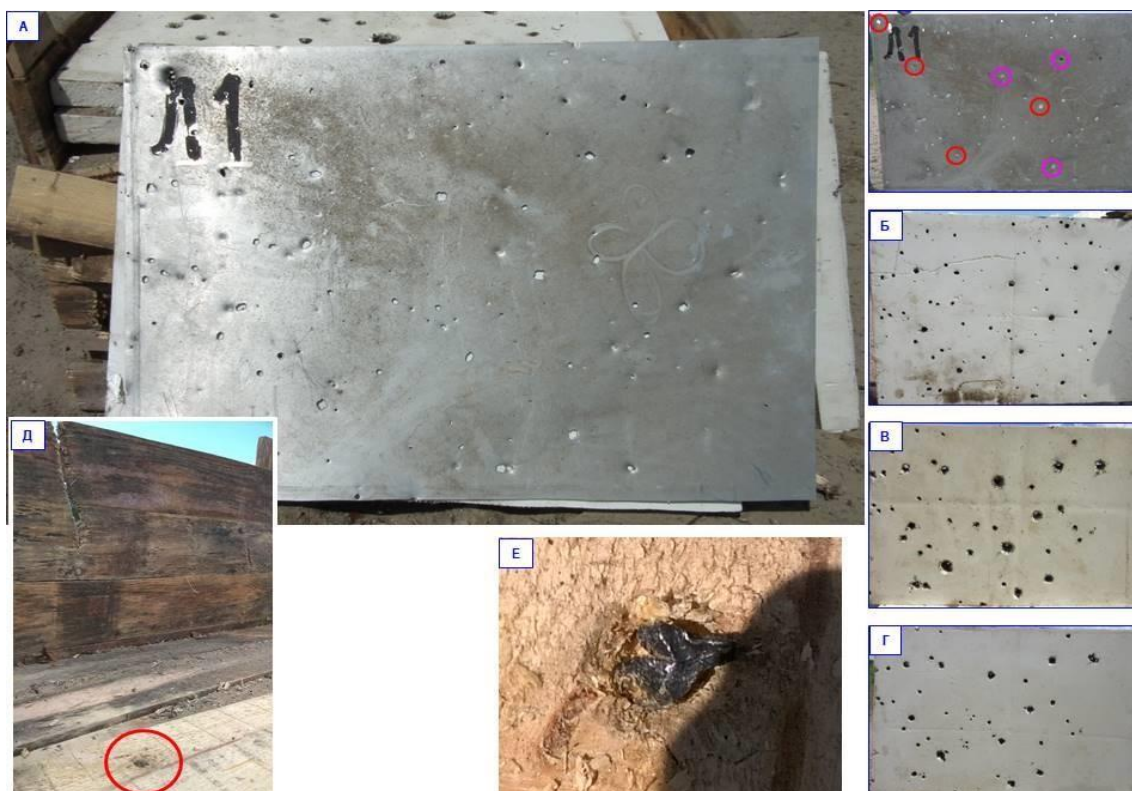
Photograph 7.21A - external trap obstacle (2.0 mm aluminium alloy sheet AMg6M), photographs 7.21B through 7.21G - PS-150 foam sheets (total thickness of 260.0 mm), photographs 7.21D and 7.21E - extraction of 9H314M 1-10 fragment (highlighted in red in photograph 7.21D) from boards at the depth of more than 400.0 mm.²⁴

Figure 7.21 - Condition of trap L1 obstacles after the testing

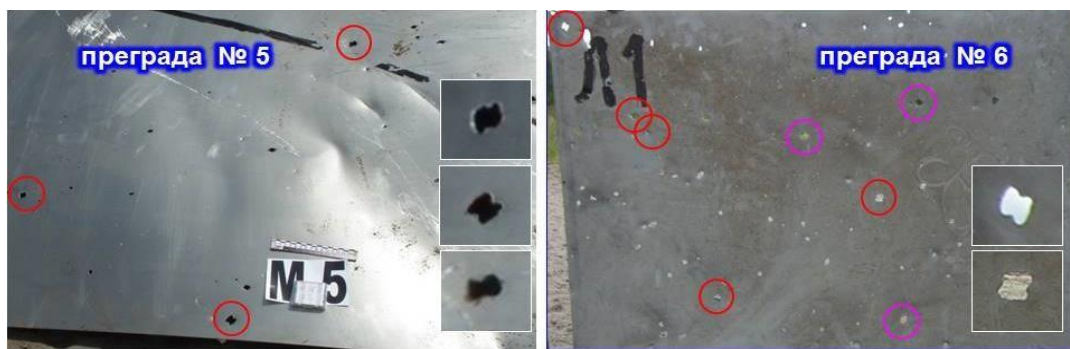
Further, 9H314M 1-10 heavyweight ("bowtie") fragments leave distinctive butterfly-shaped holes not only on the first obstacle but also on all subsequent obstacles. Figure 7.22 shows examples of "butterfly" holes left in the dispersed shield target layout: obstacle No. 5 (shield target) and obstacle No. 6, the outer layer of a particularly tough obstacle (trap) designed to trap projectiles.

Figure 7.22 - Characteristic butterfly-shaped holes on dispersed obstacles in the shield target layout

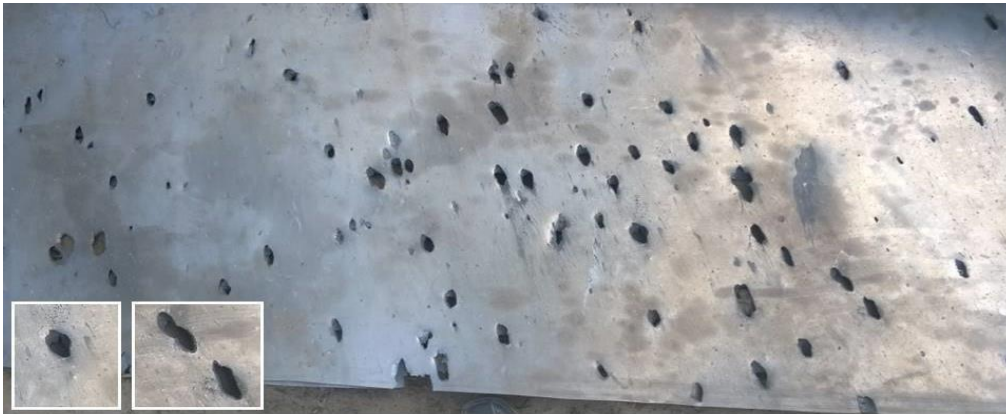
Figure 7.23 - Fragment of shield target 1.5

Figure 7.23 shows a fragment of shield target 1.5 positioned at angles of 20-30 degrees to the direction of impact from the flow of preformed fragments.

There is no non-penetrating, non-piercing damage (ricochets) caused by preformed fragments to sheets in the first layer of the first obstacle in the target layout²⁵.

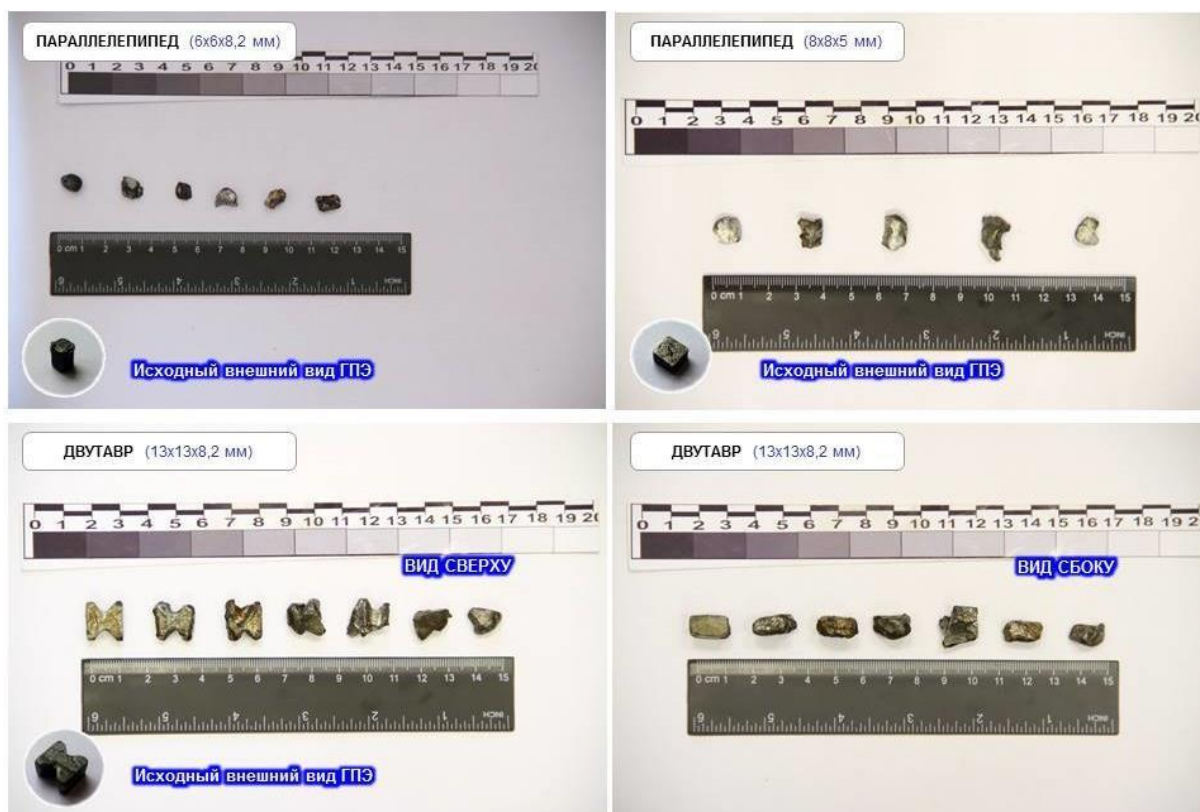
An analysis of the experiment results shows that all three types of projectiles contained in 9H314M warhead are extracted from the elements of the target layout (structure of the target aircraft). Further, 9H314M1-10 heavyweight ("bowtie" shaped) projectiles account for **at least 38%** of the total number of projectiles extracted.

Figure 8.2 - Extracted projectiles:

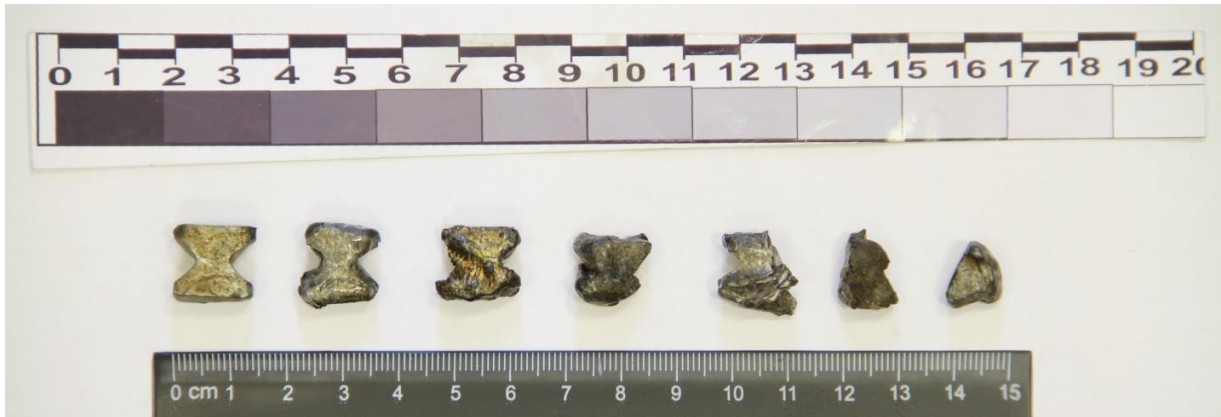
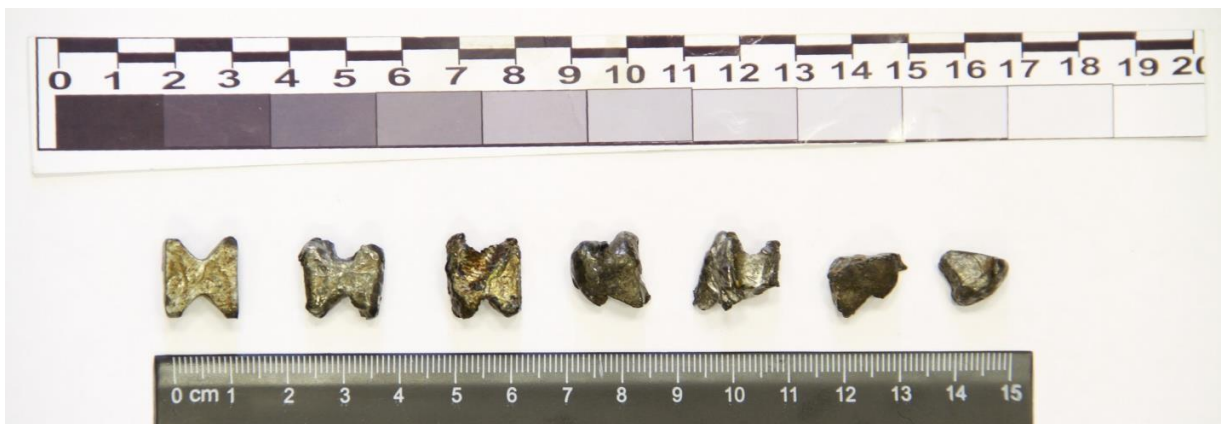
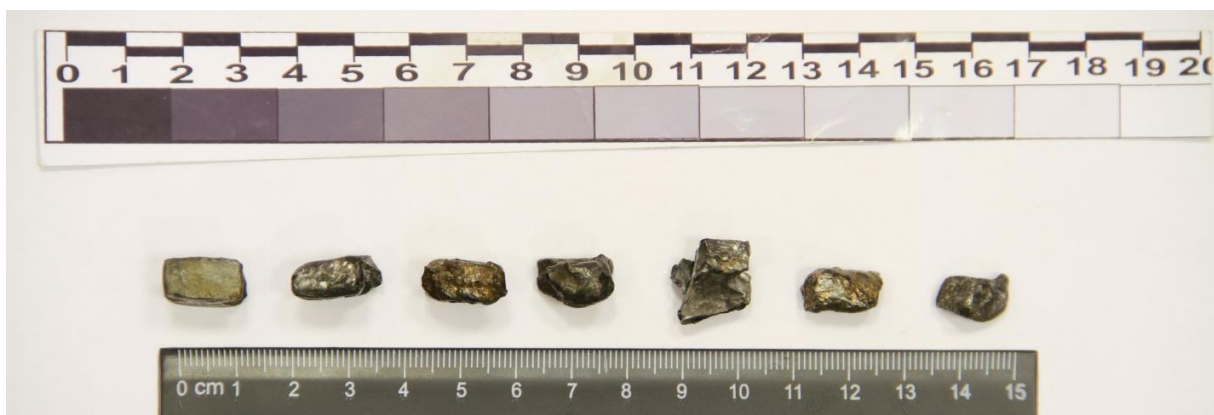
Figure 8.3 - Extracted 9H314M 1-10 projectiles (top view)

Figure 8.4 - Extracted 9H314M 1-10 projectiles (top view)

Figure 8.5 - Extracted 9H314M 1-10 projectiles (Side view)

The undestroyed heavyweight 9H314M 1-10 projectiles, the shape of which resembles an "bowtie" shape have a residual weight ranging from 7.3 to 7.9 g (1, 2 and 3 at the left in figures 8.3-8.5).

Highly deformed and fractured projectiles that lost their "bowtie" shape have a residual weight in the range of 3.9 to 6.4 g (4-7 at the left in figures 8.3-8.5). Their weight loss ranges from 21 to 52%.

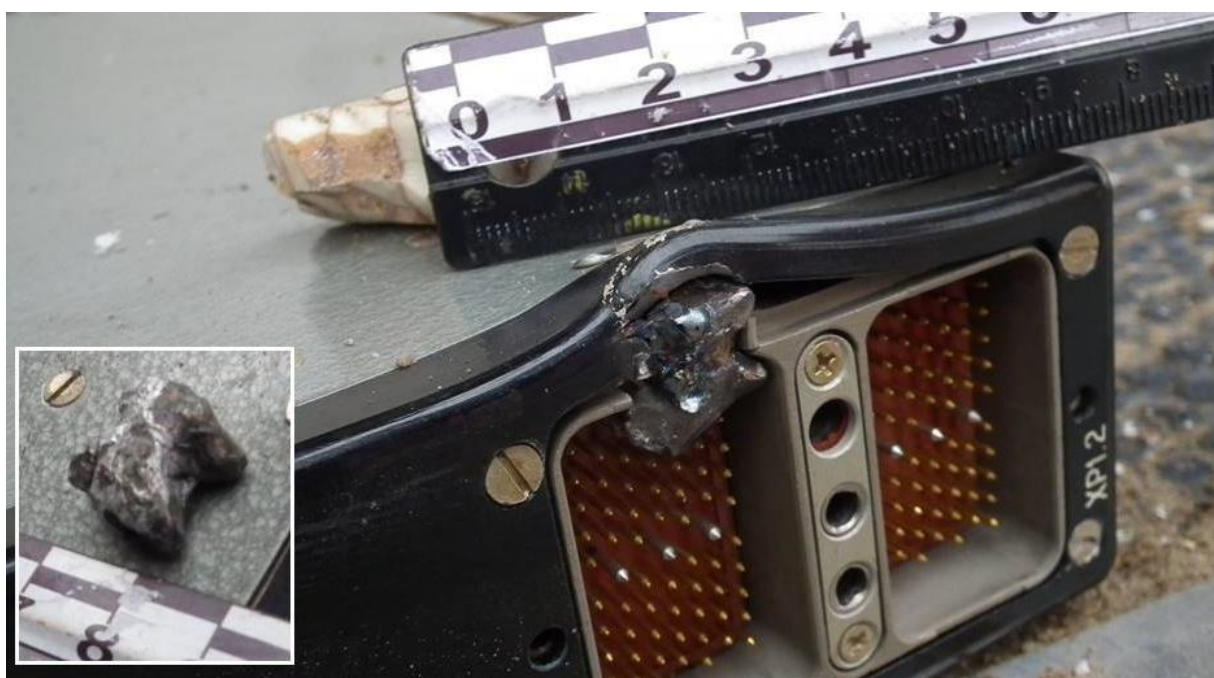
Part of the ready-made 9H314M 1-10 ("bowtie" shaped) projectiles was removed from the aircraft's avionics equipment.

Figure 8.6 - Removing a 9H314M 1-10 projectile from avionics equipment

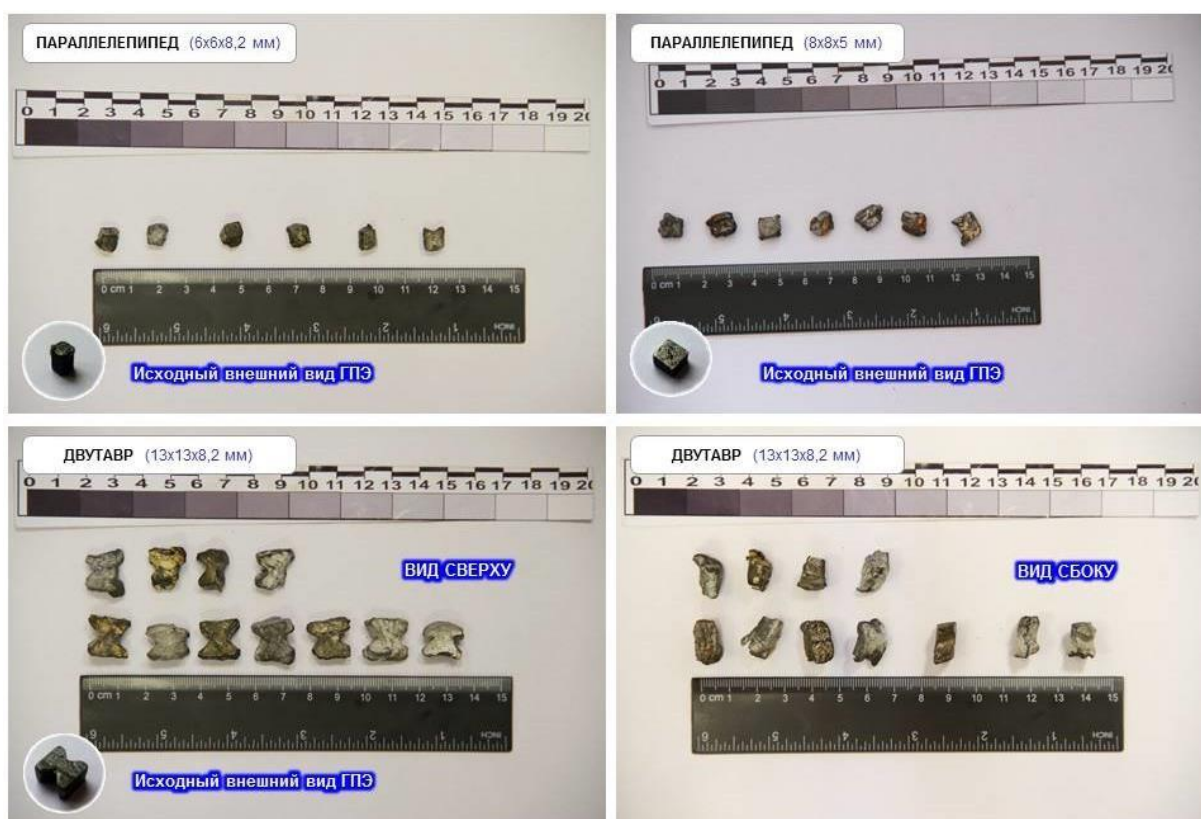
In the course of the experiment, 71 projectiles of all three 9H314M warhead fractions were extracted from the shield target and traps. Photographs showing examples of extracted projectiles of different fractions are shown in figure 8.7 and figures A.202-A.211 in Appendix A.

Figure 8.7 – Ready-made 9H314M projectiles extracted from the target and traps

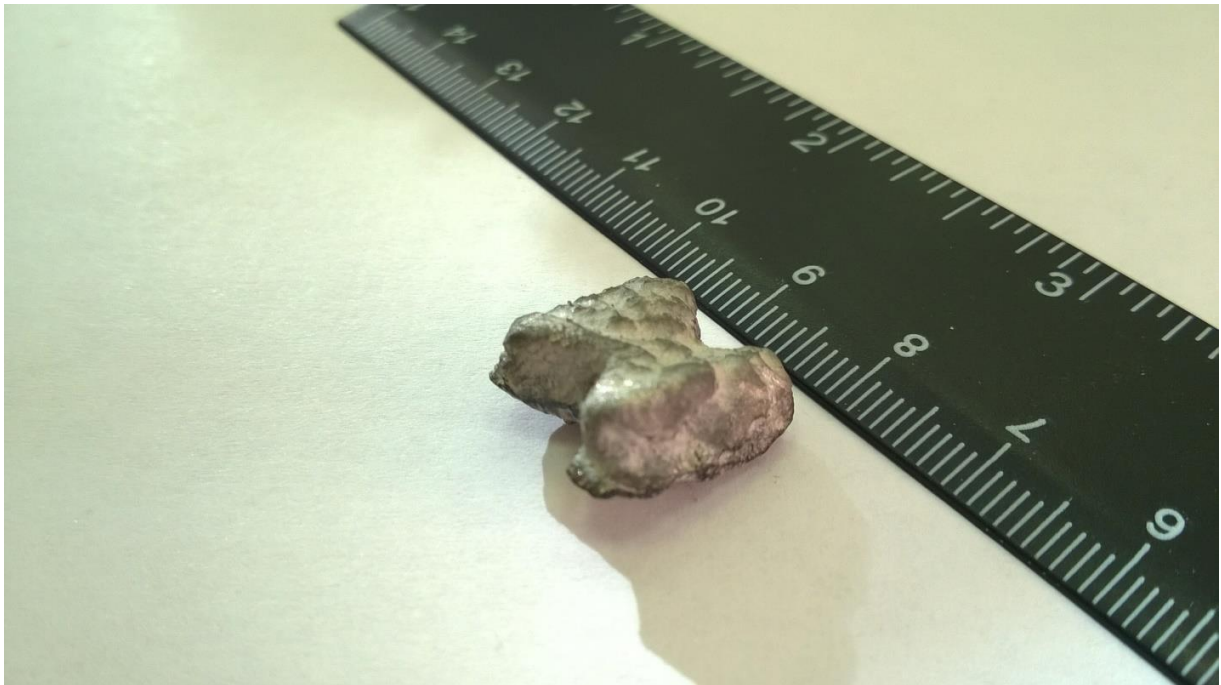
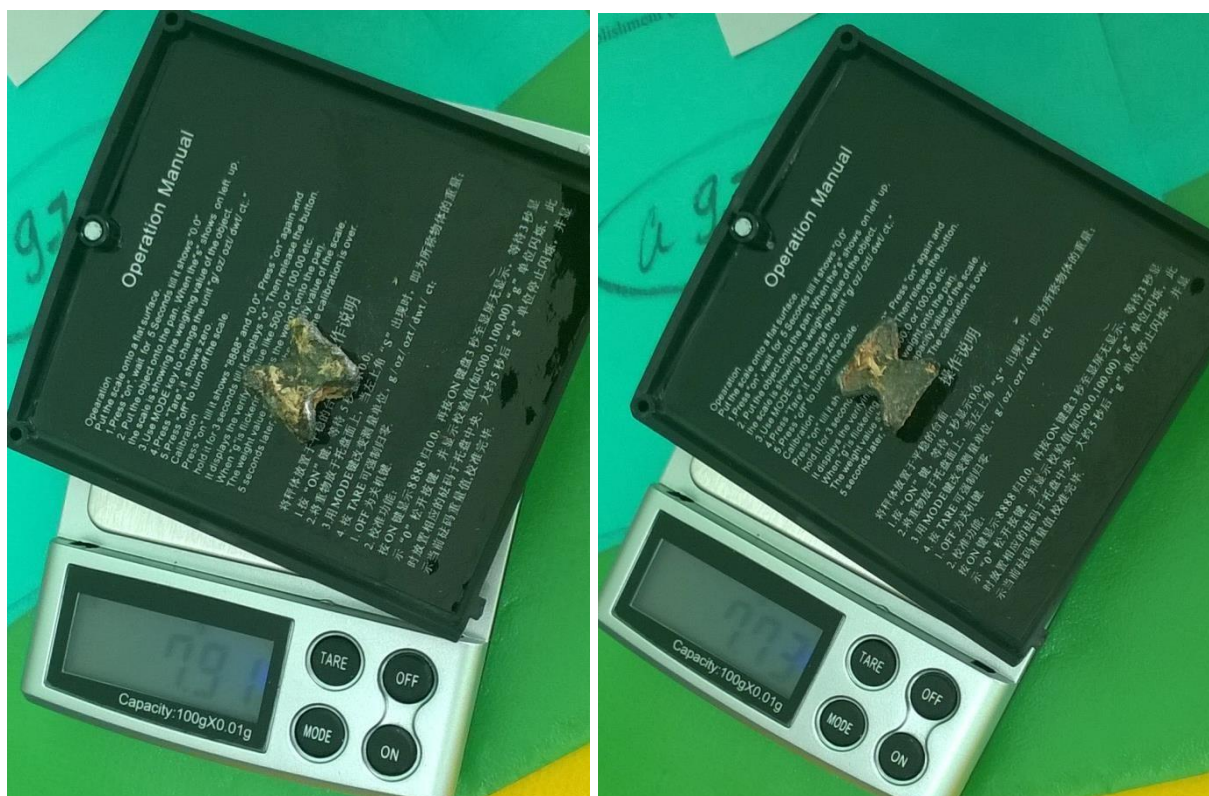
Sixteen out of the 39 9H314M 1-10 heavyweight ("bowtie"-shaped) projectiles extracted from the target and traps retained their original "bowtie" shape, accounting for more than 41% of all 9H314M 1-10 projectiles extracted from the target and traps.

Figure 8.8 - 9H314M 1-10 projectile ("bowtie")

Figure 8.9 - Weight of 9H314M 1-10 projectiles after the testing

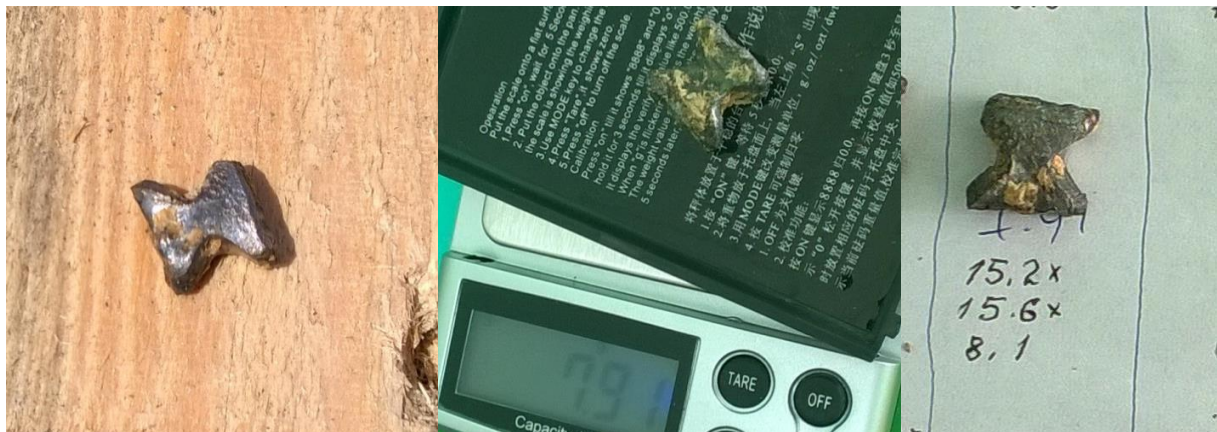
As a result of the deformation, the linear dimensions of the 9H314M 1-10 projectiles exceed their original linear dimensions (length and width).

Figure 8.10 - 9H314M 1-10 projectile: after removal from the trap (left), at weighing (centre) and after dimensional measurements (right)

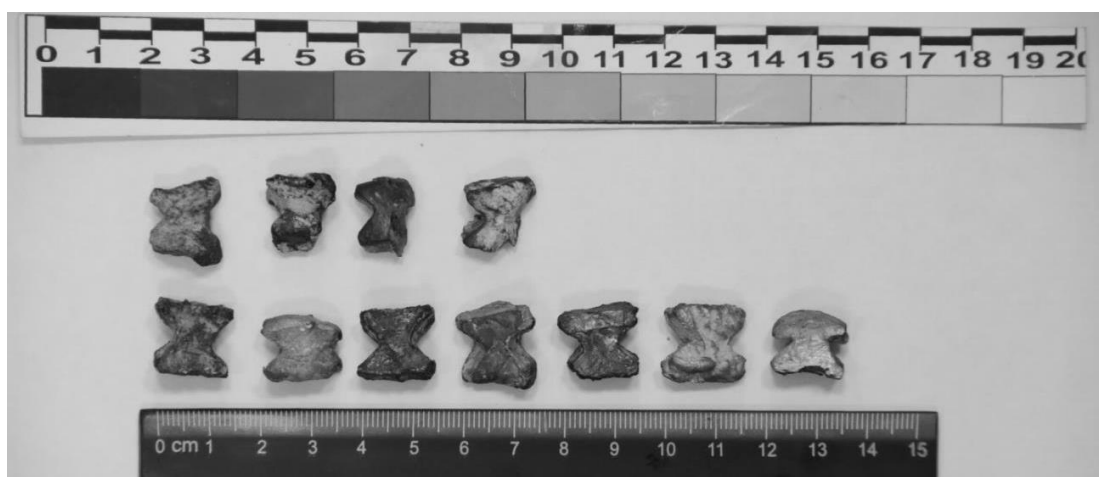
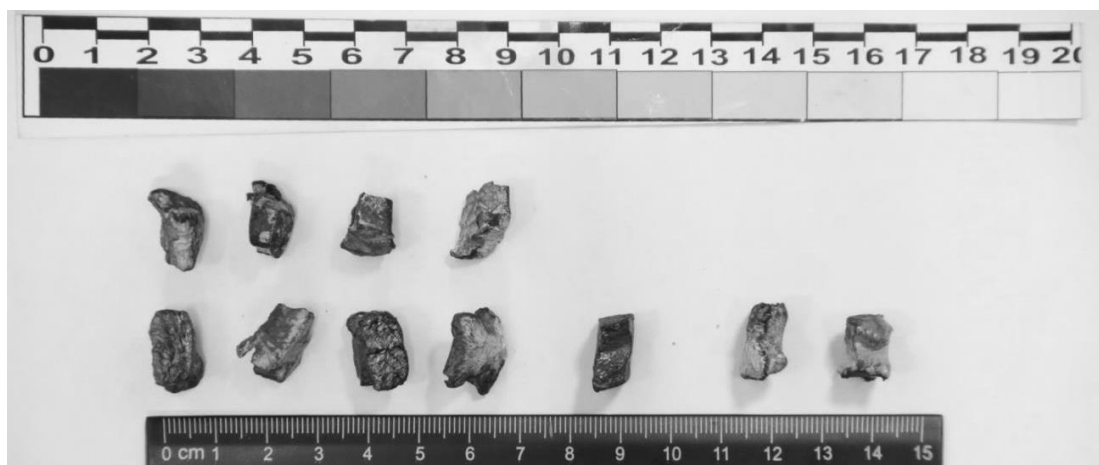
The 9H314M 1-10 projectiles with a weight loss of more than 15 - 19% are deformed and destroyed, losing their shape resembling a bowtie. An analysis of the characteristics of the destroyed and deformed 9H314M 1-10 projectiles that lost their bowtie shape shows that, as a result of the tests, the weight loss and dimensional changes are within a substantial range.

Figure 8.11 - 9H314M 1-10 projectiles (top view)

Figure 8.12 - 9H314M 1-10 projectiles (side view)

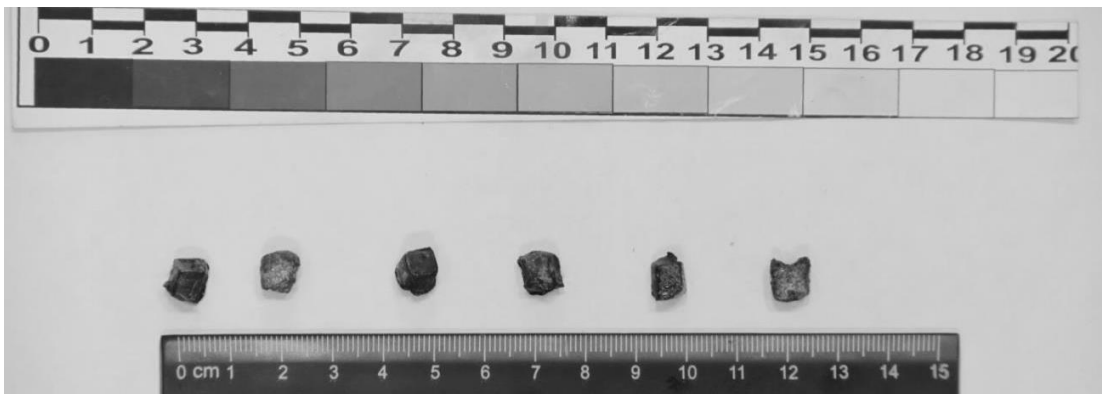
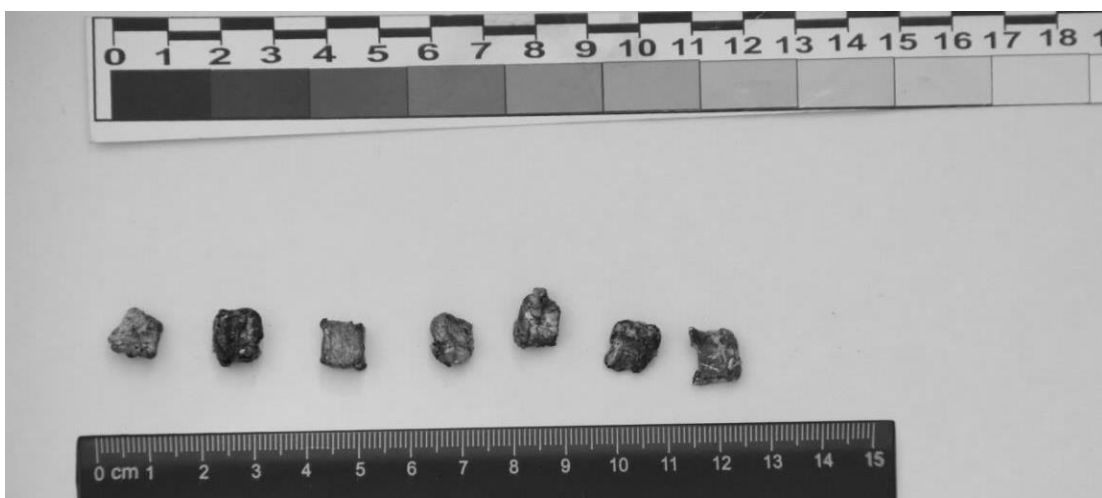
Figure 8.13 - 9H314M 1-11 projectiles

Figure 8.14 - 9H314M 1-9 projectiles

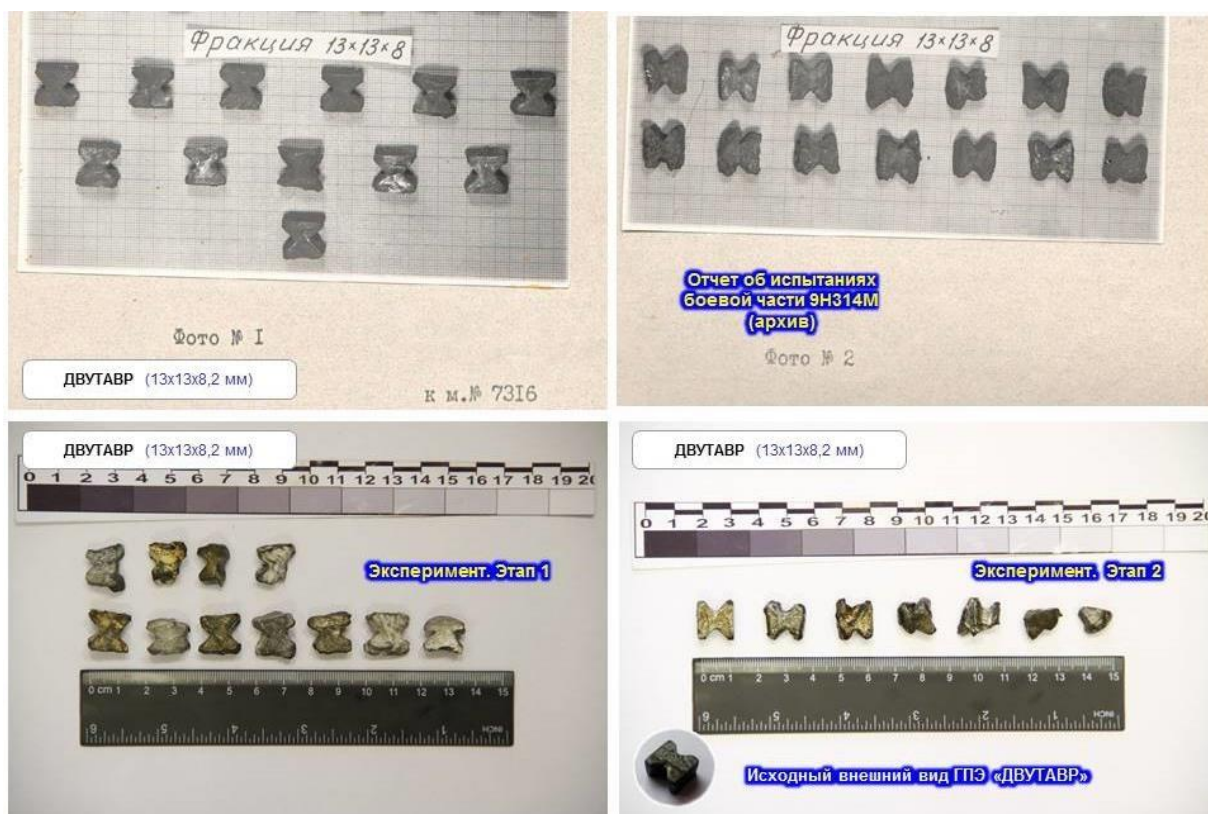
Figure 8.15 - Comparative analysis of 9H314M 1-10 ("bowtie" shaped) ready-made projectiles

Thus, according to the results of detonation tests at ground static conditions in the compartment hull of 9M38M1 missile and 9M38M1 missile assembled, which were conducted under different conditions of the encounter of projectiles with obstacles, the average weight loss by a single undestroyed projectile that retained "bowtie" shape does not exceed 10-11%, and the maximum weight loss is about 15%.

9H314M 1-10 projectiles with an initial weight loss of more than 15-19% deform significantly and deteriorate.

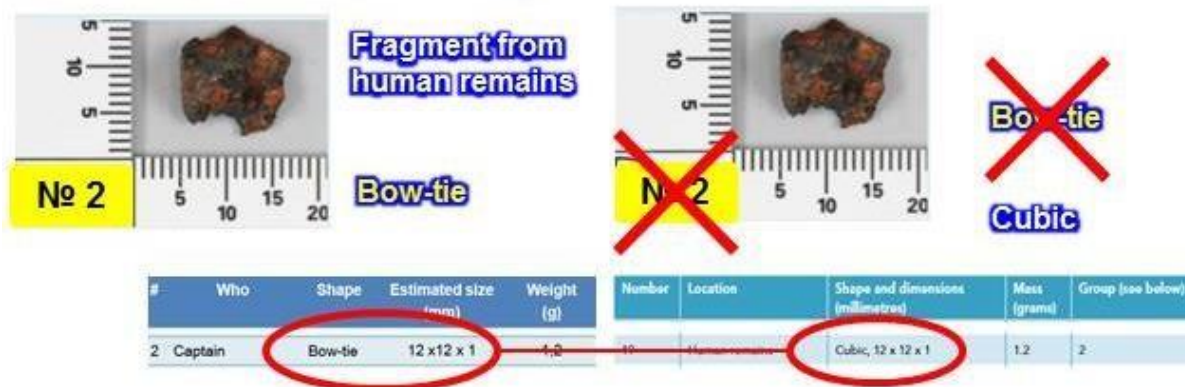
Figure 8.16 - Projectile No. 2 appearing in the Draft Final Report as a "bowtie"

This fragment cannot be a 9H314M 1-10 heavyweight bowtie-type projectile because weight mass is too low.

In the DSB Report this fragment is already referred to as "Cubic" (Fig. 8.16, right) and only two fragments (#1 and #3) are presented as "bowtie" shaped fragments.

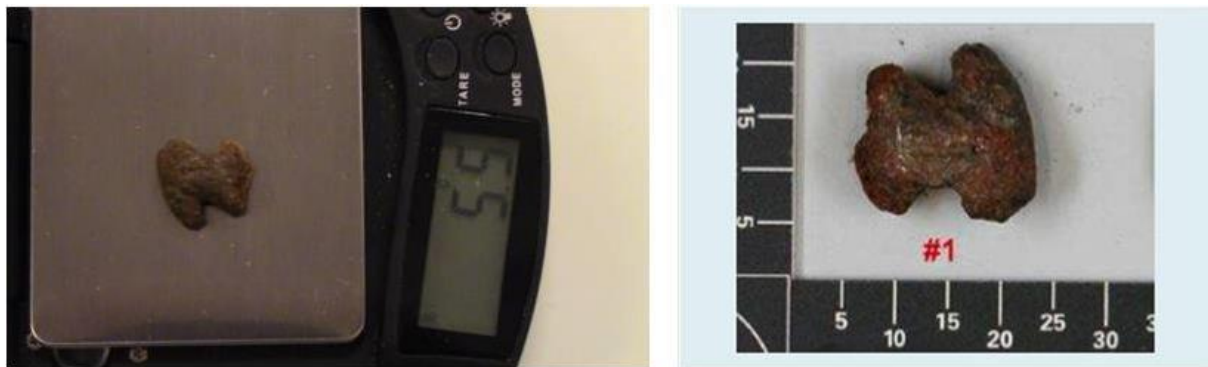
Figure 8.17 - Appearance of the # 1 target

This fragment (#1) was first shown to Russian experts in February 2015. When weighed in the presence of Russian experts, it weighed 5.5 g (left photo of figure 8.17). In the DSB Report, in Tables 11 (Overview of the 20 selected fragments) and 12 (Composition in (percentage) of elements found in steel of the two groups of fragment examined) the following data are given on this fragment³⁶:

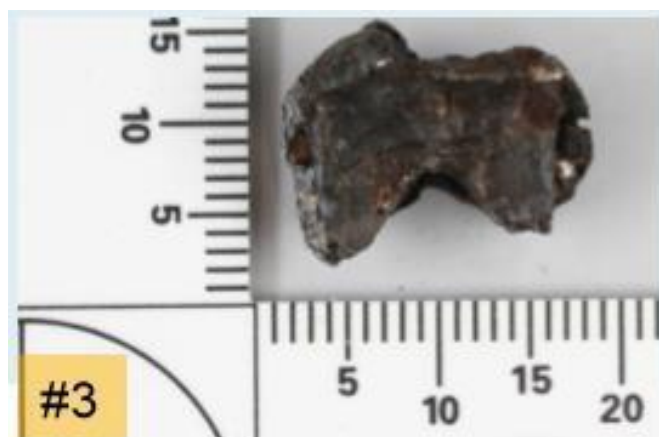
Figure 8.18 - Appearance of projectile #3

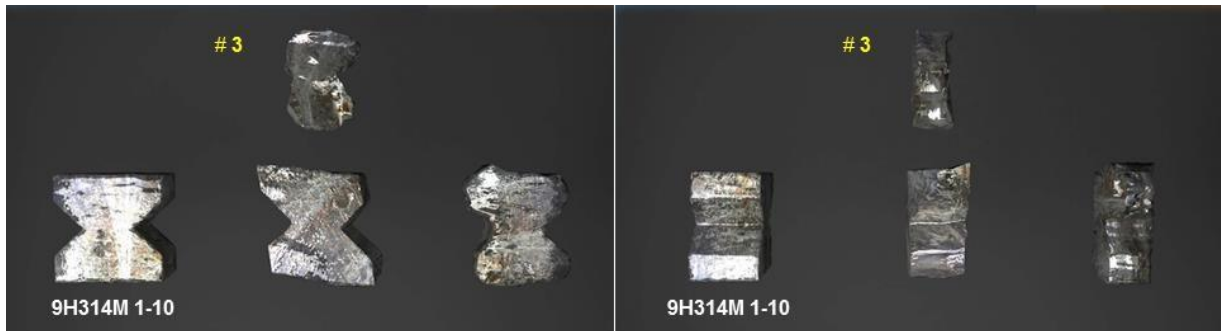
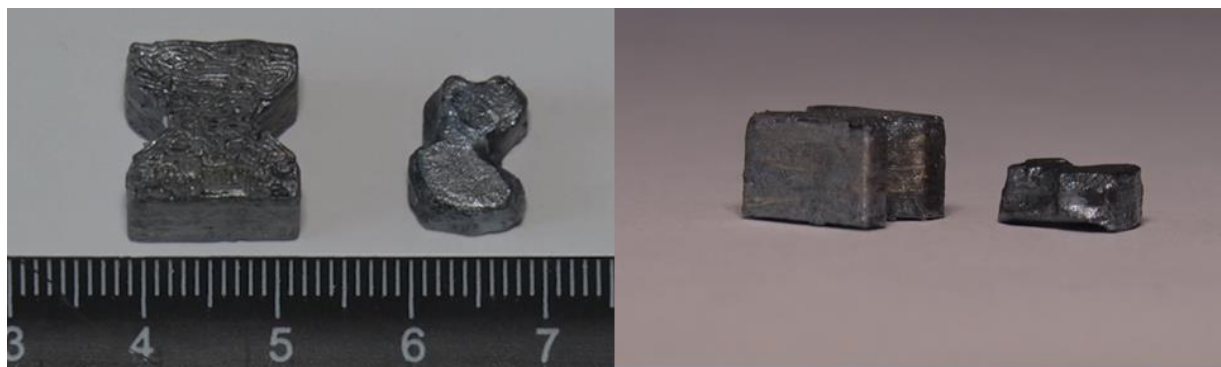
Figure 8.19 - Appearance of mock-ups of fragment #3 (top) and 9H314M 1-10 projectiles after the tests (bottom)

Figure 8.20 - Comparison of sizes of fragment #3 (from DSB Report) and 9H314M 1-10 projectile

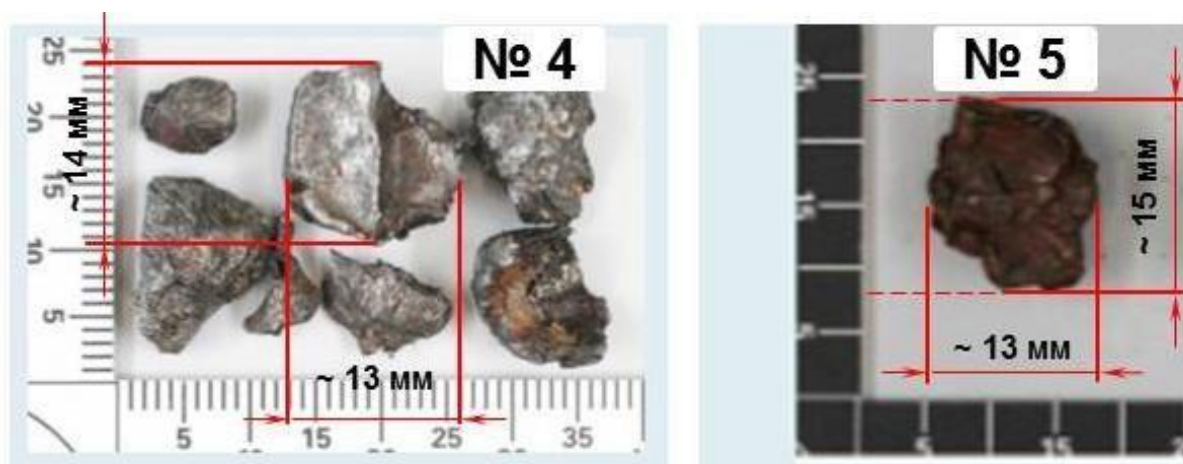
An analysis of the photographic material provided by the DSB experts⁴⁰ shows that some of the steel projectiles recovered from the aircraft structure and human remains and not belonging to the aircraft structure cannot be projectiles of 9H314M warhead.

Figure 8.21 - Appearance of fragments #4 and #5

Fragment No. 4 was recovered from the body of a crew member and fragment No. 5 was recovered from the wreckage of the Boeing 777 structure⁴¹. These fragments have dimensions of approximately 13 x 14 mm and 13 x 15 mm, respectively. The lack of data on the third dimension (thickness) and the residual weight of the fragments in the DSB Report does not allow their unequivocal identification.

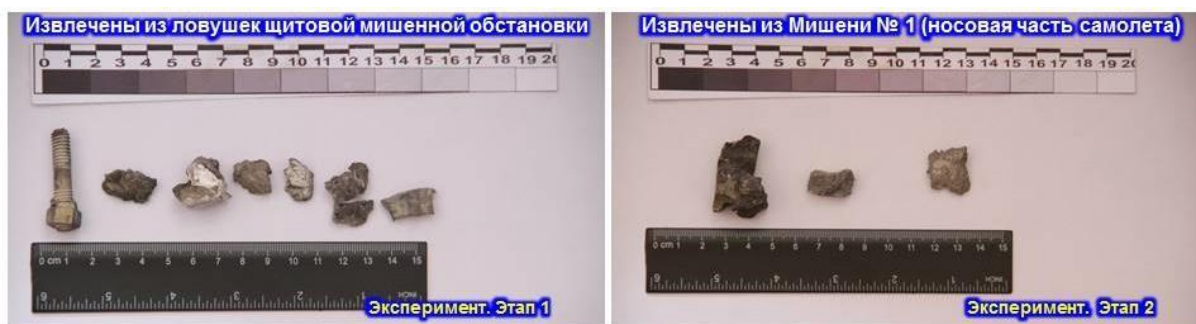
Figure 9.1 - Second compartment (warhead compartment) hull fragments

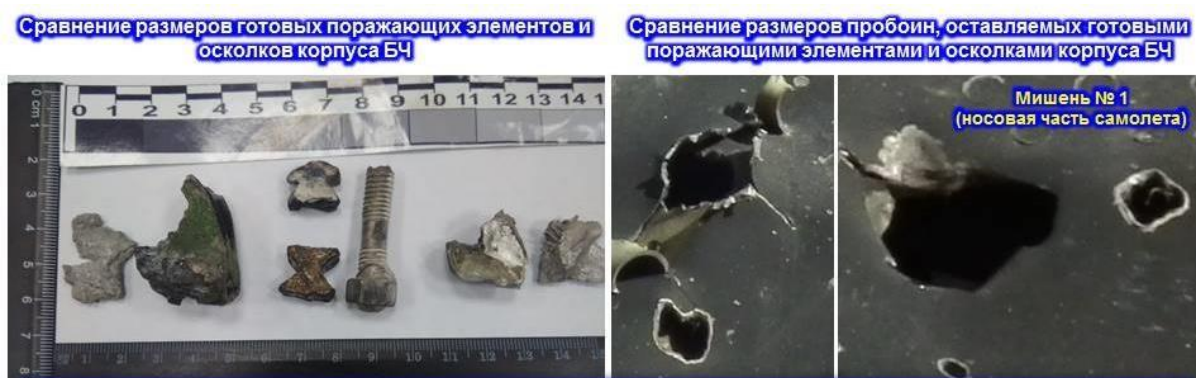
Figure 9.2 - Comparison of dimensions of and holes left by hull fragments from the first group with the dimensions of and holes left by ready-made projectiles

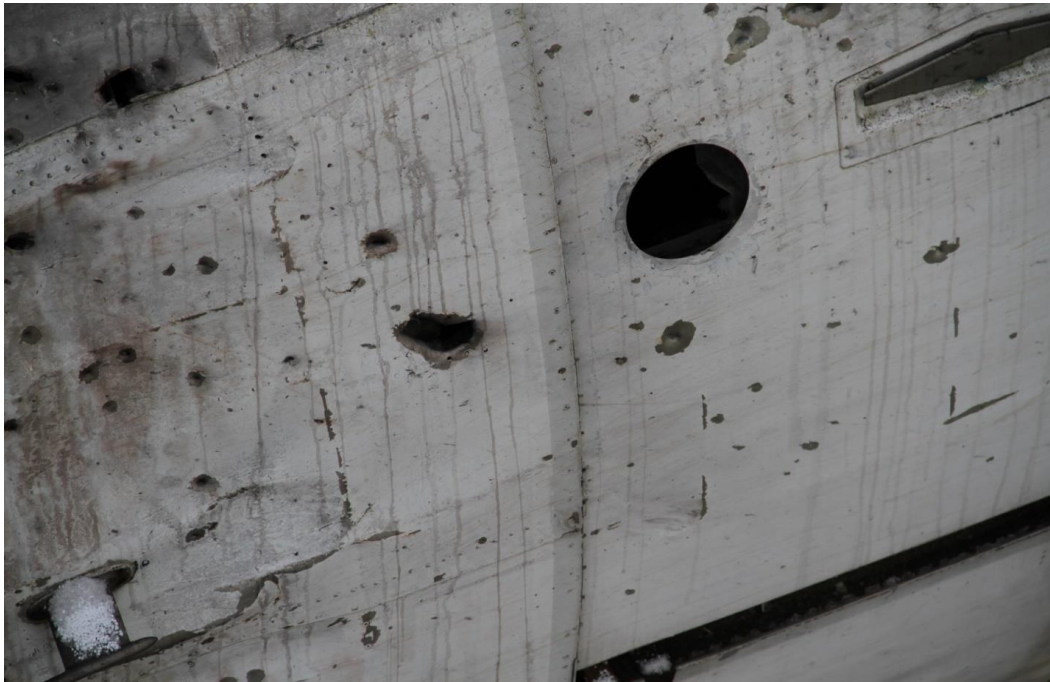
Figure 9.3 – Holes left by second compartment hull fragments on the port side of the target in the area of door L1

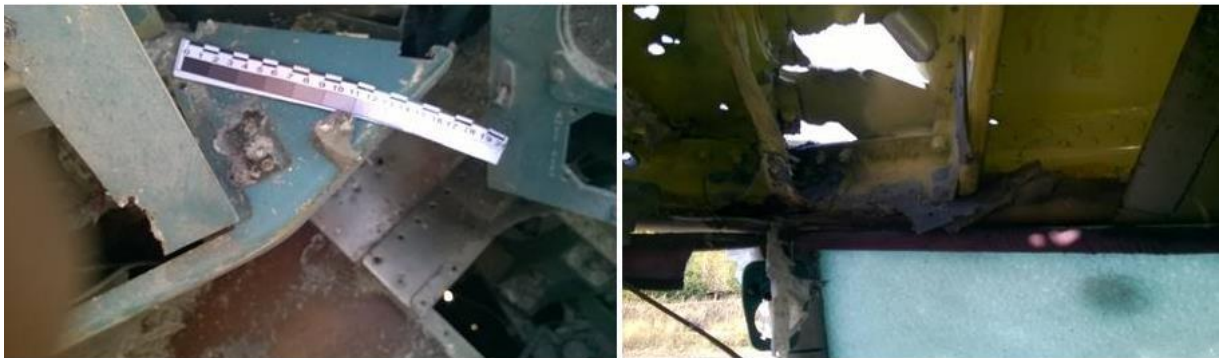
Figure 9.4 - Second compartment hull fragments and holes left by them

The hull fragments shown in figure 9.4 were found in the cockpit of the target aircraft and are approximately 35mm and 50mm in size, respectively. The right side of the photograph in figure 9.4 shows the appearance of a hole in the roof of the cockpit left by one of such hull fragments.

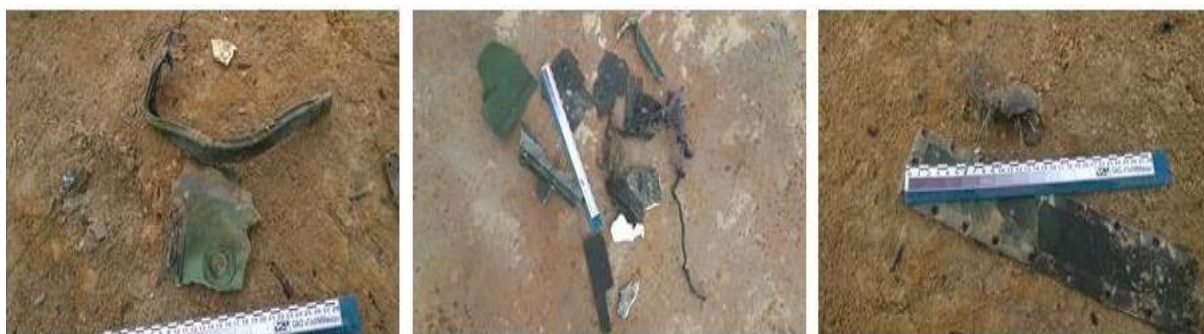
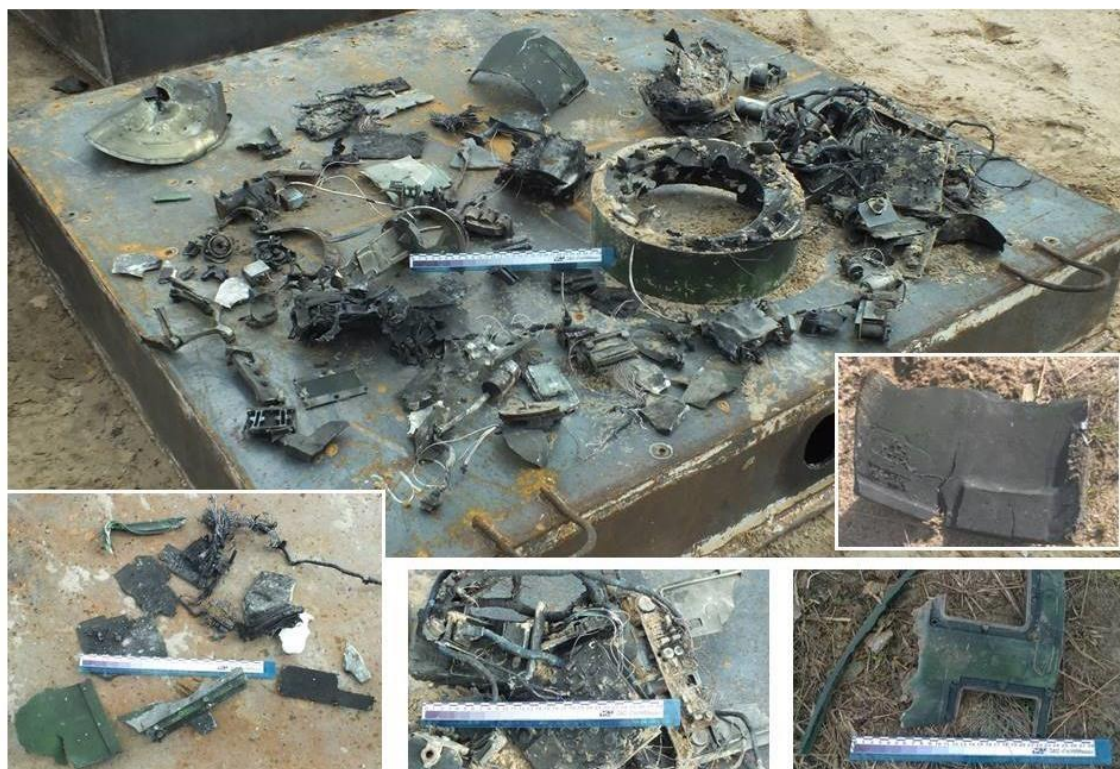
Figure 9.5 - Fragments of the 9M38M1 missile compartments

Figure 9.6 - Fragments of the 9M38M1 missile compartments

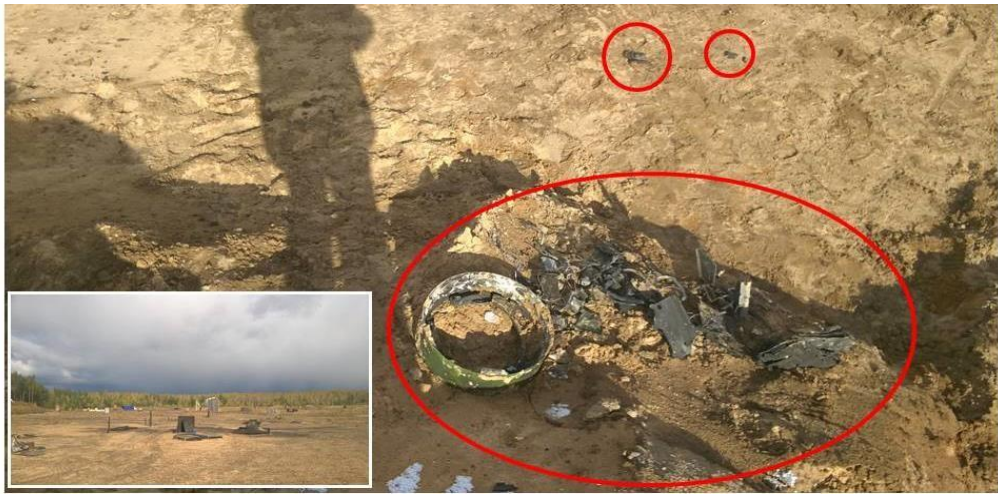
The bulk of the first compartment fragments were found at the impact point (insert in the lower left corner of figure 9.7) at a distance of about 100 m from the test stand.

The linear dimensions of the main fragments of the first compartment reach 100-250 mm or more.

Figure 9.7 - First compartment fragments impact point
(the place where first compartment fragments fell is shown in the bottom left corner)
