**APPLICATION OF THE INTERNATIONAL CONVENTION FOR THE SUPPRESSION
OF THE FINANCING OF TERRORISM AND OF THE INTERNATIONAL
CONVENTION ON THE ELIMINATION OF ALL FORMS OF RACIAL
DISCRIMINATION**

REJOINDER

Report of JSC Air and Space Defense Corporation "Almaz-Antey" on the results of studies related to the technical investigation into the crash of the Malaysian airlines Boeing 777-200 9M-MRD (flight MH17), 2023

on the results of studies related to the technical investigation into the crash
of the Malaysian airlines Boeing 777-200 9M-MRD (flight MH17)

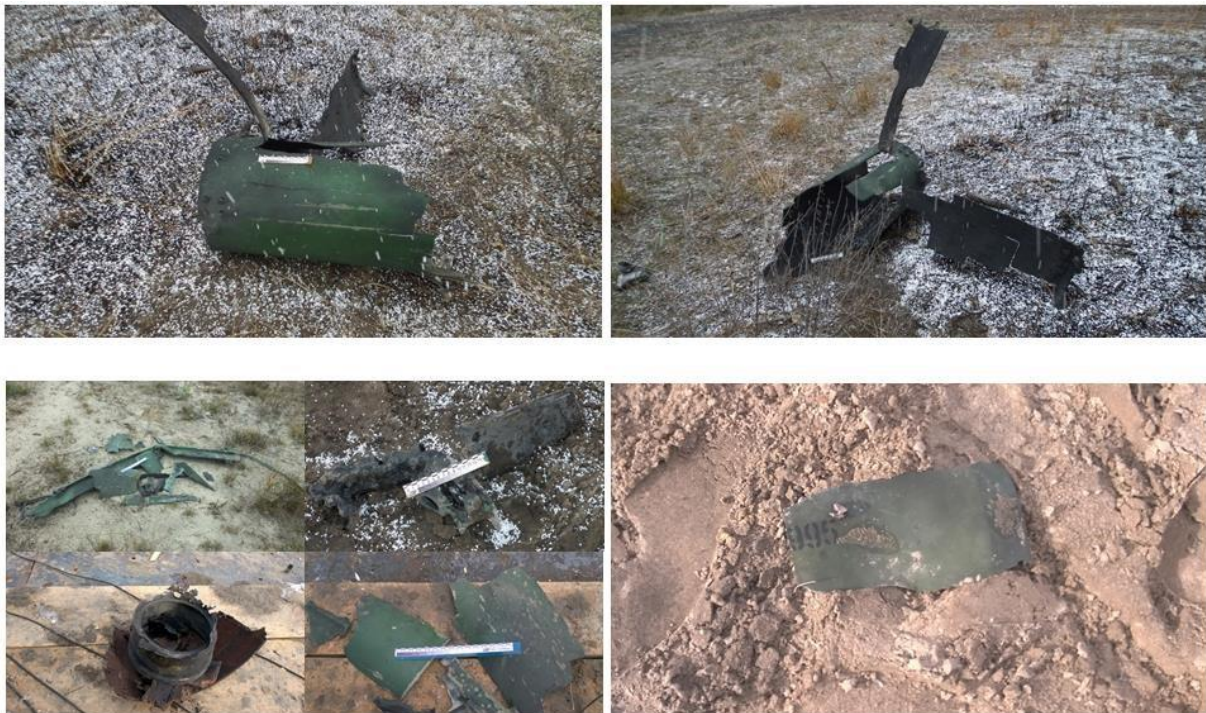
Figure 9.8 - Fragments of the third and fourth compartments of the missile

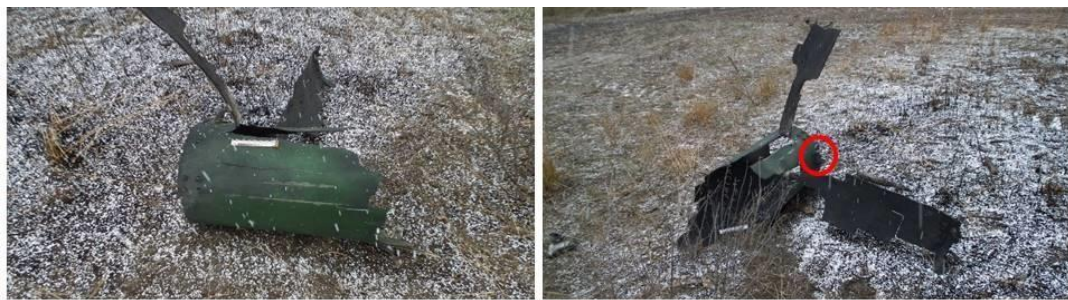
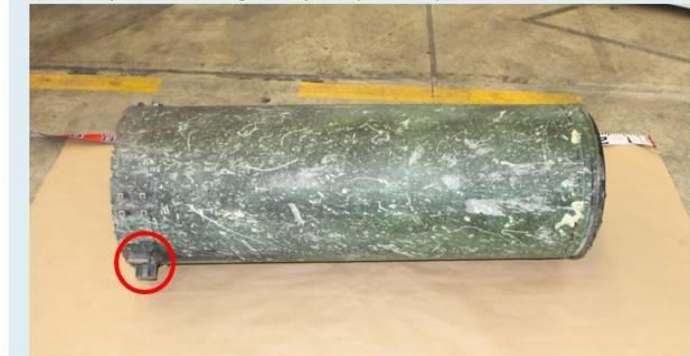
In the photos of figure 9.9, the missile's lug is marked in red, indicating that the objects in question may be the third compartment of the missile mentioned in the DSB Report materials.

However, the undamaged condition of the shown part of the third compartment hull shown and the absence of traces of deformation caused by the explosion or deformation caused by its fall from an altitude of about 10,000 m and its hitting the ground, cast doubt that its belongs to the missile the impact of which caused the Boeing 777 to crash.

Figure 9.9 - Comparison of fragments of the missile's third compartment: appearance of fragments following the tests (top) and of those from DSB materials (bottom)

Thus, the appearance and damage assessment analysis and the analysis of the explosive deformation of a fragment of the third compartment of 9M38M1 missile body after its experimental detonation showed the existence of fundamental differences as compared to a similar fragment discussed in the DSB Report's working papers.

Such differences cast doubt as to whether the fragment of the body of the third compartment in the possession of the DSB belonged to the missile the impact of which caused the Boeing 777 to crash.

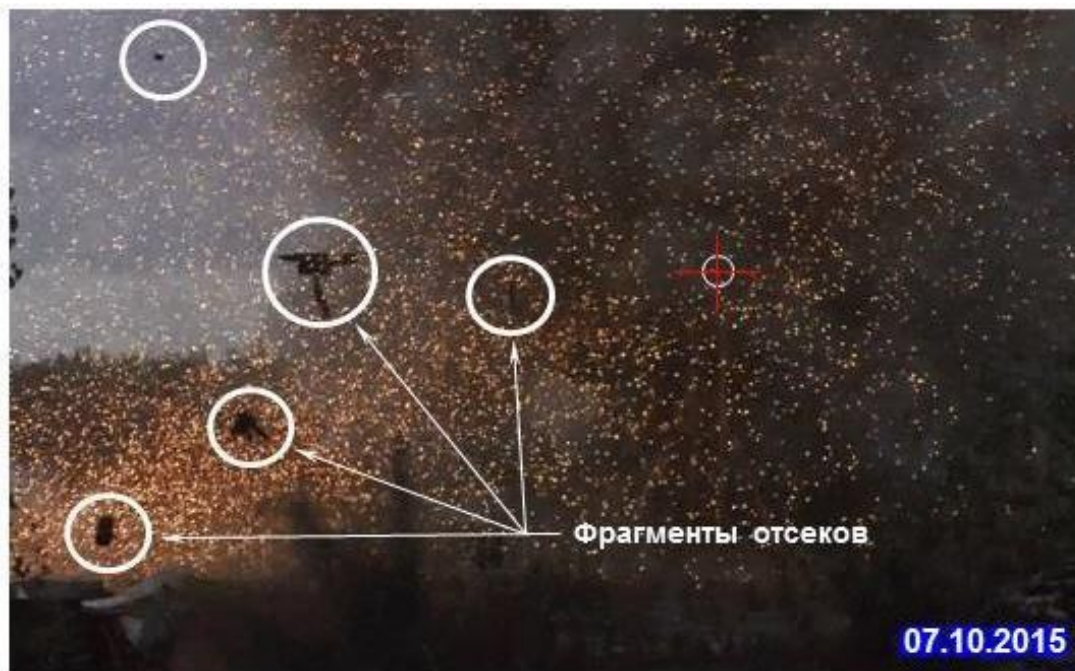
Figure 9.11 - Disintegration of fragments of compartments 3 and 4 of 9M38M1 missile as a result of the detonation of the 9H314M warhead

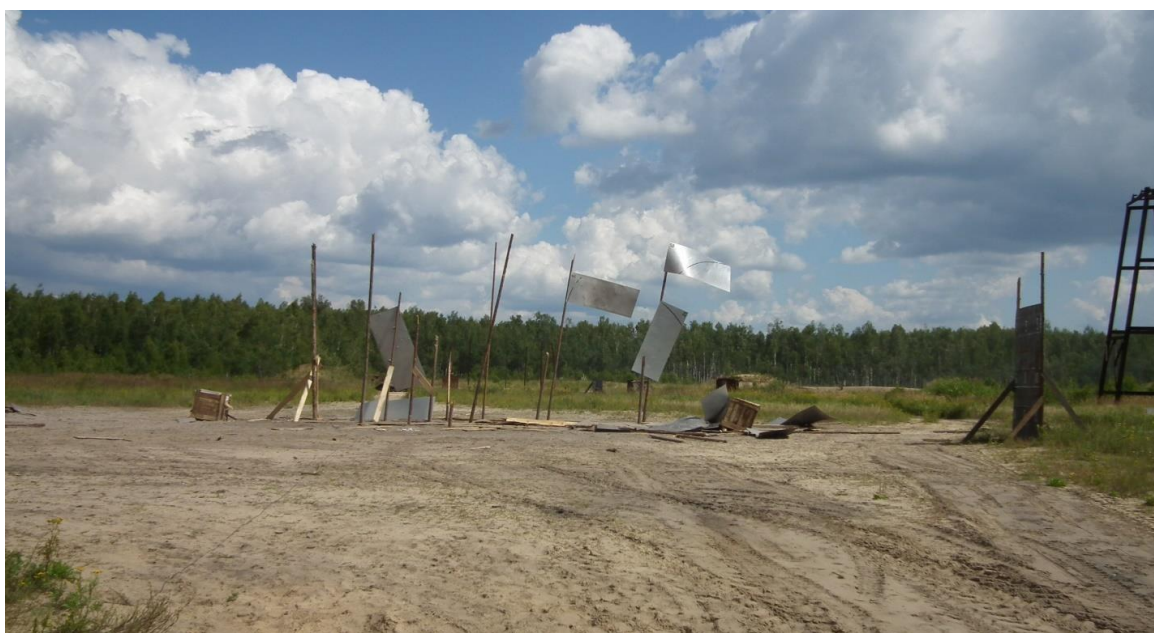
Figure A.30 – View of the layout target after the testing

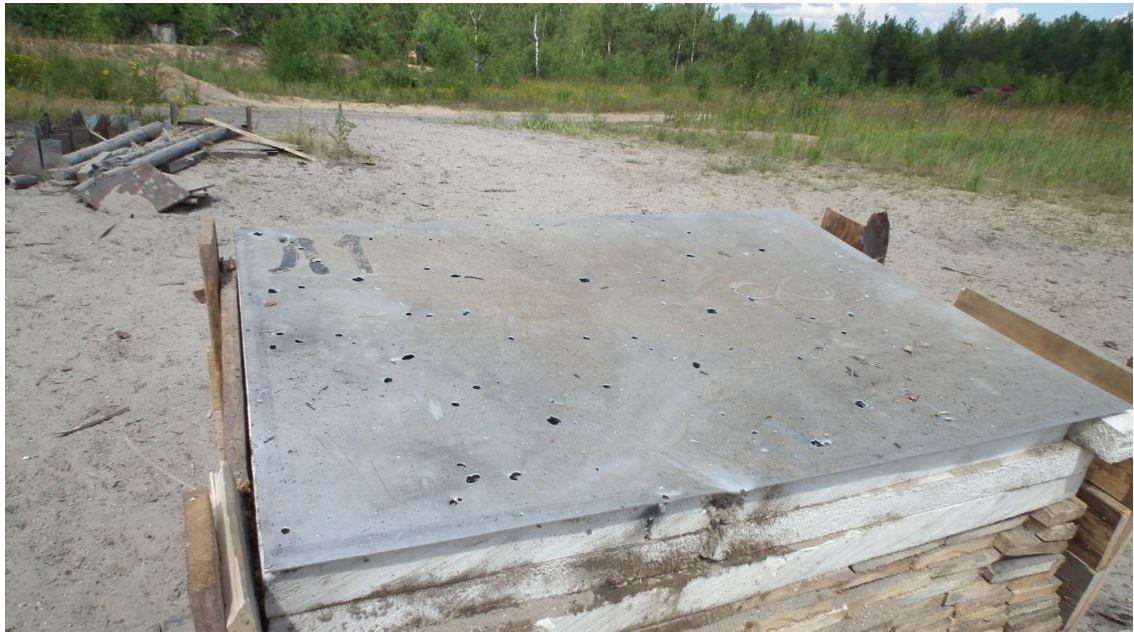
Figure A.31 - General view of trap L1 after the testing

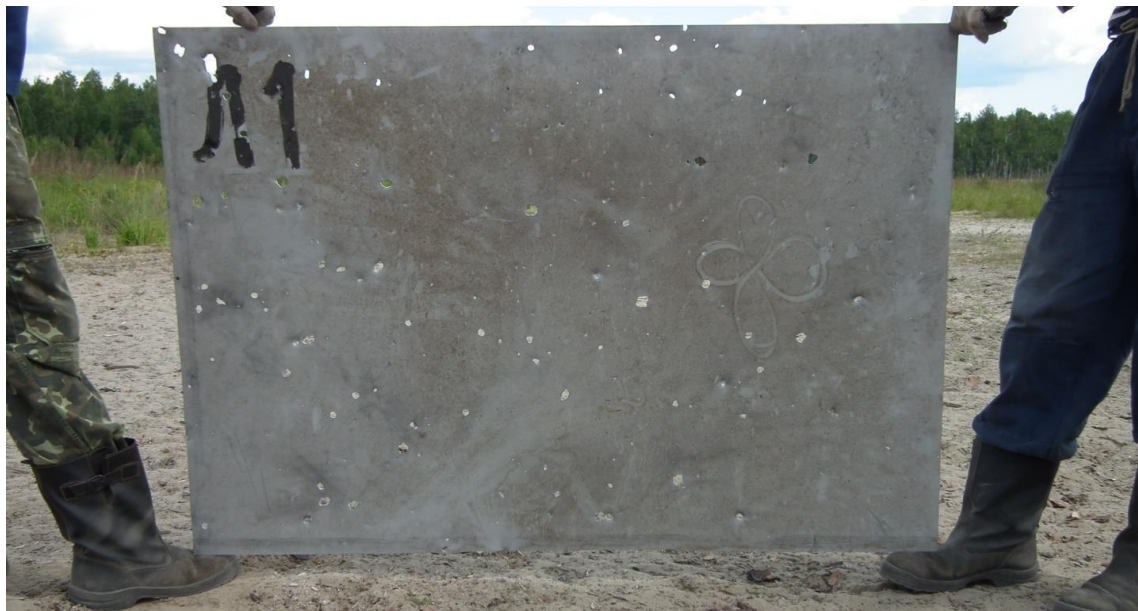
Figure A.32 - First barrier of trap L1 (2.0 mm thick sheet of aluminium alloy AMg6M) after the testing

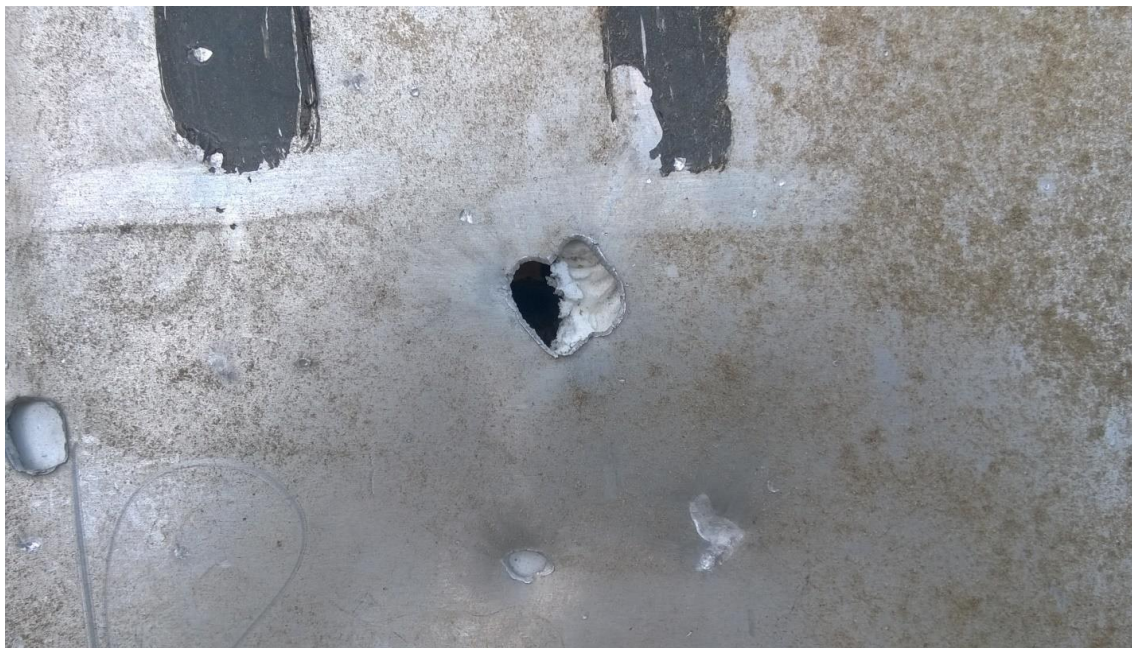
Figure A.33 - Example of a "butterfly"-shaped hole in the first barrier of trap L1 after the testing

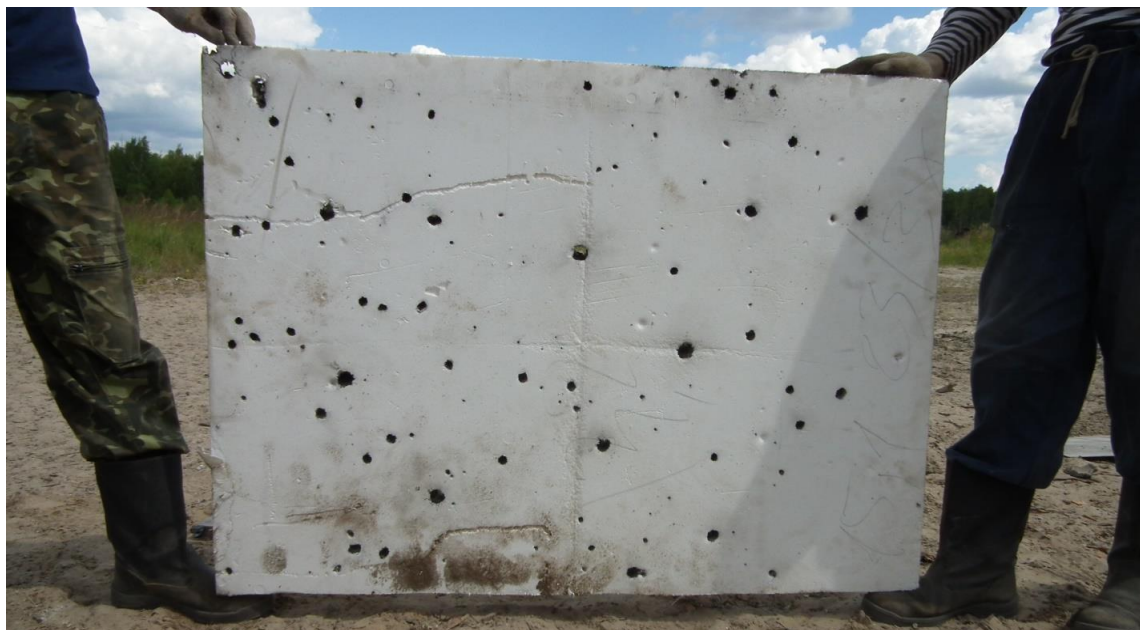
Figure A.34 - Second barrier of trap L1 (first layer of foam plastic PS-1-150) after the testing.

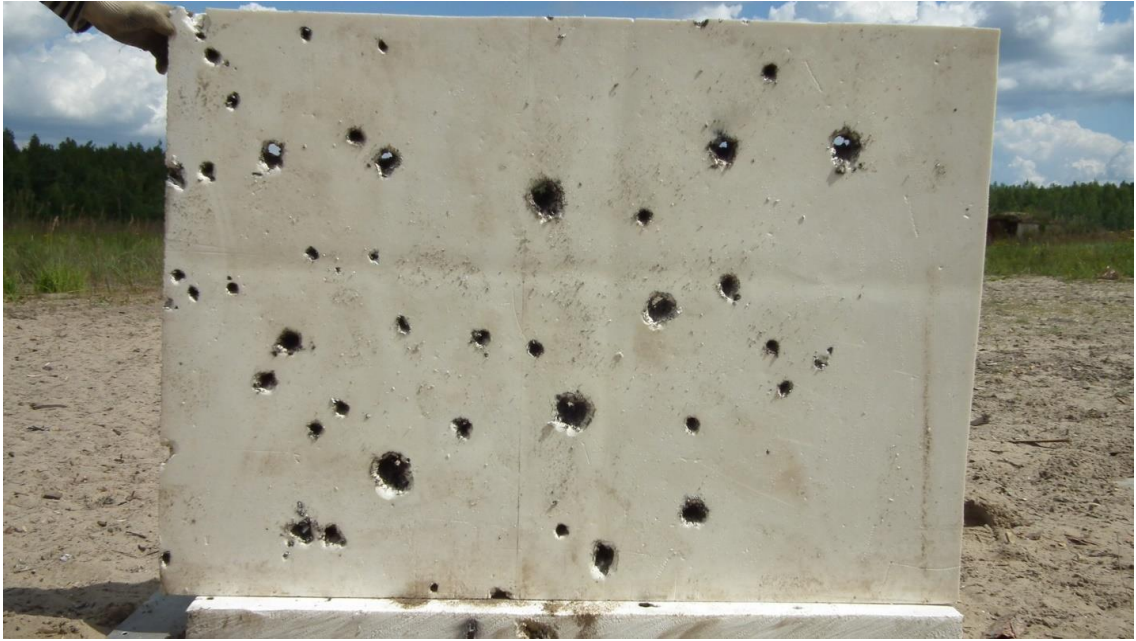
Figure A.35 - Second barrier of trap L1 (second layer of foam plastic PS-1-150) after the testing

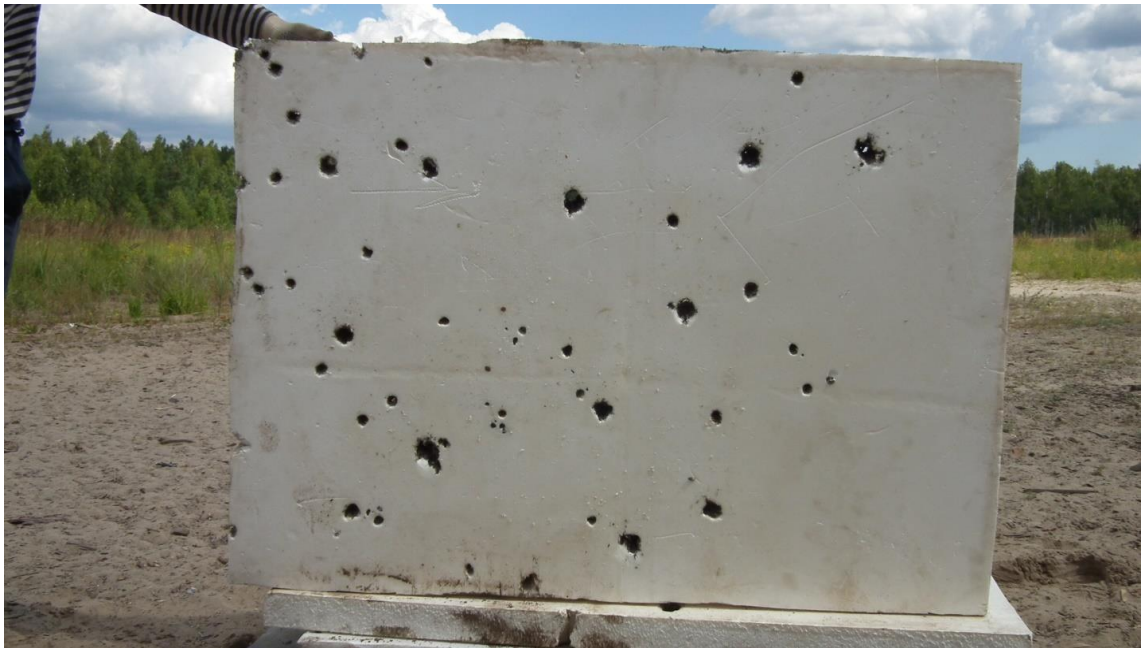
Figure A.36 - Second barrier of trap L1 (third layer of foam plastic PS-1-150) after the testing

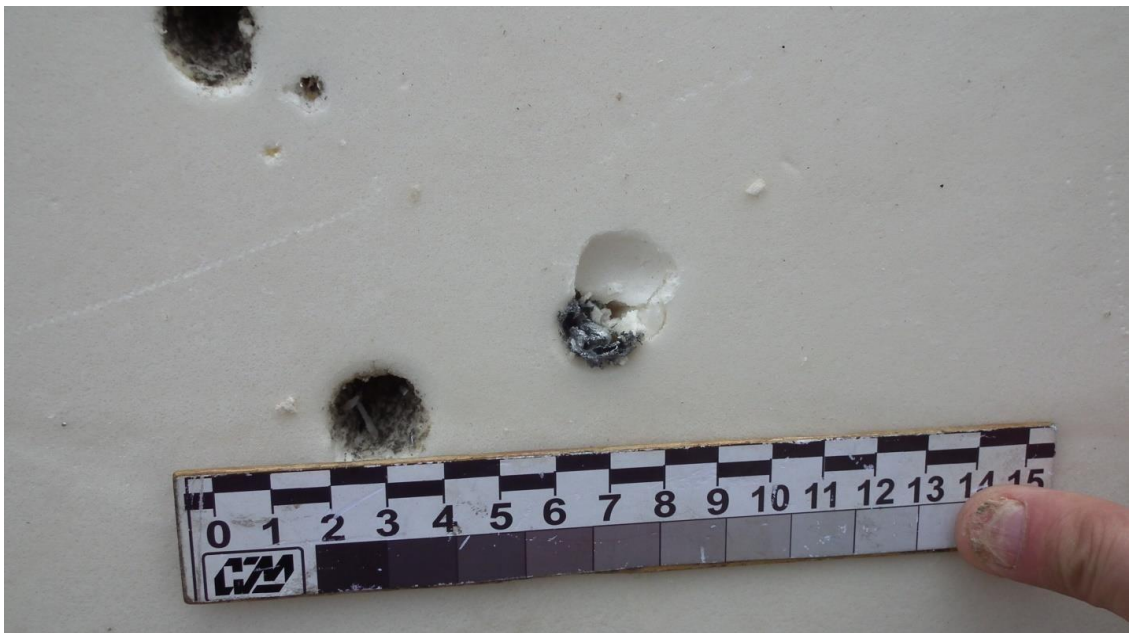
Figure A.37 - Hull fragment (that of the compartment hull) lodged in the third layer of stopping foam plastic PS-1-150

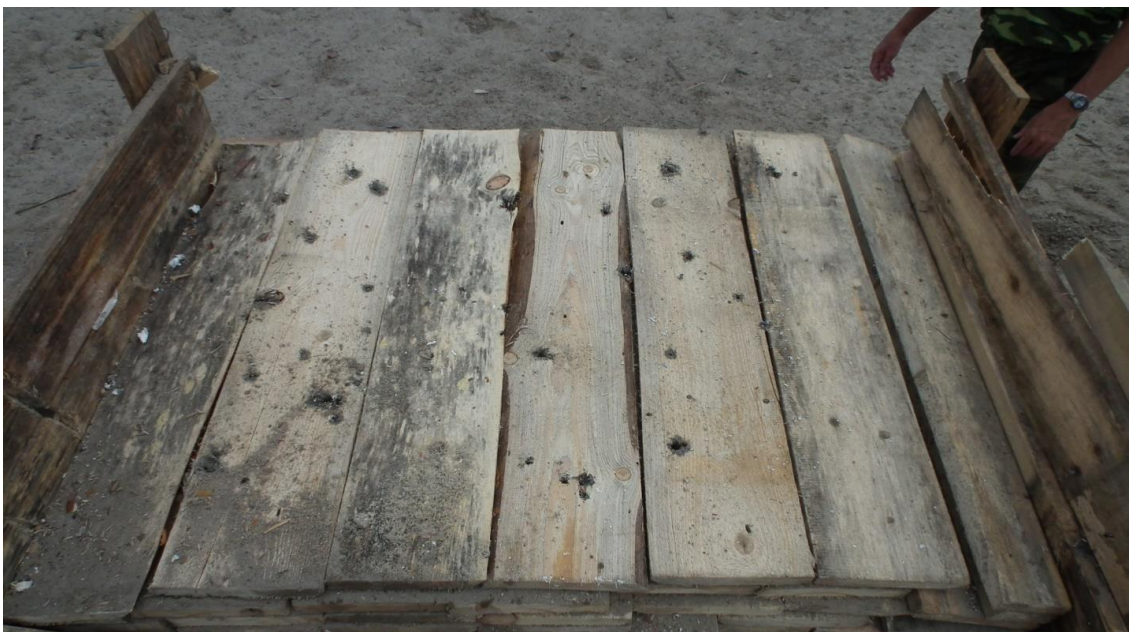
Figure A.38 - Third barrier of trap L1 (boards with a total thickness of 750 mm) after the testing

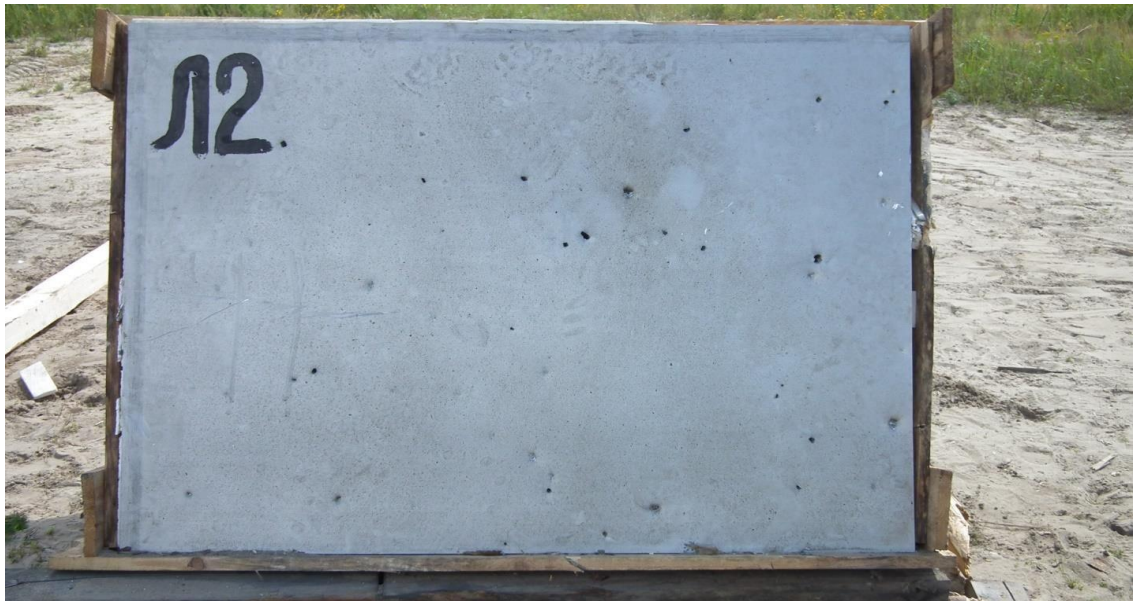
Figure A.39 - General view of trap L2 and first barrier (2.0 mm thick sheet of aluminium alloy AMg6M) after the testing

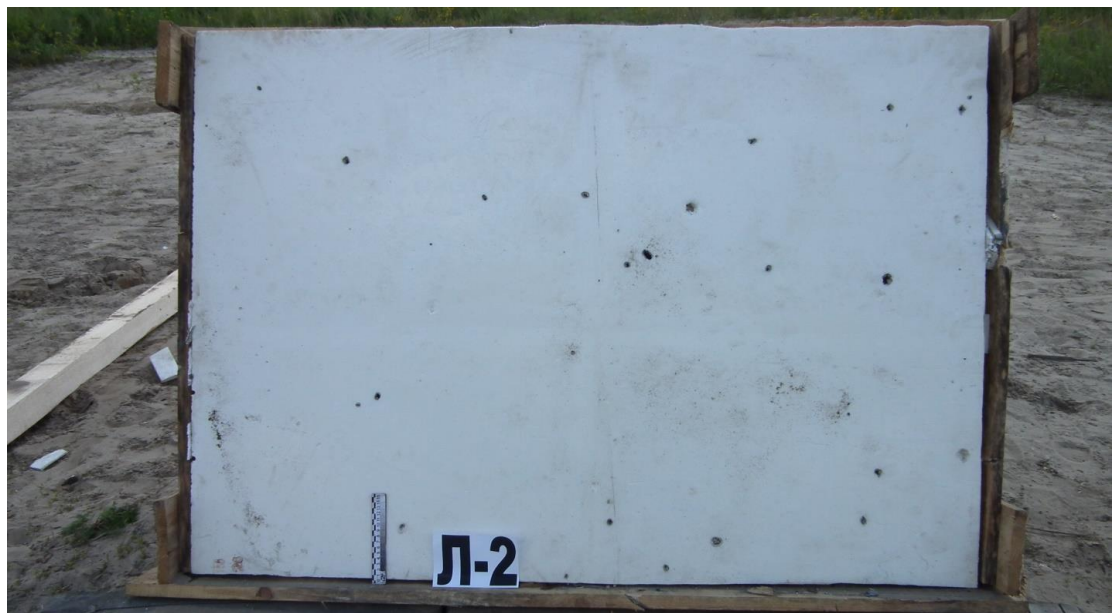
Figure A.40 - Second barrier of trap L2 (first layer of PS-1-150 foam plastic) after the testing

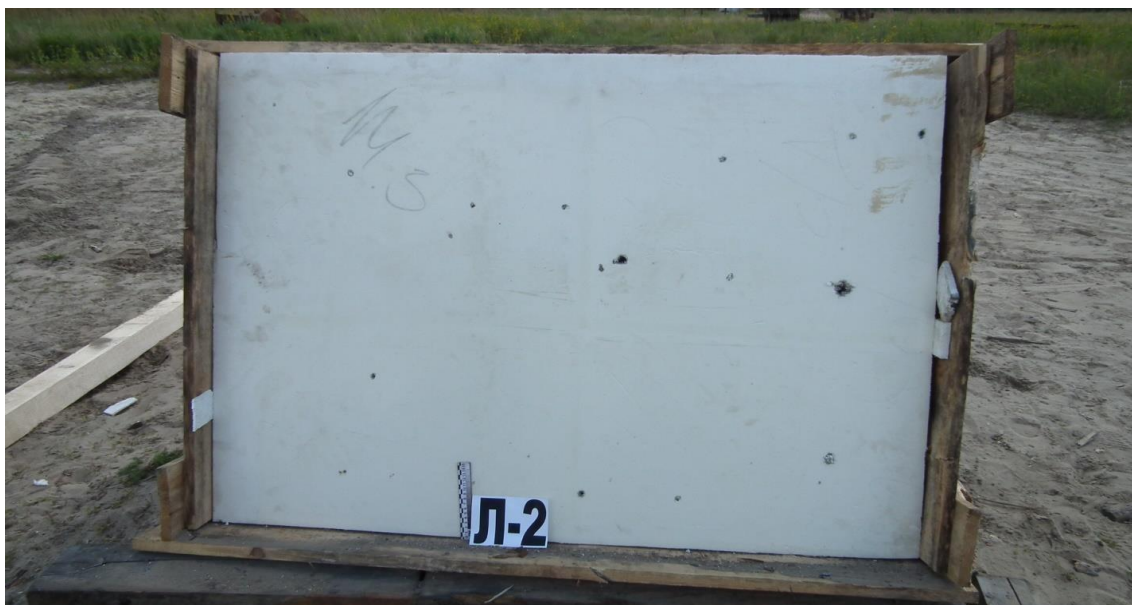
Figure A.41 - Second barrier of trap L2 (second layer of foam plastic PS-1-150) after the testing

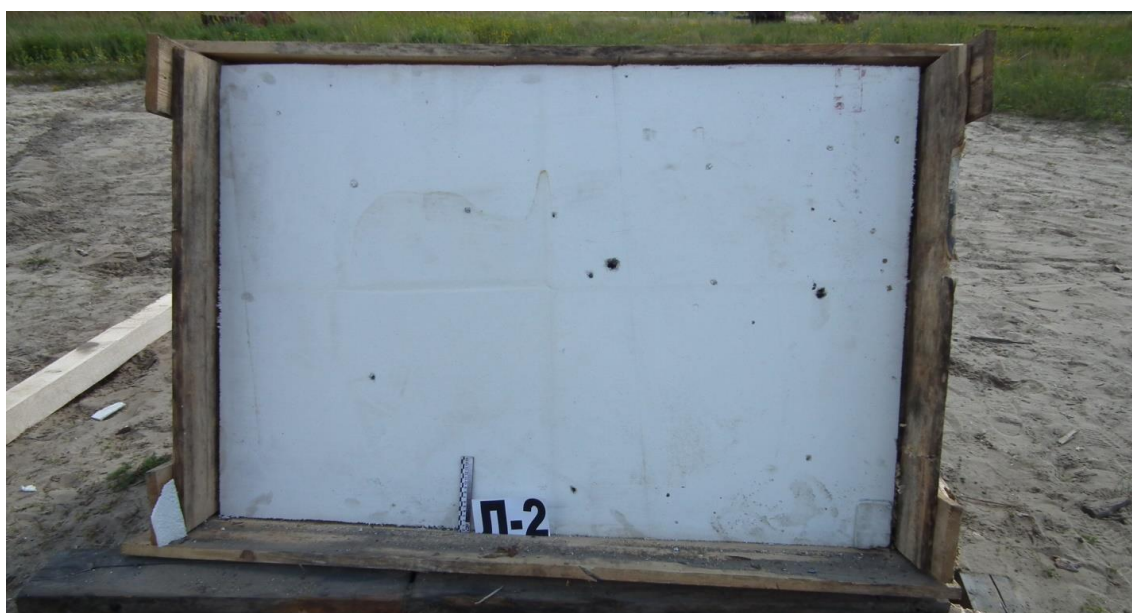
Figure A.42 - Second barrier of trap L2 (third layer of foam plastic PS-1-150) after the testing

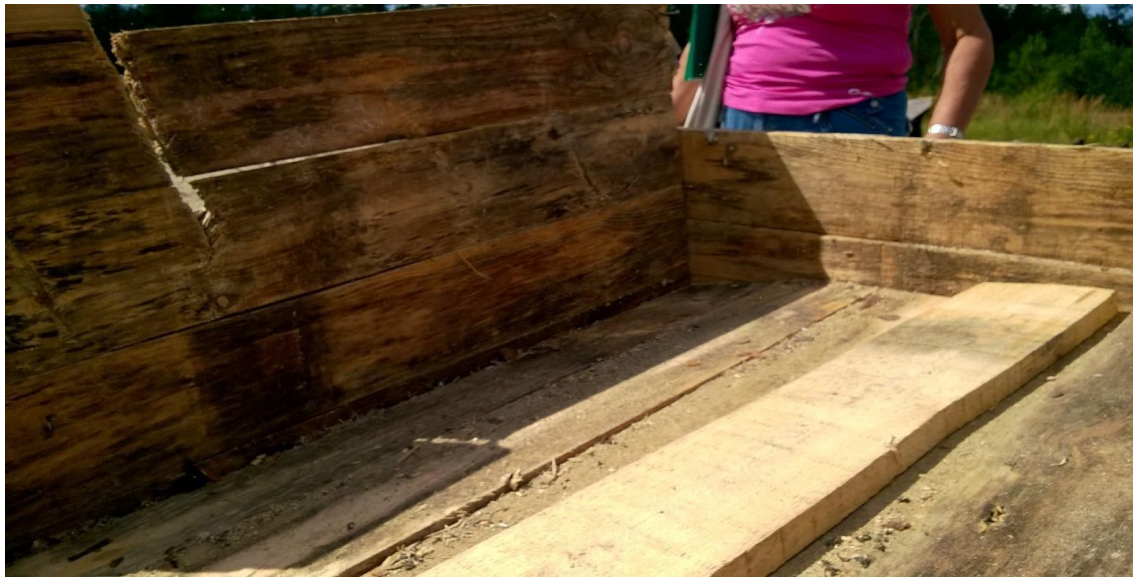
Figure A.44 - Depth of penetration of ready-made projectiles into trap L1

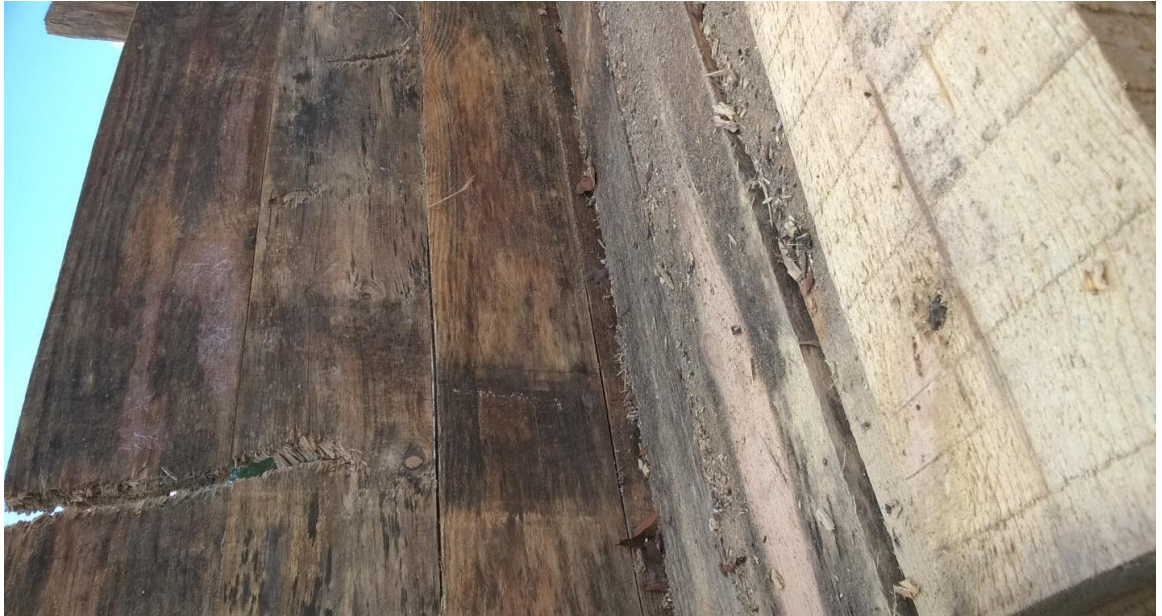
Figure A.45 - General view of a projectile lodged in trap L1

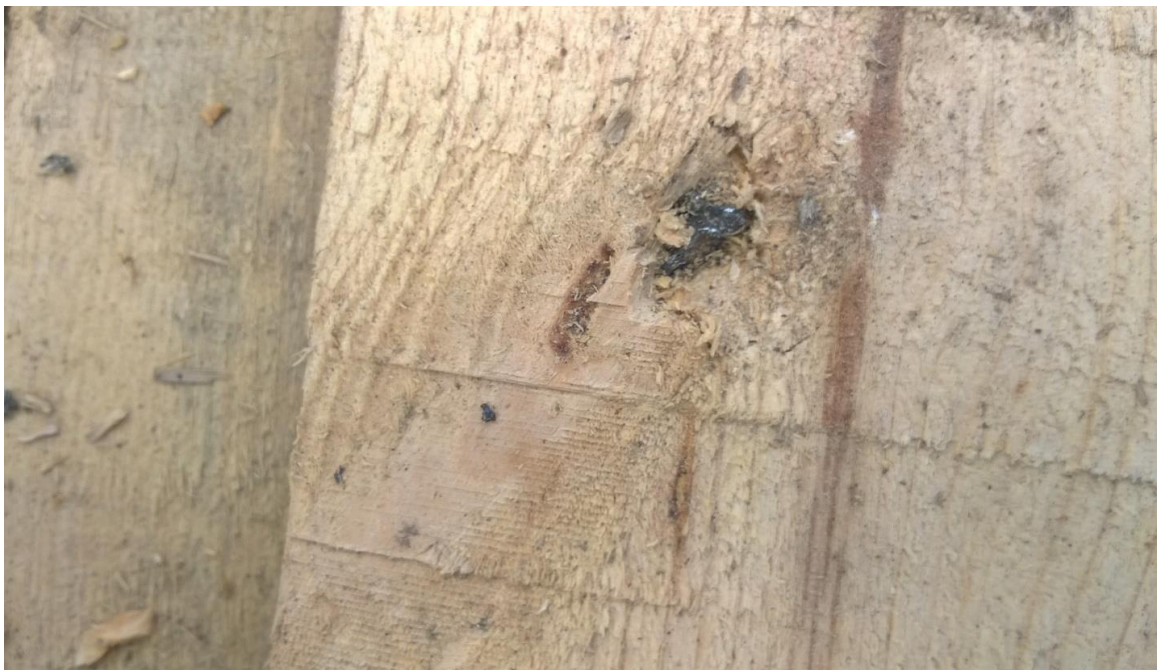
Figure A.46 - Projectile lodged in trap L1

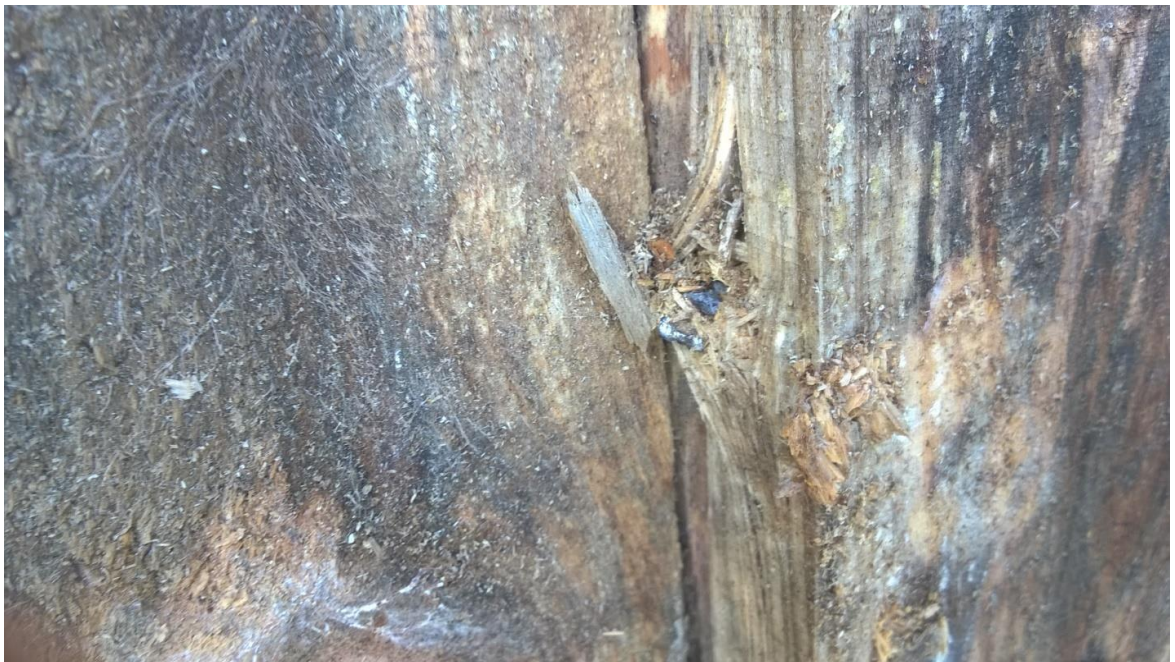
Figure A.48 - Projectile lodged in trap L2

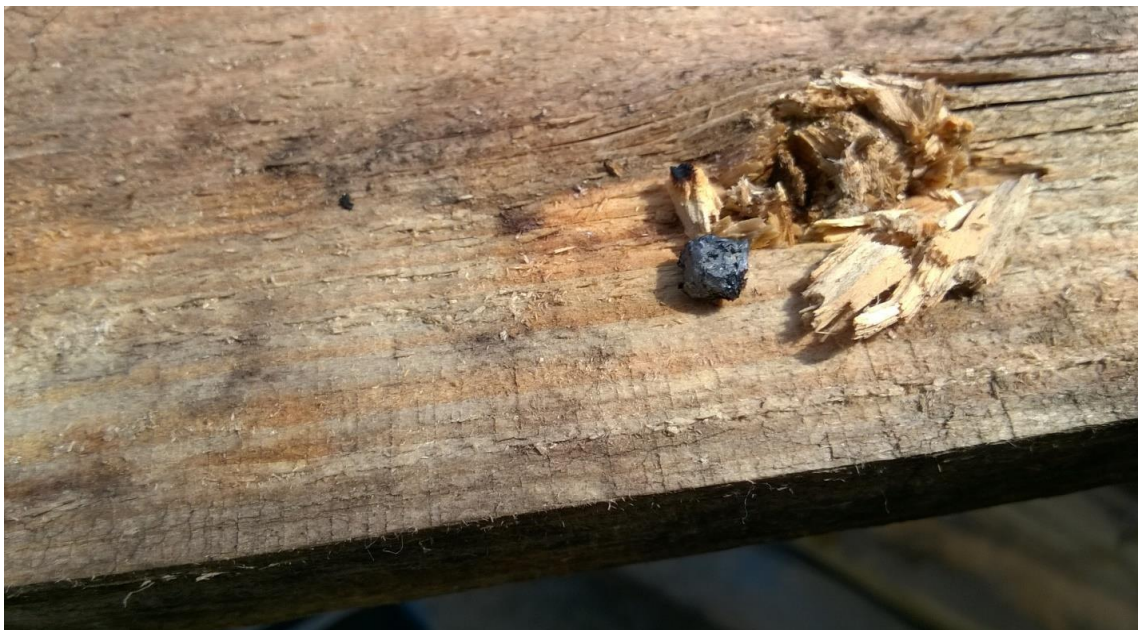
Figure A.49 – Removal of a projectile lodged in trap L2

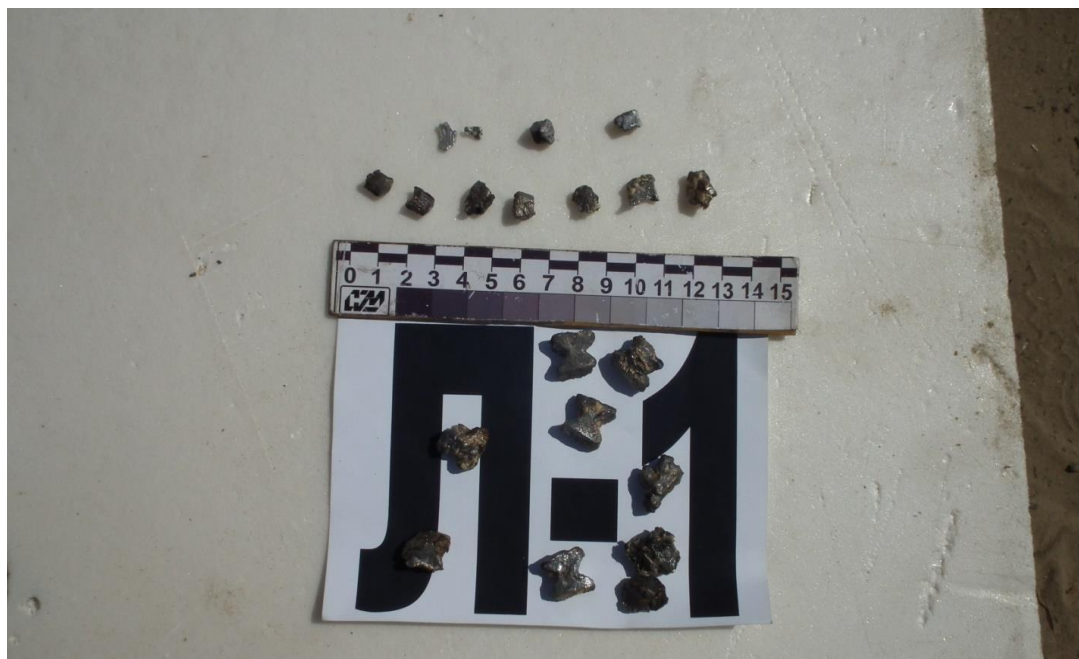
Figure A.50 – Ready-made projectiles of three fractions extracted from trap L1

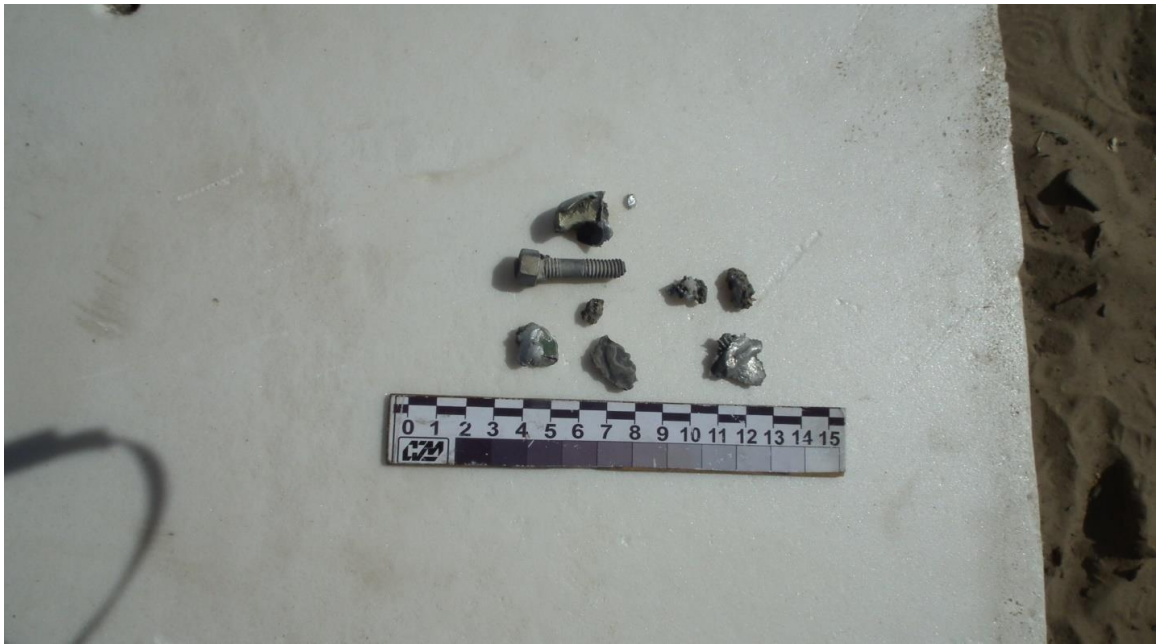
Figure A.51 - Hull fragments (those of the compartment hull) recovered from traps

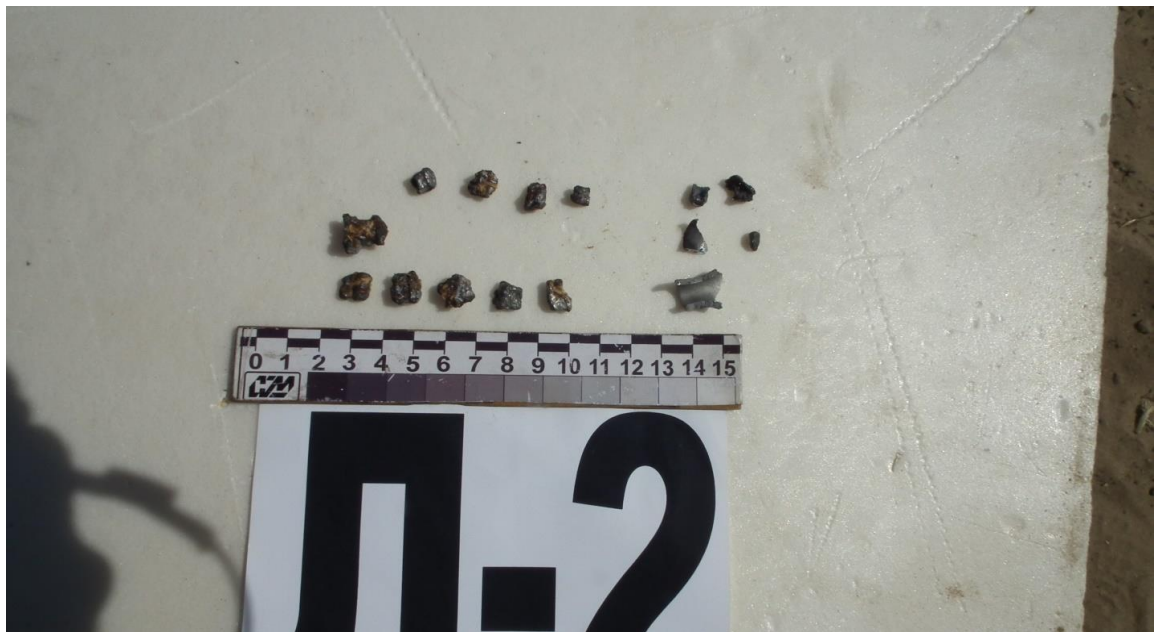
Figure A.52 - Ready-made projectiles and hull fragments (those of the compartment hull) removed from trap L2

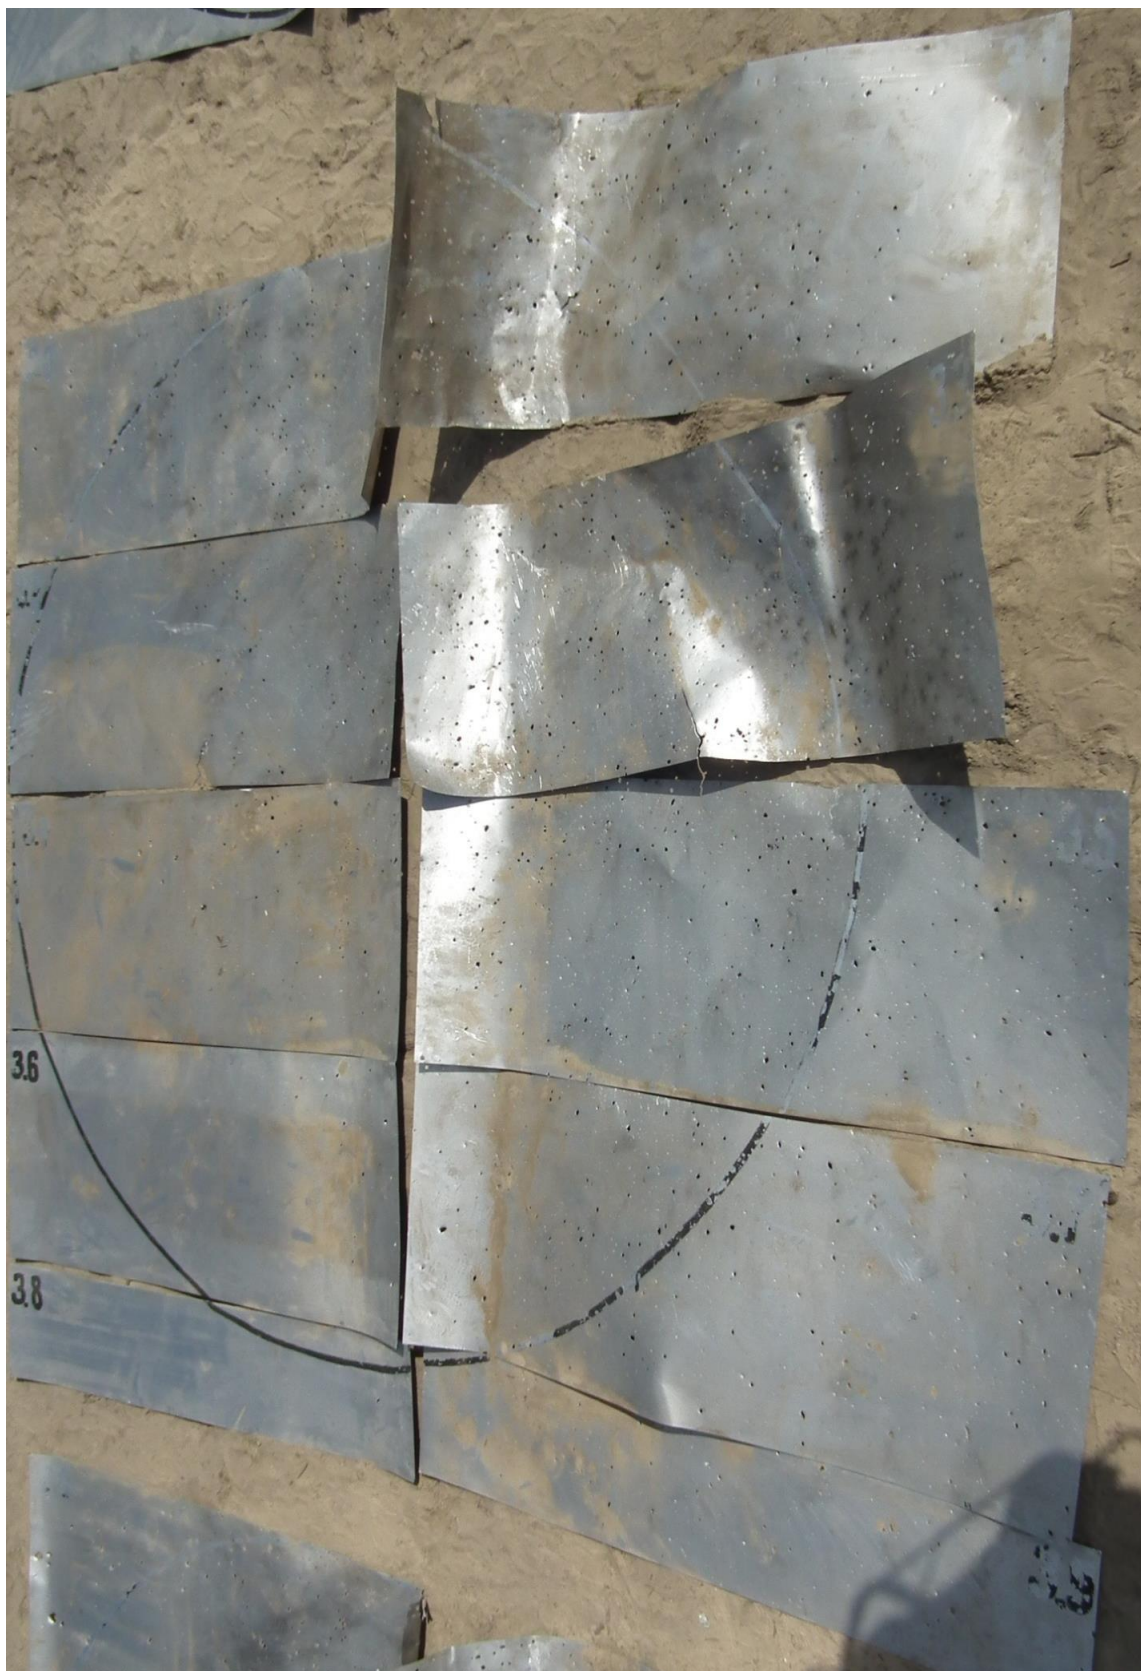
Figure A.98 - Target No. 3

Figures A.98 through A.124 show the appearance of target No. 3 and its fragments after they were collected. The sides of the target correspond to the simulated fuselage of the Boeing 777-200 aircraft. The left side of the aircraft is represented by shields 3.1, 3.3, 3.5, 3.7 and 3.9; the right side by shields 3.0, 3.2, 3.4, 3.6 and 3.8.

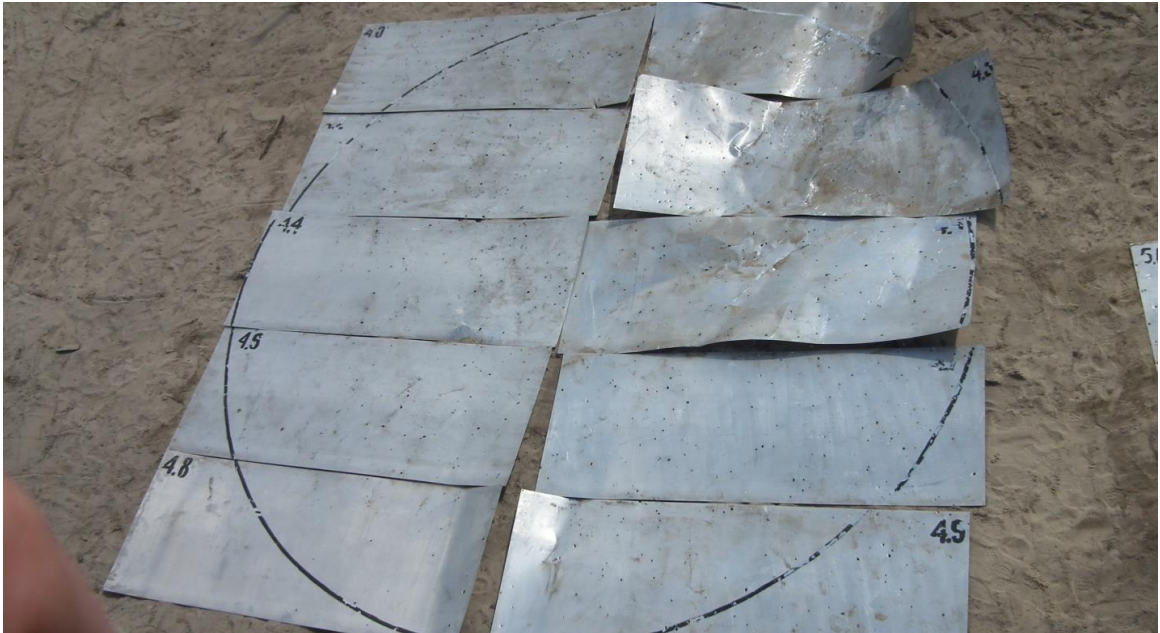
Figure A.125 - Target No. 4

Figures A.125 through A.145 show the appearance of target No. 4 and its fragments after they were collected. The sides of the target correspond to the simulated fuselage of the Boeing 777-200 aircraft. The left side of the aircraft is represented by shields 4.1, 4.3, 4.5, 4.7 and 4.9; the right side by 4.0, 4.2, 4.4, 4.6 and 4.8.

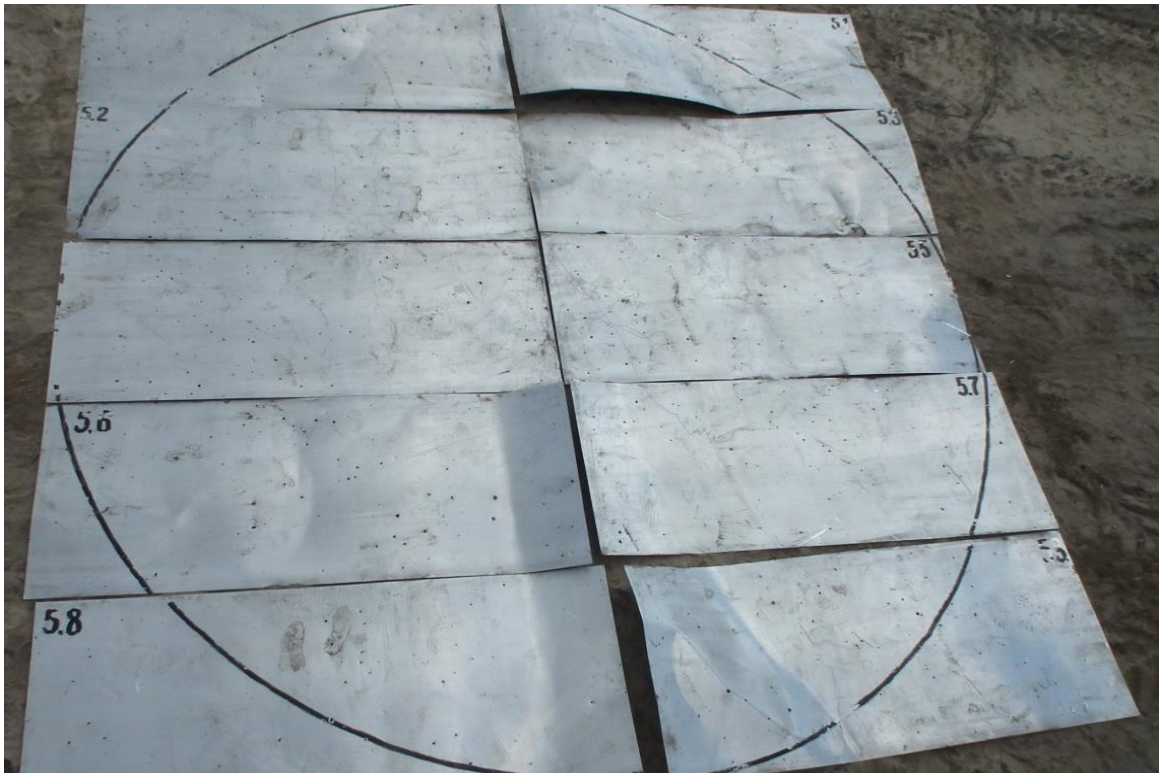
Figure A.146 - Target No. 5

Figures A.146 through A.166 show the appearance of target No. 5 and its fragments after they were collected. The sides of the target correspond to the simulated fuselage of the Boeing 777-200 aircraft. The left side of the aircraft is represented by shields 5.1, 5.3, 5.5, 5.7 and 5.9; the right side by shields 5.0, 5.2, 5.4, 5.6 and 5.8.

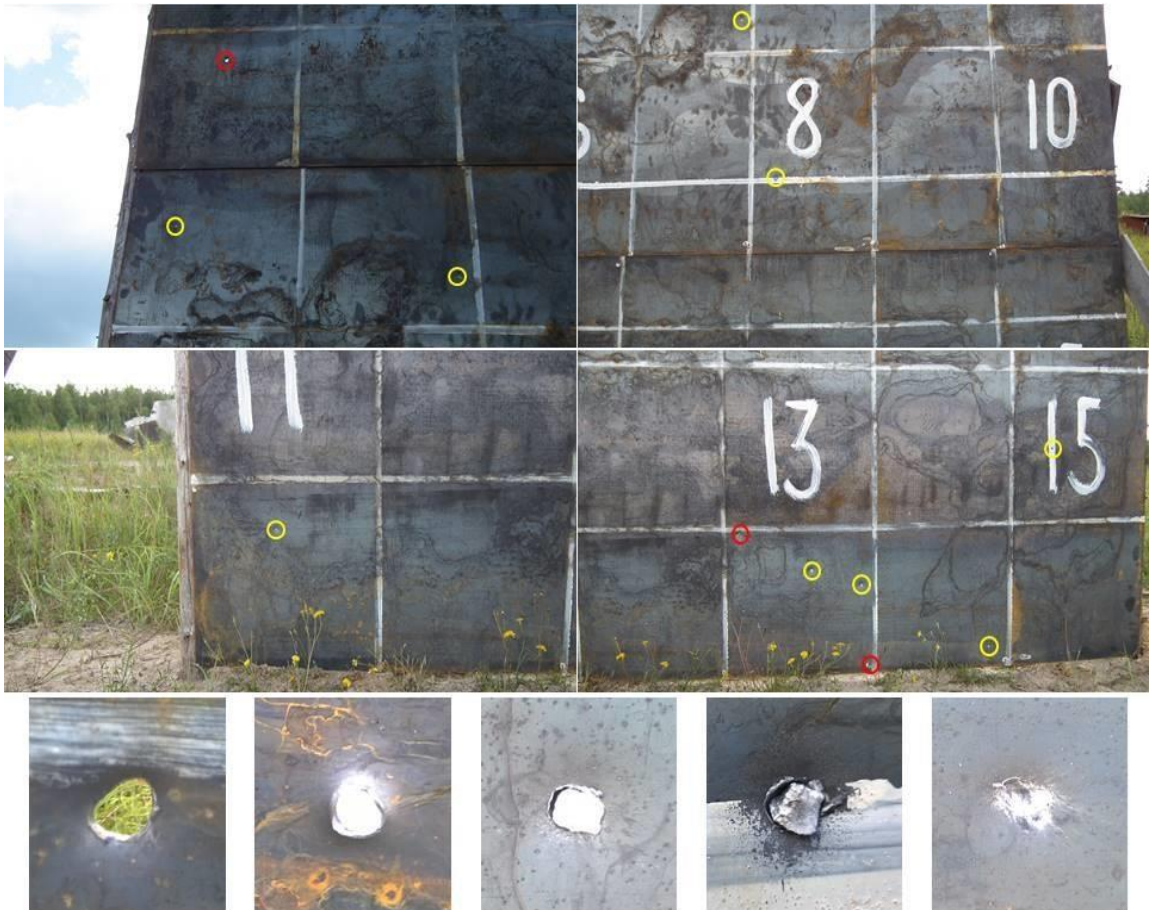
Figure A.167 shows the appearance of target No. 6M.D (left engine imitation) and examples of piercing and non-penetrating damage. The through-holes are highlighted in red and non-penetrating damage is highlighted in yellow.

Figure A.167 - Fragments of target No. 6 (top) and examples of damage to the target (below)
