**APPLICATION OF THE INTERNATIONAL CONVENTION FOR THE SUPPRESSION
OF THE FINANCING OF TERRORISM AND OF THE INTERNATIONAL
CONVENTION ON THE ELIMINATION OF ALL FORMS OF RACIAL
DISCRIMINATION**

REJOINDER

Report of JSC Air and Space Defense Corporation "Almaz-Antey" on the results of studies related to the technical investigation into the crash of the Malaysian airlines Boeing 777-200 9M-MRD (flight MH17), 2023

on the results of studies related to the technical investigation into the crash
of the Malaysian airlines Boeing 777-200 9M-MRD (flight MH17)

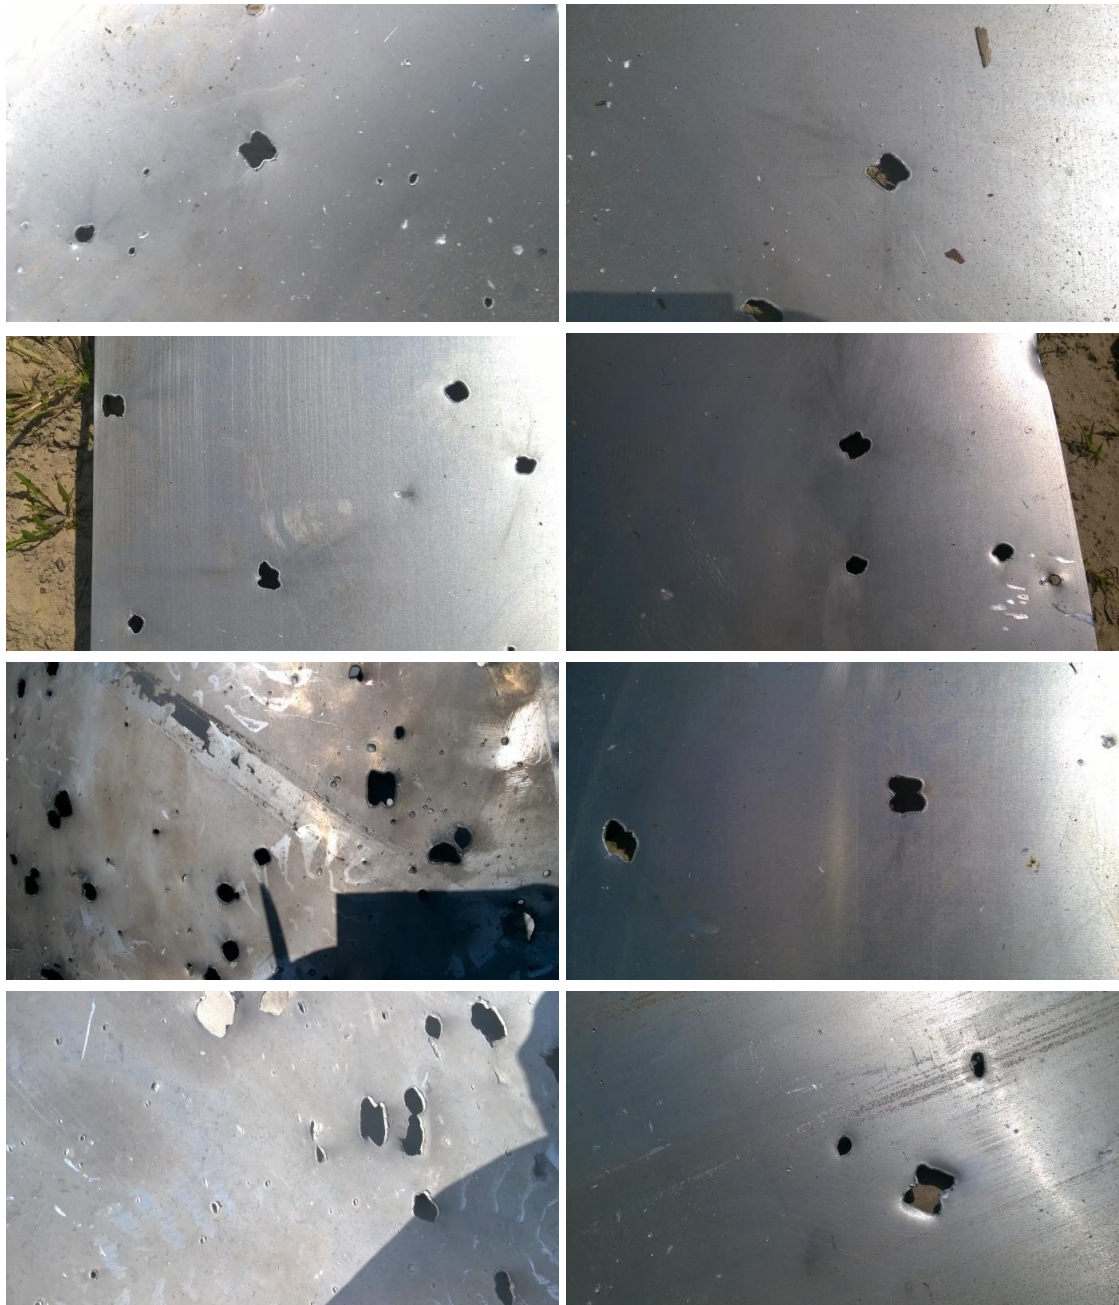
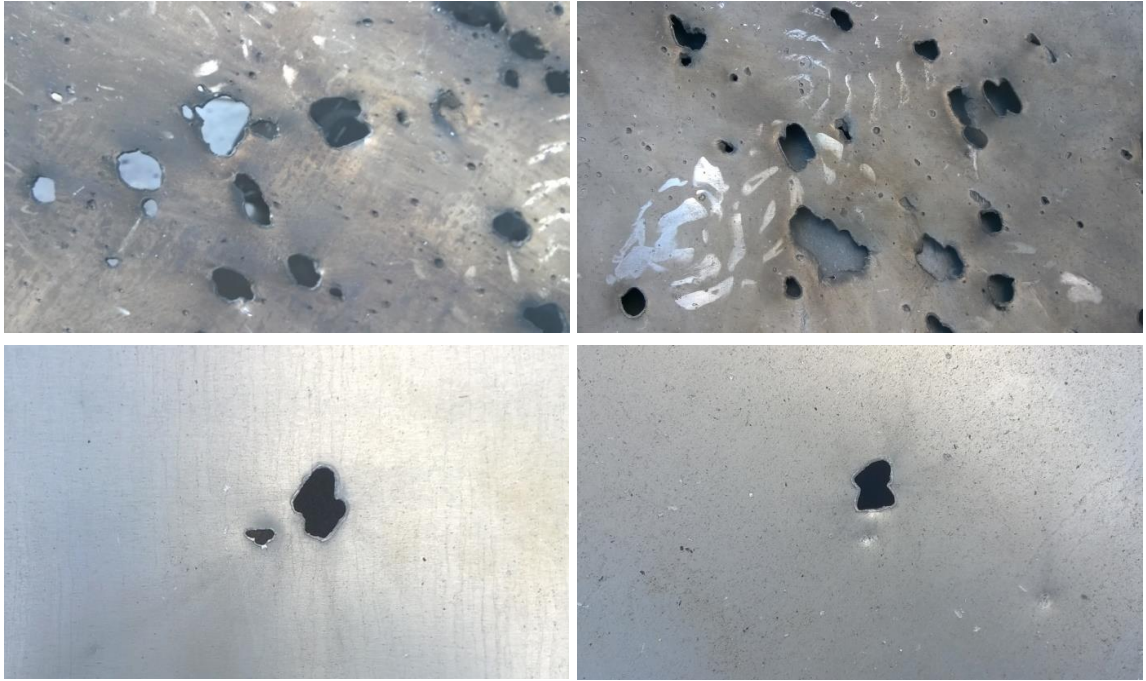
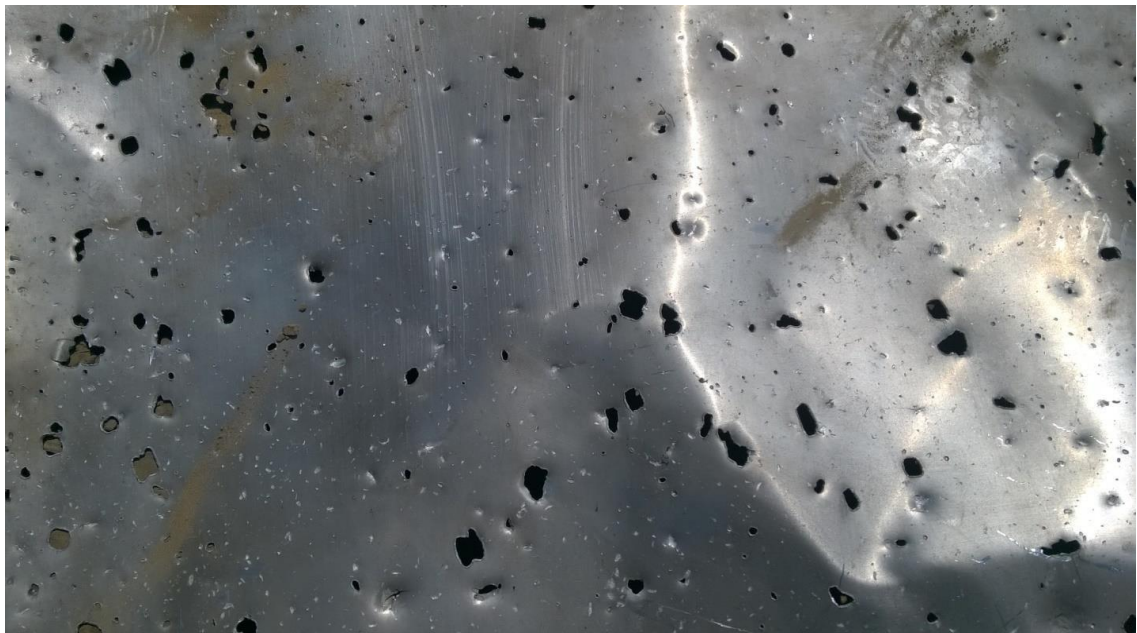
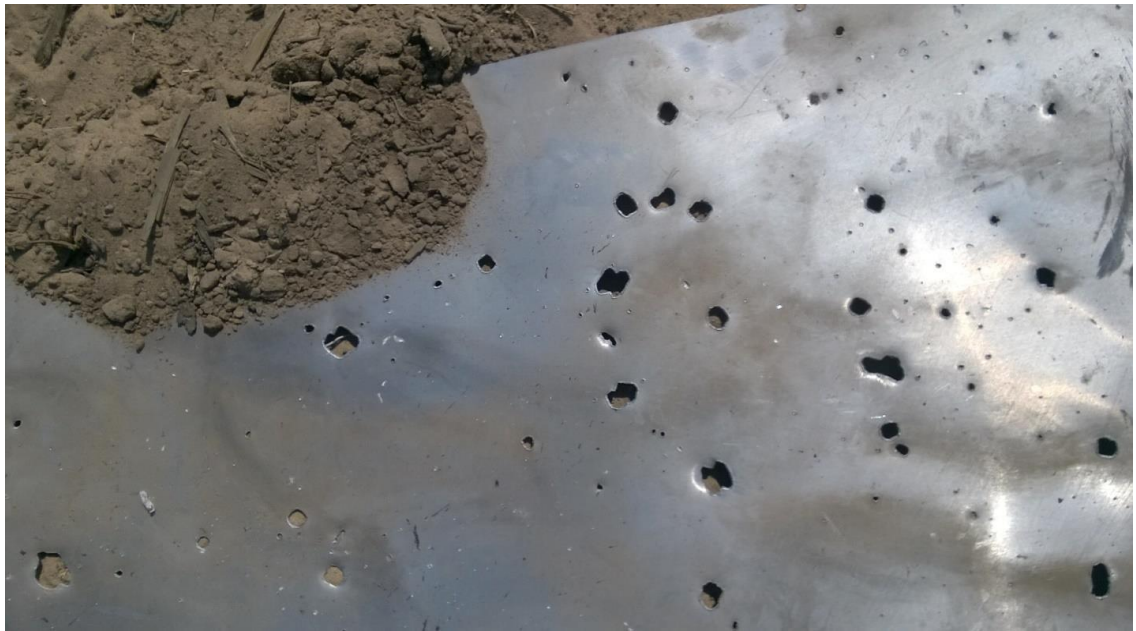
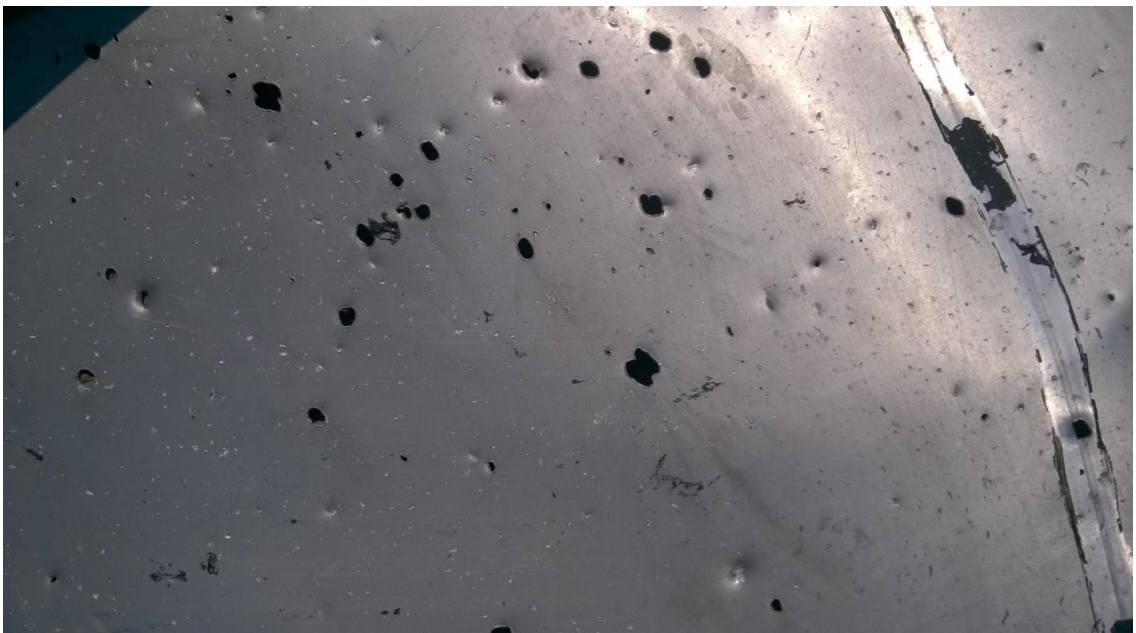
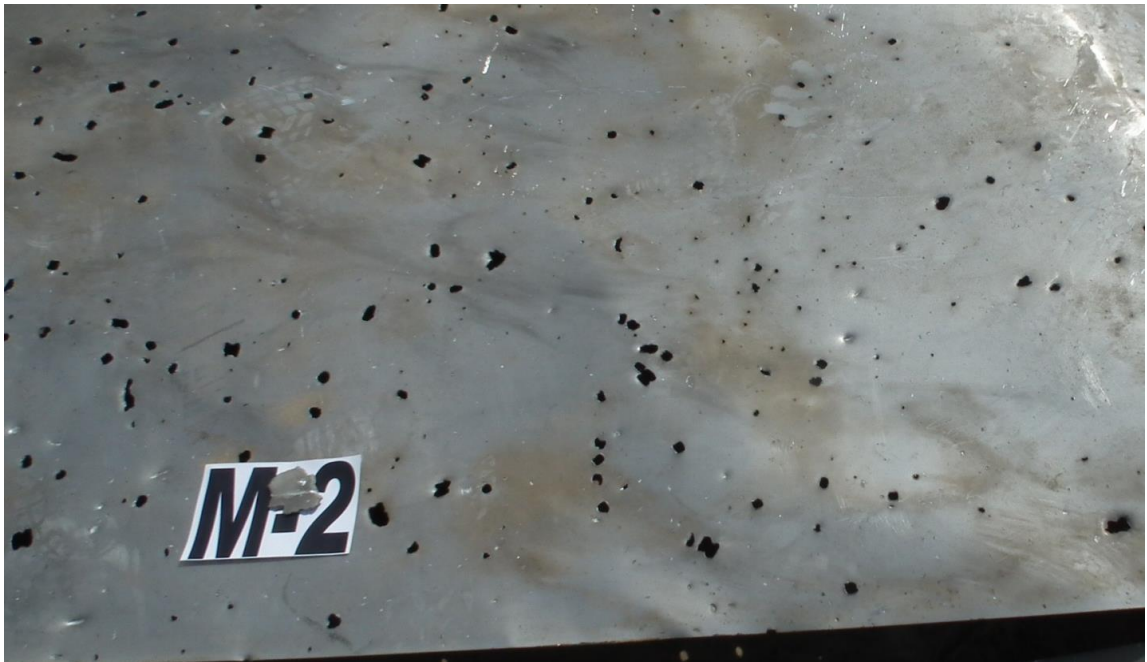
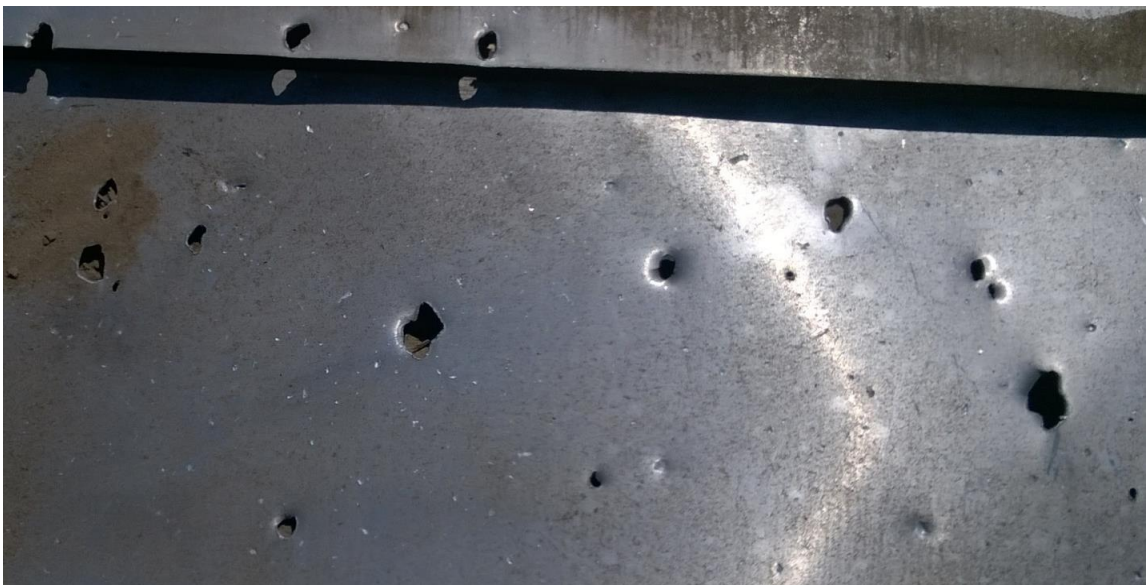
An examination of damage to (through-holes in) fragments of the target layout revealed that all the targets made of duralumin alloy have a large number of "butterfly"-shaped holes, which are left the 9H314M 1-10 heavy fraction "bowtie"-shaped projectiles (Figures A.168 through A.174).

Figure A.168 - Characteristic "butterfly"-shaped holes

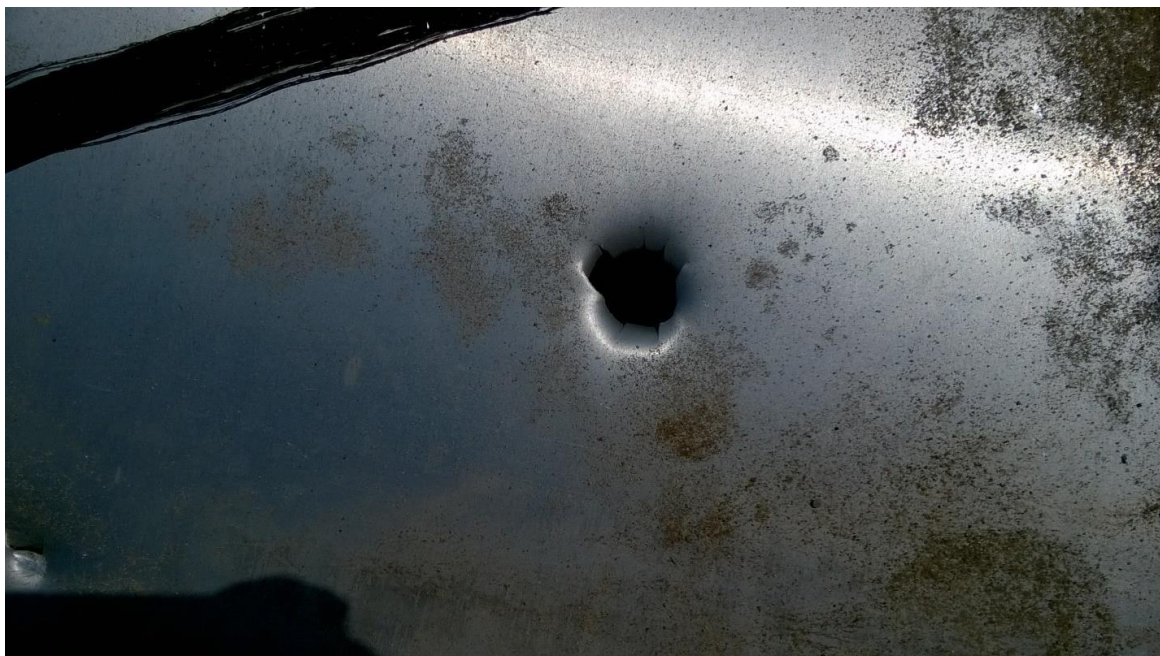
Some of the holes were significantly larger in size than the linear dimensions of the ready-made projectiles. Most of the "non-standard" through-holes left by hull fragments were located near the front and rear boundaries of the fragmentation flow, but within the meridional angle of dispersion of ready-made projectiles.

Figure A.175 – Holes left by hull fragments

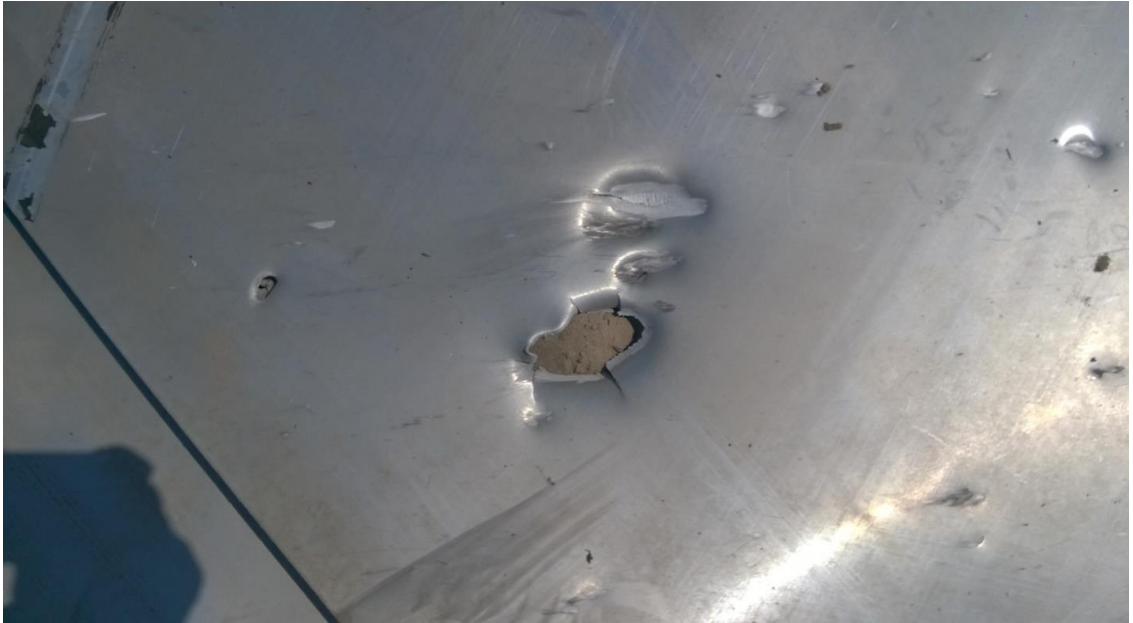
Figure A.176 - Piercing and non-penetrating damage caused by hull fragments

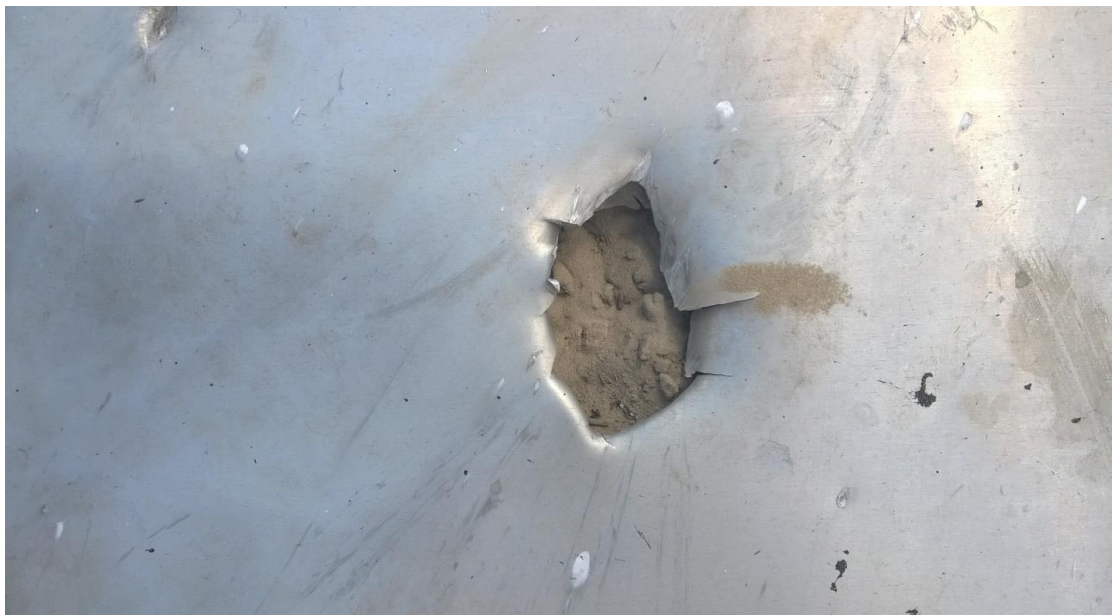
Figure A.177 - Hole left by a hull fragment

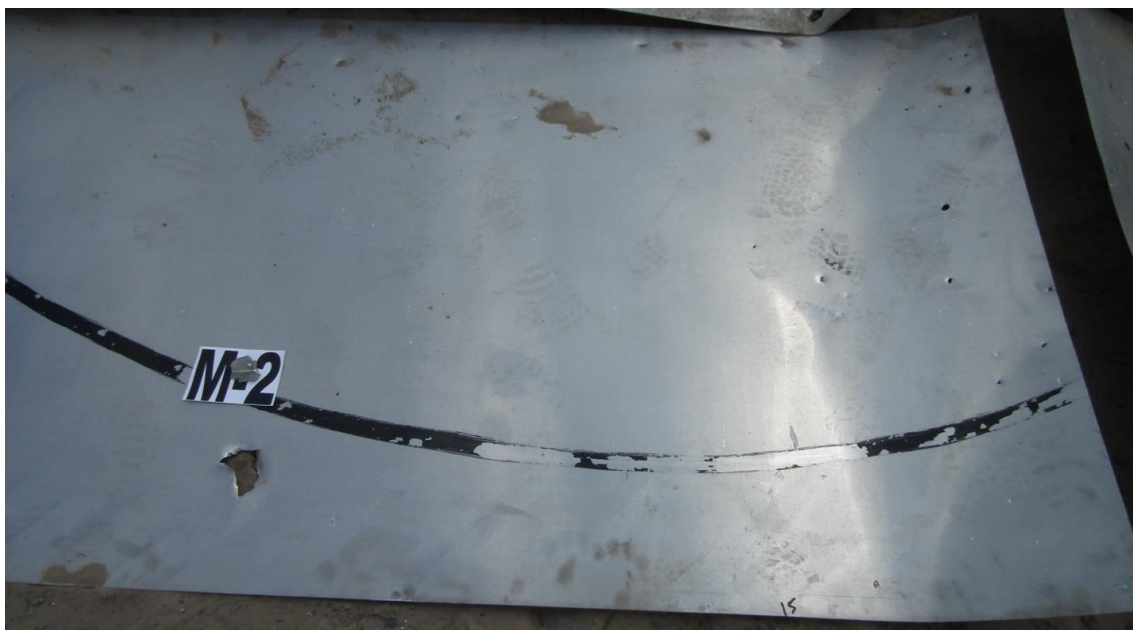
Figure A.178 - Hole left

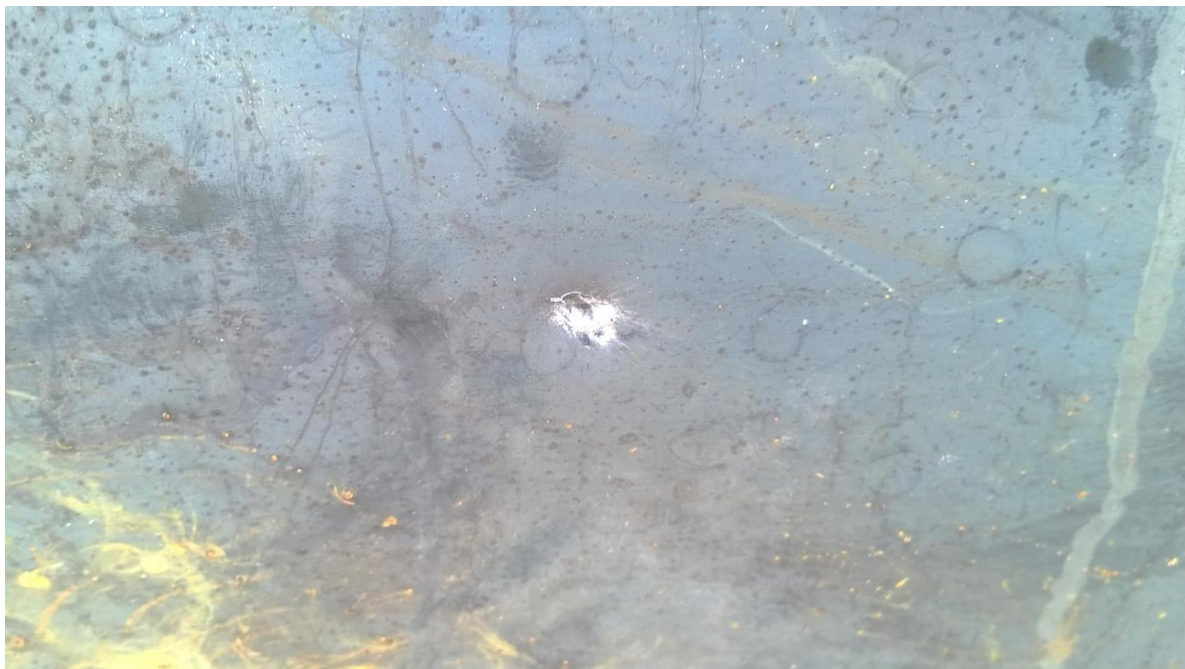
None of the hull fragments that hit target No. 6M.D (left engine imitation) pierced the shields. An example of non-penetrating damage caused by a hull fragment is shown in Figure A.179.

Figure A.179 - Non-penetrating damage to target No. 6M.D
(left engine) caused by a hull fragment

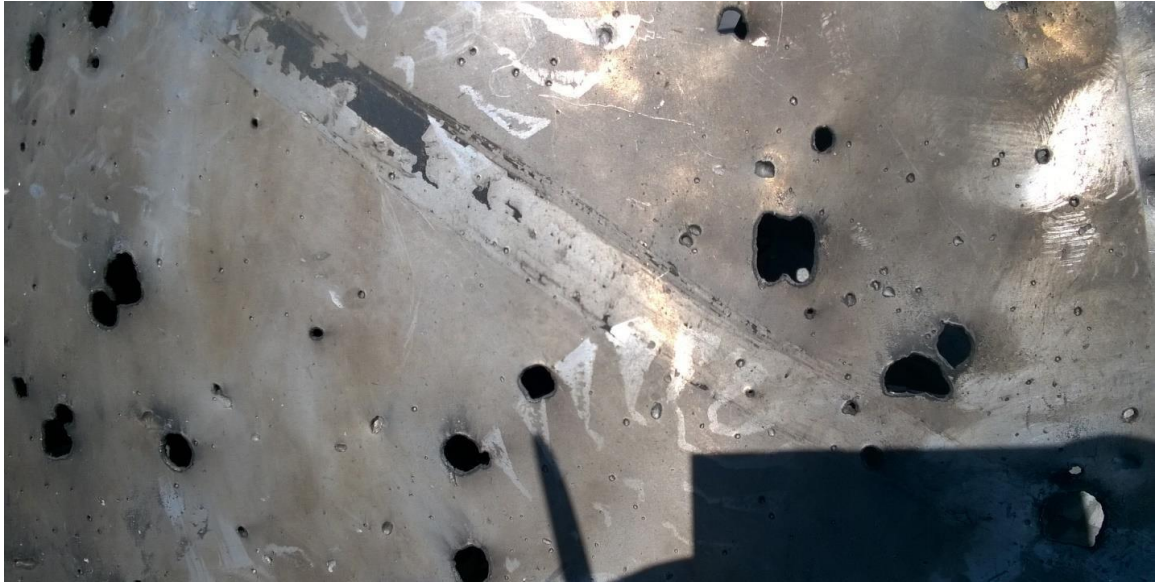
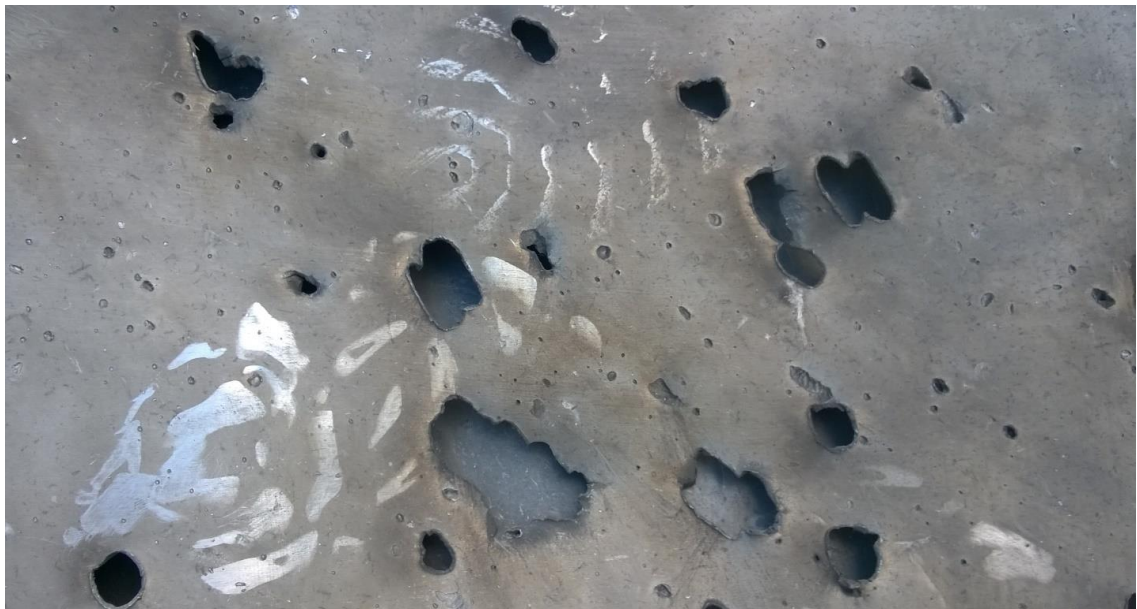
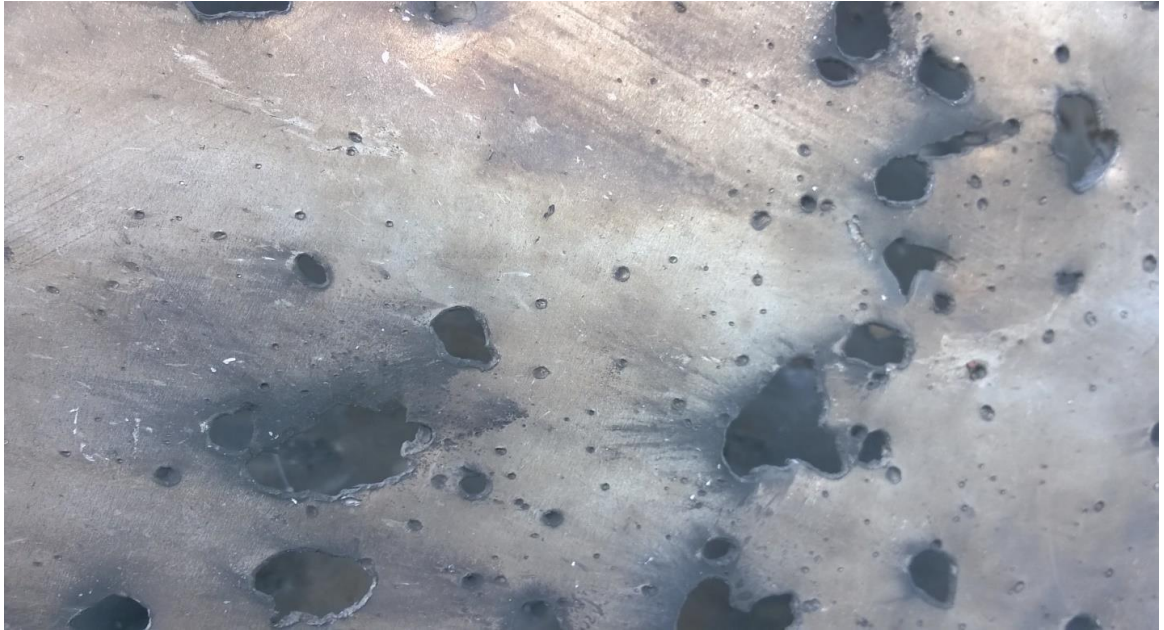
The traces left on the shield target fragments by the effects of a close explosion are manifested in the existence of micro-crater areas, thermal oxidation, compression, deformation and rupture of the target sheets. Examples of such damage are shown in Figures A.180 to A.187.

Figure A.180 - Target fragment with micro-crater marks and thermal oxidation

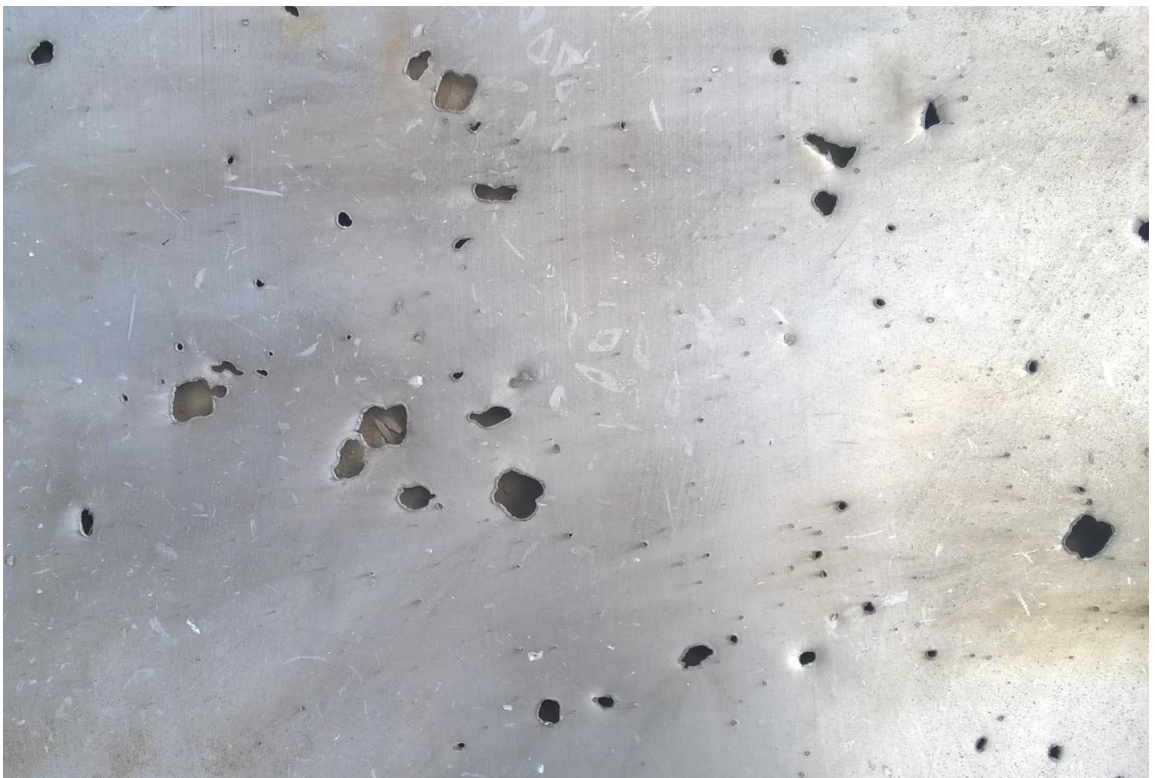
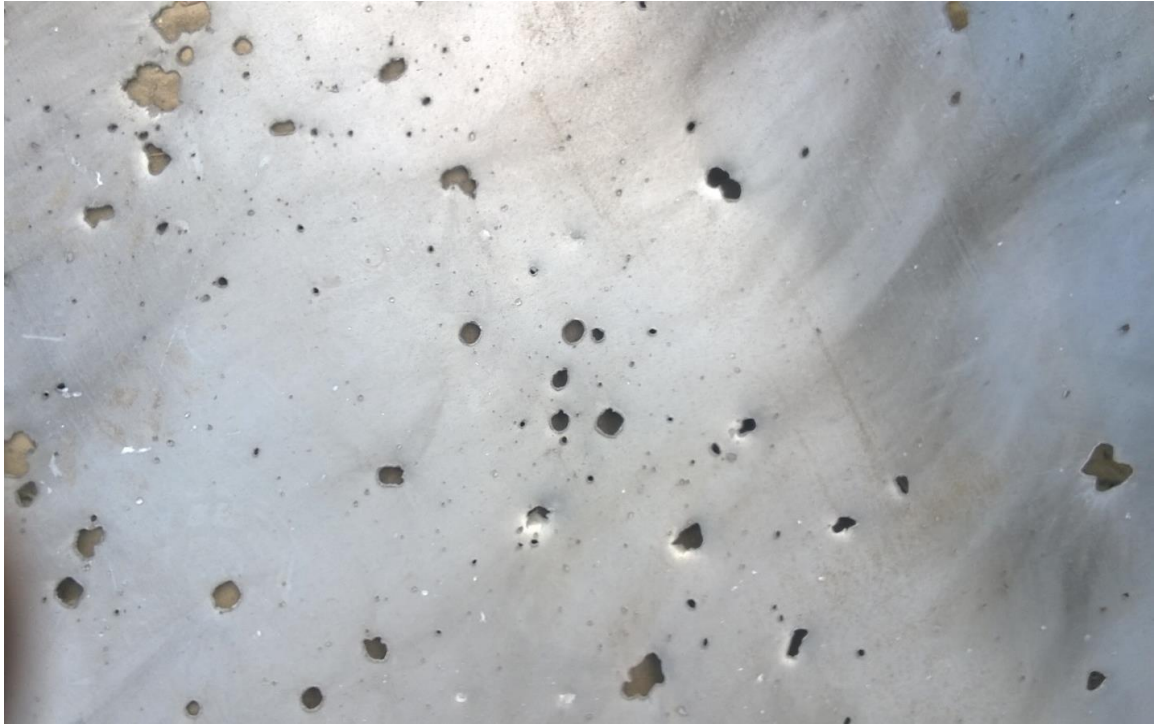
Figure A.183 - Target fragment with micro-crater marks and minor thermal oxidation

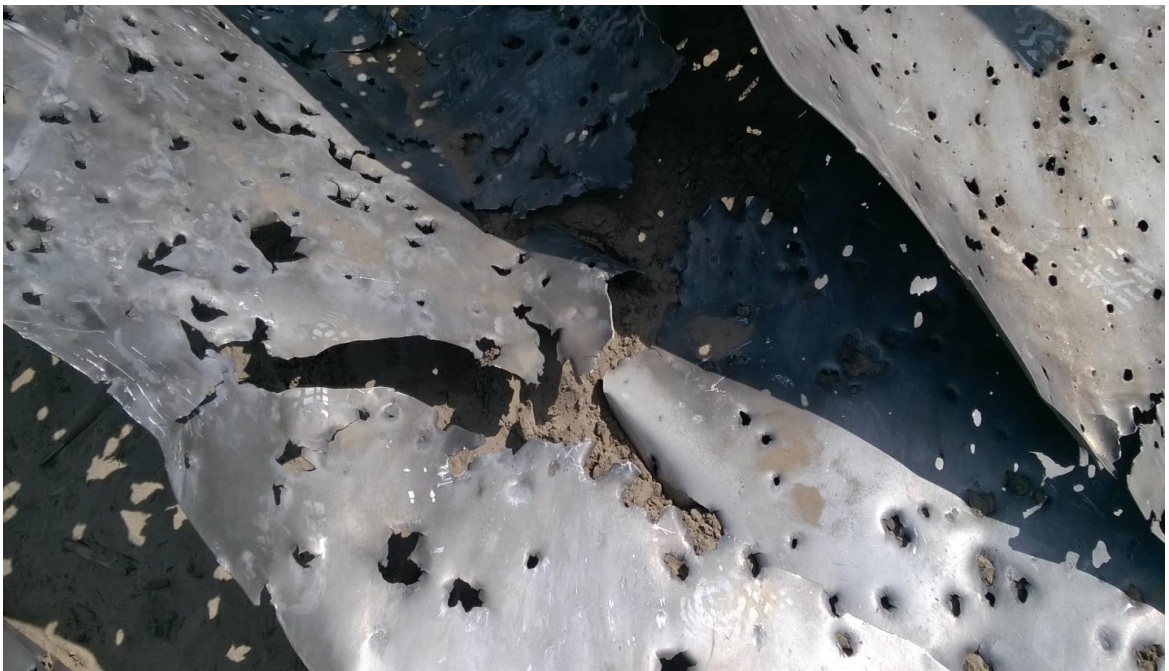
Figure A.185 - Target fragment with traces of compression, deformation and rupture of skin sheets

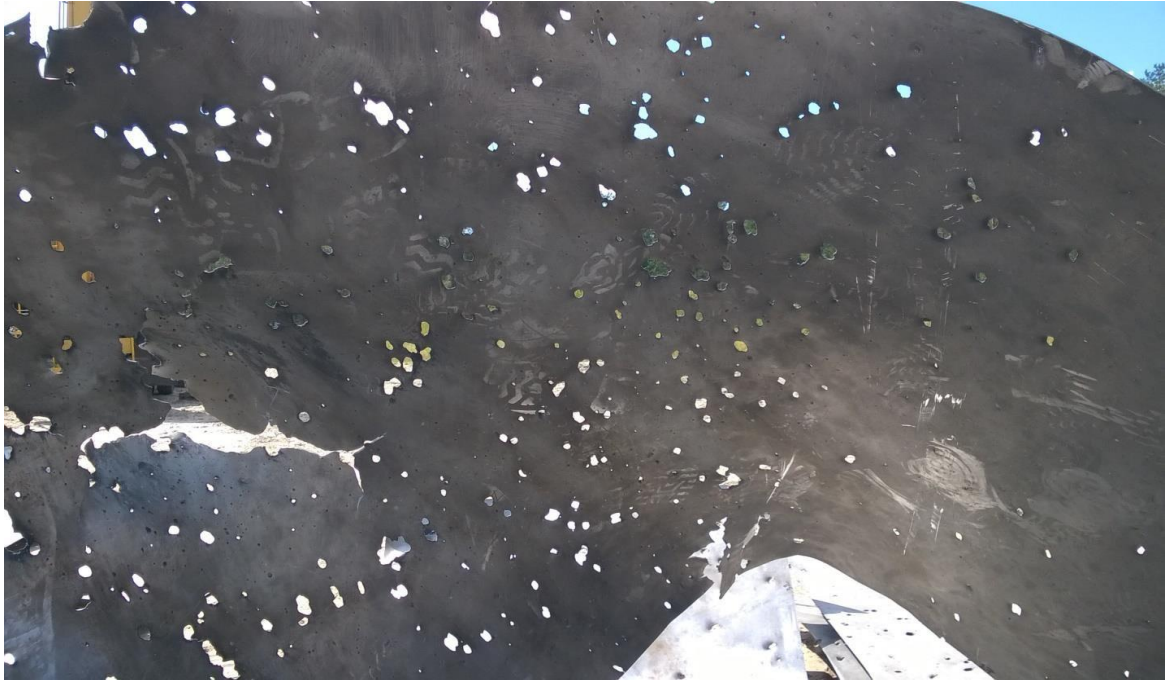
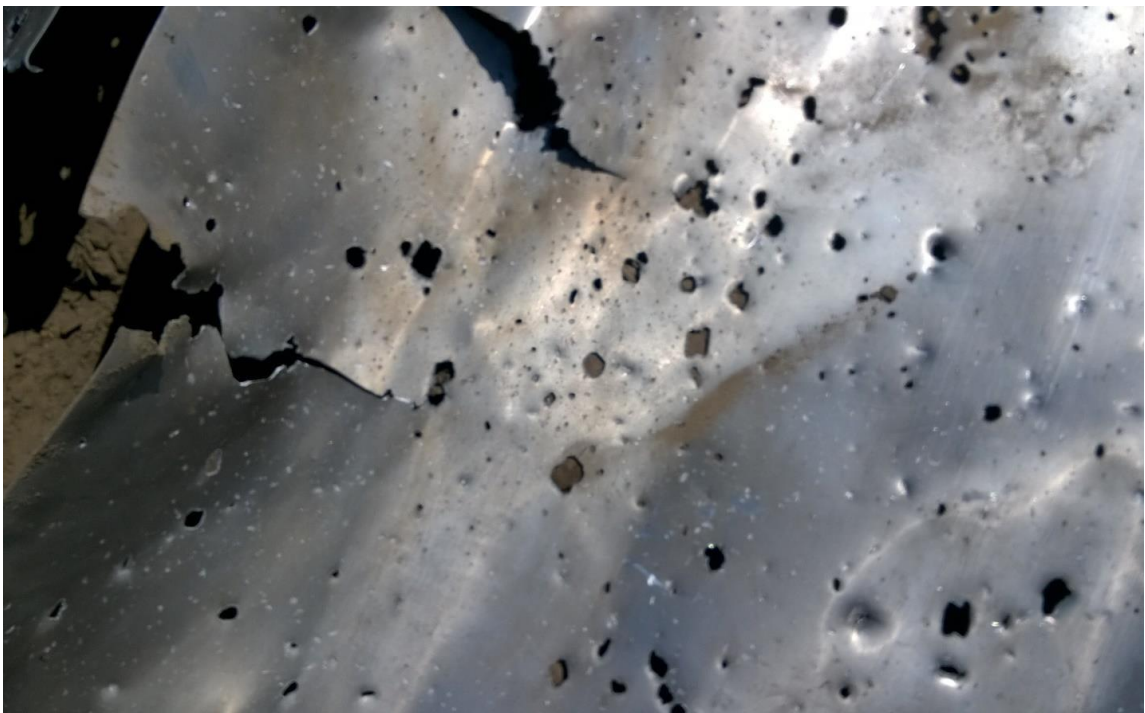
Figure A.186 - Target fragment with traces of deformation and rupture of skin sheets

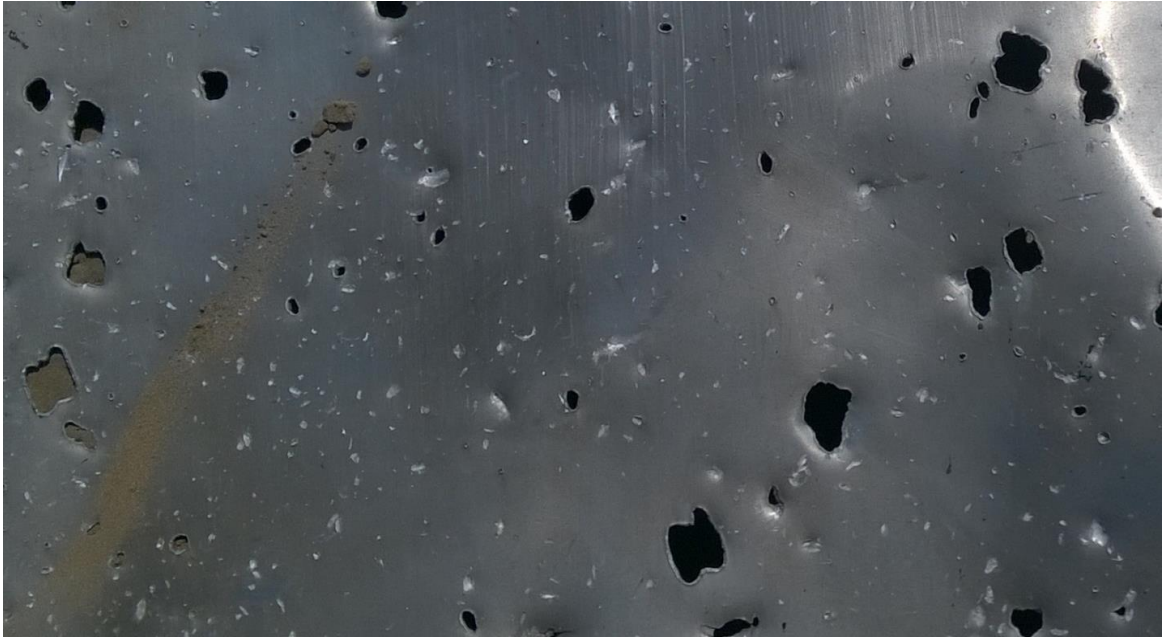
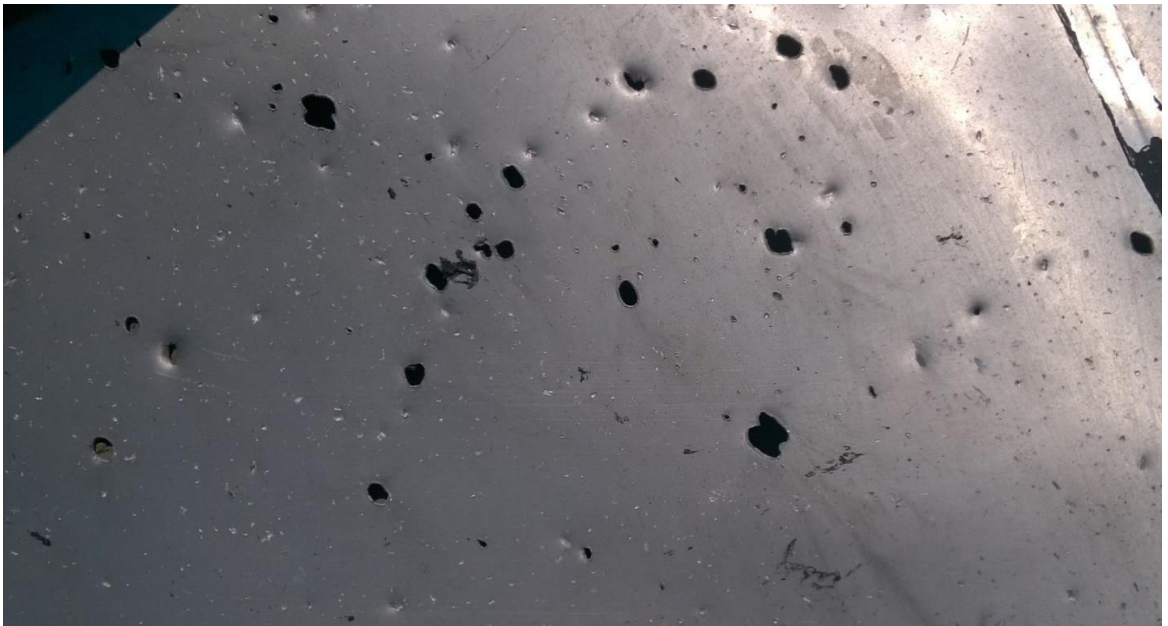
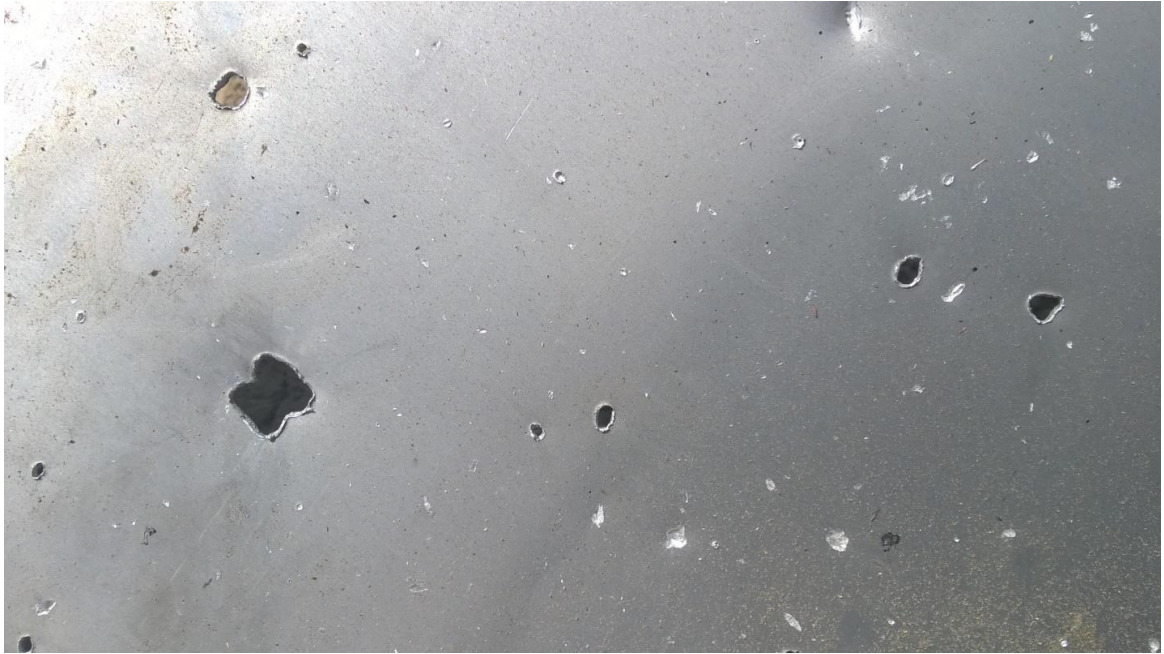
Fragments of shield target #2 and #3 show a large amount of damage from secondary striking elements - fragments ("plugs") of the target sheets knocked out of the first /second barrier. Examples of such damage are shown in Figures A.188, A.189 and A.190.

Figure A.188 - Fragment of target with marks of secondary damage

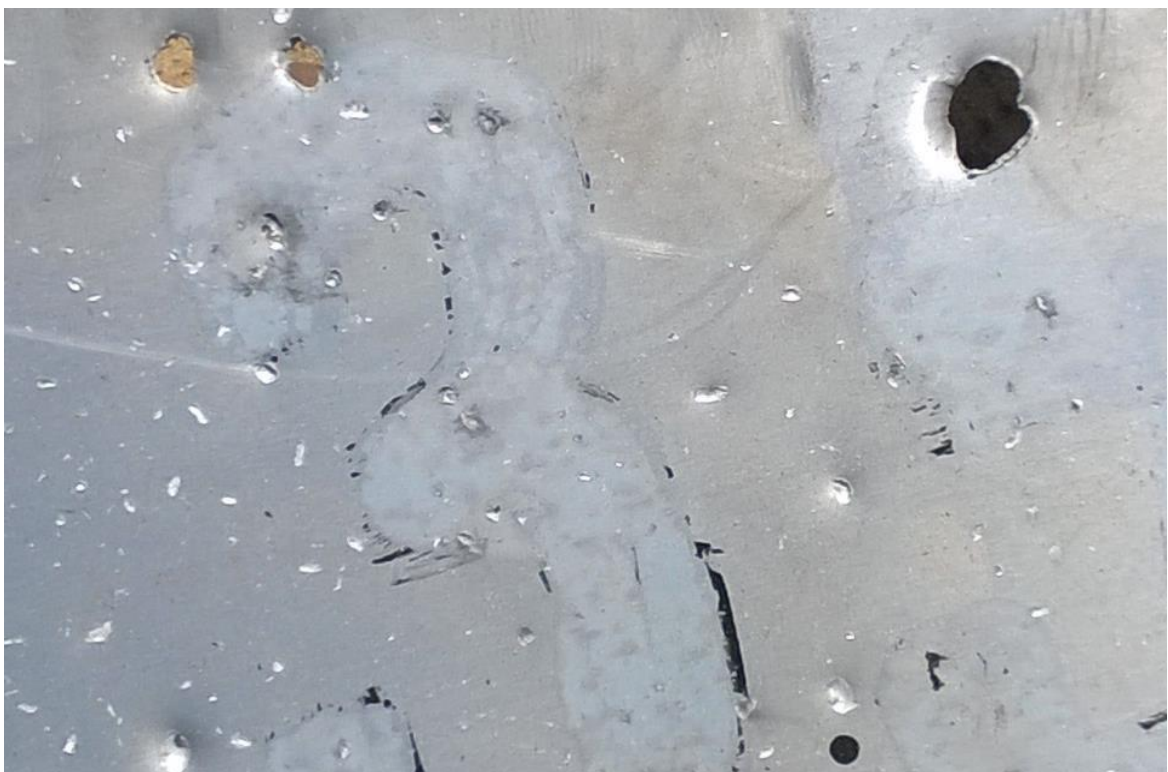
Figure A.191 shows a close-up view of secondary damage manifesting itself in "scratches" on target fragment No. 3.

Figure A.191 - Fragment of target with "scratches" from secondary striking elements

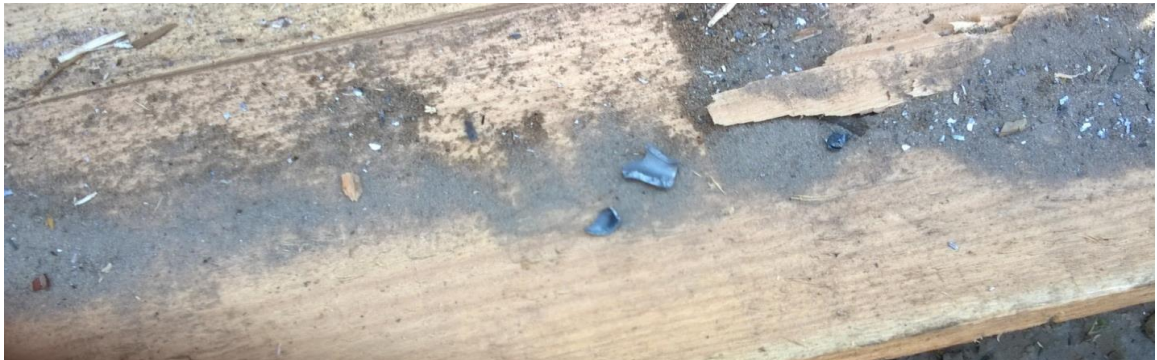
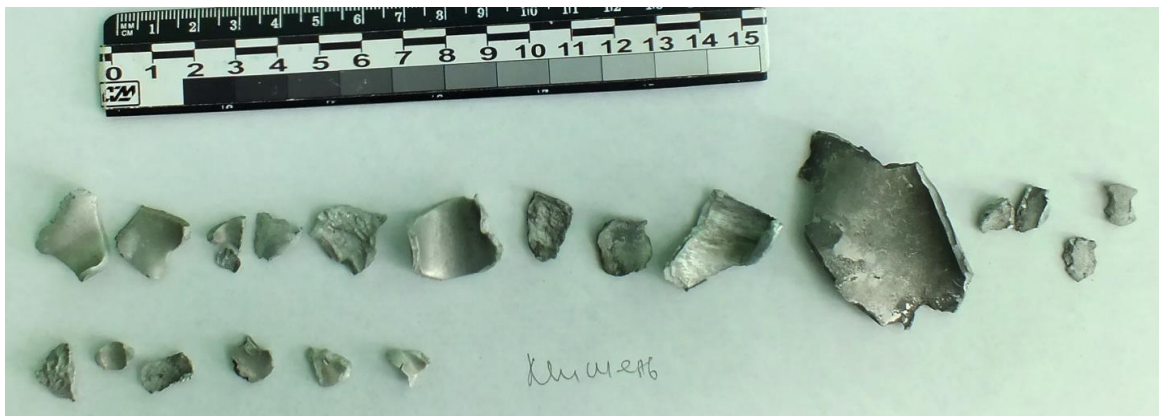
Figure A.192 - Secondary striking elements ("plugs" from target sheets)

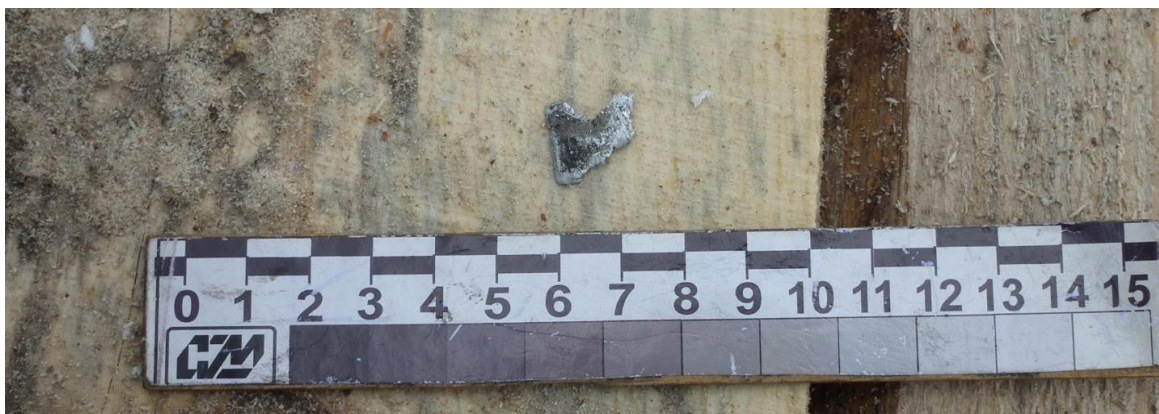
Figure A.194 - Secondary striking element ("plug") shaped like a "bowtie"
