**APPLICATION OF THE INTERNATIONAL CONVENTION FOR THE SUPPRESSION
OF THE FINANCING OF TERRORISM AND OF THE INTERNATIONAL
CONVENTION ON THE ELIMINATION OF ALL FORMS OF RACIAL
DISCRIMINATION**

REJOINDER

Report of JSC Air and Space Defense Corporation "Almaz-Antey" on the results of studies related to the technical investigation into the crash of the Malaysian airlines Boeing 777-200 9M-MRD (flight MH17), 2023

on the results of studies related to the technical investigation into the crash
of the Malaysian airlines Boeing 777-200 9M-MRD (flight MH17)

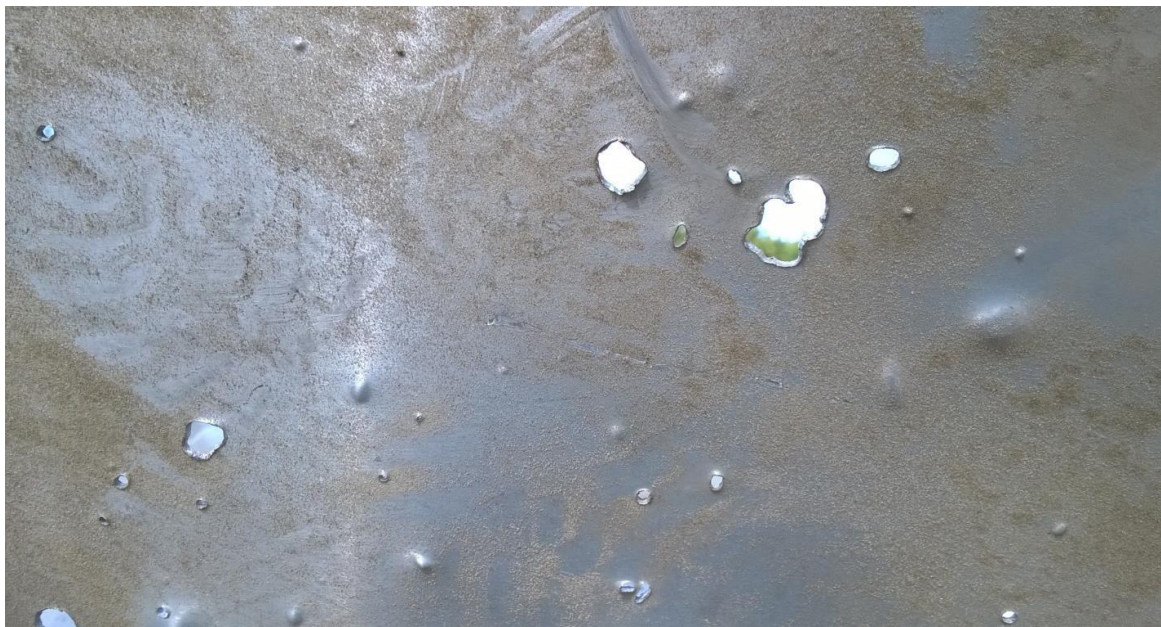
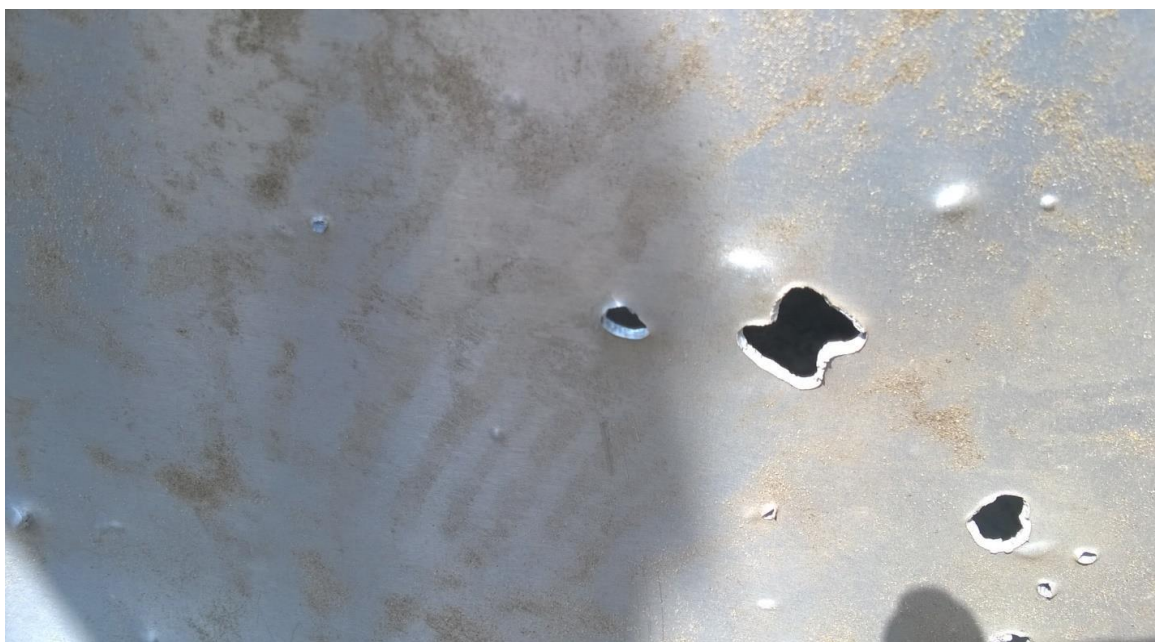
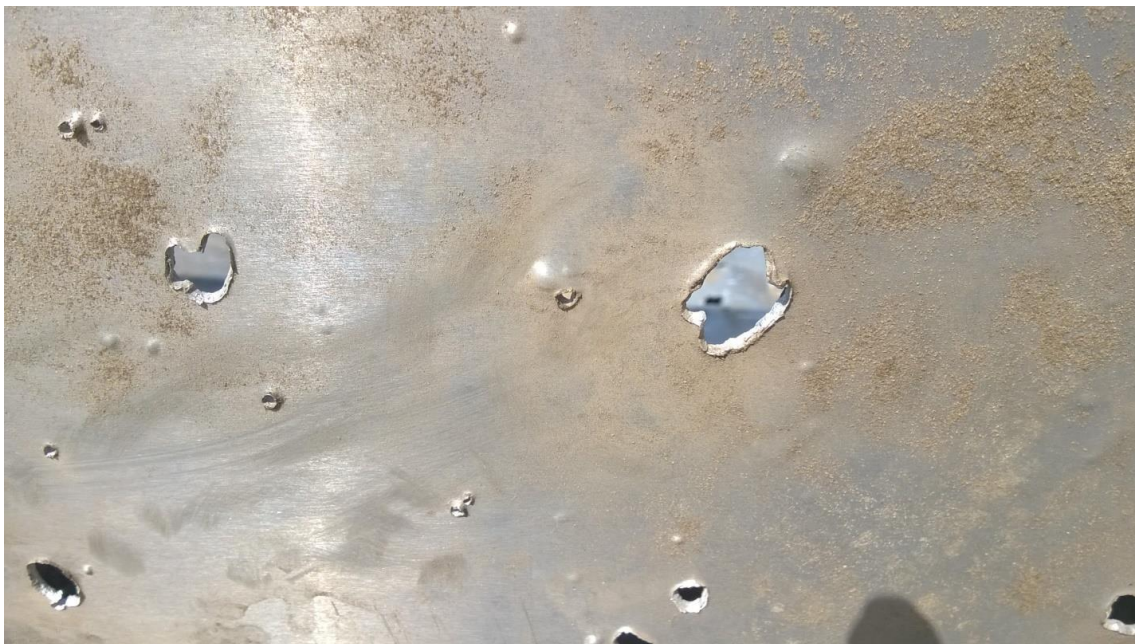
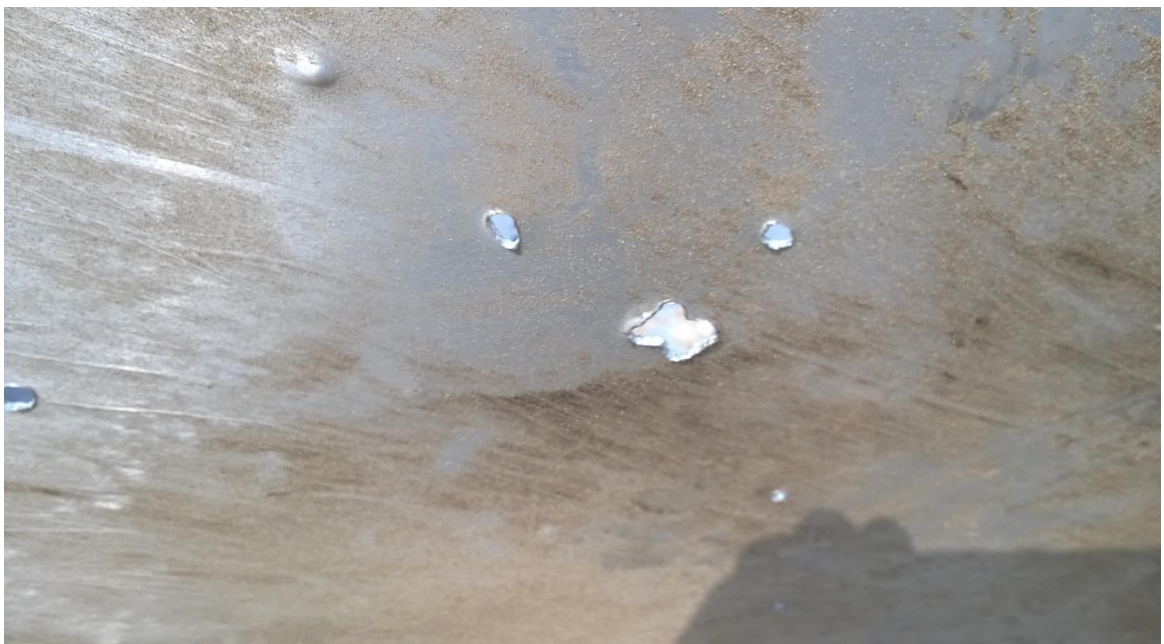
Figures A.196 through A.201 show examples of through-holes from ready-made projectiles and of non-penetrating damage from hull fragments and secondary striking elements in shield target sheets.

Figure A.196 - Exit holes and non-penetrating damage
(view from the back of the shield)

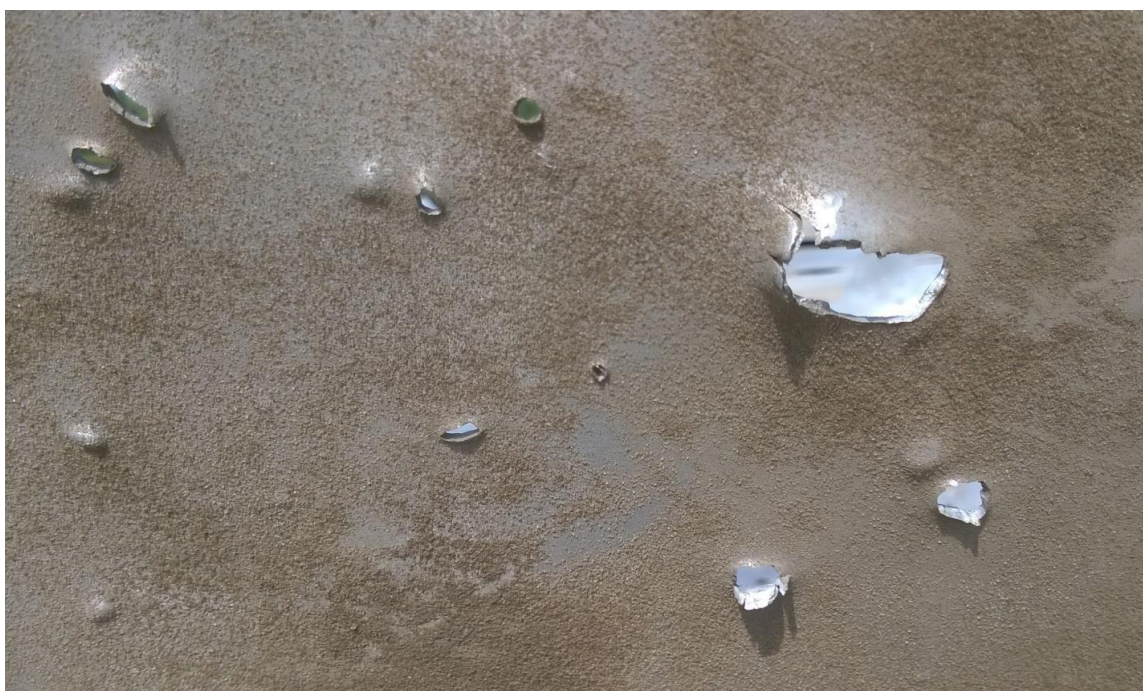
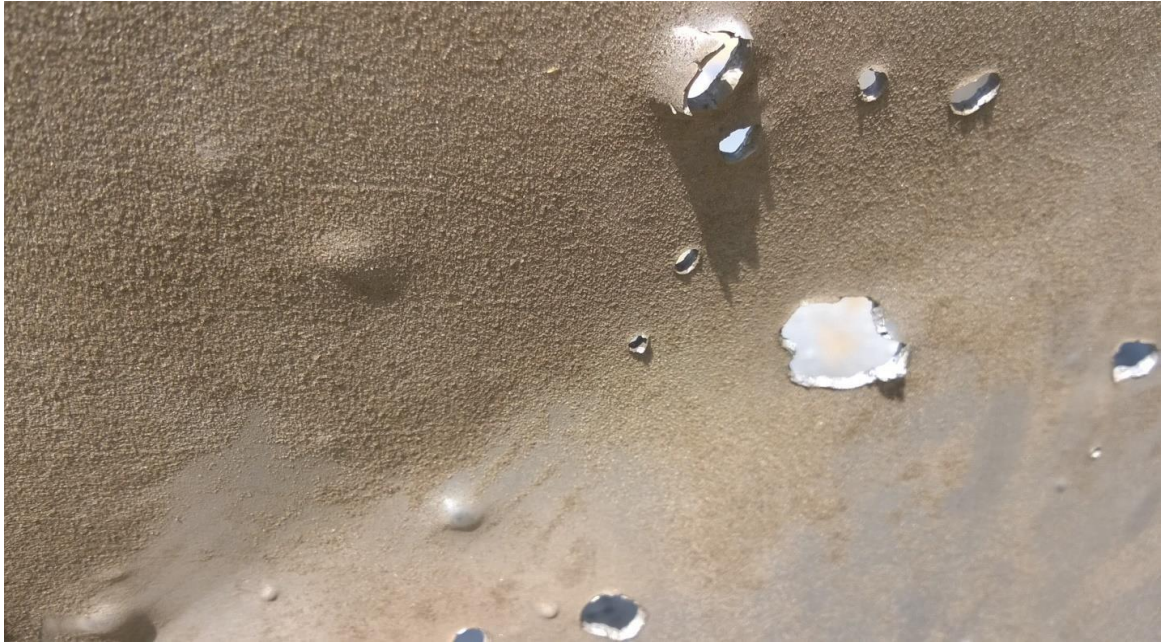
Figure A.199 - Exit holes with jagged edges and non-penetrating damage on
target No. 4 (view from the back of the shield)

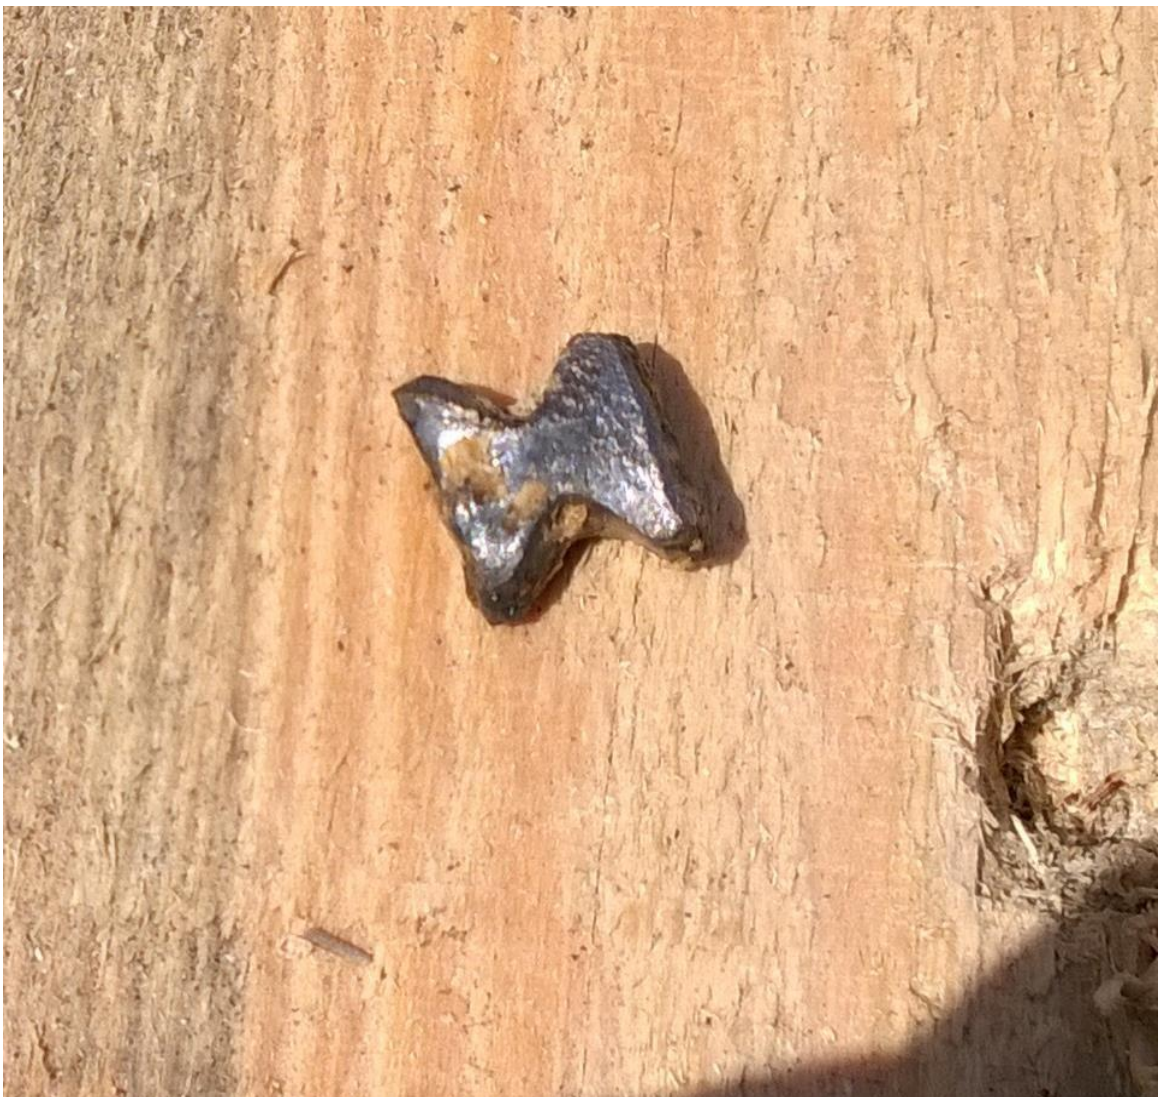
Figure A.202 - 9H314M 1-10 ("bowtie") projectile retaining its original shape

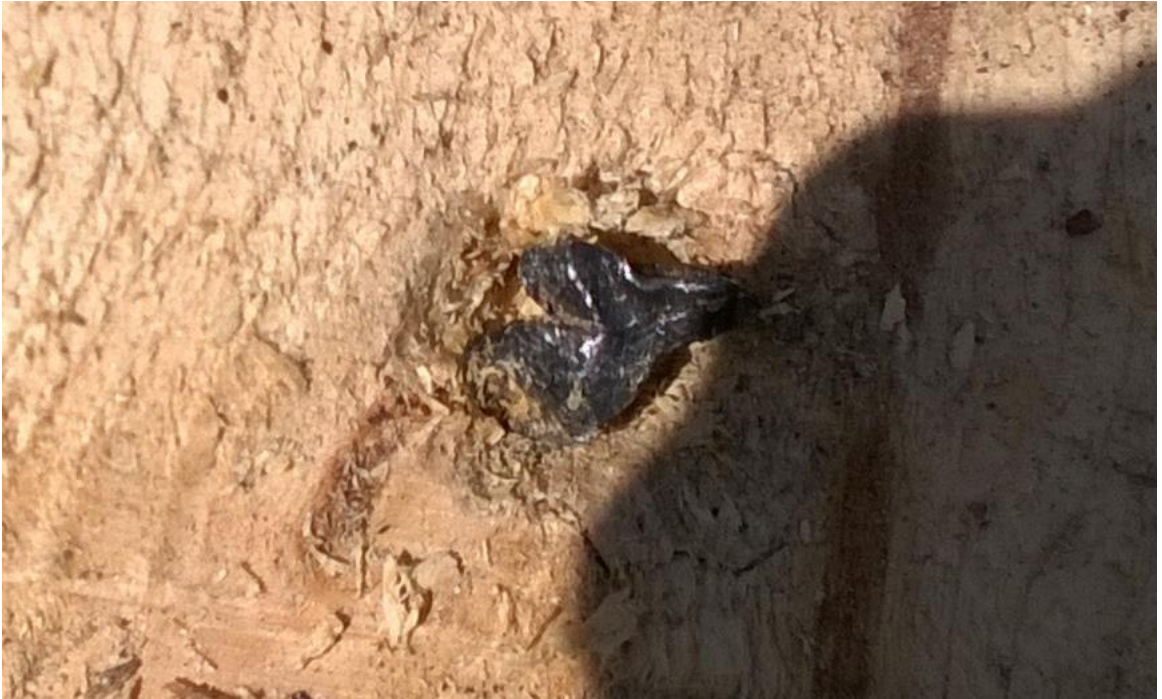
Figure A.203 - 9H314M 1-10 projectile ("bowtie ") which was deformed but retained its original shape

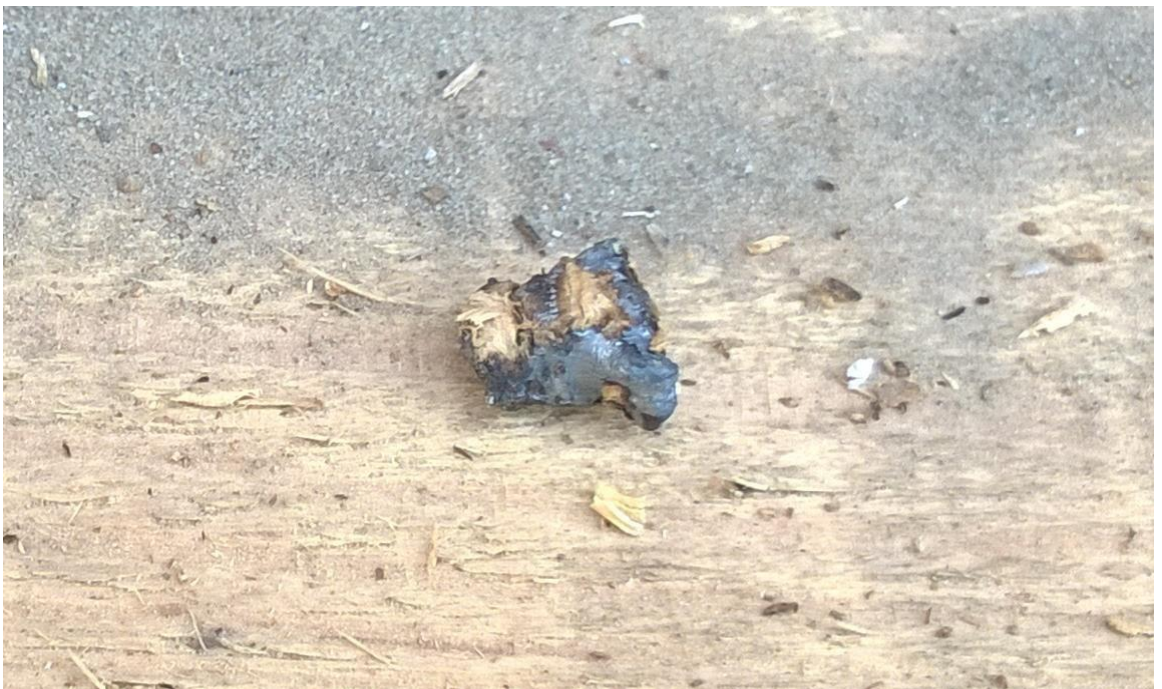
Figure A.204 - 9H314M 1-10 projectile ("bowtie") which lost its original shape

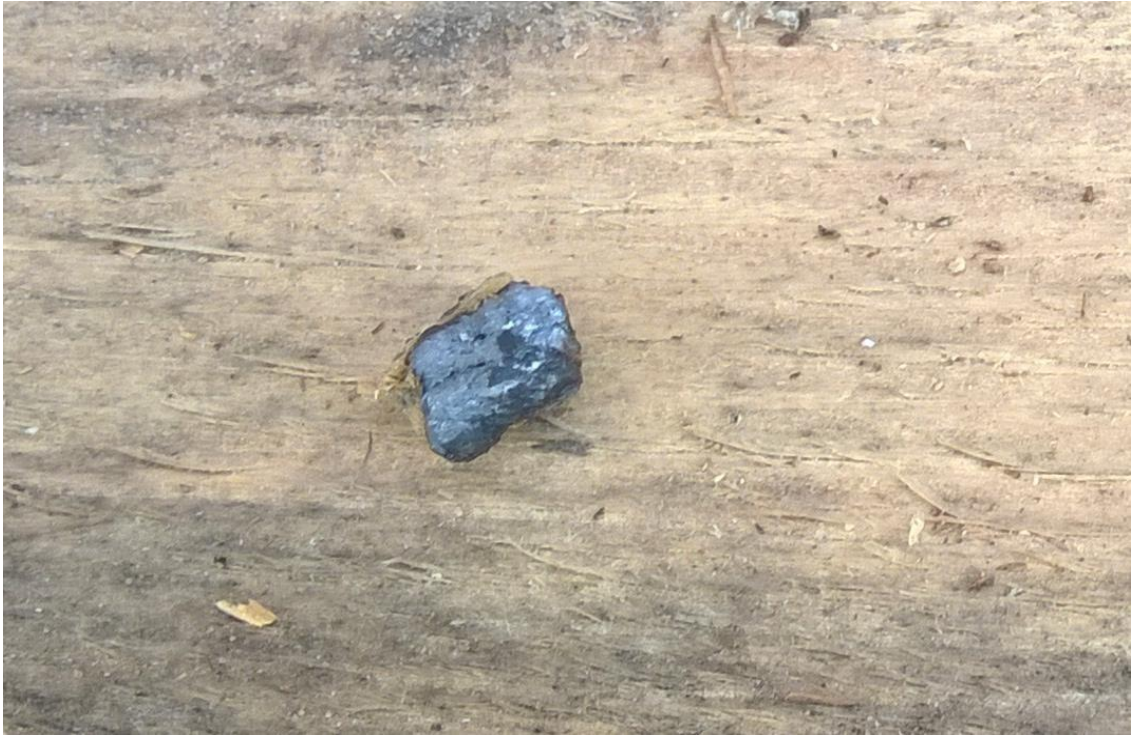
Figure A.205 - 9H314M 1-9 projectile ("parallelepiped")

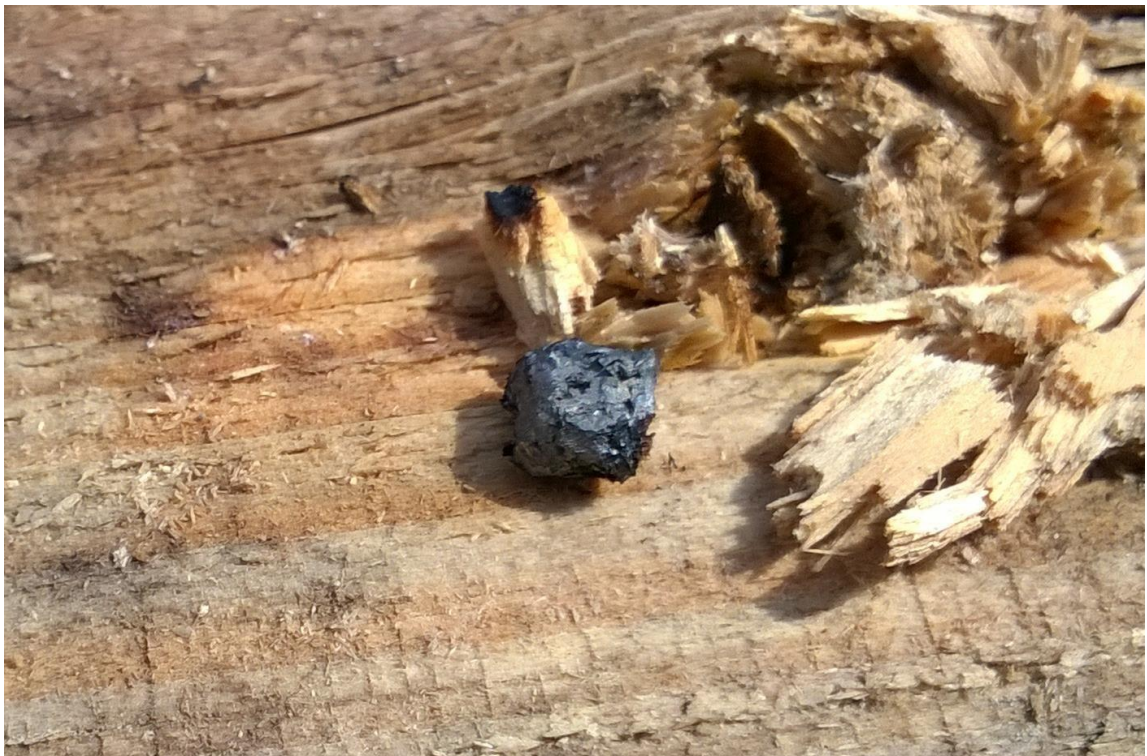
Figure A.206 - 9H314M 1-11 projectile ("parallelepiped")

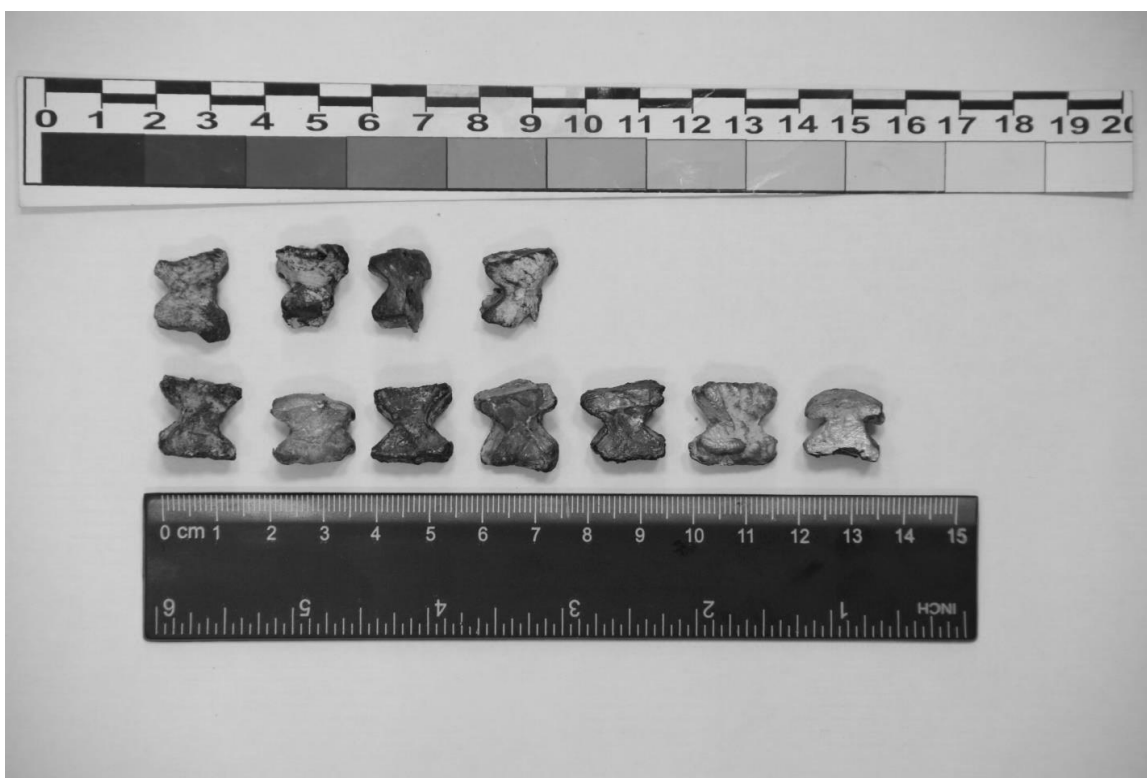
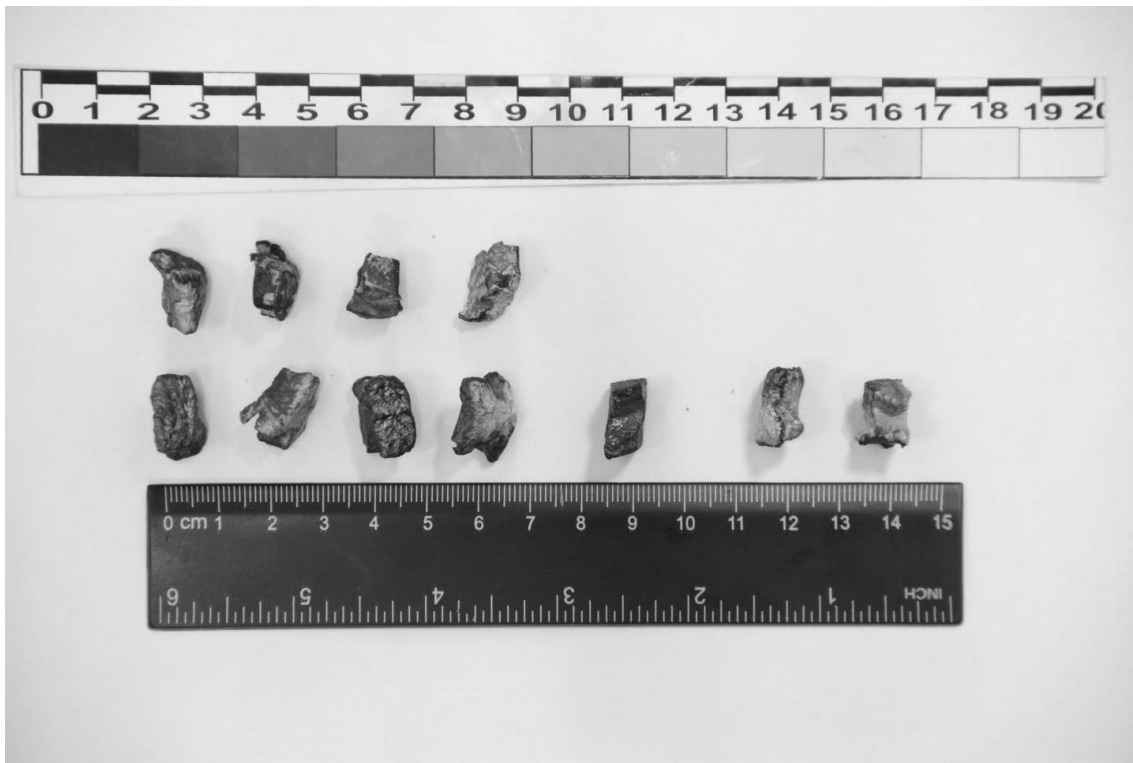
Examples of 9H314M 1-10 "bowtie"-shaped projectiles (13x13x8.2 mm fractions) recovered from traps and the target structure are shown in Figures A.207 through A.209.

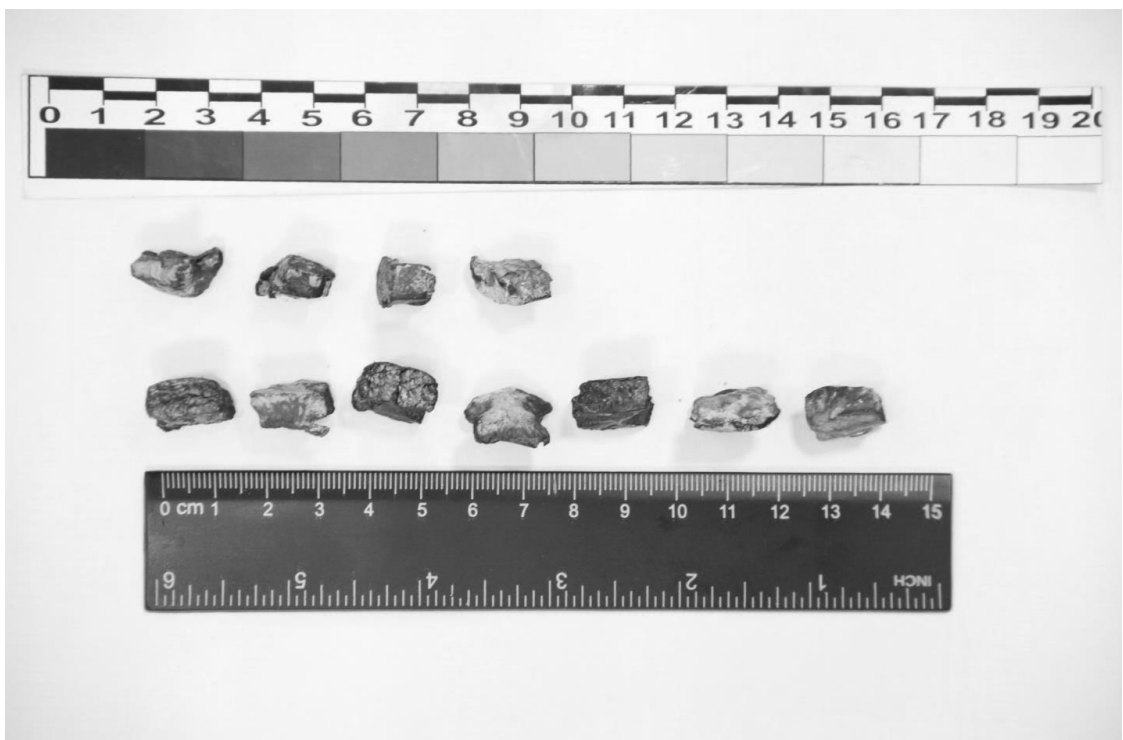
Figure A.209 - 9H314M 1-10 projectiles (side view 2)

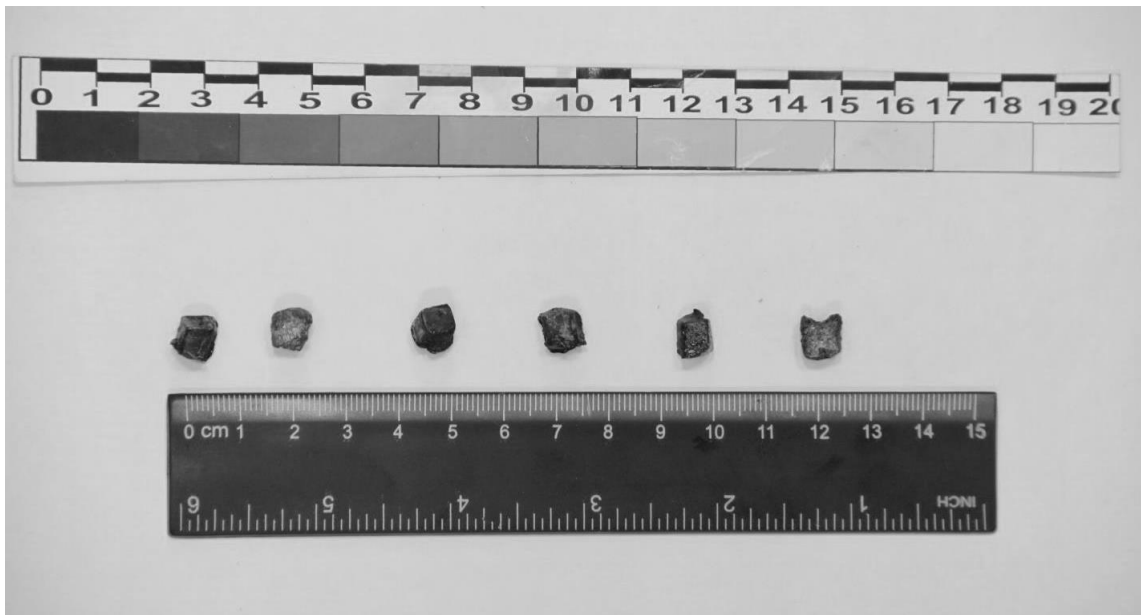
Figure A.210 - 9H314M 1-11 projectiles (top view)

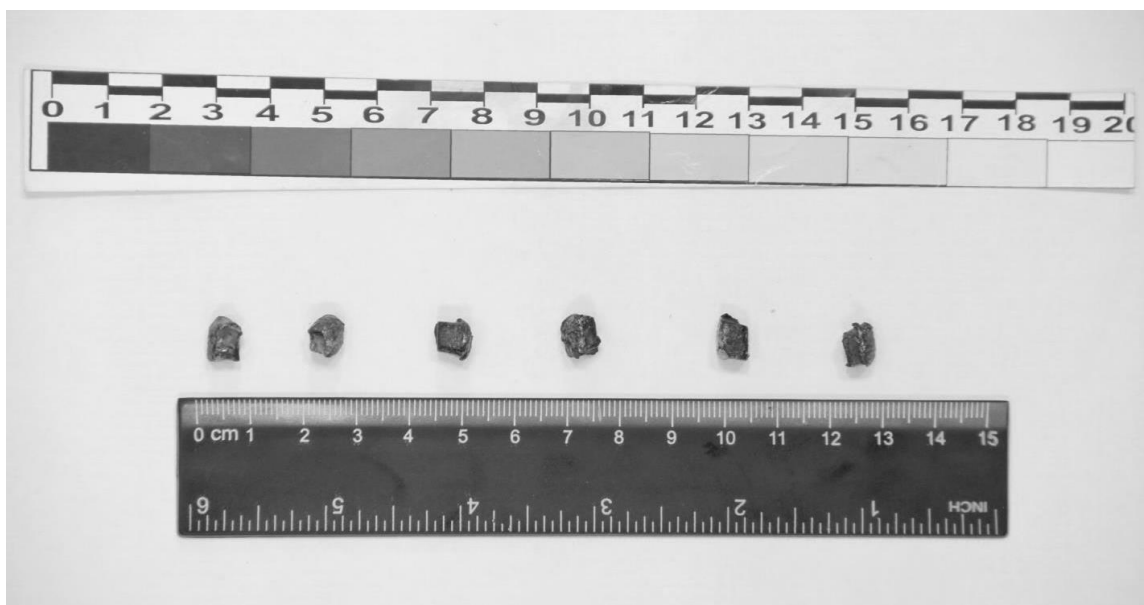
Figure A.211 - 9H314M 1-10 projectiles (side view)

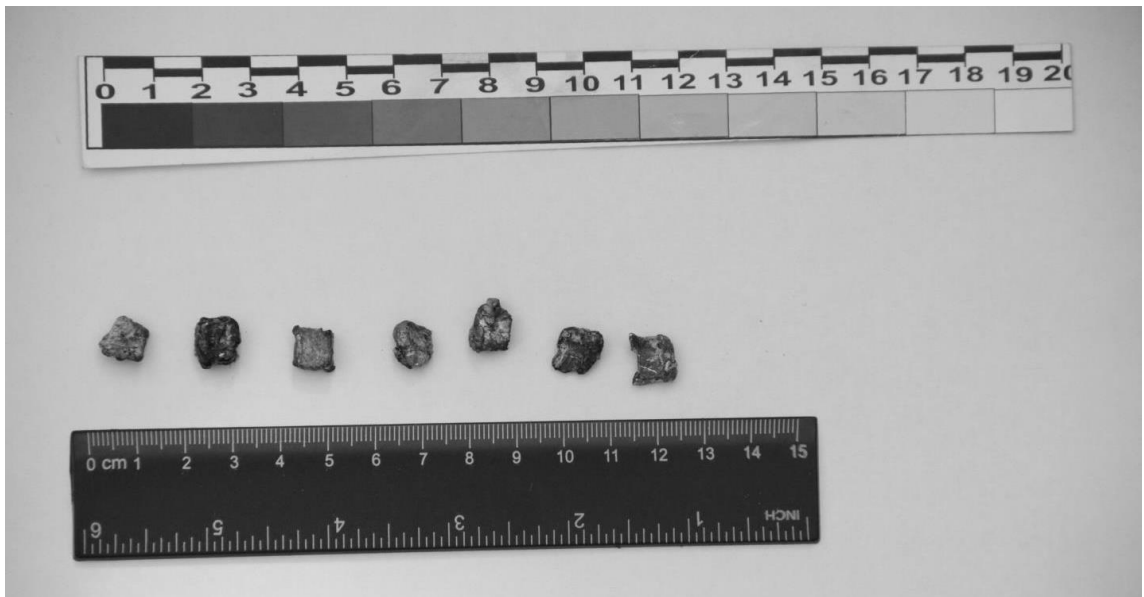
Examples of "parallelepiped"-shaped 9H314M 1-9 projectiles (8x8x5 mm fractions) extracted from traps and the target structure are shown in Figure A.212.

Figure A.212 - 9H314M 1-9 projectiles (top view)

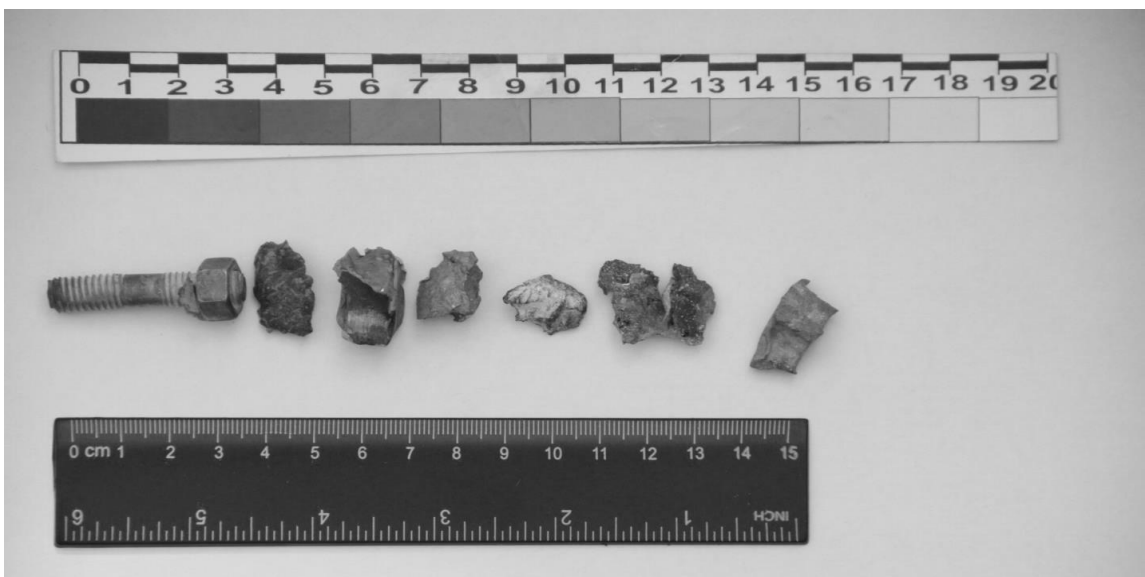
Examples of hull fragments (those of the compartment hull) recovered from traps and the target structure are shown in Figures A.213 and A.214.

Figure A.213 - Hull fragments

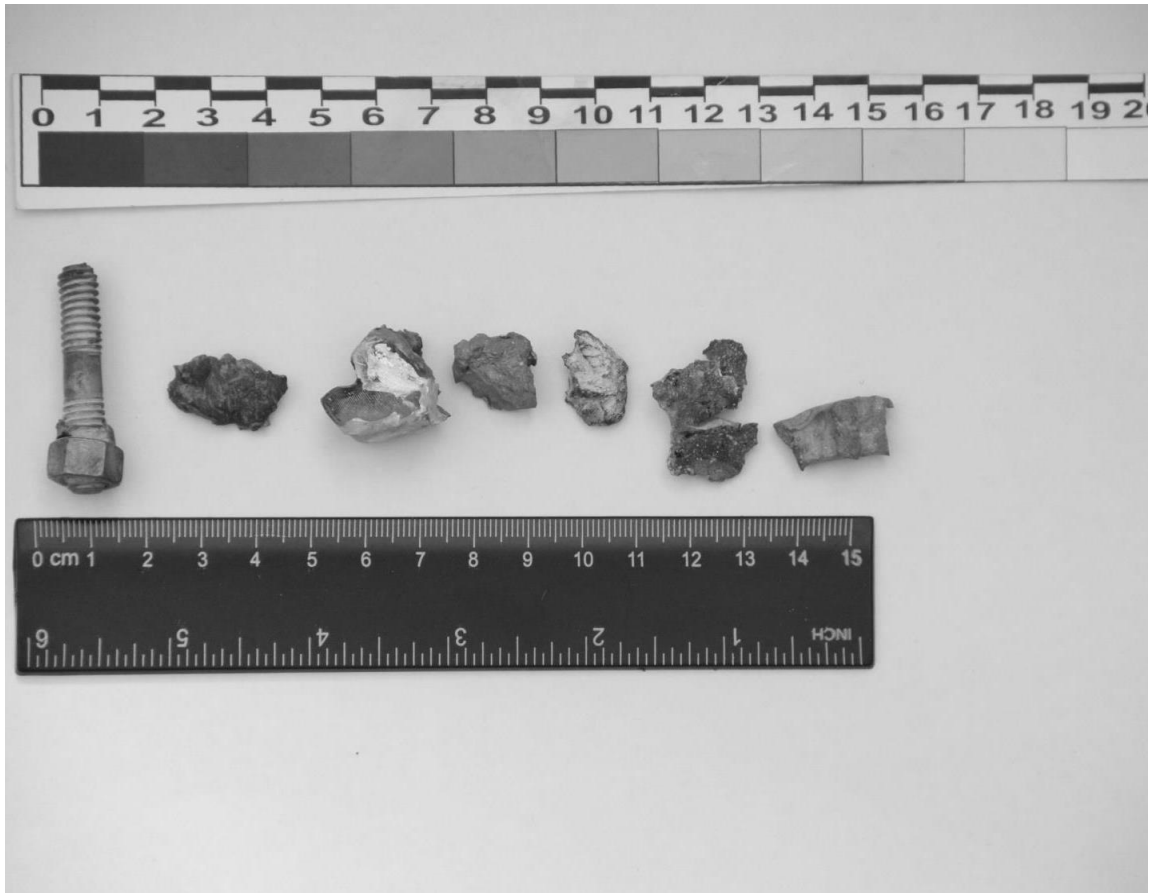
Figure A.214 - Hull fragments

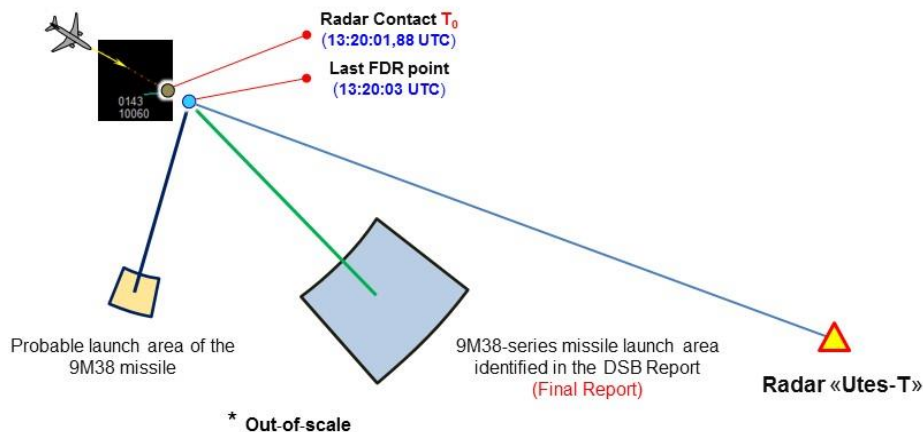
- The launch area could be the area shown in yellow in Figure 1 and shown in the presentation⁴ at Almaz-Antey Air-Defence Corporation's press conference held in October 2015 to present the results of the full-scale experiment;

Figure 1 - Presumed missile launch areas

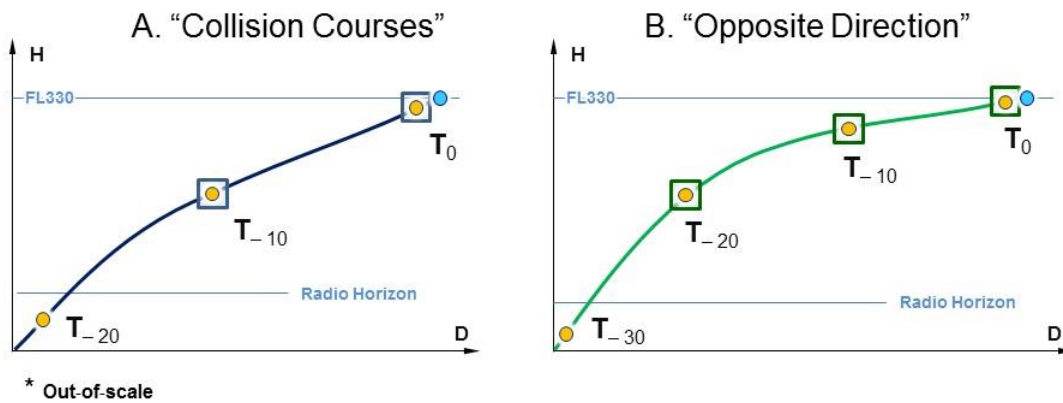
The 9M38 missile flight trajectories for the two hypotheses are shown in Figure 9 (time T_0 corresponds to the time of the last measurement in relation to the Boeing 777, while time T_{-10} and T_{-20} correspond to 10 s and 20 s before the last measurement, respectively). One can see from the figure that given the time of the missile's flight to the Last FDR point, the missile should have entered the ARRC's coverage area at least twice in case of a flight "on a collision course" and should have entered that area three times in case of a flight in "an opposite direction".

Figure 9 - Possible trajectories of 9M38 missile flight
A - "collision course"; B - "opposite direction"

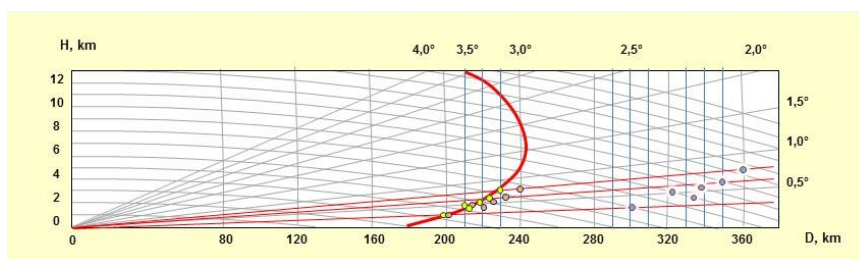
According to the results of the flight around Utes-T ARRC, the detection range for an airborne object the RCS of which corresponds to that of a 9M38 missile (recalculated using the formula for free-space RCS, taking into account equal angular positions) should be at least 200-218 km. The results of confirmation of the far edge of the detection area for the RCS equal to 0.85 m^2 and 1.0 m^2 are shown in Figure 11.

Figure 11 - Confirmation of estimated area of detection of a 9M38-type missile at altitudes above 3,500 m based on the results of reference targets' test flight

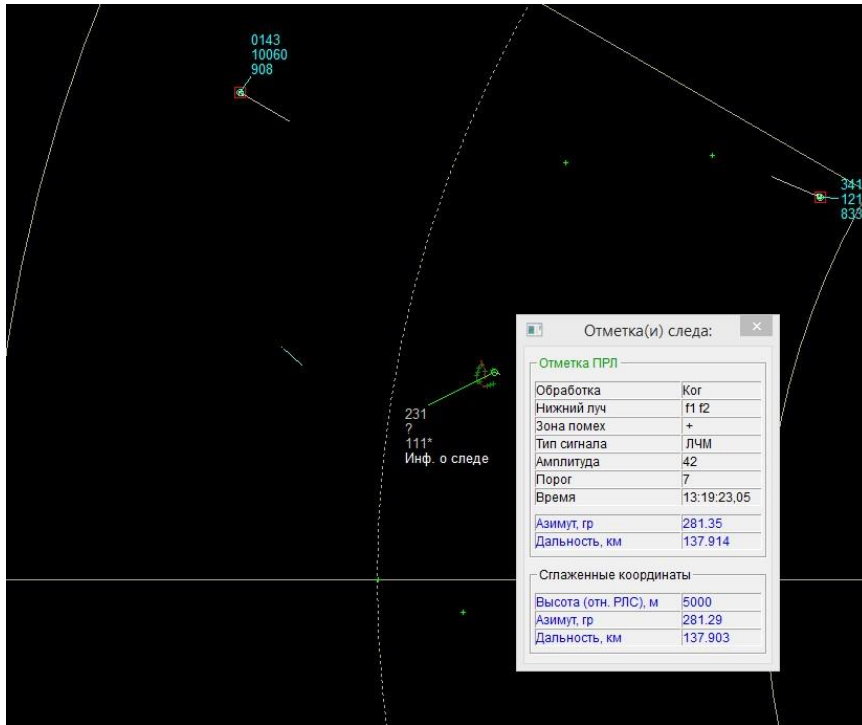
The primary radar's capability to detect small targets is additionally confirmed by the fact that at the time of the events that occurred on 17.07.2014 an Orlan-10-type UAV, the RCS of which is 3-5 times smaller than that of a BUK missile, was detected and tracked by the ARRC. The radar mark and the airborne object ("Orlan-10") form are shown in Figure 12.

Figure 12 - Radar mark and form in respect of airborne object No. 231 (Orlan-10 UAV) at a distance of 137.9 km from Ute-T transponder. Time: 13:19:23.05 UTC (registration file "14-07-17_fragment.kt")

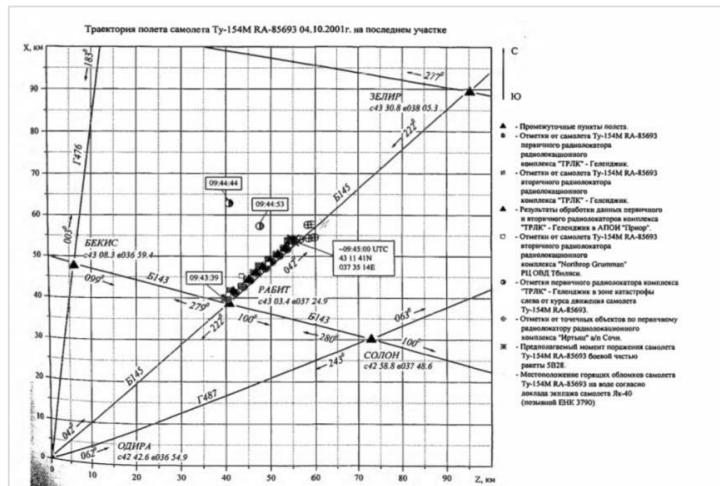
At that time, the primary radar detected an unidentified airborne object moving in the direction of the Tu-154M aircraft's flight path at a speed of about 1,000 m/s. Subsequently, the recorded marks were identified as S-200 SAM missile that caused the crash⁶.

Figure 15 – The last segment of the flight path of Tu-154M RA-85693 on 04.10.2001. There are marks from an airborne object detected by the ARRC at Gelendzhik position to the left of the aircraft's path.

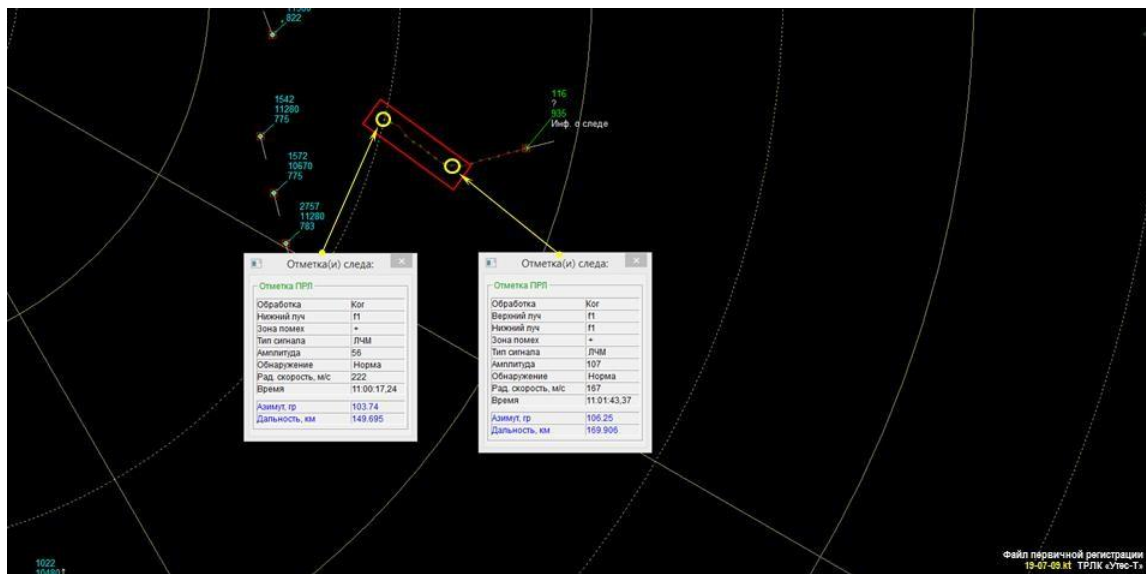
The object simulating the missile flight "in an opposite direction" was detected immediately after it went beyond the radio horizon (during the first scan period). Following that, the reference airborne object was tracked steadily throughout its flight in the reference segment of the trajectory (Figure 18) and until it exited the detection area at a distance of over 320 km.

Figure 18 – Airborne object No. 116 in "an opposite direction" trajectory.
The airborne object in the reference segment of the trajectory was observed steadily

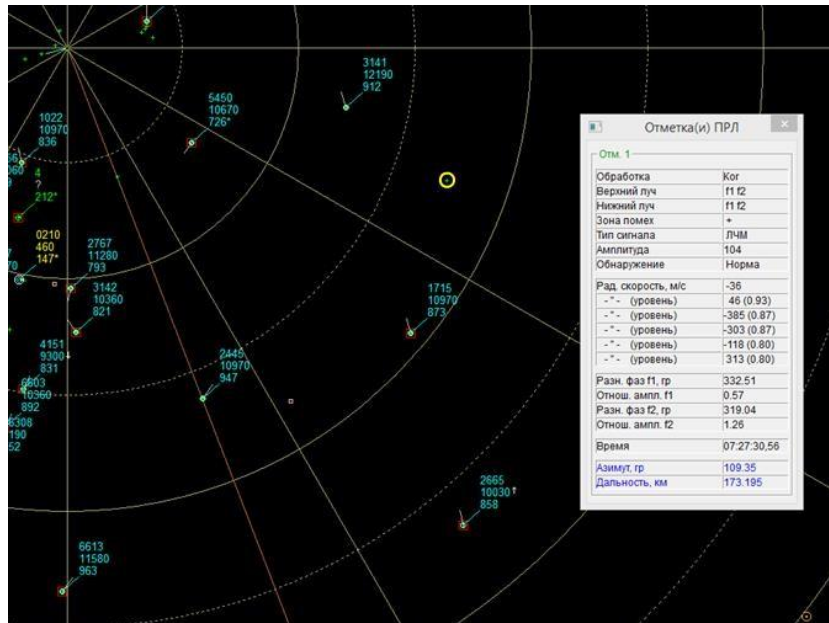
Figure 19 - First mark of the reference airborne object after completion of its flight along the special trajectory simulating the missile flight from the southern direction. The distance is 173.2 km

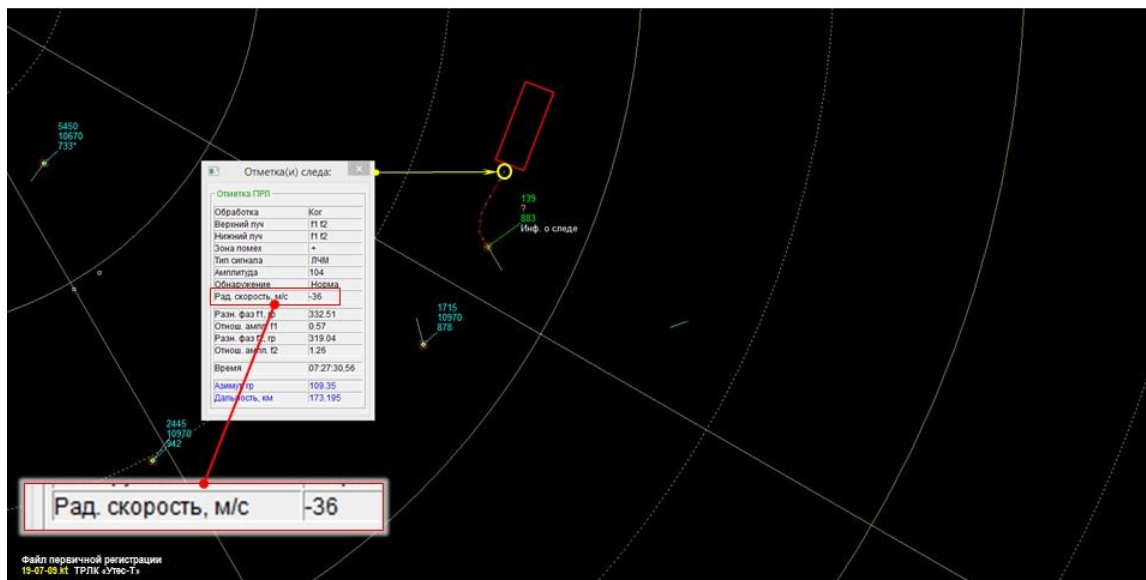
No information about this reference object flying along a special trajectory simulating the missile flight from the southern direction ("on a collision course") was displayed on the radar operator's screen or saved in the primary registration file "19-07-09.kt". The reference object was detected by the primary radar at 07:27:30,56 UTC at an altitude of 10,360 m only after completion of the trajectory flight, when the MTS radial velocity threshold of "-36 m/s" was exceeded.

Figure 21 – Tracking of the reference airborne object after completion of the flight along a special trajectory simulating the missile flight from the southern direction

Thus, a missile in the ARRC's observation area may fly undetected by the primary radar, if its radial velocity is below the MTS threshold (in this case below 30 m/s).
