**DISPUTE CONCERNING
CERTAIN ACTIVITIES CARRIED OUT BY NICARAGUA
IN THE BORDER AREA
(COSTA RICA V. NICARAGUA)**

**COUNTER - MEMORIAL
OF THE REPUBLIC OF NICARAGUA**

**VOLUME IV
(ANNEXES FROM 112 TO 142)**

Technical Report
Environmental Impact Assessment on “Construction of 120 km road on
the San Juan de Nicaragua River’s right bank”

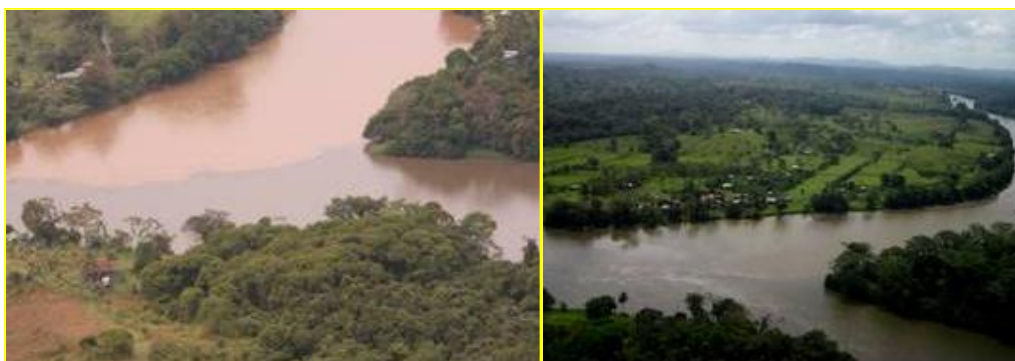
Figure 3: Water quality comparison to Sarapiquí and San Carlos rivers

Figure 3 shows two photographs where concentration of sediments from Costa Rican rivers can be seen in water color difference. On the left, the mouth of the Sarapiquí River, and on the right the San Carlos River, coordinates UTM 794-57E/1207-986N. Figure 4 shows two Costa Rican backhoes extracting sediments from the San Carlos River to build the bridge over the river that will connect with the road under construction along the San Juan River.

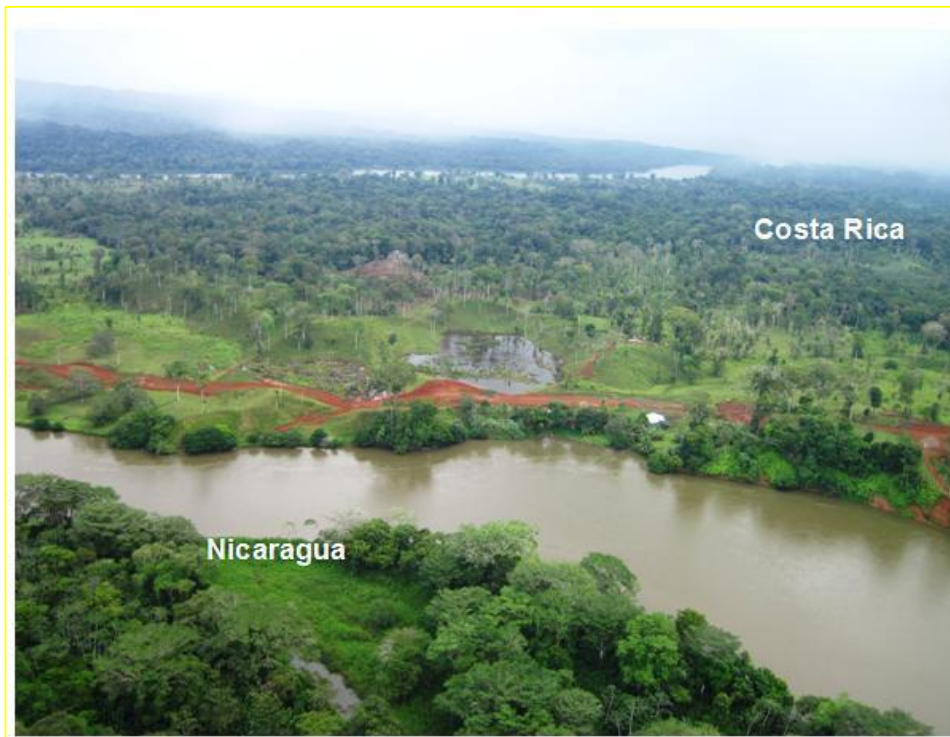
Figure 6: Expanding deforestation process in Costa Rican territory

Forest area reduction in Costa Rican territory leads to fragmentation of the habitat of many species living in ecosystems shared by both countries, and contributes to major damages arising on river banks from lack of vegetation and soil constitution. The shift in soil use from forest to agriculture on the San Juan River’s right bank in Costa Rican territory can be seen in Figure 6, whereas the left bank is conserved in the Indio-Maíz Biological Reserve on the Nicaraguan side.

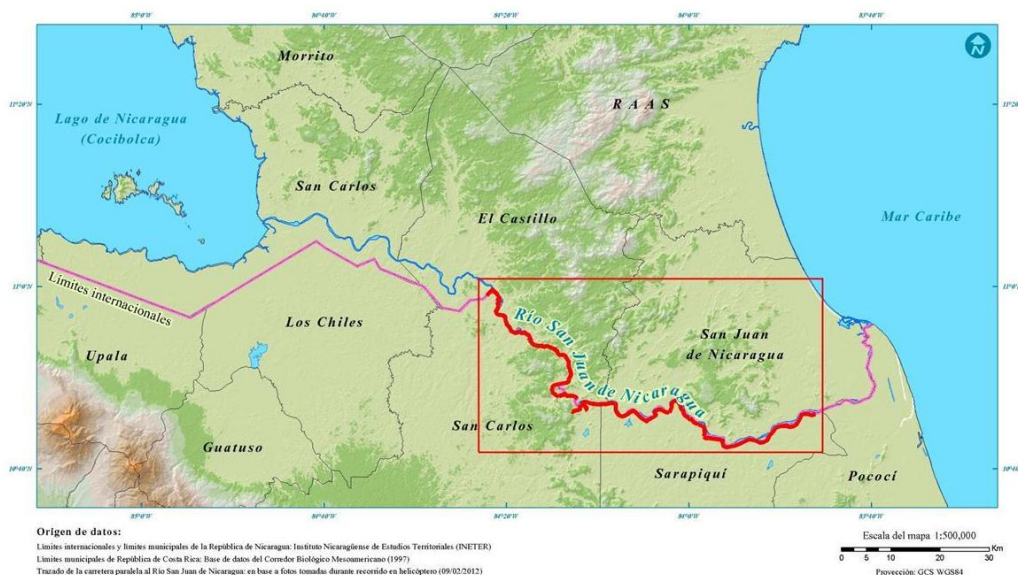
Figure 7: Road layout along the San Juan River’s right bank

1. **Location:** It starts at the Nicaragua-Costa Rica border and lies within the inalienable Nicaragua-Costa Rica Border Corridor National Wildlife Refuge, which extends from Punta Castilla on the Caribbean to Salinas Bay on the Pacific.
2. **Total 160-km Length:** For some 40 km, the road runs parallel to the land border (between Los Chiles and Milestone N° 2), but for the remaining 120 km it hugs the San Juan River’s right banks very tightly until it ends at the delta. Thus, it is disturbing the remnants of moist tropical forests and blocking the drainage of natural bodies of water flowing to the San Juan River from Costa Rica (Figure 7).

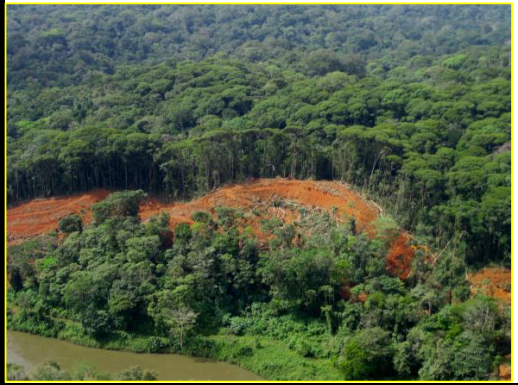
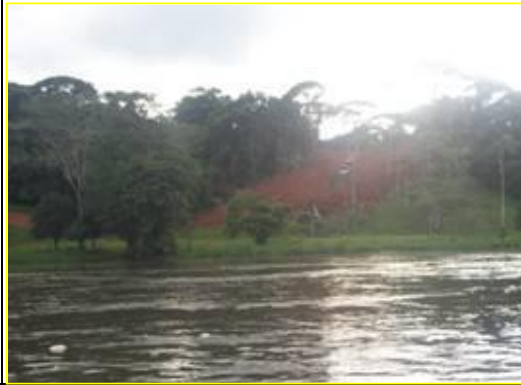
<p>Figure 17: Destruction of gallery forest protecting the right bank of the San Juan River</p>	<p>Figure 18: Sediment disposal site on the right bank of the San Juan River</p>

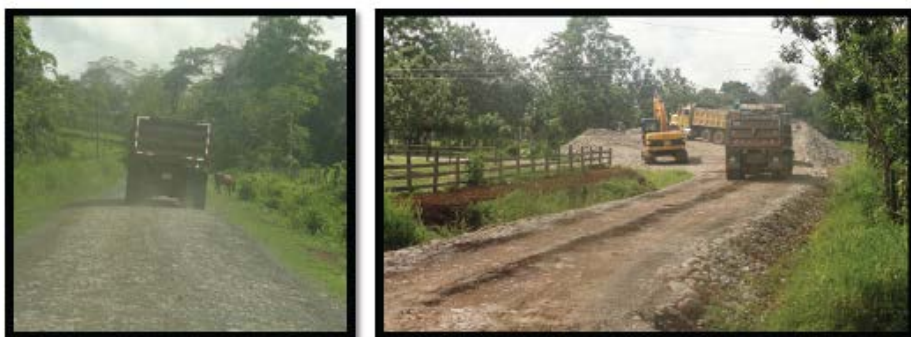
F9. The route is generally in good condition.

F10. Machinery and stored supplies were observed.

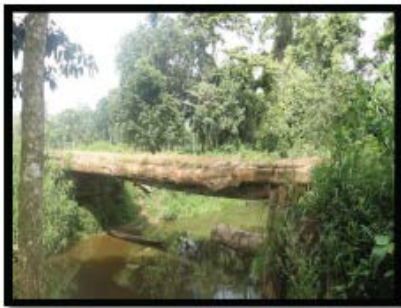
F13. Different bridges on wooden pillars can be observed.

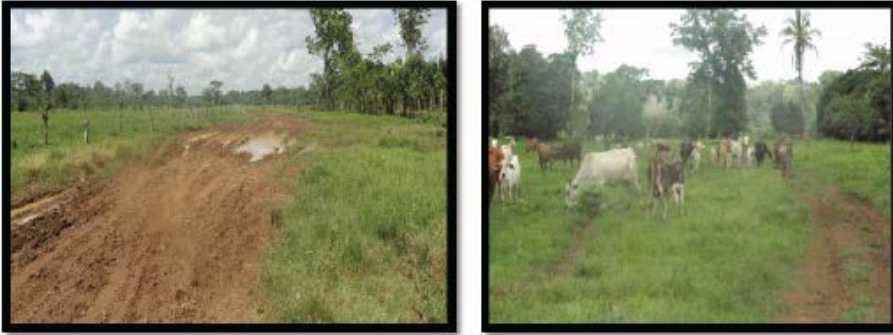
F15. An approximately 10 kilometer stretch which basically consists of paths between lots; transit along this road is very difficult even with 4x4 vehicle.

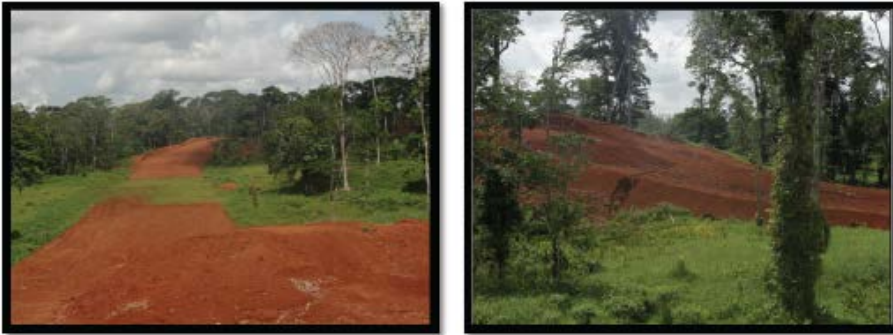
F16. Deforestation and impact on the zone's wetlands are evident.

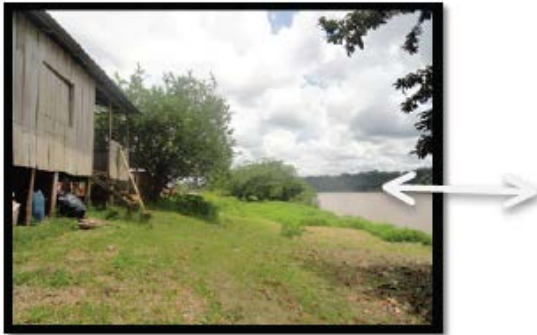
F18. There are stretches of the road where its path is very close to the bank of the Río San Juan, these stretches of the road should be re-evaluated.

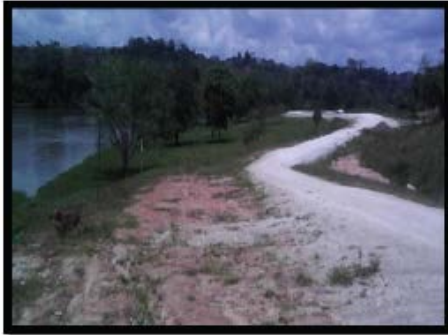
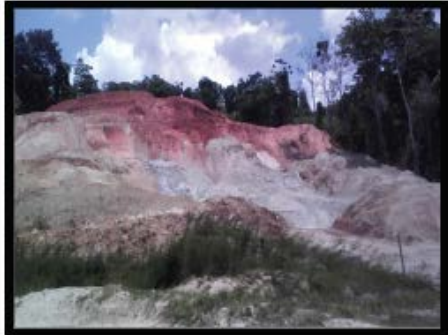
F29. In this area the recess from the Río San Juan is approximately 15 meters.

F30. In this area there is also a trench from which materials were extracted.

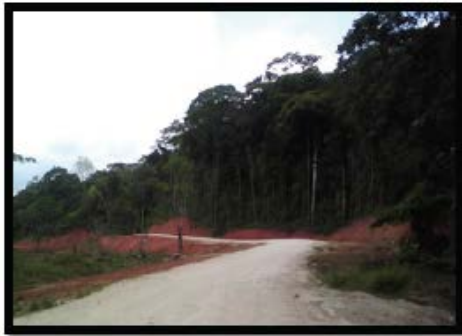
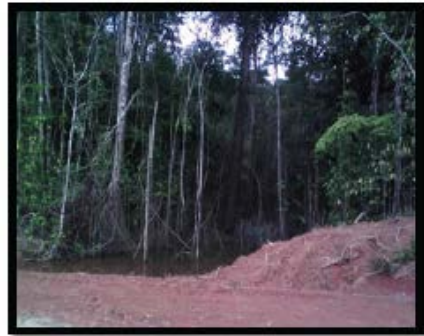
F31. Deforestation in wetlands area.

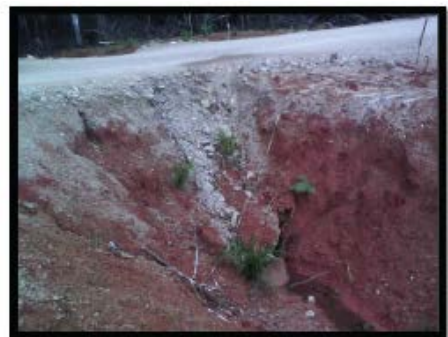
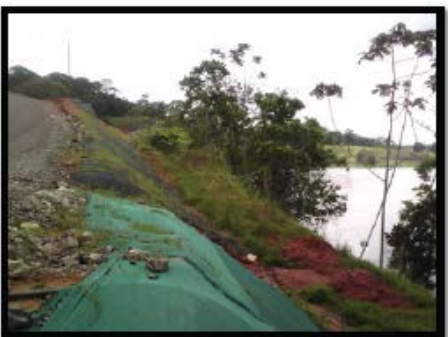
F32. Wooden logs are used to allow for the drainage of water.

F33. Recess from the river in this area should also be evaluated for compliance with the law.

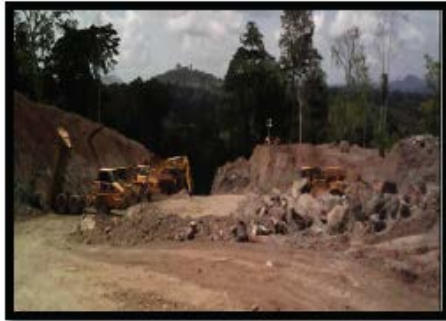
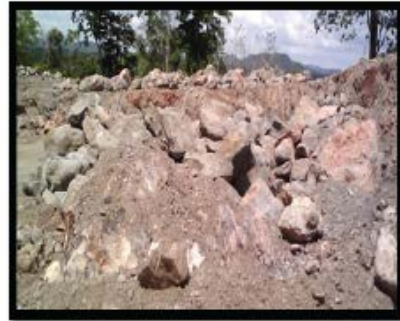
F35. Materials and machinery depot.

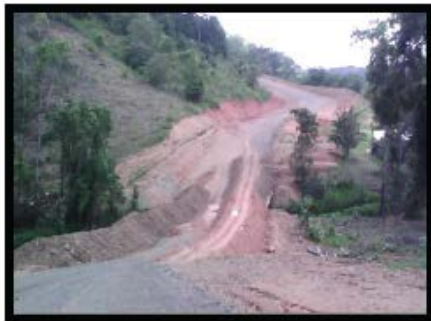
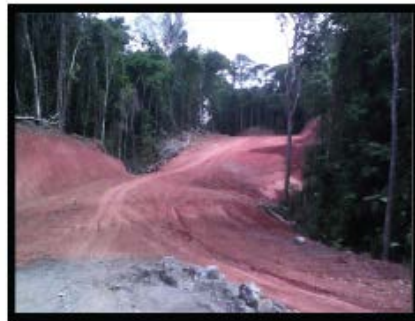
F36. Work in this area is incomplete.

F37. Gravel ends in this area. The dirt road is almost impossible to transit. Impact on the forest is noticeable.

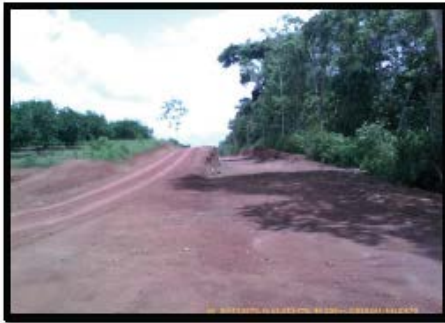
F39. Front-view of a stretch of the road where the earth is uneven.

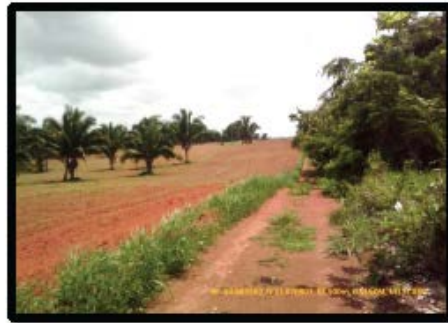
F40. A stretch of the road wide enough for only one vehicle.

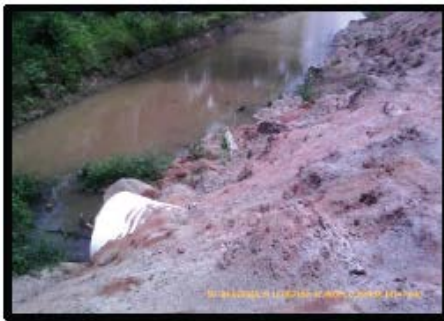
F41. Circular pipe serving as outlet for river water.

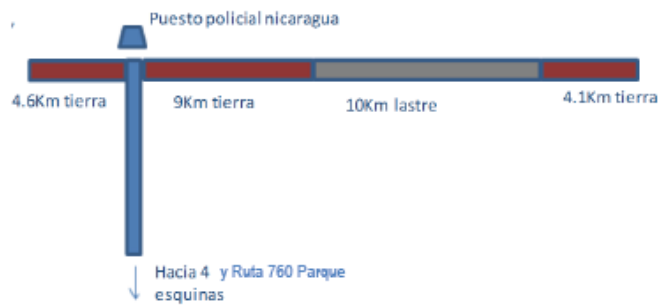
Diagram No. 6. Construction details regarding areas of this stretch that was visited.

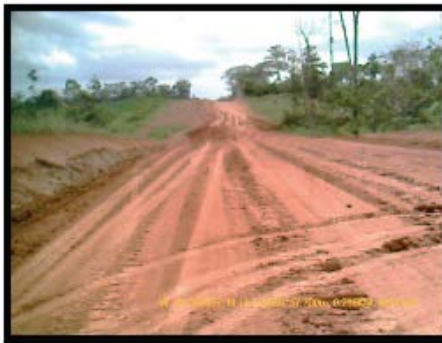
F44. View of a dirt stretch.

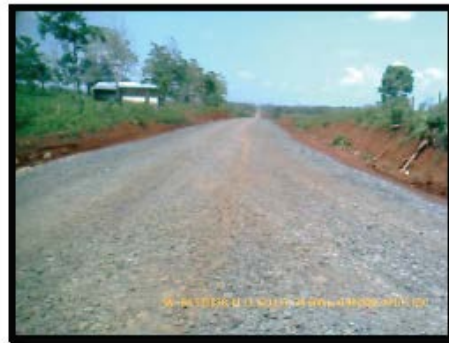
F45. View of a gravel stretch.

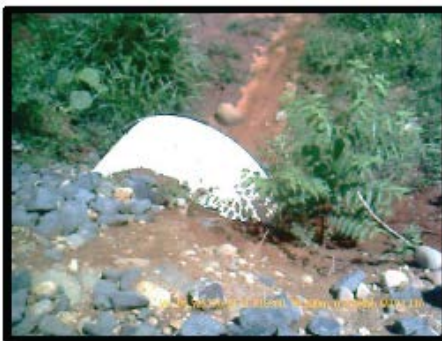
F46. Circular pipes serving as outlets for river water.

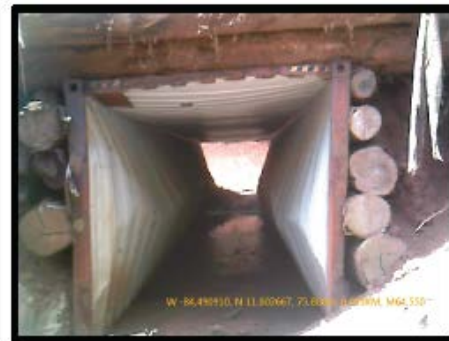
F47. Trailer container used as a bridge.

- 5.4 The lack of adequate drainage for channeling rainwater was observed. It can be foreseen that this situation can prematurely erode the work already done. It should be mentioned that in some areas trailer containers were used for greater drainage in the channeling of brooks. These trailer containers already reflect deterioration and are at risk of collapsing as reflected in the photographs included in this report.

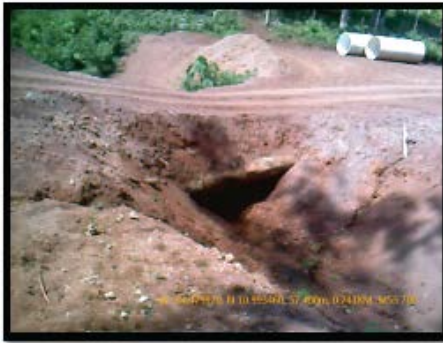
F48. Bridge and waterway with wooden logs.

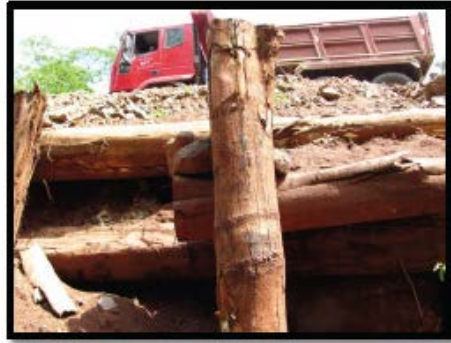
F49. Bridge being used for heavy machinery.

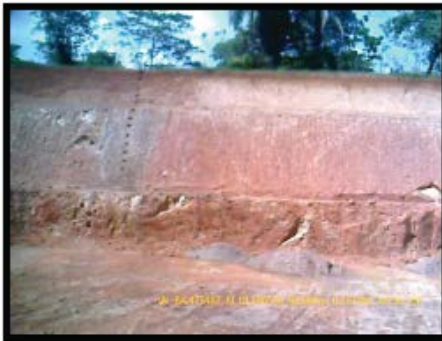
F50. Clearing of slope approximately six meters high.

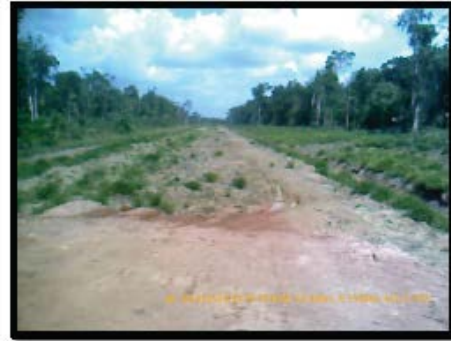
F51. End of the part of the road that can be transited.

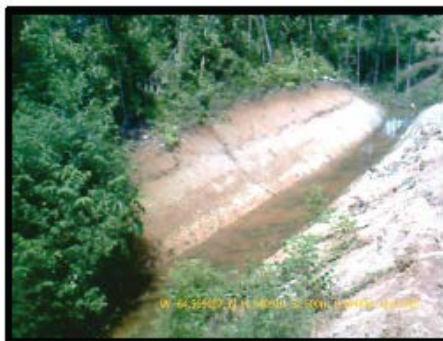
F52. Dirt drainage ditch serving as water outlet.

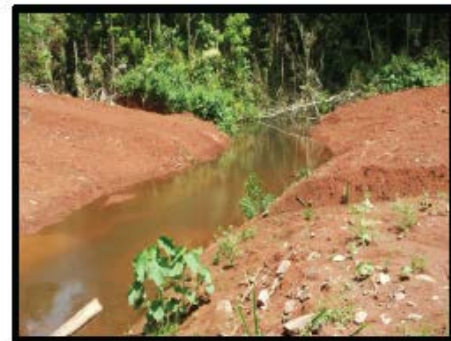
F53. Stagnant water present in some parts.
